September 30, 2011

ISSUED FOR USE  
EBA FILE: W14101068.037

**Subject:** Mill Water Pond – 2011 Annual Review, Minto Mine, YT

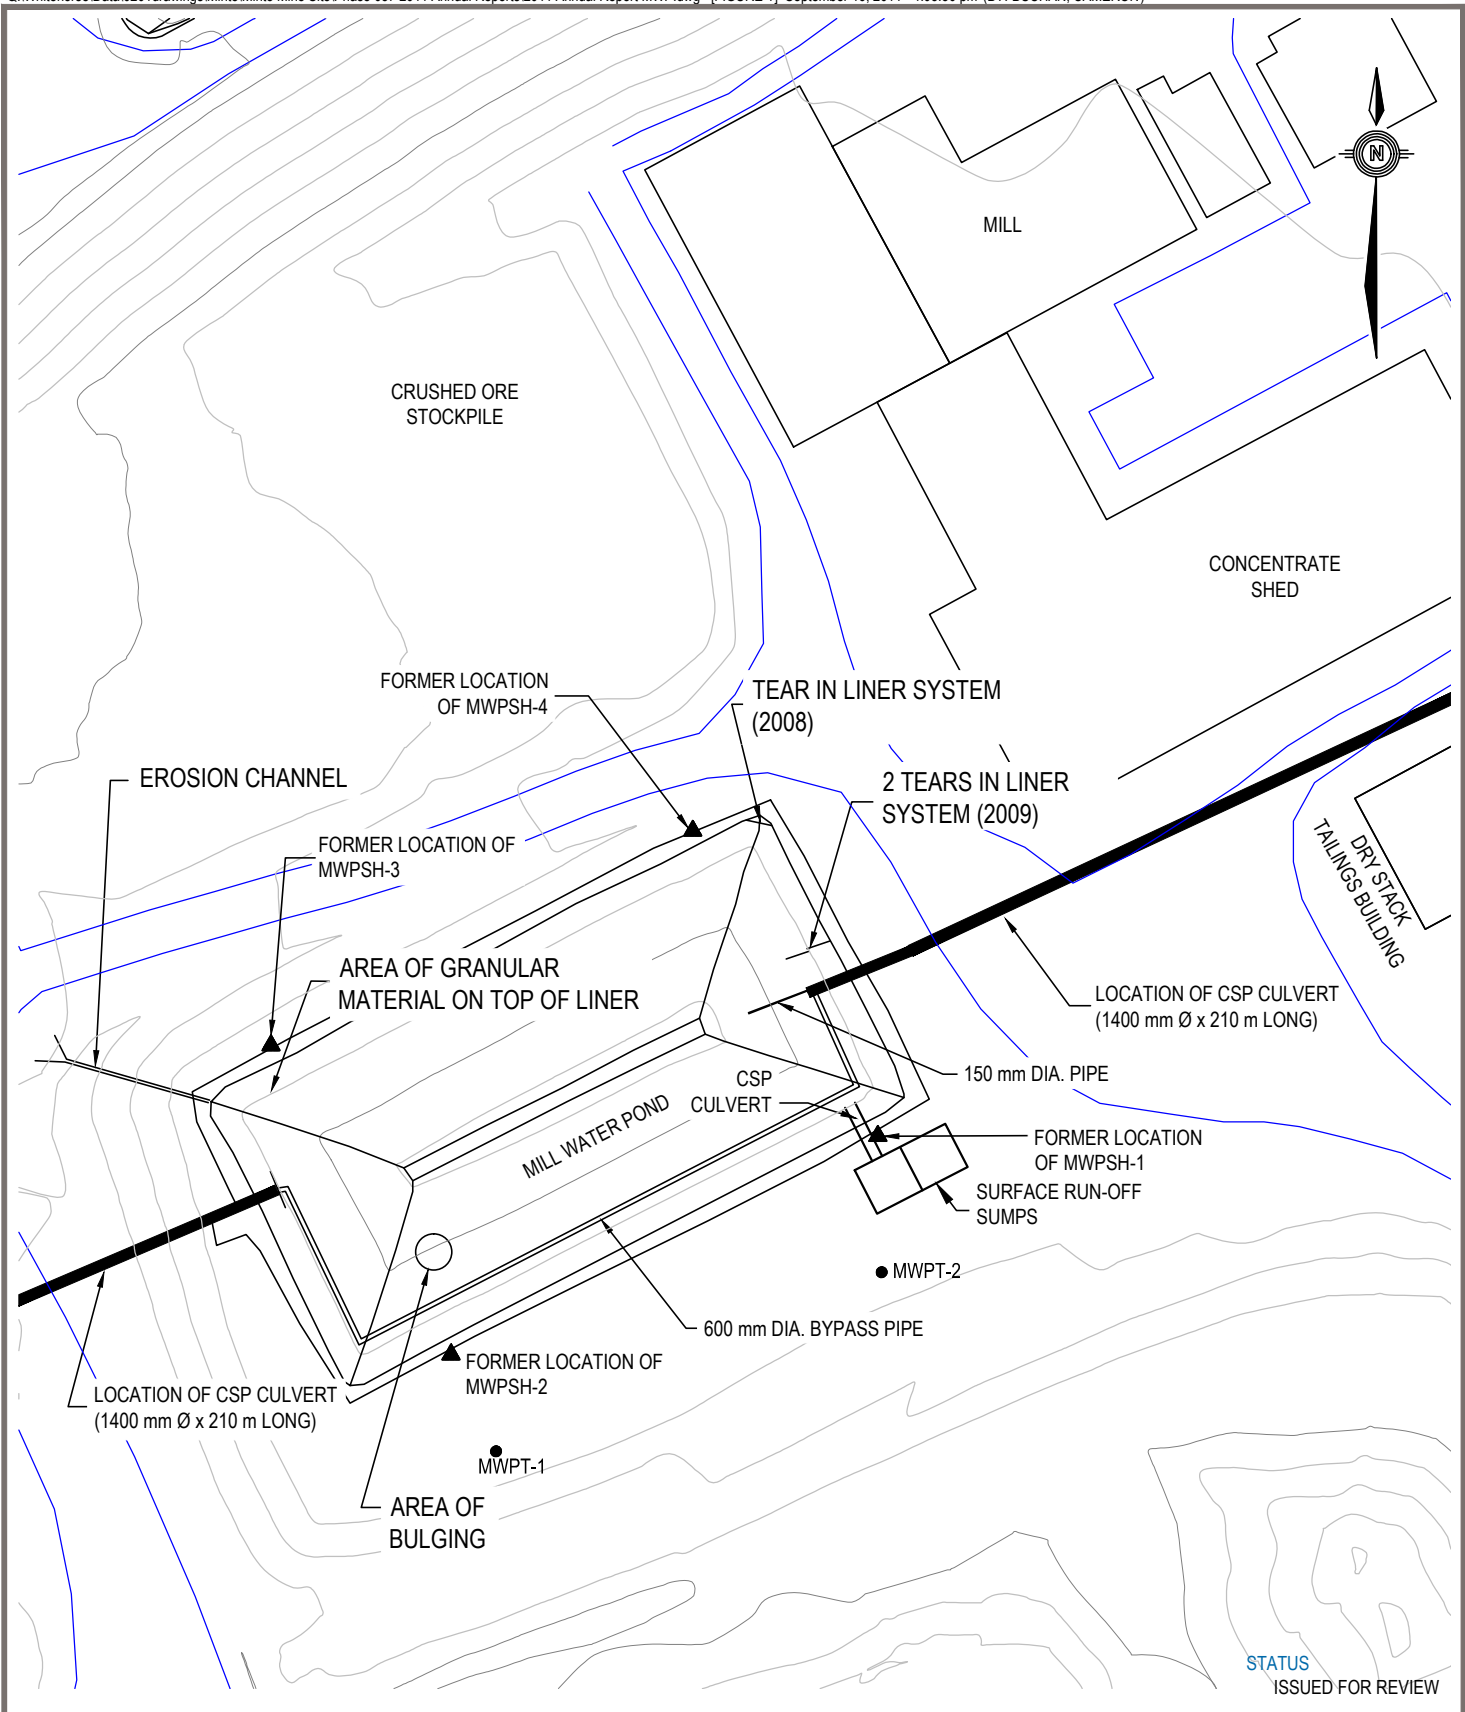
**Figure 1**

- Although difficult to tell because of the water level within the MWP, the slopes of the cell still appear consistent with construction with no signs of slumping or bulging noted with the exception of what appears to be a minor bulge under the liner system in the vicinity of the southwest corner. This bulge is just visible (Photo 2) at the water level elevation at the time of the site visit. The potential bulge noted in the northeast corner during the 2007/2008 review does not appear to have changed over the past few years.

- There was no water flow through the additional culvert installed on top of the berm in the southeast corner which allows the flow of surface runoff from two small settling ponds into the MWP. The two settling pond were full of sediment up to the bottom of the culvert.

Once the water level drops during regular operation, the observed bulge in the vicinity of the southwest corner should be inspected further.

The settling ponds in the southeast corner of the MWP should be cleaned out to allow for collection of the sediment from surface runoff the flows into the MWD.

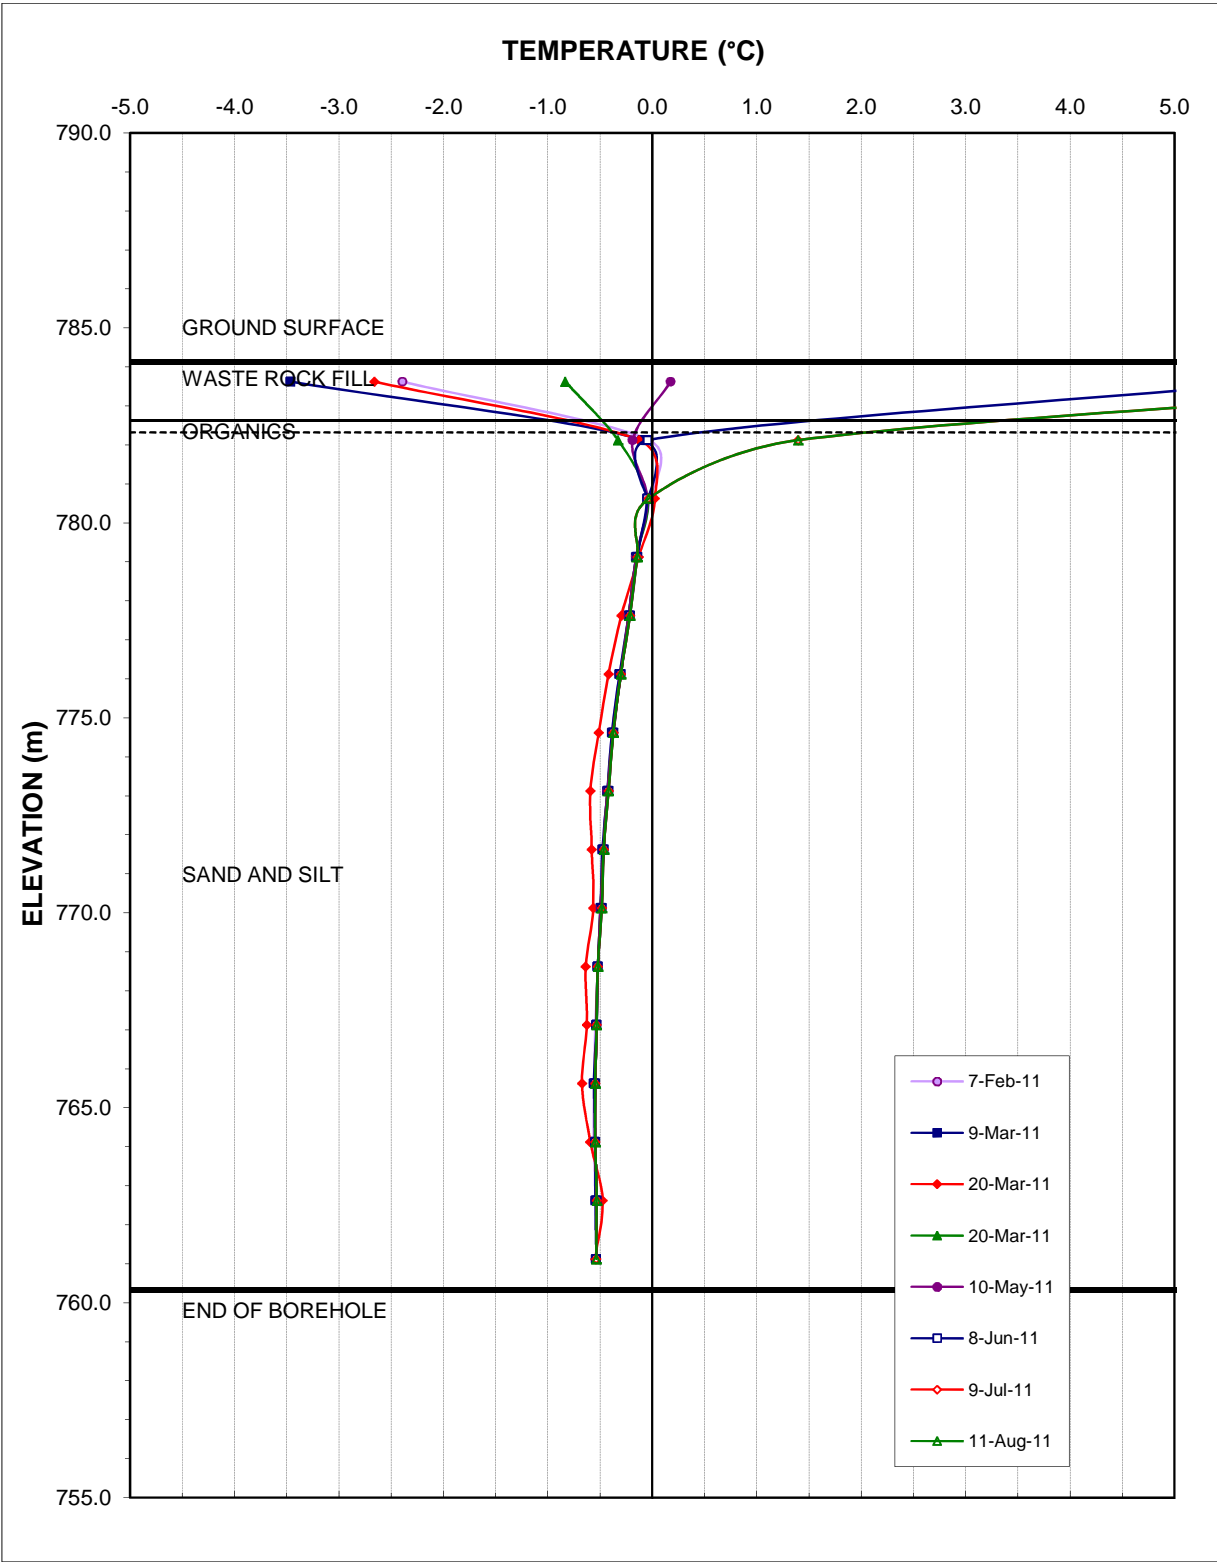
Mill Water Pond  
Ground Temperature Profile - MWPT-1  
Figure T1

Ground temperature profiles from the two ground temperature cable locations are presented in Figures T1 and T2. The two profiles indicate that permafrost in the foundation soils within the vicinity of the pond has been maintained to date. The active layer extended to a depth of 4.3 m in August 2011, this is slightly deeper than the active layer depth noted in September 2010.

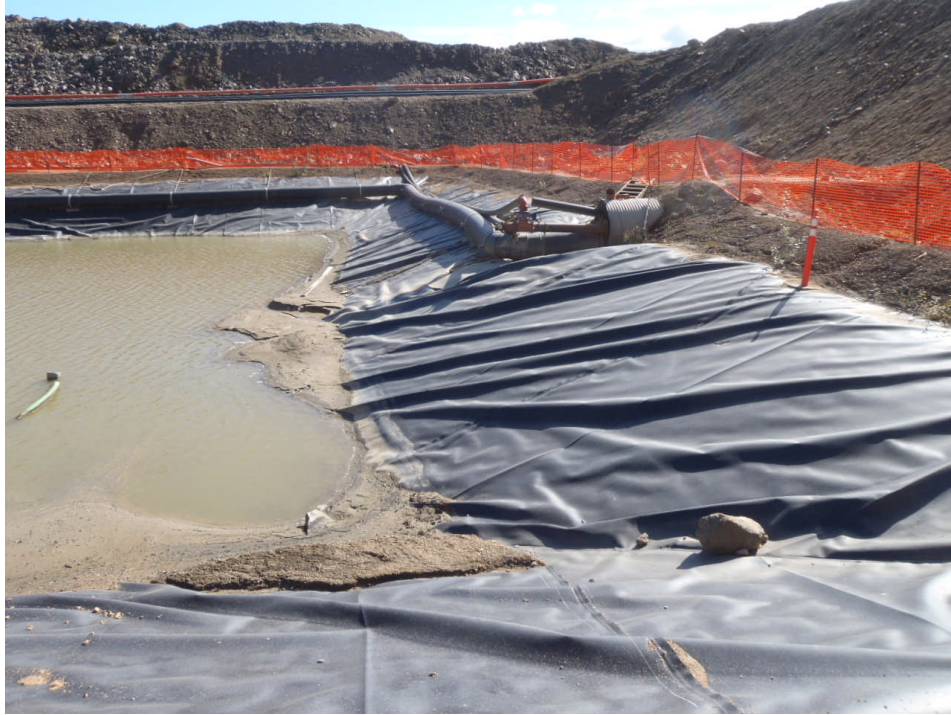
**Photo 1**

- The 600 mm dia. bypass pipe from the inlet culvert across the south slope to the outlet culvert (Photos 1 and 2) installed by Minto in April 2008 is still present. During the site visit, the inlet of this pipe was closed off to back up the water from entering the MWP or bypassing it entirely. Some water was however still entering the pond.
- As mentioned in previous inspection reports the bypass pipe and most of the associated metal clamp supports are still resting directly on portions on the liner.

Looking South along the West side of the MWP at the entry culvert and bypass pipe. (August 25, 2011)

As previously stated in the 2010 review it is recommended that Minto personnel monitor the components of the installed bypass pipe system and miscellaneous piping to ensure they do not cause any negative effects on the MWP or its liner system. If the bypass pipe is not to be used in the future it should be removed from the system. If the bypass pipe is used in the future, this could result in wearing a hole in the liner.

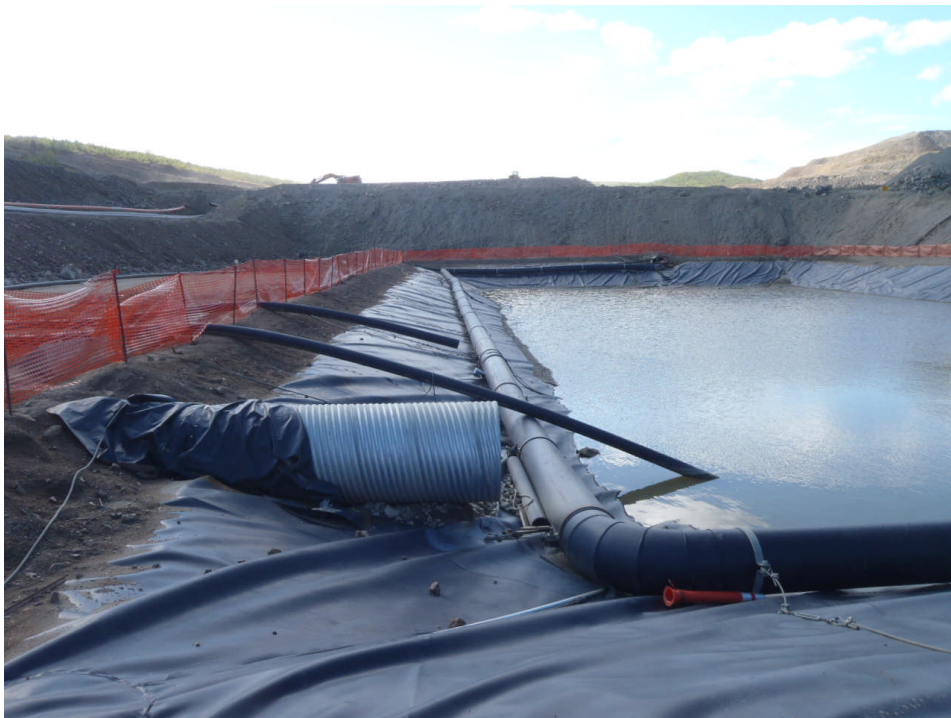
**Photo 2**

Looking West along the South side of the Mill Water Pond at the bypass pipe. (August 25, 2011)

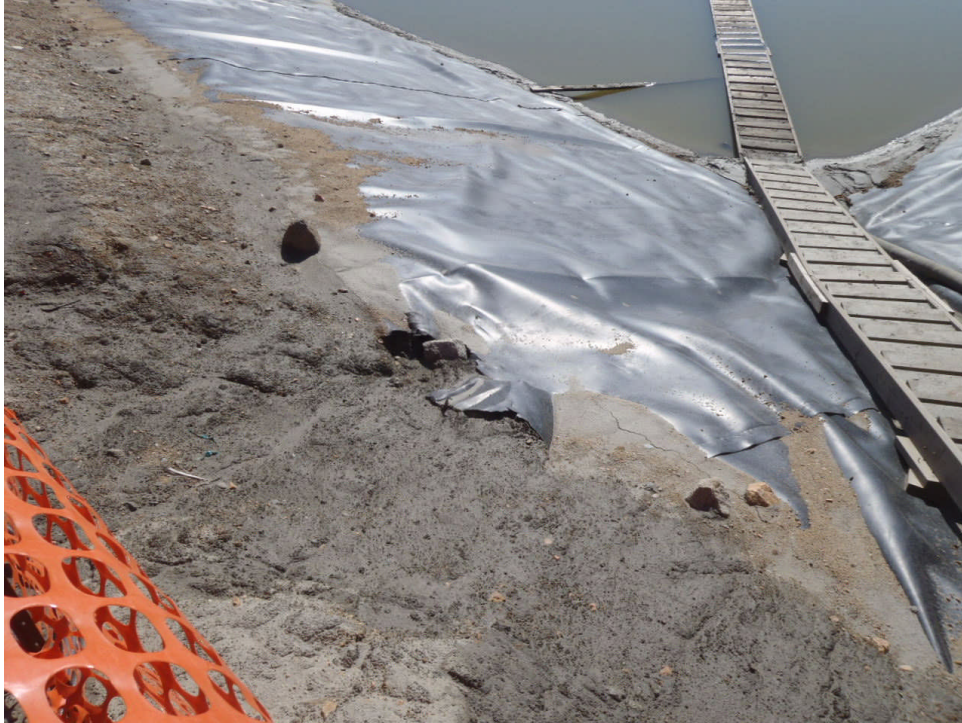
**Photo 3**

- The tear in the liner system, roughly 1 m in length, at the crest of the berm in the northeast corner noted since the 2007/2008 review is still present (Photo 3).

Tear in the liner system in Northeast corner of MWP. (August 25, 2011)

The tear in the liner system in the northeast corner is near the crest of the slope and has minimal effect on the normal operation of the MWP. However, a patch should be installed when a qualified installer is on site to maintain the integrity of the liner. Deterioration of the subgrade material beneath the tear location has increased; therefore, additional fill will be required to support the liner patches. In the interim, pieces of liner should be placed over the tears, anchored at the crest and partially covered to reduce water infiltration into the base of the liner system.

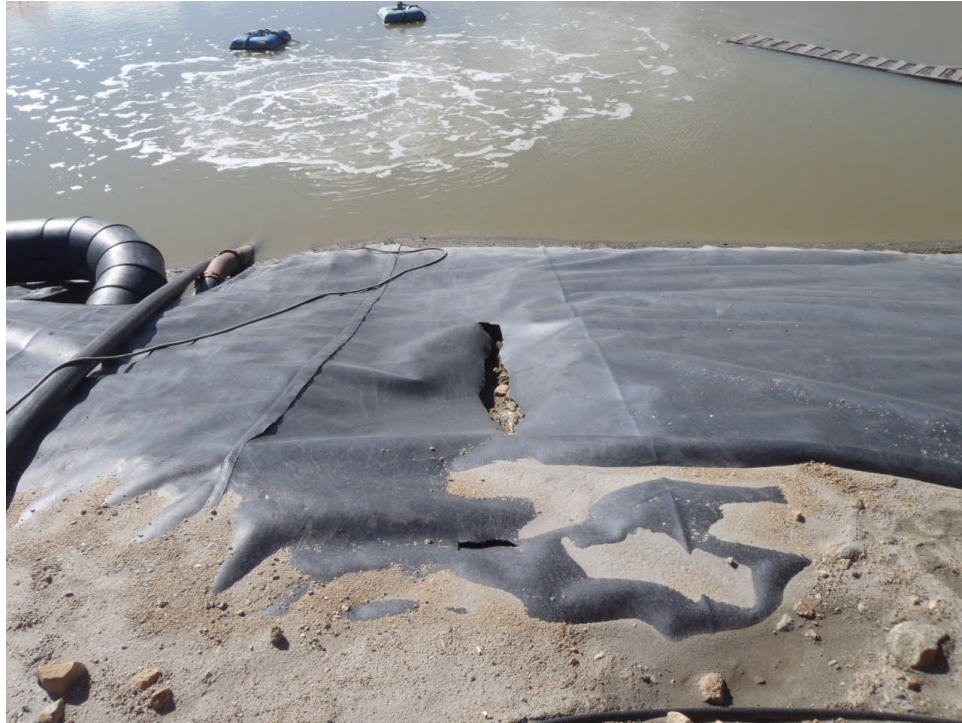
**Photo 4**

- There are two tears, the large tear roughly 1.5 m in length, is in the liner system north of the outlet culvert on the east side (Photo 4). During every inspection EBA has noted that the void beneath the larger tear is increasing in size due to water penetration from the surface.

Two tears in liner system near the MWP discharge culvert. (August 25, 2011)

The two tears in the liner system along the east sideslope is above the outlet culvert and will therefore not effect the normal operation of the pond. As shown on Photo 4, deterioration of the subgrade material beneath the tear locations has increased; therefore, it is recommend that additional subgrade material be placed beneath the liner and the liner patched as soon as possible. The subgrade material should be inspected prior to placement of the liner patches as additional fill will be required to support the liner. In the interim, a piece of liner should be placed over the tear and anchored to the MWP crest to reduce any water infiltration into the base of the liner system.
