ISSUED FOR USE  
EBA FILE: W14101068.037

**Subject:** South Diversion Ditch – 2011 Annual Review, Minto Mine, YT

As requested, this letter presents a report by EBA Engineering Consultants Ltd. (EBA) resulting from a site visit completed to examine the current condition of the South Diversion Ditch at Minto Mine, YT. The intent of the inspection was to provide a geotechnical engineering report on the condition of the ditch, in partial fulfillment of the requirements of the existing Quartz Mining Licence QML-0001.

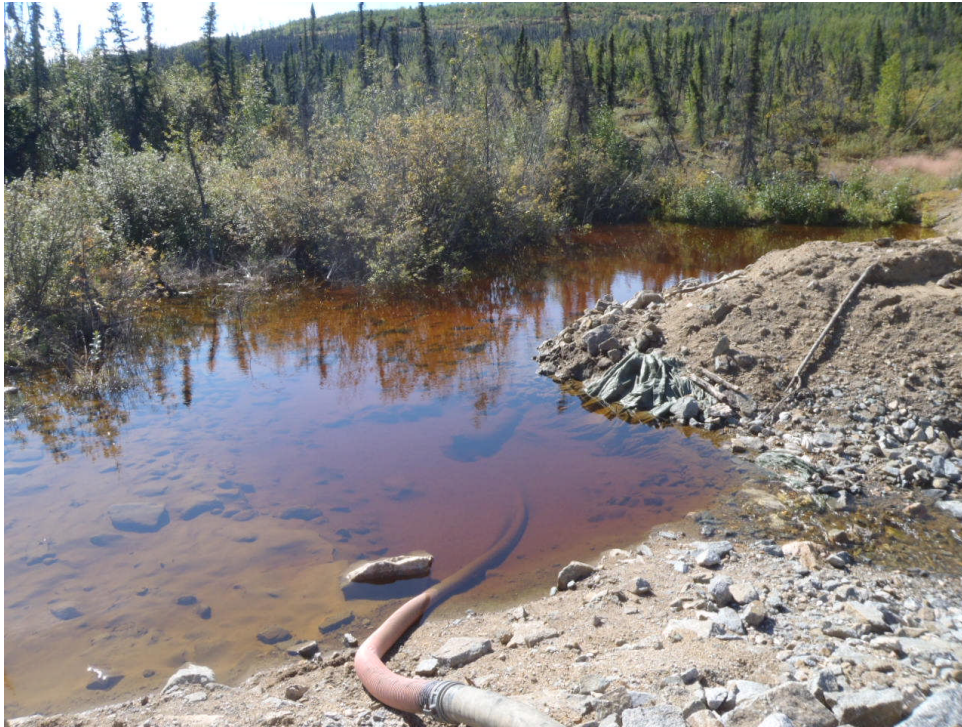
- Ponded water is still present at the inlet of the ditch, STA 0+957 (Photo 1). This is caused by a partially removed temporary drop structure that was constructed off and on since 2008 to provide a water source during exploration drilling programs.

**Photo 1**  
Ponded water at the inlet end of ditch. (August 25, 2011)

It is recommended that the temporary structures be removed from the ditch section when not required as they will collect and deposit fines in the ditch bottom.

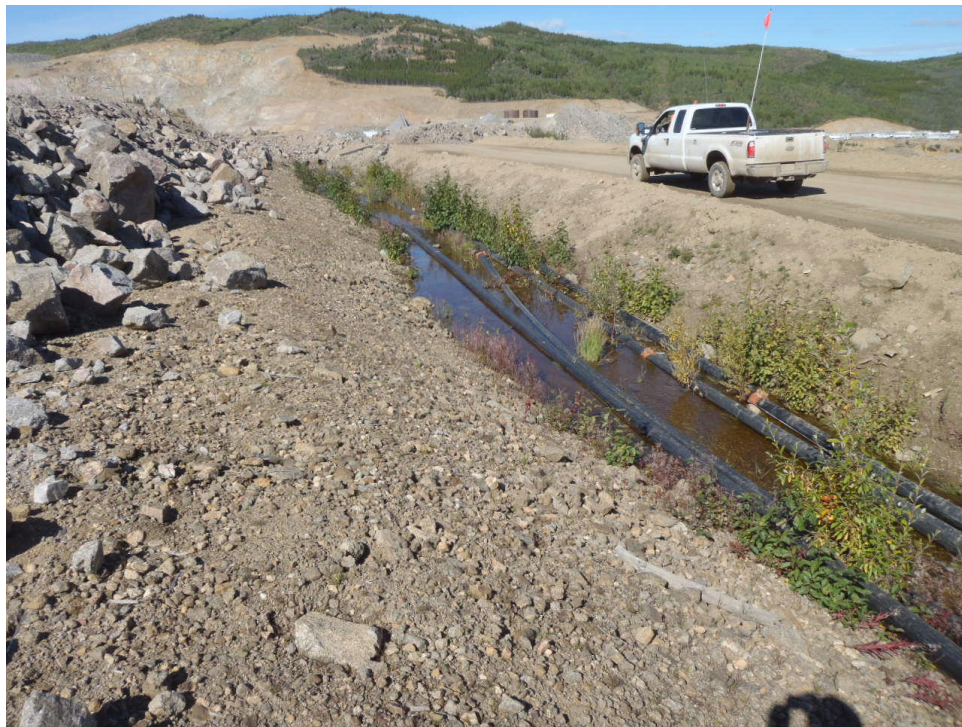
- There was evidence of ditch and berm settlement between STA 0+600 and STA 0+650 (Photo 2).
- Small tension cracks are present along the crest of the west side of the ditch in the location of the top of the liner system. These are consistent with those noted in 2008, 2009 and Spring 2010.

**Photo 2**  
Area of settlement between STA 0+600 and STA 0+650. (August 25, 2011)

No action is required for the minor slope instabilities noted, which are limited to tension cracks at this time.

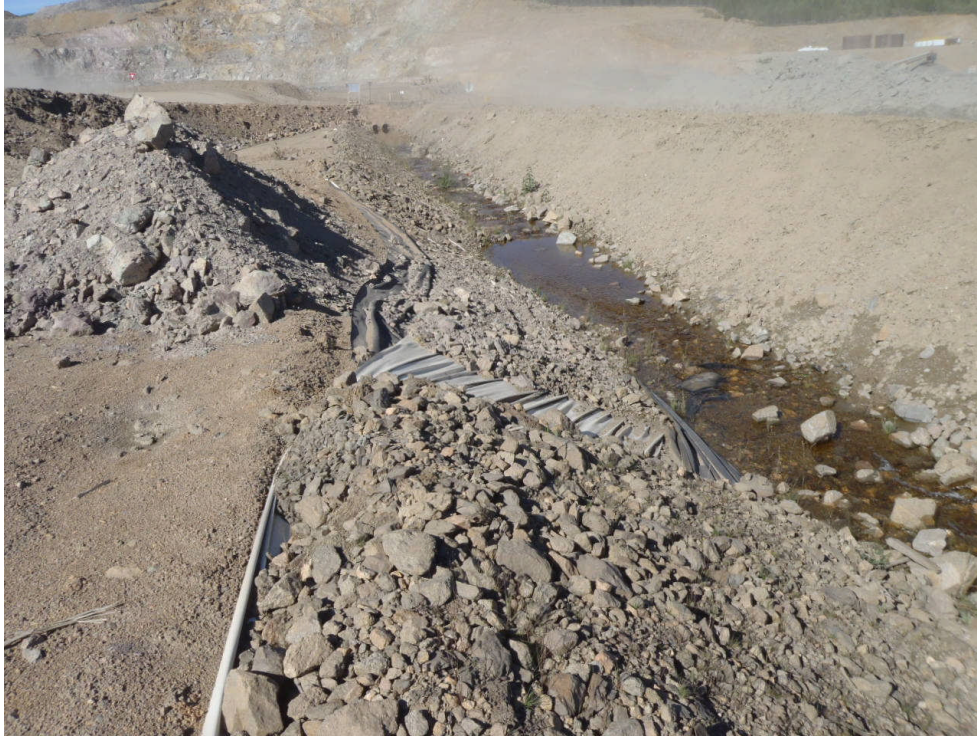
**Photo 3**

- The construction material appears to have remained in place and has not been affected by the water flow to date.
- The section of sideslope around STA 0+300 (Photo 4) still remains without rip rap cover. It appears that the material has been removed as there is stockpiled material adjacent to the ditch.

Section of ditch requiring riprap placement at STA 0+300. (August 25, 2011)

The rip rap material removed from the west slope at STA 0+300 should be replaced.

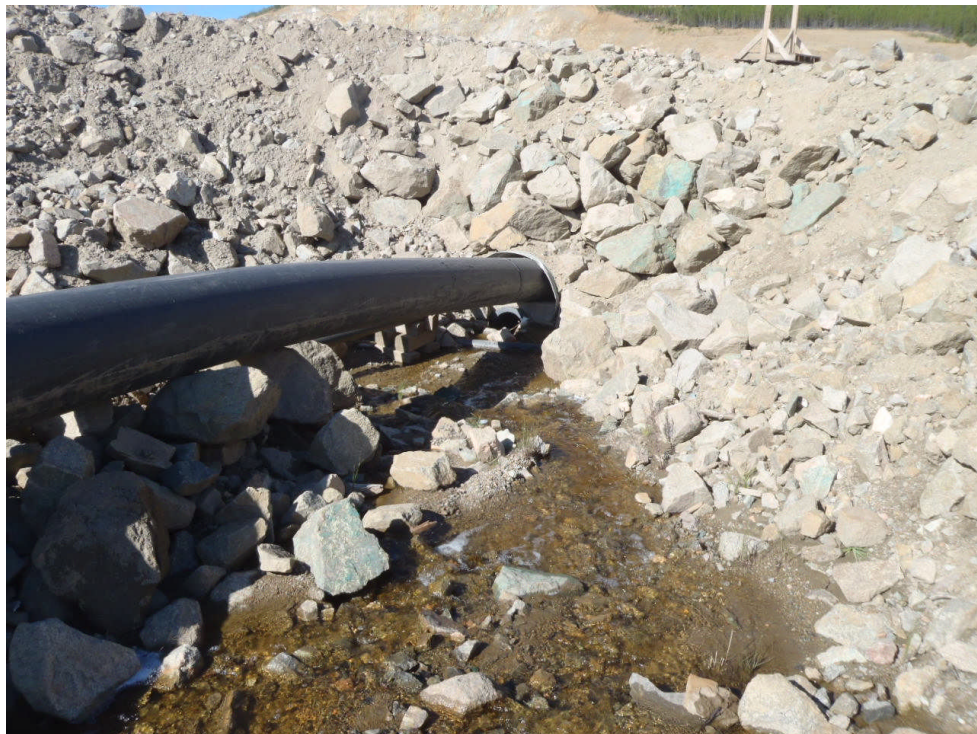
**Photo 4**

- The segment between STA 0+180 and the haul road culvert inlet at STA 0+110 appears to have been constructed with rip rap material and constructed to the rough dimensions of the upper portion.
- The surface water diversion pipelines were installed in Spring of 2010 at the STA 0+110 access road culvert inlet and outlet to allow for diversion to the Open Pit or the Water Retention Pond. The new 600 mm diameter HDPE pipe (Photo 5) receives the water flow from the South Diversion Ditch.

Surface water directed into water diversion system. (August 25, 2011)
