October 5, 2011

ISSUED FOR USE  
EBA FILE: W14101068.037

**Subject:** Water Storage Pond Dam – 2011 Physical Observation Report  
Minto Mine, YT

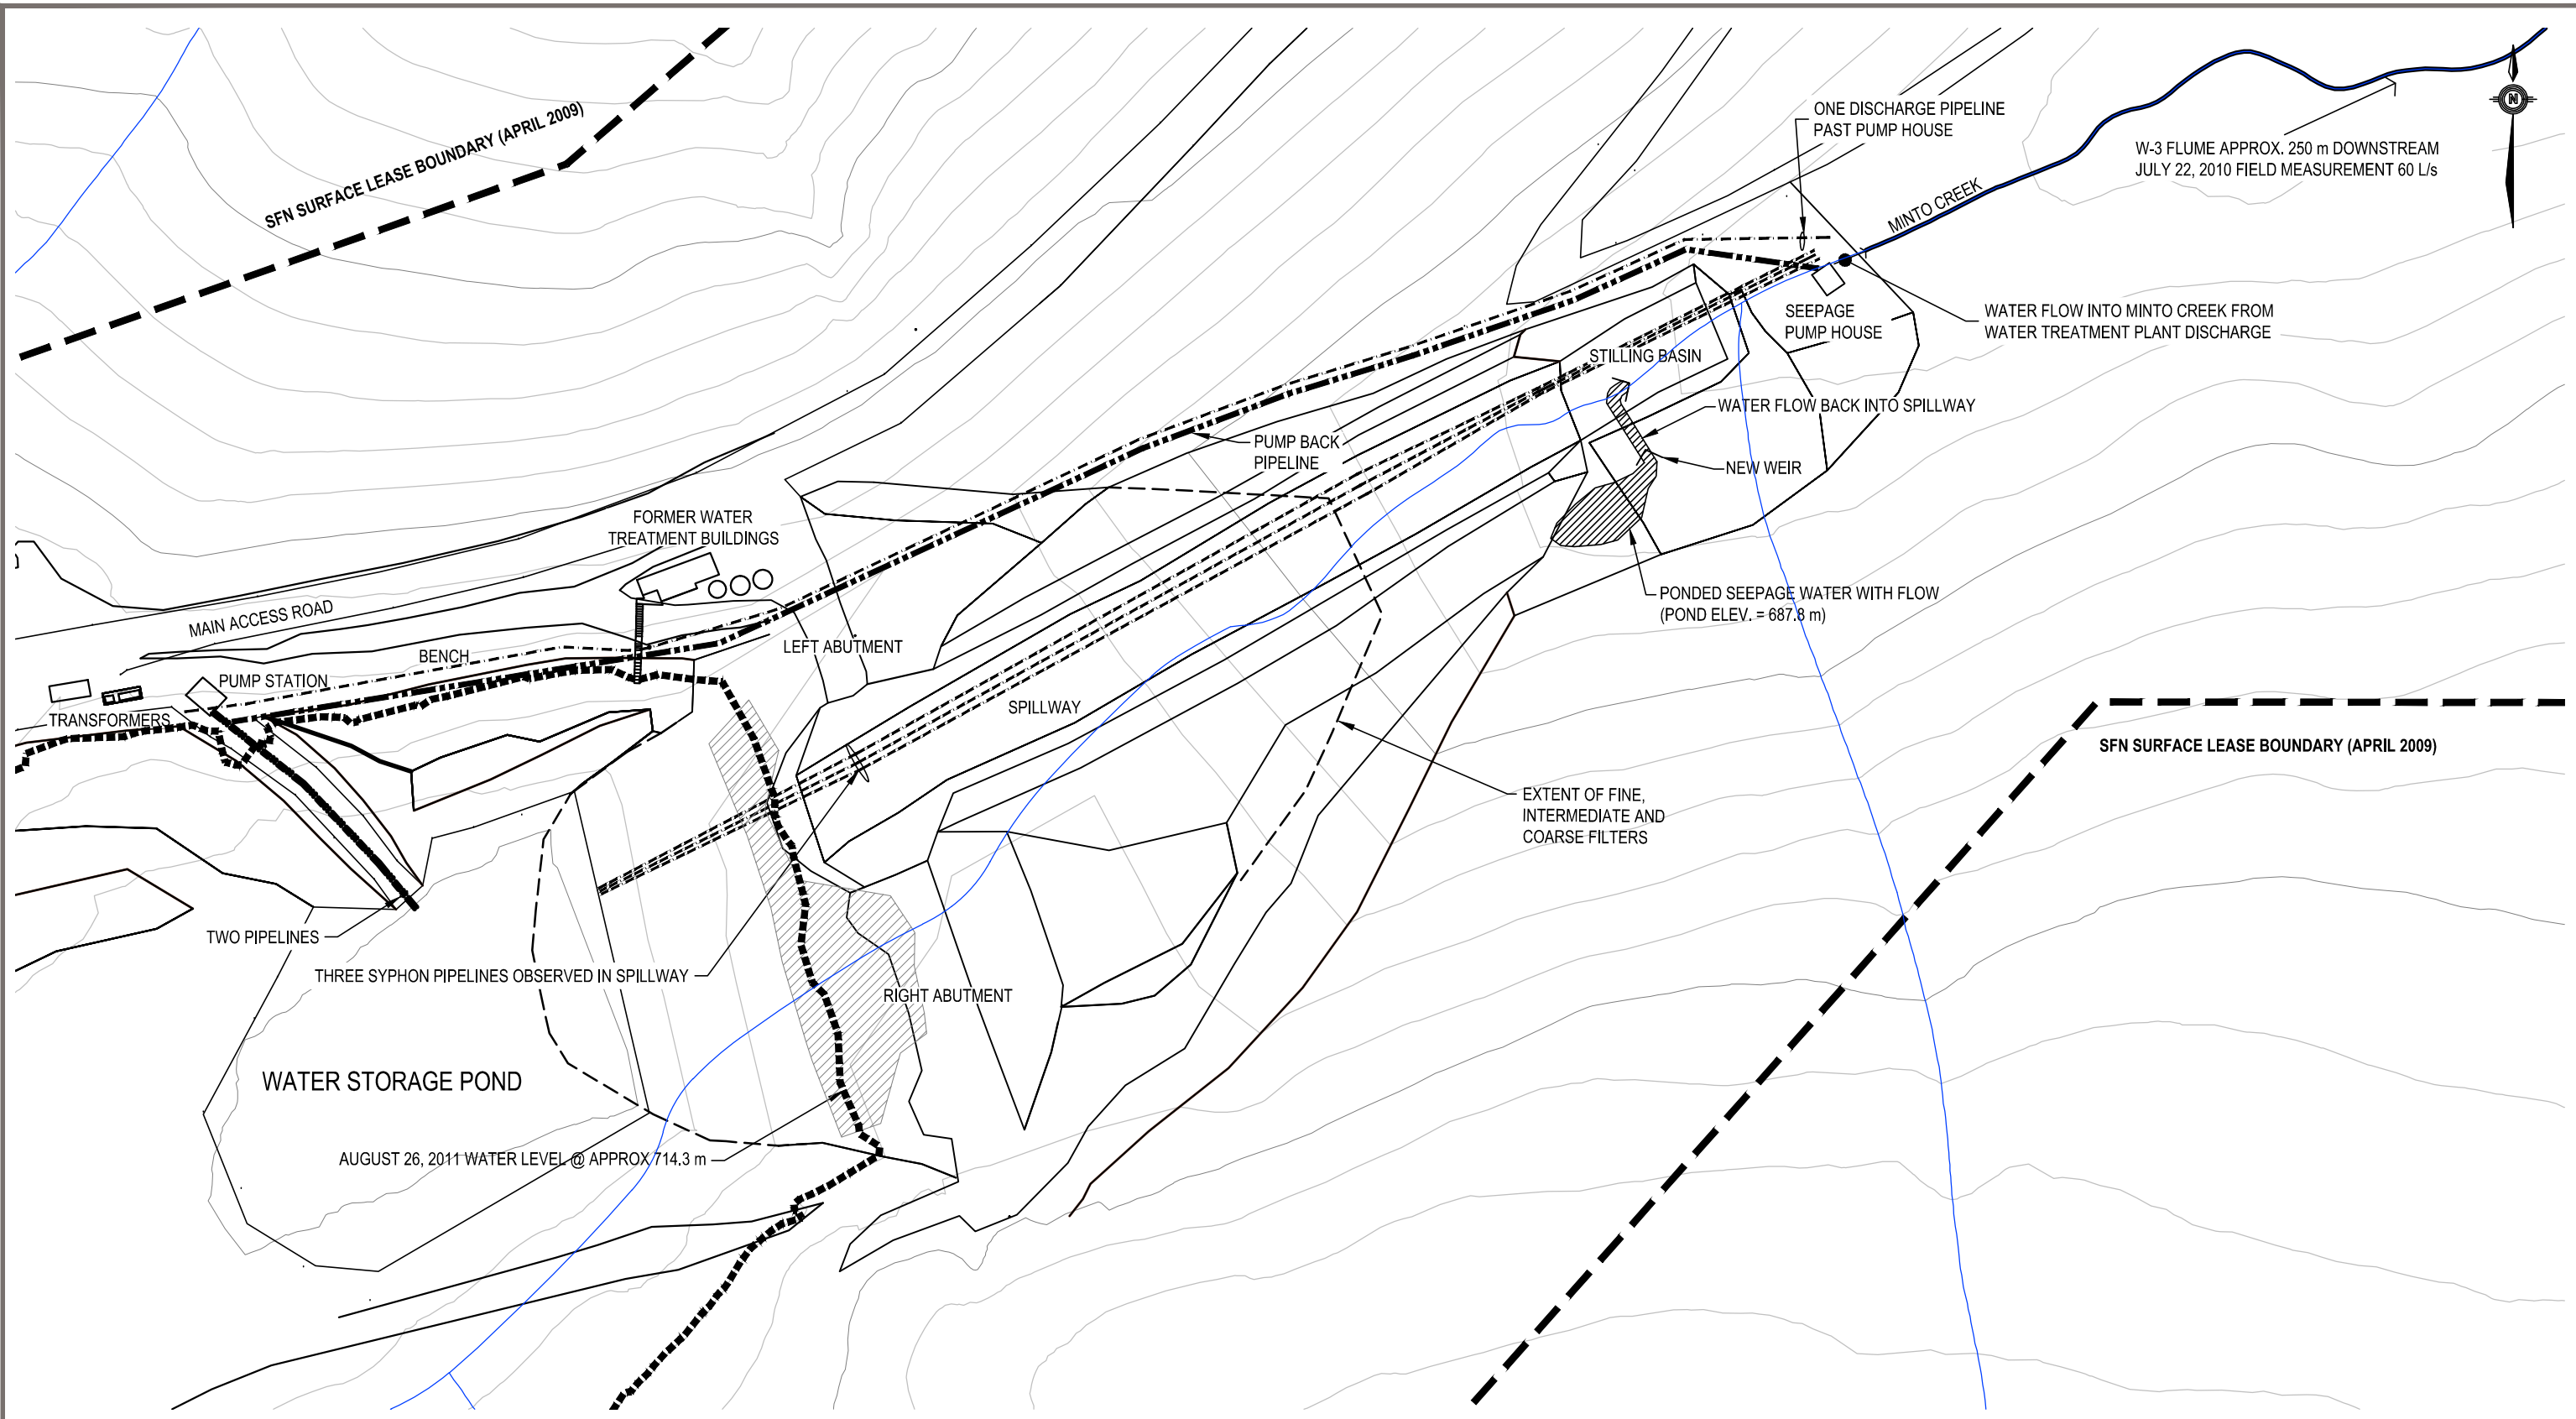
Figure I      Site Plan

- The left upstream abutment at the general fill soil/Zone 1 fill contact did not show any signs of settlement or movement. The general fill soil was used in the construction of the pad for the water treatment buildings and does not form a part of the actual dam. A minor erosion channel was noted in the general fill in this area that resulted from surface water flow from the main access road as noted in Figure 1. This erosion channel does not affect the actual Zone 1 dam fill.

- The right downstream abutment at the natural soil and rock fill contact appears consistent with original construction and did not show any signs of instability. As noted in the 2008, 2009 and 2010 inspection reports, ponded seepage water was observed southwest of the spillway as depicted in Figure 1 and Photo 6. This water flows back into the spillway as presented in Figure 1. Water flow could not be heard within the spillway north of the ponded water.

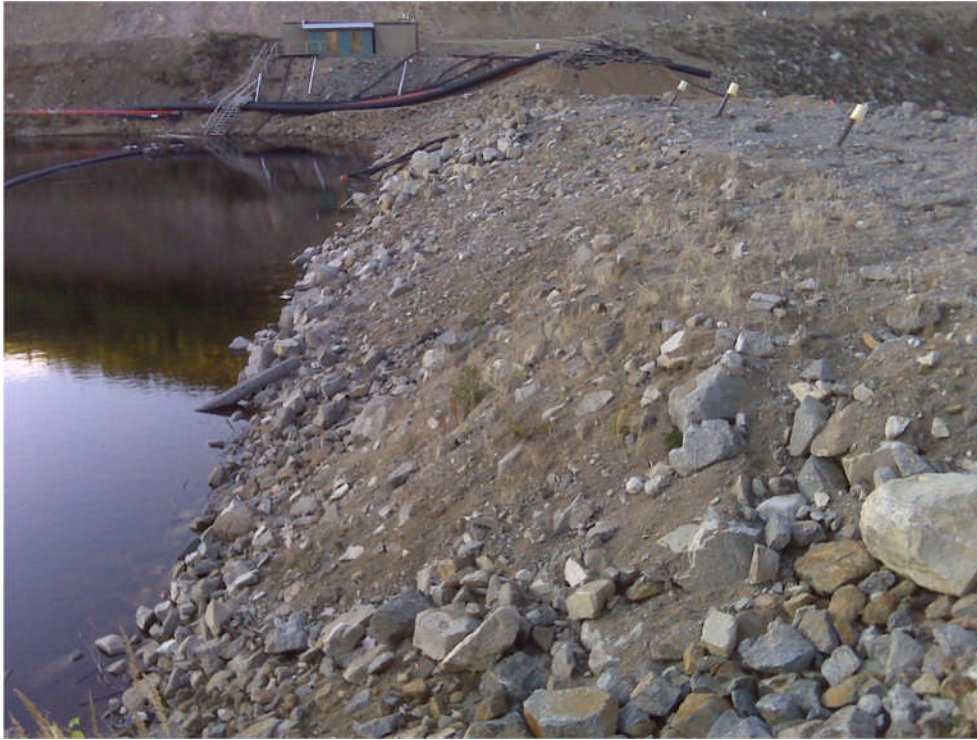
**Photo 1**

- The upstream sideslope of the dam appears consistent with original construction and does not show any signs of instability (settlement, bulging or slumping). Photo 1 shows the extent of the visible upstream sideslope.

Upstream slope of the WSP dam. (August 26, 2011)

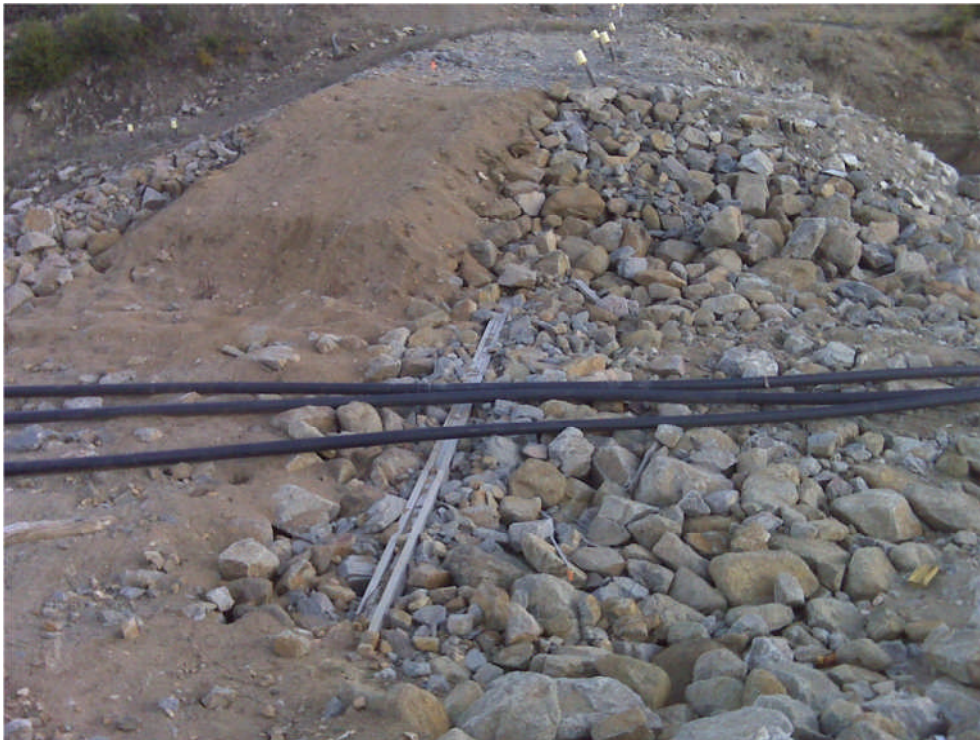
**Photo 2**

- The crest of the dam was relatively level with coarse rock fill and some Zone 1 fill material at the surface as shown in Photo 2. Localized depressions or evidence of settlement were not observed. Any unevenness observed was attributed to drill pad and access road construction for instrumentation installations that were completed in November 2007. Three 200 mm diameter siphon pipelines are present in the spillway and run its entire length to the seepage pump house.

Crest of the WSP dam. (August 26, 2011)

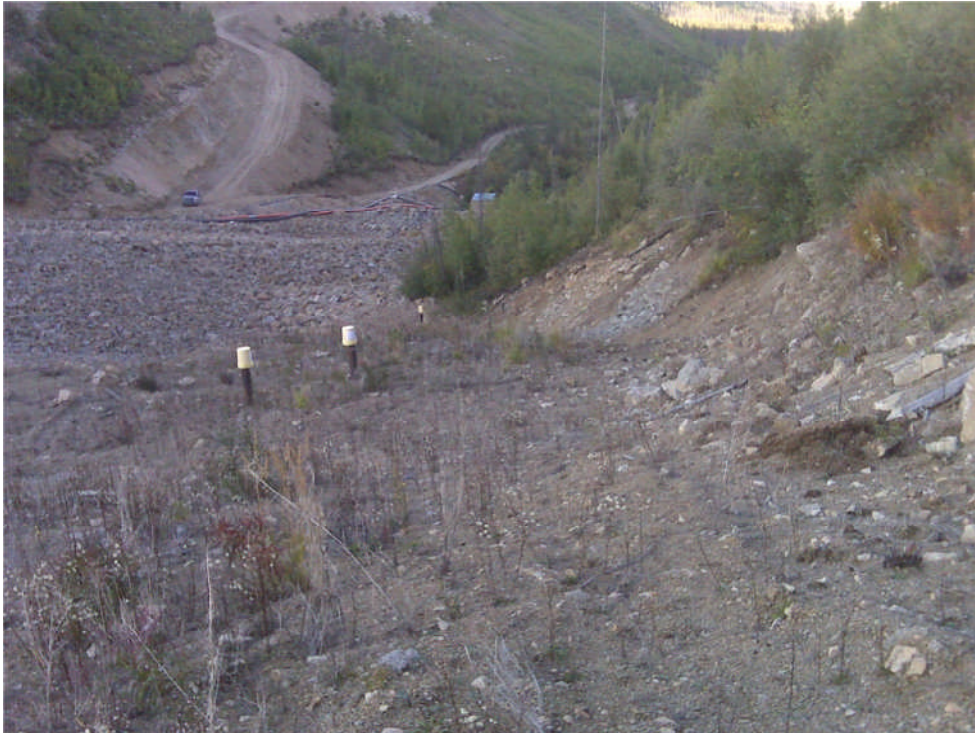
**Photo 3**

- The downstream sideslope of the dam including the spillway appears consistent with original construction and did not show any signs of instability (settlement, bulging or slumping). Photos 3, 4 and 5 show the downstream sideslope of the dam, including the left and right abutments and the spillway.

Looking at the right downstream slope. (August 26, 2011)

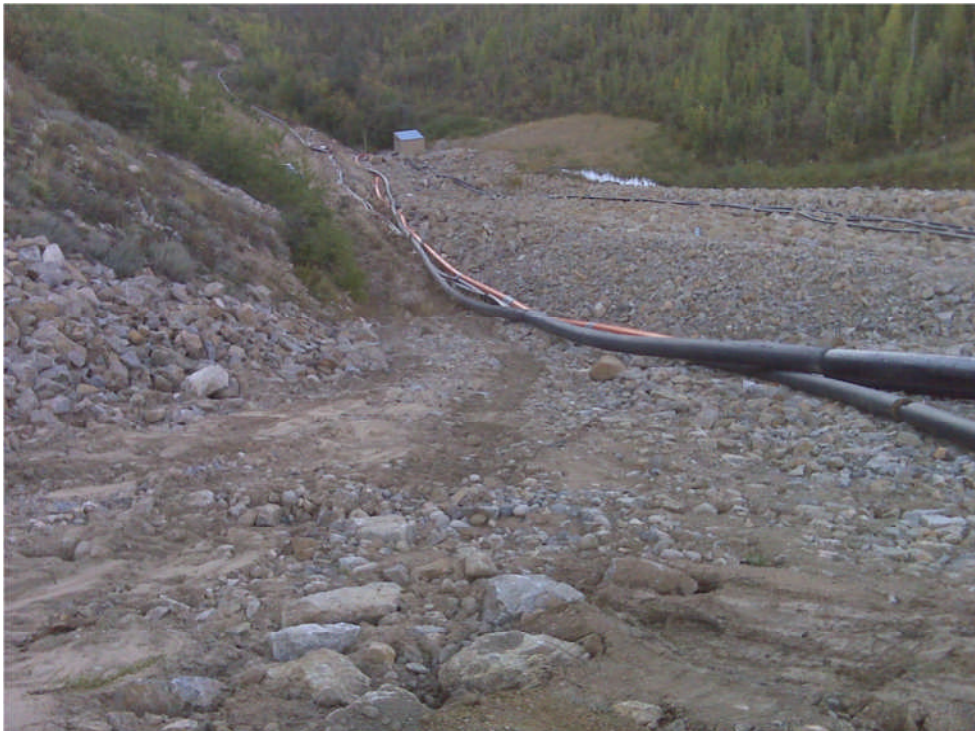
**Photo 4**

Looking at the left downstream slope. (August 26, 2011)

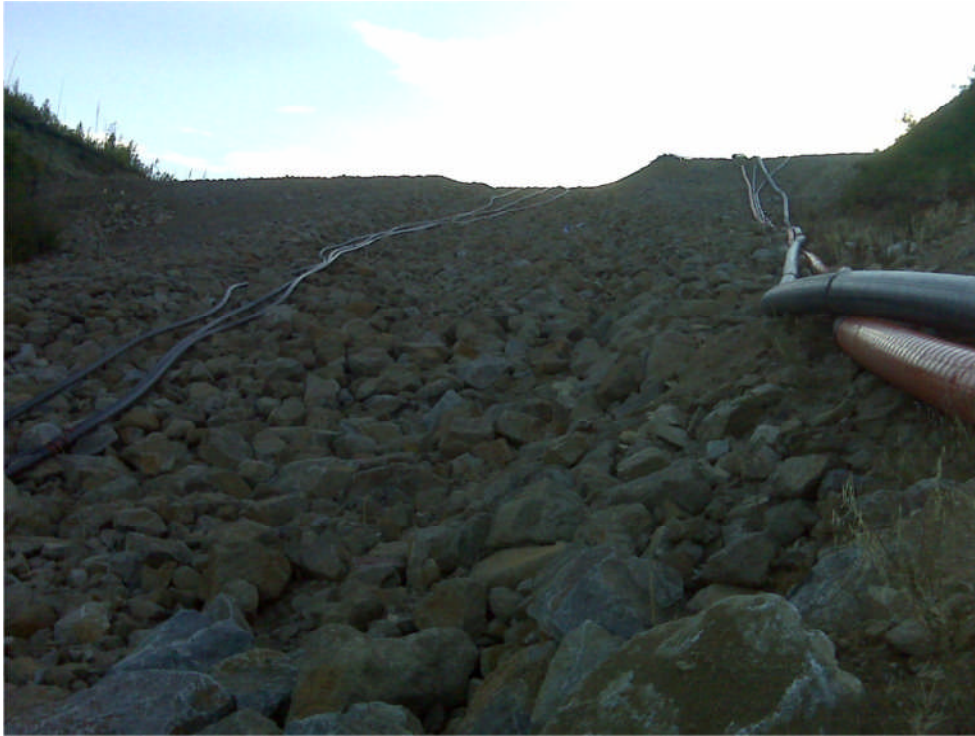
**Photo 5**

Looking up at the spillway. (August 26, 2011)

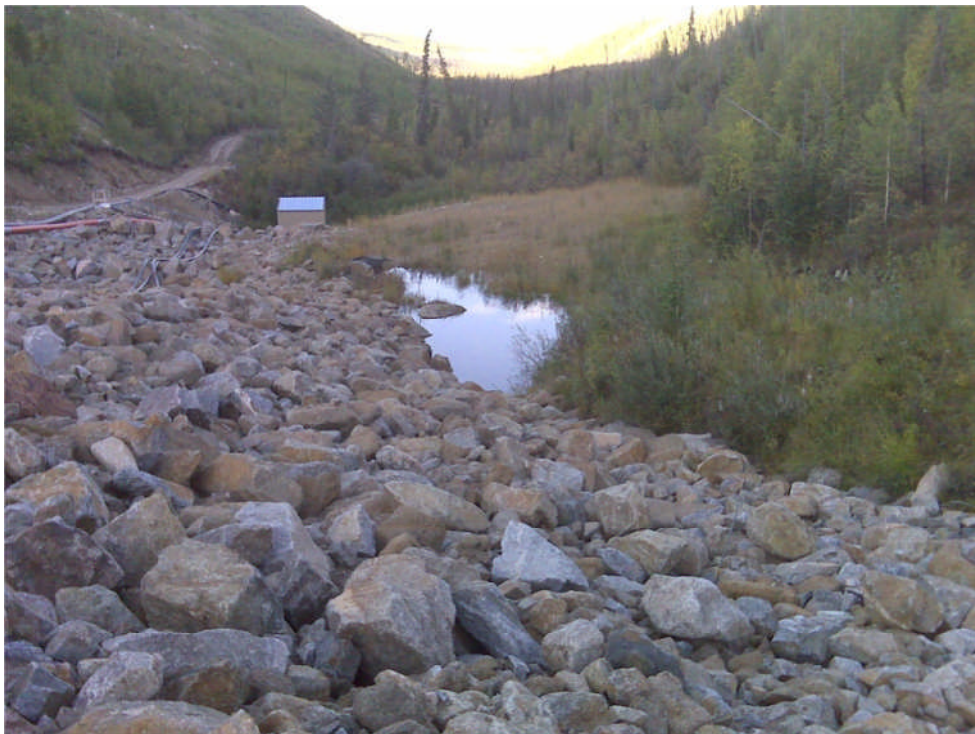
**Photo 6**

- The observed seepage water was clear with no turbidity or suspended solids. Accumulations of eroded sand and silt were also not observed. It is EBA's opinion that this area of ponded water and any water in the fill of the spillway is the result of seepage through the ungrouted right abutment dam foundation that then passes through the zoned filter materials along the base of the downstream shell. Review of the existing instrumentation and construction records are currently taking place to confirm this assumption.

Ponded seepage water at the WSP dam toe – right side. (August 26, 2011)

- Minto should continue to complete regular inspections of the dam, and specifically note the clarity of the seepage at the noted seepage pond at the toe of the right abutment and flow exiting the stilling basin. Written records of these inspections should be kept by Minto staff.

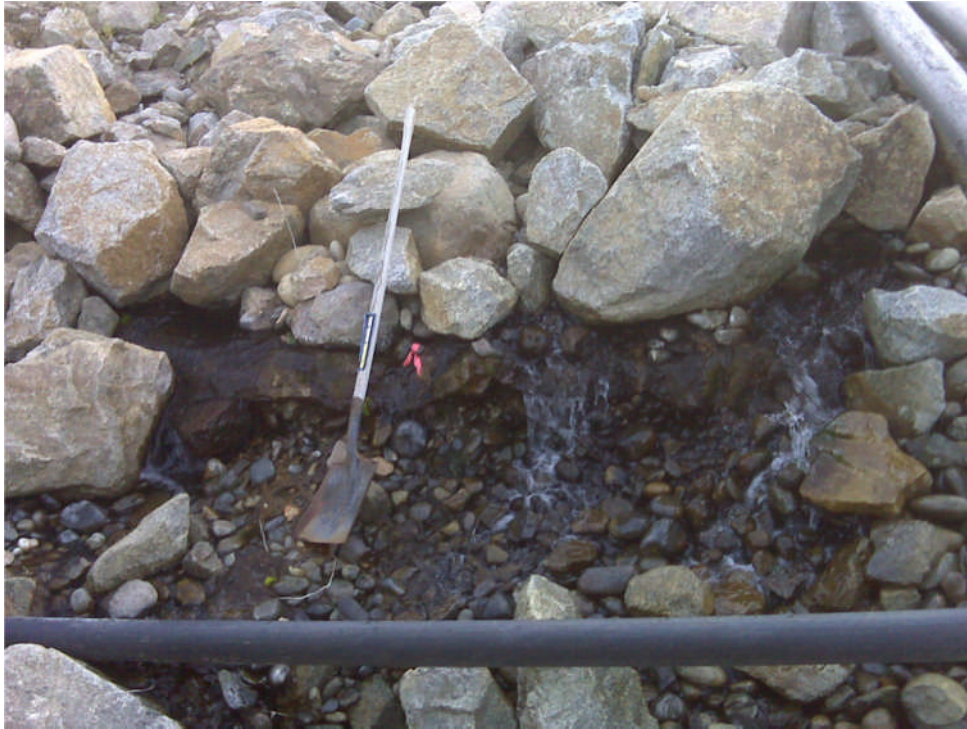
**Photo 7**

- The stilling basin appears to be in satisfactory condition and functioning properly as it was full of water which overflowed into the gravels upstream of the seepage pump house (Photo 9). The observed seepage water was clear with no turbidity or suspended solids. Accumulations of eroded sand and silt were also not observed.

Seepage at the stilling basin toe upstream of seepage pump house. (August 26, 2011)

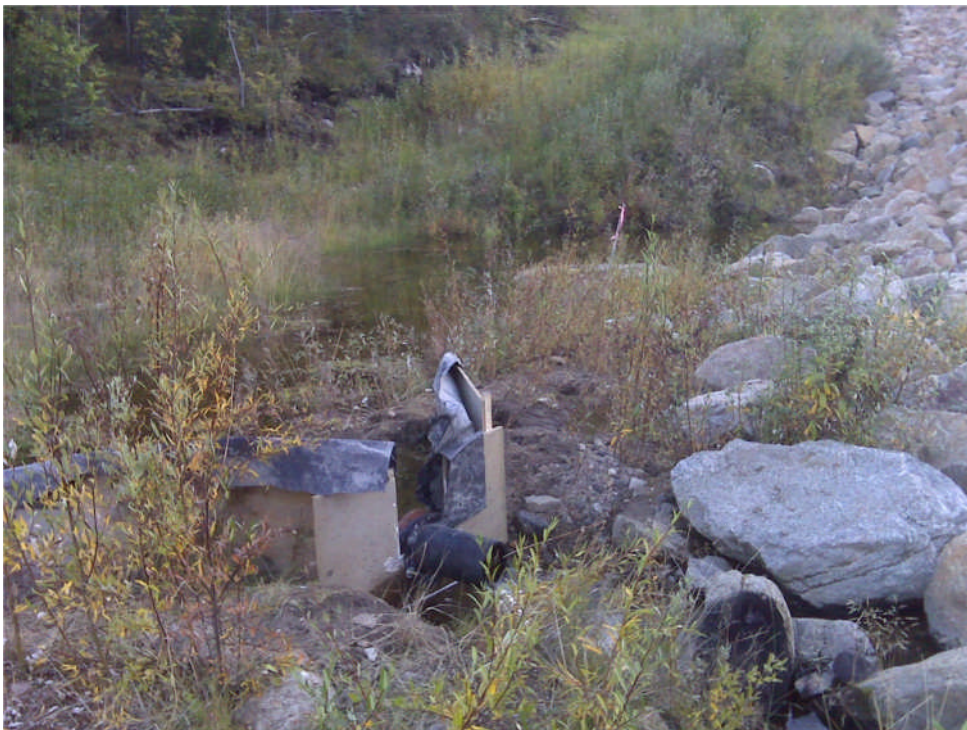
**Photo 8**

- At the time of this site visit, EBA noted that Minto had constructed a weir along the discharge side of the ponded seepage water to monitor the amount of seepage coming from the dam toe (Photo 11). The estimated flow rate through the weir was 5 L/s.

Weir at the ponded seepage water near the WSP dam toe. (September 14, 2010)

- Minto should continue to measure the actual seepage rate through the weir for the ponded seepage water next to the dam toe and compare it to the flow at the W-3 flume. To determine how much water is being collected at the seepage pump house at the dam toe and being pumped back to the Water Storage Pond, it is suggested that the seepage pump be periodically shut-off and the flow rate recorded at the W-3 monitoring station after the flow rate has stopped increasing in response to the cessation of pumping. Once the maximum flow rate has been recorded the pumping could be started again. This should be conducted once a month during summer months with surveys of the WSP level taken each time.
