2012 Geotechnical Annual Review, Minto Mine, YT

MINTO EXPLORATIONS LTD.

SRK Consulting (Canada) Inc.

November 2012

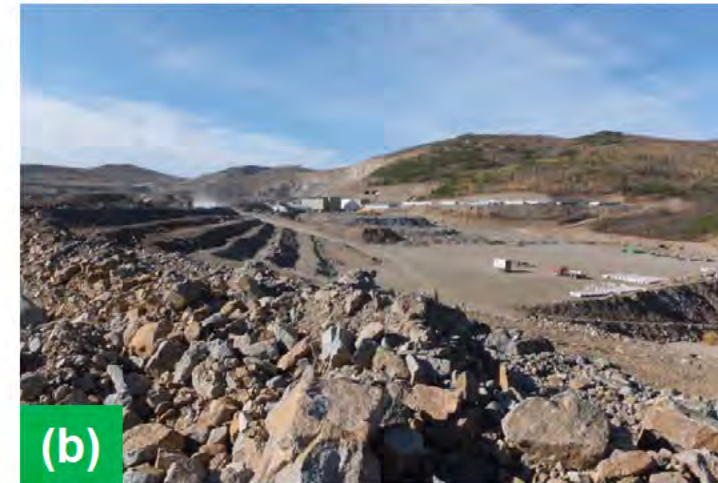
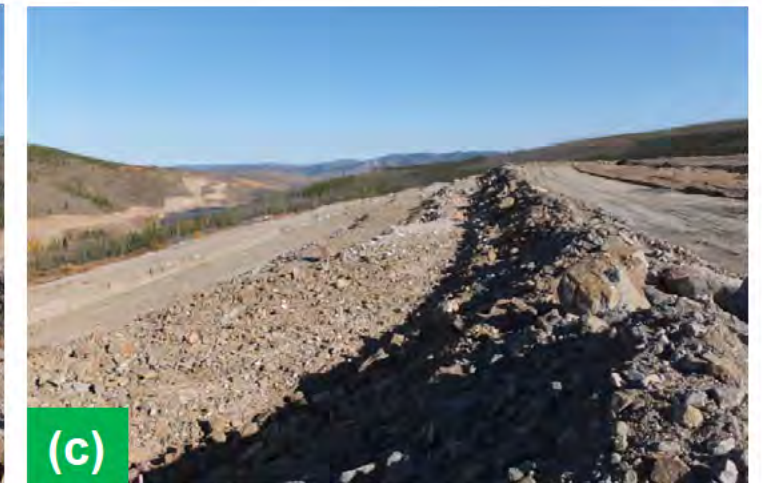
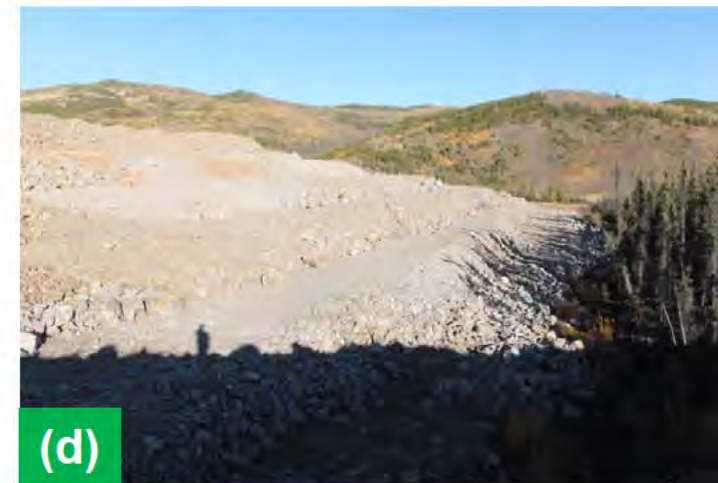
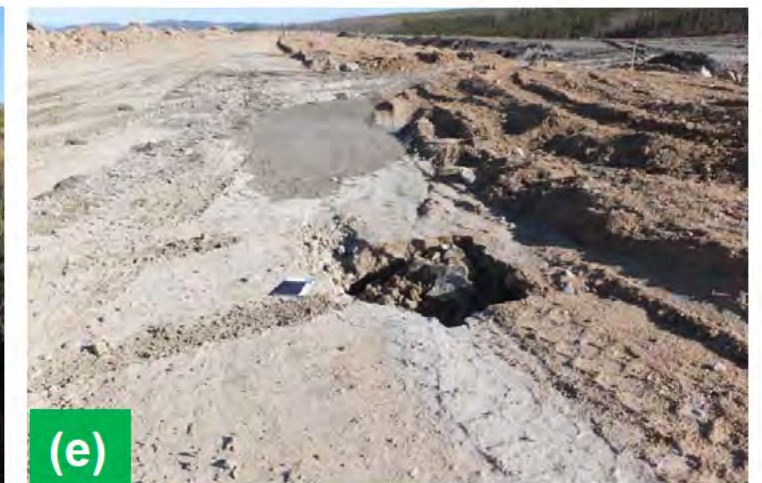
- Photos show the condition of the waste rock shell and slopes.
- The slopes appear to be consistent with original placement: no signs of slumping, bulging or tension cracks were observed.
- One small sinkhole was observed – see Photo (e).

- (c) North-east end of the waste rock shell looking east.
- (d) East end of the waste rock shell looking north
- (e) A small sinkhole was observed (handheld GPS coordinates: 6,944,850N, 385,757E, NAD83) with a diameter of approximately 1.5 m and a depth of 0.5 m. The hole is located on the inside edge of the shell access road and appears to be approximately above (or close to) one of the finger drain locations. The original shell toe in the area has been covered as part of mill valley fill construction and was not inspected. It is suspected that the sink hole is the result of excessive runoff from the facility collecting and infiltrating at this location and resulting in fines movement (note the wetter appearance of the sediments in the photo on the far side of the sinkhole).

- (f) Seepage from the facility was observed at one location at Photos (f) and (g) just upstream of the Minto Creek Detention Structure. (Note seepage observed at 3 locations during the 2011 inspection, two of the locations (W-8 and W-8A) have been covered due to the mill valley fill construction. The water was clear with no deposition of sediments observed).

- The sinkhole should be filled in to prevent equipment damage.
- The area should be regraded to direct surface runoff away from this location.

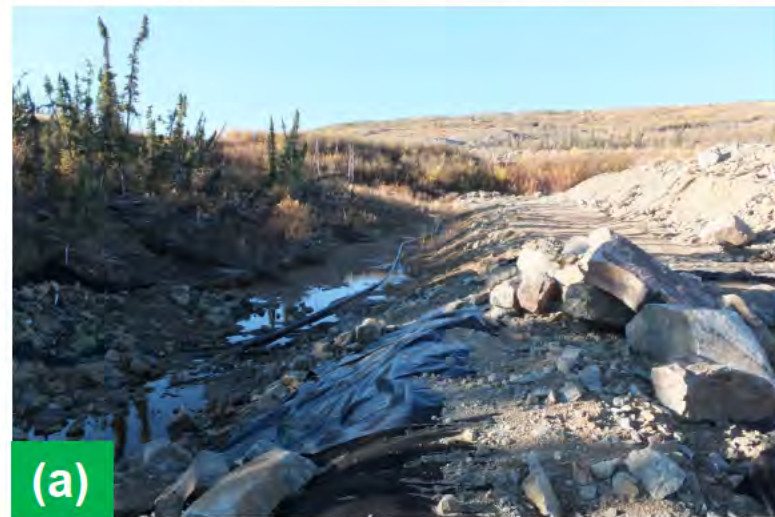
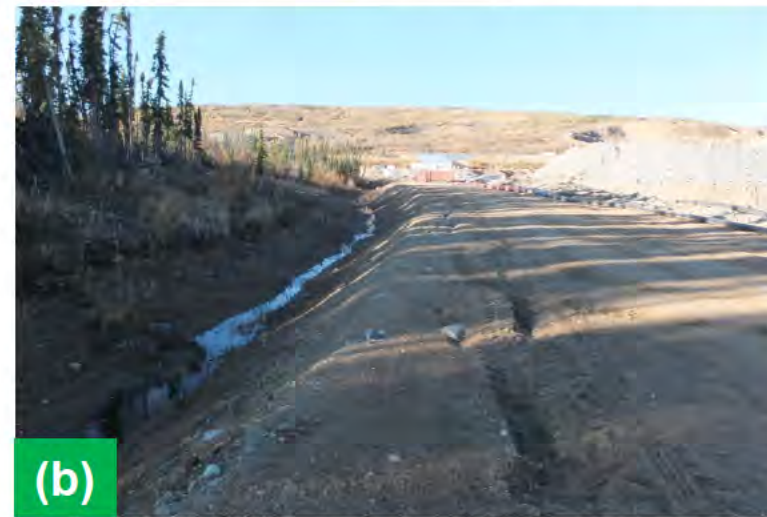
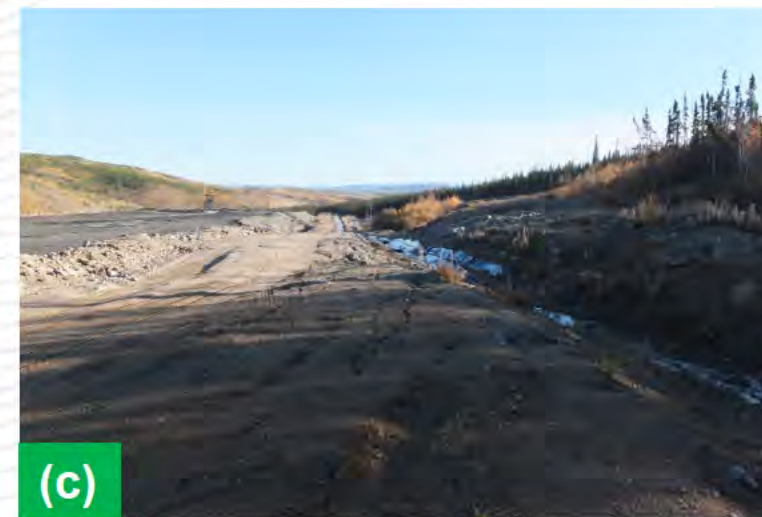
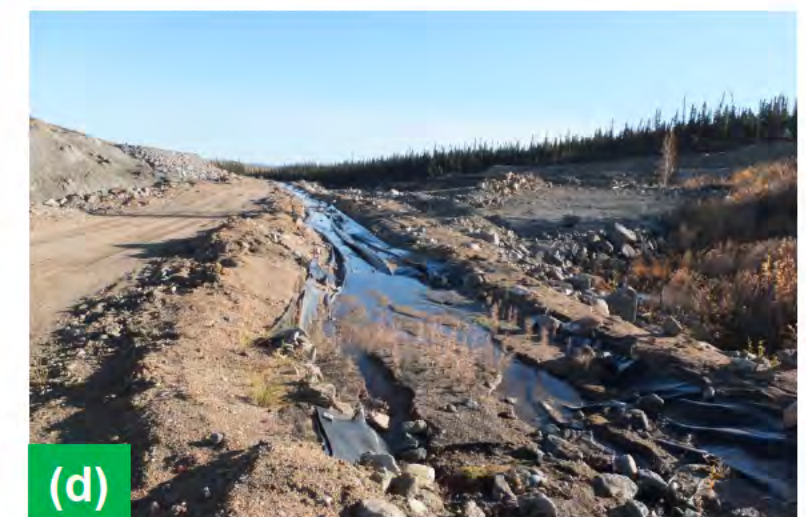
1 Dry Stack Tailings Facility – Surface Diversion Berm – Western Portion

- In general, the western portion of the berm and ditch was functional at the time of inspection, with conditions deteriorating towards the east. East of the location of Photo (d), the ditch is in very poor condition. Details on the eastern portion of the ditch are provided in Figure 5.
- Two seeps were observed below the berm near the locations noted in the 2011 inspection and on the plan in this figure.

- (a) A ditch block at the upstream portion of the ditch has been removed. Layers of geotextile and liner remain across the channel, a small amount of water remains ponded upstream of the block. A small waste rock stockpile is present to the right of the photo.

- (b) Tension cracks are present on the berm side of the ditch over a significant length of the ditch.
- (c) Looking downstream in the western portion of the ditch. Tension cracks visible along the road. The geosynthetic liner is exposed at all points downstream of this location.

- The ditch near this location and further downstream is not well formed, with sediments building up in the channel, and the liner sagging down the channel sides.

- Liner sections are over-lapped, but not welded. Gaps are present between some sections allowing water to pass through.
- Water was also observed to flow over the sides of the liner in places.

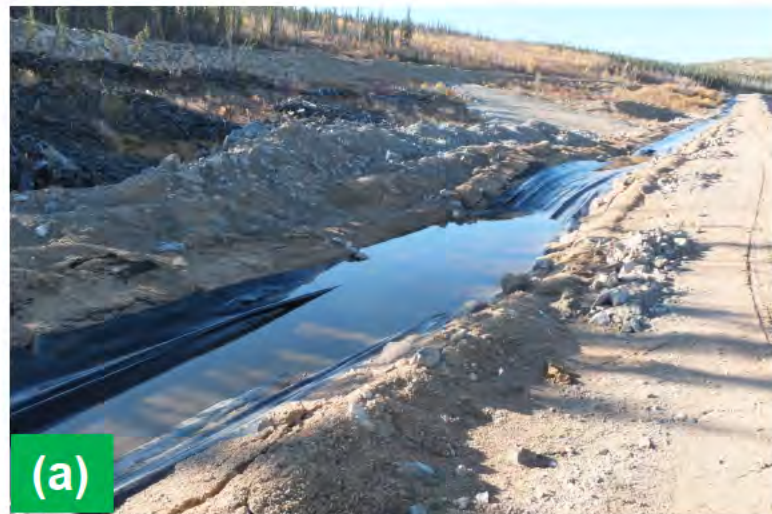
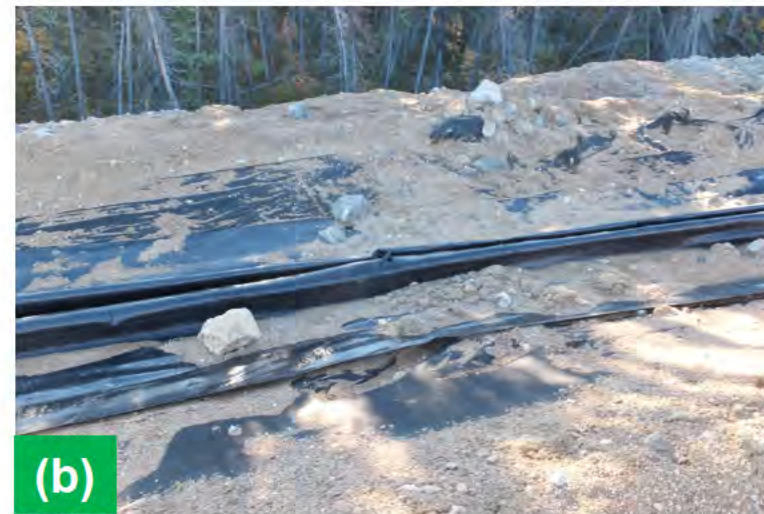
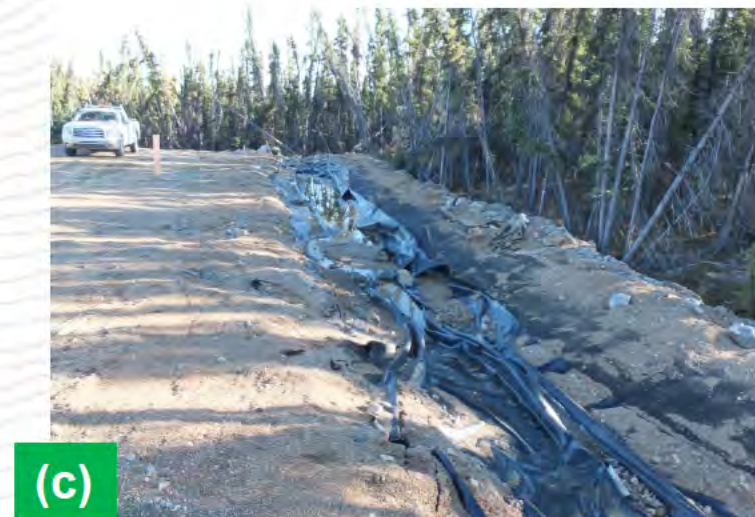
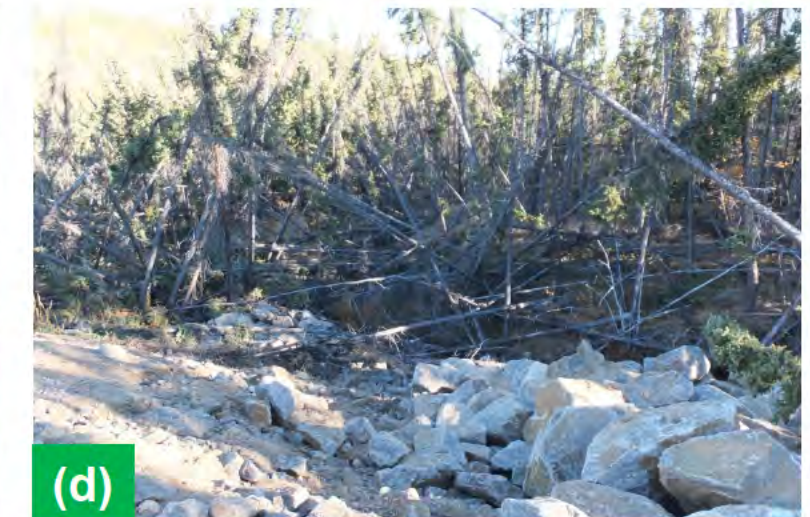
1 Dry Stack Tailings Facility – Surface Diversion Berm – Eastern Portion

The eastern portion of the ditch is in poor condition. At the time of the inspection, it is estimated that approximately half of the flow was lost along the east portion of the ditch.

- the channel appears undersized (Photo (b) and (c));
- The channel bed has settled in some areas resulting in ponding water (Photo (a));
- the liner has torn in many locations (Photo (c)),
- The anchoring of the liner has failed resulting in the liner slumping down the sides of the channel (Photo (b)),
- There are gaps in the liner resulting in water flowing beneath the liner and over the sides of the liner (Photo (a)).
- As noted in the 2011 inspection, the discharge point of the ditch (Photo (d)) was also not constructed in accordance with the March 23, 2010 Issued for Use Drawing TDD-01, where flow should discharge into a lined stilling basin.
- The vegetation surrounding the discharge point is stressed with many leaning dead trees in the area.

- The surface diversion berm should be rehabilitated to capture and convey water along the entire length of the ditch.
- The ditch discharge should be constructed to an engineered design.

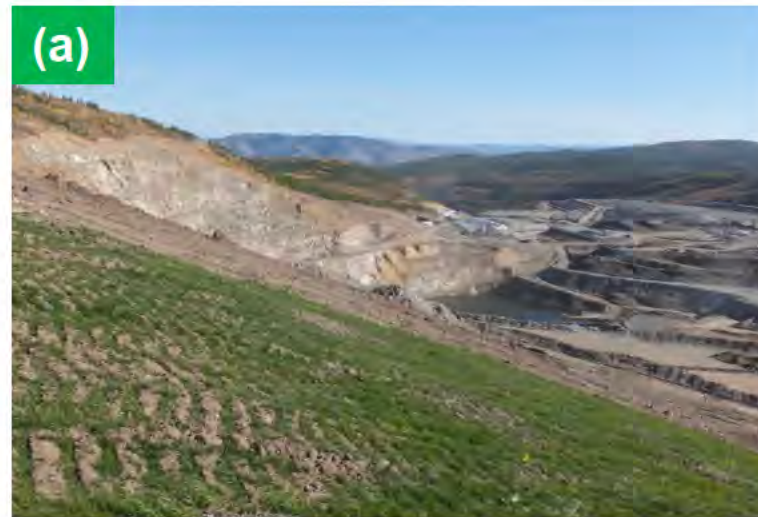
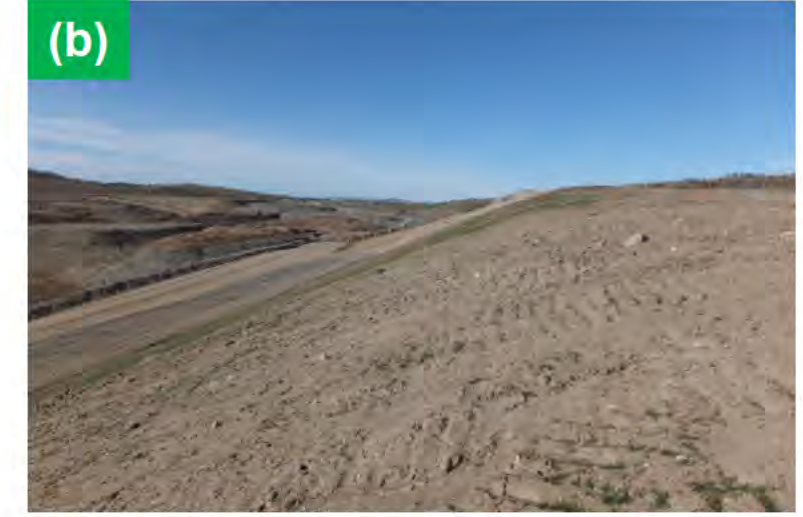
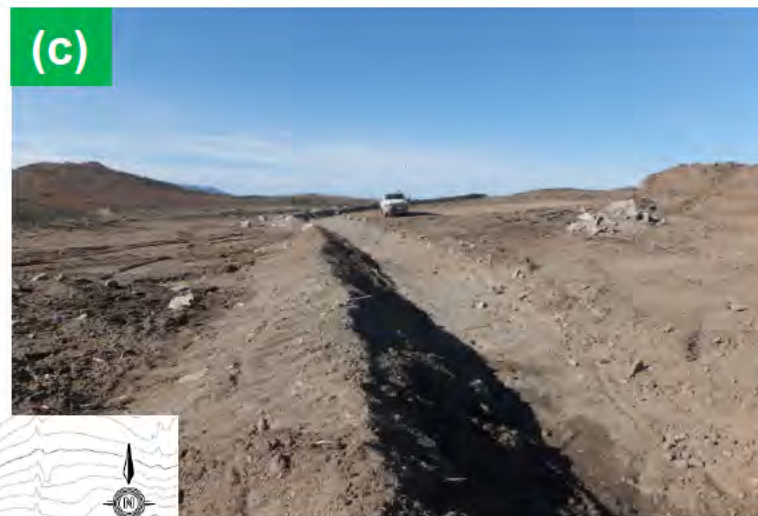
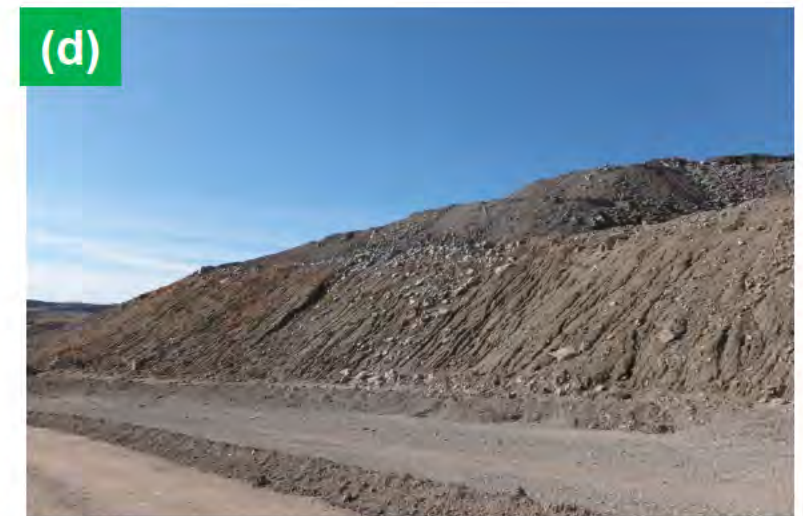
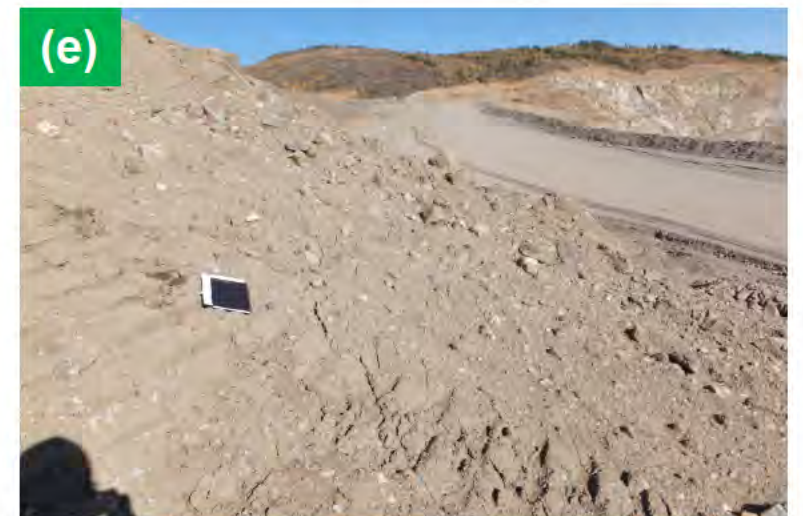
- During the 2011 inspection, reclamation activities at the dump had started with re-contouring. The resloping area is noted in the plan below. At the time of the 2012 inspection, re-contouring was completed, a reclamation cover was placed over a portion of the regraded area and revegetated. It appears that different vegetation prescriptions have been placed on different portions of the cover.

- The area of slumping noted in the 2011 inspection was not observed during the site visit as the area has likely been graded over.
- The blockage of the ditch at the toe of the southern portion of the MWD was also not found and is assumed to have been cleared as recommended in the 2011 inspection report.

- Photo (d) shows minor erosional channels above the access road west of the dump.
- Photo (e) show tension cracks found near the location where cracks were noted in the 2011 inspection. The area noted in 2011 has been graded over. The cracks in photo (e) are near the edge of the regraded area near the edge of a slope at the angle of repose.

- As signs of instability in the vicinity of photo (e) have been noted in past inspections, the area should be monitored by mine personnel on a regular basis to determine if there is any additional movement.

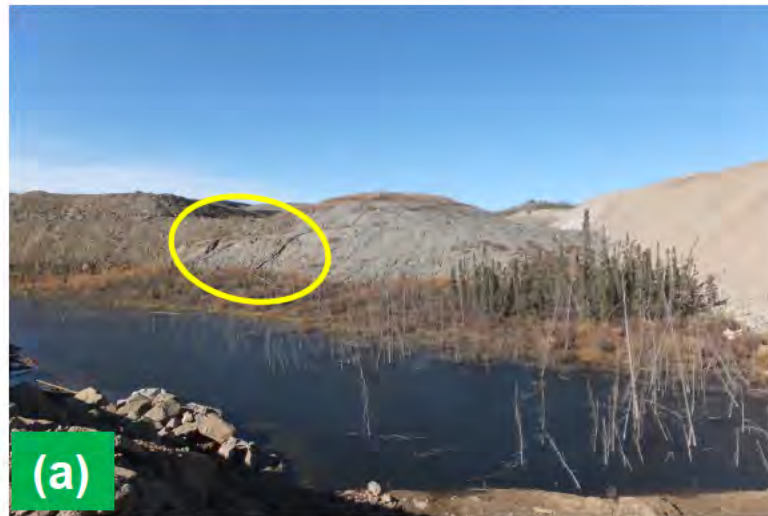
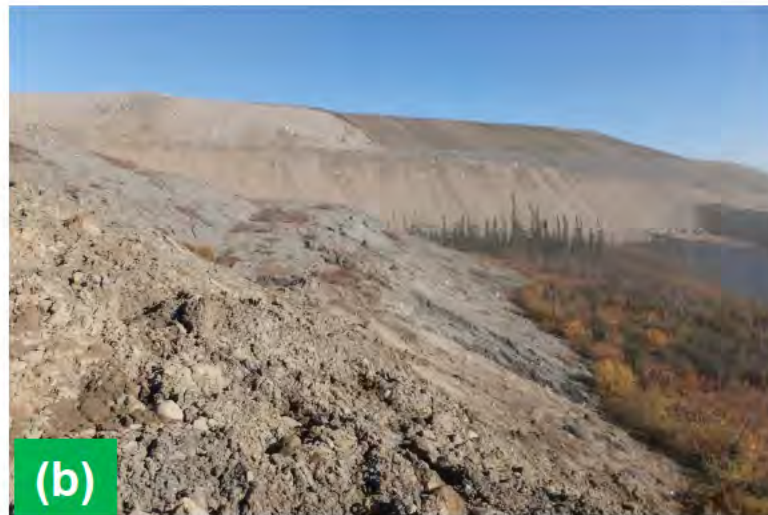
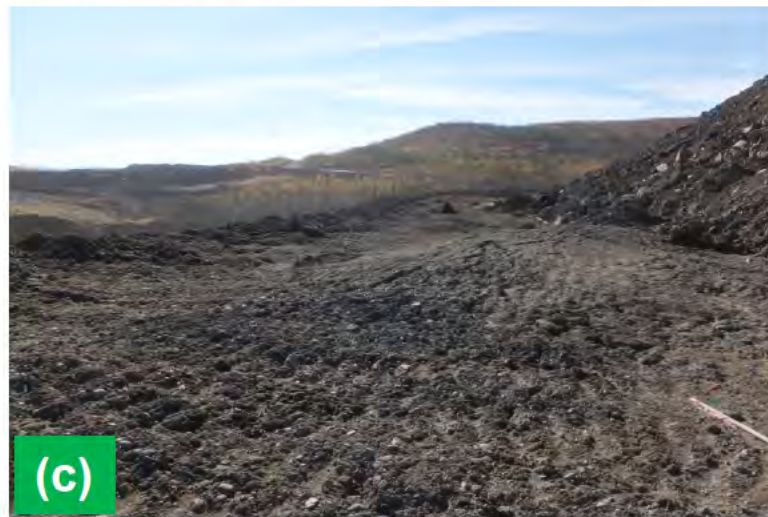
4 Reclamation Overburden Dump

• Conditions of the dump are similar to conditions reported in the 2011 site inspection completed by EBA. Slumping, settlement and tension cracks are expected in the dump as it is constructed with frozen overburden with thawing expected.

- a) Ponded water adjacent to the Dyno Access Road southeast of the ROD. Two small erosional channels were observed (circled in yellow).
- b) Localized slumping of the perimeter slope. The 2011 inspection notes that some of the sloughing areas have increased in size.
- c) Discontinuous tension cracks and differential settlement observed along the perimeter crest (above the slope shown in Photo (b)).
- d) Overview of the ROD dump area.
- e) Tension cracks and zones of differential settlement present throughout the lift whose location is shown in Photo (d) and the figure below. The ground is undulating by approximately 0.3 m.

- Installation of a rip-rap channel down the slope to minimize slope erosion. Areas near the exiting erosion channels should be regraded to direct runoff to the rip-rap channel.
- Monitoring of the ponded water to ensure that the offset from the dump toe is maintained as stipulated in the design report.
- The toe of the dump should be surveyed annually to confirm it is within the permitted boundary.

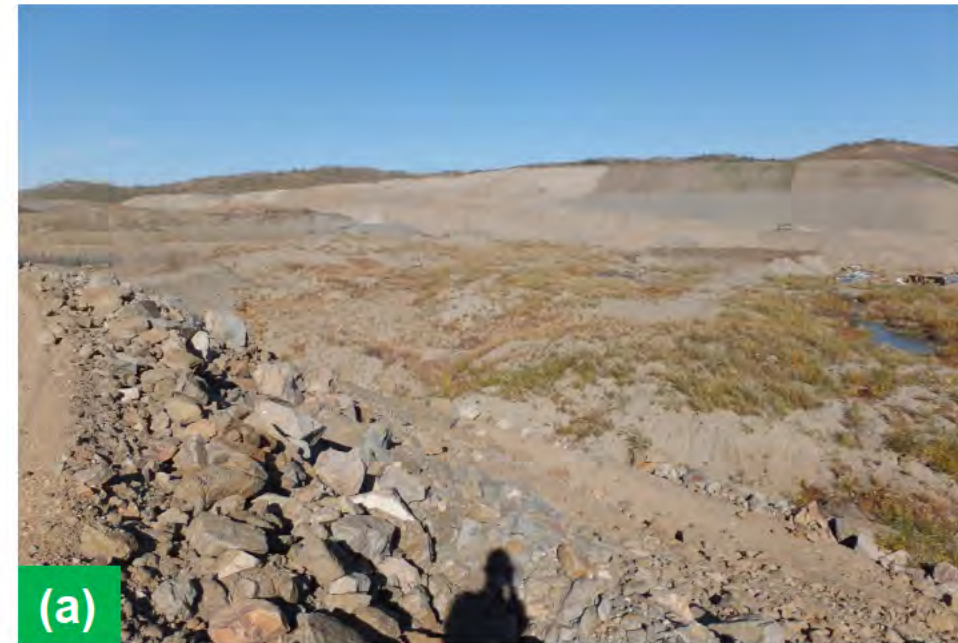
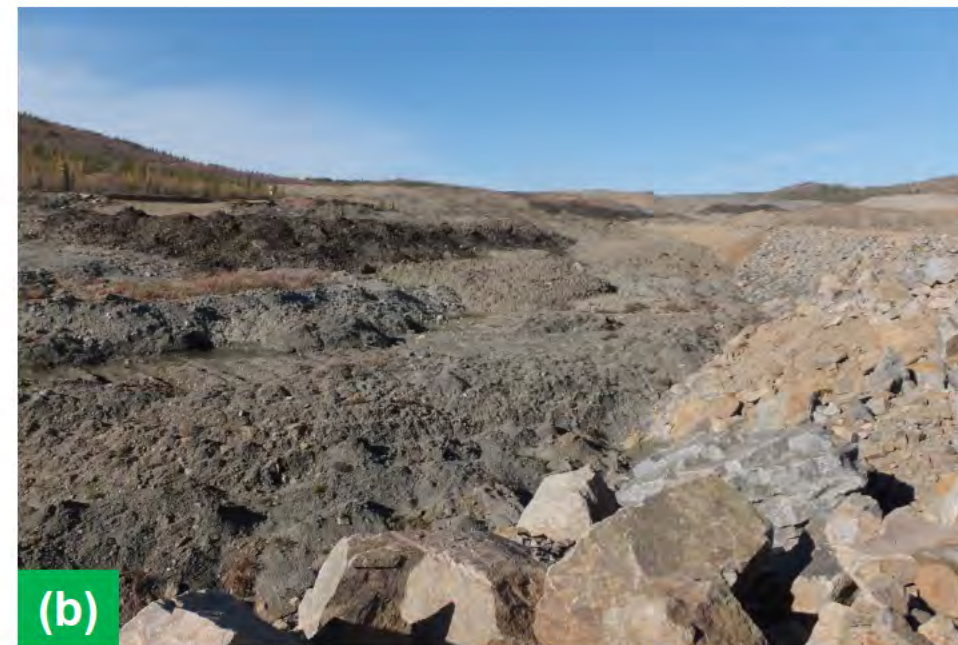
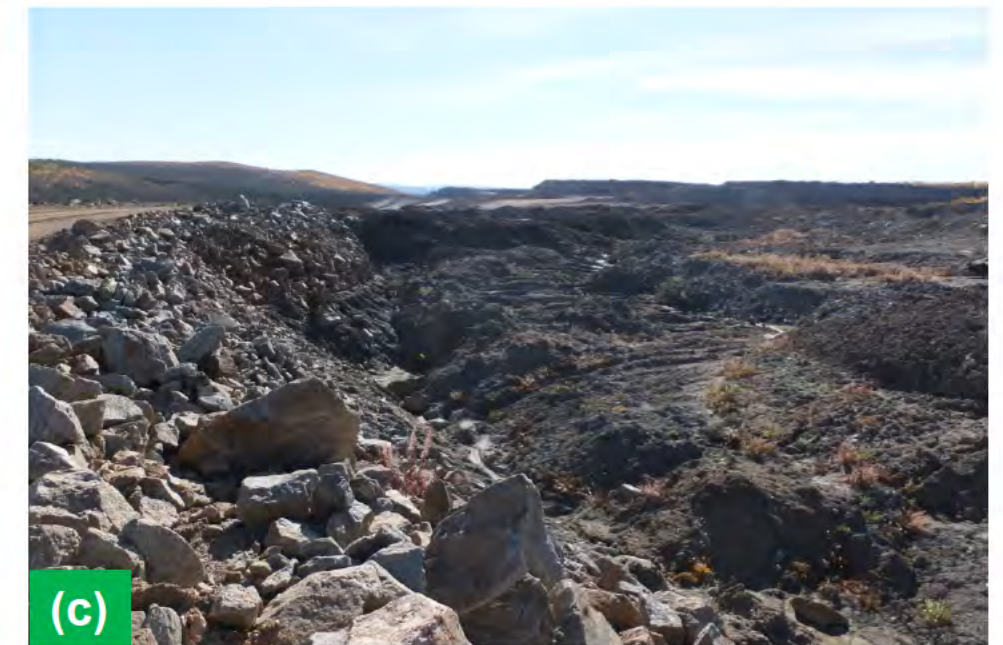
5 Ice Rich Overburden Dump

- A containment berm constructed of coarse waste rock is present on the north, east and south sides of the dump.
- Photo (a) shows outside slope of the berm, while Photos (b) and (c) show the inside slope and ice rich overburden material.
- No signs of instability were observed along the containment berm. Safety berms were present along the entire length of the crest on both sides.
- Discussions with site personnel indicate that no material has been placed in the dump since the last inspection.
- No pooling water was visible from the berm inside of the dump, and it appears the berm is functioning as intended by allowing most water to drain to the outside of the facility.

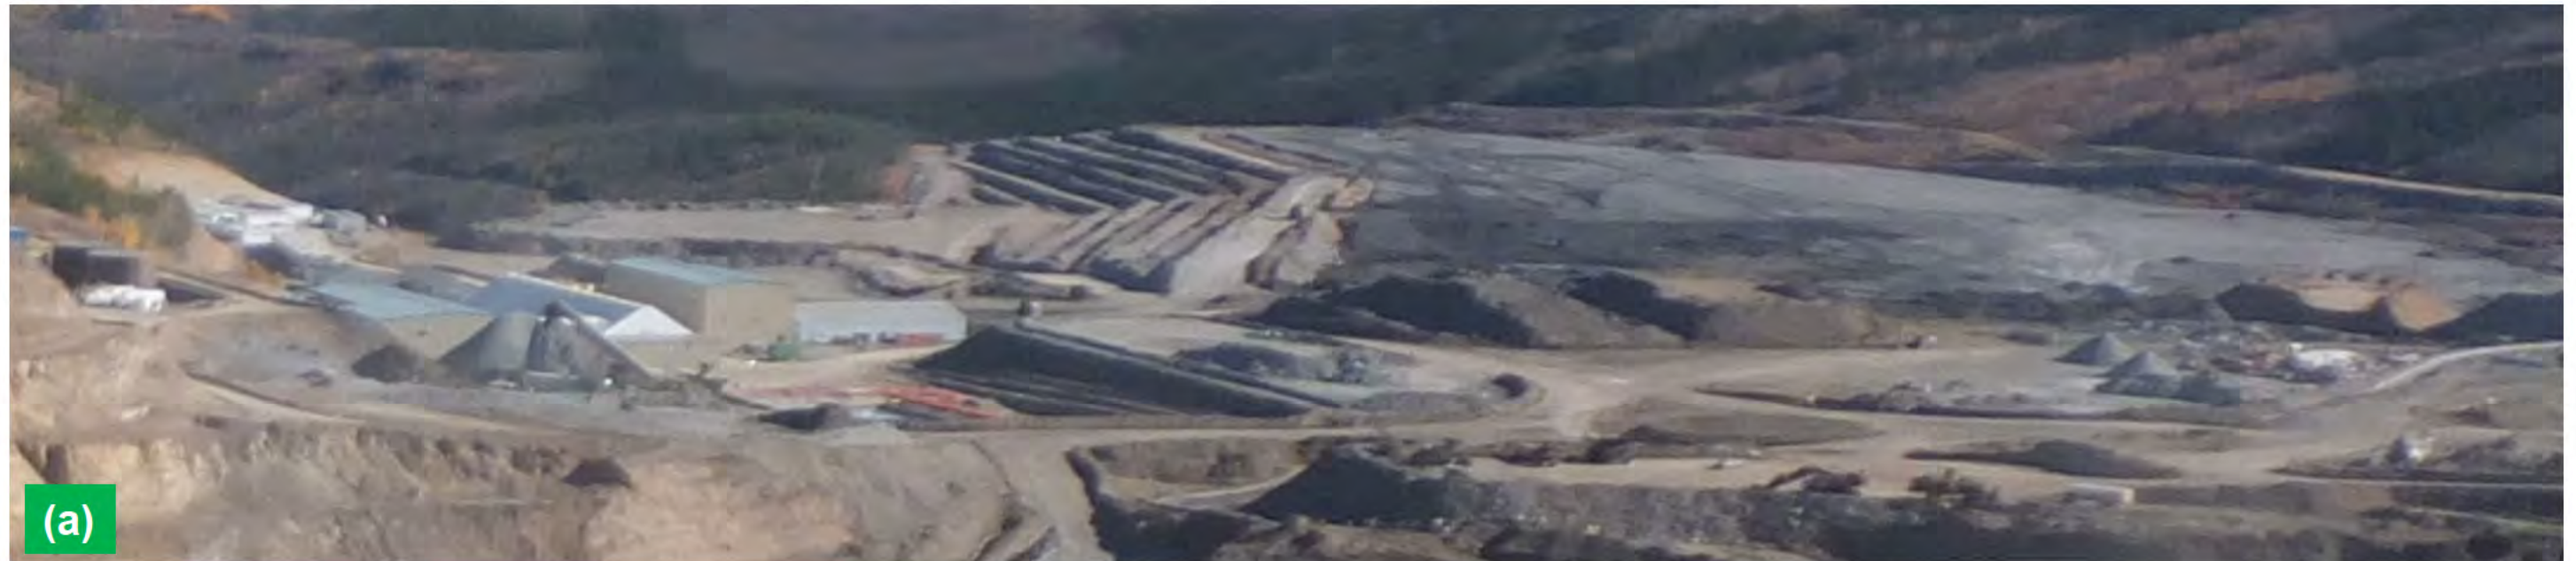
6 Ore Stockpiles

- The ore stockpile area was investigated briefly in passing. All slopes appeared in good condition: no slumping, bulges, cracks, or other signs of instability were observed.

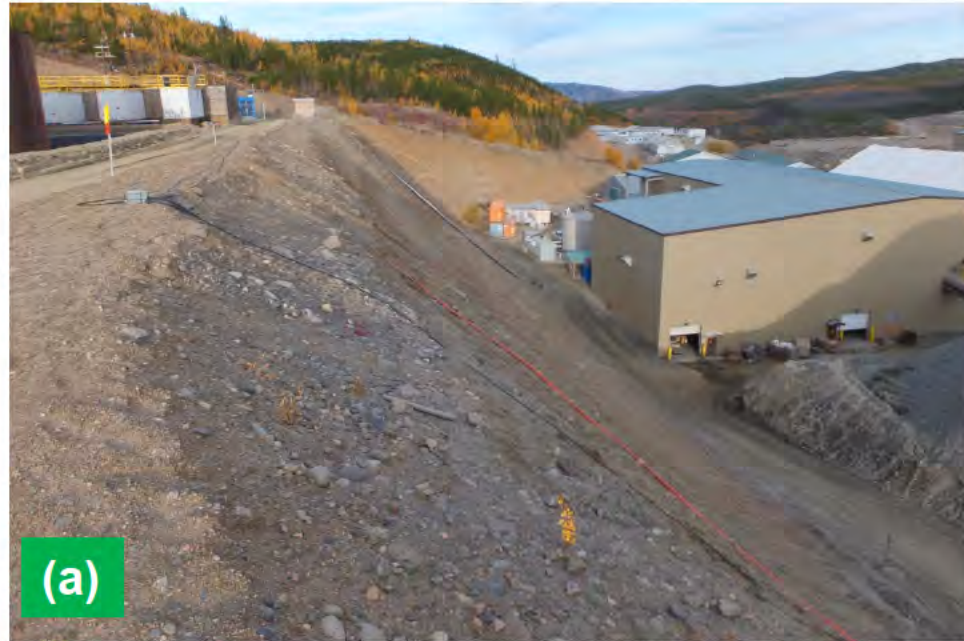
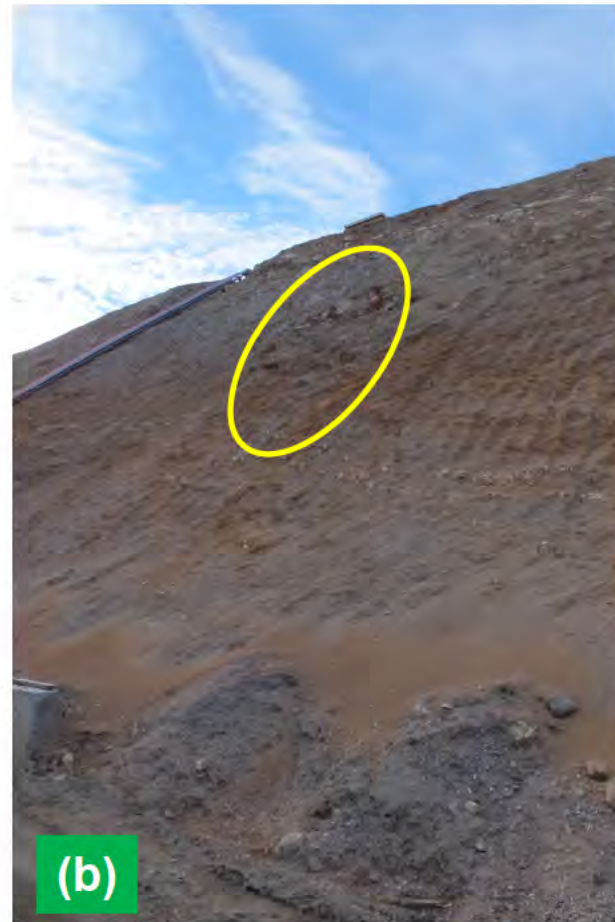
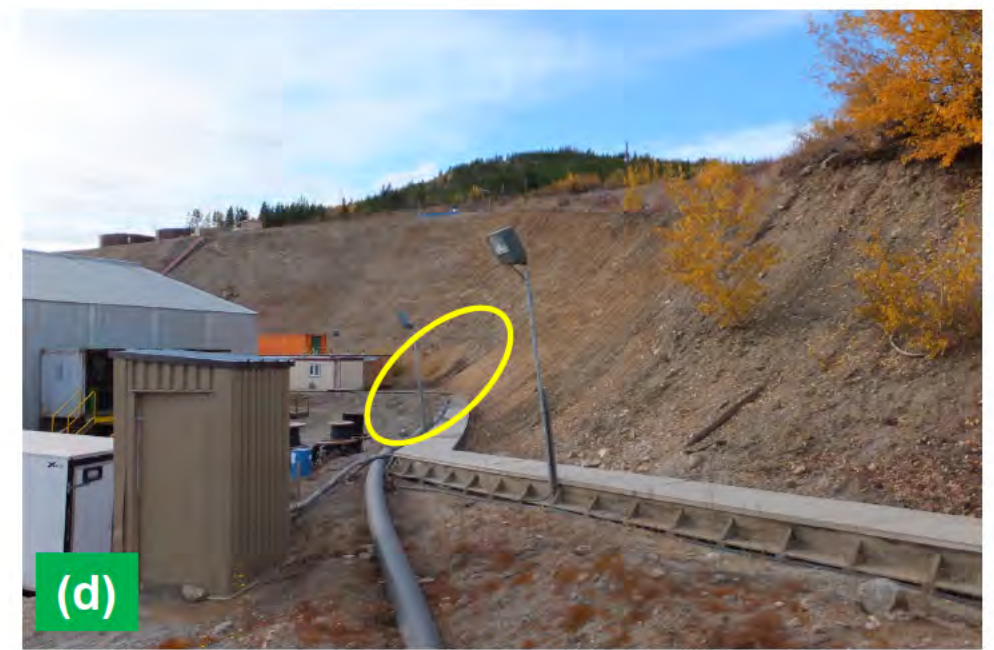
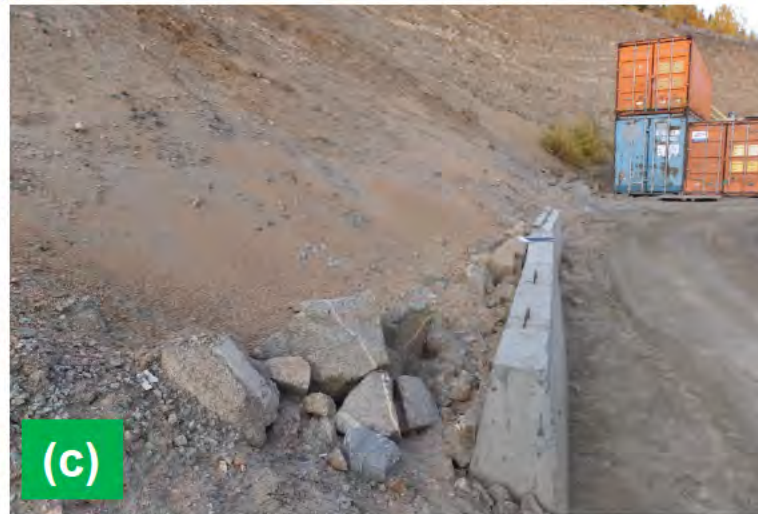
7 Mill and Camp Site

- a) Slope above the main mill site appears stable
 - Safety berms at the top of the slope are in good condition.
 - Eroded sand/gravel is generally present at the base of the slope with occasional cobbles/boulders up to 300 mm.
- b) A small slough is present near the center of the slope approximately 10 m east of the electrical corridor where there appears to be some larger rocks that have raveled down the slope.
- c) Concrete barriers are present at the toe below this area. The barrier is approaching the capacity for containment.
- d) East end of the mill slope looking northwest. Two small seeps (circled and shown in 'e') are present at the corner of the slope, emerging approximately 2 m above the toe.
- e) View of the seep location. The flow is a minor trickle, with algae present along the stream path.

- It is recommended that the concrete barrier (Photo (c)) be cleaned out or raised to capture any additional sloughing material. A simple solution to raise the barrier may be to place wooden planks anchored by rebar.

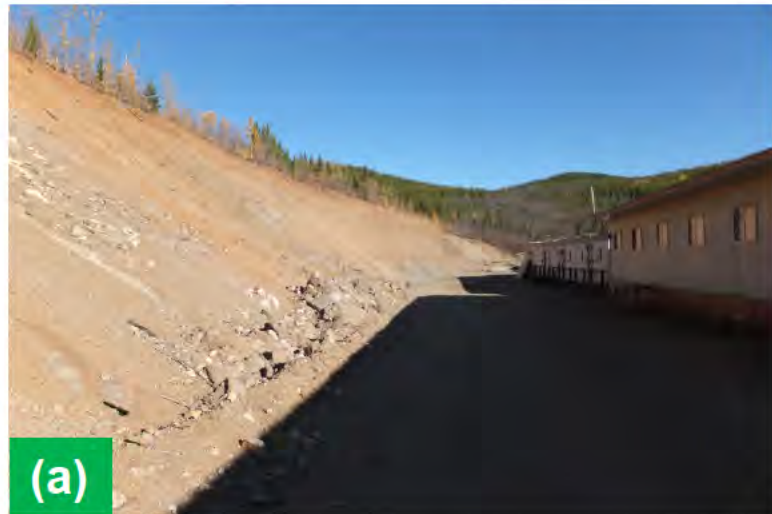
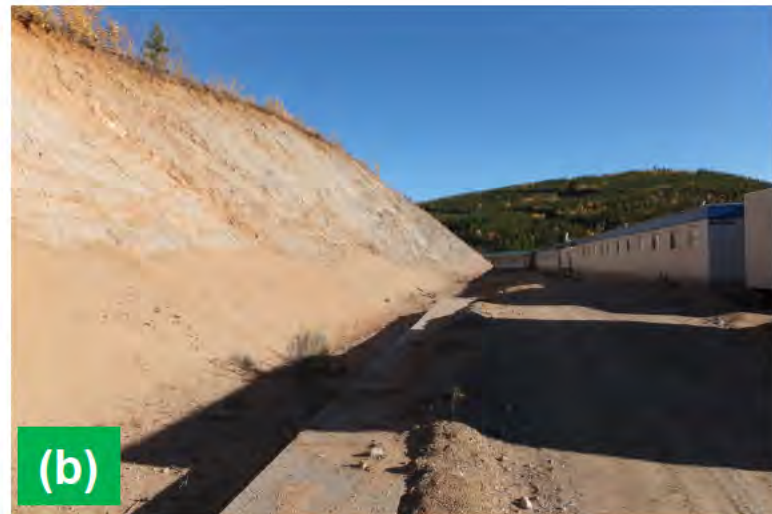
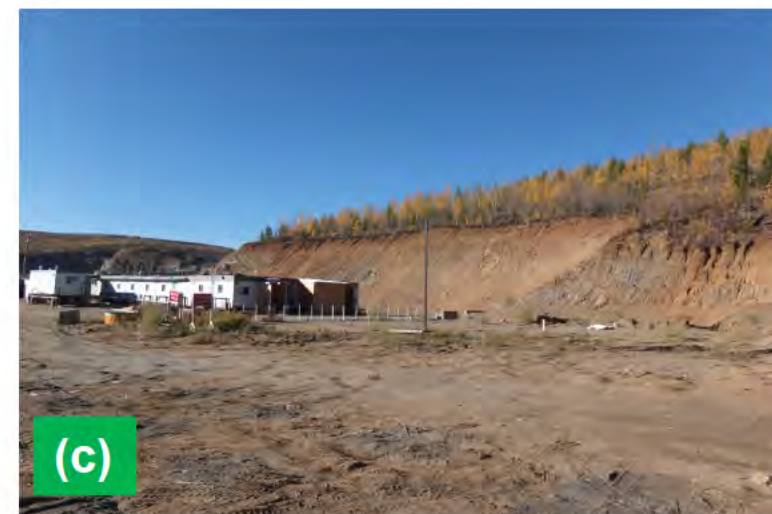
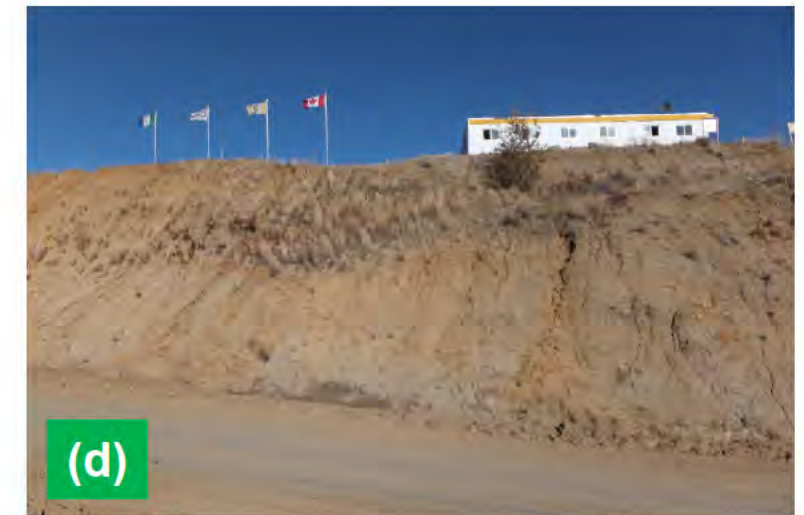
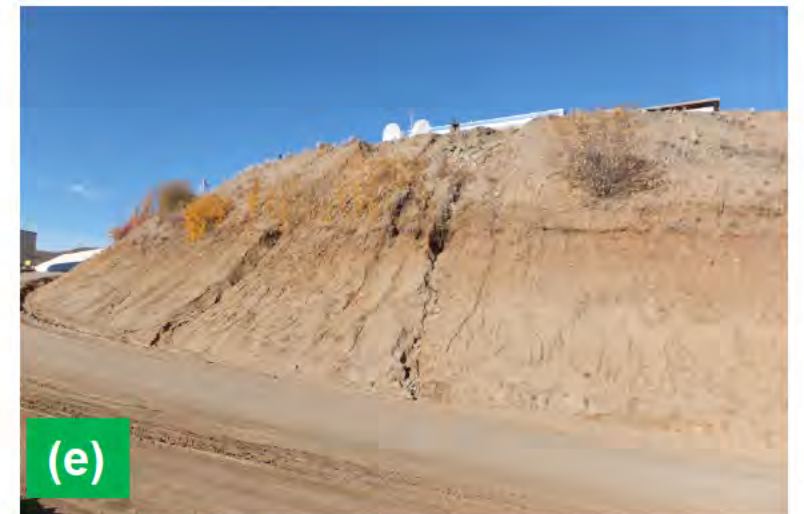
7 Mill and Camp Site

- a) & b) Slope above the main camp site appears stable.
 - Eroded sand/gravel is generally present at the base of the slope with occasional cobbles/boulders up to 300 mm.
- c) Minor erosion channels present at the north end of the camp area. Three minor erosion channels were noted in the EBA 2011 in this area. There are numerous other minor erosion channels in this area, as can be seen in photos (c) and (d). It is unclear if these channels were present in 2011.
- d) & e) Erosion channels present south of the camp site pad. It appears that the same erosion channels noted in the 2011 inspection are still present as well as additional erosion channels, as noted in the figure below.

Note: Since the 2011 inspection, fill was placed below the main access road as part of the Mill Valley Fill pad that have covered over the erosion channels noted in the figure below.

- The 2011 EBA annual review recommended the area above the erosion channels below the camp pad be regraded to promote runoff away from these areas and that one of the channels be filled with rip-rap or a "half culvert to provide a path for the water to drain". It appears that no action has been taken in the past year and that further erosion channels have developed.
- It is recommended that these actions be completed in the following year. In place of the surface grading, a small ditch could be constructed near the slope crest to direct runoff to the drop channel or half-culvert.

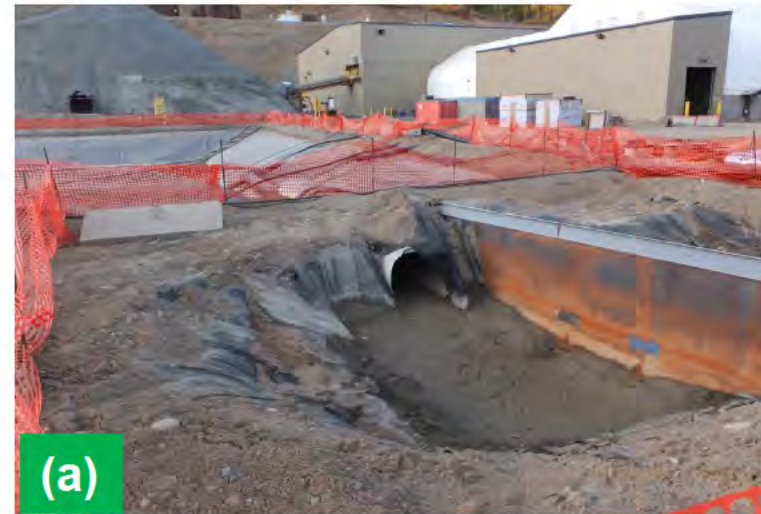
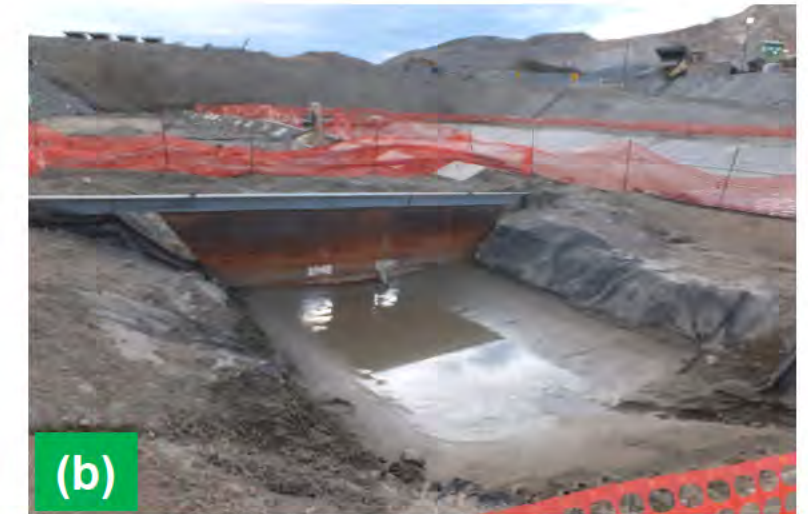
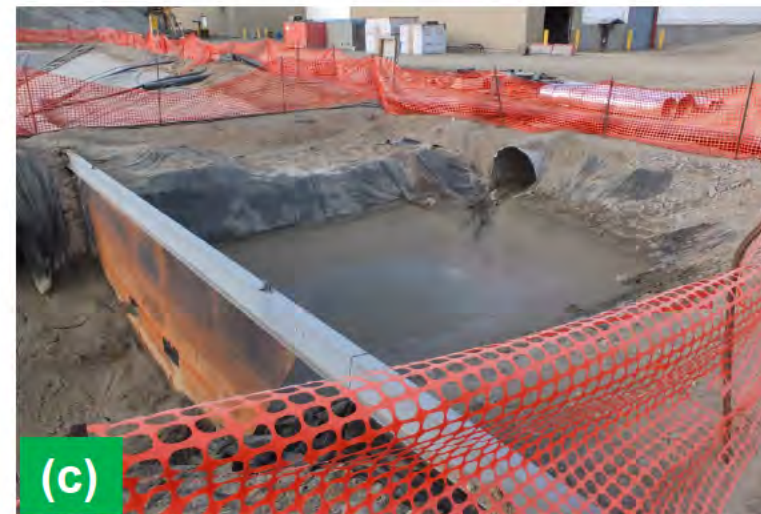
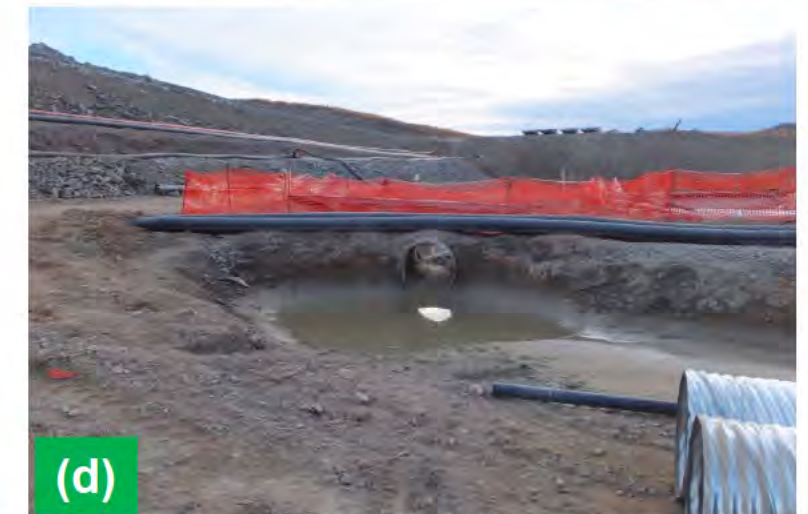
- The 2011 observation of a “minor bulge under the liner system in the vicinity of the southwest corner” was not observed during this visit. The liner in the area did not appear to be stressed or contain defects.

- e) View of the inlet culvert on the east side of the pond with a small flow of water entering the pond.

- The liner tears should be patched the next time a liner crew is onsite. For the liner tear noted in Photo (c), Figure 14, sand should be placed to fill the void beneath the tear.
- The liner condition beneath the bypass pipe supports should continue to be monitored.
- The sediments accumulated in the surface runoff ponds and culverts should be cleaned out.

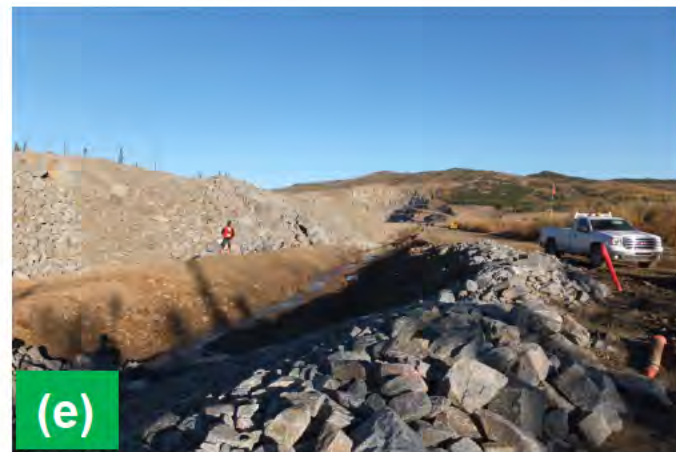
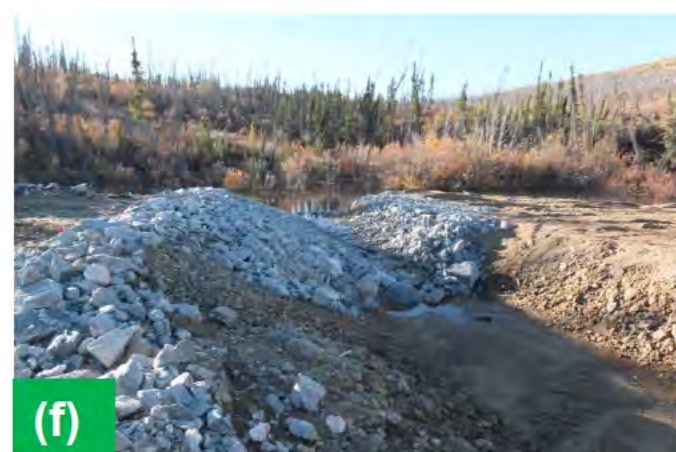
- STA 0+540 to 0+957 of the ditch were inspected during the site visit. The lower portion of the channel has been blocked off at a road crossing at STA 0+540 with flow diverted through two 16" HDPE pipes.
- The 2011 Annual Review completed by EBA notes that the upper portion of the channel is a lined ditch constructed to the specifications outlined in the "South Diversion Ditch Collection Pond IFC drawings, Figures SD1 through SD3, dated July 2007.
- The channel is generally in good condition with no blockages or instability along the side-slopes.
- The area of settlement noted in the 2011 annual review between STA 0+600 and 0+650 was not observed.

- a) View of pooled water at the downstream end of the channel near STA 0+540 and road crossing.
- b) Exposed liner at the top of the south bank near STA 0+600.
- c) View looking downstream of the two 16" HDPE pipelines and vegetation. Pounded water is present
- d) Obstructed view of the inlet structure to two 16" HDPE diversion pipes. Vegetation up to 6 feet high has become established in the area.
- e) Upper portion of the channel looking downstream from near the inlet structure.
- f) Pounded water present at the inlet structure. It is understood that the drop structure is in place to provide a water source for exploration drilling activities.

- To increase the capacity of flow into the diversion piping, it is recommended that the vegetation be removed. If the downstream portion of the channel is re-established (between STA. 0+540 and 0+650), vegetation along the channel should also be removed to increase flow capacity.
- The exposed liner should be covered as per the channel design.
