2012 Geotechnical Annual Review, Minto Mine, YT

MINTO EXPLORATIONS LTD.

SRK Consulting (Canada) Inc.

November 2012

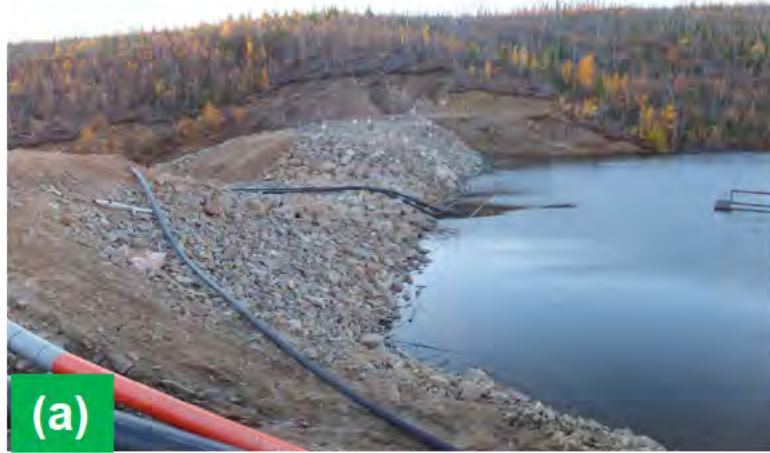
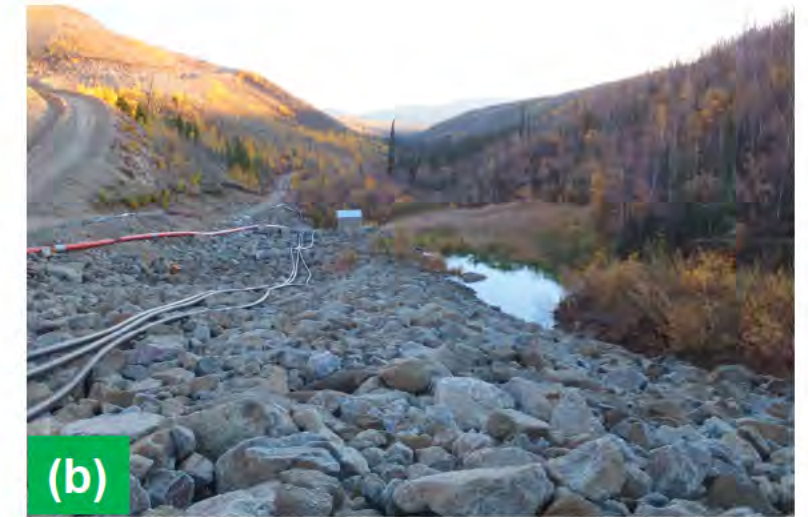
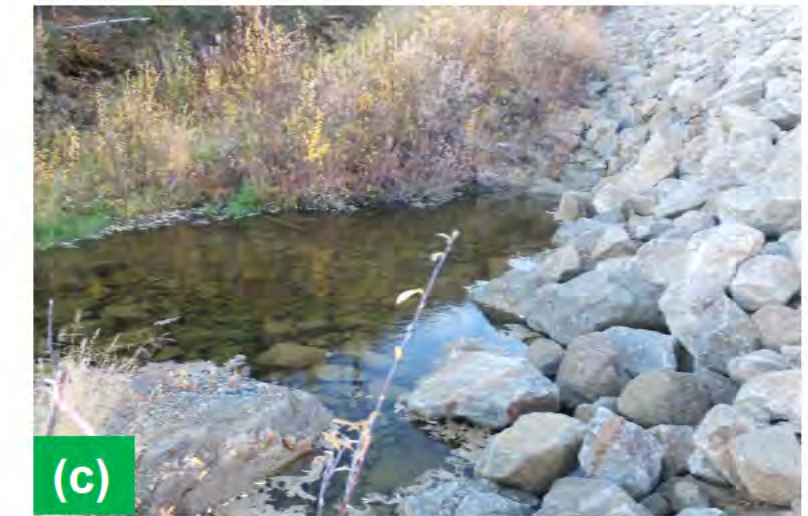
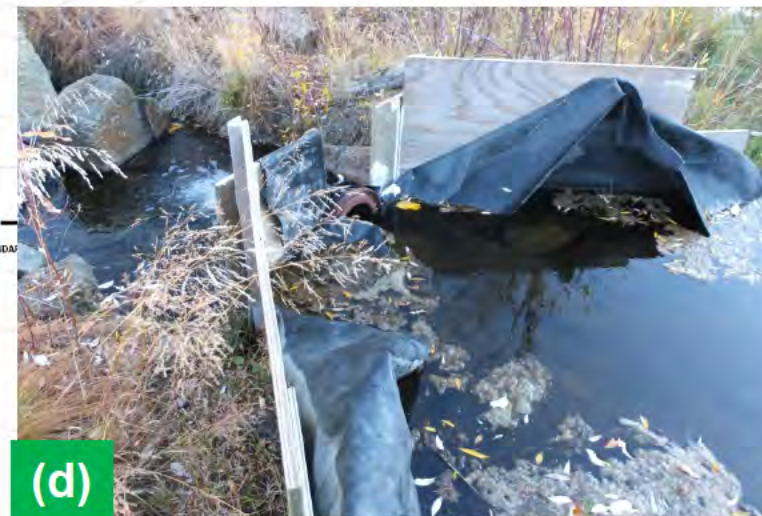
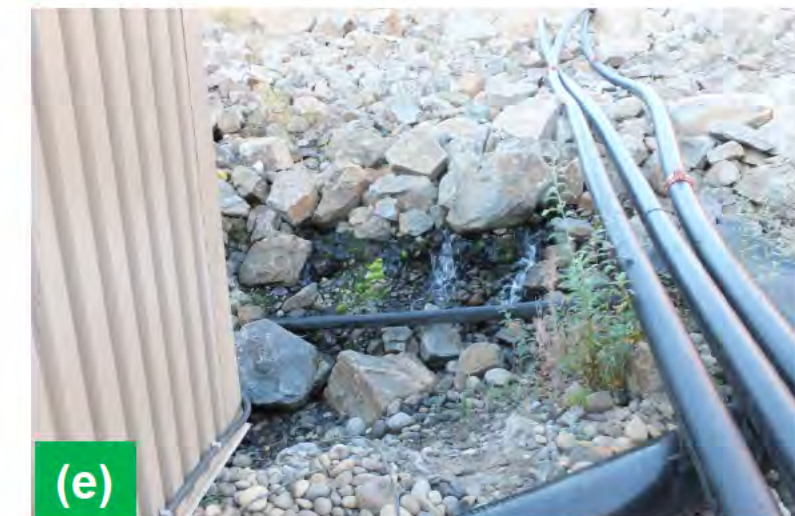
11 Water Storage Pond Dam

- Conditions of the dam appear to be unchanged since the 2011 Physical Observation Report issued by EBA on Oct. 5, 2011.
 - The WSP water level was estimated to be approximately the same as during the 2011 (714.3 m) estimated based on photographs provided in the 2011 report.

- The crest, upstream slope and abutments shows no signs of instability (settlement, bulging, slumping).
 - During the 2011 inspection, a minor erosion channel was noted in the general fill in the water treatment building pads. The erosional channel could not be found during the 2012 inspection.

- The estimated flow rate at the time of inspection was 1 L/s.
 - View of the stilling basin upstream of the seepage pump house.
 - The seepage water was clear with no turbidity. No accumulation of sediments were observed.
