2013 Geotechnical Annual Review, Minto Mine, YT

Minto Explorations Ltd.

SRK Consulting (Canada) Inc.
1CM002.012.005
October 2013

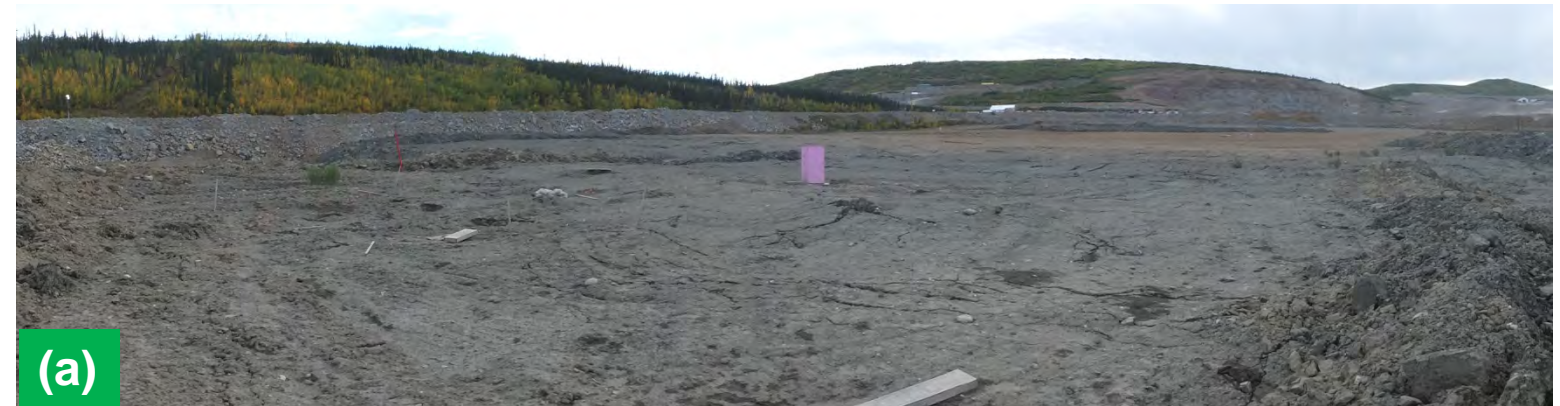
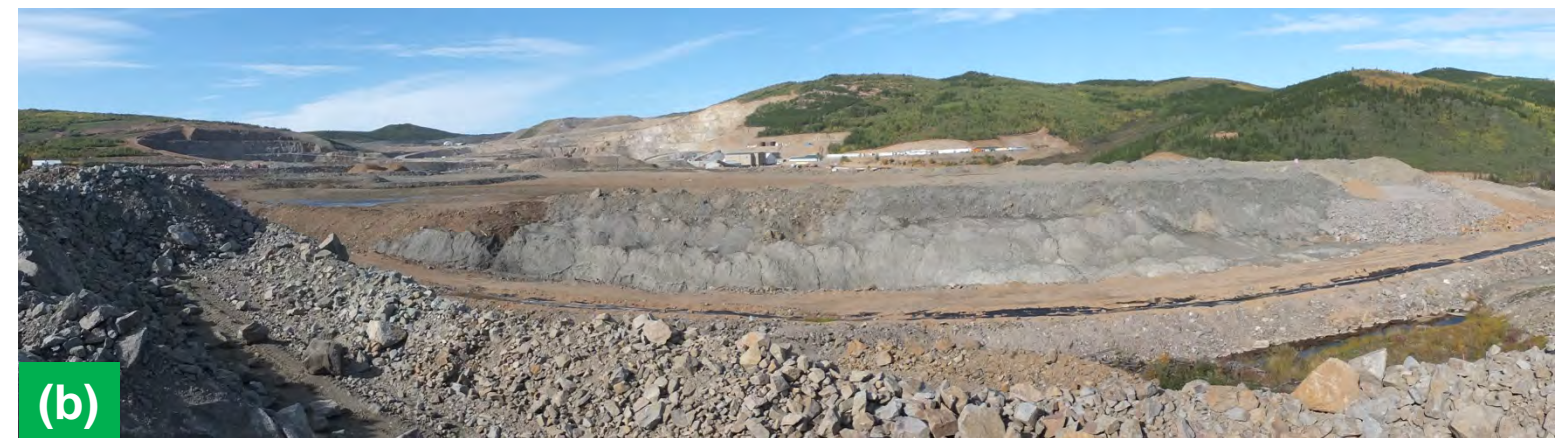
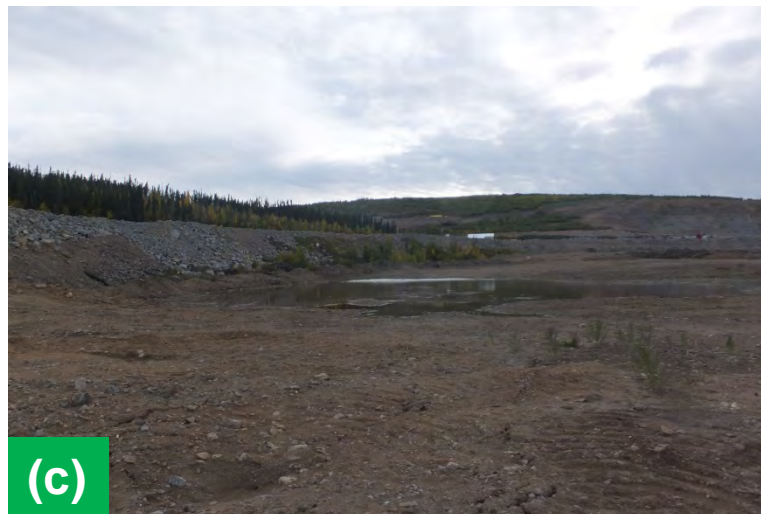
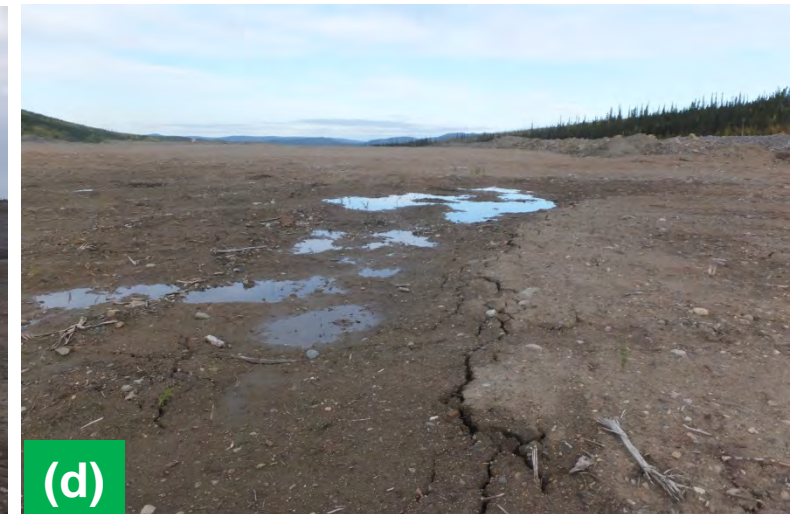
- There are a significant number of thaw bulbs, surface cracking and differential settlement throughout the cover, which can be expected as the overburden due to the winter placement.

- Photo (b) shows the south edge of the DSTSF. Tailings remains exposed at surface on the south slope of the facility adjacent to the Tailings Diversion Ditch. Water was observed to be impounded against the DSTSF on the south side of the facility at various locations. Seep locations and areas where the water was observed to flow beneath the tailings are noted on Figures 4 and 5. The water can be attributed to melting snow, recent precipitation and from water not captured by, or flowing under, the tailings diversion ditch.

- Photos (c) and (d) show the tailings cover surface in the soft areas noted on the aerial photo below.

- The recently placed overburden material was placed during winter and has experienced differential settlement due to thawing of frozen materials over the summer. It is recommended that the area be graded as required to promote runoff.
- The remaining areas of exposed tailings should be covered and the uphill area south of the DSTSF should be regraded as required to control surface drainage, avoid ponding, and limit infiltration of water into the tailings as per Clause 36 and 37 of the water license QZ96-006, Amendment 8.

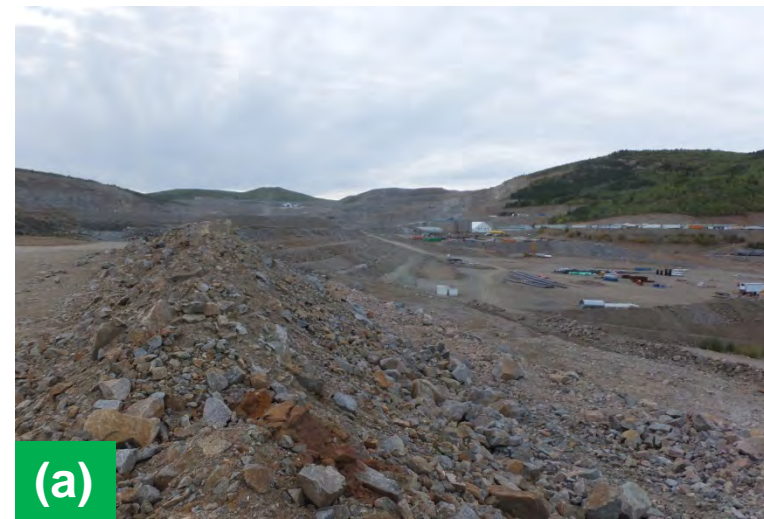
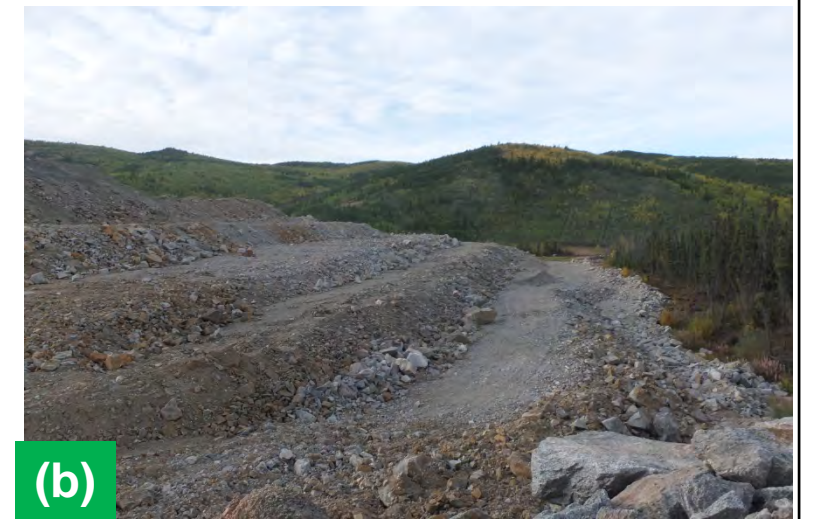
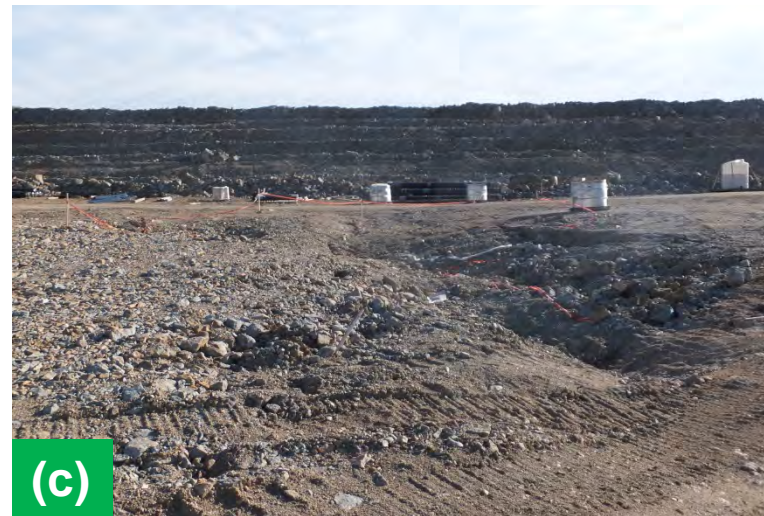
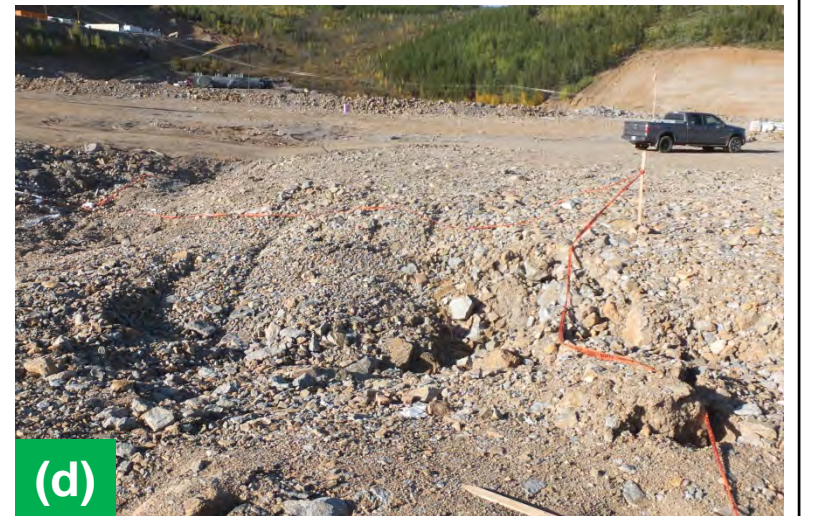
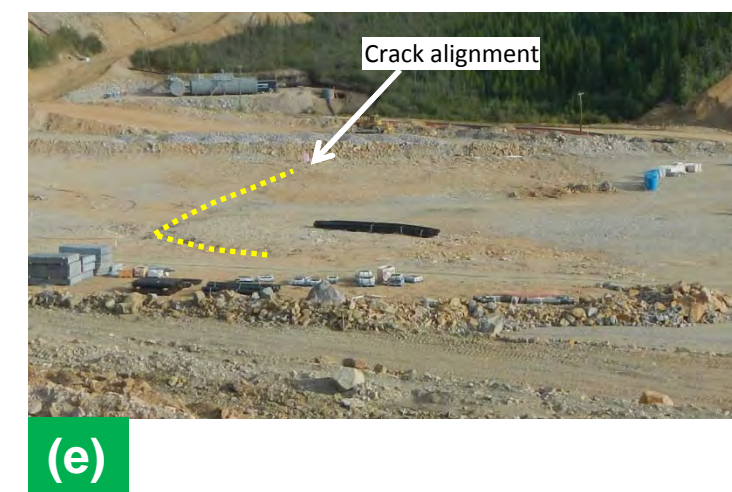
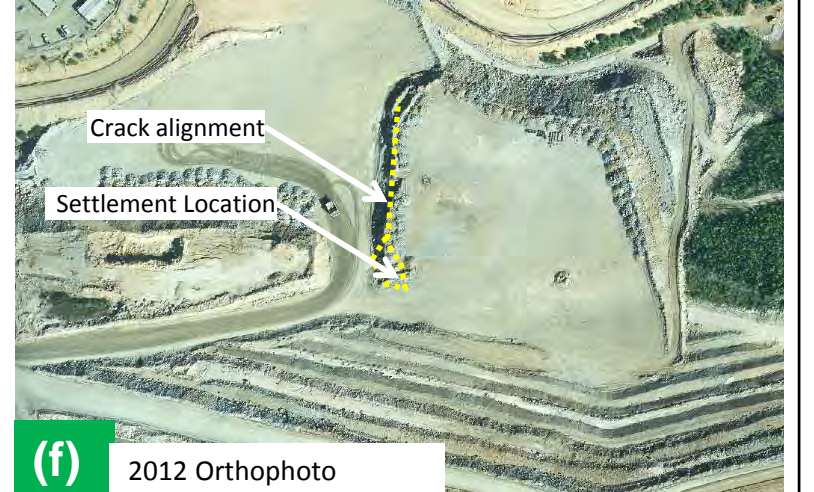
- Photos (a) and (b) show the condition of the waste rock shell and slopes. The slopes appear consistent with original placement: no signs of slumping, bulging or tensions cracks were observed.

- Photos (c) to (e) show an area of differential settlement and cracking on the Mill Valley Fill Extension.
 - The area of settlement at the south end of the crack measures 15m x 22 m with a depth of up to approximately 0.6 m.

- The locations are plotted below over the 2013 orthophoto as well as the 2012 orthophoto (Photo (f)).
 - Comparison of the settlement and crack alignment to the 2012 surface has shown that the alignment corresponds to the crest of a lift of the Mill Valley Fill Extension that has since been filled in.

- The settlement and cracking is believed to be caused by differential settlement between the two lifts placed at different times. The newer lift may be settling within the coarser material at the older outer bench face. If the new lift was placed during winter, snow may have also been present on the slope that has now melted.

- The settlement area should be graded and filled in.

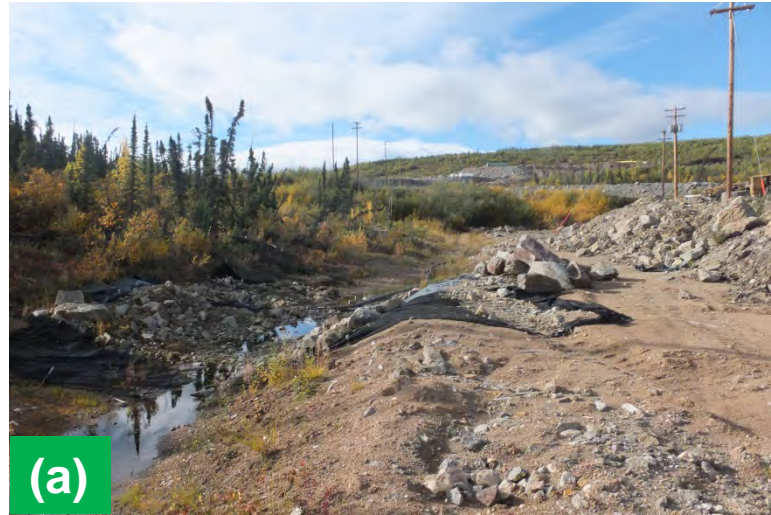
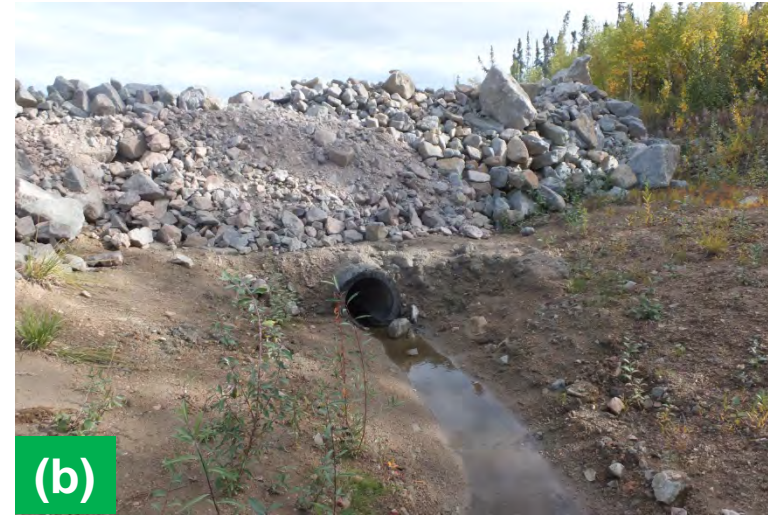
1 Dry Stack Tailings Facility – Tailings Diversion Ditch

- Since the May 2013 inspection, the eastern portion of the Tailings Diversion Ditch is being upgraded as per the EBA design outlined in the memo, “Upstream Water Management for the Mill Valley Fill Expansion and Dry Stack Tailings Storage Facility” dated 2011.
- At the time of the inspection, a road was being constructed along the new alignment in the downstream (eastern) portion of the channel. The TDD was blocked at the location noted in photo (b) and flow is directed into a 0.49 m diameter pipe to old eastern portion of the ditch shown in photo (d).
- In general, the remaining western portion of the berm and ditch upstream of the pipe intake was functional, with conditions similar to those observed in previous inspections. No signs of instability other than minor tension cracking along the berm side of the ditch over a significant length of the ditch.

- (a) An energy dissipation area at the upstream portion of the ditch at the end of a 3” pipeline from the South Diversion Ditch Area. The rip-rap in the ditch is underlain by layers of geotextile and liner. The area remains unchanged compared to 2012 photographs.
- (b) View of the temporary ditch block and pipe intake.
- (c) View of the eastern portion of the ditch downstream of the new road construction. Conditions along the old eastern portion of the ditch remain the same as previous inspections with the ditch not functioning effectively.
- (d) View of the new road construction looking east.

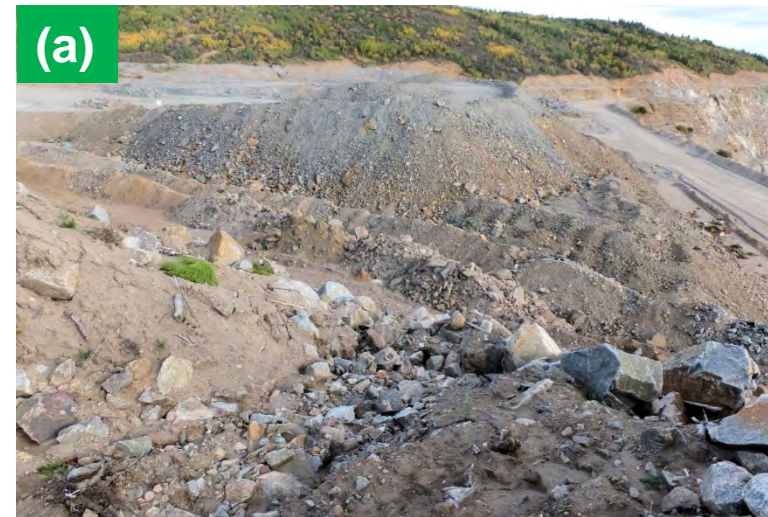
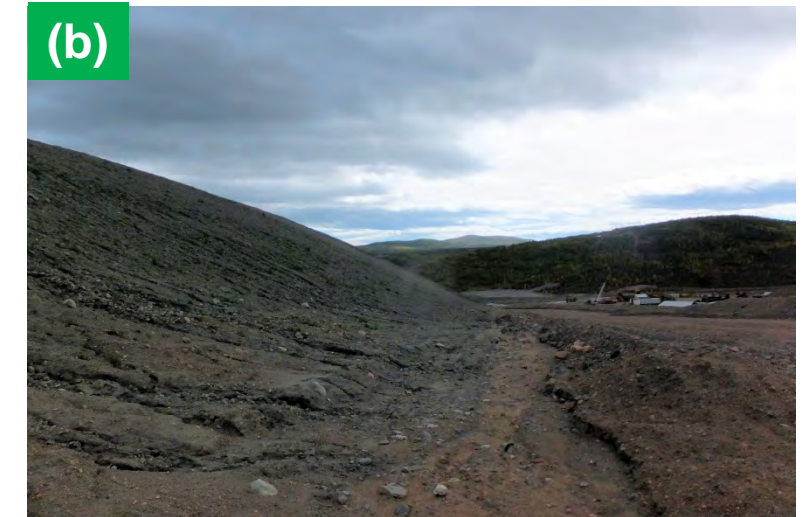
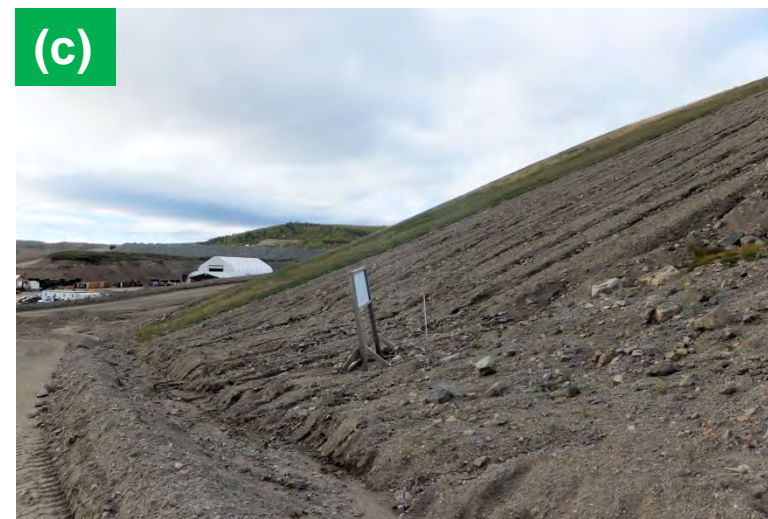
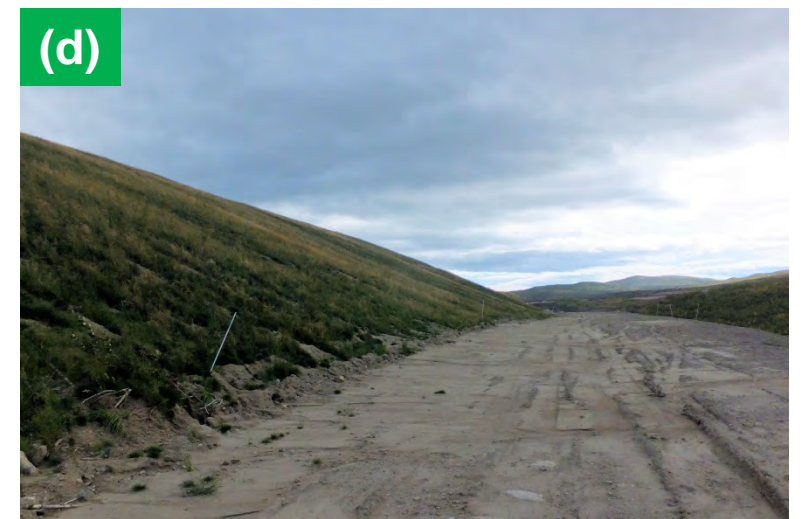
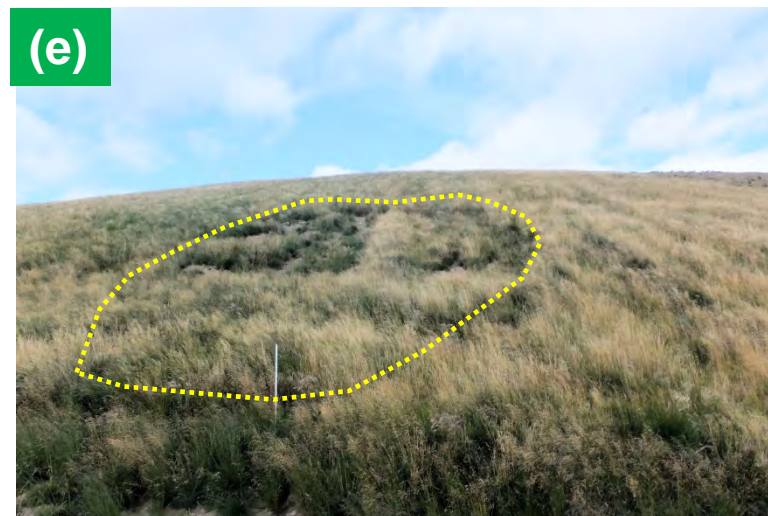
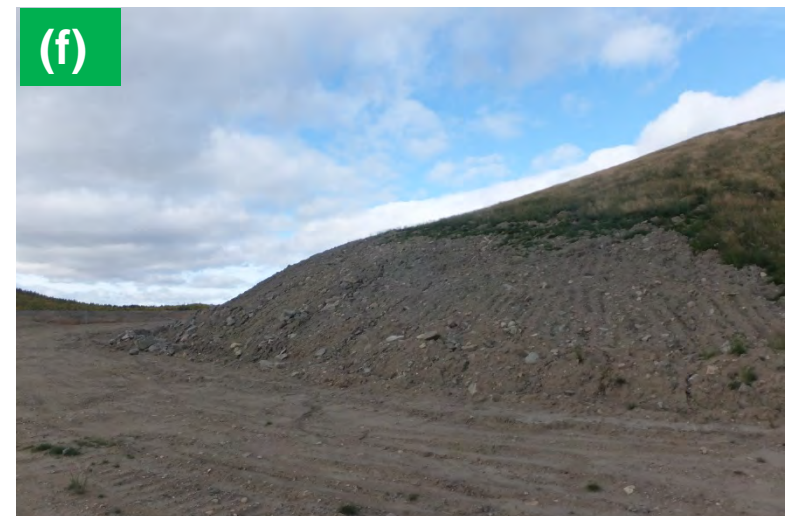
- Reclamation activities at the dump were completed between 2011 and 2012 with re-contouring of portions of the dump slopes. The regraded area is noted in the plan below. The regraded slopes have been covered and revegetated with different vegetation prescriptions placed on different portions of the cover.

- The tension crack noted in the 2011 and 2012 inspection at the location noted in the plan below was not observed during two 2013 inspections. The crack may have been hidden by vegetation or self-healed.

- Photo (a) view of the Oxidized Ore Stockpile. The tension crack observed near the crest during the spring 2013 was not observed during this inspection.

- Photos (b) and (c): View of the dump toe. Minor rills and gullies are present at the base of the regraded slope where vegetation is not yet established. No signs of instability were observed.

- Photo (d) shows the mid-bench toe.
- Photo (e) shows the small surficial slough noted in previous 2012 and spring 2013 inspections. The slough is contained within the cover material. Minor bulging is present at the base of the slope. No action is required.

| Area | Appendix A Figure # | Recommendation |
|--|---|---|
| Main Waste Dump | 5 | As part of regular site inspections, continue to monitor the slough location and the area where tension cracks were noted in the 2011 and 2012 inspections. Check for signs of additional movement or instabilities. |

- The slough, as well as the area where tension cracks were noted in the 2011 and 2012 inspections should continue to be monitored as part of regular site inspections for signs of additional movement or instabilities.

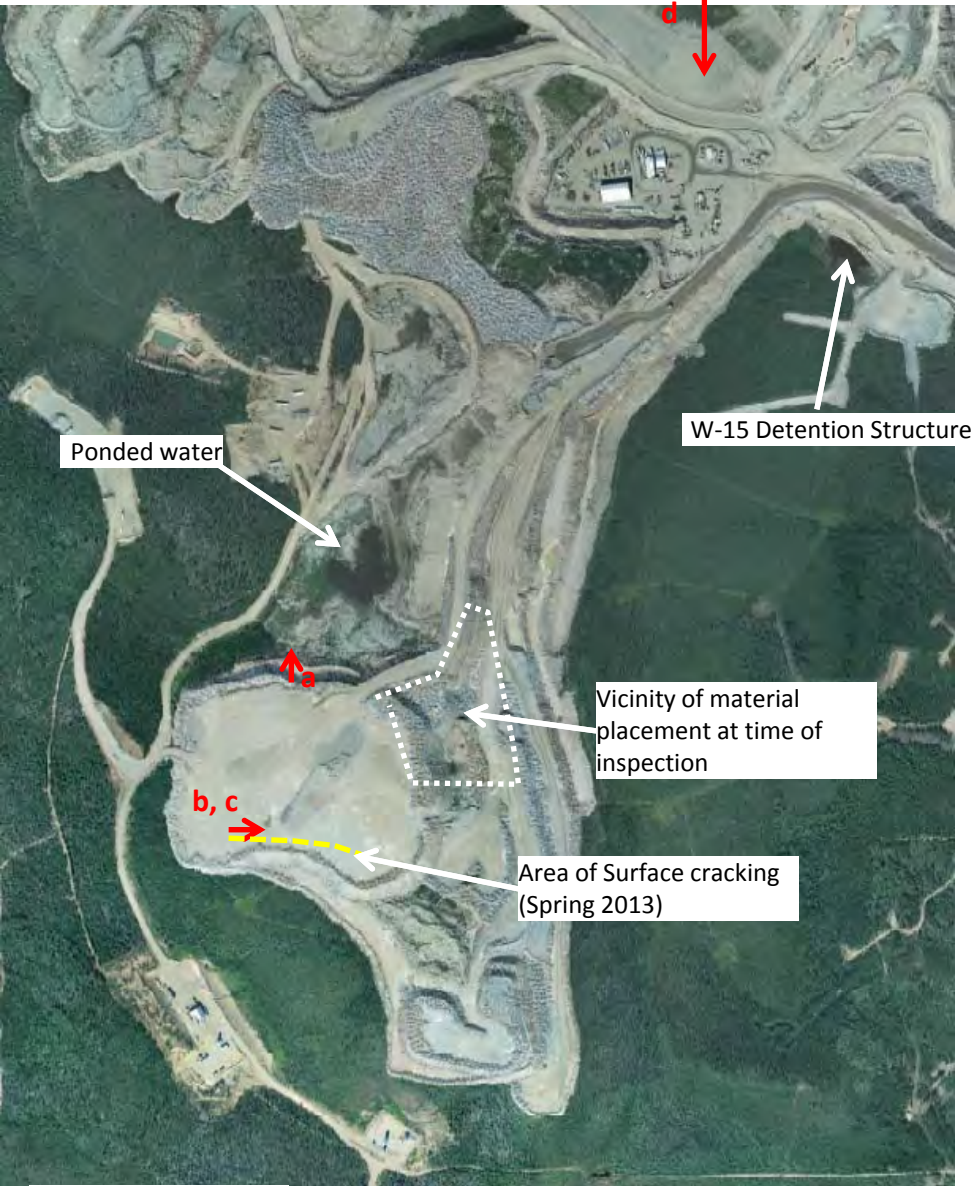
- During the Spring 2013 inspection, tension cracks were observed in the southern end of the dump in the location noted on the plan and noted in photo (b). Since the last inspection, the area has been graded and the cracks are no longer visible. The cracks were offset from the crest by approximately 5 m and extend over a distance of 60 m in total. The crack is 20mm wide at the widest location.

- No signs of instability (slumping, bulging, tension cracks, differential settlement) were observed. Erosion was observed at the outlet of the culvert located north east of the dump (see Figure 8).

- Construction of the dump appears to be in accordance of the method described above.
- Safety berms were present throughout the dump.
- Ponded water was observed in one location (Photo (a))

| Area | Appendix A Figure # | Recommendation |
|--|---|---|
| | 6 | One large ponded area of water was noted. Before placing the next lift, regrade this area to promote runoff. |

- Prior to placement of the next bench in the ponded water area, the area should be graded to promote runoff and drain the water.
- Crests on the larger lifts should be monitored
- Equipment should not be stored within 5m of the crest.

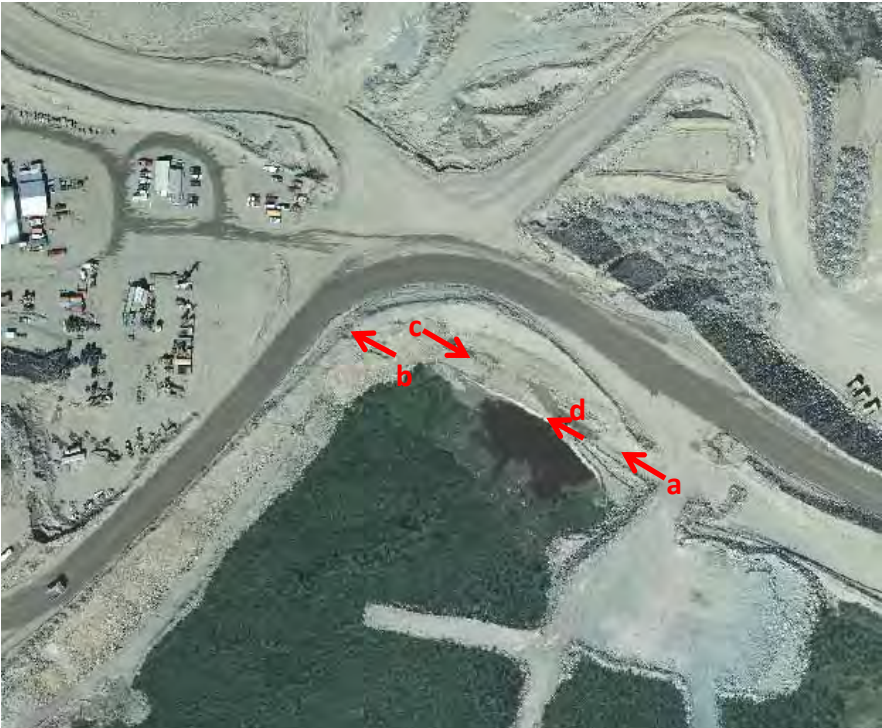
- Large diameter boulders have been placed on the slope below the culvert to mitigate erosion. The appearance of the rip-rap/boulders downstream of the culvert are unchanged compared to previous photos taken in 2012 and Spring 2013.
- Sediment is accumulating inside of the culvert, with some cobbles present with diameters up to 8 inches observed. No change was observed compared to the Spring 2013 inspection.

Photos (c) and (d) show the W-15 Detention Structure Area. The conditions of the area are the same as that reported in 2012.

| Area | Appendix A Figure # | Recommendation |
|--|---|---|
| | 7 | Continue to monitor erosion at the culvert outlet located near the W-15 Detention Structure and maintain a photographic record to inspect for changes in condition. |
| | 7 | Continue to monitor sediment accumulation in the culvert at the inlet and outlet. Maintain a photographic record to inspect for changes in condition. |

- Continue monitoring of sediment accumulation in the culvert and erosion at the outlet. A photographic record should be maintained to inspect for changes in condition.

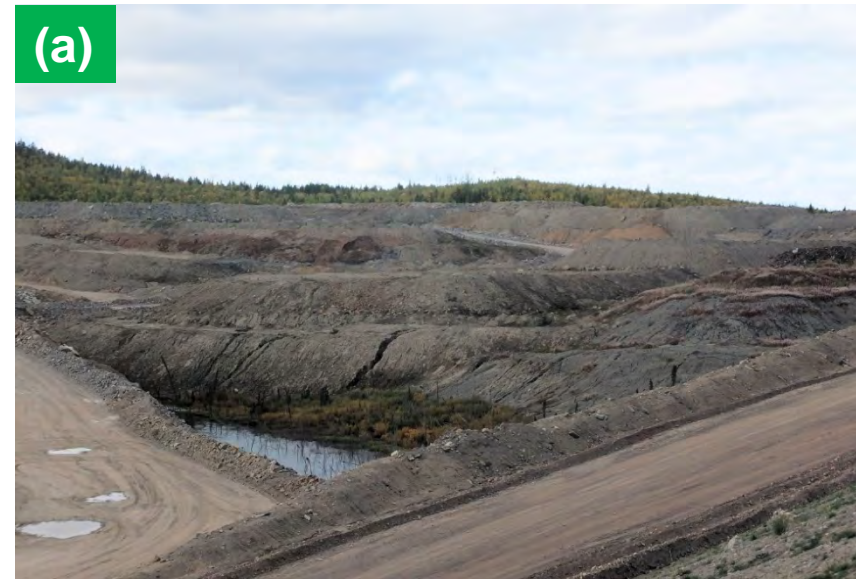
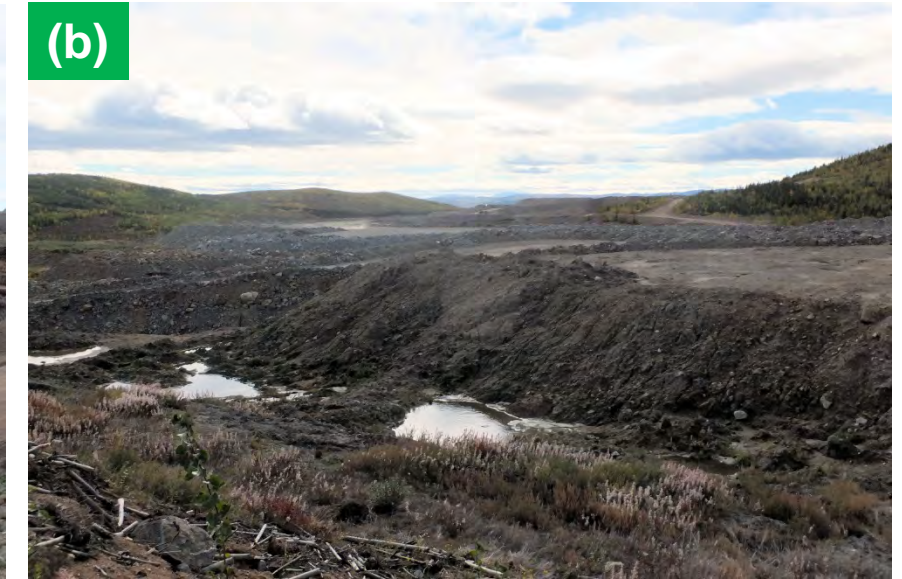
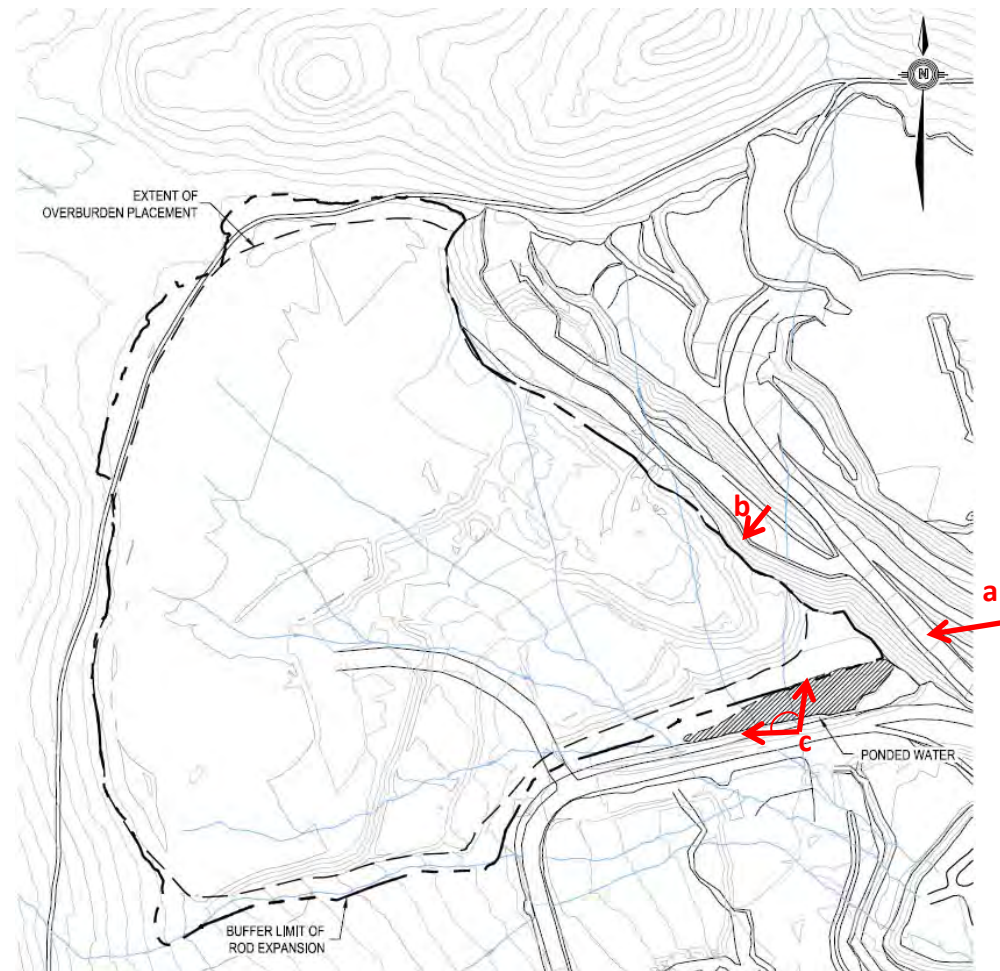
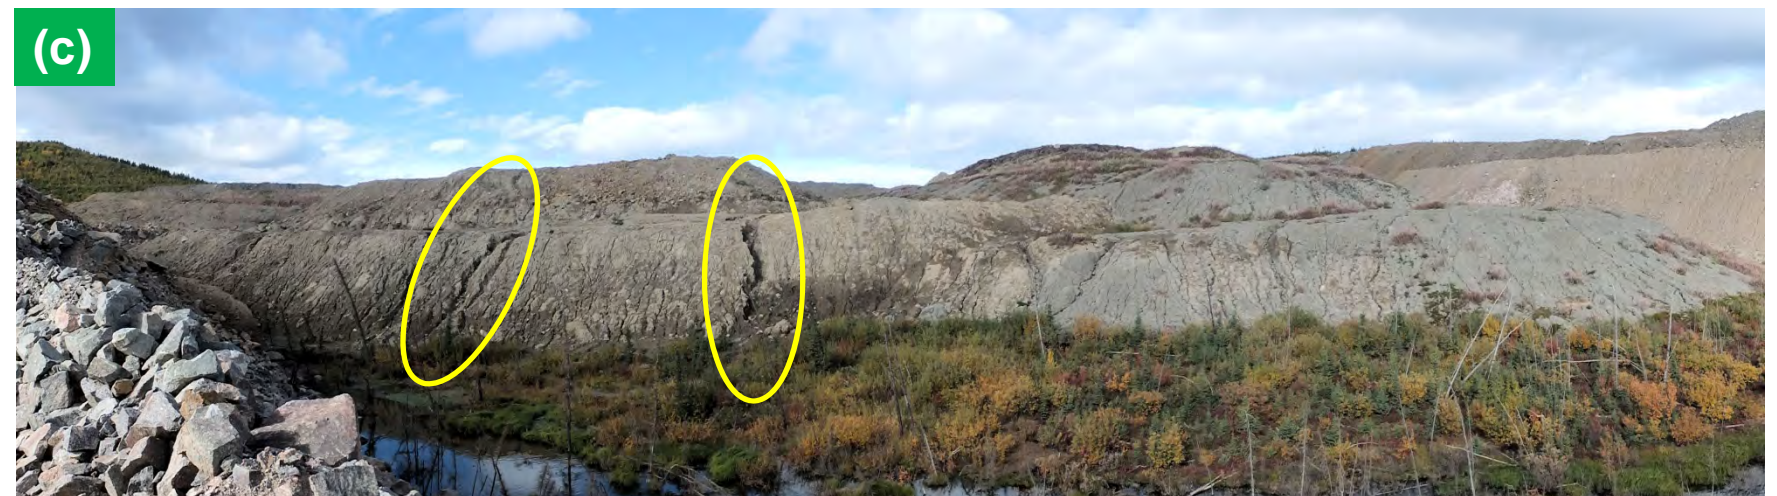
- Conditions of the dump are similar to conditions reported in the 2012 and spring 2013 site inspections. Slumping, settlement and tension cracks are expected in the dump as it is constructed with frozen overburden with thawing expected.
- There is localized slumping of the perimeter slope. Discontinuous tension cracks and differential settlement observed along the perimeter crest. Ground undulation is typically 0.3 m and is prevalent throughout the facility.
- Photos (a) and (c) provide an overview of the ROD and the ponded water adjacent to the Dyno Access Road southeast of the ROD. Two small erosional channels were observed (circled in yellow) to be in similar condition as reported in previous inspection.

- Installation of a rip-rap channel down the slope to minimize slope erosion. Areas near the exiting erosion channels should be regraded to direct runoff to the rip-rap channel.
- Monitoring of the ponded water to ensure that the offset from the dump toe is maintained as stipulated in the design report.
- The toe of the dump should be surveyed annually to confirm it is within the permitted boundary.

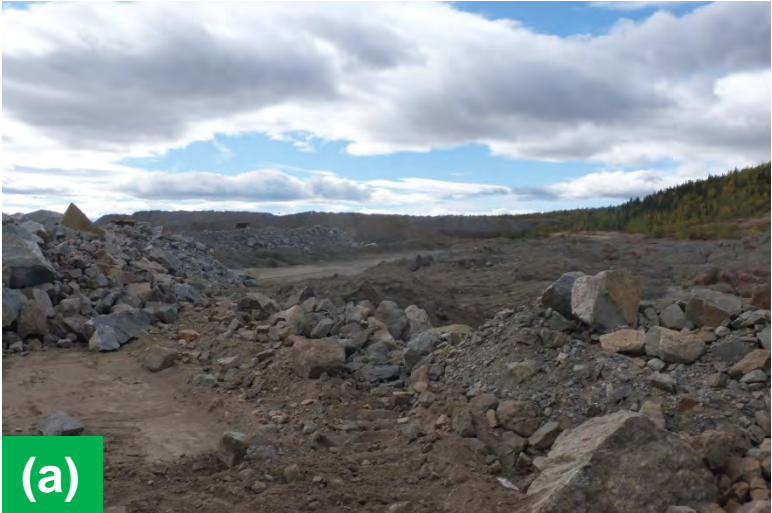
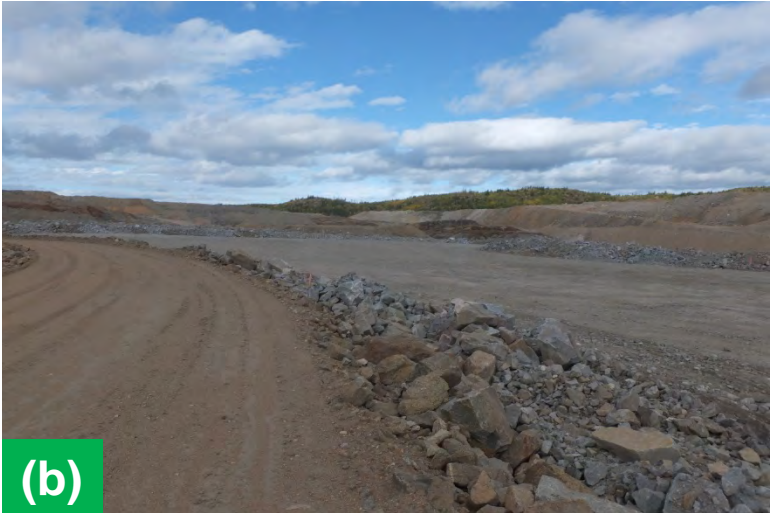
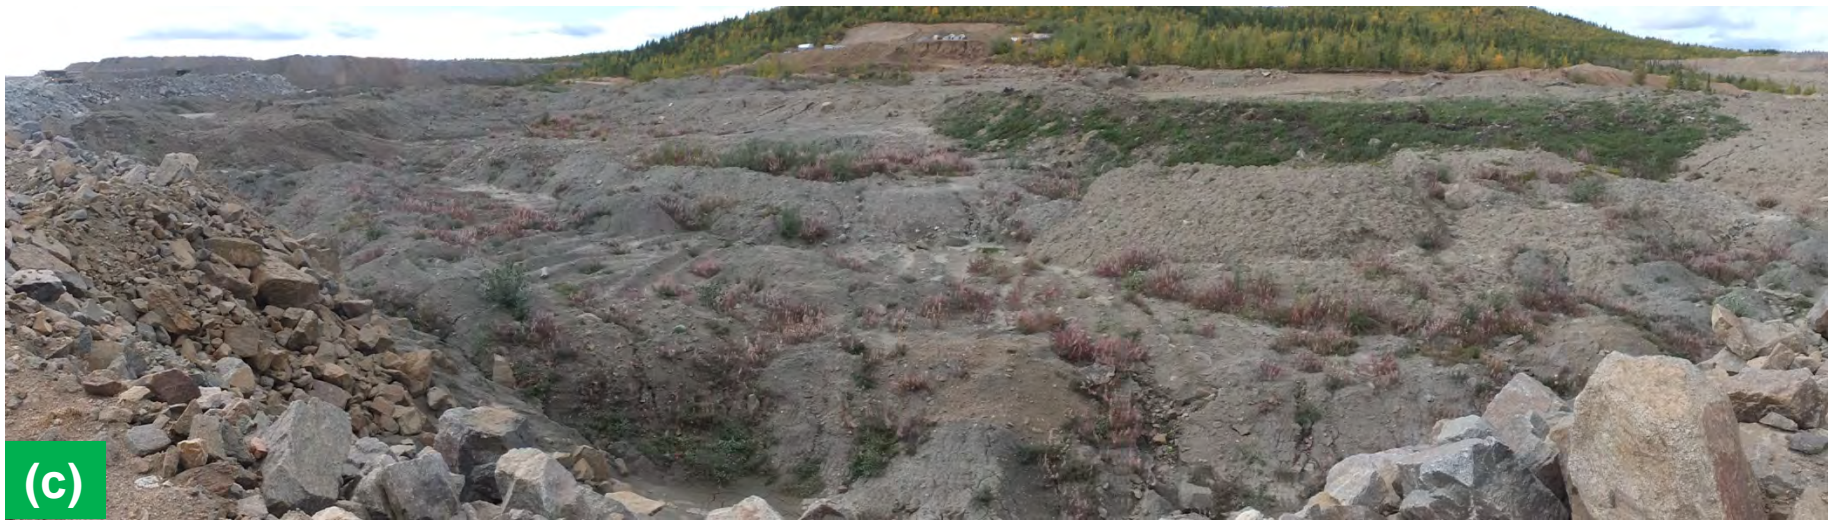
5 Ice Rich Overburden Dump

- A containment berm constructed of coarse waste rock is present on the north, east and south sides of the dump.
- Since the previous inspection in May 2013, additional waste rock has been placed outside of the berm up to the berm crest elevation as part of the Southwest Waste Dump Expansion (Zero and Low Grade Waste).
- Photos (a) and (c) shows the material placed inside of the berm.
- Photo (b) shows the newly placed waste material outside of the berm.
- No signs of instability were observed along the containment berm.
- No pooled water was observed against the berm. A minor amount of pooled water was observed during the freshet inspection and it appears that water inside of the berm is still able to drain through the berm to the outside of the facility.

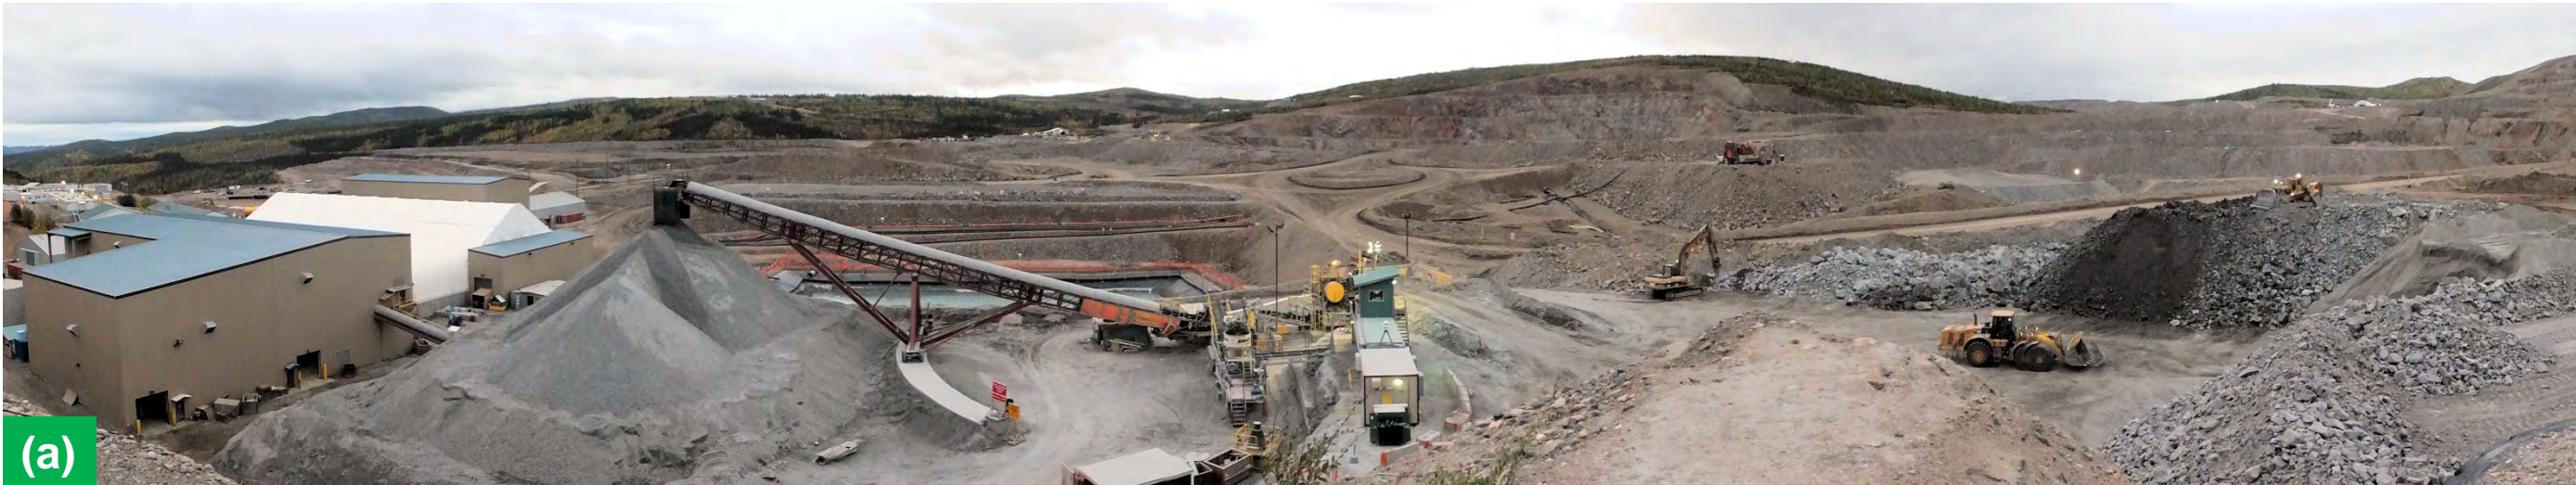
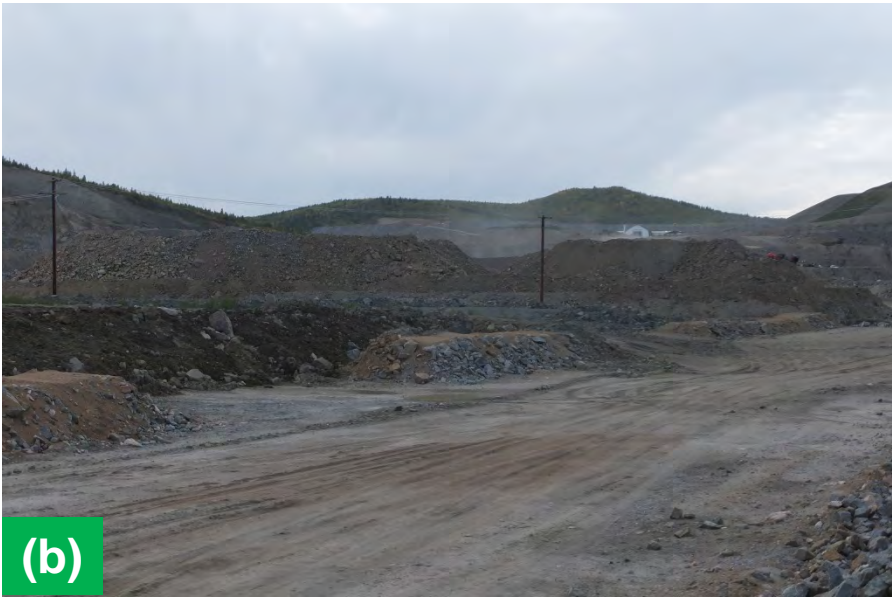
6 Ore Stockpiles

- The ore stockpile area was investigated briefly in passing. All slopes appeared in good condition: no slumping, bulges, cracks, or other signs of instability were observed.

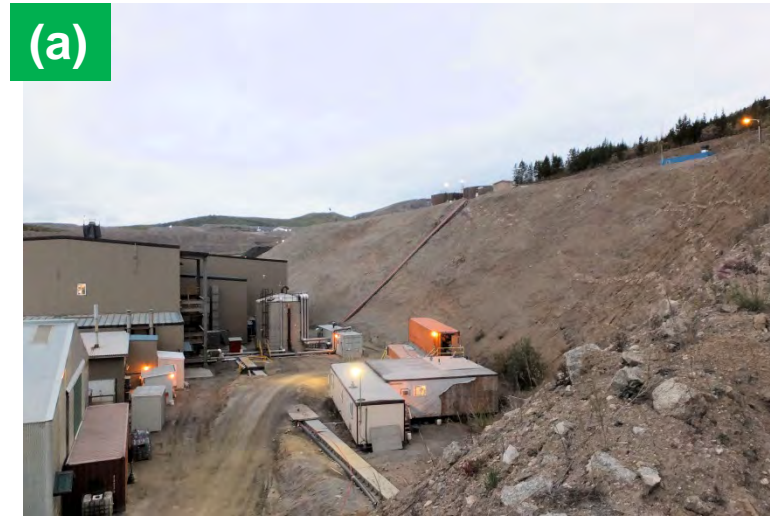
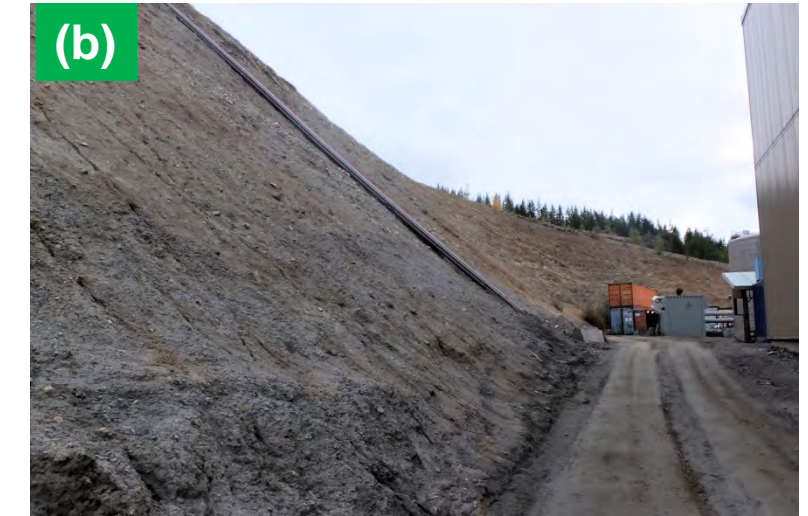
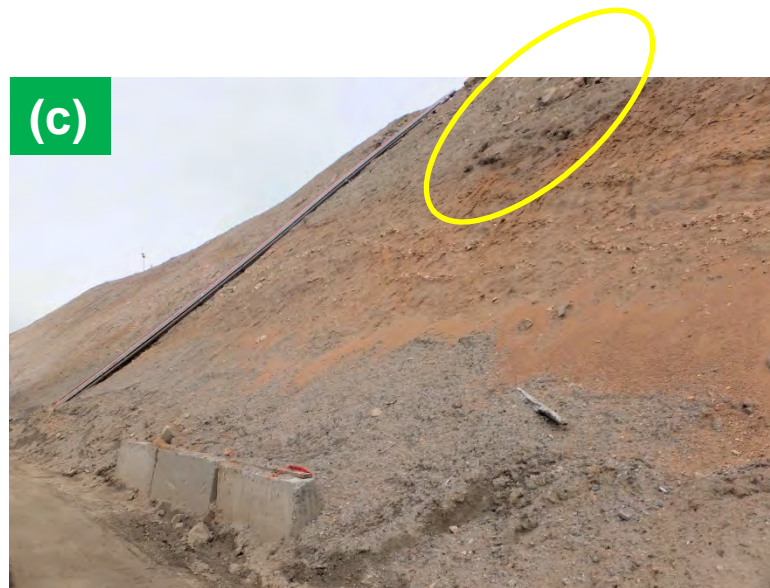
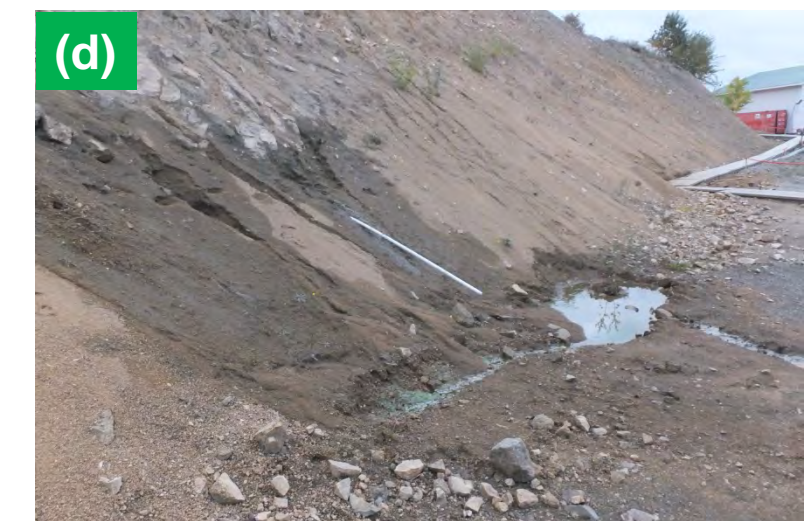
Conditions of the mill area are the same as those reported in the 2011 to Spring 2013 site inspections.

- a) Slope above the main mill site appears stable.
 - Safety berms at the top of the slope are in good condition.
- b) West end of the mill slope looking east. Eroded sand/gravel is generally present at the base of the slope with occasional cobbles/boulders up to 300 mm.
- c) As noted in previous inspections, a small slough is present near the center of the slope approximately 10 m east of the electrical corridor. The 2012 inspection noted some larger rocks that have raveled down the slope and the concrete barriers at the toe were approaching the capacity for containment. The area around the concrete barriers appear to have been cleared with the large rocks removed.
- d) East end of the mill slope looking east. Two small seeps observed at the same location as noted in previous inspections. The seep location is noted in the plan below.

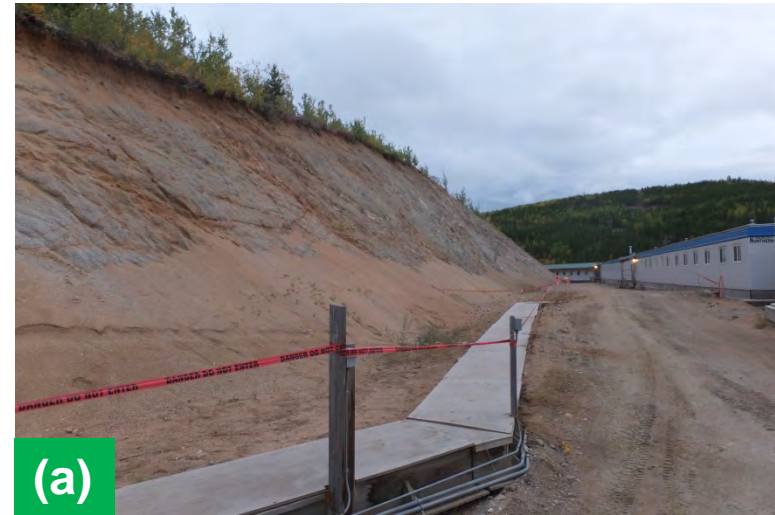
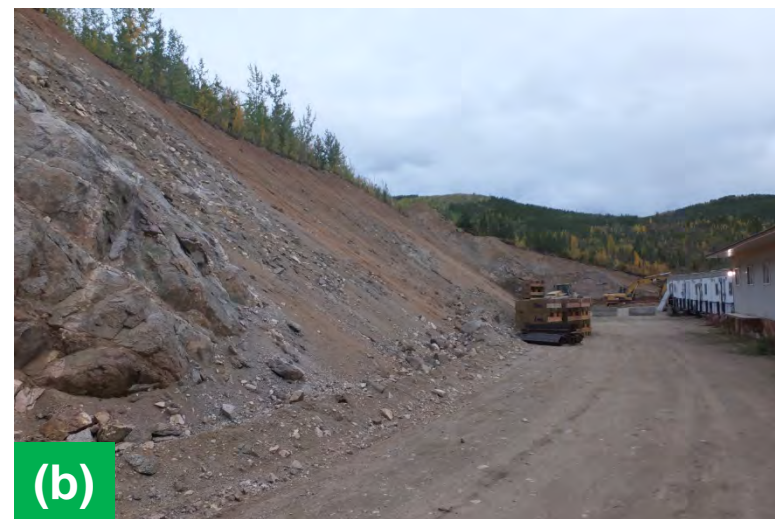
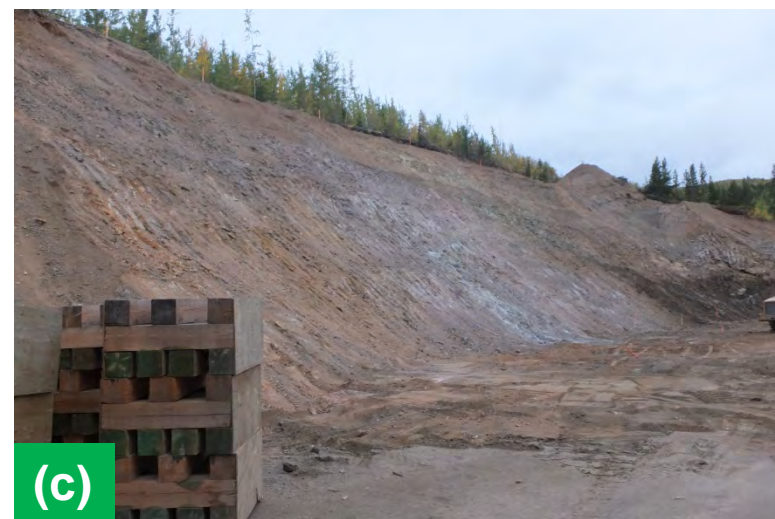
7 Mill and Camp Site

- a) & b) Slope above the main camp site appears stable.
 - Eroded sand/gravel is generally present at the base of the slope with occasional cobbles/boulders up to 300 mm.
- c) Since the spring inspection, this slope has been further excavated as part of camp expansion. No signs of instability in this area.
- d) Erosion channels present south of the camp site pad near the flags. No changes compared to the photographs taken during the 2012 and Spring 2013 inspections.
- e) & f) Erosion channels present south of the camp site near the carpenter's shop. Conditions are similar to the spring 2013 inspection. Compared to 2012, the scarp of the erosion channel appears to have receded and undercuts the utilidor. Actions are required to prevent further erosion of the area.

Note: Since the 2011 inspection, fill was placed below the main access road as part of the Mill Valley Fill pad that have covered over the erosion channels noted in the figure below.

- The area above the erosion channels on the camp pad should be regraded to promote runoff away from the channels.
- The channel by the carpenter's shop should be filled with rip-rap or a "half culvert to provide a path for the water to drain". It appears that no action has been taken in the past year and that further erosion channels have developed.
- It is recommended that these actions be completed in the following year. In place of the surface grading, a small ditch could be constructed near the slope crest to direct runoff to the drop channel or half-culvert.
