2013 Geotechnical Annual Review, Minto Mine, YT

Minto Explorations Ltd.

SRK Consulting (Canada) Inc.
1CM002.012.005
October 2013

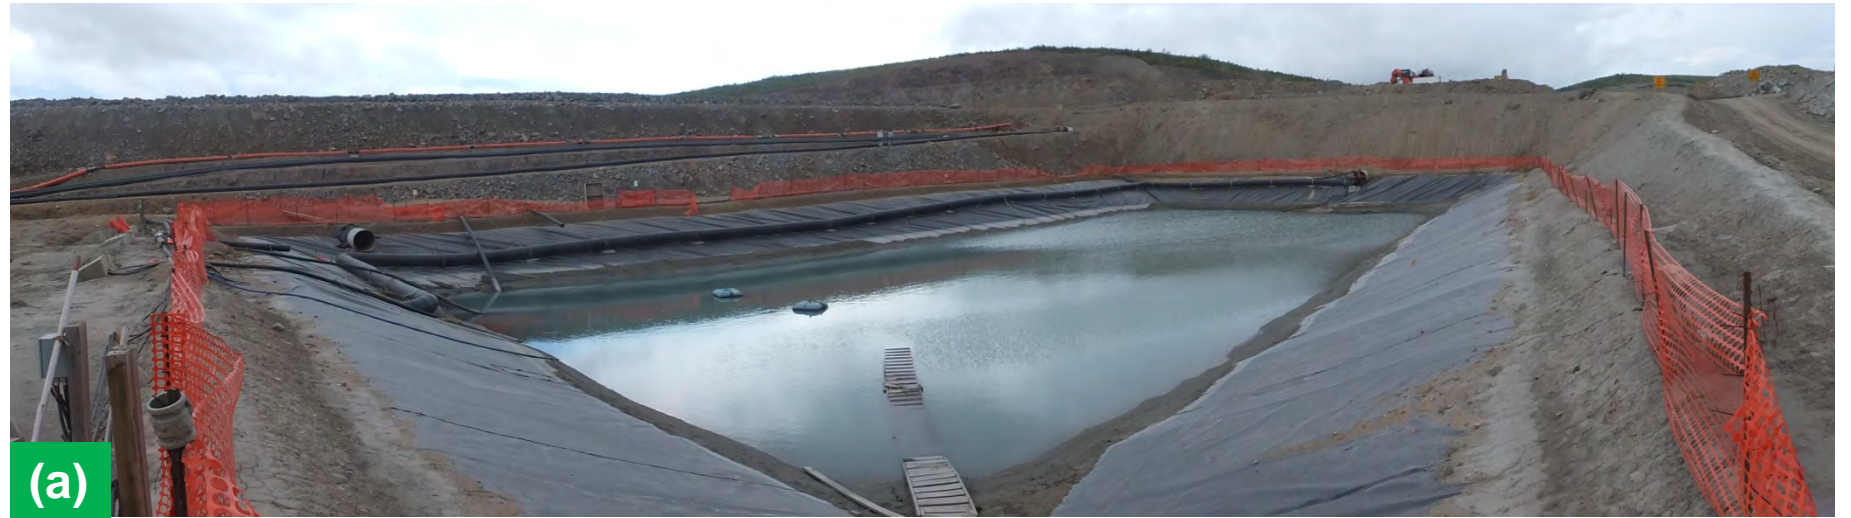
(a)

Conditions of the Mill Water Pond are unchanged compared to the 2012 and Spring 2013 inspection.

- a) Panoramic view of the mill pond. Tears in the liner system are the same as that reported in the previous inspection. No new tears or liner defects were observed.

- b) View of the tear in the liner at the north corner of the pond. The tear is approximately 1m in length and first noted in the 2008 inspection.
- c) Two tears in the liner midway along the northeast edge of the pond. These tears were first observed in the 2009 inspection. The largest tear is approximately 1.5m in length and is parallel to the slope. The smaller tear (white arrow) is approximately 0.5m in length and is orientated across the slope. A void is present beneath the slope that in previous EBA inspections has been noted to be increasing in size due to water penetration from surface.

- d) View of the south east side of the pond and by-pass pipe.
 - The bypass pipe and metal clamps are resting on pieces of plywood, while the 2011 review notes that they were resting directly on the liner. Placement on plywood is an improvement, but particular attention should be made at each support for liner damage in future inspections.

- e) View of the inlet culvert on the east side of the pond with a small flow of water entering the pond.

| Area | Appendix A Figure # | Recommendation |
|---|---|---|
| | 13 | Continue to monitor the condition of the liner under the by-pass pipe supports. |

- The liner tears should be patched the next time a liner crew is onsite. For the liner tear noted in Photo (c), Figure 14, sand should be placed to fill the void beneath the tear.
- The liner condition beneath the bypass pipe supports should continue to be monitored.
- The sediments accumulated in the surface runoff ponds and culverts should be cleaned out.

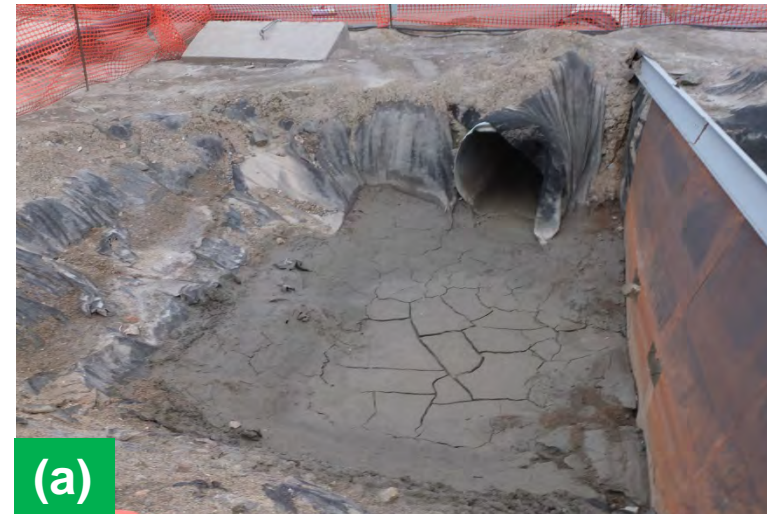
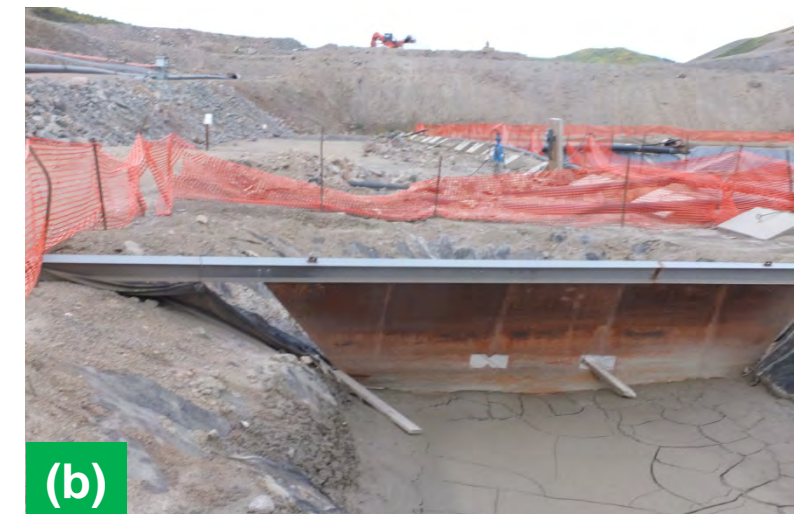
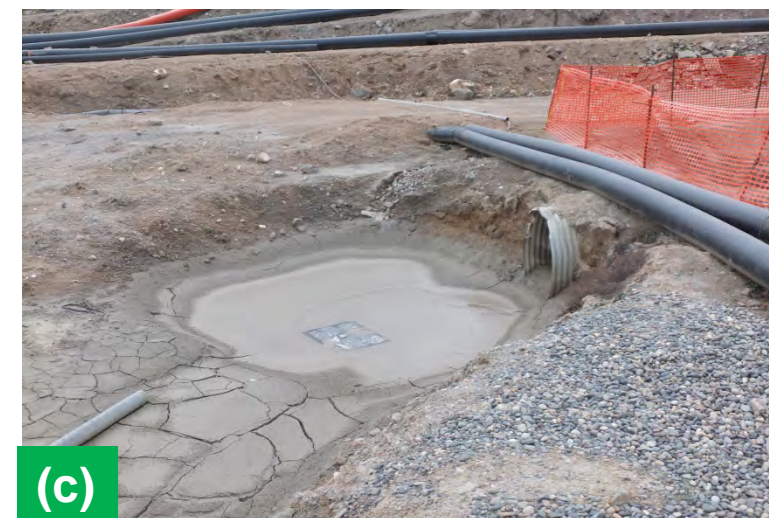
- Photos show the condition of the surface runoff ponds south east of the mill water pond. Conditions are unchanged compared to the 2012 and spring 2013 inspections.
- There are significant sediments in both ponds, each culvert, and outside the ponds to the east. It is recommended that each pond/culvert be cleaned.

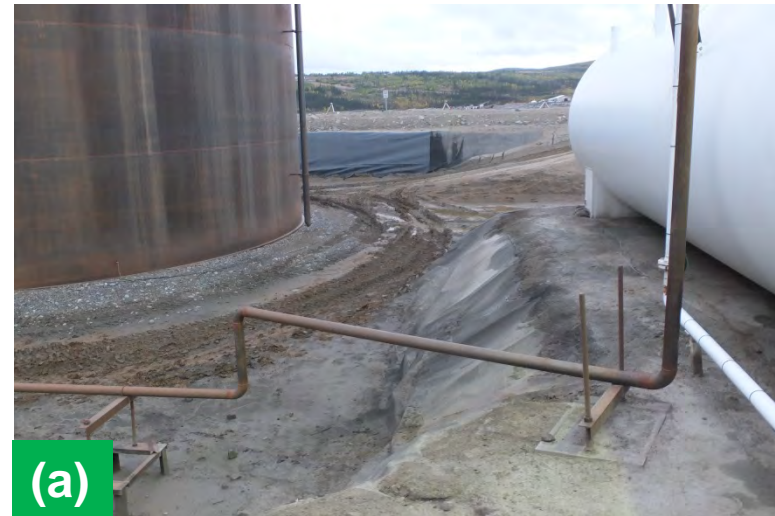
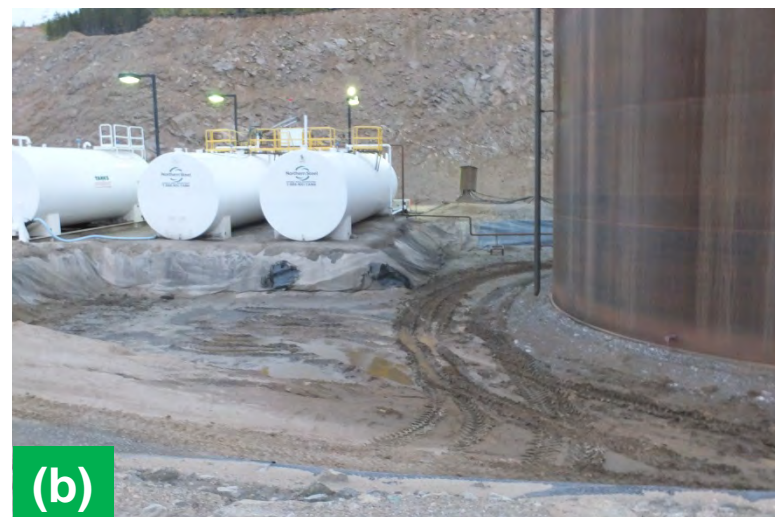
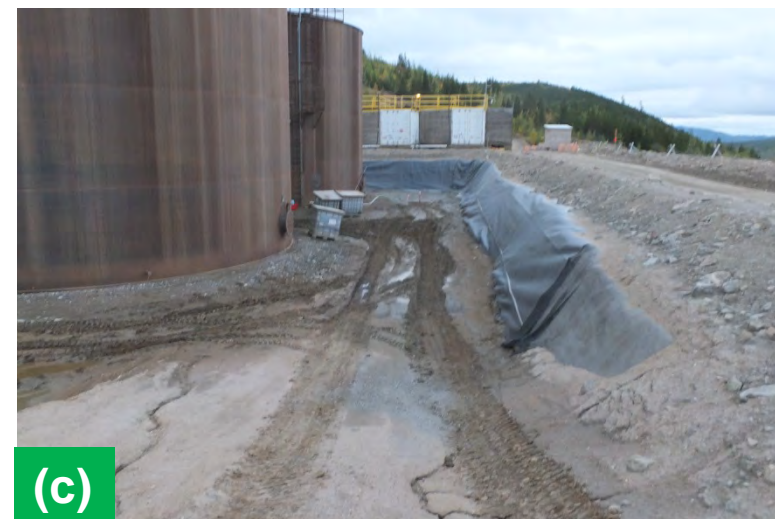
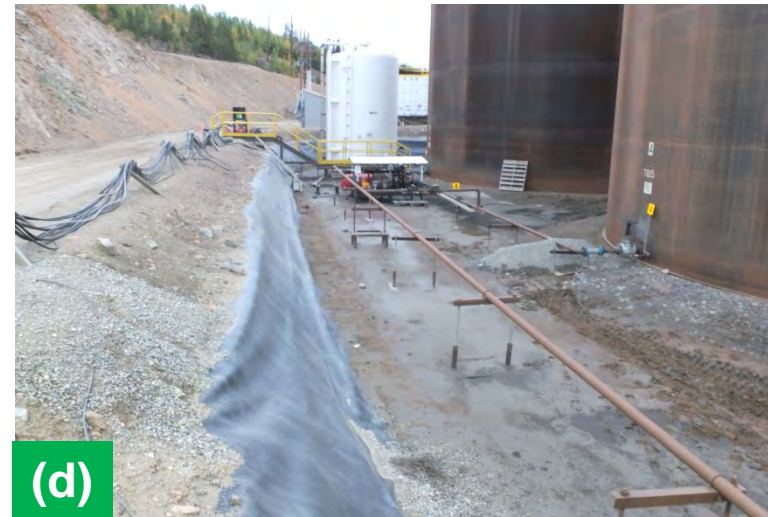
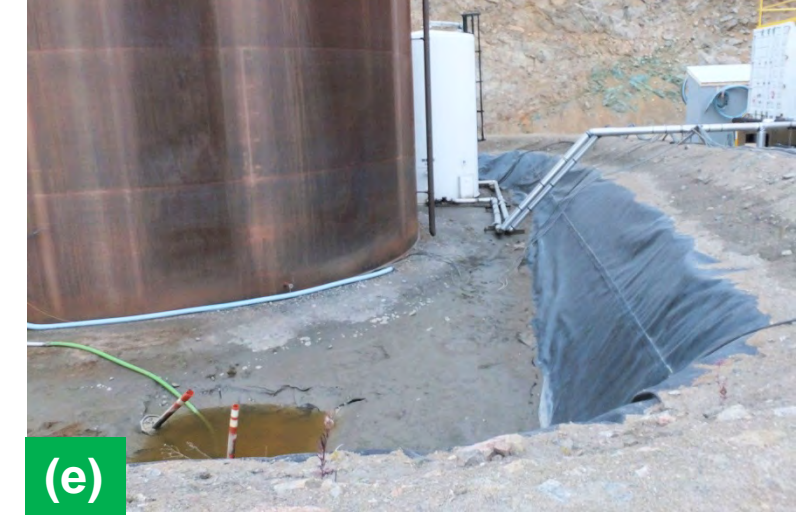
9 Fuel Containment Facility

- Photos (a) to (e) show the condition of the liner on each side of the facility.
- Conditions of the facility appear to be the same as reported in the 2012 review.
- No tears or defects in the liner were observed.
- Since the Spring inspection, the water level has lowered, with water only present in the sump in the SE corner of the facility. The facility appears to drain into containment area as per design.
- Additional ruts are present in the southern half of the facility. Rutting is significant (approximately 2-3 inches deep) between the two tanks where equipment was turning. No liner is exposed as a result of the trafficking.

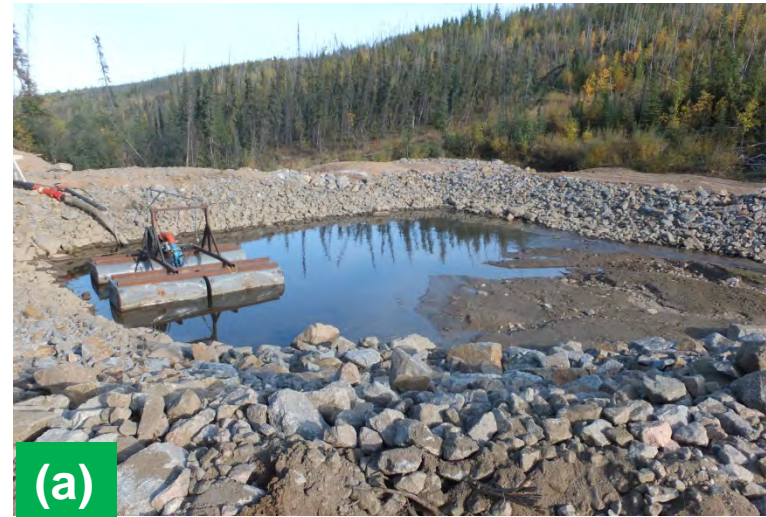
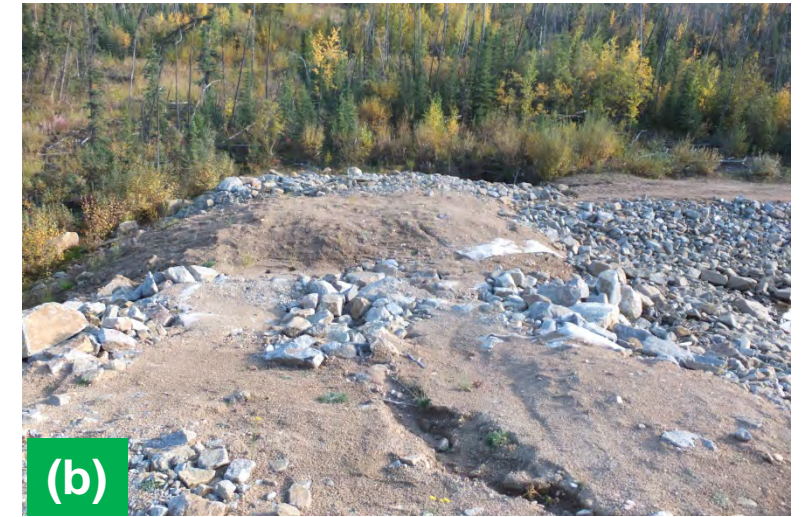
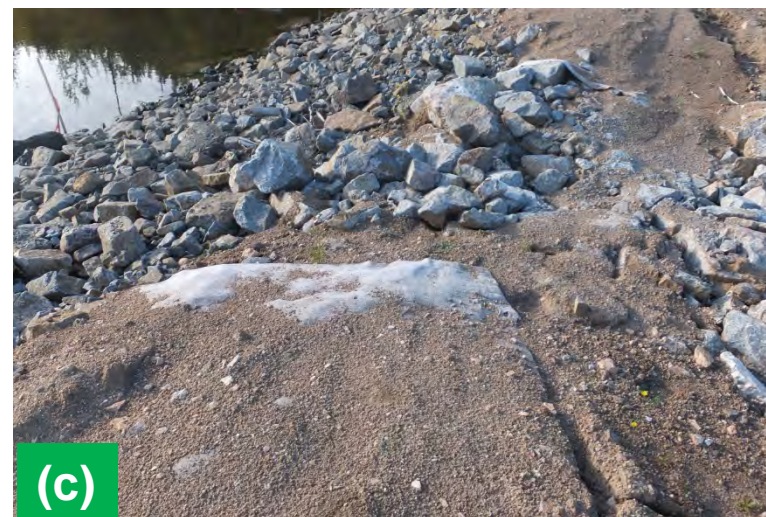
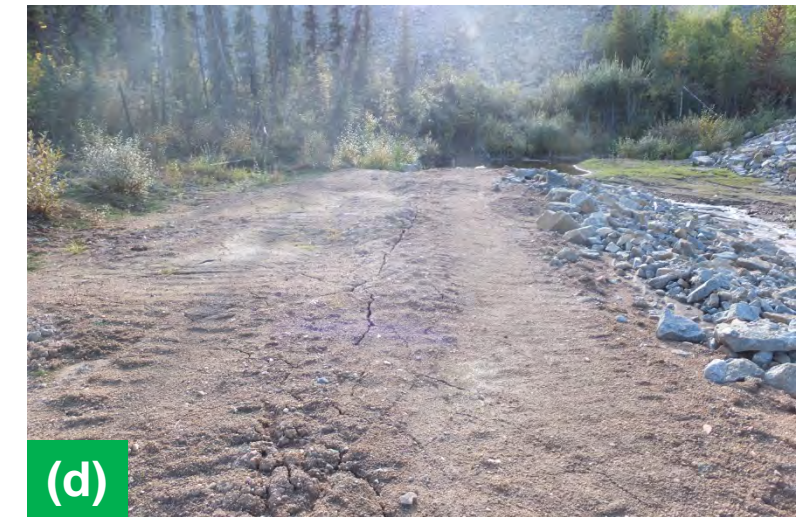
- Significant surface cracking is present along the crest of the south and east side of the structure. No signs of instability were noted along the downstream slopes and no seepage was observed downstream of the MCDS.

- The seepage entering the MCDS from the Mill Valley Fill Extension (MVFE) was clear. There appears to be some sediment accumulation upstream of the structure, however, conditions along the flow path into the MCDS are similar compared to 2012 inspection photographs, and there are no sediments observed immediately downstream of the MVFE toe.

- a) View of the Minto Creek Detention Structure (MCDS) looking southeast.
 - b) View of the downstream side of the MCDS. An overflow spillway can be seen in the center of the photo. Exposed GCL is present on the upstream side of the spillway. A large settlement crack is located on the north side of the spillway, measuring up to approximately 2 inches wide and 2 inches deep for a length of approximately 4m.

- c) Close up of the exposed GCL on the south side of the spillway.
 - d) View of the south side of the MCDS looking west. Settlement cracking is evident along the mid-point of the crest.

| Area | Appendix A Figure # | Recommendation |
|---|---|---|
| | 16 | Remove the three large boulders at the overflow spillway and replace with traffic pylons. |

- Continue regular annual monitoring for further signs of instability or seepage on the downstream slope of the MCDS.

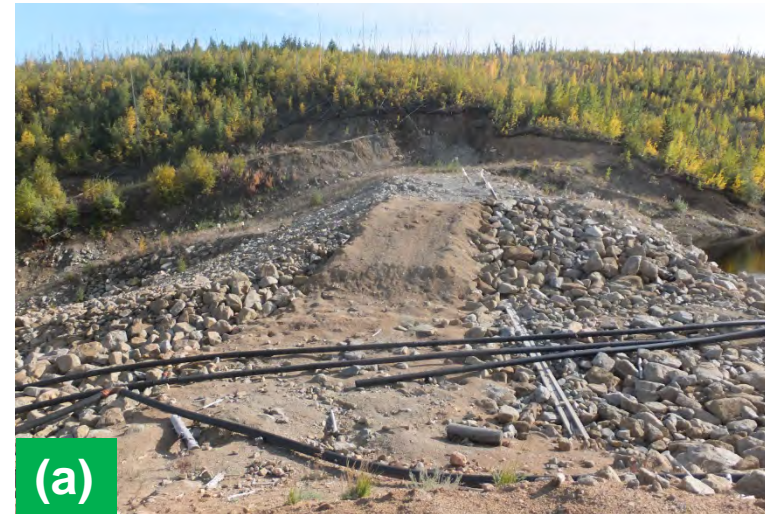
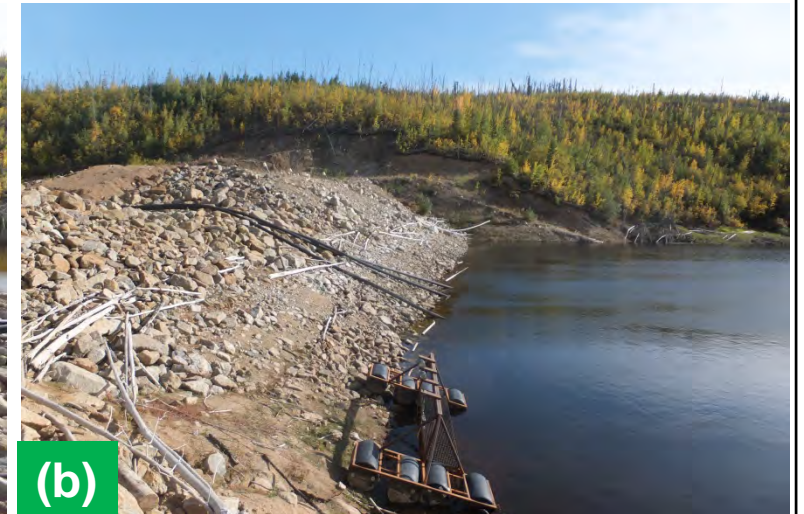
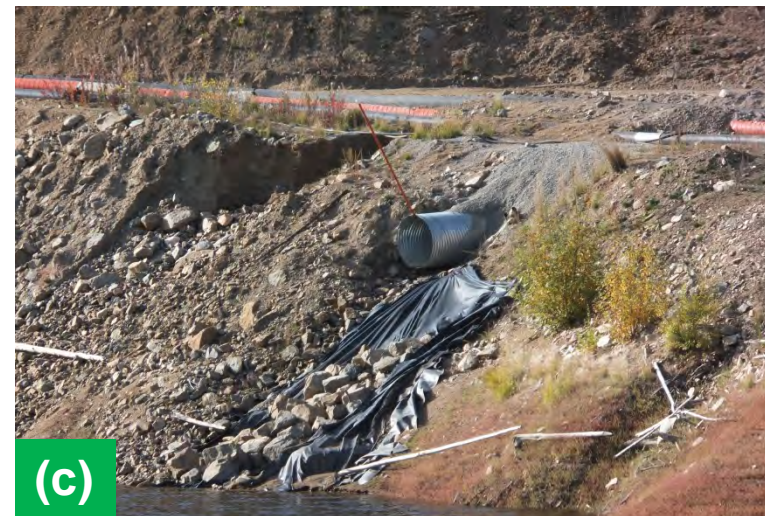
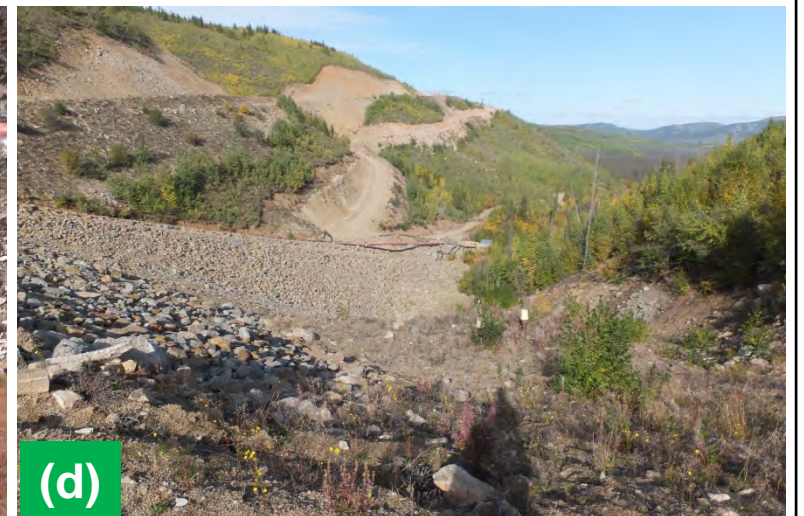
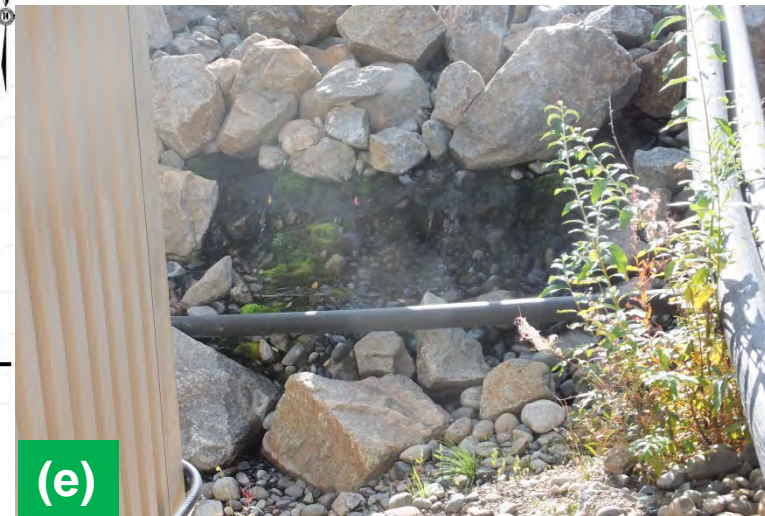
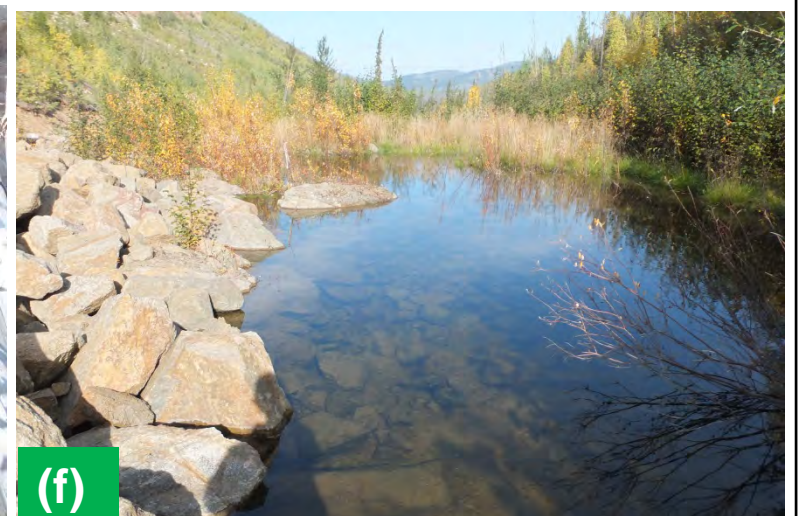
- Conditions of the dam are unchanged since the 2013 freshet inspection completed by SRK in May 2013. The WSP water level is significantly lower than the last inspection and was estimated to be approximately 711m.

- d) View of the downstream slope and spillway. Three 200 mm diameter siphon pipelines are present in the spillway that run from the WSP to the pump house. No signs of instability, settlement or erosion were observed on the downstream slopes or abutment areas.

- e) View of the stilling basin upstream of the seepage pump house. The seepage water was clear with no turbidity. No accumulation of sediments were observed.

- Continue regular monitoring of the dam, noting specifically the clarity of the seepage and flow exiting the stilling basin, and the seepage rate through the weir.
- A review of the seepage pump data and the flow rates measured at W-3 in the seepage pump house indicates that the pump data is influenced by discharge from other sources (the pit, water treatment plant, etc.). Options to obtain accurate seepage measurements should be reviewed. One solution would be to move the discharge point of water a minimum of 20 m down stream of the sump. The issue should be resolved prior to 2014 spring melt
- The current version of the Operation, Maintenance, and Surveillance Manual for the dam was last updated in 2008. Many of the emergency contacts listed in the manual are out of date. It is recommended that the manual be reviewed and updated.

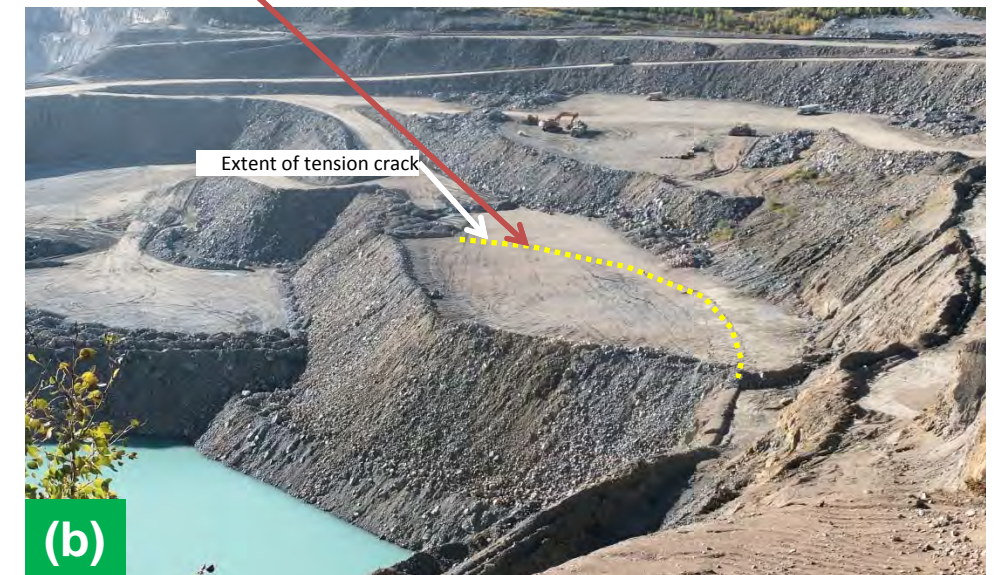
(b)

Extent of tension crack

| Area | Appendix A Figure # | Recommendation |
|---|---|---|
| South Wall Buttress | 20 | Continue regular monitoring of the surface cracking at the west end of the buttress maintaining a photographic record to inspect for changes in condition. Following completion of the buttress, additional survey hubs should be installed along the crest to monitor movement. |

- The tension crack area should be continue to be visually monitored. A photographic record should be maintained to inspect for changes in condition.
- Following completion of the buttress, additional survey hubs should be placed along the crest to monitor movement.
