# 2013 Freshet Geotechnical Site Inspection, Minto Mine, YT

SRK Consulting (Canada) Inc.  
1CM002.012.005  
July 2013

Project No: 1CM002.012.005

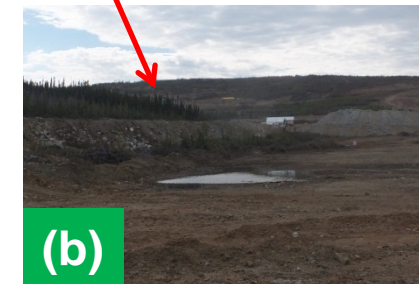
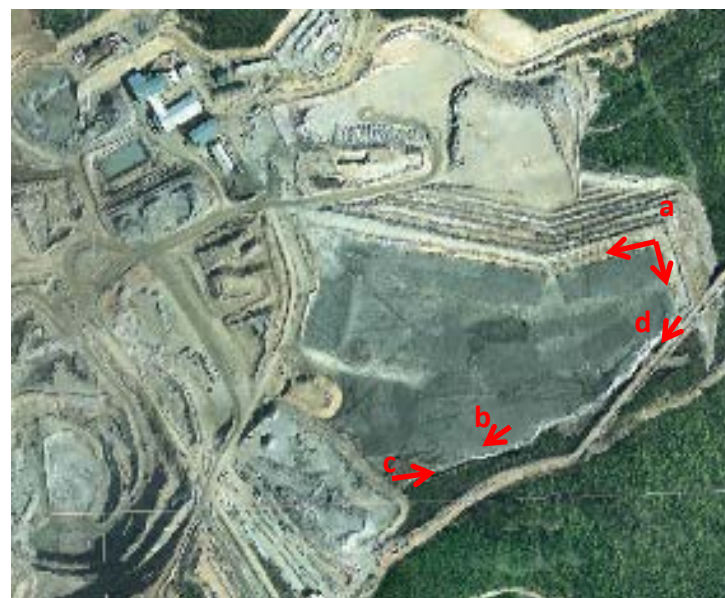
- Since the last inspection, approximately 2 m overburden has been placed over the entire tailings surface. It is understood that this is a temporary cover that was designed to have a 2% grade.
- In general, there are a significant amount of thaw bulbs, surface cracking and differential settlement of the material, which can be expected as the overburden was placed during winter. It is recommended that the surface be regraded in the fall once the frozen material has thawed.
- The pink box near the center of the photo is a protective cover for a recently installed inclinometer.

(b) One small area of ponded water was observed at the southern end of the facility measuring approximately 10m x 5m. The water was clear and likely attributed to recent precipitation events.

(c) Tailings remains exposed at surface on the south slope of the facility adjacent to the Tailings Diversion Ditch. Water was also observed to be impounded against the DSTSF on the south side of the facility at various locations as shown in photos (c) and (d). The water can be attributed to melting snow, recent precipitation and from water not captured by, or flowing under, the tailings diversion ditch. Seep locations and areas where the water was observed to flow beneath the tailings are noted on Figures 4 and 5.

- The recently placed overburden material was placed during winter and will likely experience differential settlement due to thawing of frozen materials over the summer. In the fall, the grading and surface water management of the surface of the facility should be reviewed and areas graded as required to promote runoff.
- The remaining areas of exposed tailings should be covered and the uphill area south of the DSTSF should be regraded as required to control surface drainage, avoid ponding, and limit infiltration of water into the tailings as per Clause 36 and 37 of the water license QZ96-006, Amendment 8.

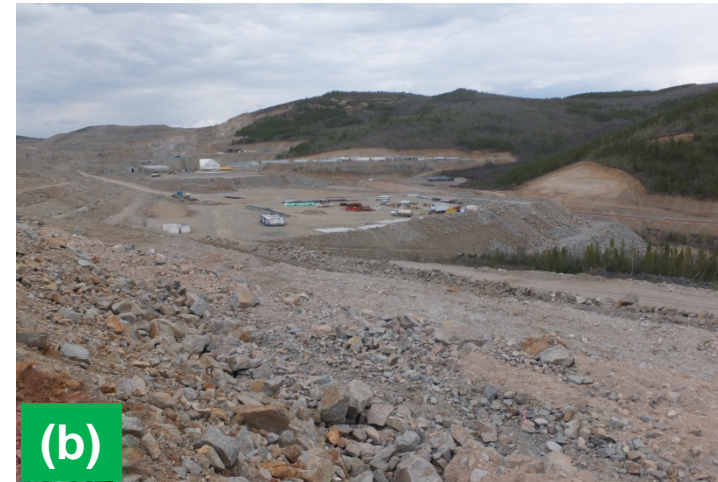
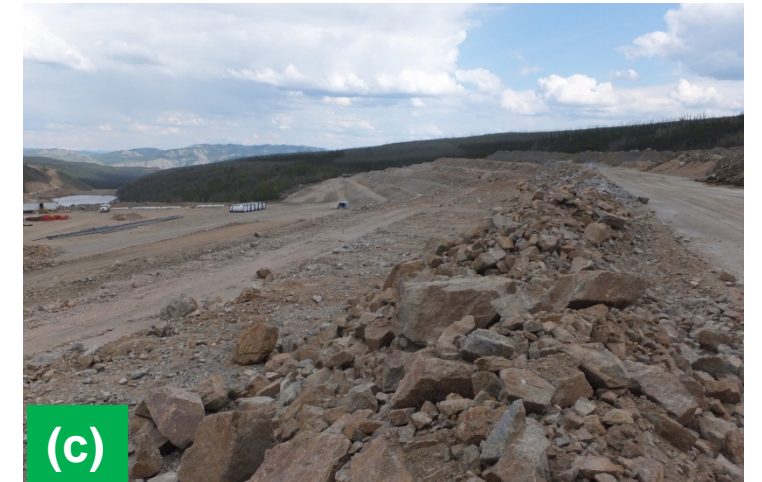
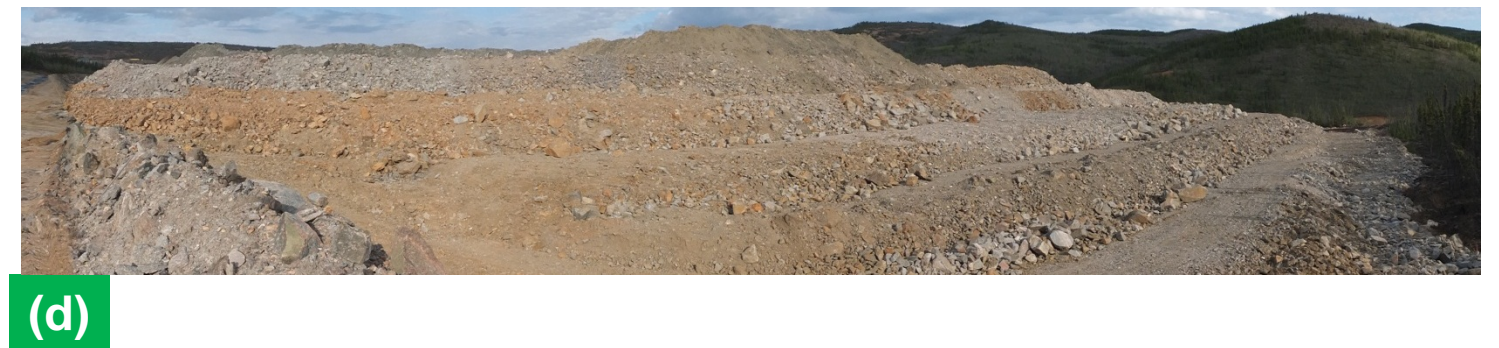
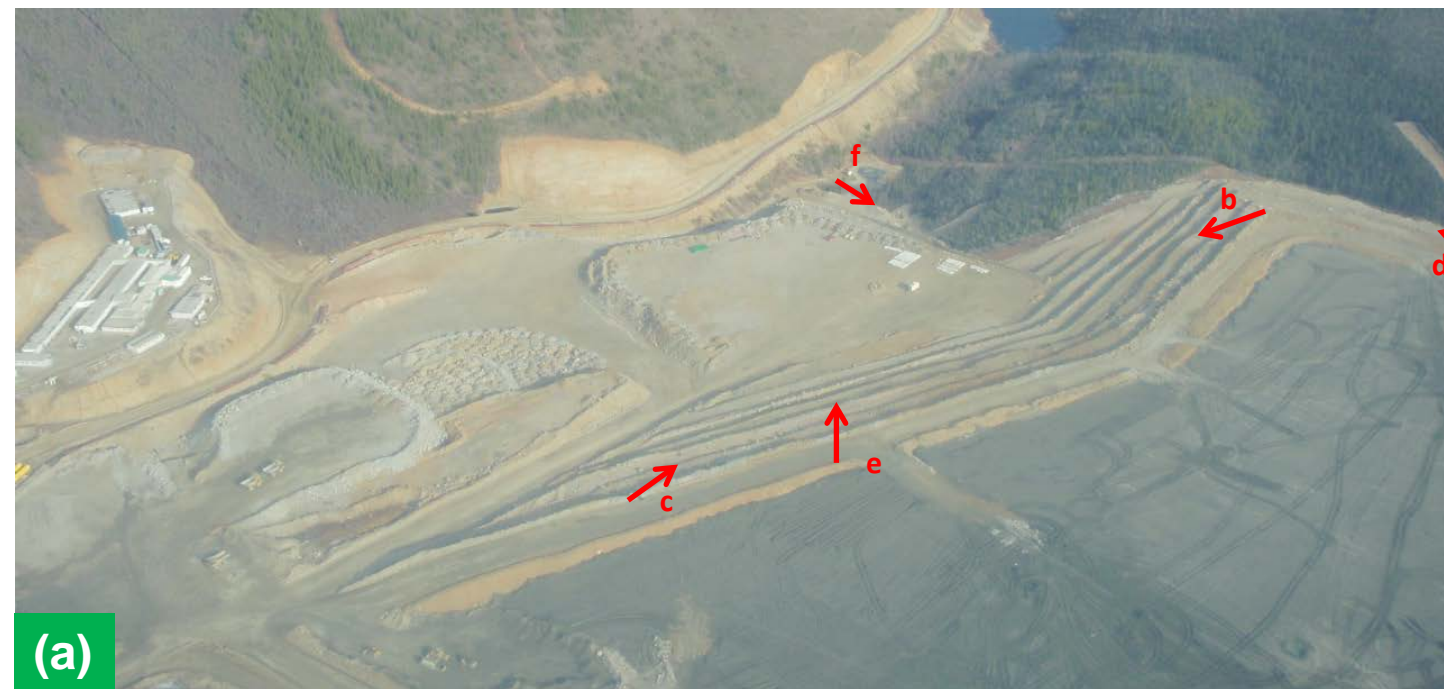
2013 Freshet Geotech Inspection		
		<b>Dry Stack Tailings Storage Facility</b>		
Job No: 1CM002.012.05 Filename: Minto 2013 FreshetSite Inspection.pptx	Minto Mine	Date: June 2013	Approved: PHM	Figure: <b>3</b>

- Photos show the condition of the waste rock shell and slopes.
- The slopes appear to be consistent with original placement: no signs of slumping, bulging or tension cracks were observed.
- The small sinkhole (1.5 m diameter, 0.5 m depth) noted in the 2012 inspection has been filled in.
- Seepage from the toe of the Mill Valley Fill (MVF) near the Minto Creek Detention Structure (MCDS) is documented in Figure 18.

- (a) Aerial view of the north end of the DSTSF showing the waste rock shell and the extent of the MVF placement on October 2, 2012.
- (b) View of the MVF taken from the NE corner of the DSTSF.
- (c) North-east end of the waste rock shell looking east.
- (d) East end of the waste rock shell looking north
- (e) View of the MVF area looking north east.
- (f) View of the north-east slope of the MVF taken from the northern corner of the MVF.

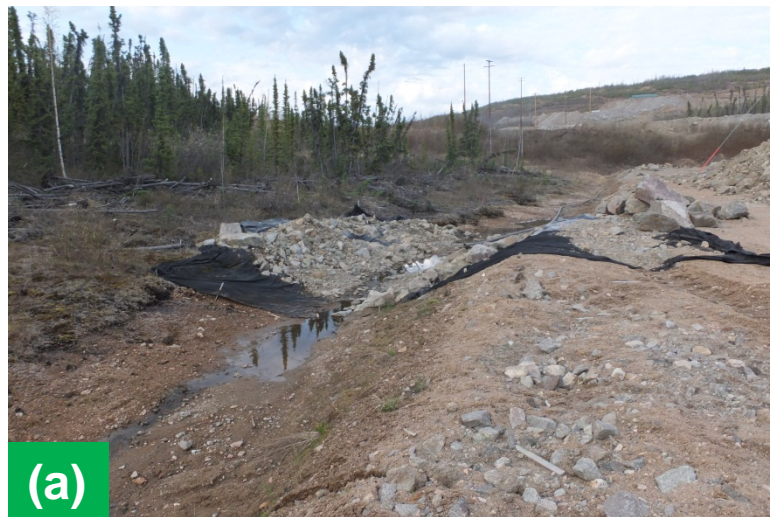
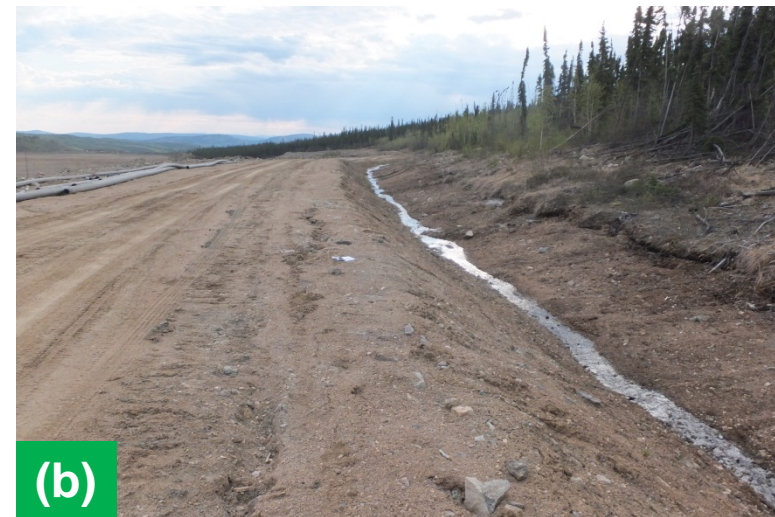
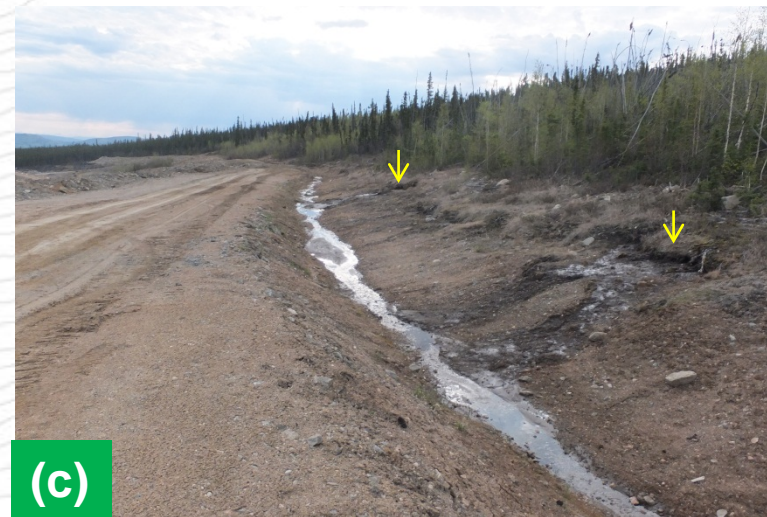
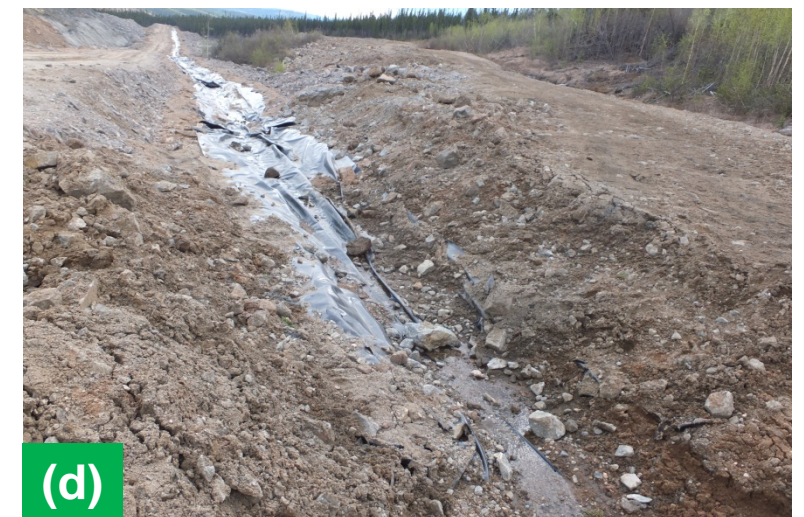
- In general, the western portion of the berm and ditch was functional at the time of inspection, with conditions deteriorating towards the east. East of the location of Photo (d), the ditch is in very poor condition. Details on the eastern portion of the ditch are provided in Figure 5.
- Conditions are similar to those observed to the 2012 inspection.
- Two seeps were observed below the berm near the locations noted in the 2011 inspection and on the plan in this figure.

- (a) An energy dissipation area at the upstream portion of the ditch at the end of a 3" pipeline from the South Diversion Ditch Area. The rip-rap in the ditch is underlain by layers of geotextile and liner. The area remains unchanged compared to 2012 photographs.

- (b) Tension cracks are present on the berm side of the ditch over a significant length of the ditch.
- (c) Looking downstream in the western portion of the ditch. Tension cracks visible along the road. Two small seeps enter the ditch (locations noted in yellow). There is minor sloughing of the side-slopes at these locations, but the sloughing has not significantly impacted the flow capacity of the ditch.

- The ditch near this location and further downstream is not well formed, with sediments building up in the channel, and the liner sagging down the channel sides.

- Liner sections are over-lapped, but not welded. Gaps are present between some sections allowing water to pass through.
- Water was also observed to flow over the sides of the liner in places.

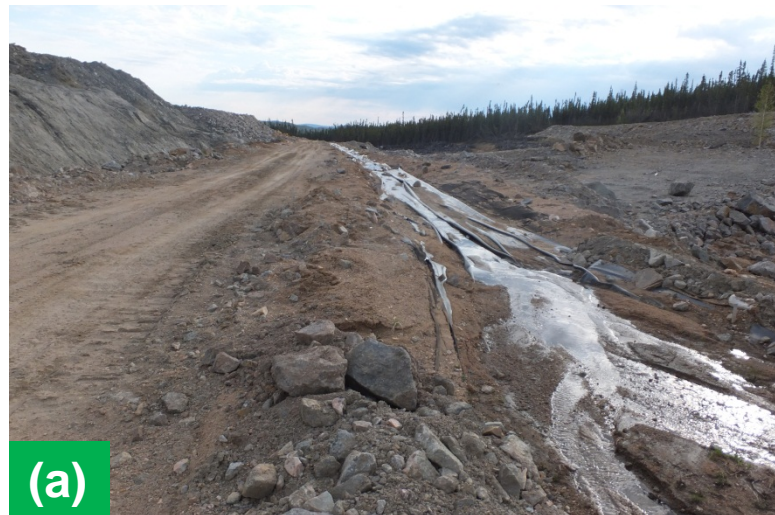
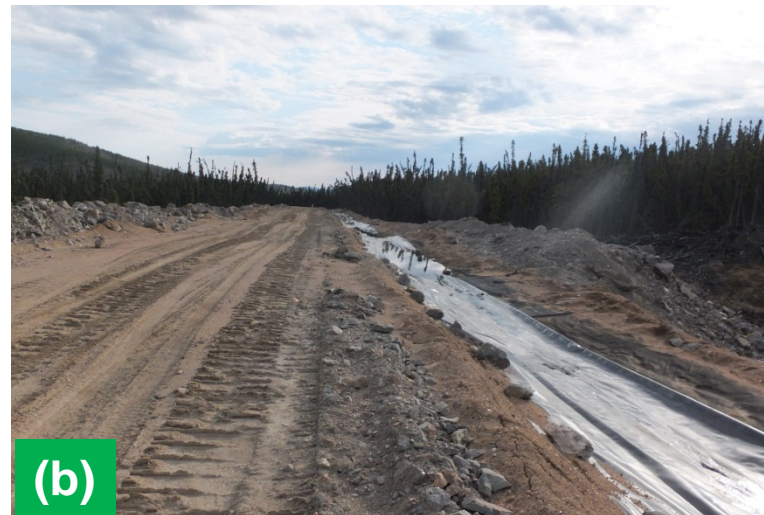
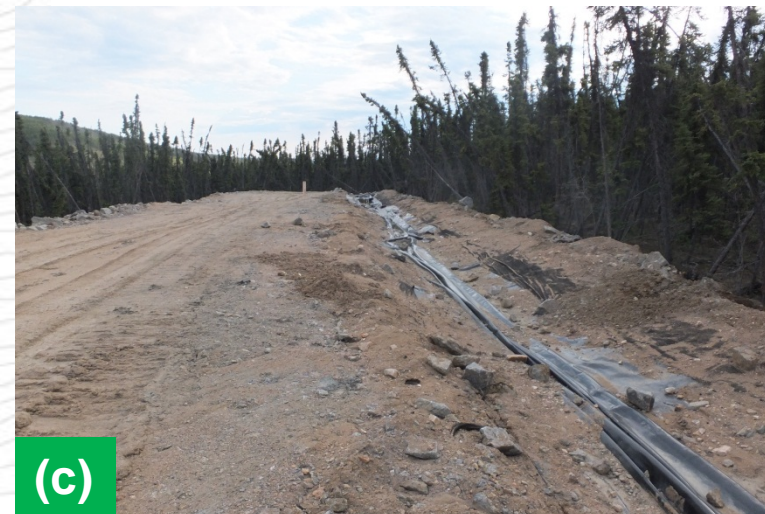
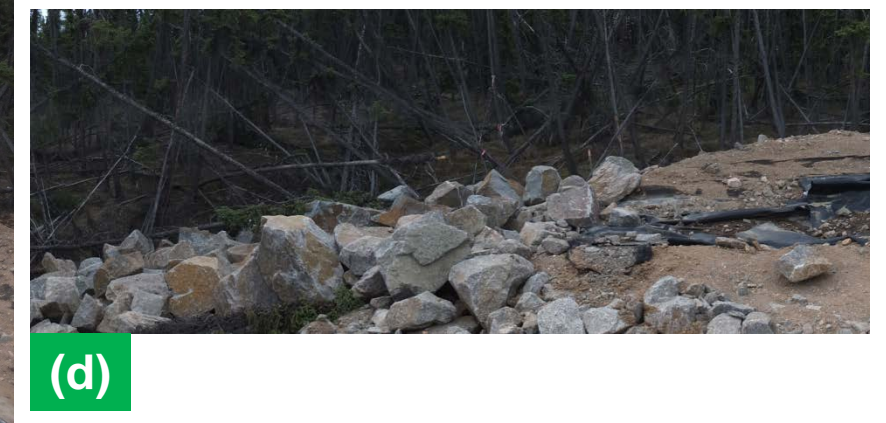
Figure: 4

Conditions of the channel are unchanged compared to the 2012 inspection. The eastern portion of the ditch is in poor condition. At the time of the inspection, it is estimated that approximately half of the flow was lost along the east portion of the ditch.

- The channel is undersized in many locations;
- The channel bed has settled resulting in areas of ponding water;
- The liner has torn in many locations;
- The anchoring of the liner has failed resulting in the liner slumping down the sides of the channel,
- There are gaps in the liner resulting in water flowing beneath the liner and over the sides of the liner.
- As noted in the 2011 and 2012 inspection, the discharge point of the ditch (Photo (d)) was also not constructed in accordance with the March 23, 2010 Issued for Use Drawing TDD-01, where flow should discharge into a lined stilling basin.
- The vegetation surrounding the discharge point is stressed with many leaning dead trees in the area.

- The surface diversion berm should be rehabilitated to capture and convey water along the entire length of the ditch.
- The ditch discharge should be constructed to an engineered design.

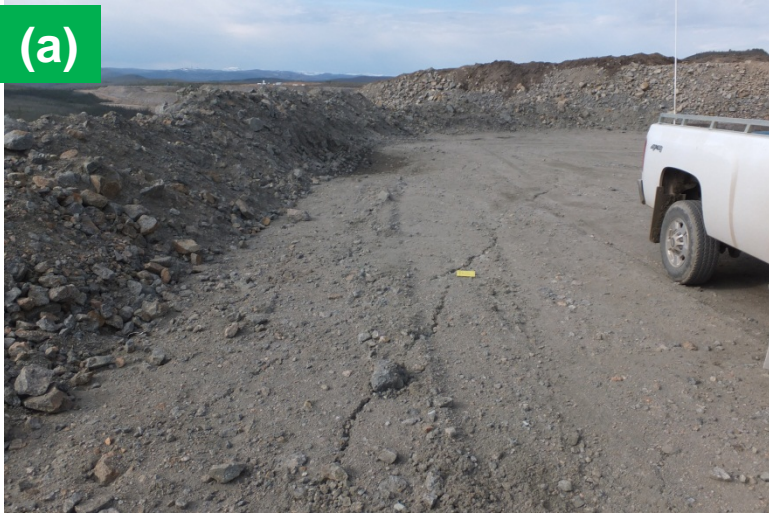
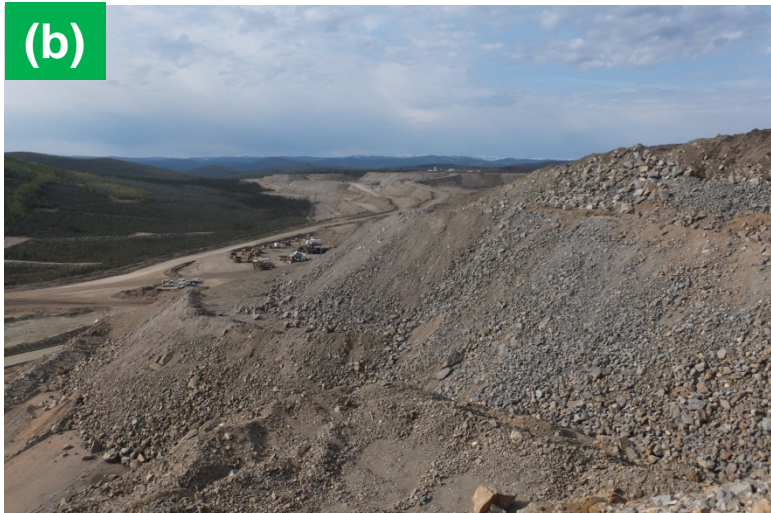
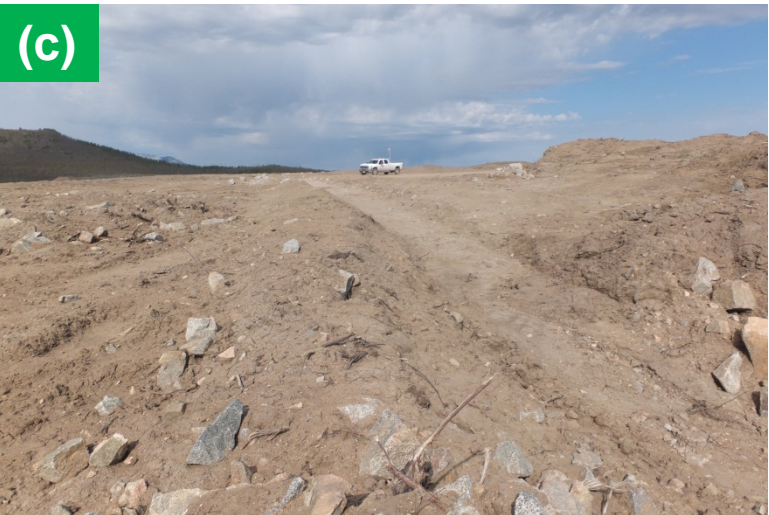
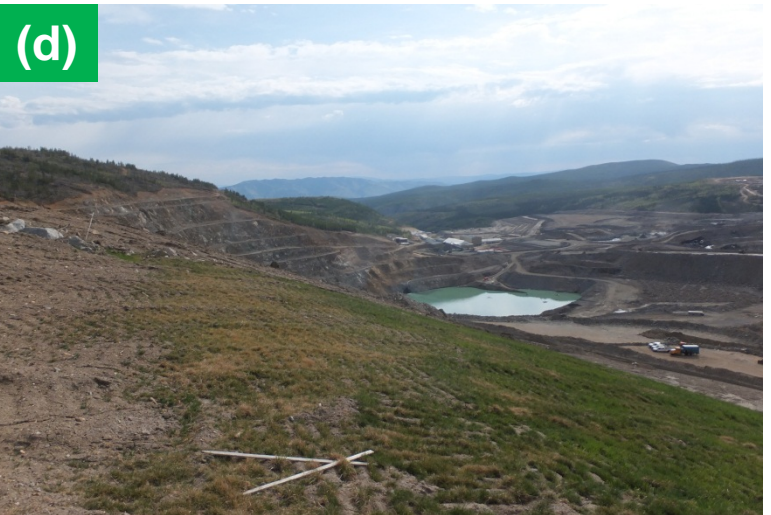
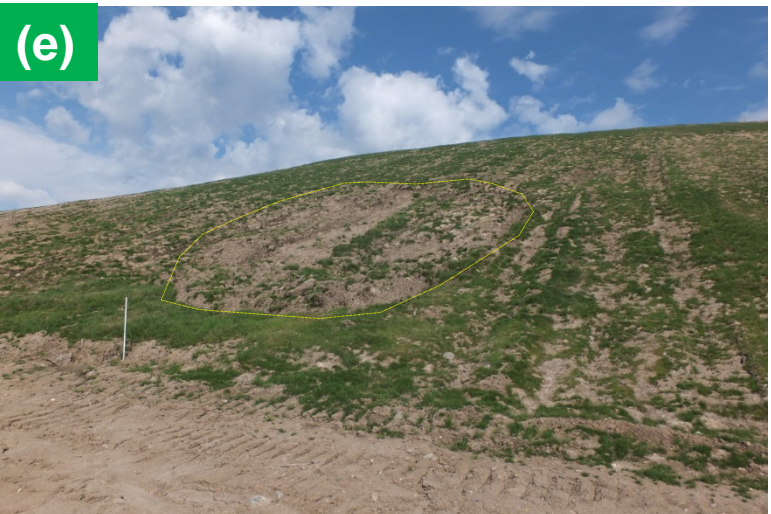
- Reclamation activities at the dump started in 2011 with re-contouring of portions of the dump slopes. The regraded area is noted in the plan below. The regraded slopes have been covered and revegetated with different vegetation prescriptions placed on different portions of the cover.
- The tension crack noted in the 2011 and 2012 inspection at the location noted in the plan below was not observed during the May 2013 inspection. The crack may have been hidden by vegetation.

- Photo (a) show a tension crack found near the crest of the Low Oxide Stockpile. The crack is parallel to the slope that is dumped at an angle of repose.
- Photo (b) shows the southeast end of the Main Waste Dump that is dumped at an angle of repose, no signs of instability were observed.
- Photo (c) shows a diversion channel excavated near the crest to direct runoff away from the reclamation plots.
- Photo (d) shows the regraded slopes and vegetation growth on the south end of the dump.
- Photo (e) shows small surficial sloughing of the cover material. The extent of the Failure is outlined in yellow. Minor bulging of material is present at the base of the slope. No action required.

- The slough, as well as the area where tension cracks were noted in the 2011 and 2012 inspections should continue to be monitored as part of regular site inspections for signs of additional movement or instabilities.

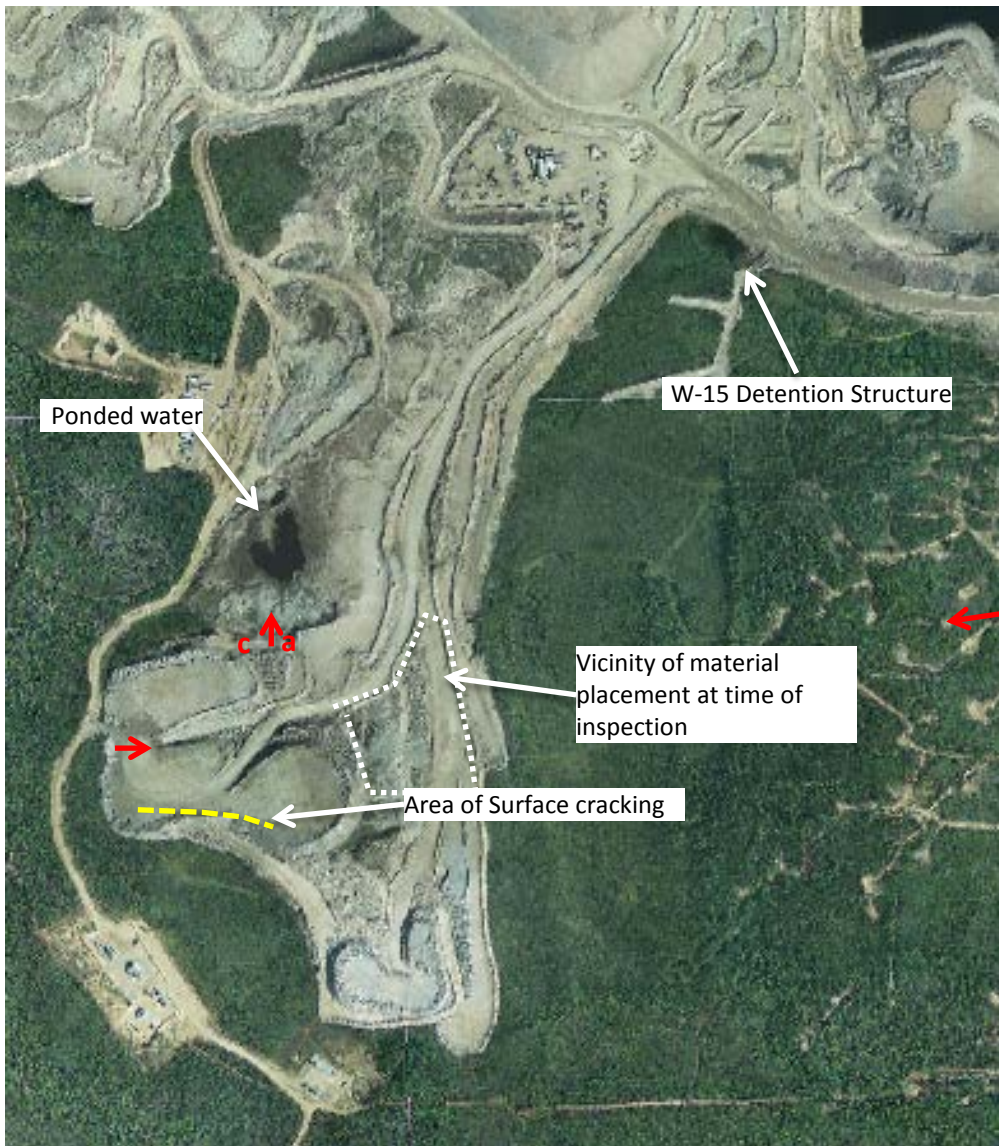
- Tension cracks were observed in the southern end of the dump in the location located on the plan and noted in photo (b). Photo 2 was taken of the slope located adjacent of the cracks. A series of cracks are offset from the crest by approximately 5 m and extend over a distance of 60 m in total. The crack is 20mm wide at the widest location.

- No other signs of instability (slumping, bulging, tension cracks, differential settlement) were observed. Erosion was observed at the outlet of the culvert located north east of the dump (see Figure 8).

- Construction of the dump appears to be in accordance of the method described above.
- Safety berms were present throughout the dump.
- Ponded water was observed in one location (Photo (a)),

- Prior to placement of the next bench, areas with ponded water should be regraded to promote runoff and drain the large ponded areas.
- The tension cracks along the crest should continue to be monitored semi-annually as part of the regular geotechnical inspections for signs of additional movement.

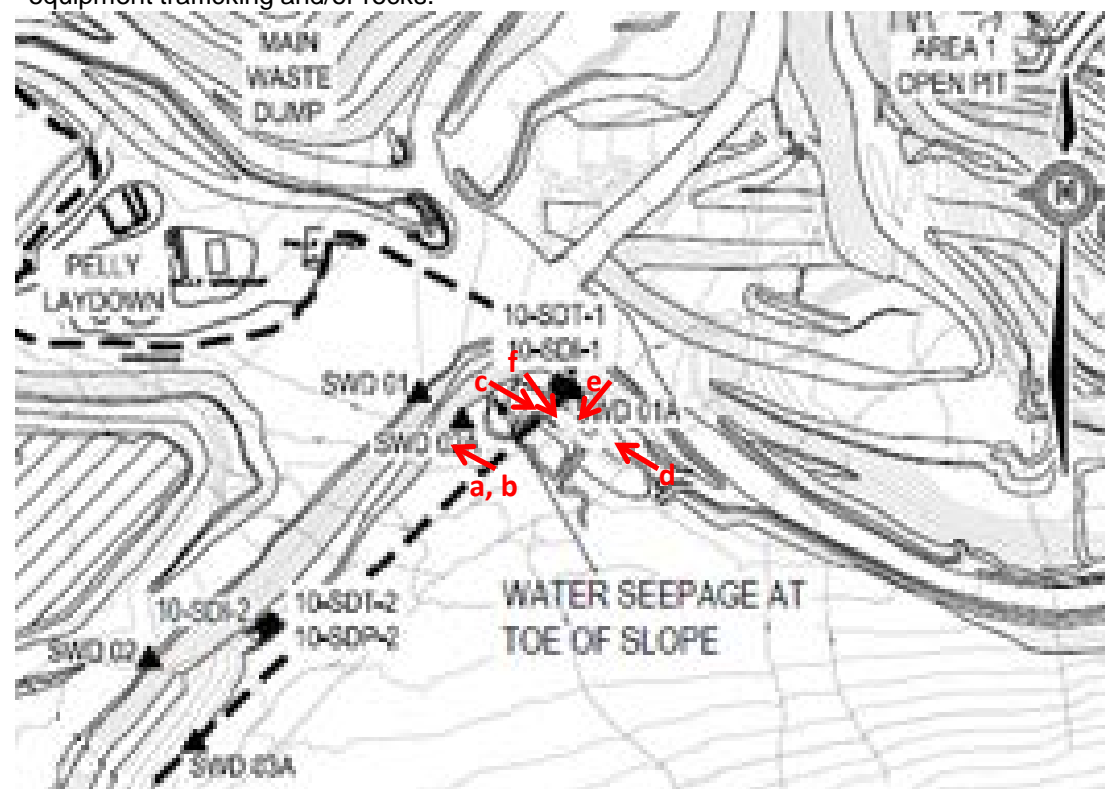
- Photos (a) shows the outlet of the culvert at the NE corner of the dump and east of the Pelly Laydown area.
- Based on equipment tracks in the area, it appears that the large diameter boulders have been placed along the slope to mitigate erosion. The area should be monitored at least annually with a photographic record maintained to observed for changes.
  - The appearance of the rip-rap/boulders downstream of the culvert are unchanged compared to previous photos taken in 2012.

Photo (b) shows sediment accumulating inside of the culvert, with some cobbles present with diameters up to 8 inches observed.

Photos (c) to (f) show the W-15 Detention Structure Area. The conditions of the area are the same as that reported in 2012. Due to high water levels as shown in (c), photos (d) to (f) are from the 2012 inspection.

- Water continues to seep from the toe of the fill slope into the W-15 Detention Structure Area. The water was clear, with low turbidity.
- Sediment is accumulating at the west end of the pond. The weight of the sediment appears to have stretched the liner and resulted in a large tear from along the crest of the berm at the anchorage point.
- There are 3 punctures in the liner located near the crest west of the pump (Punctures shown in photo (e)). The punctures were caused by either equipment damage or rocks raveling down the slope.
- Photo (d): The inlet line for the pump is placed on a layer of rip-rap placed directly on the liner. A large boulder is in the foreground of the photo directly on the liner.

- Continue monitoring of sediment accumulation in the culvert and erosion at the outlet. A photographic record should be maintained to inspect for changes in condition.
- The liner anchor system on the west side of the facility should be repaired the next time a liner crew is on site. At the same opportunity the holes in the liner should be repaired.
- Placement of a safety berm or snow fencing should be considered to prevent further damage to the liner from equipment trafficking and/or rocks.

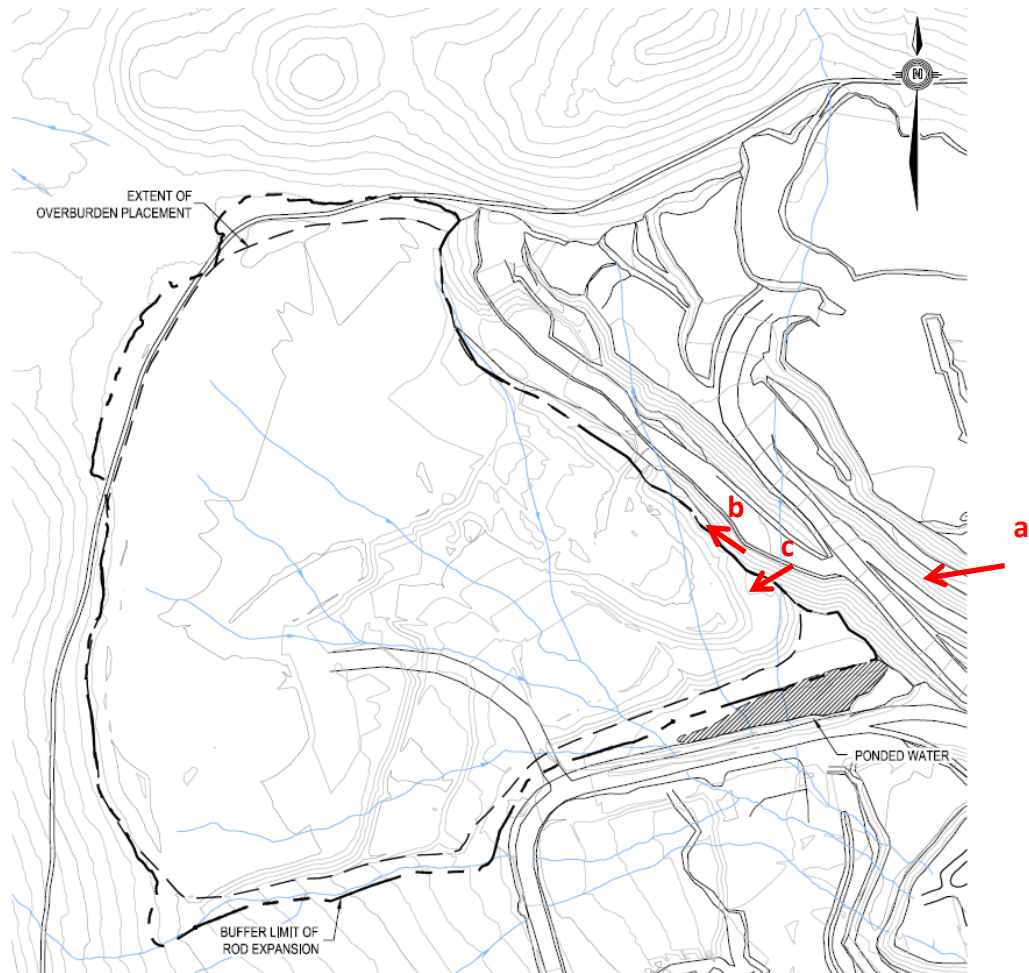
- Conditions of the dump are similar to conditions reported in the 2011 and 2012 site inspections. Slumping, settlement and tension cracks are expected in the dump as it is constructed with frozen overburden with thawing expected.
- a) Overview of the ROD and the ponded water adjacent to the Dyno Access Road southeast of the ROD. Two small erosional channels were observed (circled in yellow) to be in similar condition as reported in previous inspection.
- b) Photo shows recent placement of overburden/organic material on the dump, the source of the material can be seen in the background of photo (c).
- c) Localized slumping of the perimeter slope. Discontinuous tension cracks and differential settlement observed along the perimeter crest. Ground undulation is typically 0.3 m and is prevalent throughout the facility.

- Recommendations are the same as those mentioned in the 2011 and 2012 inspections:
- Installation of a rip-rap channel down the slope to minimize slope erosion. Areas near the exiting erosion channels should be regraded to direct runoff to the rip-rap channel.
  - Monitoring of the ponded water to ensure that the offset from the dump toe is maintained as stipulated in the design report.
  - The toe of the dump should be surveyed annually to confirm it is within the permitted boundary.

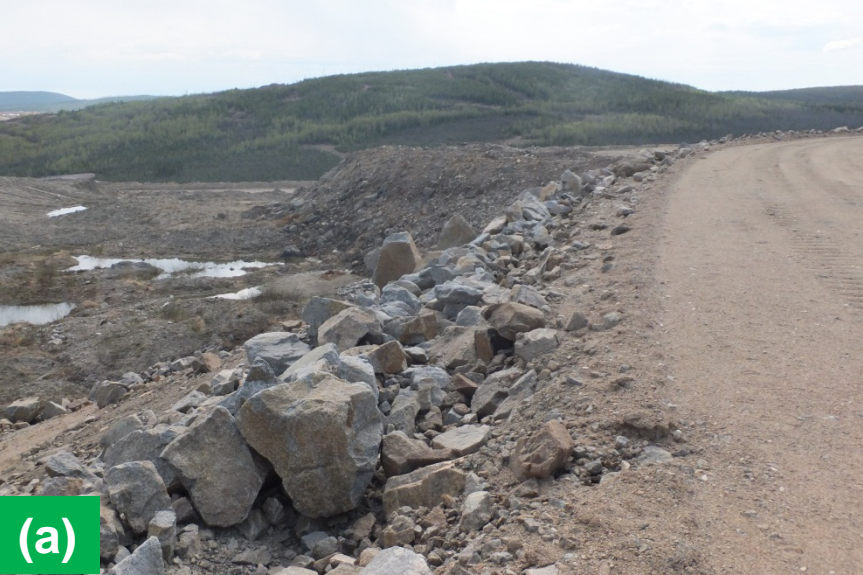
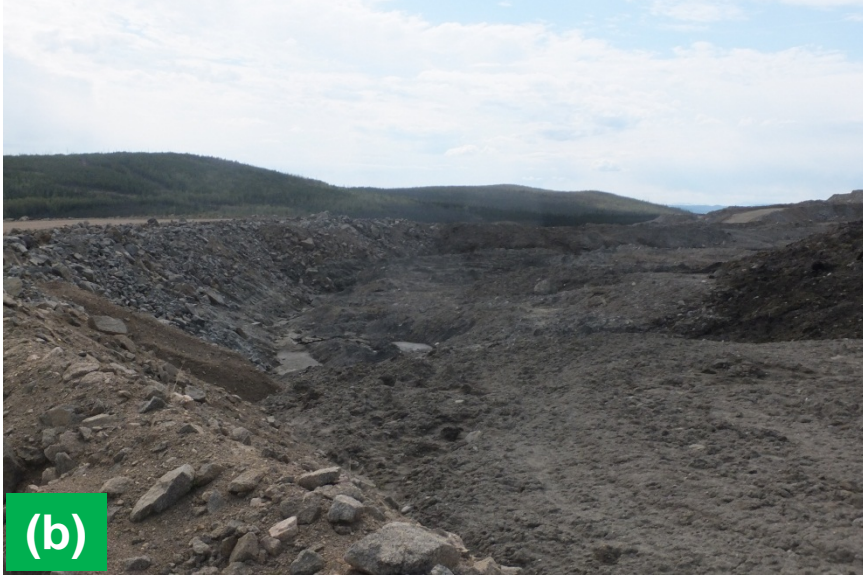
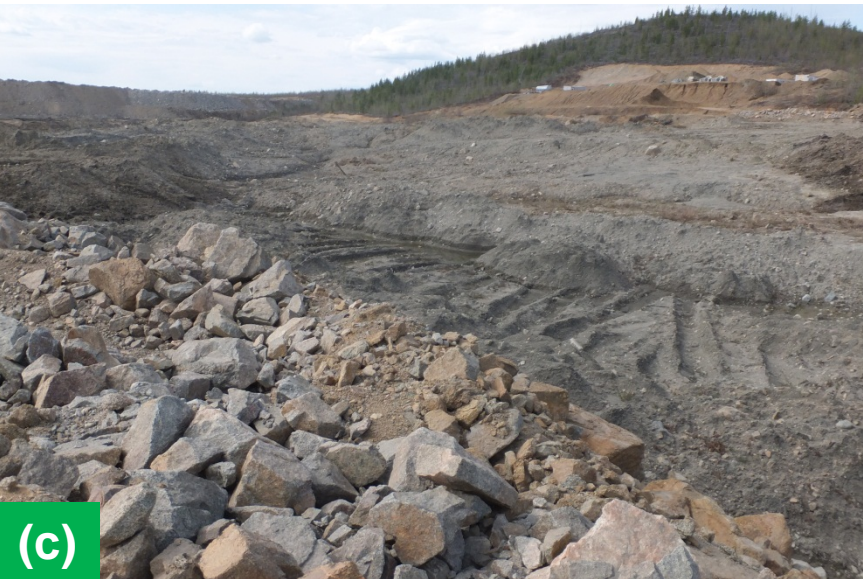
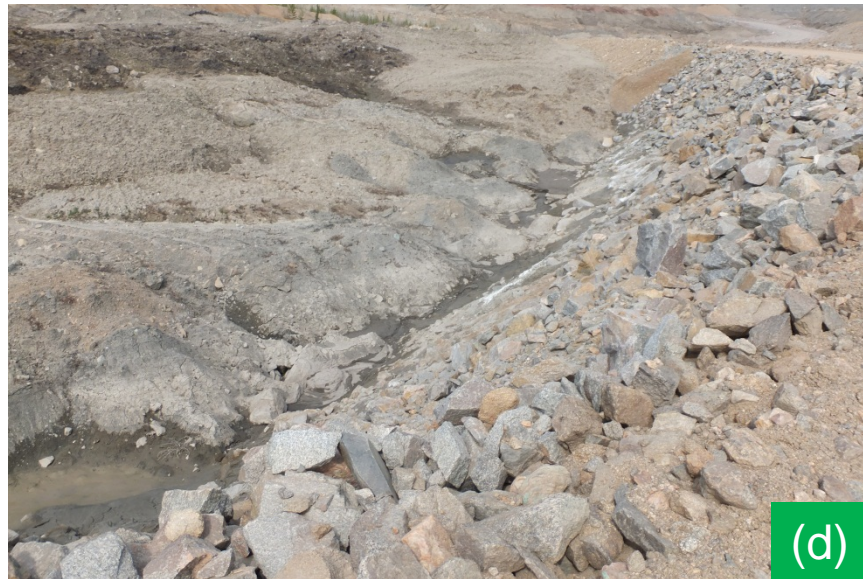
2013 Freshet Geotech Inspection		
		<b>Ice Rich Overburden Dump</b>		
Job No: 1CM002.012.05 Filename: Minto 2013 FreshetSite Inspection.pptx	Minto Mine	Date: June 2013	Approved: PHM	Figure: <b>10</b>

- A containment berm constructed of coarse waste rock is present on the north, east and south sides of the dump.
- Photo (a) shows outside slope of the berm, while Photos (b) through (d) show the inside slope and ice rich overburden material.
- No signs of instability were observed along the containment berm.
- Minor amounts of pooled water were observed against the berm, with water levels appearing to be dropping (see photo (d) in the lower left corner). This indicates that the berm is functioning as intended by allowing most water to drain to the outside of the facility.

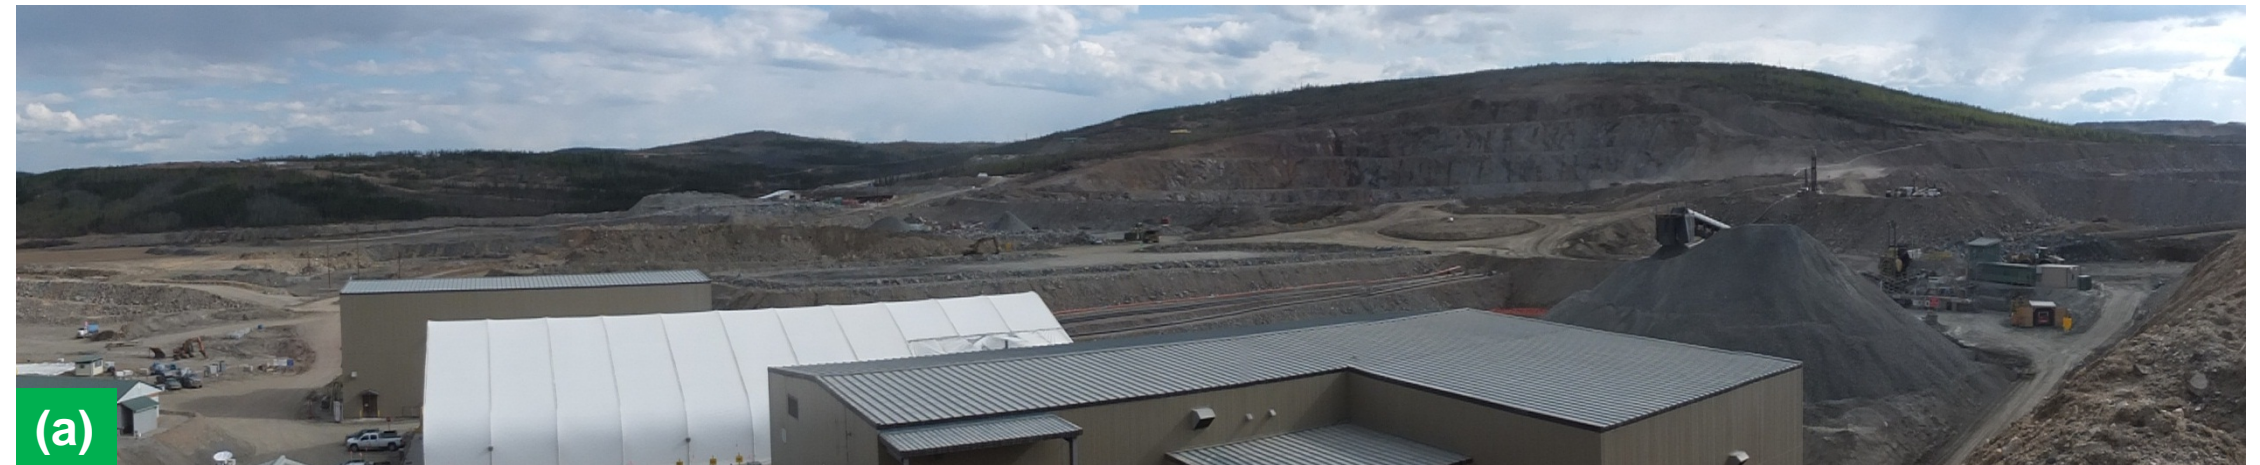
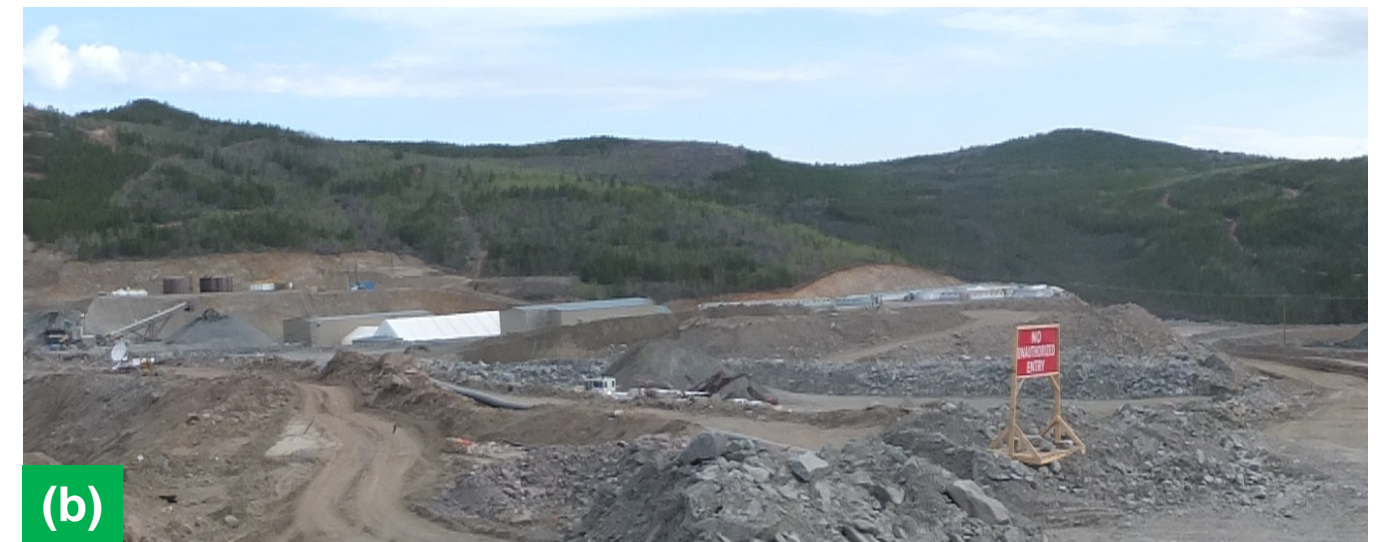
2013 Freshet Geotech Inspection		
		<b>Ore Stockpiles</b>		
Job No: 1CM002.012.05 Filename: Minto 2013 FreshetSite Inspection.pptx	Minto Mine	Date: June 2013	Approved: PHM	Figure: <b>11</b>

- The ore stockpile area was investigated briefly in passing. All slopes appeared in good condition: no slumping, bulges, cracks, or other signs of instability were observed.

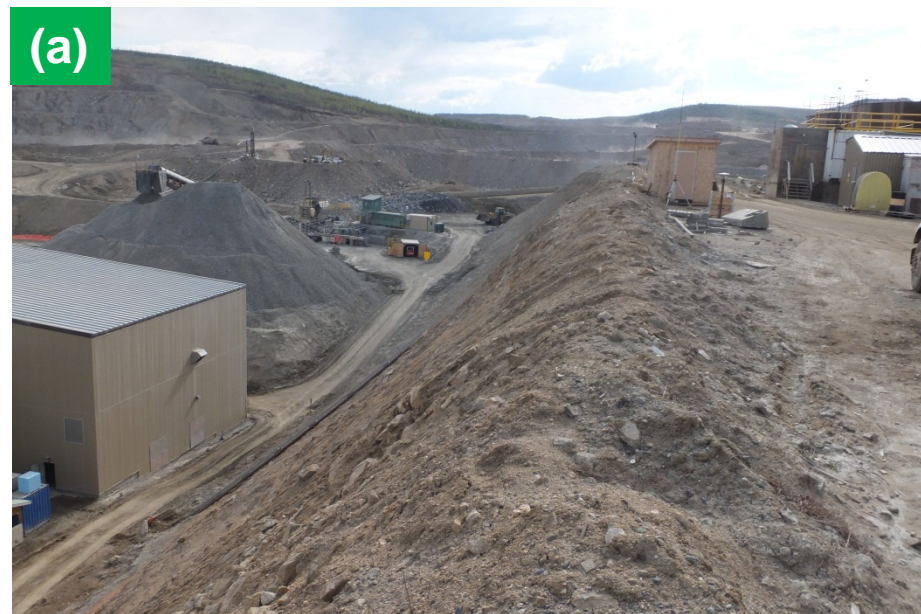
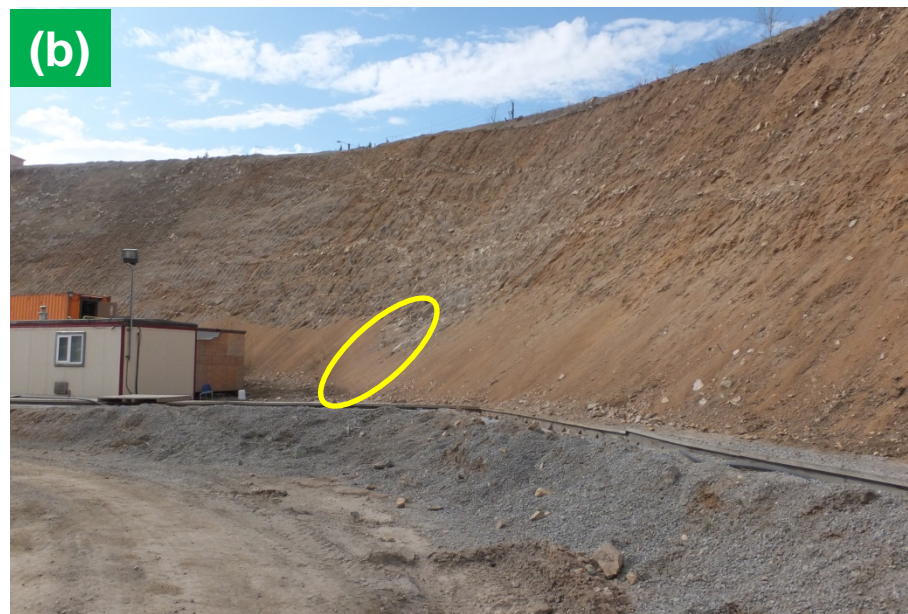
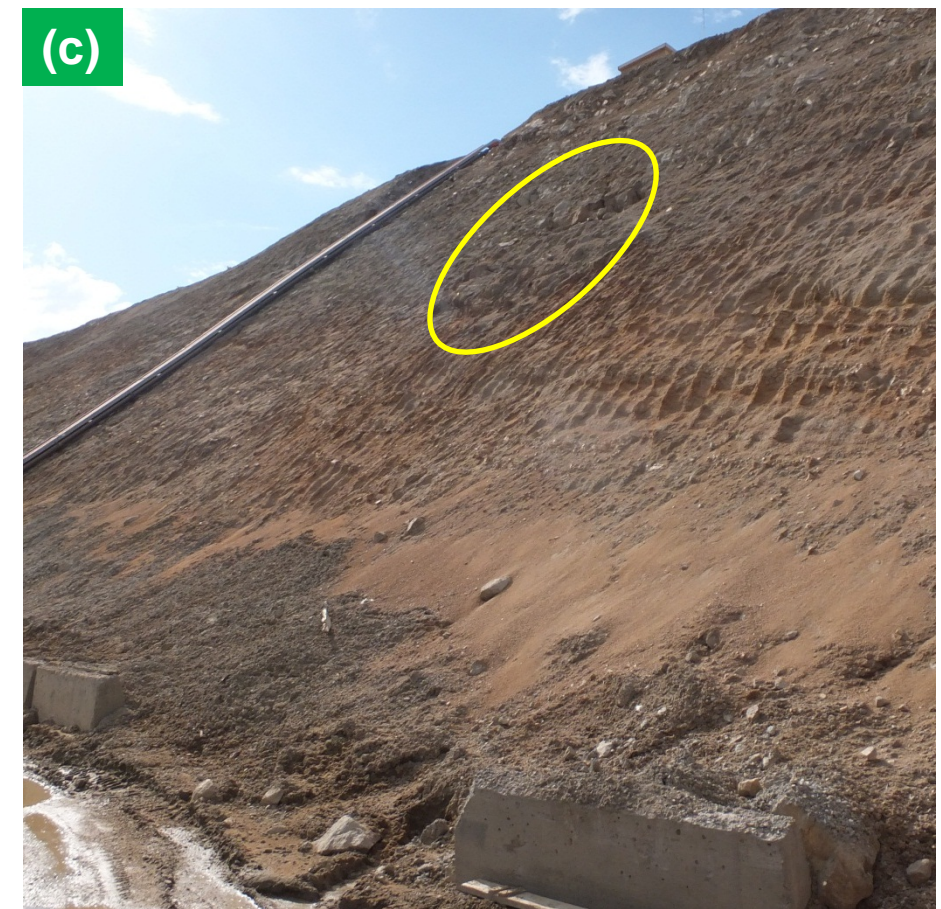
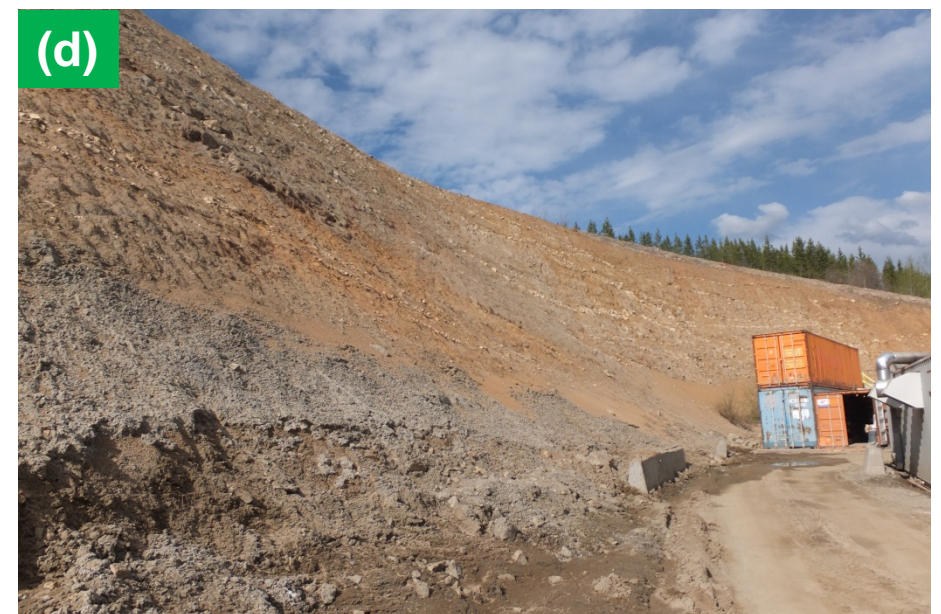
2013 Freshet Geotech Inspection		
		<b>Mill and Camp Site</b>		
Job No: 1CM002.012.05 Filename: Minto 2013 FreshetSite Inspection.pptx	Minto Mine	Date: June 2013	Approved: PHM	Figure: <b>12</b>

- a) Slope above the main mill site appears stable.
  - Safety berms at the top of the slope are in good condition.
  - Eroded sand/gravel is generally present at the base of the slope with occasional cobbles/boulders up to 300 mm.

- b) East end of the mill slope looking northwest. The two small seeps noted in 2011 and 2012 were not observed to be flowing at the time of this inspection, however, the base of the slope in this area was observed to be wet. The seep locations are circled in yellow in photo (d) and is noted in the plan below.

- c) As noted in previous inspections, a small slough is present near the center of the slope approximately 10 m east of the electrical corridor.
- d) The 2012 inspection noted some larger rocks that have raveled down the slope and the concrete barriers at the toe were approaching the capacity for containment. The area around the concrete barriers appear to have been cleared since the last inspection with the large rocks removed.

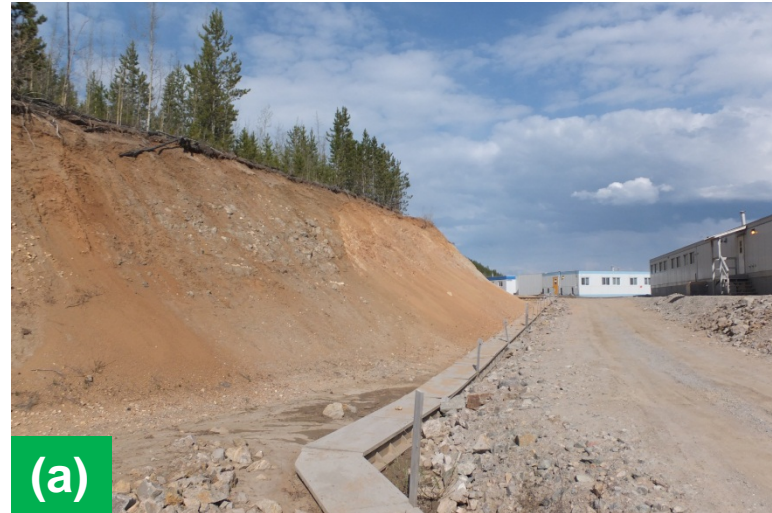
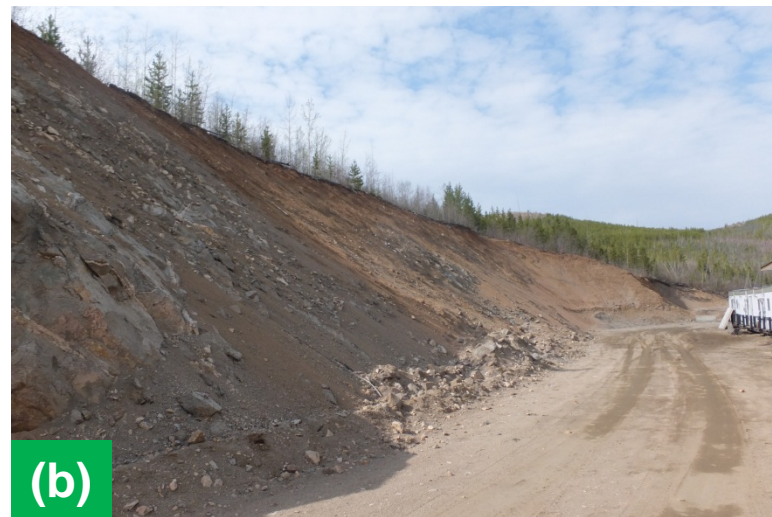
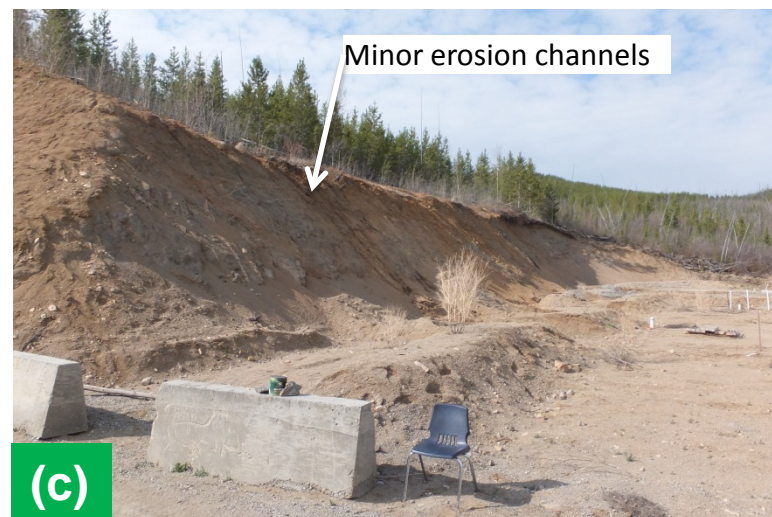
- a) & b) Slope above the main camp site appears stable.
  - Eroded sand/gravel is generally present at the base of the slope with occasional cobbles/boulders up to 300 mm.
- c) Minor erosion channels present at the north end of the camp area. Three minor erosion channels were noted in the 2011 in this area marked on the plan below.
- d) Erosion channels present south of the camp site pad near the flags. No changes compared to the photographs taken during the 2012 inspection.
- e) & f) Erosion channels present south of the camp site near the carpenters shop. The scarp of the erosion channel appears to have receding and now undercuts the utilidor. There appears to have been pooled water in the area. Actions are required to prevent further erosion of the area.

Note: Since the 2011 inspection, fill was placed below the main access road as part of the Mill Valley Fill pad that have covered over the erosion channels noted in the figure below.

- The area above the erosion channels on the camp pad should be regraded to promote runoff away from the channels.
- The channel by the carpenter's shop should be filled with rip-rap or a "half culvert to provide a path for the water to drain". It appears that no action has been taken in the past year and that further erosion channels have developed.
- It is recommended that these actions be completed in the following year. In place of the surface grading, a small ditch could be constructed near the slope crest to direct runoff to the drop channel or half-culvert.
