# 2013 Freshet Geotechnical Site Inspection, Minto Mine, YT

SRK Consulting (Canada) Inc.  
1CM002.012.005  
July 2013

Project No: 1CM002.012.005

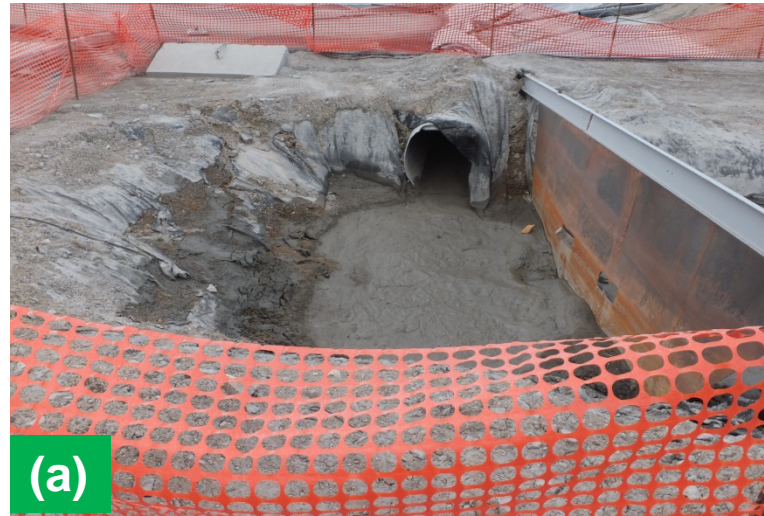
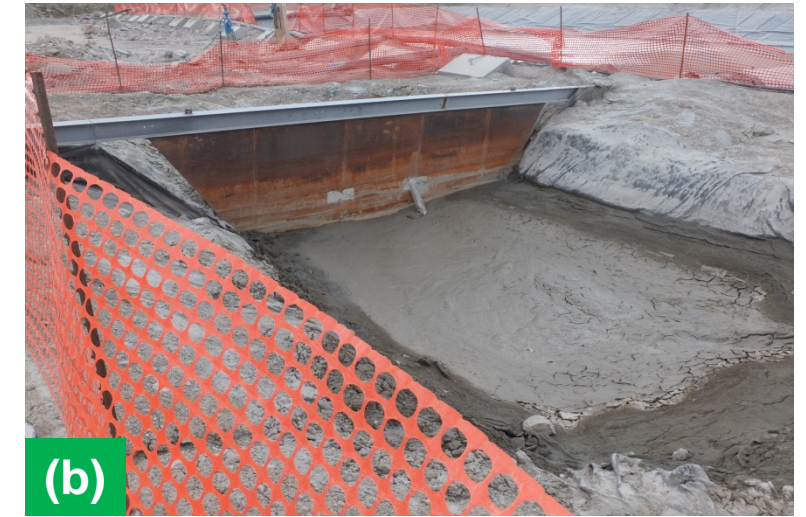
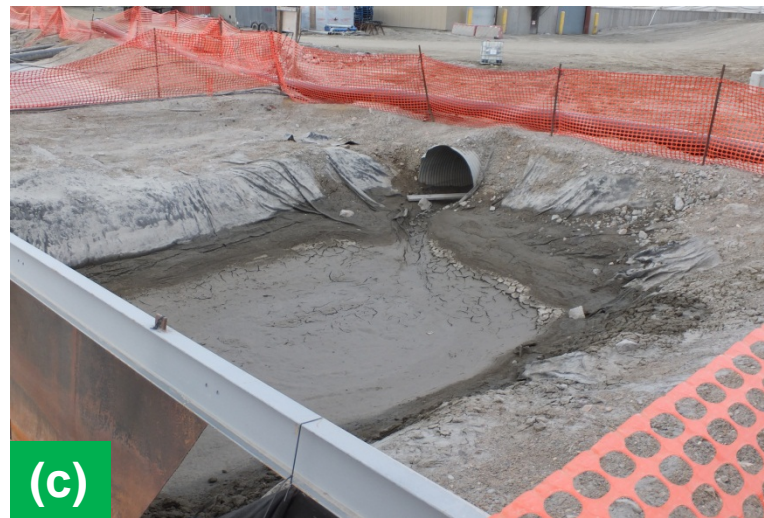
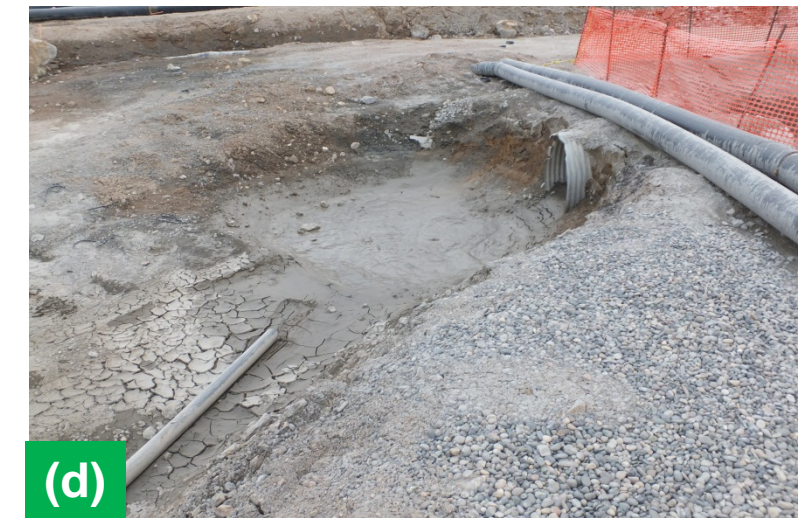
2013 Freshet Geotech Inspection		
		<b>Mill Water Pond</b>		
Job No: 1CM002.012.05 Filename: Minto 2013 FreshetSite Inspection.pptx	Minto Mine	Date: June 2013	Approved: PHM	Figure: <b>15</b>

- Photos show the condition of the surface runoff ponds south east of the mill water pond. Conditions are unchanged compared to the Sept. 2012 inspection.
- There are significant sediments in both ponds, each culvert, and outside the ponds to the east. It is recommended that each pond/culvert be cleaned.

- The liner tears should be patched the next time a liner crew is onsite. For the liner tear noted in Photo (c), Figure 14, sand should be placed to fill the void beneath the tear.
- The liner condition beneath the bypass pipe supports should continue to be monitored.
- The sediments accumulated in the surface runoff ponds and culverts should be cleaned out.

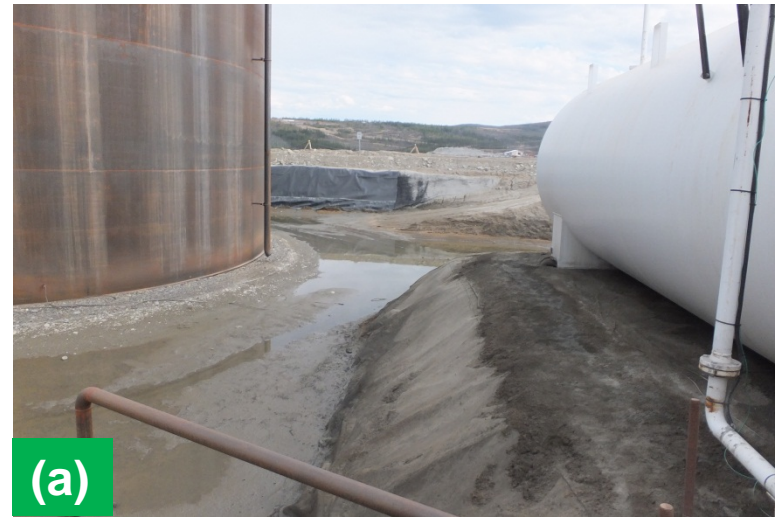
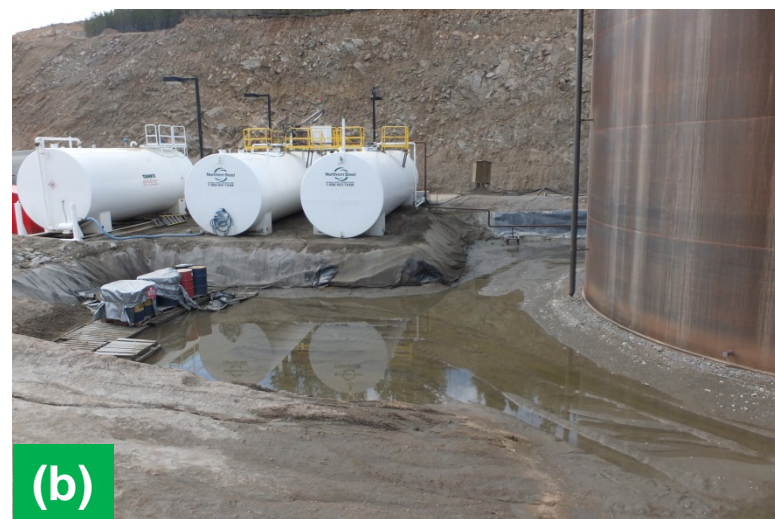
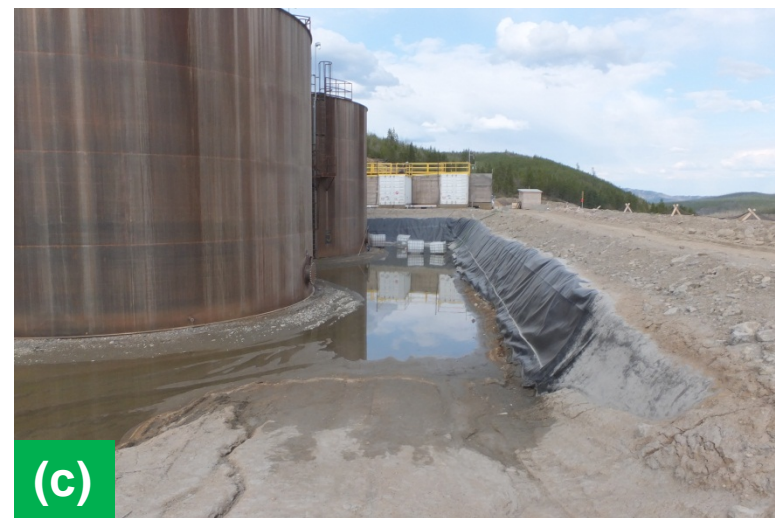
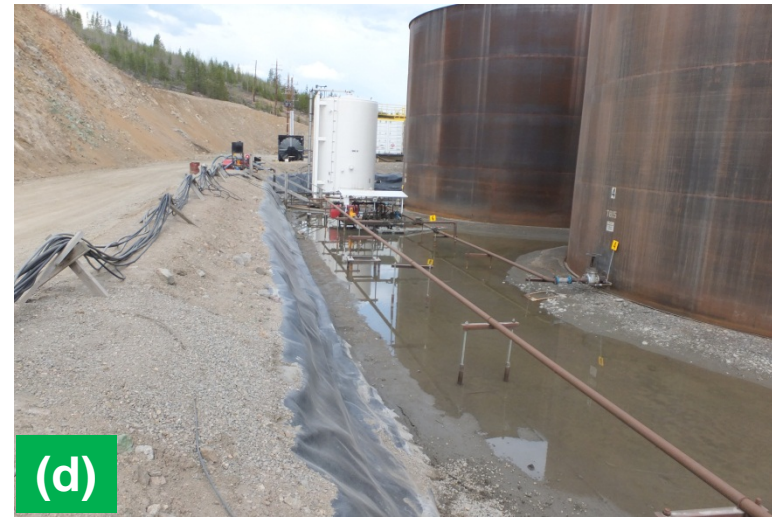
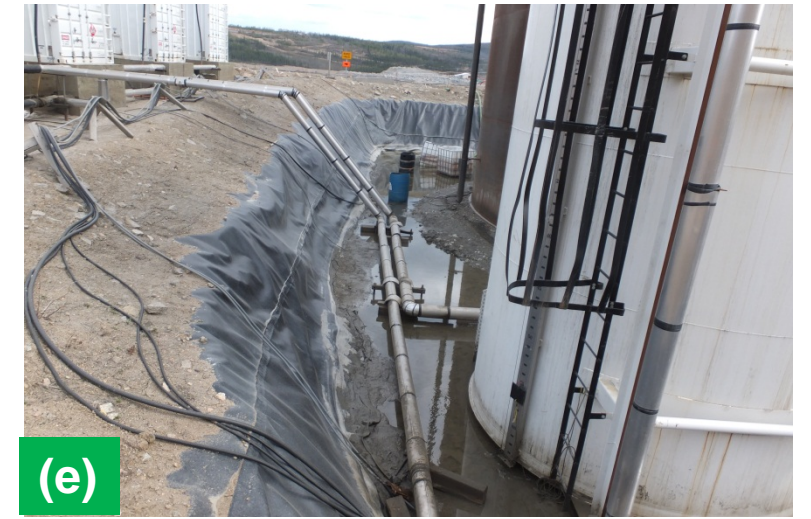
- Photos (a) to (e) show the condition of the liner on each side of the facility.
- Conditions of the facility appear to be the same as reported in the 2012 review.
- No tears or defects in the liner were observed.
- Ponded water is present throughout the facility.
- No ponded water was observed at the filling station area northwest of the containment area. The area appears to drain into containment area as per design.
- Ruts are present at the base of the ramp and at the western portion of the facility as seen in Photo (b). The rutting appear to be unchanged compared to the 2012 inspection photos.

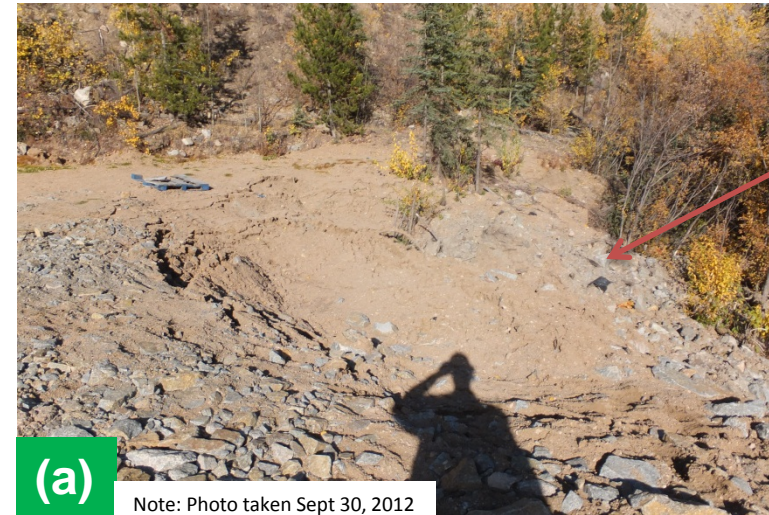
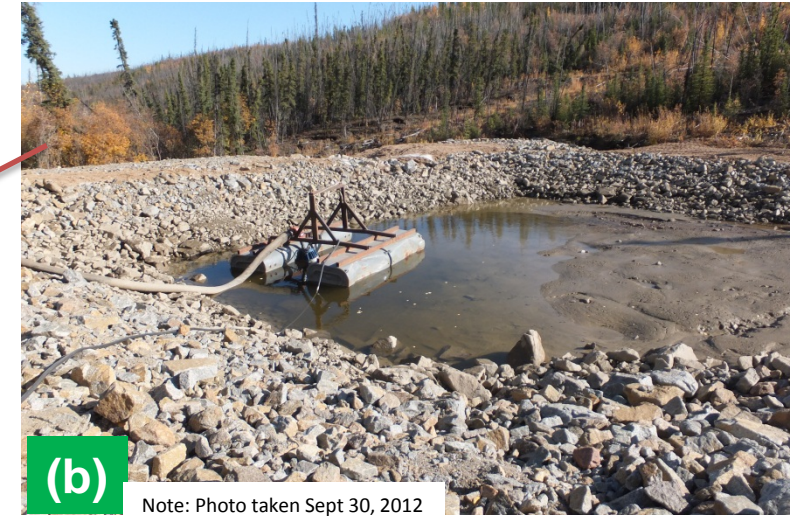
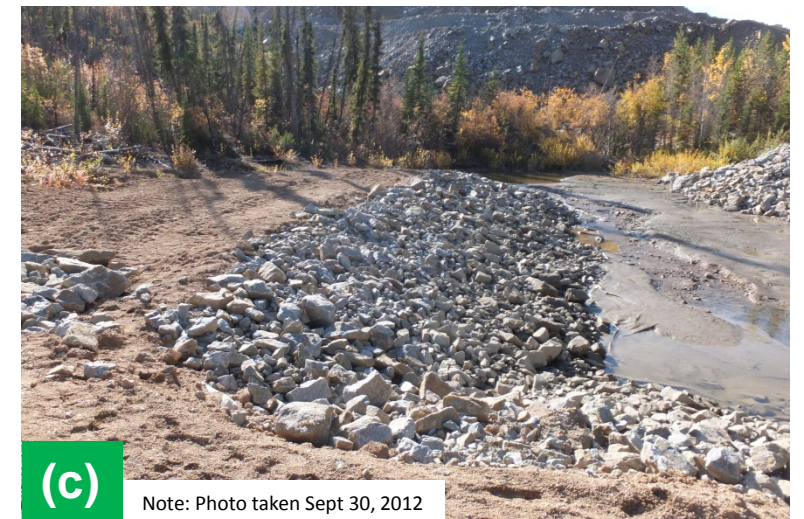
- Photos (a) to (c) were taken during the 2012 inspection to show the condition of the Minto Creek Detention Structure (MCDS) as during the 2013 inspection, a significant portion of the MCDS was covered by snow as seen in photos (d) and (e).
- No signs of instability (bulges, cracks, settlement, sloughing, surficial erosion) were observed during the 2013 inspection.
- Photo (a) shows a depression near the downstream toe of the structure noted during the 2012 inspection. The area was covered by snow during the 2013.
- A seep was observed overtop of the snow from the Mill Valley Fill toe to the MCDS. The outfall of the seep into the MCDS can be seen in Photo (e). The seepage water was clear with no signs of sediment accumulation on the snow lined channel.
