2014 Geotechnical Annual Review, Minto Mine, YT

SRK Consulting (Canada) Inc.
1CM002.028
November 2014

Fall 2014 Geotech Inspection		
		Dry Stack Tailings Storage Facility		
Job No: 1CM002.012.028 Filename: Minto 2014 Fall Inspection.pptx	Minto Mine	Date: November 2014	Approved: PHM	Figure: 2

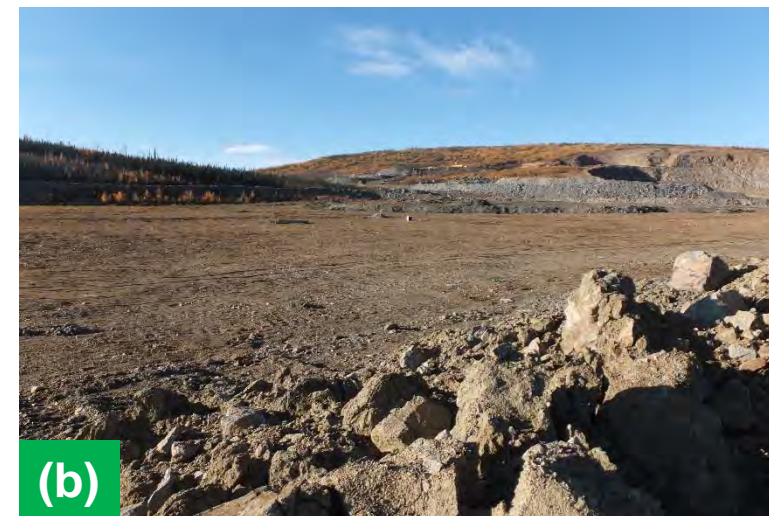
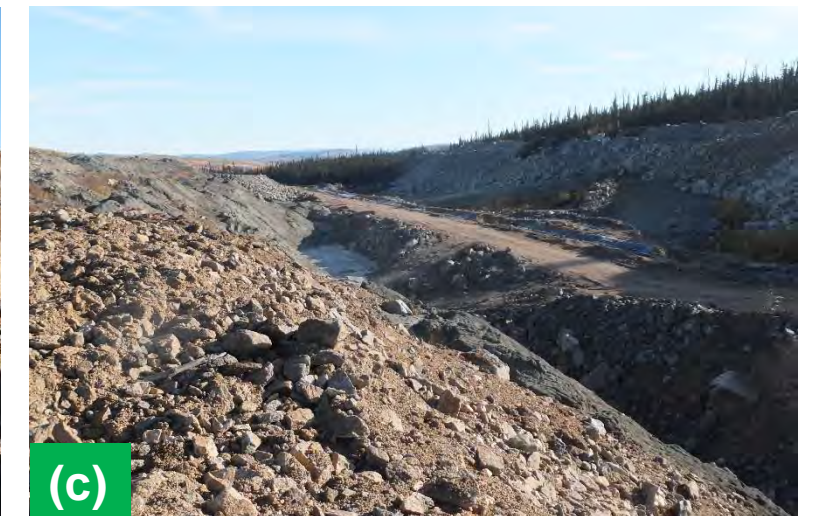
- Photo (a) shows the cover surface from the north east corner.
- Photo (b) shows the cover in the western portion of the DSTSF. There is considerably less vegetation established in the area.
- Photo (c) shows the south edge of the DSTSF where tailings remain exposed at surface on the south slope of the facility adjacent to the Tailings Diversion Ditch. Water was observed to be impounded against the DSTSF on the south side of the facility at various locations. Seep locations and areas where the water was observed to flow beneath the tailings. The water can be attributed to melting snow, recent precipitation and from water not captured by, or flowing under, the Tailings Diversion Ditch.
- Photo (d) shows survey hub DSSH 25, which is experiencing frost heave with approximately 30 cm of cement exposed at its base.

- The remaining areas of exposed tailings should be covered and the uphill area south of the DSTSF should be regraded as required to control surface drainage, avoid ponding, and limit infiltration of water into the tailings as per Clause 36 and 37 of the water license QZ96-006, Amendment 8.
- The condition of all survey hubs on site should be reviewed. Hubs experiencing frost heave should be noted and replaced with hubs that are not susceptible to frost heave.

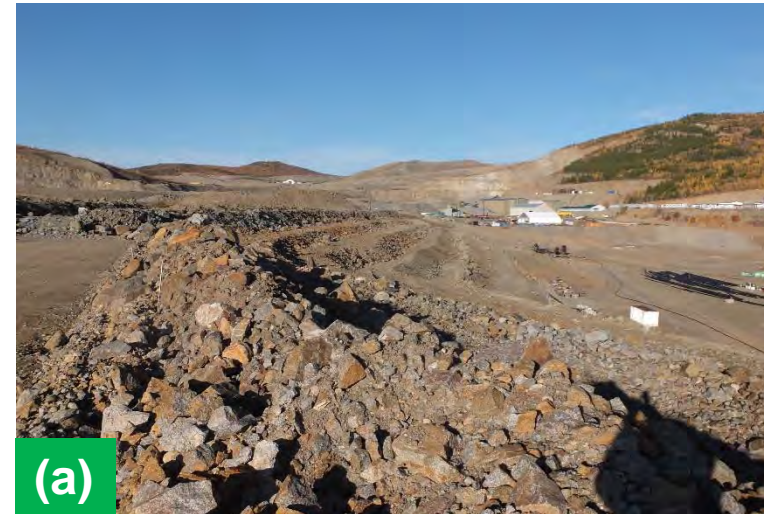
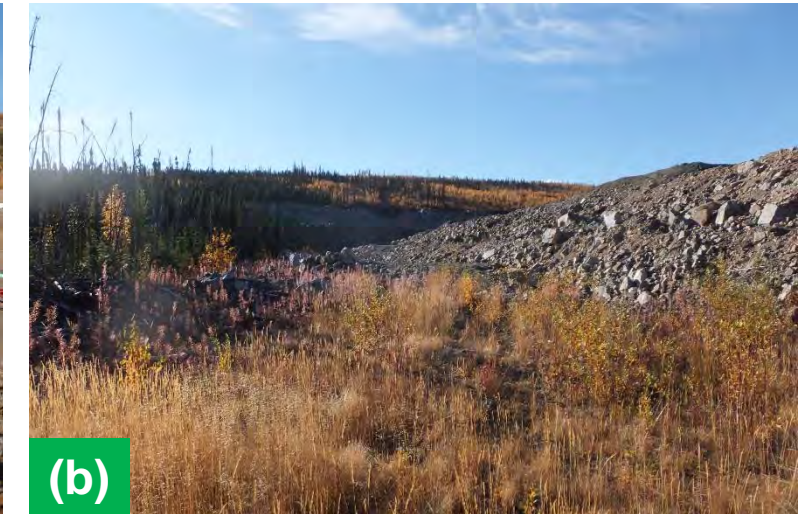
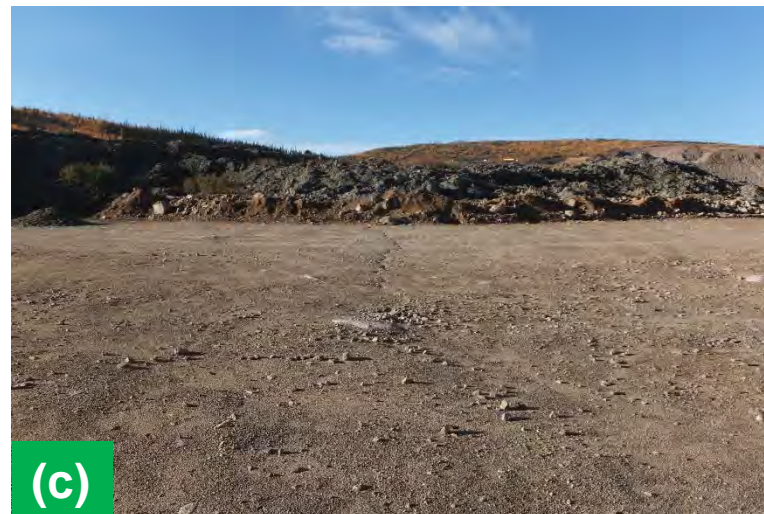
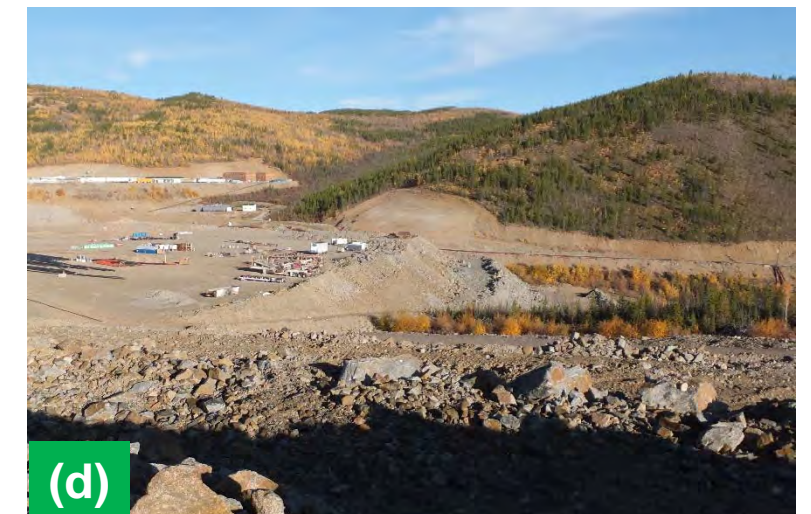
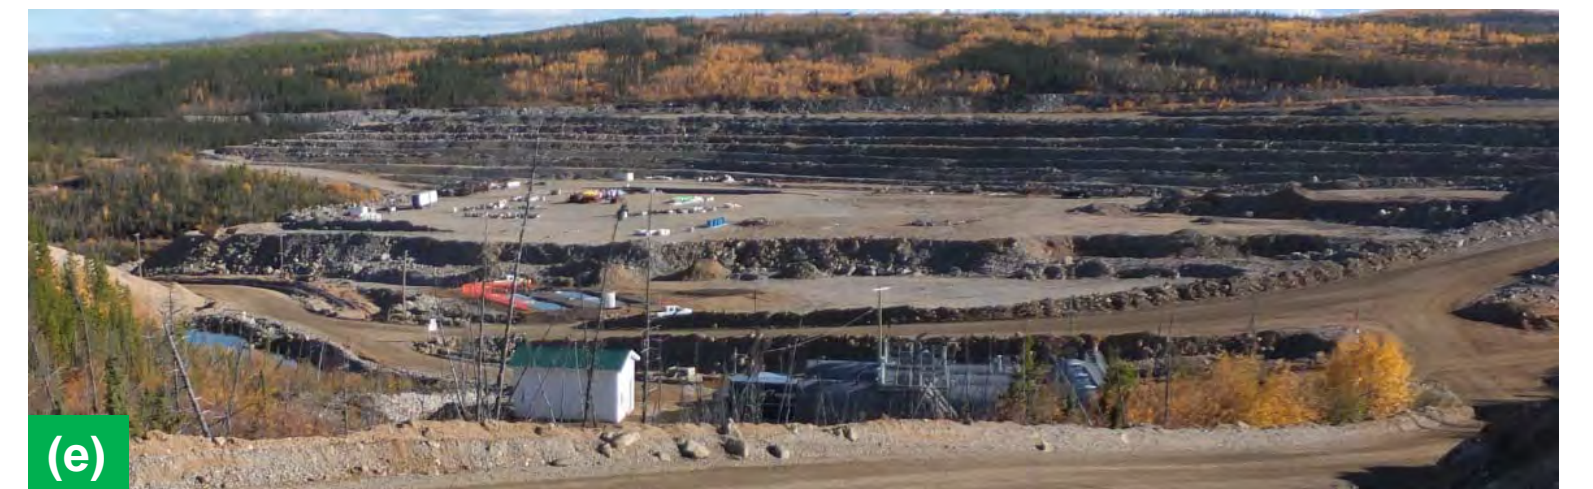
- Photos (a) to (c) show the condition of the waste rock shell and slopes.
 - One tension crack was observed at the northeast corner of the DSTSF at the crest (Photo c) The crack is 2.5 cm wide at its widest point. This area should continue to be inspected to monitor for crack progression.

- No other signs of instability were observed.
- Photos (d) and (e) show the condition of the Mill Valley Fill Extension.
 - Since the last inspection by SRK in September 2013, the area of settlement and cracking (area noted in plan below) was graded and filled in. The settlement and cracking was believed to be caused by differential settlement between two lifts placed at different times. The newer lift may have been settling within the coarser material at the older outer bench face or due to snow melting (if placed during winter).

- Continue to monitor the 2013 crack and settlement area.
- Continue to monitor the 2014 crack and install two survey nails/pins (one on each side of the crack) to measure the relative displacement. Consider spray painting lines across the crack to aid in monitoring any future displacement.

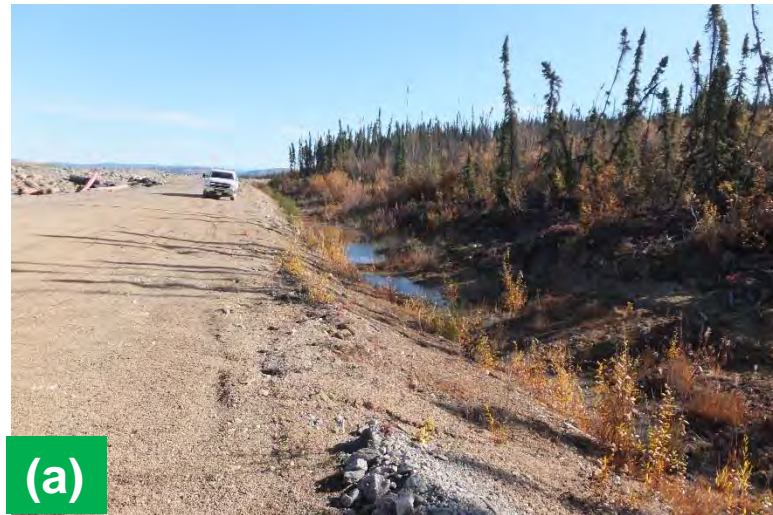
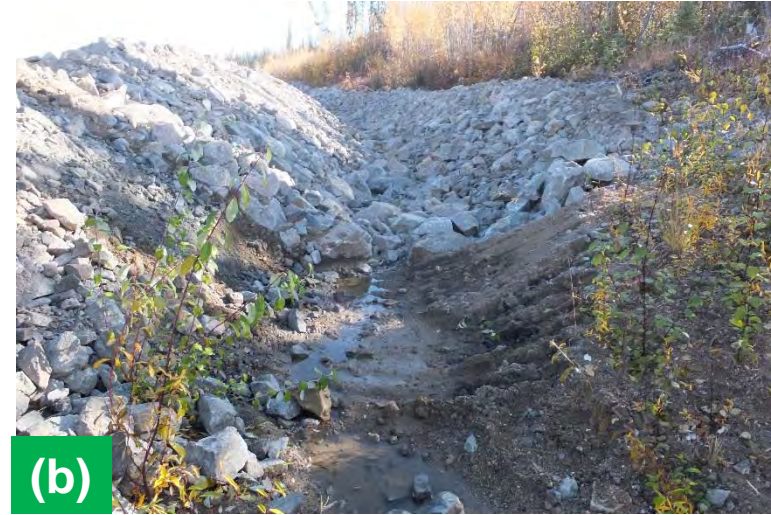
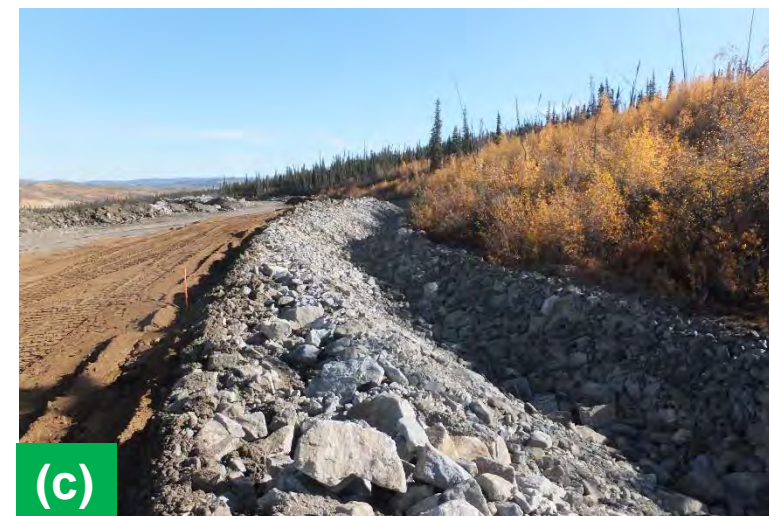
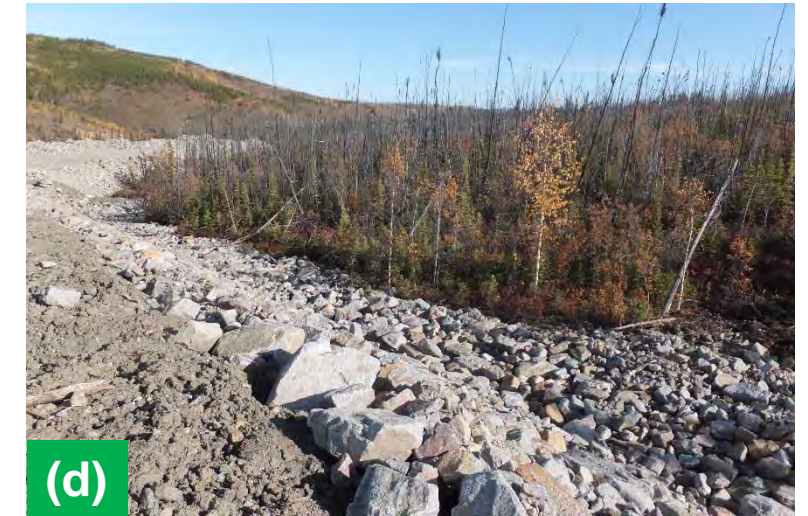
- Since the last SRK inspection in September 2013, construction of the eastern portion of the Tailings Diversion Ditch has been substantially completed according to the EBA design outlined in the memo, “Upstream Water Management for the Mill Valley Fill Expansion and Dry Stack Tailings Storage Facility” dated 2011.
- In general, the berm and ditch appeared functional, with conditions in the western portion similar to those observed in previous inspections. No signs of instability or ditch obstructions were noted.

- (a) View of the upstream portion of the channel. The area remains unchanged compared to 2013 inspection.
- (b) View of the upstream end of the recently constructed eastern portion of the TDD. The channel generally consists of a layer of GCL overlain by rip-rap with a minimum channel depth (compared to the downslope berm of 1.5 m). A small flow of water (<0.1 L/s) was entering the ditch at the time of the inspection.
- (c) View of the eastern portion of the ditch looking east. No visible signs of flow could be observed.
- (d) View of the downstream end of the eastern portion of the TDD looking northeast.

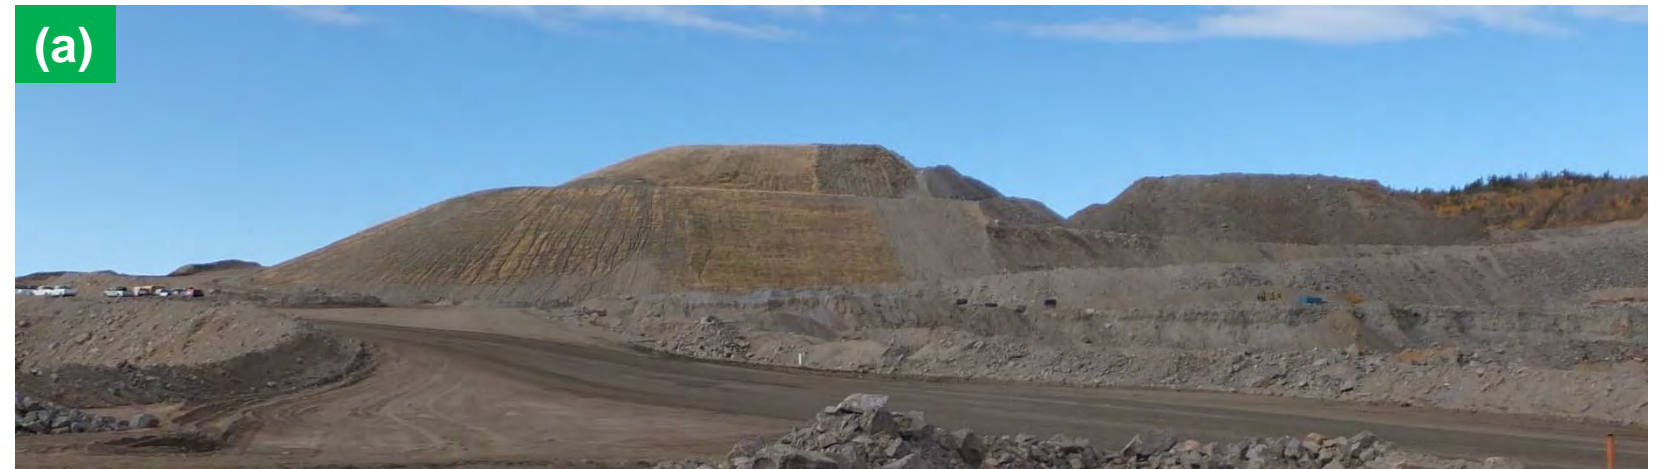
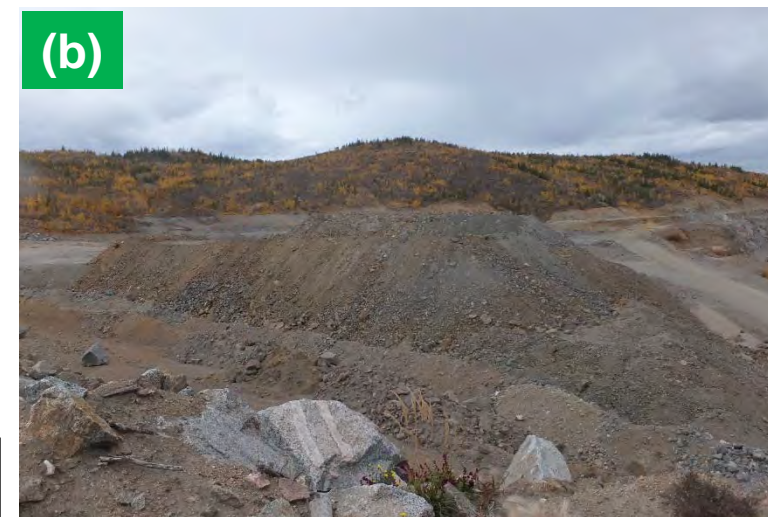
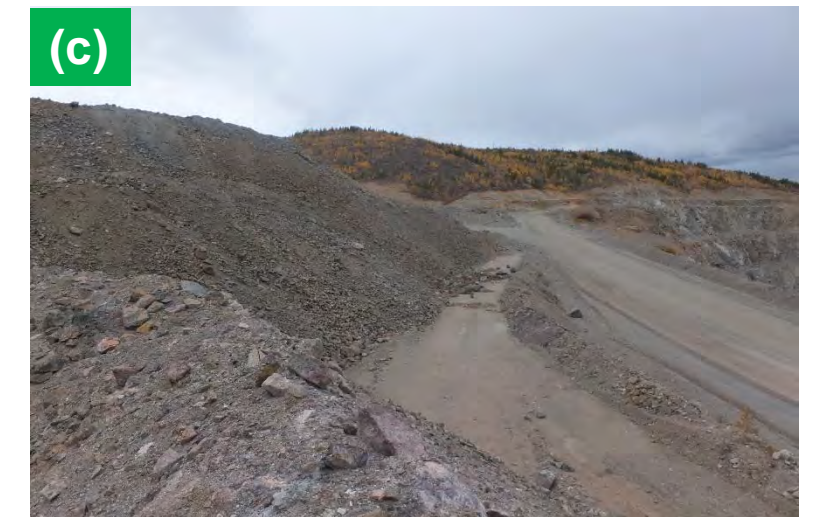
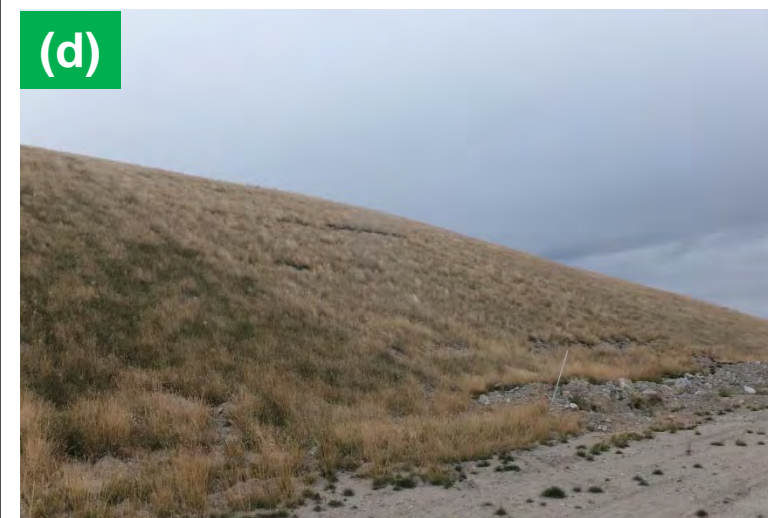
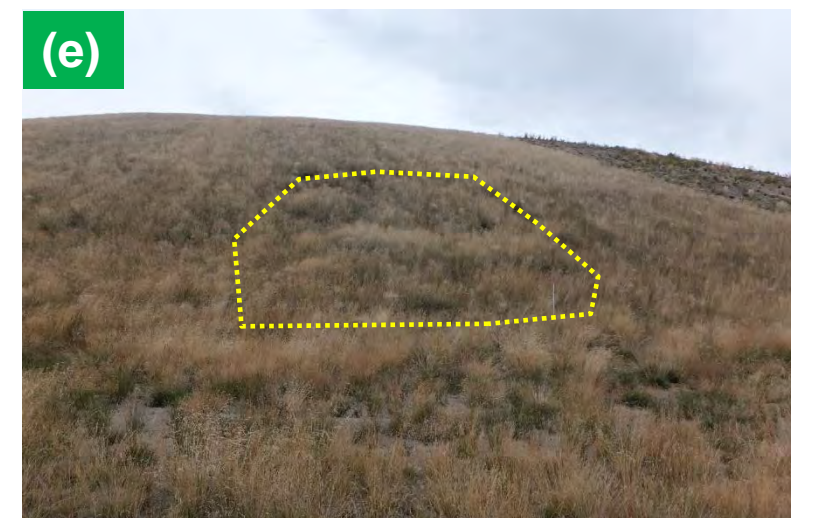
- No signs of instability were observed.
- Photo (a): Overview of the Main Waste Dump and Low Oxide Stockpile looking northwest.
- Photos (b) and (c): View of the Oxidized Ore Stockpile.

- Photos (b) and (c): View of the dump toe. Minor rills and gullies are present at the base of the regraded slope where vegetation is not yet established. No signs of instability were observed.

- Photo (d): View of the regraded slope taken from the mid-bench toe. Minor rills and gullies are present at the base of the slope. No signs of instability were observed.

- Photo (e): Location of the small surficial slough noted in the previous 2012 and spring 2013 inspections. The slough is contained within the cover material with minor bulging present at the base of the slope. The slough appears to be self-healing and no action is required.

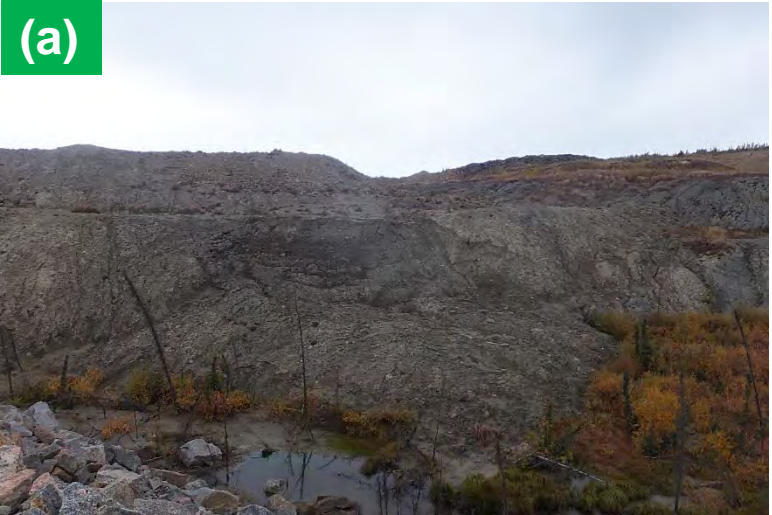
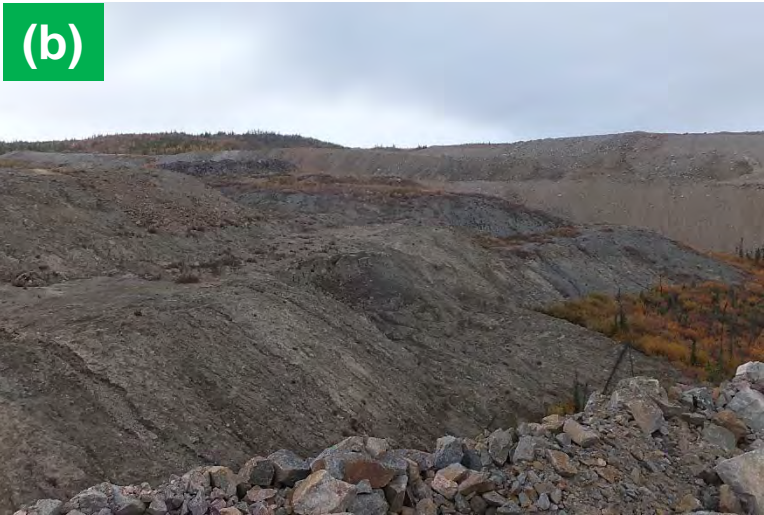
- Photos (a) and (b) show the shallow slope failure noted in the Spring 2014 Geotechnical inspection. Previous year's inspections noted localized slumping, discontinuous tension cracks, and erosion gullies within the area. The scarp is within approximately 5 m of the original crest. The failure has not compromised the overall dump slope angle and as a result, the failure is not expected to reduce the overall stability of the dump.
- Other areas of the ROD remain the same as noted in previous years' inspections:
 - Slumping, settlement and tension cracks are expected in the dump as it is constructed with frozen overburden with thawing expected.
 - Discontinuous tension cracks and differential settlement observed along the perimeter crest.
 - Ground undulation is typically 0.3 m and is prevalent throughout the facility.

- Continue to monitor the slope failure area for further signs of movement or instability.

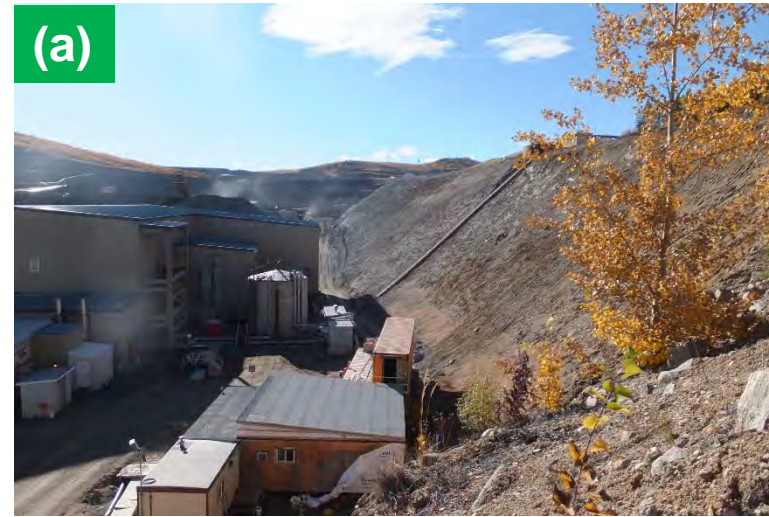
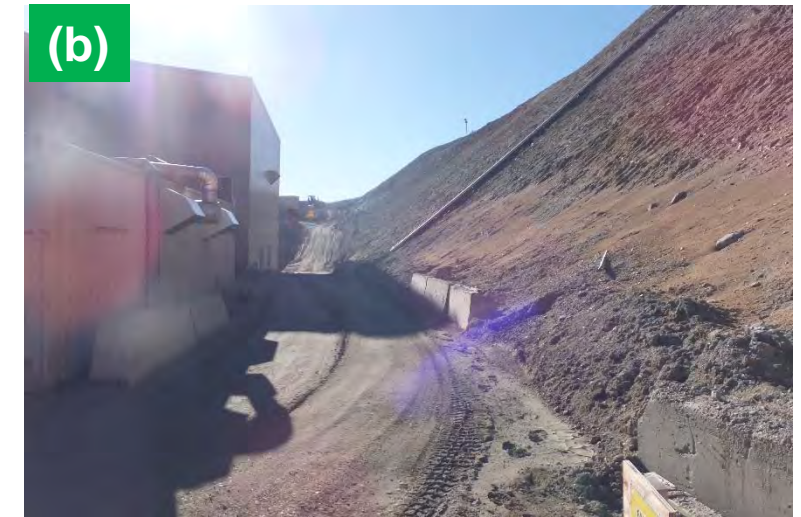
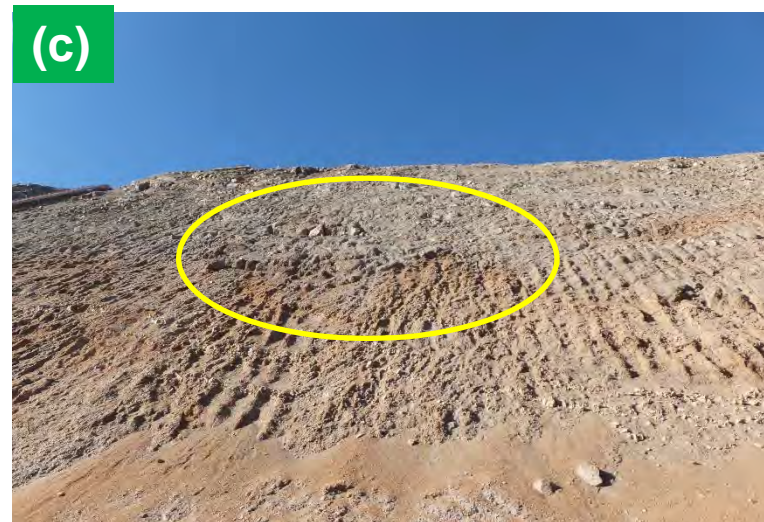
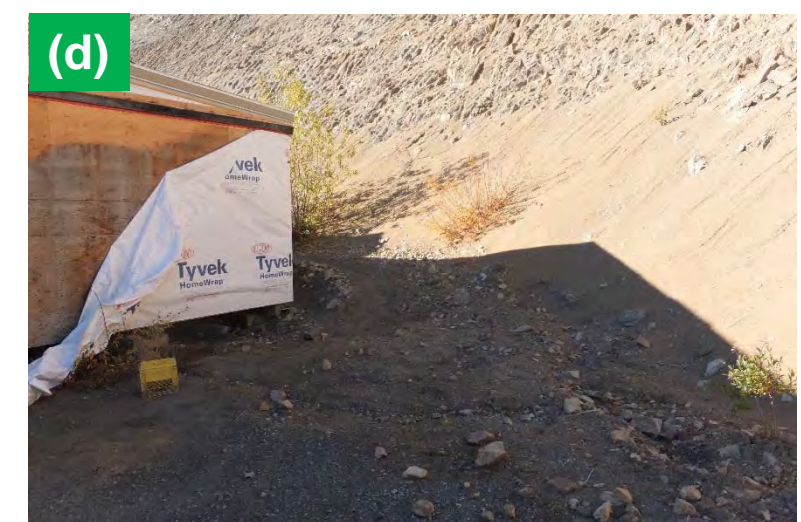
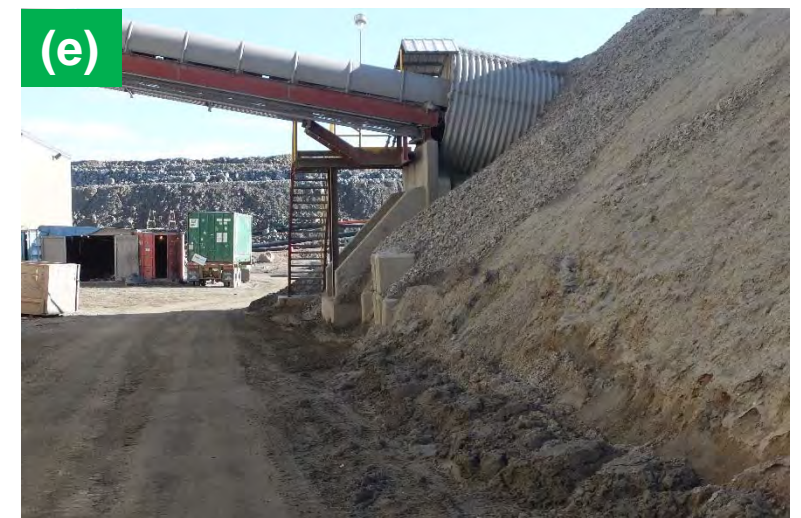
- a) The slope above the main mill site appears stable. Safety berms at the top of the slope are in good condition.
- b) East end of the mill slope looking west. Eroded sand/gravel is generally present at the base of the slope with occasional cobbles/boulders up to 300 mm.

- Continue to monitor the retaining wall near the mill's apron feeder tunnel and maintain a photographic record of its condition.

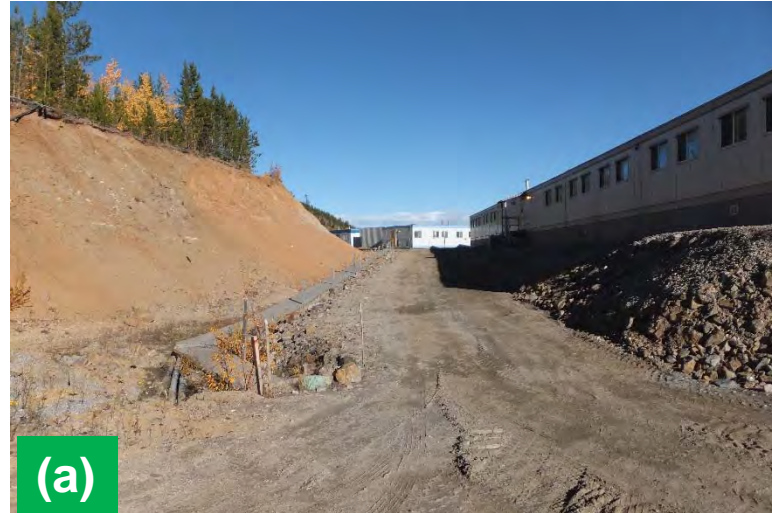
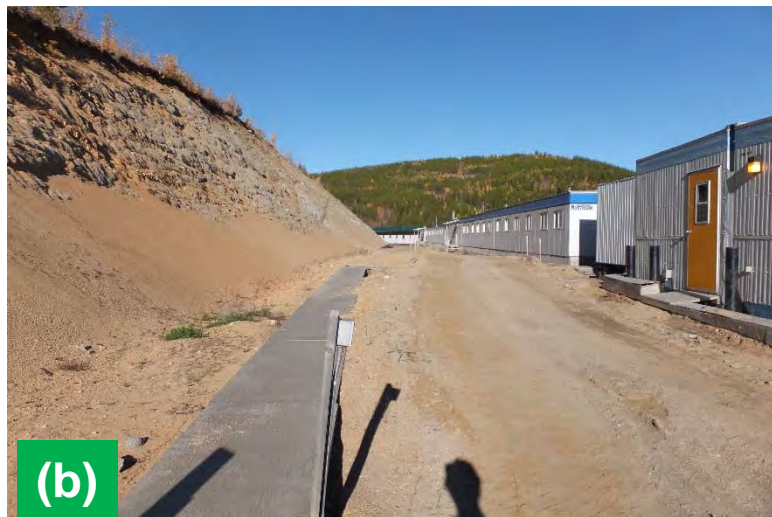
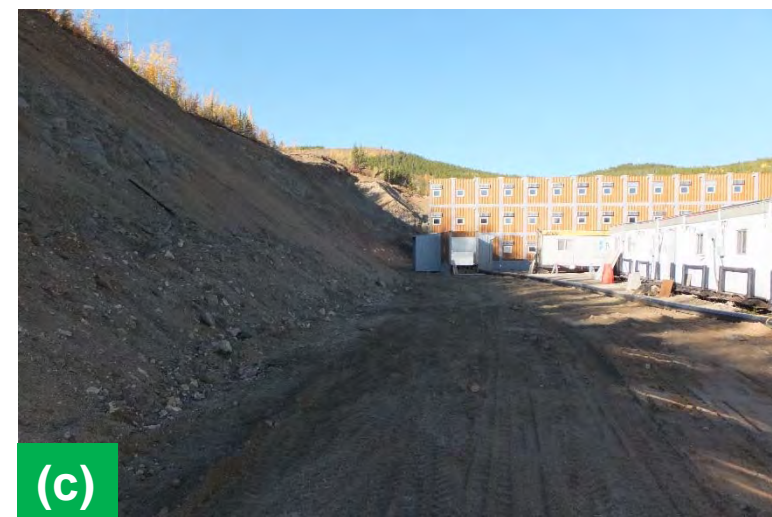
- a) & b) Slope above the main camp site appears stable.
 - Eroded sand/gravel is generally present at the base of the slope with occasional cobbles/boulders up to 300 mm.
- c) View of the new camp site looking north. No signs of instability in this area.
- d) View of the seep at the northwest corner of the camp expansion.
- e) & f) Erosion channels present south of the camp site near the carpenter's shop. Conditions are similar to the Fall 2013 inspection.

- The area above the erosion channels on the camp pad should be regraded to promote runoff away from the channels.
- The channel by the carpenter's shop should be filled with rip-rap or a half culvert to provide a path for the water to drain.
- It is recommended that these actions be completed in the following year. In place of the surface grading, a small ditch could be constructed near the slope crest to direct runoff to the drop channel or half-culvert.

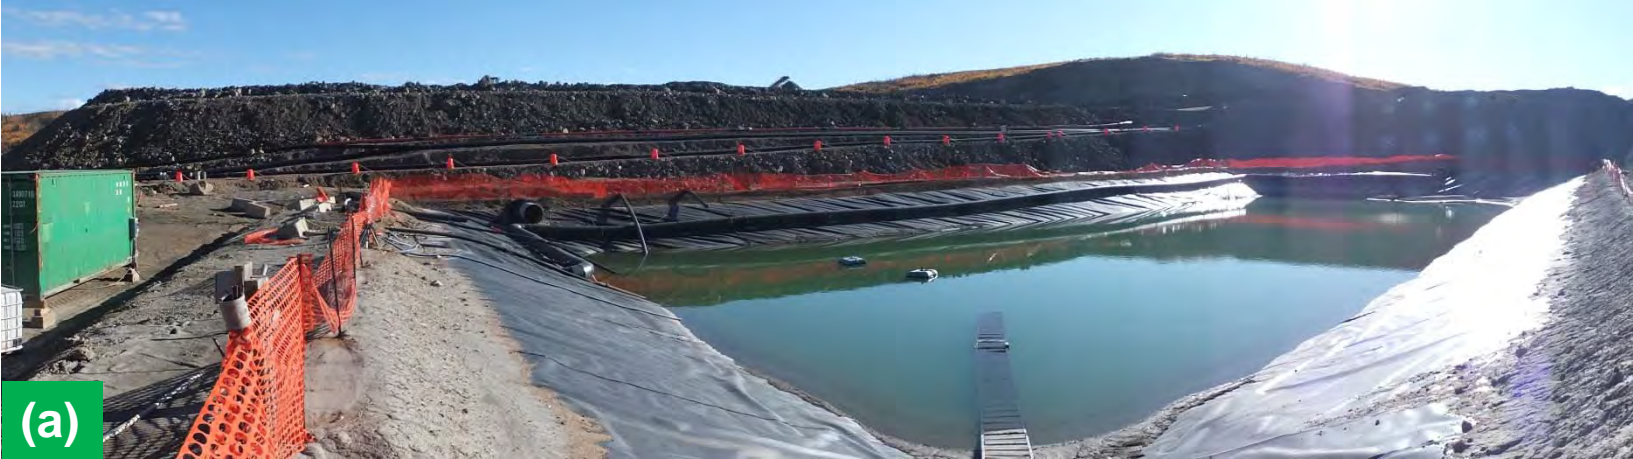
(a)

- a) Panoramic view of the Mill Water Pond. Tears in the liner system are the same as reported in previous inspections. No new tears or liner defects were observed.
- b) View of the tear in the liner at the north corner of the pond. The tear is approximately 1 m in length and first noted in the 2008 inspection.
- c) Two tears in the liner midway along the northeast edge of the pond. These tears were first observed in 2009. The largest tear is approximately 1.5 m in length and is parallel to the slope. The smaller tear (white arrow) is approximately 0.5 m in length and orientated across the slope. A void is present beneath the slope that has been noted to be increasing in size due to water penetration from surface.
- d) View of the south east side of the pond and by-pass pipe. The bypass pipe and metal clamps are resting on pieces of plywood placed on top of the liner.

- The liner tears should be patched the next time a liner crew is onsite. For the liner tear noted in Photo (c), Figure 14, sand should be placed to fill the void beneath the tear.
- The sediments accumulated in the surface runoff ponds and culverts should be cleaned out.

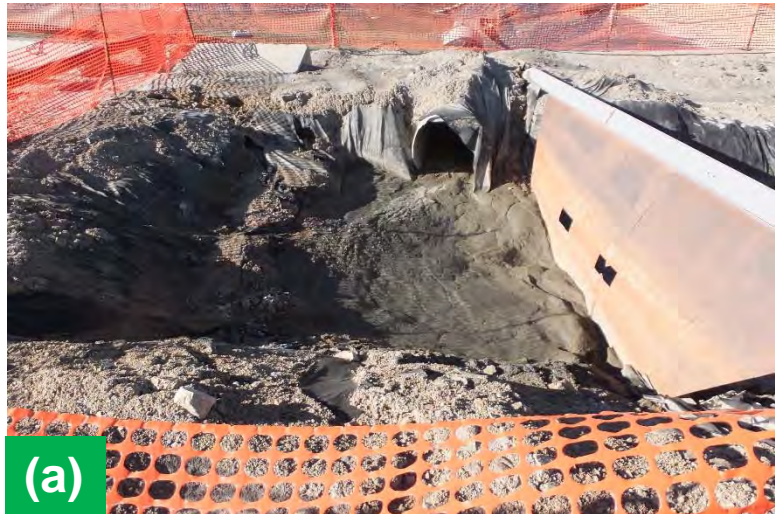
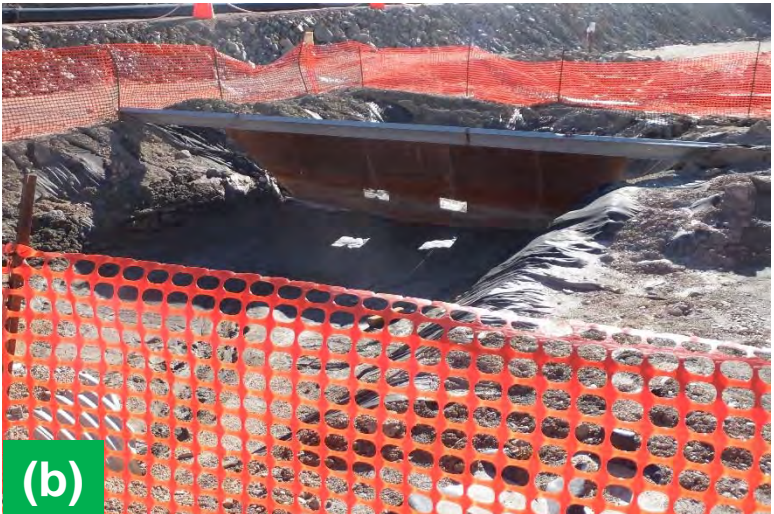
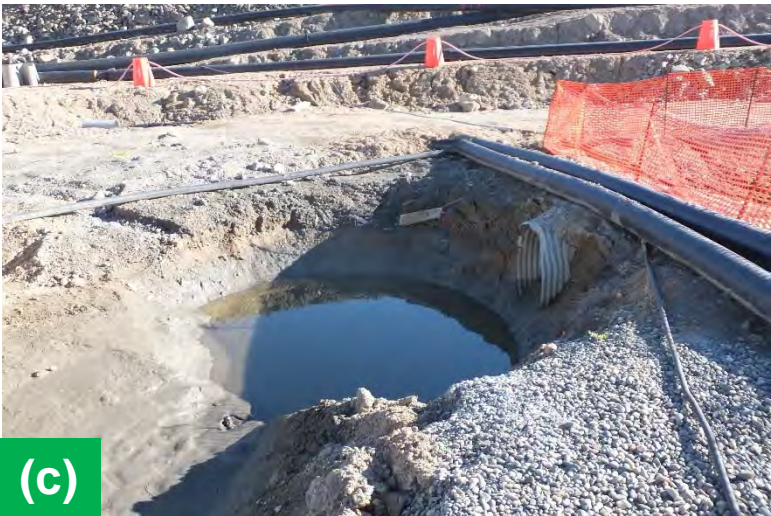
- Photos show the condition of the surface runoff ponds south east of the Mill Water Pond. Conditions are unchanged compared to the 2012 and 2013 inspections.
- There are significant sediments in both ponds, each culvert, and outside the ponds to the east.

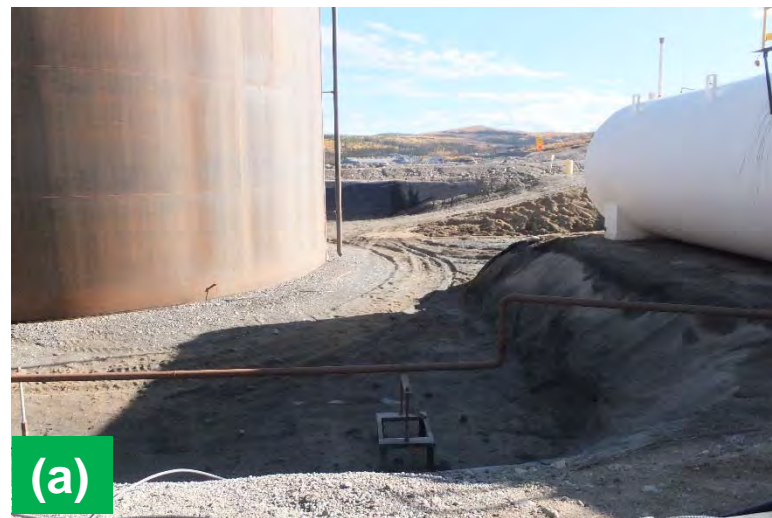
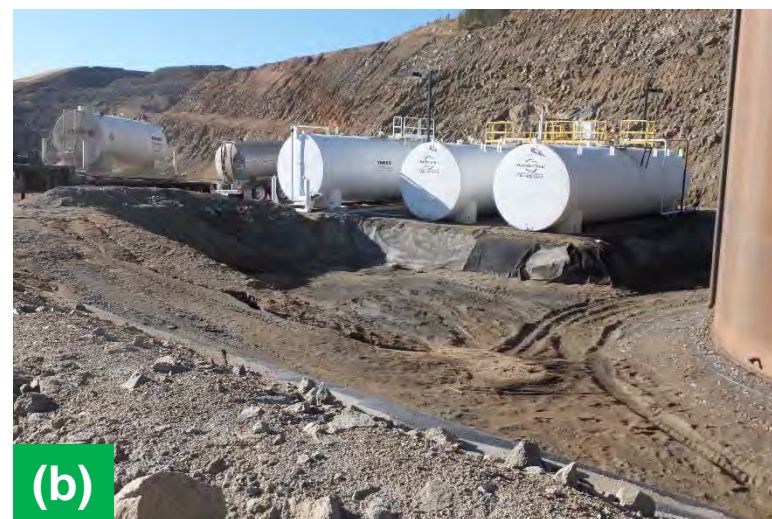
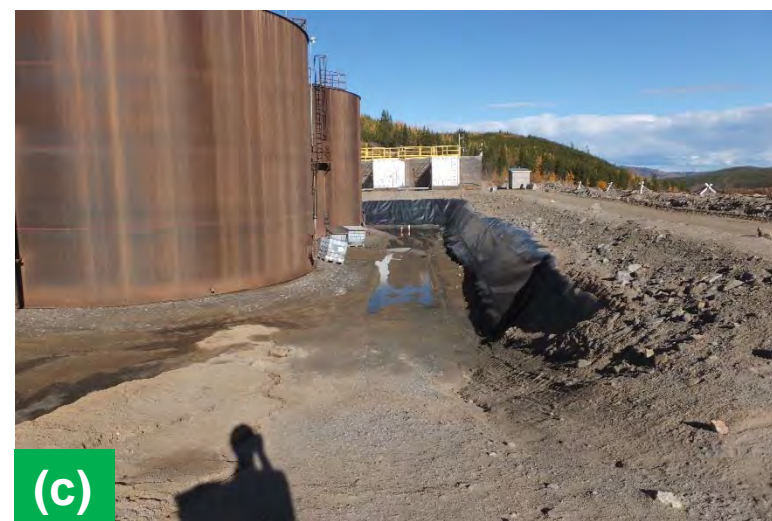
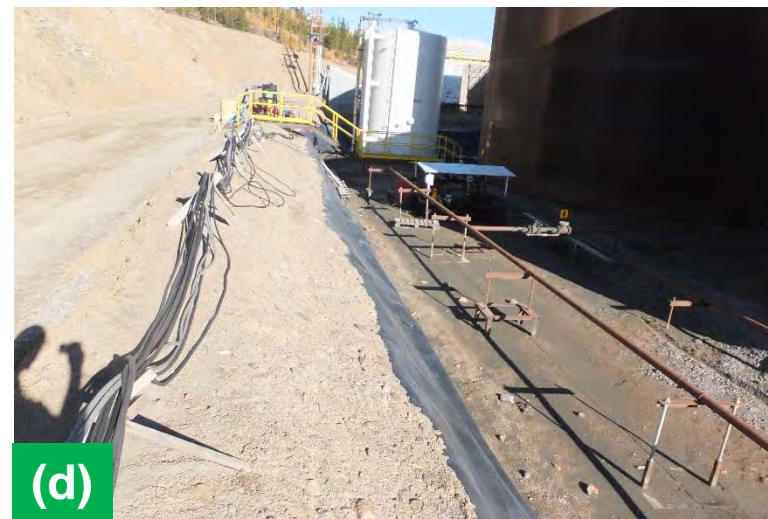
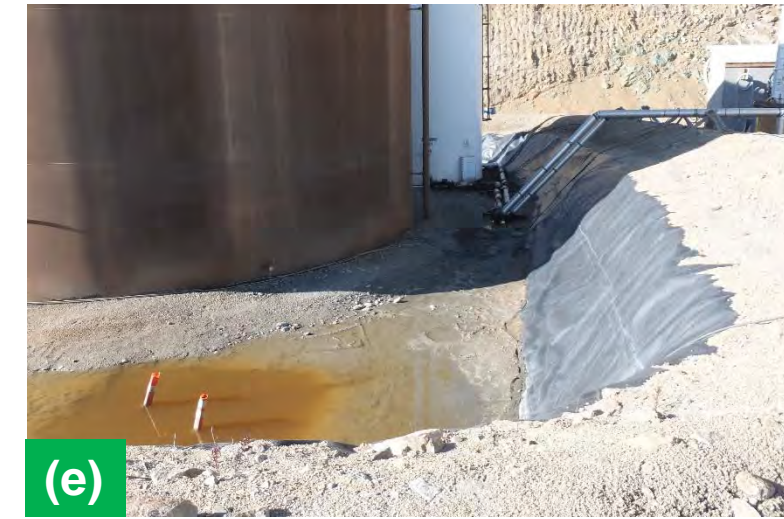
- Photos (a) to (e) show the condition of the liner on each side of the facility.
- Conditions of the facility appear to be the same as reported in the 2012 review.
- No tears or defects in the liner were observed.
- Minor pooling was observed. The facility appears to drain into containment area as per design.
- No new rutting observed. Ruts are present in the southern half of the facility. Rutting is significant (approximate 2-3 inches deep) between the two tanks where equipment was turning. No liner is exposed as a result of the trafficking.

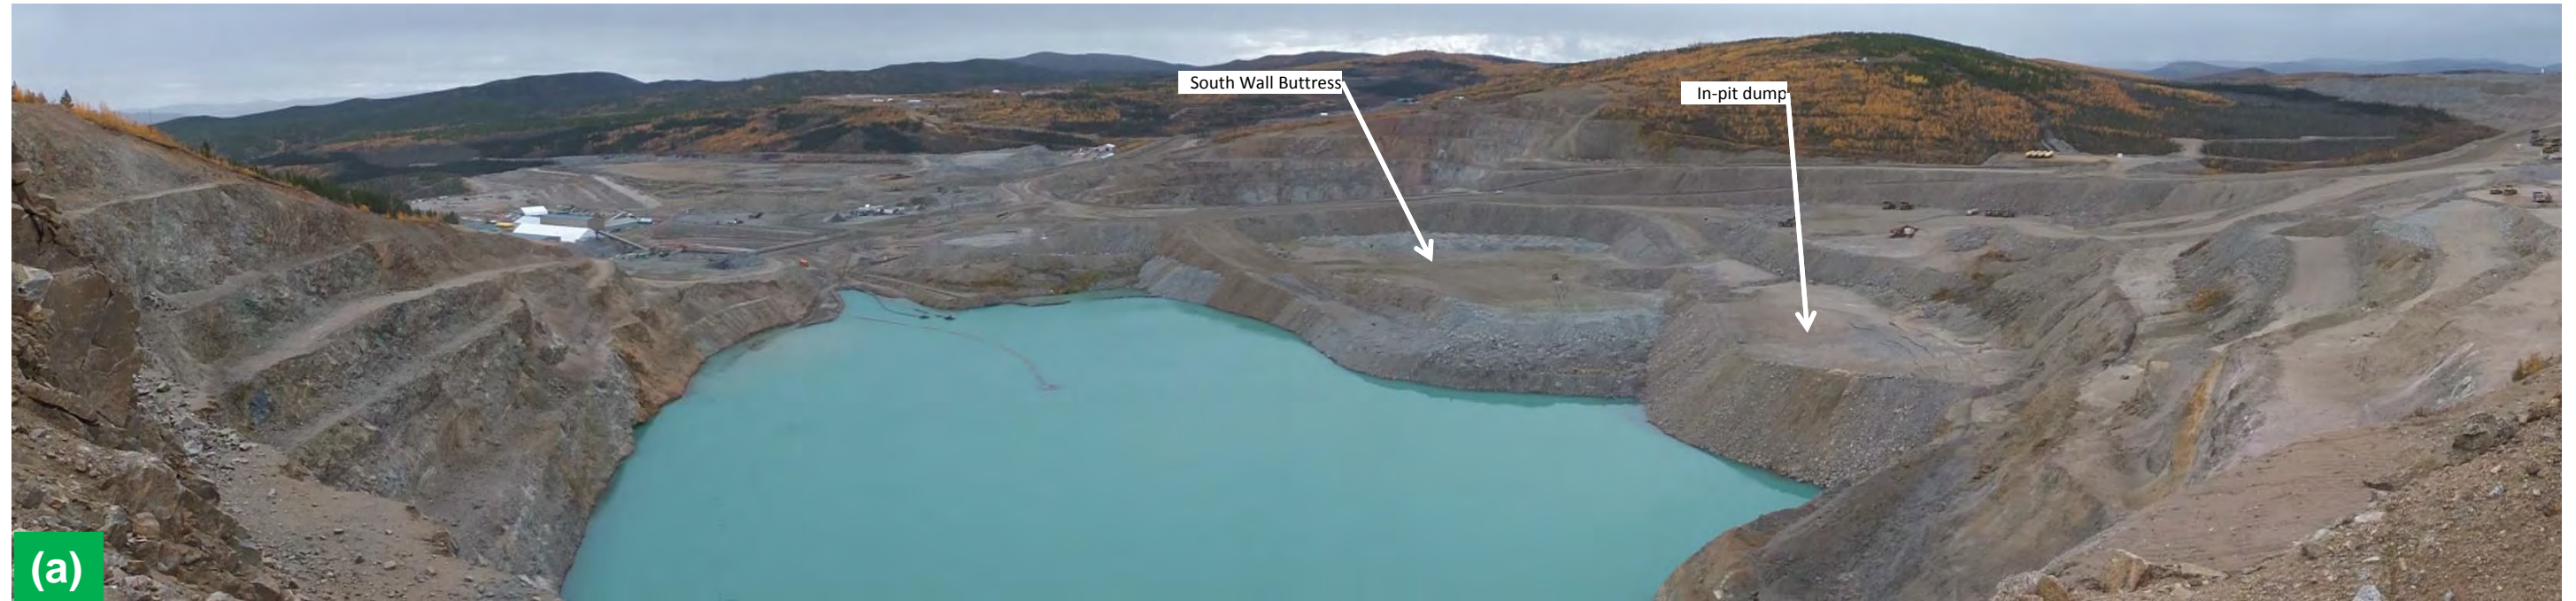
Photo a: View of the Main Pit, South Wall Buttress and In-Pit Dump taken from the north west corner of the pit.
 Photos b and c: View of the tension cracks on the In-Pit Dump located west of the South Wall Buttress. This area has been blocked off and is inaccessible to equipment. Cracks on the In-Pit Dump are up to 50 cm wide with a 40 cm elevation difference across the crack. The movement is believed to be due to the large dump height, with the material end dumped directly into the pit water.

- The tension crack area should be continue to be visually monitored. A photographic record should be maintained to inspect for changes in condition.
- Additional survey hubs should be placed on the South Wall Buttress to monitor movement.
