2014 Spring Geotechnical Inspection

Prepared by:
Minto Explorations Ltd.
Minto Mine
August, 2014

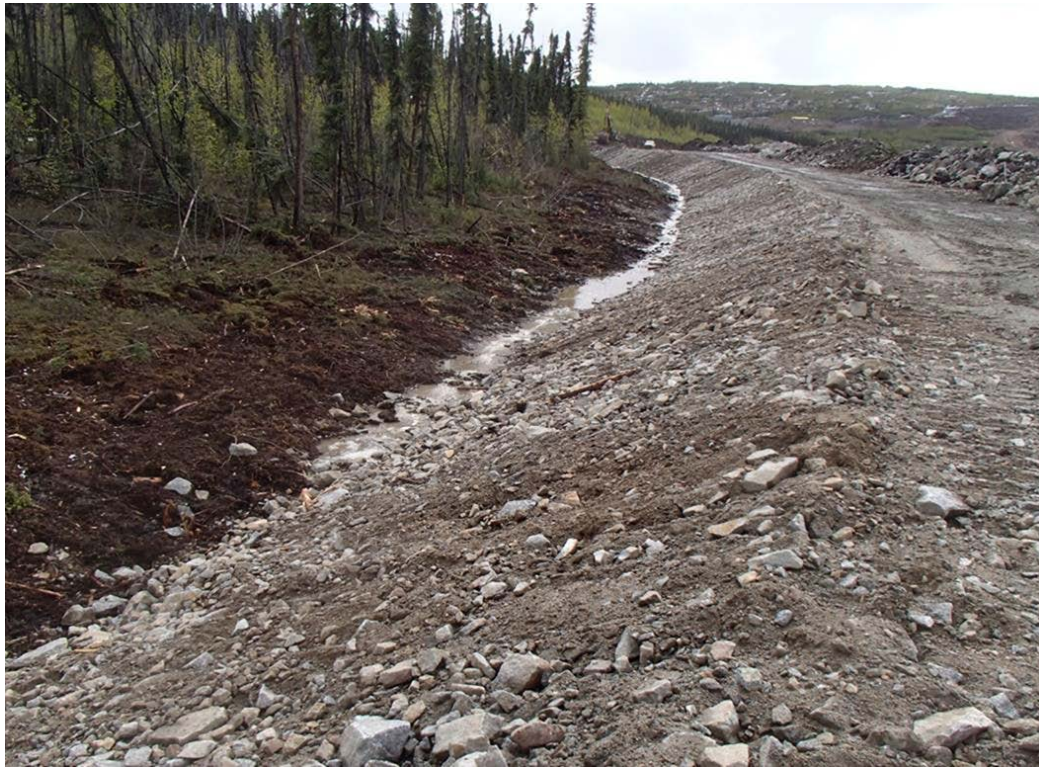
Construction was observed at the Tailings Diversion Ditch, please see Figure 1 in Appendix A. Construction methodology was observed to be following general specifications and guidelines outlined in EBA's construction quality assurance manual, file number 0201-95-11509 August 1997.

Figure 1: Tailings Diversion Ditch – Construction was observed at the Tailings Diversion Ditch

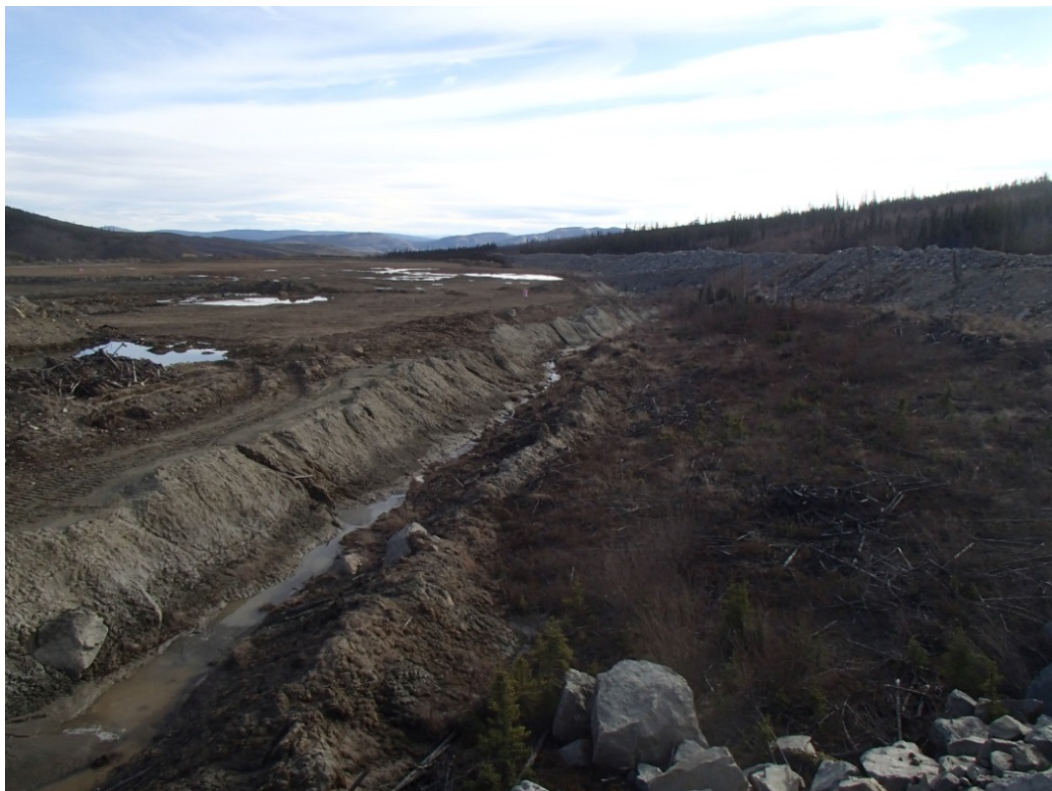
Figure 2: Dry Stack Tailings Storage Facility - South side of DSTSF.

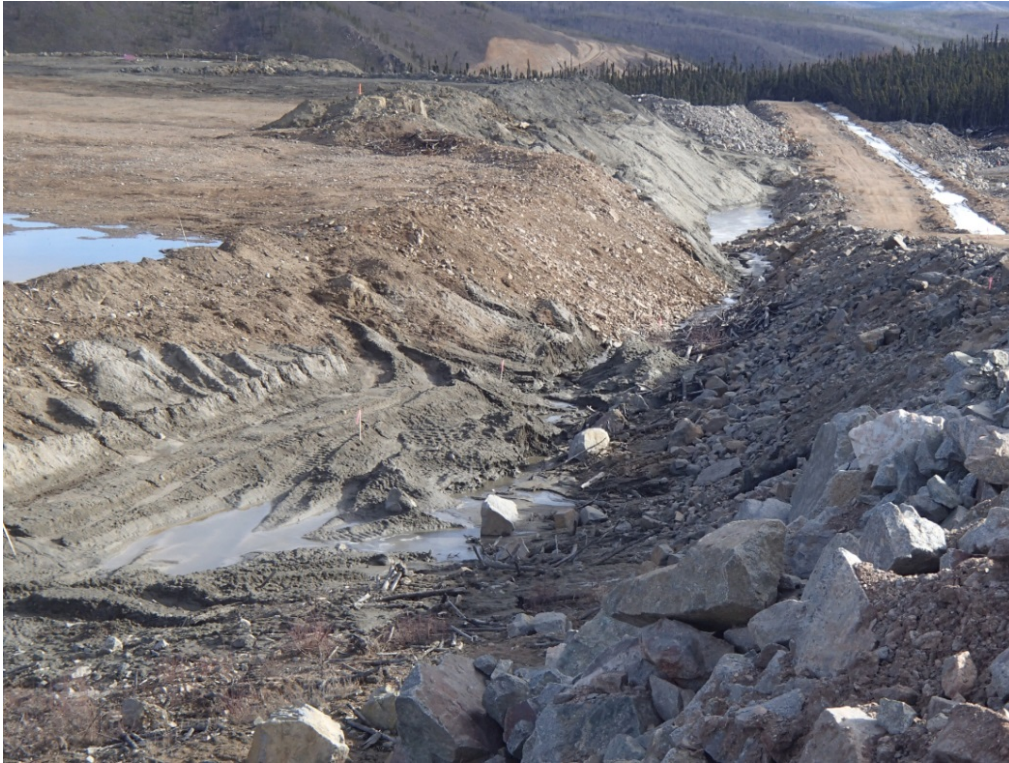
Figure 3: Dry Stack Tailings Storage Facility - South side of DSTSF at East end.

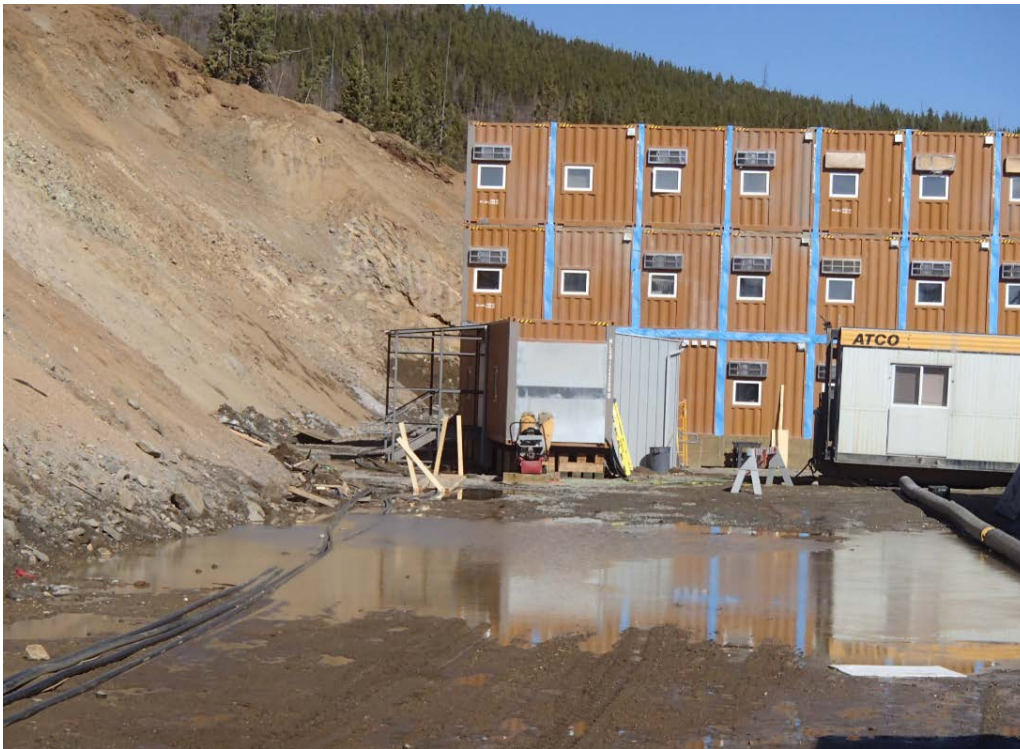
Figure 4: Mine Camp - The low spot behind the new camp should be graded using gravel to continue the drainage channel behind the back of the new camp, as opposed to the ponding which currently occurs.

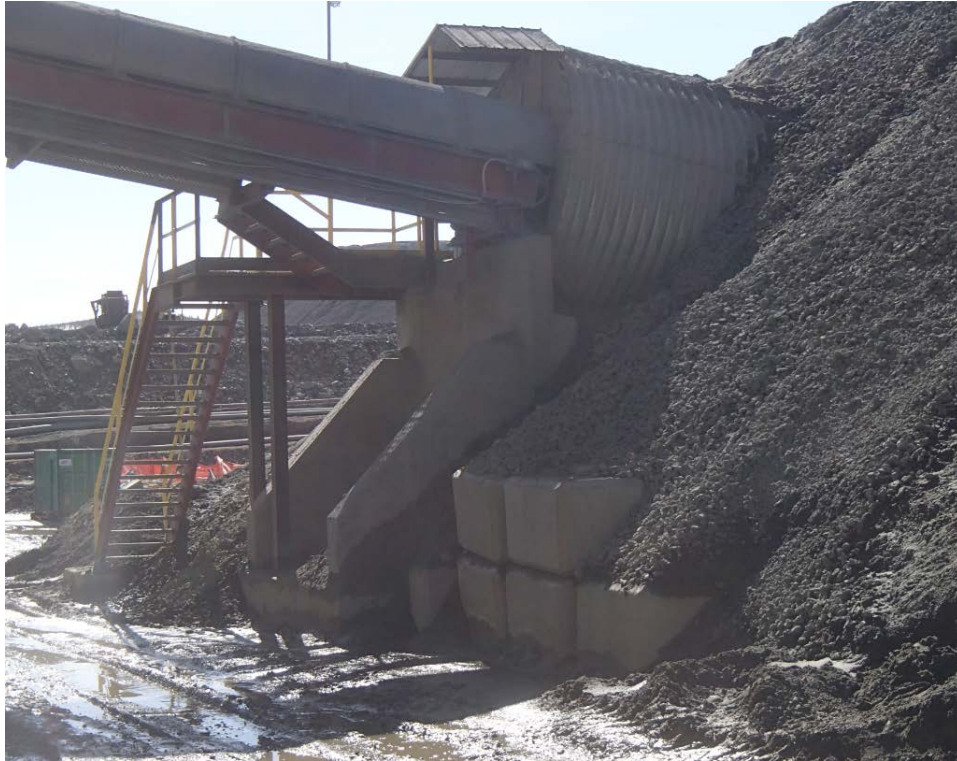
Figure 5: Mill - The retaining wall at the mill's apron feeder tunnel should be monitored, it is tilting forward in an active condition with the potential for overtopping.

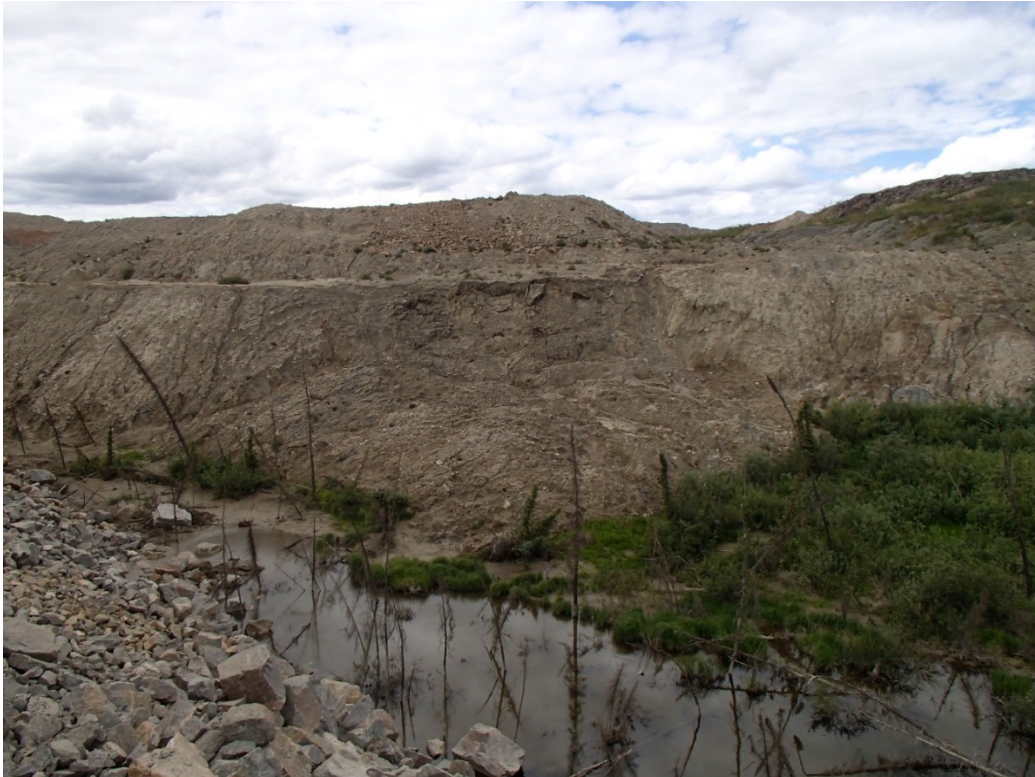
Figure 6: Reclamation Overburden Dump - Crest failure on southeast side of the ROD. Not a concern to large scale stability.

Minto Creek Detention Structure	-	Continue annual monitoring for signs of instability or seepage on the downstream slope of the MCDS.
Ore Stockpiles	-	None.
Reclamation Overburden Dump	6	None. Localized crest failure on the southeast toe into the ponded water area was observed but is not a large scale stability concern.
South Diversion Ditch	7	Remove ditch obstructions such as road fill, vegetation, GCL to increase the flow capacity. This was completed in July 2014 (after the inspection was conducted)
	8	Remove the three large boulders at the overflow spillway and replace with traffic pylons.
	9	Complete an as-built survey of the pipe intake structure and overflow spillway and confirm that the spillway is constructed to design.
South Wall Buttress	10	Tension cracks on the west wall fill appear to have increased/dilated since the previous inspection. Install prisms to monitor movement.
Southwest Waste Dump	-	Continue monitoring instruments. Review if movement rates do not stabilize after completion.

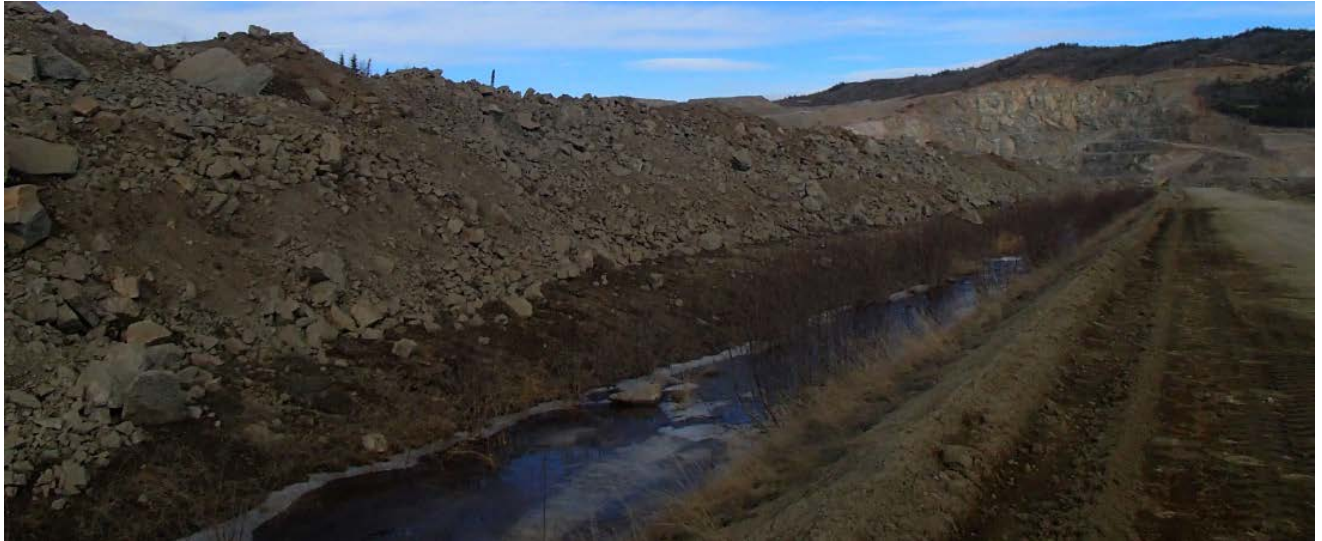
Figure 7: South Diversion Ditch - Should the South Diversion Ditch continue service, the deciduous vegetation should be cut back and removed.

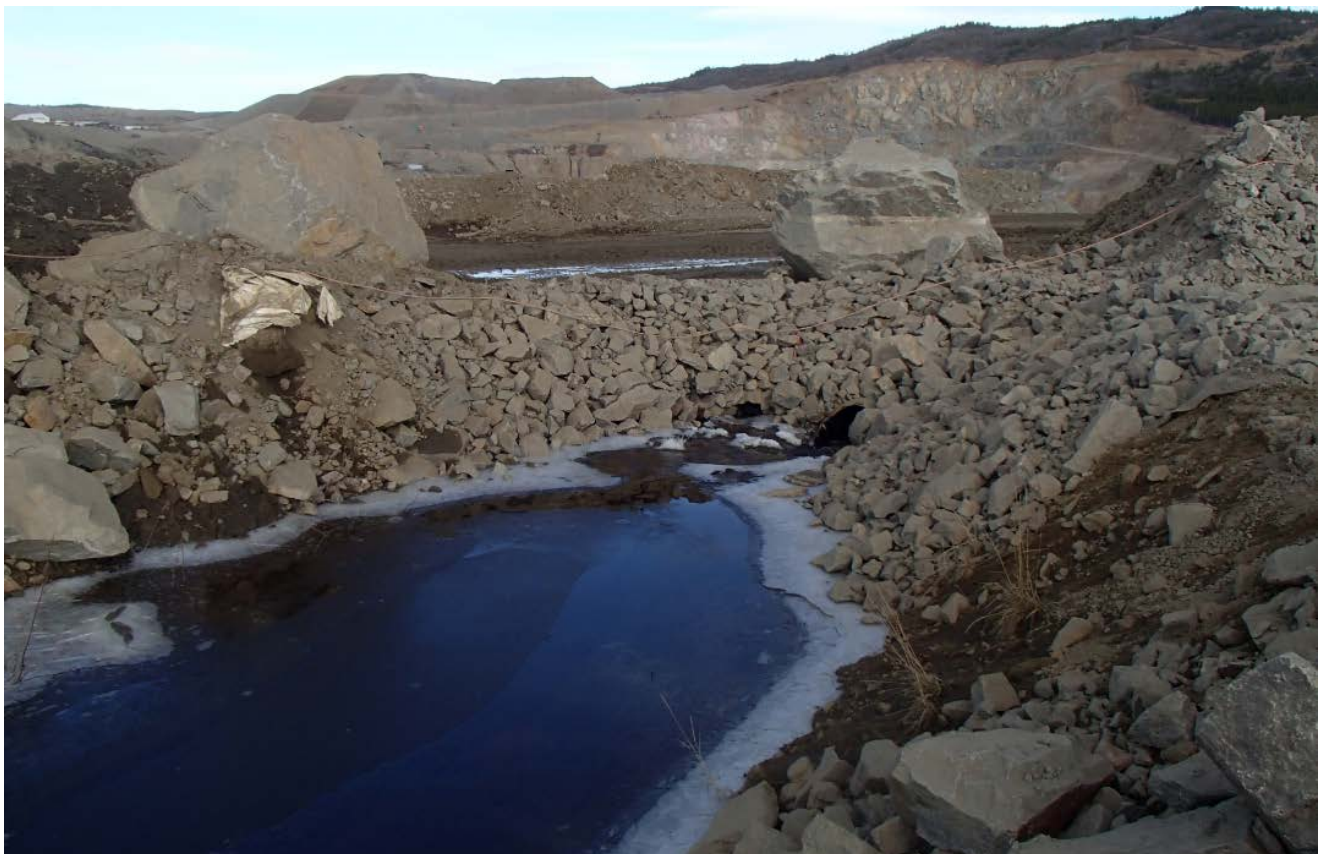
Figure 8: South Diversion Ditch - The swale for the South Diversion ditch should be completed as per SRK's South Diversion Ditch construction drawings, it is lacking width. The two boulders should also be removed.

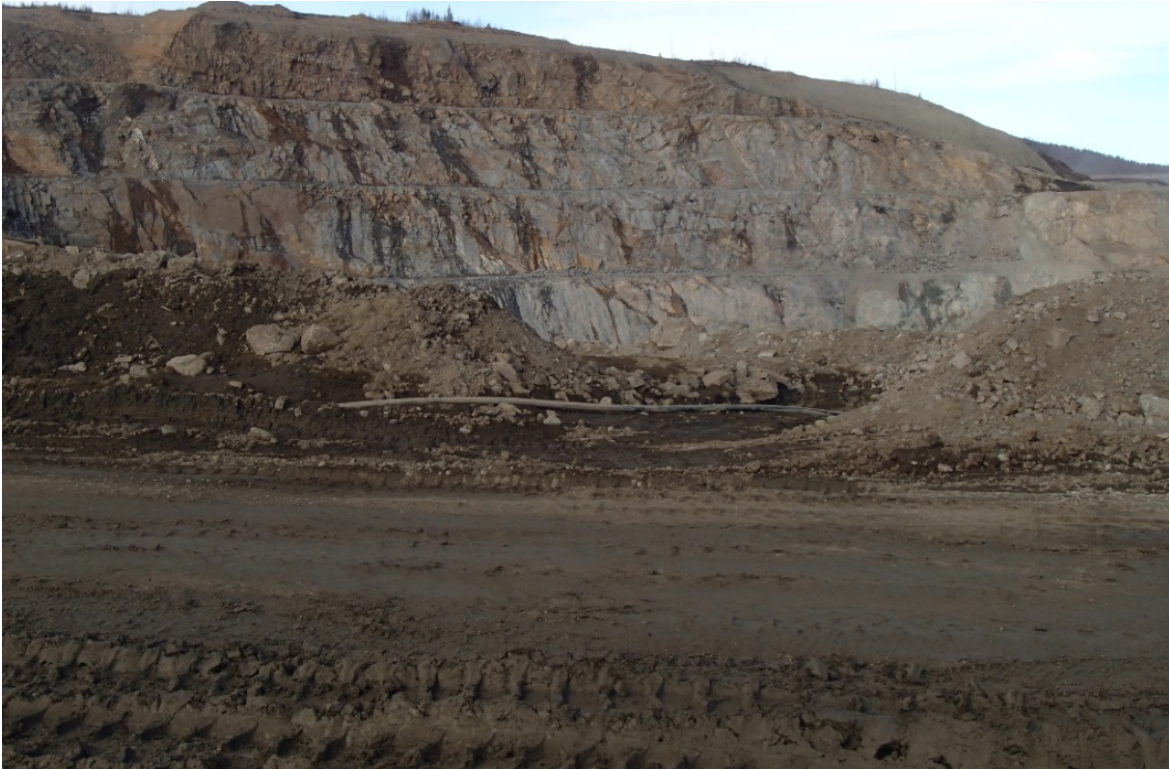
Figure 9: South Diversion Ditch, cont'd - The swale for the South Diversion ditch should be completed as per SRK's South Diversion Ditch construction design, it is lacking width, the downstream outlet for the swale is blocked

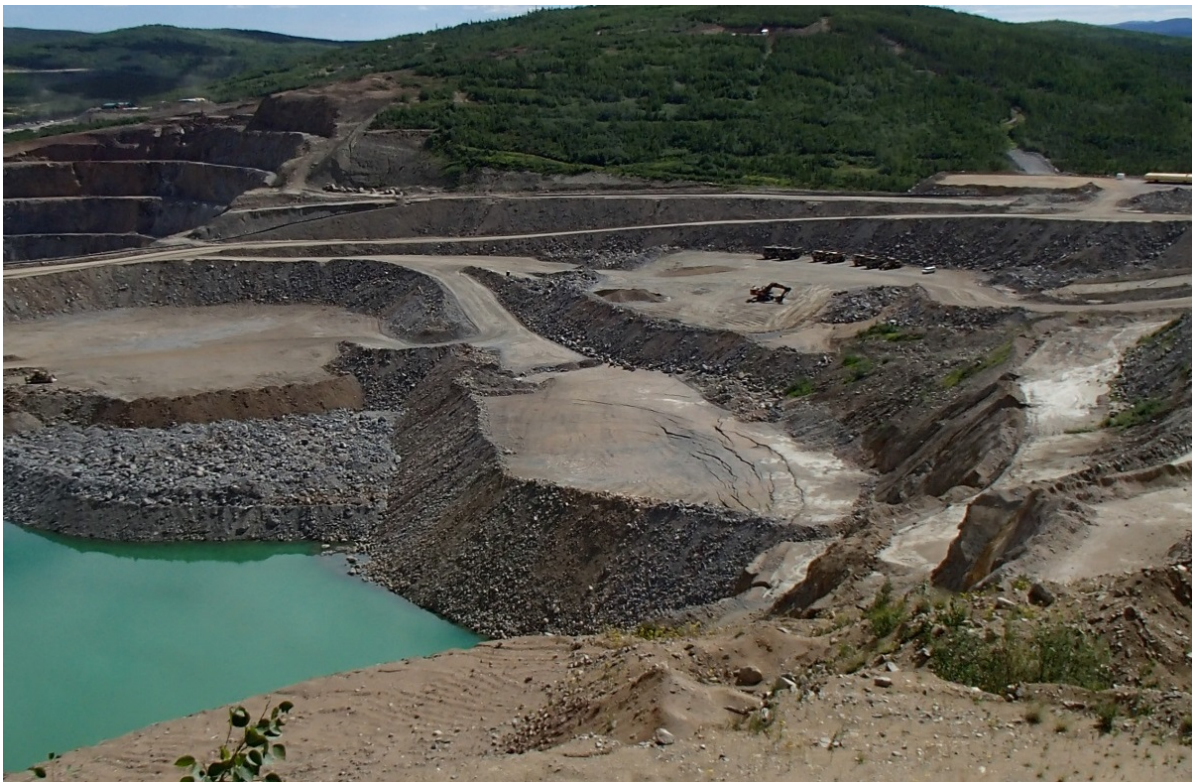
Figure 10: Main Pit South Wall Buttress – Tension cracks appear to have increased/dilated from the previous inspection. Install prisms along crest to monitor movement.

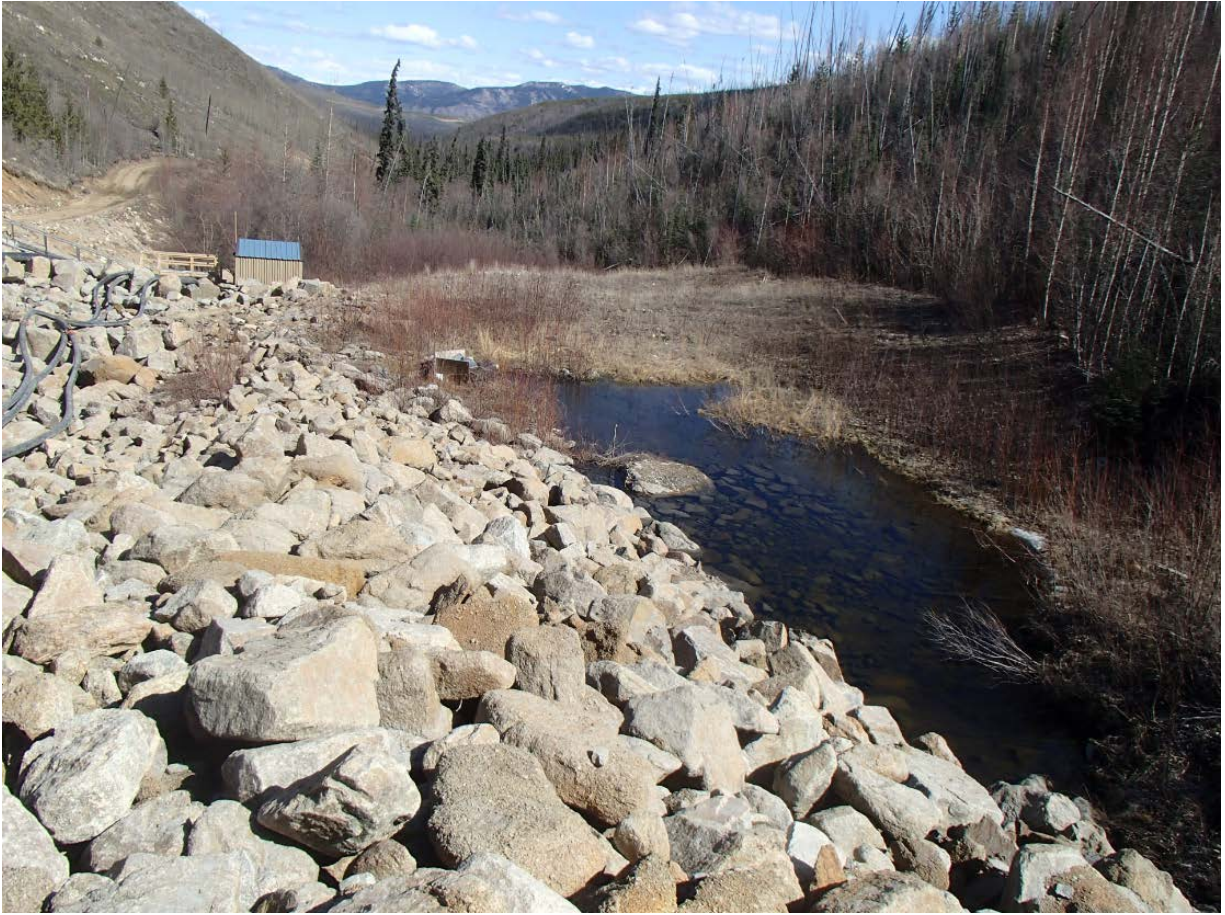
Figure 11: Water Storage Pond Dam - Ditching of the ponded water on the south abutment of the WSP Dam should be considered to ensure low groundwater pressures are maintained on the dam face

Area	Appendix A Figure #	Recommendation
	11	Ditching of the ponded water on the south abutment of the WSP Dam should be considered to ensure low groundwater pressures are maintained on the dam face
	-	The discharge point of the water (from the pit, water treatment plant, etc.) influences the seepage pump data at W-3 in the seepage pump house. Options to obtain accurate seepage measurements should be explored such as moving the discharge point a further downstream of the pump house. The issue should be resolved prior to 2015 spring melt.

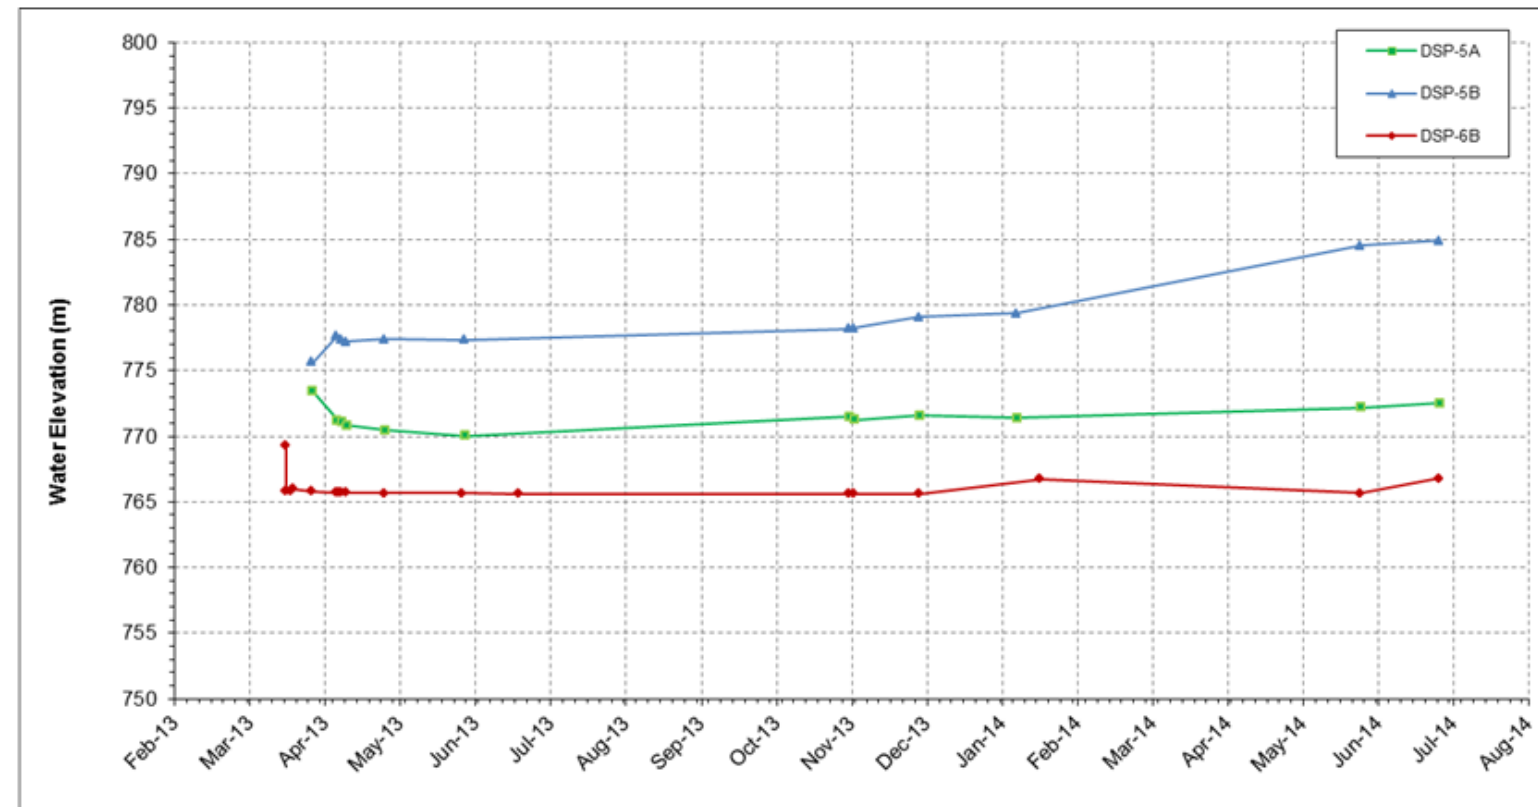
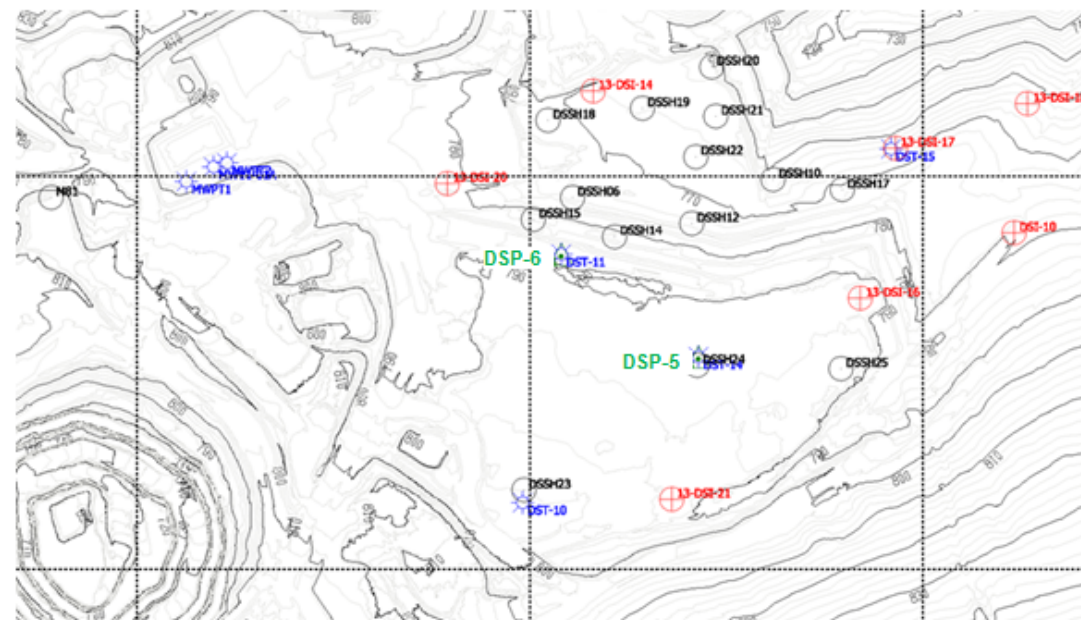
a) Piezometers DSP-5A, DSP-5B, DSP-6B

Piezometer pressures are relatively consistent with the exception of DSP-5A, which has increased approximately 6m in 2014. All sensors are in frozen ground so they may not be reliable.

Notes:
 DSP-6A is reading negative pressures and therefore has not been included

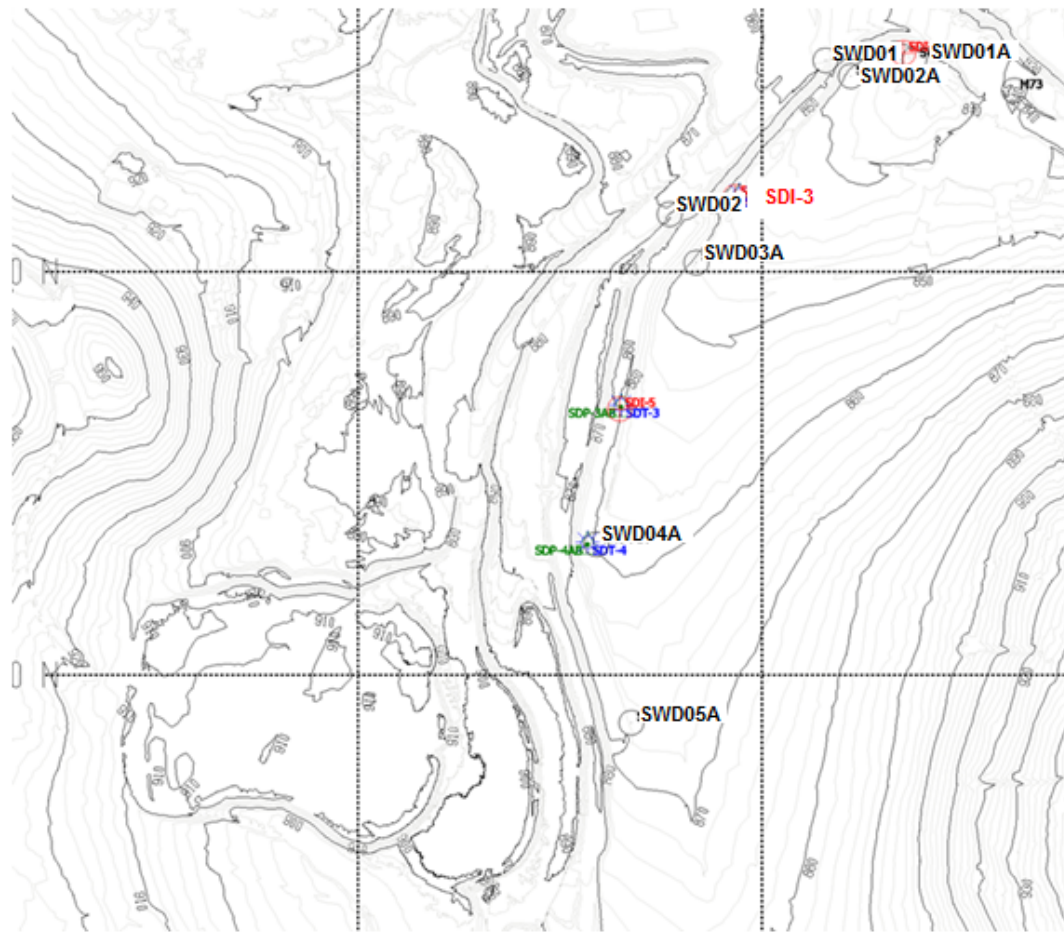
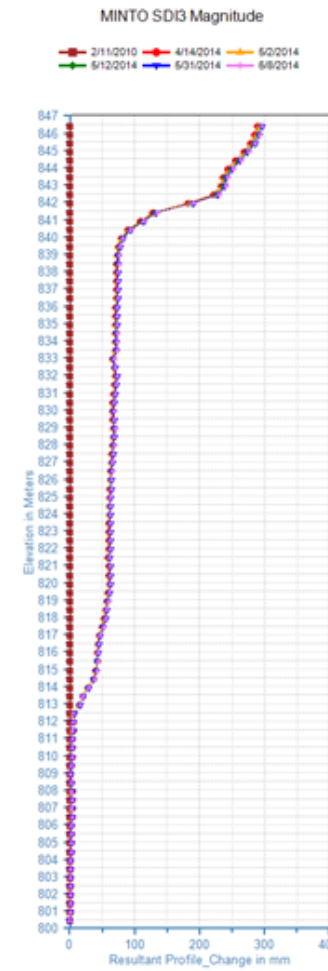
c) SDI-3 Inclinometer Data

Inclinometer SDI-3 is showing small but consistent movement. This may correspond with a slight thawing trend indicated by SDT-2. Temperatures in SDT-2 have increased slightly but are still below zero degrees and within the warm permafrost zone.

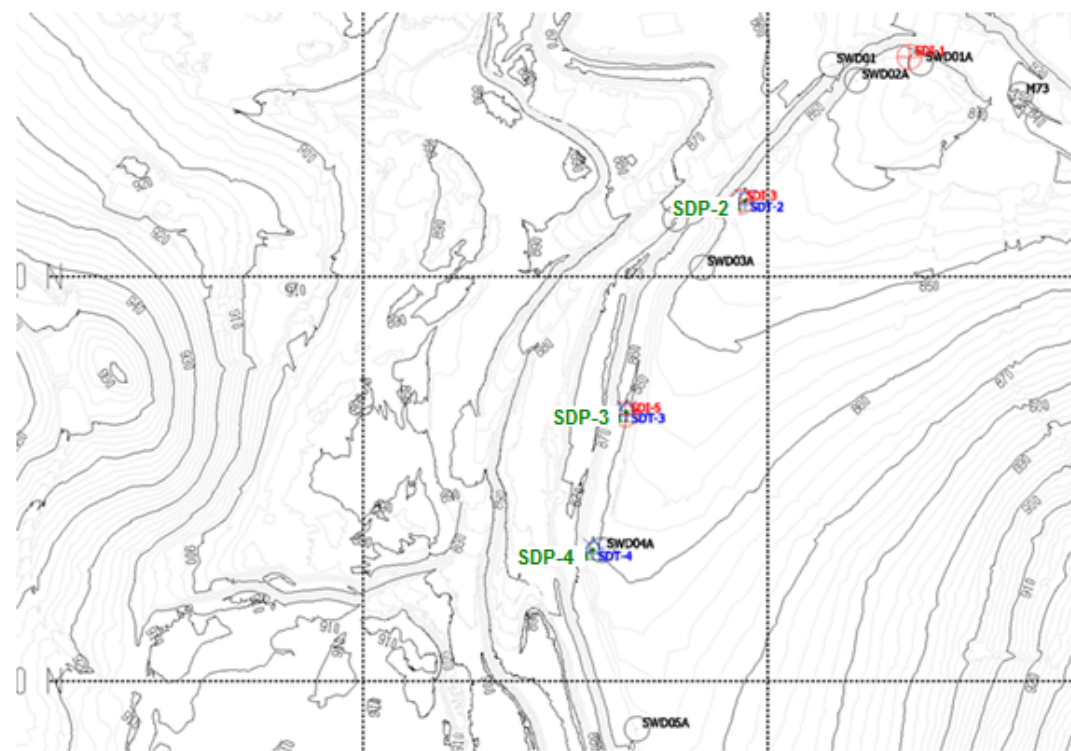
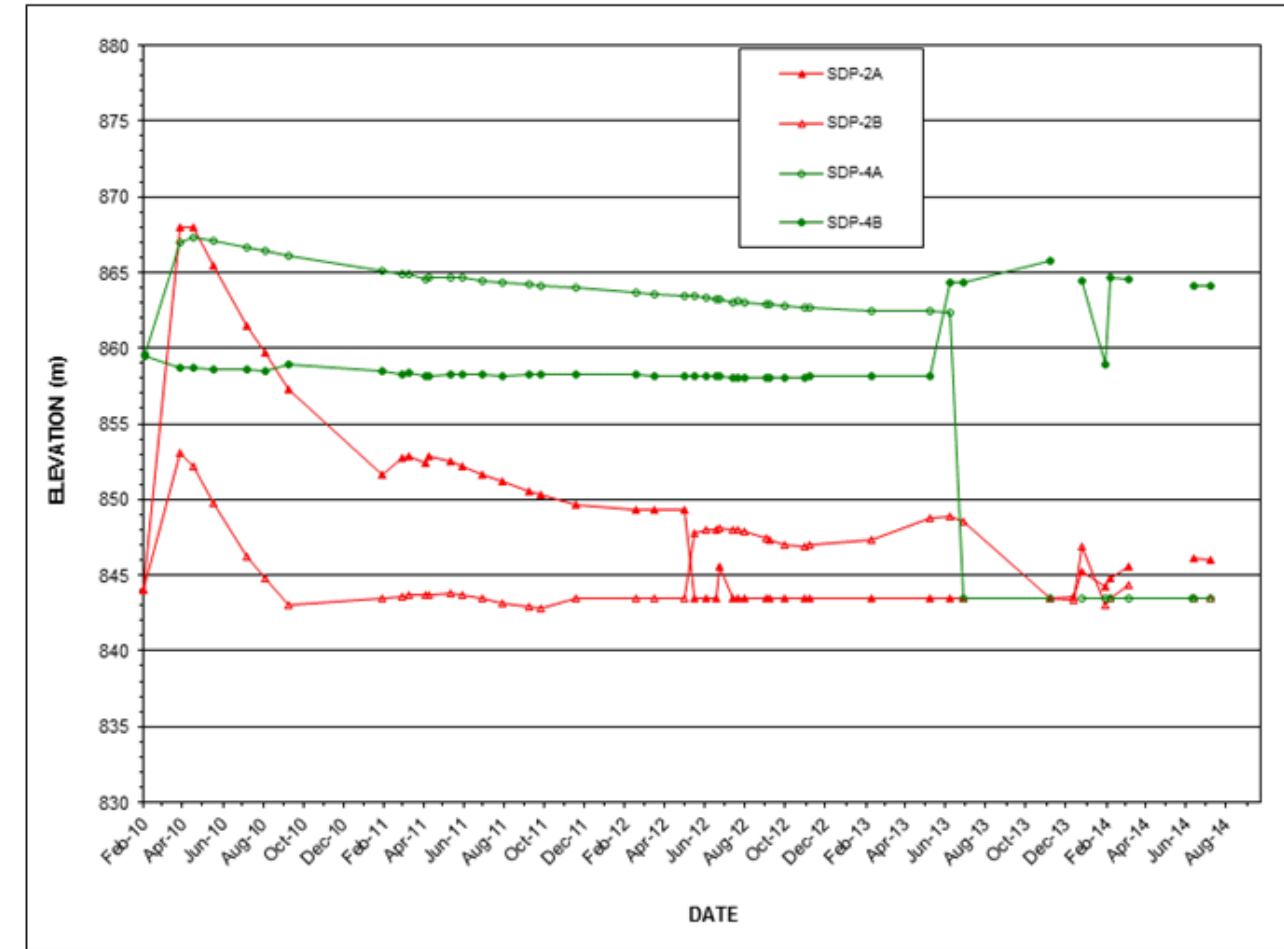
Southwest dump piezometers are showing inconsistent data, likely due to being located in frozen ground. Many sensors are reading negative pressures, which usually indicates they are either above the water table, malfunctioning, or frozen. Only SDP-2A and SDP-4B are reading positive pressure currently. SDP-4A and SDP-2B both dropped from positive to negative pressure in June 2013, whereas SDP-4B increased at the same time.

Notes: SDP-3 has been reading negative pressures since spring 2012 and therefore is not included here
 SDP-2B and SDP-4A are now reading negative pressures

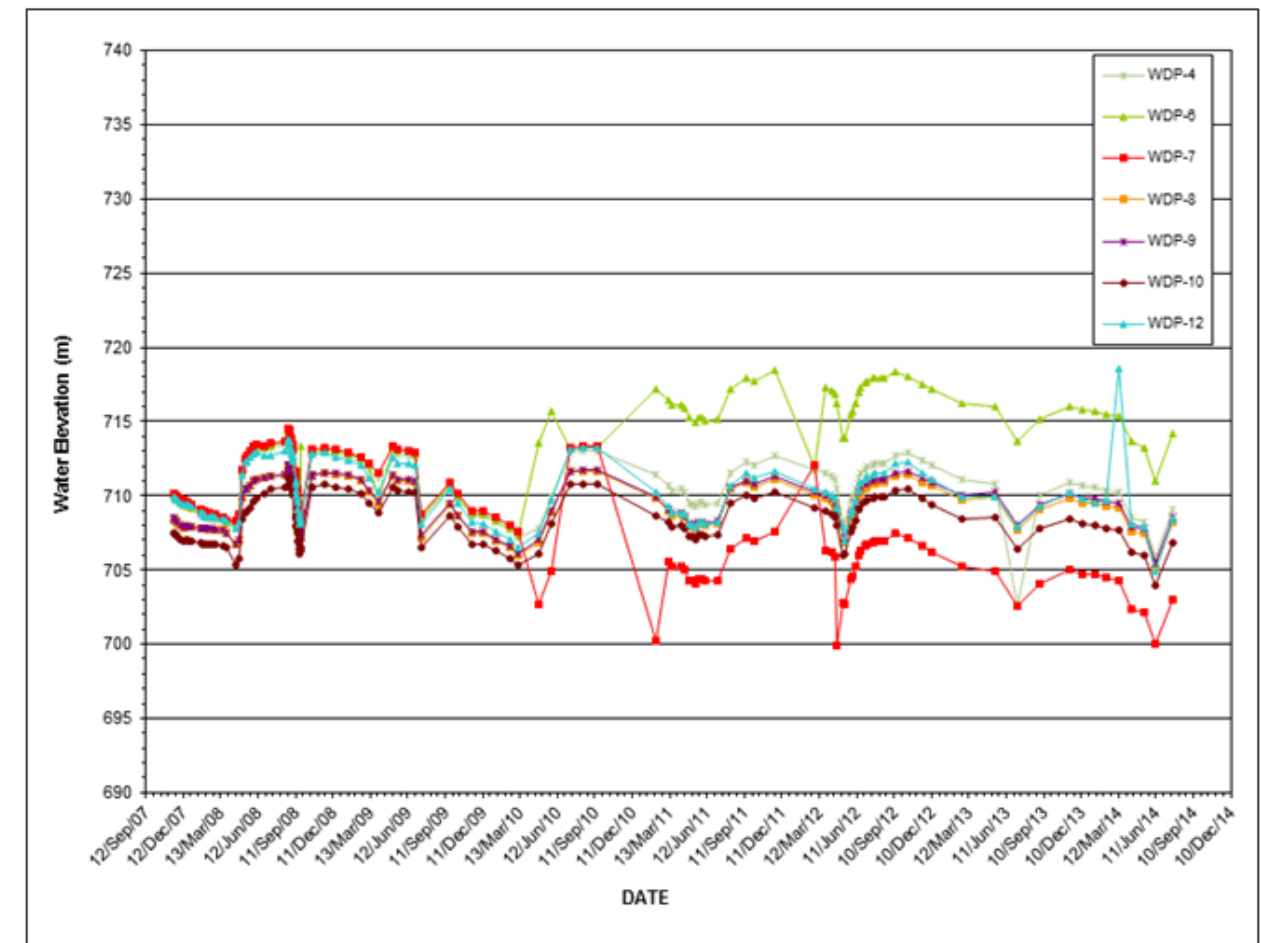
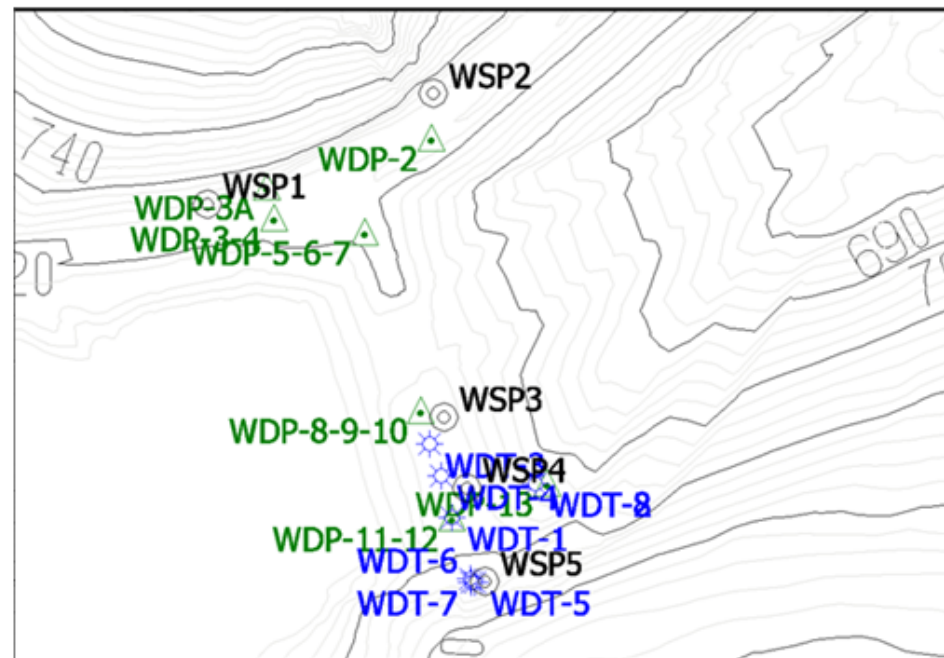
b) Water Storage Pond Piezometer Data

Piezometers indicate a moderate trend of decreasing pressure. This decrease in pressure corresponds relatively well with the lowering of the water storage pond water elevation, which has been kept progressively lower over the past two years.

WDP-2, WDP-3, WDP-5 and WDP-11 are all reading negative pressures, indicating they are above the water table and are not likely reliable
