2015 Geotechnical Annual Review, Minto Mine, YT

SRK Consulting (Canada) Inc.
1CM002.039
August 2015

Project No: 1CM002.039

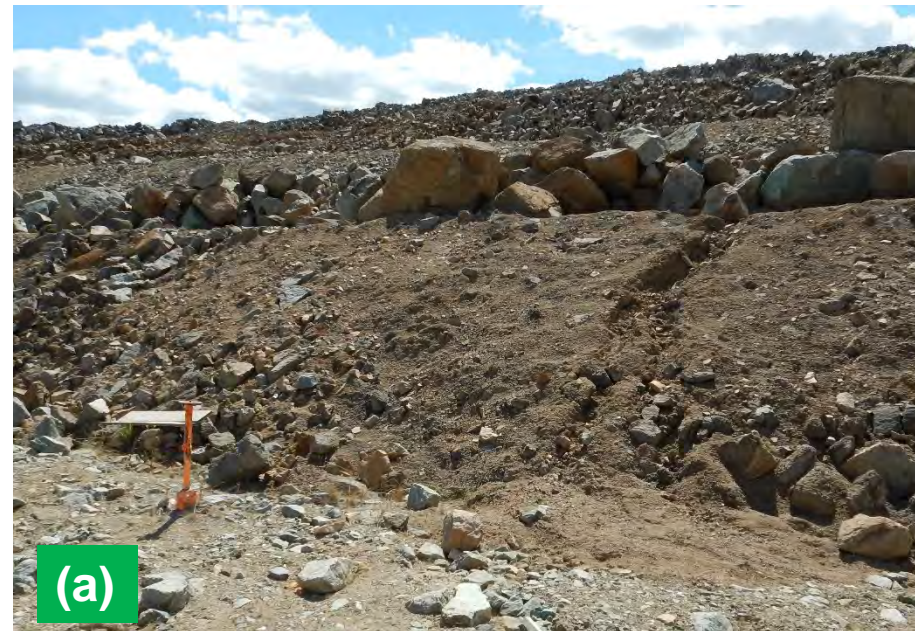
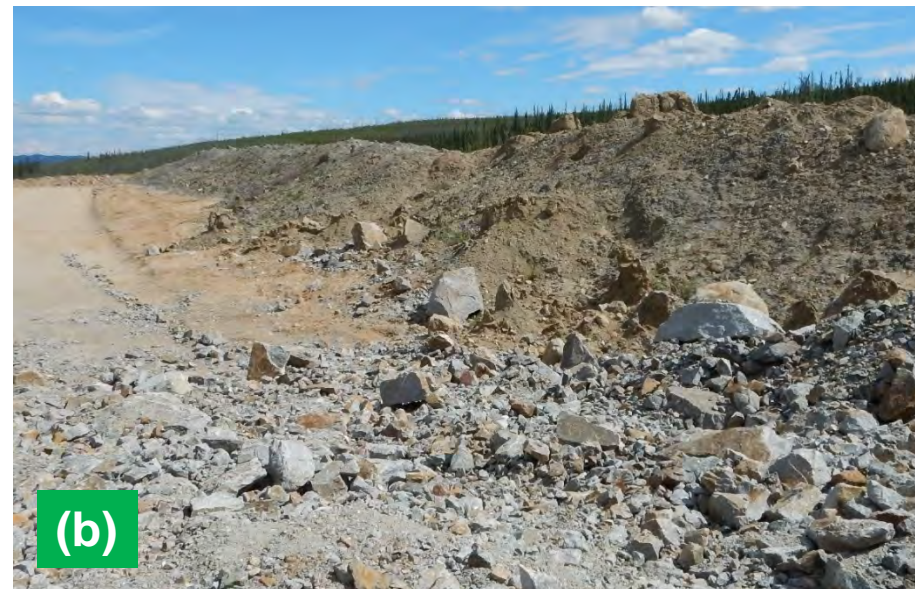
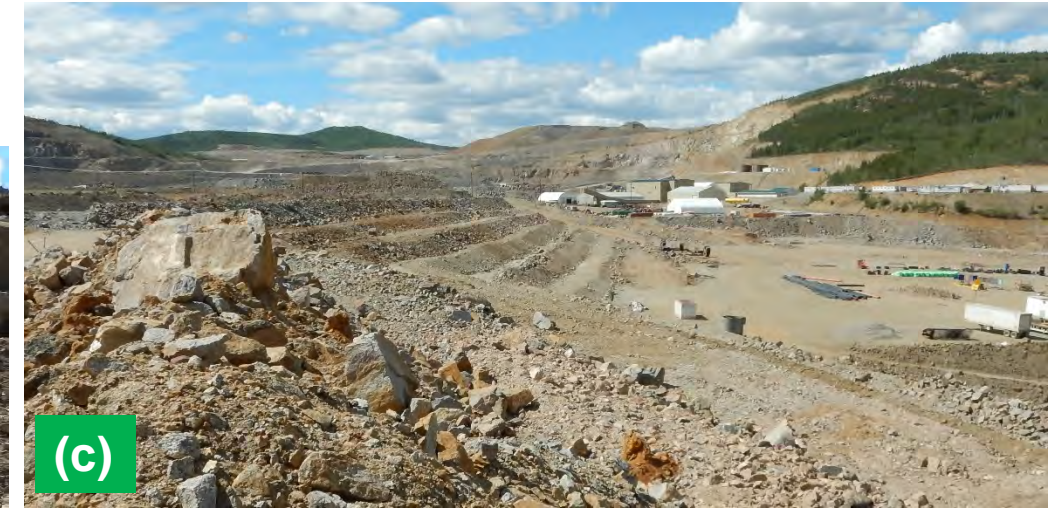
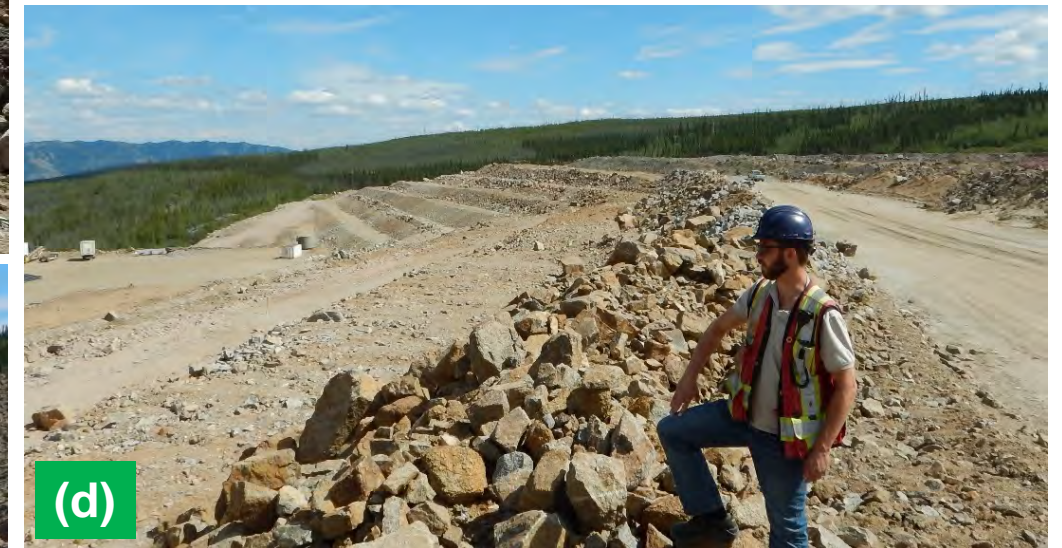
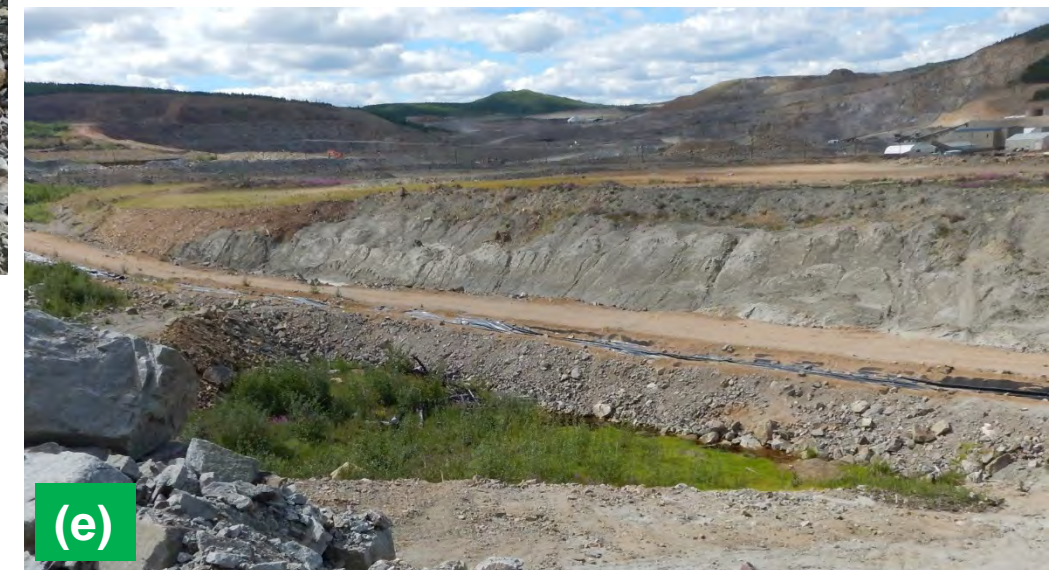
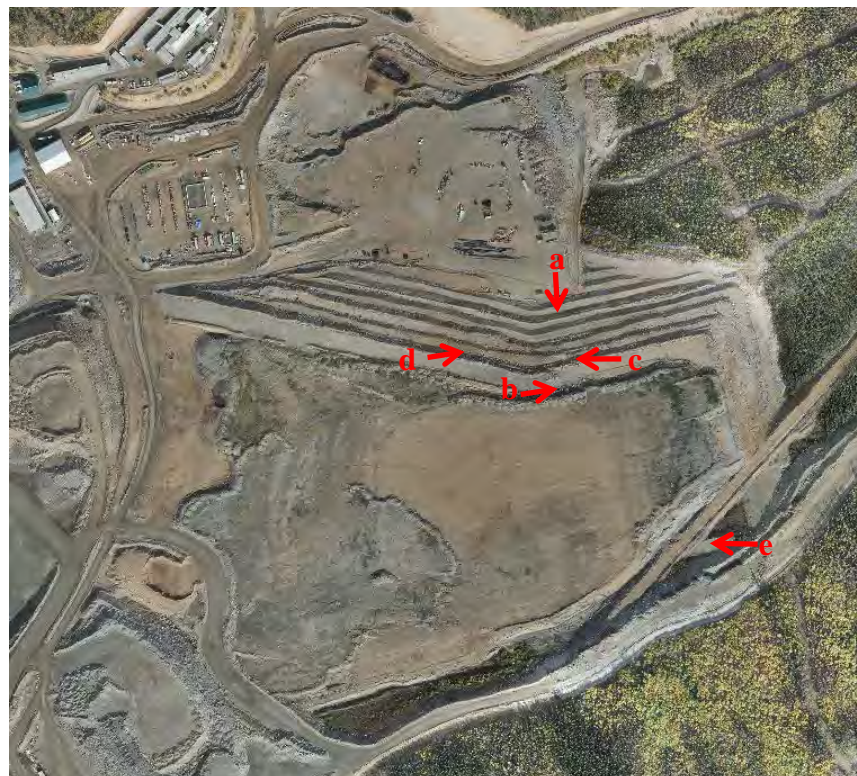
1 Dry Stack Tailings Storage Facility

- Photo (a) is the tension crack observed in 2014. The crack is actively monitored. This area should continue to be inspected to monitor for crack progression.
- Photo (b) is the old Tailings Diversion Ditch – no long in use.
- Photos (c) and (d) show the typical condition of the instrumentation.
 - Uncovered
 - Large voids surrounding the casings;
 - Uncovered.
- The condition of the Mill Valley Fill Extension.
 - The area appeared unchanged from the notes in the 2014 inspection. Evidence of a longitudinal crack is still present, although it does not appear to be actively propagating.

3	Continue to monitor the 2014 crack and install two survey nails/pins (one on each side of the crack) to measure the relative displacement using a tape measure.
Southwest Waste Dump	4	The slopes at the outlet for the tailings diversion ditch should be monitored for signs of instability and erosion.

- Continue to monitor the Mill Valley Fill Extension crack and settlement area.
- Continue to monitor the crack on the north-east corner of the DSTSF. Install two survey nails/pins (one on each side of the crack) to measure the relative displacement using a tape measure.
- Cover the historical instrumentation to prevent preferential flow paths, and develop a plan for decommissioning instrumentation that is no long used.

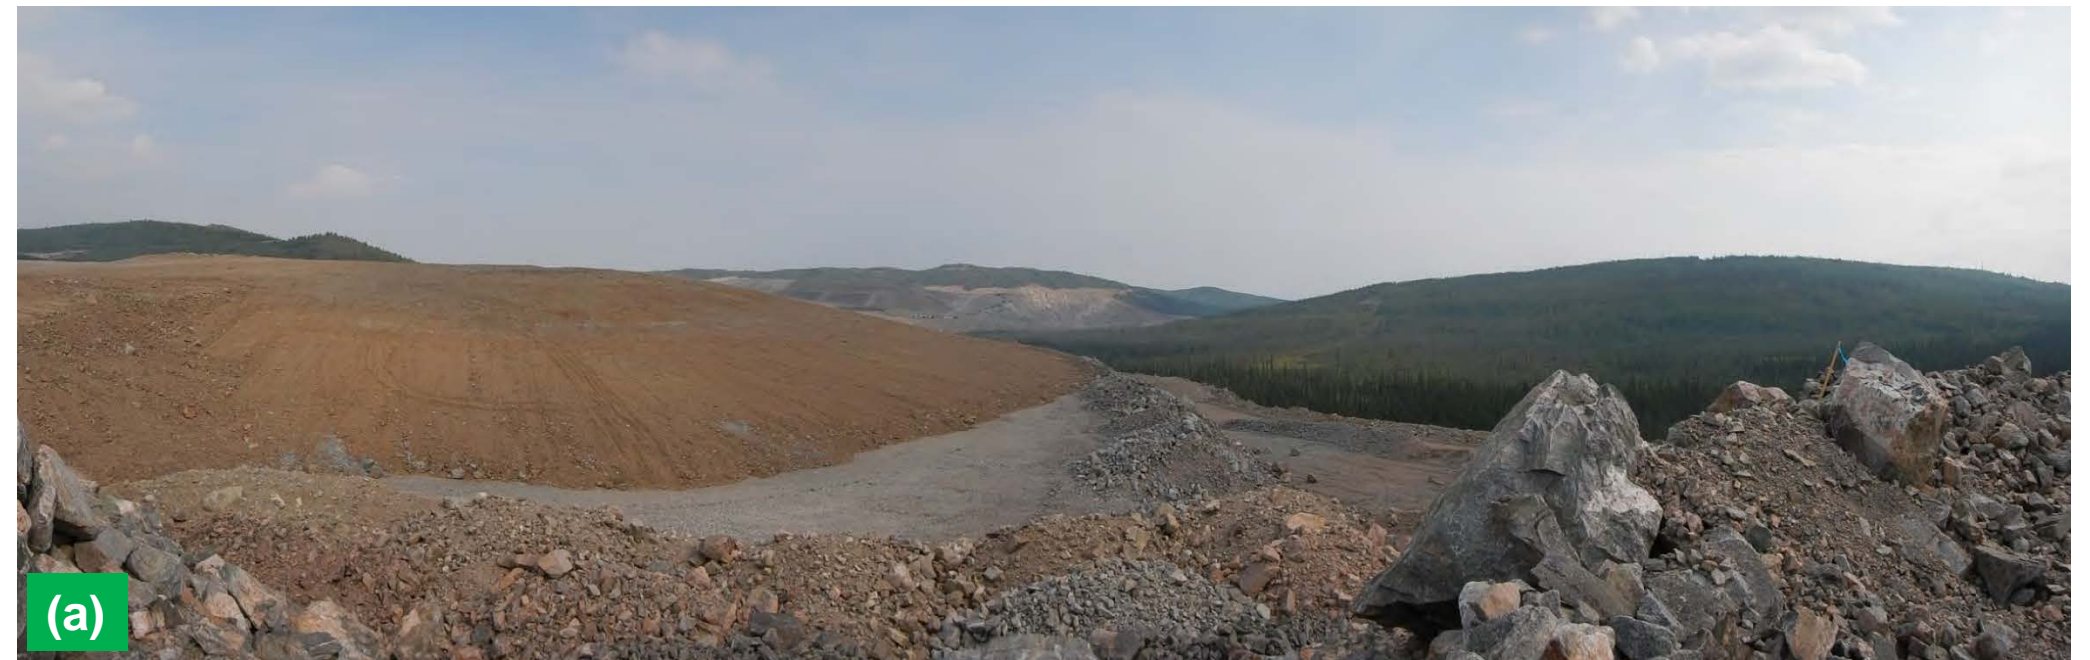
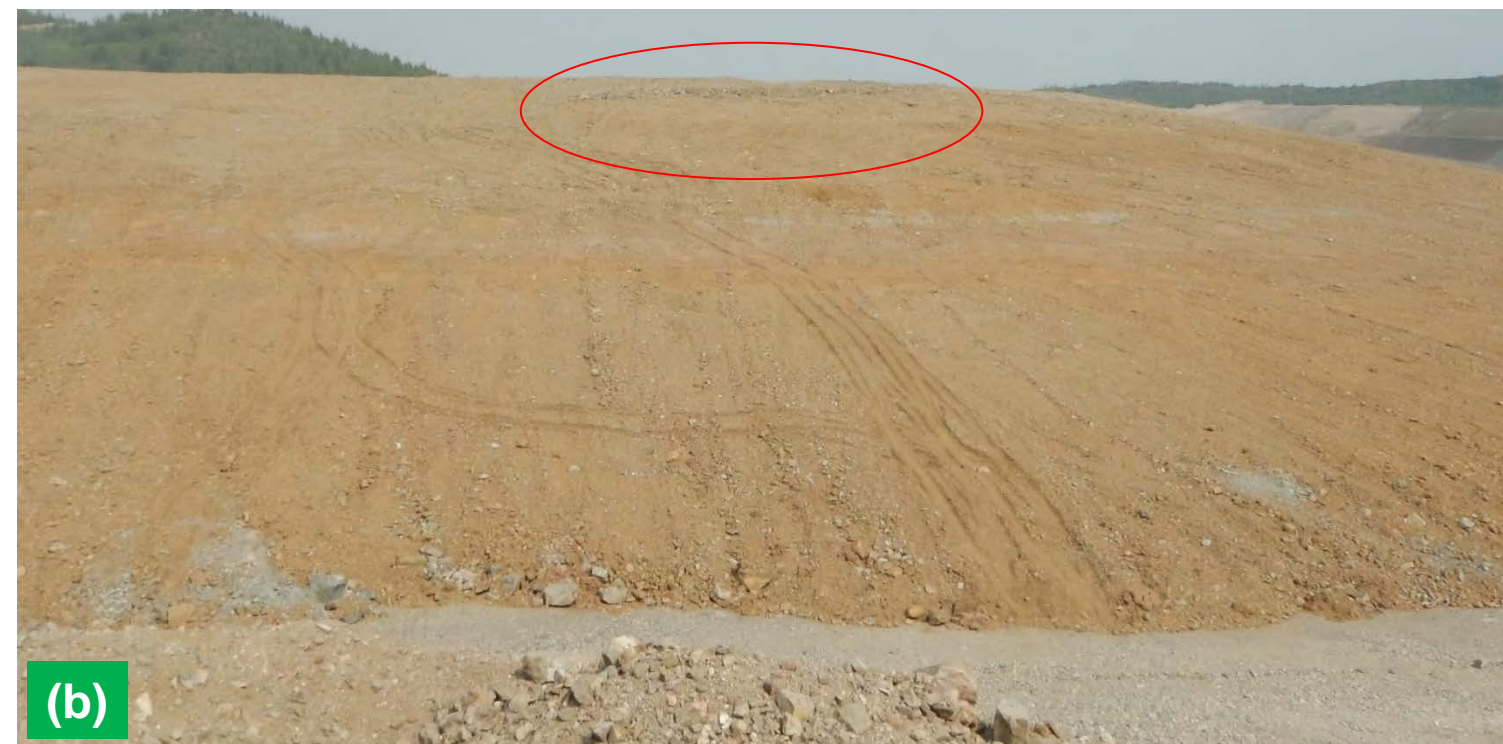
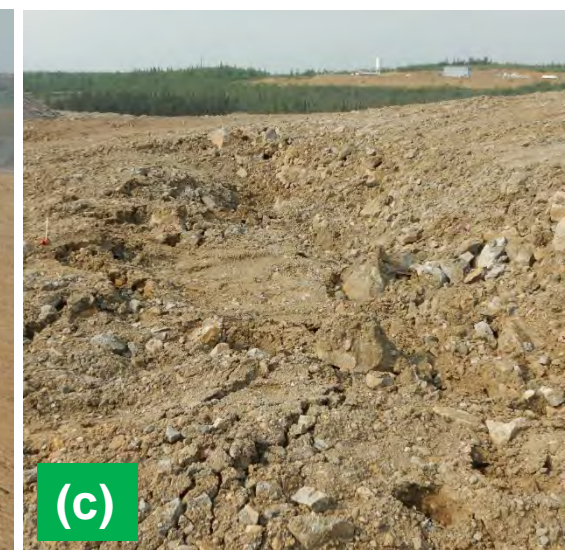
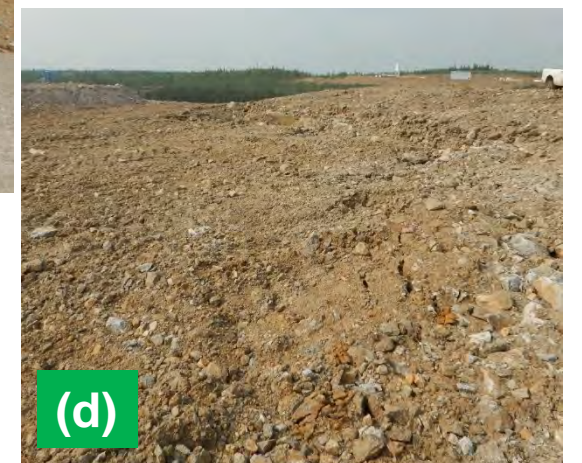
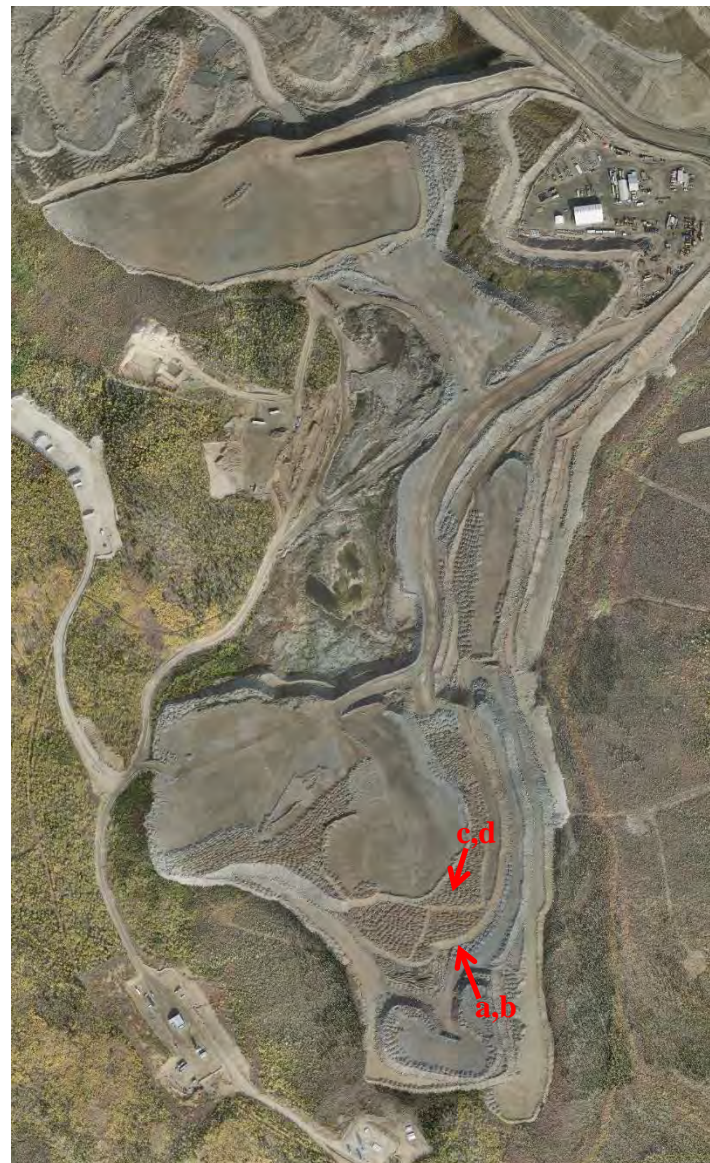
Photo (a): View of the regraded SWD looking north.
 Photos (b), (c), (d): Observed crack near crest of regraded slope.
 No signs of slumping or toe bulging were noted.

- The observed tension crack should be monitored, and the source determined. (e.g. edge of historical waste rock bench?, poor operator? Active slumping, with toe regraded?)
- The condition of the survey hubs should be reviewed for susceptibility to frost heave.

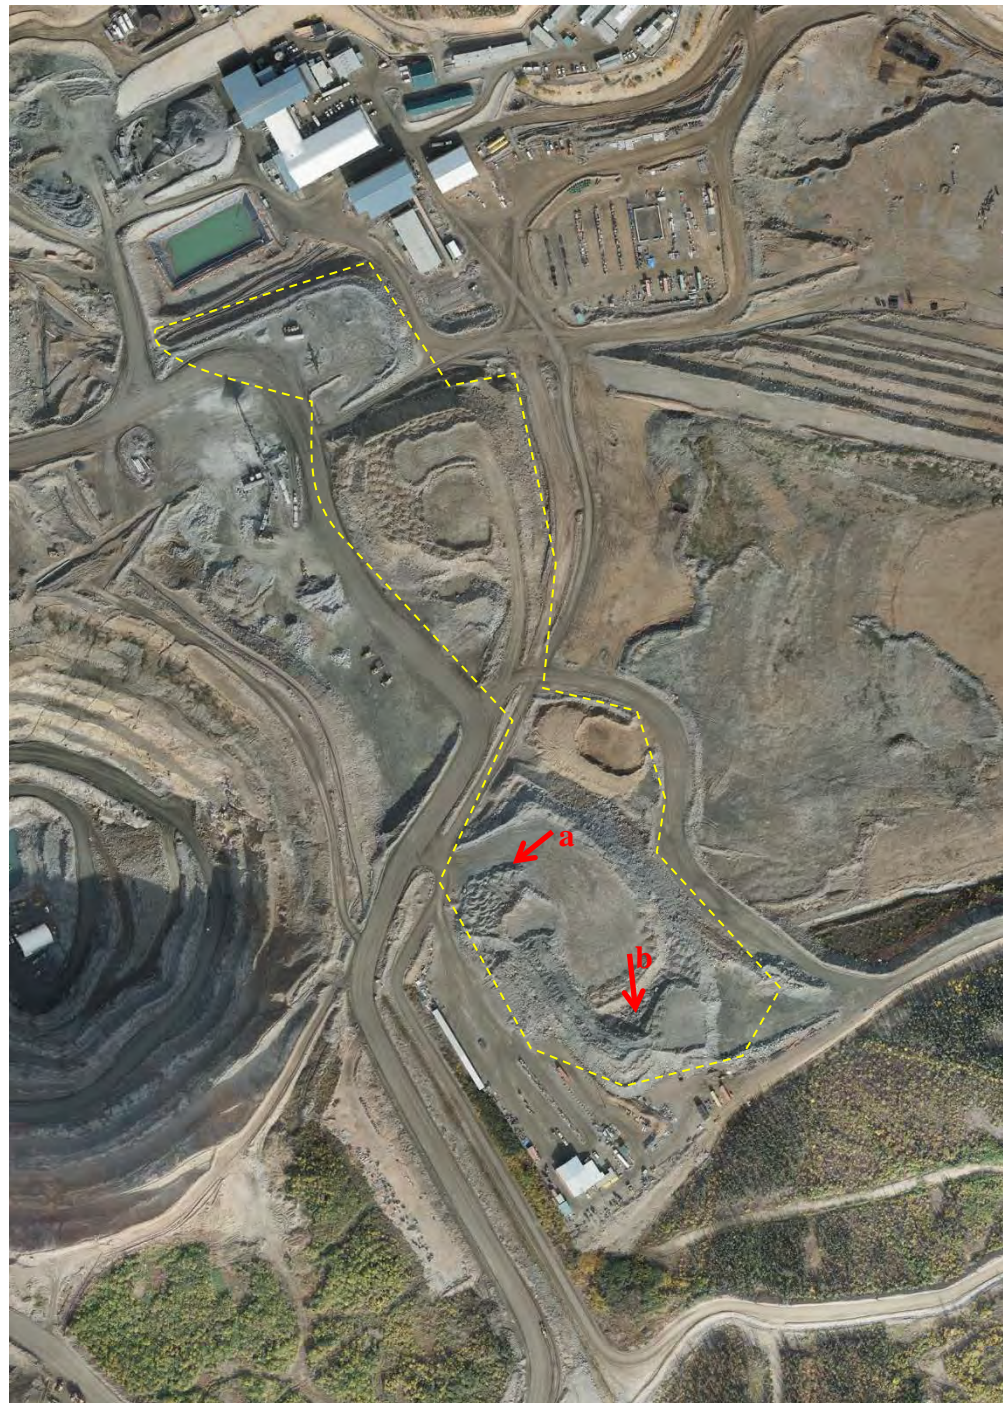
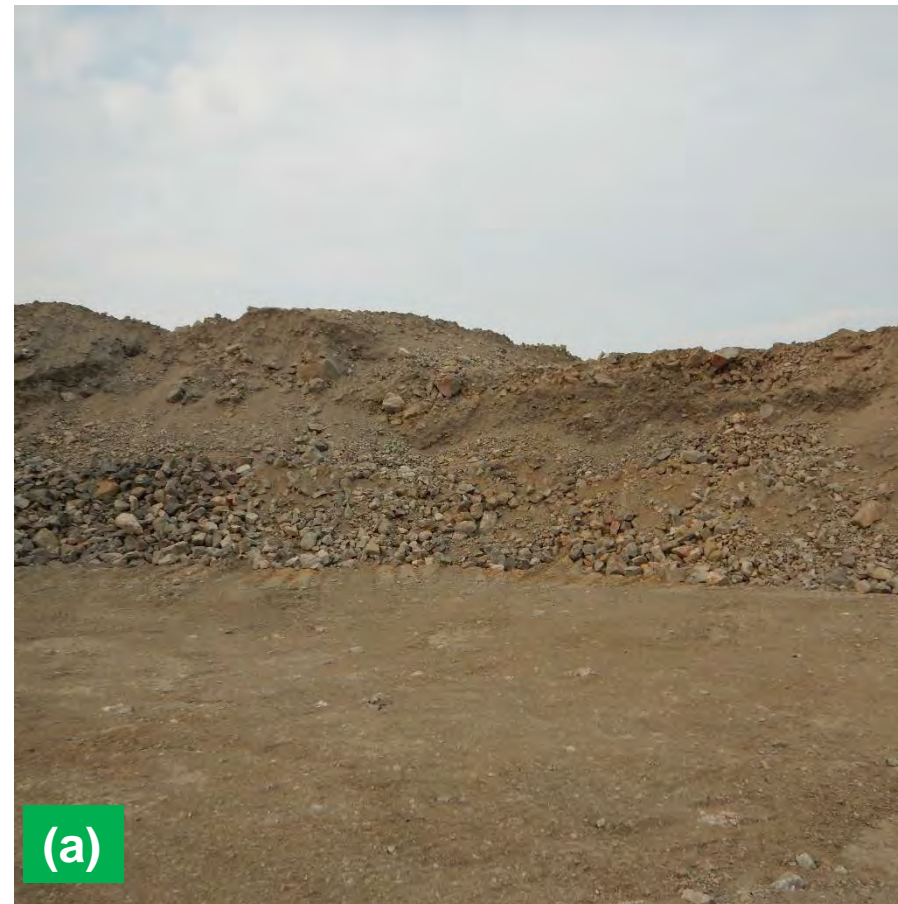
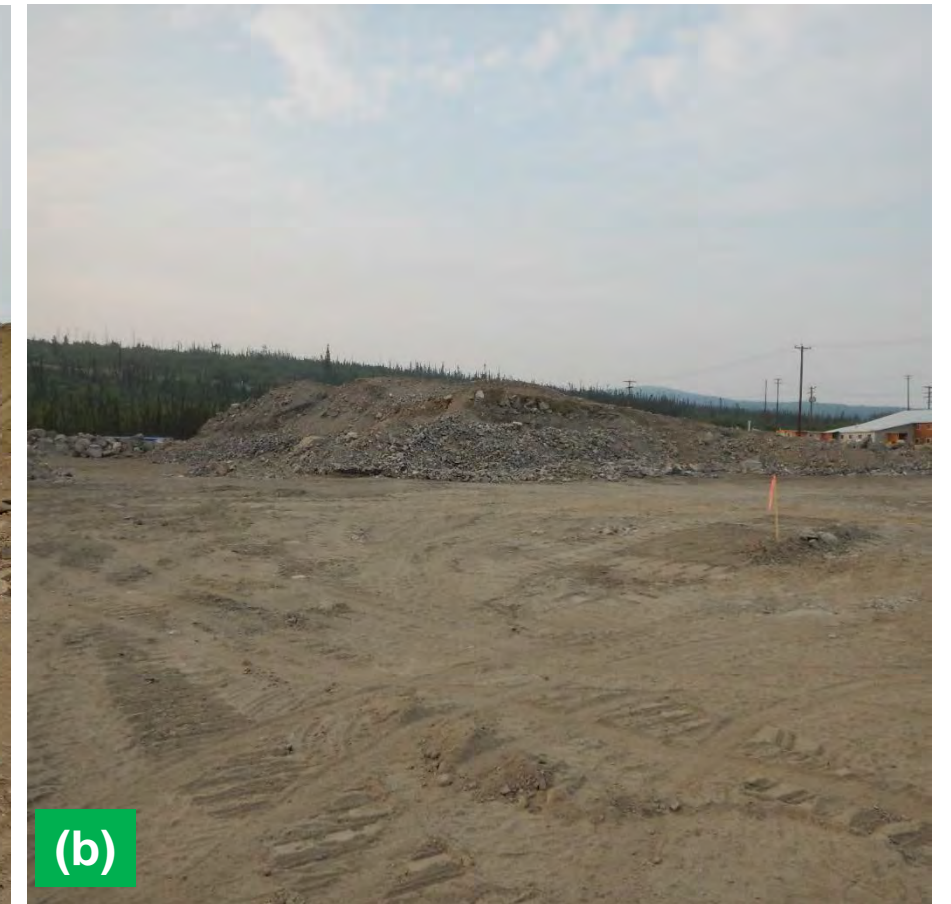
6 Ore Stockpiles

- The ore stockpiles were nearly depleted at the time of the inspection. All slopes appeared in good condition: no slumping, bulges, cracks, or other signs of instability were observed.

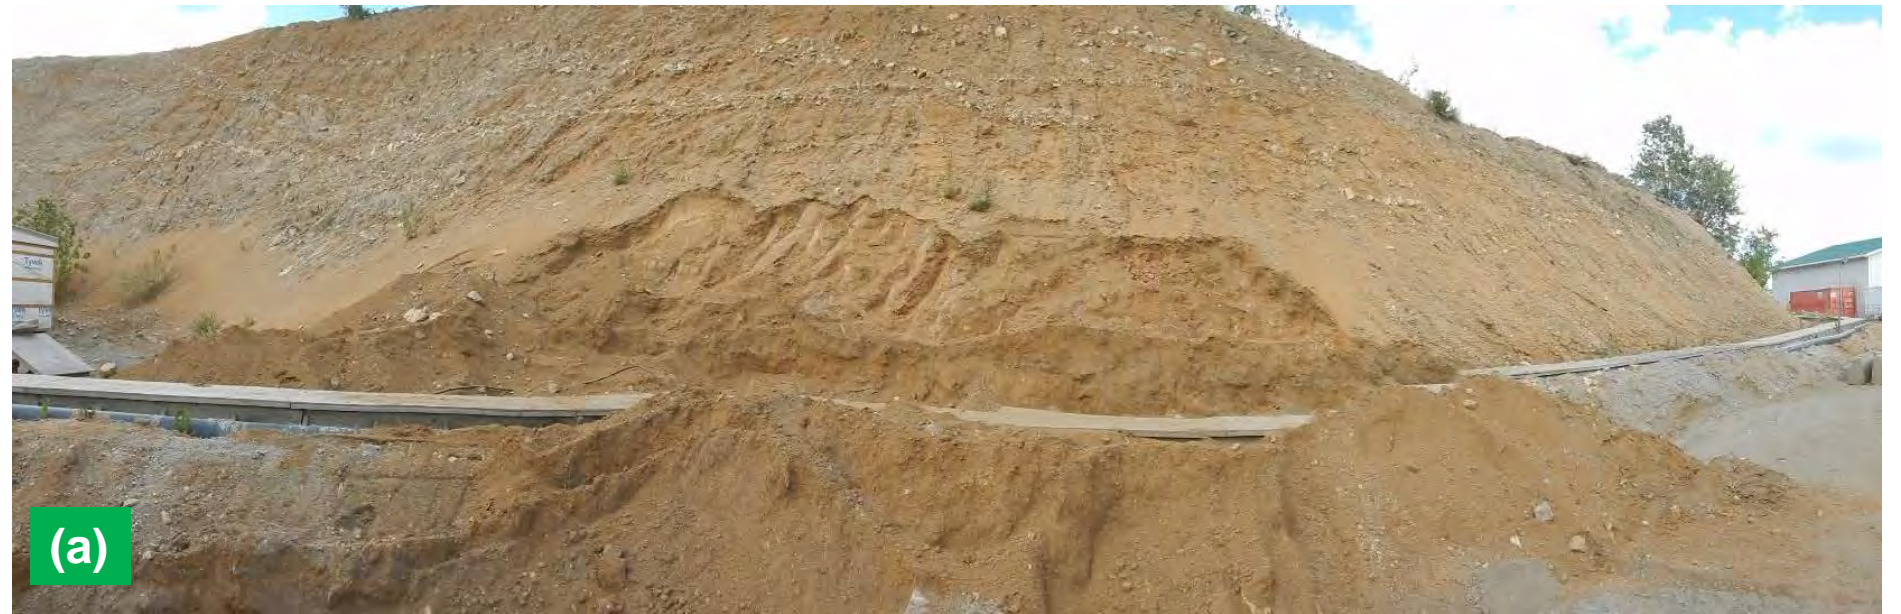
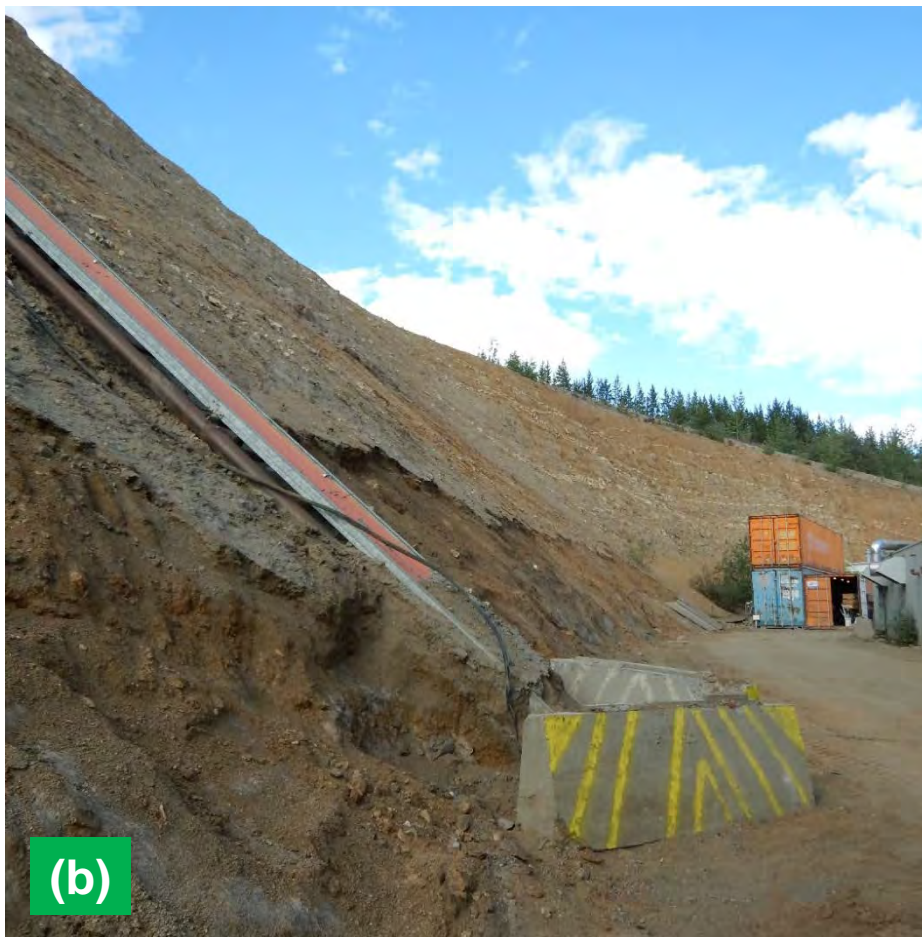
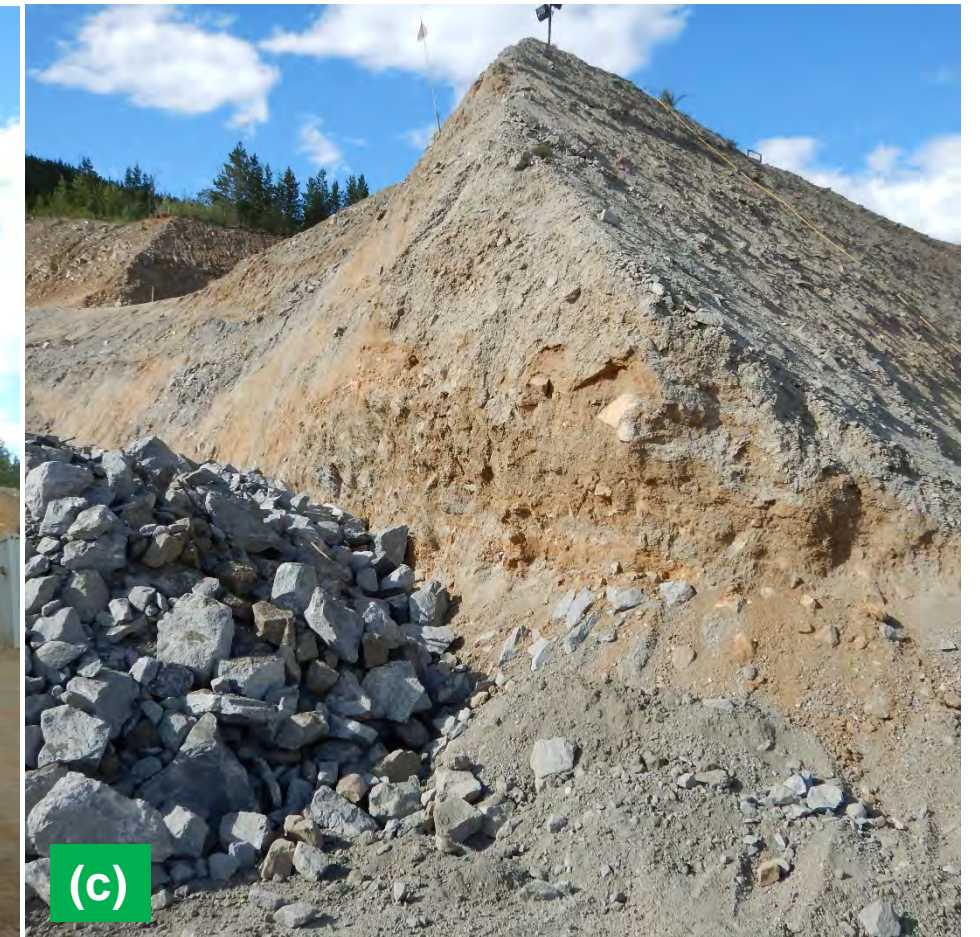
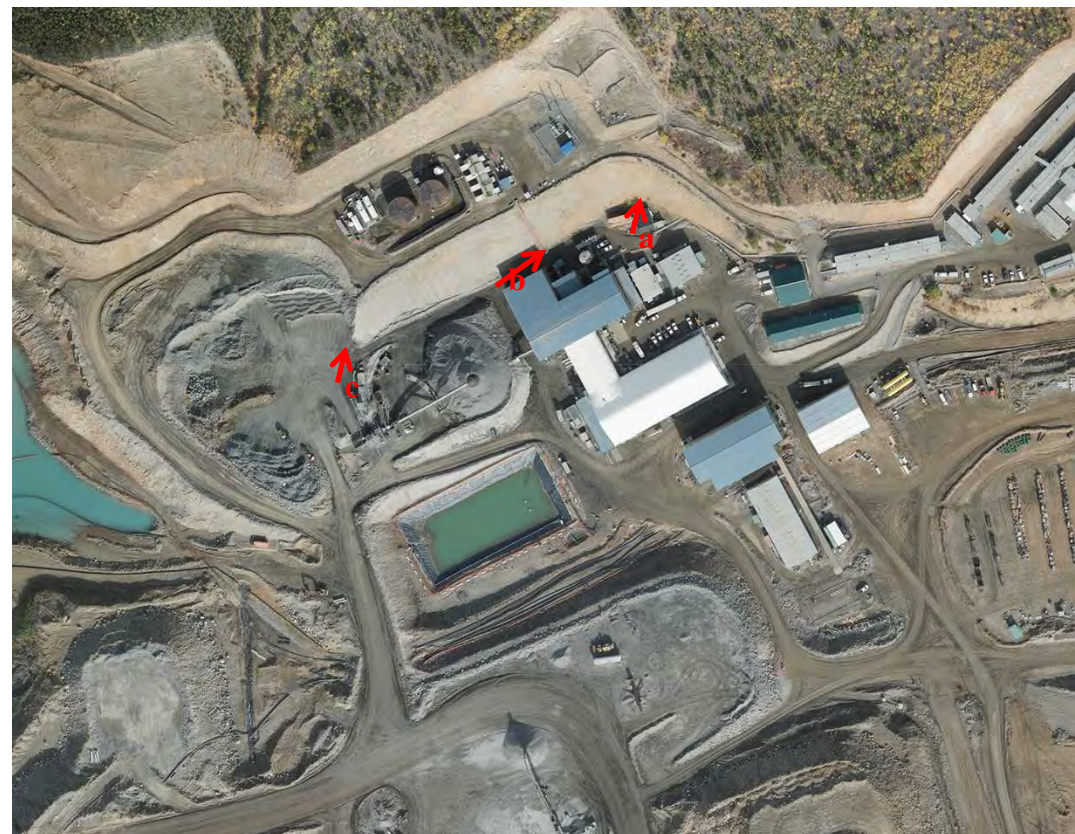
7 Mill Site

Conditions of the mill area backslope had recently undergone maintenance to remove loose debris at the toe of the slope due to active erosion. The condition otherwise was consistent with the conditions reported in previous inspections.

Photos (a) and (b): Excavation at the toe of the slope – removal of loose debris. Not signs of instability noted.

Photo (c): slope appears to be slightly undercut, no signs of instability were noted.

- Visually inspect the north slope adjacent to the mill.
- Note: The retaining wall at the mill's apron feeder tunnel was not inspected. Continue to monitor and maintain a photographic record of its condition.

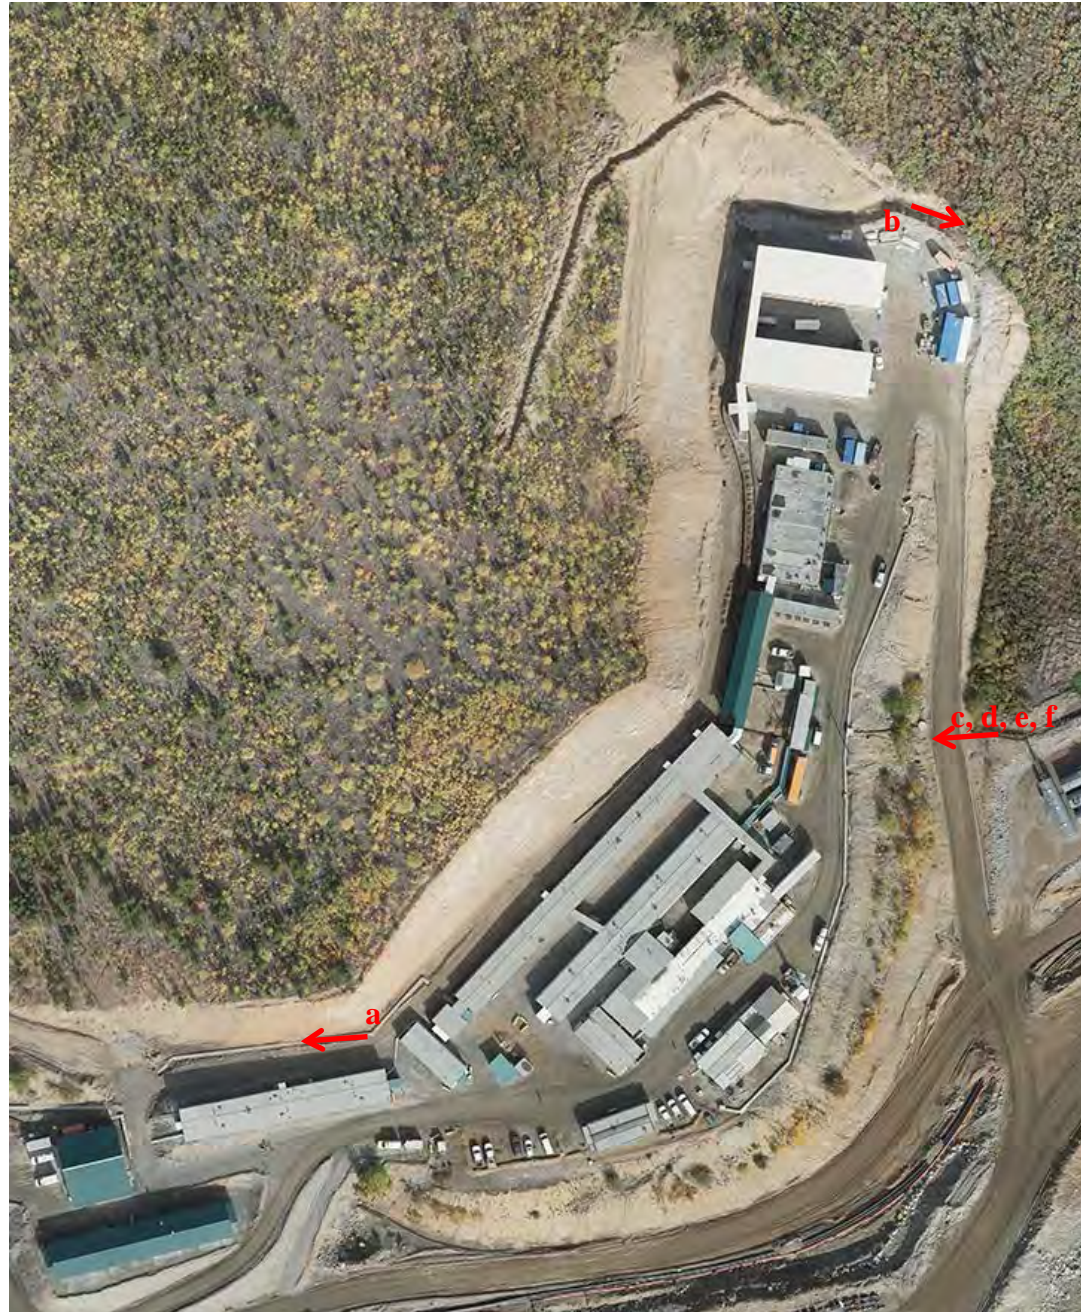
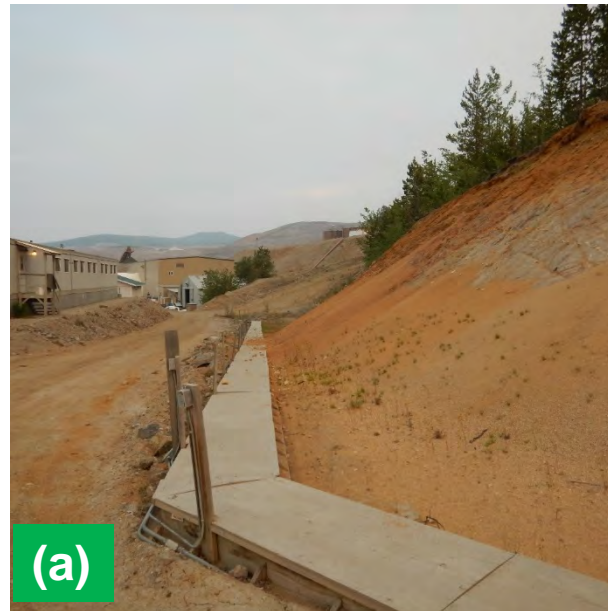
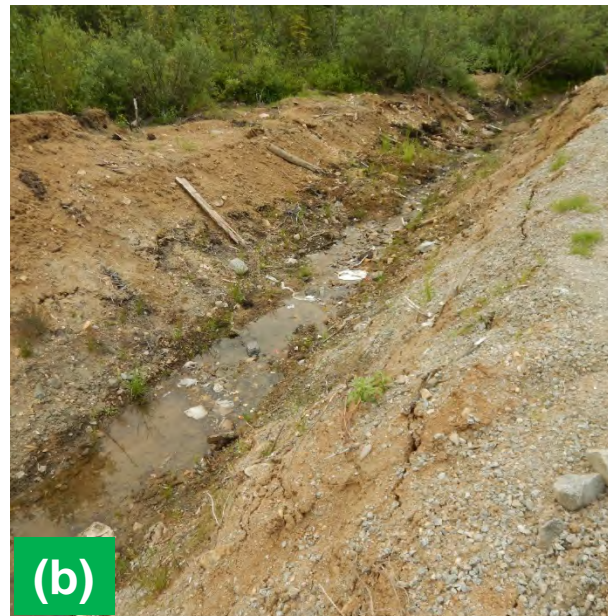
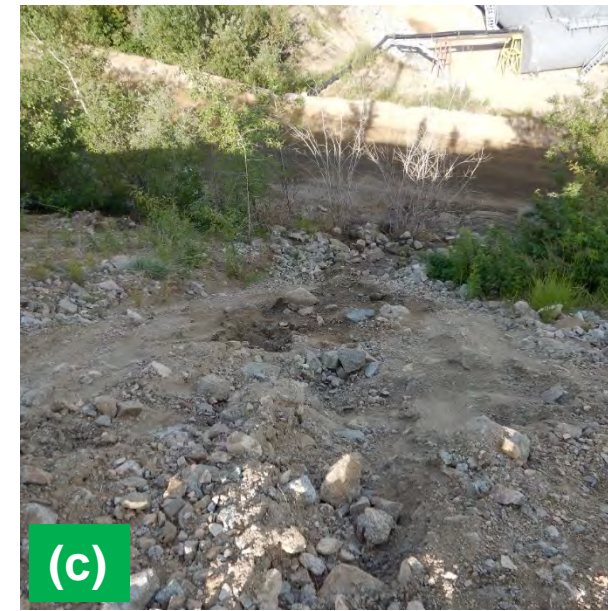
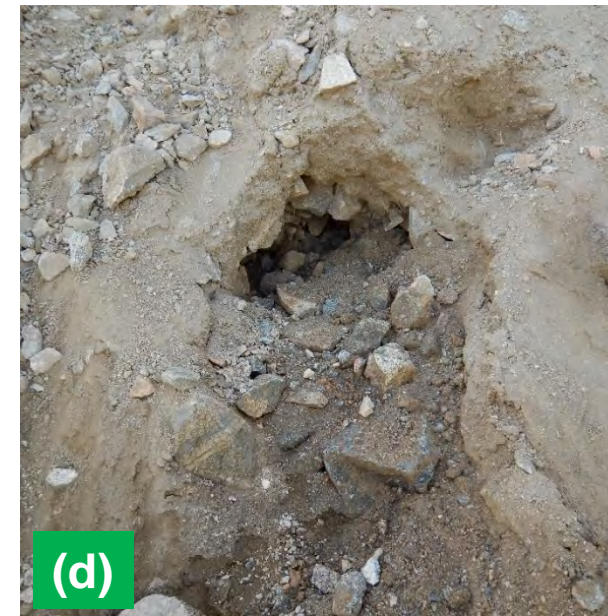
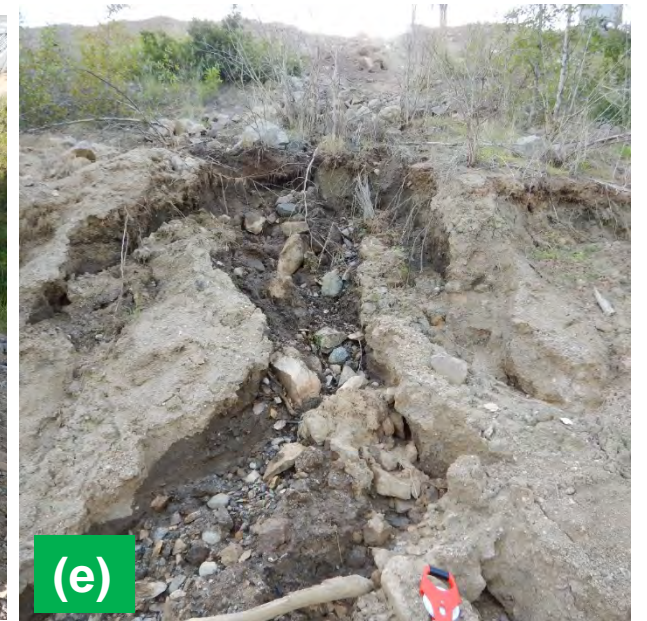
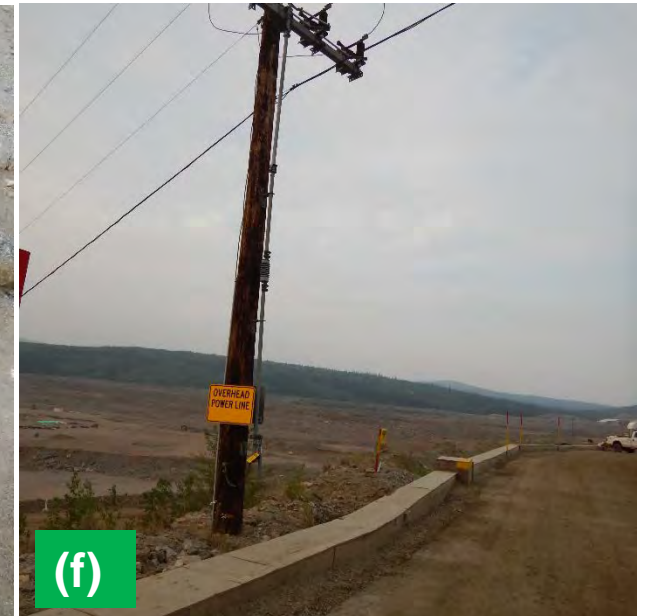
8 Camp Site

Photo (b): Cracks observed in steep slopes along the diversion ditch.

Photo (c) to (f): seepage coming out of hill causing erosion directly above the camp power line. View of the seep at the northwest corner of the camp expansion. Erosion channels present south of the camp site near the carpenter's shop. Conditions are similar to the Fall 2013 inspection.

10	Monitor the erosion gully and the seepage noted along the hillside east of the water treatment plant. Install erosion protection along the slope to limit further erosion of the pile.

Area	Appendix A Figure #	Recommendation
	10	Shallow the slopes of the diversion ditch or complete routine maintenance of the ditch to maintain appropriate drainage at the north end of the camp terrace.
Mill Water Pond	-	Due to the tears in the geomembrane, the pond is not considered functional. Repairs are required if the pond is to be brought back into service.
	11	Repair fencing around the pond such that it is continuous.
	11	If the MWP is to be brought back into service the following actions are recommended: <ul style="list-style-type: none"> • Patch tears in the liner system. • Fill the voids under the tears before patching. • Clean out sediments accumulated in the surface runoff ponds and culverts
South Diversion Ditch	13	Remove vegetation and perform routine maintenance along ditch alignment.
	13	Along the airport ditch, cover the exposed geotextile, and confirm the ditching profile through the access road drains correctly.

- The area above the erosion channels on the camp pad should be regraded to promote runoff away from the channels.
- Develop and implement measure to mitigate the erosion by the carpenter's shop.
- The source of the seepage source located east of the water treatment plan should be determined, or a rip-rapped channel should be created to prevent further erosion.
- Shallow the slopes of the diversion ditch or complete routine maintenance of the ditch to maintain appropriate drainage at the north end of the camp terrace.
- It is recommended that these actions be completed in the following year. In place of the surface grading, a small ditch could be constructed near the slope crest to direct runoff to the drop channel or half-culvert.

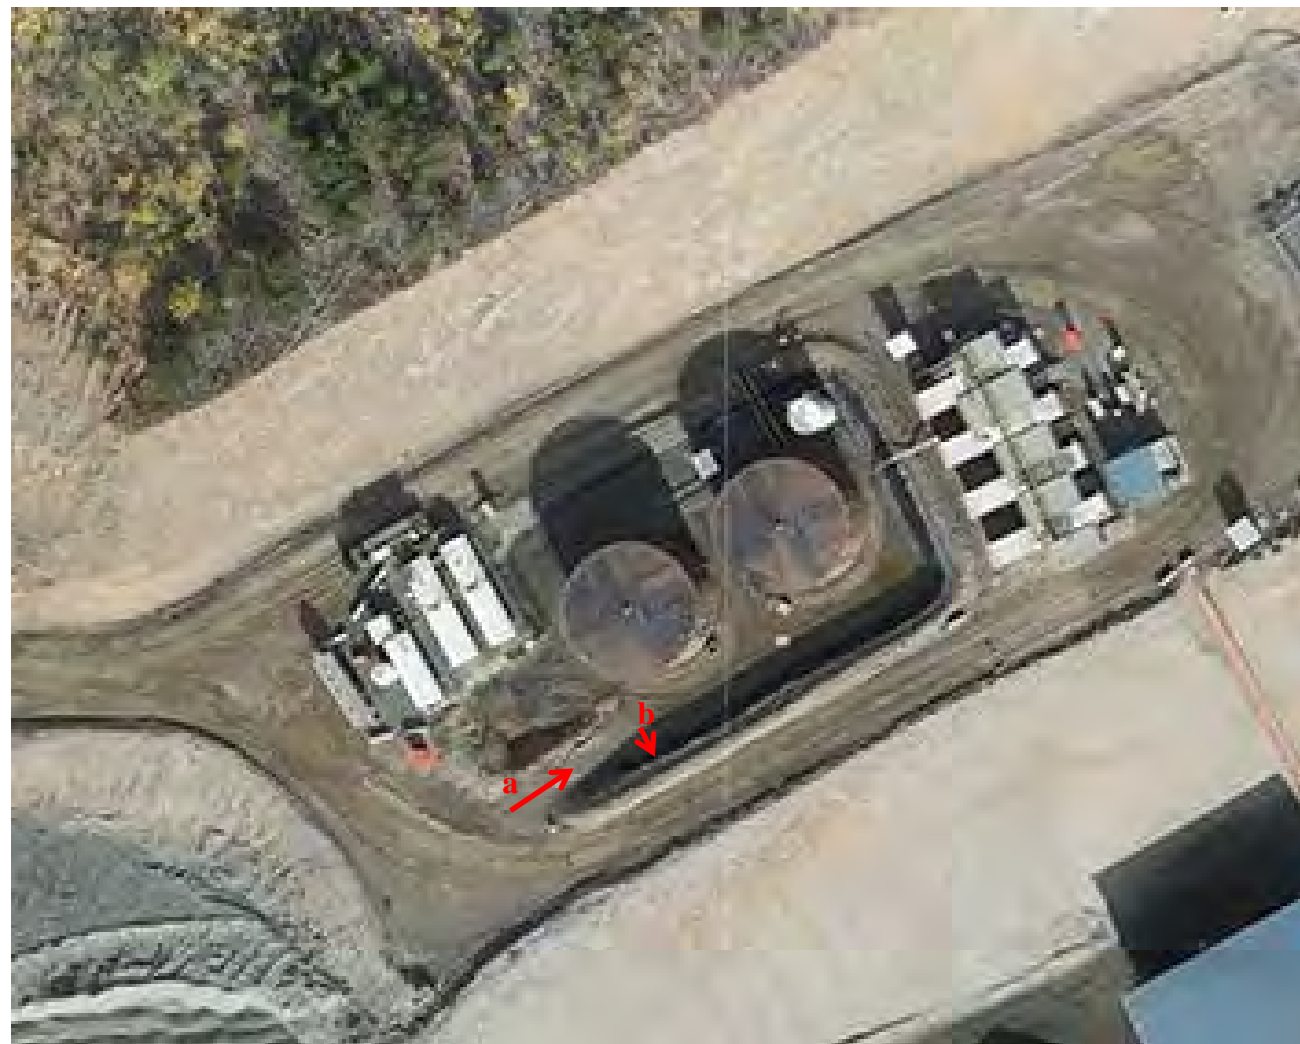
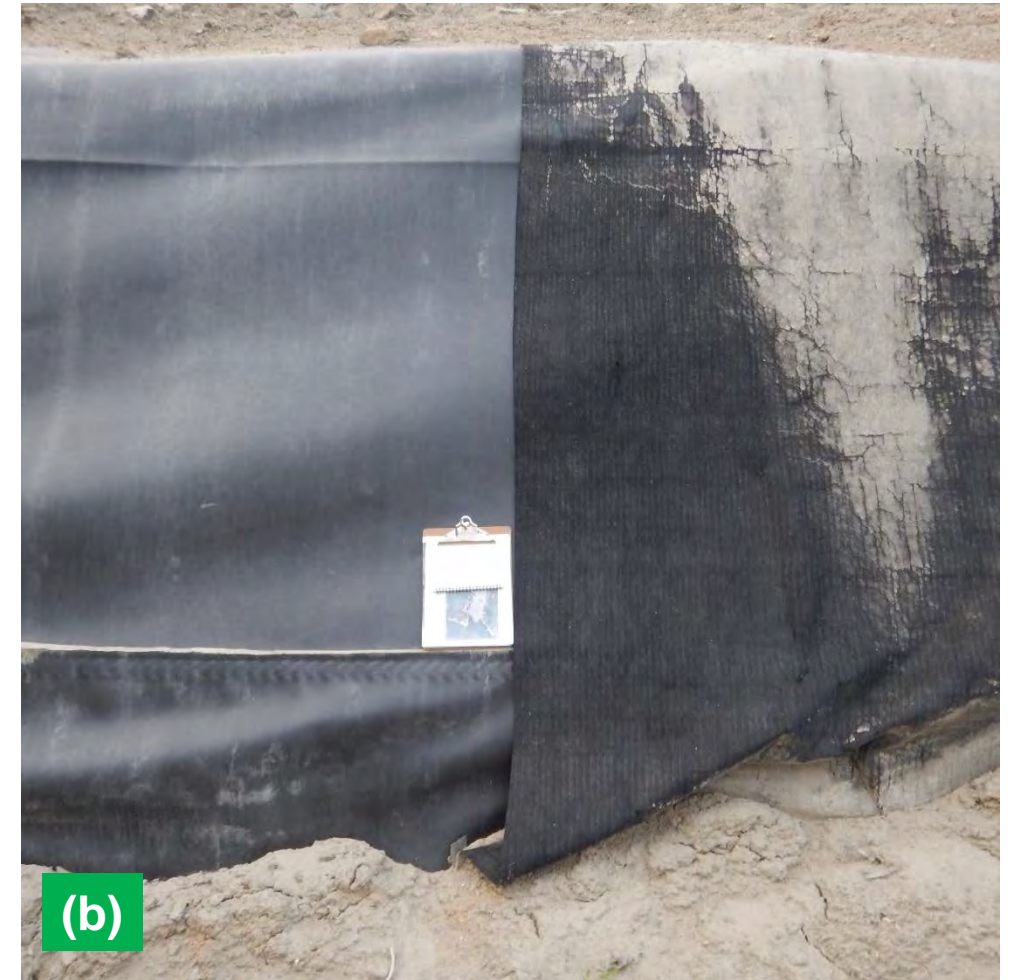
Spring 2015 Geotechnical Inspection		
		Fuel Containment Facility		
Job No: 1CM002.039 Filename: AppA_Minto2015SpringInspection_20150731.pptx	Minto Mine	Date: July 2015	Approved: EK	Figure: 12

- Photo (a) is a general overview of the fuel containment facility. Note the development of the erosion gully along the access ramp (white arrow).
- Photo (b) is a photo of the end of the geotextile cover over the geomembrane. Exposed geomembrane is visible around the perimeter of the fuel containment facility.
- Conditions of the facility appear to be the same as reported in the 2014 review.
- No tears or defects in the liner were observed.
- The liner bedding cover was saturated, but there was not pooled water present.
- Rutting is present in the southern half, and around the perimeter. No liner is exposed as a result of the trafficking.

- The bedding layer over the geomembrane (150 mm thick) was not meant for heavy equipment. Vehicle access should be limited to the occasional visit with low ground pressure equipment.
- Monitor for damage to the geomembrane around the perimeter of the fuel containment facility.
- No actions required.
