2015 Geotechnical Annual Review, Minto Mine, YT

SRK Consulting (Canada) Inc.
1CM002.039
August 2015

Project No: 1CM002.039

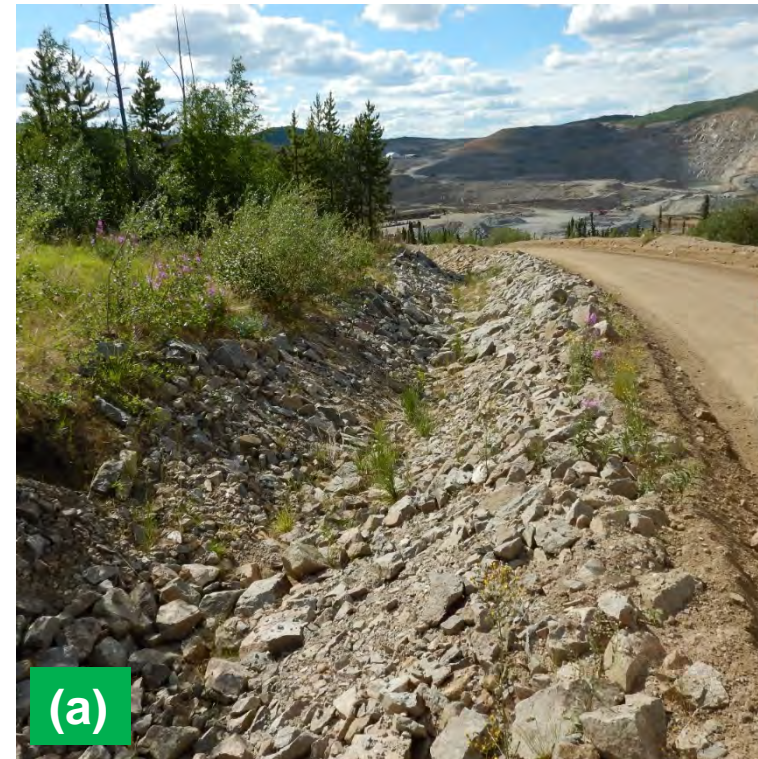
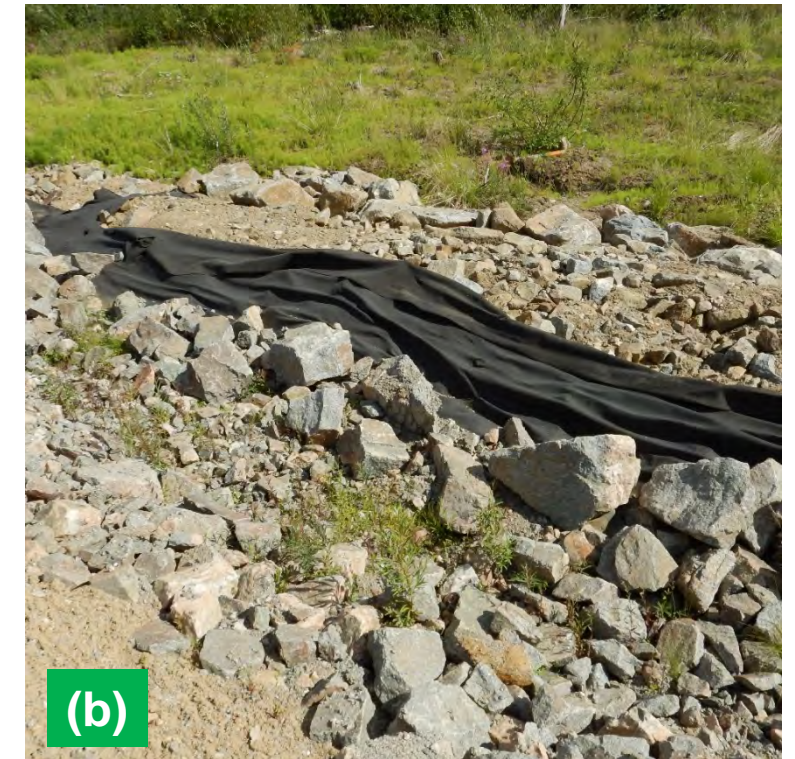
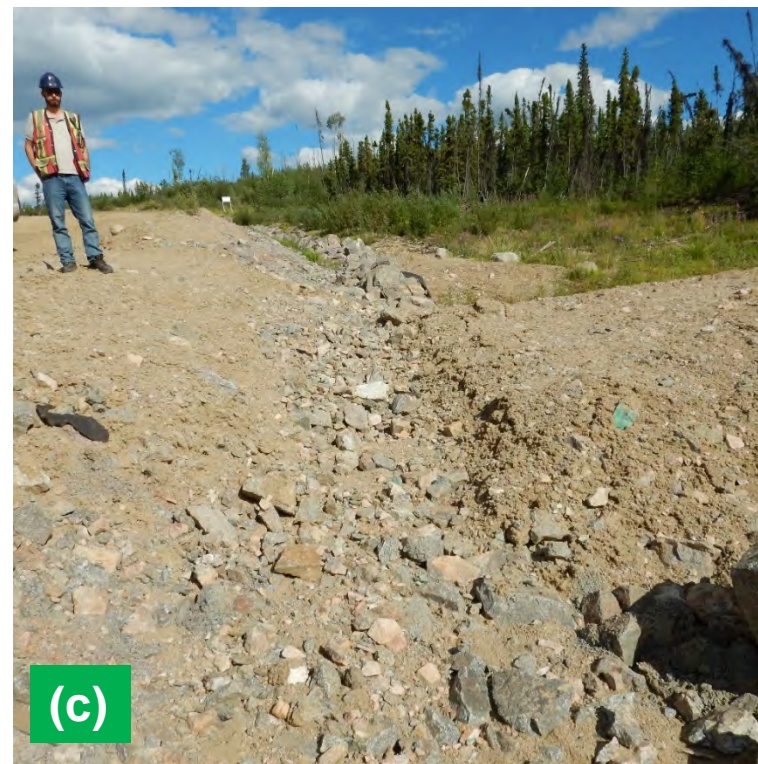
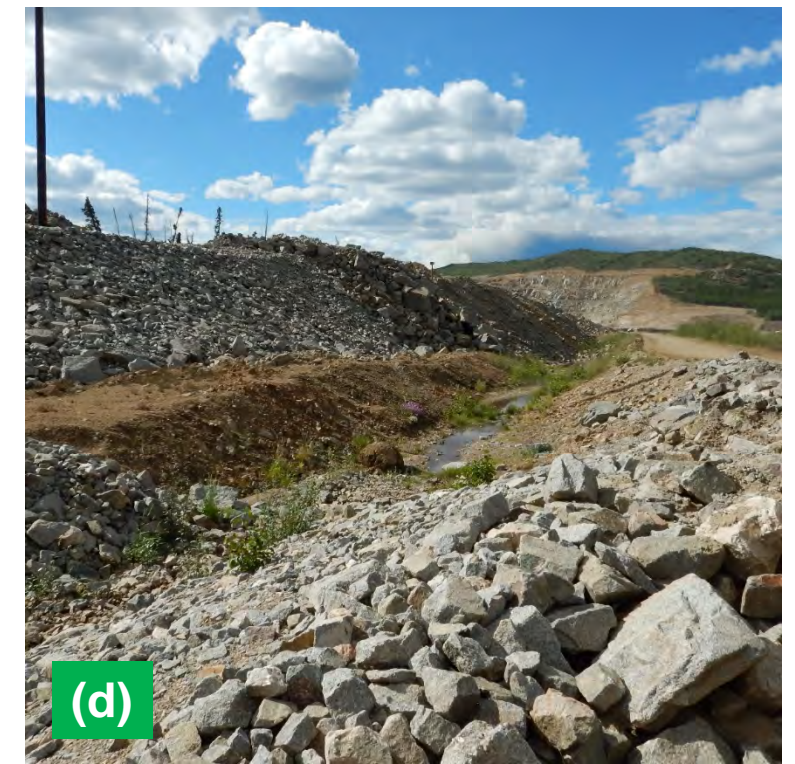
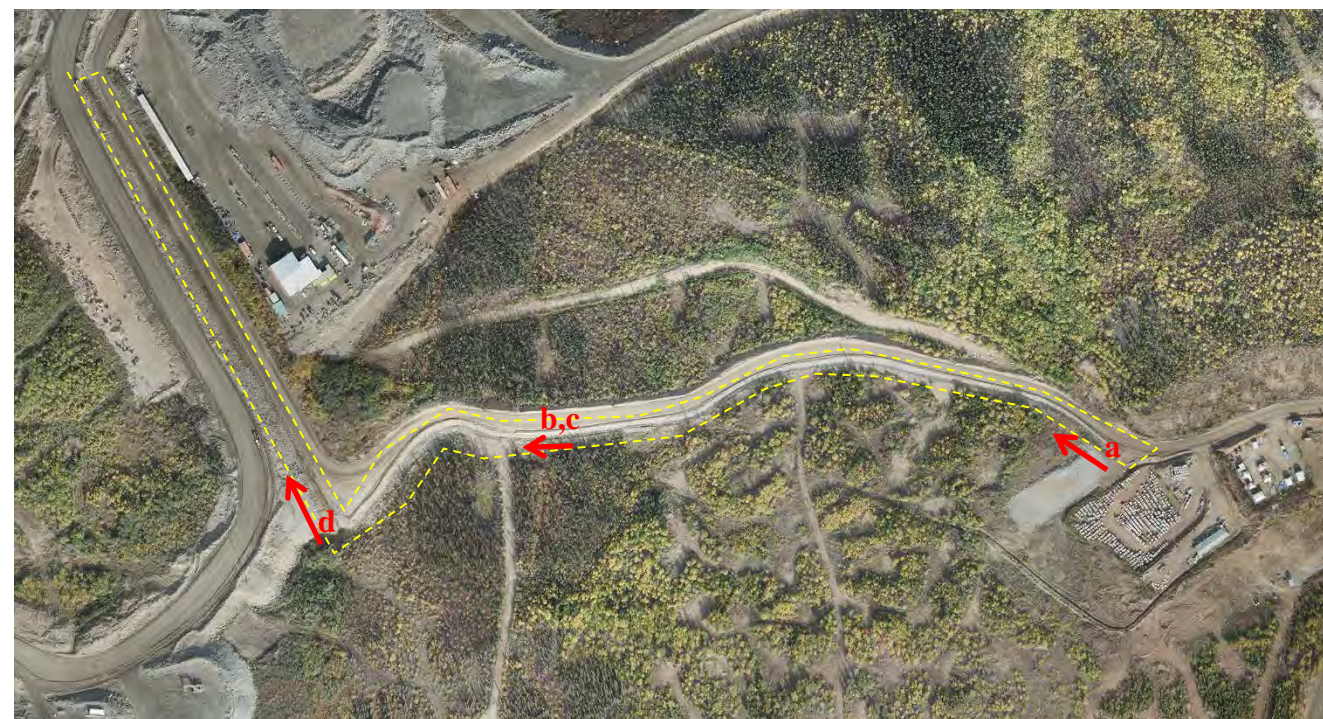
Spring 2015 Geotechnical Inspection		
		South Diversion Ditch		
Job No: 1CM002.039 Filename: AppA_Minto2015SpringInspection_20150731.pptx	Minto Mine	Date: July 2015	Approved: EK	Figure: 13

- The inspection of the South Diversion Ditch also included a portion of the ditching adjacent to the airport access road.
 - Since the Fall 2014 inspection, there appears to be vegetation within the ditch alignment.
 - The inlet structure at the end of the ditch was unobstructed.
 - No signs of instability were noted along the side-slopes.
- a) View of the ditch at adjacent to the airport road. Vegetation within the alignment was limited, and not impacting the capacity of the ditch.
 - b) Exposed geotextile along the airport road ditch alignment.
 - c) Airport road ditch at road crossing is at a higher invert than the rest of the ditch. The capacity of the ditch may be impacted.
 - d) South diversion ditch looking northwest.

- Repair / cover exposed geotextile along the airport road alignment.
- Confirm the airport road ditch profile shown in photo (c) drains properly.
- Remove vegetation within the South Diversion Ditch.

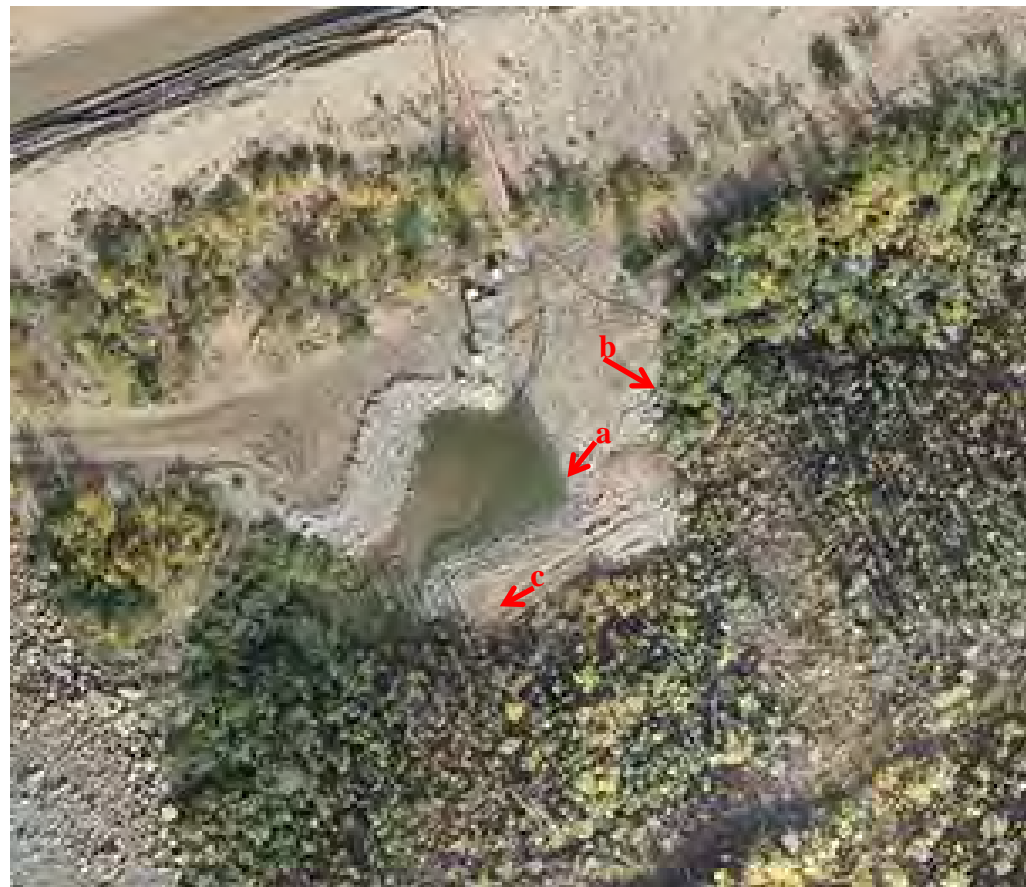
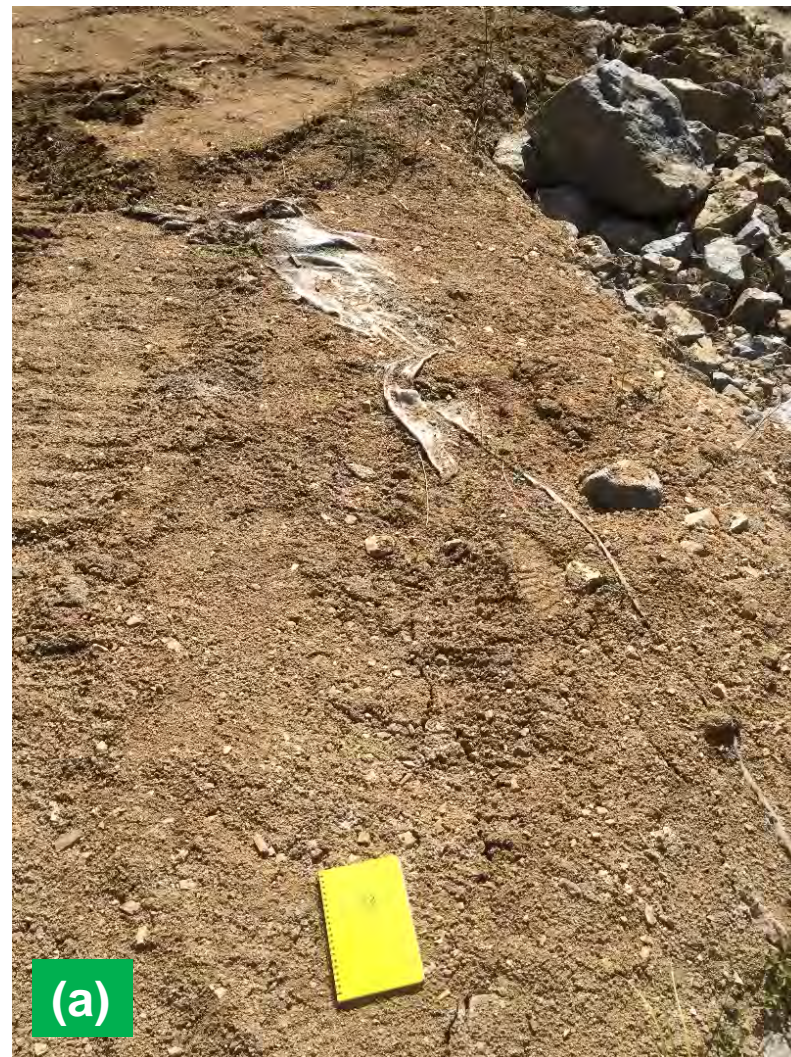
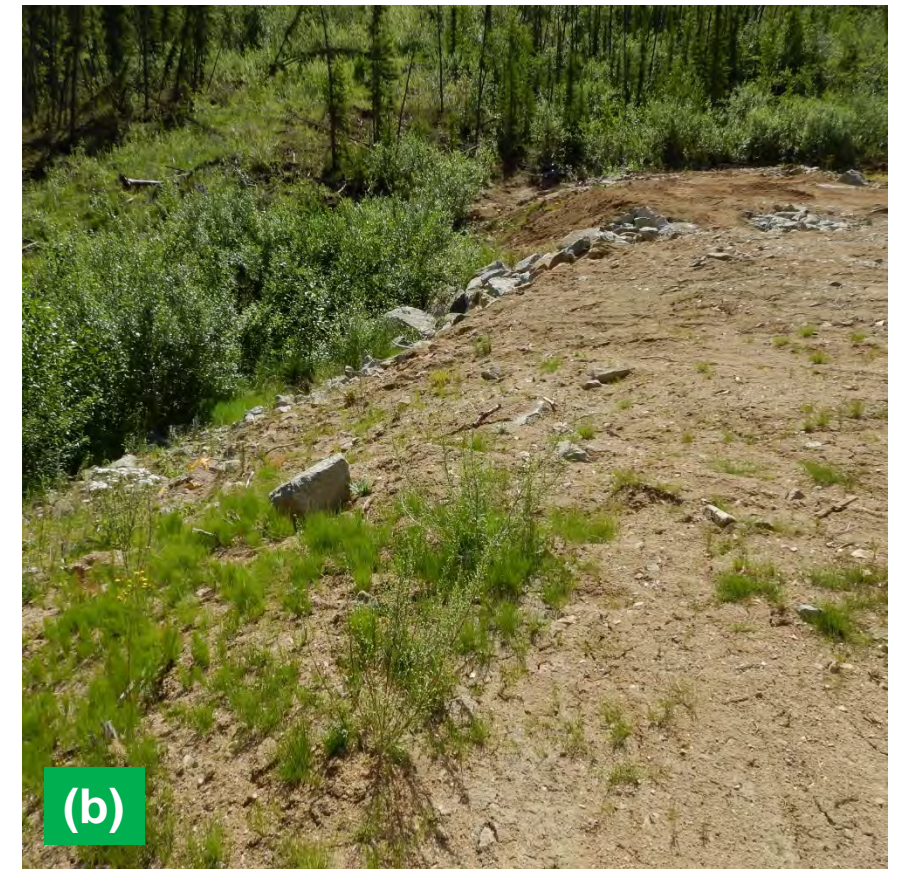
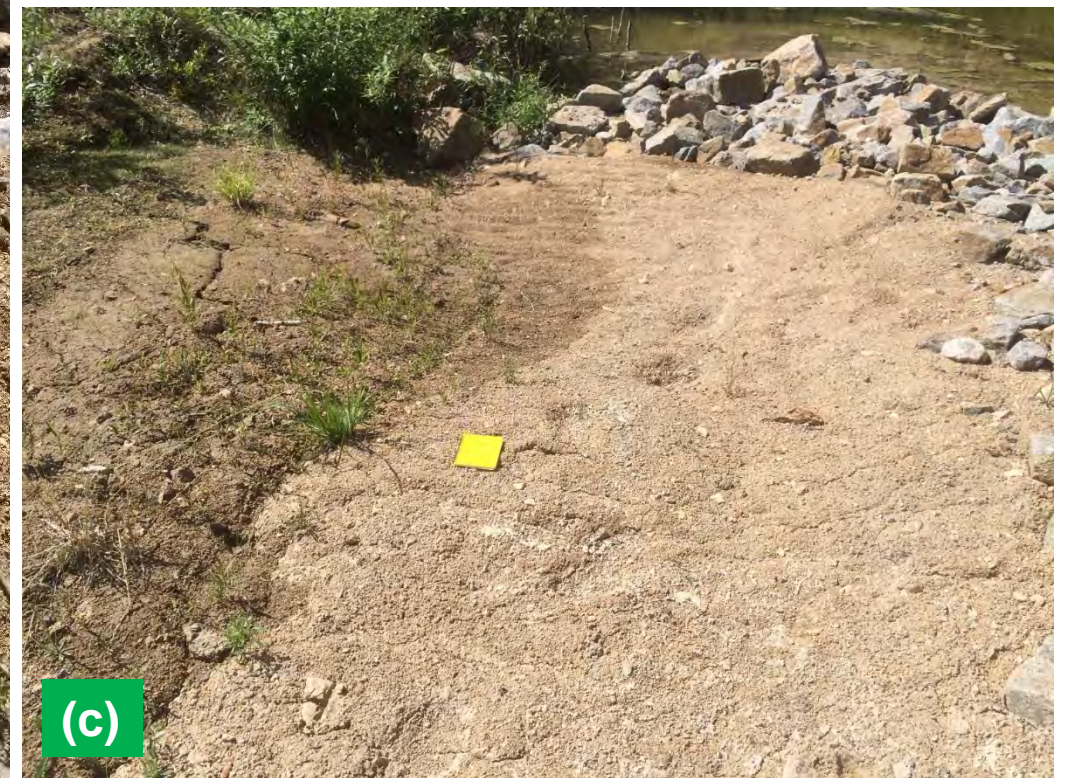
12 Minto Creek Detention Structure

- The conditions appear generally the same as previous inspections.
- Generally it appeared as though the fill used in construction of the MCDS was loose and the cracking on the surface was due to initial settlement of the material.

- a) View of exposed geosynthetic clay liner along the upstream face of the MCDS.
- b) View of the downstream crest of the MCDS.
- c) View of the settlement and cracking near the creek inlet.

Minto Creek Detention Structure	14	Continue annual monitoring for further signs of instability or seepage on the downstream slope of the MCDS.
	14	Repair the crest and exposed geotextile, or move towards replacing the pond as planned.
Water Storage Pond Dam	15	Significant erosion on the left abutment. Plans for repair should be made in conjunction with the Engineer of Record.
	15	Continue regular monitoring of the dam, noting specifically the clarity of the seepage and flow exiting the stilling basin and the seepage rate through the weir.
Big Creek Bridge	16	Continue regular annual monitoring of sediment accumulation in the culverts. If sediments continue to accumulate, clean them out. Exposed geotextile around culverts should be repaired.
South Wall Buttress / In-Pit Dump	17	The tension crack area in the In-Pit Dump should continue to be monitored. A photographic record should be maintained to inspect for changes in condition. Following completion of the buttress, additional survey hubs should be installed along the crest to monitor movement.

- Repair exposed geosynthetics.
- Continue regular annual monitoring for further signs of instability or seepage on the downstream slope of the MCDS.

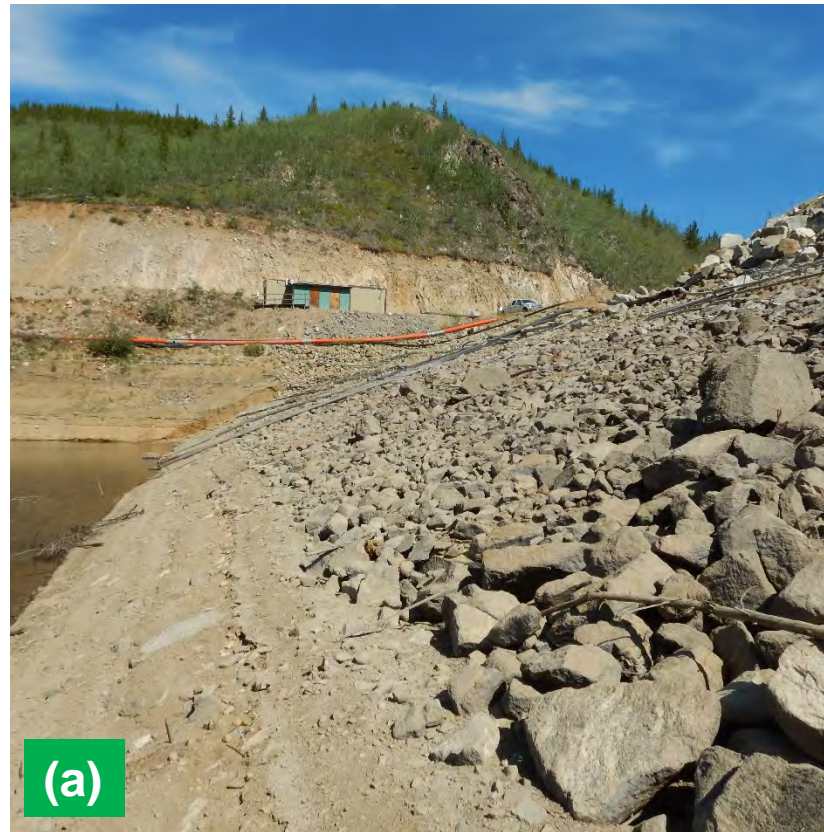
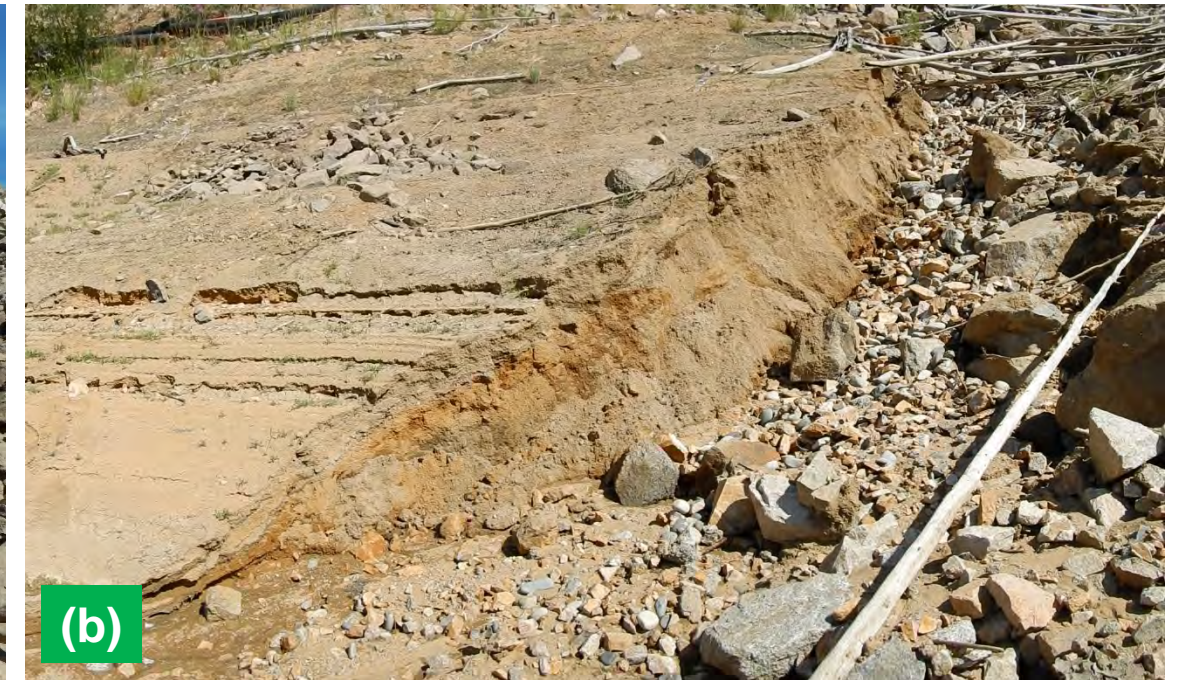
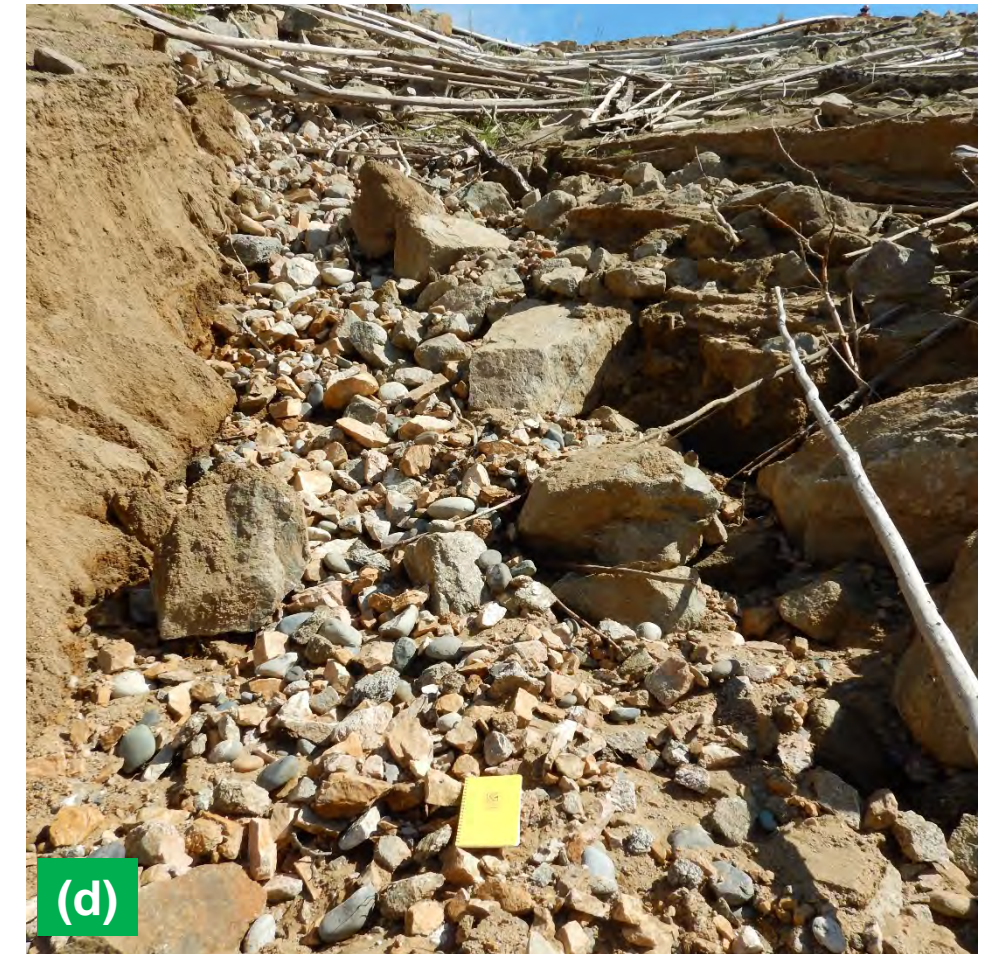
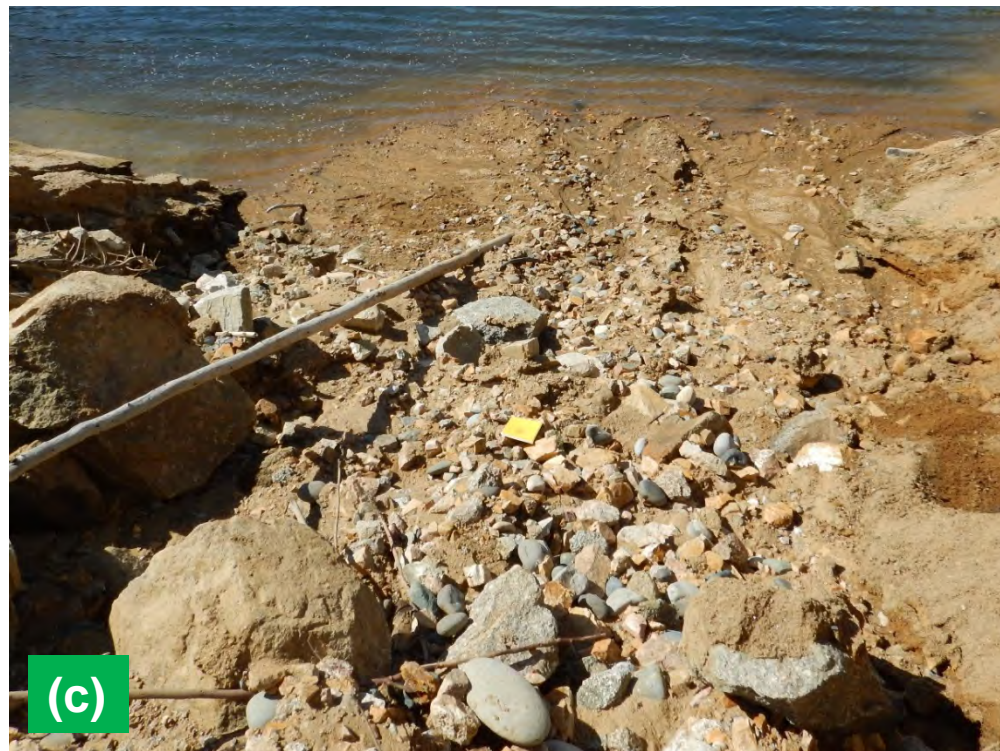
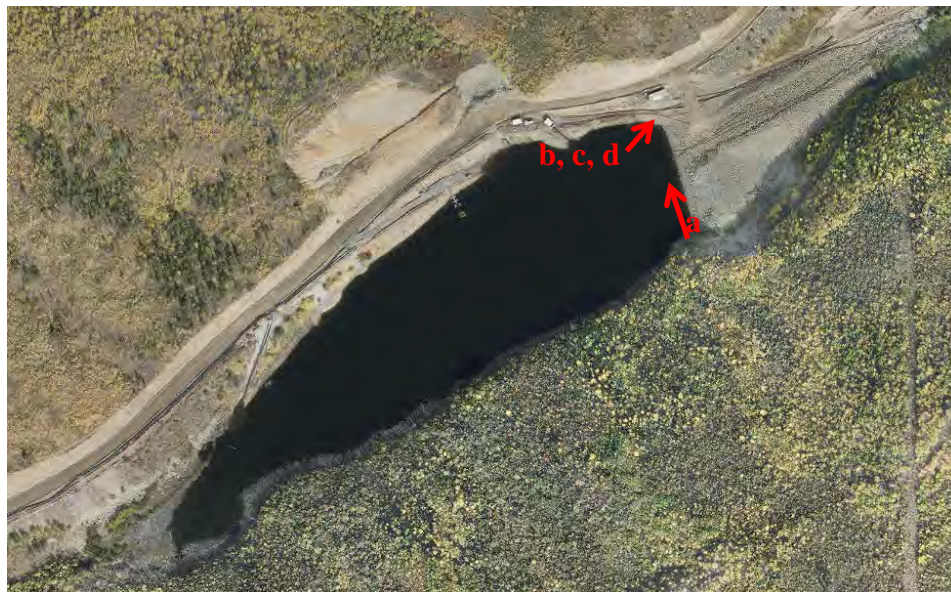
13 Water Storage Pond Dam

- A large area of erosion was evident on the left abutment of the dam.
- The water level was lower than the minimum operating level, exposing the dam to potential erosion.
- No signs of instability along the dam, or at the abutments other than the evident erosion on the upstream side of the dam at the left abutment.
- Seepage water downstream of the dam was clear and no accumulation of sediments was observed.
- The weir present downstream of the dam had an estimated flow rate of 1L/s. Condition of the seepage water appears unchanged compared to the 2013 inspection. Water flow could not be heard in the rockfill adjacent to the seep. The water was clear with no turbidity.

- Engage the Engineer of Record in the repair of the dam at the left abutment.
- Continue regular monitoring of the dam, noting specifically the clarity of the seepage and flow exiting the stilling basin, and the seepage rate through the weir.

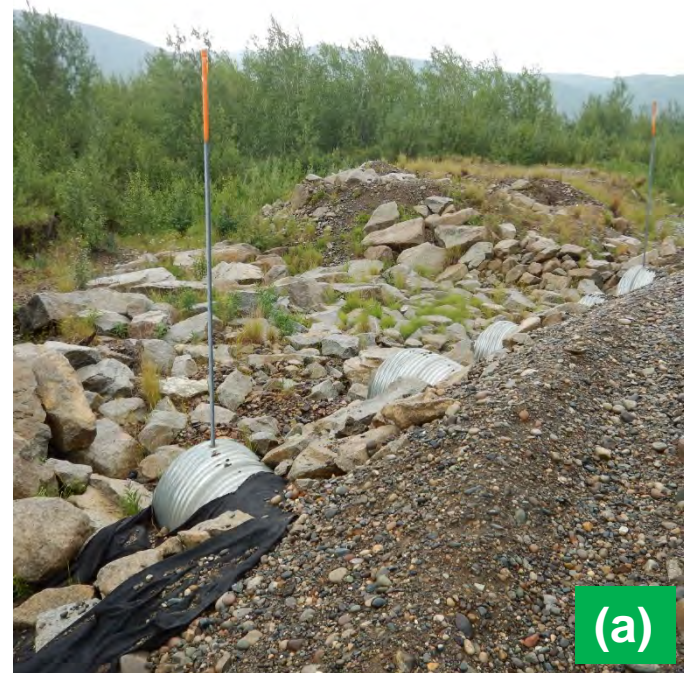
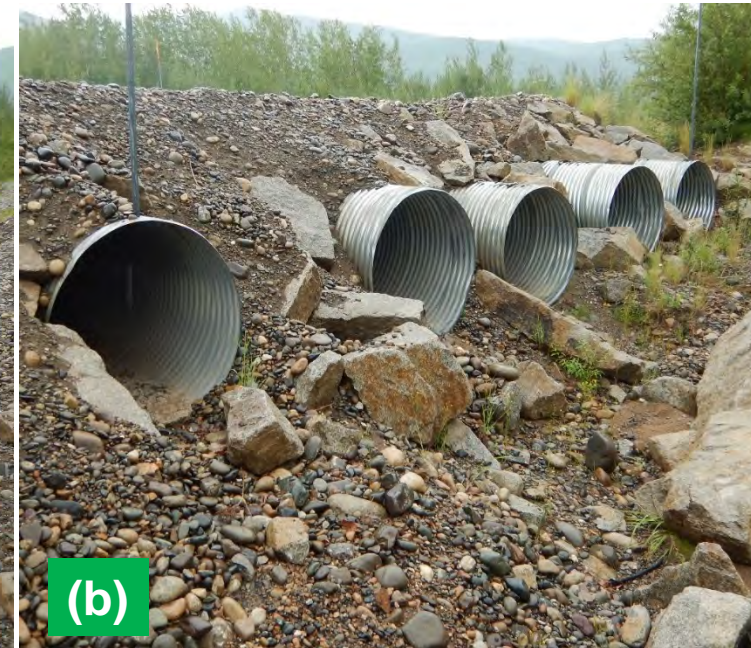
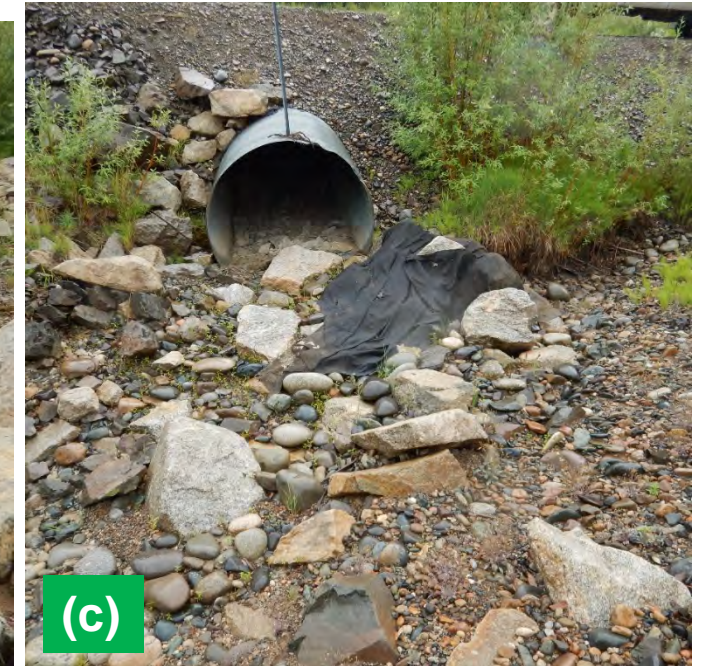
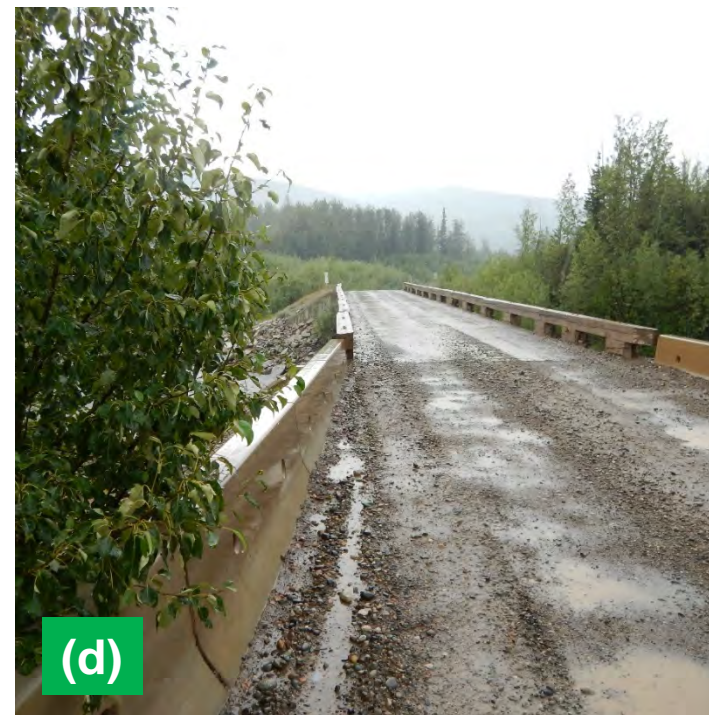
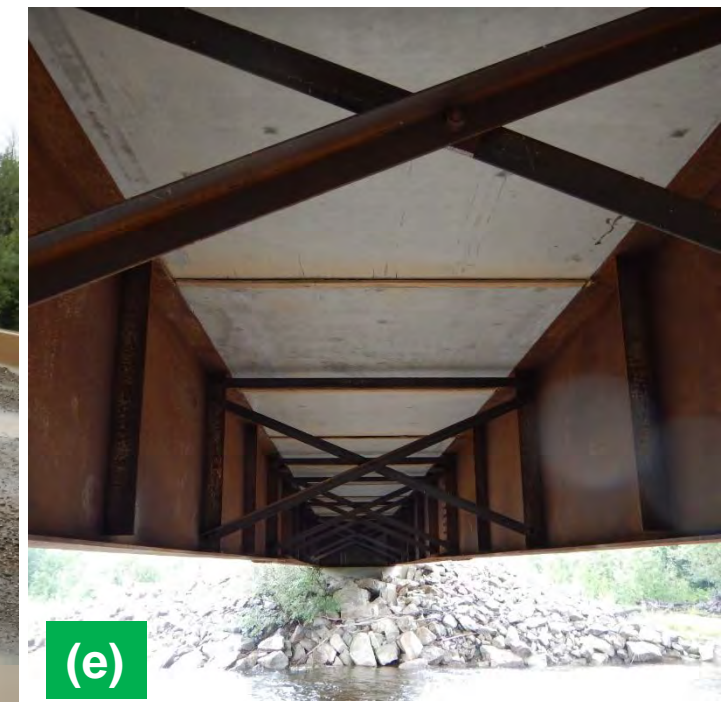
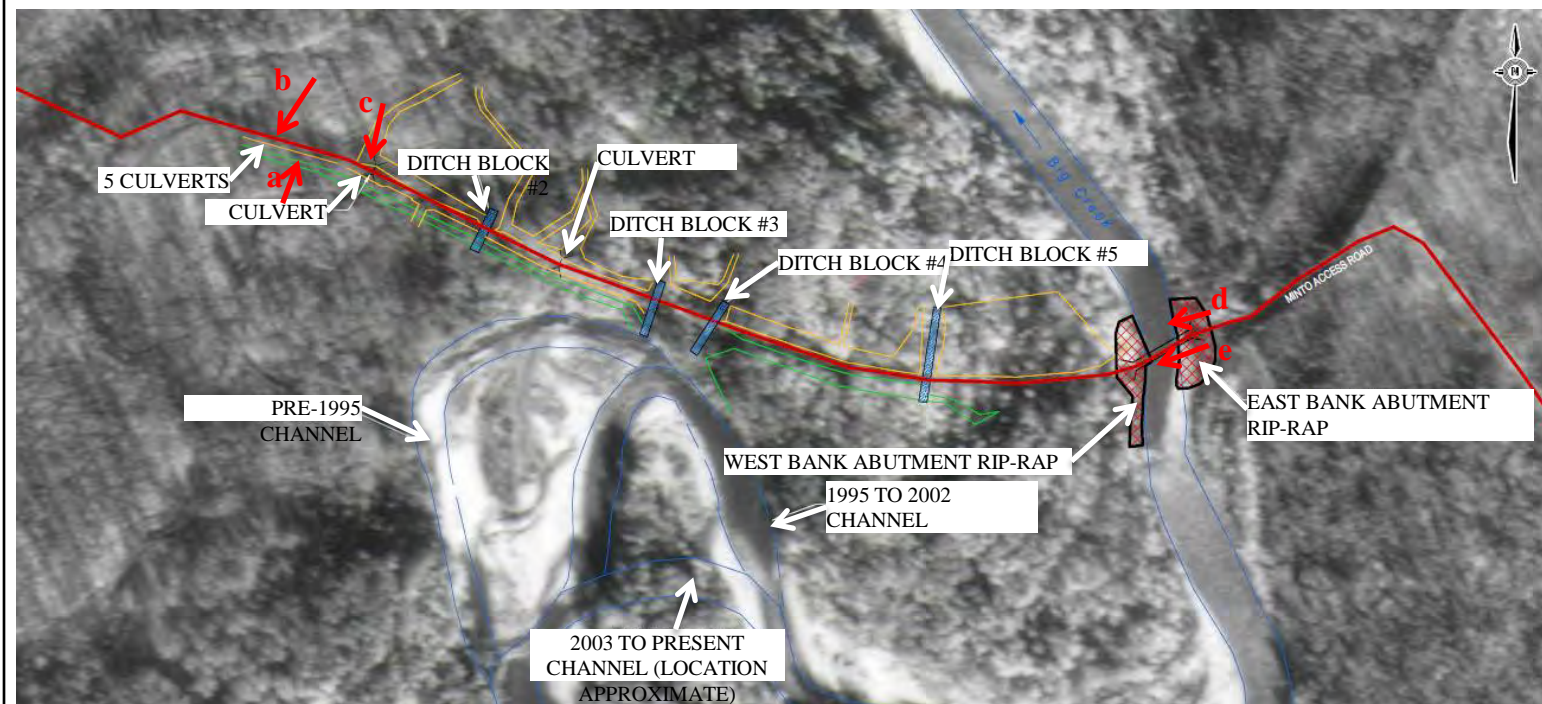
<small>MINTO MINE</small> <small>OPERATED BY MINTO EXPLORATIONS LTD.</small>	Spring 2015 Geotechnical Inspection		
		Big Creek Bridge		
Job No: 1CM002.039 Filename: AppA_Minto2015SpringInspection_20150731.pptx	Minto Mine	Date: July 2015	Approved: EK	Figure: 16

- Conditions of the culverts are unchanged since the previous Fall 2013 inspection. The first culvert west of the bridge is in satisfactory condition.
- Photo (a) and (b) shows 5 culverts, each with diameter of 1.1m. The culverts are in satisfactory condition, with no blockages at either end. Exposed geotextile on the south side should be repaired.

- Ditch Blocks were not inspected.
- Photo (c) shows the downstream end of the 2nd culvert west of the bridge. Sediment accumulation should continue to be monitored and cleaned out if sediments continue to accumulate. The exposed geotextile should be repaired.

- Photos (d) and (e) show above and below the bridge, respectively. The bridge abutments and road approaches are in good condition, no signs of instability were observed.

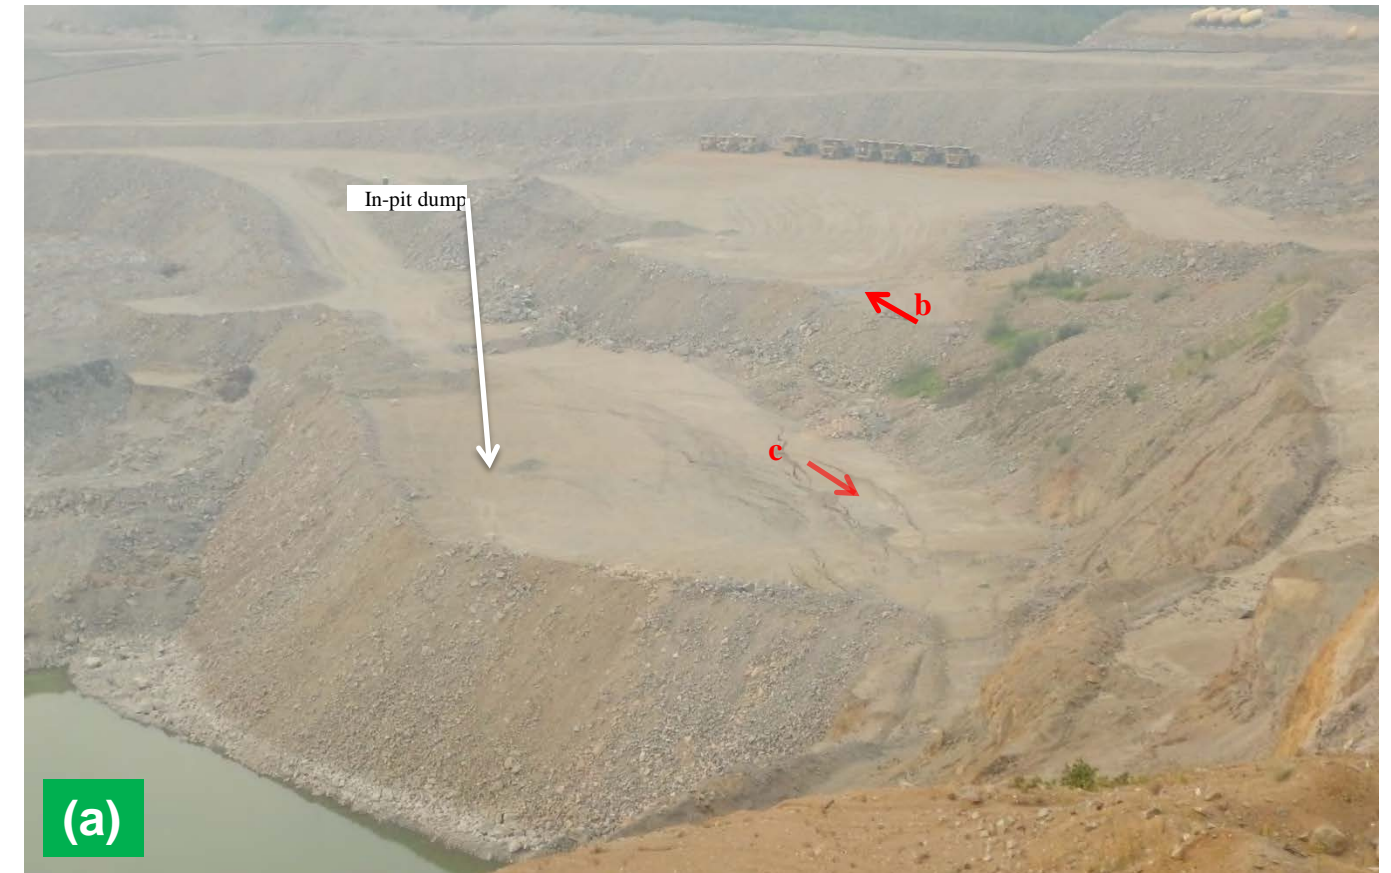
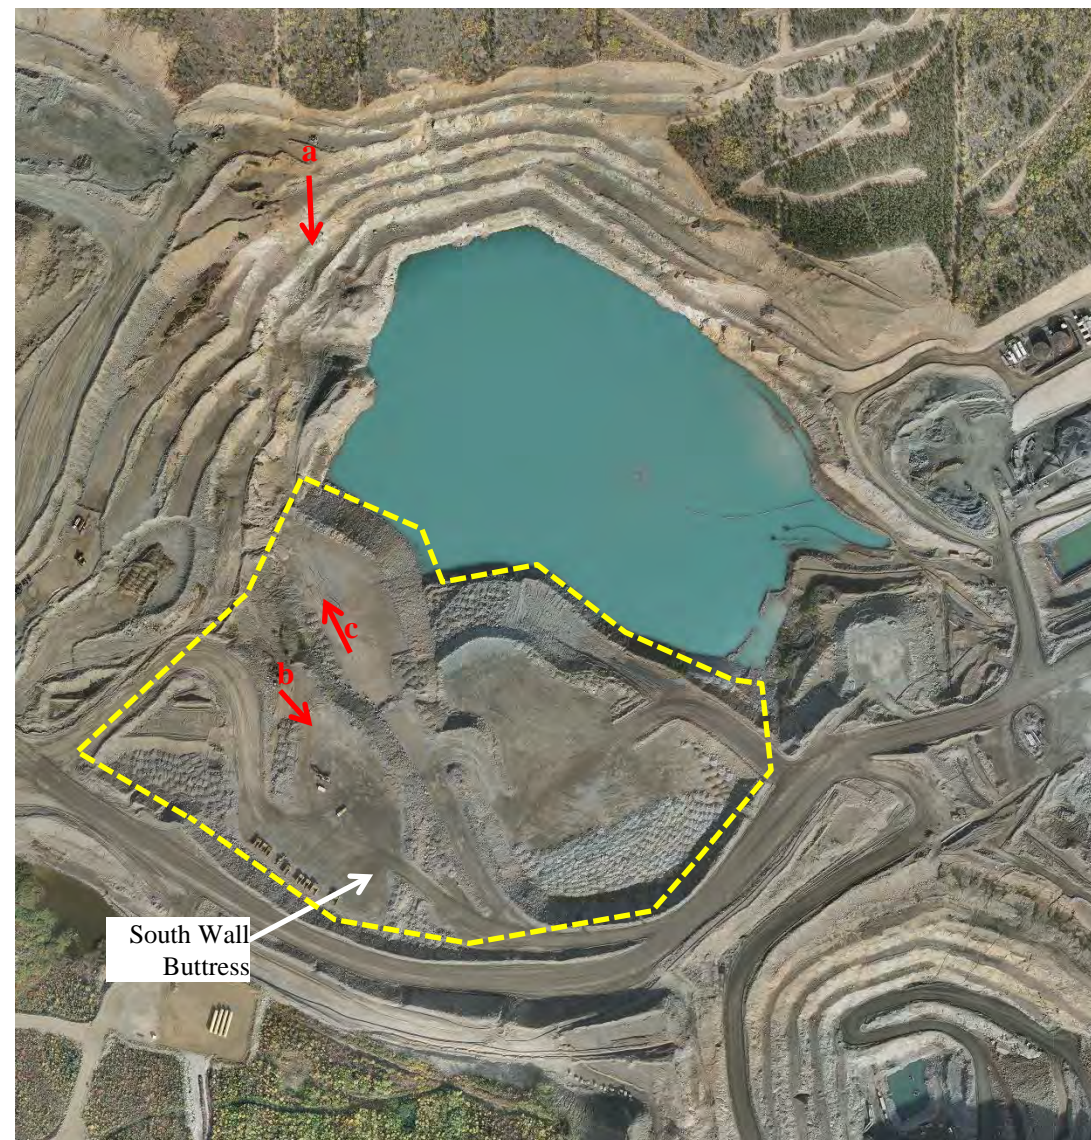
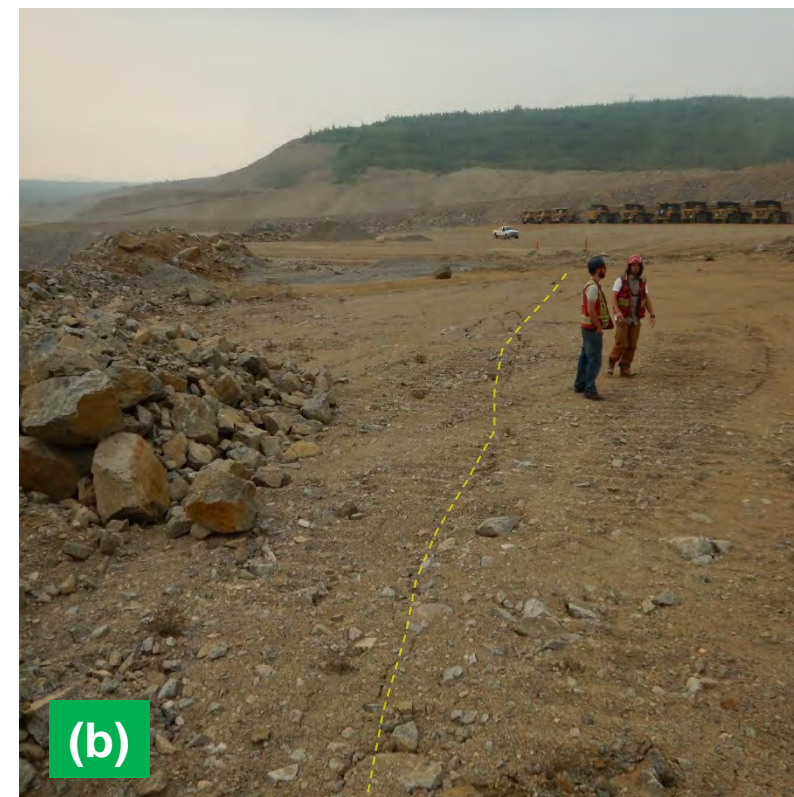
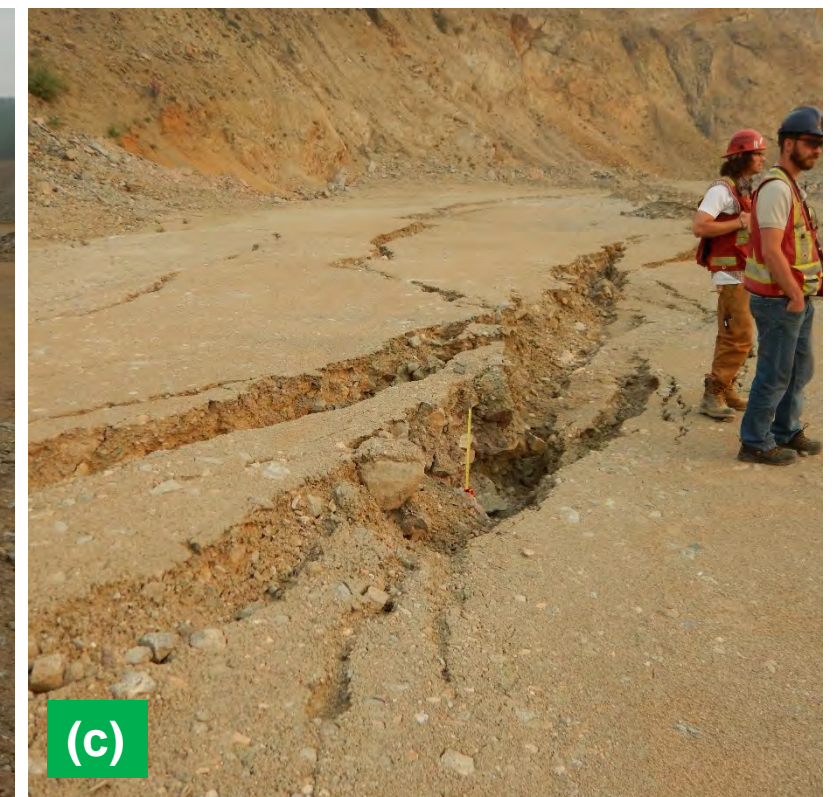
Photo b: View of the tension cracks at level 821 above the In-Pit Dump located west of the South Wall Buttress. These cracks were first observed during the 2015 site inspection.

Photo c: View of the tension cracks on the In-Pit Dump located west of the South Wall Buttress. This area has been blocked off and is inaccessible to equipment. The movement is believed to be due to the large dump height, with the material end dumped directly into the pit water.

17	Tensions cracks were observed on Level 821. Recommend adding survey monuments, and painting cracks, and adding these to the

- The tension crack area should continue to be visually monitored, and the survey hubs should continue to be monitored. A photographic record should be maintained to inspect for changes in condition.
- Survey hubs should be installed at level 821 to monitor movement and cracks should be painted.
