# 2017 Geotechnical Annual Review, Minto Mine, YT

Minto Explorations Ltd.

SRK Consulting (Canada) Inc.  
1CM002.059  
August 2017

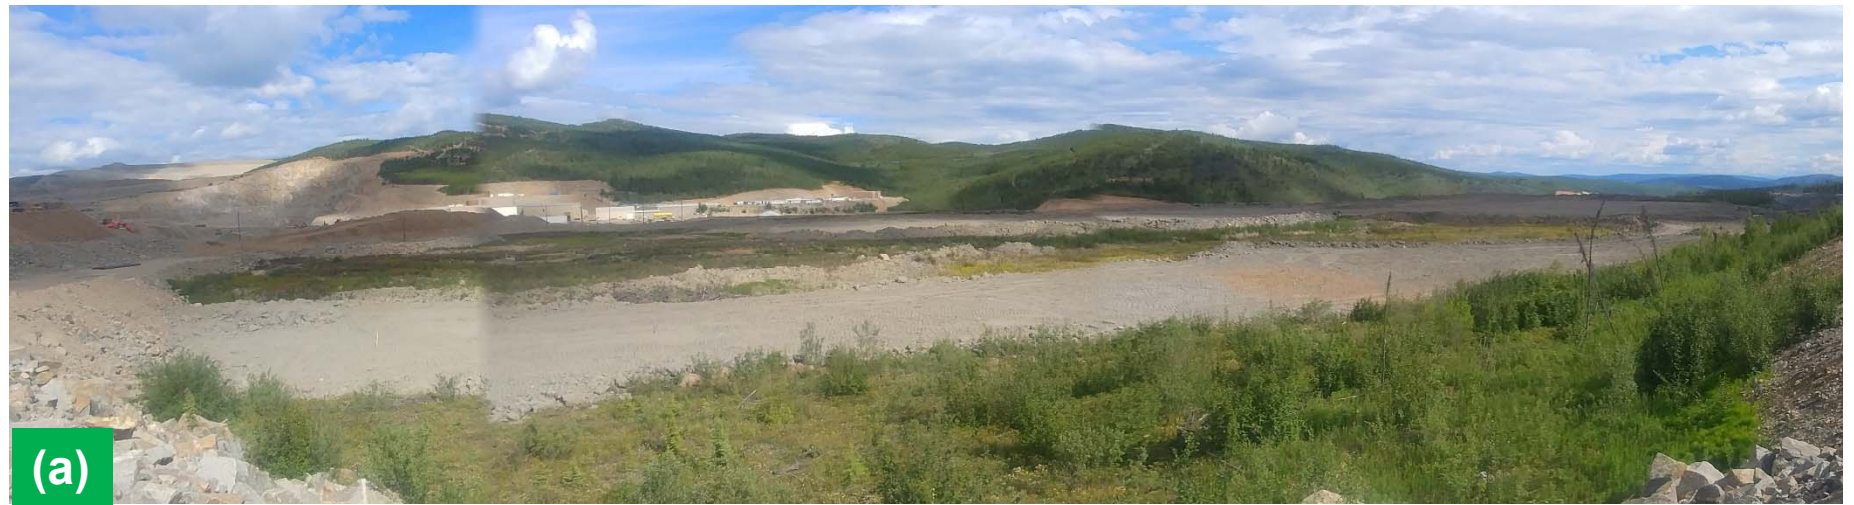
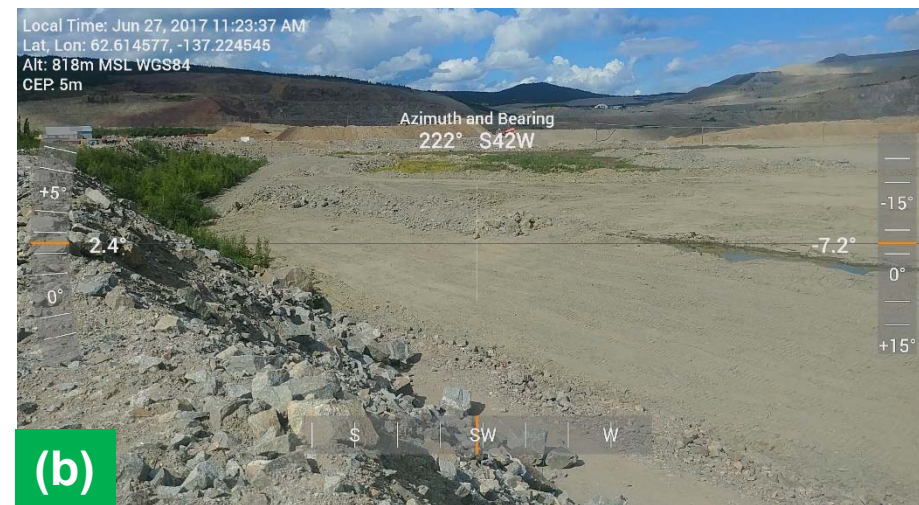
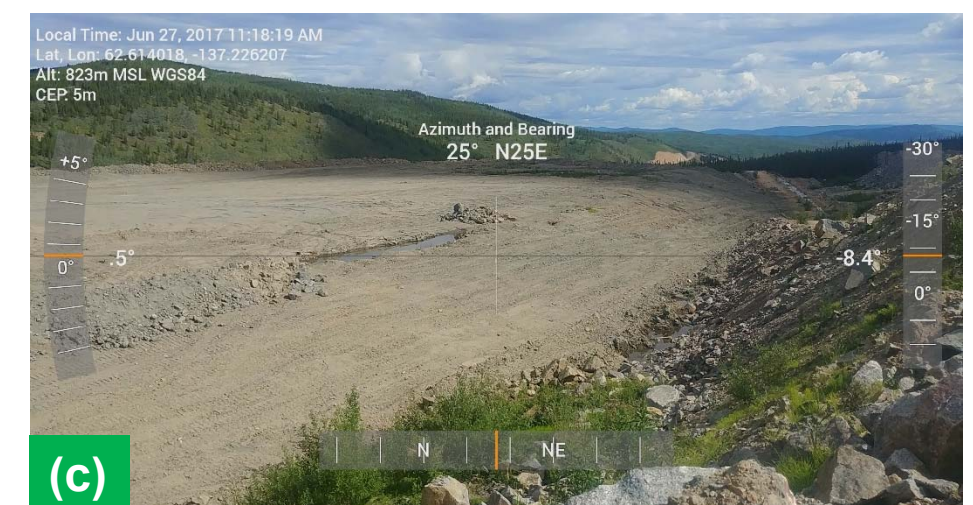
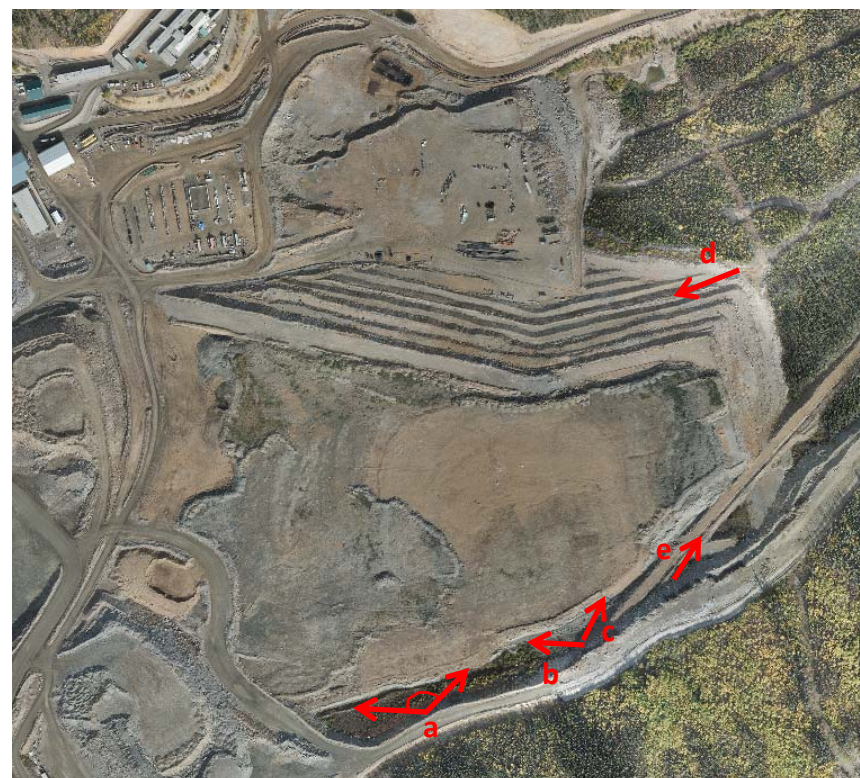
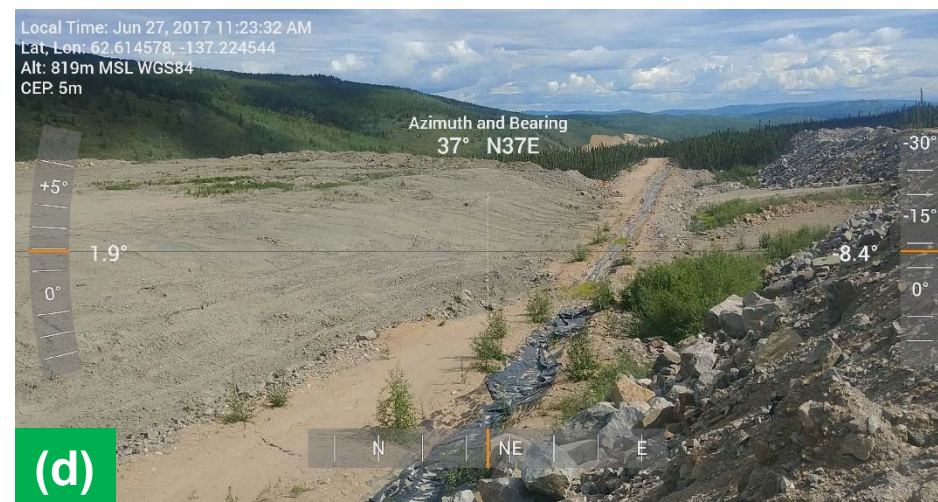
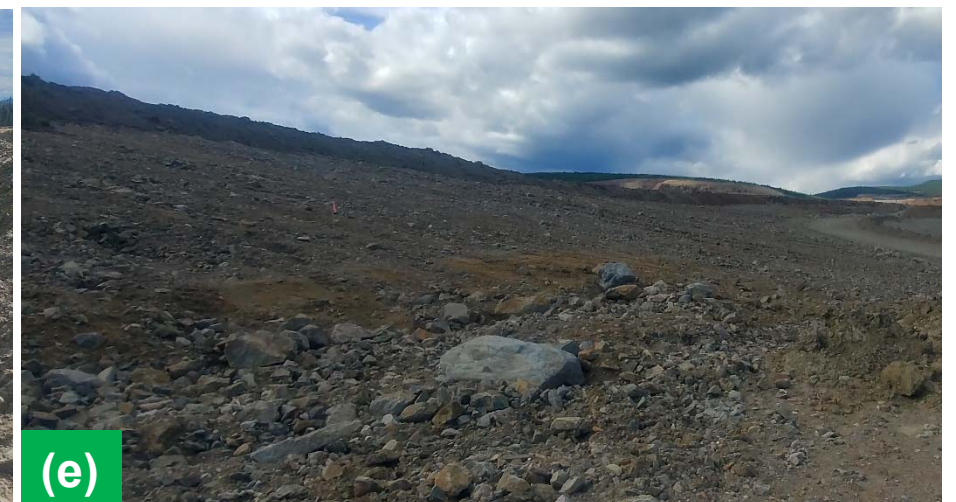
2017 Geotechnical Inspection		
		<b>Dry Stack Tailings Storage Facility</b>		
Job No: 1CM002.059 Filename: AppA_2017InspectionPhoto.pptx	Minto Mine	Date: August 2017	Approved: PHM	Figure: <b>2</b>

- Since the 2016 inspection, the implementation of closure measures has begun at the DSTSF and are currently on-going. The waste rock shell has been regraded, bulk landform regrading of the DSTSF surface has been completed, unsuitable cover soils have been removed and replaced with suitable cover soil, and overburden was placed on the south slope of the DSTSF to cover all exposed tailings and to provide positive drainage of the area between the Tailings Diversion Ditch and the DSTSF.

- Additional 'fine tuning' regrading of the cover surface and placement of cover soils over the waste rock shell remains to be completed.
- No signs of instability observed. Due to the placement of cover materials, the cracking noted in the 2016 inspection were unable to be observed.

- Additional fill should be placed in the pooled depression to prevent ponding and provide positive drainage.

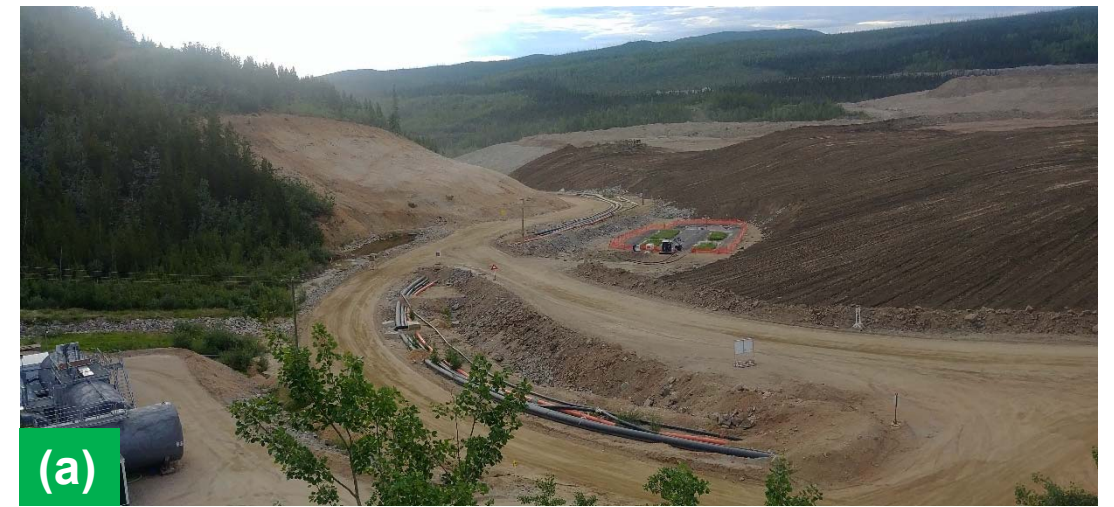
No major signs of instability were observed at the time of the inspection.

- Photo (a) shows cover soils being spread on the north slopes of the MVFE Stage 2.
- Photo (b) shows the Minto Creek Seepage Collection System. The system appears to be functioning as per design, no signs of seepage immediately downstream of the system.
- Photo (c) shows the slope south of the Minto Creek Seepage Collection System. Minor sloughing of the slope has occurred as a result of permafrost thaw.
- Photo (d): View of the down-valley slope of the MVFE Stage 2.
- Photo (e): View of one of three new inclinometers installed (DSI-22) to monitor movement rates on the east side of the DSTSF and MVFE Stage 2.

- Continue to monitor the slope to the south of the Minto Creek Seepage Collection System for signs of retrogressive sloughing to determine if any slope stabilization measures are required.

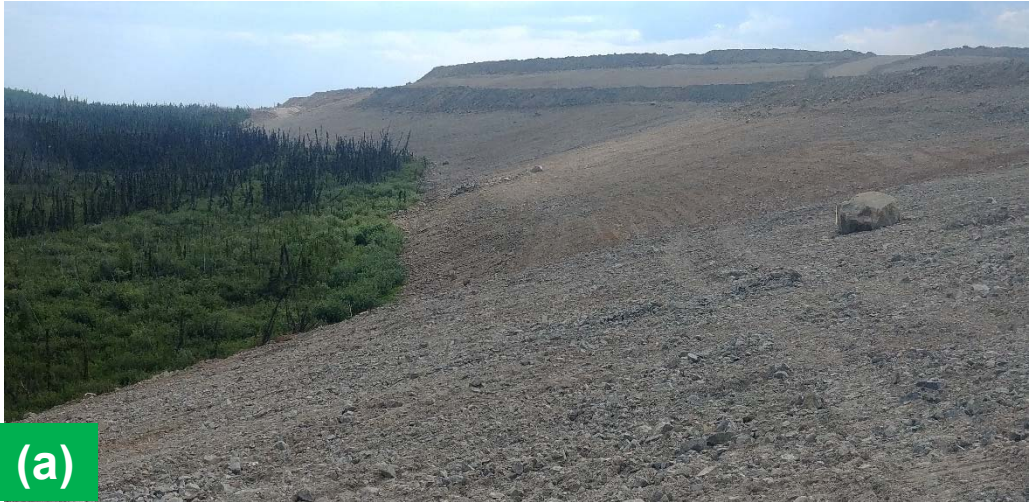
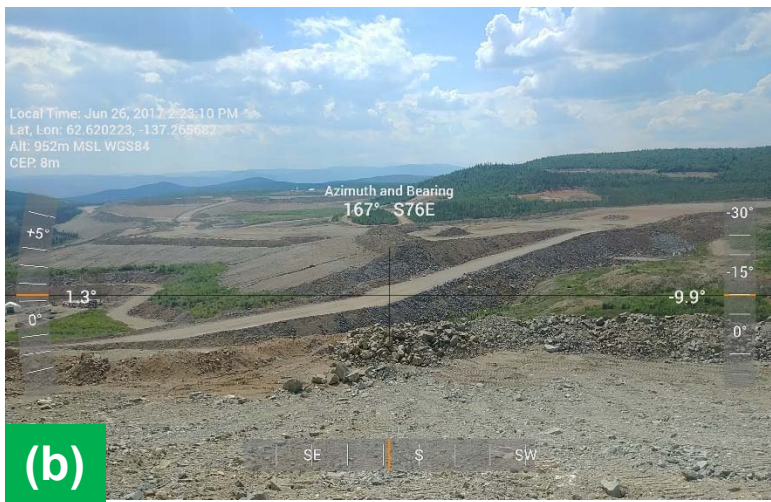
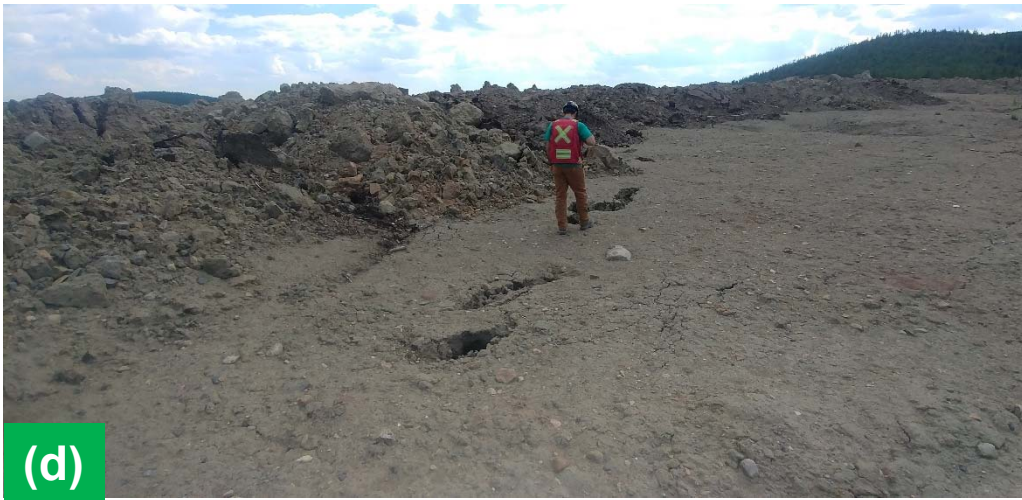
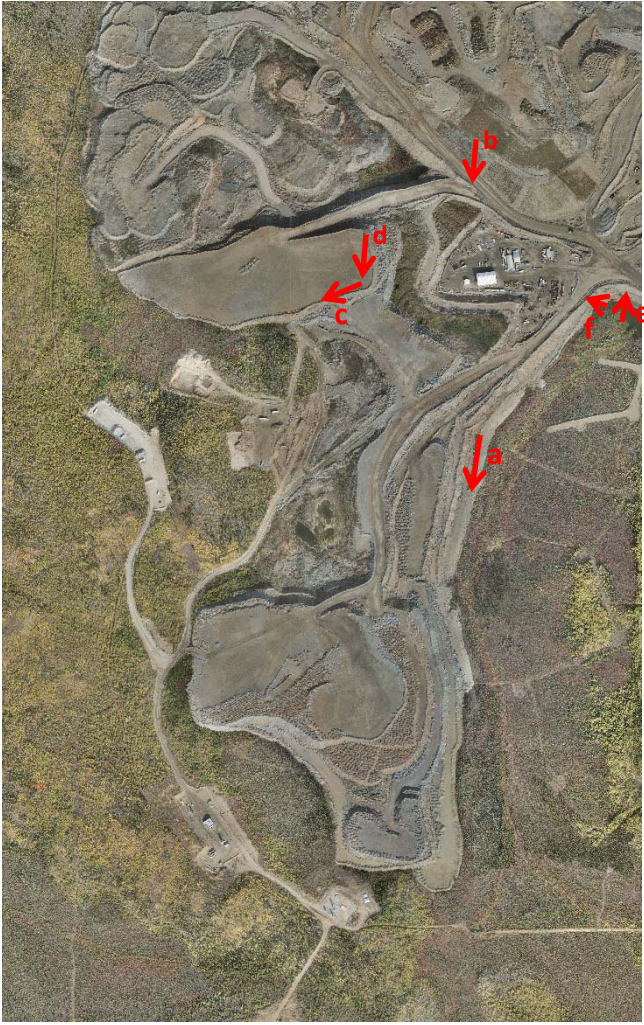
- Since, the 2016 inspection, additional regraded of the dump area has been completed, overburden cover soil from the Area 2 Stage 3 Pit has been spread on the flat dump surfaces and stockpiled along the crest of the slope. Cracks and depressions noted in the 2015 and 2016 inspections were unable to be observed as a result of the cover placement.

- The majority of the dump surfaces where cover soils were spread during the winter show differential settlement and cracking as a result of the winter placement. It is understood that additional 'fine-tune' grading of the cover soil surfaces is planned to be completed at a later date.

- Photo (a): View of regraded slope on the east side of the dump and stockpiled overburden along the crest of the slope.
- Photo (b): View of the north end of the Southwest dump taken from the Main Waste Dump. The photo shows the stockpiling of overburden along the regraded crests of the dump.

- Photos (c) and (d) show depressions, areas of differential settlement, and cracking of the overburden slope that was placed during the winter.

- Photo (e): Survey hub SWD-06 has been installed to replace SWD-01A that was impacted by frost heave. The remainder of the hubs that have experienced frost heave (SWD-02A, -03A, -04A, and -05A) have also been replaced with hubs mounted on lock-blocks or large boulders.
- Photo (f) shows the outlet of the culvert below the Pelly Laydown area. The appearance of the waste rock rip-rap below the culvert appears the same as in previous years inspection photos.

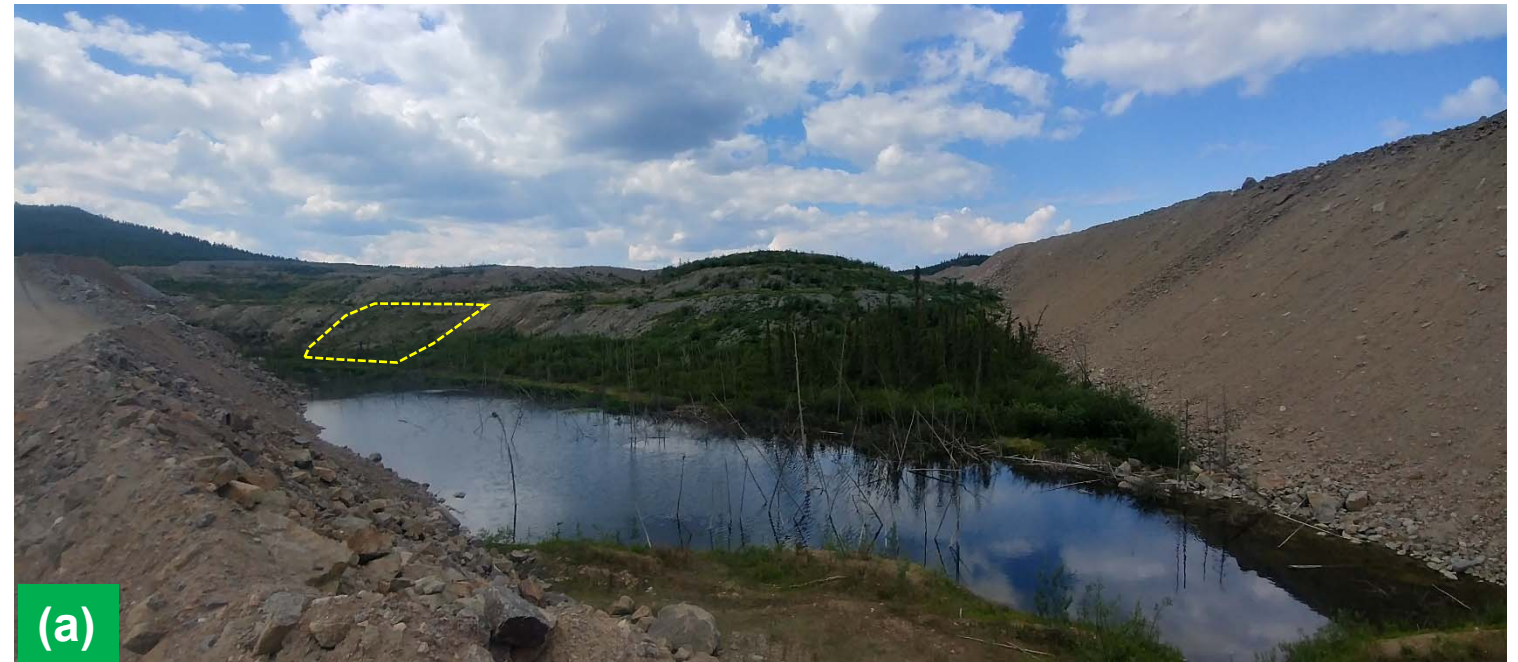
- Conditions at the Reclamation Overburden dump (ROD) remain the same as noted in previous years' inspections:
  - Slumping, settlement and tension cracks are expected in the dump as it is constructed with frozen overburden with thawing expected.
  - Discontinuous tension cracks and differential settlement observed along the perimeter crest.
  - Ground undulation is typically 0.3 m and is prevalent throughout the facility.
- The dashed yellow line in Photo (a) shows the small slope failure first observed in 2014. Vegetation has firmly been established within its footprint. The failure has not compromised the overall dump slope angle and as a result, the failure is not expected to reduce the overall stability of the dump.

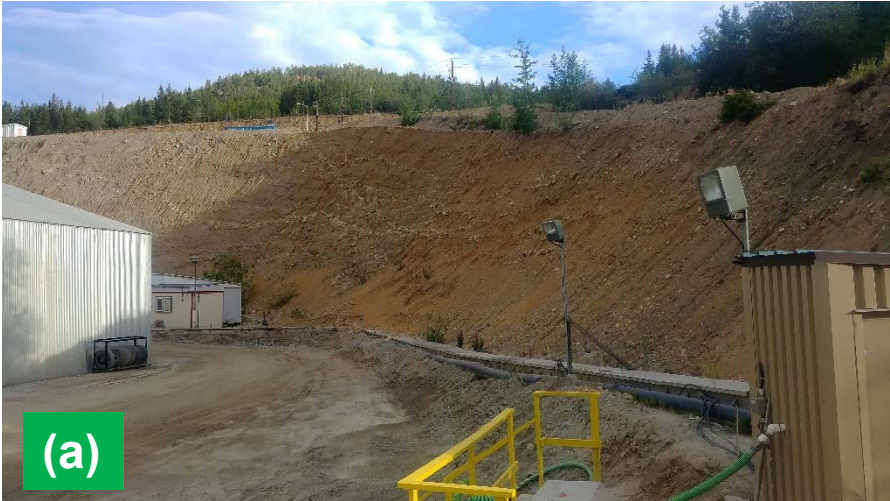
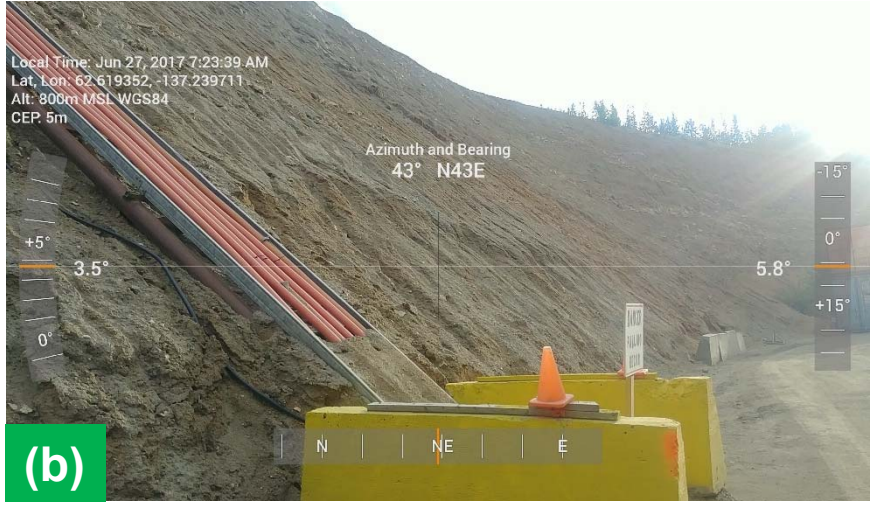
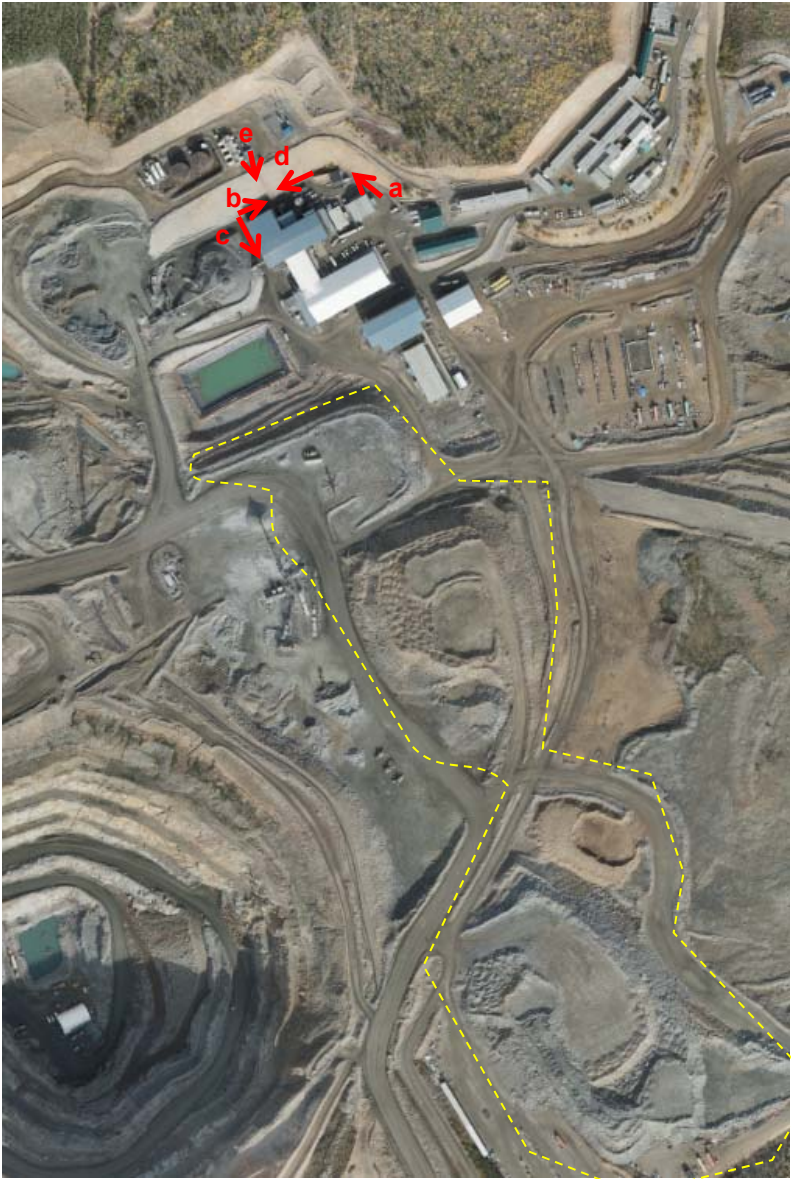
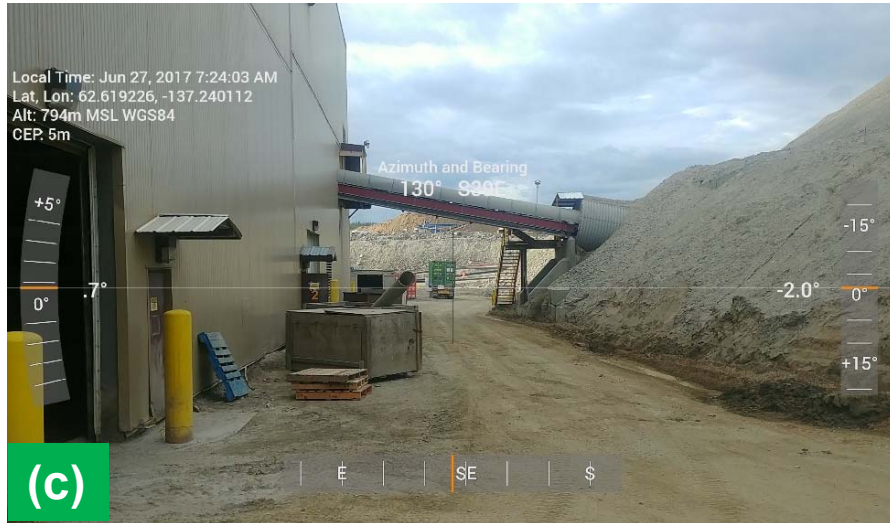
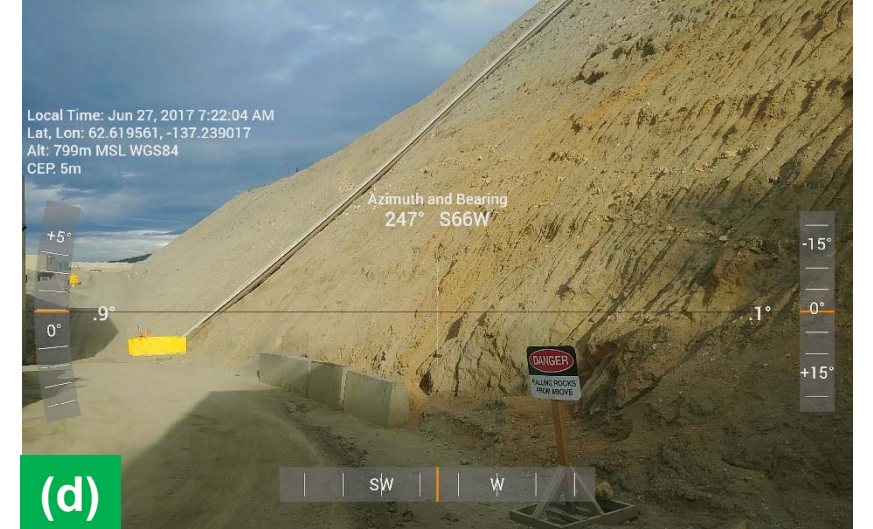
Conditions of the mill area are similar to those observed in previous inspections with minor ongoing erosion of the slope to the north of the mill.

Since the 2016 inspection a larger 'falling rocks' warning sign has been placed, and fallen rocks/cobbles have been cleaned from the base of the slope and from behind the concrete barriers (photo d).

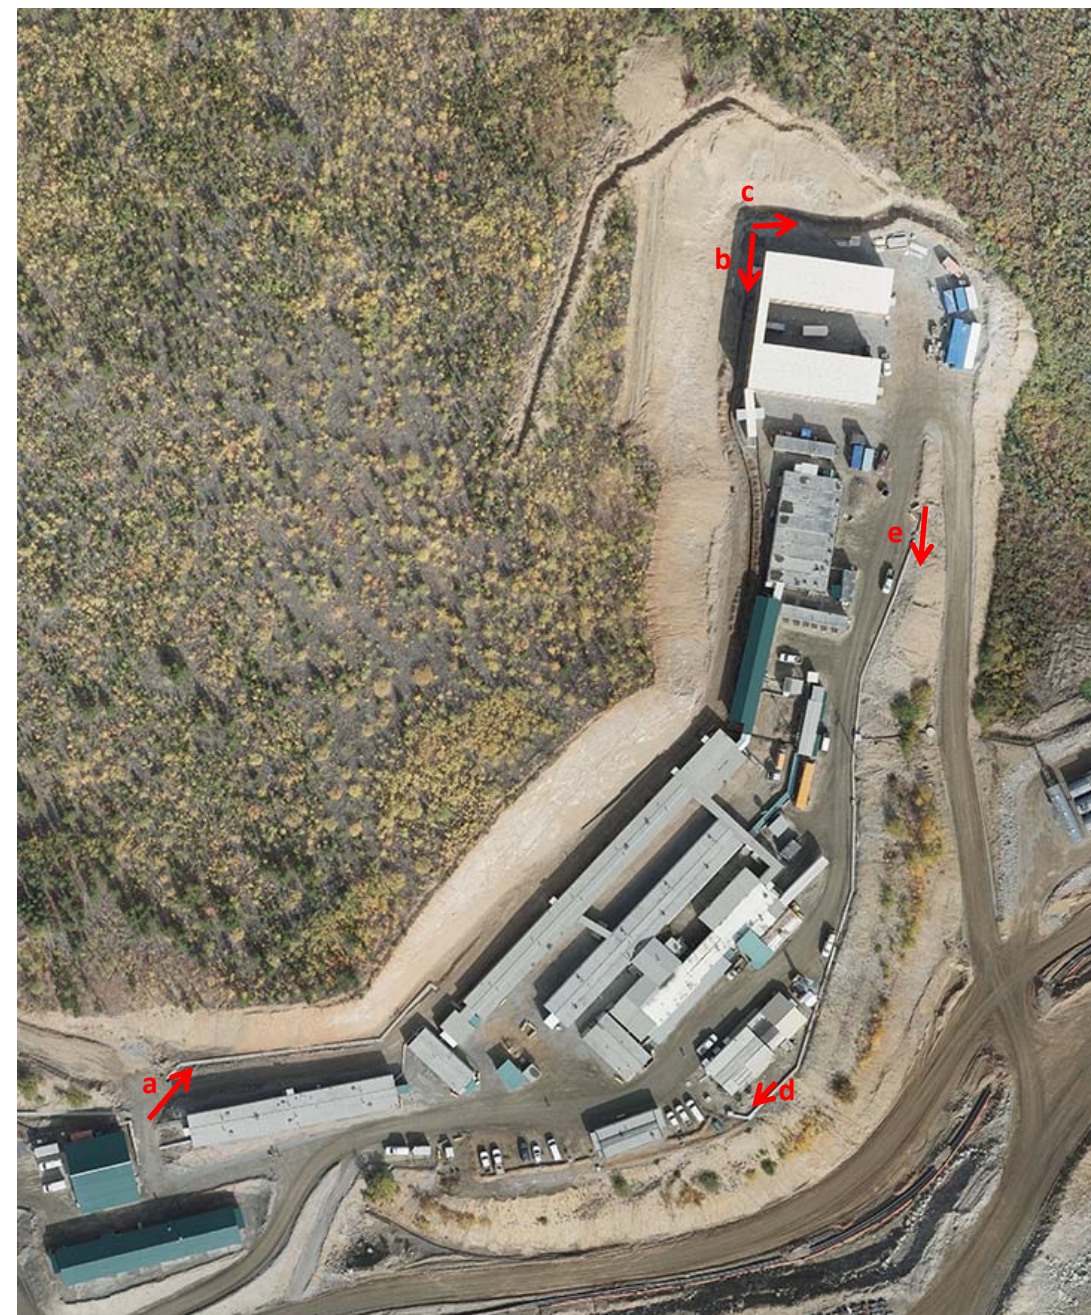
**Photo (a):** Slope above the main camp site appears stable, with some minor erosion of sands and gravels observed. Eroded sand/gravel is generally present at the base of the slope with occasional cobbles/boulders up to 300 mm.

**Photo (b):** A small slump was observed at the west end of the slope above the camp area. There is evidence of channelized surface flow above the slump area indicating that the slump may have occurred during a high rainfall event.

**Photo (c):** View of the channel to the north of the camp area. There is minor sloughing in the ditch in areas, but flow is not impeded. No water was observed in the upper diversion ditch.

**Photo (d):** View of the regraded camp pad south of the site services trailer. In 2016, the area was regraded to prevent flow of the slope and to direct flow into a sump with a pipe outlet that discharges at the base of the slope. These mitigation measures to minimize erosion of the slope below the camp pad appear to have been effective.

**Photo (e):** View of the camp pad crest looking south.

- Continue to monitor the slough at the west end of the camp area and the erosion channels below the camp pad following larger rainfall events.

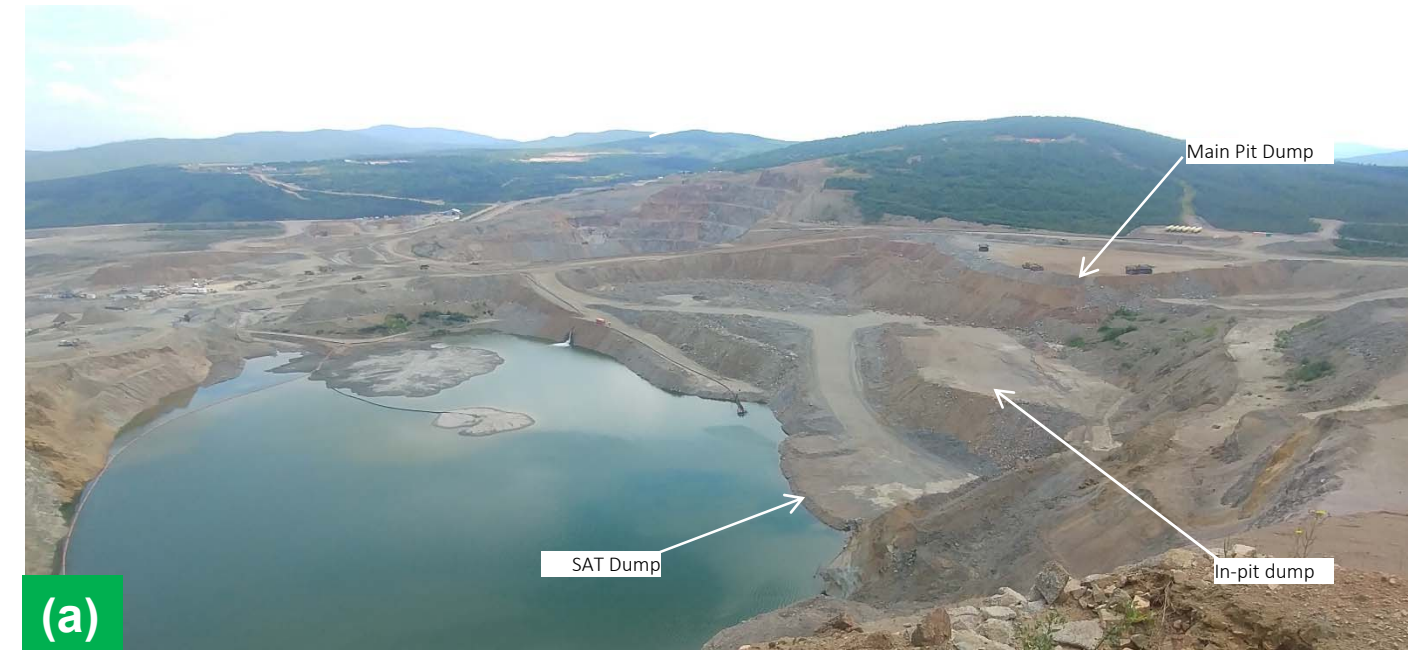
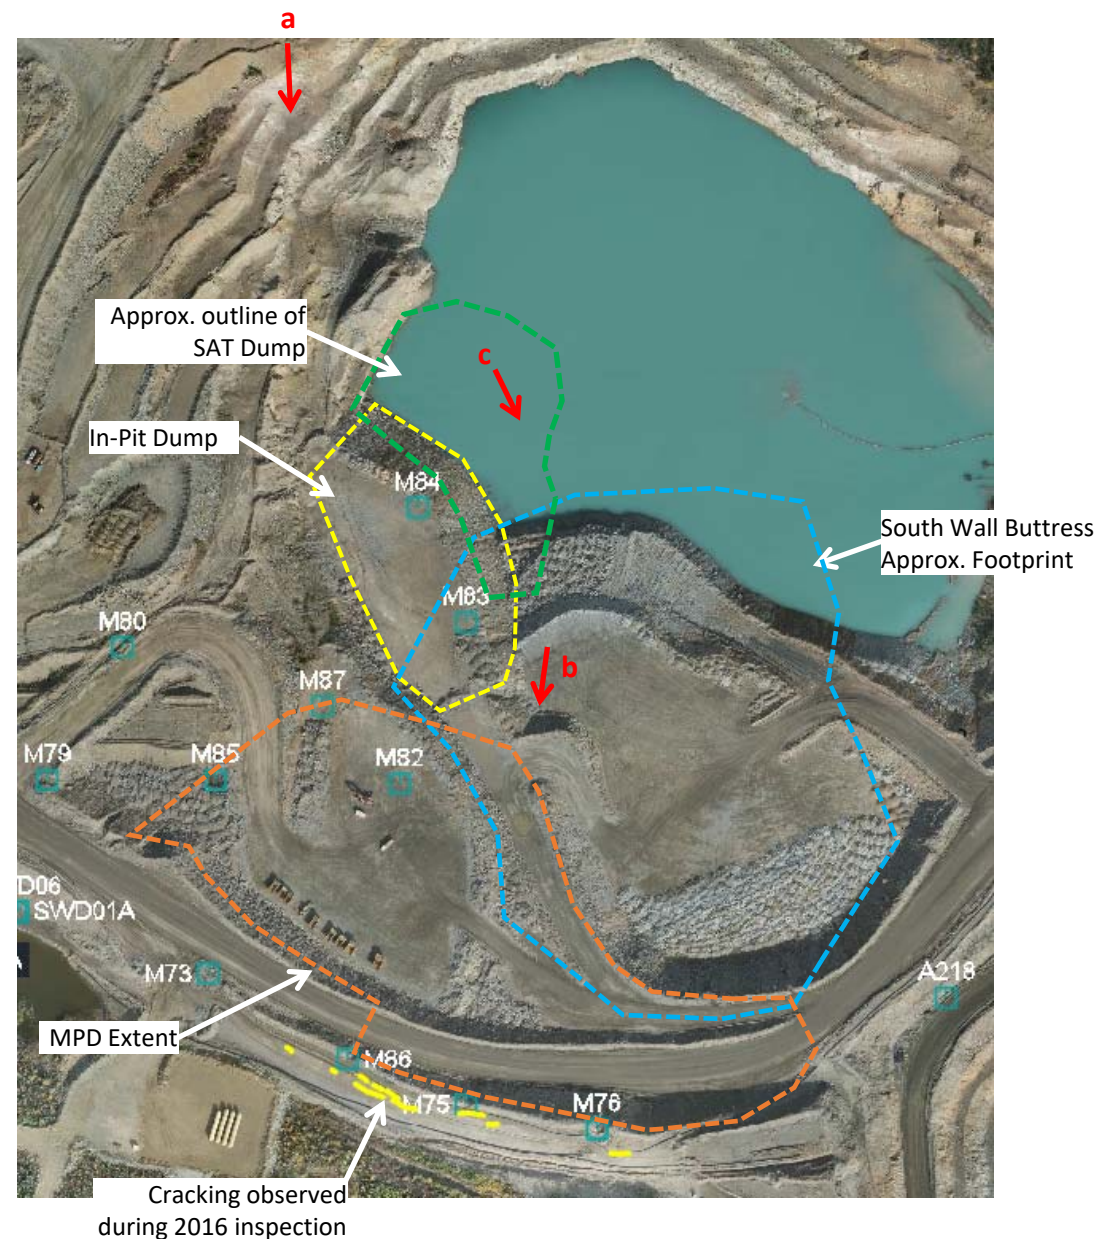
- No waste rock was placed on the 'in-pit dump' (photo (a)) and no visible changes of the cracking were observed in the with no change in the condition of the cracking observed.
- The cracks noted during the 2016 inspection parallel to the pit wall at the south end of the pit was not observed during the 2017 inspection as a result of construction of an access road over the cracking location. The 2016 cracking was believed to be due to settlement of the waste rock within Main Pit.
- Survey hub M82 (Photo (b)) was observed with rocks underneath its lock block, which is likely the cause of the variability in the survey hub readings.

- Minor cracks were observed parallel to the advancing face of the SAT dump (Photo (c)). The maximum crack width observed was 3 cm. The SAT dump is being advanced in a controlled manner with the dump face advanced 5m, followed by a minimum 7 day tailings consolidation period, and as a result, cracking is to be expected as a result of consolidation of the underlying tailings. The cracks are routinely monitored by Minto staff and spray painted to monitor propagation.
- Tracks from haul trucks were observed close to the dump face – truck traffic should be maintained a minimum of 5 meters away from the dump face, or a spotter should be present.

South Wall Buttress / In-Pit Dump / SAT Dump	<ul style="list-style-type: none"> <li>• <b>(High Priority):</b> <ul style="list-style-type: none"> <li>○ <b>Clear the loose rocks beneath M82</b></li> <li>○ <b>During SAT material placement, truck traffic is to be maintained a minimum of 5 meters away from the dump face, or a spotter is to be present.</b></li> </ul> </li> <li>• Continue to limit access to the In-Pit Dump area near M84.</li> </ul>
Area 2 Pit	<ul style="list-style-type: none"> <li>• <b>(High Priority): Review radar data of the Area 2 Stage 3 Pit to confirm any areas of movement and the rate of movement. Based on the results, establish a survey hub(s) to monitor displacement.</b></li> </ul>

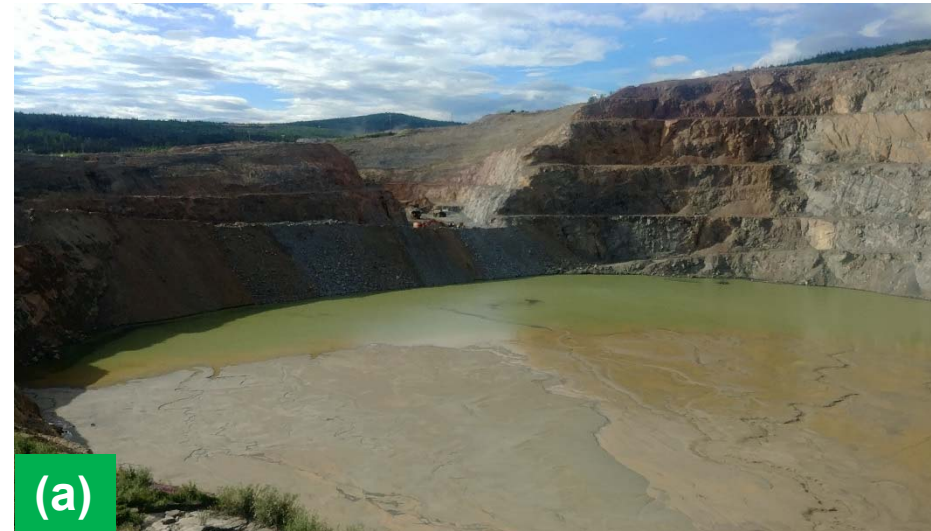
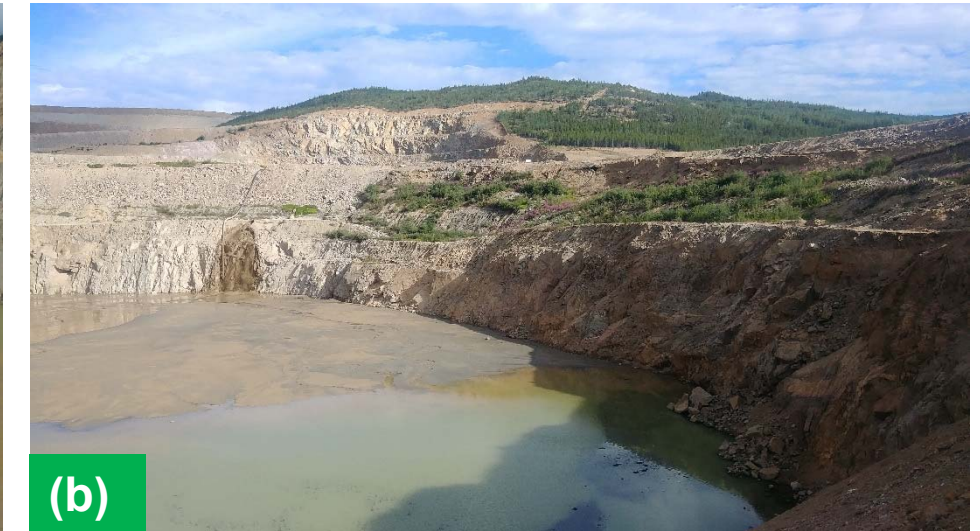
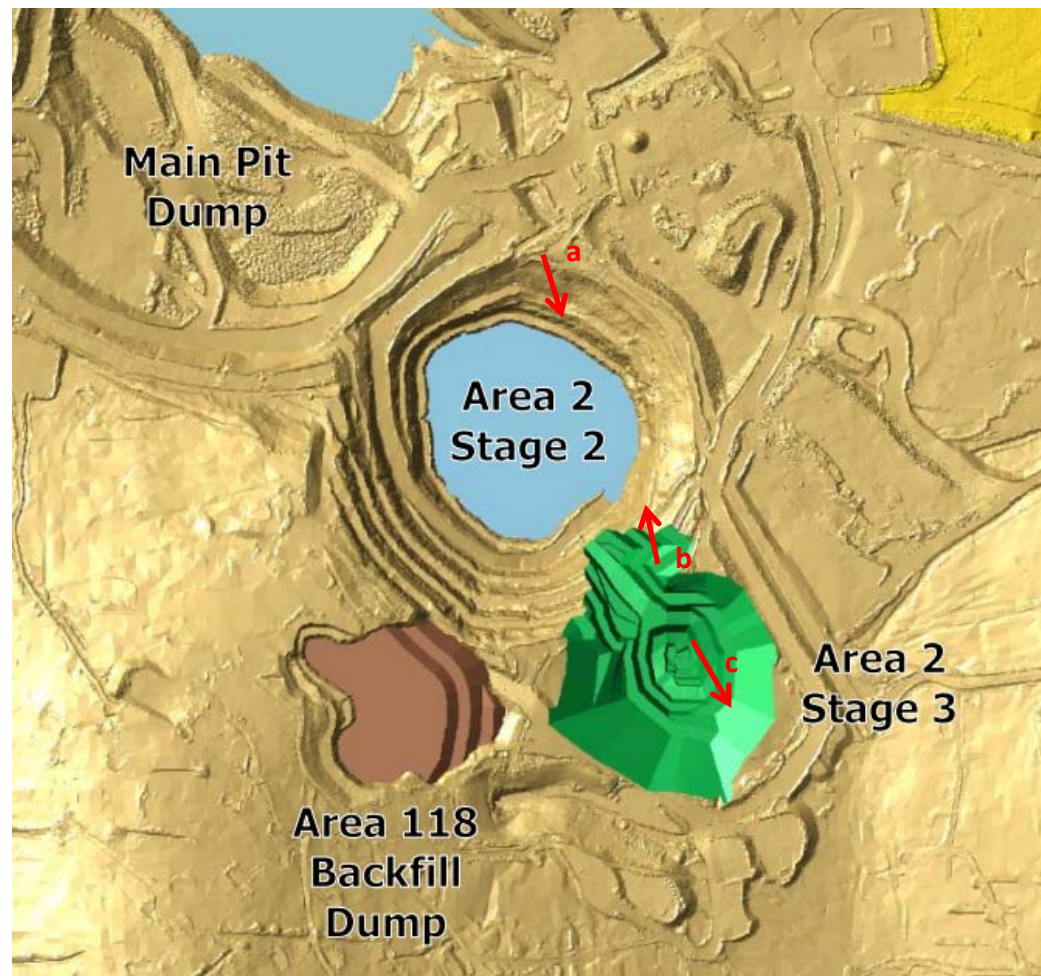
2017 Geotechnical Inspection		
		Area 2 Pit		
Job No: 1CM002.059 Filename: AppA_2017InspectionPhoto.pptx	Minto Mine	Date: August 2017	Approved: PHM	Figure: 15

- Photo (a): View of the Area 2 Stage 2 Pit taken from the north side looking south.
- Photo (b): View of the Area 2 Stage 2 Pit looking north.
- Photo (c): View of the Area 2 Stage 3 overburden slope in the south east corner of the pit. The photo notes a layer of wet, fine grained silts and clays that was thawed at the surface, with melt water draining onto the pit floor. No ice or ice lenses were observed, but the zone likely contains excess ice. The area is likely to be subject to localized instability and sloughing as a result of the melting ice similar to that experienced on the east wall of the Area 2 Stage 2 Pit (photo b), but large scale movement of the slope is a possibility. The area should be closely monitored, and it is recommended that a survey prism be established above the zone to monitor displacement.

- Recommendations:**
- **High Priority:** Review displacement of the slope based on radar (or l-site scanner) data to confirm any areas of movement and the rate of movement. Based on the results of the review, establish a survey prism/hub to monitor displacement of the south wall of the Area 2 Stage 3 Pit.

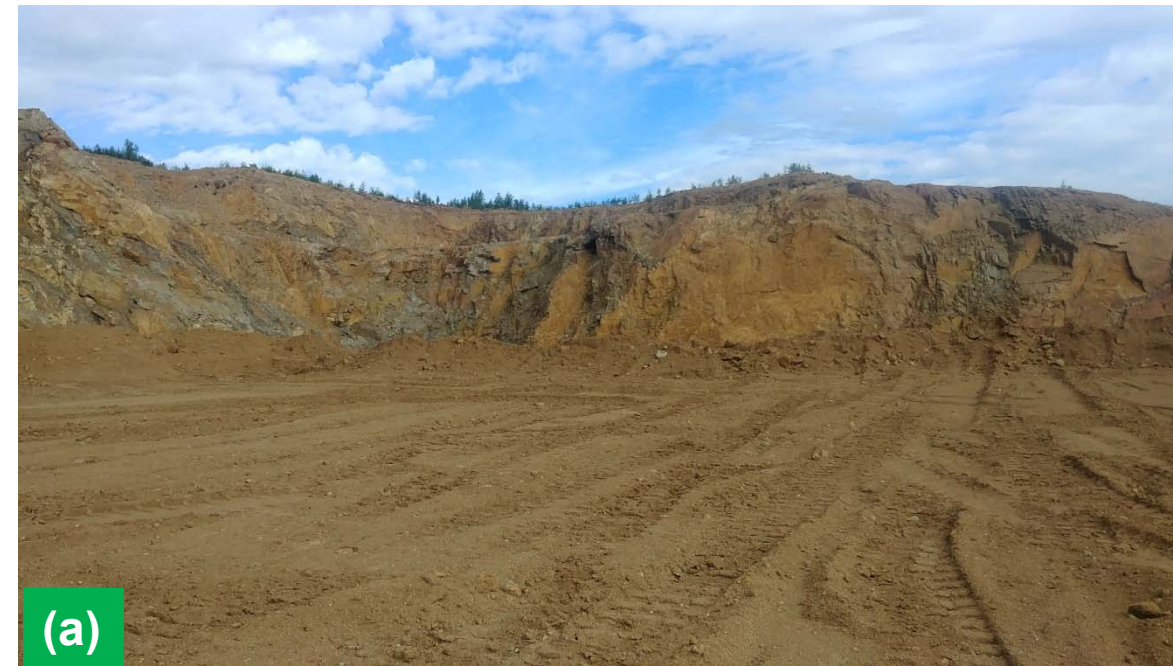
Photo a: View of the Area 118 Pit looking west..

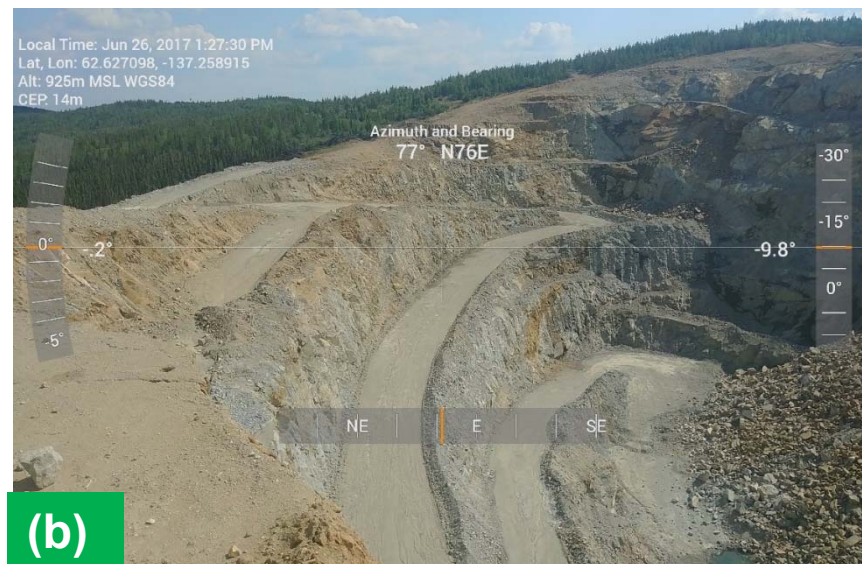
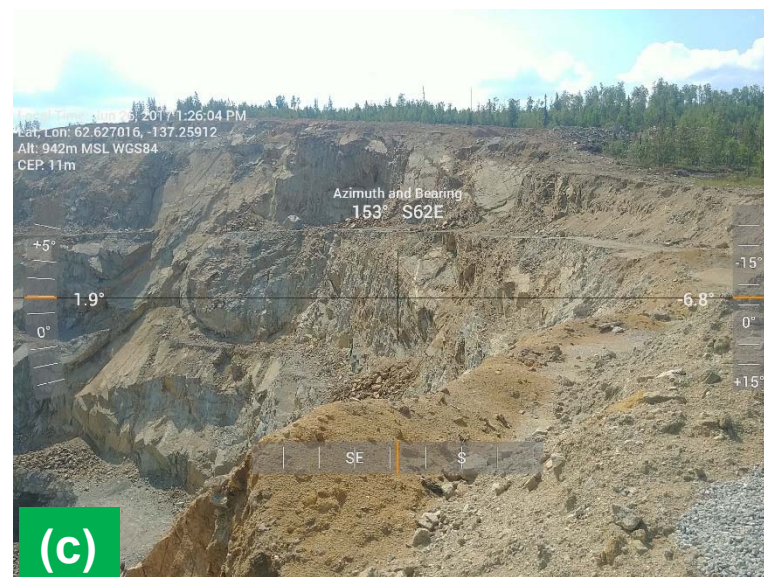
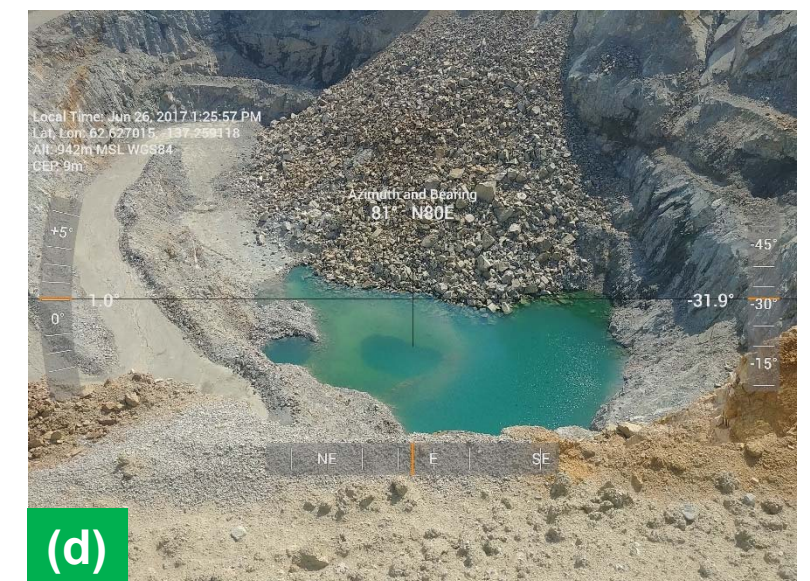
2017 Geotechnical Inspection		
		Area 2, Area 118, and Minto North Pits		
Job No: 1CM002.059 Filename: AppA_2017InspectionPhoto.pptx	Minto Mine	Date: August 2017	Approved: PHM	Figure: 16

The Minto North Pit was visually observed from the rim at the north side of the pit. Mining at the pit was completed in October 1, 2016 with no additional mining operations planned at Minto North at this time.

The failure of the south pit wall (debris shown in photos (b) and (d)) occurred one day following completion of the pit and removal of all equipment and personnel, as was predicted based on pit wall monitoring. No additional pit slopes failures have occurred since.

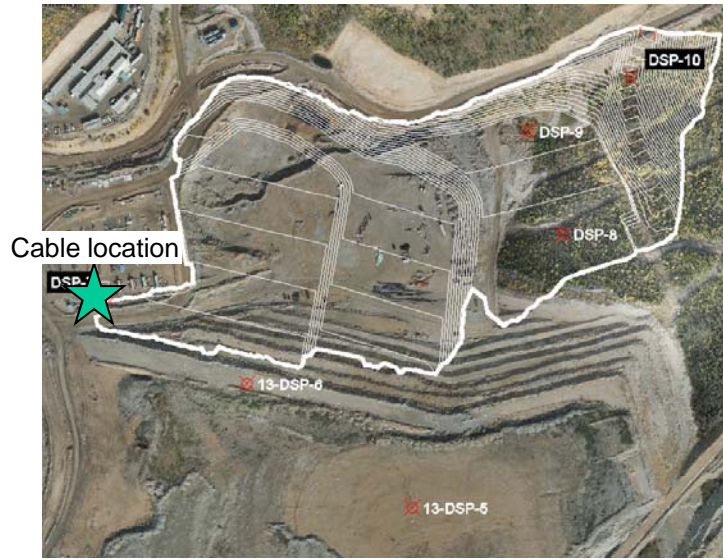
DSTSF Instrumentation Data		
		<b>Piezometers – DSP-05 and DSP-06</b>		
Job No: 1CM002.059 Filename: ApD_2017DSTSLandscape.pptx	<b>Minto Mine</b>	Date: August 2017	Prepared by PHM	Figure: <b>21</b>

DSP-05B (Figure 21, Appendix D) shows an increase in pore pressure in the past year. The cause of the pore pressure increase is unclear. The temperature at the sensor is approximately at the freezing point of water ( $-0.5^{\circ}\text{C}$ ) and the excess pore pressure as a result of an increase in the unfrozen water being unable to dissipate are a result of unfrozen conditions in the surround soils. As the survey hubs in the vicinity of the sensor shows decelerating movement, no additional action is recommended at this time.
