# 2018 Geotechnical Annual Review, Minto Mine, YT

SRK Consulting (Canada) Inc.  
1CM002.063  
August 2018

On June 26-27, 2018, SRK Consulting (Canada) Inc. completed a geotechnical inspection of the Minto Mine site. The purpose of the inspection was to document the physical condition of the site based on visual observations and to provide geotechnical assessment, noting potential signs of physical instability such as erosion, differential settlement, sloughing or bulging of material, seepage, etc. The inspection is documented in the photographic compilation provided in Appendix A. This report summarizes the findings and recommendations.

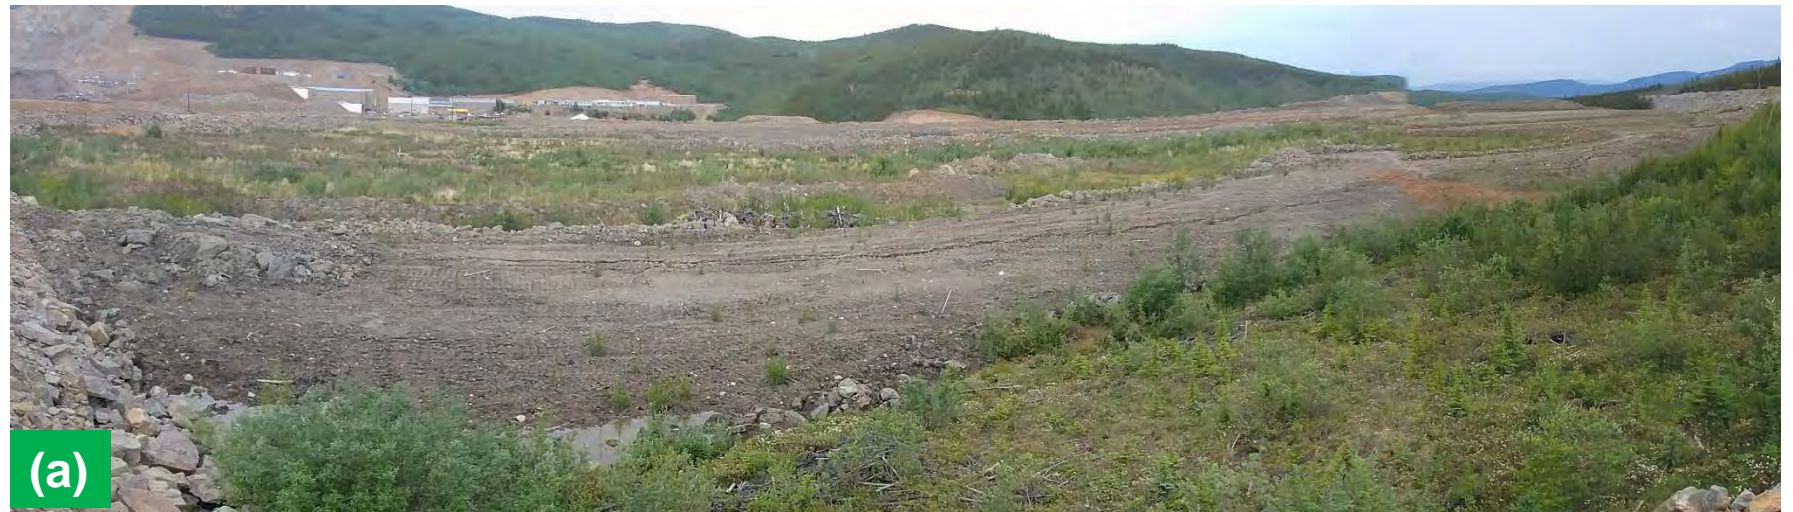
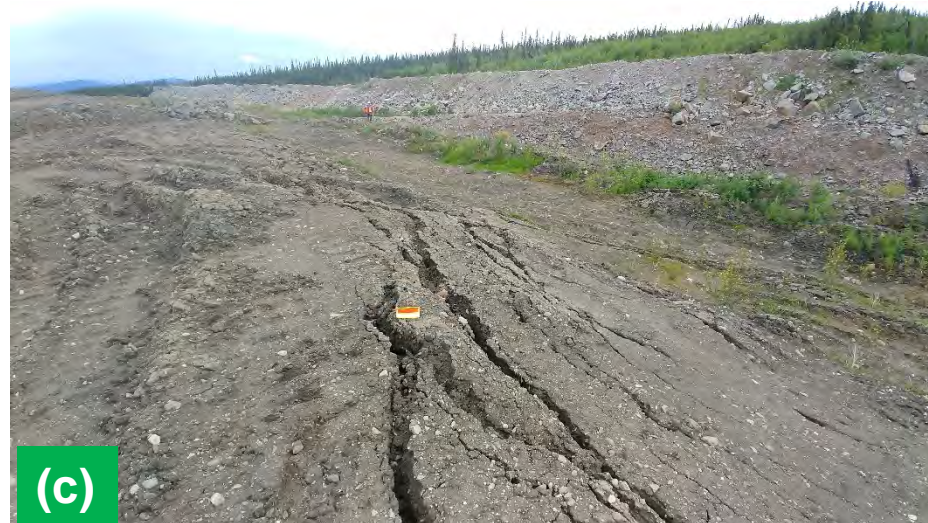
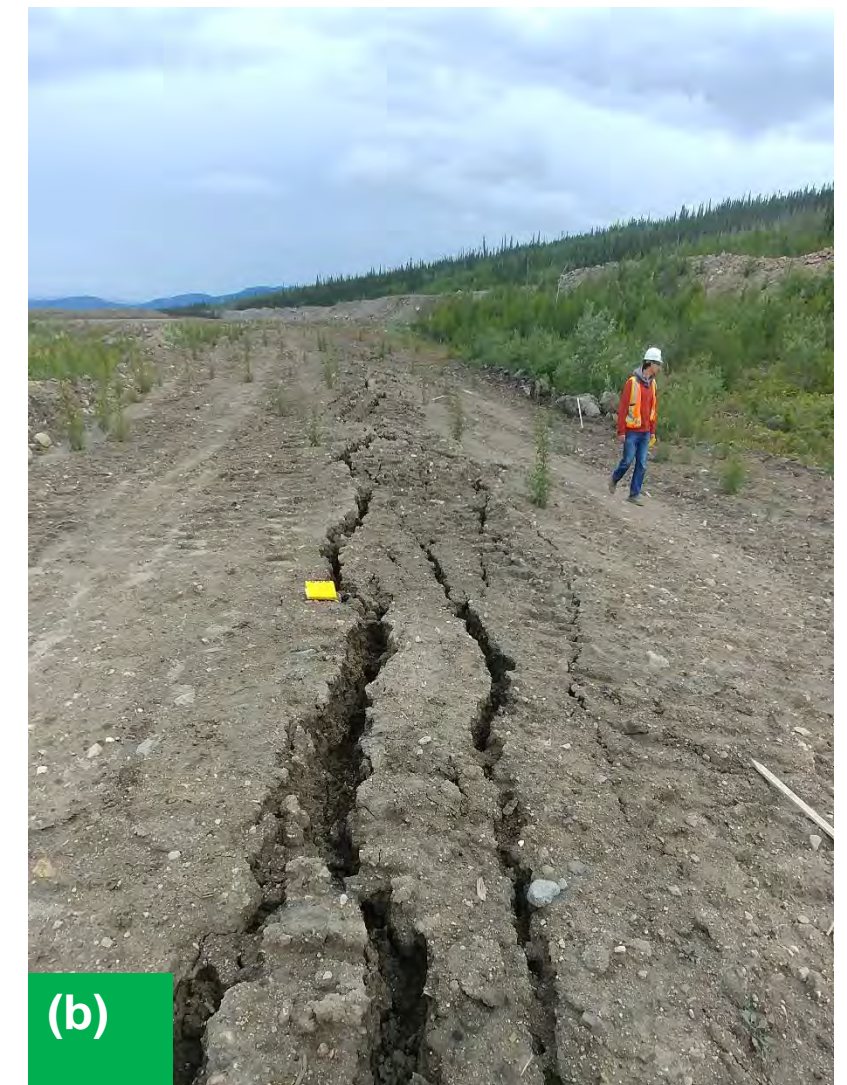
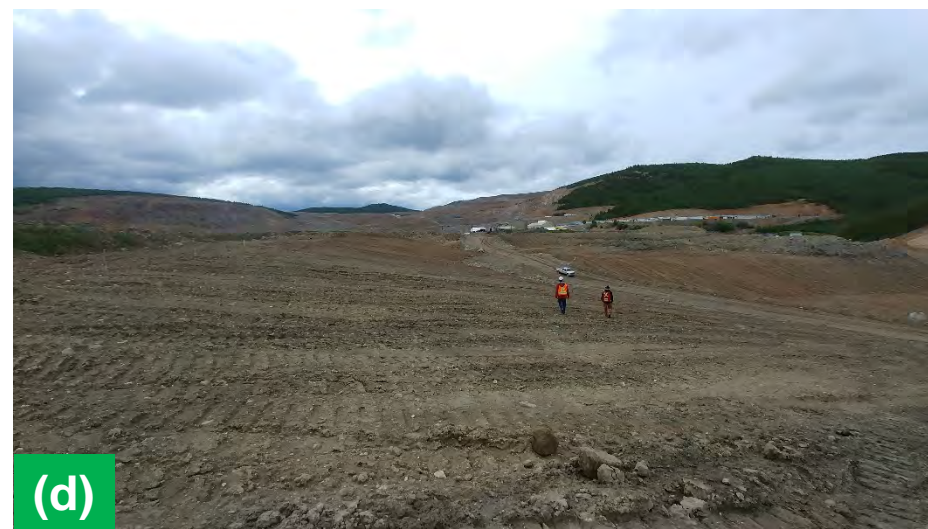
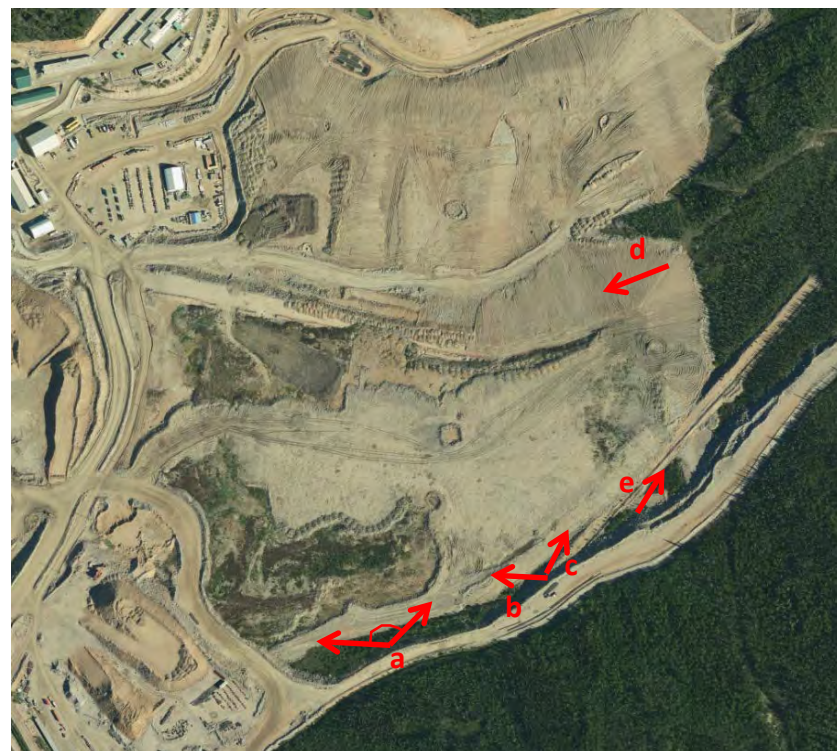
<b>Minto Explorations Ltd.</b>	2018 Geotechnical Inspection		
		<b>Dry Stack Tailings Storage Facility</b>		
Job No: 1CM002.063 Filename: AppA_2018InspectionPhoto.pptx	Minto Mine	Date: August 2018	Approved: PHM	Figure: <b>2</b>

- Bulk regrading and cover placement over the DSTSF was completed in 2016 and 2017. Since the last inspection, additional cover material has been placed over the waste rock shell as well as on the south slope of the DSTSF to cover all the exposed tailings and create positive drainage of surface runoff to the north east.
- Additional 'fine tune' regrading of the cover surface remains to be completed.
- No clear signs of instability were observed.
- Cracking was observed (Photos A, B, and C) along the southern crest where overburden was recently placed. The cracking is orientated parallel to the southern crest of the DSTSF and is likely the result of settlement of the recently placed material.
- Photo D shows the eastern end of the covered DSTSF and the transition to the Mill Valley Fill Extension (right side).

- The extent of the cracking at the south end of the DSTSF should be surveyed and a wireline extensometer should be installed at a minimum of two locations where the cracking is significant to confirm that the cracks are a result of thaw settlement of the recently placed material and not due to deep-seated movement of the DSTSF.

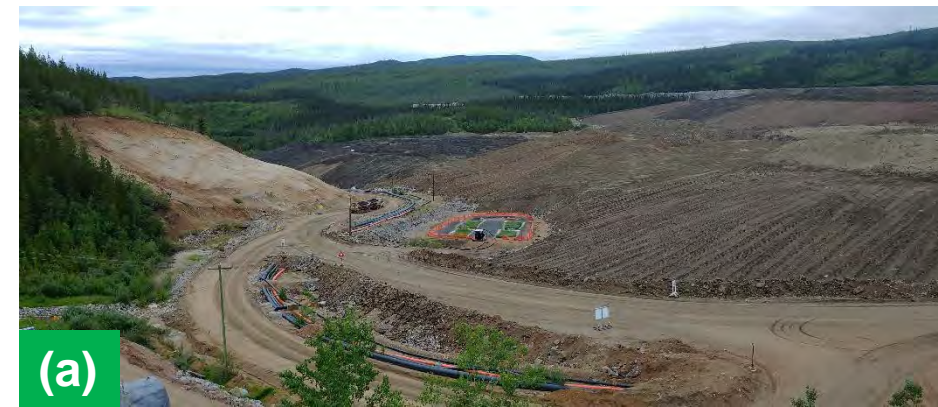
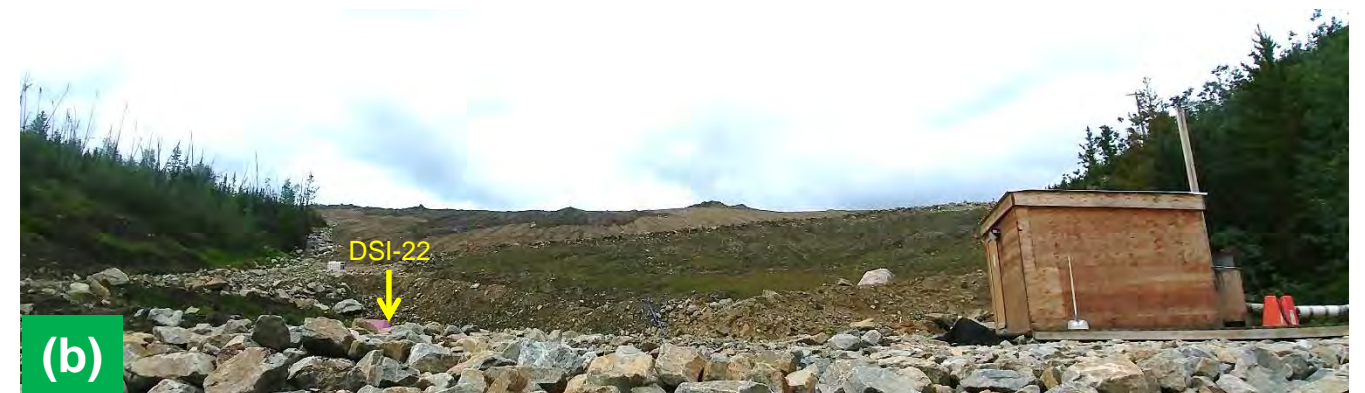
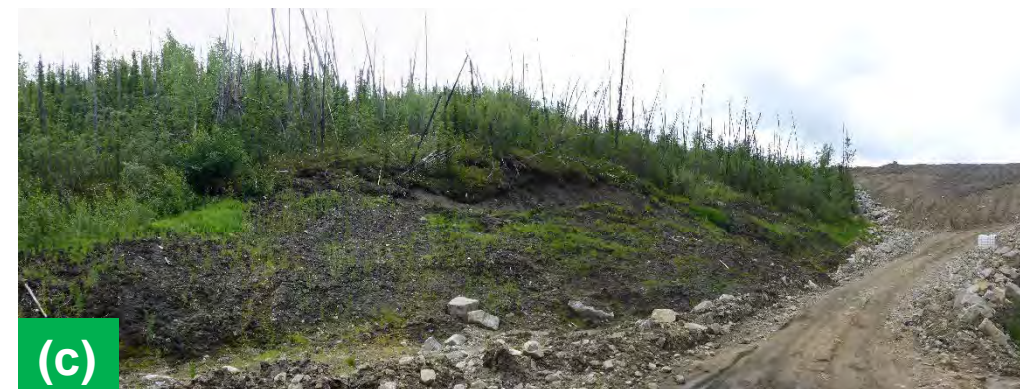
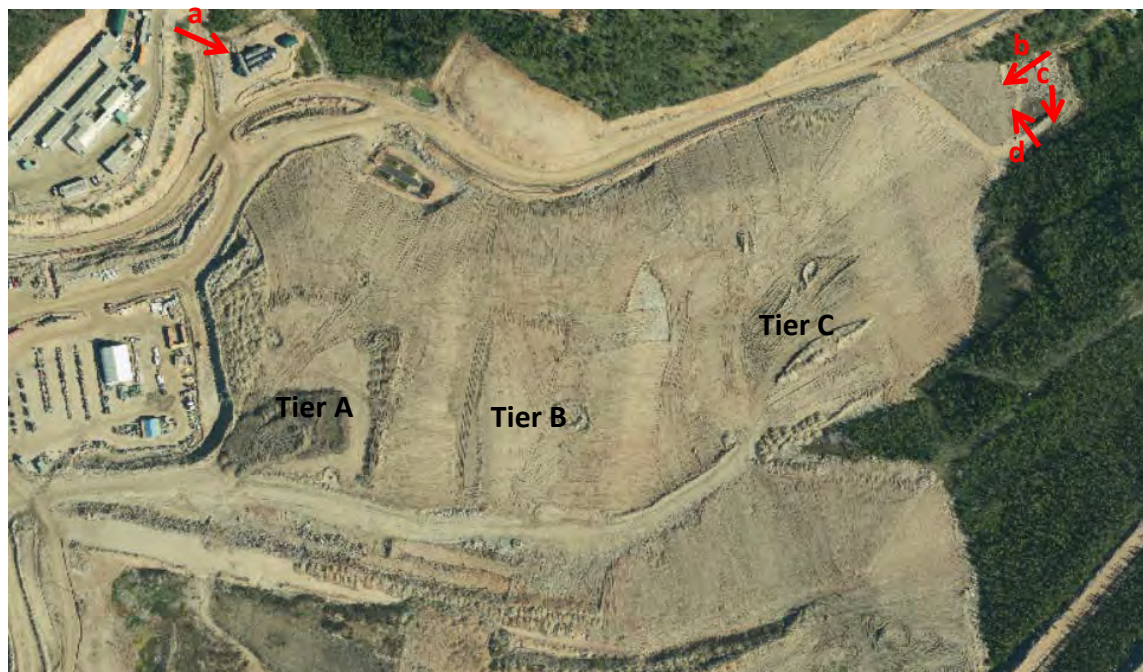
<b>Minto Explorations Ltd.</b>	2018 Geotechnical Inspection		
		<b>Mill Valley Fill Extension Stages 1 and 2</b>		
Job No: 1CM002.063 Filename: AppA_2018InspectionPhoto.pptx	Minto Mine	Date: August 2018	Approved: PHM	Figure: <b>3</b>

No major signs of instability were observed.

- Photo A provides an overview of the MVFE with cover soil spread on the north slopes. Overburden stockpiles are also present on MVFE footprint to be used as cover material in other areas at closure (mill, camp area, etc.).
- Photo B shows the Minto Creek Seepage Collection System. The system appears to be functioning as per design, no signs of seepage immediately downstream of the system.
- Photo C shows the excavated slope to the south of the Minto Creek Seepage Collection System. This slope was cut into an area of permafrost that has since thawed. The permafrost thaw does not appear to be retrogressing, with vegetation beginning to establish and no significant change compared to the 2017 inspection photographs.
- Photo D provides a view of the down-valley slope of the MVFE.

- Continue to monitor the slope to the south of the Minto Creek Seepage Collection System for signs of retrogressive sloughing to determine if any slope stabilization measures are required.

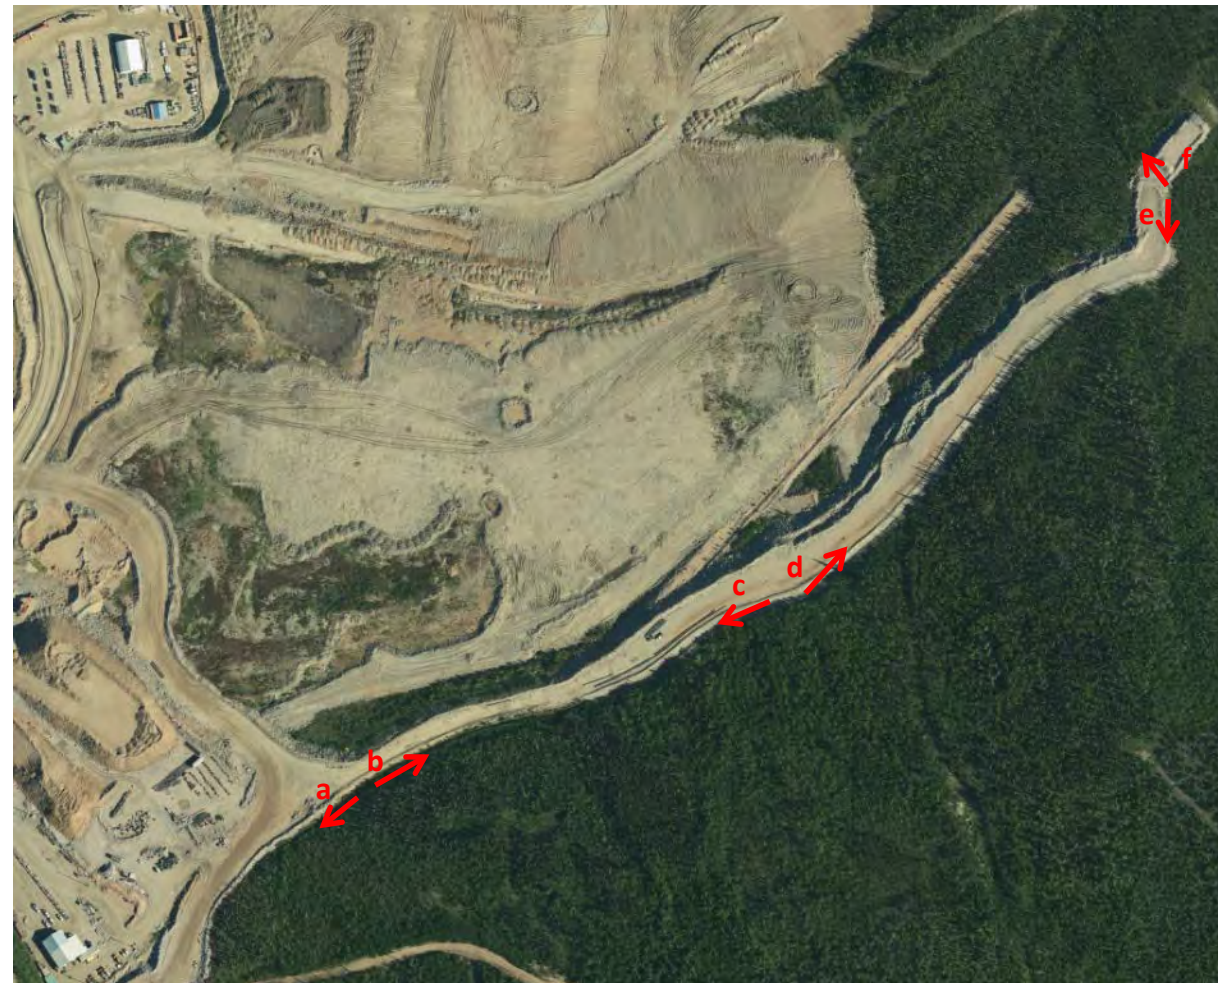
- In general, the ditch appeared functional, with conditions the same as those in observed in previous inspections. No signs of instability or ditch obstructions were noted along the ditch alignment.

- Photos A and B: View of the upper, unarmored portion of the diversion ditch. Vegetation growth is significant over a small portion of the ditch. As a result of the redirection of the SDD into the TDD the flow capacity of the ditch may be less than the design requirements for the ditch. As a result, the vegetation is recommended to be removed.

- Photos C and D: View of the middle armored portion of the diversion ditch. Rip-rap is well placed and the ditch is free of debris. Only minor vegetation in the channel was observed.

- The vegetation in the western portion of the Tailings Diversion Ditch should be cleared.

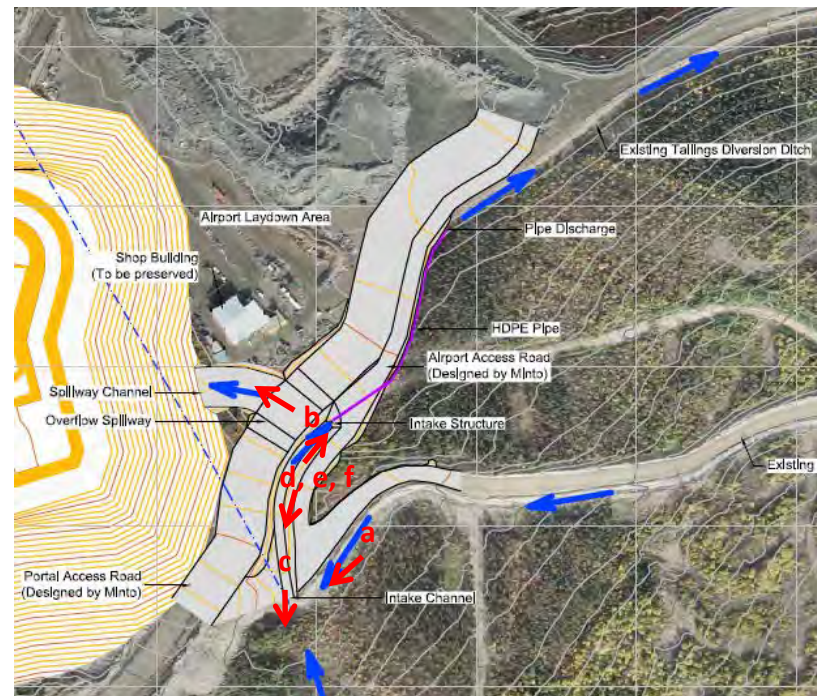
- Photo C: View of the spill point from the 'headwater pond' into the Intake Channel. The channel invert elevation was constructed 1 m higher than the design elevation and resulted in ponding upstream of the intake channel and channel depths less than the design requirements. Site staff are aware of the discrepancy and noted that the remaining construction will correct the deficiencies.

- Photos D and E: View of the Intake Channel and placed rip-rap. Some areas of exposed geotextile were observed. Additional rip-rap is required and is placed as part of the remaining construction.

- The Overflow Spillway should be widened to meet the required design channel base width (~25 meters) to minimize risk of a flood flow to the north east towards the DSTSF.
- Construction of the Inlet Channel should be completed in a manner that meets all design requirements documented in the SRK design memo that include minimum channel dimensions, grades, rip-rap gradations and thicknesses. During construction, survey and visual inspections of the channel should be implemented to confirm adequate rip-rap gradations.
- Remaining construction should be completed prior to snowfall in order to be in-place by the 2019 freshet.

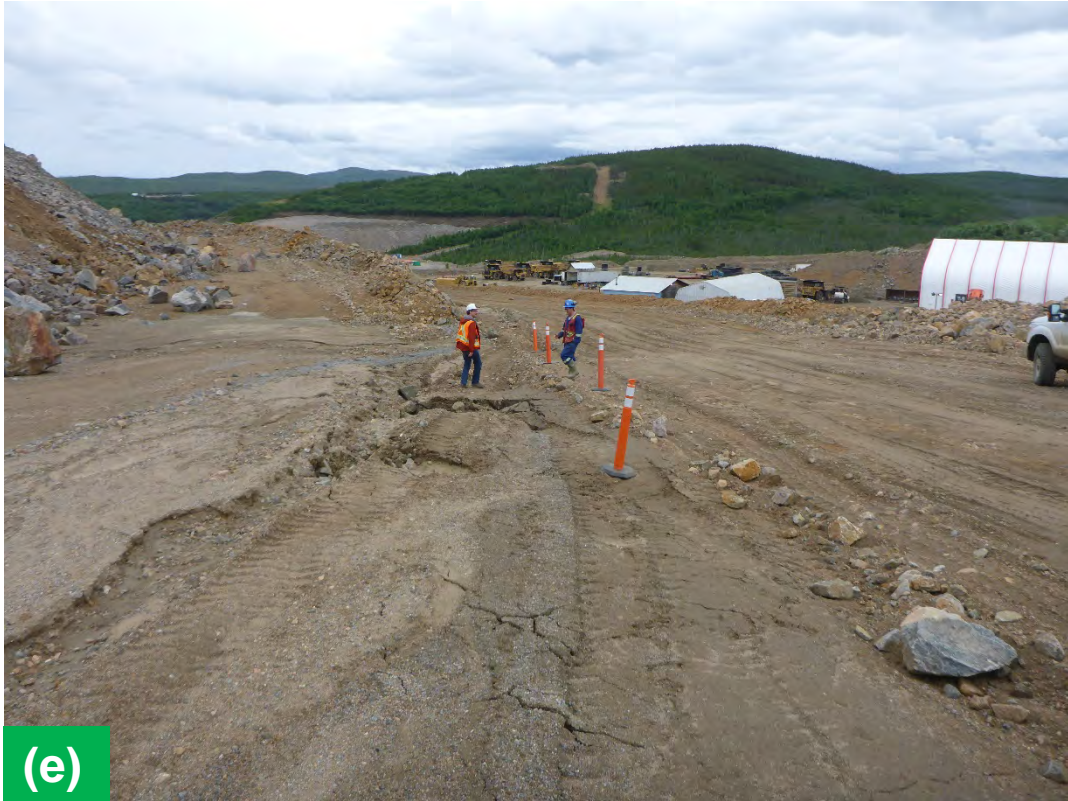
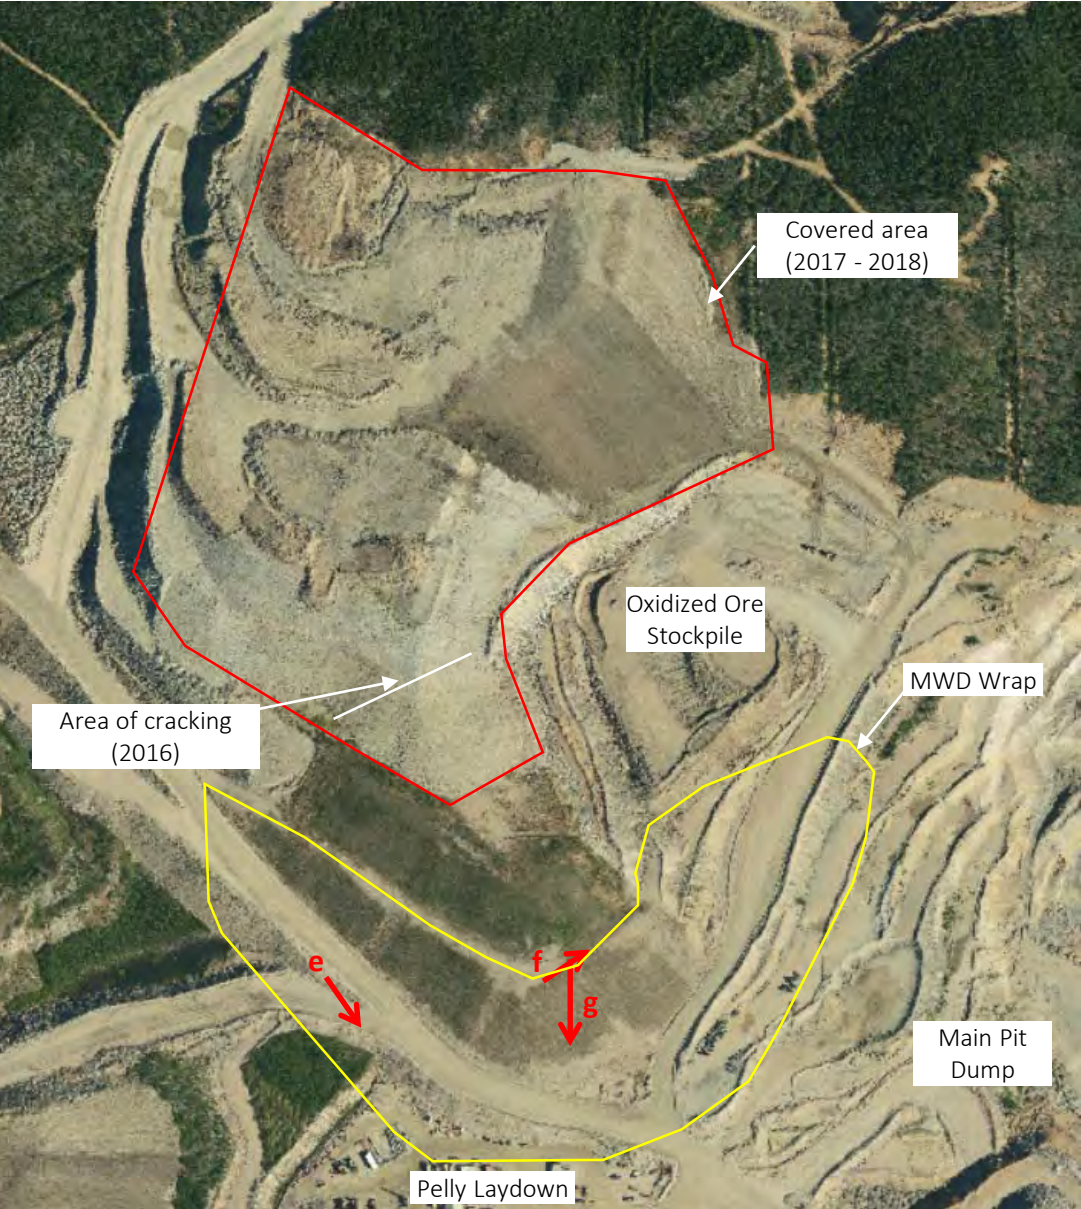
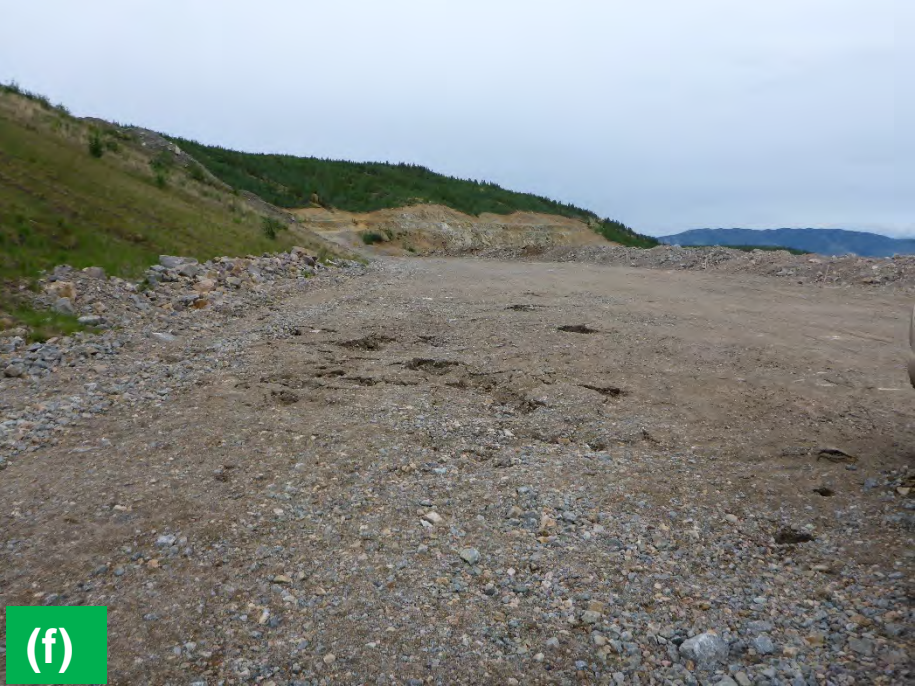
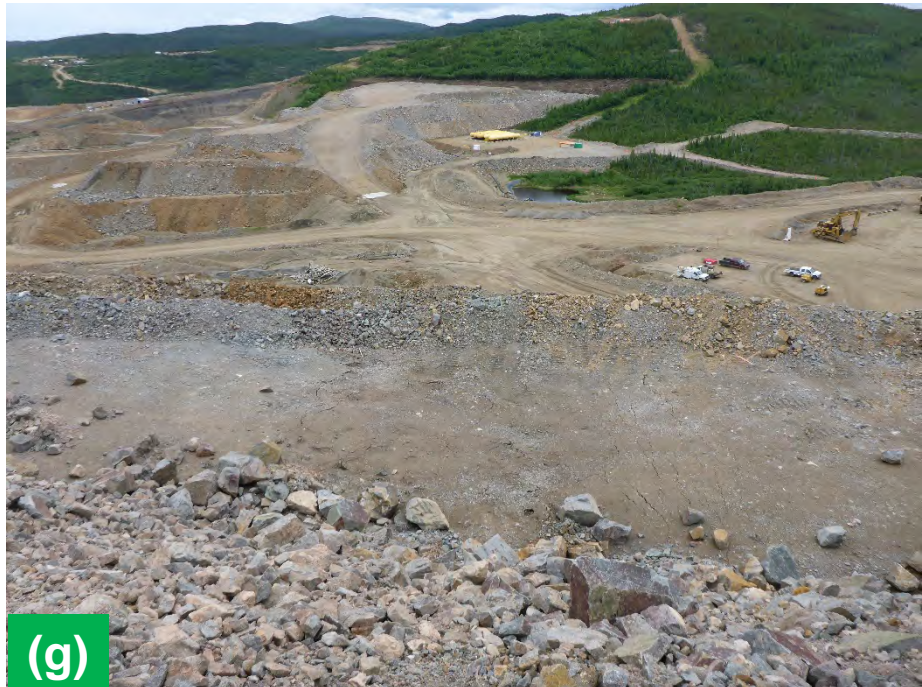
<b>Minto Explorations Ltd.</b>		2018 Geotechnical Inspection		
	Minto Mine		<b>Main Waste Dump Wrap</b>		
Job No: 1CM002.063 Filename: AppA_2018InspectionPhoto.pptx	Date: August 2018	Approved: PHM	Figure:	<b>7</b>

- No major signs of instability were observed. Minor cracking of the placed material was observed and attributed to settlement after placement, especially in winter. Much of the area has recently been graded or is actively being graded which may have covered the full extent of cracking previously observed.

- No major changes to the gullying were observed during the inspection, erosion is expected on the newly covered faces, subsiding with time and vegetation development.

- Additional survey hubs are recommended to be placed on the MWD Wrap crest and toe to confirm no large-scale mass movement is occurring.

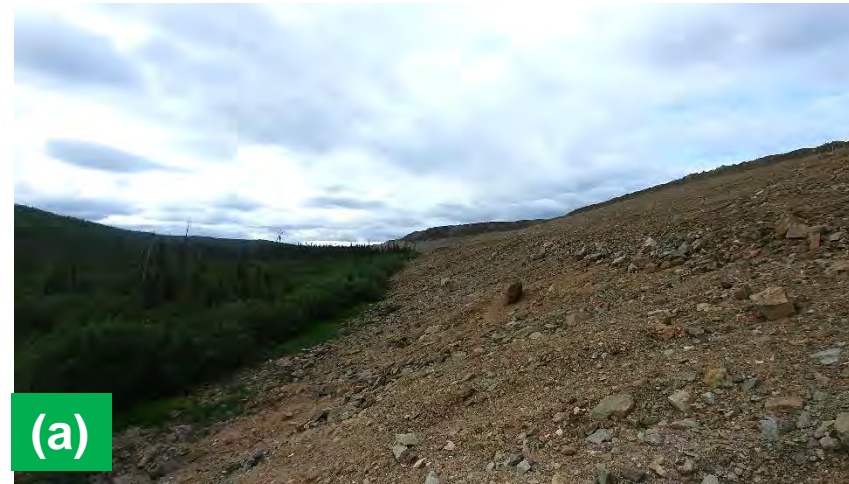
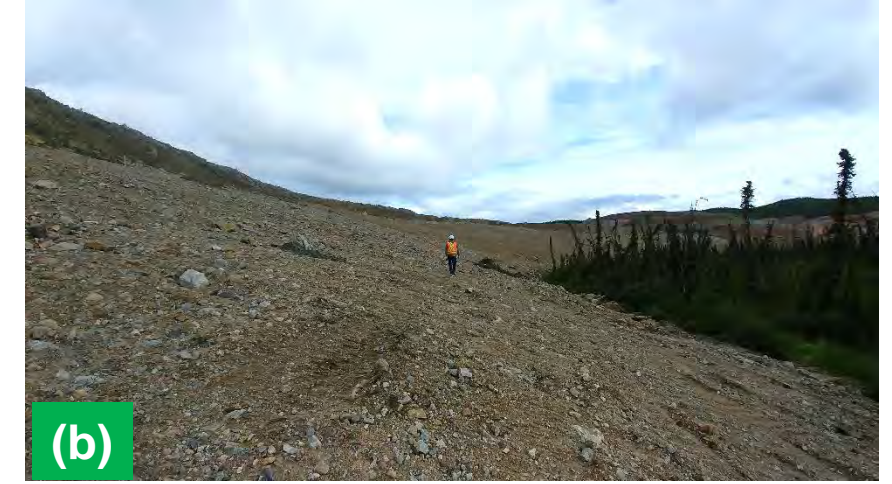
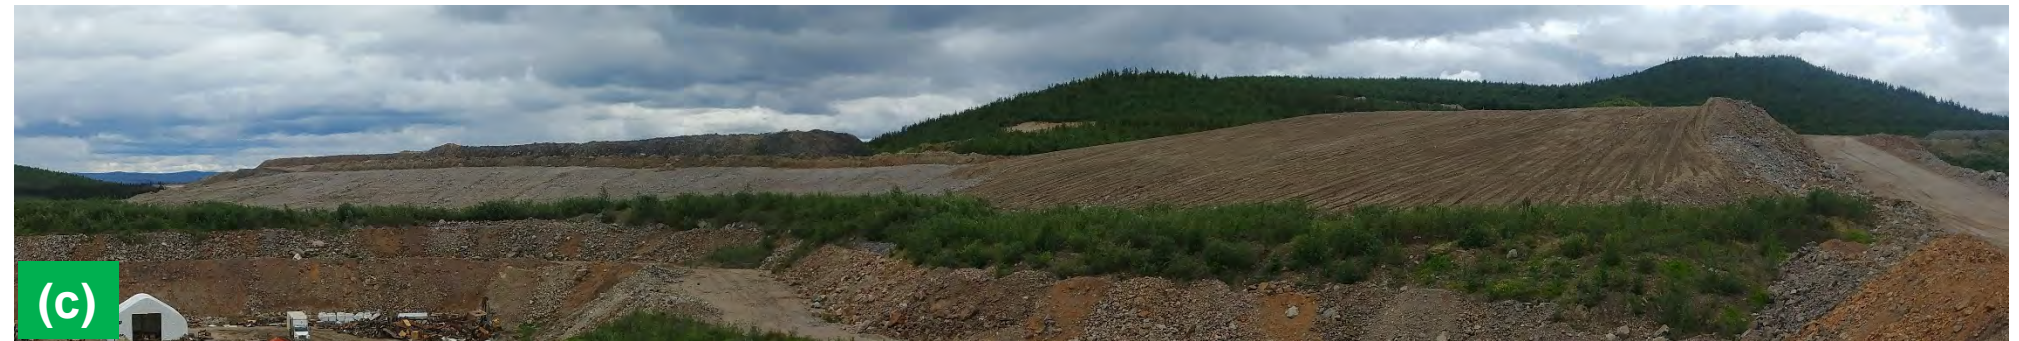
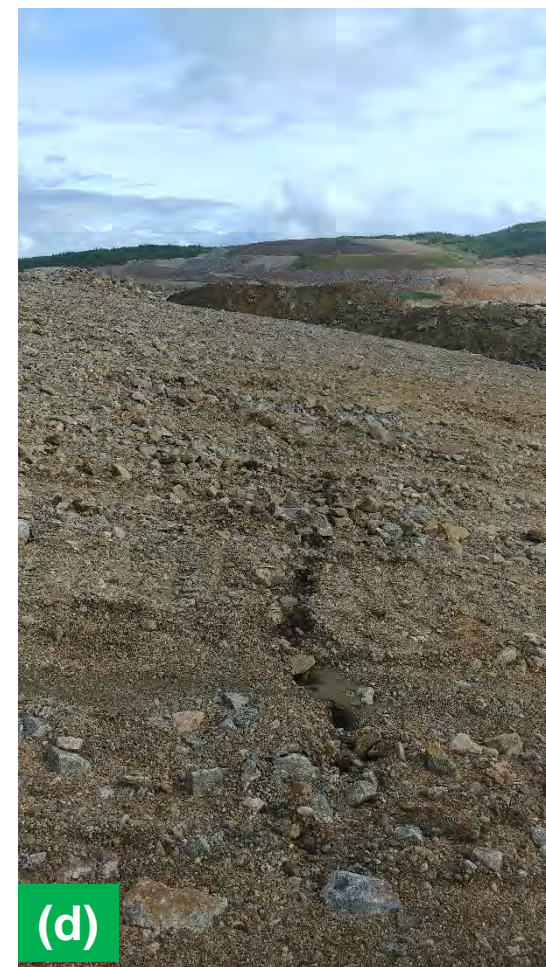
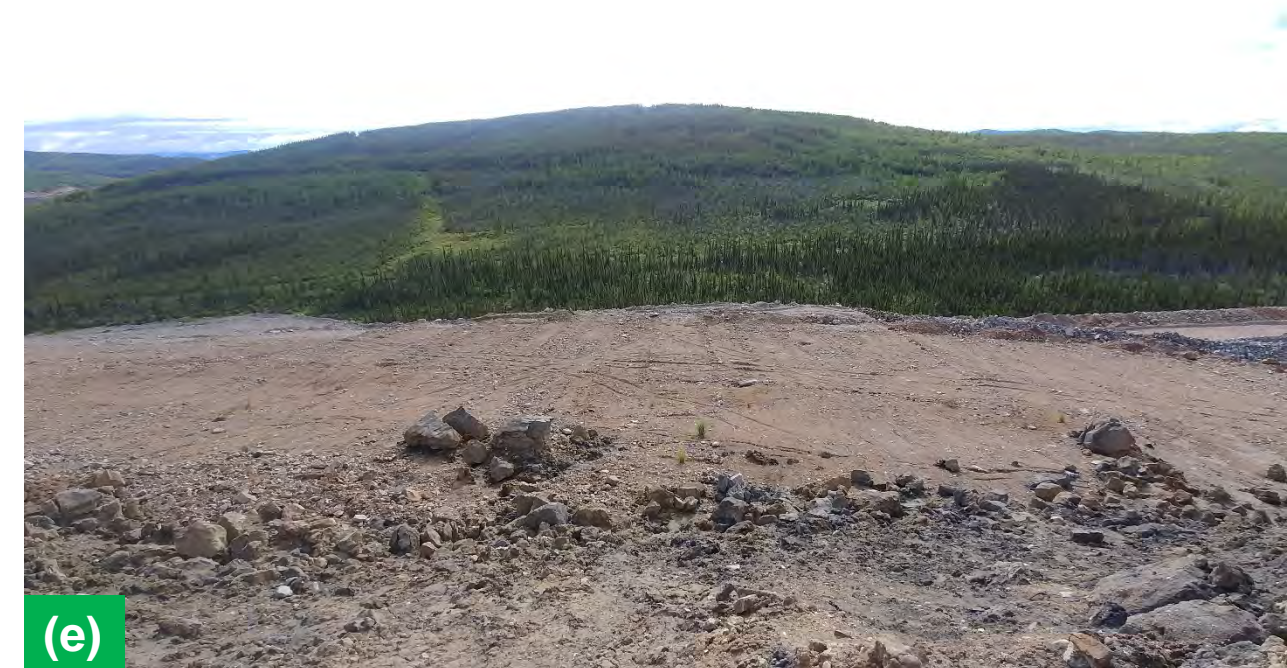
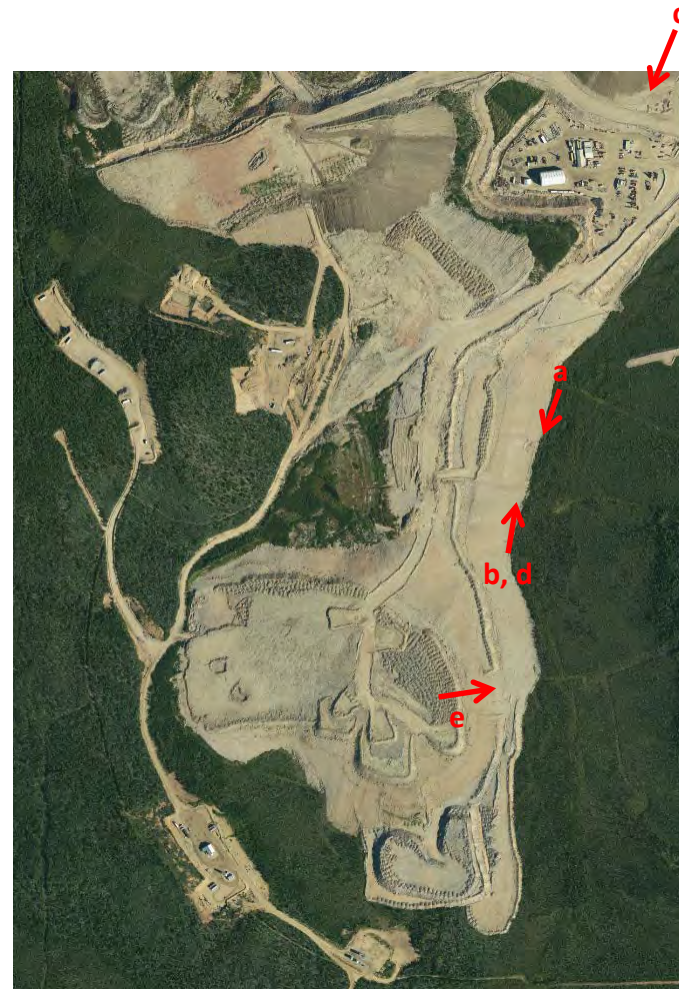
<b>Minto Explorations Ltd.</b>	2018 Geotechnical Inspection		
		<b>Southwest Waste Dump</b>		
Job No: 1CM002.063 Filename: AppA_2018InspectionPhoto.pptx	Minto Mine	Date: August 2018	Approved: PHM	Figure: <b>8</b>

- Photo C: View of regraded slope on the east side of the dump and stockpiled overburden along the crest of the slope (taken from the MWD).
- Photos D: an example of the observed cracking approximately mid way up the dump face. Cracking is believed to be due to differential settlement as a result of the slope regrading, but may be due to the ongoing movement observed at the survey hubs installed at the dump toe. As noted in Appendix F, the survey hub movement rates all show a deceleration trend.

- Photo (e): View of the south east side looking down from the upper crest.

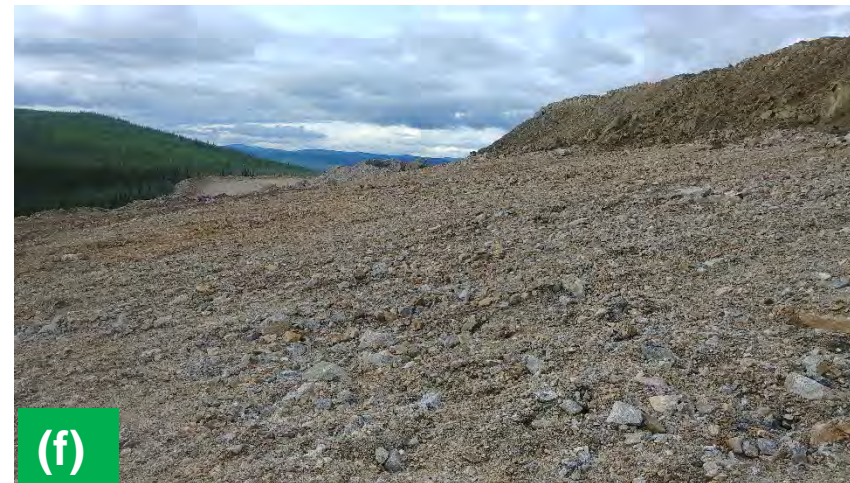
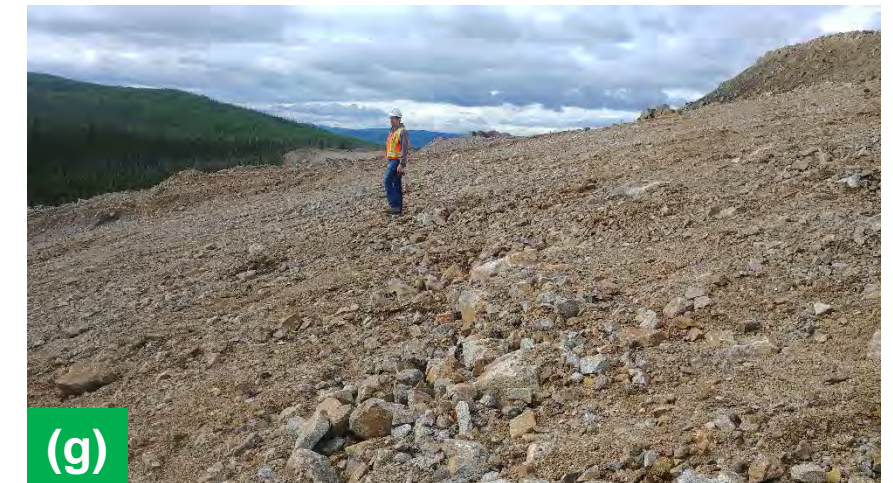
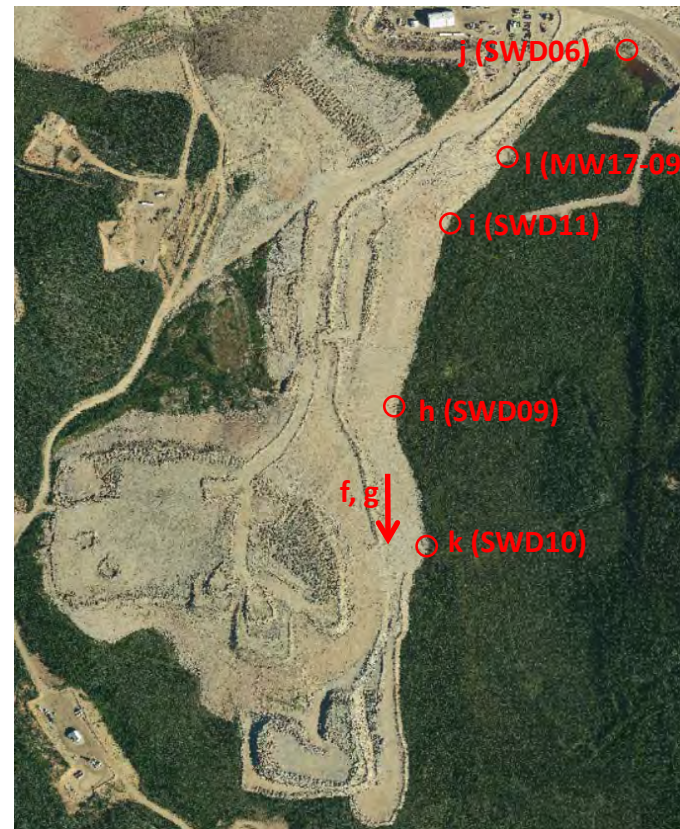
- Photo F and G: Additional views of the observed cracking approximately mid way up the regraded dump face.
- Photo H, J, K, and L: Survey hubs SWD-09, SWD-11, SWD-06 and SWD-10 were previously replaced after being impacted by frost heave.
- Some seasonal ground movement have been observed as a result of freeze/thaw cycles at the new hubs (See Appendix F), however, the horizontal displacement graphs provide a more accurate measure of the movement rates compared to the decommissioned survey hubs.
- Photo I shows the newly constructed monitoring well enclosure at MW17-09-SWD

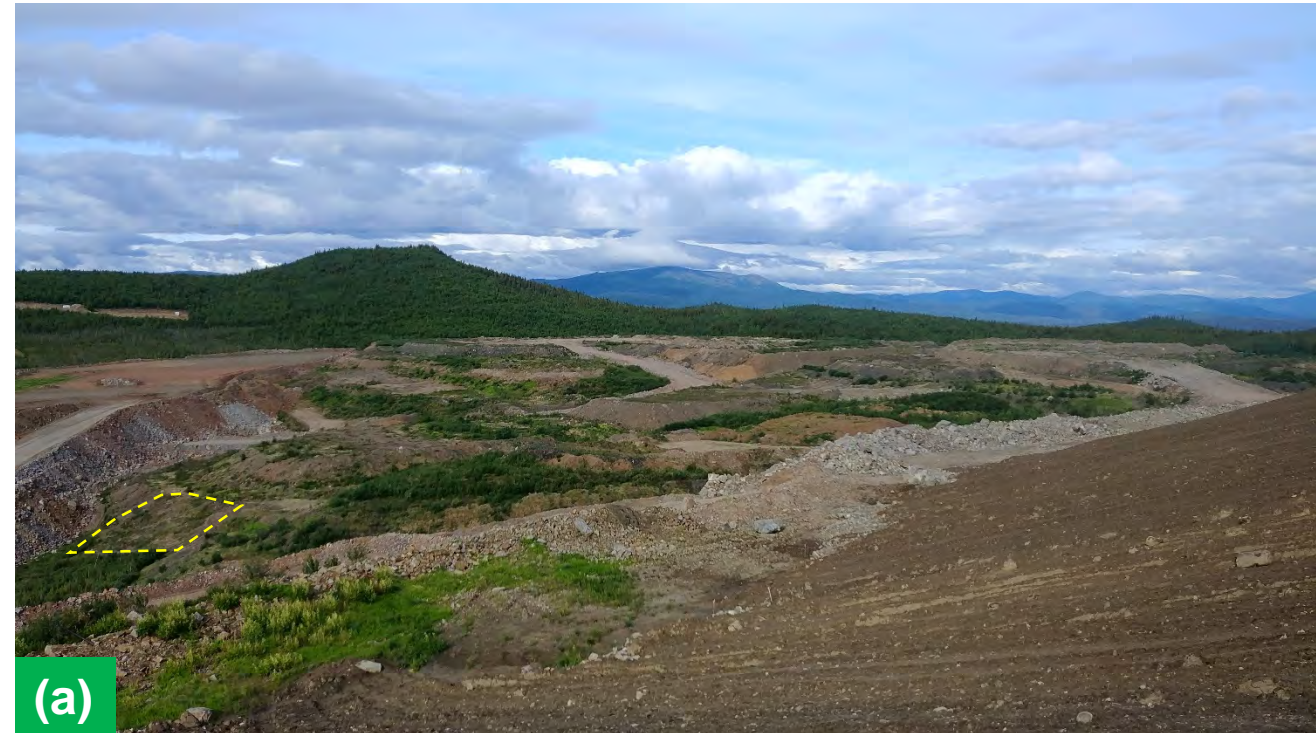
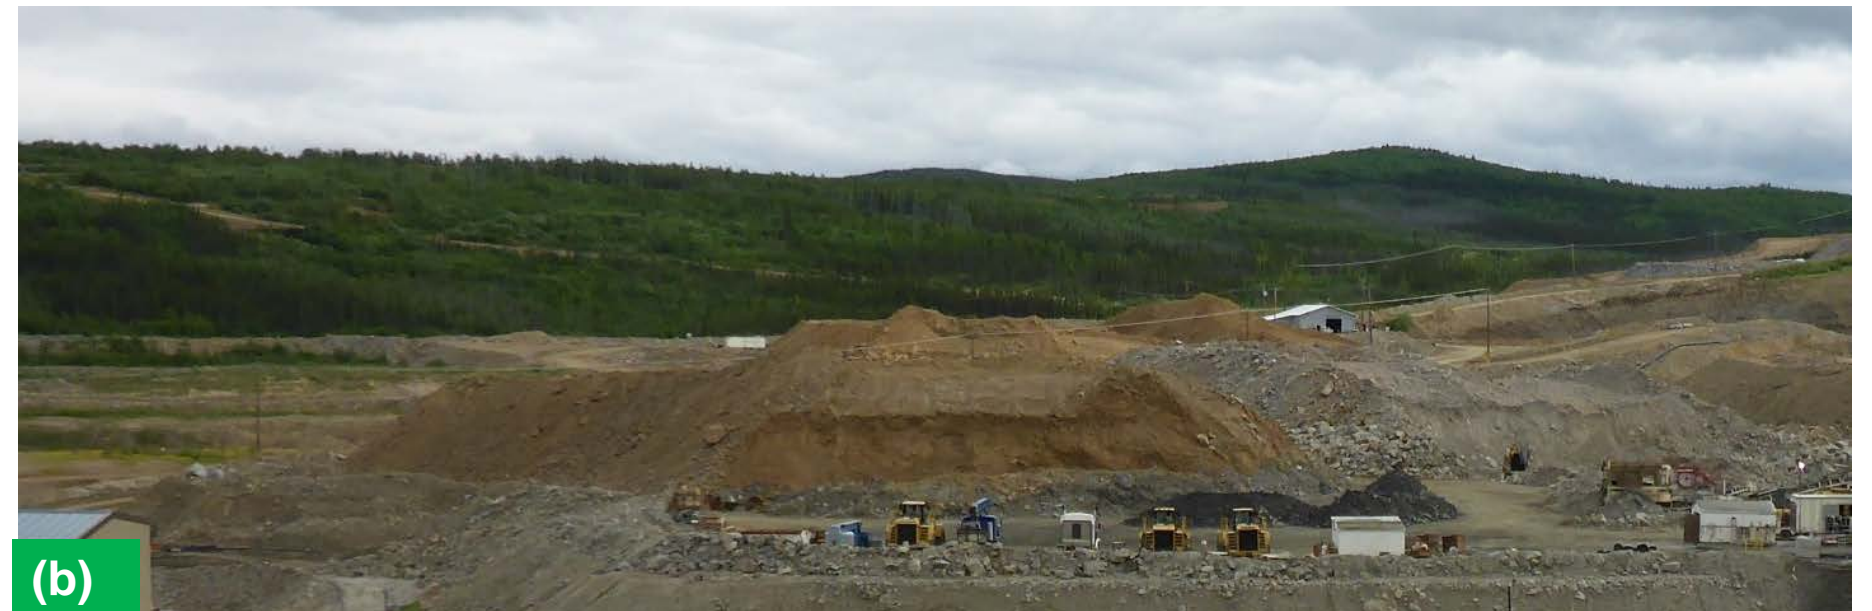
<b>Minto Explorations Ltd.</b>	2018 Geotechnical Inspection		
		<b>Reclamation Overburden Dump and Ore Stockpiles</b>		
Job No: 1CM002.063 Filename: AppA_2018InspectionPhoto.pptx	Minto Mine	Date: August 2018	Approved: PHM	Figure: <b>10</b>

- Conditions at the Reclamation Overburden dump (ROD) remain the same as noted in previous years' inspections:
  - Slumping, settlement and tension cracks are expected in the dump as it is constructed with frozen overburden with thawing expected.
  - Discontinuous tension cracks and differential settlement observed along the perimeter crest.
  - Ground undulation is typically 0.3 m and is prevalent throughout the facility.
- The dashed yellow line in Photo (a) shows the small slope failure first observed in 2014. As noted in previous inspections, vegetation has firmly been established within its footprint. The failure has not compromised the overall dump slope angle and as a result, the failure is not expected to reduce the overall stability of the dump.

- The ore stockpiles were investigated briefly in passing. All outer slopes appeared in good condition: no major slumping, bulges, cracks, or other signs of instability were observed.
- The ore was being excavated from the north side.
- Active excavation face best practices should be used to minimize the risk of equipment burial

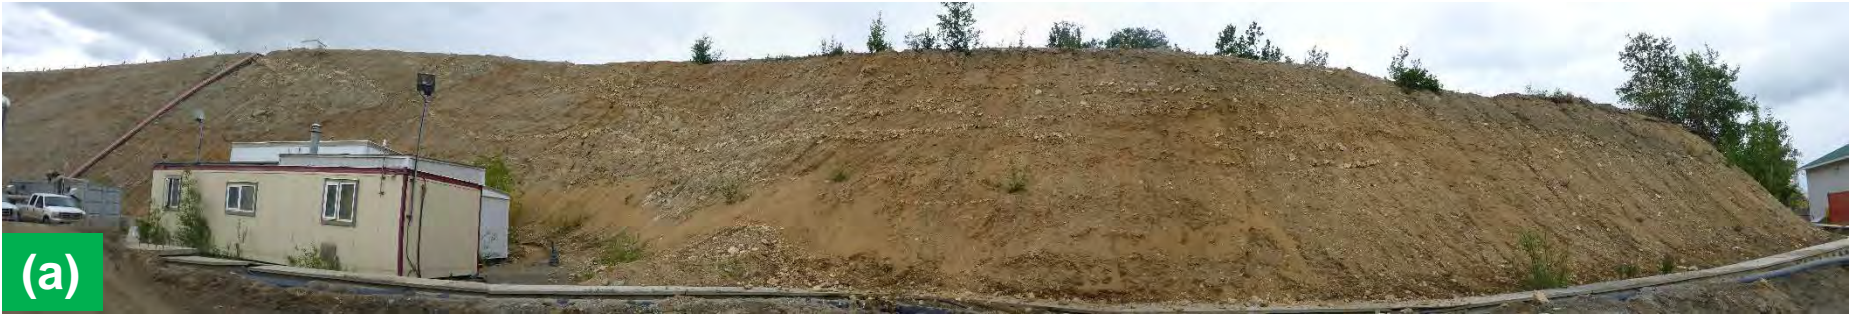
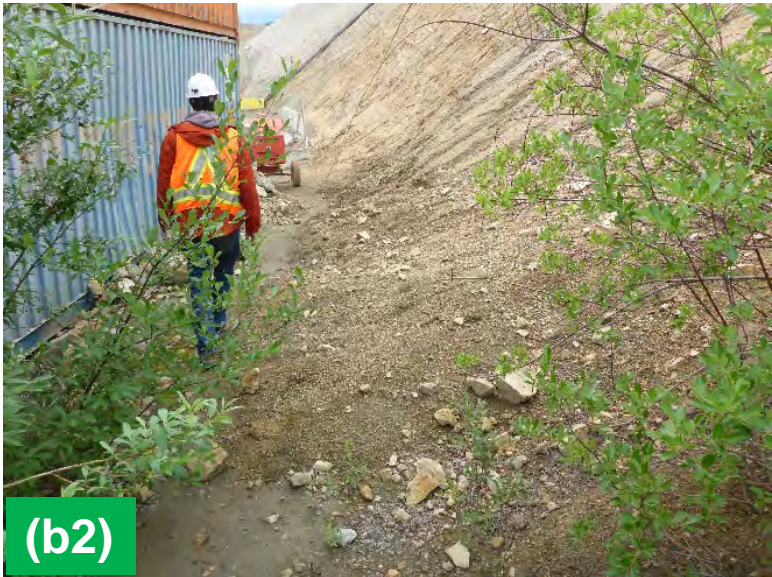
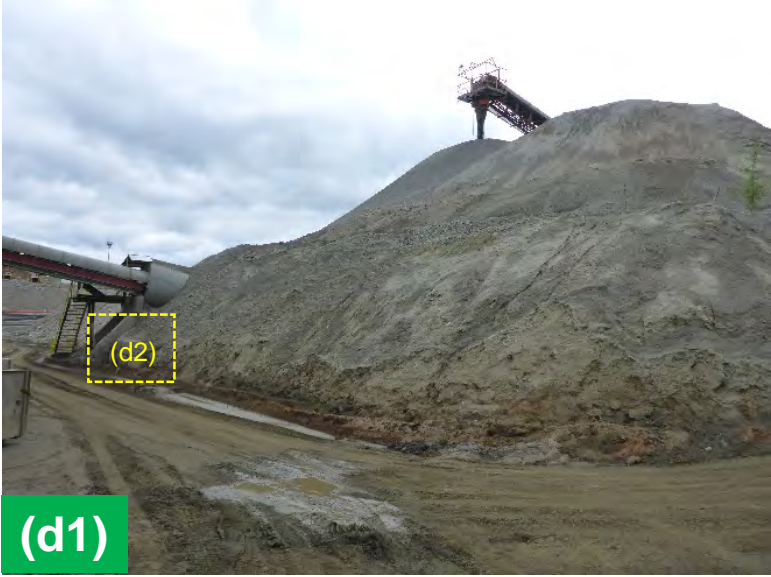
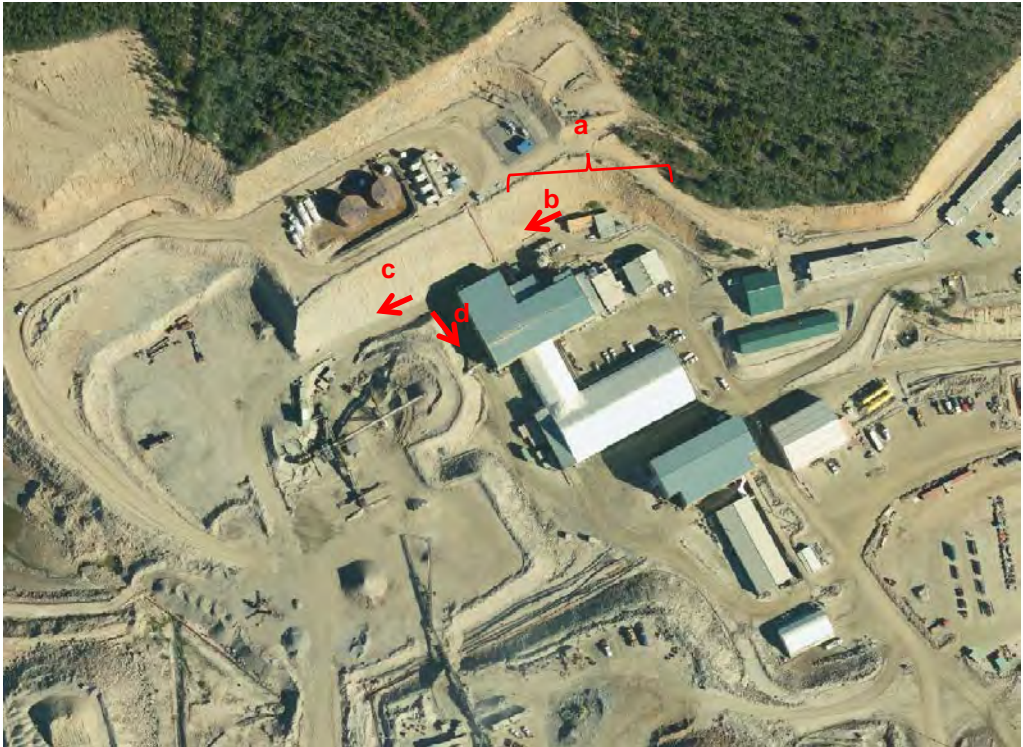
Conditions of the mill area are similar to those observed in the 2017 inspection. Minor ongoing erosion was again noted on the slope to the north of the mill (Photos A, B1, B2, and C). Fallen rocks appear to have been cleared as needed from the road and walkway on an as needed basis (Photos B and C).

Photos D1 and D2 show the mill feed stockpile. The lock-blocks located beneath the mill feed conveyor are bulging toward the road.
