# 2018 Geotechnical Annual Review, Minto Mine, YT

SRK Consulting (Canada) Inc.  
1CM002.063  
August 2018

On June 26-27, 2018, SRK Consulting (Canada) Inc. completed a geotechnical inspection of the Minto Mine site. The purpose of the inspection was to document the physical condition of the site based on visual observations and to provide geotechnical assessment, noting potential signs of physical instability such as erosion, differential settlement, sloughing or bulging of material, seepage, etc. The inspection is documented in the photographic compilation provided in Appendix A. This report summarizes the findings and recommendations.

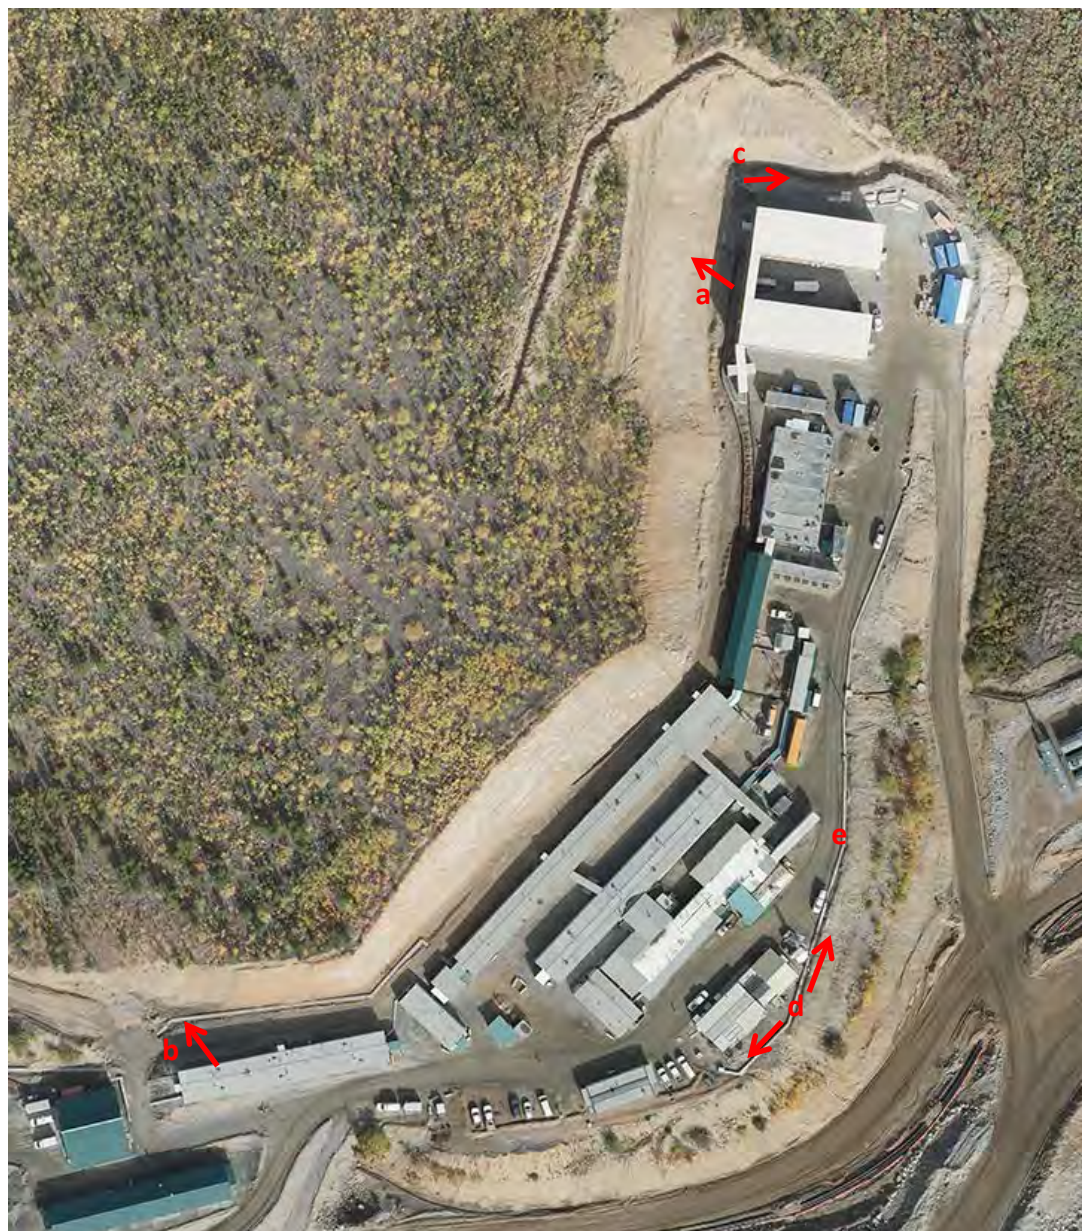
Photo D2: View of the camp pad crest looking south.

Photo E: View of erosion caused by ponding and subsequent runoff drainage undercutting the camp utilidor (along the camp pad crest). If left unmitigated, on-going erosion may result in damage to the utilidor.

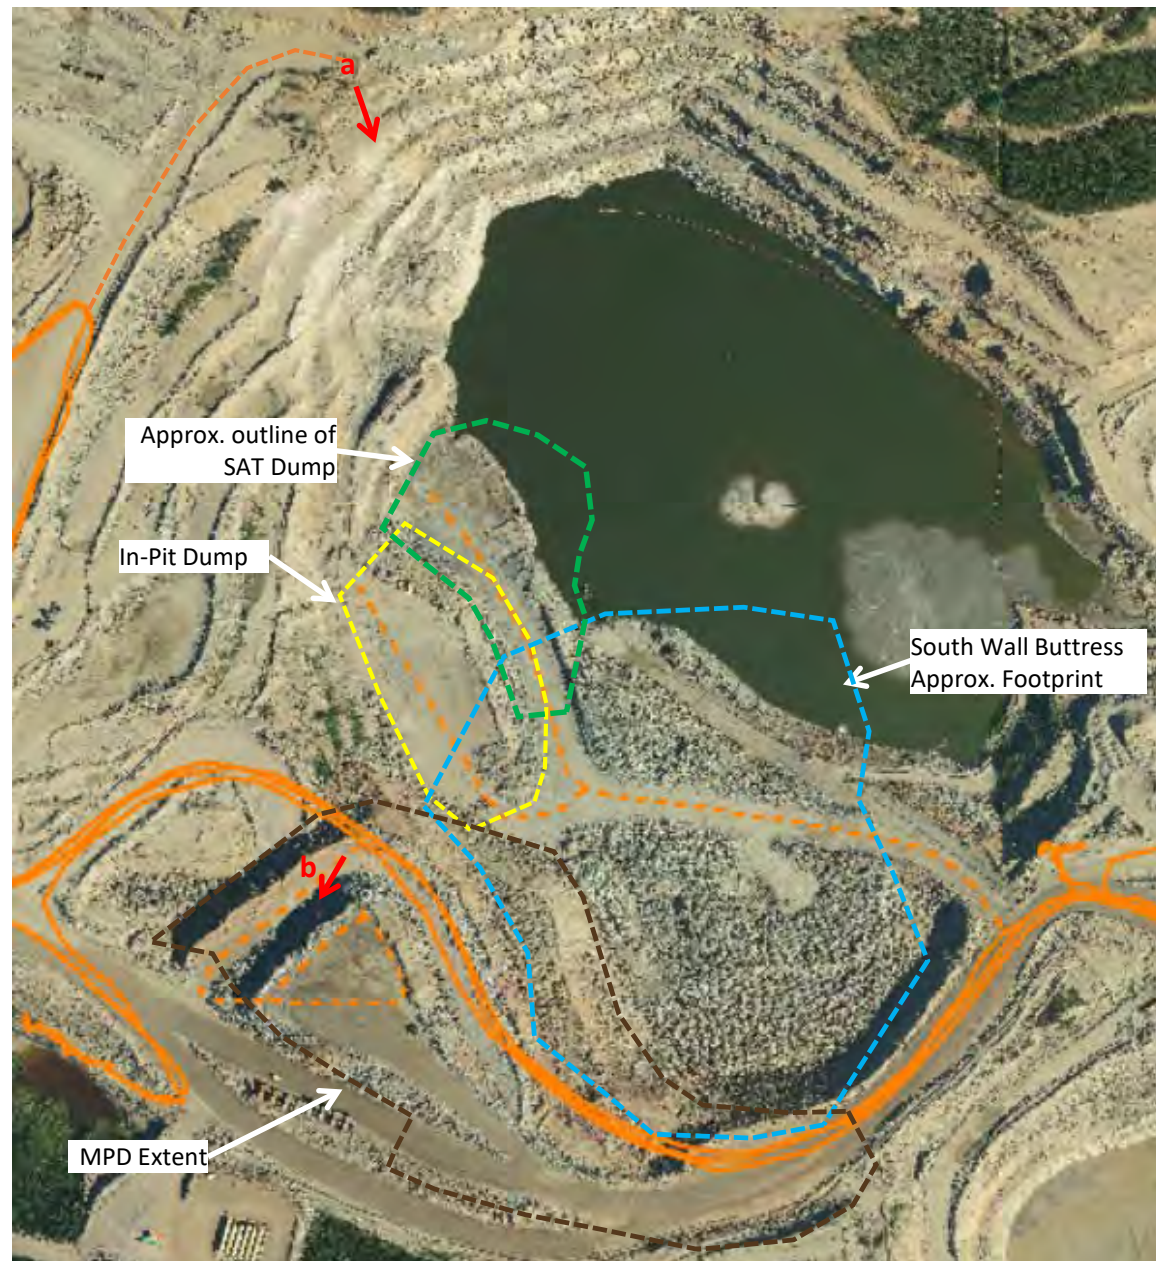
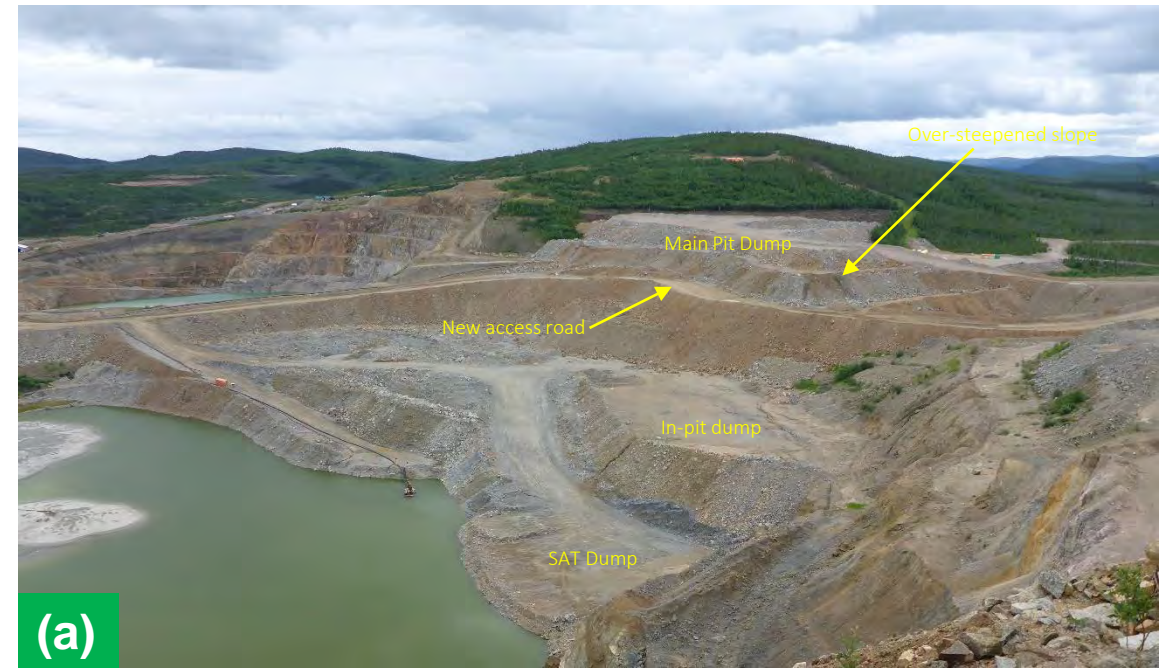
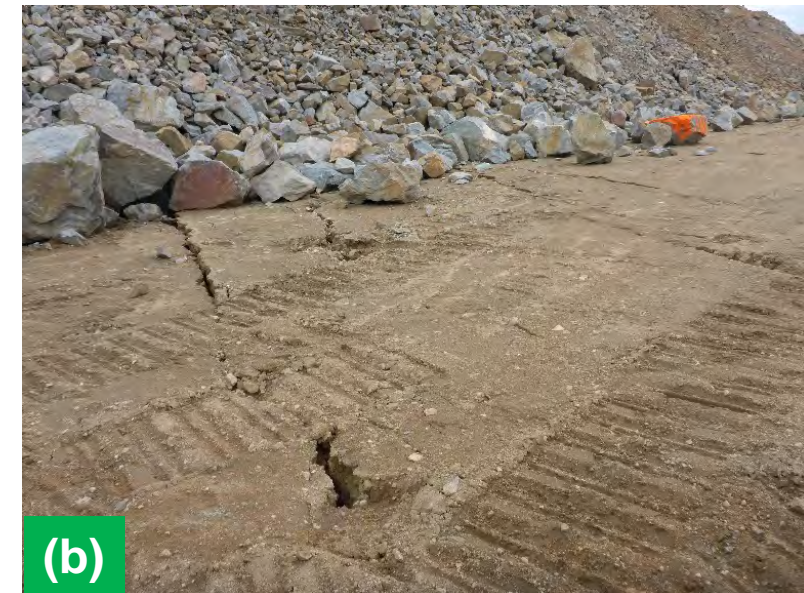
<b>Minto Explorations Ltd.</b>	2018 Geotechnical Inspection		
		<b>Main Pit, South Wall Buttress, and In-pit Dumps</b>		
Job No: 1CM002.063 Filename: AppA_2018InspectionPhoto.pptx	Minto Mine	Date: August 2018	Approved: PHM	Figure: <b>16</b>

- No change in condition was observed at the In-Pit Dump.

- Minor cracks were observed parallel to the face of the SAT dump however appear unchanged. The cracking is to be expected as a result of consolidation of the underlying tailings. During placement, the cracks were routinely monitored by Minto staff and spray painted to monitor propagation, no new cracks were observed.
- Extensometers were set up along the dump crest and are regularly monitored.

- Access to the areas above and below the over steepened slope should be restricted, or the slopes should be regraded. Signs or barricades should be considered.

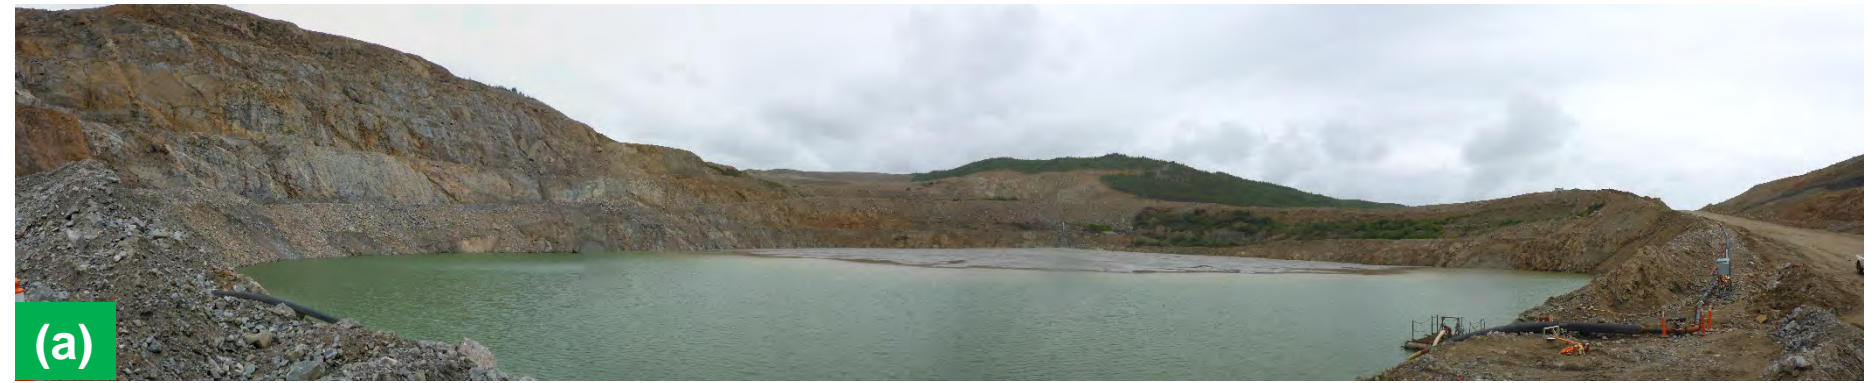
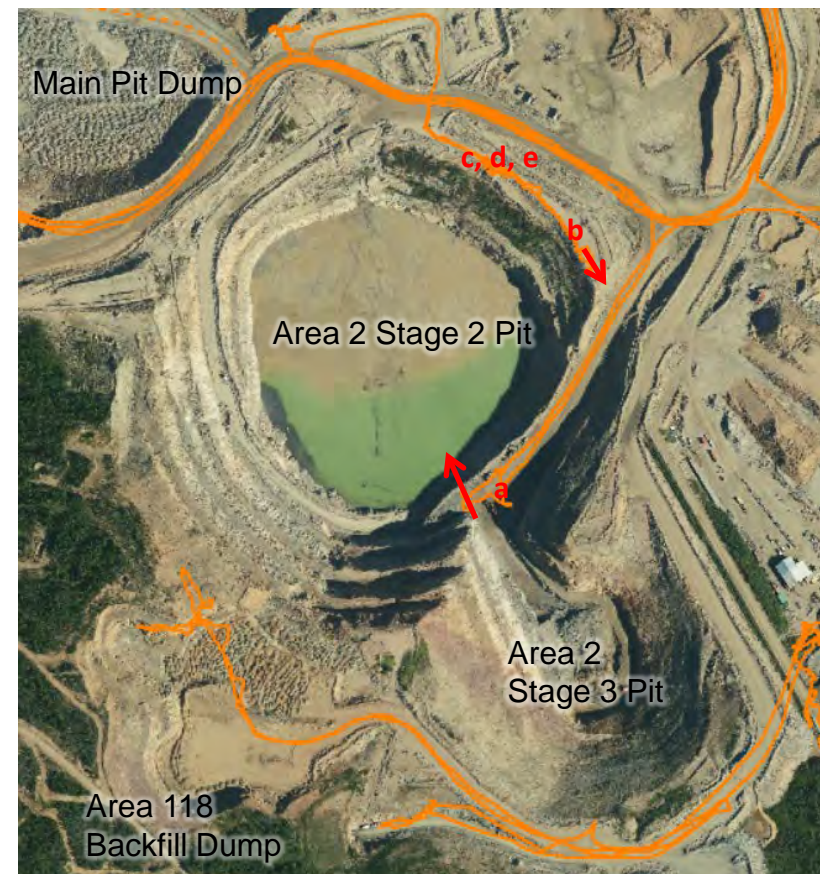
Since the 2017 Inspection, mining of the Area 2 Stage 3 Pit has been completed.

- Photo A: View of the Area 2 Stage 2 Pit taken from the road between Stage 2 and Stage 3 looking north. The conditions of the highwall on the south, west, and north sides of the pit appear unchanged compared to the 2017 inspection photographs
- Photo B, C, D: Cracking was observed on the north east side of the Stage 2 Pit parallel to the access road.
  - An electric cable and transformer are located on the pit-side of the cracks are at risk should the overburden material slough into the pit.
  - The vehicle pull-out area is experiencing the greatest amount of cracking and deformation,
- Photo E provides an additional view of the cracking with an overlay of a potential remedial measures to move the infrastructure away from the edge and construct a new berm further away from the pit.

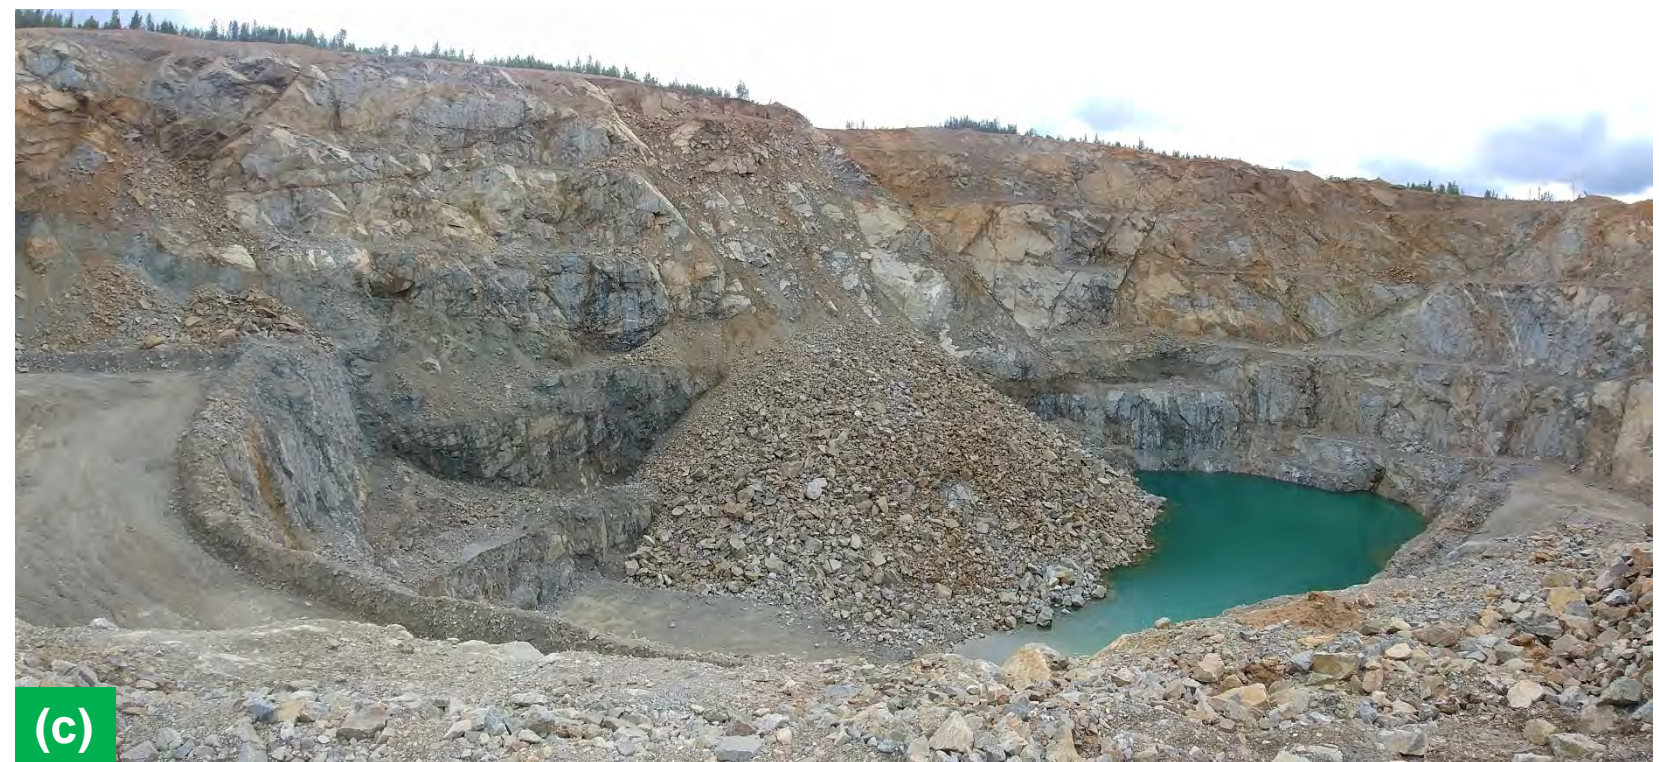
<b>Minto Explorations Ltd.</b>	2018 Geotechnical Inspection		
		<b>Area 118 and Minto North Pits</b>		
Job No: 1CM002.063 Filename: AppA_2018InspectionPhoto.pptx	<b>Minto Mine</b>	Date: August 2018	Approved: PHM	Figure: <b>19</b>

The failure of the south pit wall (debris shown in Photo C occurred one day following completion of the pit and removal of all equipment and personnel, as was predicted based on pit wall monitoring. No additional pit slopes failures have occurred since.

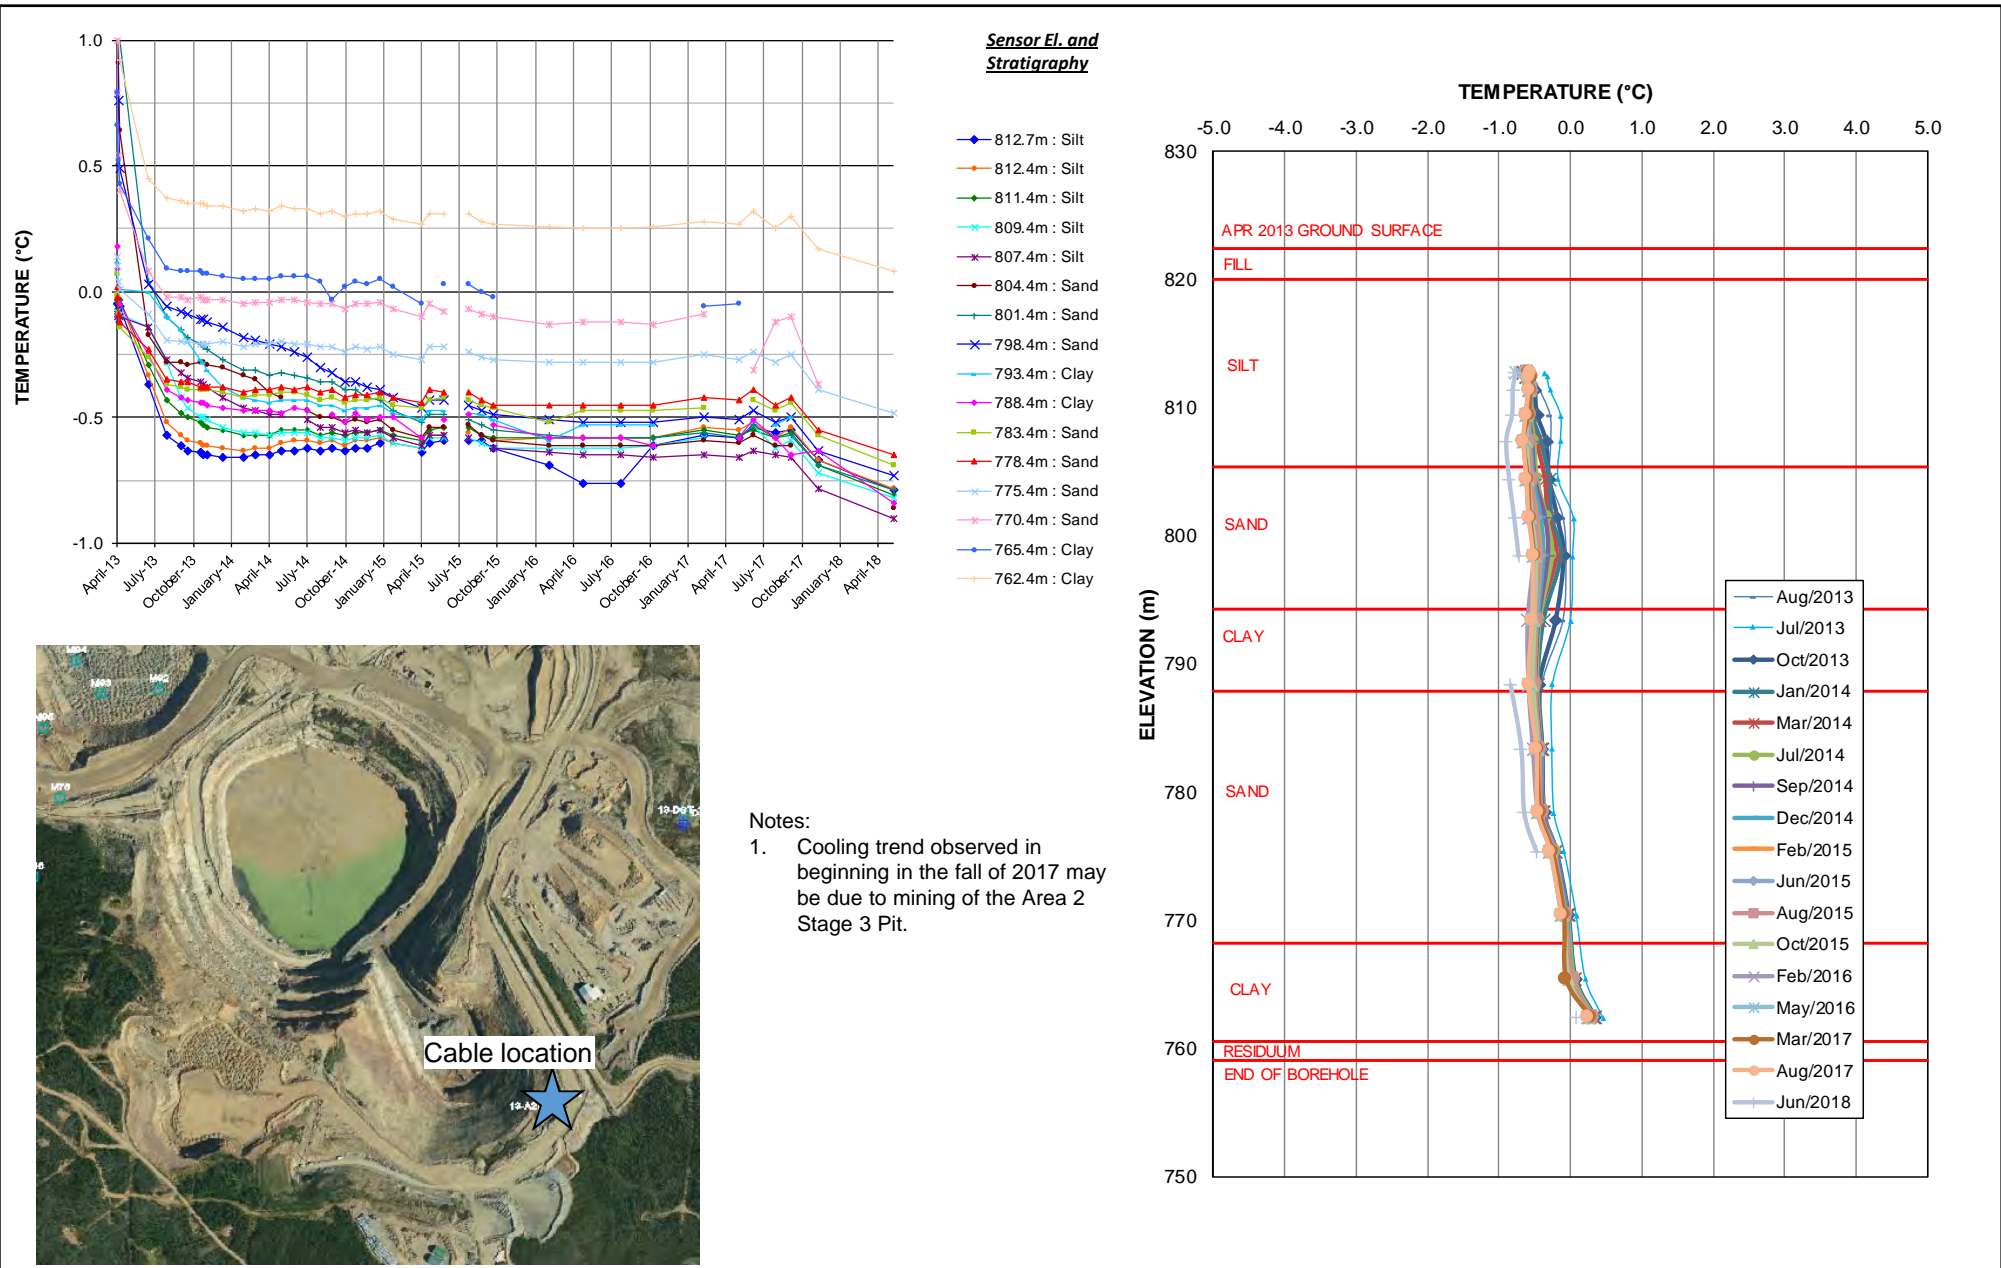
Notes:  
 1. Cooling trend observed in beginning in the fall of 2017 may be due to mining of the Area 2 Stage 3 Pit.

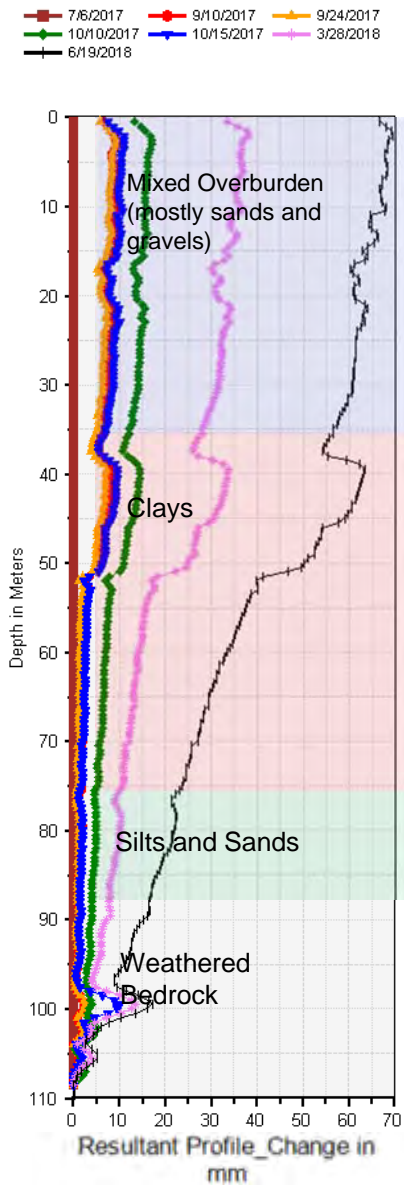
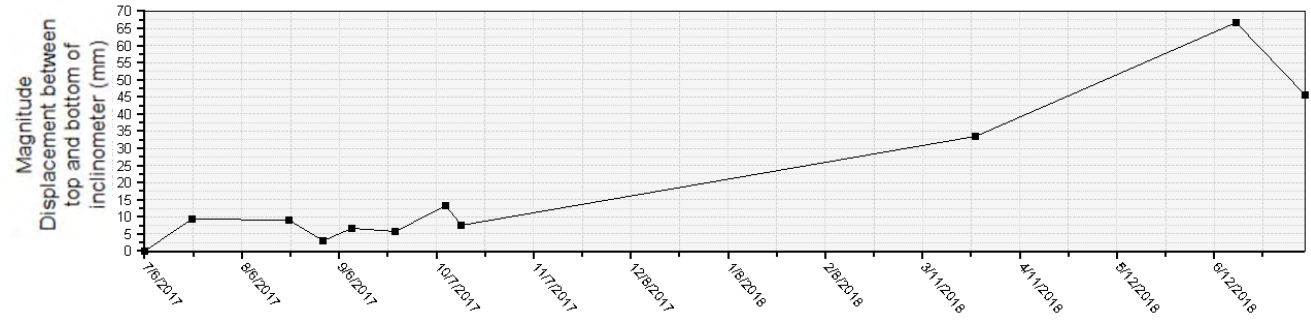
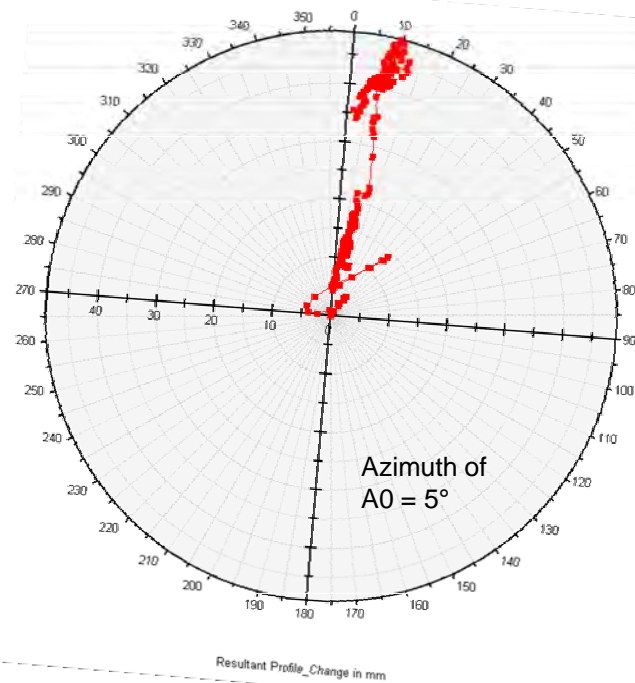
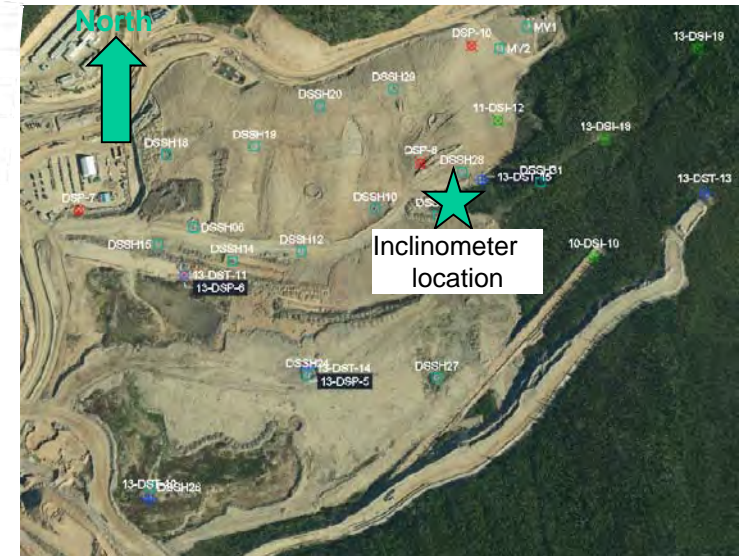
MINTO DSI-24 Magnitude

1. Data collected from this inclinometer are questionable. The checksum values from the inclinometer surveys indicate high error values, which may account for the "drift" observed in the profile change to the right.
2. It is recommended that the inclinometer probe be sent for servicing and training be provided to the staff to observe the checksum values during readings to improve the quality of the readings.
