# 2019 Geotechnical Annual Review, Minto Mine, YT

Minto Explorations Ltd.

SRK Consulting (Canada) Inc.  
1CM002.066  
August 2019

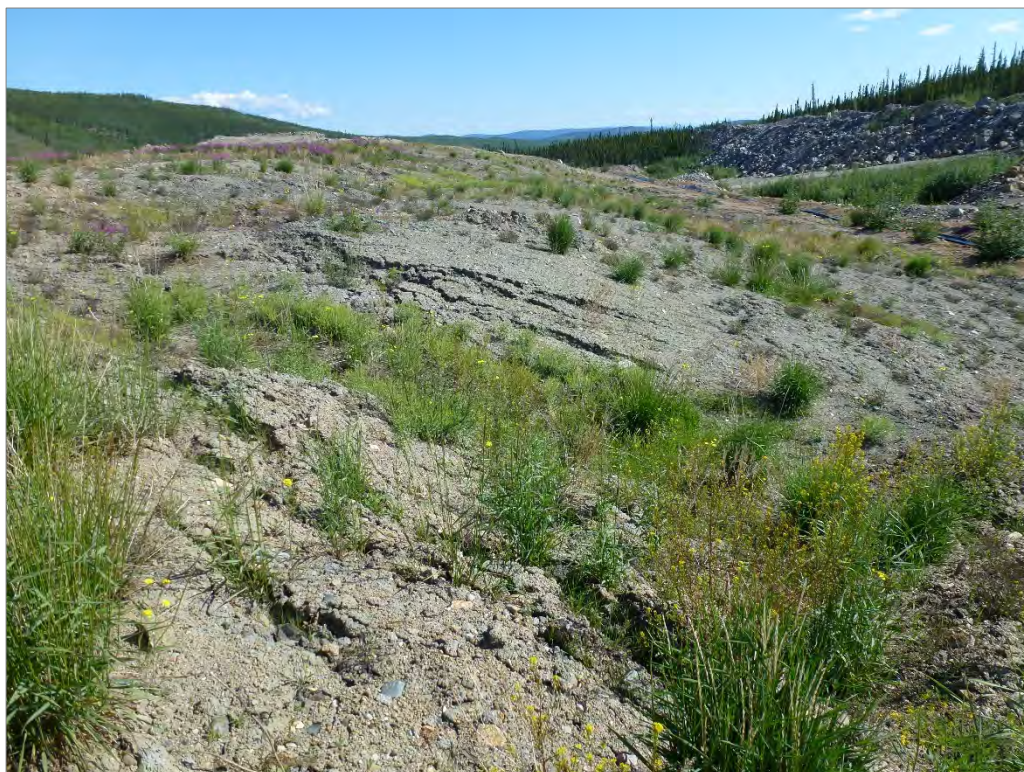
Photo 5: Settlement cracking along crest of placed cover material (looking west)

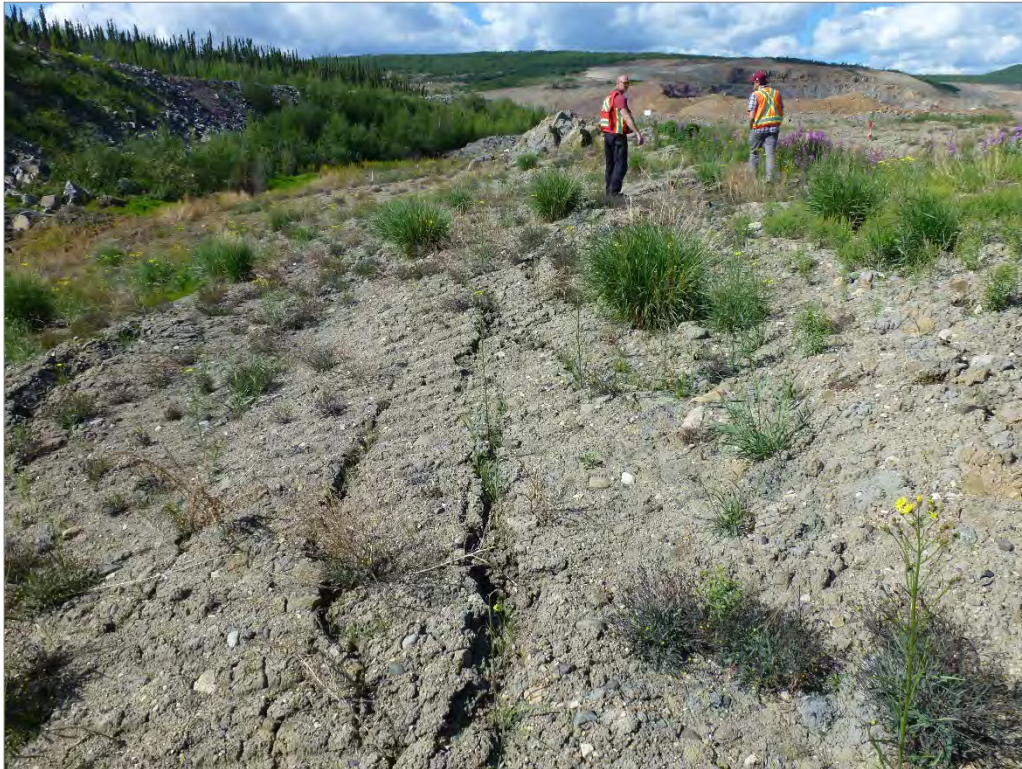
Photo 6: Settlement cracking along crest of placed cover material (looking west)

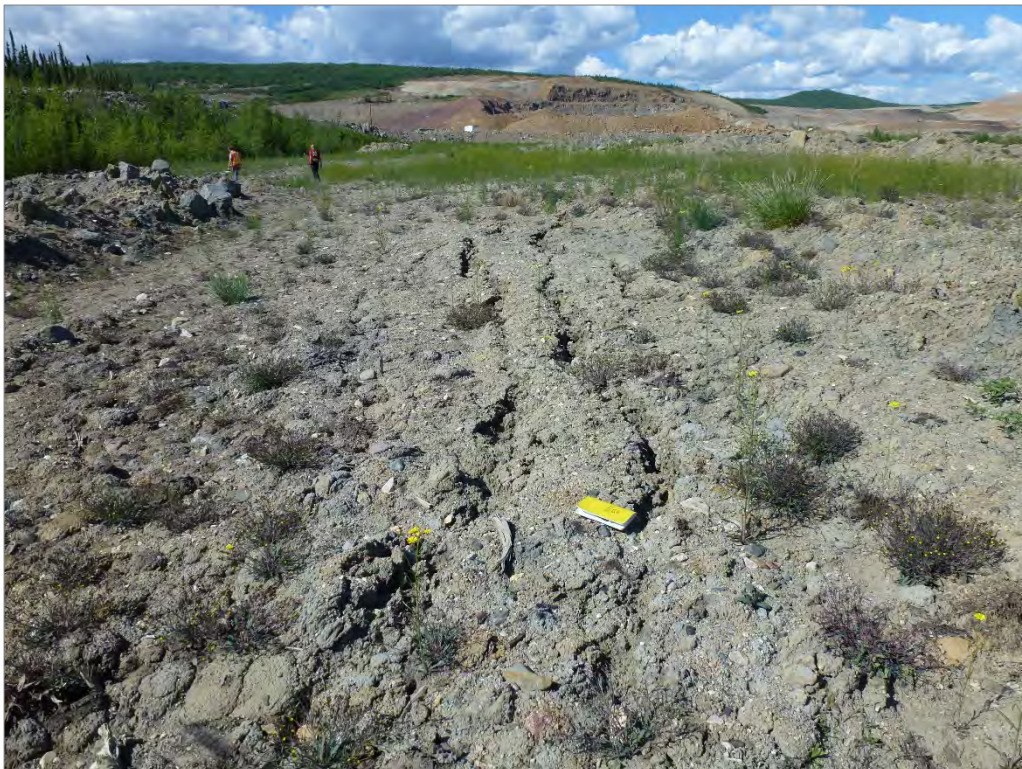
Photo 7: Portion of dry stack requiring regrading to 4H:1V closure slope (looking east)

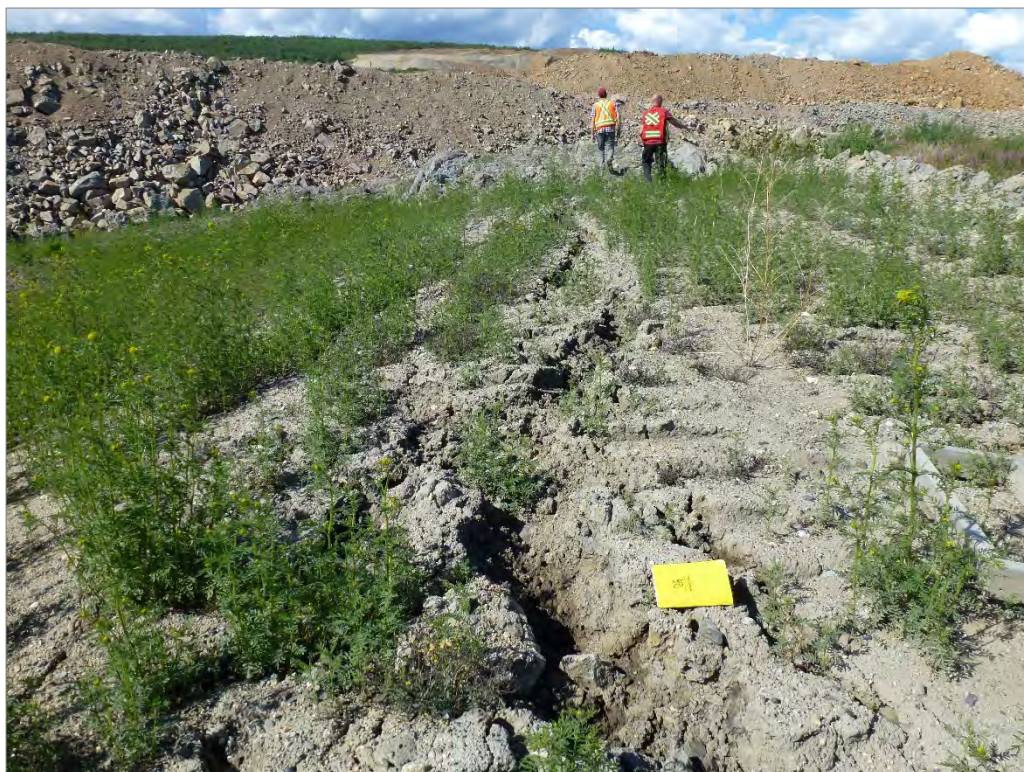
Photo 8: Settlement cracking along crest of placed cover material (looking west)

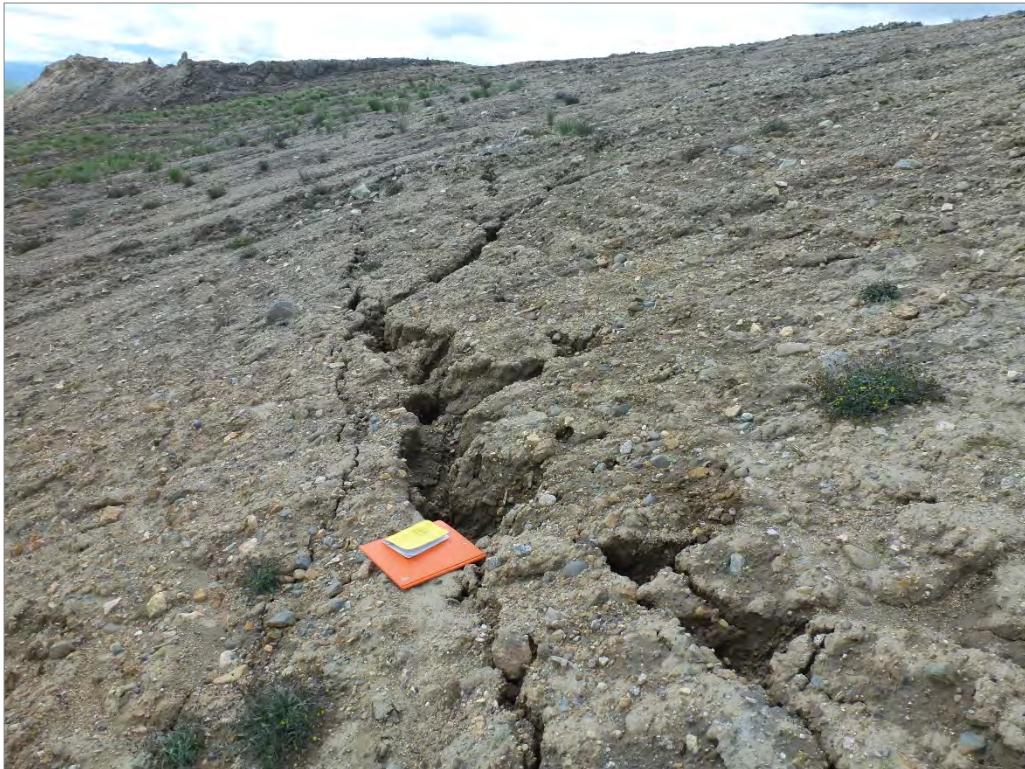
Photo 30: Longitudinal cracking

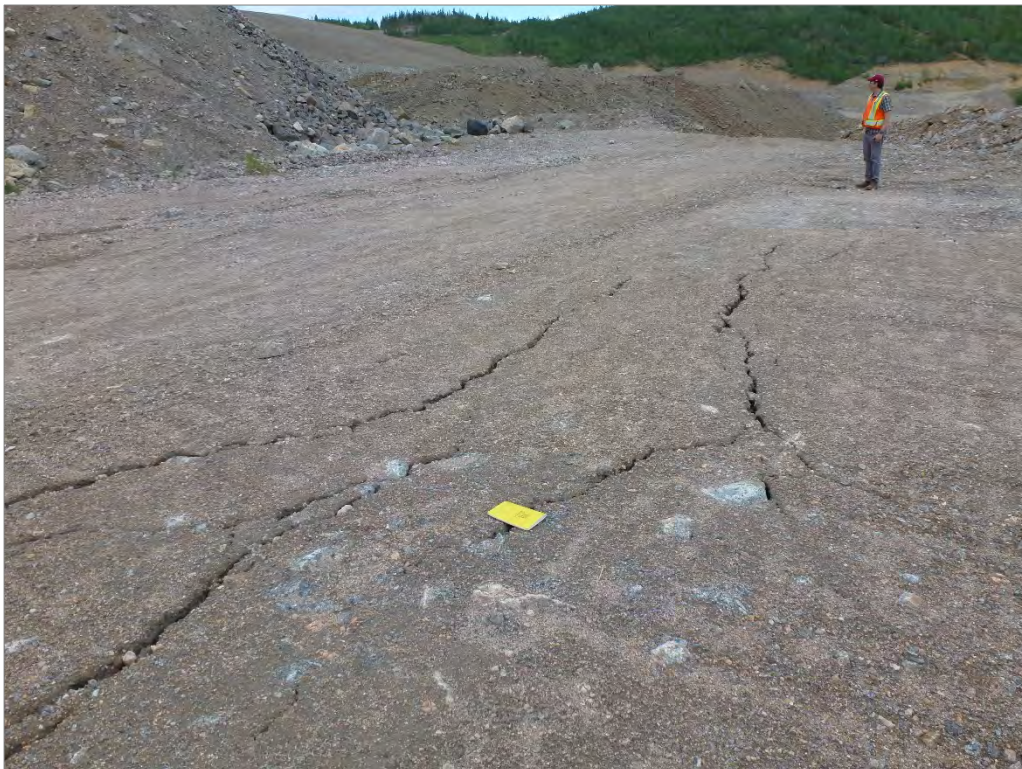
Photo 32: Cracking on the crest of the MWD Wrap (looking north)

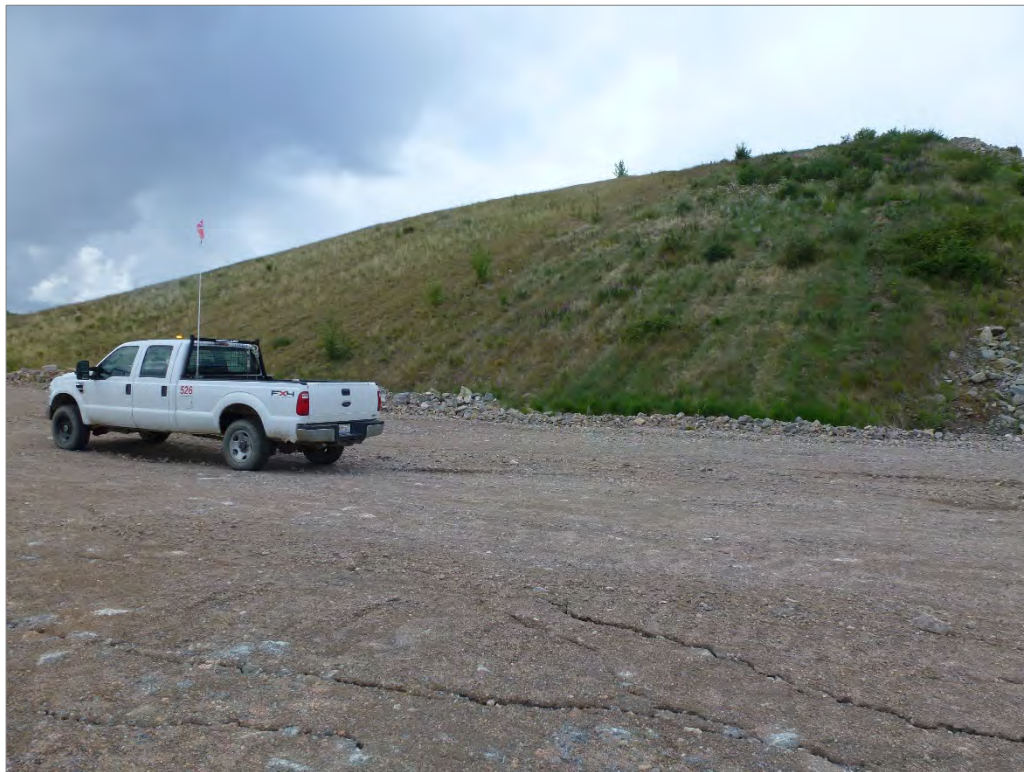
Photo 33: Cracking on the crest of MWD Wrap and vegetated slope of MWD (looking north)

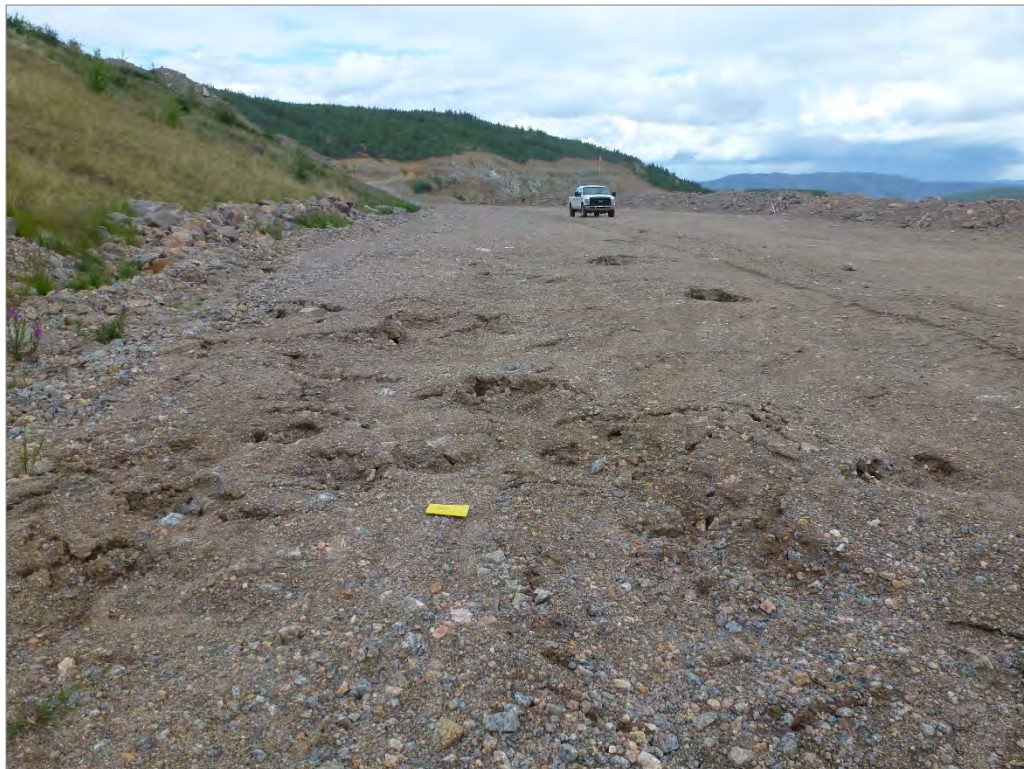
Inspection Area Number	Inspection Area Name	SRK Observations
4	Main Waste Dump (MWD)	<ul style="list-style-type: none"> <li>• No observations of global instability.</li> <li>• Erosion gullies observed in cover material (see Photo 29, Appendix A) .</li> <li>• Longitudinal cracking observed in the re-sloped area above the former PAG Oxide stockpile (see Photo 30, Appendix A). Cracking is approx. 50 m long. Area below the cracking appears to have been regraded with a concave slope, but the area has likely settled.</li> <li>• Minor vegetation has established on the cover slopes</li> </ul>
5	Main Waste Dump (MWD) Wrap	<ul style="list-style-type: none"> <li>• No observations of global instability.</li> <li>• Observations were consistent with previous years' inspection.</li> <li>• Cracking prevalent on the top bench that appear to follow the alignment of the old crest of the Main Waste Dump (see Photo 32 and 33, Appendix A).</li> <li>• Differential settlement and small sinkholes also prevalent on the top bench, likely attributed to snow within the fill during winter construction (see Photo 34 – 36, Appendix A).</li> </ul>

Photo 34: Area of differential settlement and small sinkholes (looking east)

MWD	<ul style="list-style-type: none"> <li>• Continue to monitor the crests and slopes as part of the monthly visual inspection for signs of worsening cracking and/or increased sinkholes to determine if any slope stabilization measures are required.</li> </ul>
SWD	<ul style="list-style-type: none"> <li>• Continue to monitor the cracking upslope of the overburden stockpiles as part of the routine inspections. Should the crack appear to length or widen, install in extensometer to track the crack width with monthly data readings.</li> </ul>
Mill Site	<ul style="list-style-type: none"> <li>• <b>(High Priority) Backfill the over-steepened slope at the toe of the highwall immediately north of the mill to ensure that the original design requirements are met (EBA 1994). Continue to place concrete jersey barriers as a protection barrier against minor rockfall.</b></li> </ul>
Camp Site	<ul style="list-style-type: none"> <li>• Continue to monitor the erosion channels below the camp pad as part of the routine visual inspections and following larger rainfall events. If erosion continues, implement mitigation measures. Measures to consider include surface regrading, fill placement to direct flow away from the slope, installation of a sump/drainage system.</li> </ul>

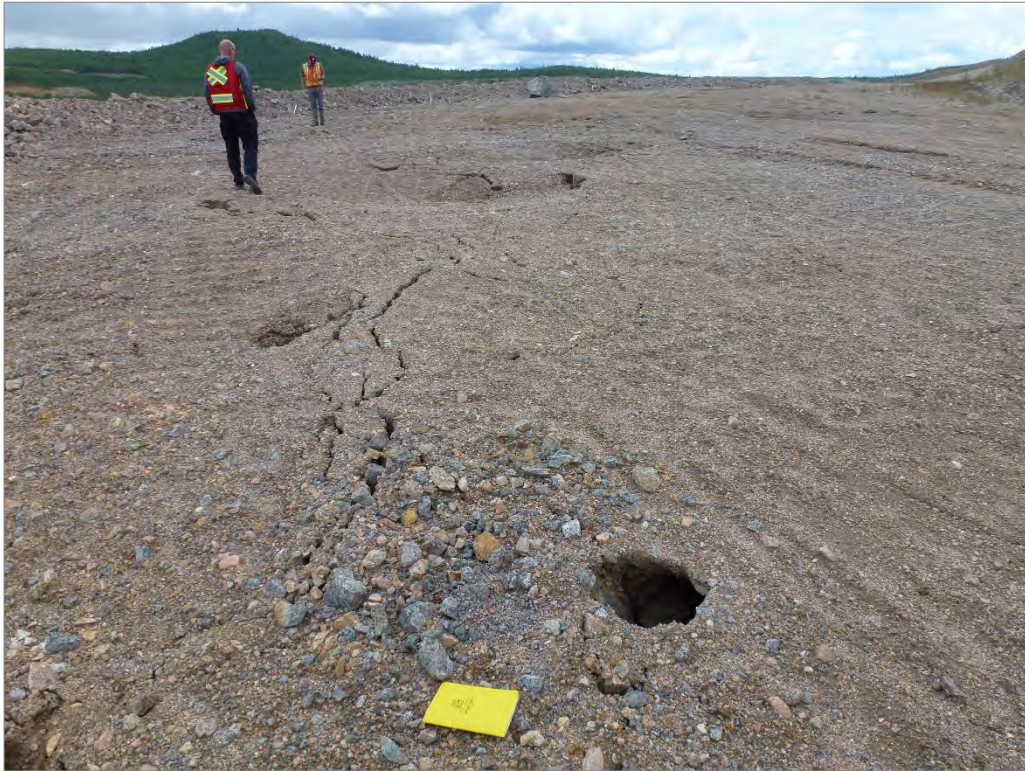
Photo 35: Small sinkholes and cracking on the crest of the MWD Wrap (looking west)

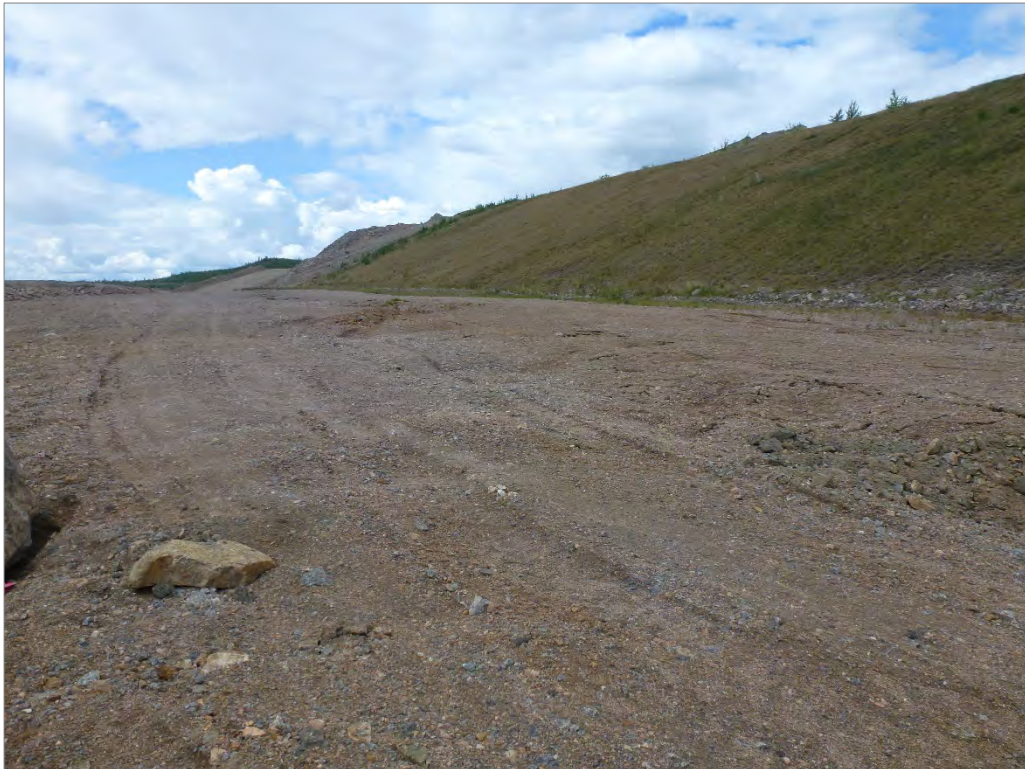
Photo 36: Additional areas of differential settlement and small sinkholes (looking west)

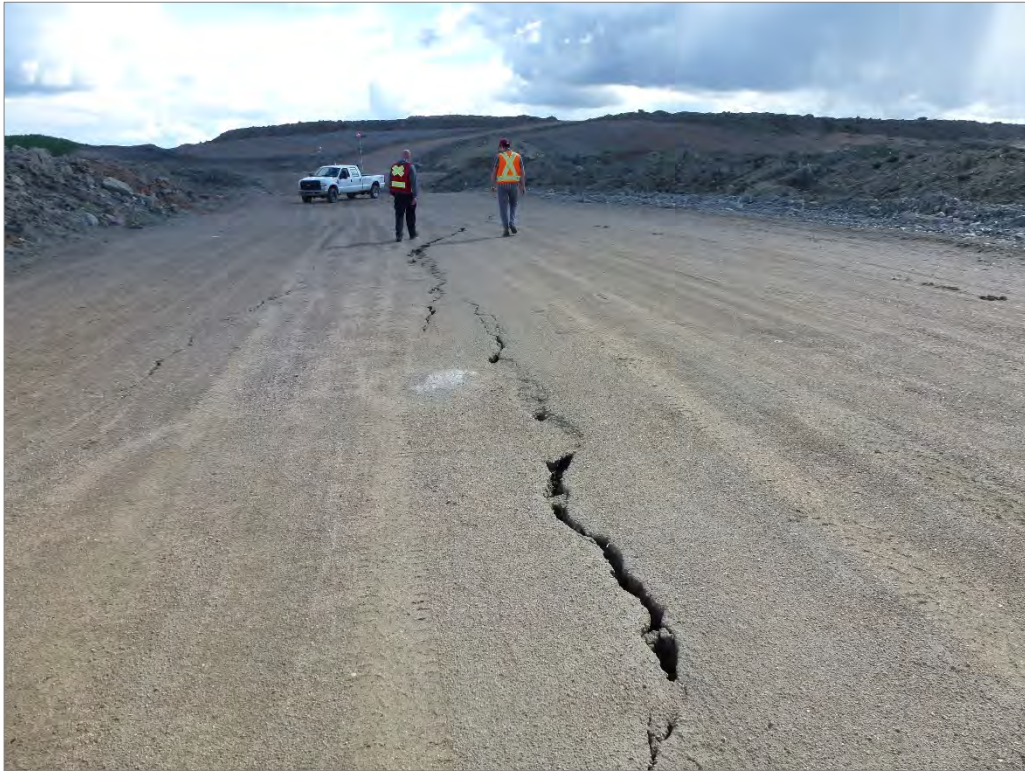
Photo 45: Observed longitudinal cracking on the crest

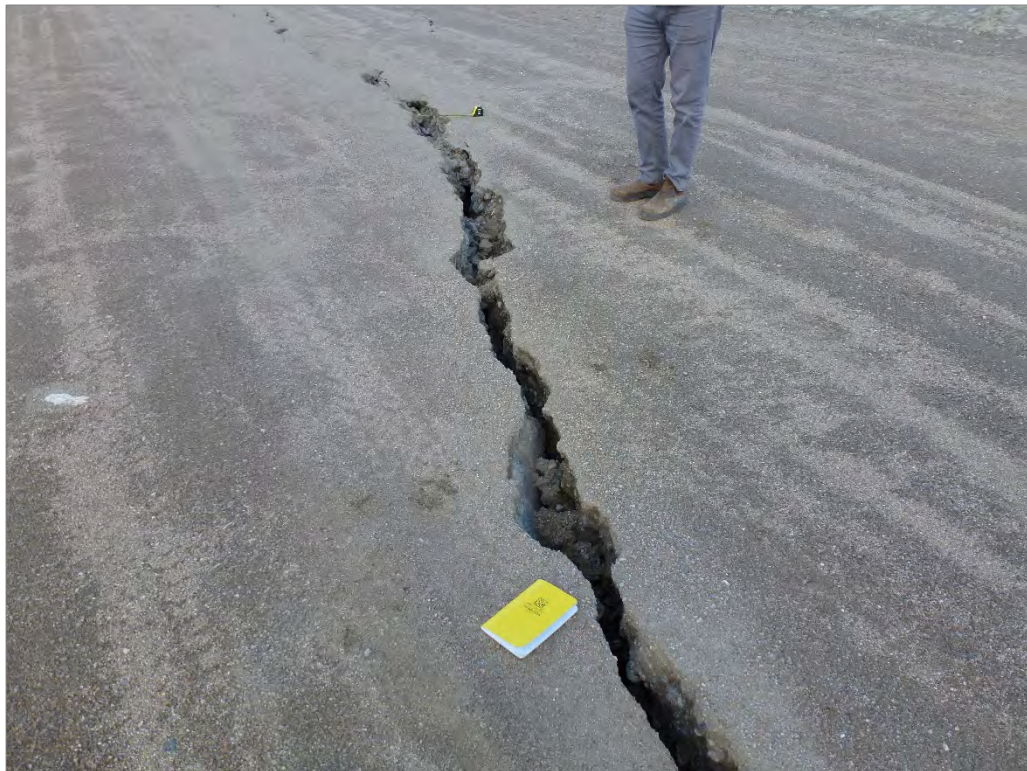
Photo 46: Close-up of longitudinal cracking at the widest point

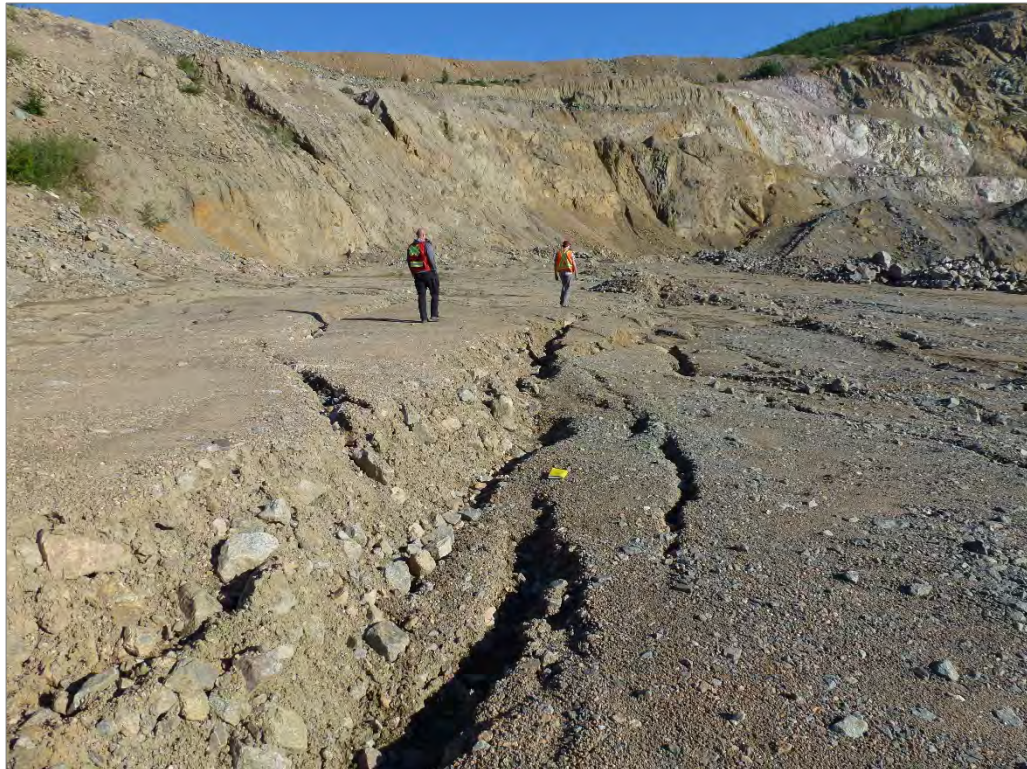
Photo 87: Longitudinal cracking in In-Pit Dump crest (looking northwest)

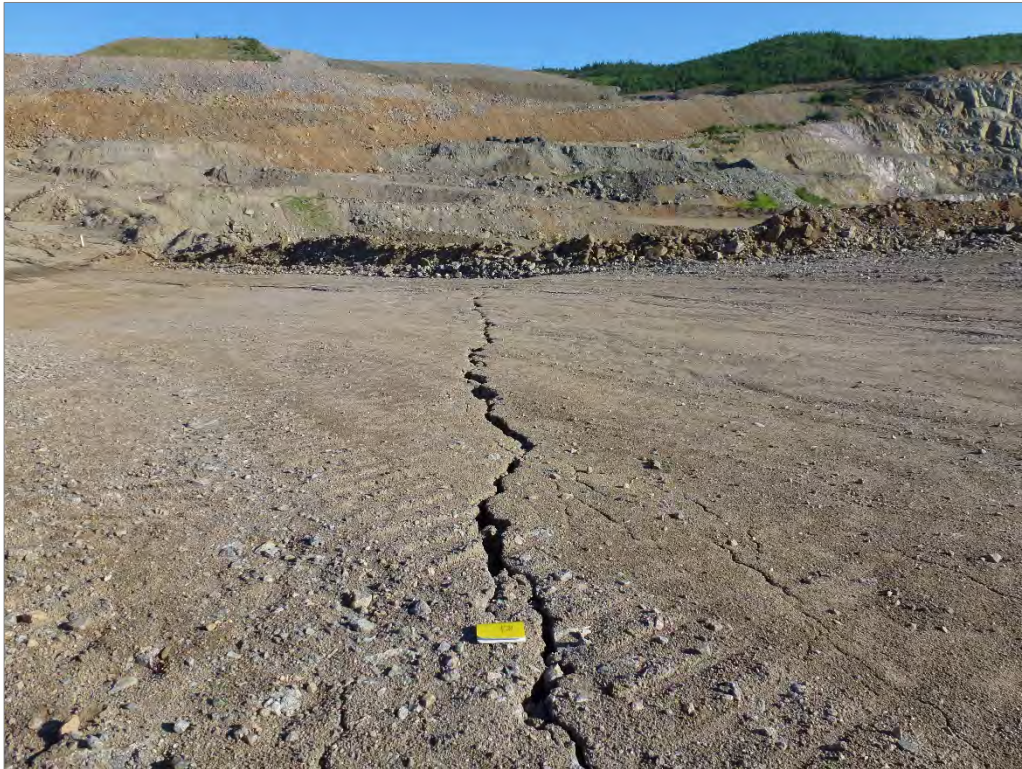
Photo 90: Cracking observed where MPD has expanded (looking north)

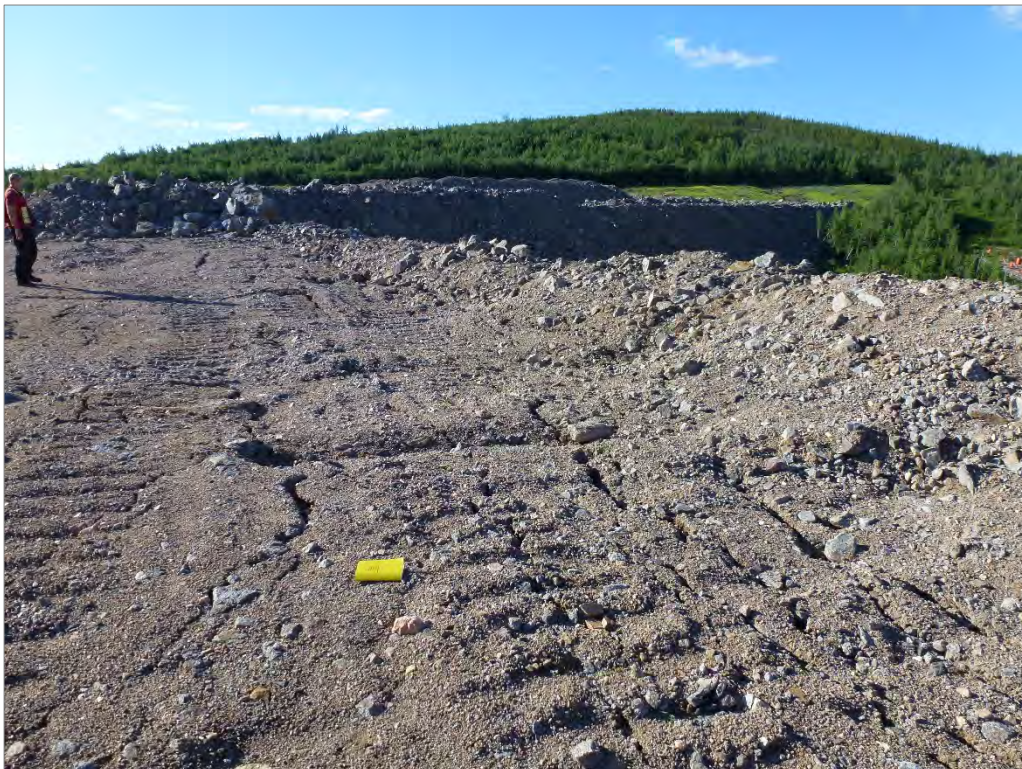
Photo 91: Further cracking in MPD (looking southeast)

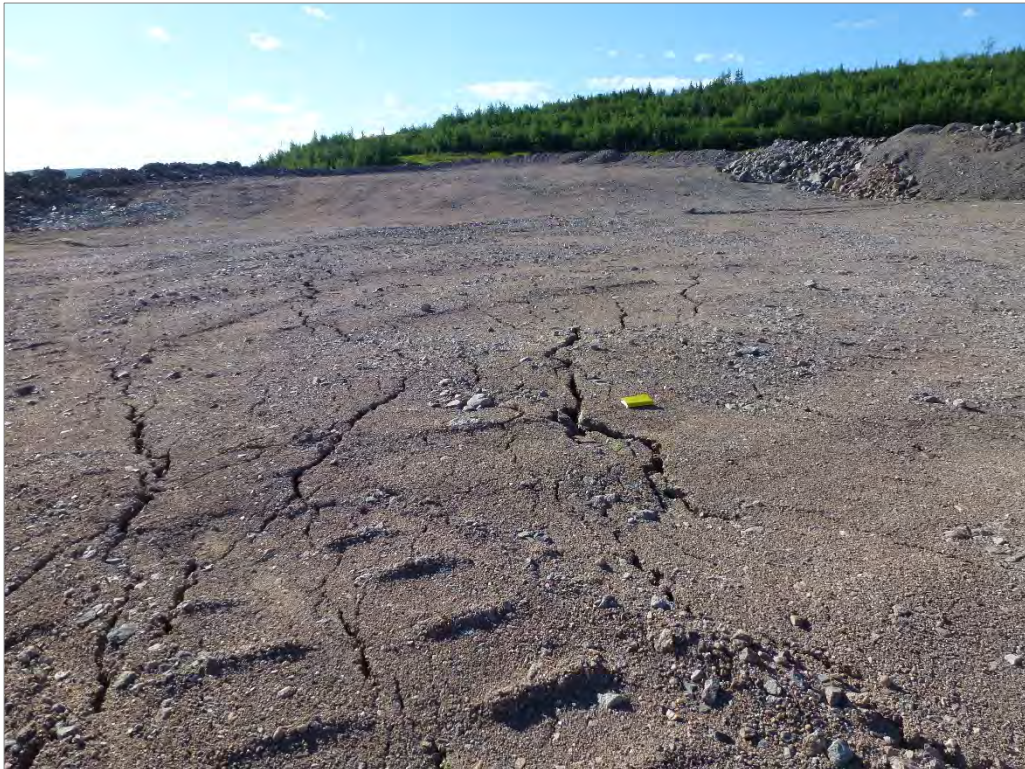
Photo 93: Further cracking in MPD crest (looking east)

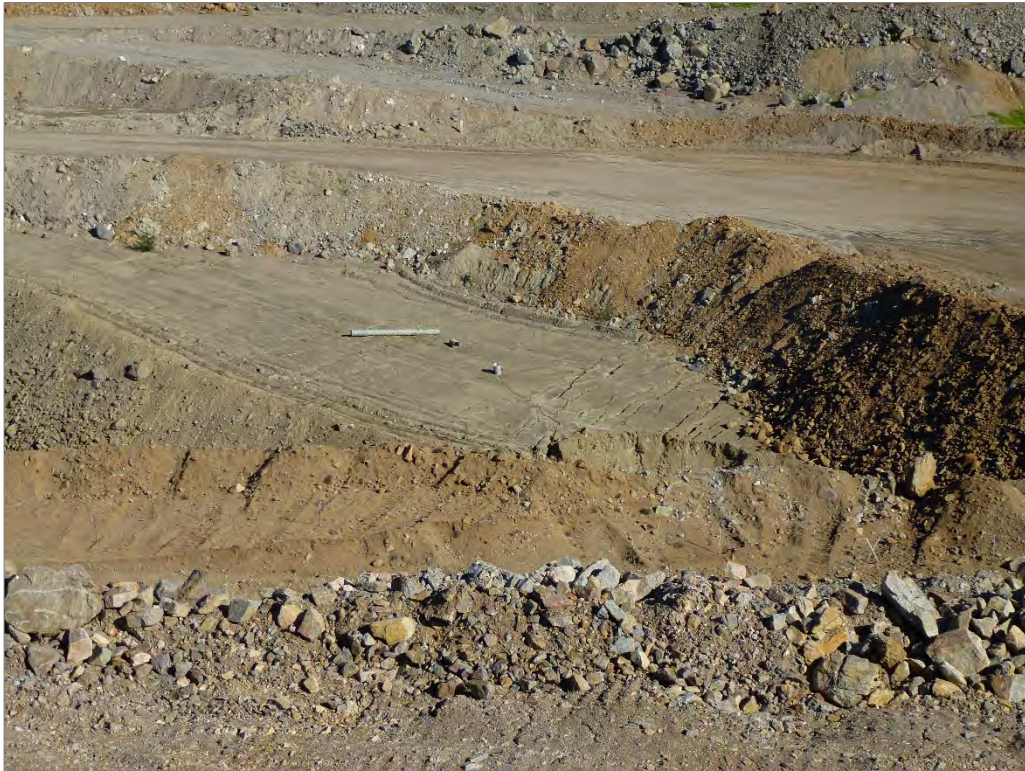
Photo 94: Cracking MPD (looking north)

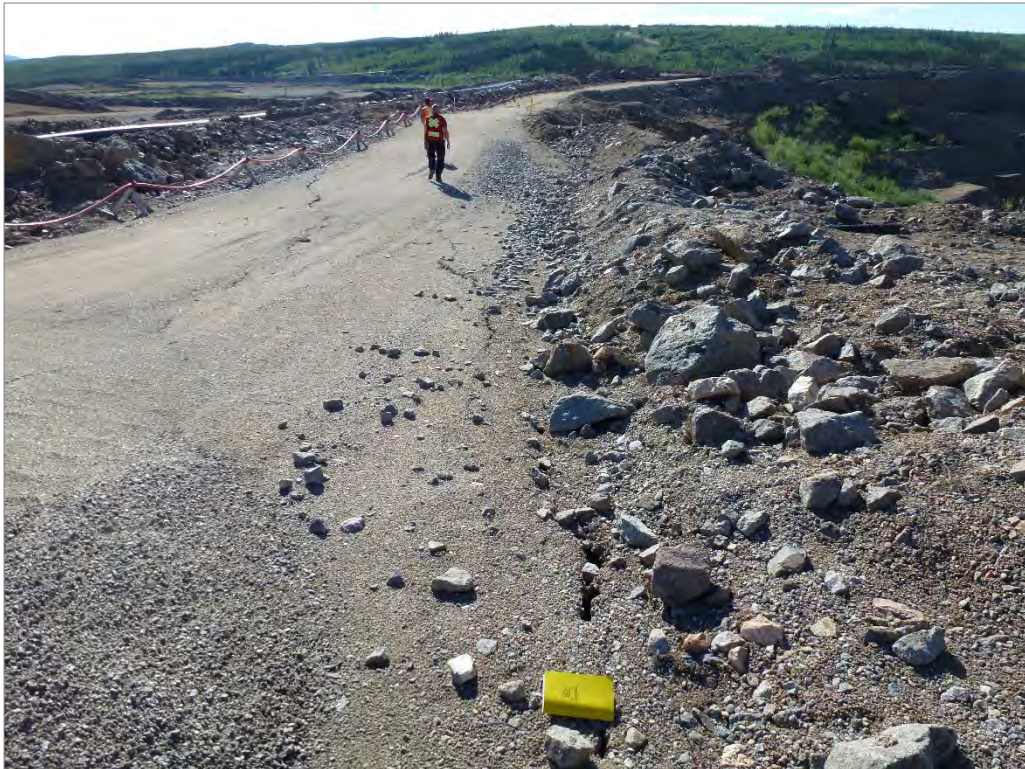
Photo 97: Cracking observed in access road along pit rim

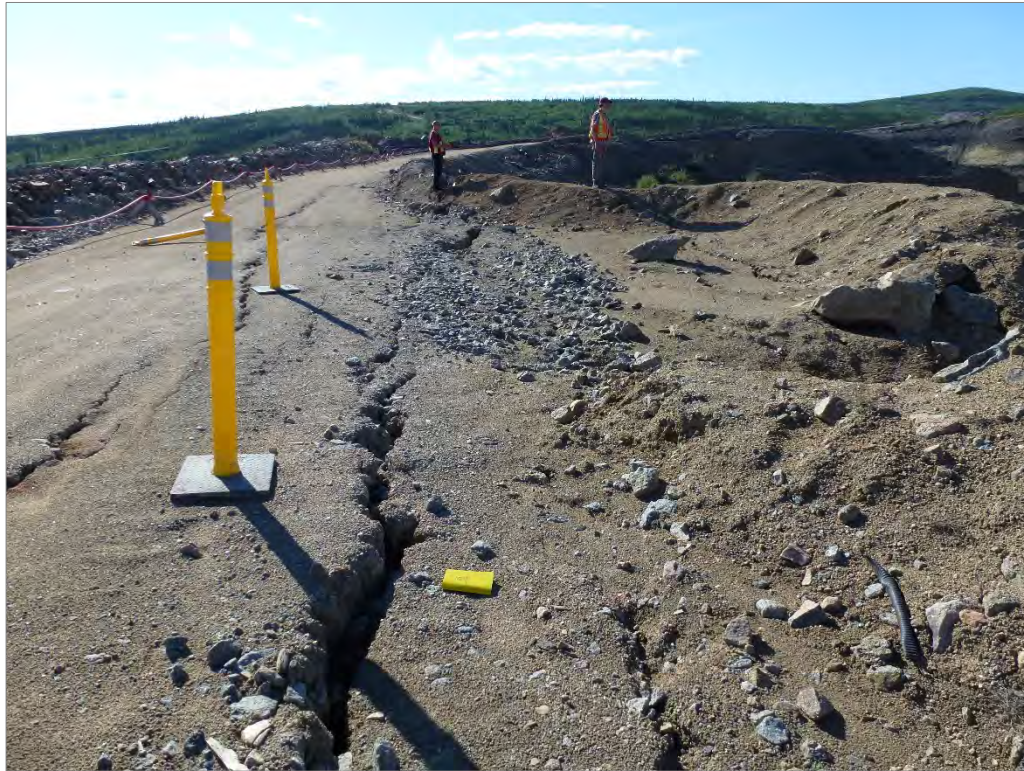
Photo 98: Observed cracking in access road along pit rim

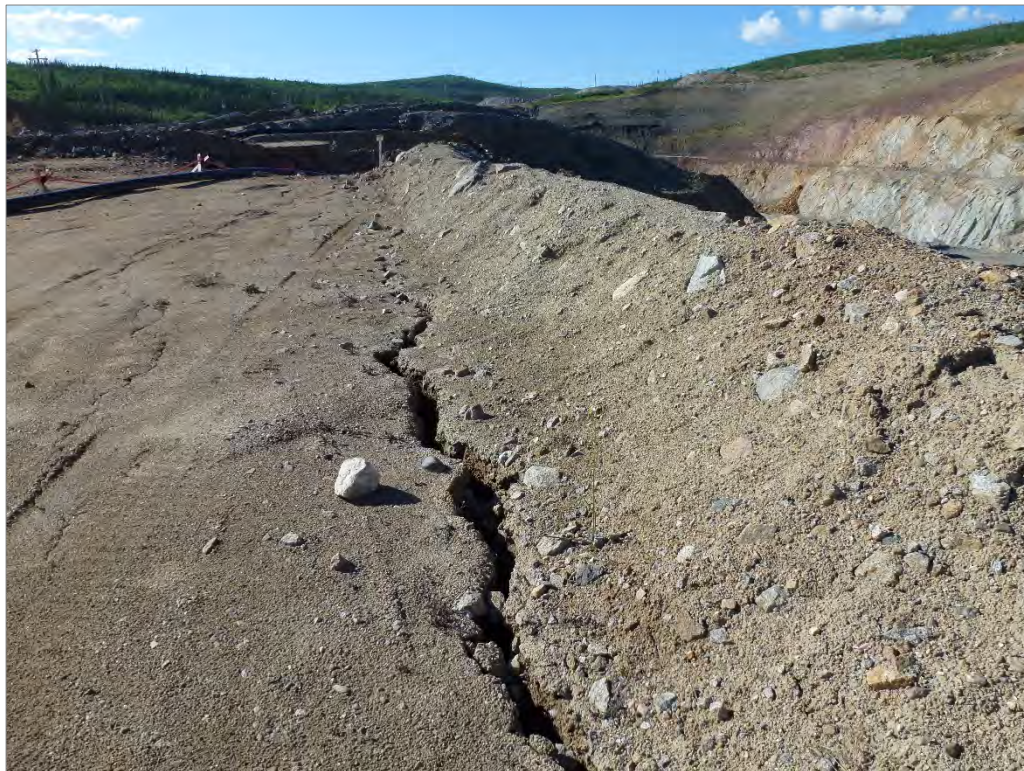
Photo 99: Observed cracking in access road along pit rim

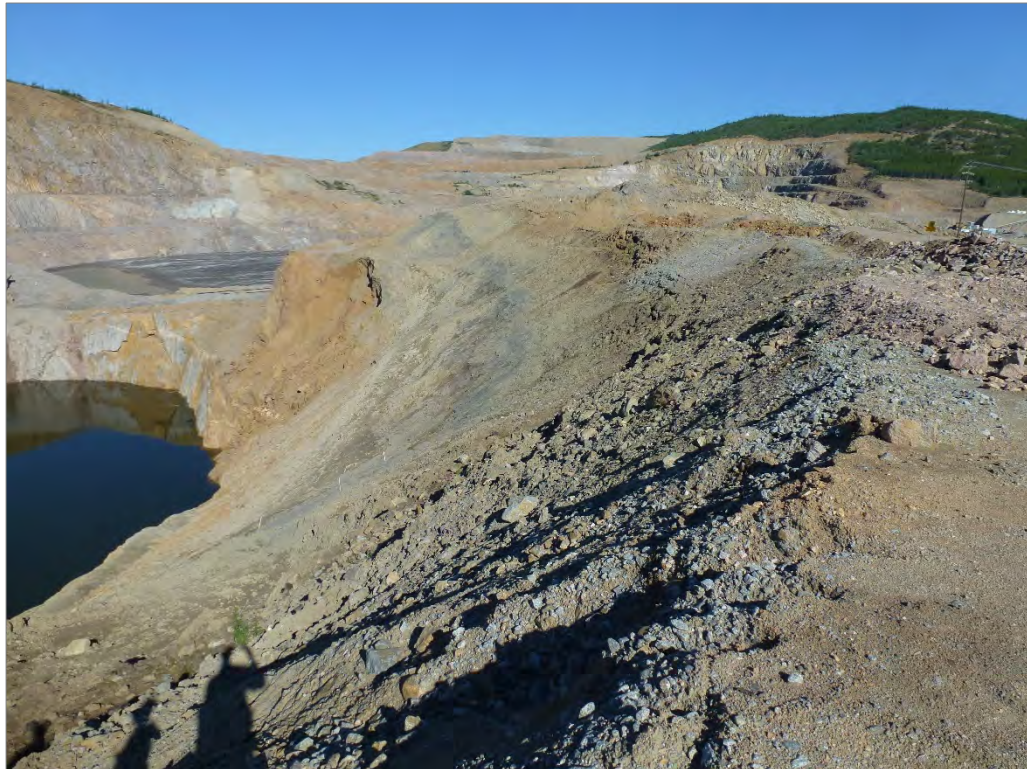
Photo 101: Slumping of the permafrost soils in the Area 2 Pit Stage 3 pit wall (looking west)

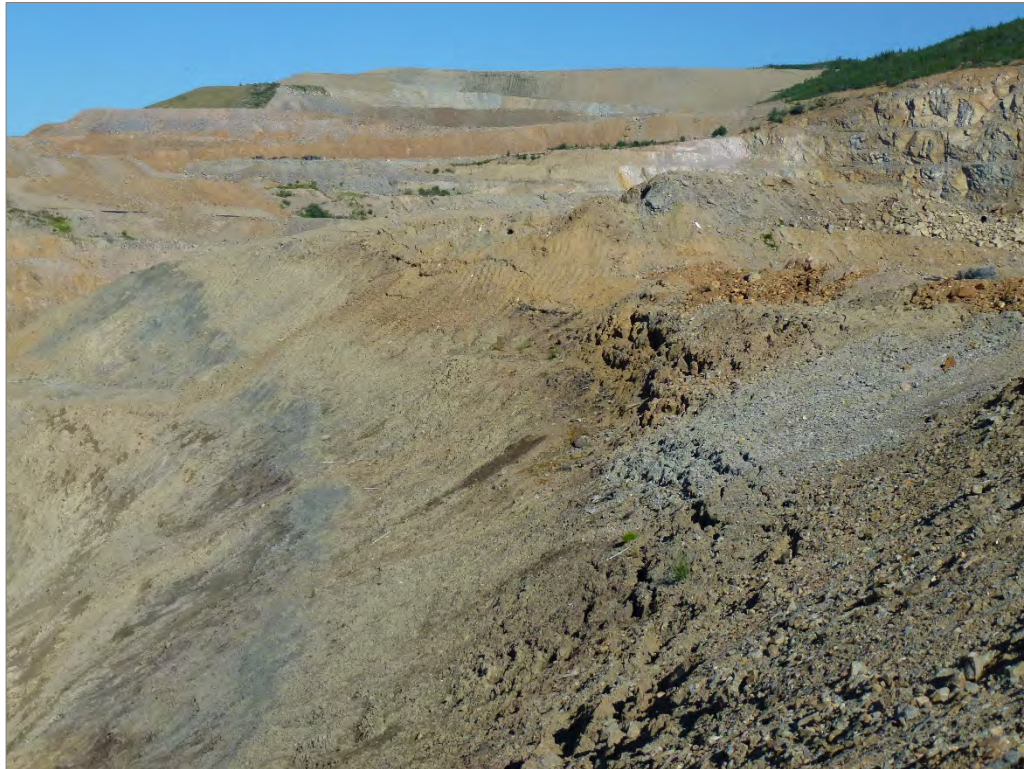
Photo 102: Tension cracking in the Area 2 Pit Stage 3 pit wall caused by slumping of the permafrost soil (looking northwest)

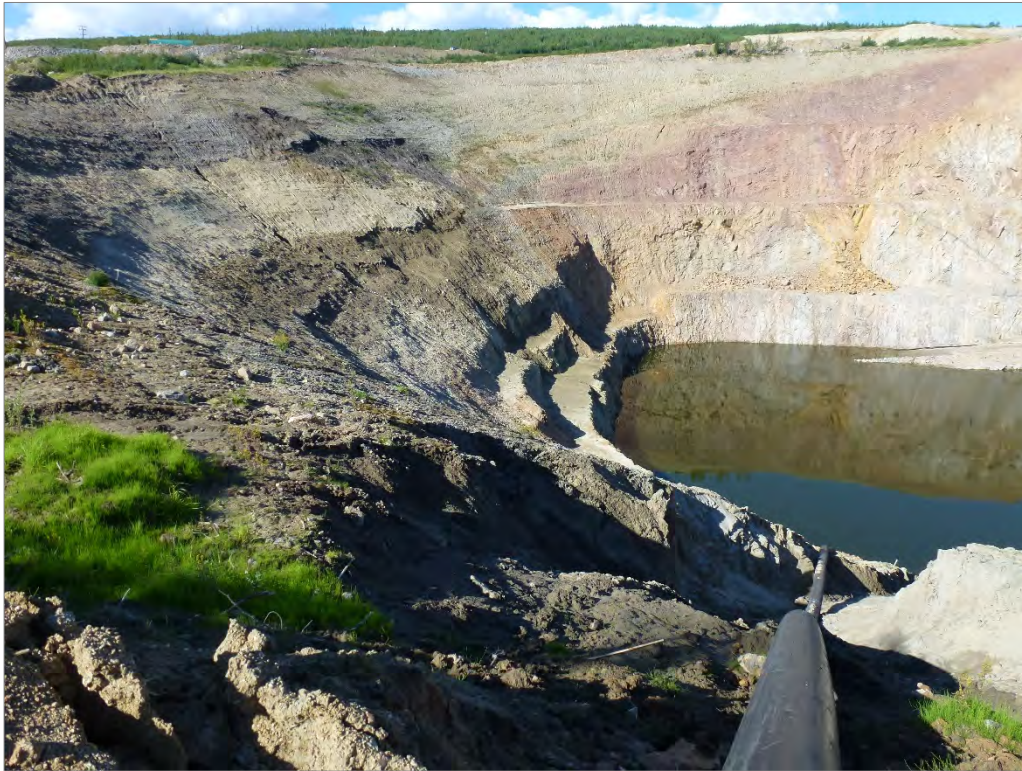
Photo 104: Erosion gully caused by surface water flow from upstream catchment

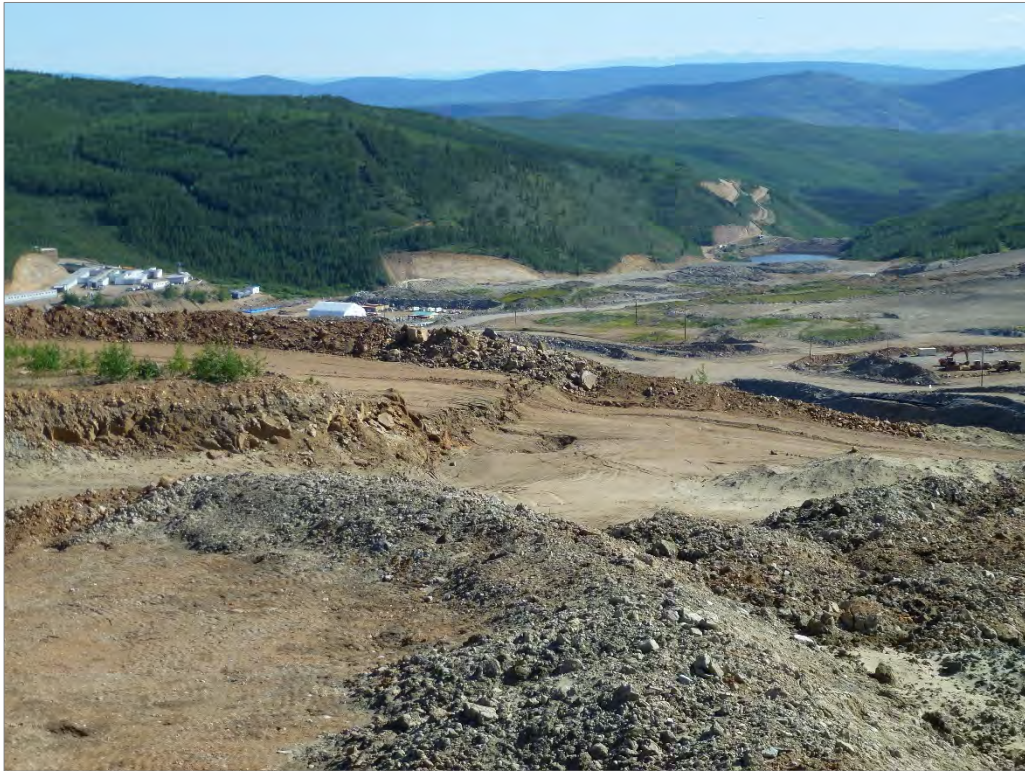
Photo 110: Slumping observed in Backfill Area

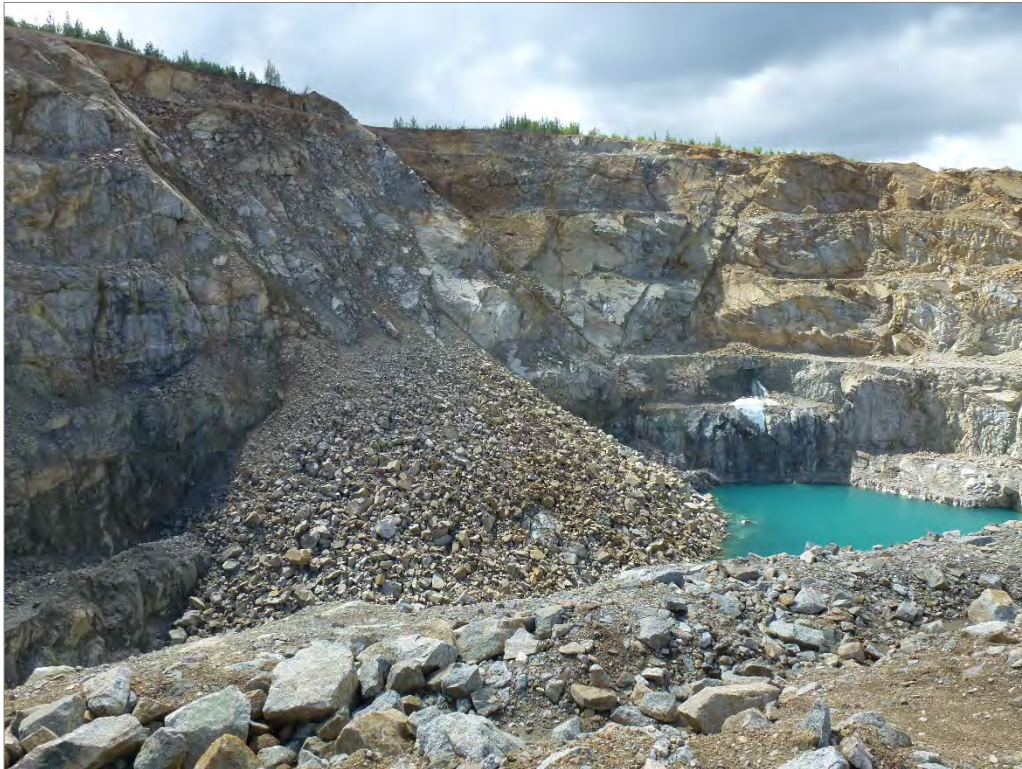
Photo 112: Previous pit wall failure in Minto North Pit (looking southwest)

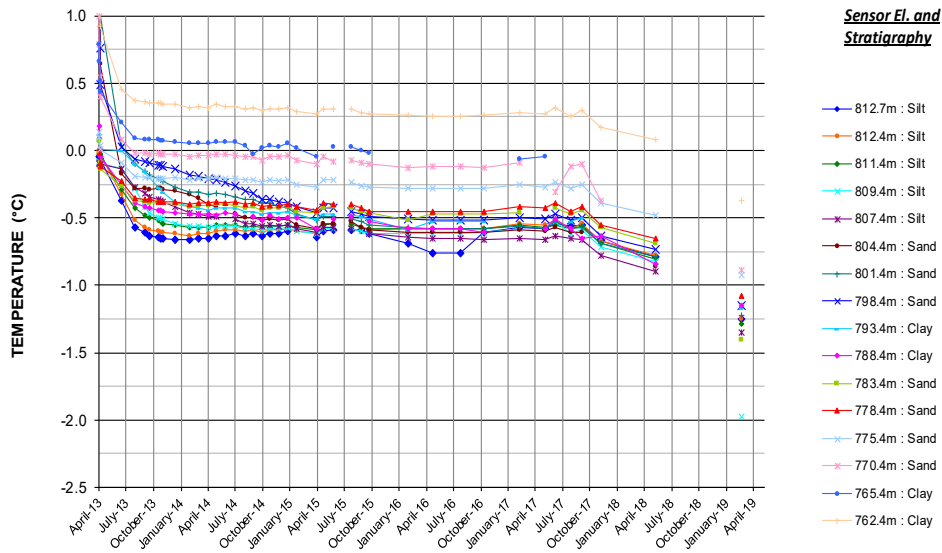
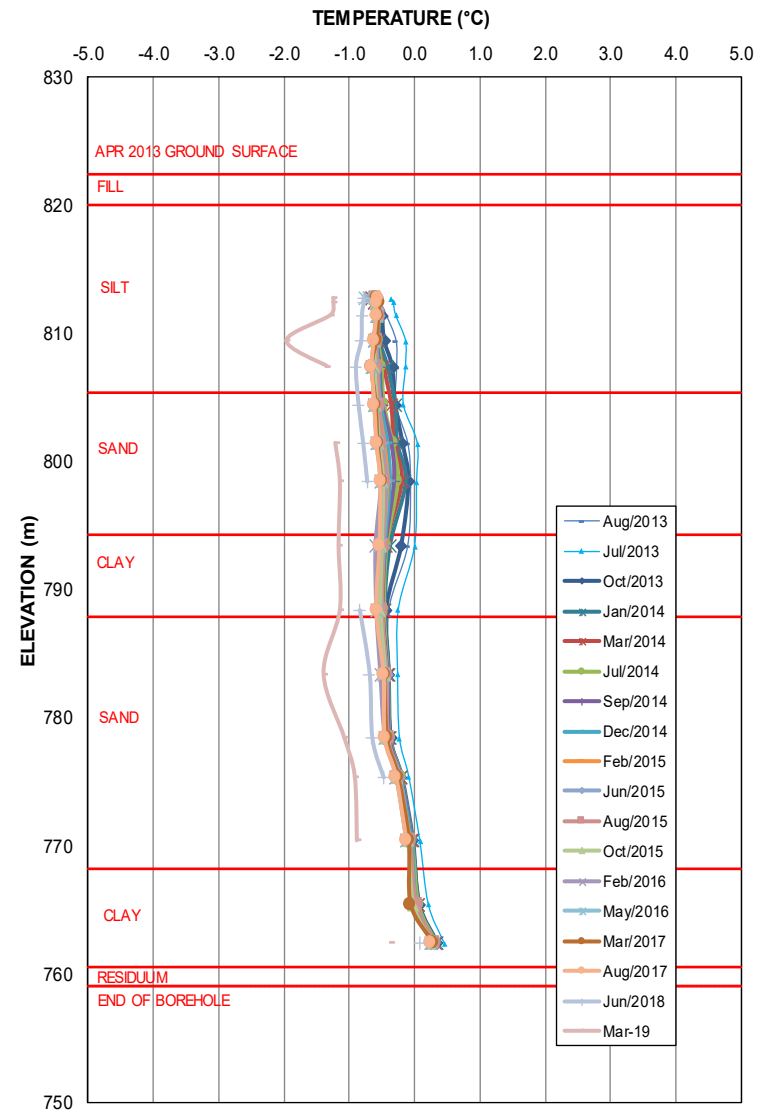
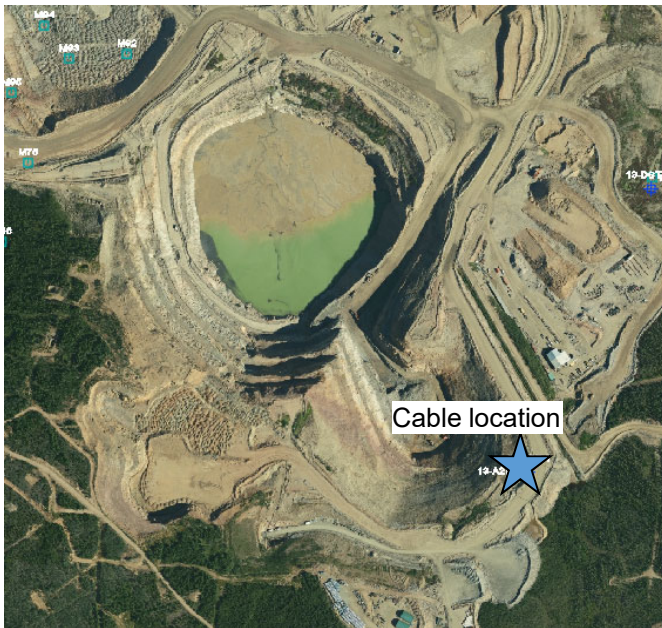
Minto Explorations Ltd.	Area 2 Pit Instrumentation Data		
	Minto Mine	Inclinometer A2I-1		
Job No: 1CM002.066 Filename: ApC_2019Area2Pit.pptx		Date: August 2019	Prepared by PHM	Figure: 1

The ground temperature data indicates permafrost conditions are present. The ground temperatures have shown an increased cooling trend in the past year, which is likely related to mining of the Area 2 Stage 3 Pit, with all temperature sensors now indicating frozen conditions.

- Notes:
- Cooling trend observed in beginning in the fall of 2017 may be due to mining of the Area 2 Stage 3 Pit.
