MINTO
EXPLORATIONS

Spring 2020 Geotechnical Inspection

Minto Mine

June 2020

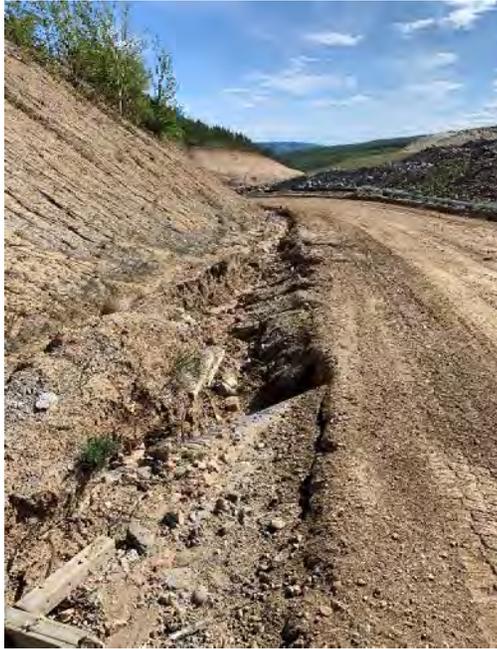
- Road is in good condition, except at between km 0 to 0.25.
- Apparent flows at Km 18.75 Culverts. evidence of recent repairs to road (unreported).
- Big Creek bridge abutments in good repair with no displaced rip-rap.

Photo 1: Heavy Erosion channel on North ditch KM 0 - 0.25

Facility	Ref. no.	Recommendation	Responsible Party / Target Date
Access Road	2020.1.1.1	(Medium Priority) Consider repairs to access road km 0 – km 0.25 - Large erosion gullies on north ditch.	Site Services / Summer 2020
Area 2 Stage 2 and Stage 3 Expansion Pits	2020.1.2.1	Stage 2: Tailings discharge pipe to be monitored during monthly inspections to ensure discharge into pit is not affected.	Mill / Ongoing
	2020.1.2.2	Stage 3: Continue to monitor water levels and pumping rates	Environment / Ongoing
	2020.1.2.3	Stage 3: Monitor overburden slope for erosion and slumping. Check crest of overburden slope for tension cracking and monitor survey hubs for accelerated movement.	Mine Tech / Ongoing
Big Creek Bridge	2020.1.3.1	(Medium Priority) Consider clearing vegetation from first culvert west of bridge.	Site Services / Summer 2020
Camp Site	2020.1.4.1	Continue to monitor erosion of slopes, especially following heavy rainfalls.	Site services / Ongoing

- Repair erosion channels in road between km0 and km 0.25.

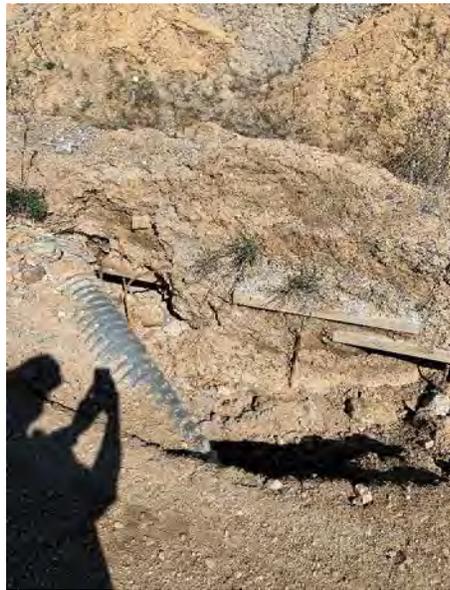
Photo 2: Heavy Erosion channel on North ditch KM 0 - 0.25

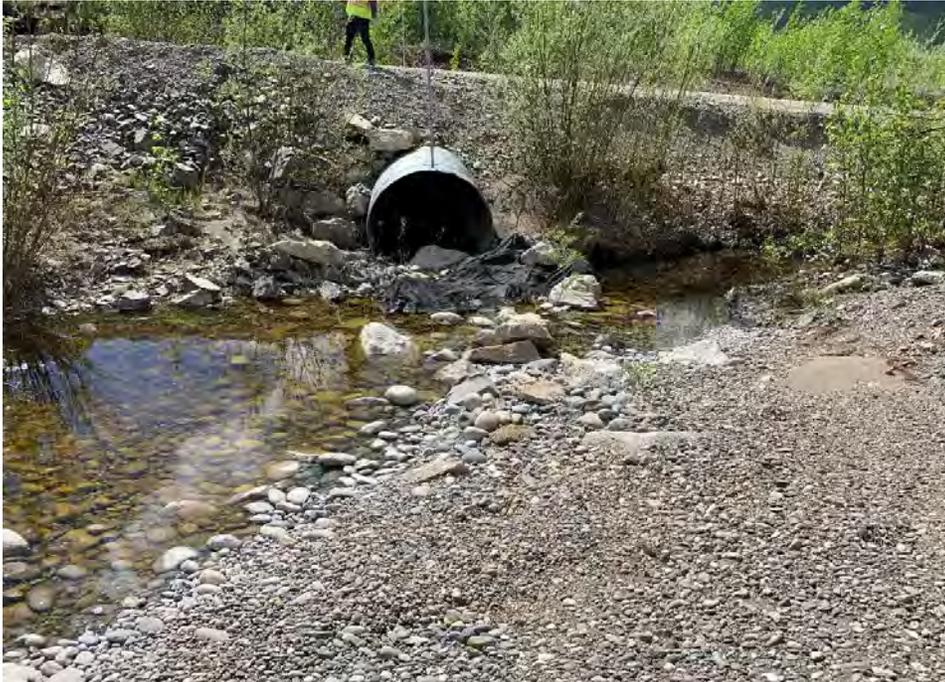
Photo 3: Big Creek Overflow Area

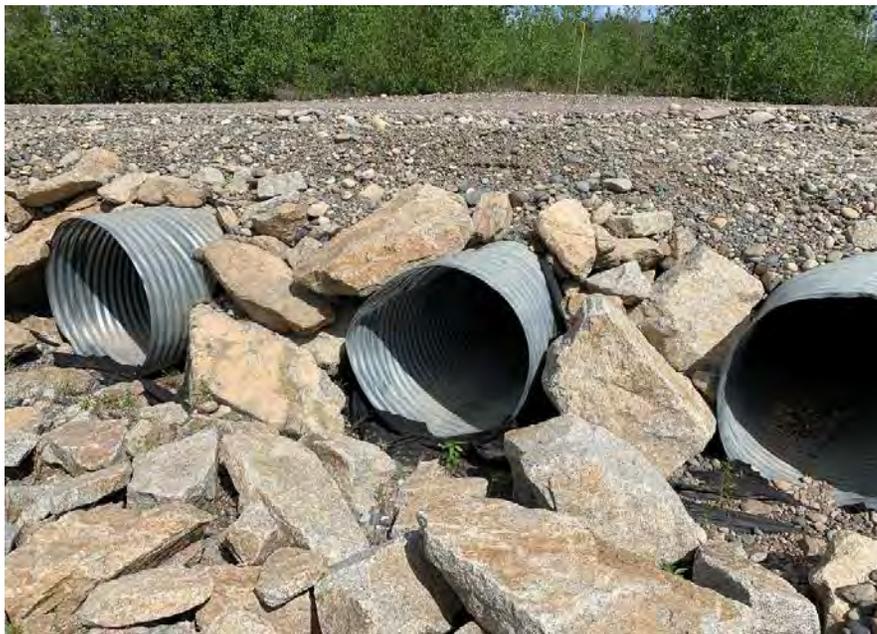
Photo 4: Aparent new material placed at Km 18.75.

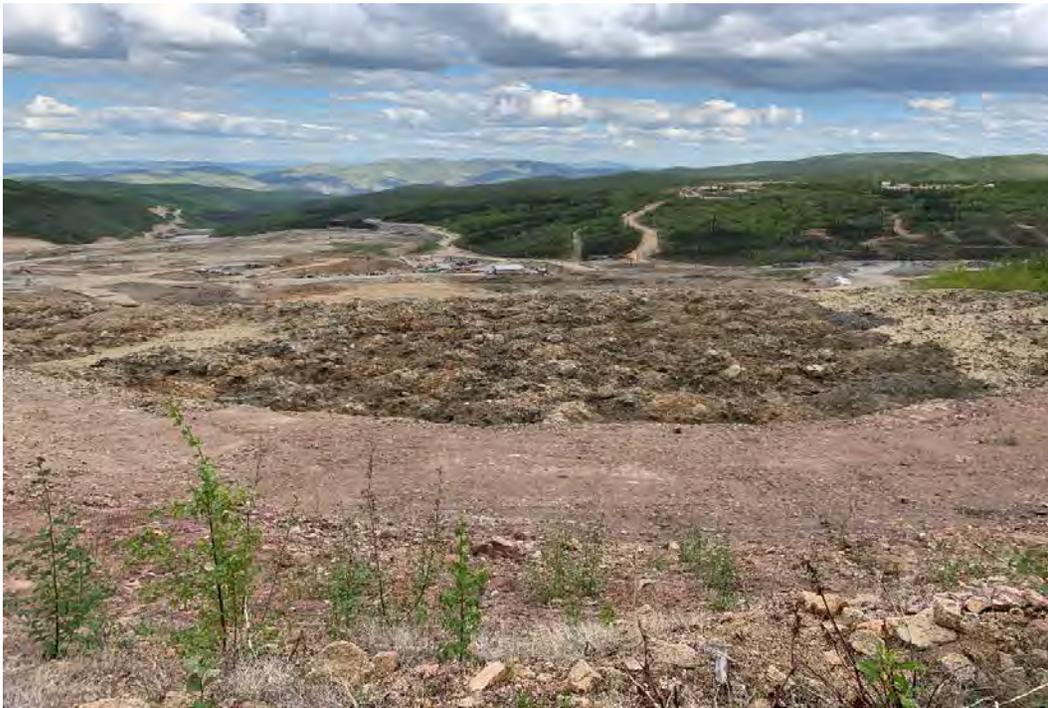
Photo 2: No slumping or issues with north/west highwall.

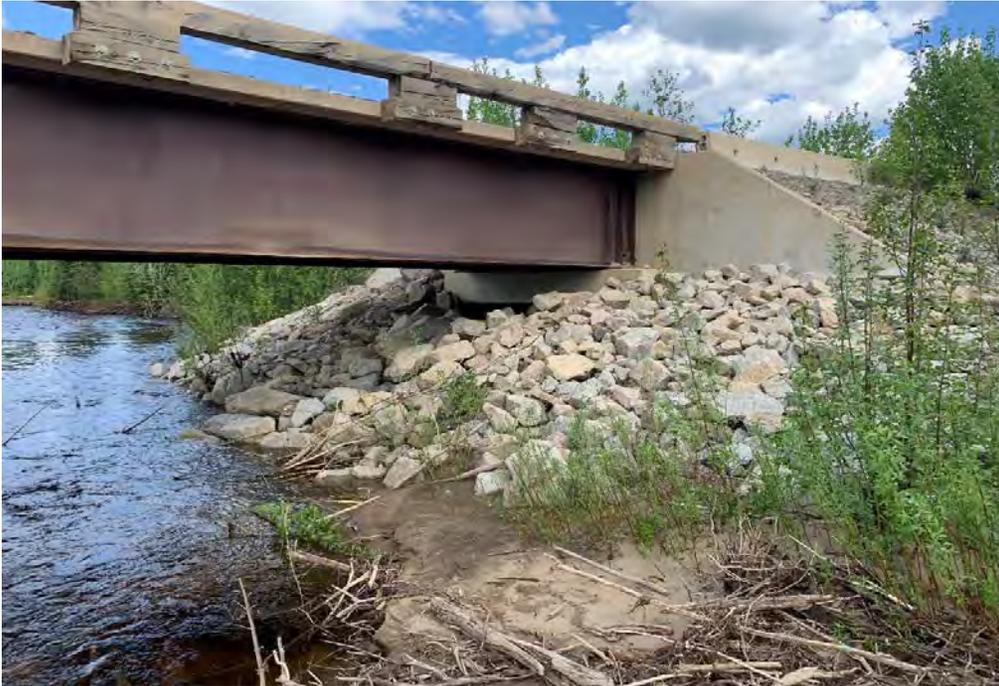
Photo 1: East abutment of bridge

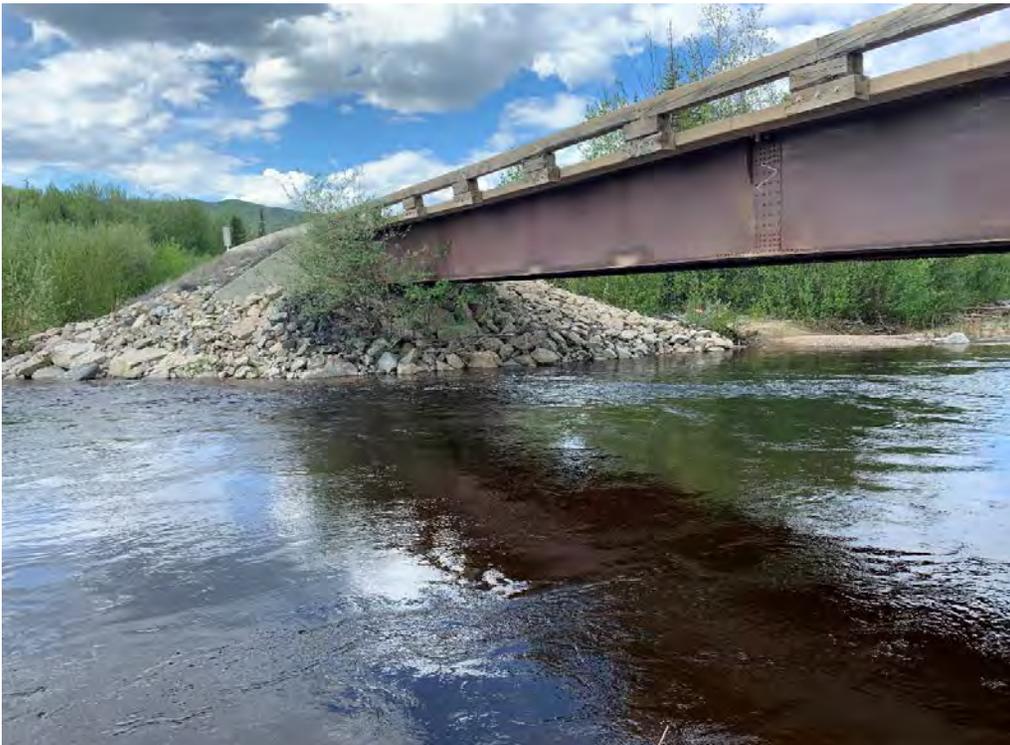
Photo 2: West abutment of bridge

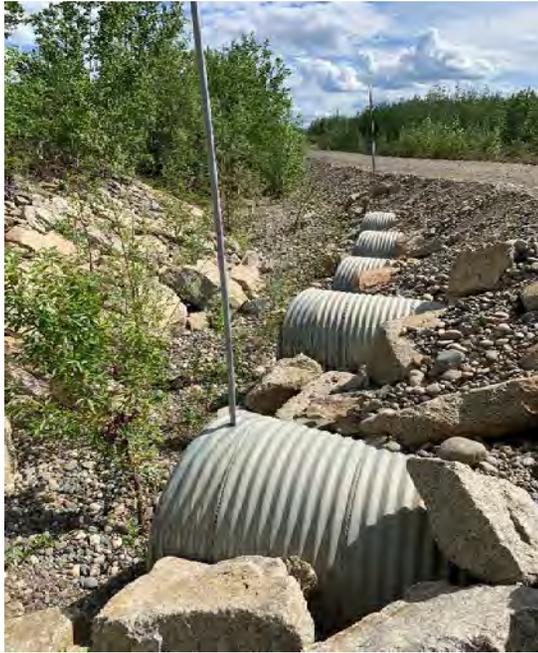
Photo 3: Five culverts (north side looking east)

- Clean up gravel accumulating around five culverts.
- Consider clearing vegetation from first culvert west of bridge.
- Continue monitoring culverts during inspections for sediment accumulation and other impediments to flow.

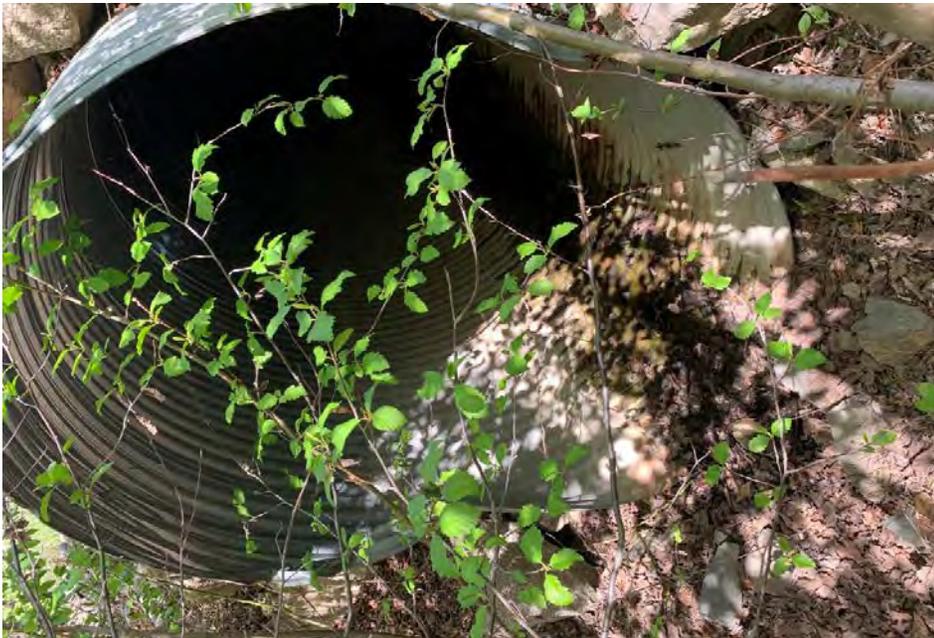
Photo 4: Second culvert west of bridge

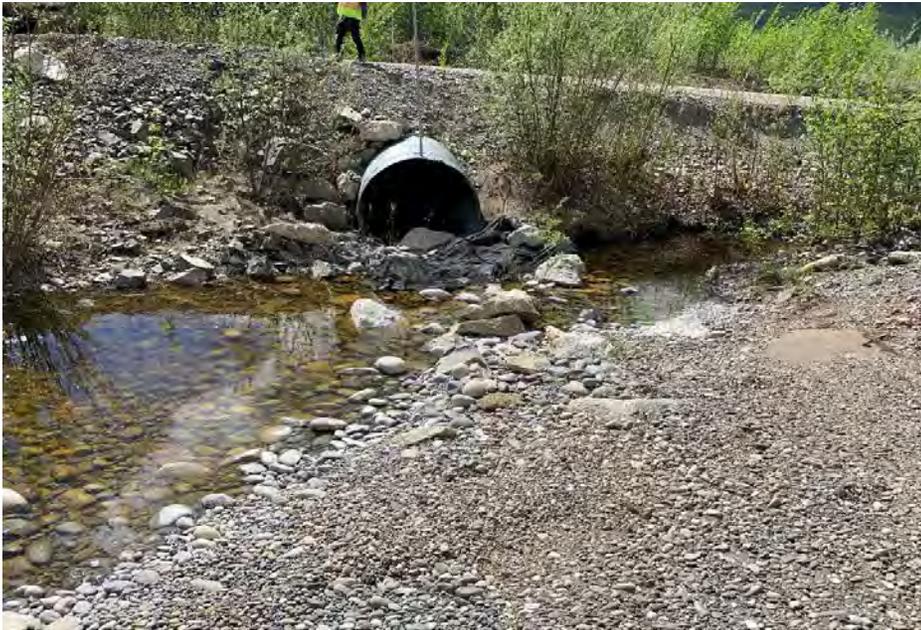
Photo 5: Standing water showing gravel movement through culverts

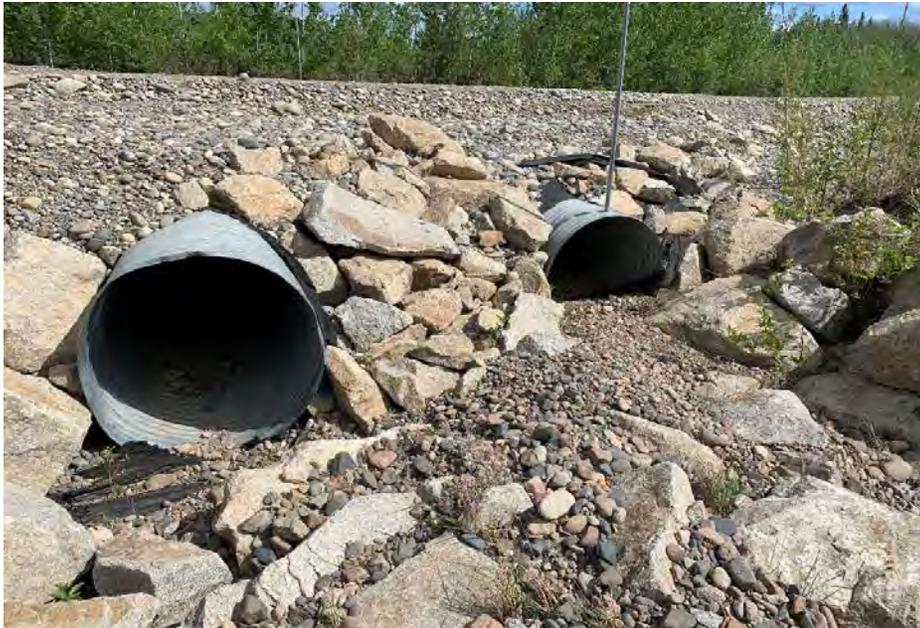
Photo 6: Photo showing gravel movement through culverts

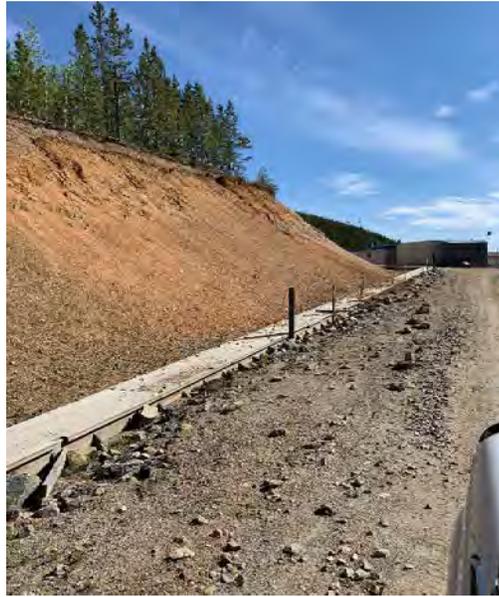
Photo 1: Slope behind camp looking east.

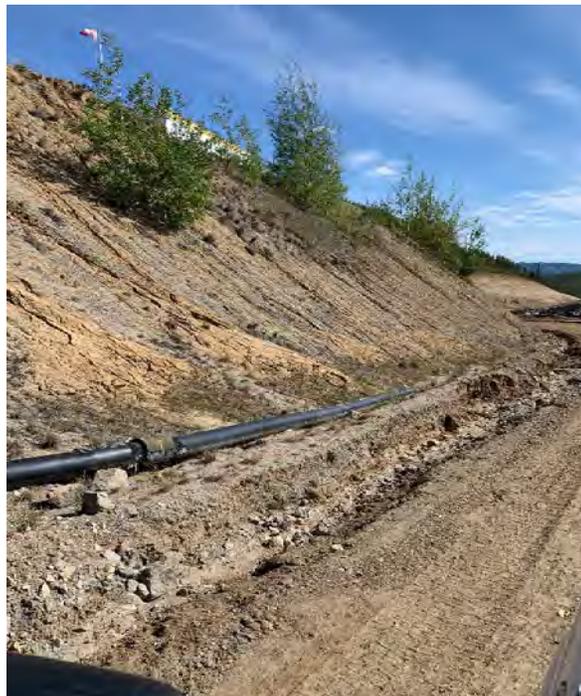
Photo 2: Slope below camp looking east. Note deep erosion channel in road prior to ditch.

- Fill in/repair km 0 - km 0.25.
- Continue to monitor erosion of slopes, especially following heavy rainfall.

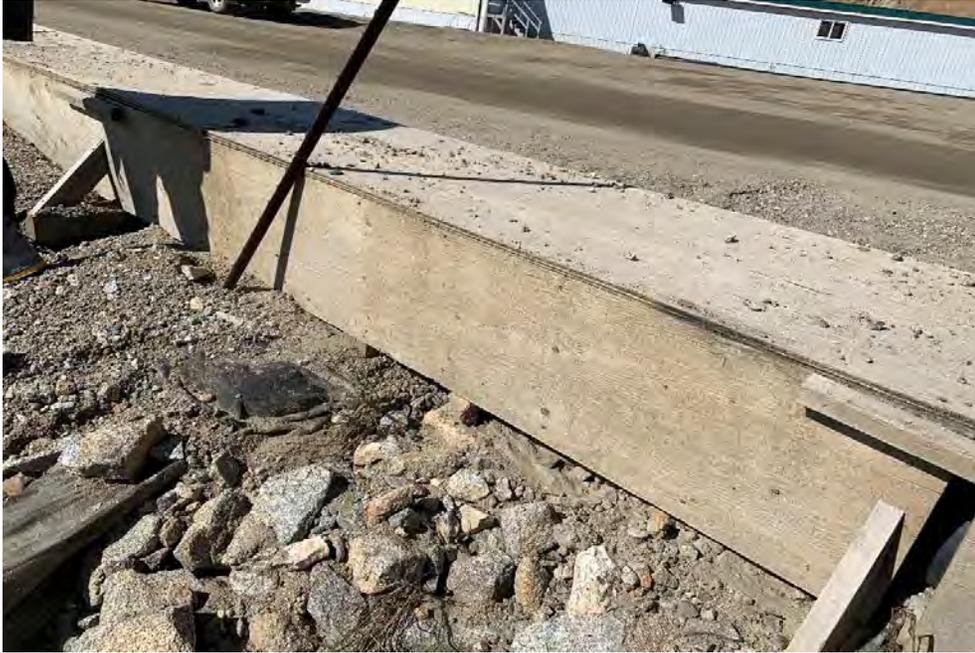
Photo 3: Example of erosion under utilidor.

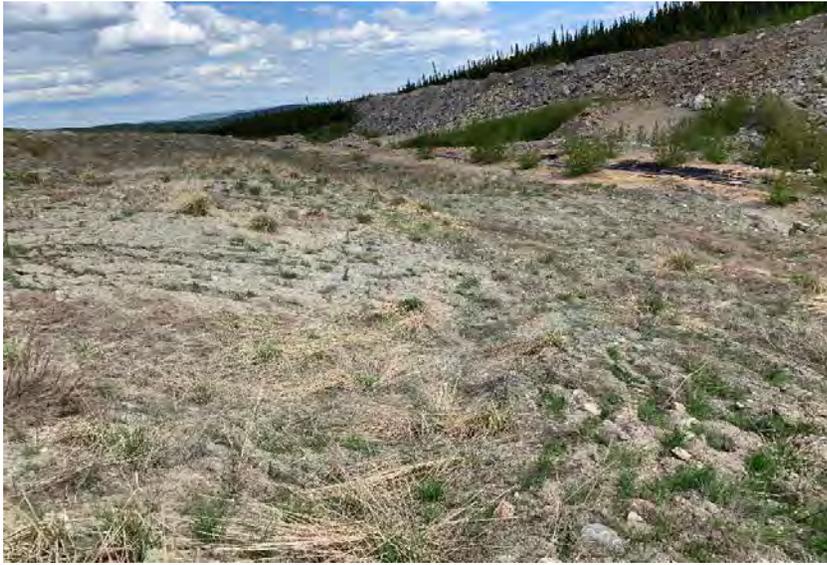
Photo 1: Looking east at DSTSF revegetated slope.

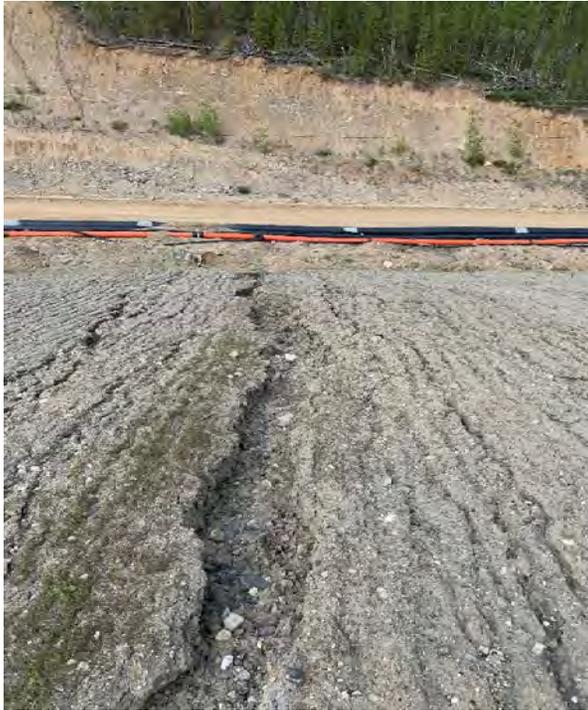
Photo 2: Looking north on MVFE2 at erosion crack (typical).

- Continue to monitor erosion /runoff channels on MVFE2. Note Self-armouring and measure depth to waste rock where exposed.

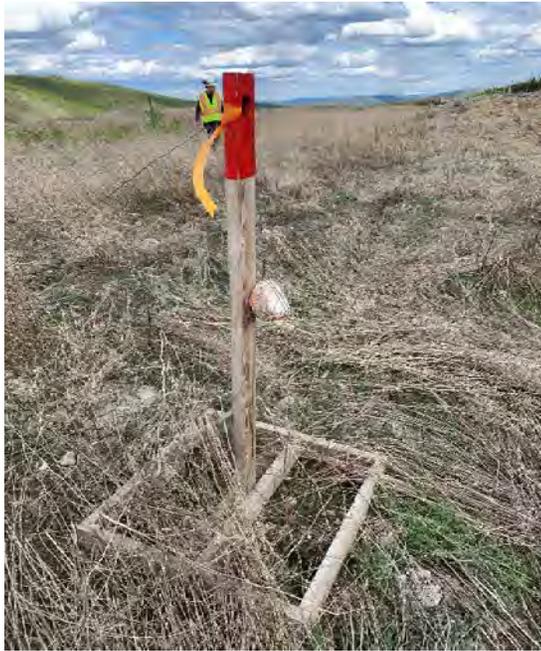
Photo 3: Extensometer that remains, No movement since 2017.

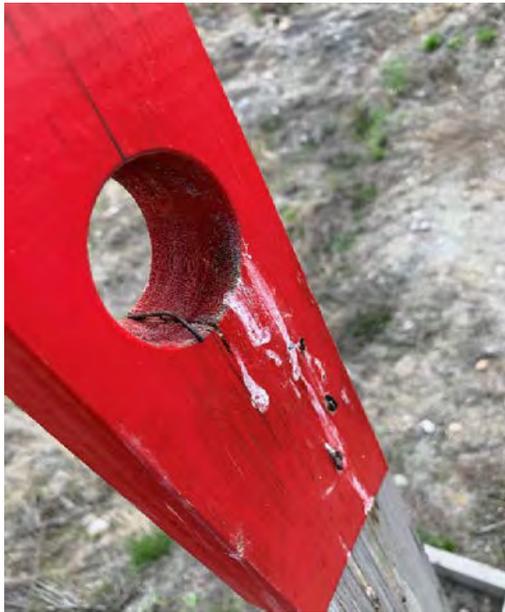
Photo 4: Western extensometer, wire has broken, but no apparent movement.

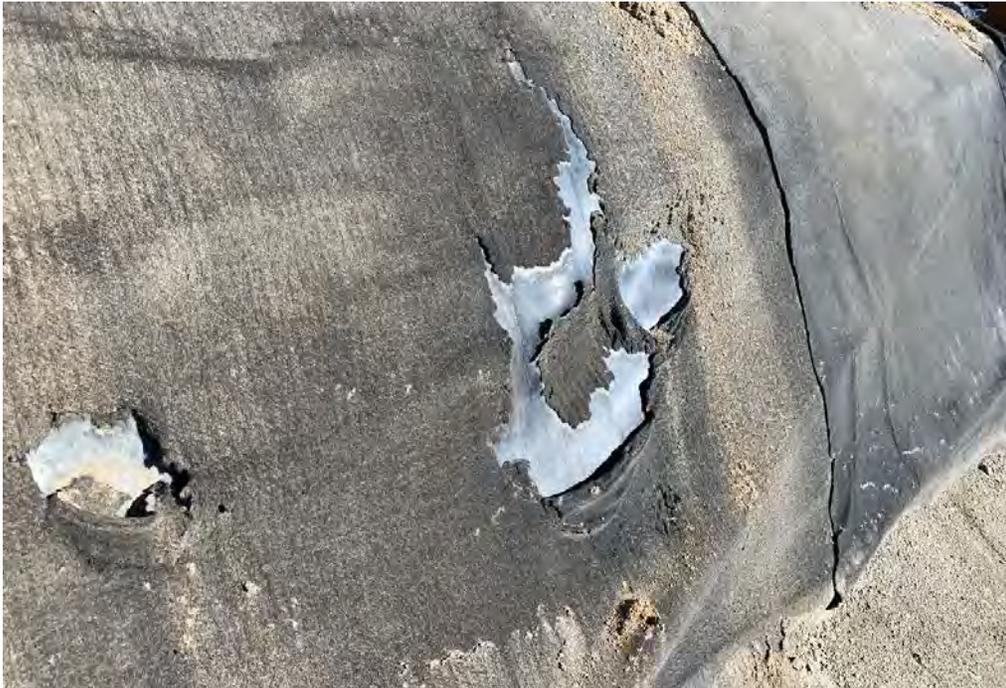
Photo 3: Looking inside containment, bear has damaged filter cloth, but no damage to liner.

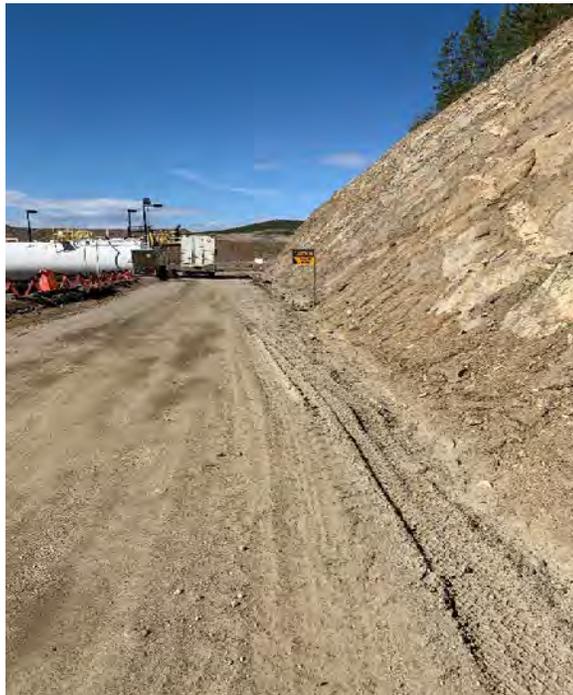
Photo 4: Looking west along slope on north side of facility. Falling rock signs in place.

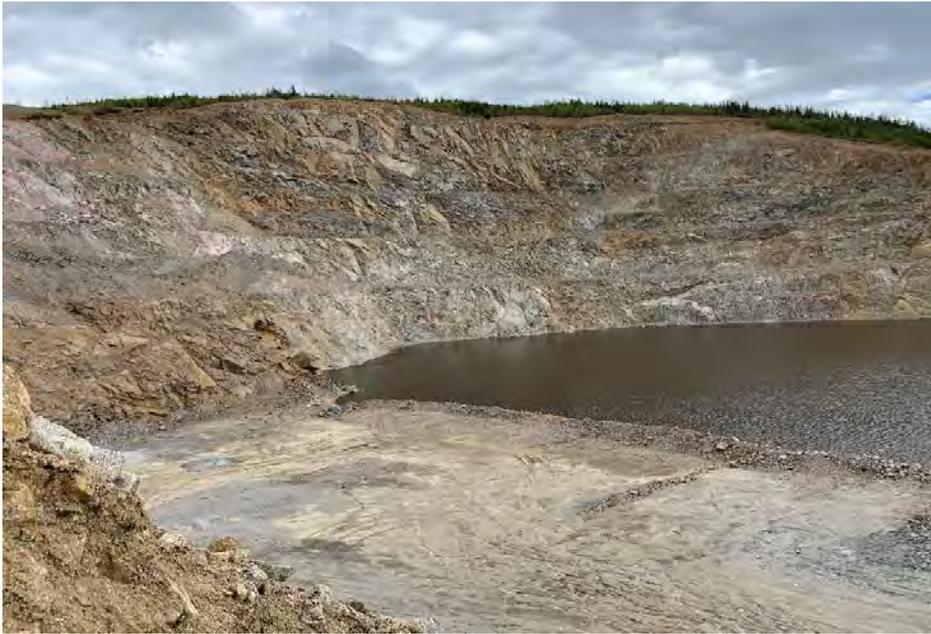
Photo 1: In-Pit PAG Dump Looking Northeast.

- Long-term plan for SAT (PAG) material to be buried.

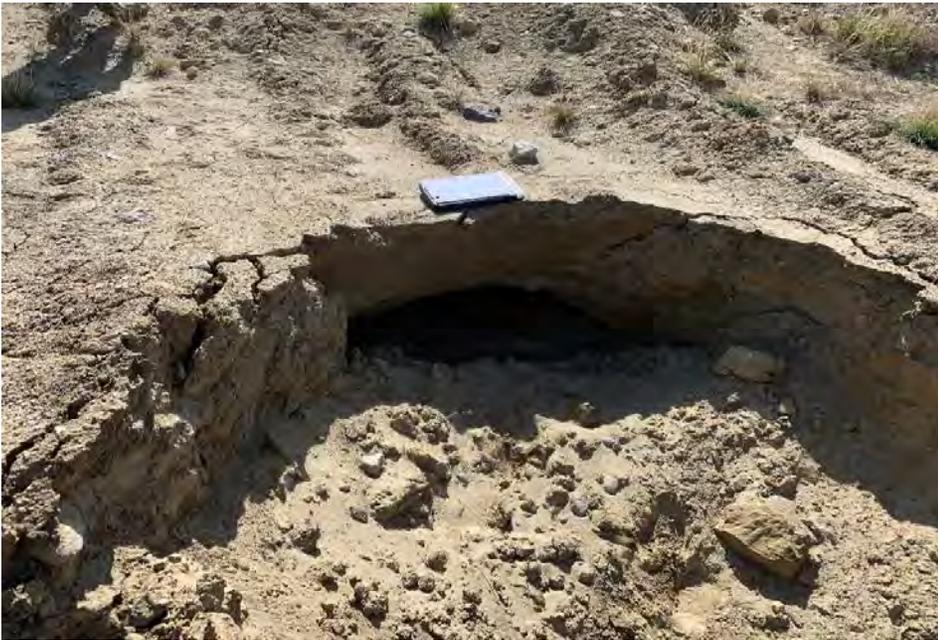
Photo 1: Pondered water drained through "rathole"

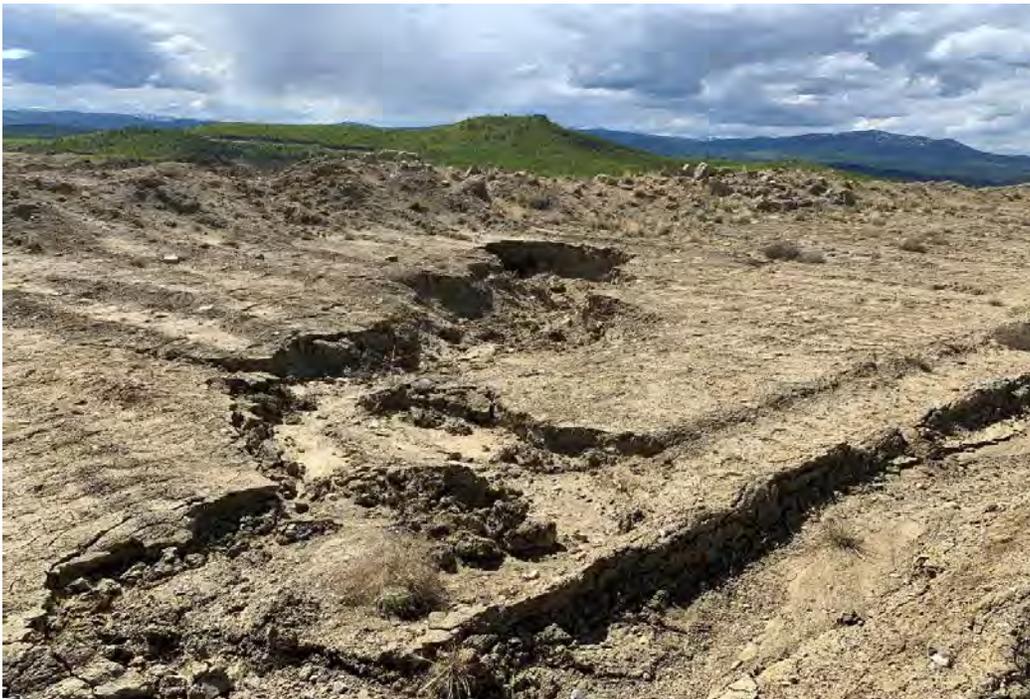
Photo 2: Surface erosion on top of MWD.

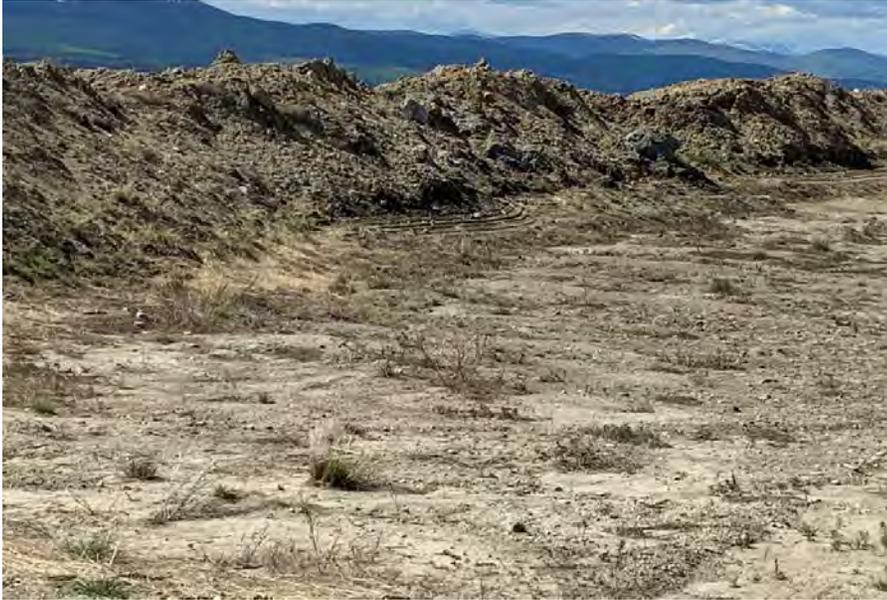
Photo 3: Top of MWD, showing ponded erosion from wave action and high water mark.

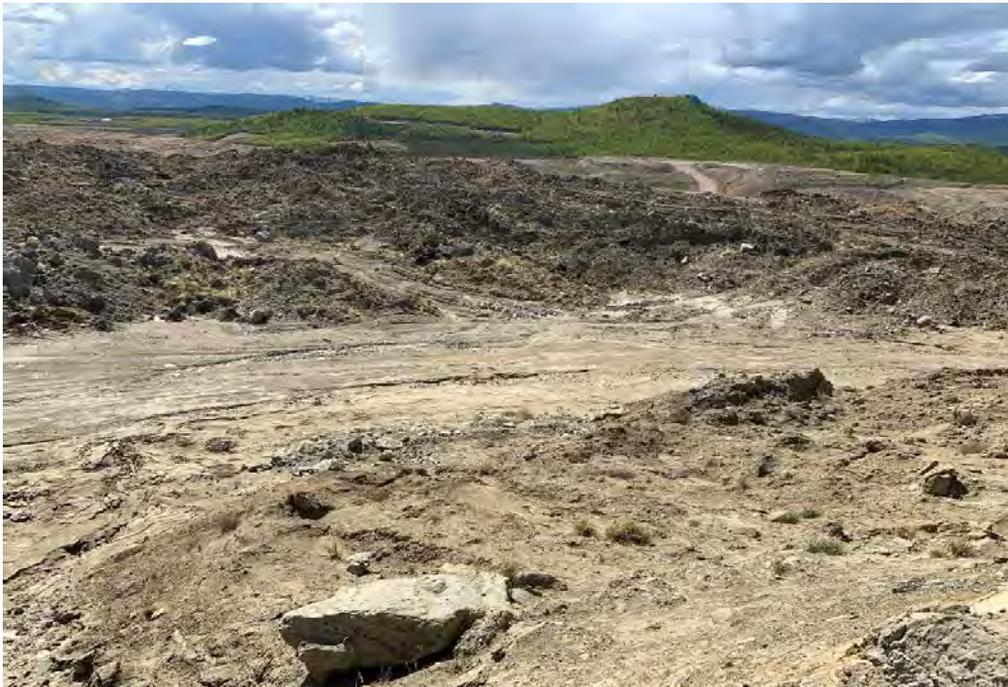
Photo 4: Area below "rathole" - No significant erosional damage.

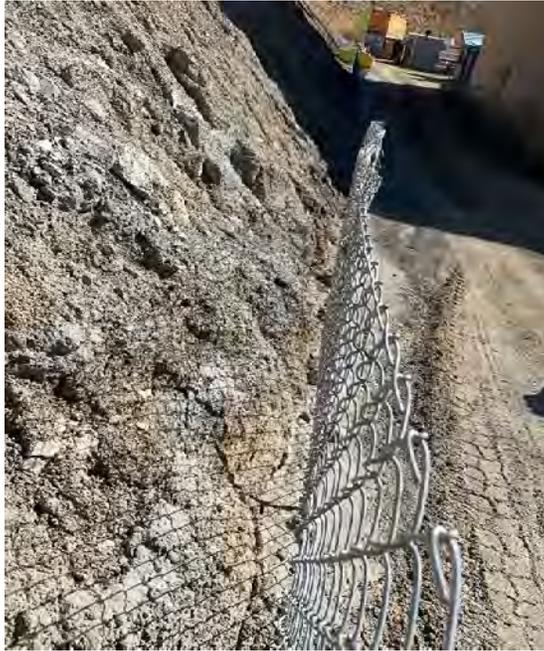
Photo 1: Looking east along 2019 installed fencing

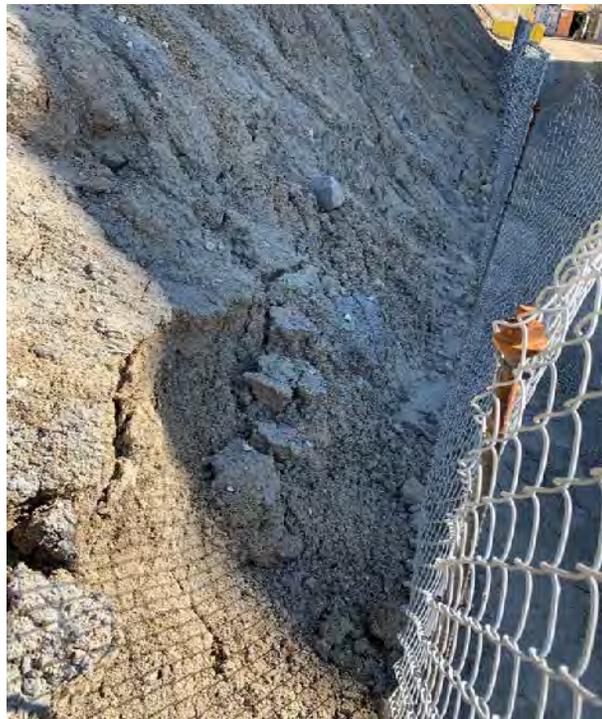
Photo 2: Slope below fuel farm/behind mill looking west. Note undercut slope that needs backfilling.

- Backfill over excavated slop at base of hill (Behind and below fencing)
- Continue to Monitor displacement of lock blocks.

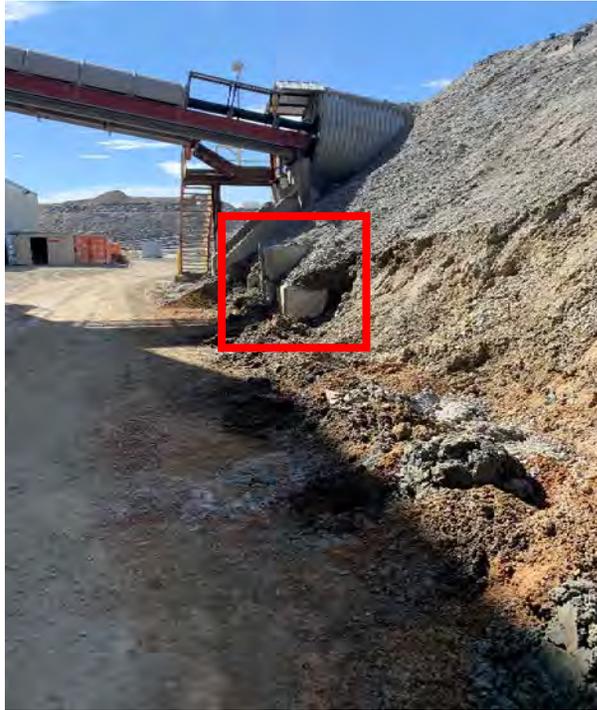
Photo 3: View of mill feed conveyor and bulging lock blocks.

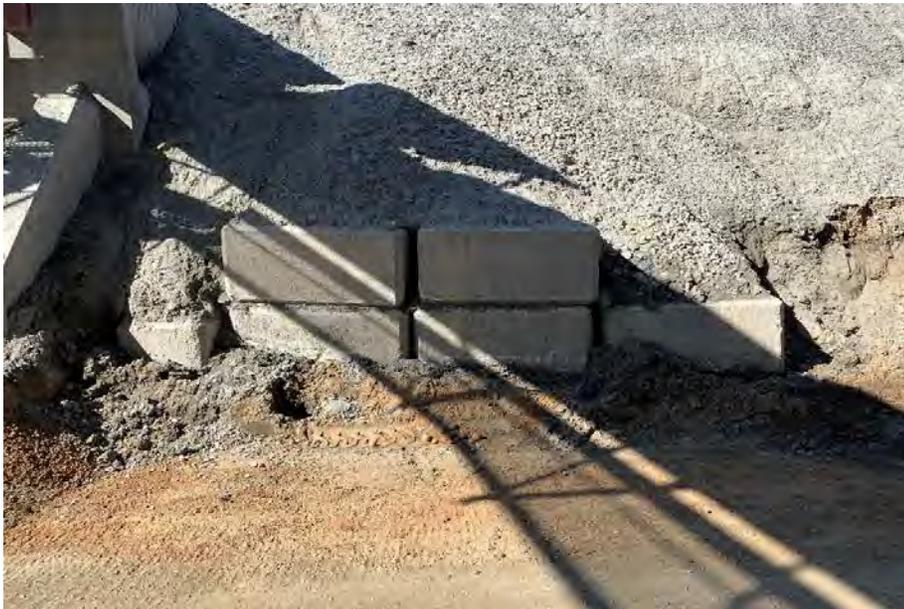
Photo 4: View of mill feed conveyor and bulging lock blocks from the front.

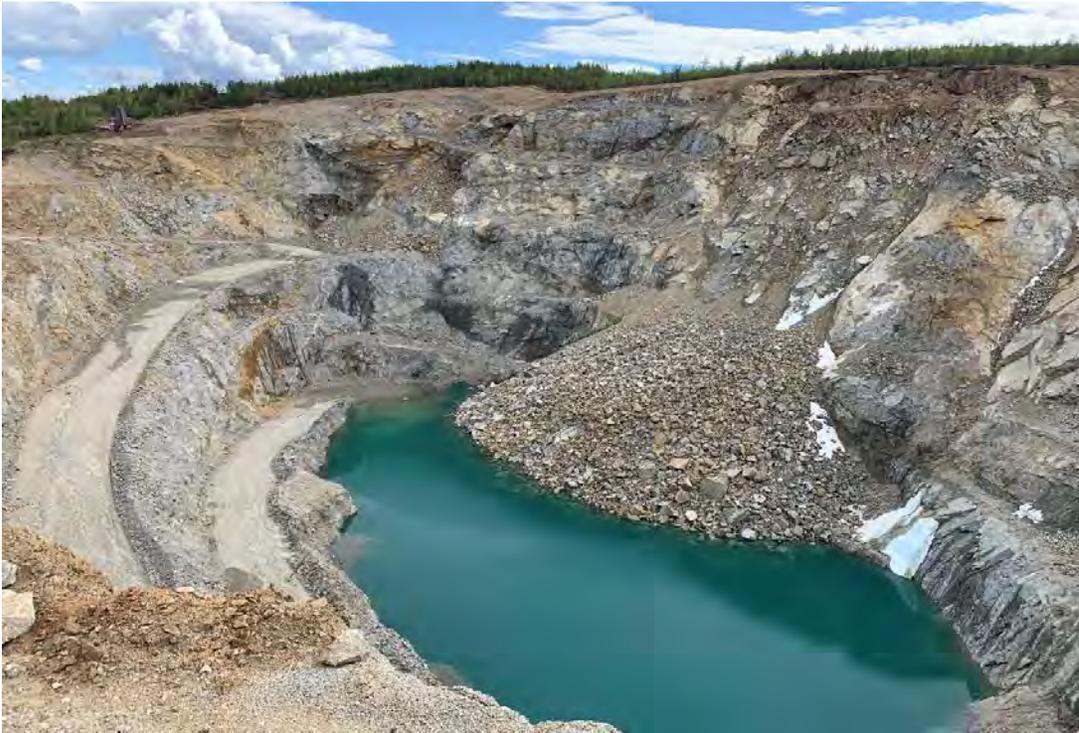
Photo 1: Wedge 1.5/South wall

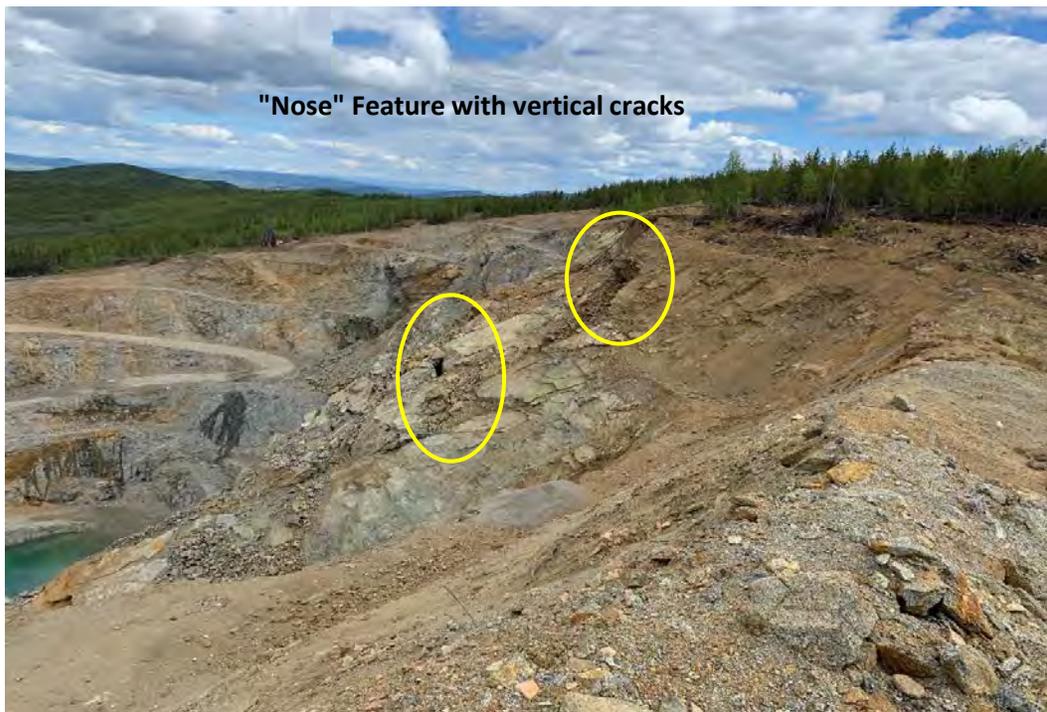
- No new slope failures on walls or visible increase to rockfall from existing failures
- "Nose" feature on south slope beside fallen wedge seems to be growing but does not appear to be eminent to fall. East, north and West walls seem very stable.
- Access to pit is granted for short durations, such as water sampling and elevation surveys.

Photo 2: North wall and Vertical Cracks in "Nose" feature

- Monitor "Nose" feature for visual changes.

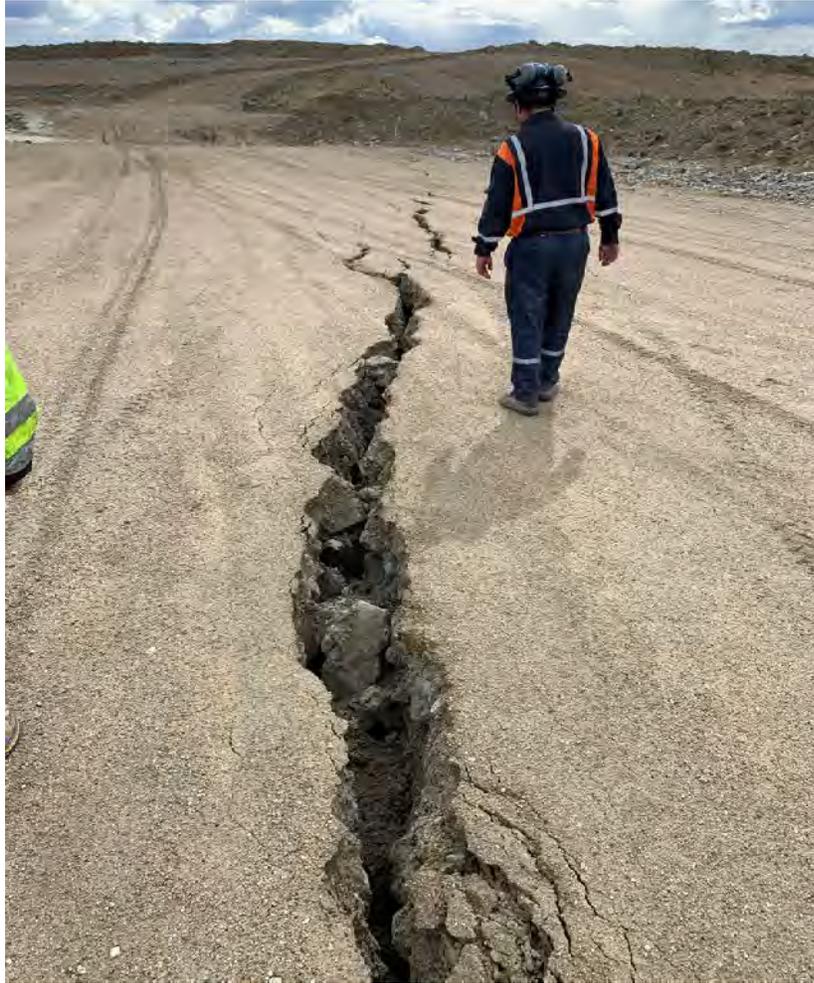
- No stability concerns.
- No new cracking observed. The large crack observed in 2019 has not changed.

Photo 3: Crack on north side of dump at crest.

- Monitor crack on north crest of dump. - Currently measured at 150 m in length, no apparent widening or new cracking since 2019

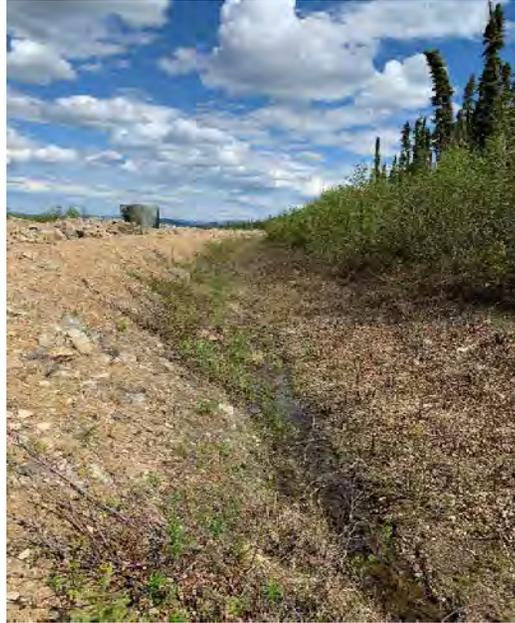
Photo 1: View of the TDD outlet structure looking east over area cleared of excess vegetation.

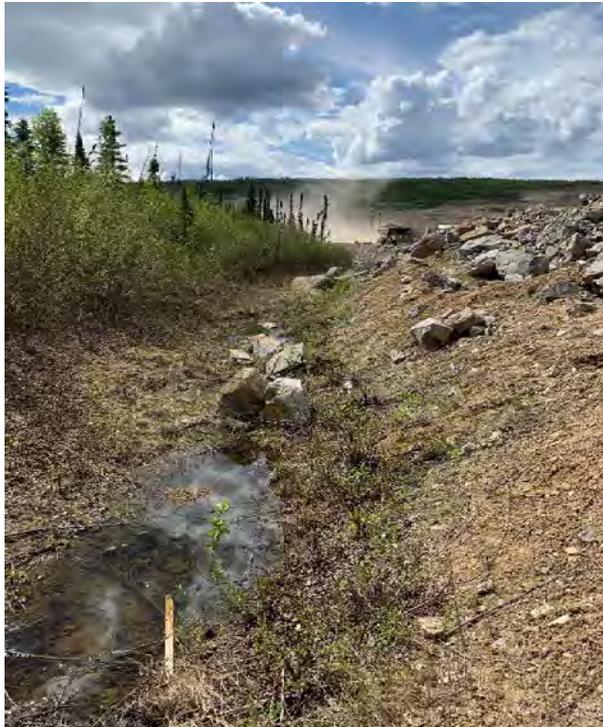
Photo 2: Looking west at TDD outlet channel.
Through area cleared of vegetation.

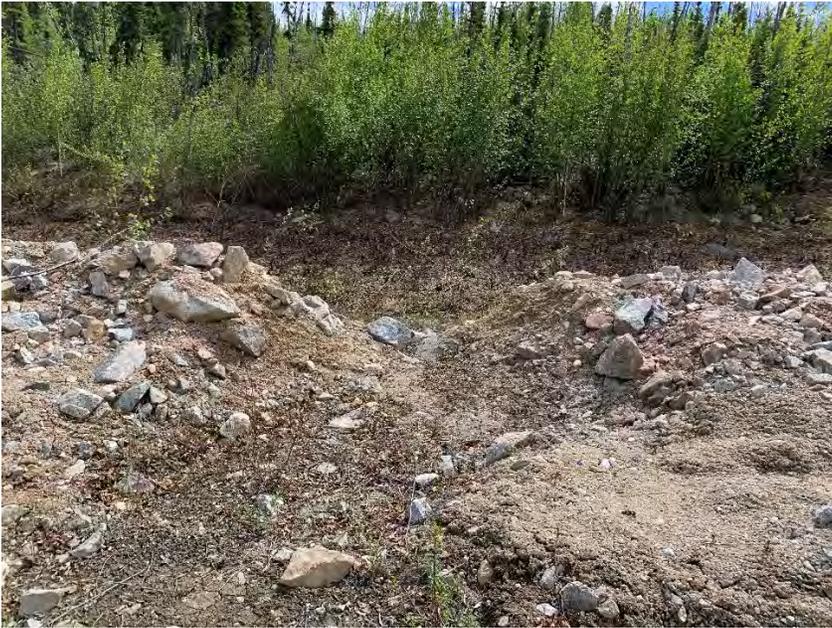
Photo 3: Portion of TDD that appears to have been breached. To be repaired.

Tailings Diversion Ditch	2020.1.11.1	(High Priority) Repair removed portion of the ditch berm (breach) as shown in the inspection photos (Appendix Page 42) .	Mine Tech / October 2020
Water Storage Pond Dam	2020.1.12.1	(High Priority) Continue with efforts to remove debris along face of Dam	Environment / complete in summer 2020.

- Complete TDD intake structure and overflow spillway construction to specifications (scheduled for summer 2020).
- Repair removed portion of ditch berm (breach) in TDD (See photo 3).

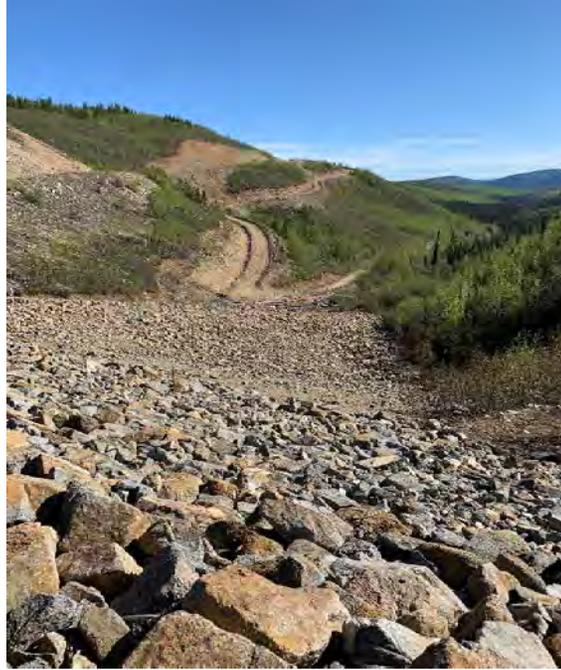
Photo 1: Downstream slope of dam.

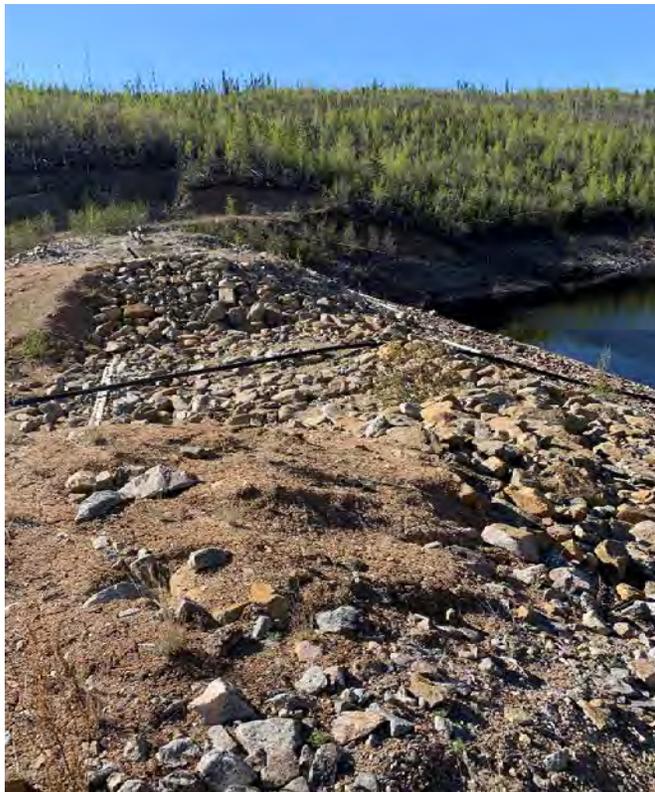
Photo 2: Looking across upstream slope of dam toward right abutment.

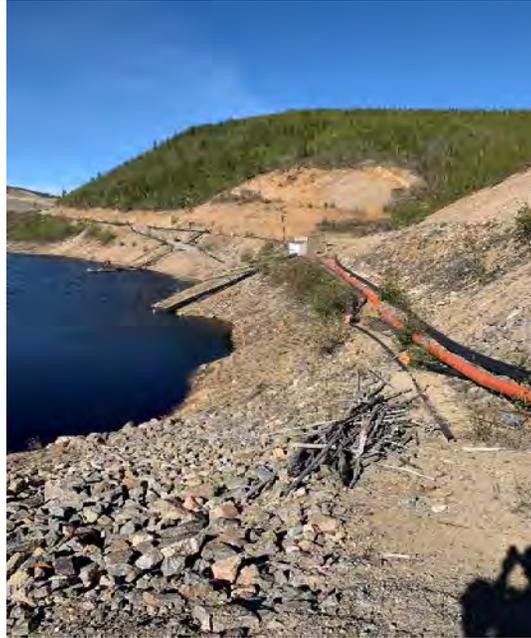
- Pond level is still low, wave action seen in Q2 2019 not significant.
- Left abutment erosion from draining the WSP Discharge line still present and could be considered for armouring.
- Pails covering the piezometers, and thermistors have been replaced.

Photo 3: Looking at left abutment upstream

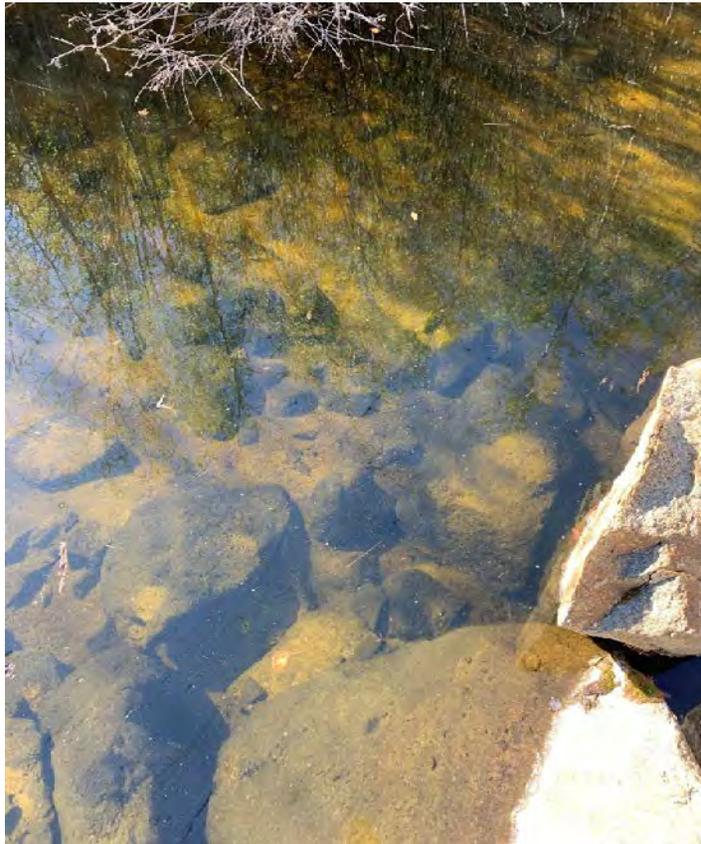
Photo 4: Seepage pond: Clear Water
