Minto Mine
Water Licence QZ96-006

Mine Waste Structures
Deformation Monitoring Plan and Report

Prepared by:
Minto Mine
December 2012

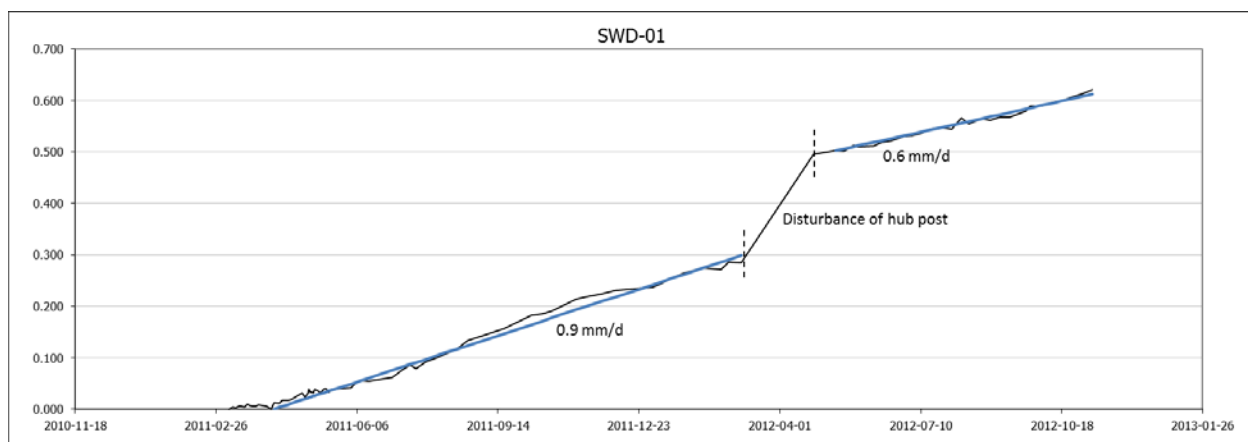
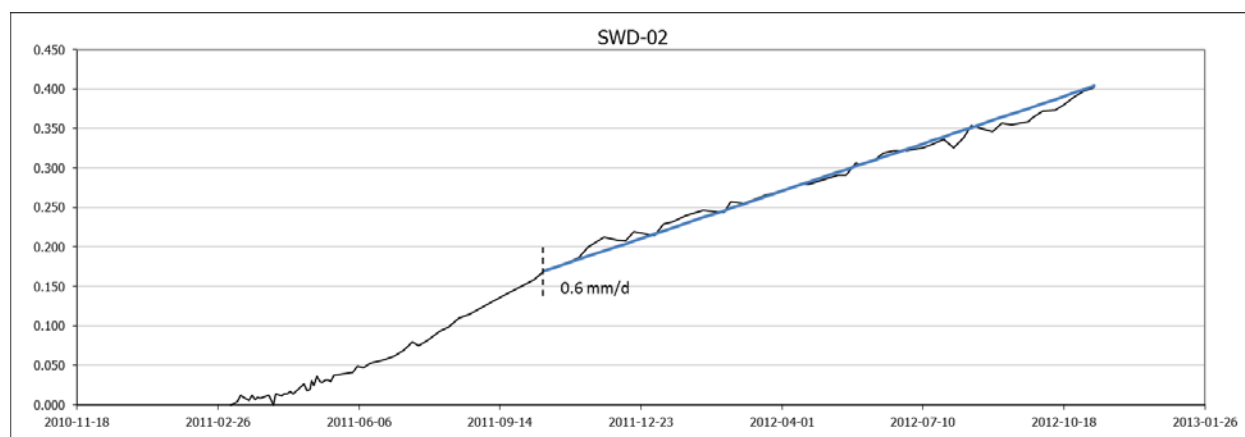
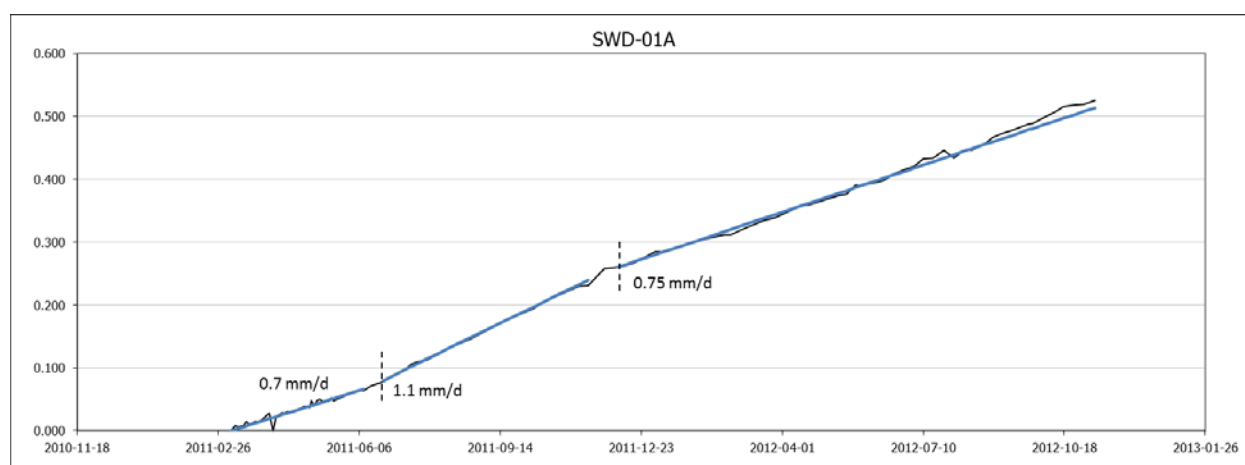
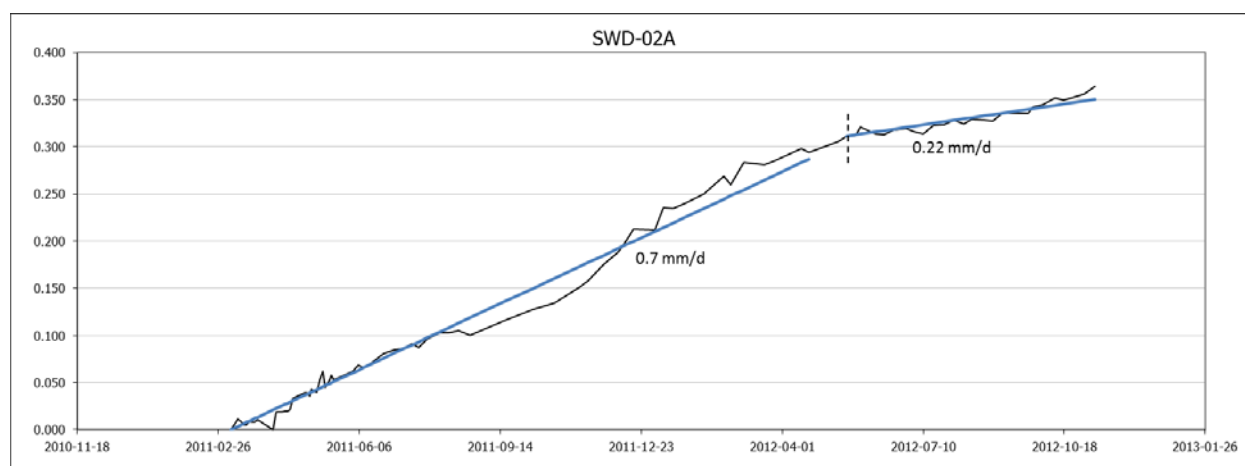
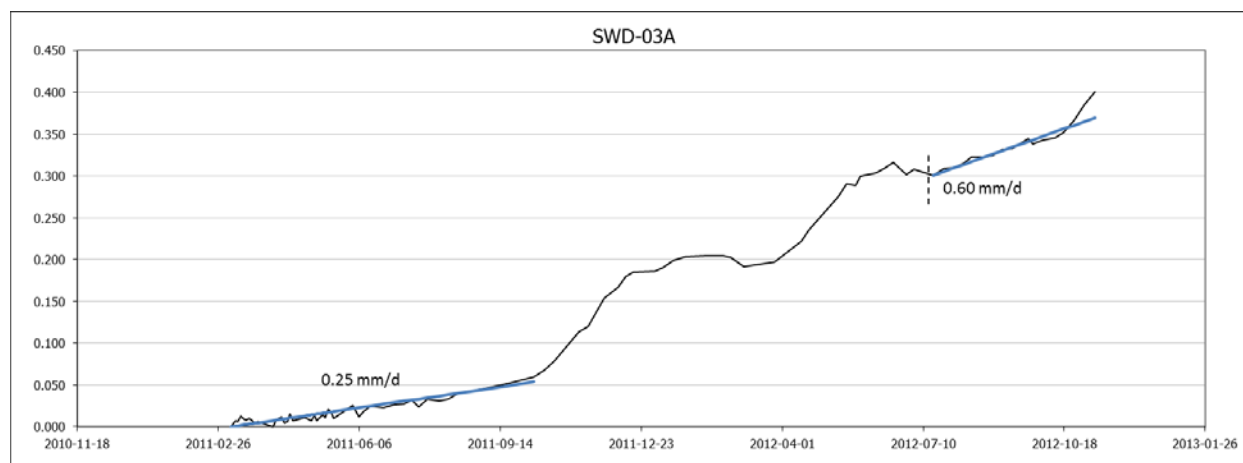
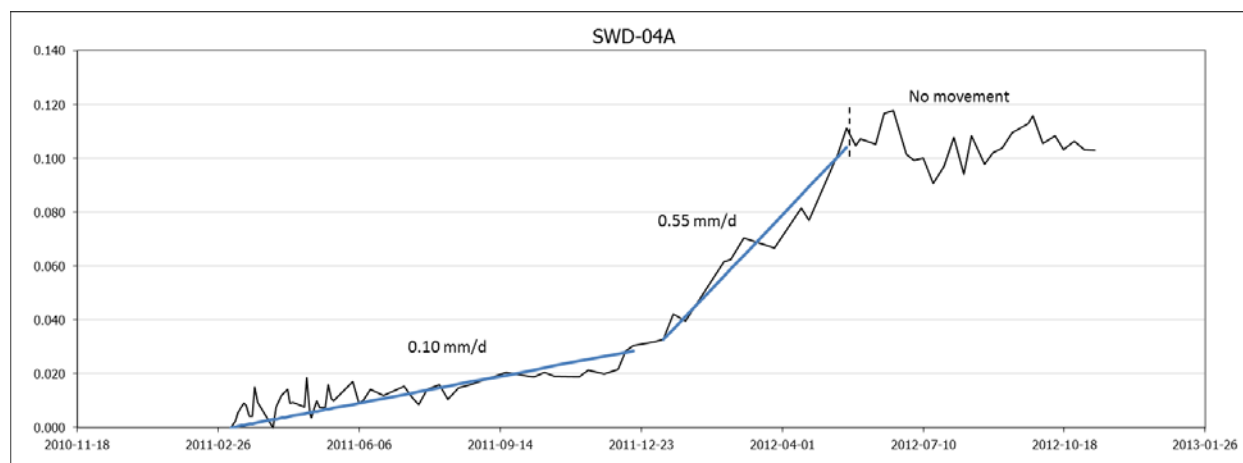
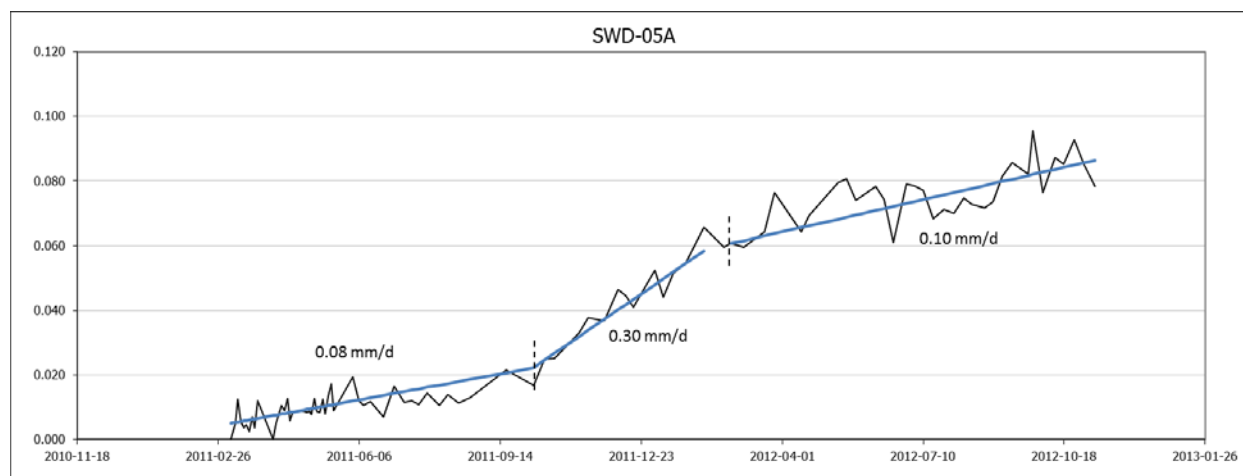
The following figures contain data from survey hubs located at the toe of the Southwest Dump.

The movement rates seen in the northeast corner of the dump indicates influence by the Area 1 pit South Wall failure; however, the movement rates seen at the toe of the dump are considerably slower than those near the rim of the pit.

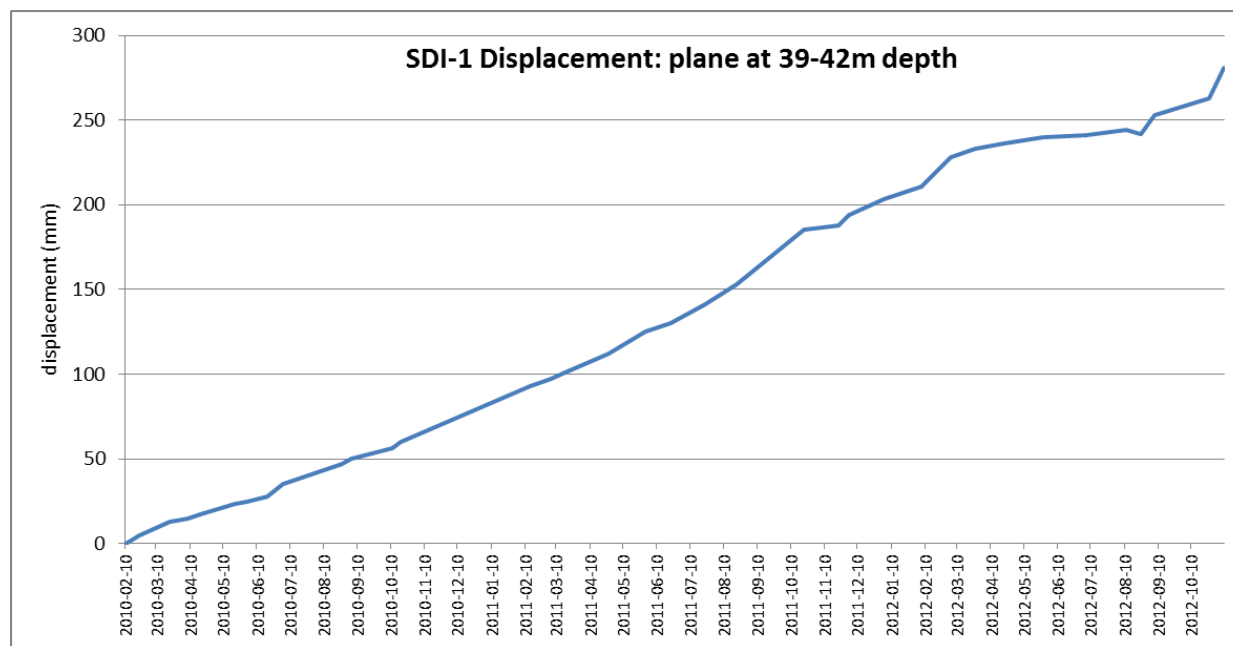
Figure 5-8: Southwest Dump SDI-1 Inclinometer Data

The SWD is also monitored by two inclinometers. SDI-1 is located directly adjacent to survey hub SWD-01A near the rim of the Area 1 pit. It shows approximately 280mm of displacement along a shear plane between 39 and 42m depth, moving at an average rate of 0.28 mm/d. The rate of this movement is plotted in Figure 5-8 ; it shows movement at a near constant rate since monitoring began in February of 2010.

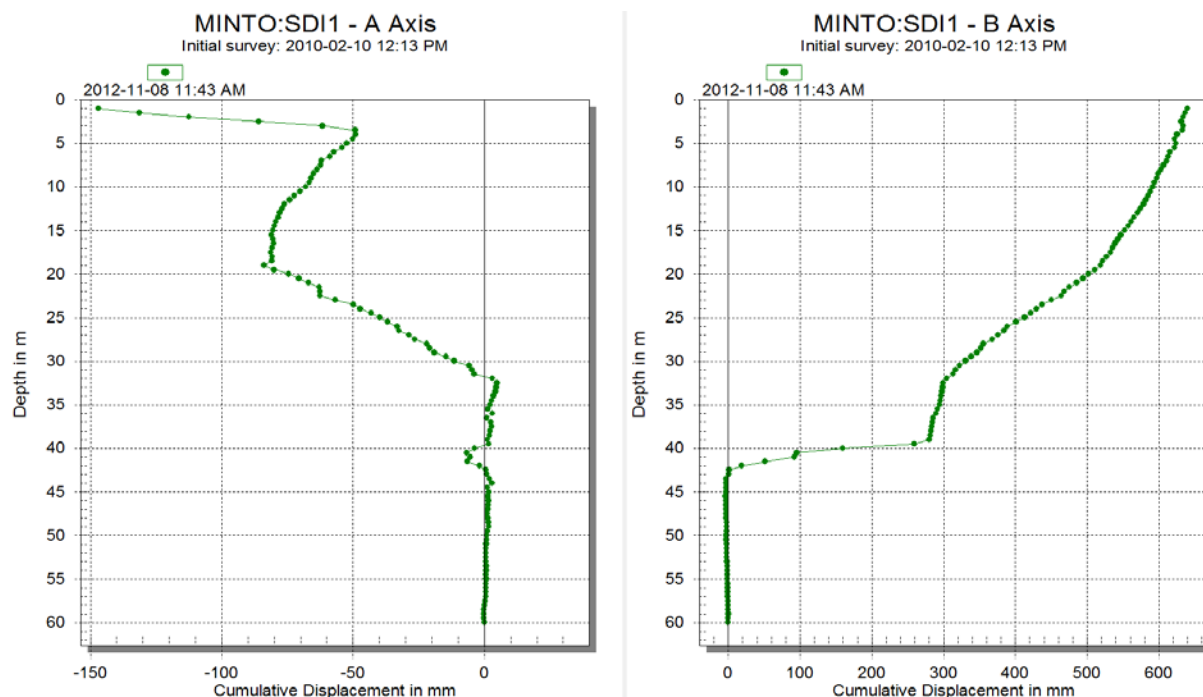
Figure 5-9: Southwest Dump SDI-1 Inclinator Data

In addition to the failure plane above the bedrock contact, the soil overburden at the SDI-1 location shows a gradual increase in displacement nearer to surface; this can be seen in Figure 5-9 on a plot of the hole profile as of November 8, 2012.

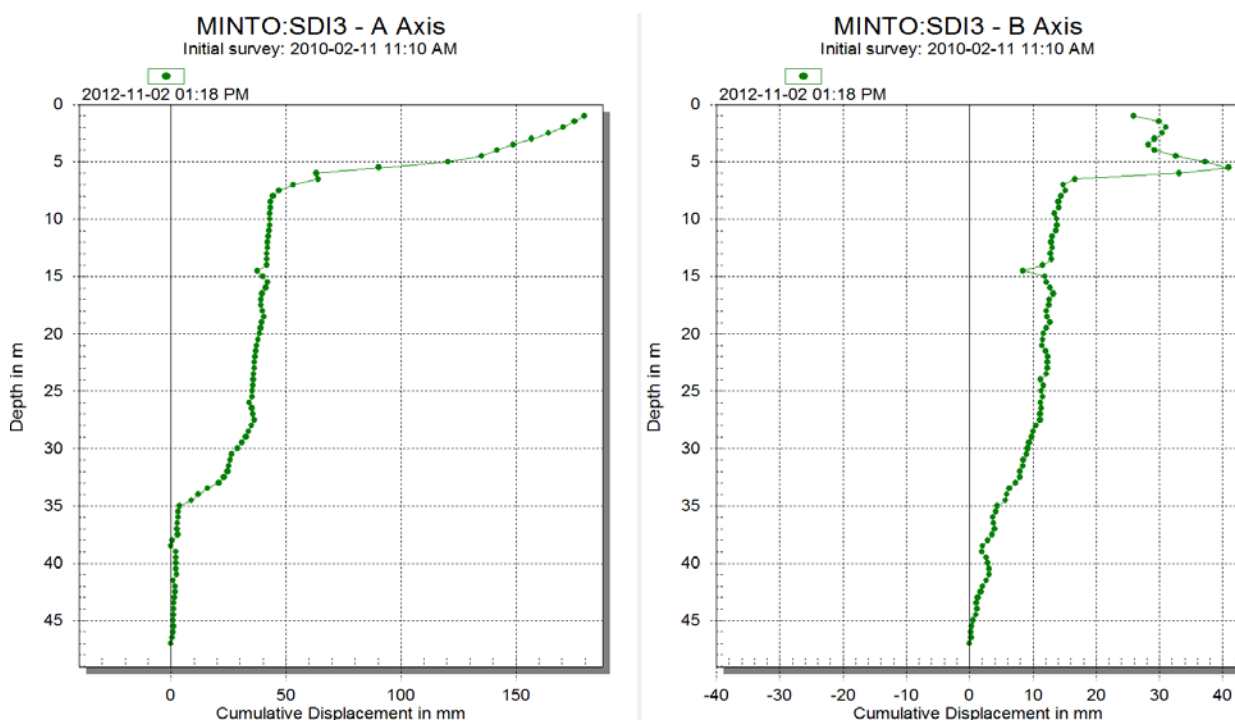
Figure 5-10: Southwest Dump SDI-3 Inclinator Data

SDI-3, at the toe of the Southwest Dump, shows movement along a zone starting at 35m depth and continuing up to 27.5m with total displacement of 37mm over 995 days for a rate of 0.037 mm/d. There is also a larger displacement in the top 7m of the hole.

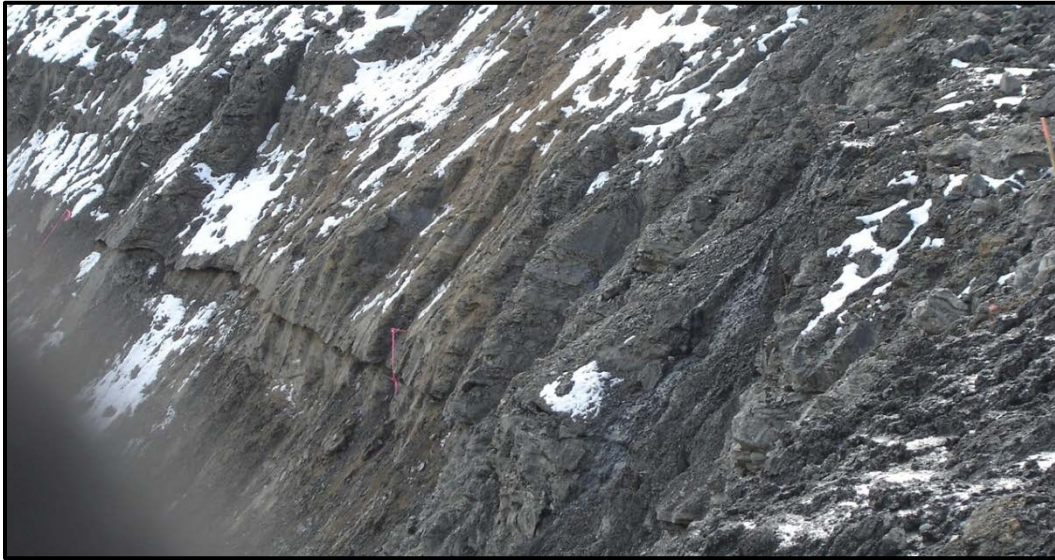
Movement along a plane above the overburden contact in the Area 1 Pit was observed during the mining of the Stage 3 pushback in April of 2009; this movement eventually led to a failure of the south wall on May 5, 2009.

Figure 6-1: Movement along failure plane in overburden, south wall, Main pit, Stage 3 pushback, April 2009.

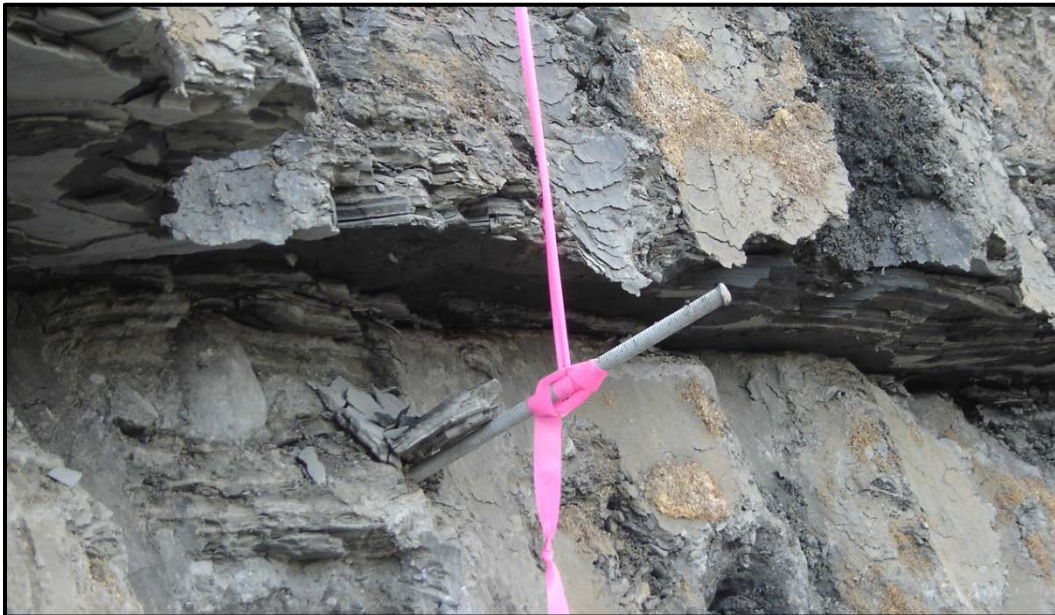
Figure 6-2: Displacement along the plane of movement: south wall, Main pit, Stage 3 pushback, April 2009.

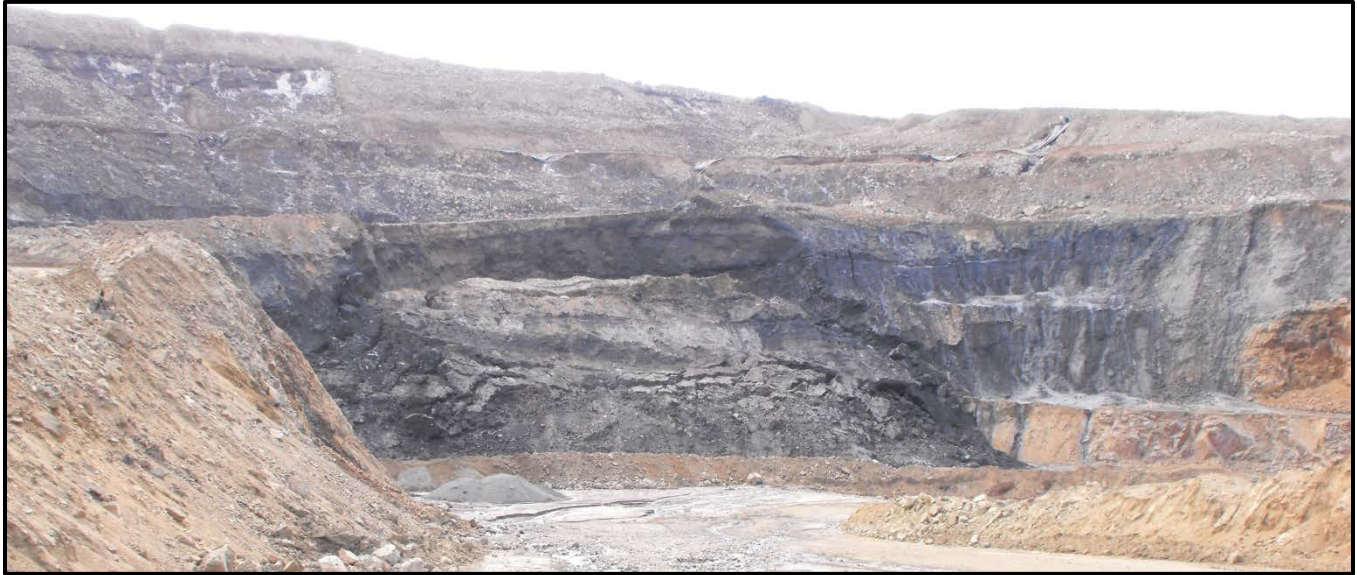
Figure 6-3: Main pit, May 2009 south wall failure.

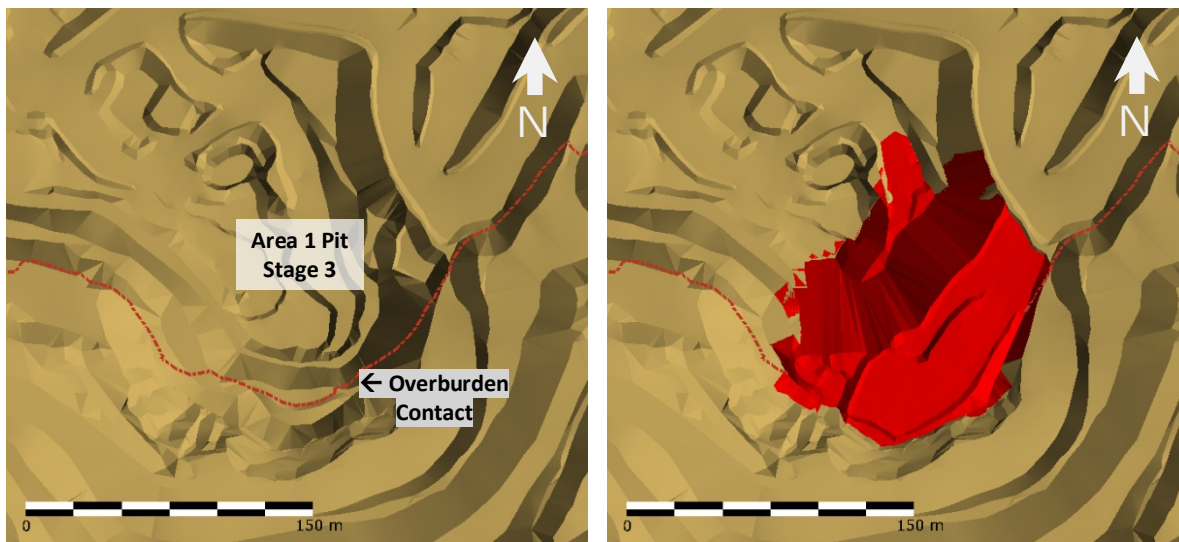
After completing the mining of Stage 3 in March of 2010, a small (approx. 210,000 m³) buttress was dumped in up to the 766m elevation to prevent movement near the toe of the overburden layer; this is shown in Figure 6-4.

Figure 6-4: Completed Stage 3 pushback of the Area 1 pit (left) and temporary buttress constructed to stabilize overburden contact (right).

This interim measure, having successfully stabilized the Stage 3 wall, was removed in the course of Stage 5 mining.

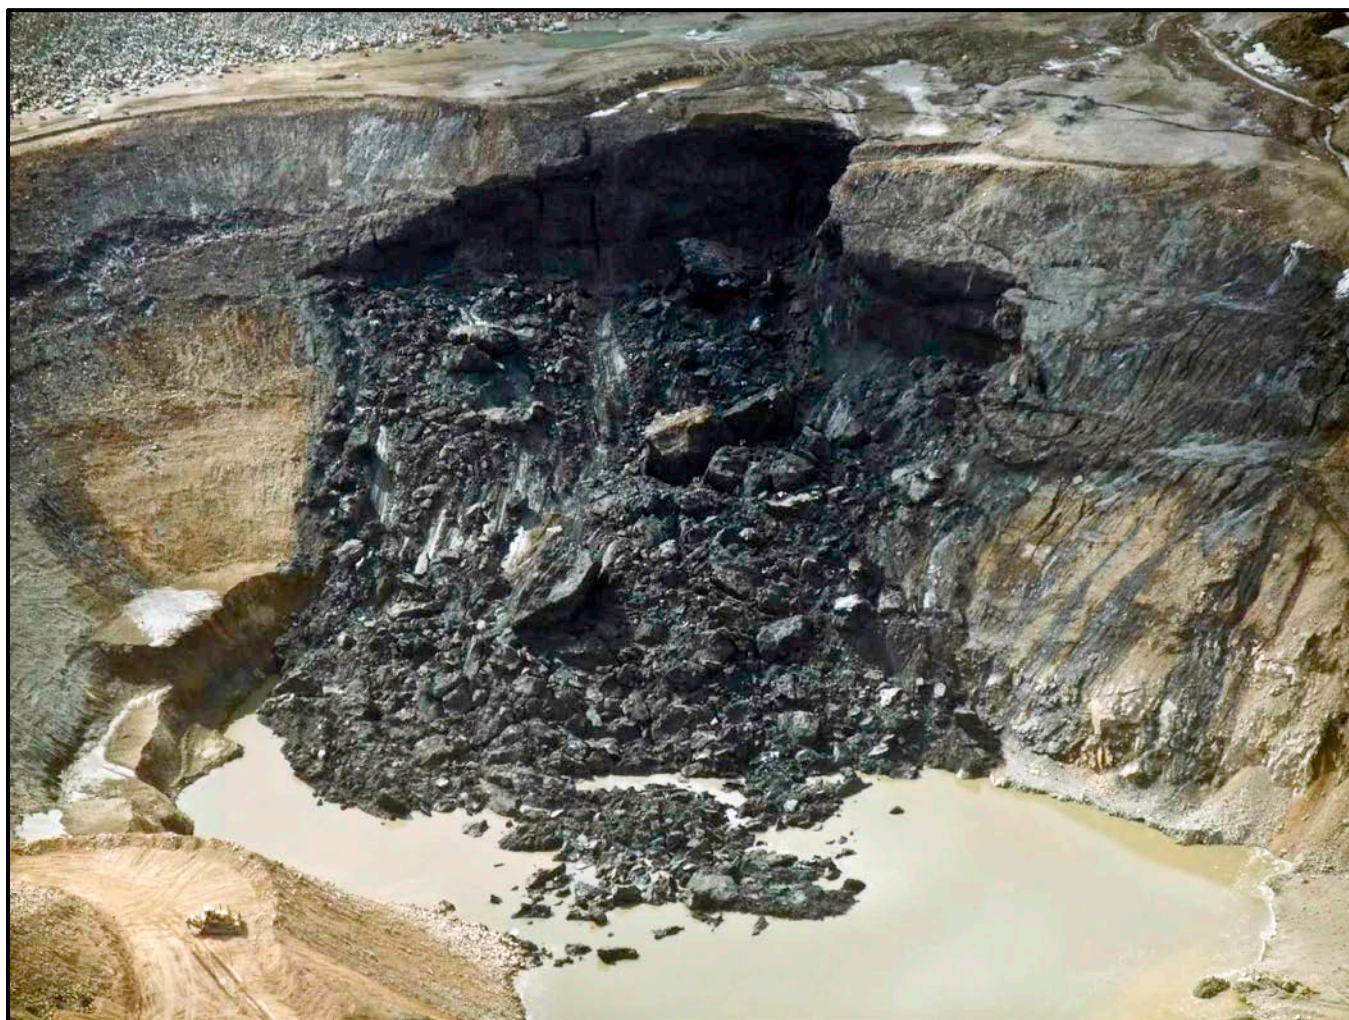
Monitoring via inclinometers and survey hubs during the mining of Stage 5 in the winter of 2010/2011 suggested a larger-scale translational failure. Analysis showed that the bulk of a 50m-thick silty / sandy overburden layer was sliding into the pit along a thin layer of ice-rich permafrost clay. After several months of accelerating movement, this translational failure resulted in a substantial piece of the slope sliding into the pit in late April 2011, bounded at the back by a large tension crack. This created an over-steepened overburden face that underwent a progressive failure, sloughing continuously throughout the summer of 2011 until winter conditions halted further degradation of the slope.

Figure 6-5: South wall failure, Area 1 pit, April 2011.

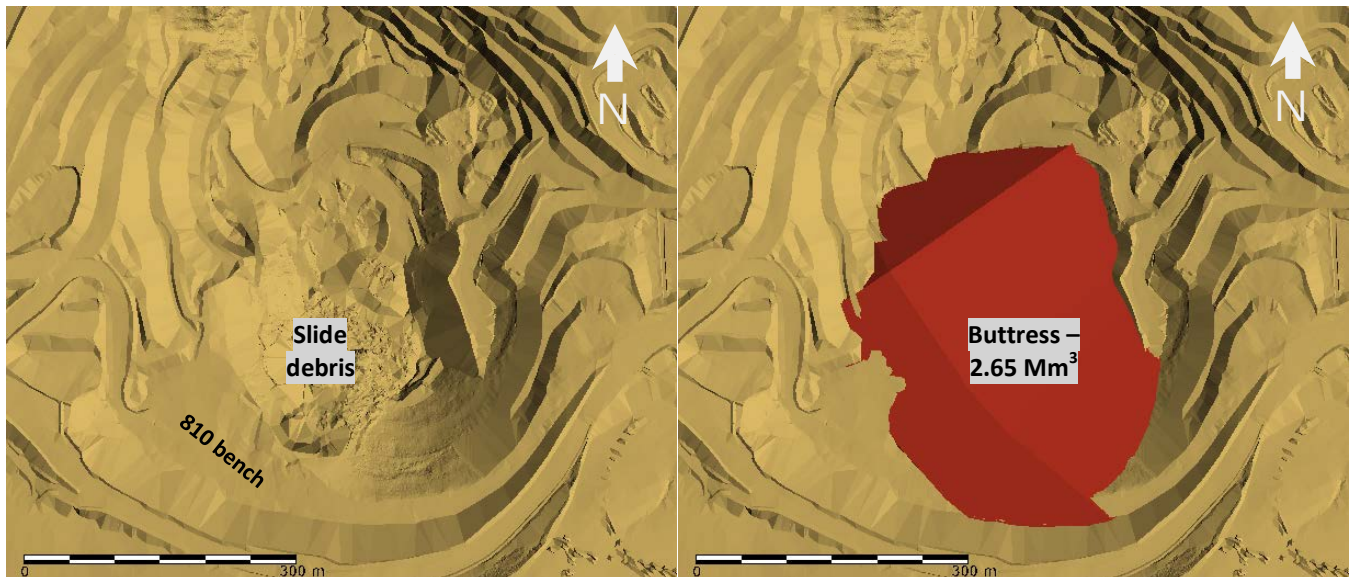
Figure 6-7: Post-failure survey of the Area 1 pit (left) and final buttress design for the south wall of the Area 1 pit (right).

EBA's report specified a 2.65 Mm³ buttress with a 4:1 front face slope, constructed out of compacted rock fill: Figure 6-7 shows the design.

The buttress was to be constructed in lifts measuring 2m in thickness, each of which is compacted with four passes of a vibratory smooth-drum compactor. EBA has indicated this is sufficient to raise the friction angle of the rock fill to 40 degrees, thereby giving the final design a factor of safety of 1.3 against further movement.

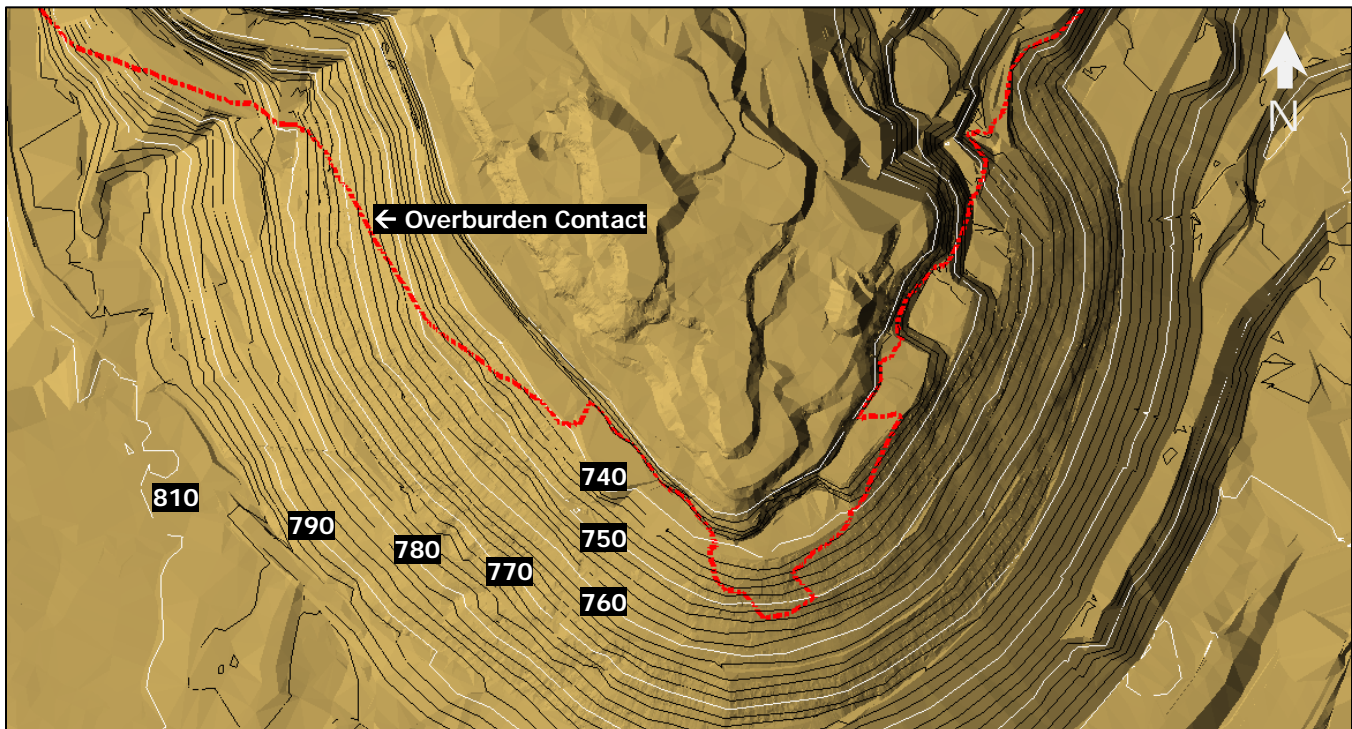
The intersection of the overburden contact with the final pre-failure as-built of the south wall is shown in Figure 6-8. It can be seen that the overburden contact intersects the south wall as low as 740m at the south corner of the pit, and as high as the 770m elevation at the west corner of the pushback. This is also illustrated in a section view of the buttress, shown in Figure 6-9.

Figure 6-8: Overburden contact (red) where it intersects the final pre-failure as-built of the south wall.

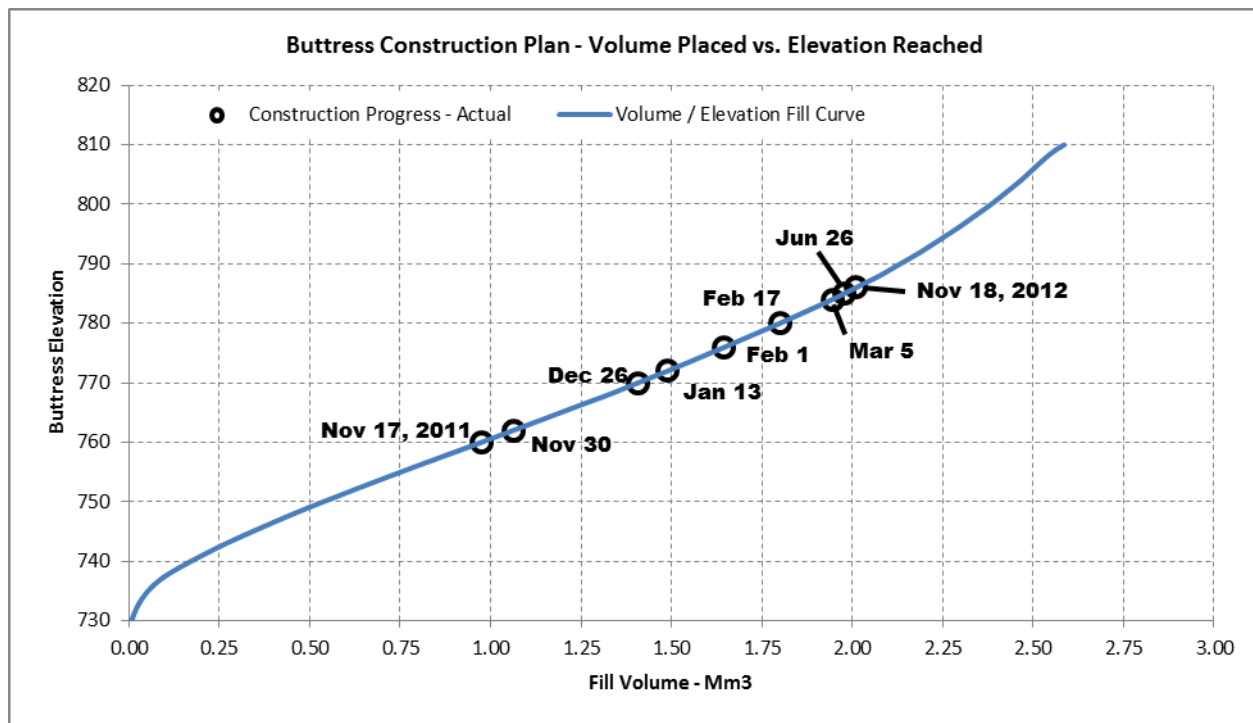
Figure 6-10: Buttress volume vs. elevation graph, showing dates at which certain elevations were reached.

As of November 18, 2012, construction is 70% complete: Figure 6-10 shows the relationship between the volume of fill placed and the elevation reached as the buttress is constructed. Also plotted are the dates at which certain elevations were reached.

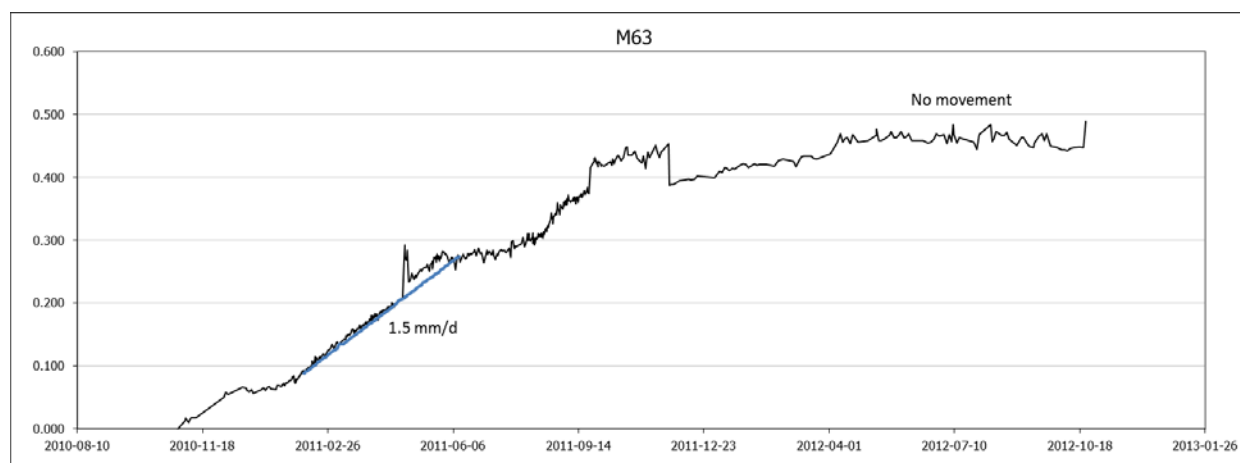
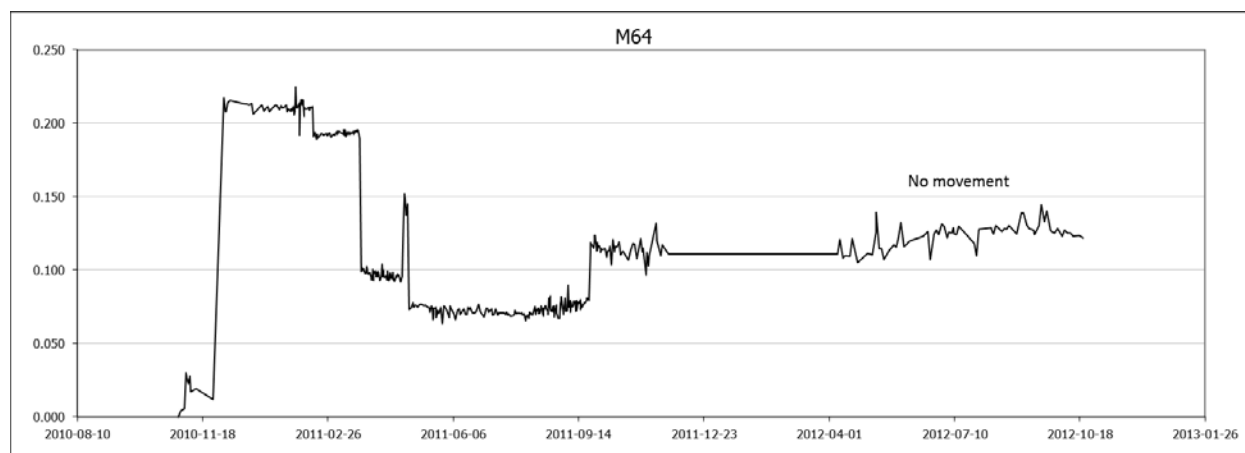
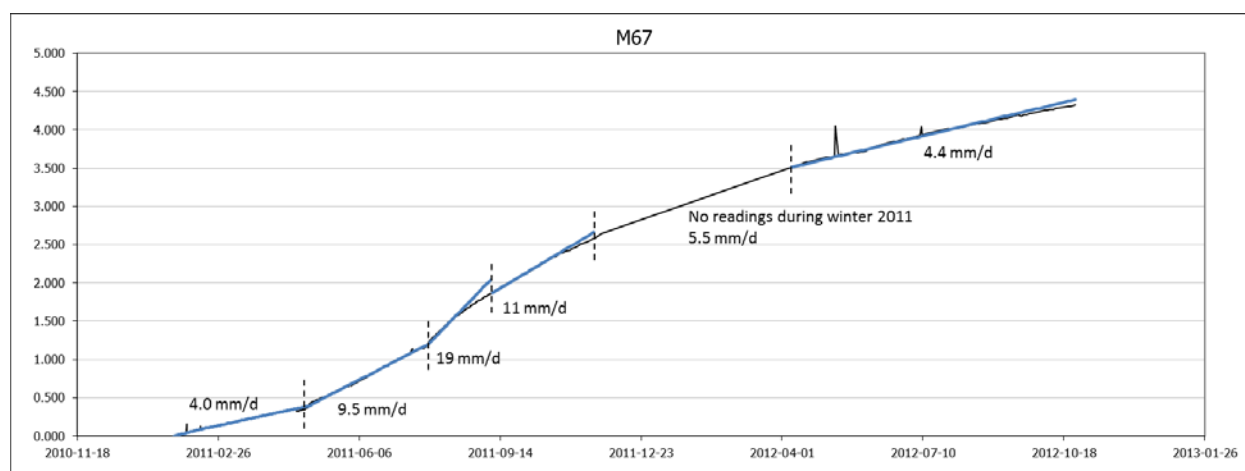
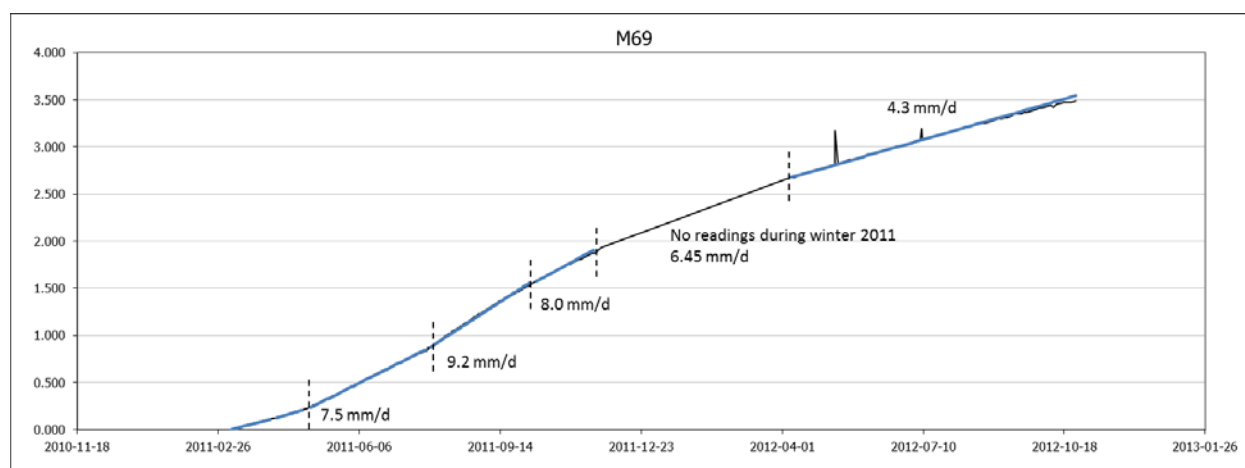
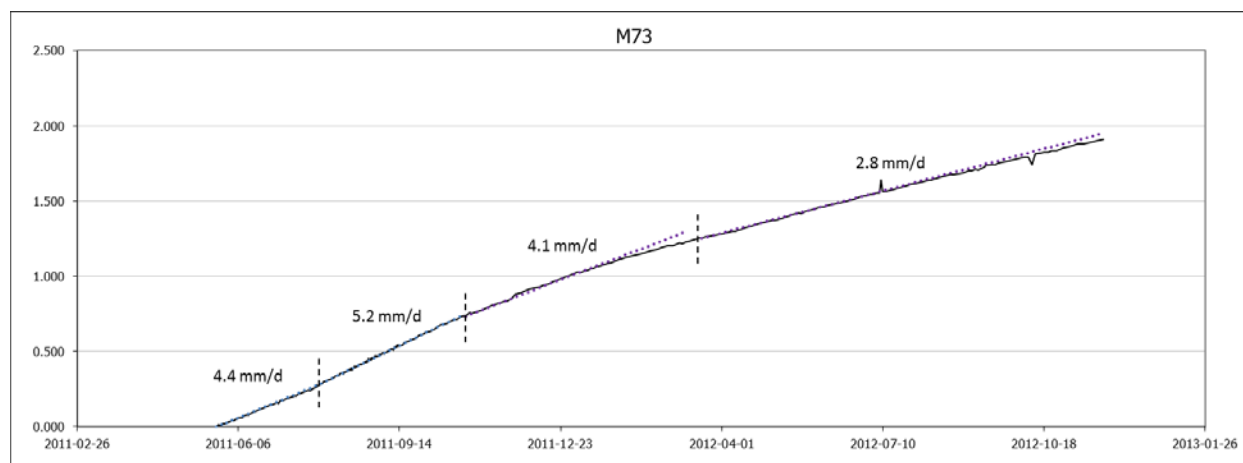
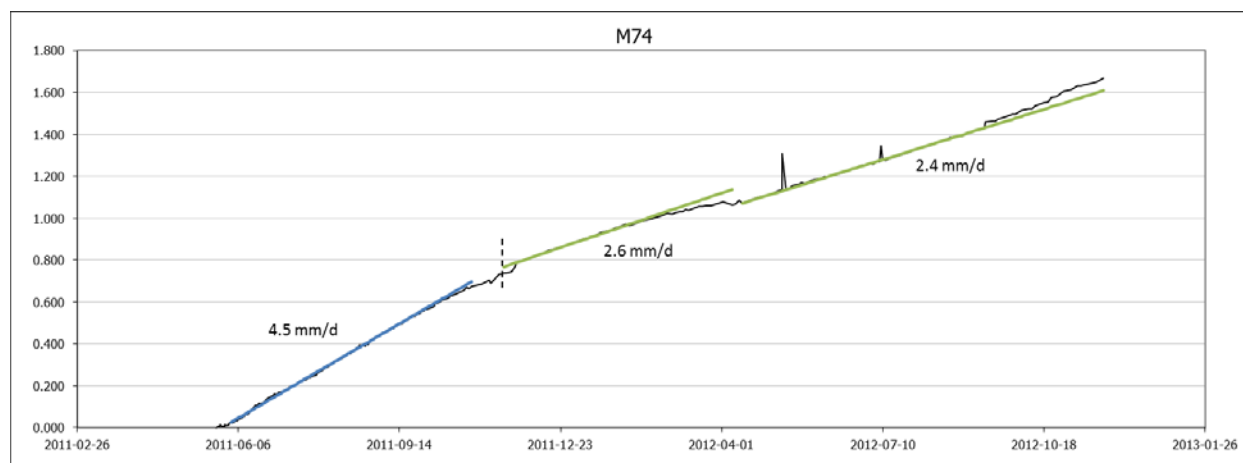
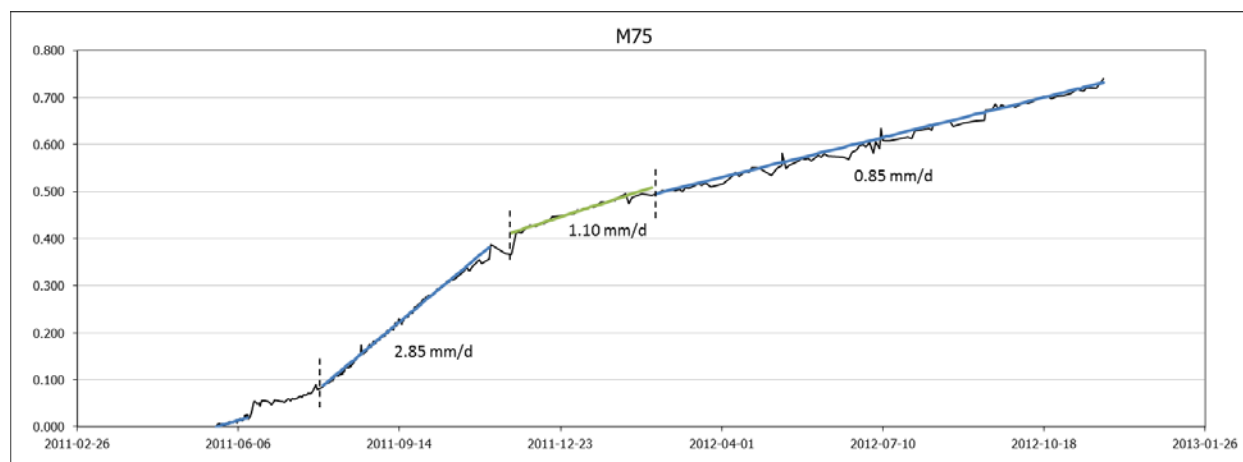
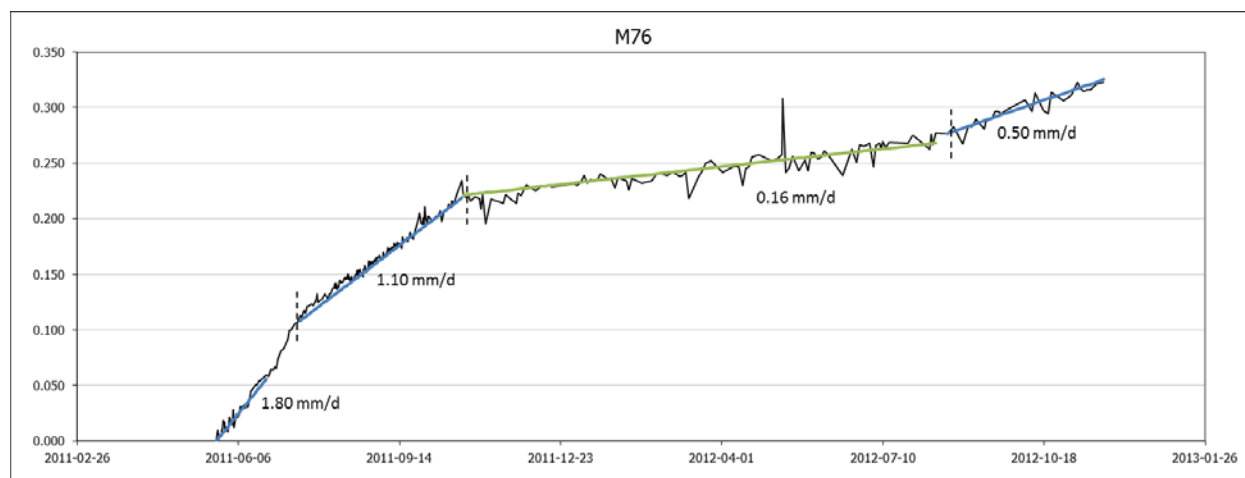
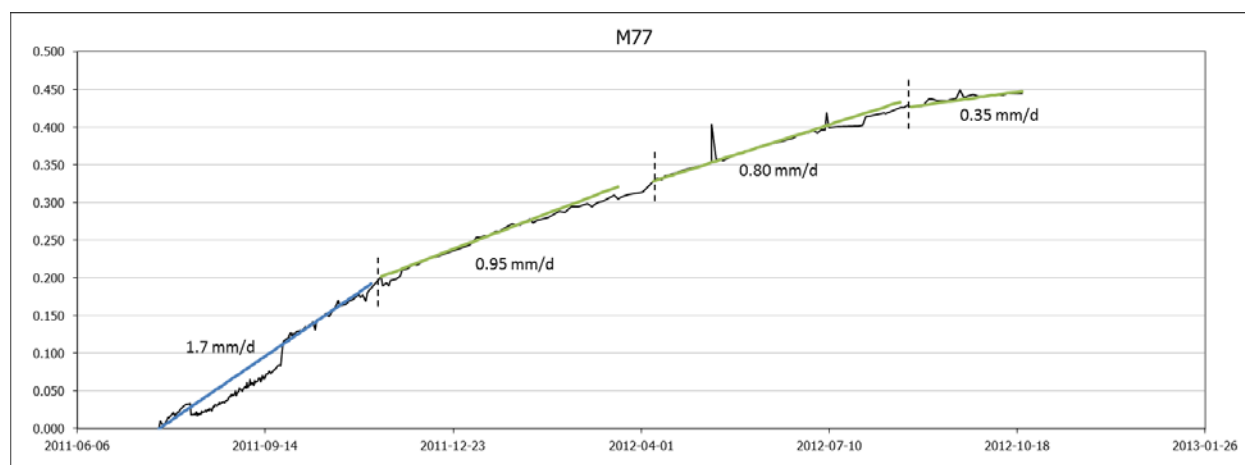
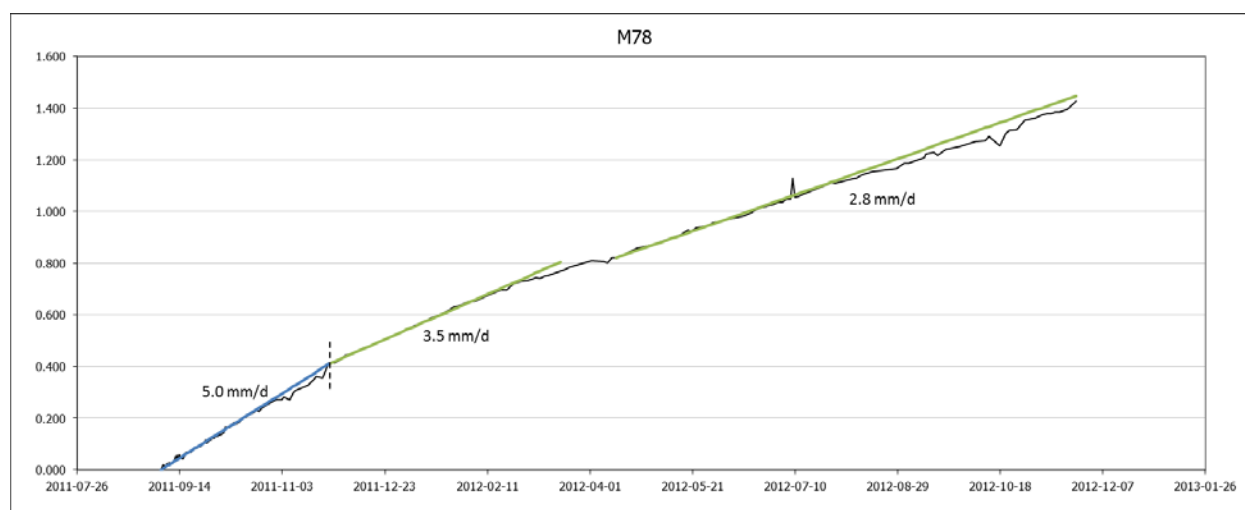
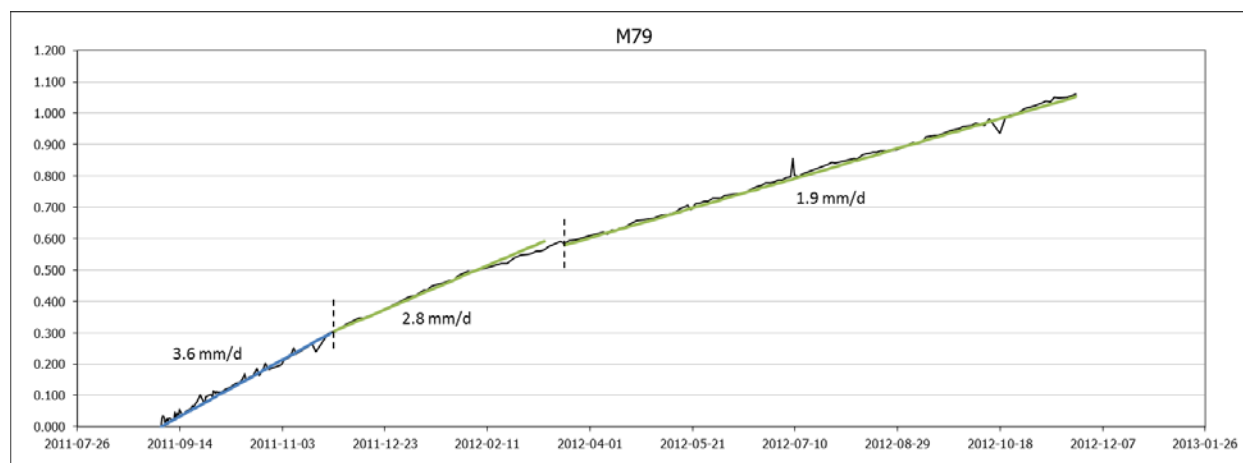
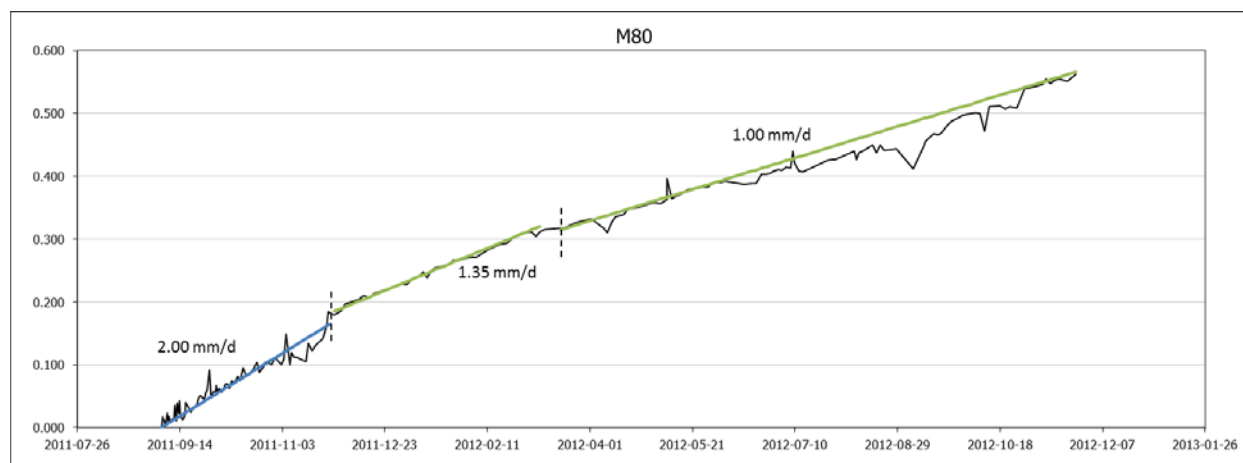
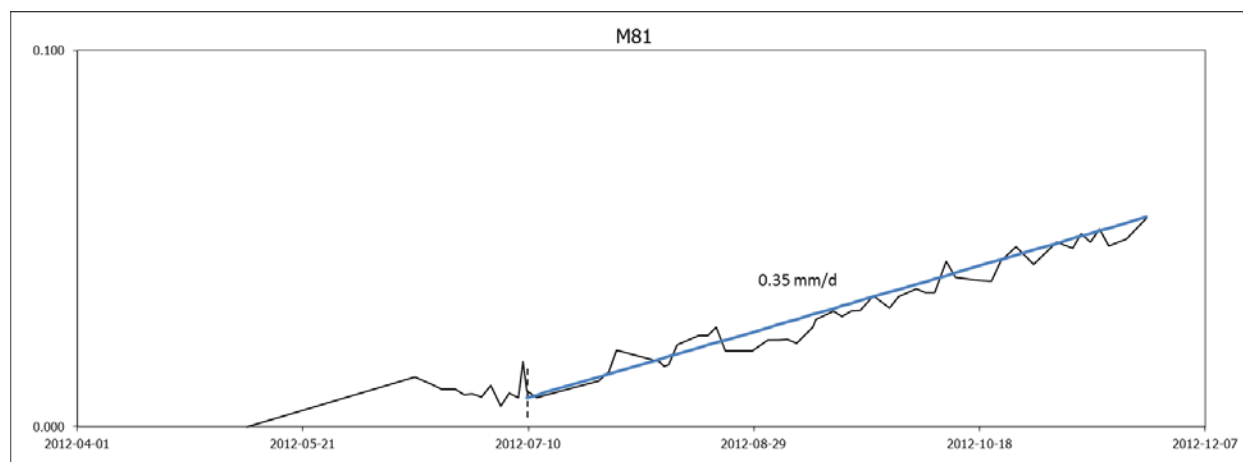
Plots for the other Area 1 survey hubs are similar: all show a long period of constant-rate movement, followed by a gradual rate decrease beginning in late 2011, continuing to the most current data.

Figures 6-12 through 6-24 contain graphs that represent survey hubs around the Area 1 pit's south wall failure.

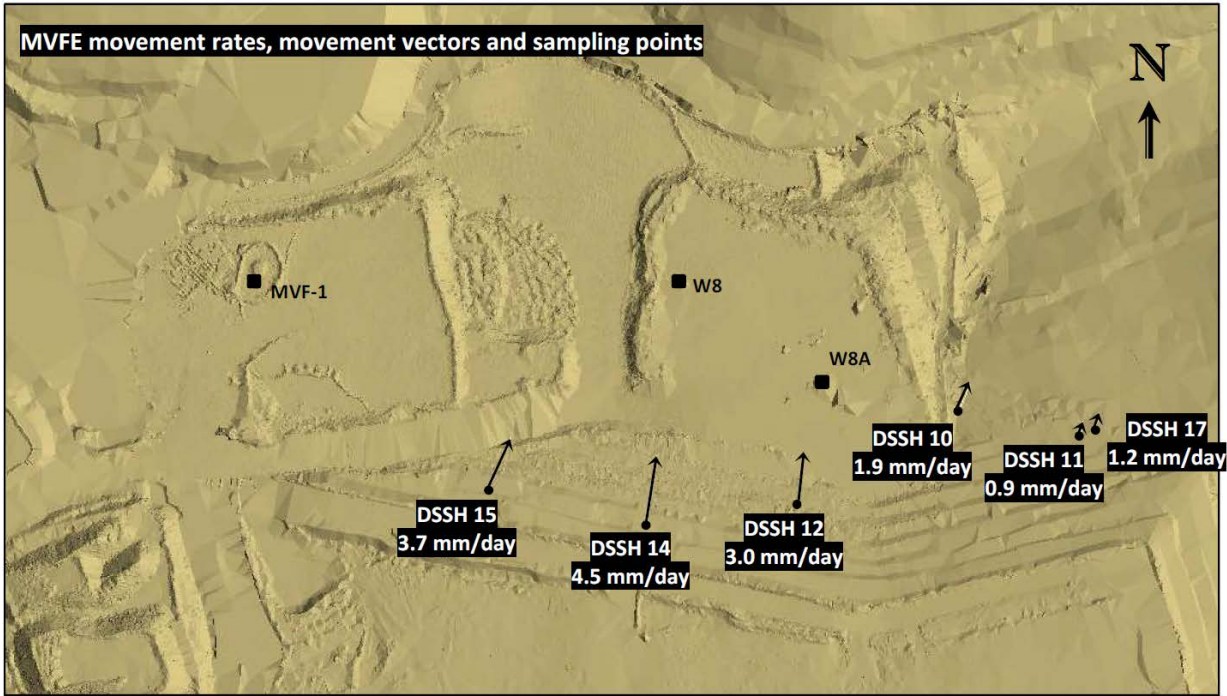
Figure 7-2: DSTSF movement rates (November 10, 2012)

Ongoing monitoring has shown a slowing of the movement of the Dry Stack Tailings Storage Facility. Movement rates at November 10th, 2012 are shown below.
