OPERATED BY MINTO EXPLORATIONS LTD.

## South Wall Buttress As-built Report

January 2015

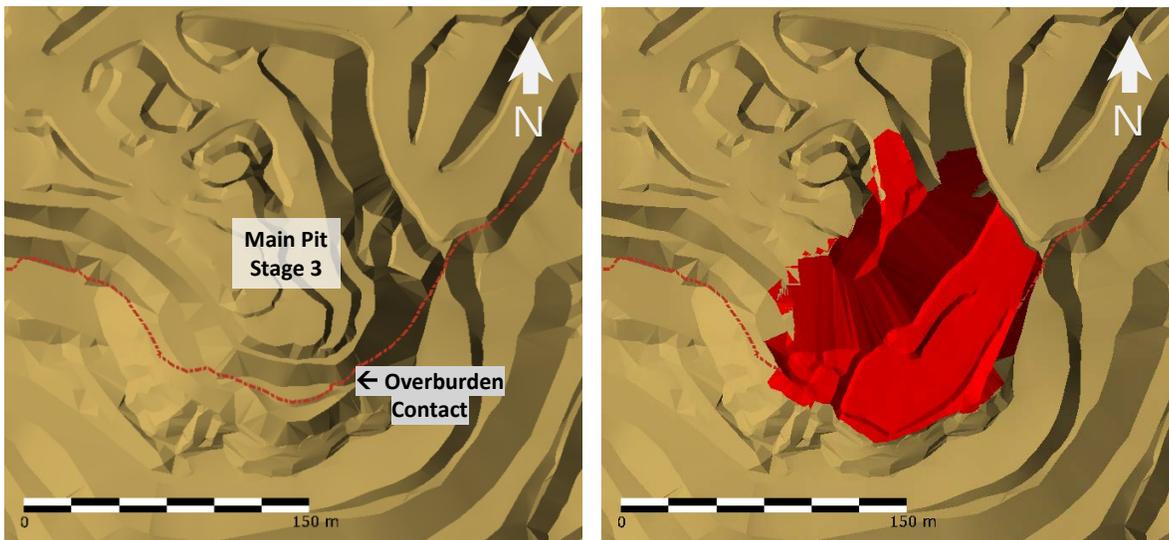
Figure 1-1: Completed Stage 3 pushback (left) and temporary buttress constructed to stabilize the slope (right).

After the completion of Stage 3 in March 2010, a small (approx. 210,000 m<sup>3</sup>) buttress was dumped in up to the 766m elevation to prevent movement near the toe of the overburden layer. This interim measure, having successfully stabilized the Stage 3 wall, was removed in the course of Stage 5 mining.

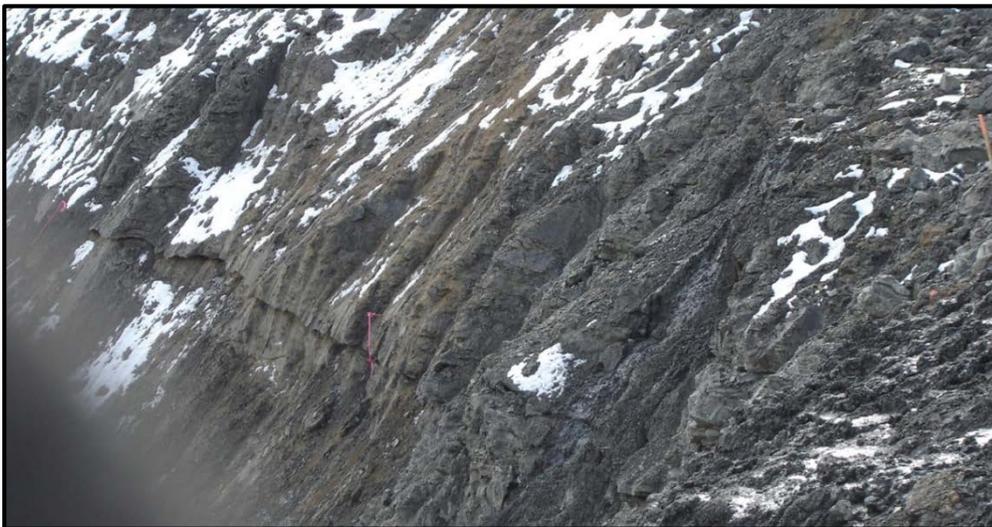
Movement along a plane above the overburden / bedrock contact had been observed during the mining of the Stage 3 pushback in April of 2009; this movement eventually led to a failure of the south wall on May 5, 2009.

Figure 1-2: Movement along failure plane in overburden, south wall, Main pit, Stage 3 pushback, April 2009.

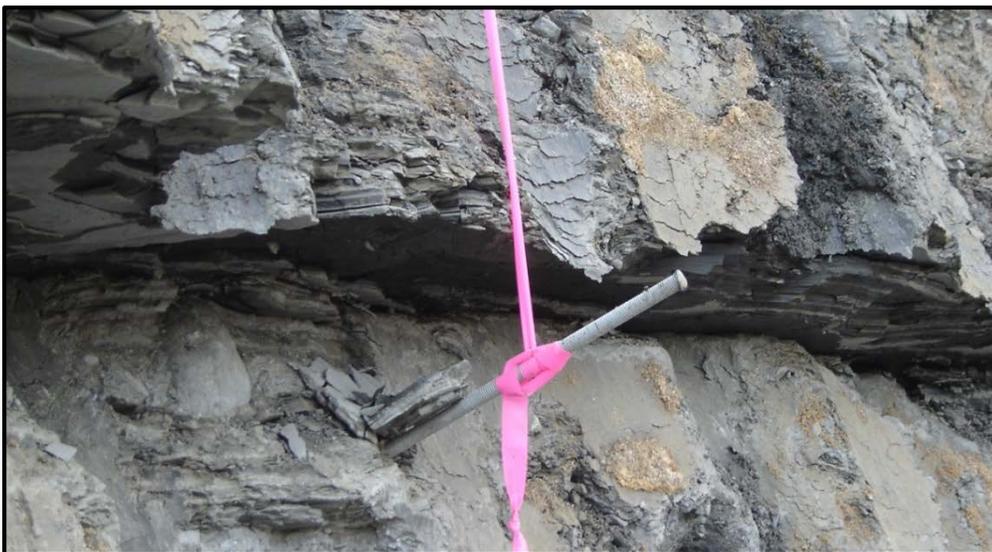
Figure 1-3: Displacement along the plane of movement: south wall, Main pit, Stage 3 pushback, April 2009.

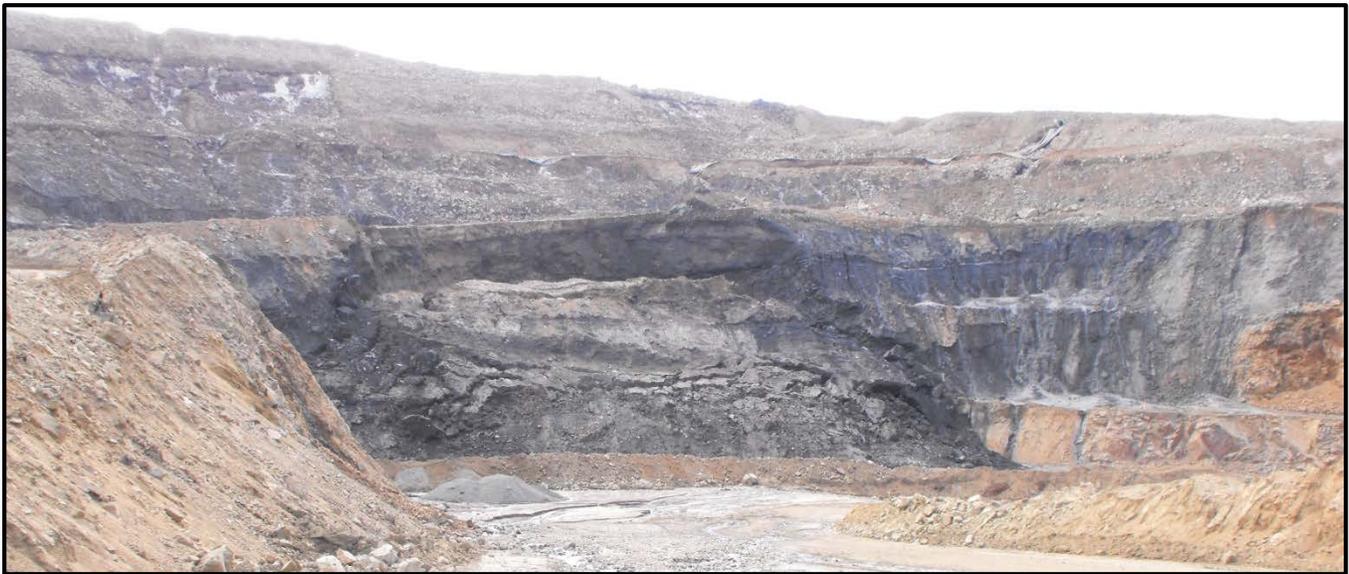
Figure 1-4: Main pit, Stage 3, May 2009 south wall failure. Looking south-southwest, camera positioned at bottom of pit.

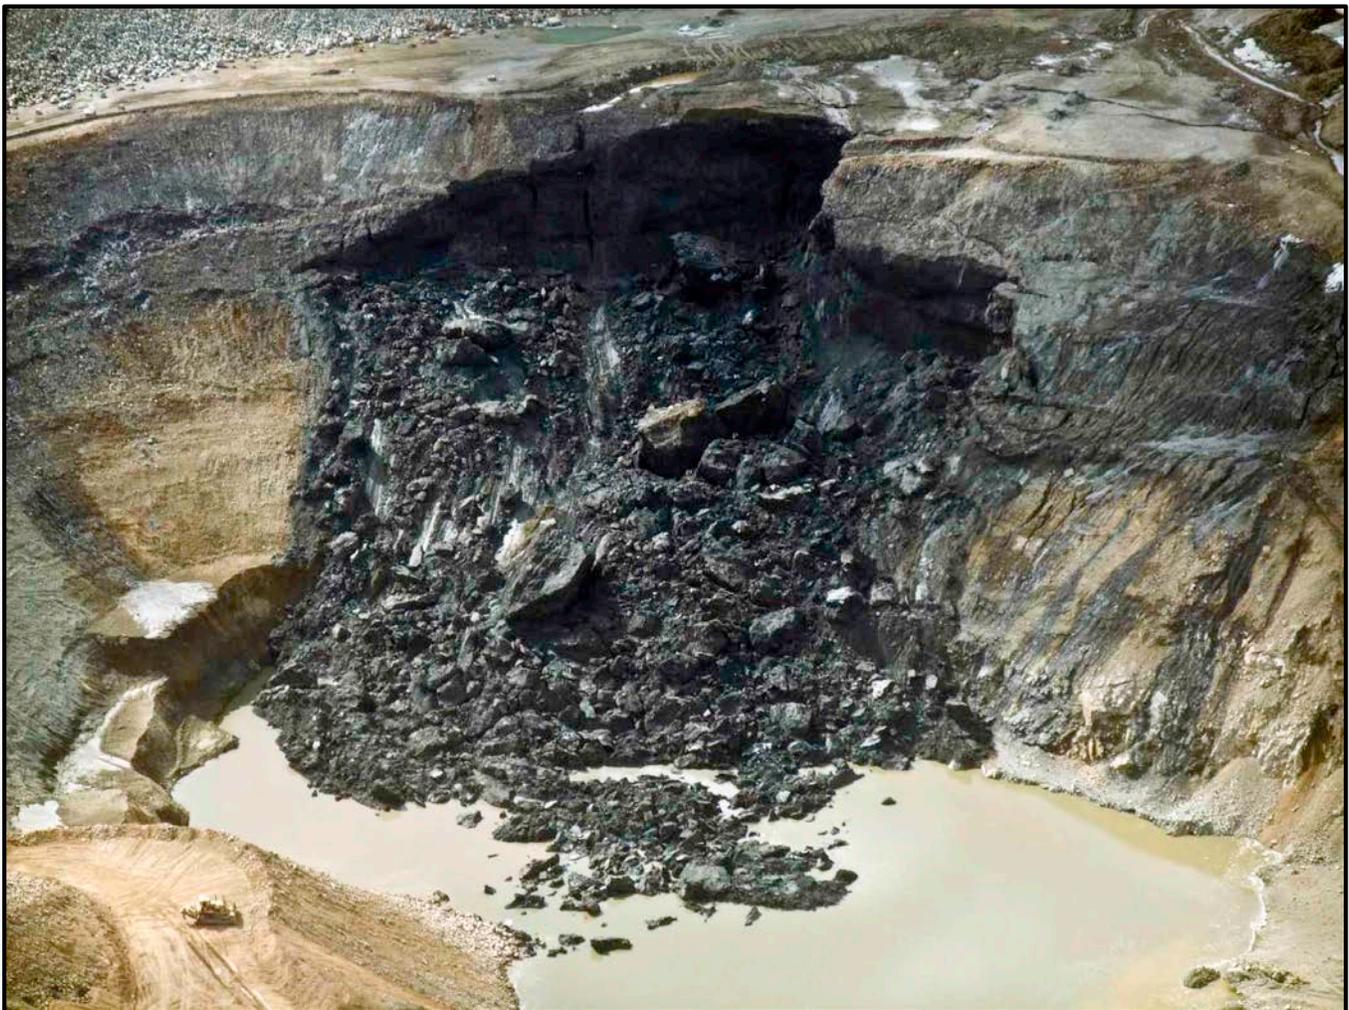
Figure 1-5: South wall failure, Main pit, April 2011. Aerial photo, looking southwest. Start of buttress construction visible at bottom left corner of the photo.

Analysis showed that the bulk of a 50m-thick silty / sandy overburden layer was sliding into the pit along a thin layer of ice-rich permafrost clay. After several months of accelerating movement, this translational failure resulted in a substantial piece of the slope sliding into the pit on April 30, 2011, bounded at the back by a large tension crack. This created an over-steepened overburden face that underwent a progressive failure, sloughing continuously throughout the summer of 2011 until winter conditions halted further degradation of the slope.

The volume of the failure initially measured 83,000 m<sup>3</sup>; by the end of the summer, the volume lost from the South Wall had increased to 302,000 m<sup>3</sup>. The following, quoted from EBA's *Area 1 South Wall Buttress Design Report*, describes the material that comprised the failure:

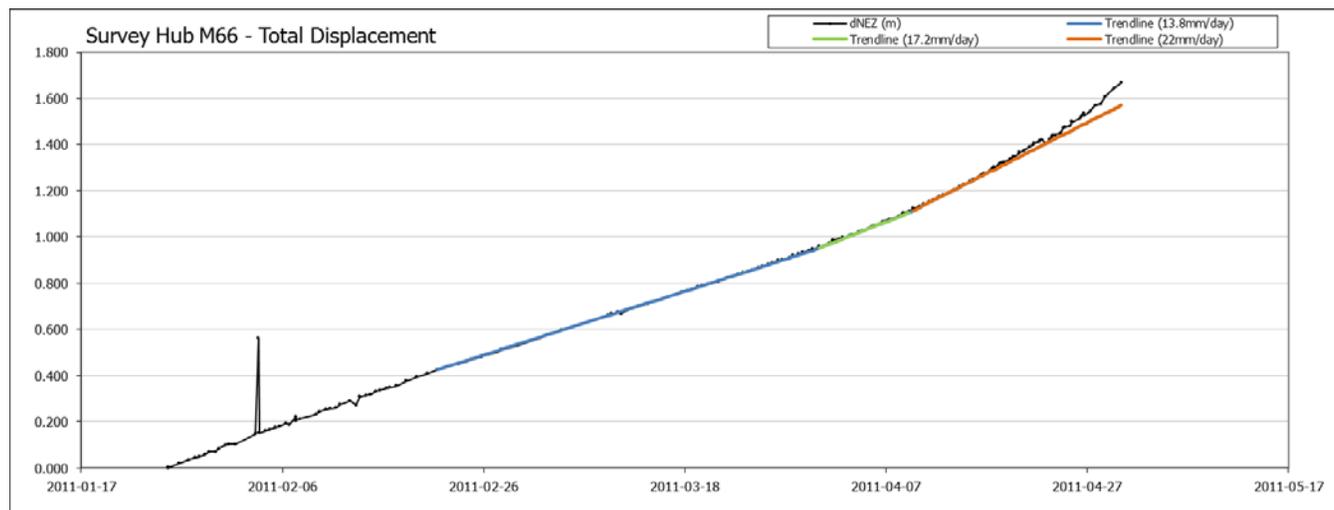
Monitoring via inclinometers and survey hubs during the mining of Stage 5 in the winter of 2010/2011 suggested a larger-scale translational failure. The graph below shows movement data for one such survey hub.

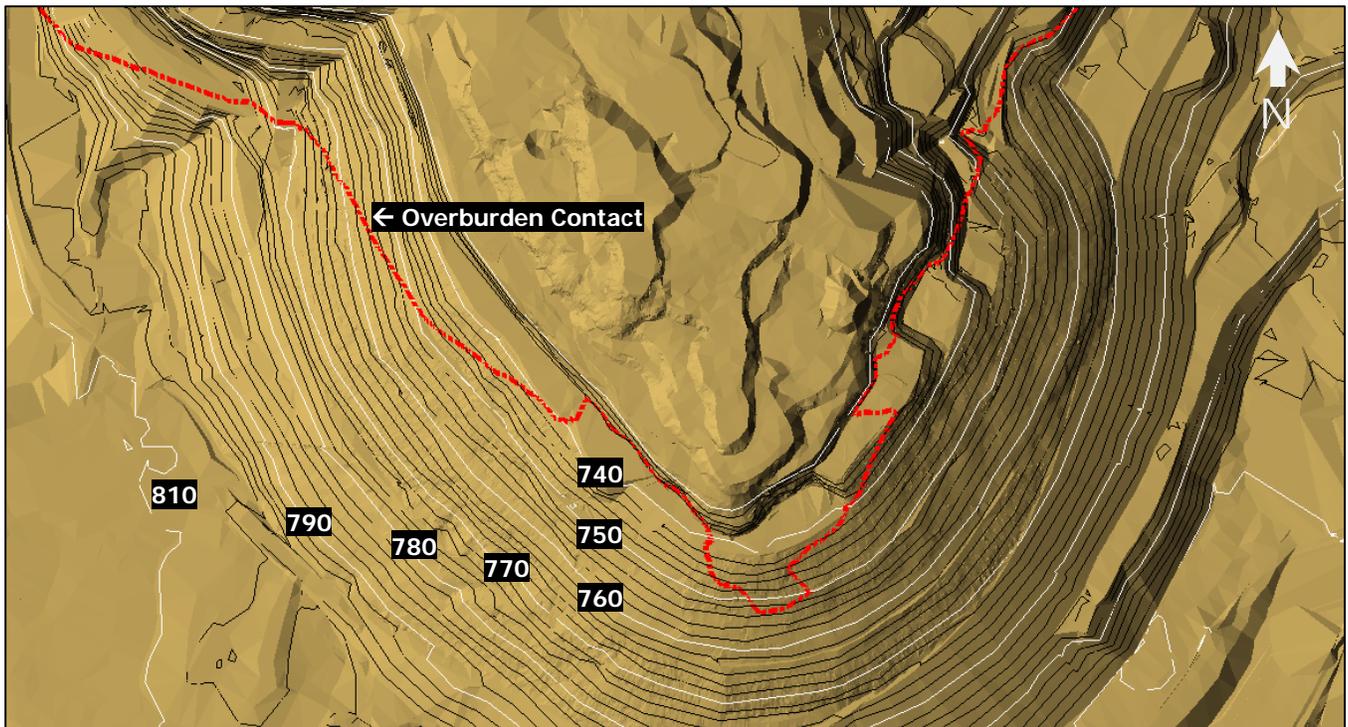
The intersection of the overburden contact with the final pre-failure as-built of the south wall is shown in Figure 4. It can be seen that the overburden contact intersects the south wall as low as 740m at the south corner of the pit, and as high as the 770m elevation at the west corner of the pushback.

Figure 2-2: Overburden contact (red) where it intersects the final pre-failure as-built of the south wall.

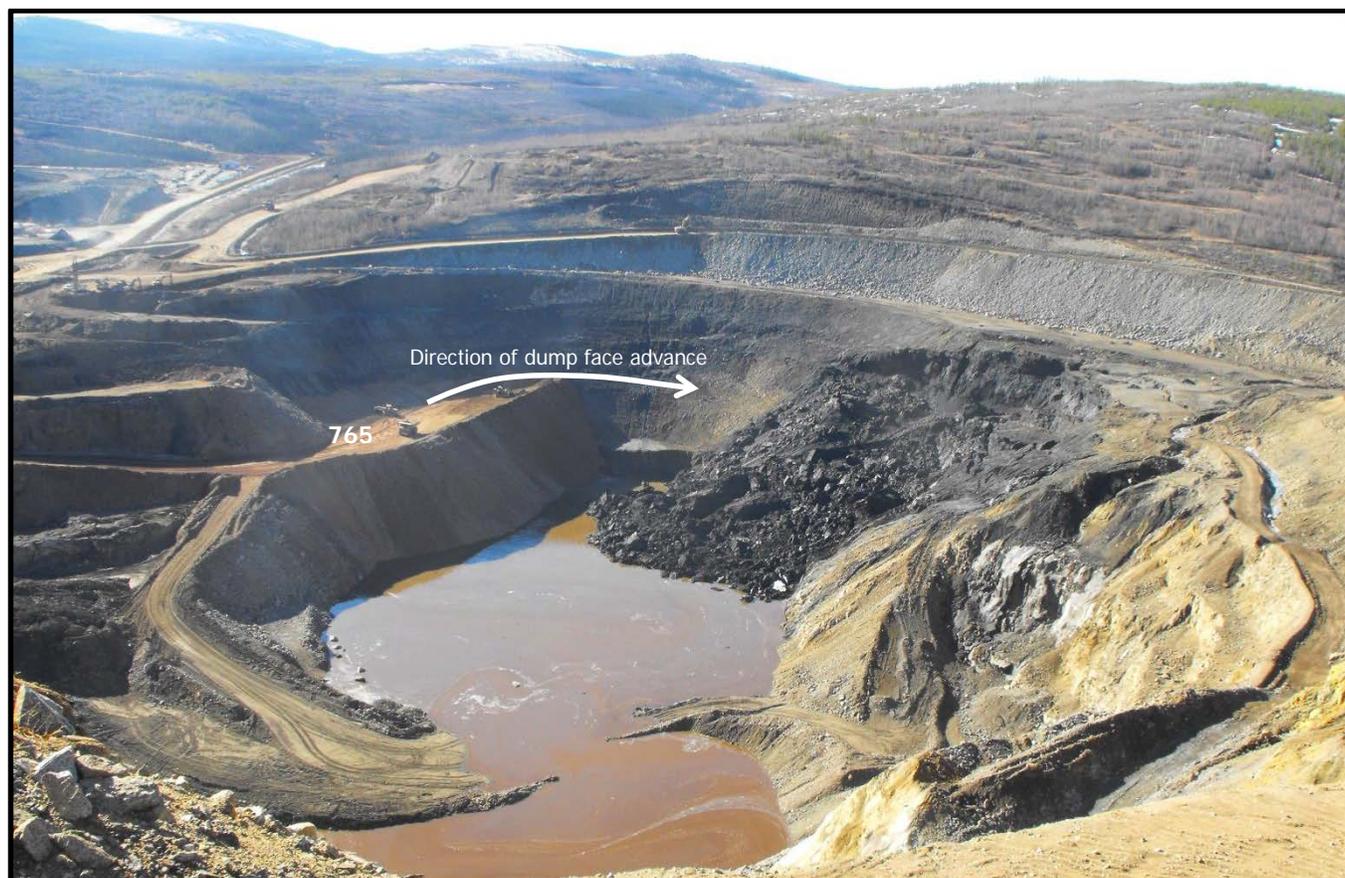
**Figure 3-1: Main Pit, looking southeast, June 15. Dumping based on the original wraparound buttress design is shown.**

Dumping of material as per the original pre-failure buttress design began on May 28, 2011, shortly before the wall failure, by end-dumping from the 765 elevation. The photo below shows this initial dumping as of June 15. Dumping continued until June 2, at which time the toe was largely resting upon the slide debris and it was no longer considered safe to proceed. Minto contracted EBA to carry out a redesign of the buttress at this time.

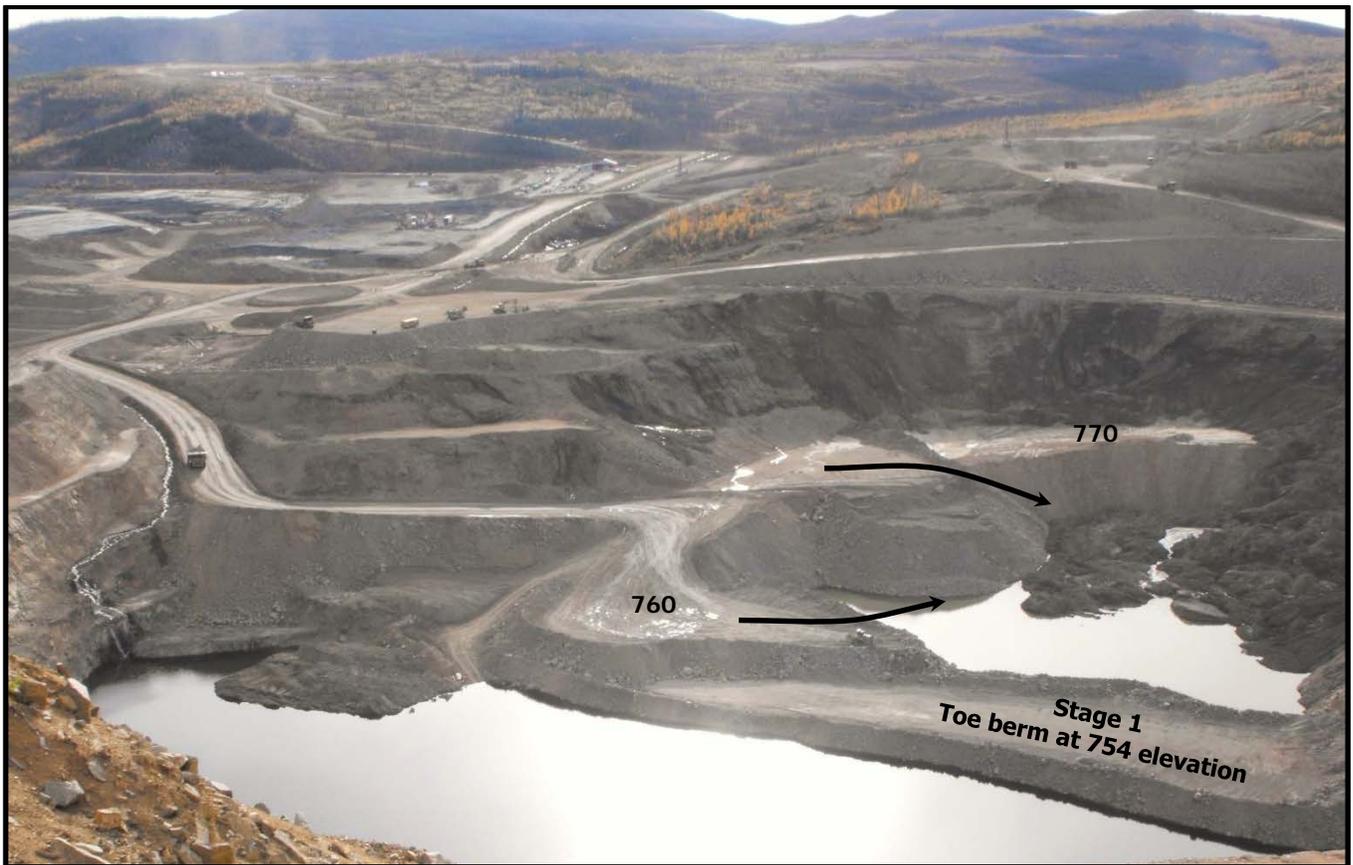
Figure 3-5: Photo showing Stages 1 and 2 of buttress development. September 17, 2011, looking S-SE.

Stage 2 padded over the slide debris from two separate faces. This approach was chosen so that dumping could advance from a stable base to cover the slide debris while maintaining sufficient dump height to permit safe travel of haul trucks on the dump surface. Stage 2, as well as the completed Stage 1 toe berm, are shown in Figures 3-5 and 3-6.

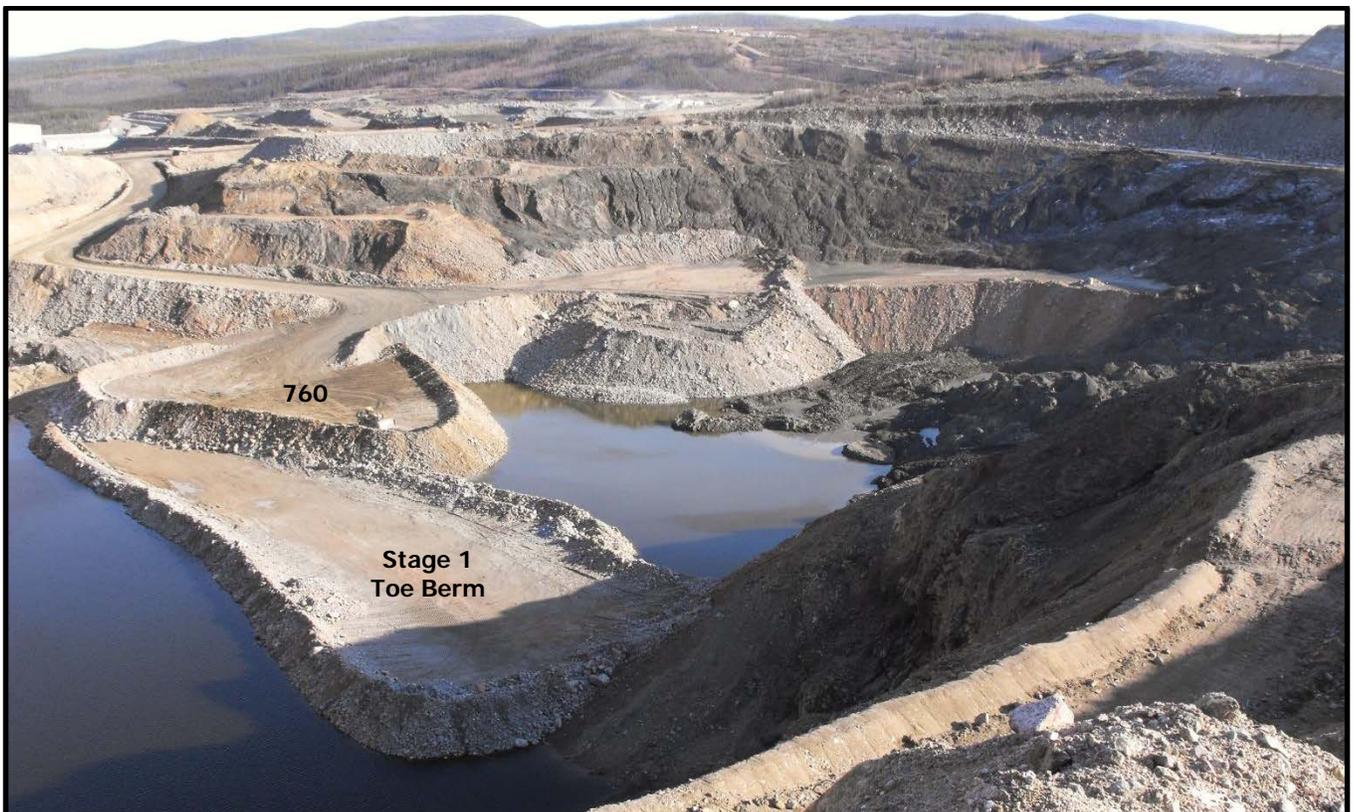
Figure 3-6: Buttress development, October 2, 2011, looking E-SE.

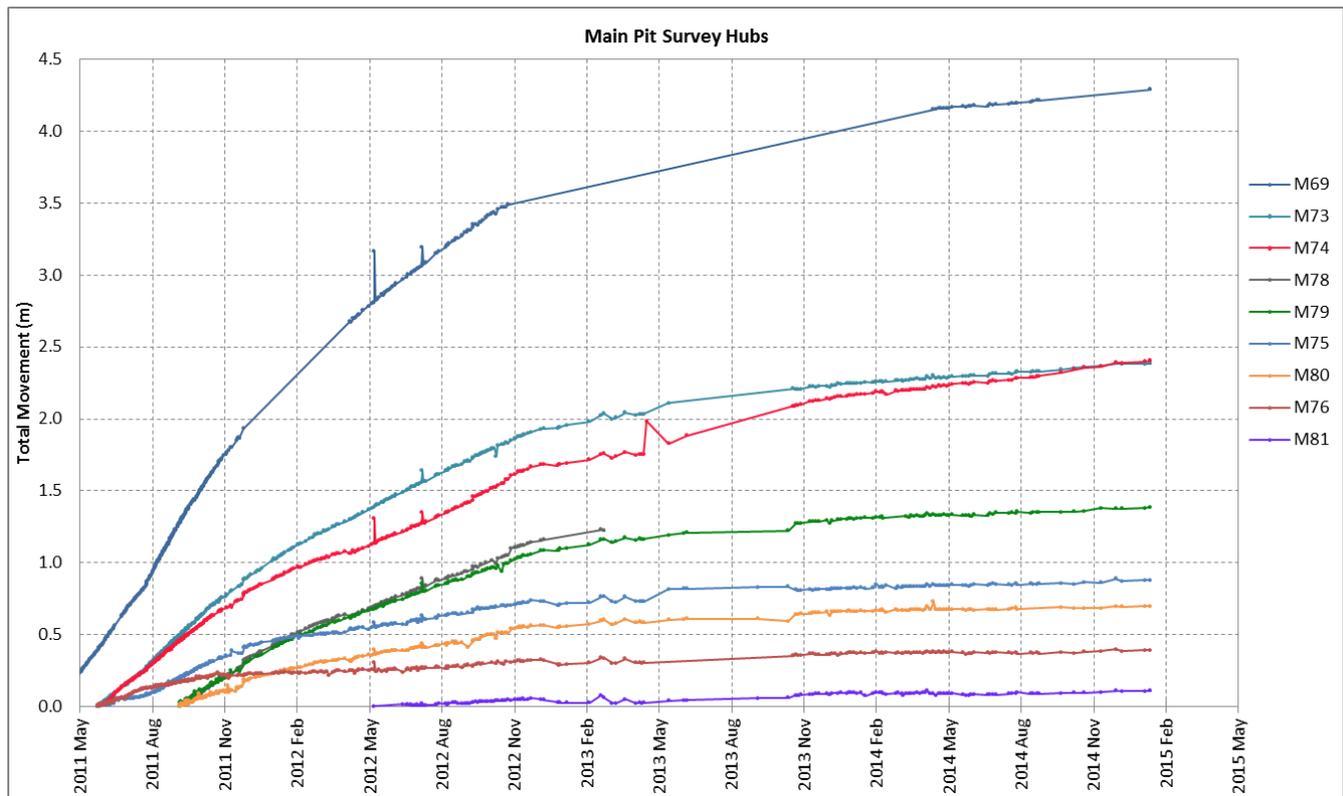
Figure 5-1: Main Pit survey hub total displacement data.

Movement rates, shown in Figure 5-1, indicate gradually decreasing movement during construction of the buttress in 2011 and 2012. By mid to late 2013, movement had decreased significantly, at which point construction of the buttress had been completed nearly to design. At the time of this report, movement has essentially stopped, with the exception of small movement (<1 mm/day) rates still recorded in mid to late 2014 on the west side of the buttress (hubs M69, M73 and M74). Hub M74 in particular has been damaged by frost heaving and there is some question if the movement being recorded is representative of ground movement or heaving/leaning of the hub post. A replacement hub is planned for this location to verify the results of M74.
