REPORT ON

Sä Dena Hes Mine 2009 Dam Safety Review

Submitted to:
Teck Metals Ltd.
Sä Dena Hes Mine
c/o Bag 2000
Kimberley, BC V1A 2E1

Project Number: 09-1427-0023

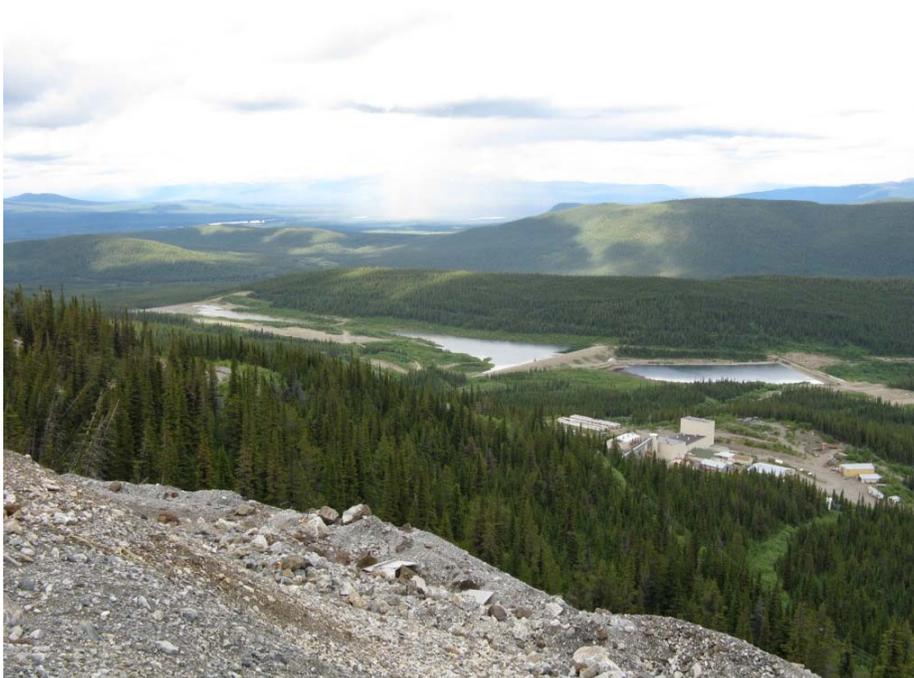
All photos of the mine site infrastructure cited in the sections below are found in Appendix A. Photo 1 present an overview of the TMF, including, from left to right, the North Dam, the Cofferdam, the South Dam and the Reclaim Dam.

Photograph 1: Overview of the TMF with, from left to right, the North Dam, the Cofferdam, the South Dam and the Reclaim Dam.

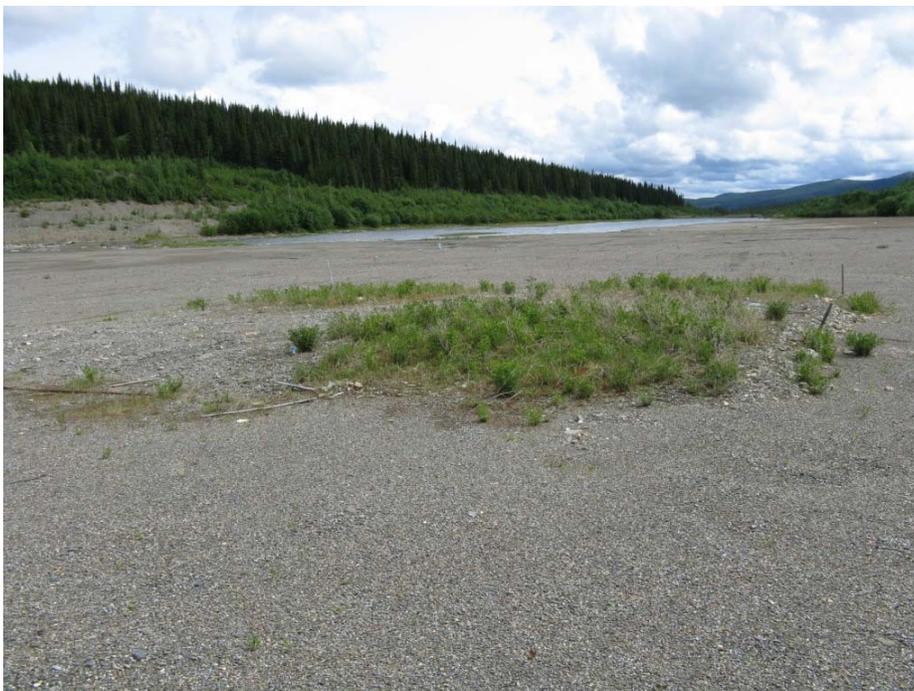
Water was observed to accumulate near the Cofferdam, as observed in Photos 2 and 3. Excess water accumulated in the northern half of the Tailings Pond was being released through a gated culvert in the Cofferdam to reach the Tailings Pond in the southern half.

Photograph 2: North Dam – Tailings beach with view toward water impoundment and the Cofferdam.

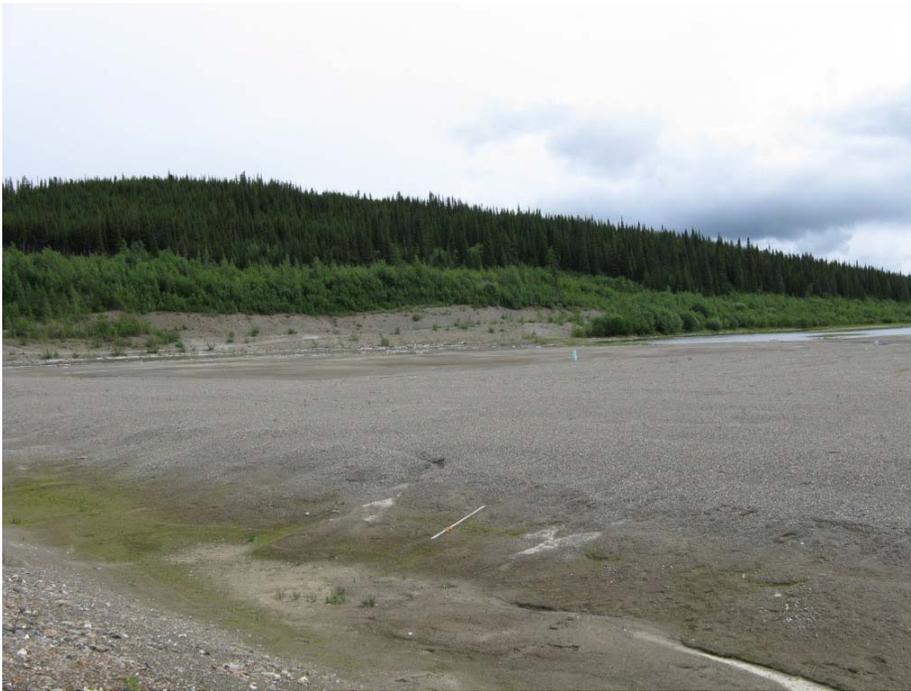
The dam was considered to be in a stable condition at the time of the visit, with a wide crest, uniform and stable slopes, and no visual indication of erosion or slope movement. Most of the tailings had been deposited in the northern half of the impoundment, between the North Dam and the Cofferdam. The tailings are gently sloped to allow surface runoff to drain from the North Dam to the Cofferdam (Photos 2 and 3). The tailings surface is relatively smooth, although a small gully has formed between the dam upstream face and the tailings (Photo 3).

Photograph 3: North Dam – Tailings beach at the upstream face of North Dam (lower left corner).

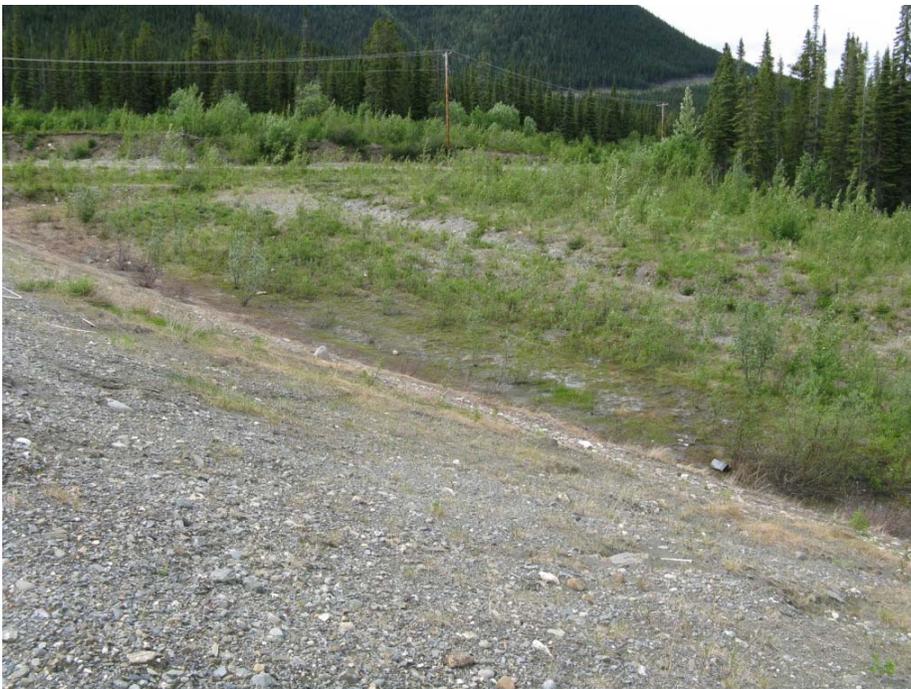
No seepage was present on the downstream end of the dam, on the east side. Seepages were observed on the west side of the dam, along the abutment (Photo 4) and at the dam toe (Photo 5). It is not certain that the seepage along the abutment originated from the tailings impoundment. The seepage long the toe is however considered as water from the tailings impoundment. Total seepage was roughly estimated at 1 L/min, which is below the estimate provided in SRK and AMC (2000). The seepage water was clear, and consequently no loss of material from the dam is suspected. All seepage from the North Dam is directed to a collection pond (Photo 6), and the water flows toward water quality monitoring station MH-02 (Figure 3).

Photograph 4: North Dam – Seepage at the dam abutment on the west side.

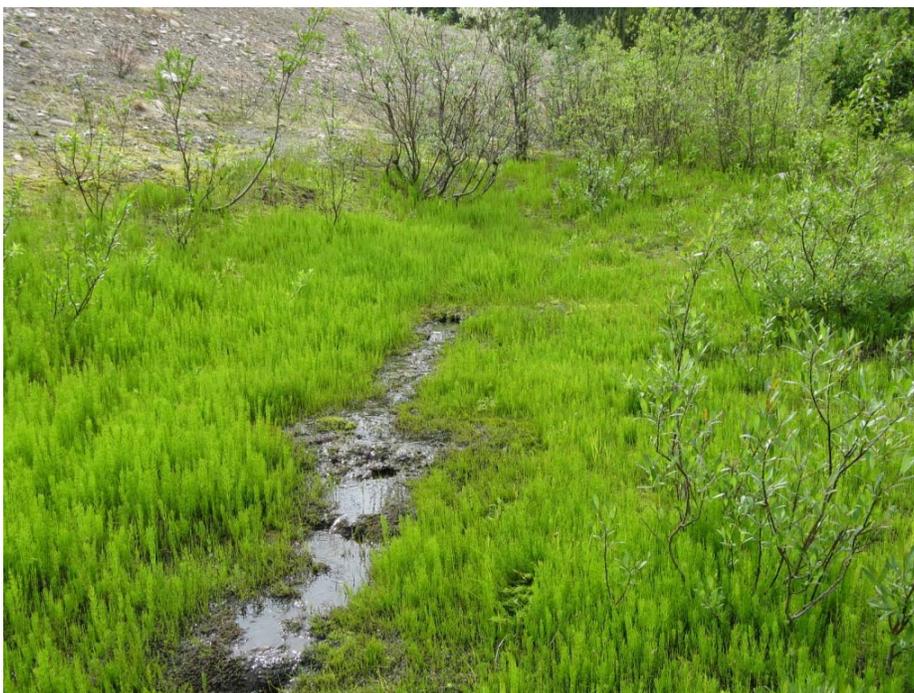
Photograph 5: North Dam – Seepage at the toe of the dam on the west side.

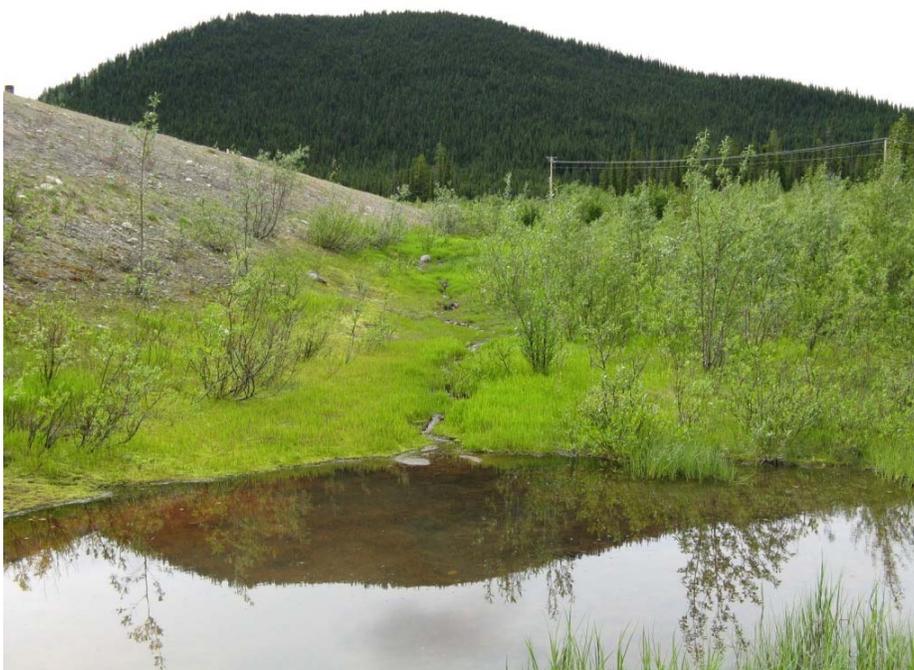
Photograph 6: North Dam – Seepage collection at the toe of the dam.

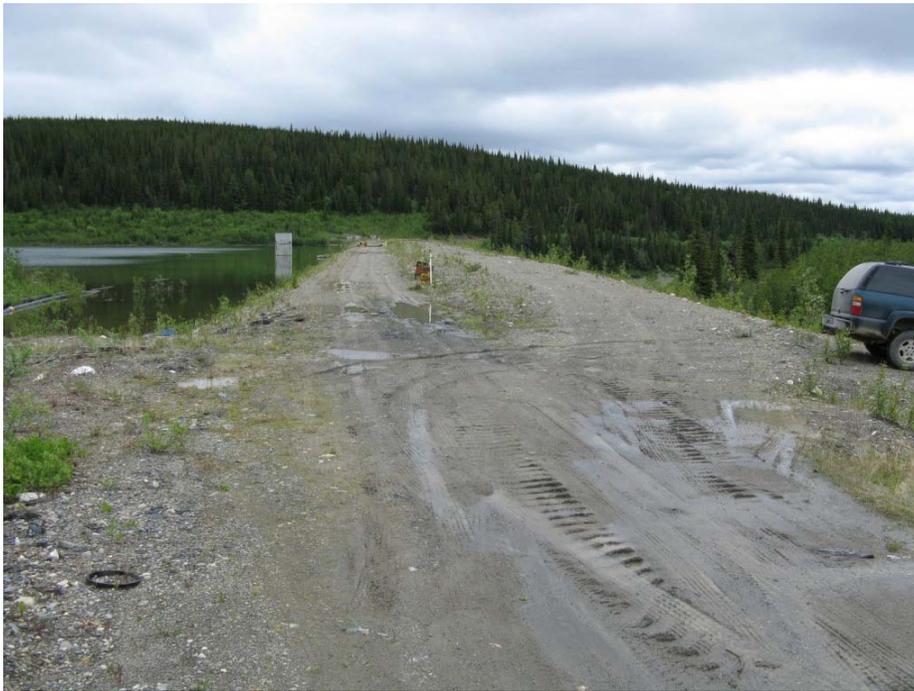
The dam is considered in stable condition at the time of the visit, with uniform and stable slopes, and no visual indication of erosion or slope movement. The dam crest is wide and consists of two benches (Photos 7 and 8); as a result of the construction sequencing. The upstream bench is lower than that downstream, and would be raised if mine operations restart. Water elevation in the Tailings Pond was estimated to be at a level that would have provided the minimum 2 m freeboard under normal operation. To facilitate site operation and inspection, markers should be permanently added or marked on the decant wall to indicate important water elevations, such as the maximum operating water level and inflow flood design water level.

Photograph 7: South Dam – Dam crest, looking east.

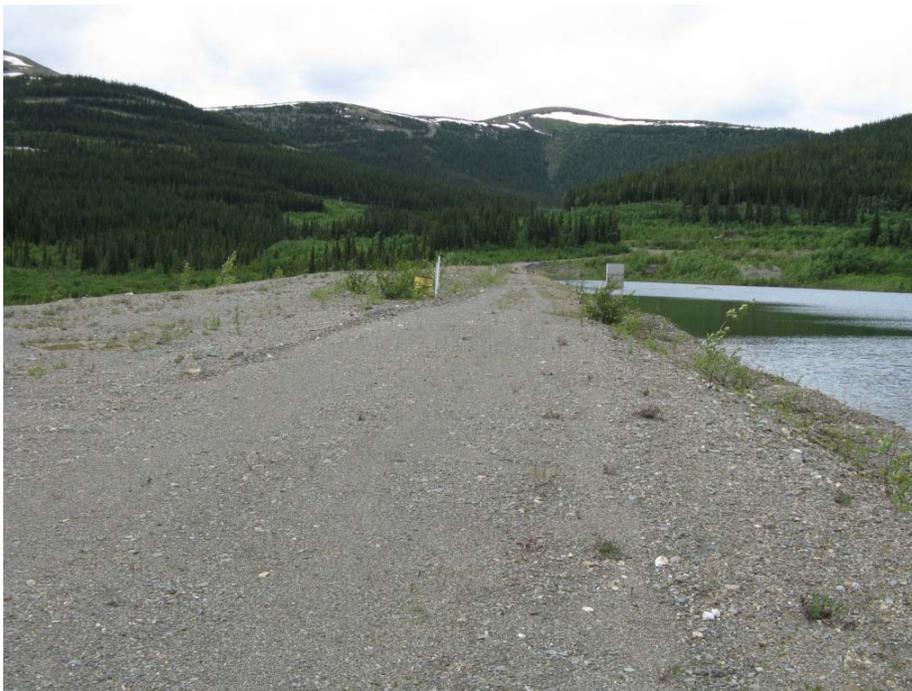
Photograph 8: South Dam – Dam crest, looking west.

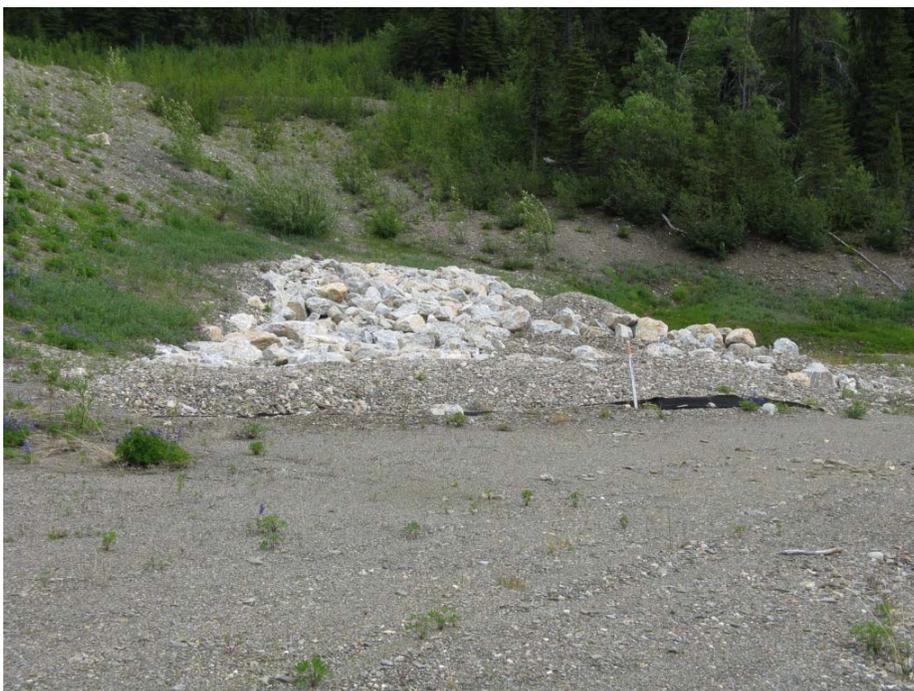
The buttress at the toe of South Dam appears in stable condition (Photo 9). Seepage was observed at the toe of the dam, on the west side of the buttress, and was estimated to be flowing at a rate of 0.25 L/min. Seepage water was clear and therefore no loss of material from the dam is suspected. No other seepage was observed

Photograph 9: South Dam – Seepage at the toe of the dam, on the east side.

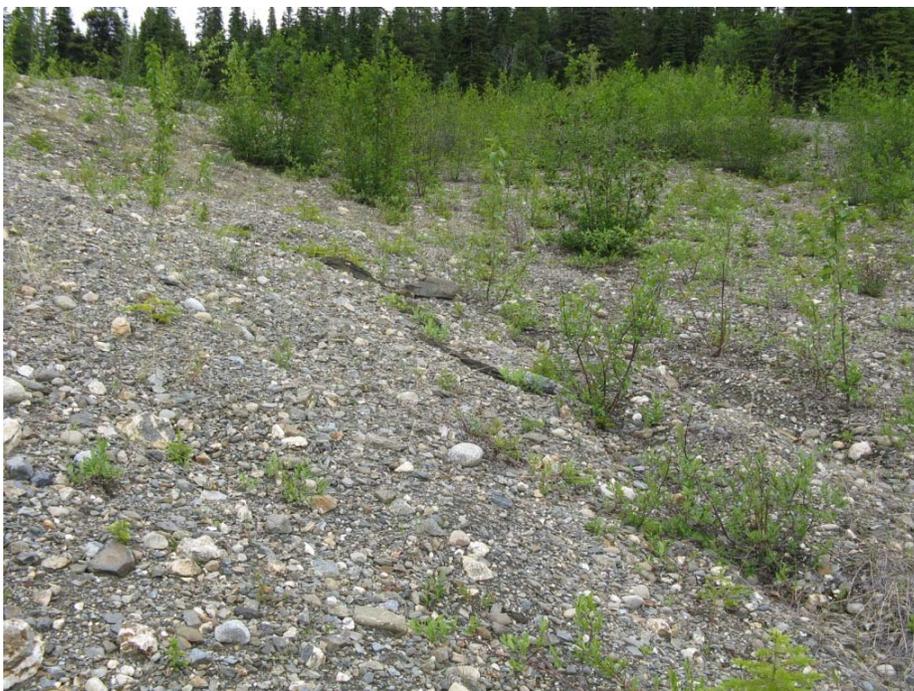
along the abutment and toe of the dam (e.g. Photo 10); however several wet areas were identified near the dam toe. Regular visits to observe drainage conditions at the toe should therefore be made.

Photograph 10: South Dam – East abutment, dry area.

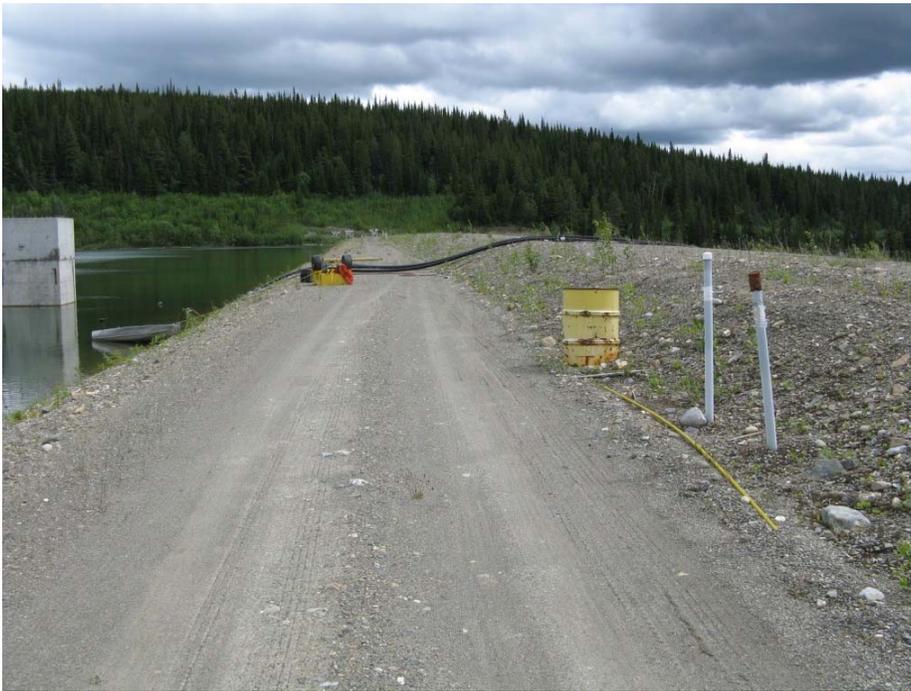
Photograph 11: South Dam – Looking east from the dam crest to the decant tower.

- An inspection of the seal of the pipe inlet at the decant structure (South Dam) would be recommended to determine if repairs or a replacement are required. Detail design of a permanent seal will be needed if the decant tower is expected to remain in place following permanent closure of the mine.

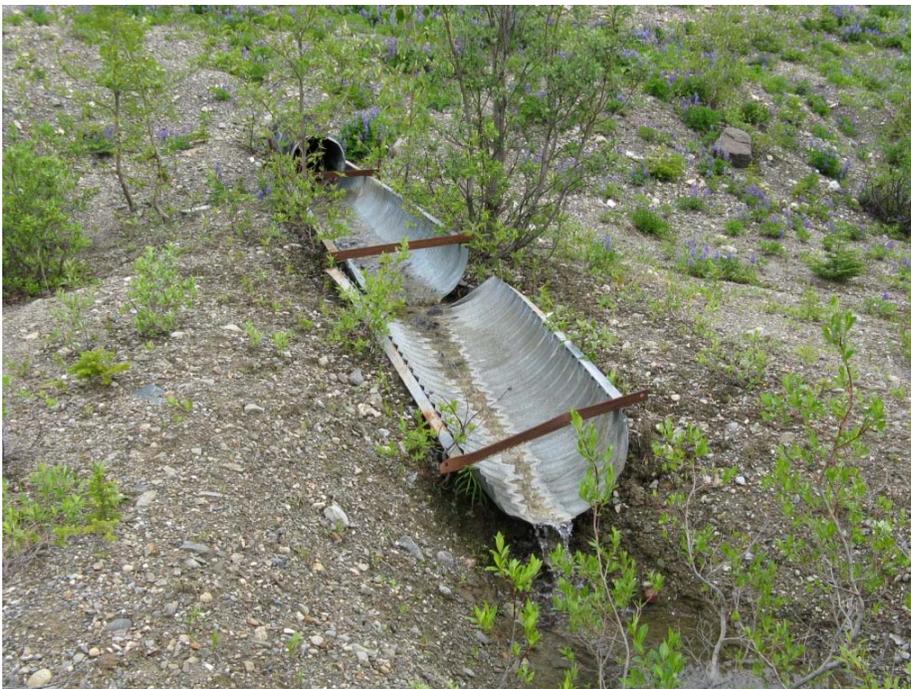
Photograph 12: South Dam – Outlet from the decant tower on the downstream face of the dam.

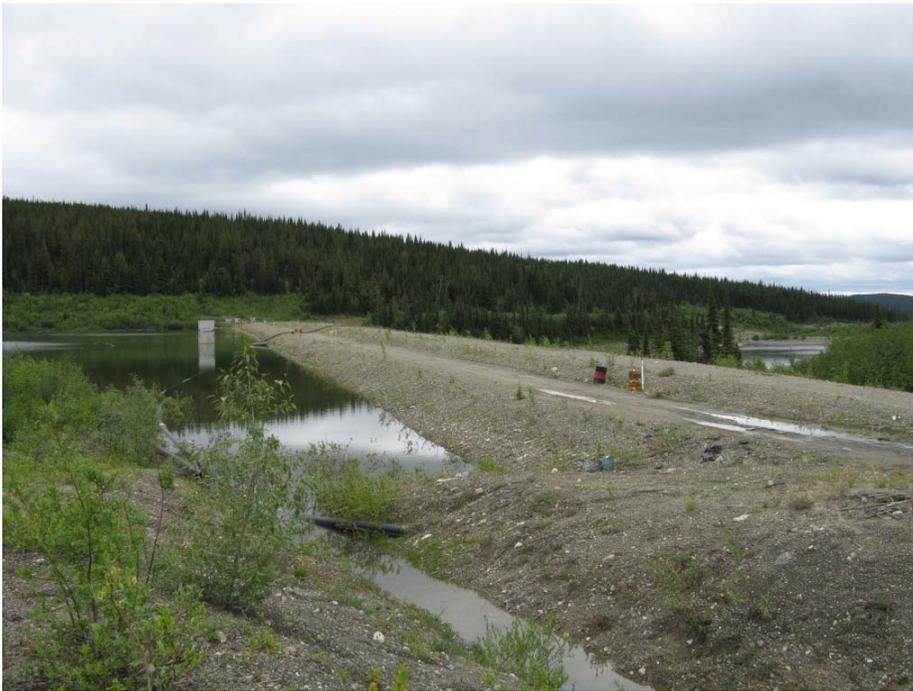
Photograph 13: South Dam – Channel to the spillway on the west side of the dam.

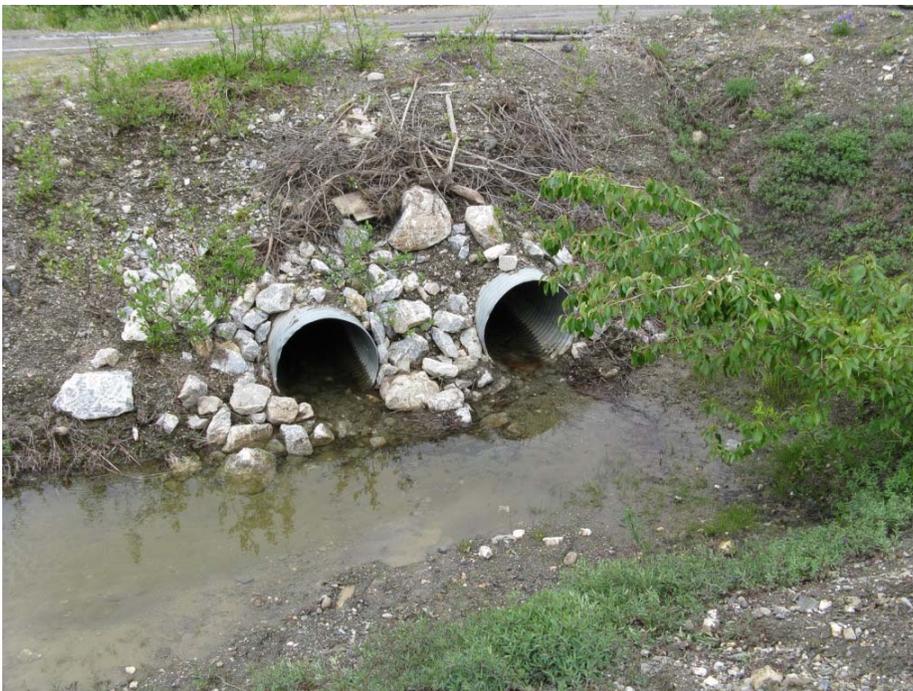
Photograph 14: South Dam – Culvert inlet of the dam spillway.

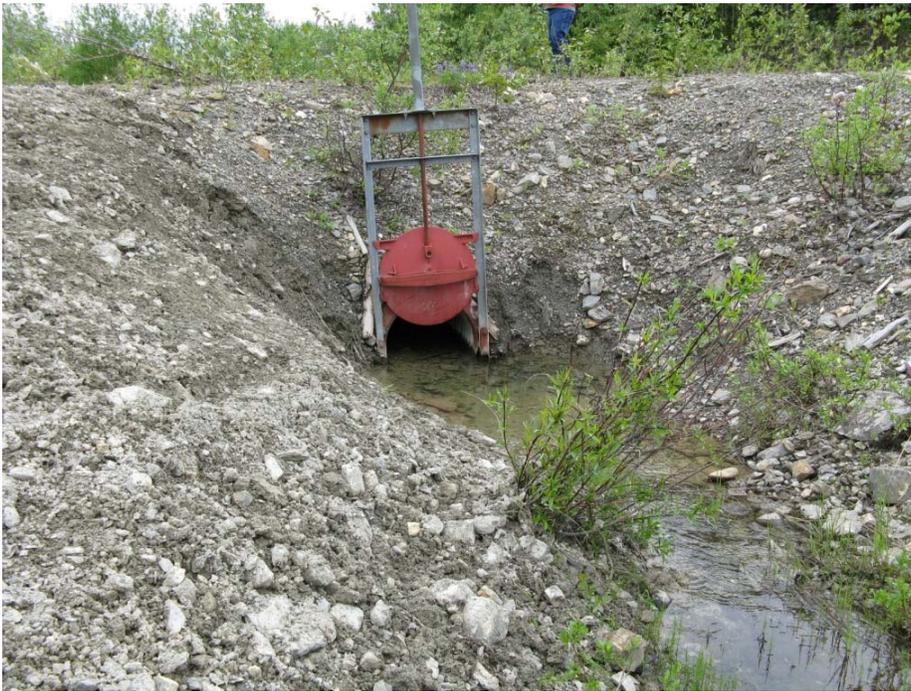
Photograph 15: Cofferdam Dam – Gate at the culvert inlet.

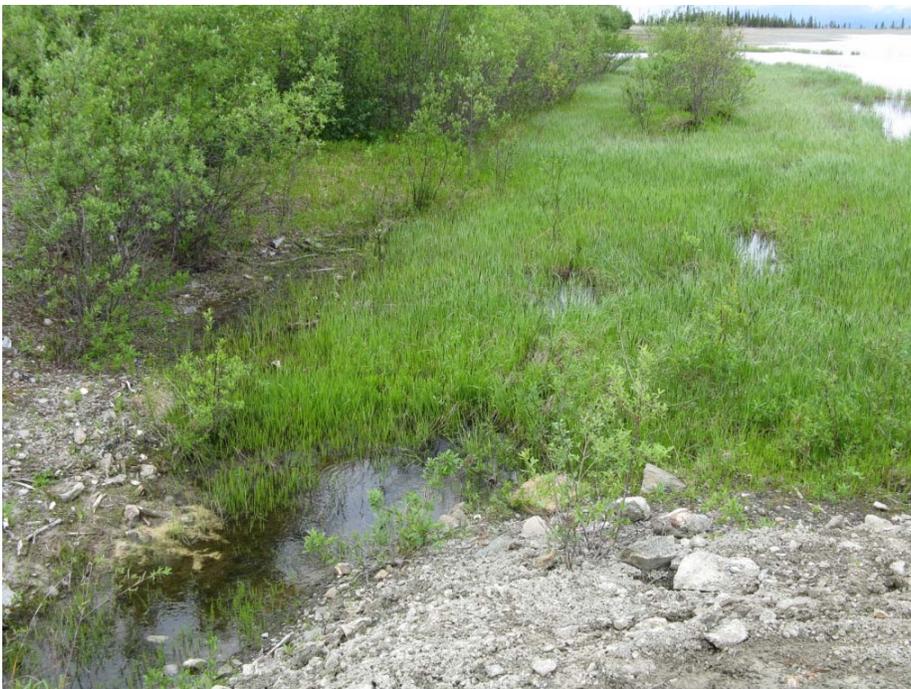
Photograph 16: Cofferdam Dam – Inlet channel to gated culvert.

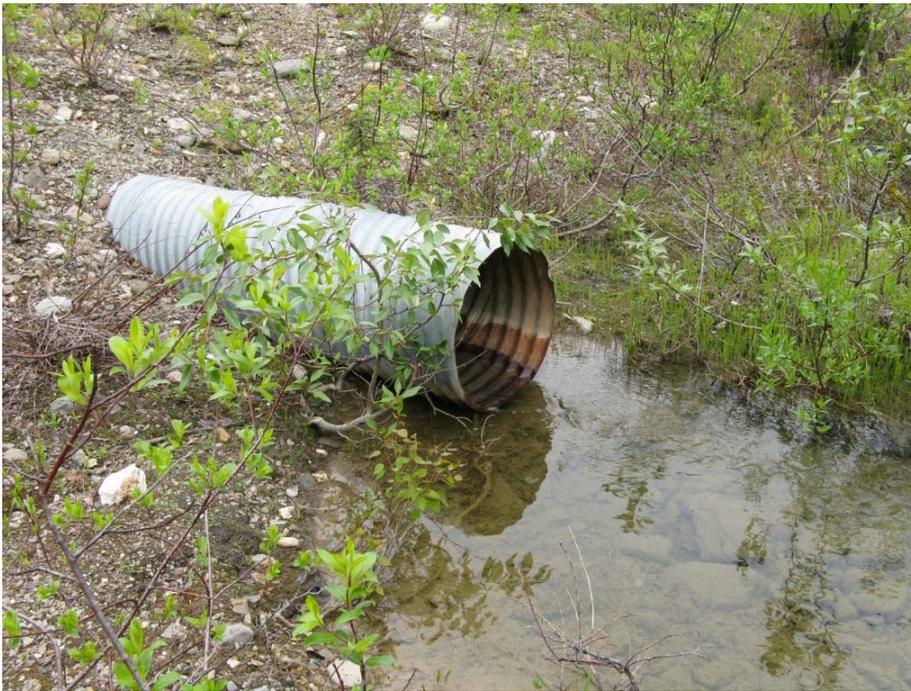
Photograph 17: Cofferdam Dam – Outlet channel to gated culvert.

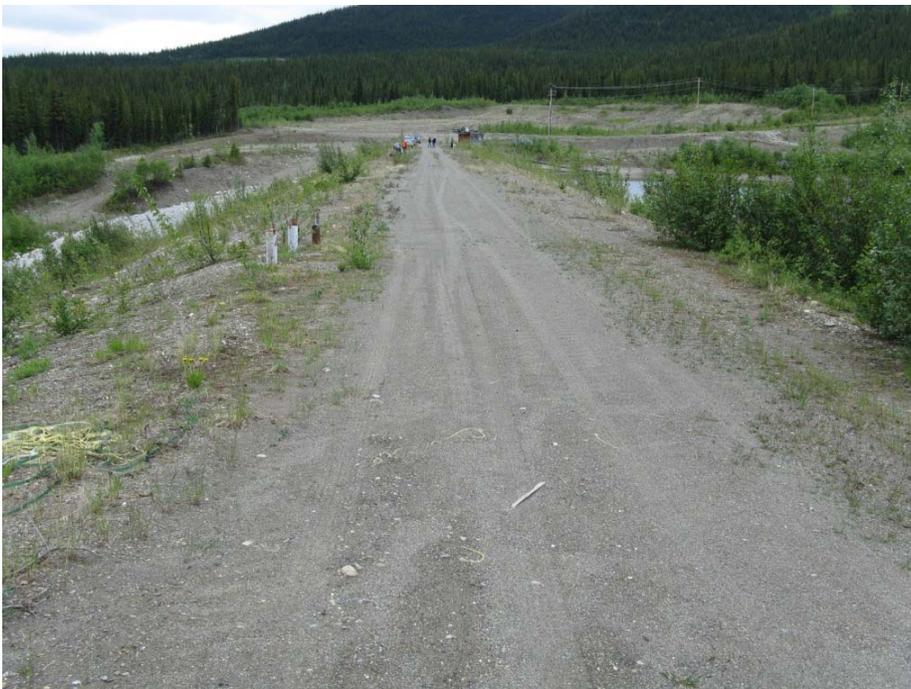
Photograph 18: Reclaim Dam – Looking west on the dam crest.

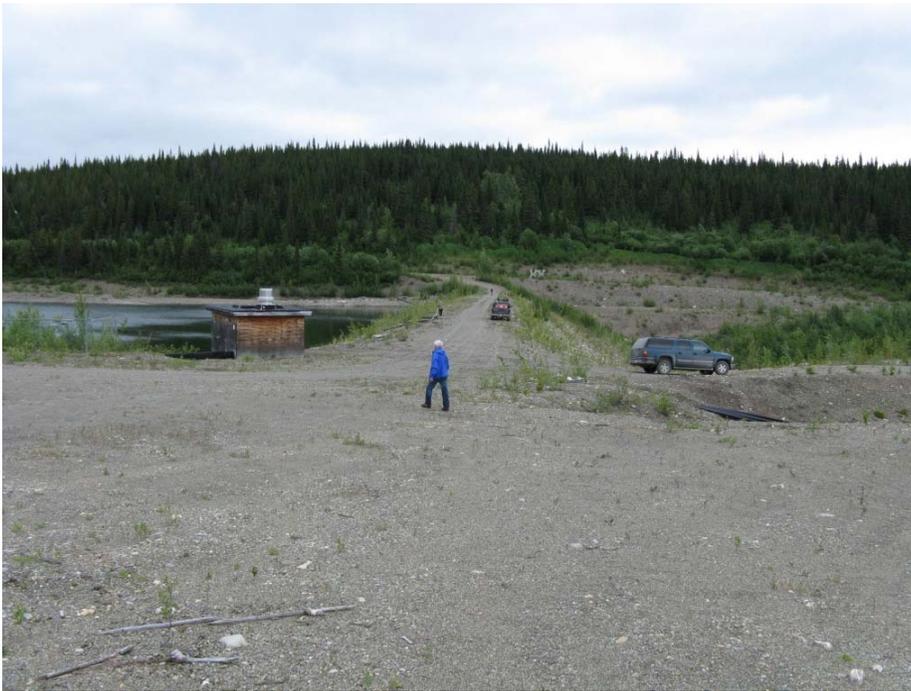
Photograph 19: Reclaim Dam – Looking east on the dam crest.

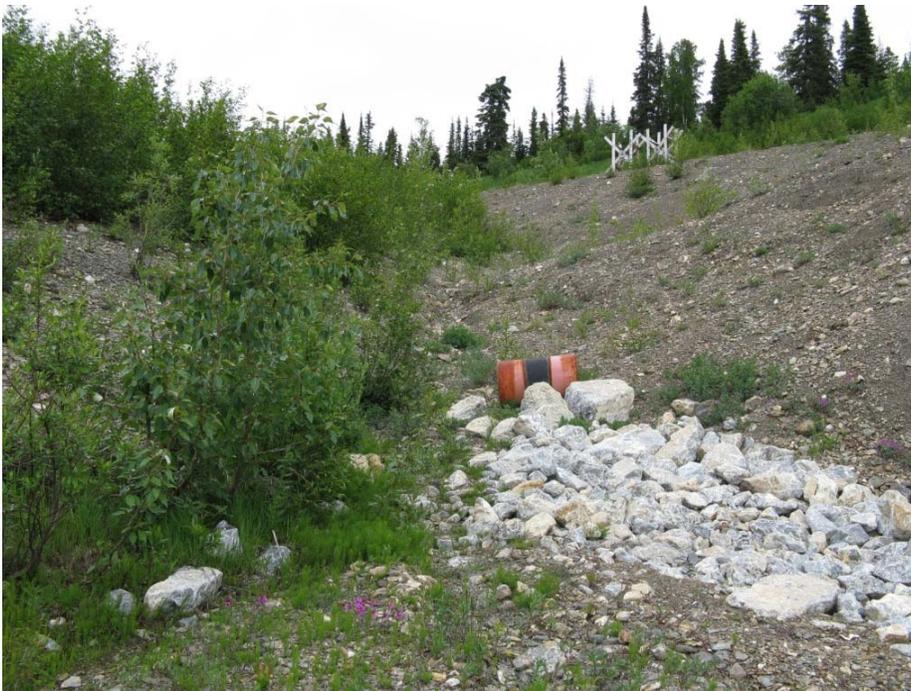
Photograph 20: Reclaim Dam – East toe area with seepage in the gully.

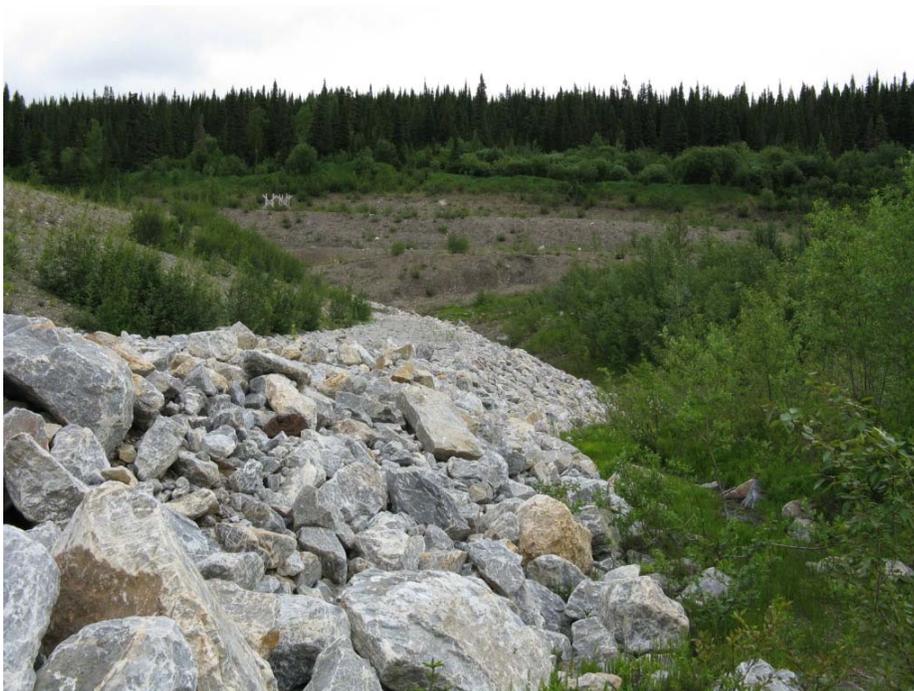
Photograph 21: Reclaim Dam – Toe buttress road.

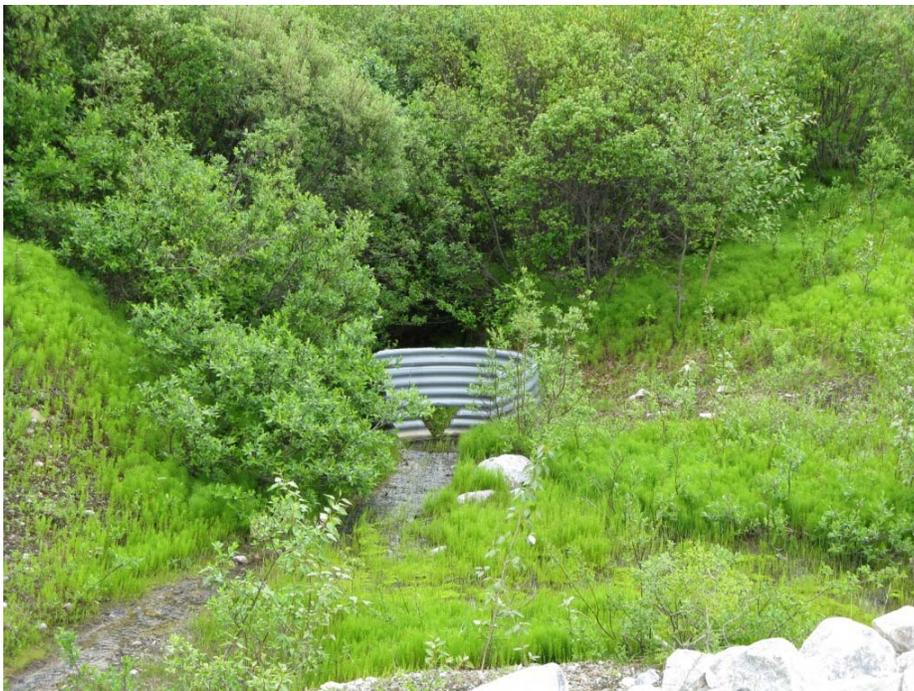
Photograph 22: Reclaim Dam – Monitoring weir at the toe of the dam.

- Repair to the weir at water quality monitoring station MH-07 should be made when possible to ensure that all water pass through the V-notch and the seepage flow from the Reclaim Dam are not underestimated.

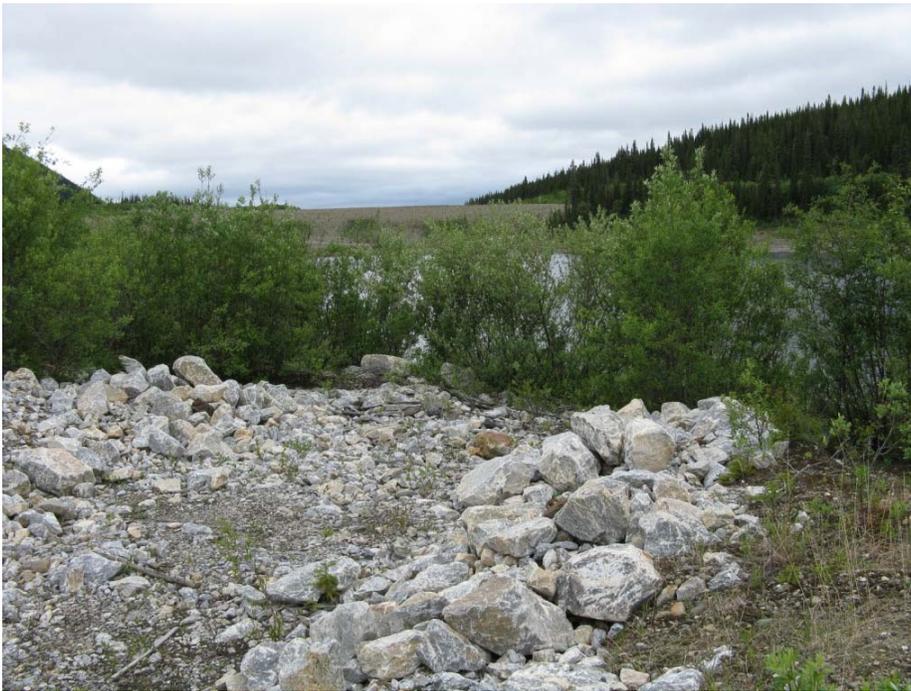
Photograph 23: Reclaim Dam – Spillway channel with the Reclaim pond behind the tree line.

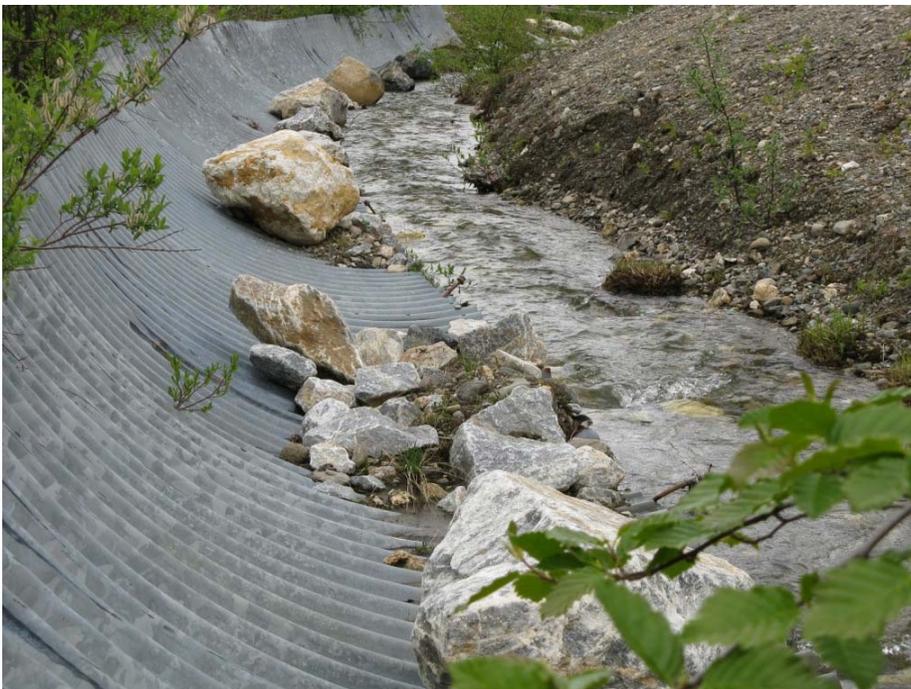
Photograph 24: Camp Creek Diversion – Channel above Reclaim Dam (water erosion below the steel plates).

- The conditions of the steel plate armour in the Camp Creek Diversion should be monitored on a regular basis and repairs undertaken as soon as possible when needed. Alternate and more stable armouring options must be considered in plans for permanent closure of the mine site.

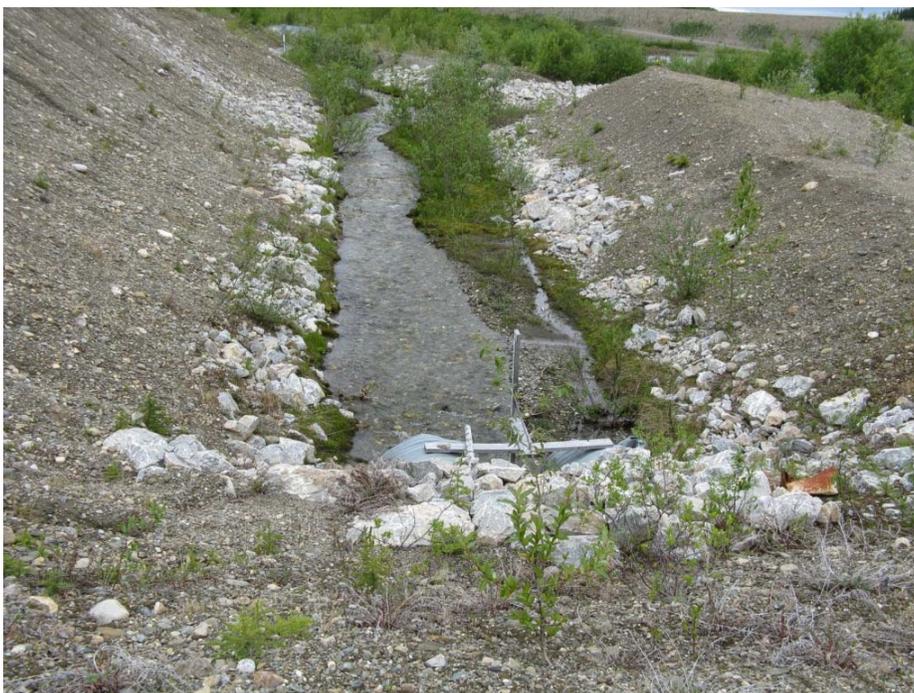
Photograph 25: Camp Creek Diversion – Channel at Reclaim Dam.

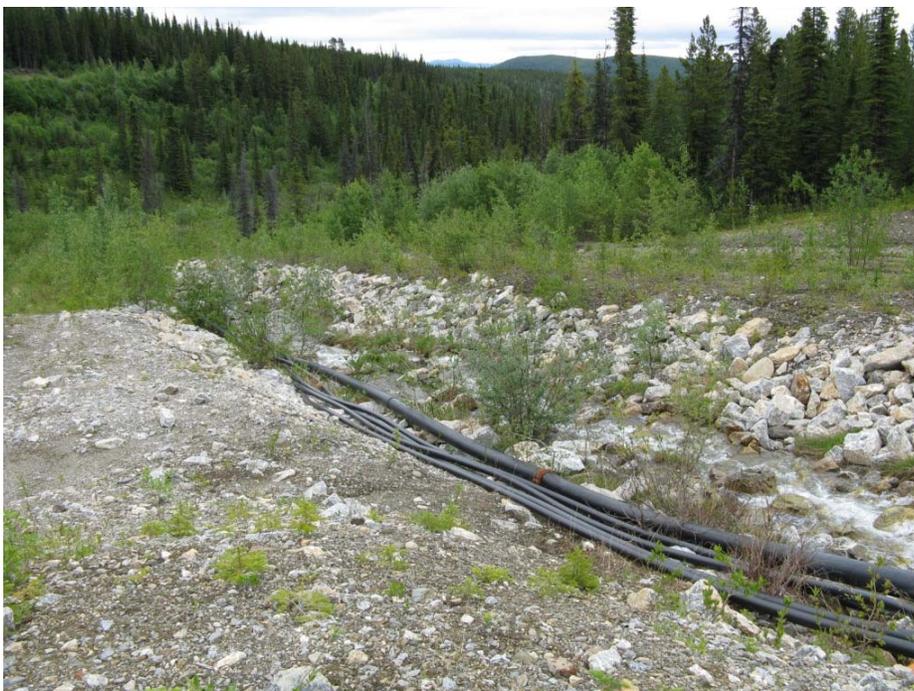
Photograph 26: Camp Creek Diversion – Spillway channel downstream of Reclaim Dam.

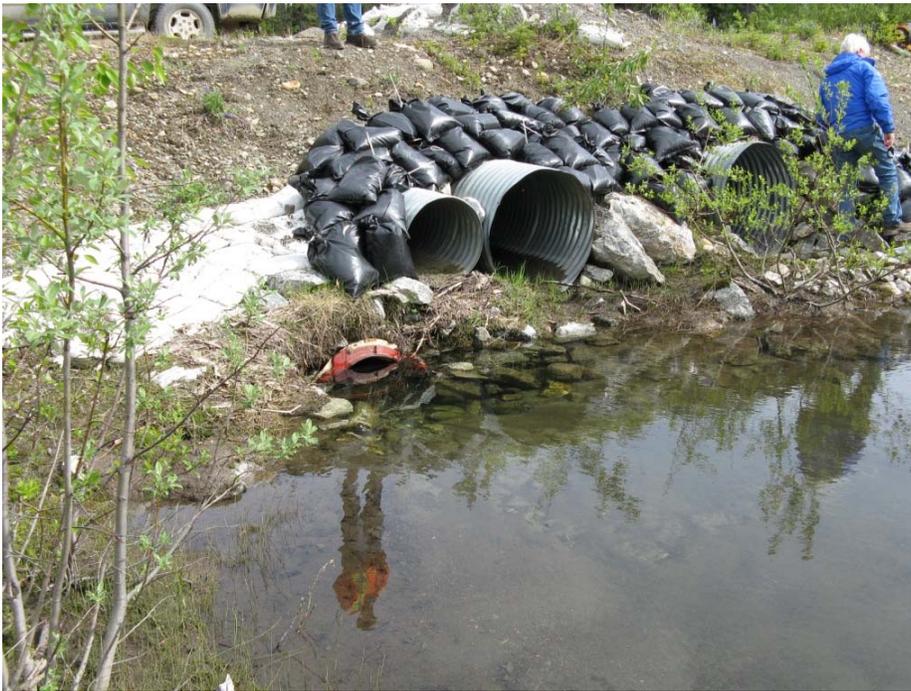
Photograph 27: North Creek Dike – Culvert inlets.

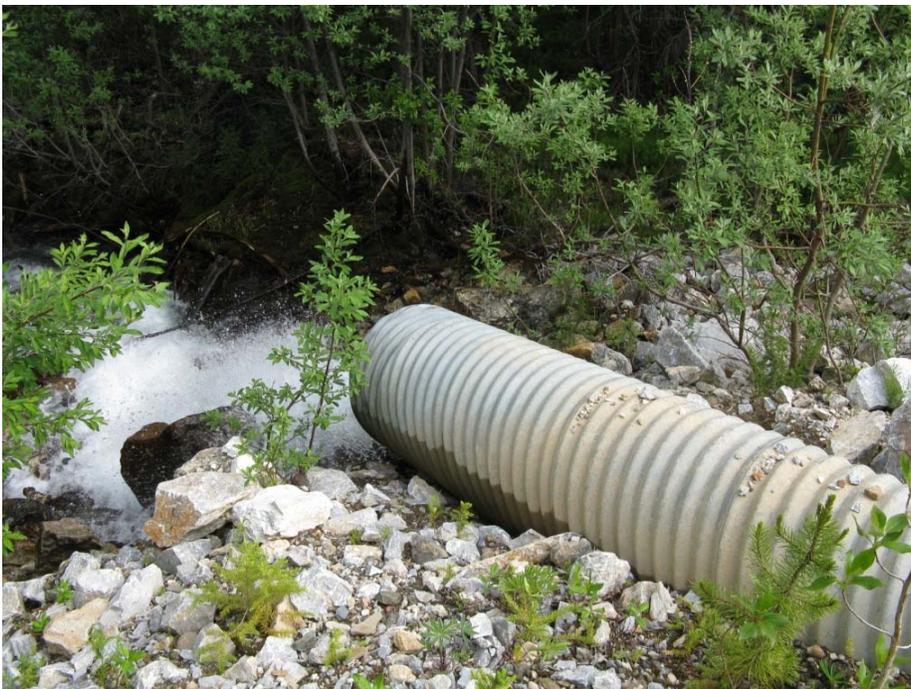
Photograph 28: North Creek Dike – Culvert outlet.
