Sä Dena Hes 2020 Annual Mine Waste Facilities Inspection

Teck Resources Limited

SRK Consulting (Canada) Inc.
1CT008.073
October 2020

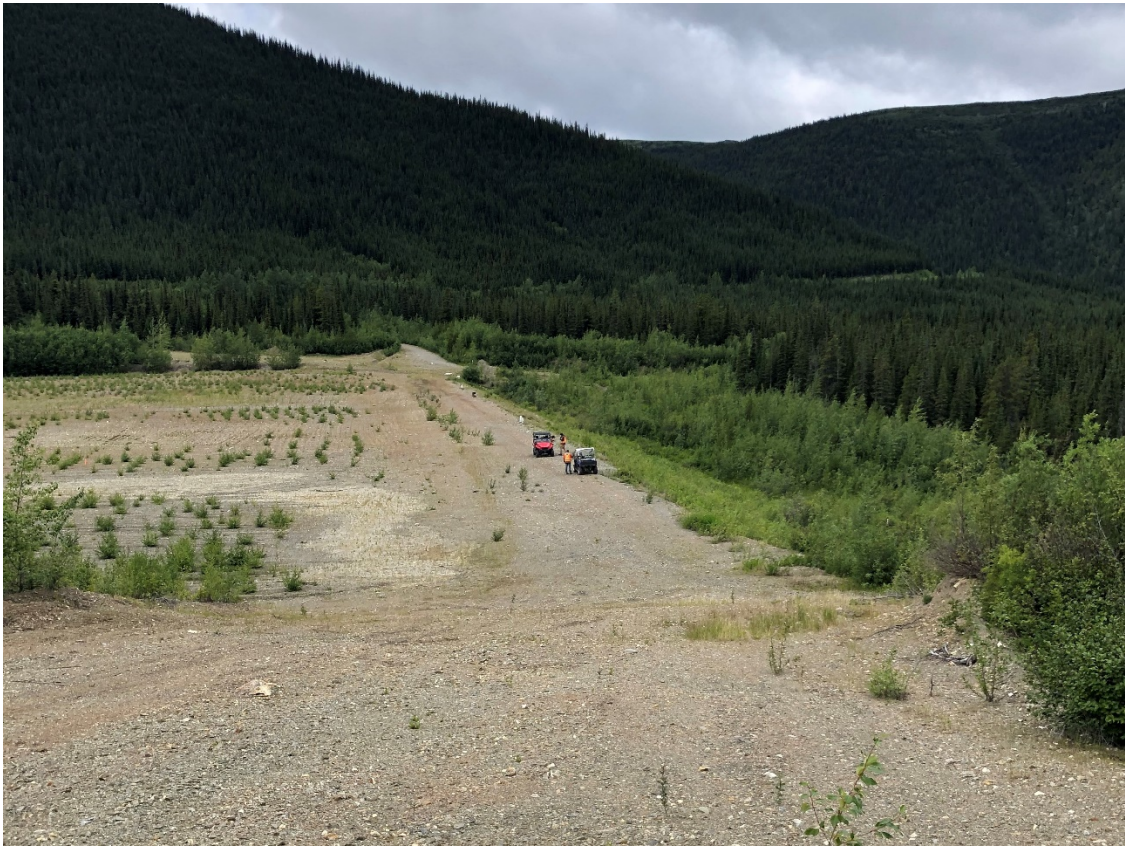
The crest of the North Dam looking west is shown in Photo 1 (Appendix A). The dam is in good condition and shows no signs of deformation or abnormal settling. The downstream slope of the dam (Photo 2) shows no signs of surficial movement or erosion nor is there any sign of bulging at the downstream toe. While there are a few shrubs and small trees on the slope, no excessive vegetation growth beyond the guidelines in OMS was noted.

Photo 1 View West of the North Dam

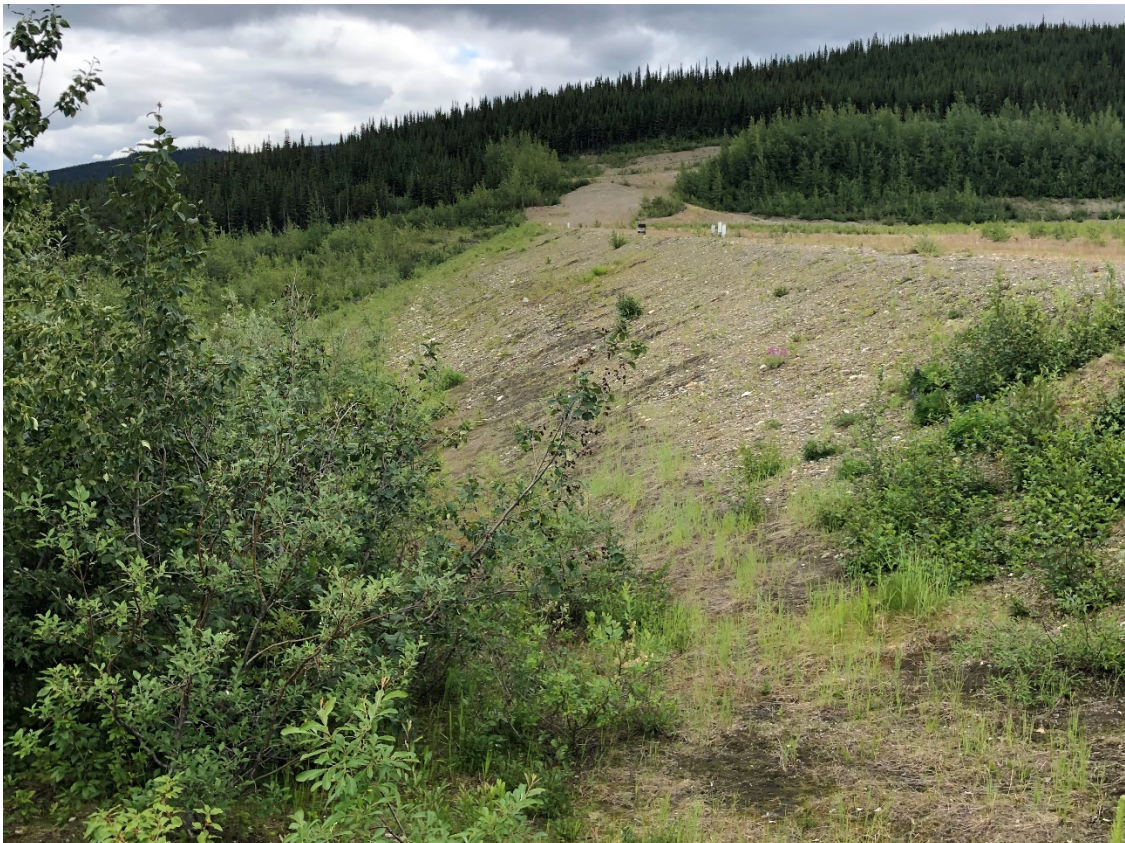
Photo 2 View east over the downstream face of the North Dam

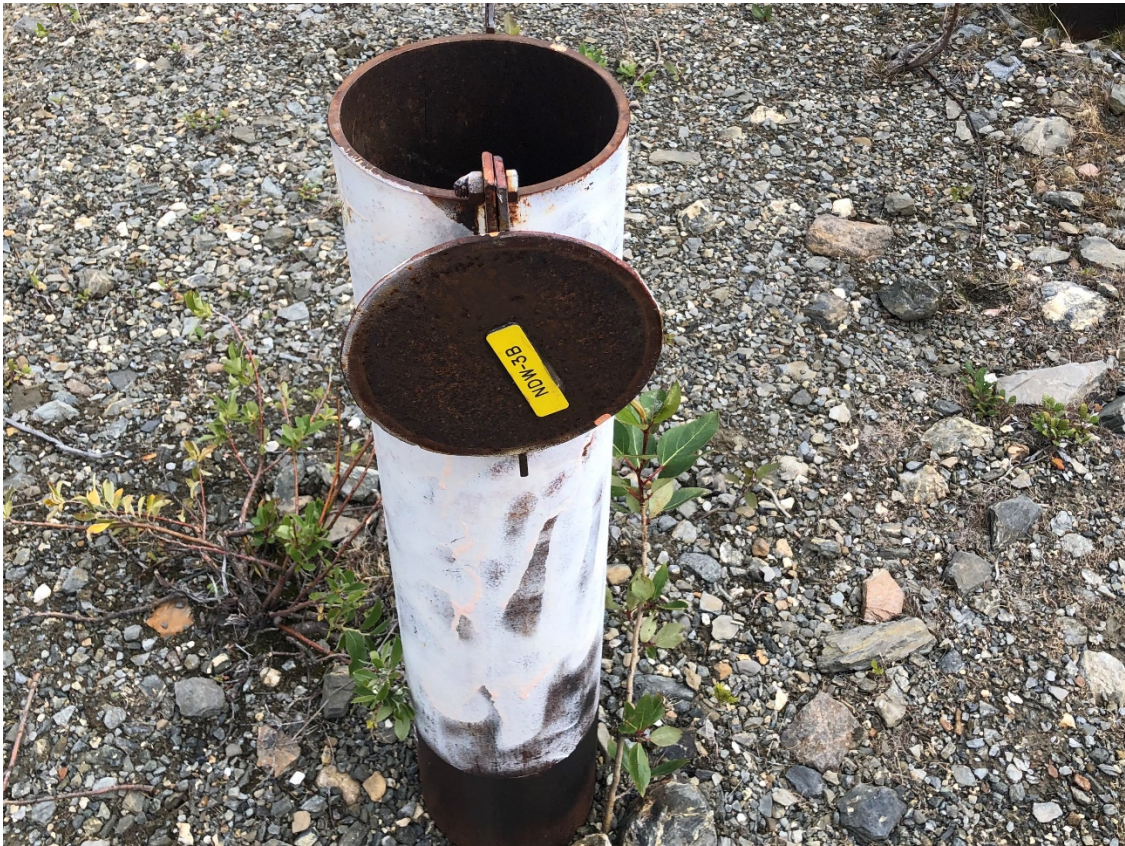
The piezometers and settlement gauges on the North Dam are in good condition and continue to function as designed. Photo 3 shows the protective steel cap at the location of the NDW 3A. The orange coloured piezometer caps provide visible identification for the monitoring team as

Photo 3 Piezometer NDW 3A protective cap

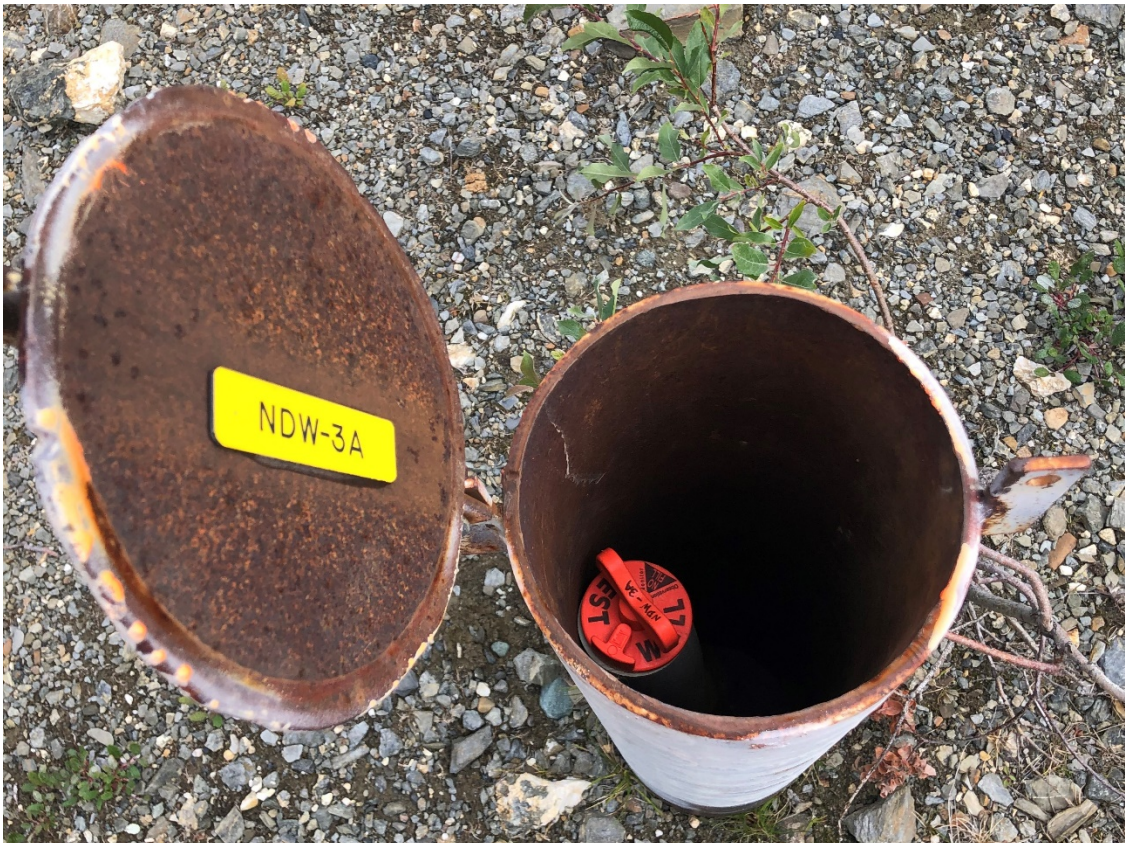
Photo 4 Piezometer NDW 3A PVC Standpipe with red cap

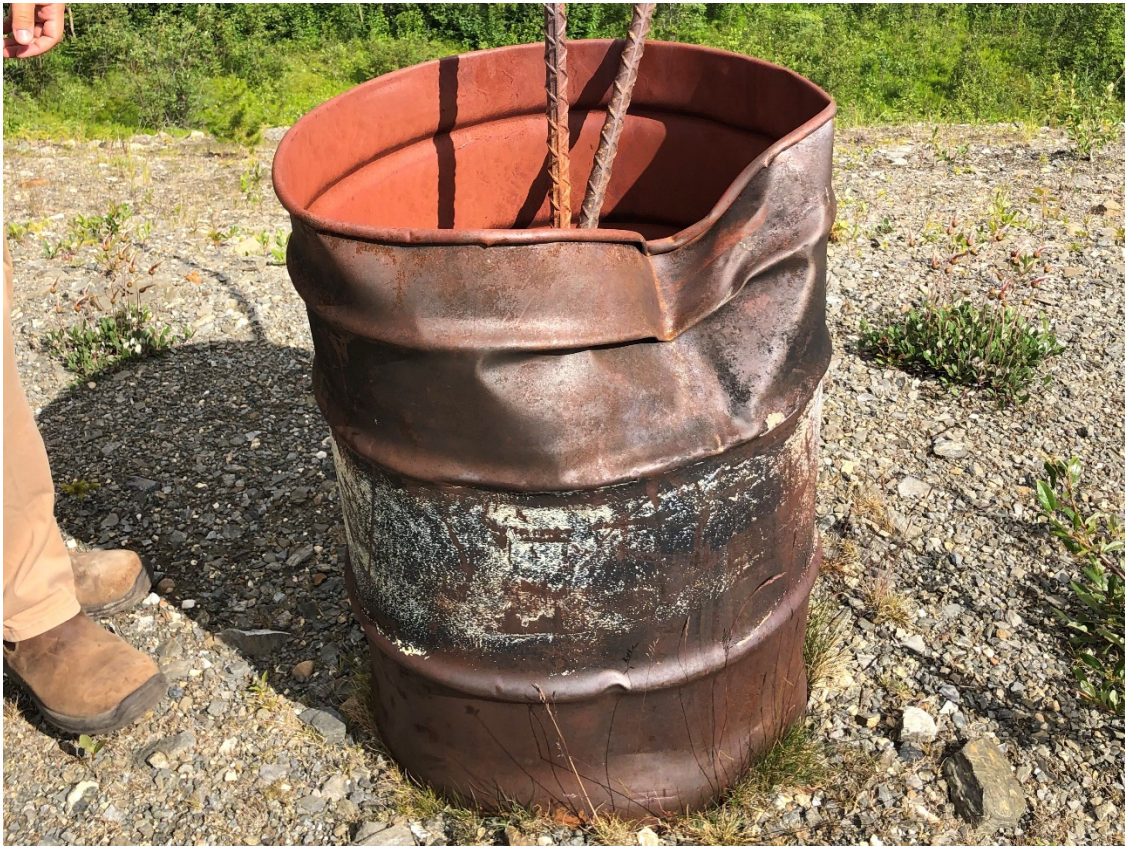
Photo 5 Displacement pins (redundant)

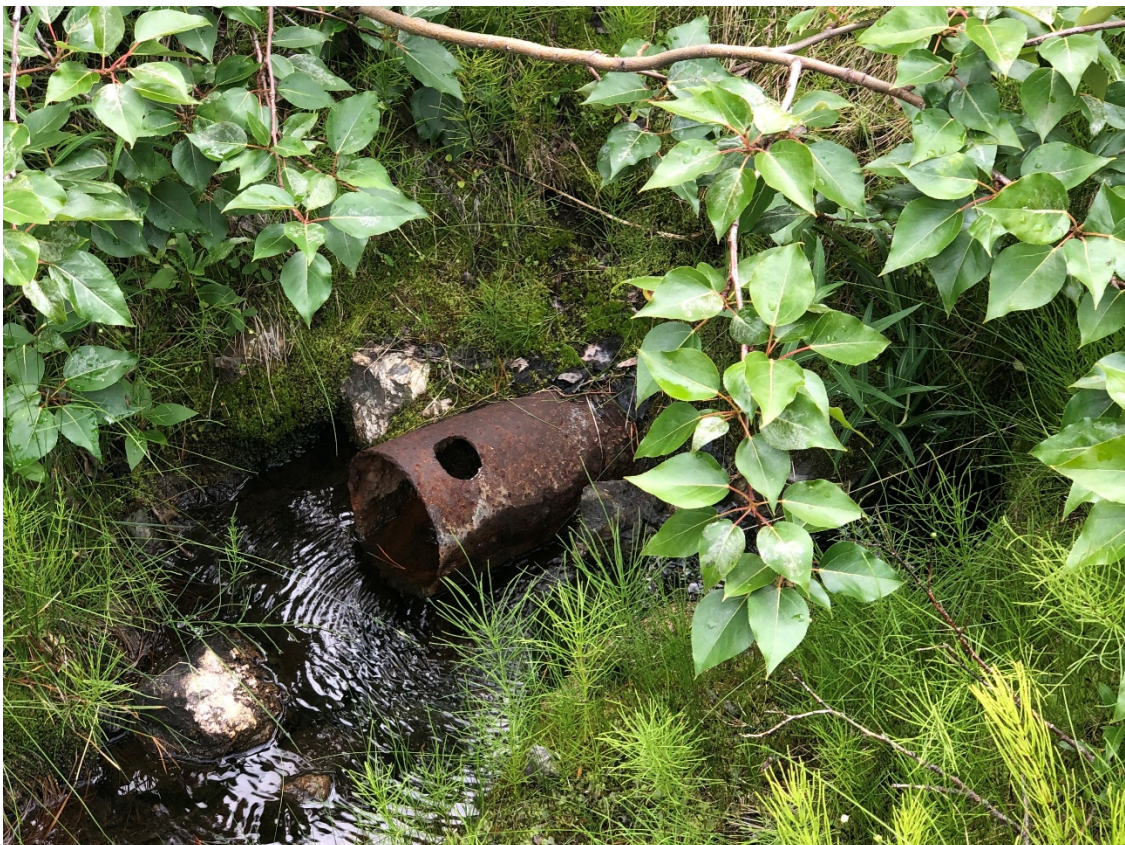
Along the downstream toe of the North Dam there is an 80 m long seepage zone. Seepage from this zone is collected at a monitoring station referred to as MH-02 and is a combination of groundwater discharge from the surrounding hillsides to the west and minimal seepage flow from the impoundment. The monitoring station consists of a 6-inch diameter steel pipe (Photo 6) embedded in sandbags. At the time of the inspection it was noted that the pipe had been displaced and will need to be adjusted. No change in the flow rate or consistency of the flow was noted during the site visit or during the routine site inspections and water quality sampling.

Photo 6 MH02 Flow Monitoring Pipe

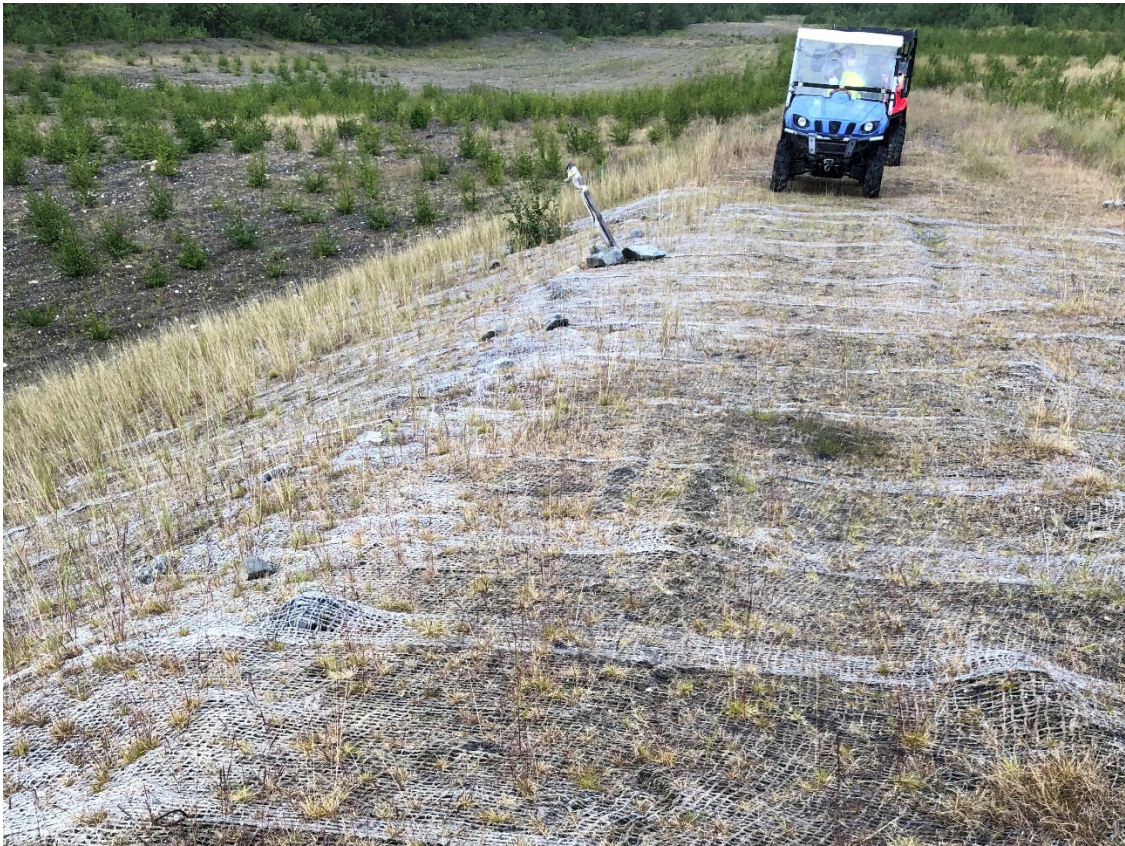
Photo 7 View west of the SRS crest. Note vegetation and geogrid for stabilization

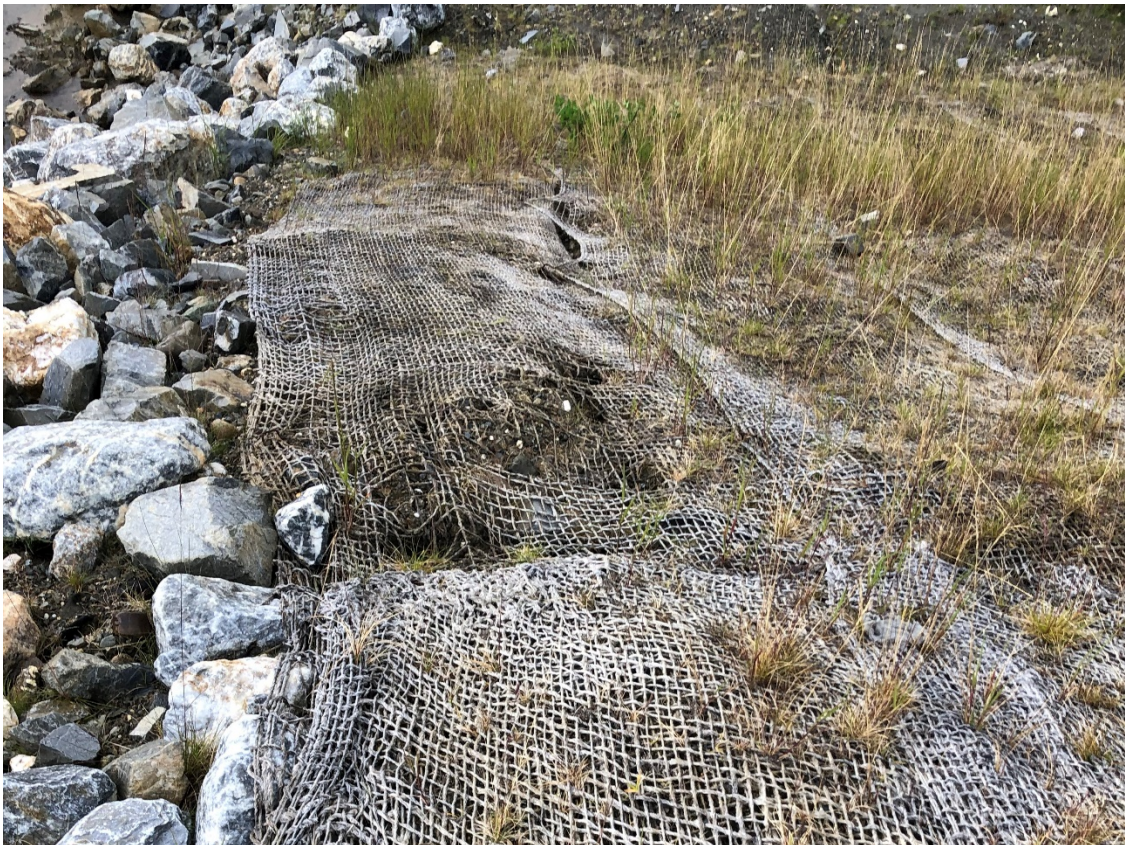
Photo 8 Downstream slope of SRS with shallow erosion rill

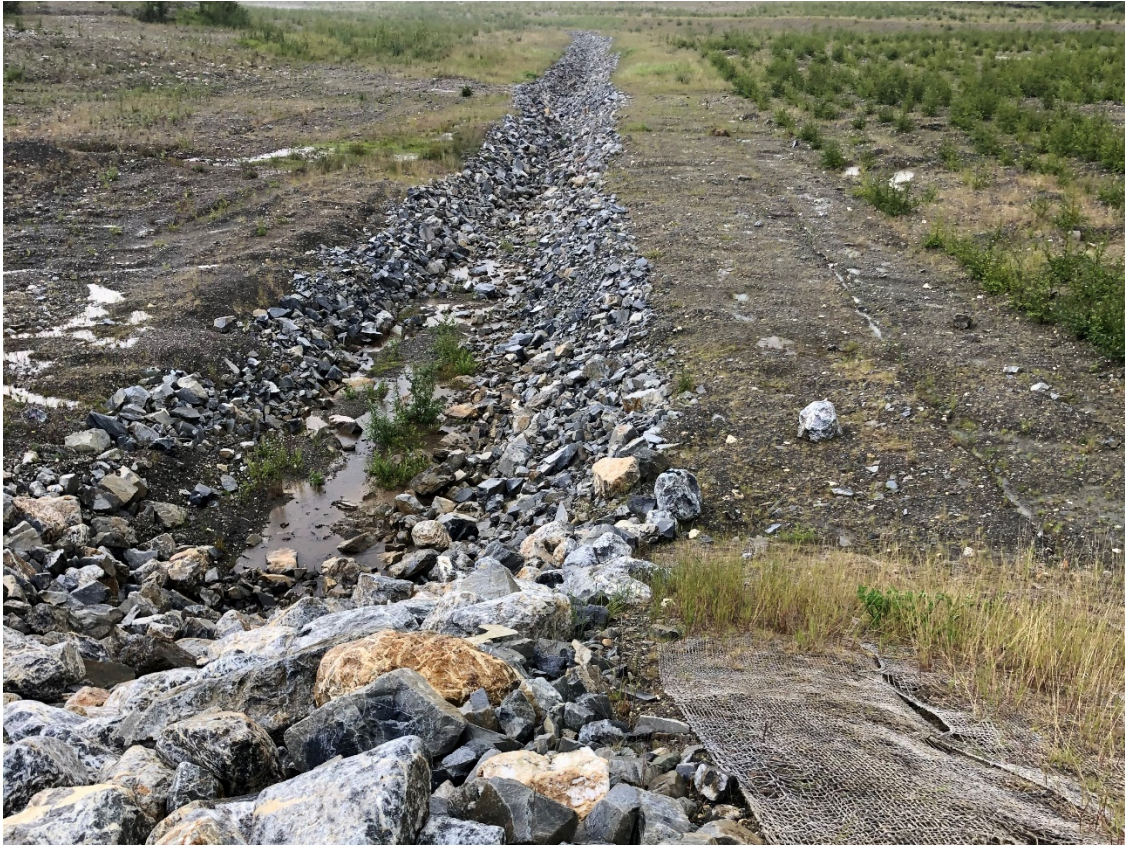
The riprapped drainage channels (the North channel, the Camp Creek channel and the South channel) were constructed during the TMA decommissioning in 2014. Photo 9 is a view looking south along the South Drainage channel. Figure 7 provides a plan view of the three channels. SRK inspected each of the channels for any signs of major subsidence and movement of the riprap erosion protection. Both the South drainage channel and the Camp creek drainage channel are functioning as designed with no significant deterioration.

Photo 9 View south of the South Drainage Channel

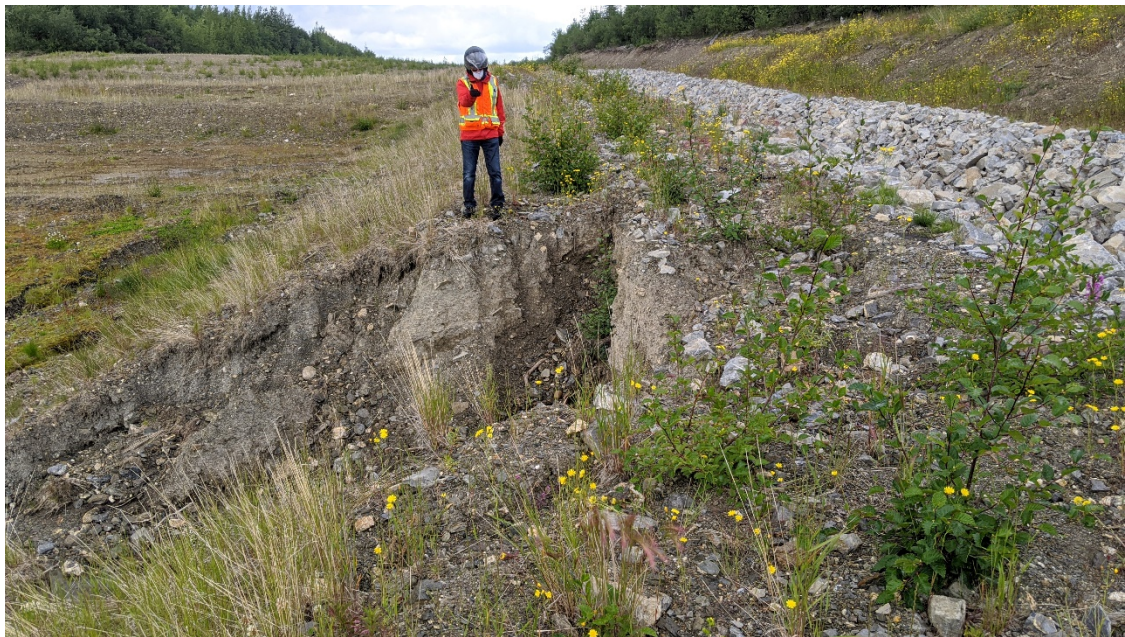
The North Drainage channel upstream of the SRS (Photo 10) was built to divert as much runoff as possible away from the tailings and soil cover during the first few years after the cover placement. Most the channel remains in stable condition except for a subsidence that has occurred about 50 m upstream of the channel outlet. (see Photos 11 and 12). It appears that seepage from the hillside above the channel triggered the subsidence and threatens to undermine the structure at that location. While this is not considered a risk to the SRS dike and once the SRS is removed and the vegetation on the cover takes hold, no maintenance of the channel will be required. However, as no immediate plans are in place to breach the SRS, the subsidence should be repaired by buttressing with riprap borrowed from the downstream portion of the North Drainage channel.

Photo 10 Subsidence in the berm adjacent to the North Drainage Channel

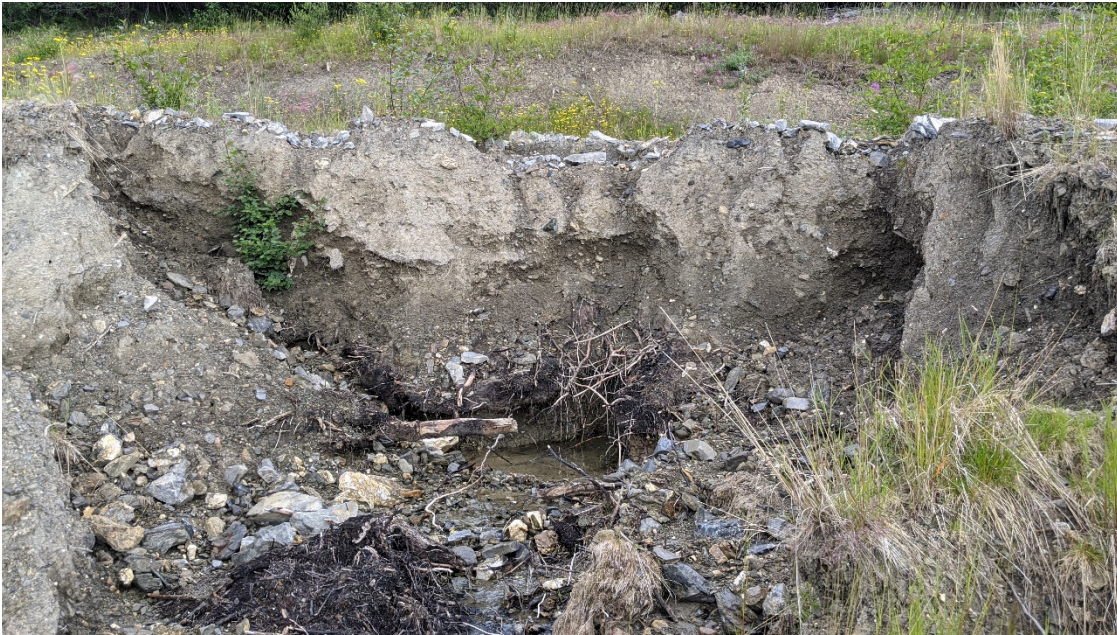
Photo 11 View of the North Drainage channel subsidence

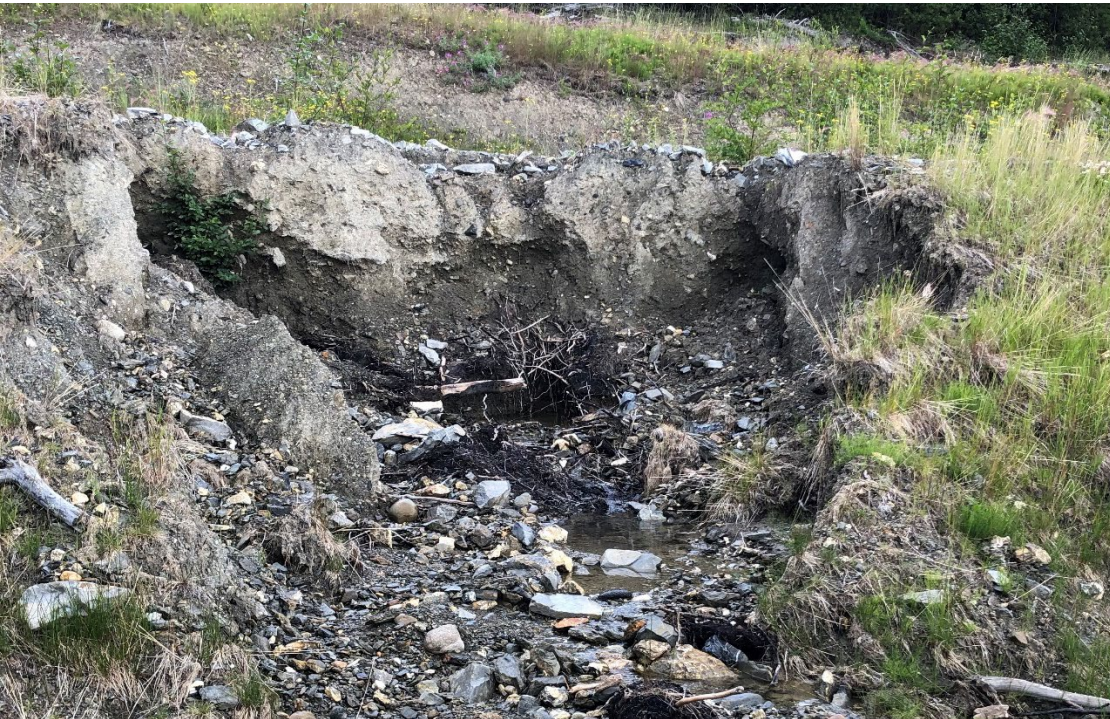
Photo 12 North Drainage Channel subsidence

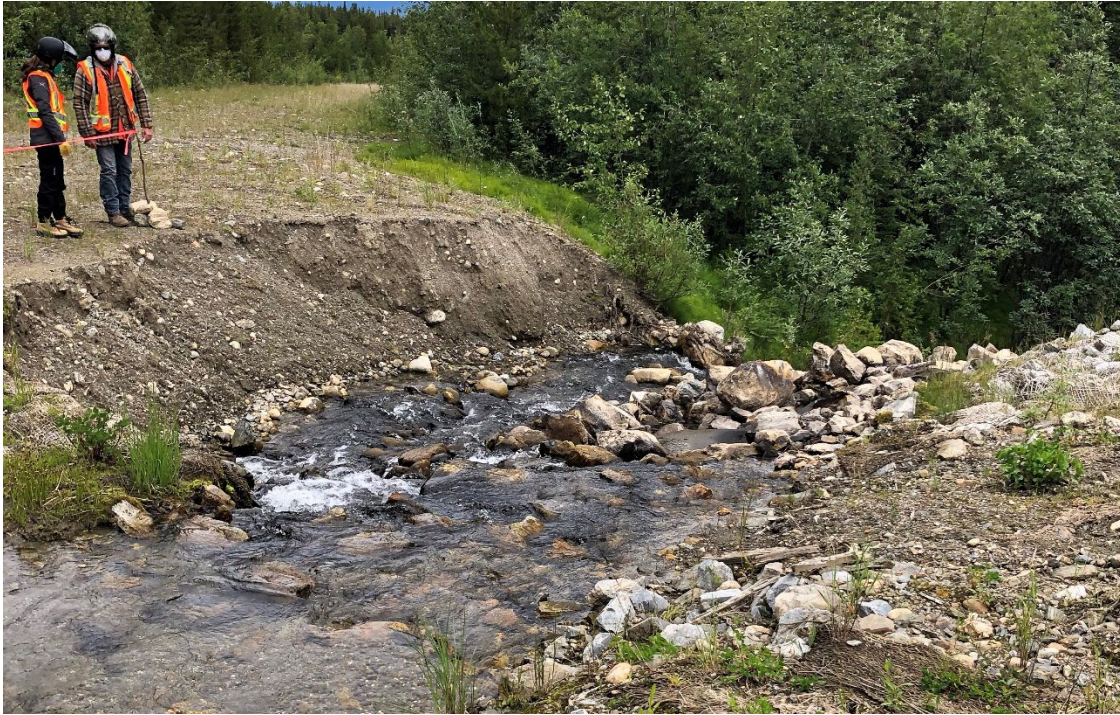
On the north side of the channel at the second crossing of the North Creek, it was noted (see Photo 13) that high flows have eroded the bank resulting in unstable conditions in the existing road fill that was placed during the mine operation. North Creek will continue to erode this section of the channel area but will eventually sustain itself without maintenance. No remedial action is required.

Photo 13 Subsidence in the channel slope at the North Creek second crossing

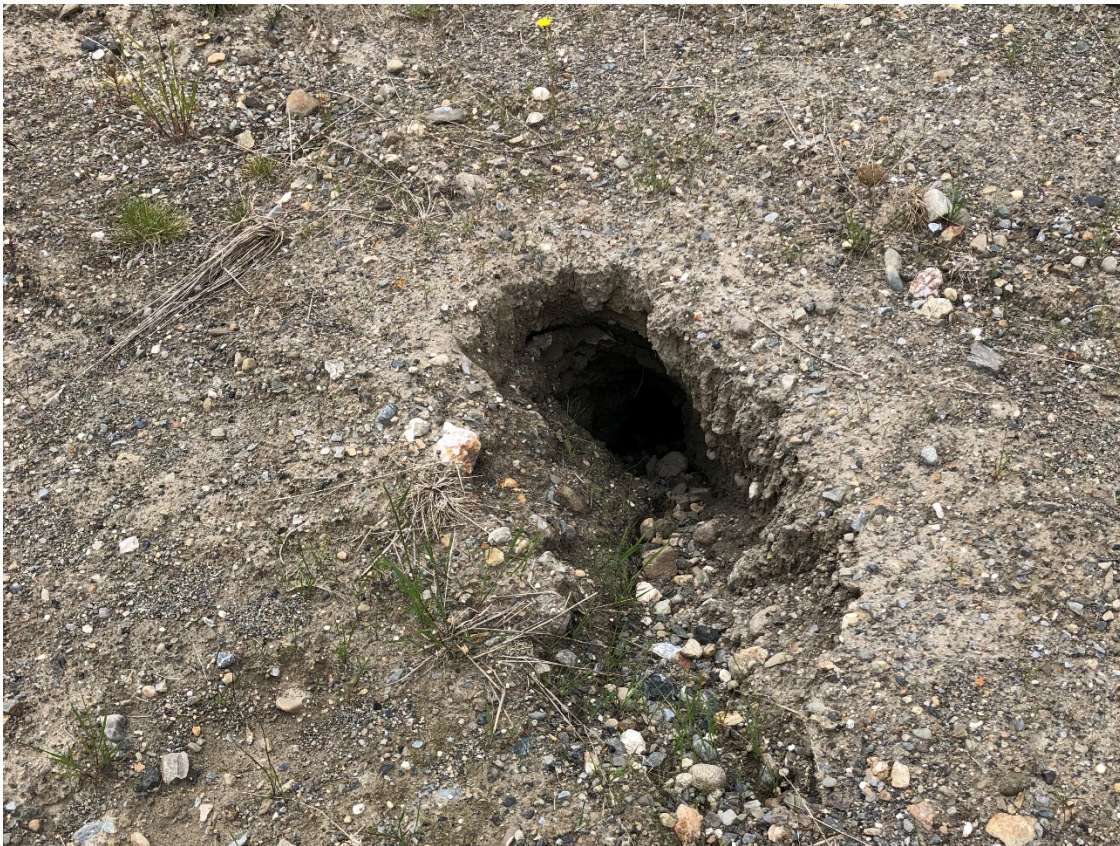
As shown in Photo 14, a small sink hole was observed in the landfill. The surface opening is about 180mm in diameter and is about 50cm deep. The landfill poses no risk to the stability of the North Dam or any other tailings and water management structures on site.

Photo 14: Small sink hole in the landfill south of the North Dam

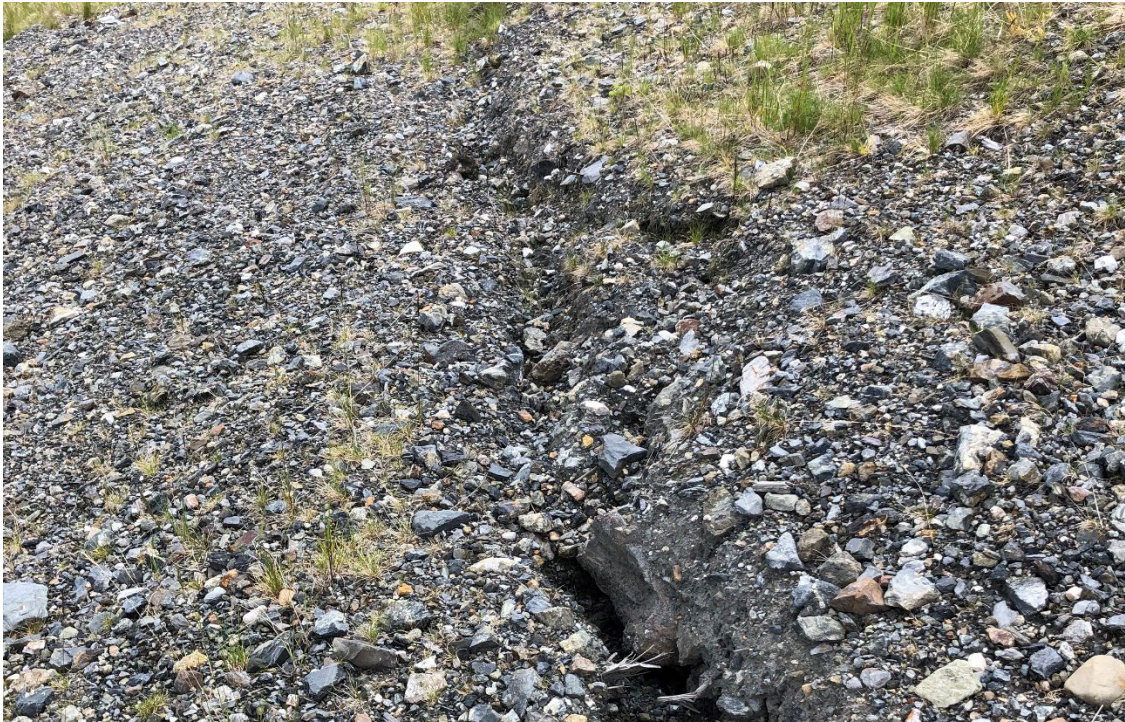
SRK also inspected the Burnick waste dumps at the locations of the reclaimed 1200 and 1300 portals respectively as shown in Figure 11. During the site decommissioning in 2014, the dumps were recontoured to provide added long-term stability. No further subsidence of the slopes was noted. Minor settlement of the fill that was placed over the 1200 portal has resulted in a shallow tension crack in the fill (see Photos 15 and 16). This crack was noted in previous inspections. No action is required.

Photo 15 Tension crack in fill at the Burnick Waste Rock Dump

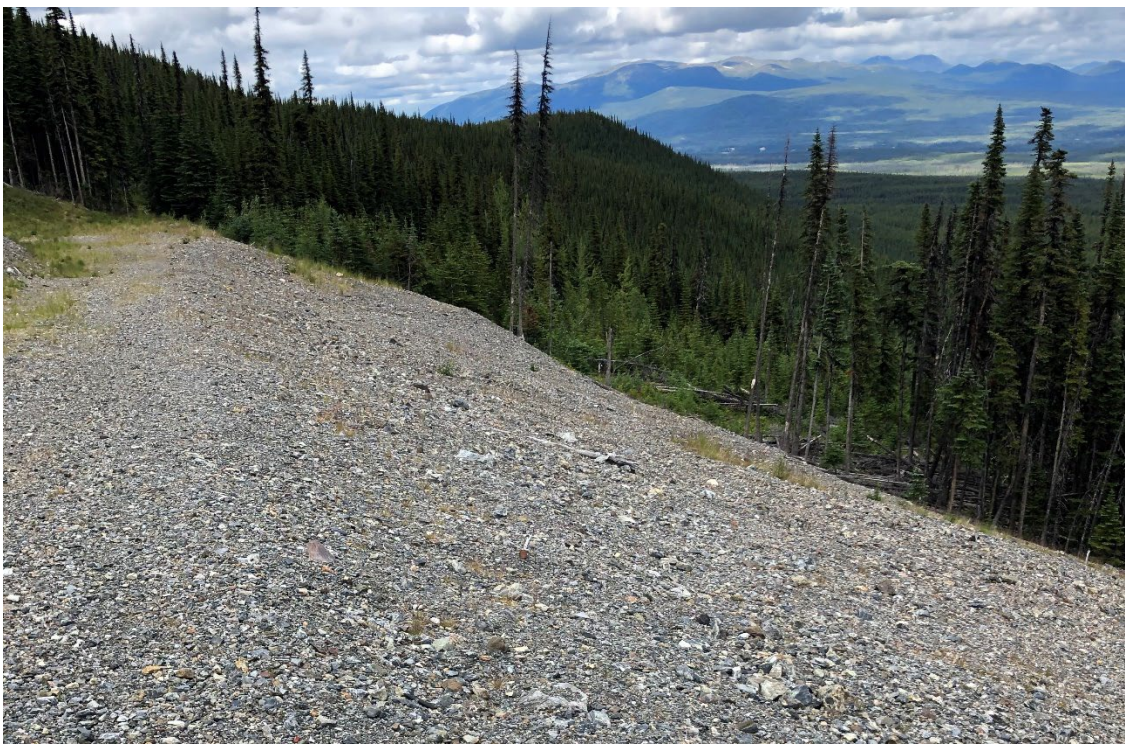
Photo 16: Downstream slope of the Burnick Waste Rock dump

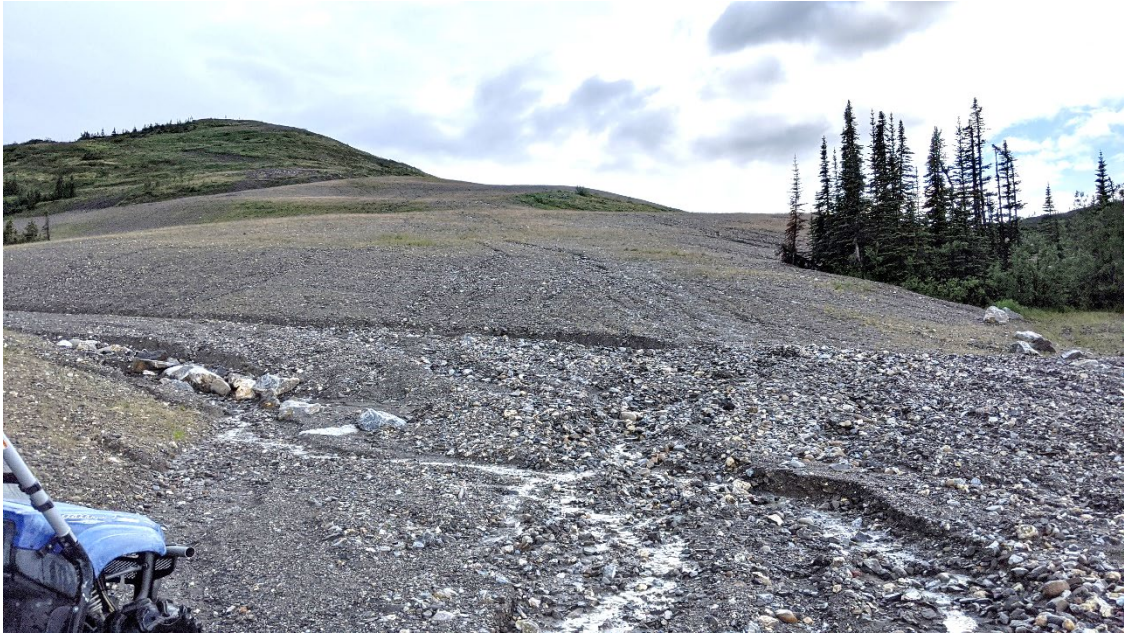
At the low point of the Jewelbox waste rock dump, the 2 to 3 m deep erosion gully that has been monitored over the last few years showed some deterioration since last year but was beginning to show signs of self armouring (See photos 17 and 18). The monitoring pins which were installed to gauge whether the gully was deepening have been displaced. There is no impact on the stability of the dump and other than re-establishing the pins, no action is required.

Photo 17 Jewelbox Waste Rock dump

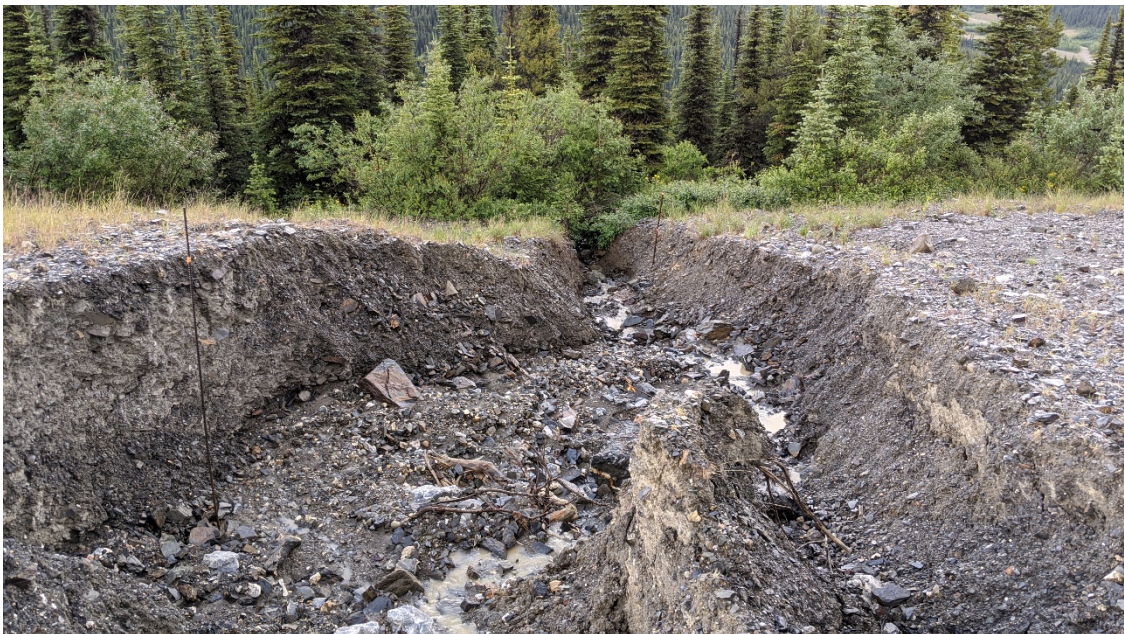
Photo 18 Erosion gully at base of Jewelbox waste rock dump

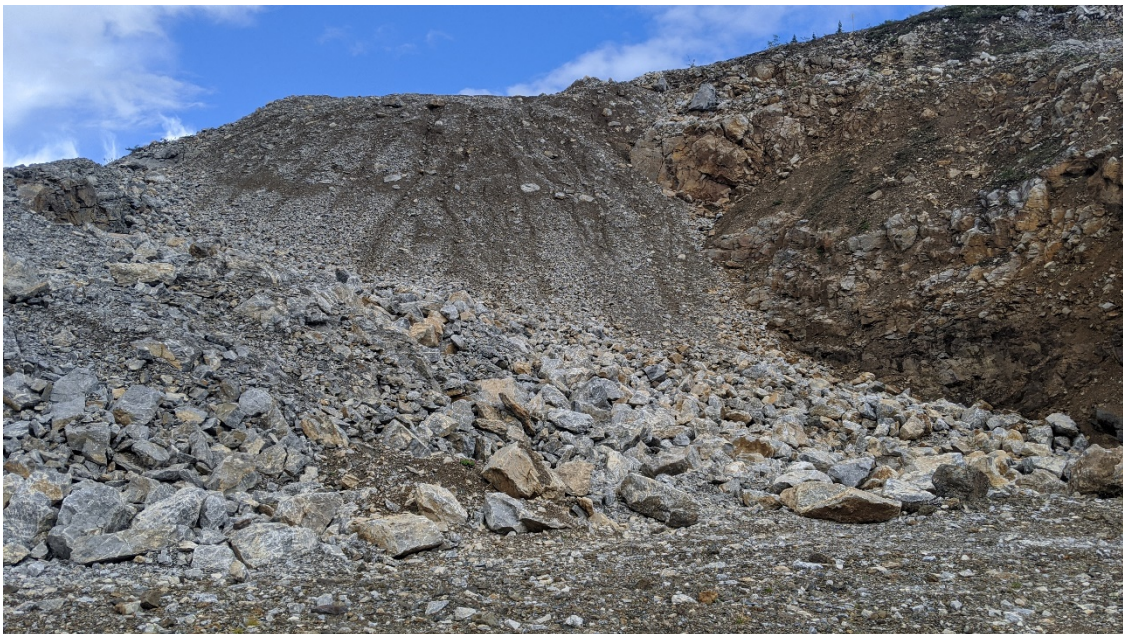
Photo 20 Backfill at the 1380 Portal below Main Zone Waste Rock dump

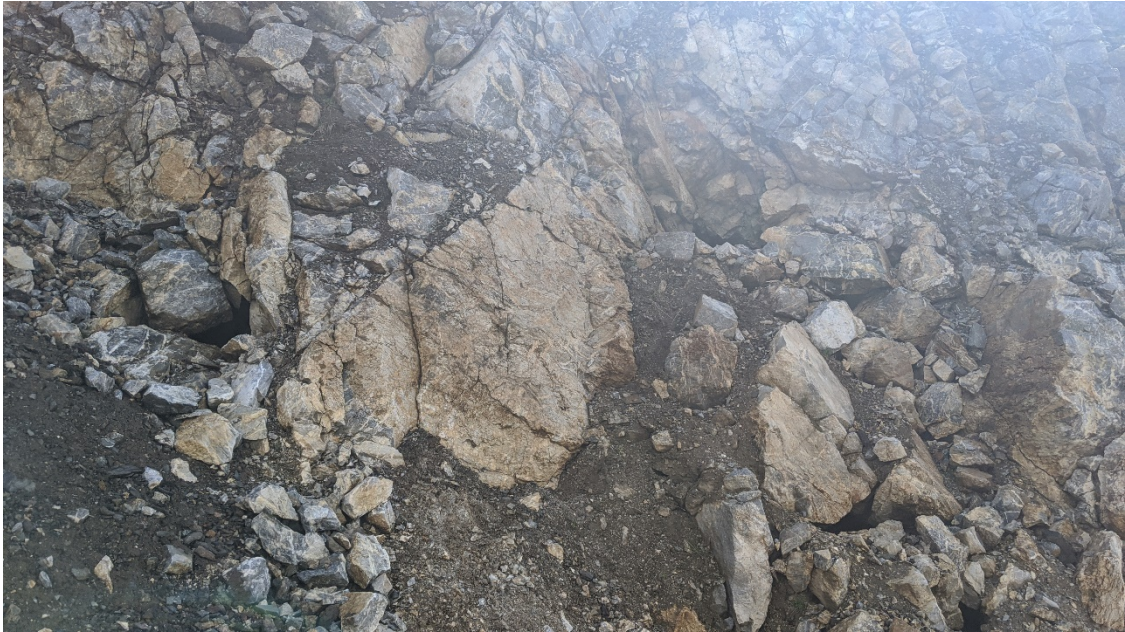
Two to three shallow openings were observed in the pit wall at the Main Zone area. These openings may have been caused by internal subsidence but currently do not pose a safety concern (see Photos 20 and 21).

Photo 21: Openings in pit wall above Main Zone Waste Rock Dump
