2023 Annual Geotechnical Inspection

Sa Dena Hes Mine, Watson Lake, Yukon
Teck Resources Ltd.

SRK Consulting (Canada) Inc. ■ CAPR002559 ■ August 2023

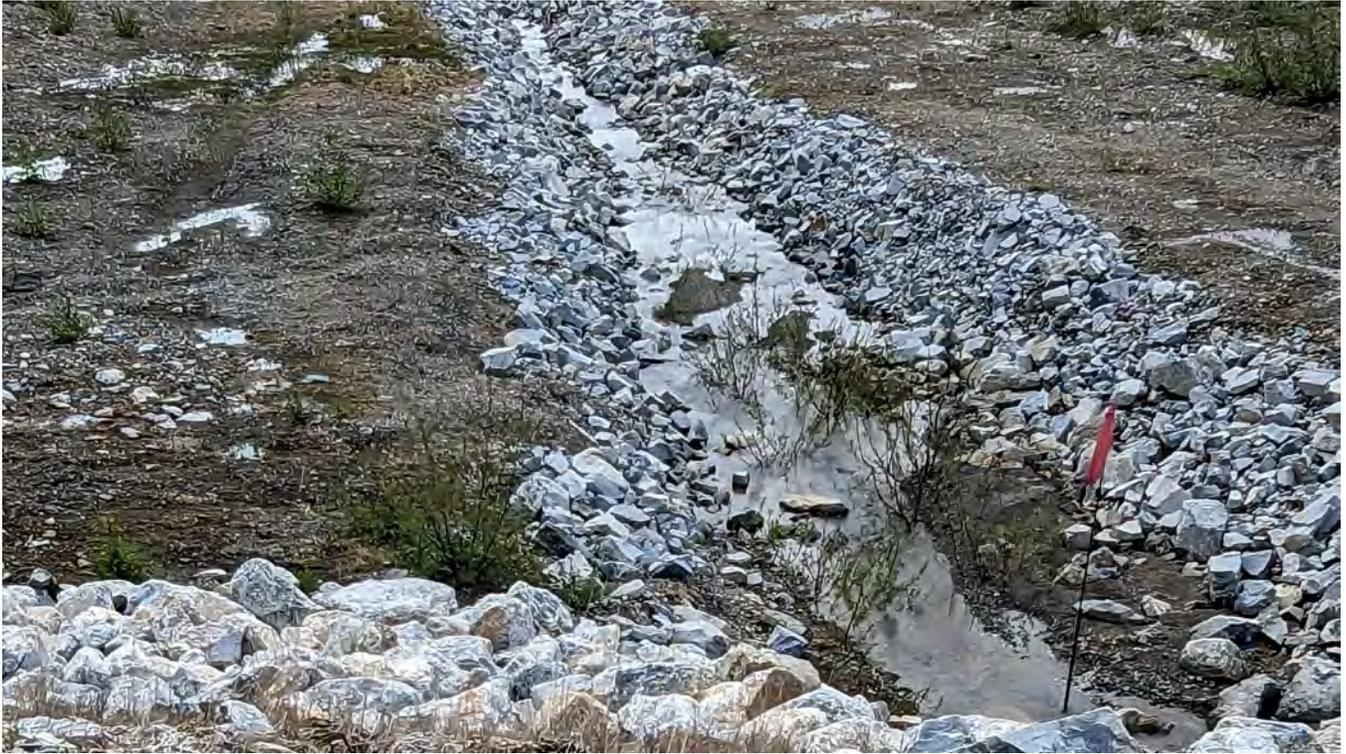
Channel	Observation	Figure (App. B)	Photo	Associated Recommendation
South Diversion Channel	<ul style="list-style-type: none"> Additional sediment accumulation has occurred at the upstream end of the channel immediately downstream of the Sediment Retaining Structure (SRS). The sediment is likely caused by water flowing beneath the spillway riprap and geotextile in the spillway that is internally eroding the underlying embankment fill. The current amount of sediment accumulation is not believed to significantly reduce the channel conveyance capacity and no actions are required. 	B-6	DC-01	n/a
	<ul style="list-style-type: none"> The condition of the remaining portions of the channel is unchanged compared to the 2022 inspection. The channel is in good condition with no signs of major subsidence or movement of the riprap erosion protection. 	B-6, B-7	DC-02, DC-03	n/a
	<ul style="list-style-type: none"> As noted in previous inspections, minor cracking is present parallel to the channel that was typically offset from the crest by 1 to 2 meters. The cracking is suspected to have resulted from frost heave and does not impact channel performance. 	n/a	n/a	n/a

Photo DC-01: Upstream end of the South Drainage Channel immediately downstream of the SRS Spillway. Sediments are accumulating in the channel due to erosion at the base of the SRS spillway.

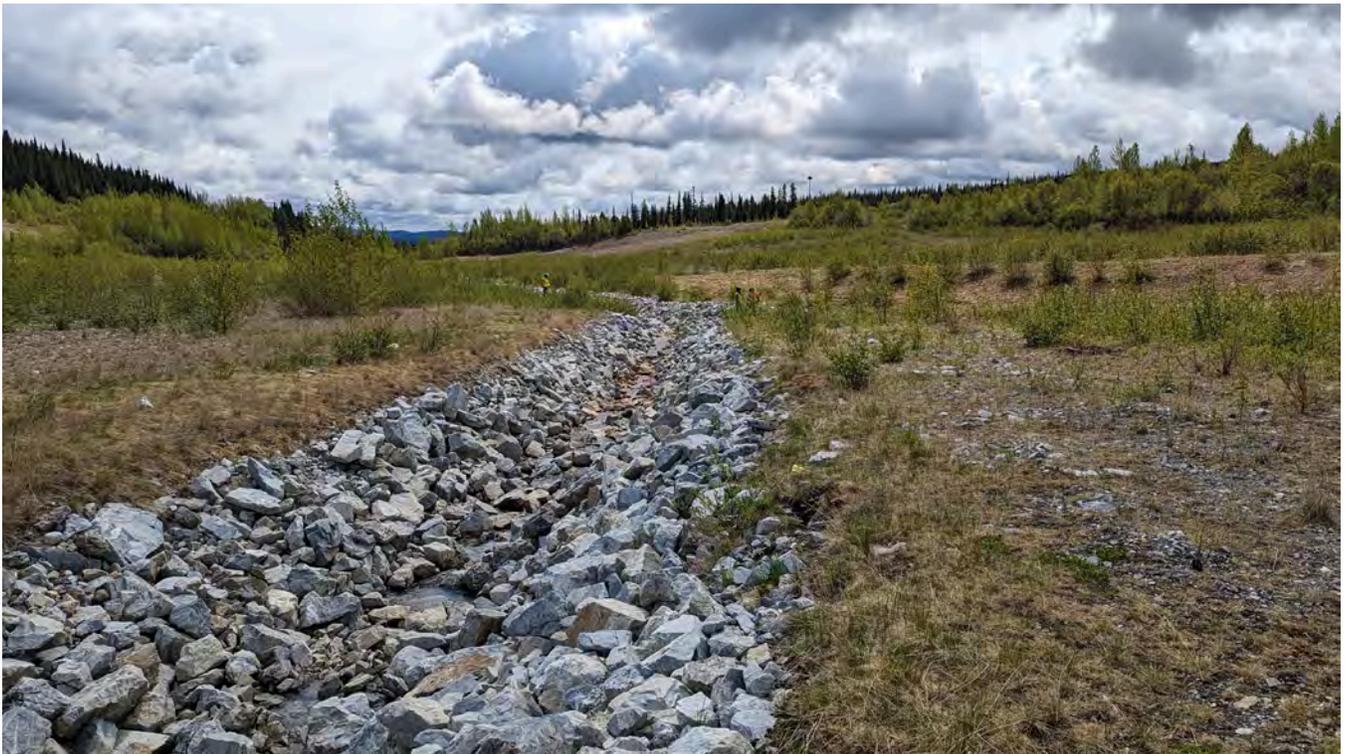
<ul style="list-style-type: none"> Iron-staining on the riprap is present over the last 30 m of the channel. 	B-7	DC-03, DC-04	n/a
Camp Creek Channel	<ul style="list-style-type: none"> The Camp Creek Channel is in good condition with no signs of major subsidence or movement of the riprap erosion protection. 	B-7, B-8	DC-04, DC-05, DC-06	n/a

Photo DC-02: Downstream end of the South Drainage Channel looking downstream towards the confluence with the Camp Creek Channel Iron-staining on the riprap is present over the last 30 m of the channel.

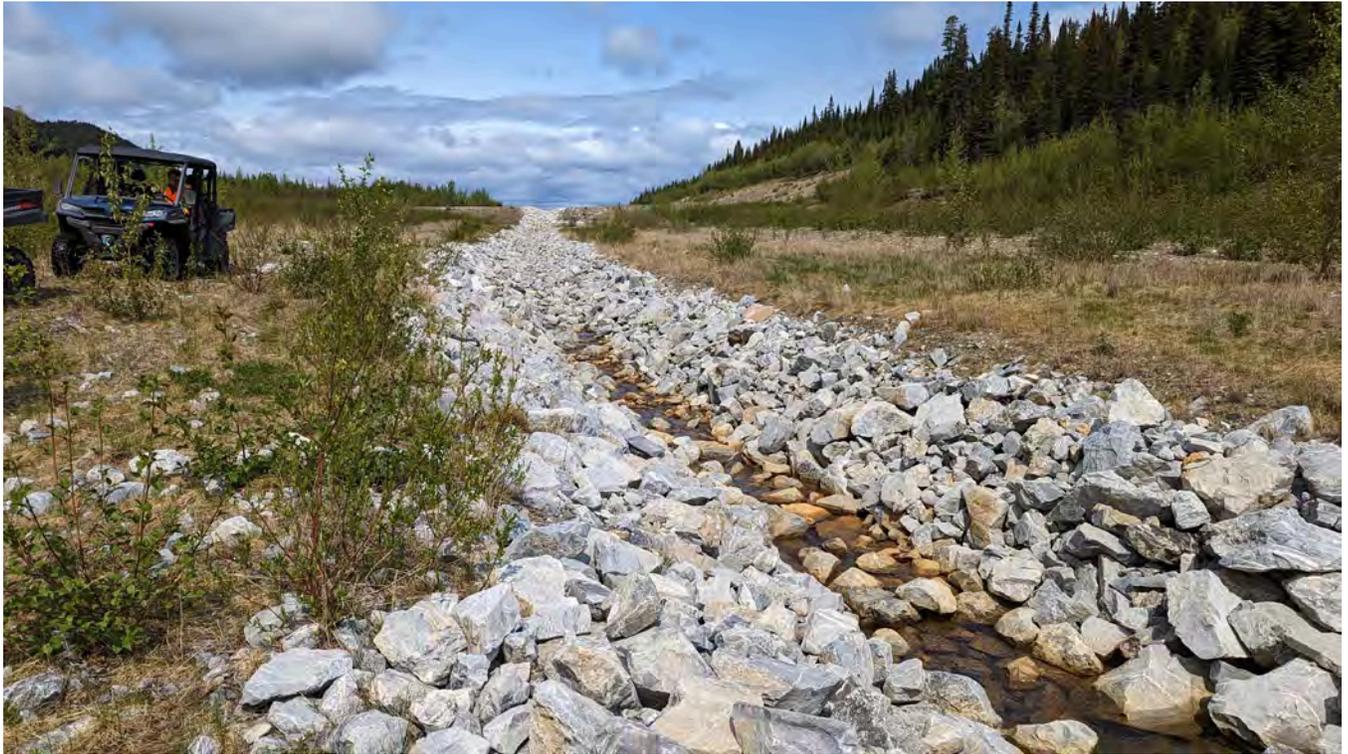
Photo DC-03: South Drainage Channel looking upstream from the confluence with Camp Creek.

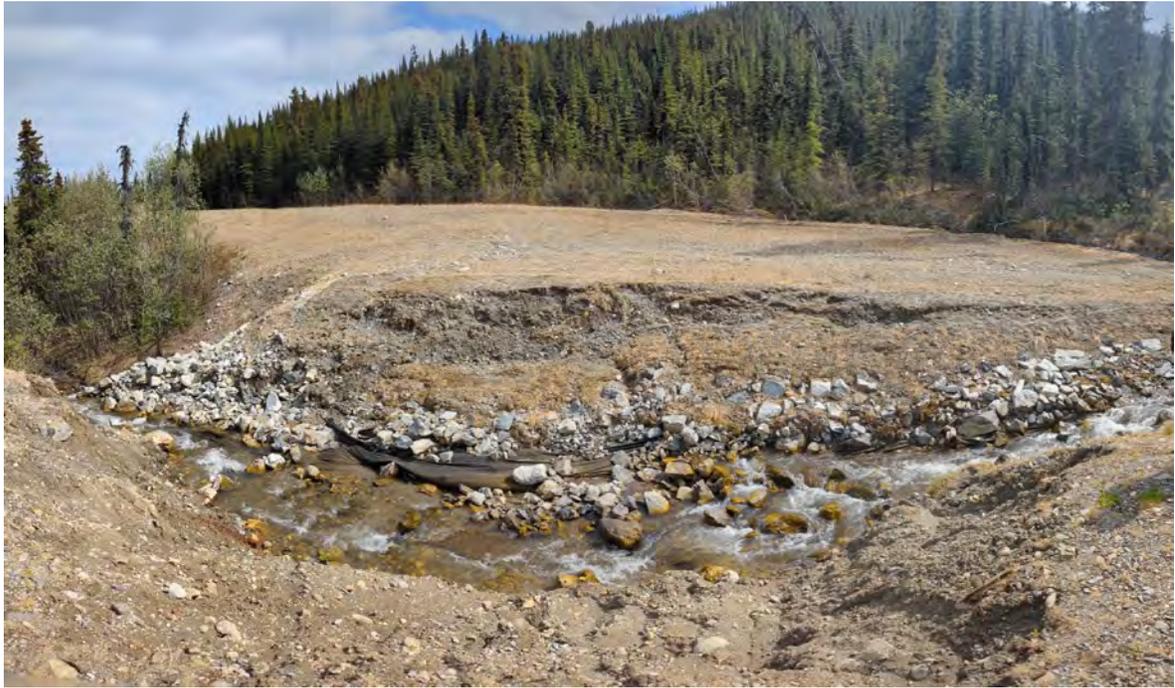
Observation	Figure (App. B)	Photo	Associated Recommendation
<ul style="list-style-type: none"> Continued channel erosion observed across the decommissioned access road to the Burnick Zone. In the 2021 inspection, subsidence of the south slope of the road crossing was observed with the erosion protection material in good condition (jute netting and riprap). In the 2022 inspection, the south slope was in similar condition, but new erosion observed on the north bank, along with some displacement of the erosion protection riprap and exposing of the underlying geotextile. Seepage was observed entering the channel on the north bank with rusty reddish coloured staining. In the 2023 inspection, conditions were similar with on-going erosion on the north bank extending in the upstream direction. 	B-9	NC-01, NC-02	n/a

Photo NC-01: Decommissioned Access Road Crossing to Burnick Zone looking south.

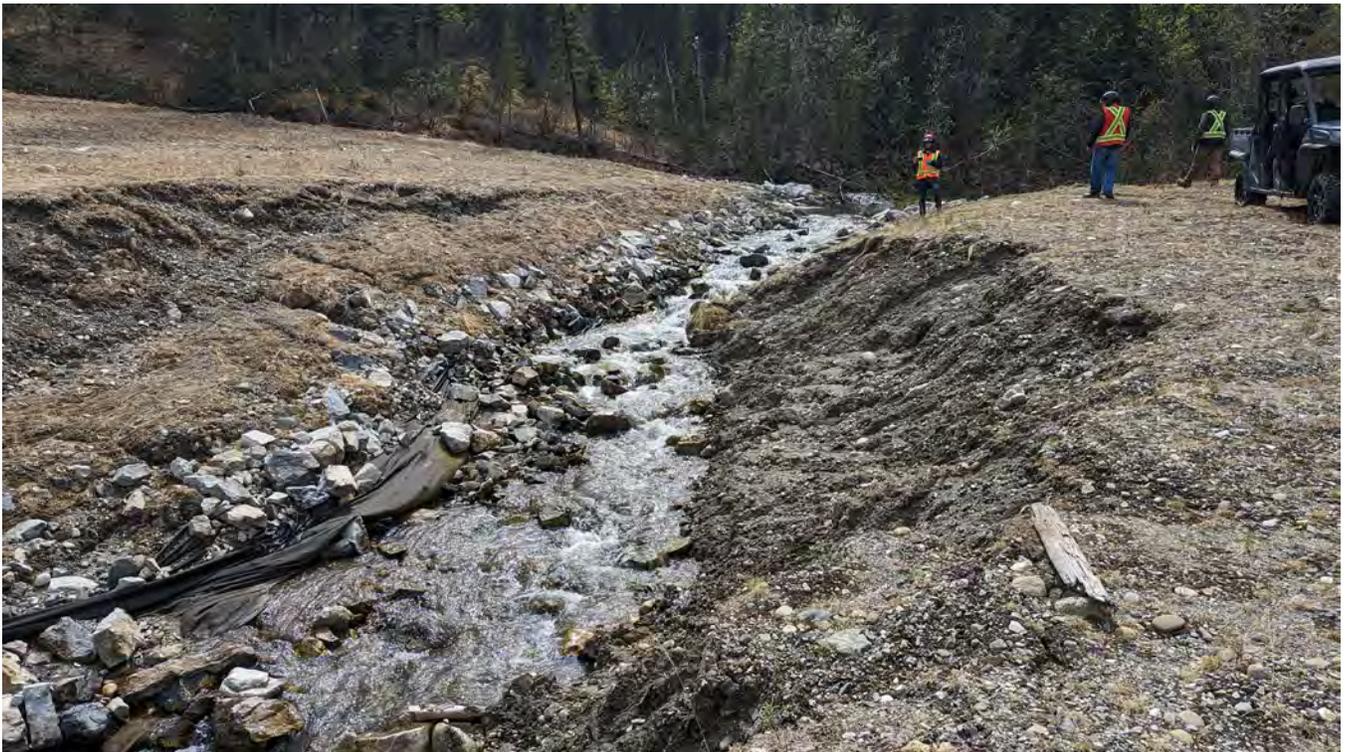
Photo NC-02: Decommissioned Access Road Crossing to Burnick Zone looking upstream.

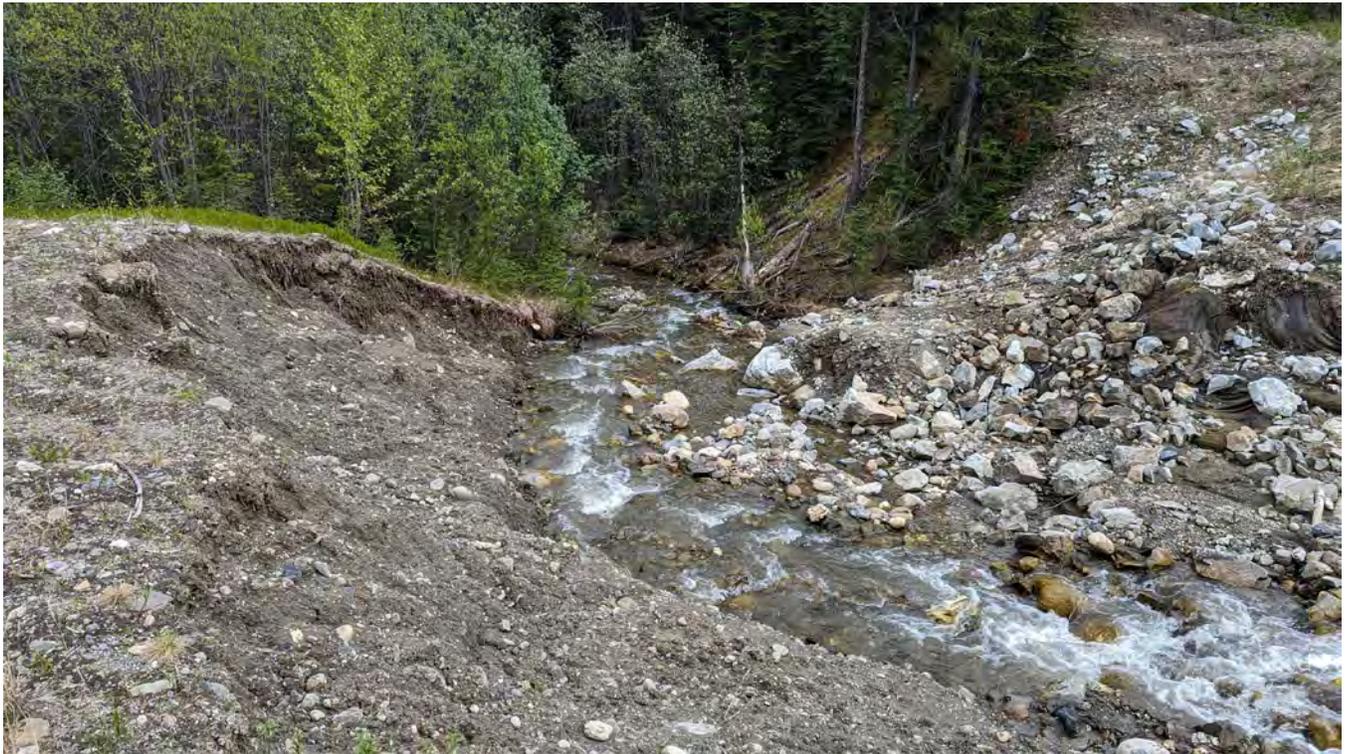
Observation	Figure (App. B)	Photo	Associated Recommendation
<ul style="list-style-type: none"> ■ The creek will continue to erode this section of the channel area but will eventually sustain itself with no intervening maintenance required. 			
<ul style="list-style-type: none"> ■ The beaver dam present during the 2022 inspection has been removed and no further beaver activity observed. A beaver dam was previously removed in 2020, with no dam observed in 2021. 	B-10	NC-03	n/a
<ul style="list-style-type: none"> ■ No change in condition was observed of the channel erosion at the downstream end of the decommissioned North Creek Dyke Structure. The creek will continue to erode this section of the channel area but will eventually sustain itself with no intervening maintenance required. 	B-10	NC-04	n/a
<ul style="list-style-type: none"> ■ At the landfill area road crossing (also known as the “Second Crossing”), erosion of the north side slope of the channel is ongoing. Additional sloughing of the bank has occurred since the 2022 site inspection. A fence delineation barrier was installed to prevent inadvertent access for UTV traffic crossing the creek. 	B-11	NC-05, NC-06	n/a

Photo NC-05: On-going erosion at the North Creek second crossing (to landfill) looking downstream.

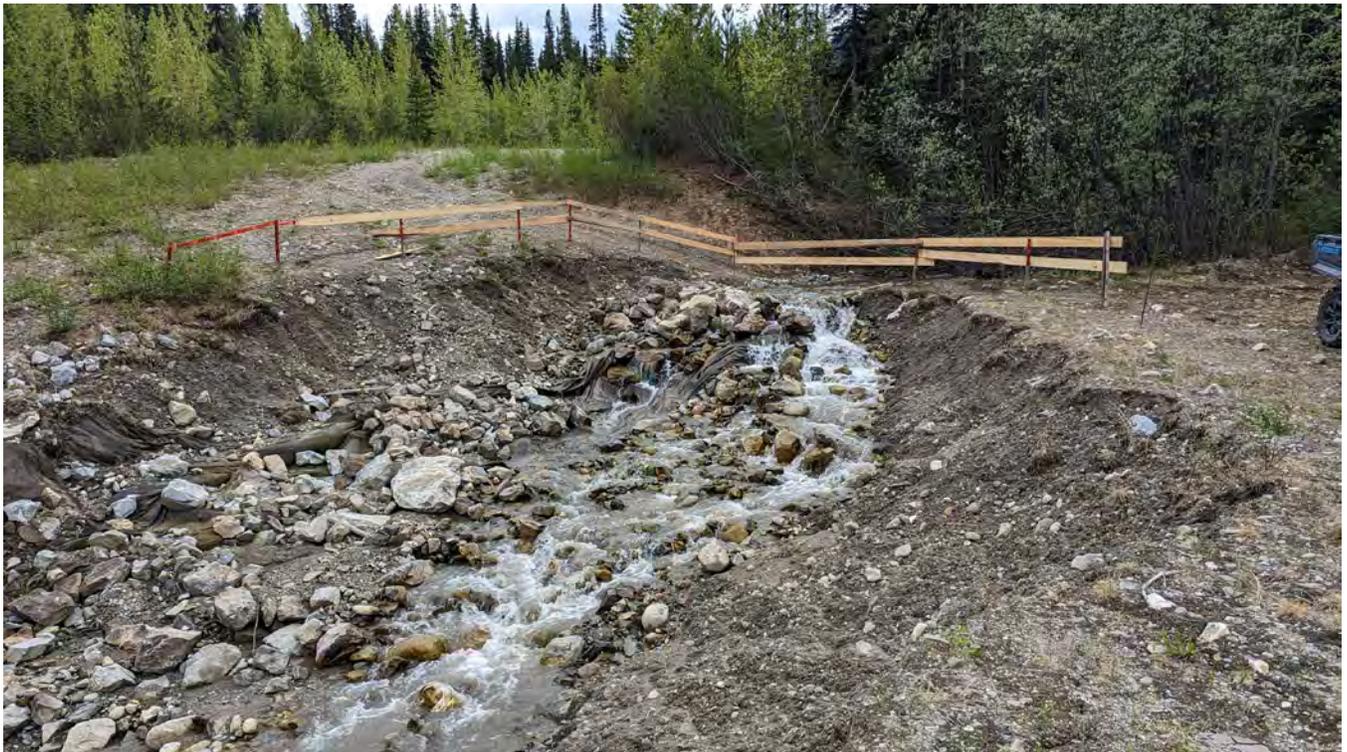
Photo NC-06: On-going erosion at the North Creek second crossing (to landfill) looking upstream.

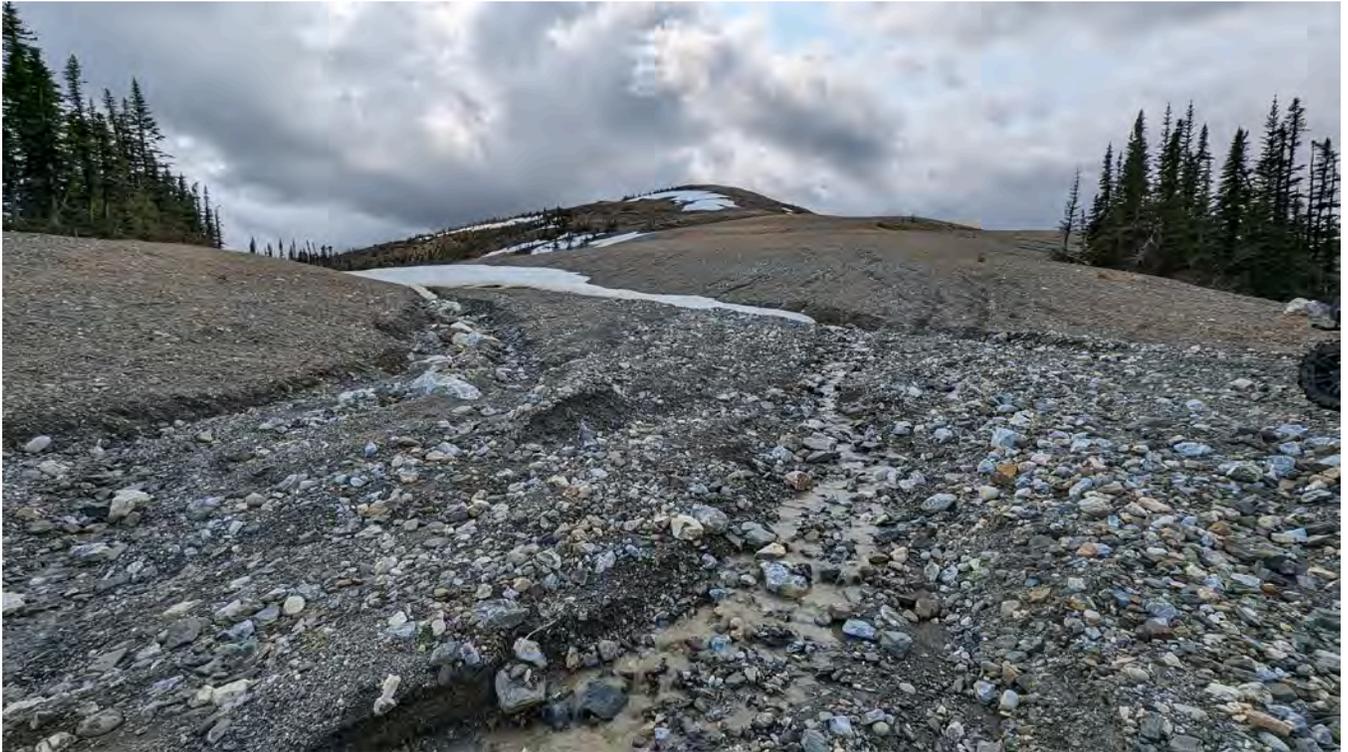
Observation	Figure (App. B)	Photo	Associated Recommendation
<ul style="list-style-type: none"> ■ At the low point of the Jewelbox waste rock dump, the 2 to 3 m deep erosion gully that has been monitored over the last few years showed some additional deterioration since last year, but the extent of the erosion appears to be unchanged. The base of the gully is primarily situated in bedrock. The sidewalls of the gully are near vertical and prone to further erosion. There is no impact on the stability of the dump and no action is required. 	B-13	WR-03, WR-04	n/a
<ul style="list-style-type: none"> ■ Water that flows down the gully mentioned above, crosses the decommissioned access road to the waste rock area at four locations. Erosion gullies were noted at the upper three crossings that are up to 0.3 m deep. These gullies appear to be self-armouring, and no action is needed at this time. 			
<ul style="list-style-type: none"> ■ Surficial sloughing of the soil cover is located downslope of the 1408 Portal. The circular sloughs are typically 0.3 m deep and resulted in bulges at the slough toe. There is no impact on the overall dump stability and no action is required. 	B-14	WR-05	n/a

Photo WR-03: Erosion at the lowest point of the Jewelbox Waste Rock Dumps through the former Jewelbox Haul Road (looking south).

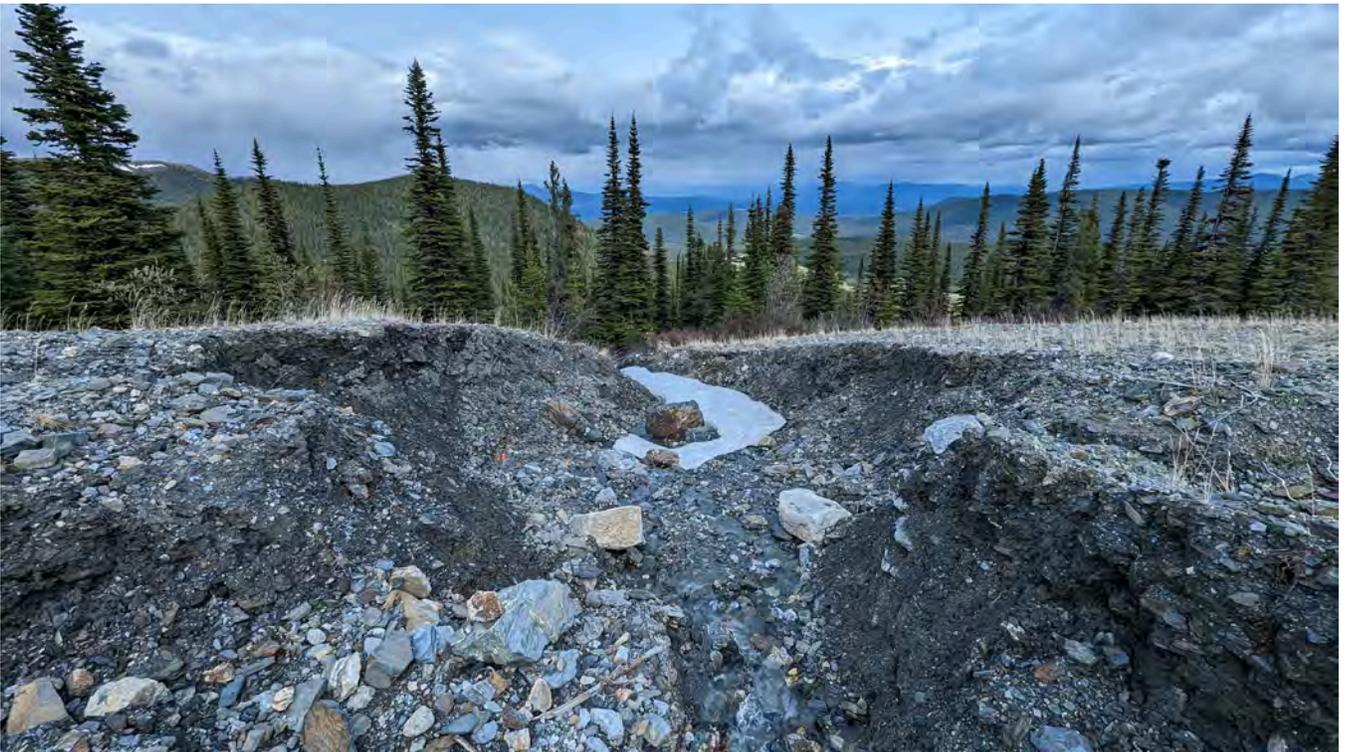
Photo WR-04: Erosion at the lowest point of the Jewelbox Waste Rock Dumps through the former Jewelbox Haul Road (looking north). Erosion has developed down to bedrock. Extent of erosion is unchanged compared to 2022 inspection.

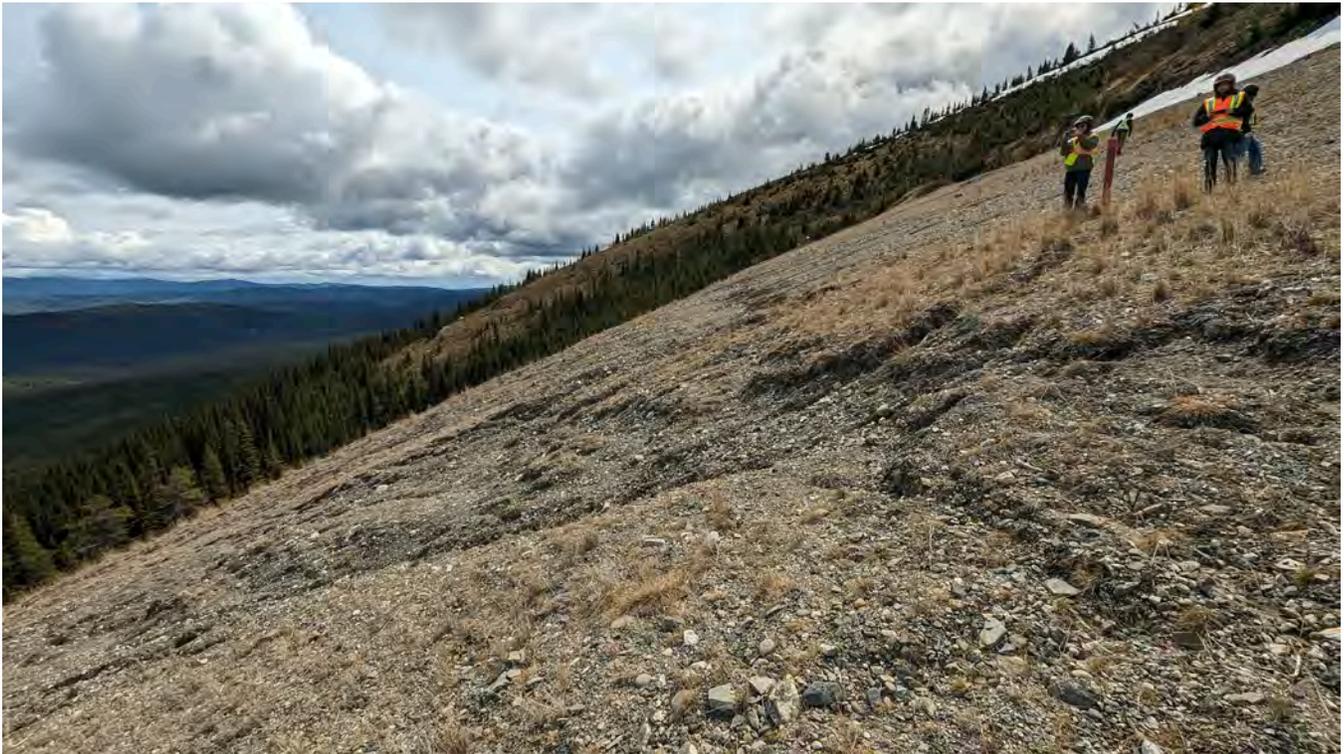
<ul style="list-style-type: none"> ■ The 1408 Portal drainpipes and the vent pipe in the 1408 Portal area are in good condition. 	B-14	WR-06a, WR-06b	n/a
<ul style="list-style-type: none"> ■ Rill erosion in the soil cover is present at the south end of the 1408 Portal WRD where the slope is approximately 2H:1V. The condition of the rill erosion appears unchanged compared to the 2021 inspection and no action is required. 	B-14	WR-05	n/a

Photo WR-05: Surficial slumping near the south end of the 1408 Portal Waste Rock Dump.

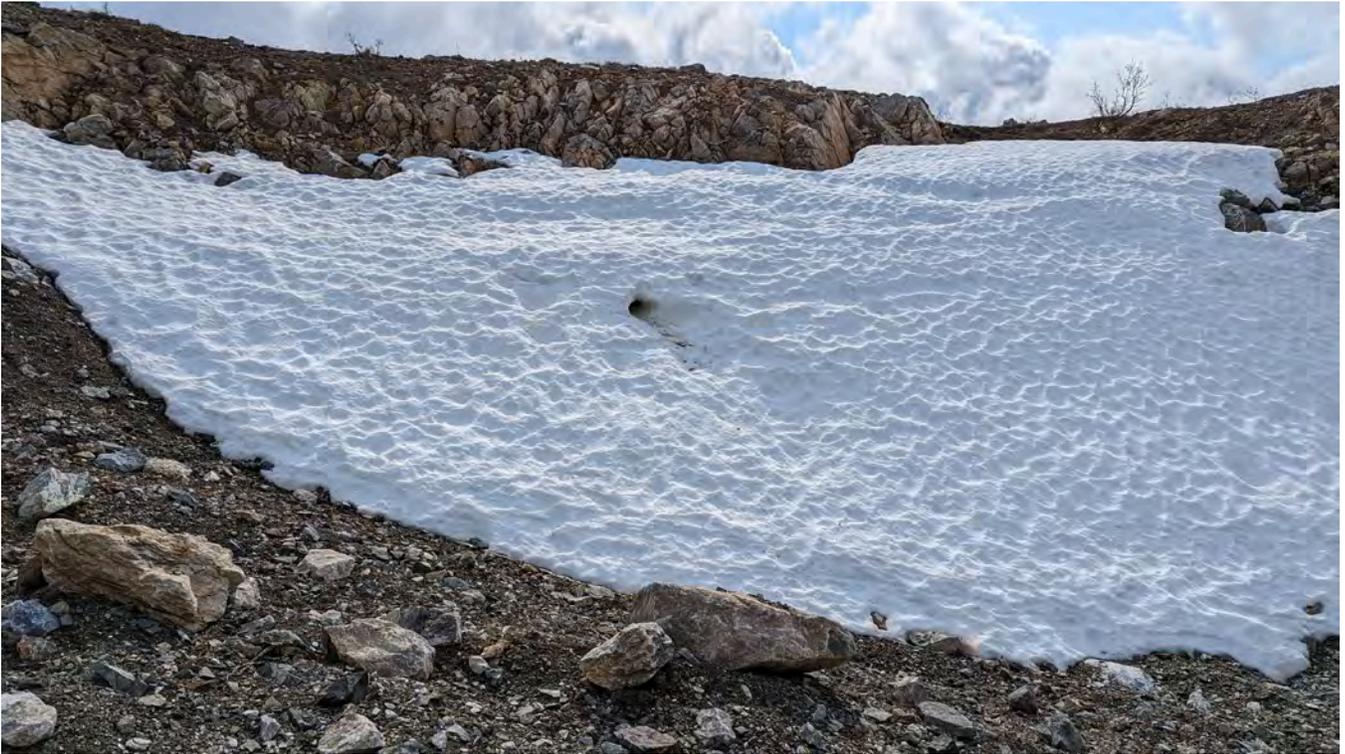
Observation	Figure (App. B)	Photo	Associated Recommendation
<ul style="list-style-type: none"> Previous inspections have noted two small openings in the Jewelbox Pit highwall. These openings may have been caused by internal subsidence but currently do not pose a safety concern. During the 2023 inspection, the openings were covered with snow, with an apparent animal burrow opening present. No action is required. 	B-15	WR-08	n/a
<ul style="list-style-type: none"> The erosion gully first observed in 2022 on the Main Zone Pit backfill above the 1380 Portal appears unchanged from the 2022 inspection. The gully is situated in waste rock and appears to be self-armouring with no significant catchment that reports to the gully at the upstream end. No remedial action is required. 	B-16	WR-09	n/a
<ul style="list-style-type: none"> The two 1380 Portal drainpipes are functional. 	B-17	WR-10a, WR-10b	n/a

Photo WR-07: Potential animal burrow in the Jewelbox Pit wall. .

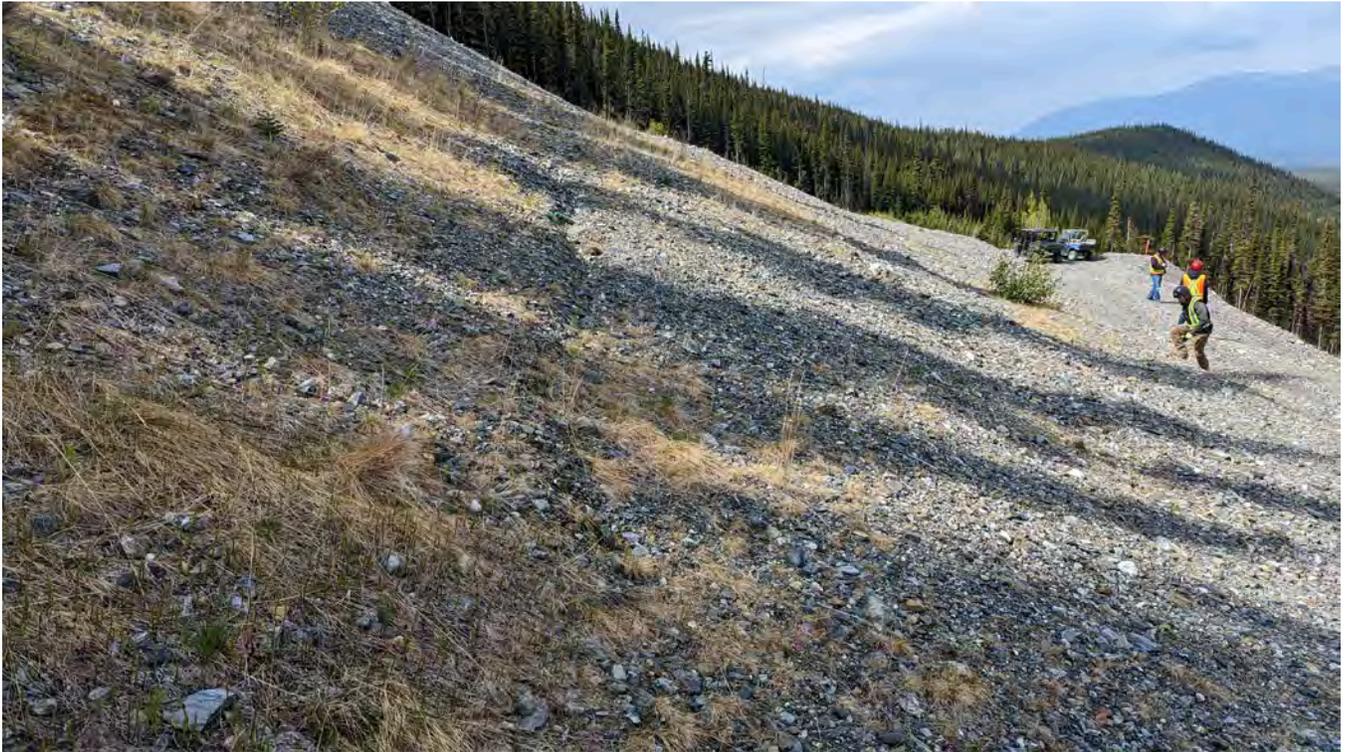
Observation	Figure (App. B)	Photo	Associated Recommendation
<ul style="list-style-type: none"> The regraded fill over the 1200 Portal is in good conditions and the portal drainpipe is functional. Minor settlement of the fill that was placed over the 1200 portal has resulted in a settlement crack in the fill. This crack was noted in previous inspections and is approximately 10 m long, up to 15 cm wide, and up to 10 cm deep. No action is required. 	B-17	WR-11, WR-12	n/a
<ul style="list-style-type: none"> The regraded waste rock in the 1300 Portal area is also in good condition with no signs of deformation. The 1300 Portal drainpipe appears functional with no flow observed. A drip-like sound could be heard through the pipe indicating no blockage. 	B-18	WR-13, WR-14	n/a

Photo WR-11: Regraded Burnick Waste Dump at the 1200 Portal. A crack is present above the portal that is approximately 10 m long, up to 15 cm wide, and up to 10 cm deep.

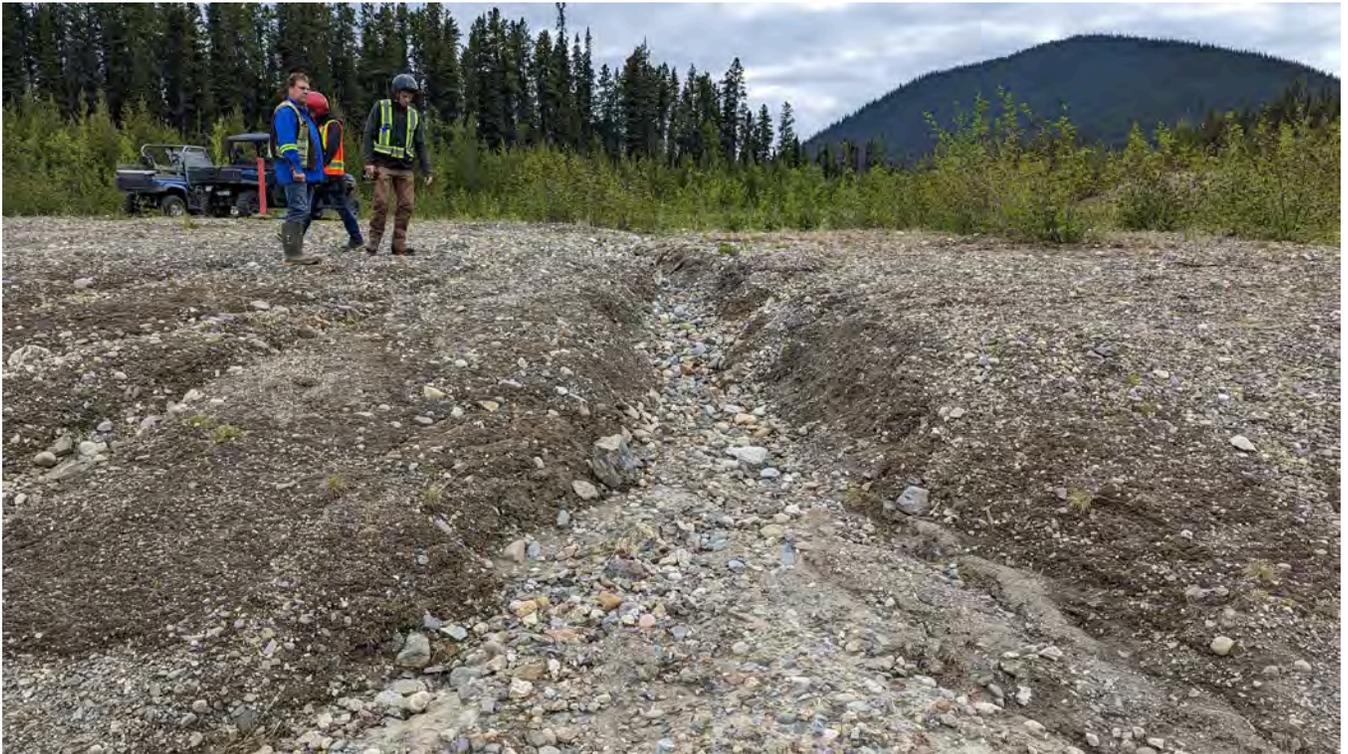
Observation	Figure (App. B)	Photo	Associated Recommendation
<ul style="list-style-type: none"> ■ The condition of the landfill is unchanged since the 2022 inspection. 			n/a
<ul style="list-style-type: none"> ■ The main drainage channel near the center of the spillway was dry with no erosion. 	B-19	L-1, L-2	n/a
<ul style="list-style-type: none"> ■ No change in condition was observed in the erosion gully that drains into the main drainage channel that was first noted in the annual inspection in 2021. The gully is about 20 cm deep and appears to be self-armouring. No landfill debris was exposed at the base of the gully. A comparison to the landfill as-built plan (AMEC 2015) indicates that the gully location is to the west of the miscellaneous site debris disposal cell. No action is required to repair the gully as it appears to be self armouring. 	B-20	L-3	n/a

Photo L-3: Erosion channel that enters the Landfill drainage channel. The condition of the channel is unchanged compared to the 2022 inspection and no signs of debris were observed.

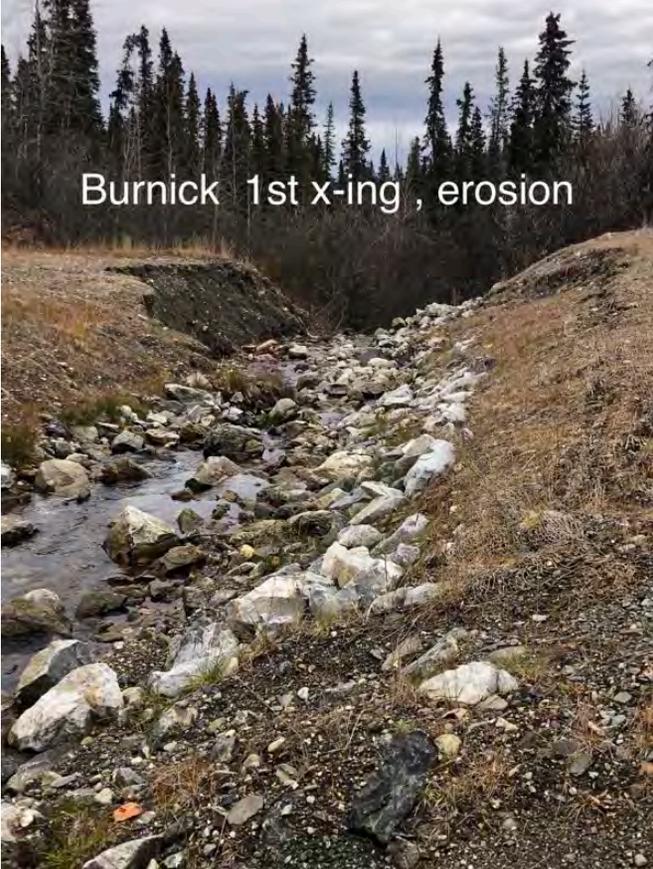
<p>Burnick 1st x-ing , erosion</p>

Photo Discription	Photo	Photo Location
Erosion at Burnick 1st crossing.

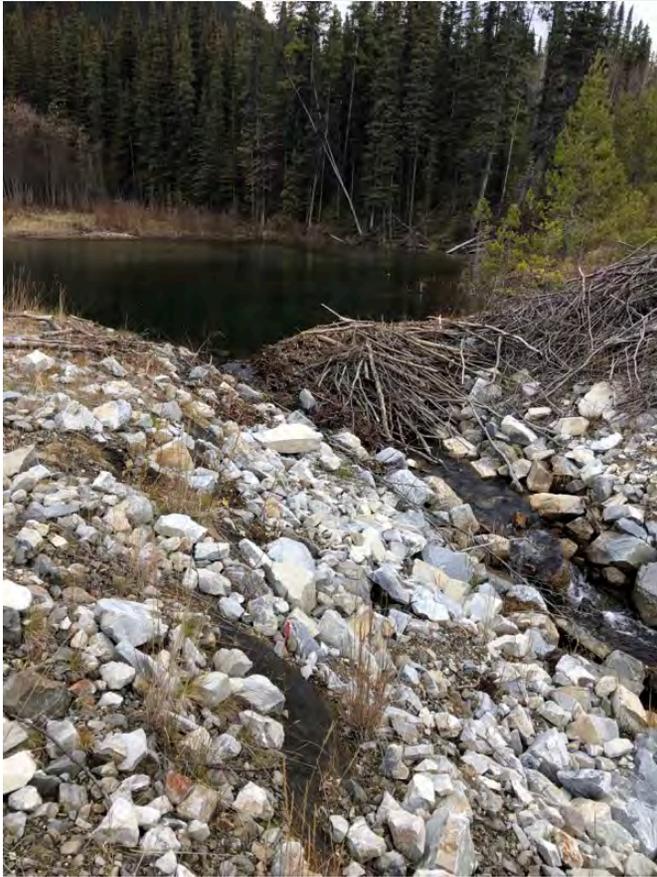
Photo Discription	Photo	Photo Location
<p>Beaver debris at N. creek dyke breach</p>

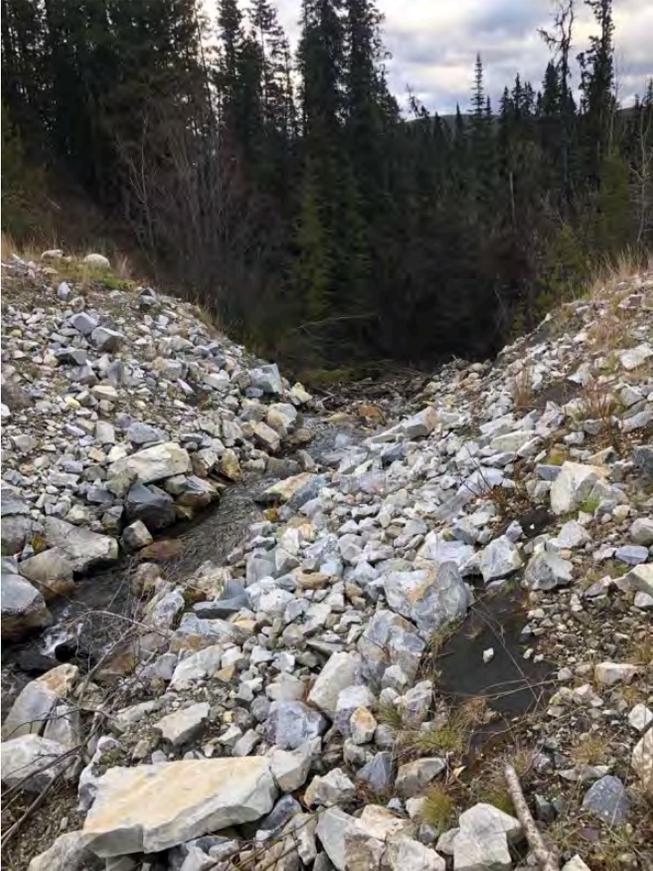
Photo Discription	Photo	Photo Location
Erosion at dyke breach

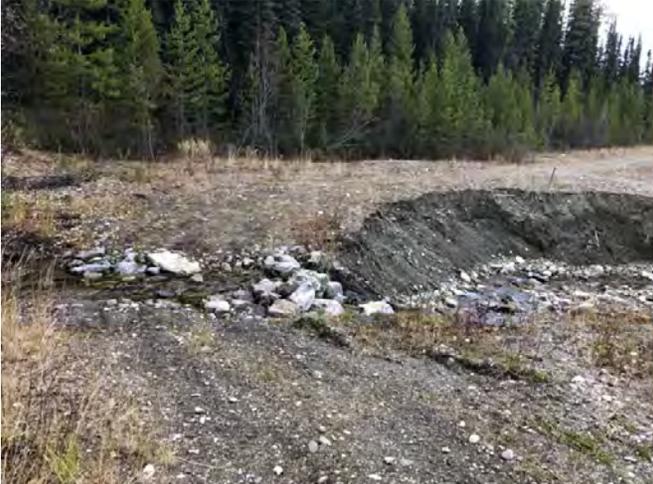
Photo Discription	Photo	Photo Location
Erosion at 2nd crossing

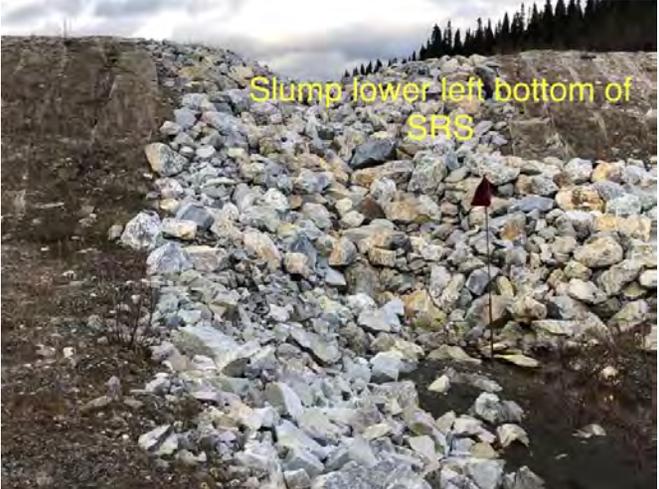
Major erosion issue , west of center of N. Dam. Large erosion gulley washed from tailings cap to the toe of downstream face. Contacted appropriate supervisor and repairs were performed.

Photo Discription	Photo	Photo Location
Slump at bottom west side of riprap, vertical cracking along downstream riprap, under jute matting.

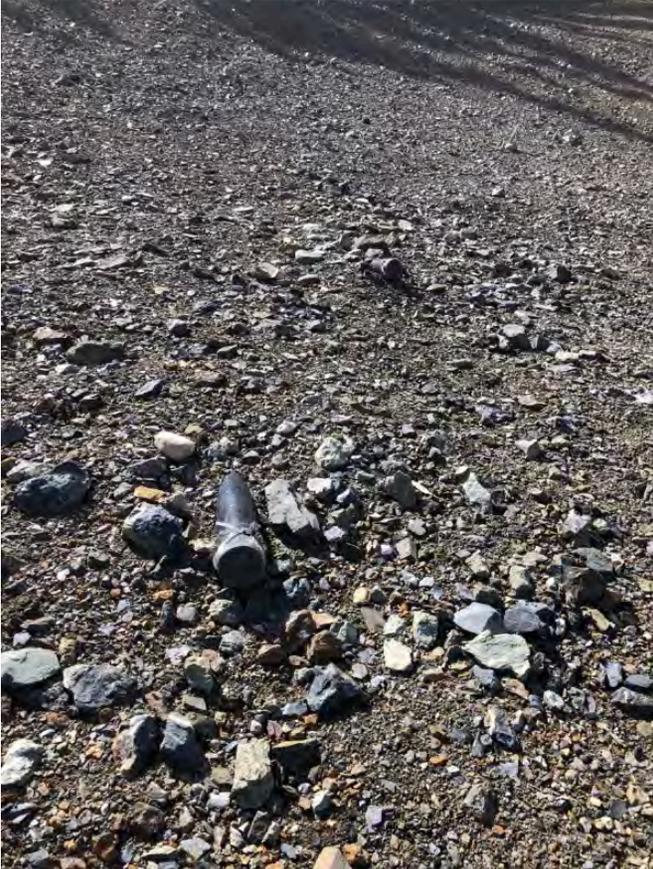
Photo Discription	Photo	Photo Location
Portal drains 1300, upper pipe heartbeat weak & irregular

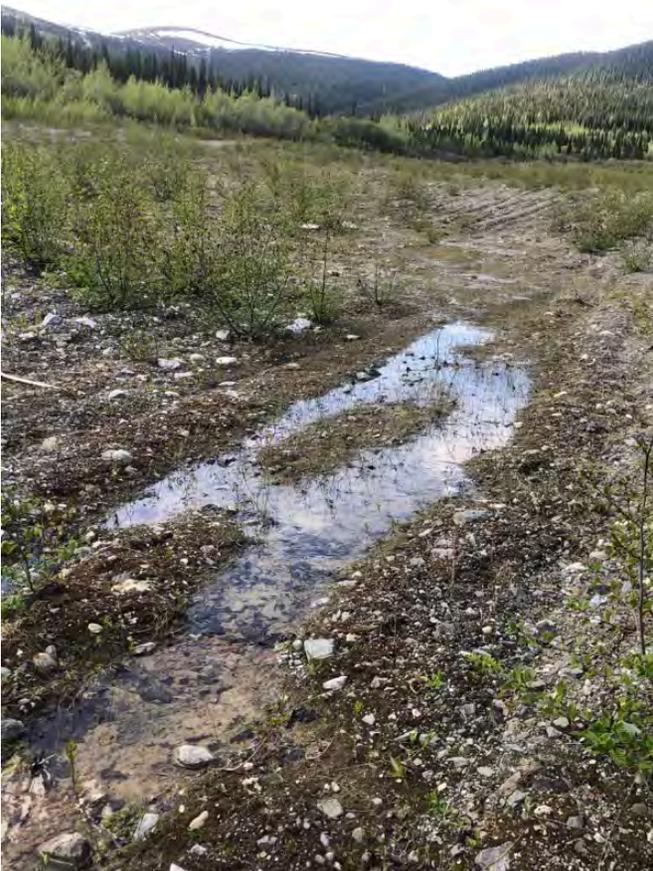
Photo Discription	Photo	Photo Location
Hillside seepage- West side of Lower Camp Cr.
