2023 Annual Facility Performance Review - SDH Tailings Management Area

Sä Dena Hes Mine, Yukon Territory, Canada
Teck Resources Limited

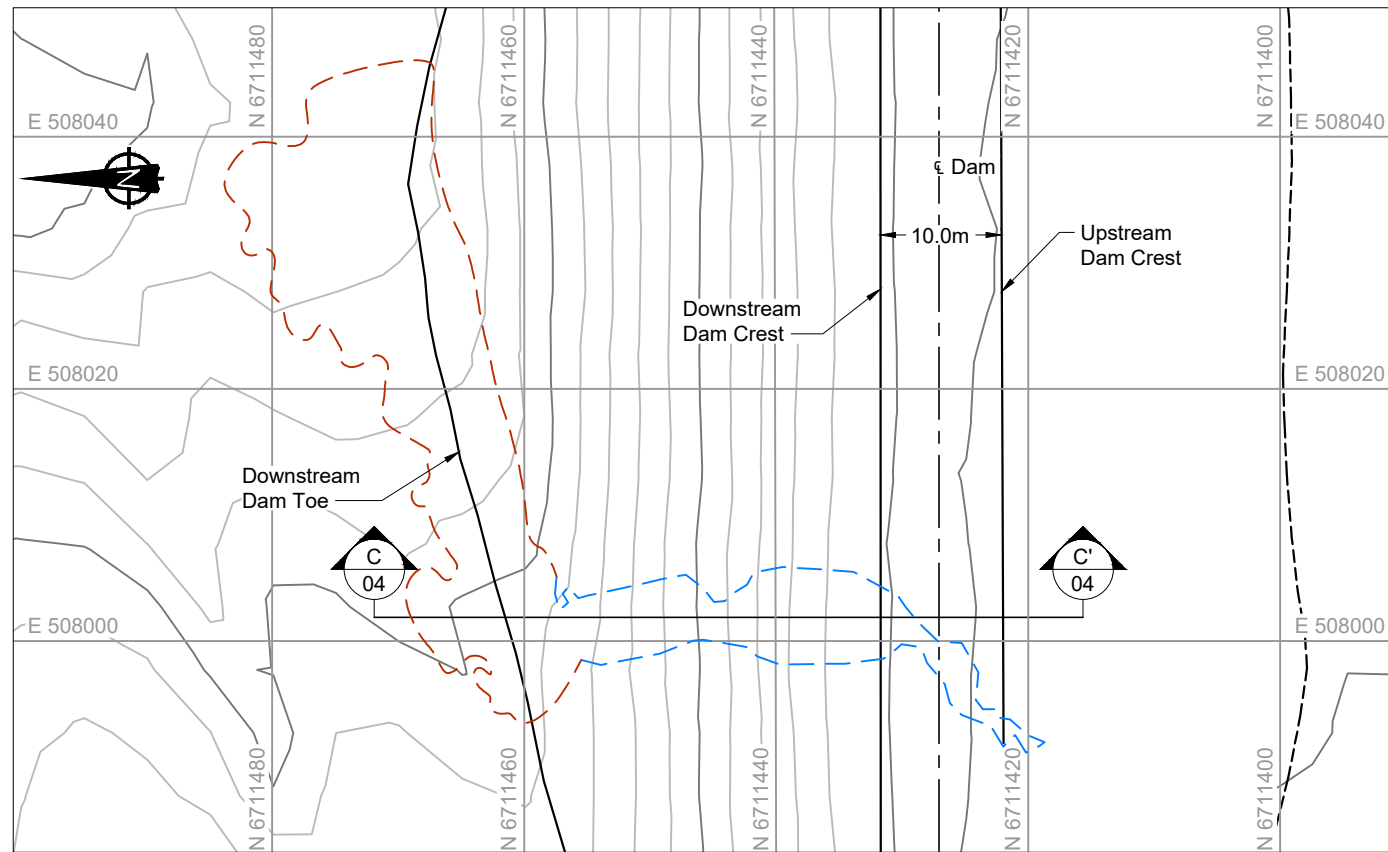
Plan View of Completed Repairs

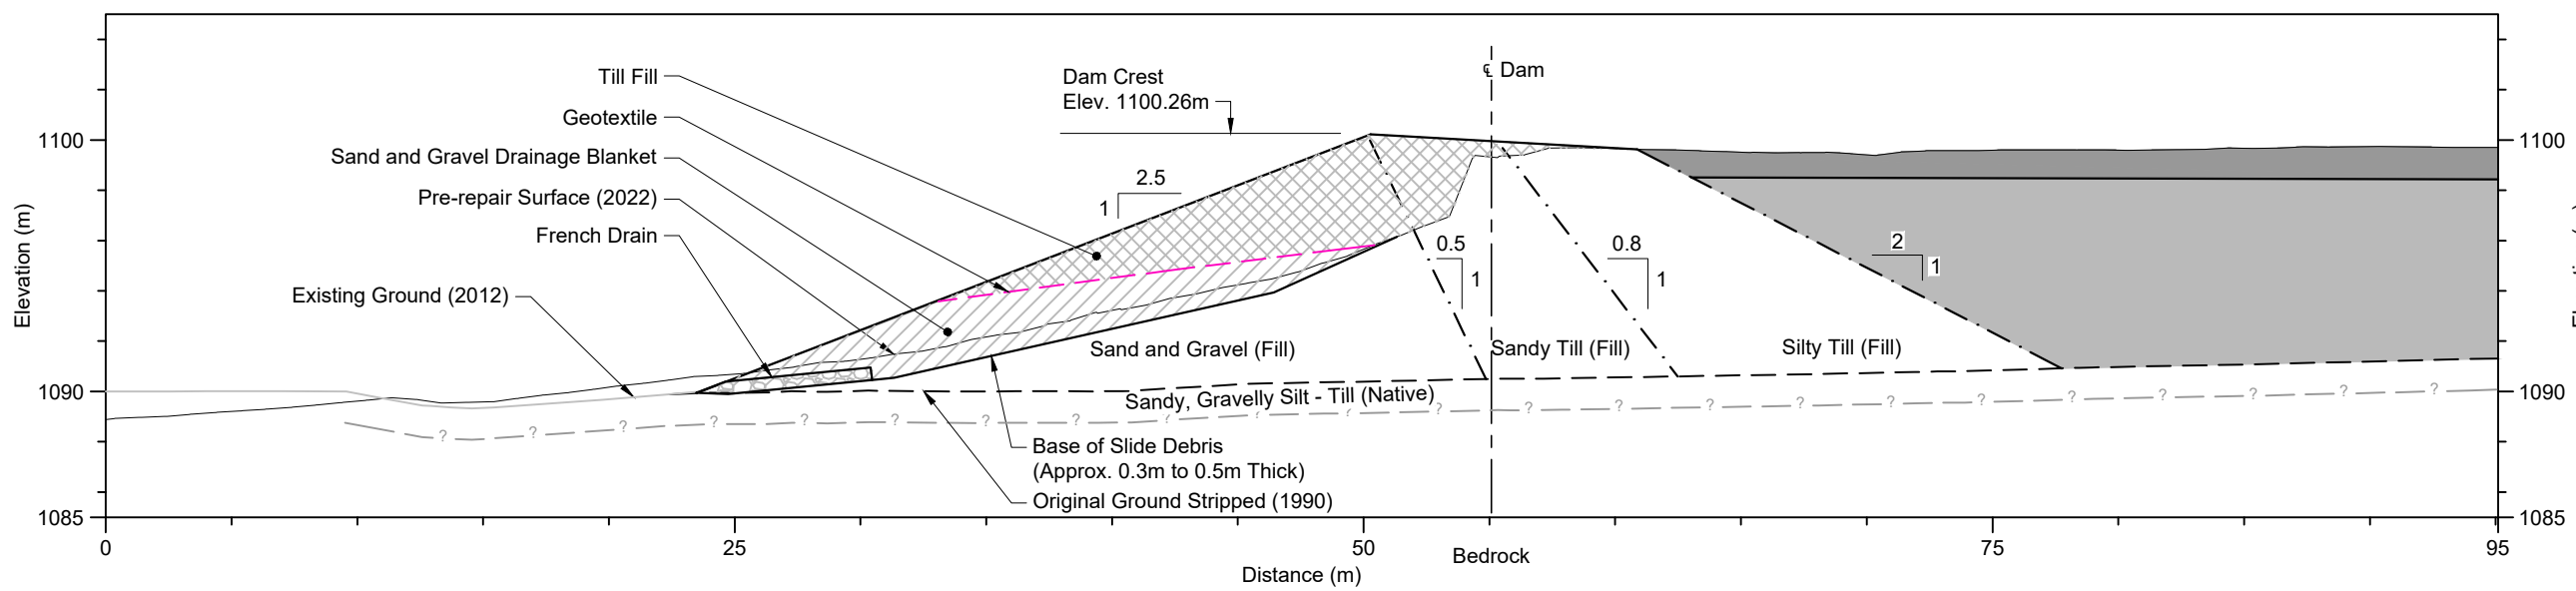
Erosion Gulley Cross Section

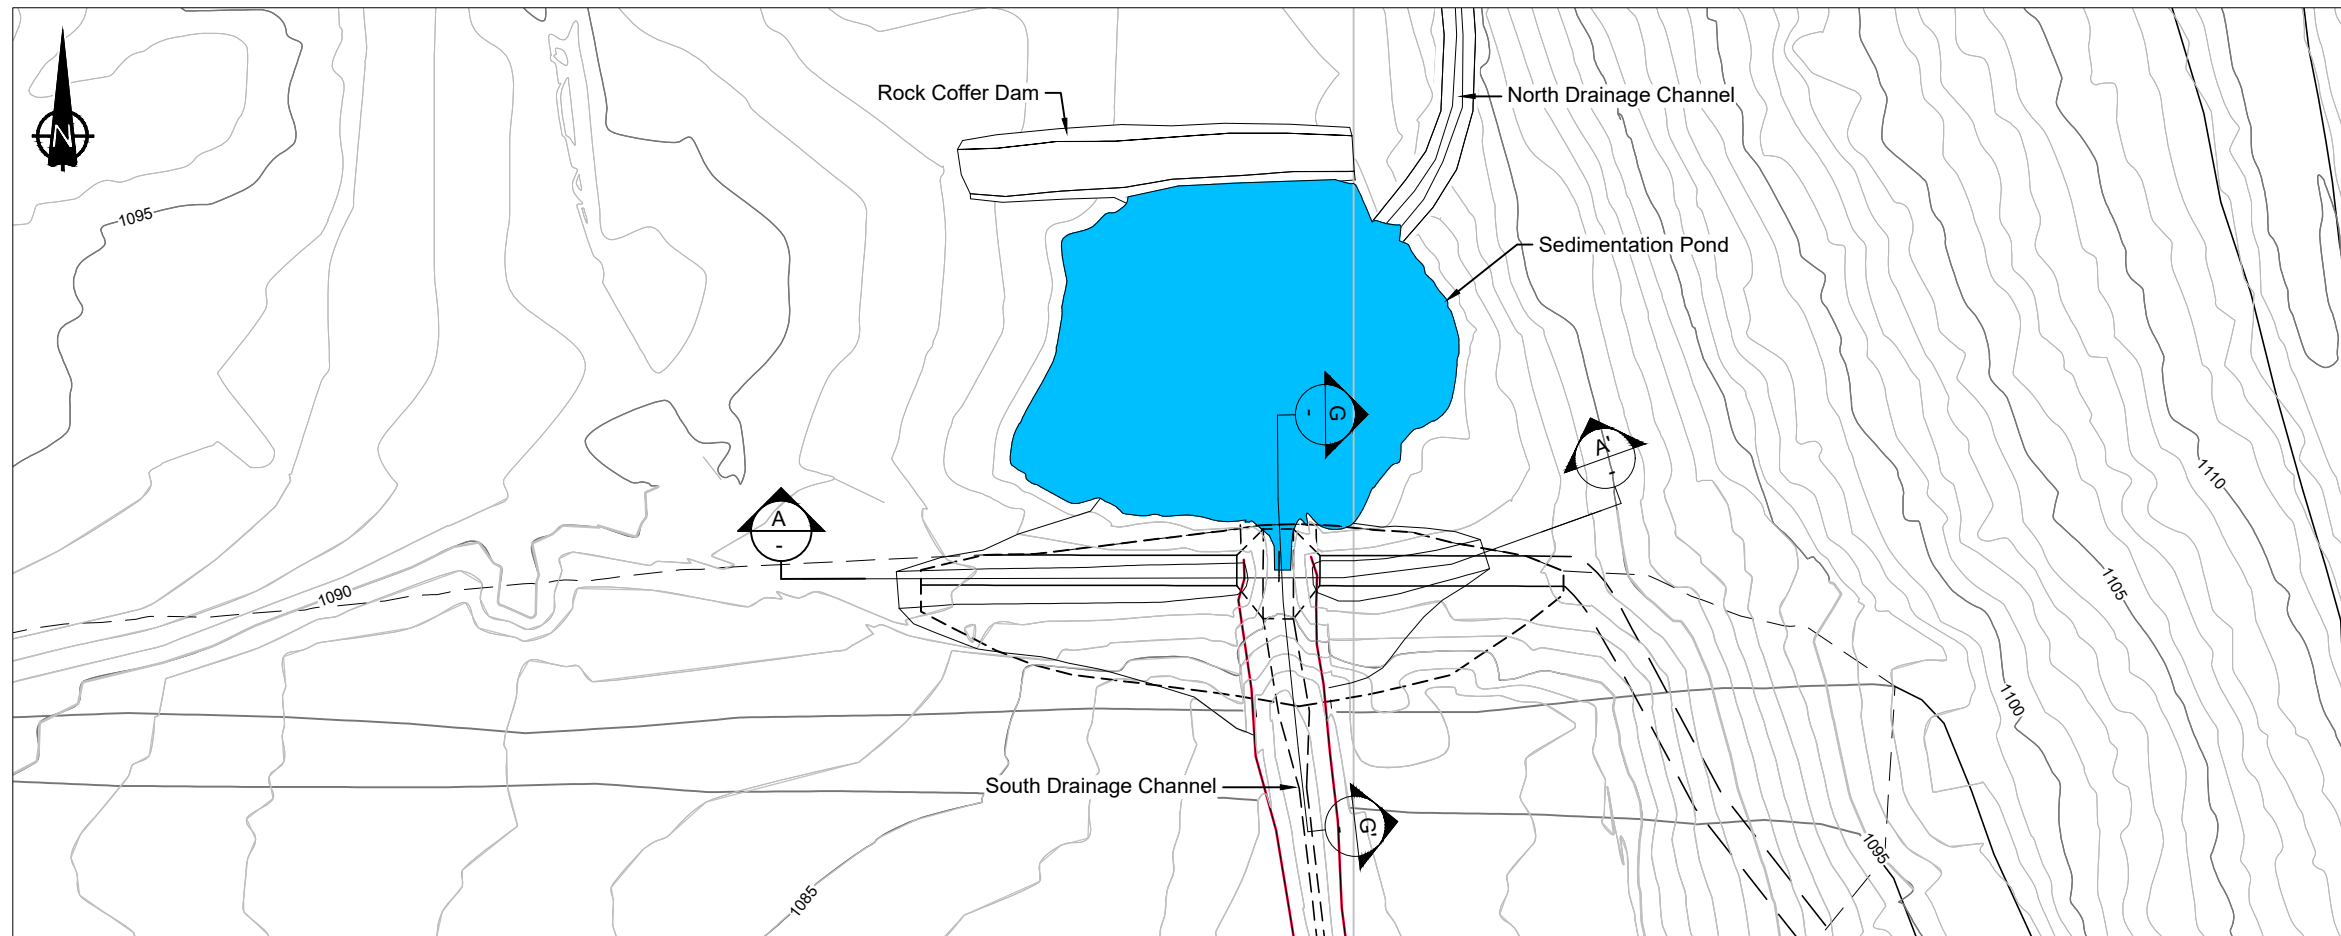
2023 Annual Facility Performance Review		
		DRAWING TITLE: North Dam Repaired Cross Section		
SRK JOB NO.: CAPR002559	REG. NO.:	Sä Dena Hes		DATE: July 2023
FILE NAME: CAPR002559 - North Dam Repair.dwg		APPROVED: PM	FIGURE: 04

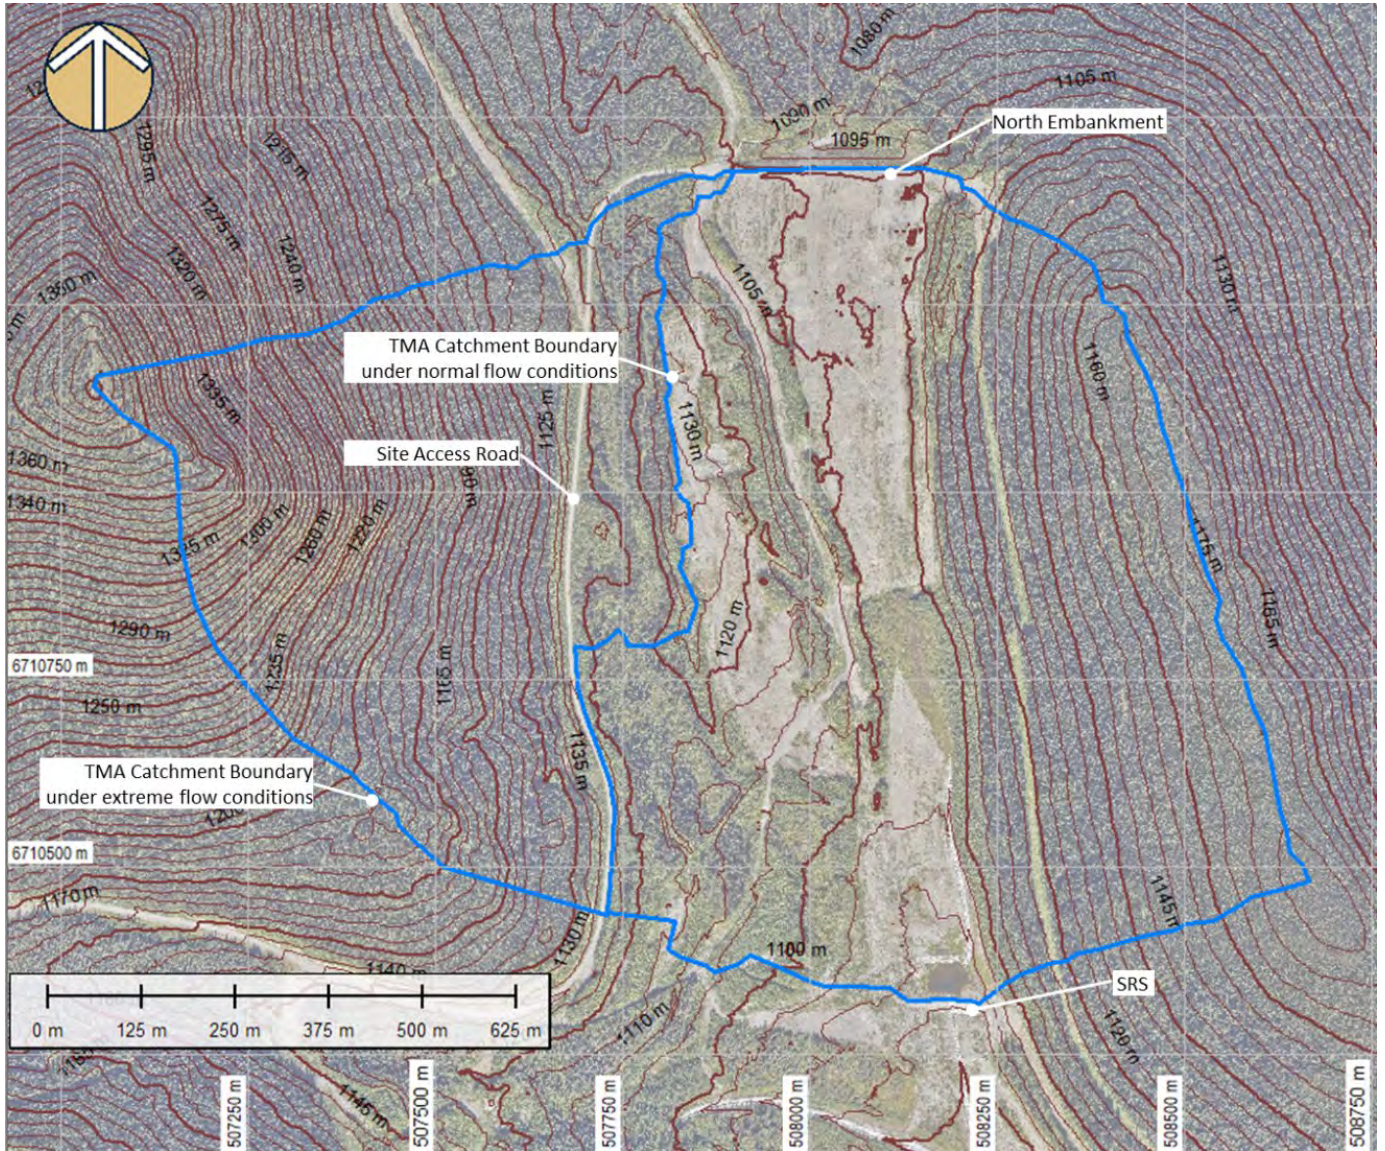
Sources : https://srk.sharepoint.com/sites/NA1CT008.075/Deliverables/Climate_Report/03_Figures/Fig2-3_TMA%20Catchment.pptx?web=1

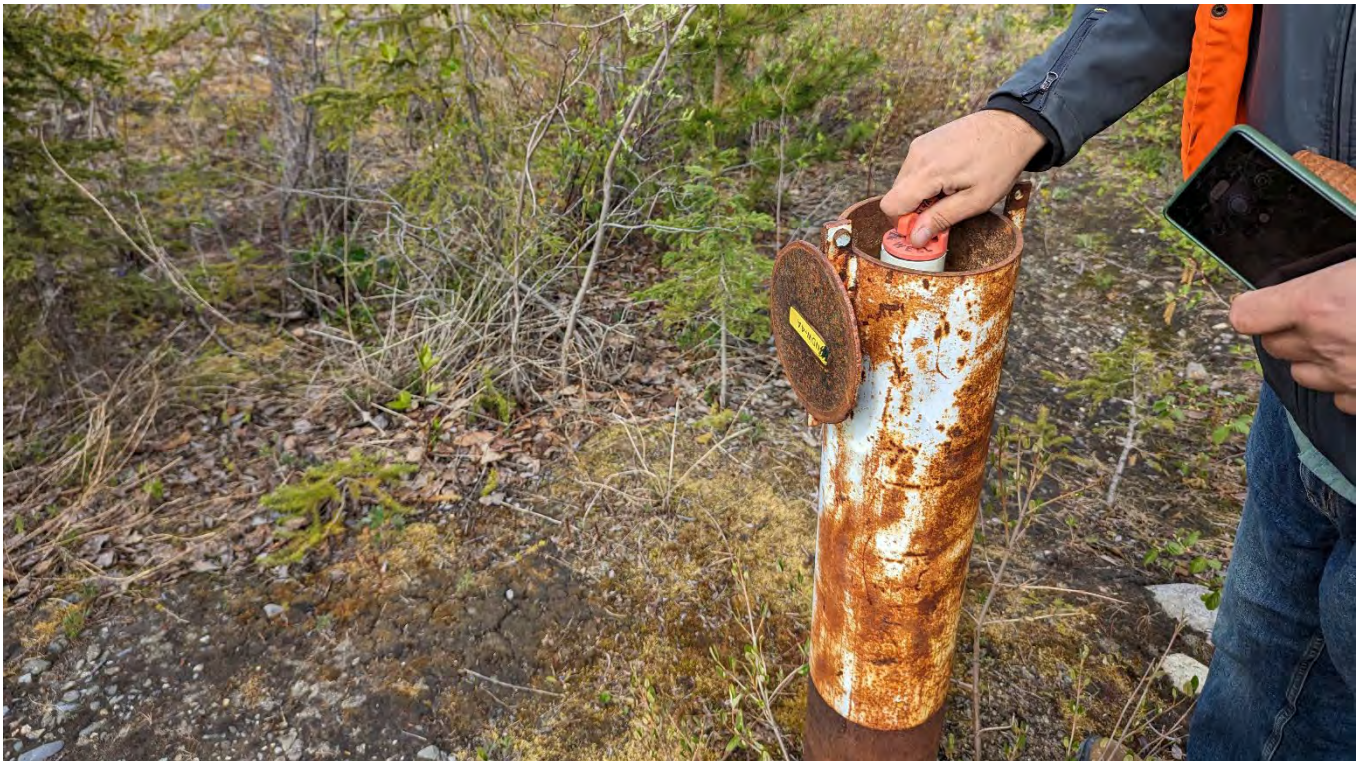
Photo NE-04: NDW-A4 Piezometer fitting in the casing after being trimmed following the 2022 recommendations.

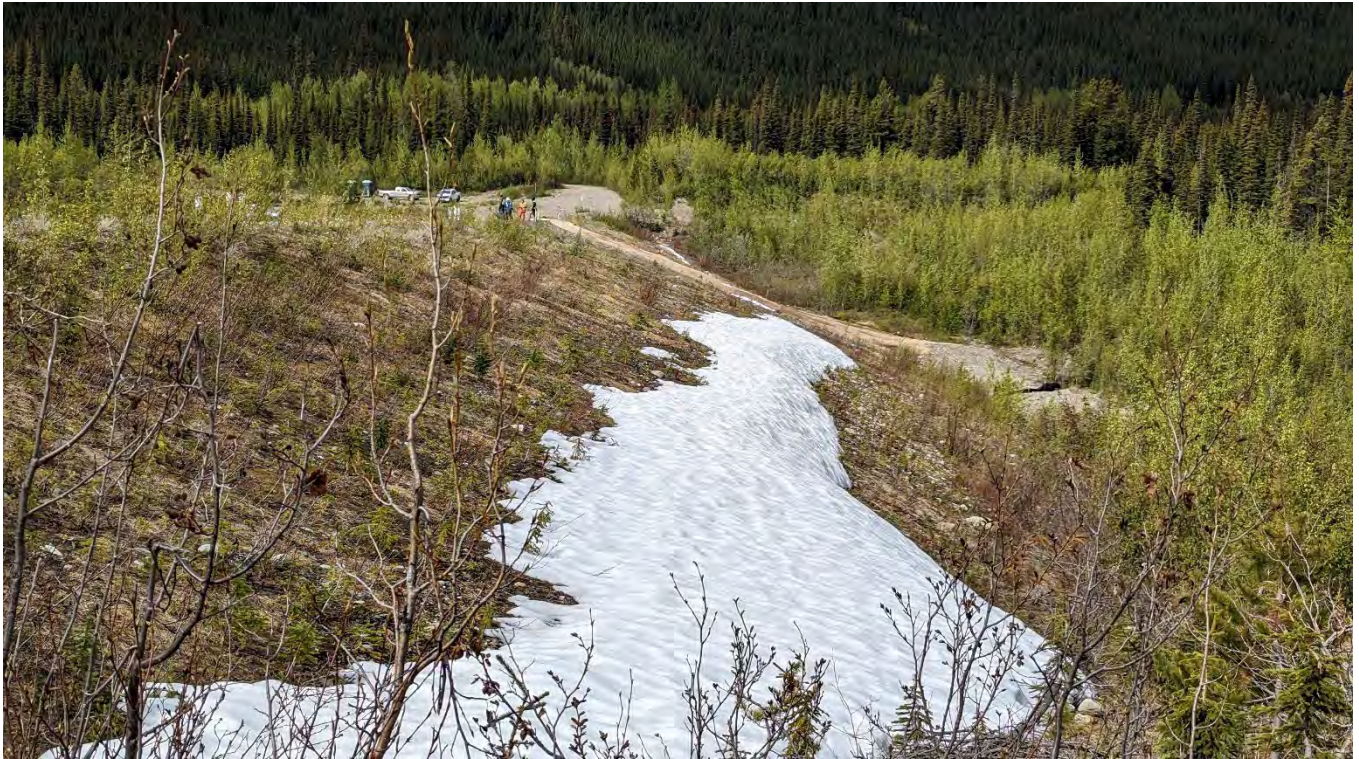
Photo NE-05: North embankment downstream slope vegetation seen from the east abutment.

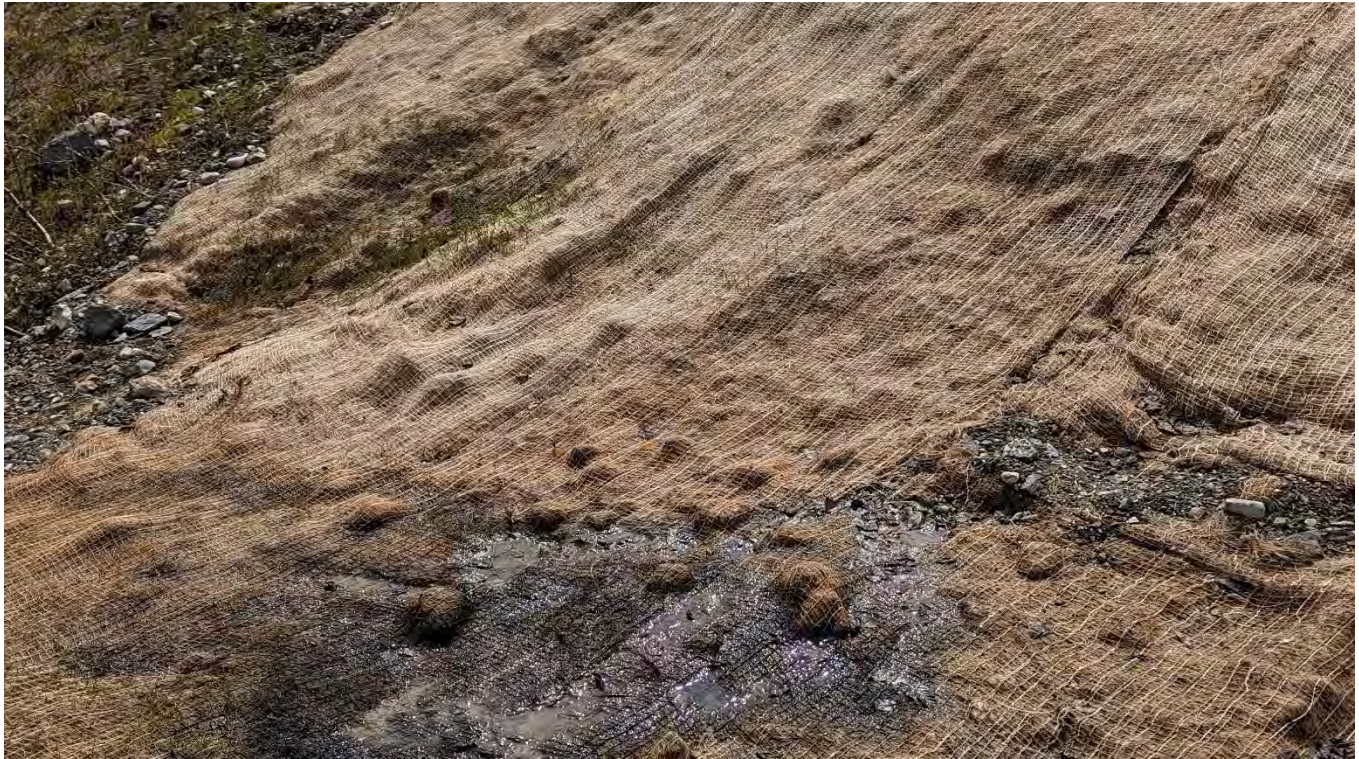
Photo NE-07: North embankment gully repair erosion protection mat at the toe of the repair.

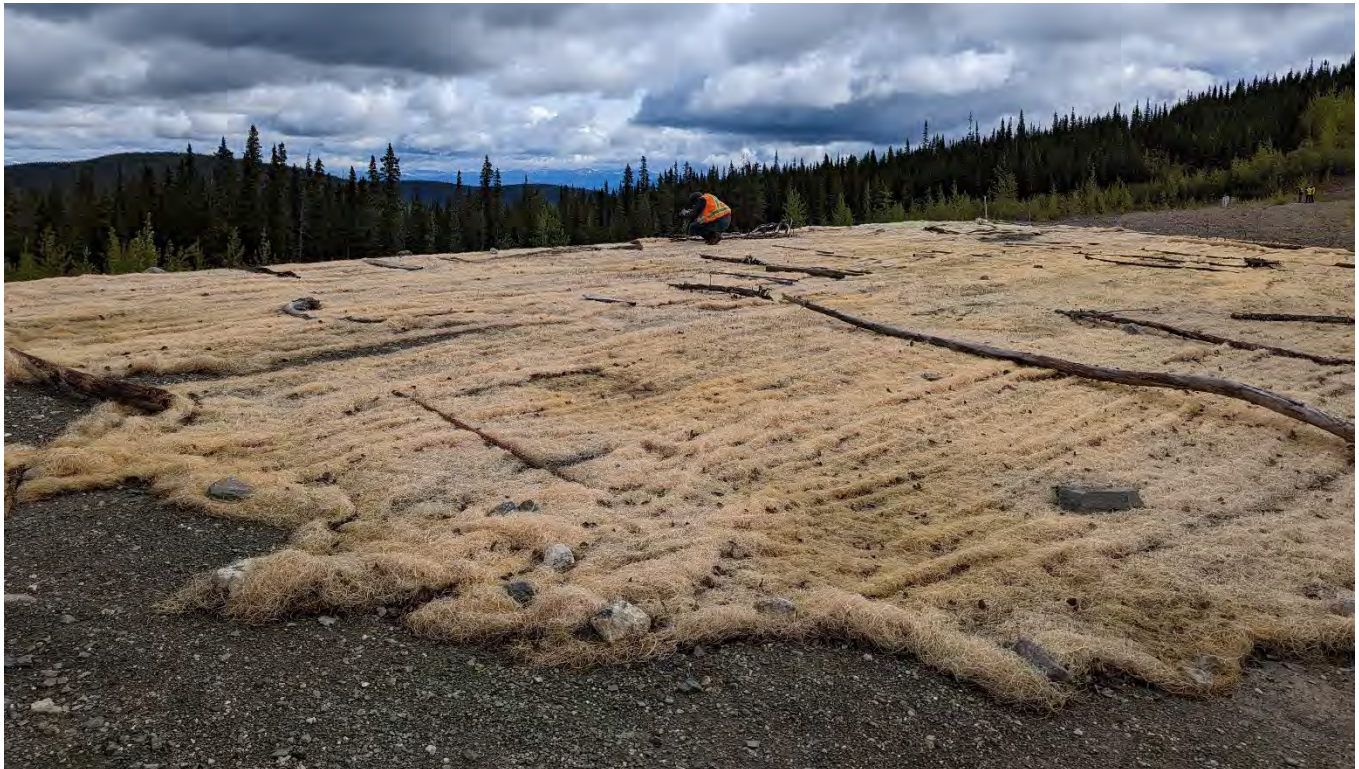
Photo NE-08: North embankment gully repair erosion protection mat.

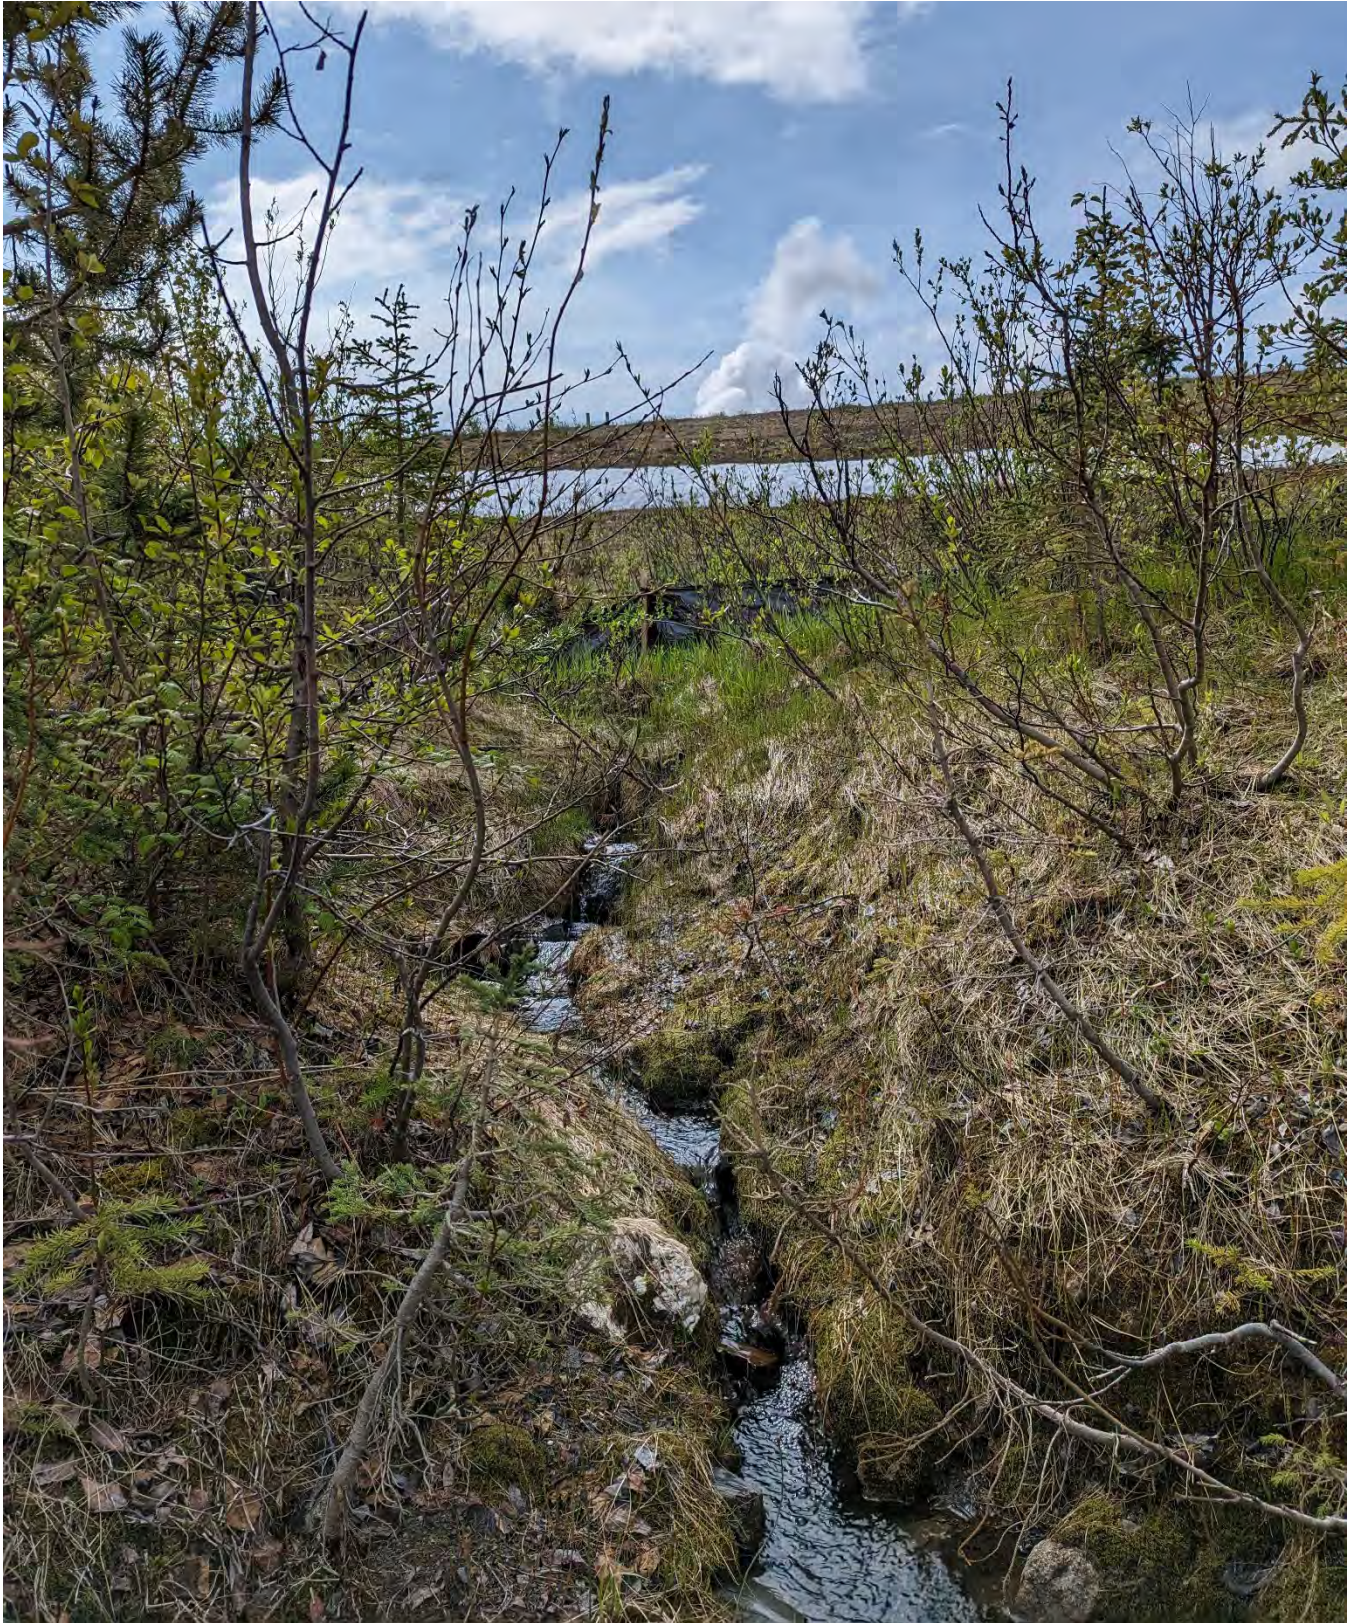
Photo NE-09: North embankment seen from the seepage monitoring station location. The flow appears to be clear.

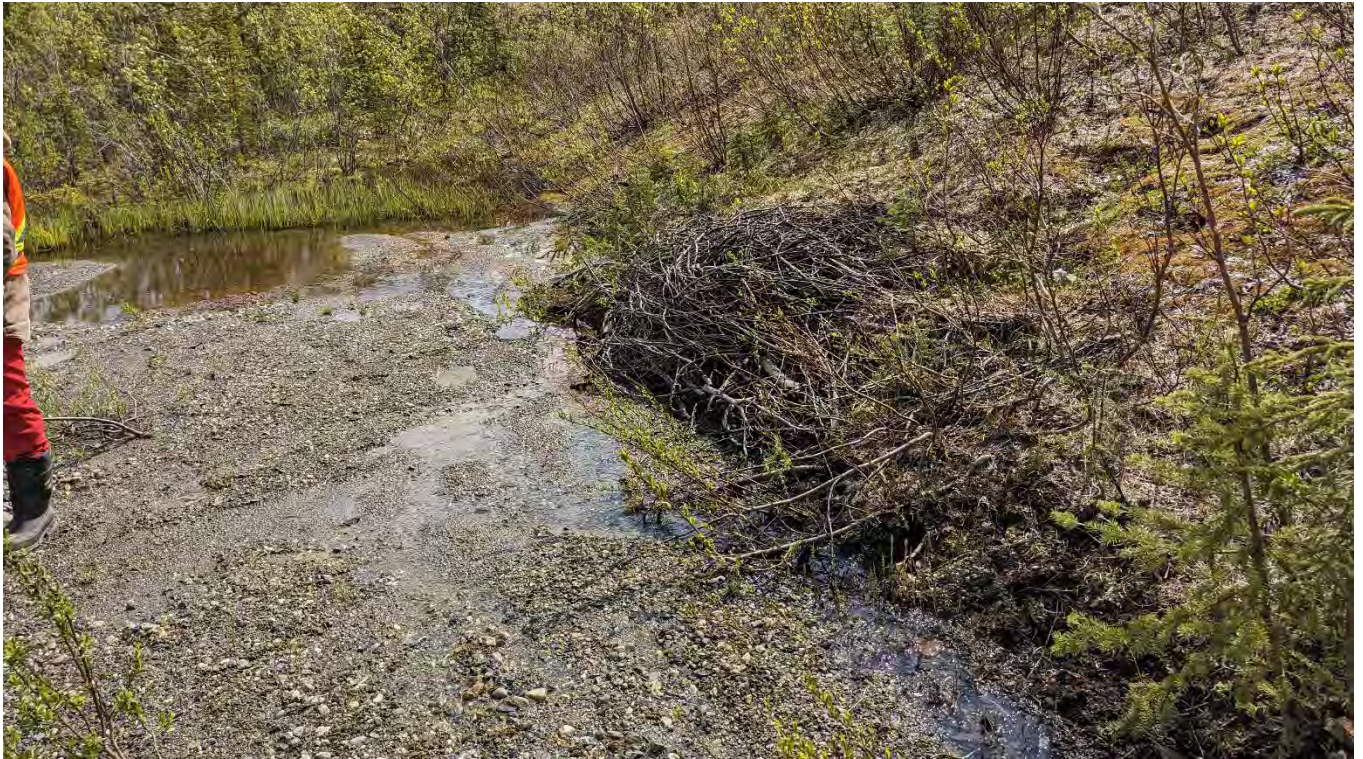
Photo NE-10: Seepage observed at the dam toe during the inspection.

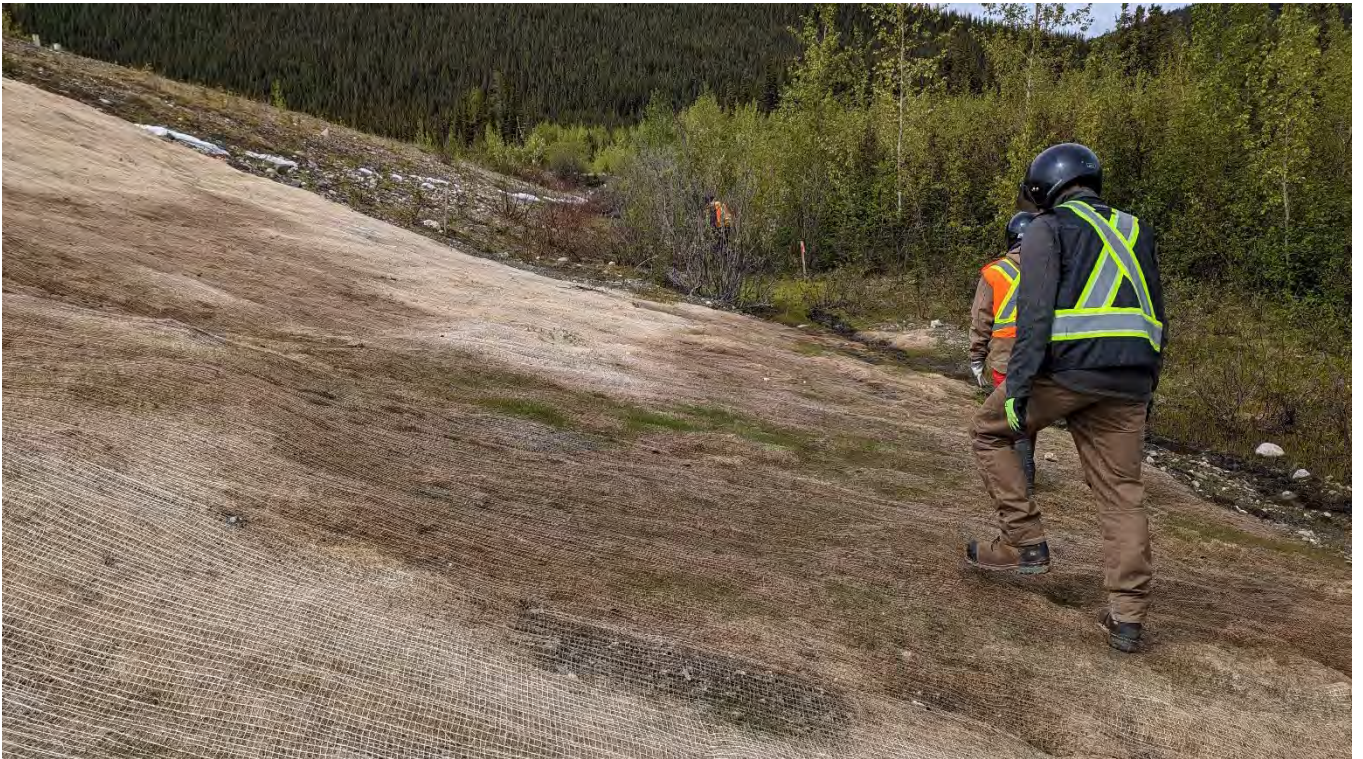
Photo NE-11: North embankment gully repair erosion protection mat at the toe was wet and the material underneath was soft.

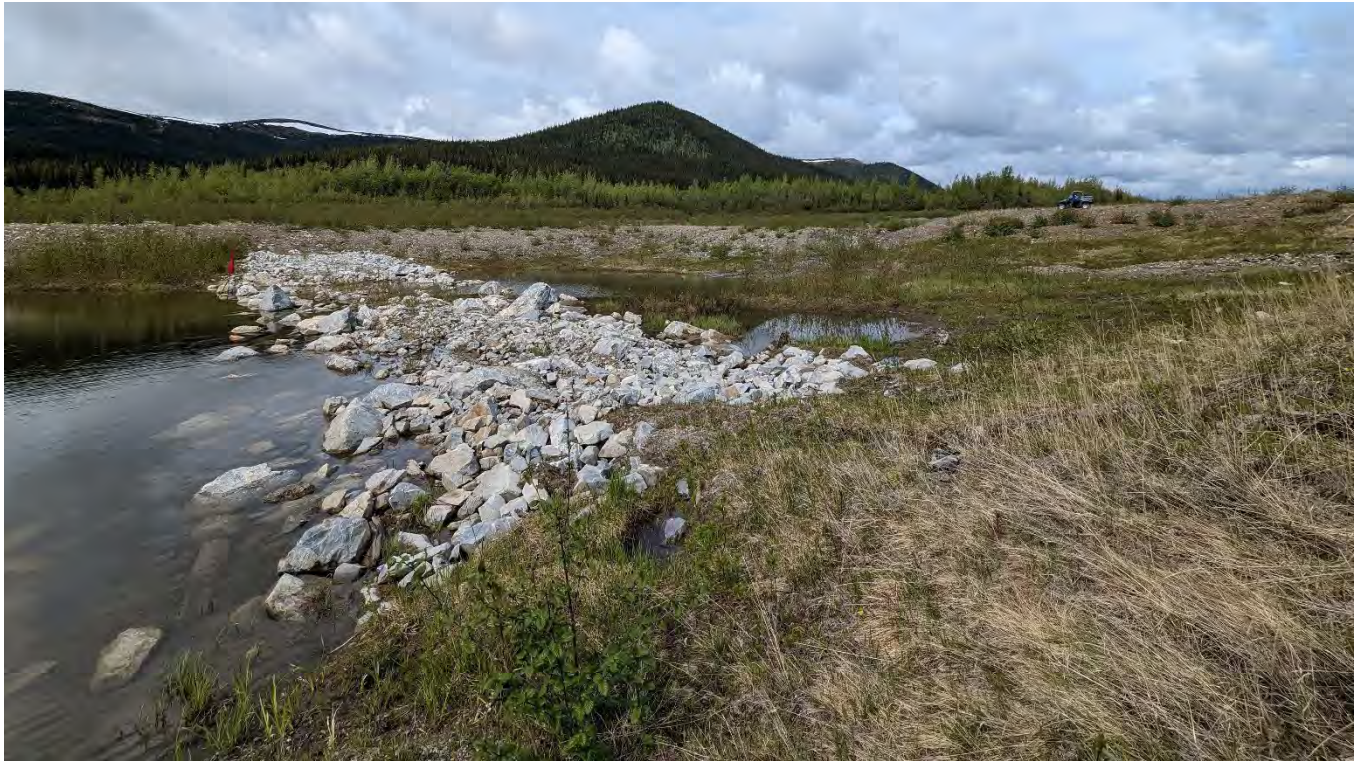
Photo SRS-01: Rock cofferdam seen from the west. The water appears to be clear.

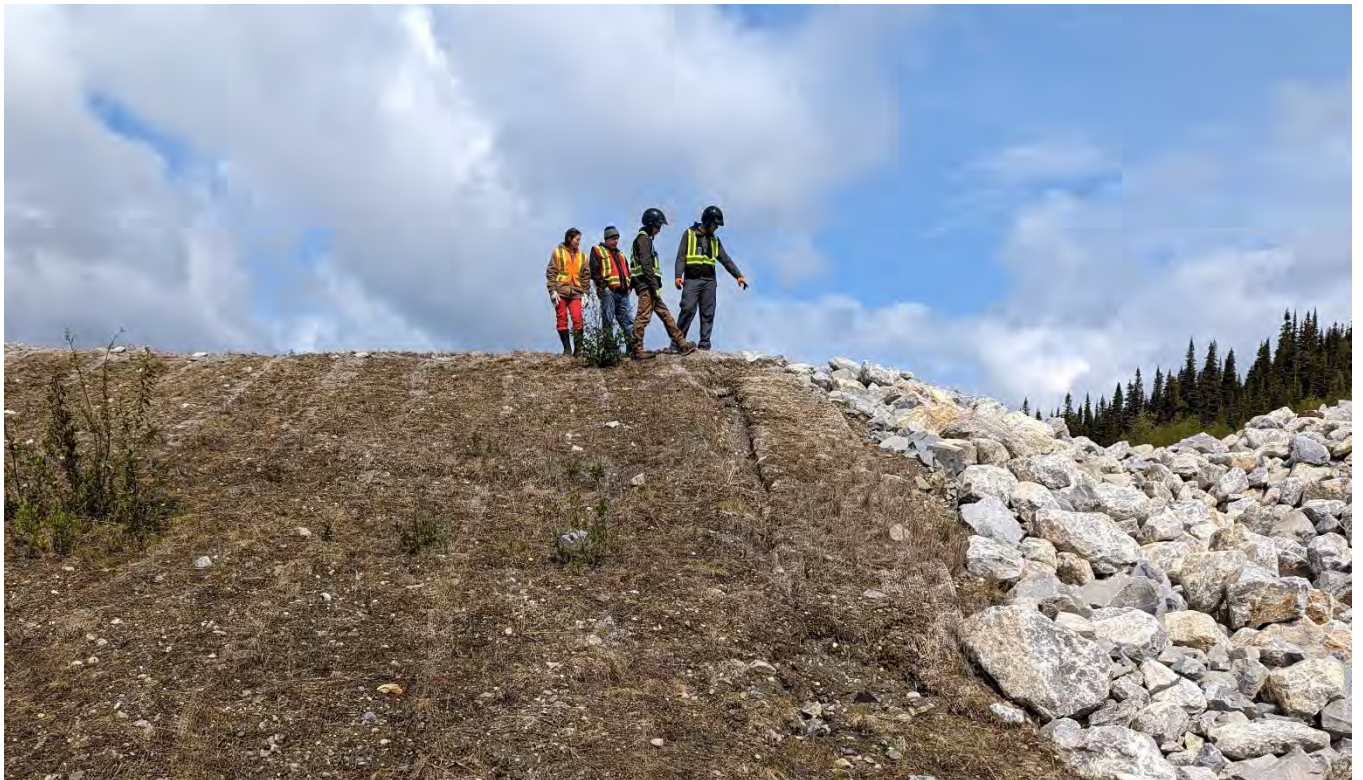
Photo SRS-02: Transverse crack across the dam crest approximately 1m east of the spillway seen from downstream.

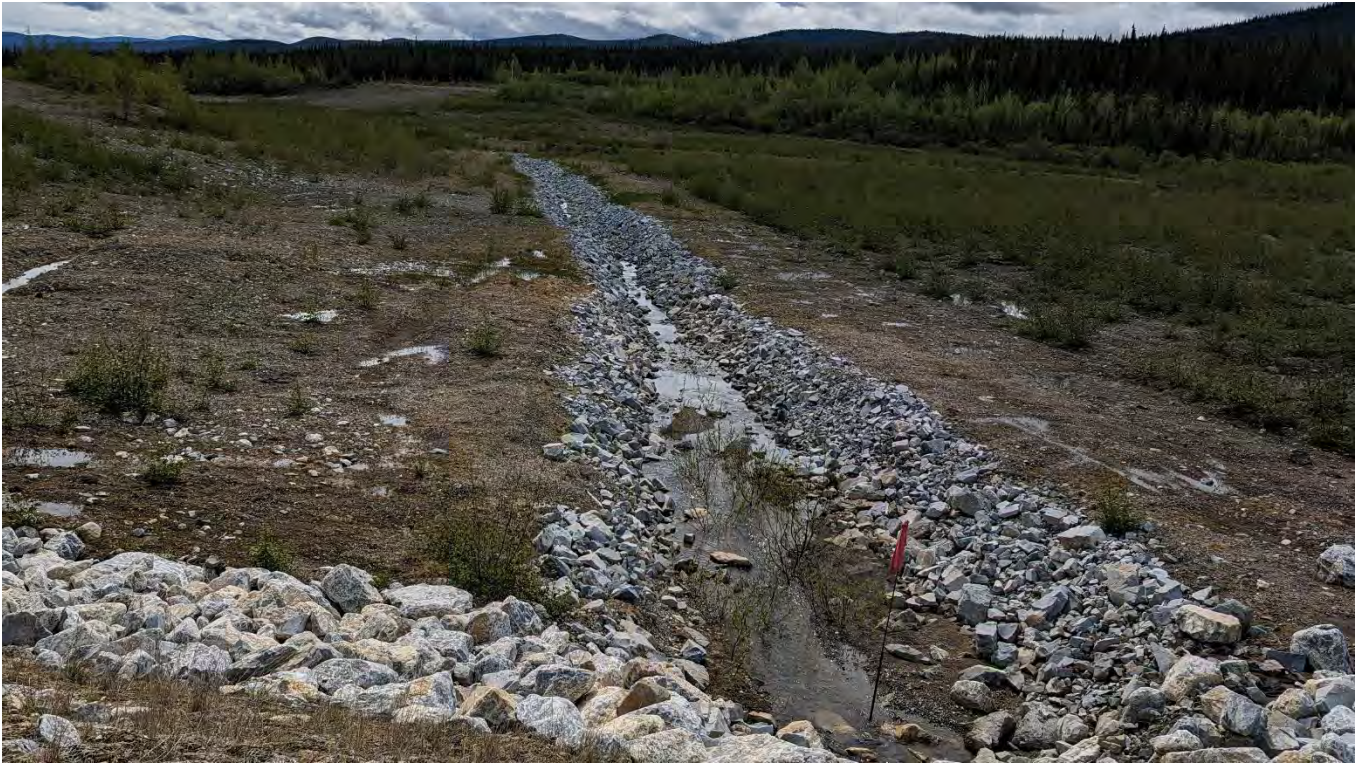
Photo SRS-03: Sediment accumulation in the spillway outlet seen from the east margin of the spillway.

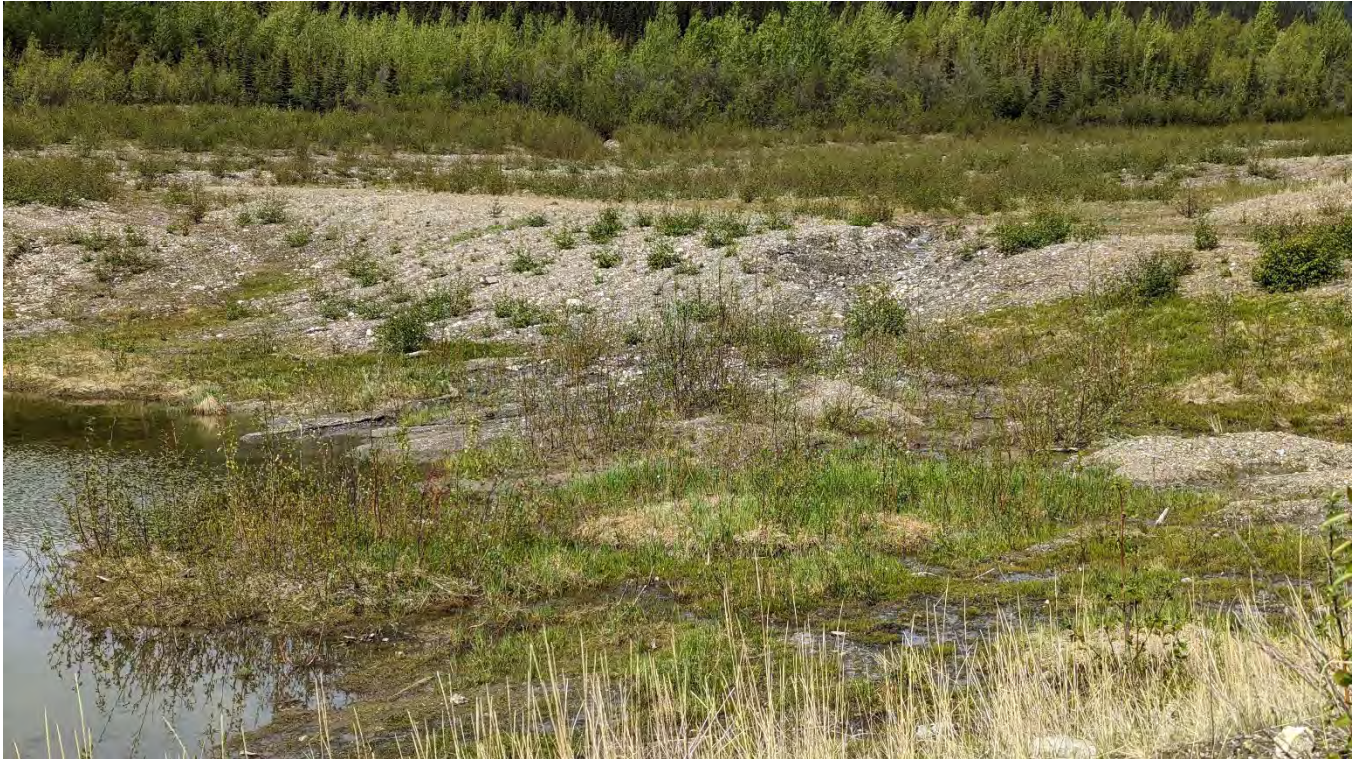
Photo TC-07: Erosion gully observed near the south end of the main tailings area. Unchanged since 2022

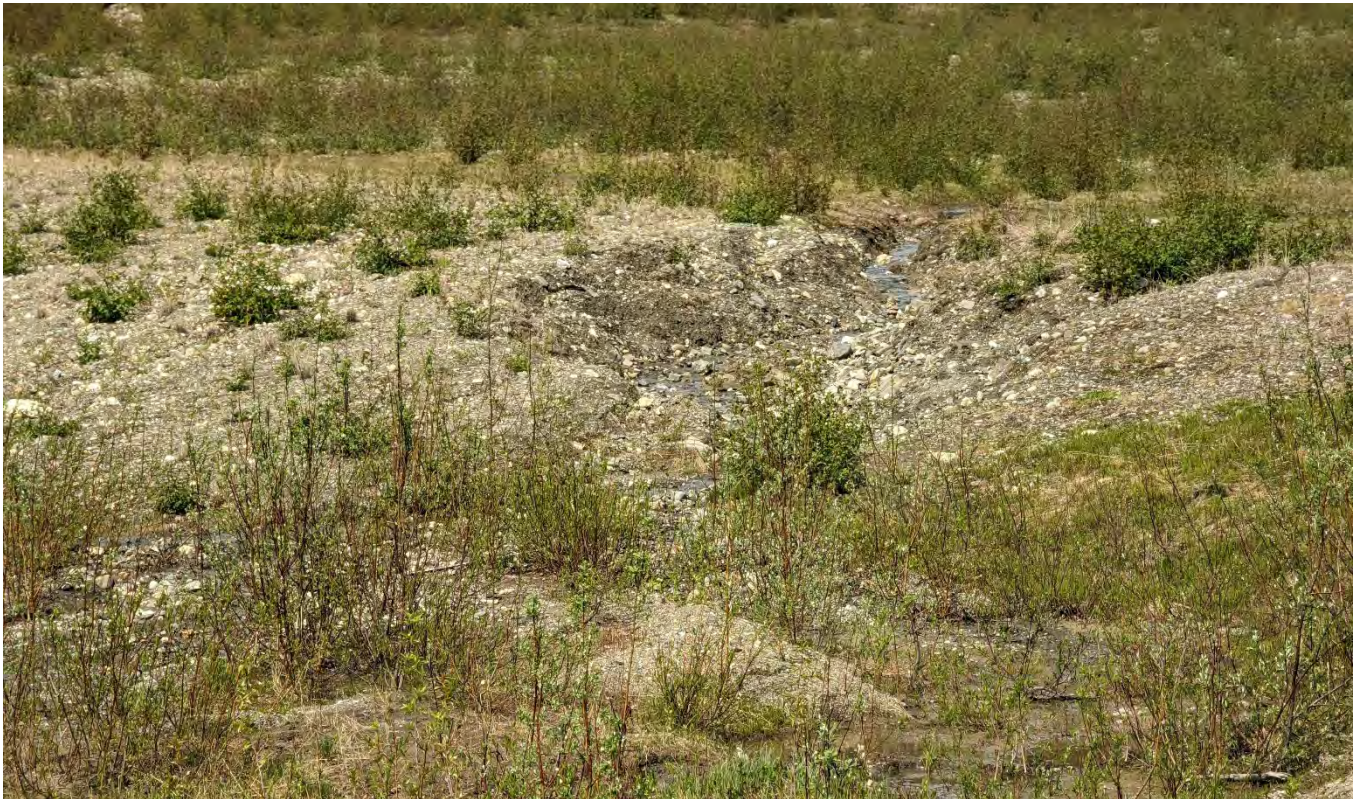
Photo TC-08: Vegetation is developing over the area, being less dense in the center. Photo taken from the North Embankment.

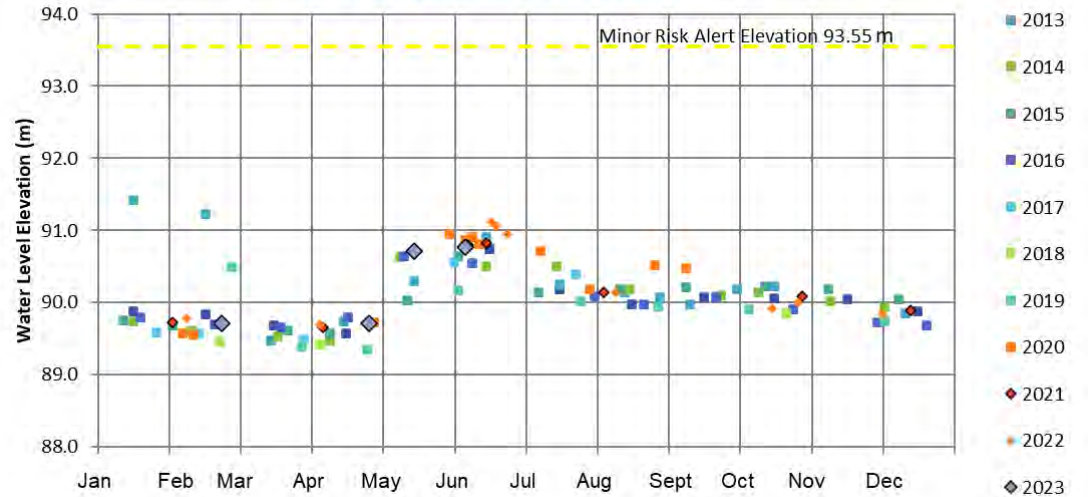
Center Crest, screened in dam foundation

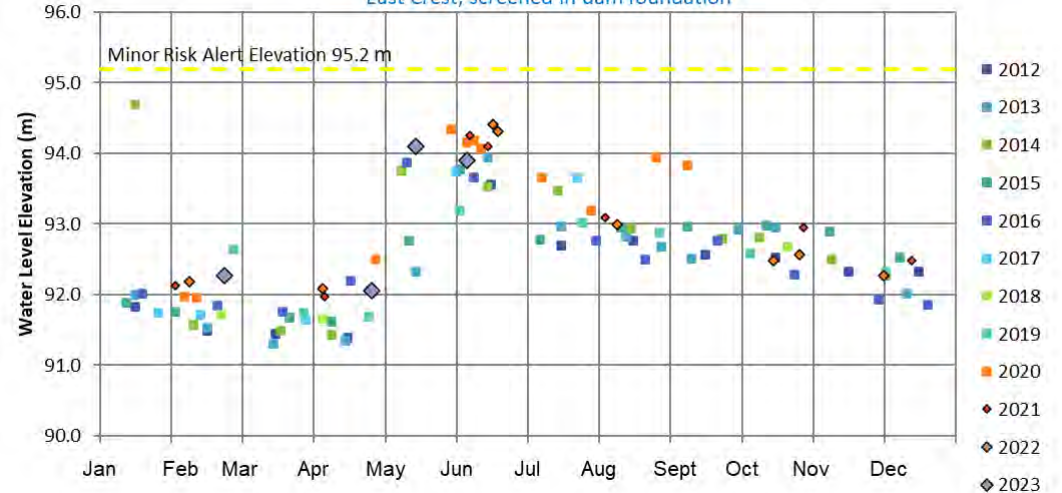
East Crest, screened in dam foundation

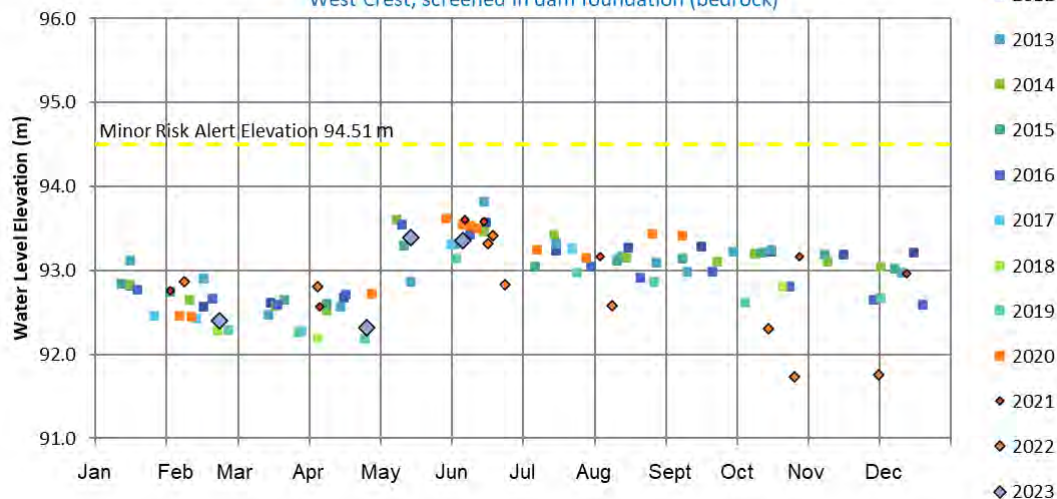
West Crest, screened in dam foundation (bedrock)

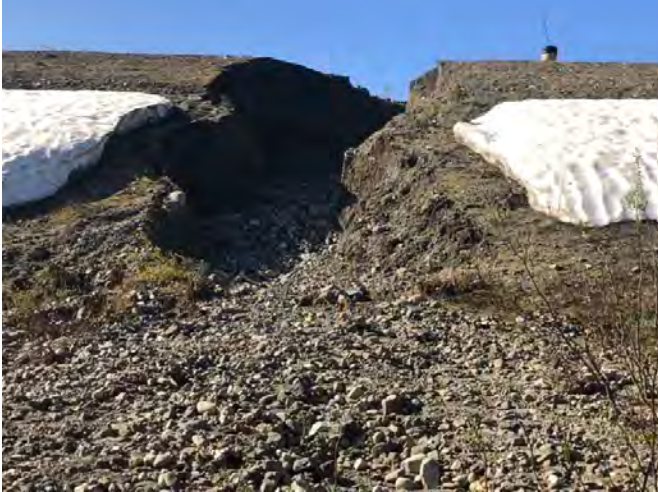
Photo Discription	Photo	Photo Location
North Dam erosion

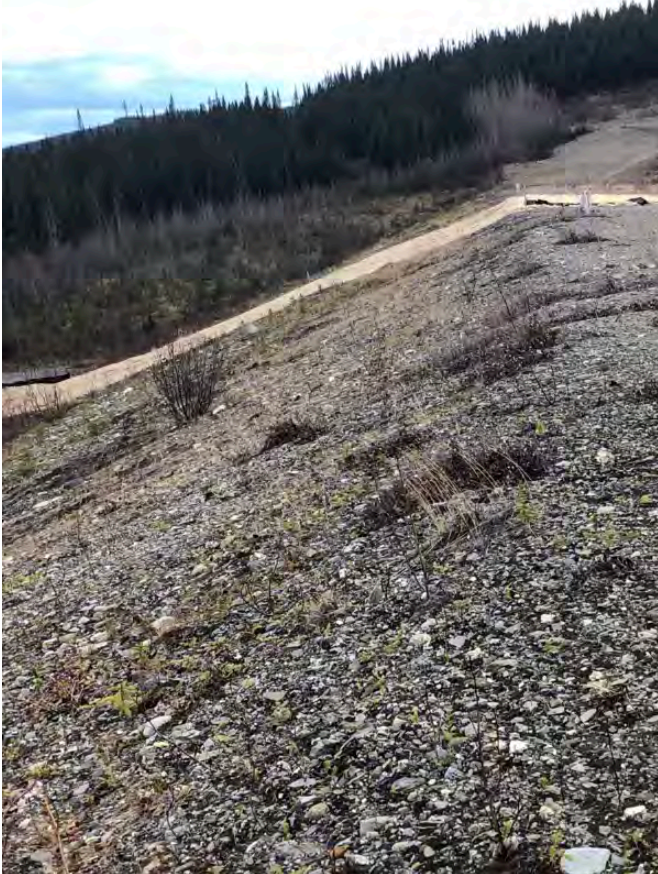
Photo Discription	Photo	Photo Location
Jute placement
