2023 Annual Facility Performance Review - SDH Tailings Management Area

Sä Dena Hes Mine, Yukon Territory, Canada
Teck Resources Limited

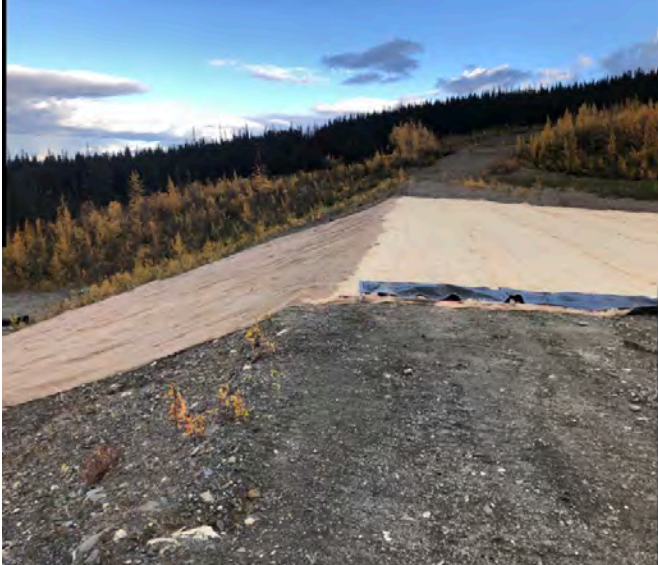
Photo Discription	Photo	Photo Location
Dam repairs tidied up

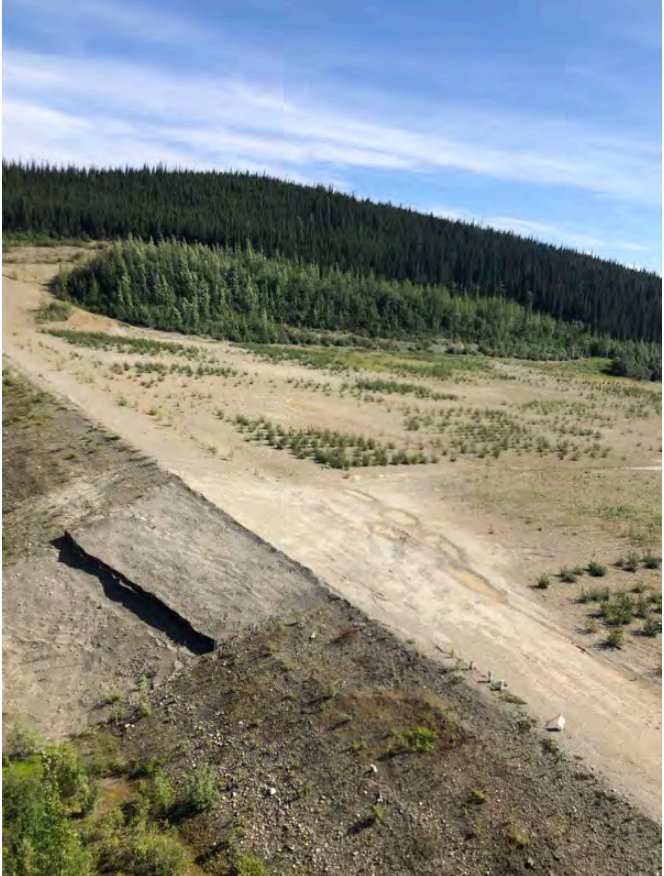
Photo Discription	Photo	Photo Location
Curlex fiber used for flat area of dam crest

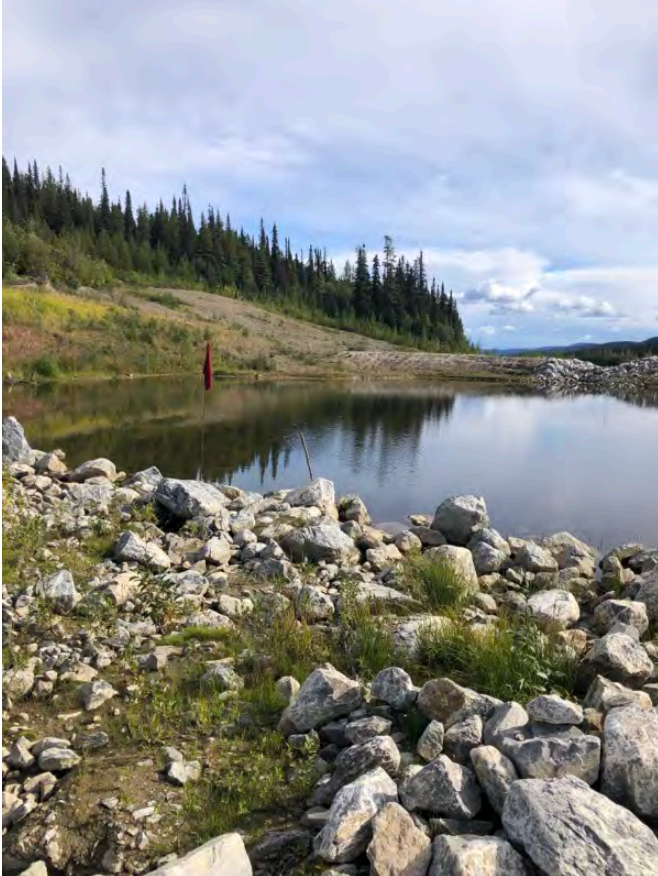
Photo Discription	Photo	Photo Location
Slump at bottom west side of riprap, vertical cracking along downstream riprap, under jute matting.

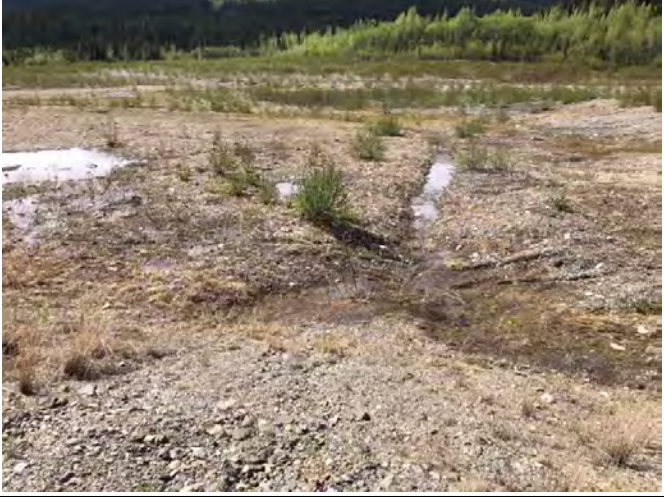
Latitude: 60.530457 Longitude: -128.850510
Looking South west across South pond cap
