April 4, 2016

Re: **Sä Dena Hes Mine – Quartz Mining License QML-0004 – 2015 Detailed Decommissioning and Reclamation Plan Report**

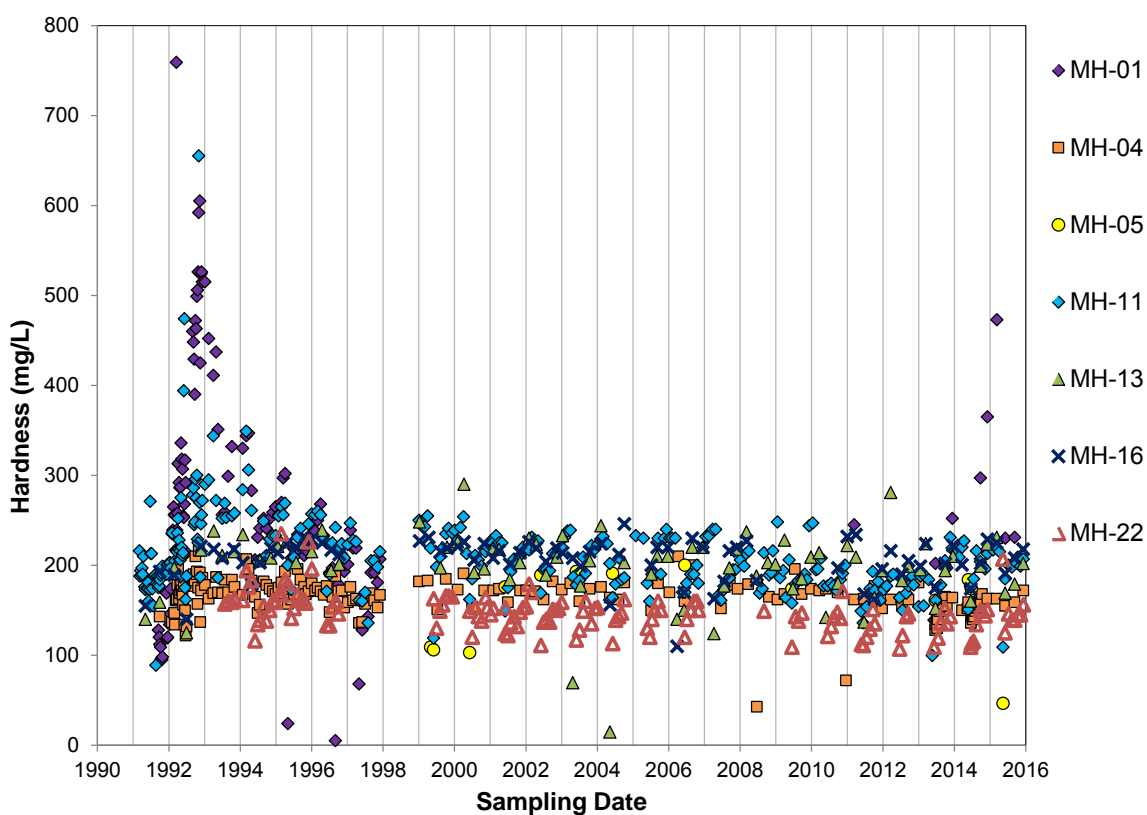
**Figure 4-6: Sä Dena Hes Long Term Hardness Concentrations**

Hardness levels exhibit long term stability at all seven stations. With the exception of MH-05, hardness generally ranged from 110 to 230 mg/L at all stations. These results are consistent with historical ranges. Hardness levels for the South Tailings Outflow (MH-01) periodically has had higher levels. The Burnick 1200 Portal (MH-22) has generally had the lowest levels of hardness.

The May sample at the Portal Creek station (MH-05) was substantially lower than the sample results from previous years. This may be related to the flow of high turbid water from the mill area,.

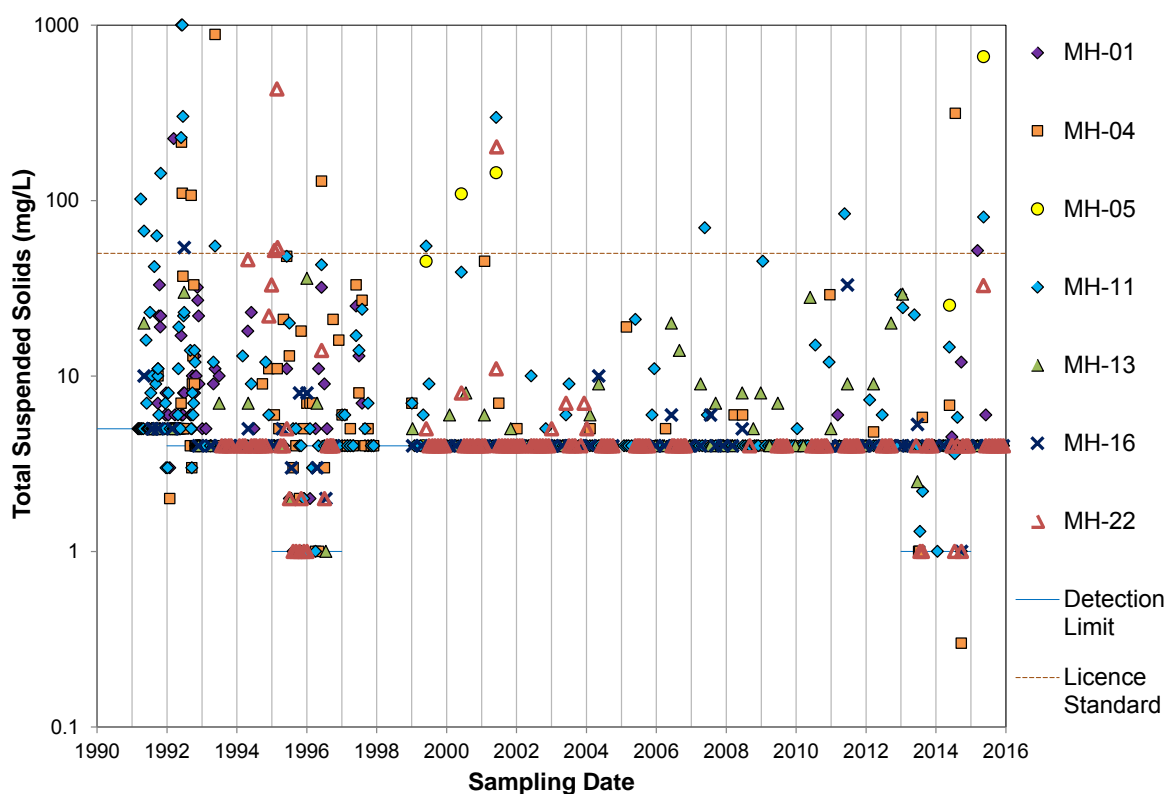
**Figure 4-7: Sä Dena Hes Long Term Total Suspended Solids Concentrations**

The March sample at the South Tailings Outflow (MH-01) and the May samples at the Portal Creek station (MH-05) and upper False Canyon Creek (MH-11) exceeded the licence standard for TSS.

The other False Canyon Creek stations (MH-13 and MH-16), Lower Camp Creek (MH-04), Portal Creek (MH-05), and the Burnick 1200 Portal discharge (MH-22) did not exceed 50 mg/L of TSS in 2015. None of the routine monthly water monitoring samples collected from these stations have exceeded the licence standard since 2001.

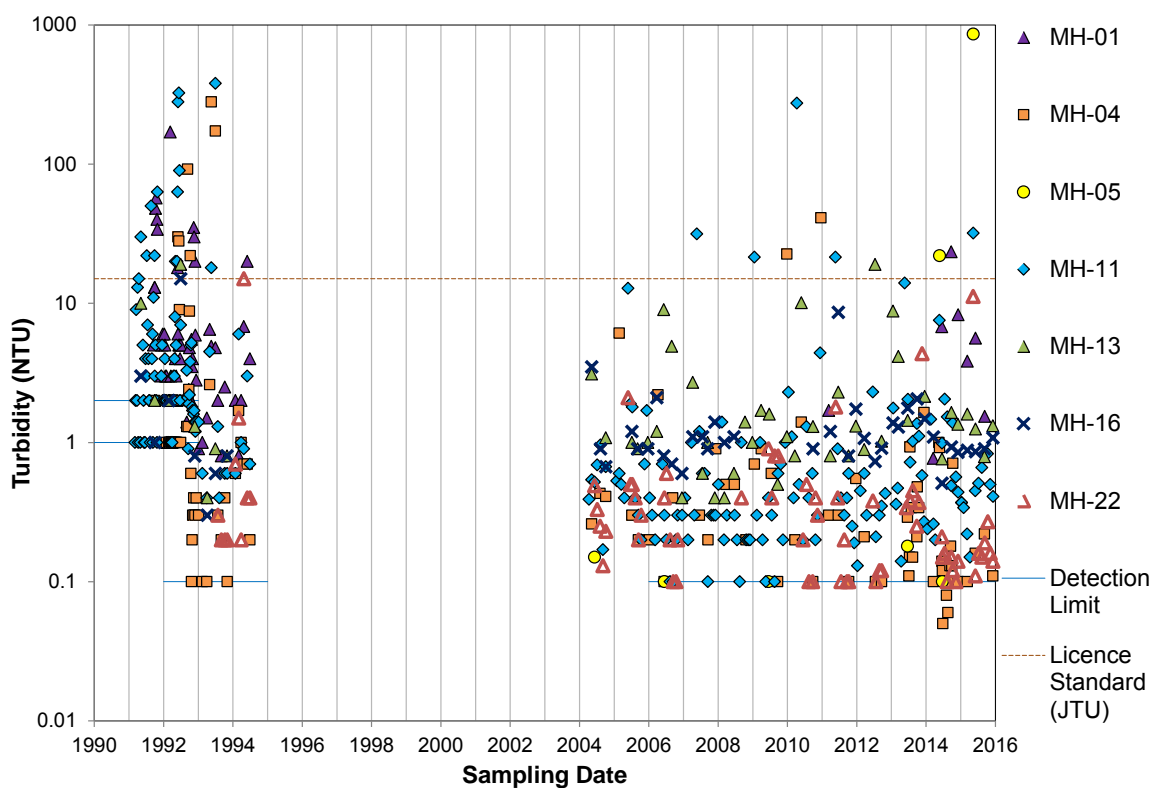
**Figure 4-8: Sä Dena Hes Long Term Turbidity Levels**

The May 2015 samples from Portal Creek (MH-05), 1200 Burnick Portal (MH-22) and Upper False Canyon Creek (MH-11) stations were higher than previous years. Levels exceeded the licence standard at MH-05 and MH-11 only. As with TSS, the increase in turbidity levels is likely related to the flushing of sediments from decommissioning activities during the freshet period.

The turbidity readings at the remaining stations were approximately the same or lower than their respective historical trends.

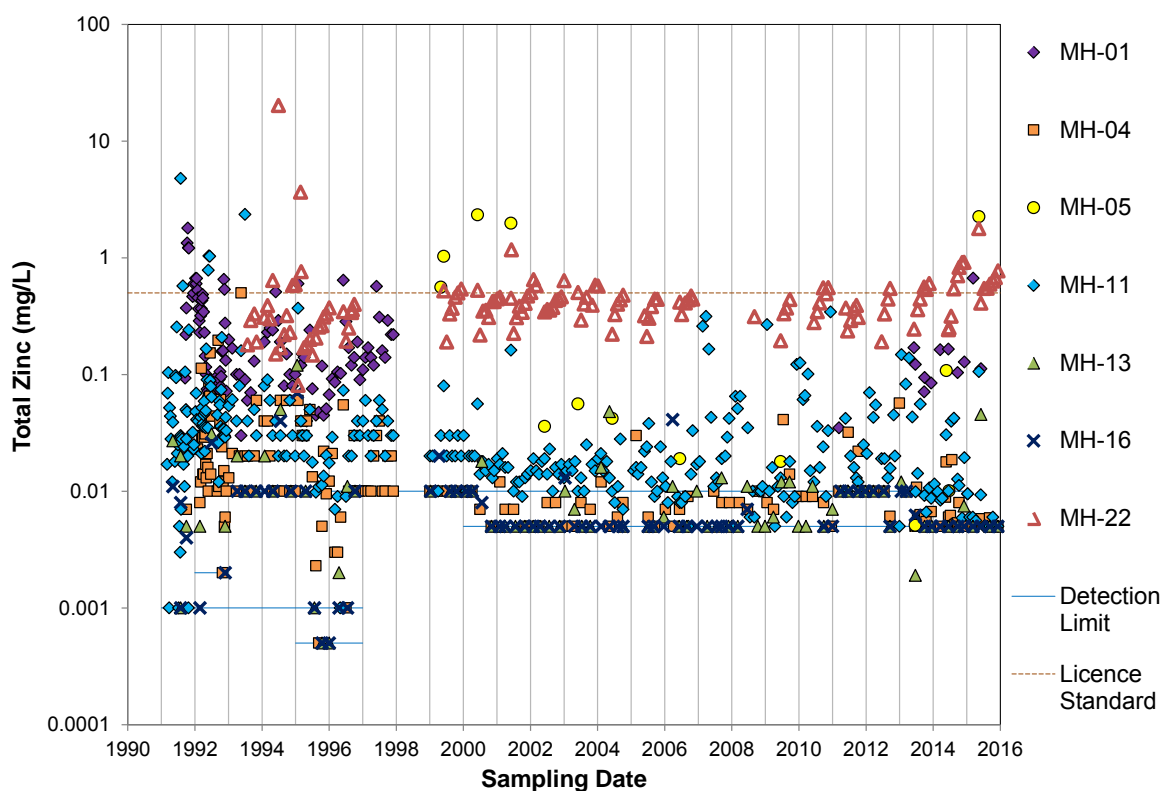
Figure 4-11: Sä Dena Hes Long Term Total Zinc Concentrations

Six of the seven Burnick 1200 Portal discharge (MH-22) samples in 2015 exceeded the licence standard. Since 2012, there appears to be an increasing trend in total zinc levels. Although the Burnick 1200 portal discharge (MH-22) is compared to the licence standards, it is important to note that it does not discharge directly to the receiving environment.

One sample from the South Tailings Outflow (MH-01) was above licence limits in 2015. Data are within the range of historical data. At the Portal Creek station (MH-05), total zinc levels (2.3 mg/L) were higher than in 2014 but within the range of historical data.

No other samples from 2015 exceeded the licence standard. Lower Camp Creek (MH-04) concentrations ranged from below the analytical detection limit (0.005 mg/L) to 0.0059 mg/L. Upper False Canyon Creek (MH-11) had a maximum concentration of 0.11 mg/L. Further downstream in False Canyon Creek (MH-13 and MH-16), concentrations were all below the level of analytical detection (<0.005 mg/L) with the exception of one sample (0.046 mg/L).

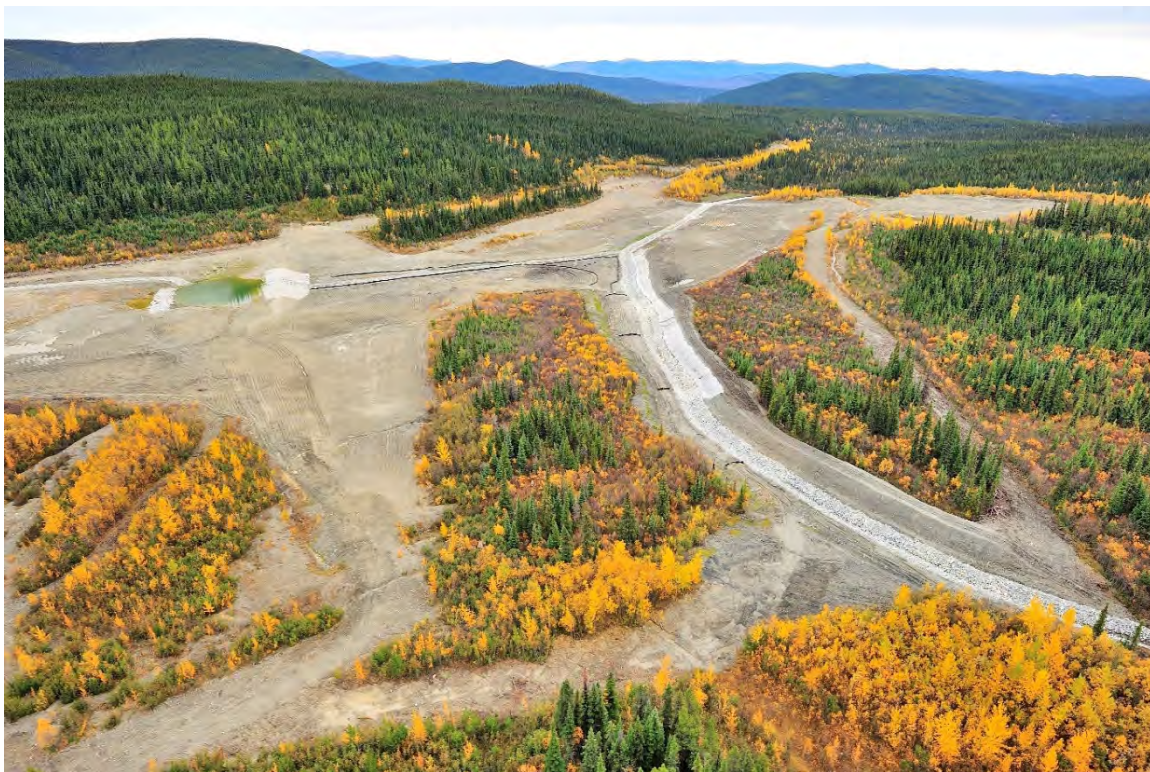
**Photo 3: View east over the Sediment Retaining Structure**

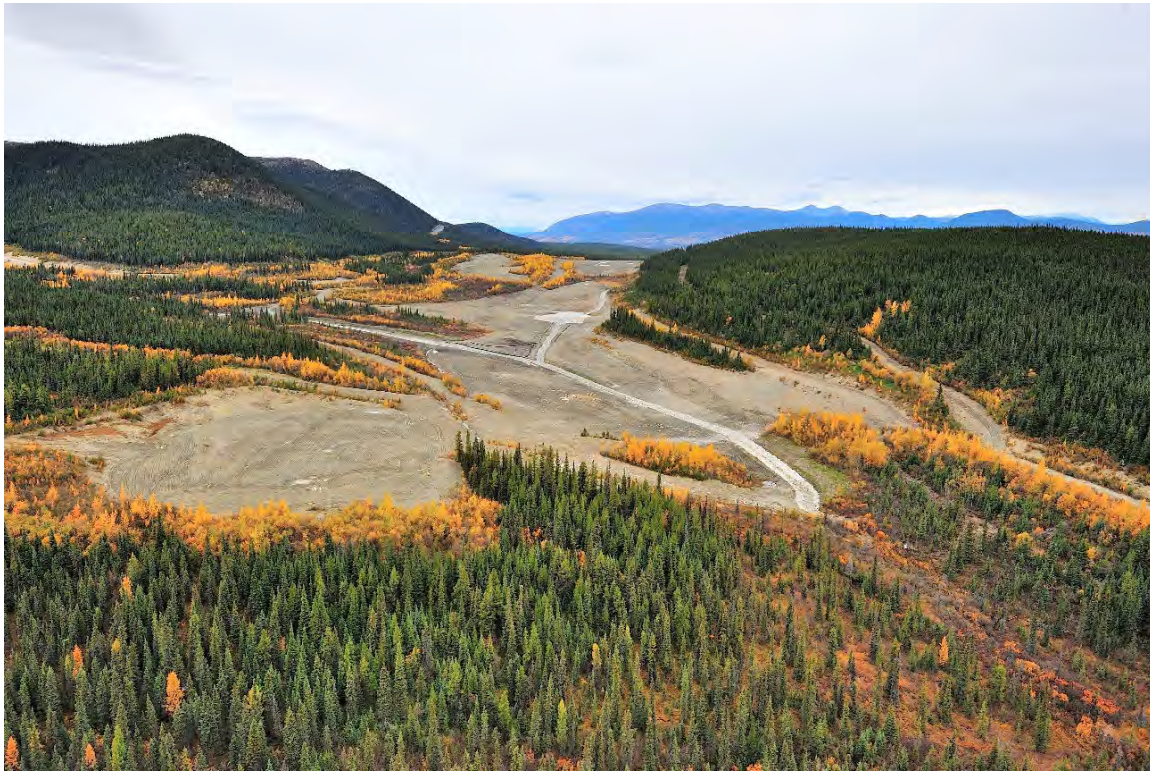
**Photo 4: View North of the new Camp Creek Drainage Channel**

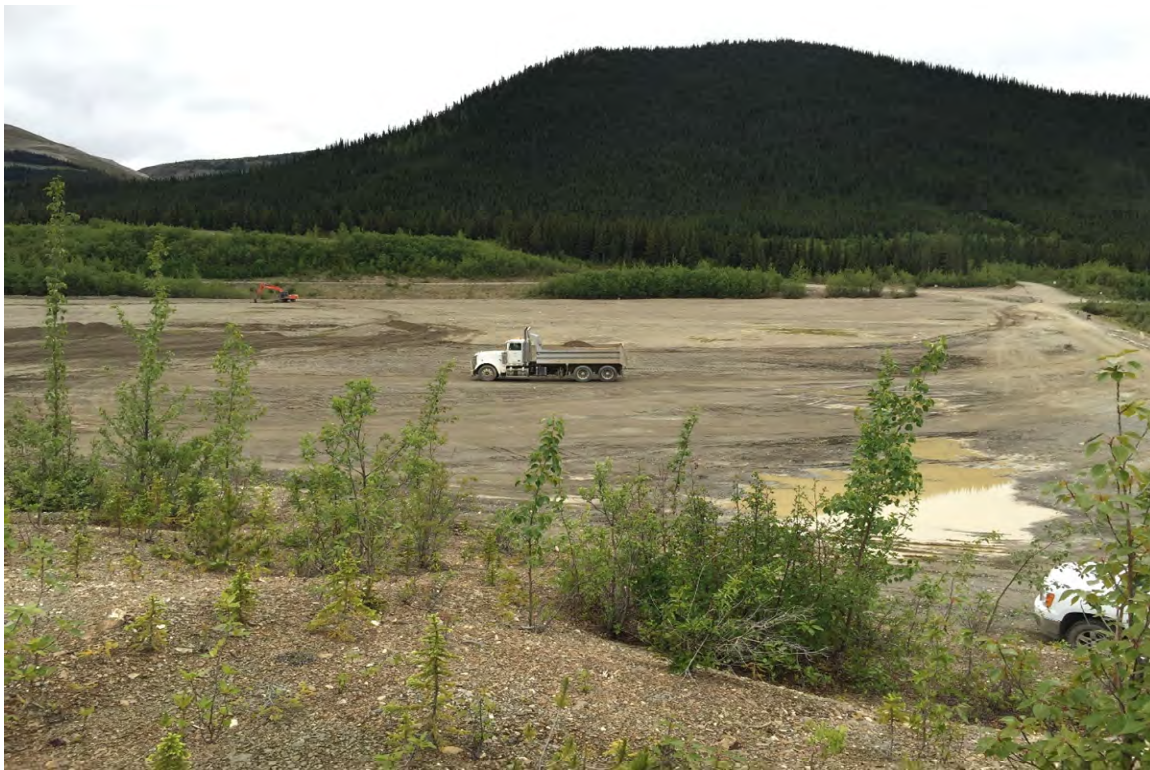
**Photo 5: View looking west over the North Dam**

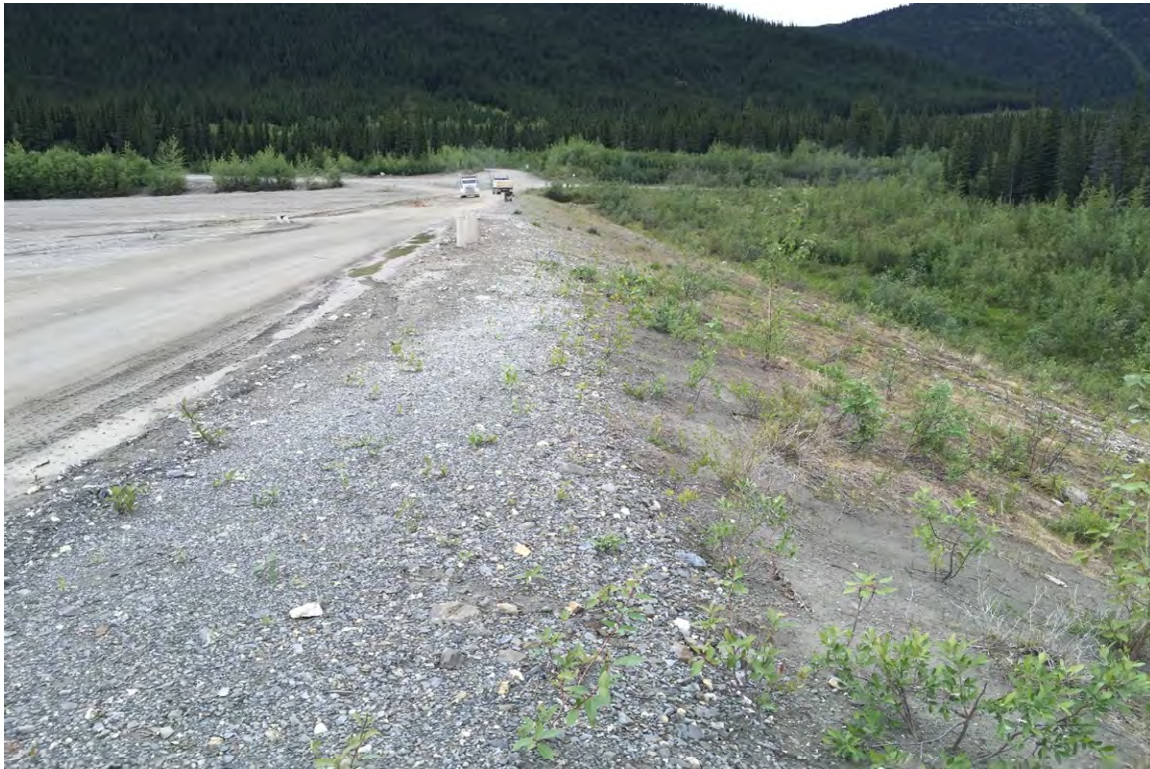
**Photo 6: View looking west along the North Dam showing the downstream slope**

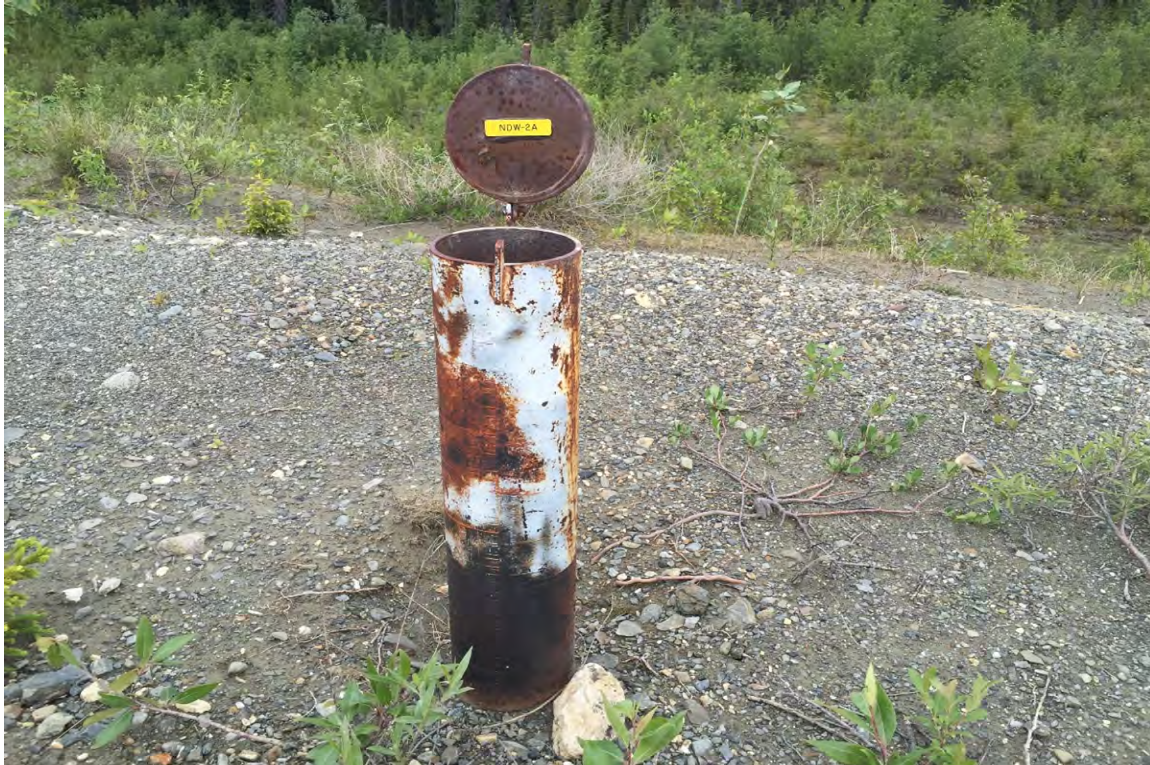
**Photo 7: Protective steel casing for the Piezometers in the North Dam**

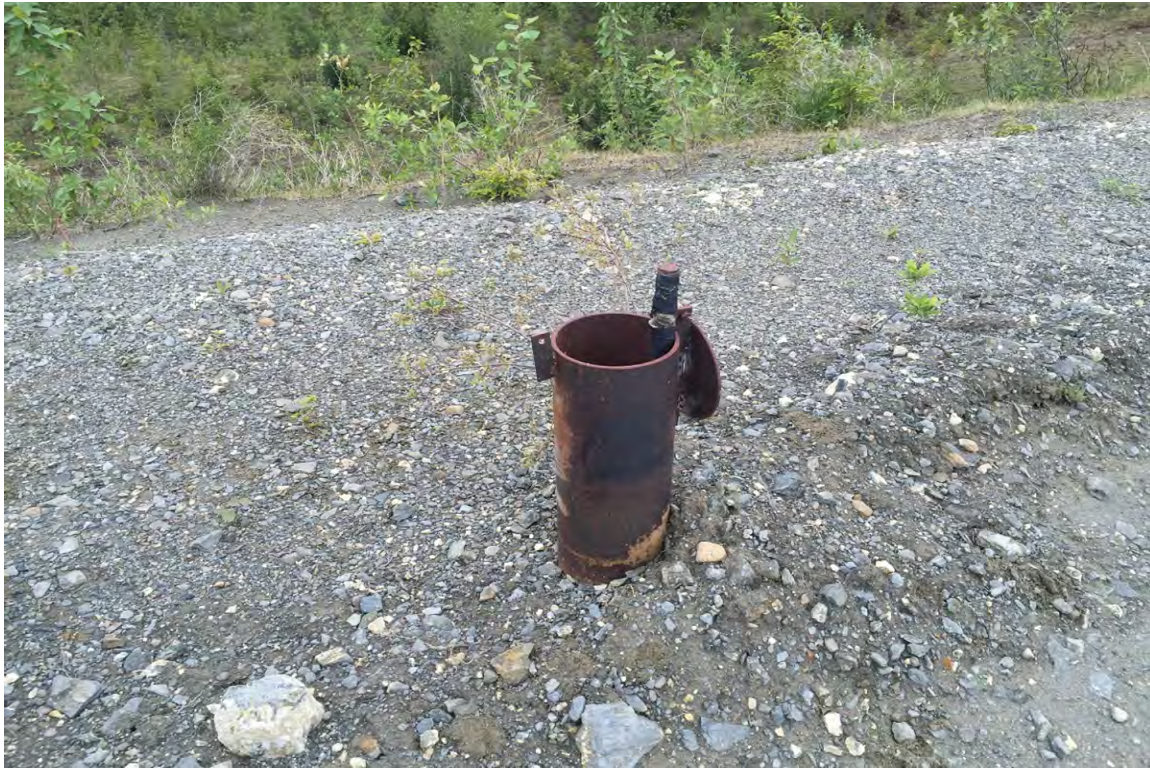
**Photo 8: North Dam Settlement gauges**

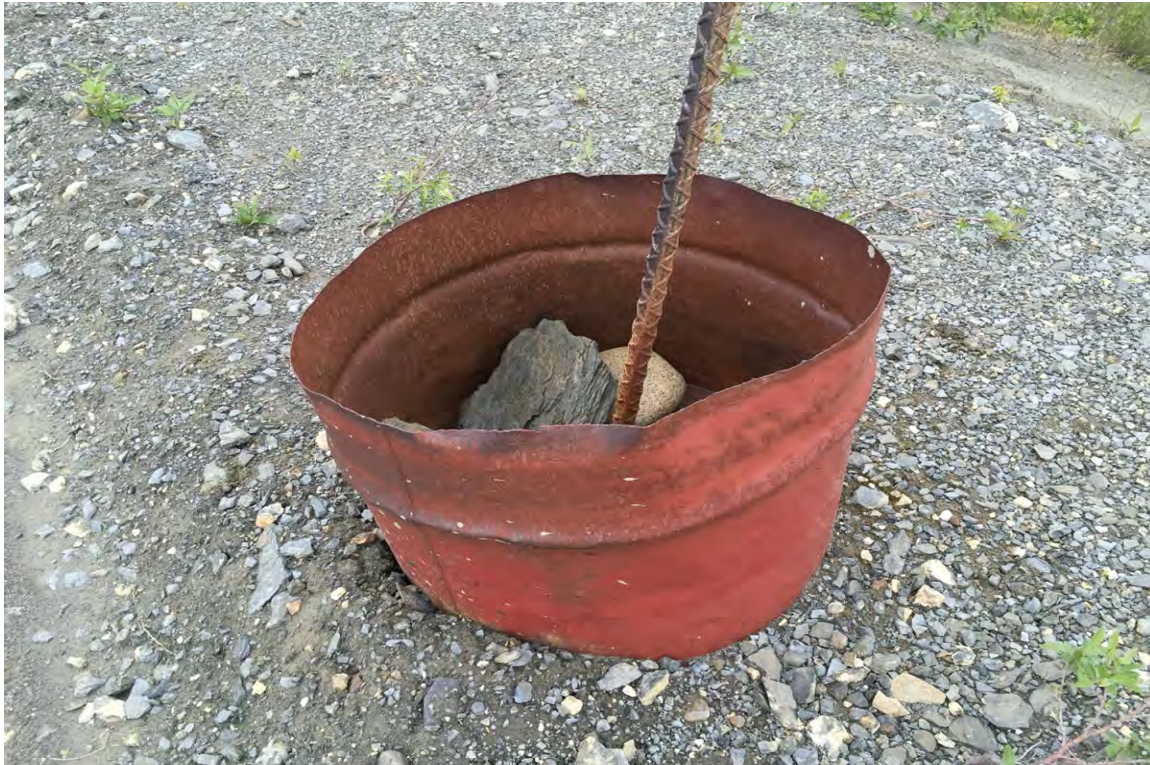
**Photo 9: Deformation gauges installed during construction of the North Dam. Removed during decommissioning.**

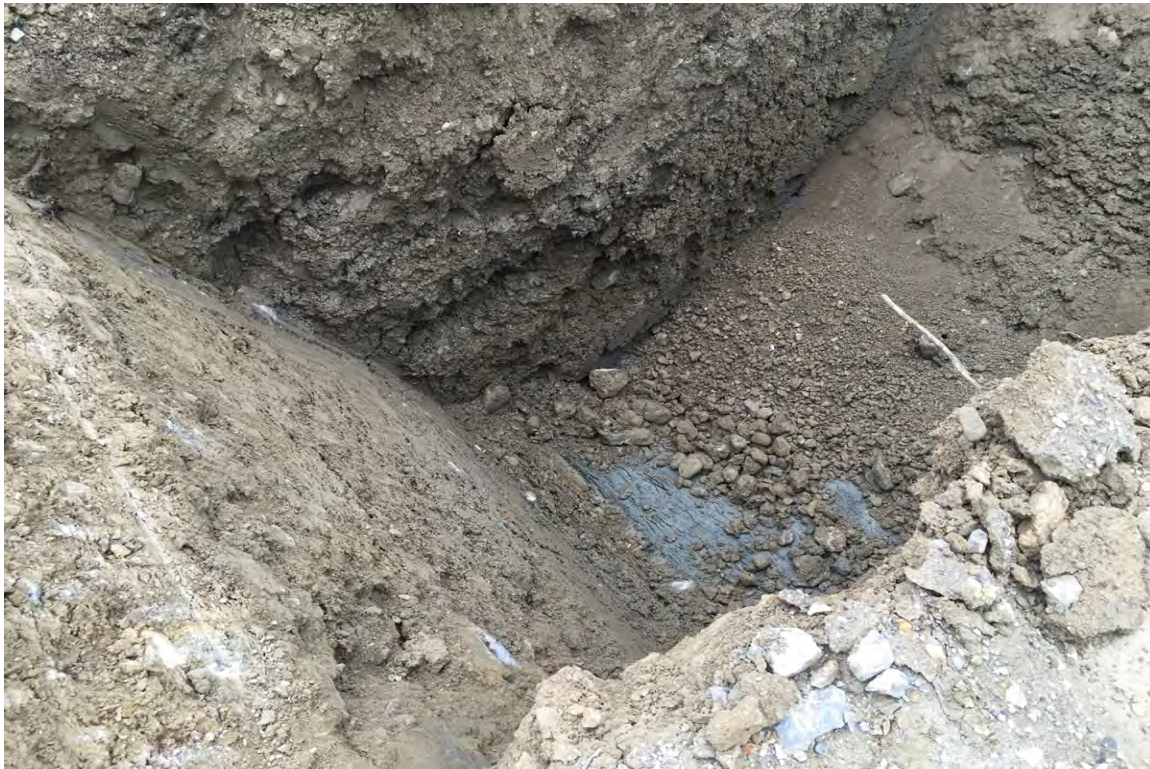
**Photo 10: Test through the till cover on the tailings. Depth of cover about 2.14m**

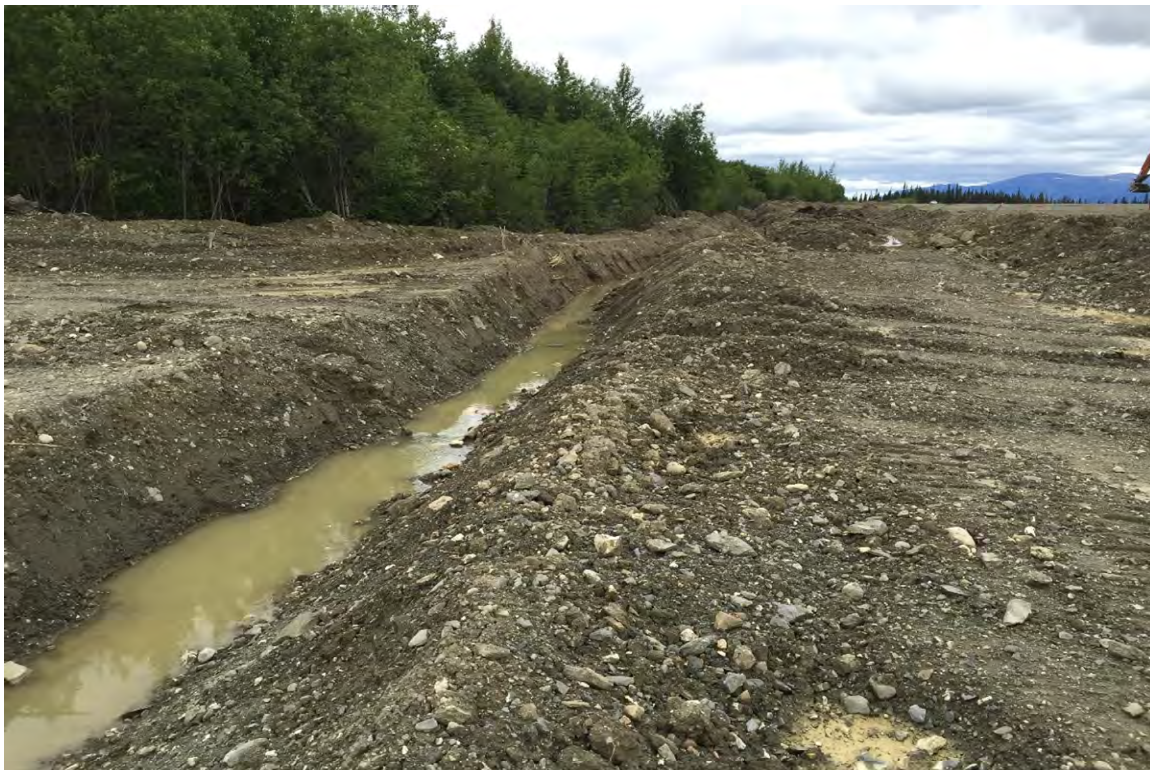
**Photo 11: Temporary drainage ditch to manage water during cover placement**

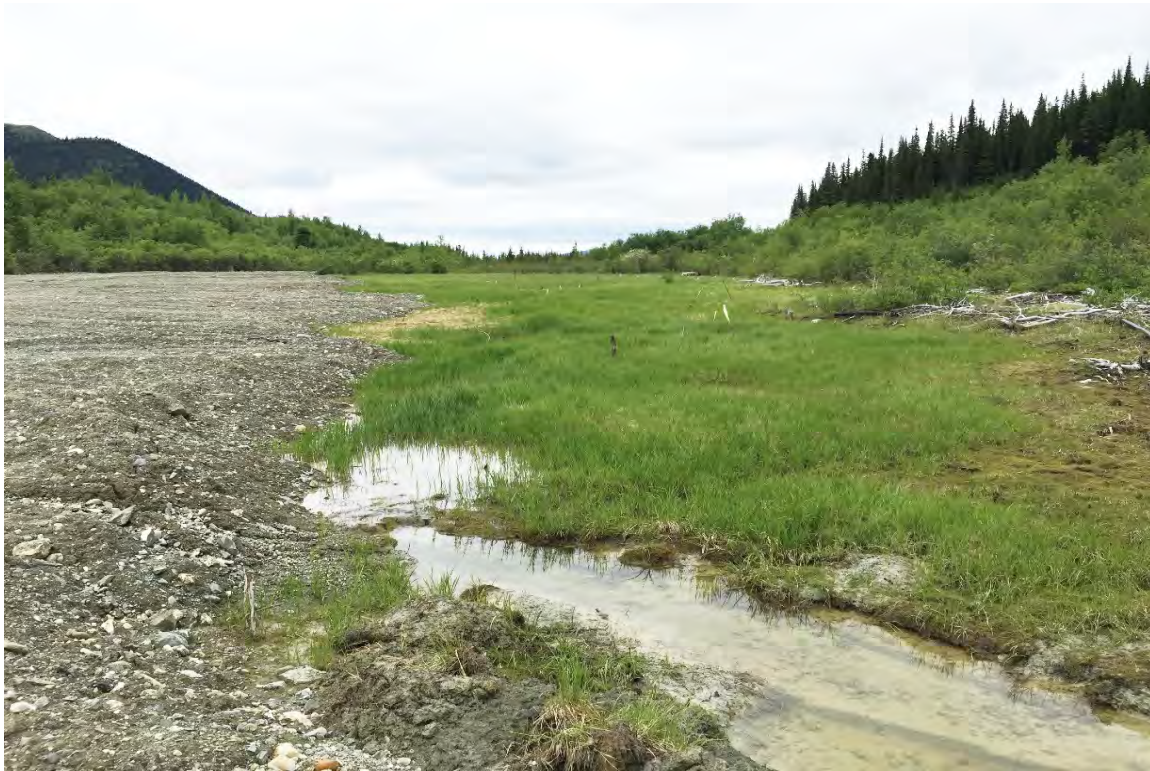
**Photo 12: Wetland area on the east side of the TMA just above the SRS**

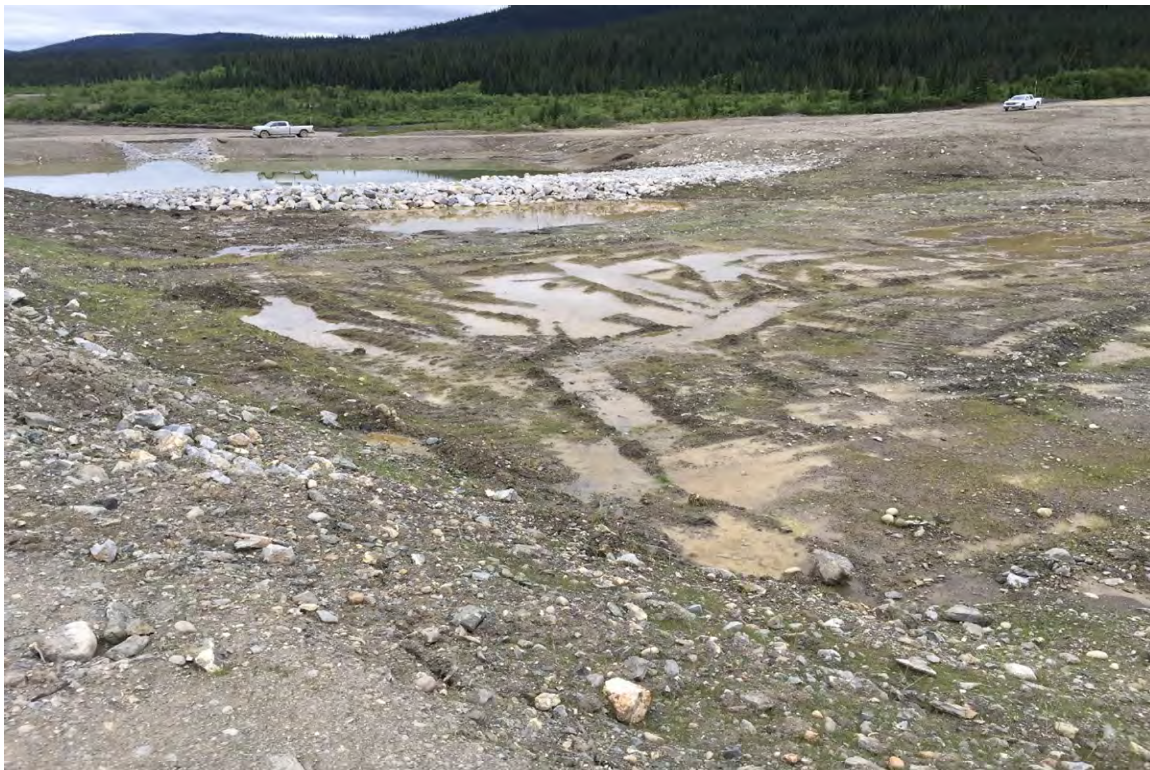
**Photo 13: View of the rockfill cofferdam above the SRS**

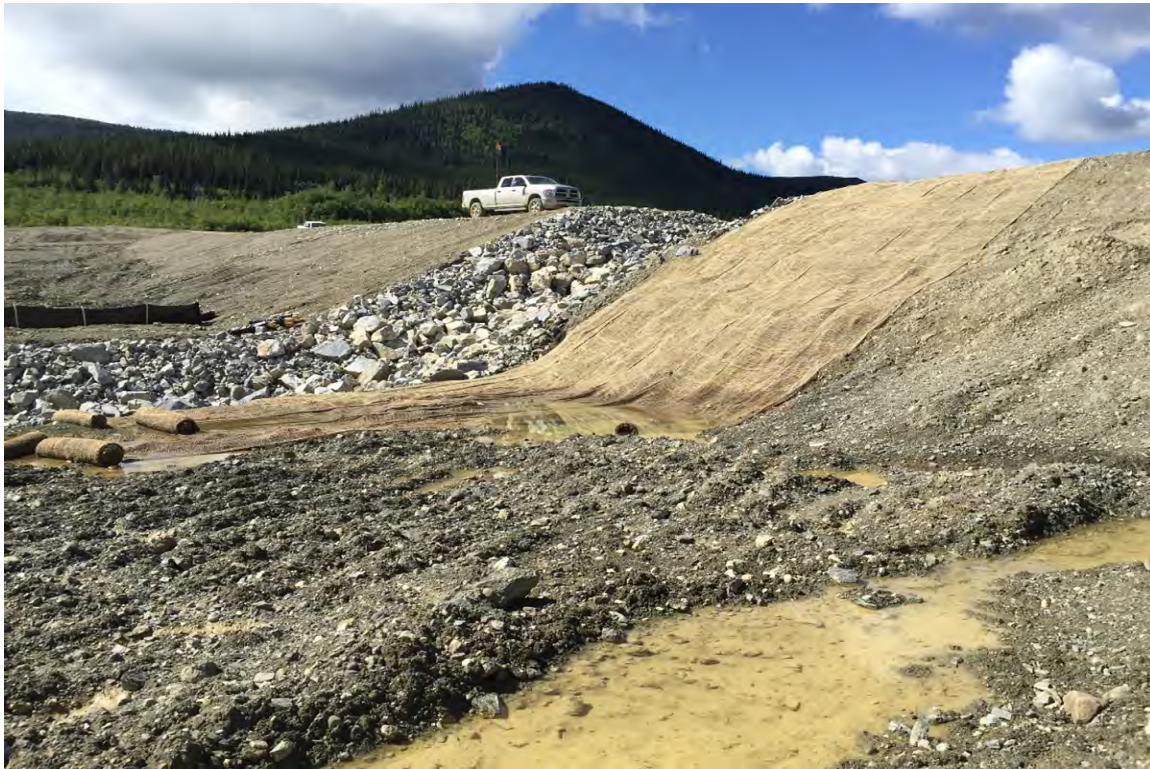
**Photo 14: View looking west of the spillway through the SRS.**

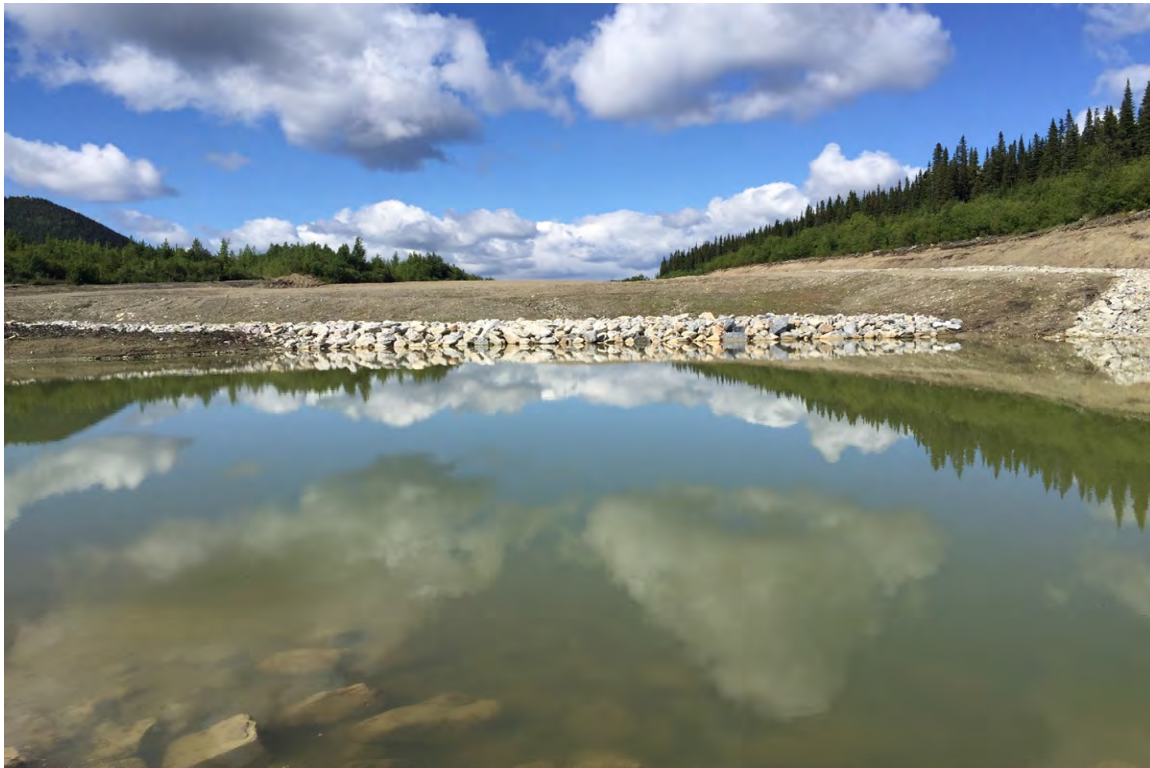
**Photo 15: Sedimentation Pond at the SRS. North diversion channel is seen to the right of the photo.**

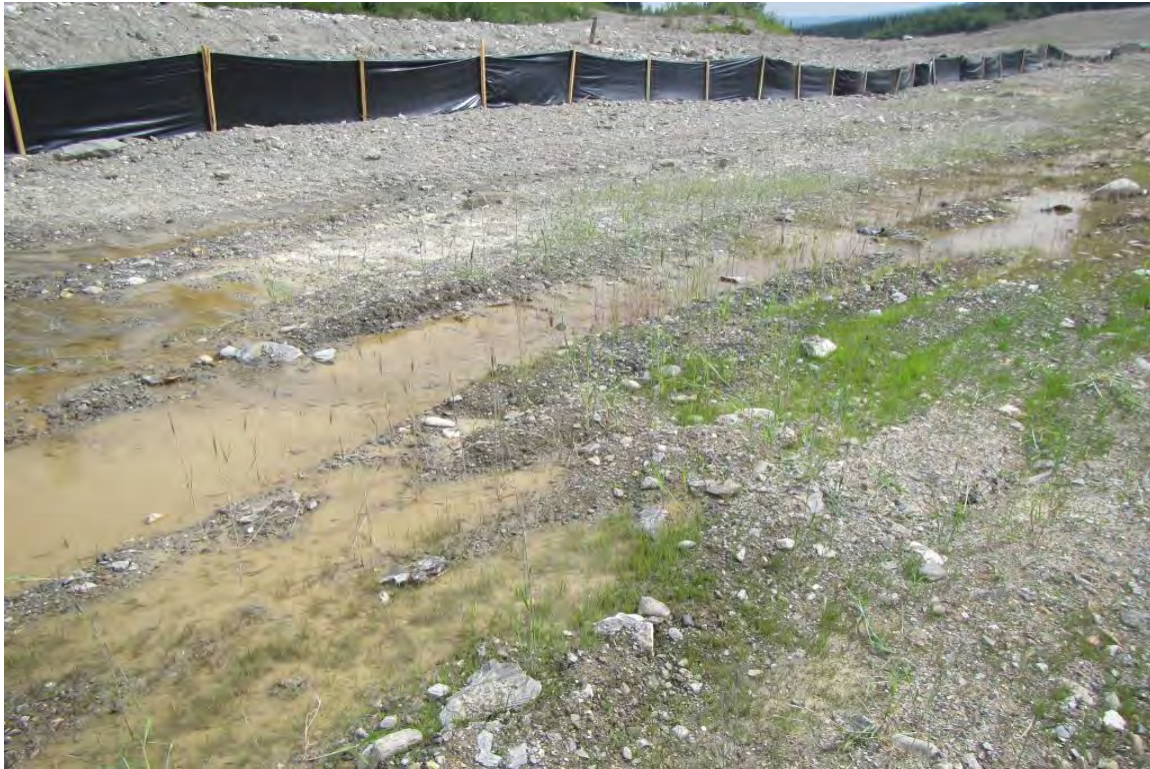
**Photo 16: Silt fences for TSS management**

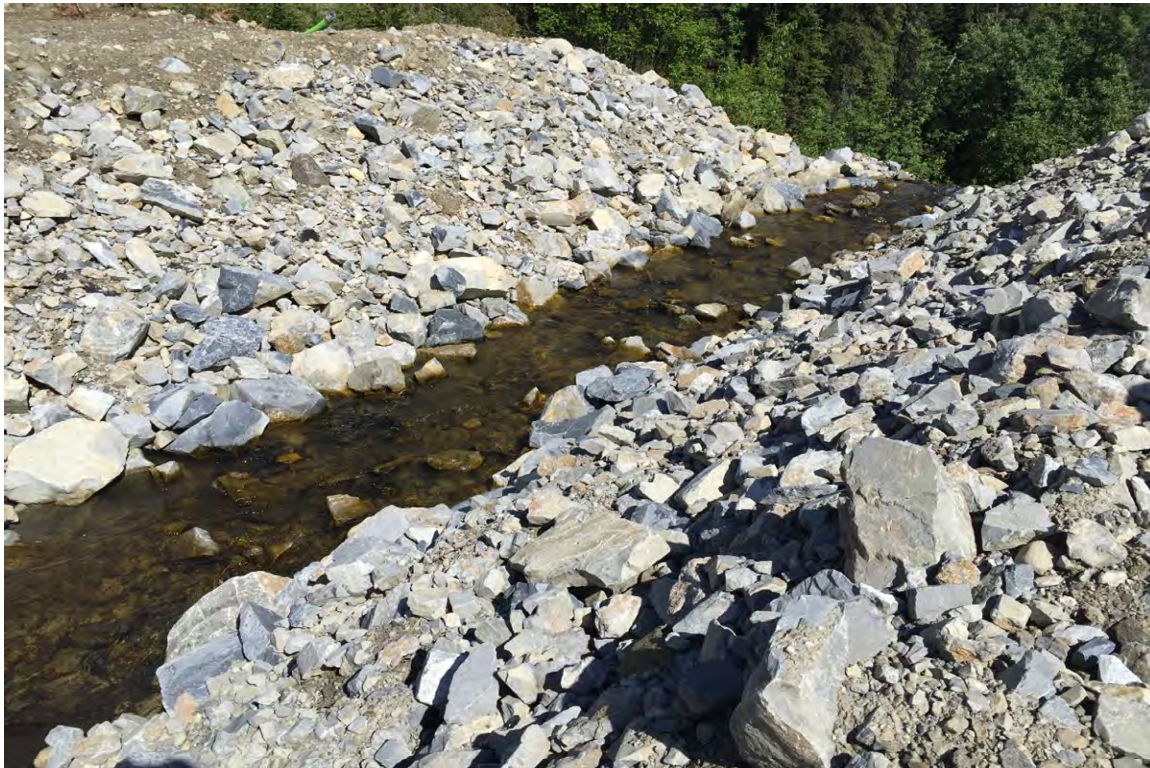
**Photo 17: Channel through the North Creek Dyke following removal of the CMP culvert**

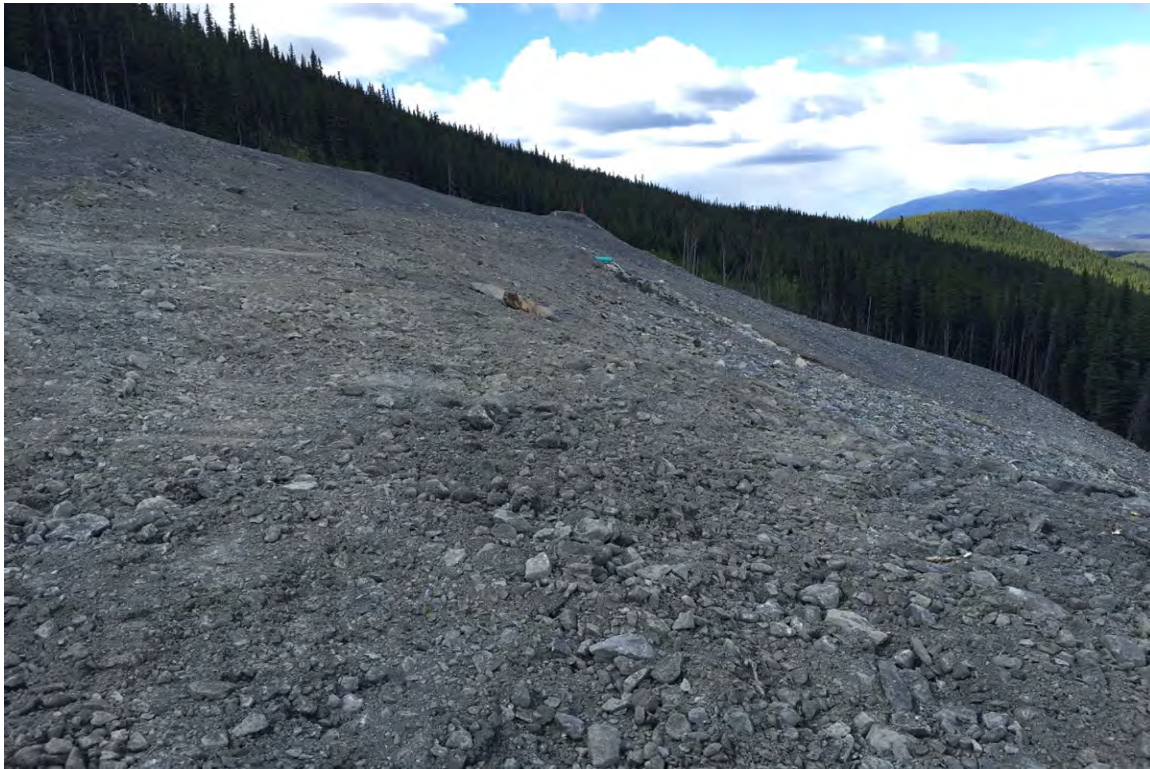
The Burnick 1200 Portal and Jewelbox Waste Rock Dumps were recontoured in 2014 to ensure greater long term stability. SRK found no evidence of instability for these dumps in 2015. The dump at the 1300 Portal was not inspected because of restricted access.

**Photo 18: Burnick Dump**

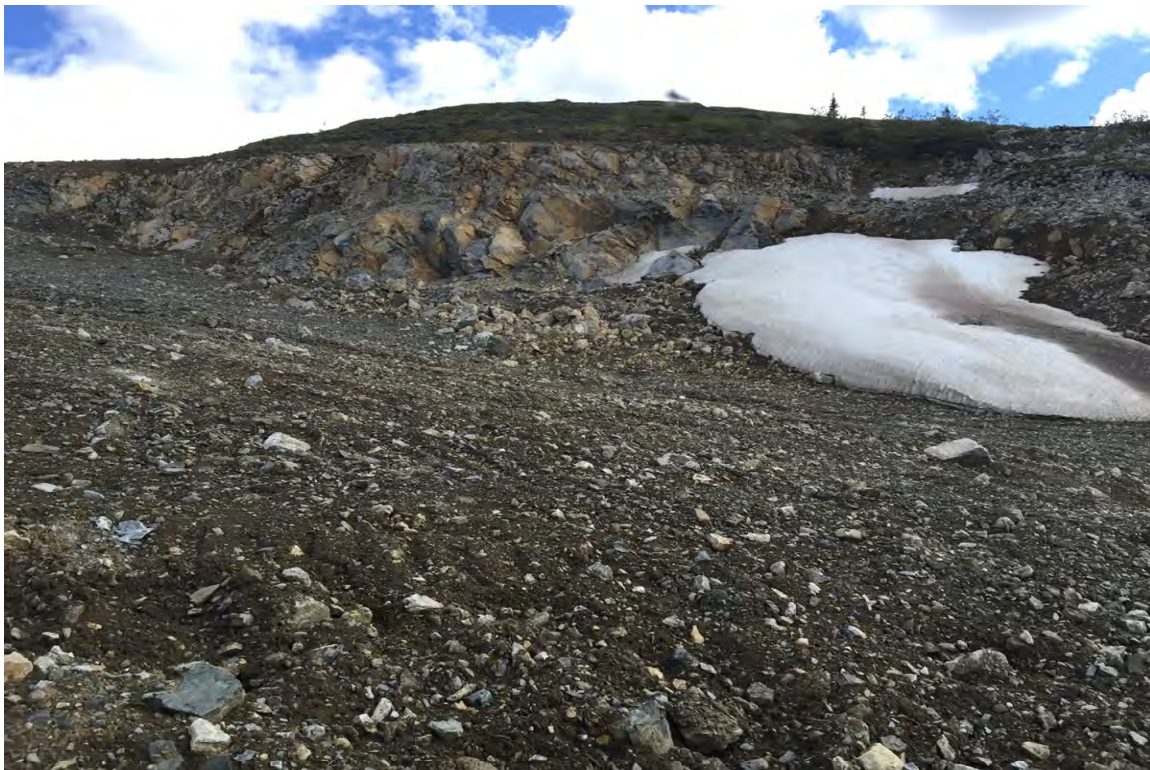
**Photo 19: Main Zone dump**
