**TECK RESOURCES LIMITED – LEGACY PROPERTIES
SÄ DENA HES MINE
DECOMMISSIONING AND RECLAMATION**

**2015 RECLAMATION ACTIVITIES AND AS-BUILT
REPORT**

**Re: Sä Dena Hes Mine, Yukon Territory
2015 Reclamation Activities and As-Built Report**

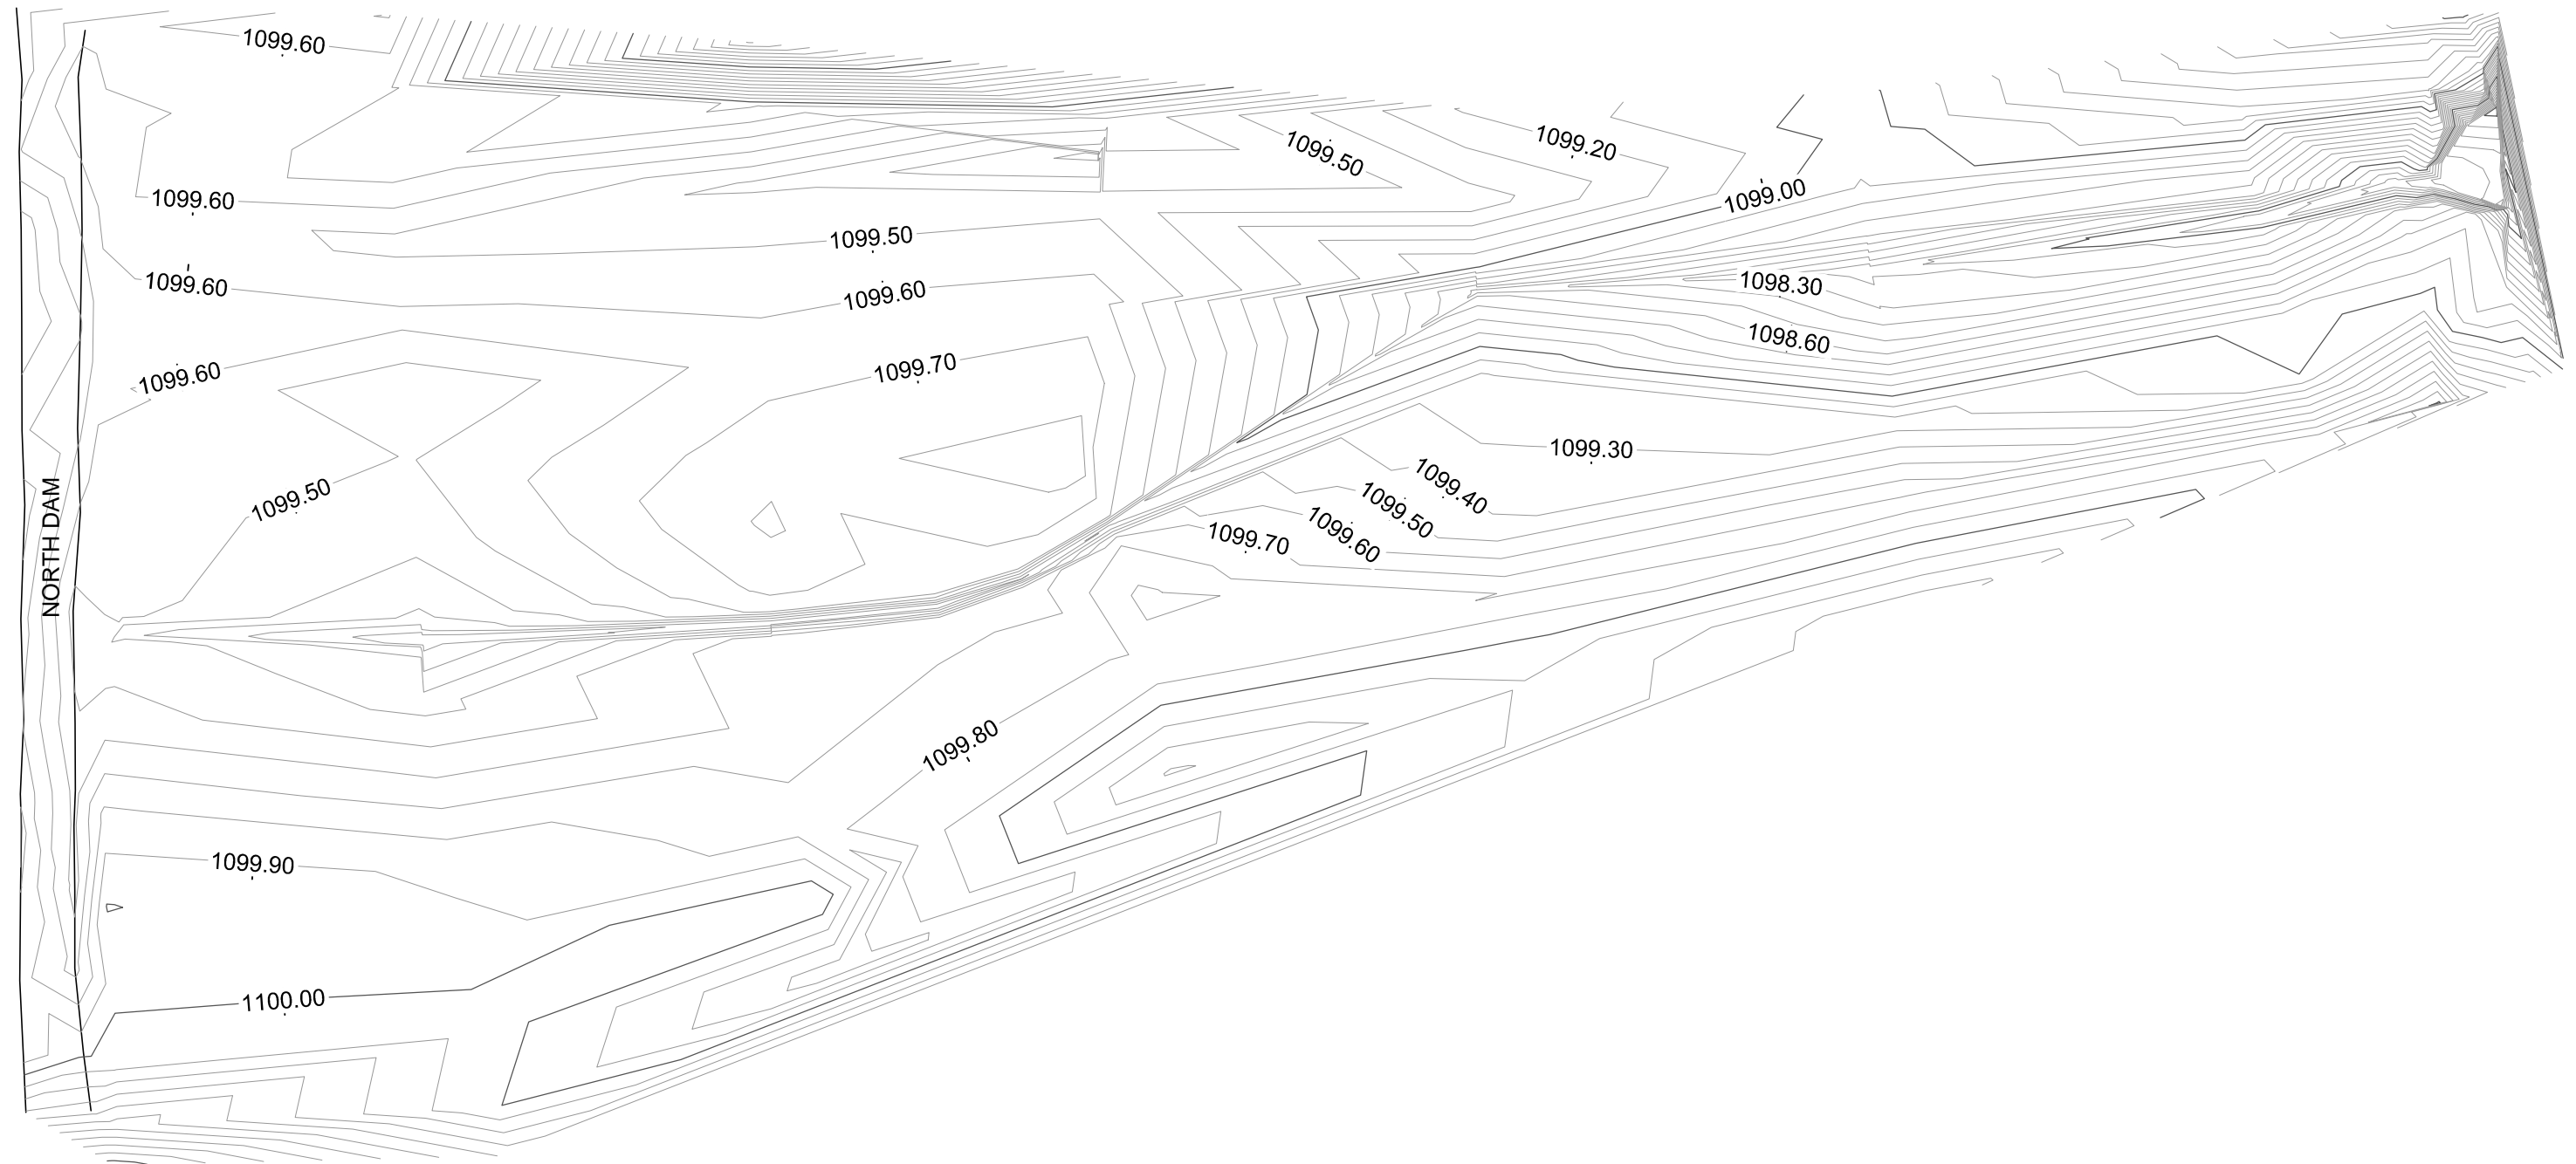
Drawing SDH03_B_C_0009.....North Tailings Pond Topography

Due to the areas of tailings migration, grading operations in these areas were halted and some areas did not fit into the uniform drainage paths, therefore a swale was left around these higher areas to convey water around them rather than through them, in order to achieve the design of southerly drainage, while avoiding potentially significant damage to the cover from further tailings migration. A minor amount of water remains within the northern portion of the swale itself which extends from the North Dam to the former cofferdam. The elevations within the swale were not lowered any further due to concerns of encountering tailings. During major rain events in 2015, runoff water drained to the south, although in some areas, due to limited grade, some pooling was observed to occur up-gradient of the swale. Typically the pooled water would drain off the surface within 24 hours of the rainfall event. The final topography of the North Tailings Pond cover is shown in Drawing SDH03_B_C_0009 in Appendix B. Photo 44 in Appendix C shows a helicopter view of the as-built conditions. Upon reviewing the as-built conditions / topography on Drawing SDH03_B_C_0009 there is some concern with regards to drainage that should be reviewed. A dam safety review is in progress.

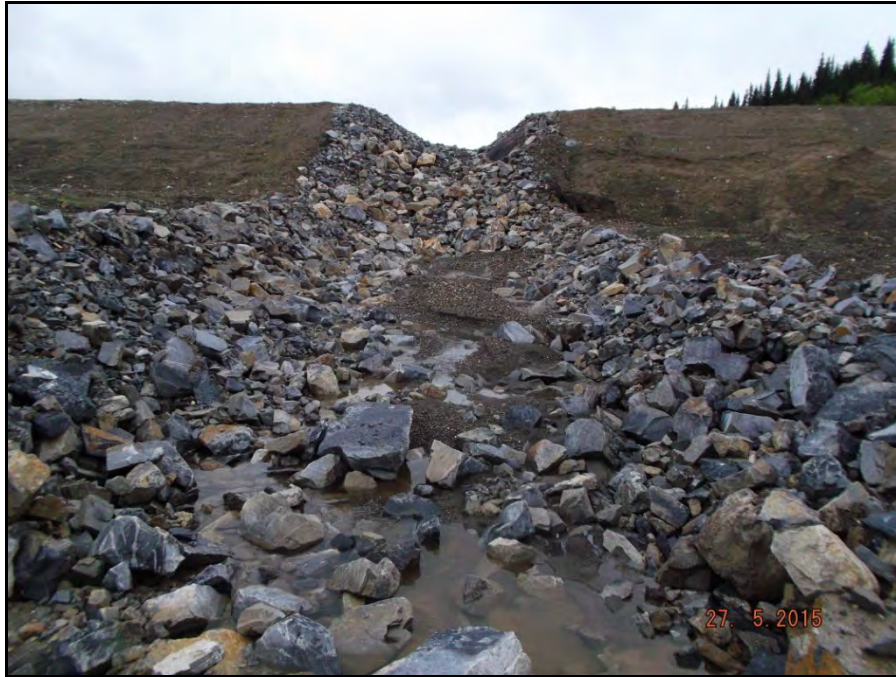
During a late May 2015 inspection of the sediment retaining structure (SRS) and associated spillway, subsidence was observed within the spillway and migration of some riprap downstream was causing sub-lying geotextile to be visible. Additionally, erosion of the downstream toe of the SRS, east of the spillway, was observed. This was causing eroded sediment to migrate into the South Drainage Channel. A site visit with SRK (Project Designer) was held and it was agreed that the migration of riprap was likely due to an insufficient amount of rock within the spillway and the size of some of the rock (within the spillway) not meeting the required gradation specification. The subsidence within the spillway was not deemed to be a concern at this time. The erosion of the SRS downstream toe was likely caused by the spring melt washing some of the material toward the South Drainage Channel, combined with seepage flow from the former South Dam east abutment which flowed west along the toe of the SRS and into the South Drainage Channel.

Photograph 1: Photo taken during spring inspection showing erosion on east downstream toe of SRS (right of photo) with sediment in channel and sloughing within spillway causing rock migration (May 27).

To address both issues, large rock from the rock cofferdam (installed in the South Pond in 2014) were relocated to the SRS and placed in the spillway and along the SRS east downstream toe to stabilize both features. Nonwoven geotextile was placed beneath the rock along the SRS downstream toe. Photo 1 in Appendix C shows the early inspection conditions and Photos 3 and 4 in Appendix C show conditions after stabilization of the SRS and spillway with further rock.

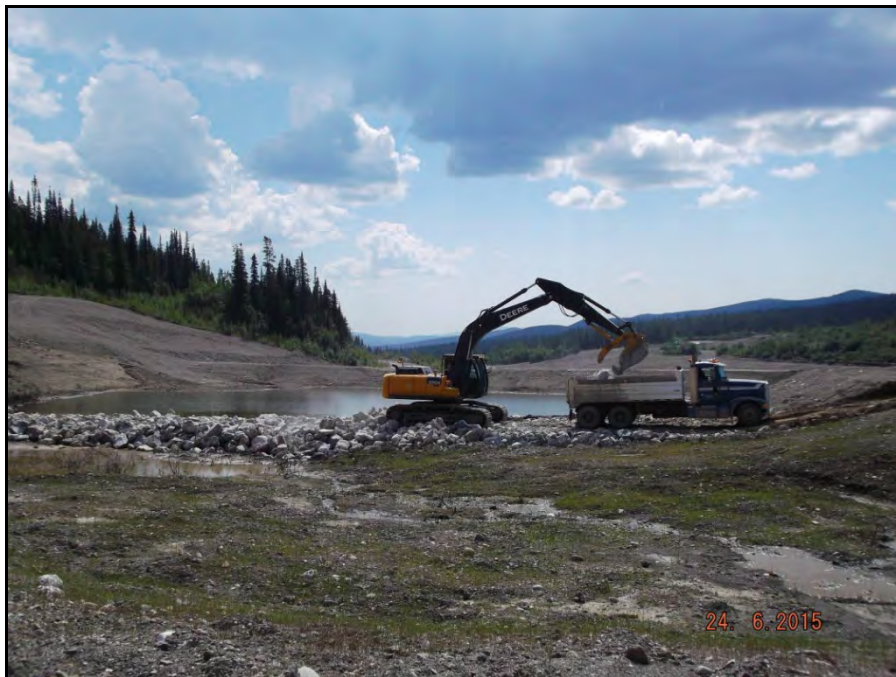
Photograph 2: Excavator removing top layer of rock from rock cofferdam in South Pond and placing in truck to haul to spillway and SRS to repair spring damage (June 24).

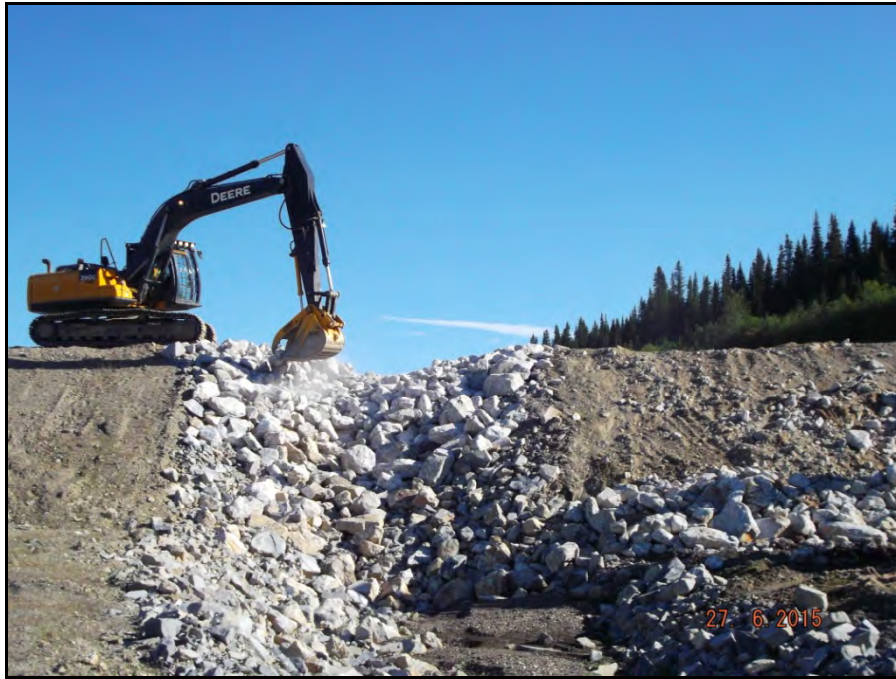
Photograph 3: Excavator placing additional rock in spillway and along east (right) downstream toe of SRS (June 27).

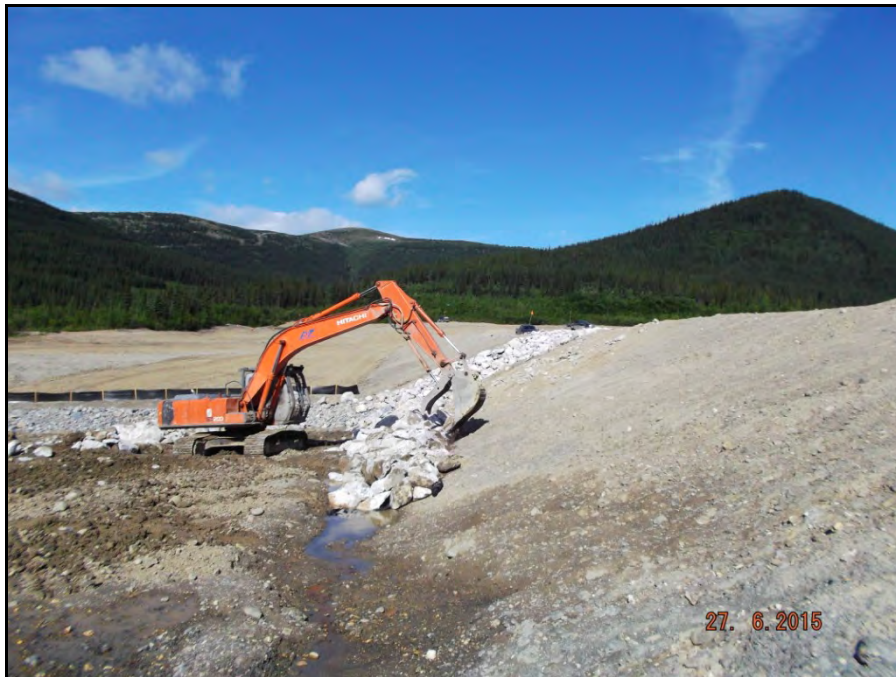
Photograph 4: Excavator placing rock from rock cofferdam along east downstream toe of SRS. Underlain geotextile was placed below rock material. Seepage seen running along toe was diverted away from toe following placement of rock fill (June 27).

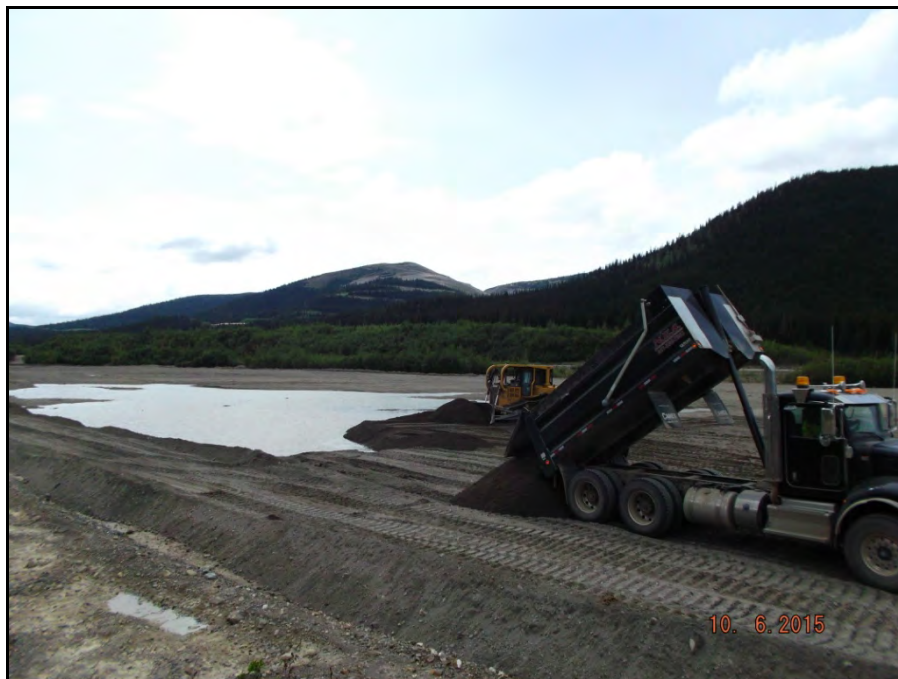
Following the spring melt in 2015, ponded water was observed on the surface of the capped North Tailings Pond. The majority of the water was ponded in the northeast corner of the surface, between the North Dam and one of the problem areas noted above, and located approximately 200 m south of the North Dam. Other minor ponding was also observed across the remainder of the northern extent of the surface. It was observed that ice was blocking the drainage channel established in 2014. Once the ice melted, approximately half the volume of ponded water drained through the channel and flowed south toward the former cofferdam along

Photograph 6: Gravel from pit north of the landfill being dumped and spread at northeast corner of North Pond to raise the grade of the cover, push ponded water to the south, and promote drainage from the surface (June 10).

To achieve the design of the North Tailings Pond cover of positive drainage away from the North Dam and to the south, some further fill placement and grading of the cover was required in 2015. During cover construction in 2014, heavy equipment had caused some liquefied tailings to migrate to the surface due to an increase in pore pressures beneath the surface. To ensure all tailings were covered, more material was added to cover these tailings, which initially appeared effective. However, tailings continued to migrate to the surface in these areas and outside the perimeter of the areas. To avoid causing any further damage, the Contractor was required to leave the areas alone and wait for the tailings to finish migrating to the surface, drain and dry out. Once these tailings “volcanos” had dried out, they were scraped from the surface using a light excavator and the tailings were hauled to the South Pond for capping. The intent of the design of the North Tailings Pond cover was taken to mean uniform drainage to the south. However, due to the soft conditions of these areas, they were left alone to avoid having more tailings migrate and cause further pore pressures to be released from beneath the cover. This impeded some drainage to the south in 2014 in the northeast corner of the cover. Therefore, to achieve the design, a drainage channel was established from the northeast corner to the west side of the North Tailings Pond to promote drainage into a vegetated area to the west, with water then draining to the south.

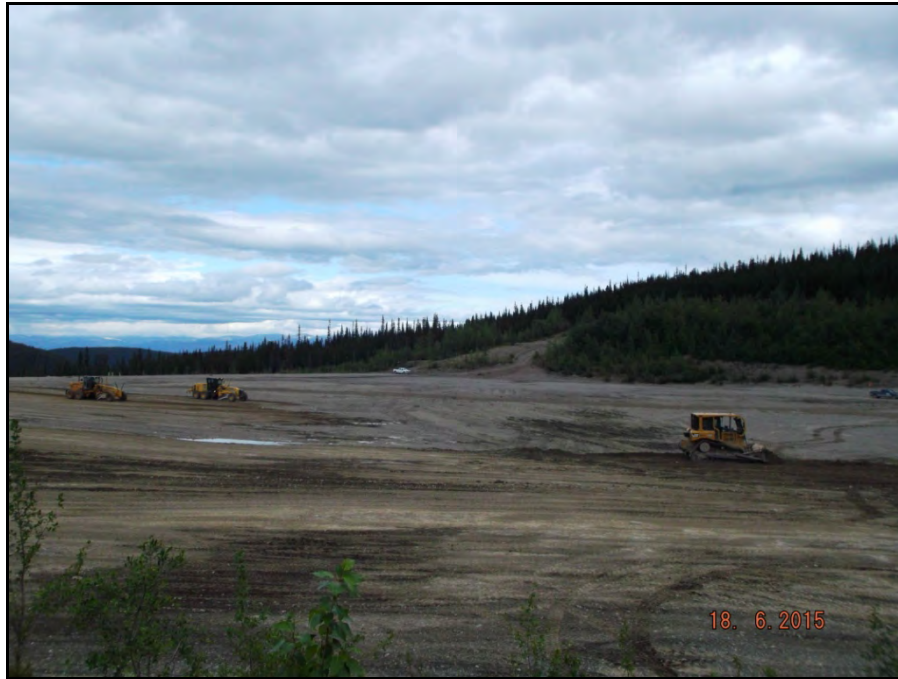
Photograph 7: Bulldozers and graders grading the surface of the North Pond after the grade had been raised and all ponded water had been pushed to the south (June 18).

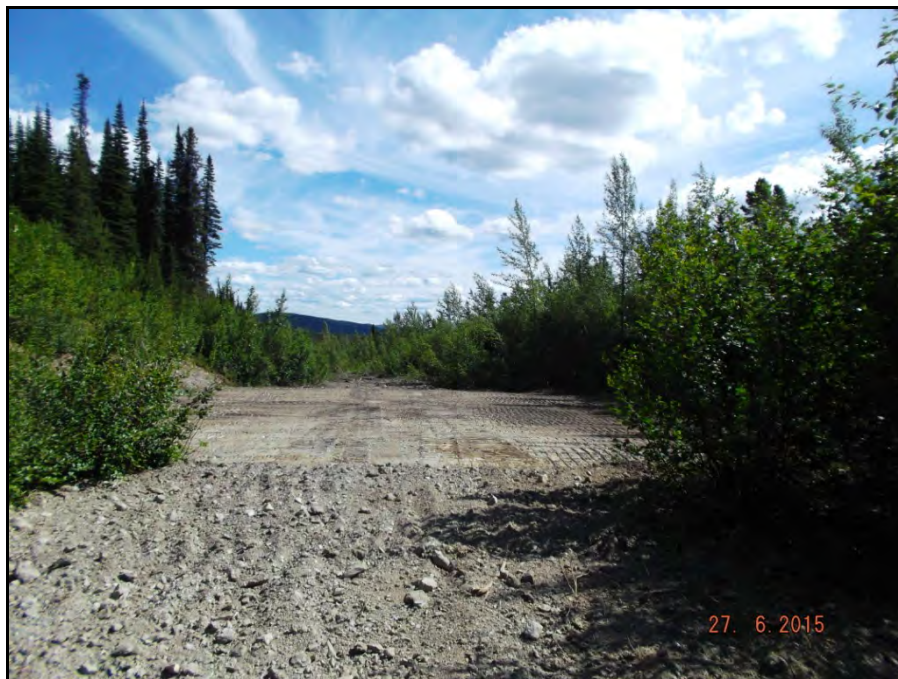
Photograph 10: Helipad for post-closure monitoring constructed near MH28/MH28-A during road decommissioning (road shown decommissioned at both ends) (June 27).

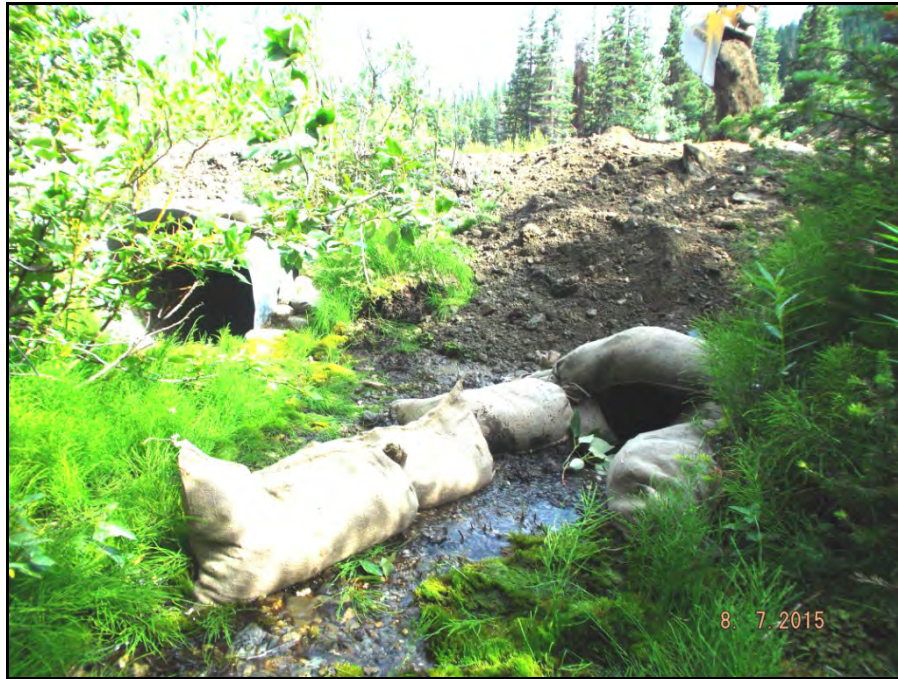
Photograph 15: Burnick Creek diverted into HDPE pipe using sand bags (right) to allow removal of culvert (left) in the dry (July 8).

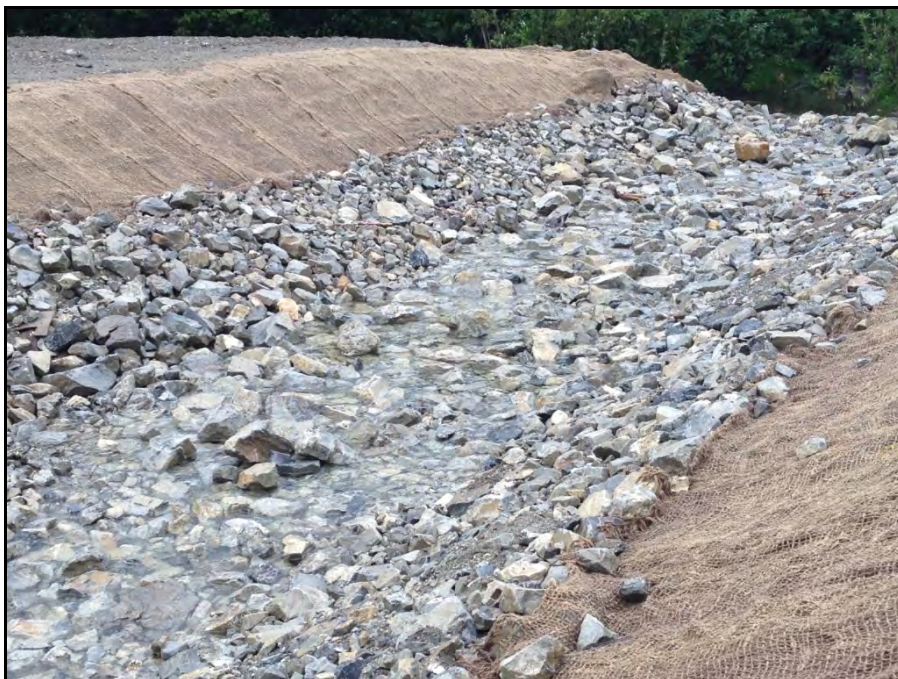
Photograph 20: Photo taken at Camp Creek crossing along short access road (MH-04 sample point) following road decommissioning and culvert removal. Erosion protection installed including rolled erosion control blanket on upper portion of slopes (July 22).

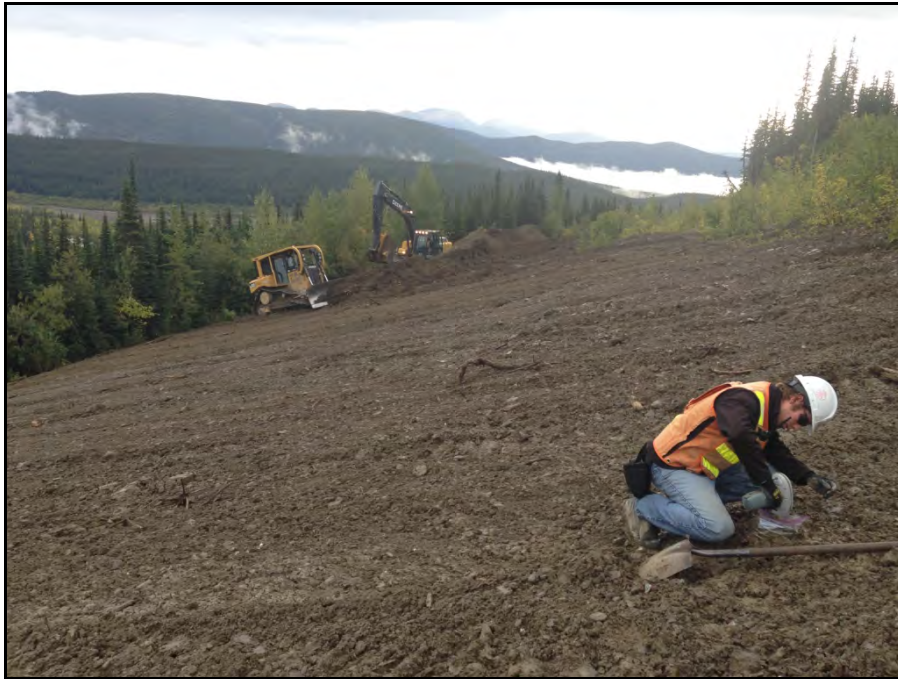
However, due to metals concentrations of the existing road surface exceeding site-specific standards (specifically for lead and zinc) this decommissioning effort was conducted with a concurrent X-Ray Fluorescence (XRF) soil sampling program to ensure that the reclaimed surface at the completion of road decommissioning achieved acceptable site-specific soil conditions. The sampling program was carried out by Amec Foster Wheeler. Over the course of the decommissioning effort, approximately 450 XRF samples were collected. Teck identified the acceptable metals concentrations for lead and zinc to be 400 ppm and 665 ppm, respectively. Where material exceeded these concentrations during decommissioning, more material was excavated from the downslope side of the road and brought up the slope and spread across the surface. In some cases, multiple lifts were required. Once testing indicated that the material was acceptable, the decommissioned road was shaped and sloped and a final set of readings were taken across the final surface as a confirmatory check. A total of 123 confirmatory readings were taken along the finished surface. Locations of these confirmatory samples and their associated readings are presented in Figure SDH01_FIG_05 (Appendix A). The raw data from the XRF analyzer for the overall switchback decommissioning sampling program has been provided to Teck.

Photograph 35: Amec Foster Wheeler carrying out confirmatory XRF sampling on final surface of decommissioned Jewelbox switchback (August 29).
