## PRE-DEMOLITION HAZARDOUS BUILDING MATERIALS ASSESSMENT

# Mine Infrastructure and Camp Buildings, Sä Dena Hes Mine, Yukon Territory

**Report Number:** 1210210006-005-R-Rev0-1000

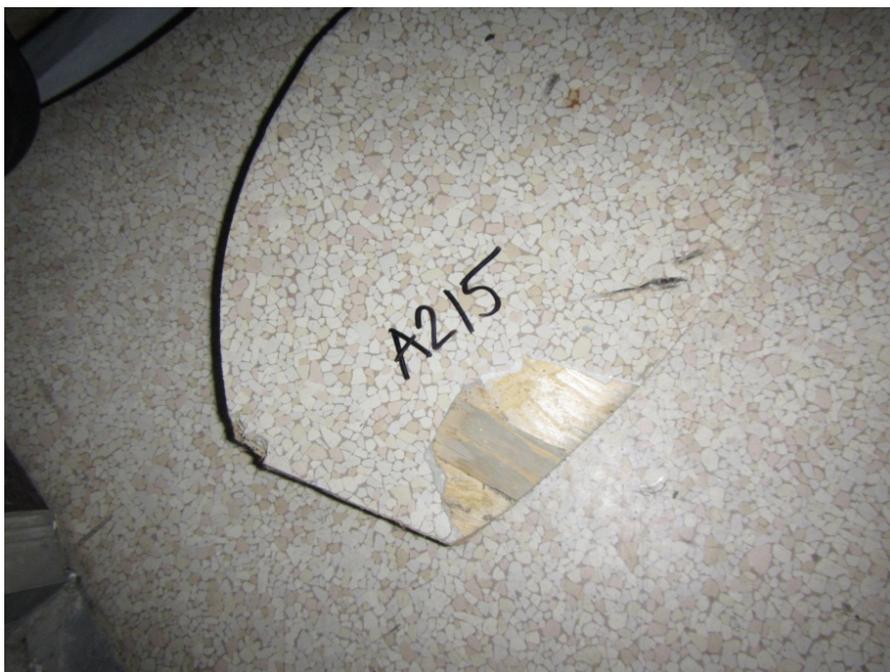
*Photograph 1: Asbestos-containing brown mosaic sheet flooring with paper backing found in Bunk Trailers 1, 3, 4, and 5, the Kitchen Trailer (Samples A32, A210, A215).*

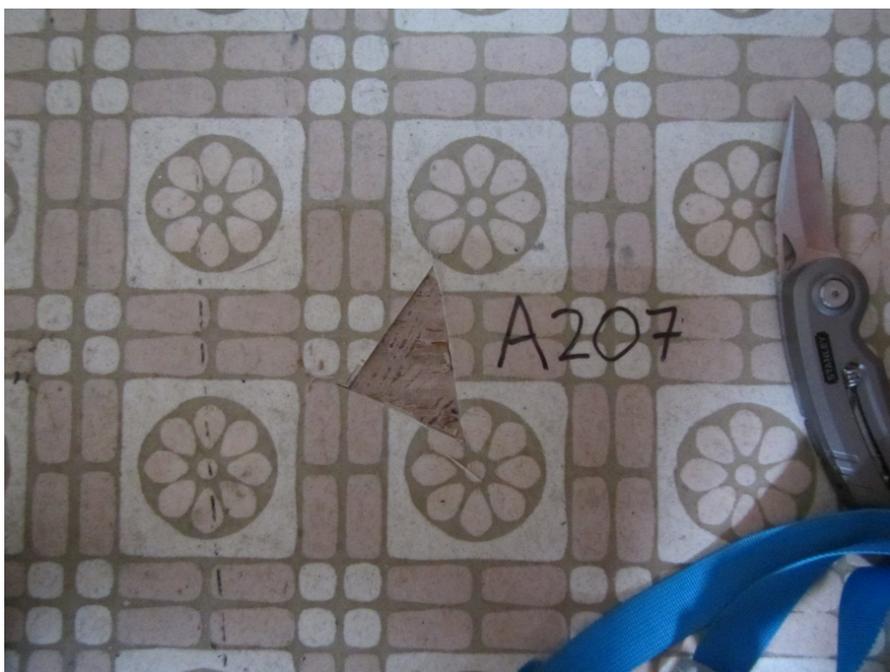
*Photograph 2: Asbestos-containing flower and square pattern sheet flooring with paper backing found in Bunk Trailers 1, 2, 3, 4, and 5 (Samples A207 and A230).*

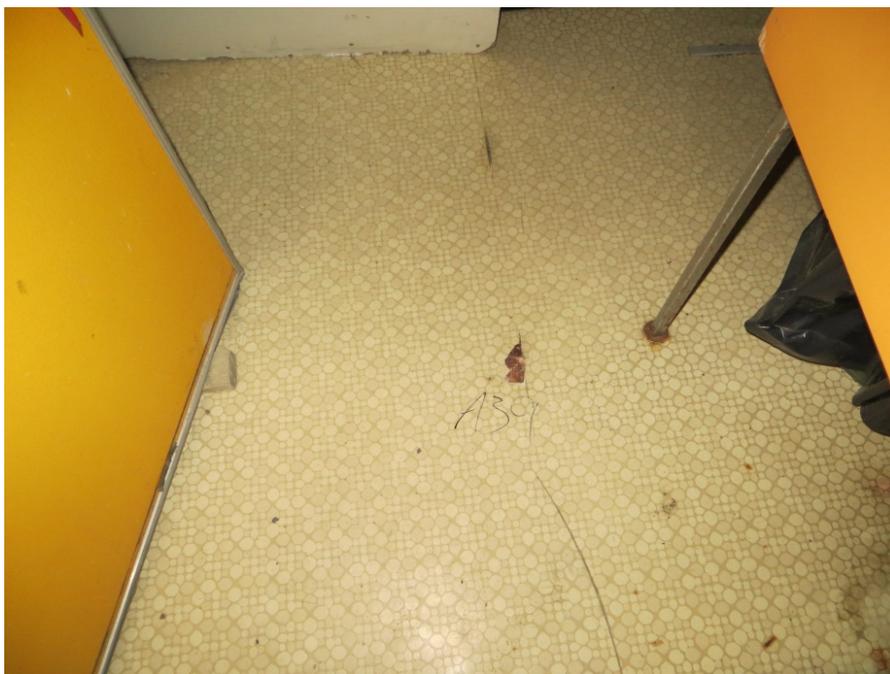
*Photograph 3: Asbestos-containing beige speckled sheet flooring with paper backing found in Bunk Trailer 2 and the Kitchen Trailer (Sample A39).*

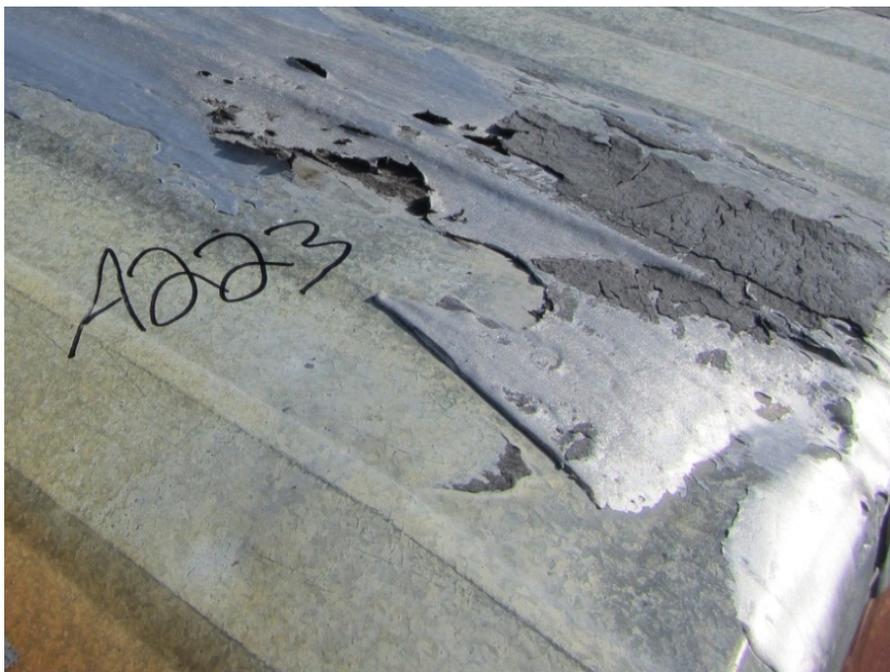
*Photograph 4: Asbestos-containing dark charcoal grey mastic patch on roof of Bunk Trailer 4 (Sample A223).*

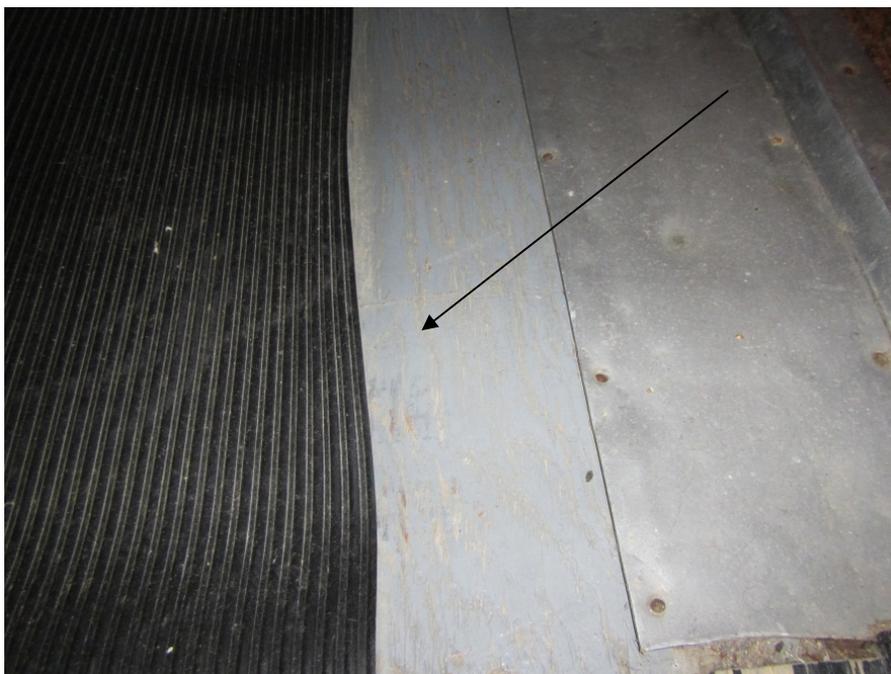
All of the samples collected within the Camp Buildings contain measurable quantities of lead. However, only one sample contains lead at a concentration required to be considered LCP as defined in the Hazardous Products Act (>90 mg/kg). The grey paint present on the Corridor Floor in Bunk Trailer 1 contains 1210 mg/kg of lead, or 0.121% by weight. Sample results are applicable to all paints of similar colour in all Camp buildings.

*Photograph 5: Lead-containing grey paint on corridor floor in Bunk Trailer 1 (Sample L205).*

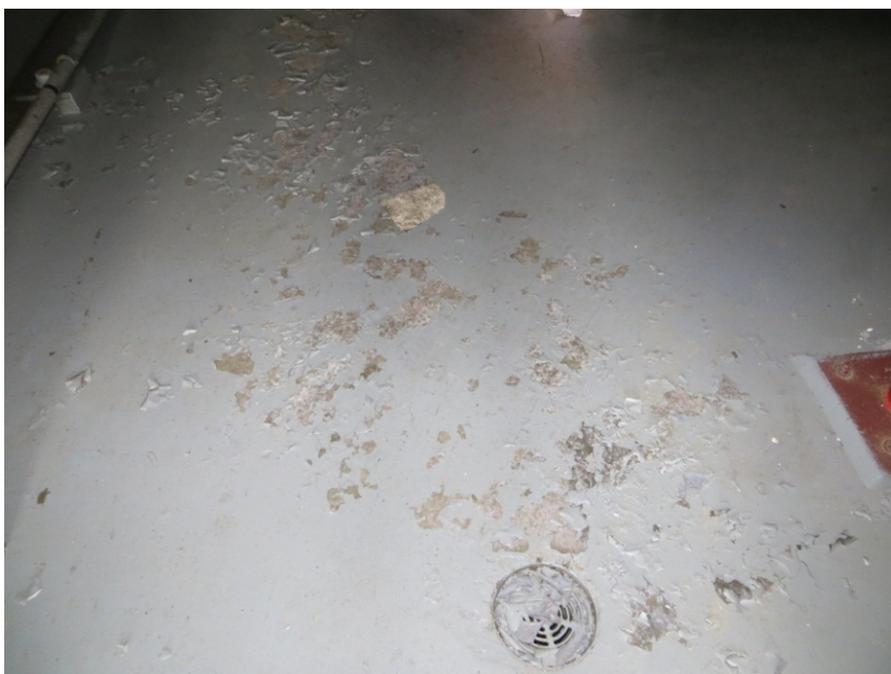
All of the samples collected within the Powerhouse contain measurable quantities of lead. However, only two samples contain lead at a concentration required to be considered LCP as defined in the Hazardous Products Act (>90 mg/kg). The highest concentration of lead was found in the white paint on the Glycol Pipelines present in the building. Sample L6 contains 1,380 mg/kg lead, or 0.138% by weight. The lowest concentration of lead (in LCP) was found in the grey floor paint (Sample L5) which contains 1,270 mg/kg lead, or 0.127% by weight. Sample results are applicable to all paints of similar colour in the Powerhouse.

*Photograph 6: Grey loose and flaking LCP (Sample L5) from the floor in the Powerhouse.*

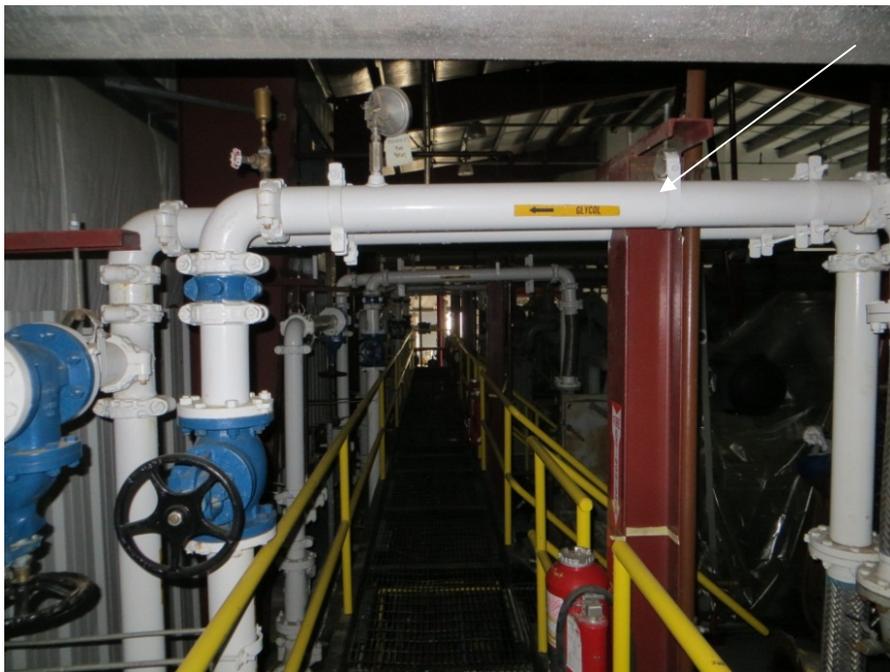
Photograph 7: White loose and flaking LCP (Sample L6) from the Glycol pipelines in the Powerhouse.

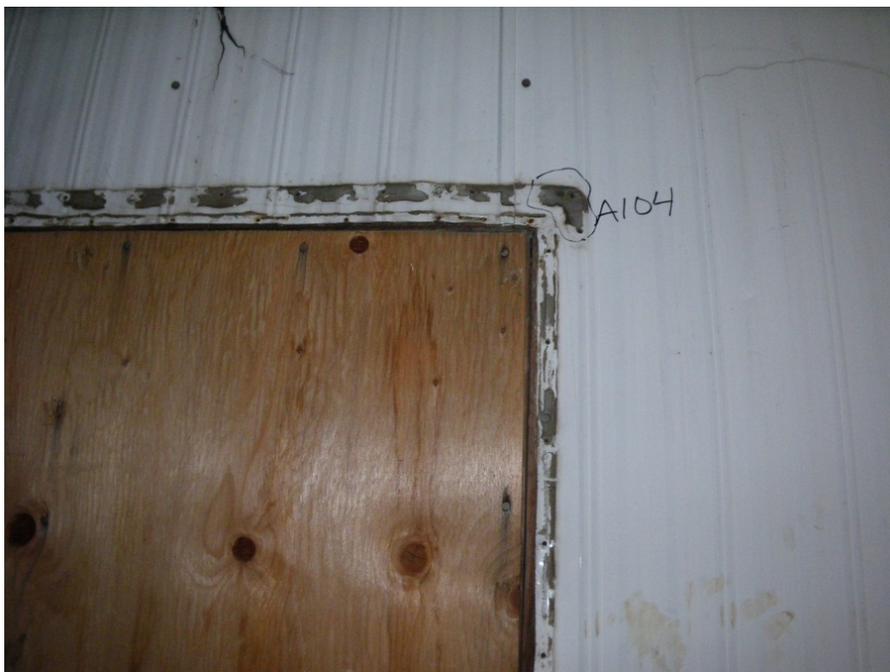
- Grey window putty present in the Small Storage, Office 3, and Hallway 1 (Sample A104); and
- Black fire stop around electrical conduit in Lab 2 (Sample A114). This material may be present at other locations in the building not observed at the time of this assessment. Consequently, any similar material uncovered during demolition should be considered to be asbestos-containing.

Photograph 8: Asbestos-containing grey window putty (Sample A104) in the Warehouse, Dry, and Lab.

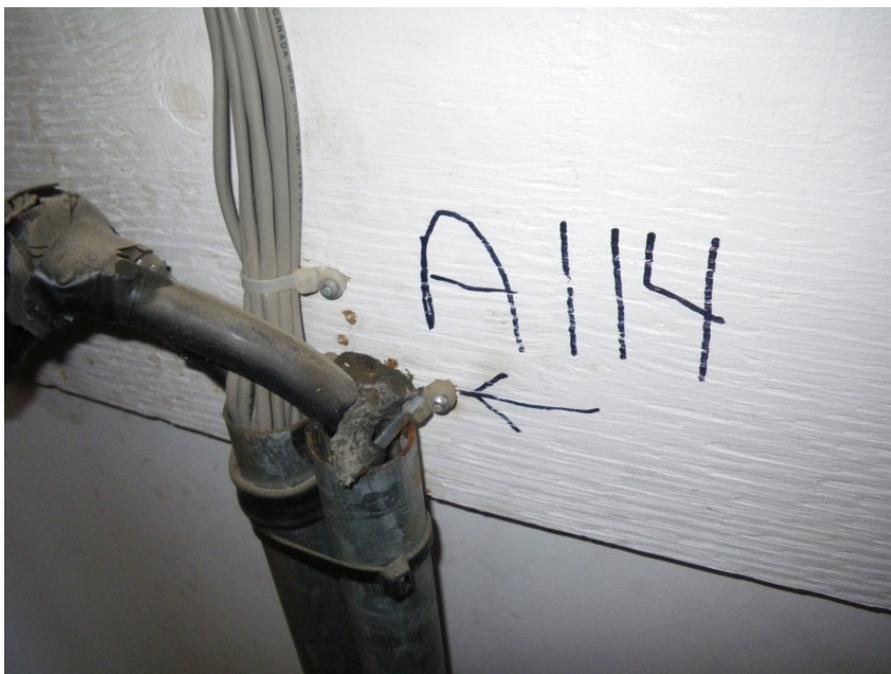
Photograph 9: Asbestos-containing black fire stop (Sample A114) around electrical conduit in Lab 2 of the Warehouse, Dry, and lab.

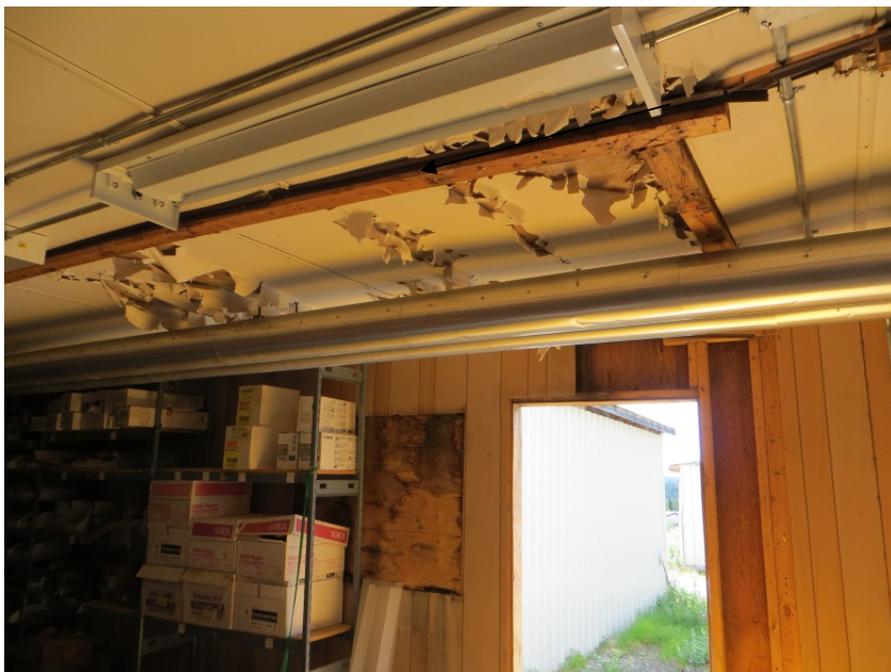
Photograph 10: White loose and flaking LCP (Sample L1) in the Small Storage of the Warehouse, Dry, and Lab.

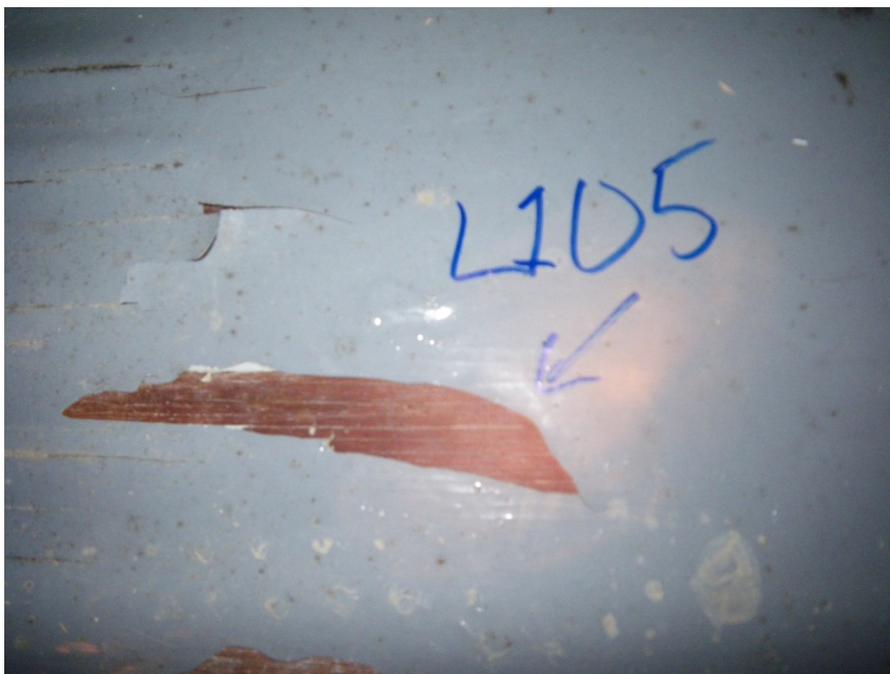
Photograph 11: Grey loose and flaking LCP (Sample L105) from the floor in Warehouse, Dry, and Lab.

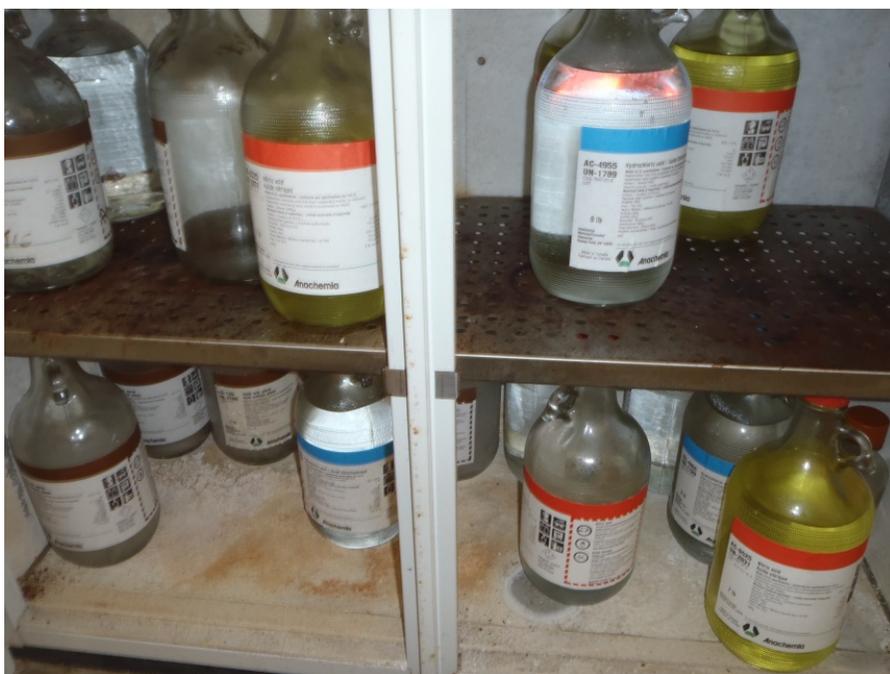
Photograph 12: Stored chemicals in Warehouse, Dry, and Lab, Laboratory.

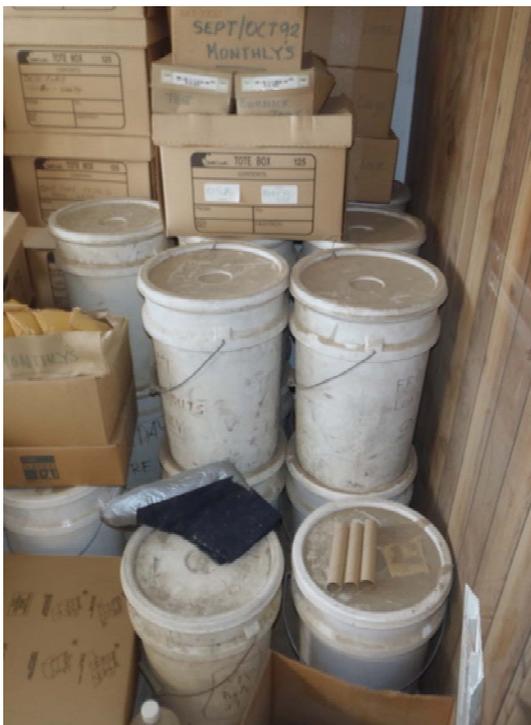
Photograph 13: Stored chemicals in the Laboratory of the Warehouse, Dry, and Lab.

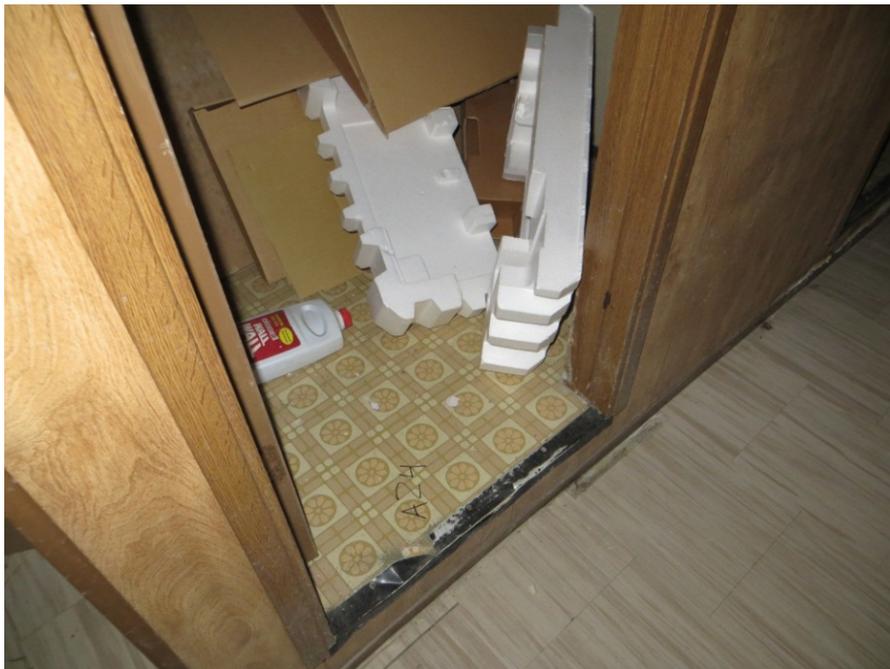
- Flower pattern sheet flooring with asbestos-containing paper backing present in Rooms 13, 14, 15, 20, and 21 (Sample A24);
- Cement board lining furnace closets present in Hallway 4, Hallway 7, and Room 22 (Sample A27);
- Black window putty present in Hallway 2 (Sample A121); and
- Black fire stop around electrical conduit in Room 19 (Sample A122). This material may be present at other locations in the building not observed at the time of this assessment. Consequently, any similar material uncovered during demolition should be considered to be asbestos-containing.

Photograph 14: Asbestos-containing flower pattern sheet flooring with paper backing (Sample A24) in the Office Complex Building.

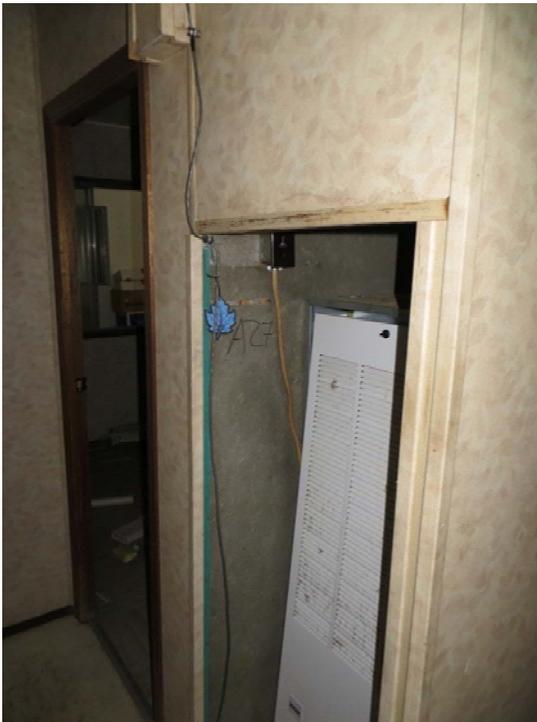
*Photograph 15: Asbestos-containing cement (Sample A27) board lining the furnace closets in the Office Complex.*

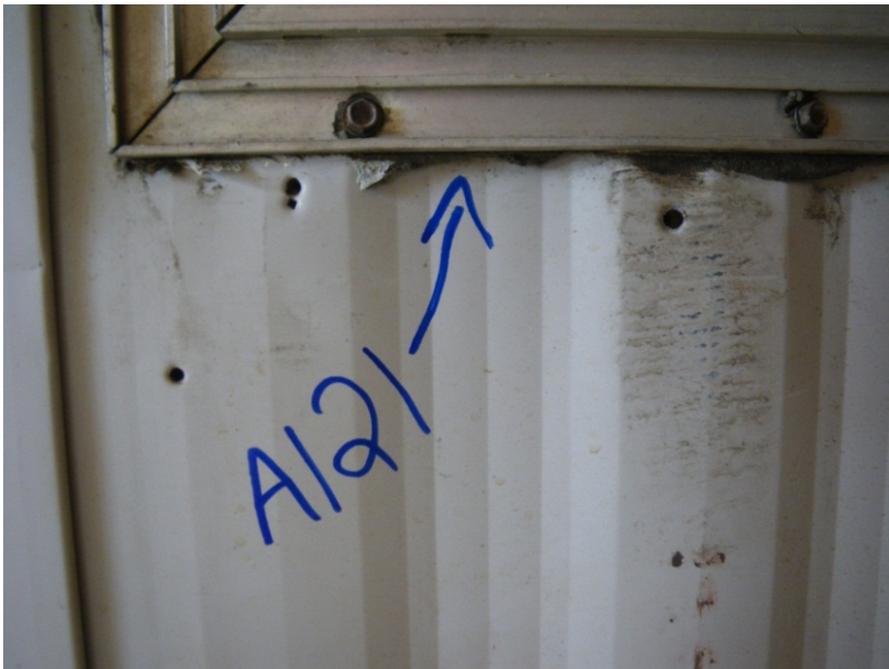
*Photograph 16: Asbestos-containing black window putty (Sample A121) in the Office complex building.*

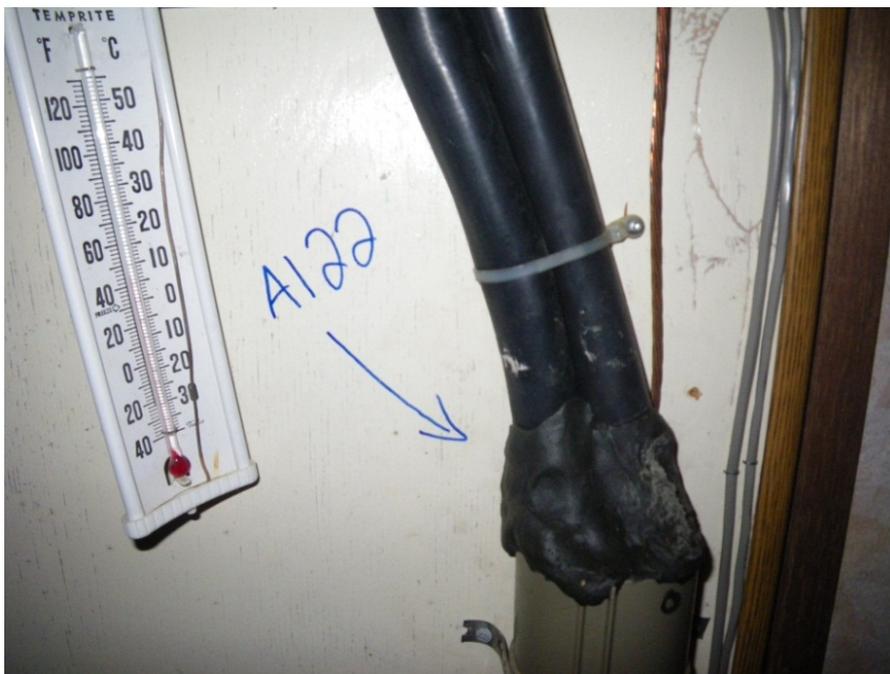
Photograph 17: Black fire stop around electrical conduit (Sample A122) in the Office Complex.

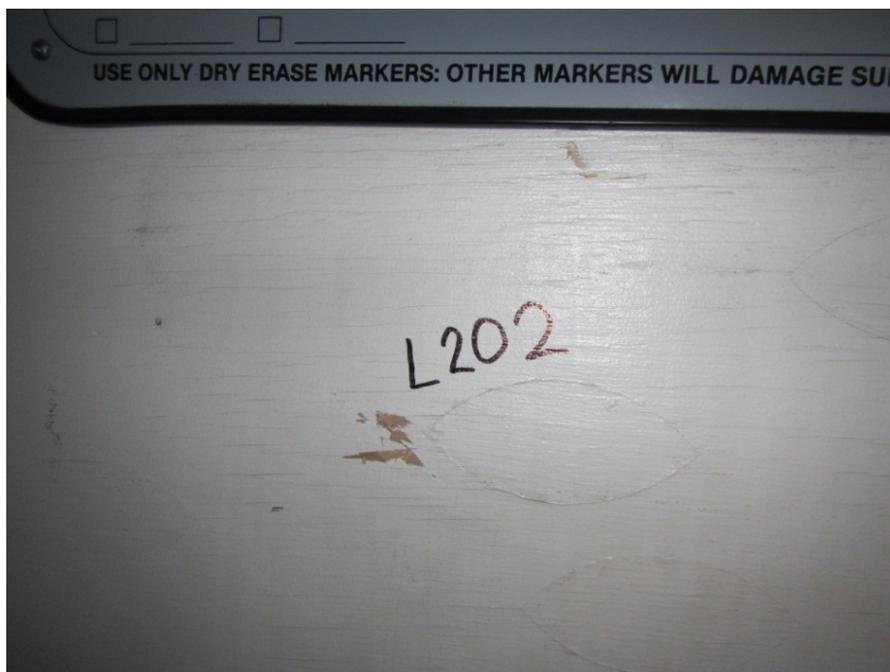
Photograph 18: White minor loose and flaking LCP (Sample L202) in the floor of the Shop.

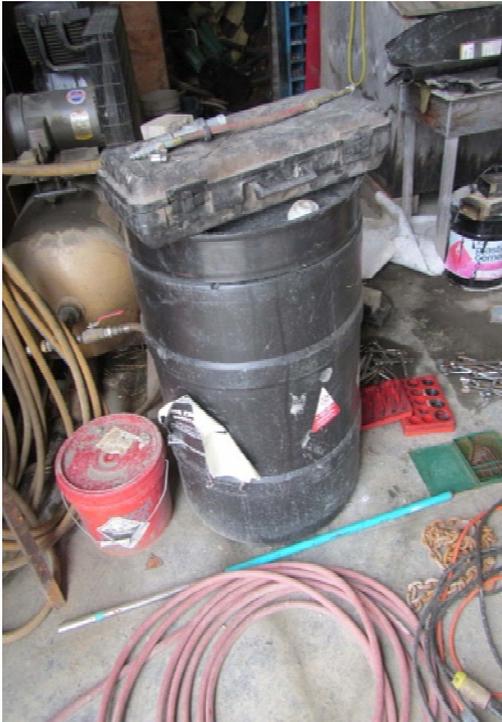
*Photograph 19: Stored chemicals in Shop.*

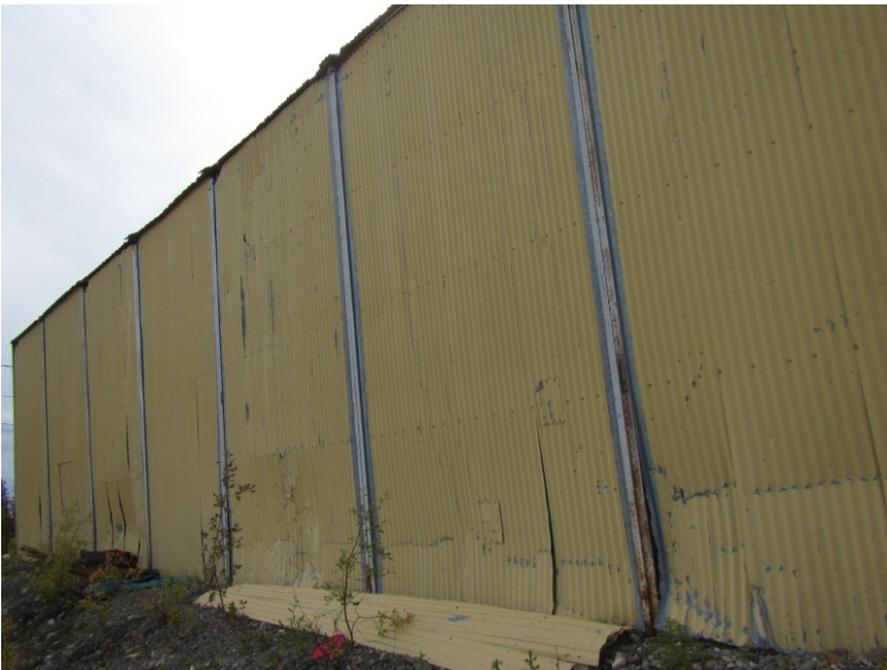
*Photograph 20: Orange Loose and Flaking LCP (Sample L8) on the exterior of the Cold Storage Warehouse.*

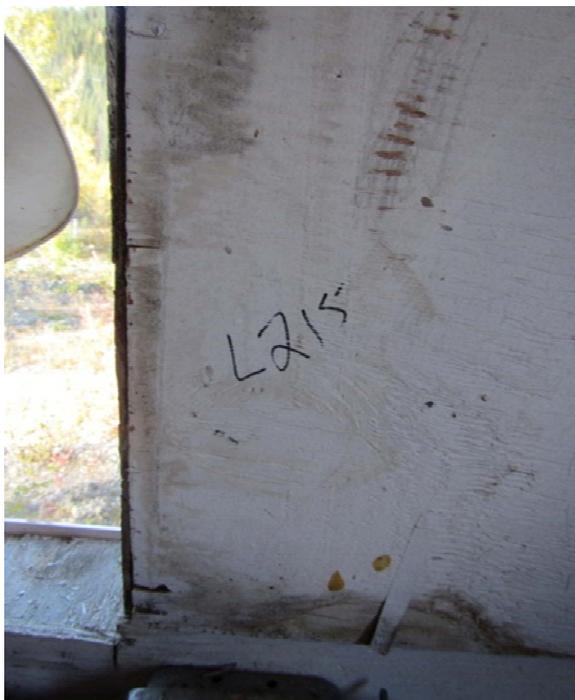
*Photograph 21: White LCP (Sample L215) from the interior wall of the Carpentry Garage.*

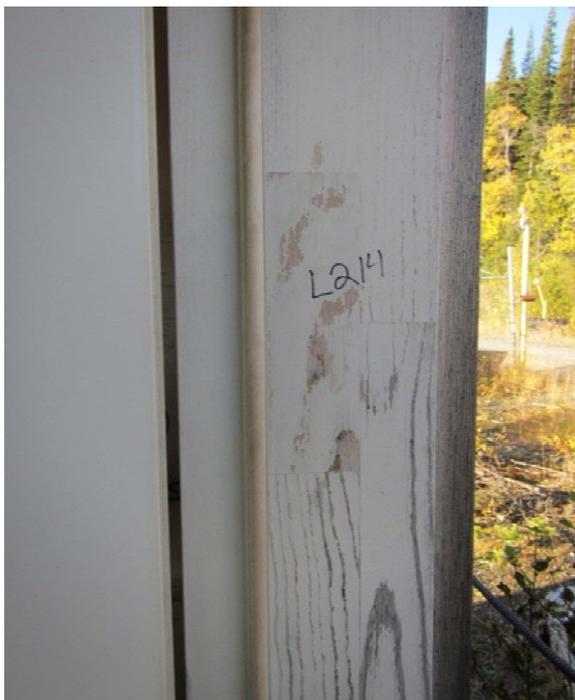
*Photograph 22: White LCP (Sample L214) on door frame of Security Building.*

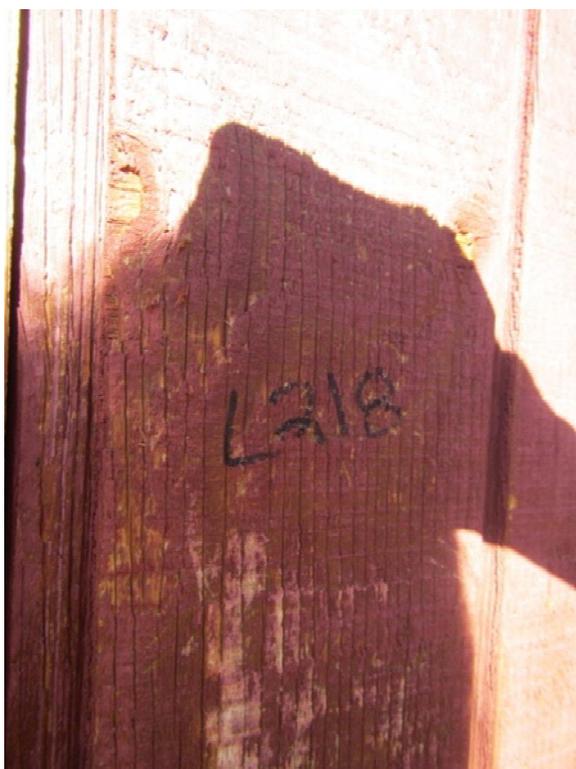
Photograph 23: Red LCP (Sample L218) from the exterior of the Lake Pump House.

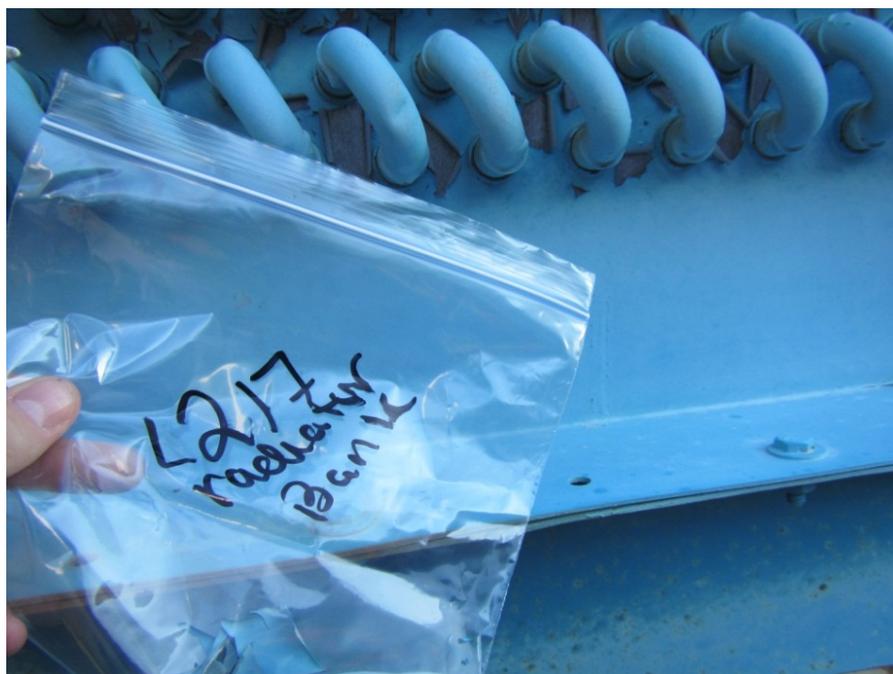
Photograph 24: Blue loose and flaking LCP (Sample L217) from the Radiator Bank.

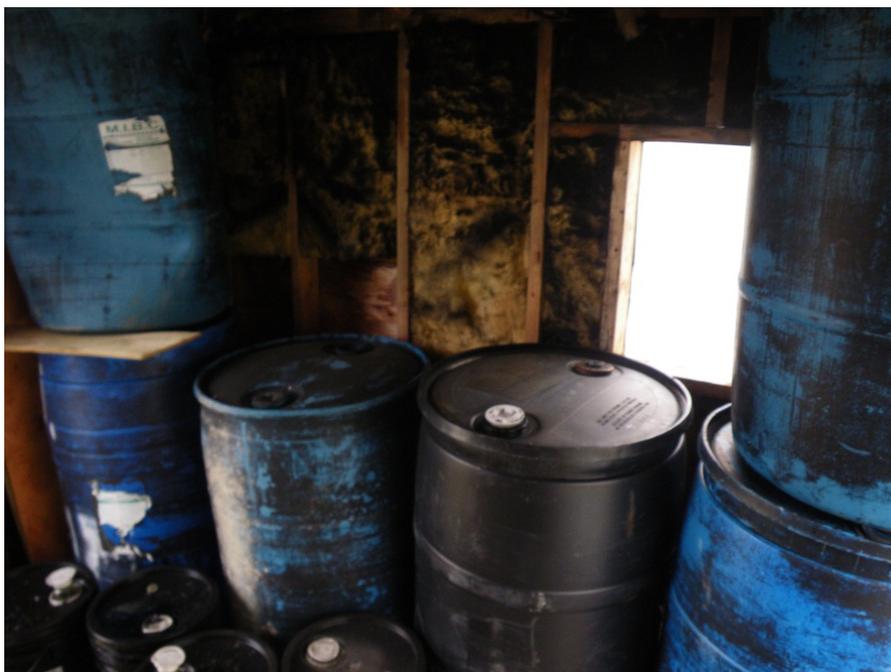
*Photograph 25: Stored drums in Water Distribution Pump House.*

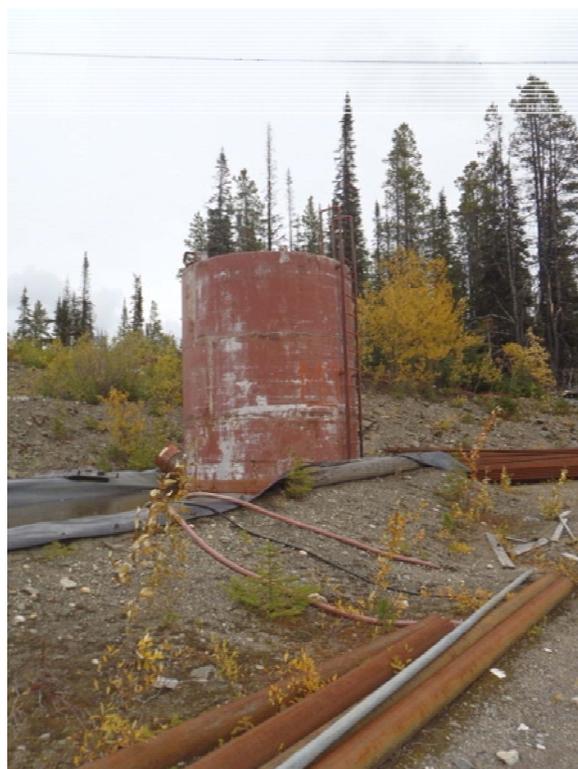
*Photograph 26: Tank with red loose and flaking LCP (Sample L 103) near the Ball Storage.*

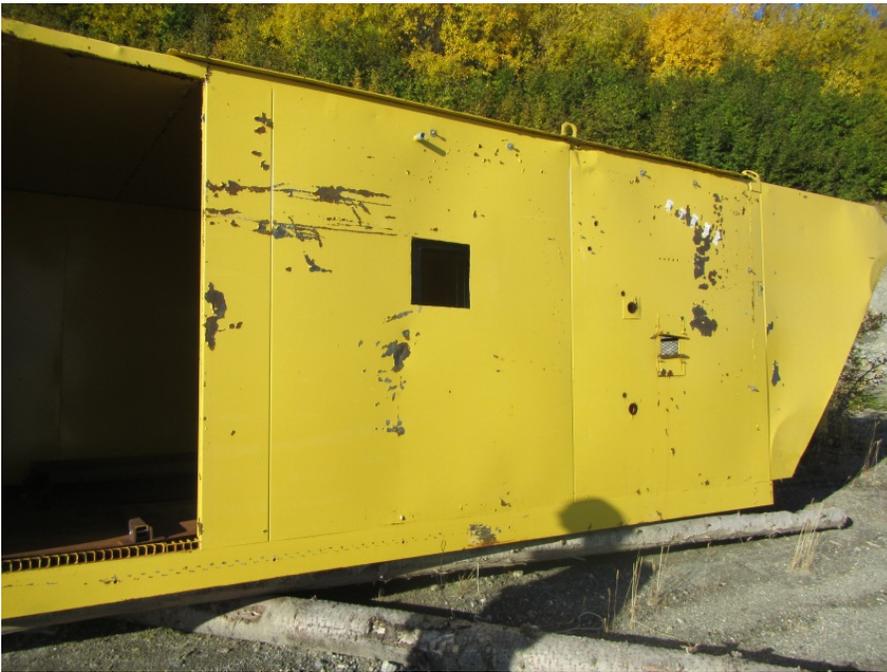
*Photograph 27: Yellow container near the Crusher Building with yellow loose and flaking LCP (Sample L216).*
