Tantalus Butte Coal Property

Preliminary Site Assessment

Prepared for: Government of Yukon
Department of Energy, Mines and Resources

September 2007

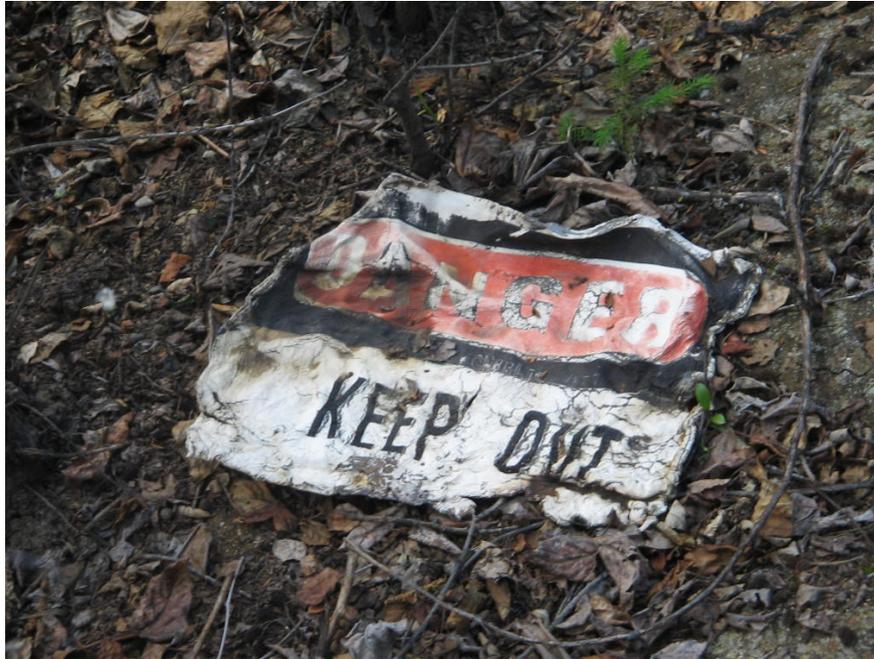
Signage was erected at most locations and gave warnings such as: **“Danger Former Minesite. Use Caution While Walking in the Area”**, **“Keep Out Former Underground Mine Entrance”** and **“DANGER Former Cave in Area. Approach with Caution”**. Appendix 1, Plate 5 is a typical example the signage found on site. A sign found on the ground near site S7 had been melted (Photo 1).

Photo 1 – Heat impacted warning sign. Site S7 (June 21, 2007)

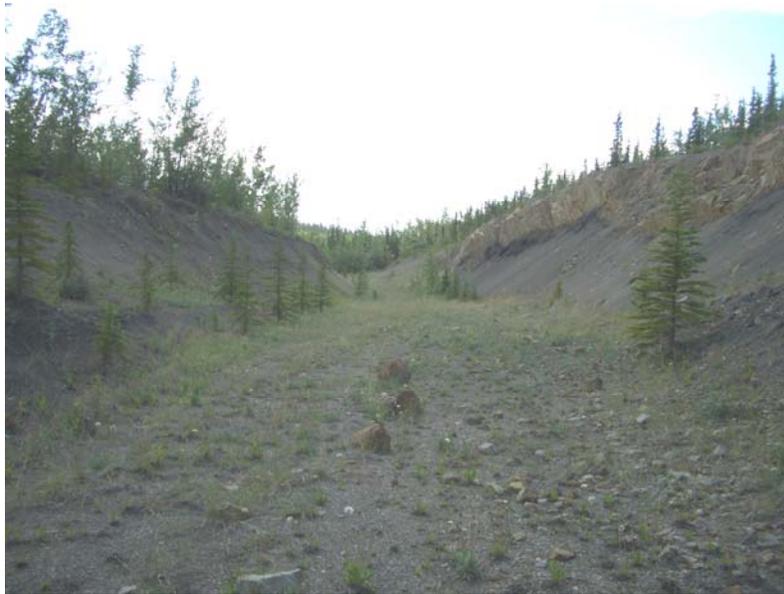
Throughout the pit, the west pit wall is mainly vertical, brecciated and can reach heights of over 22m. Several rock slides were noted below the west wall. The rim of the pit has grown in with willow, poplar and spruce and is no longer apparent when approaching. To the east the wall is also heavily brecciated. The east wall is about 10m in height at the north end and reduces to ground level to the south. Revegetation is occurring on east wall locations with less exposed bedrock (Photo 2).

Photo 2 - Revegetation at foot of open pit wall, east side of pit. Site S3. (June 21, 2007)

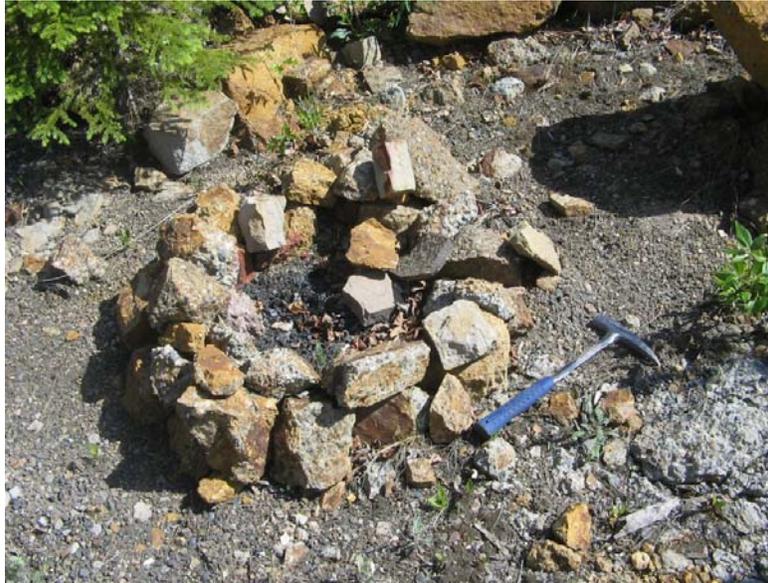
The east, or left, branch travels around the north end of the pit and continues south down the east side. An access road to the pit bottom is approximately 465m down the east side. From the pit floor at location S3 it was noted that volunteer revegetation is occurring to on the east side of the pit floor and up shallowly slope sections of the wall. A circular 6 inch diameter hole about 10m south of the access road mouth was found supporting a young poplar tree. This hole is likely the result of 1977 percussion drilling. A fire ring and several empty beer bottles were also found at the mouth of the access road (Photo 3).

Photo 3 – Remains of fire pit, open pit. Site S3. (June 21, 2007)

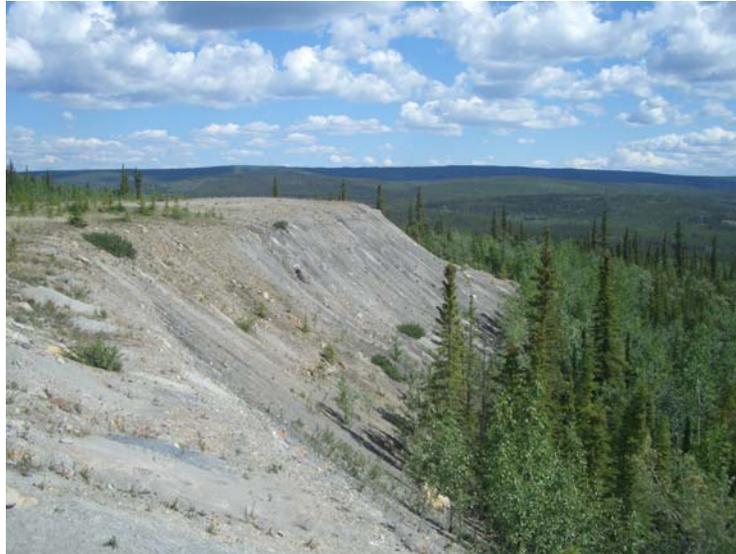
The waste rock dump is located on the east facing slope approximately 400m from the southern extent of the open pit. Upon inspection, the dump appeared to be stable with no tension cracks discovered. The sloped face of the dump is below the angle of repose and mass movement is not expected to occur at this location. Voluntary revegetation is occurring at this site with no apparent reseeding present (Photo 4). Several beer bottles were found at this location indicating human presence further into the site (Appendix 1, Plate 13).

Photo 4 – Waste rock dump slope and volunteer revegetation. Site S4. (June 21, 2007)

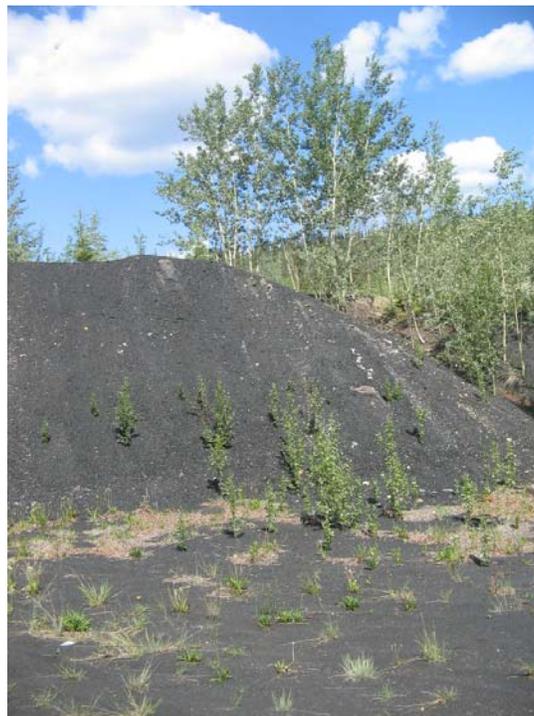
There were no indications of environmental contamination present at this location.

Photo 5 – Coal stock pile in loadout area. (June 21, 2007)

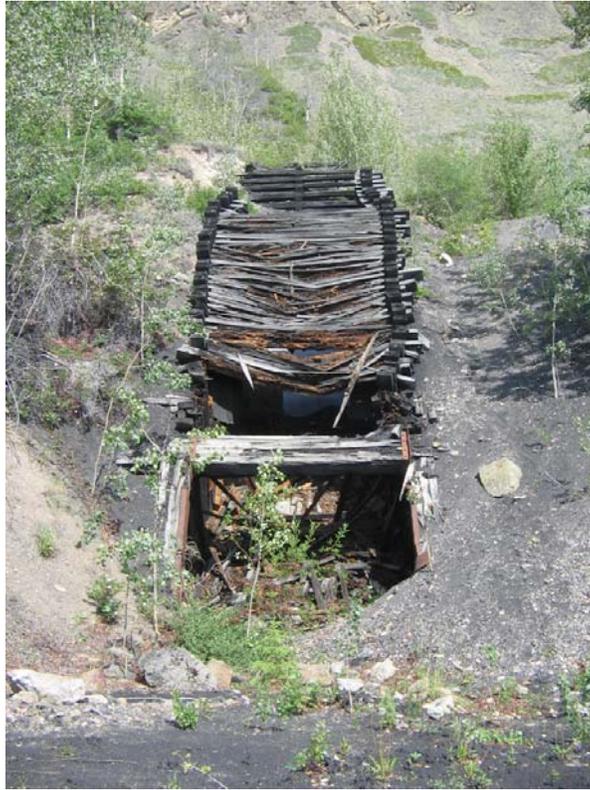
Standing on the road the surface facilities, possibly dating back to 1923, are between 10m and 20m up the slope to the north. These include a tibble and shoot (Appendix 1, Plate 1). The structures are constructed of heavy timber and are thoroughly degraded. A large piece of sheet metal remains inside the shoot and coal and minor structural debris are scattered in the immediate area. This location is described in Table 3.

Plate 1 – Tipple and shoot structure, Site S22, Figure 2. (June 21, 2007)

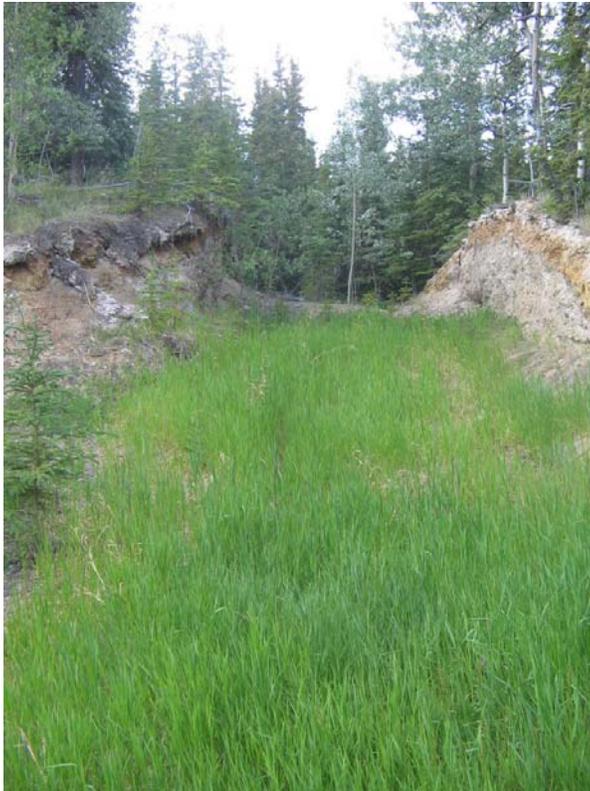
Locations immediately south of the open pit showed evidence of bulldozer trenches. Most of the trenches were seeded with grasses and volunteer revegetation was occurring (Appendix 1, Plate 2). The remains of a shaft collar and notched ladder were found at site S6 (Appendix 1, Plate 3, and Plate 4).

Plate 2 – Bulldozer trench with active revegetation seeded grasses. Site S8, Figure 2 (June 21, 2007)

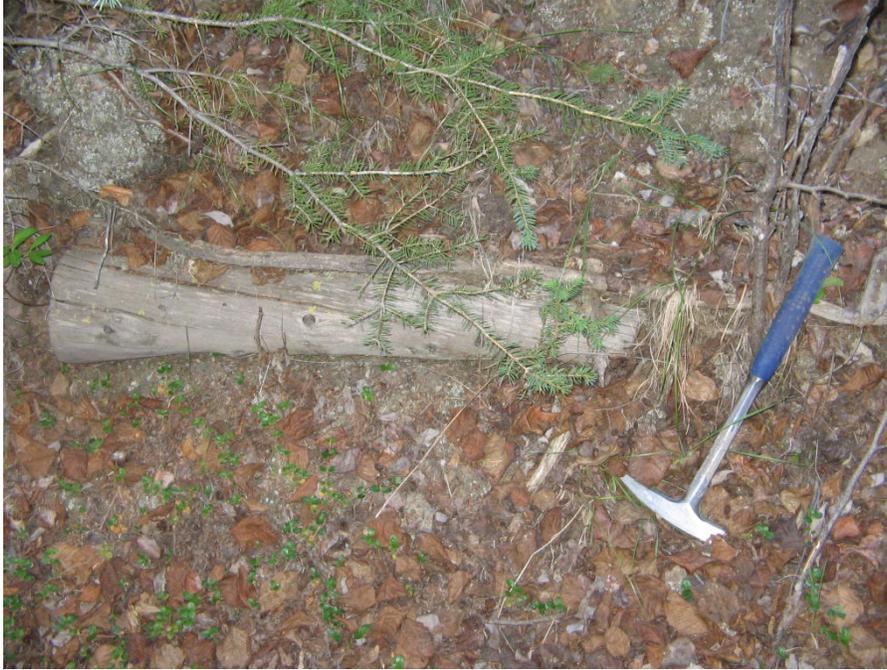
Plate 3 – Remains of shaft collar. Site S6, Figure 2 (June 21, 2007)

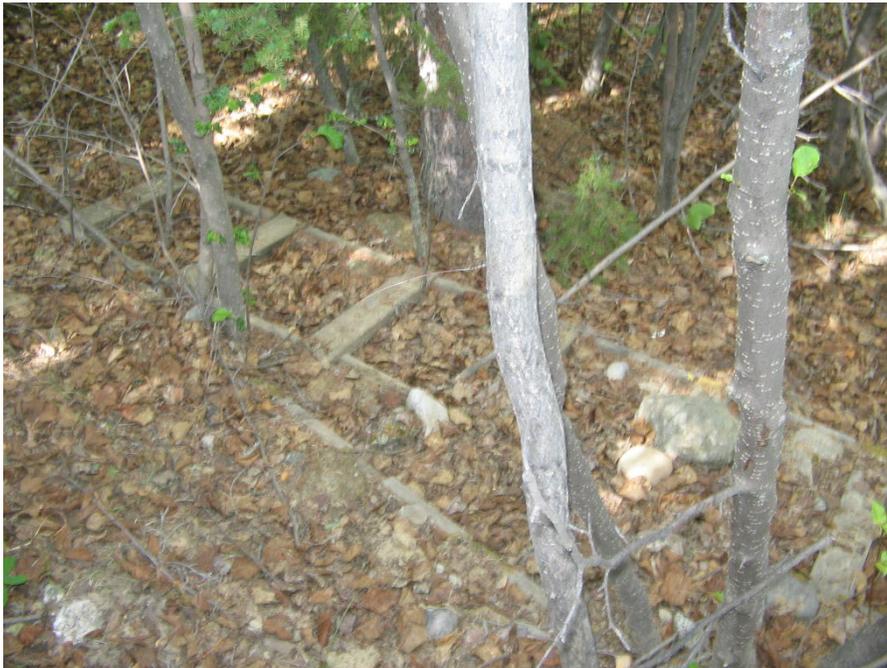
Plate 4 – Underground ladder near shaft collar. Site S6, Figure 2 (June 21, 2007)

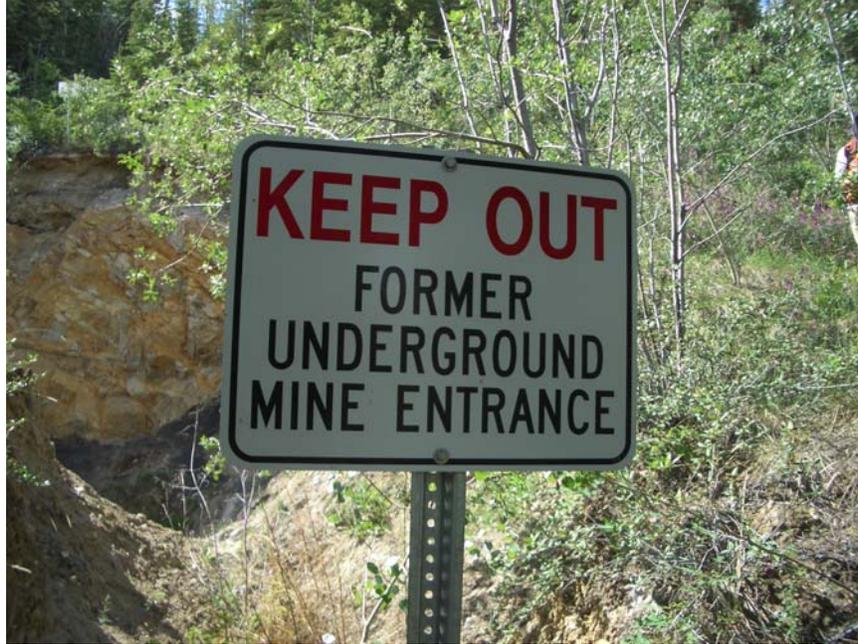
Plate 5 – Example of signage present around the site (June 21, 2007)

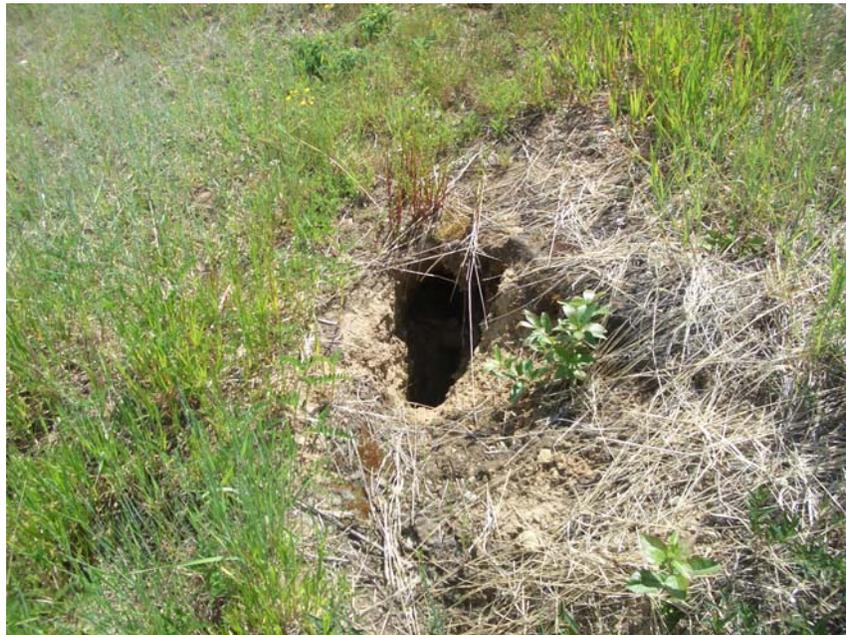
A fist sized hole of undetermined depth was located at site S 11 (Appendix 1, Plate 6). Cracks forming around this hole are aligned parallel to strike. Vegetation within 30cm of the rim was burned, and heat was actively emitting from the hole at the time of inspection. A fissure opening about 5m in length was located at site S12 (Appendix 1, Plate 7). This opening was also actively emitting heat and showed evidence of burned vegetation around its rim. Unidentified mosses within 20cm of the rim were brown in colour and dry to the touch. Based on the position of this fissure it could be anticipated that slope movement may occur in the future. The potential for landslides in the Tantalus Butte area was described by Archer Cathro in a report produced in the early 1970's.

Plate 6 – Fist sized hole emitting heat and gasses. Site S11, Figure 2 (June 21, 2007)

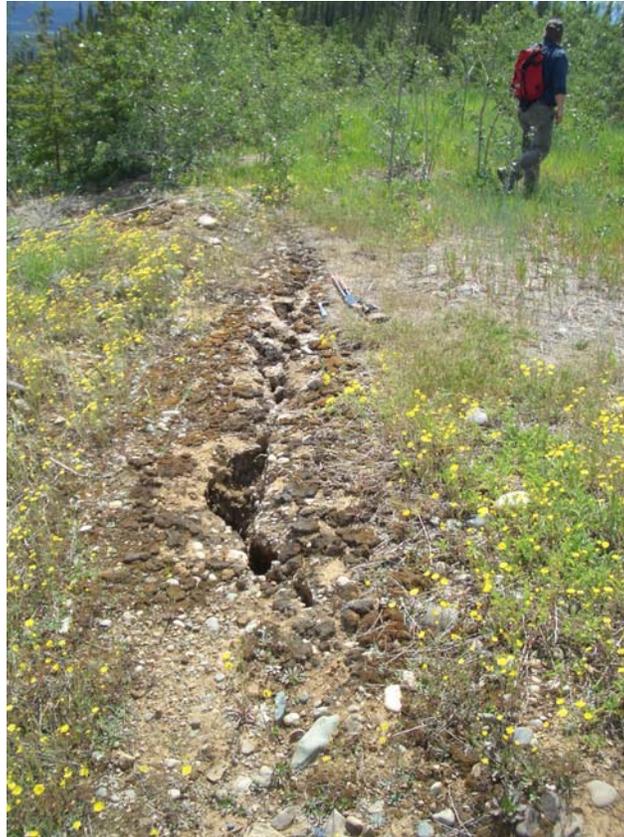
Plate 7 – Opening actively emitting heat and unknown gasses. Site S12, Figure 2 (June 21, 2007)

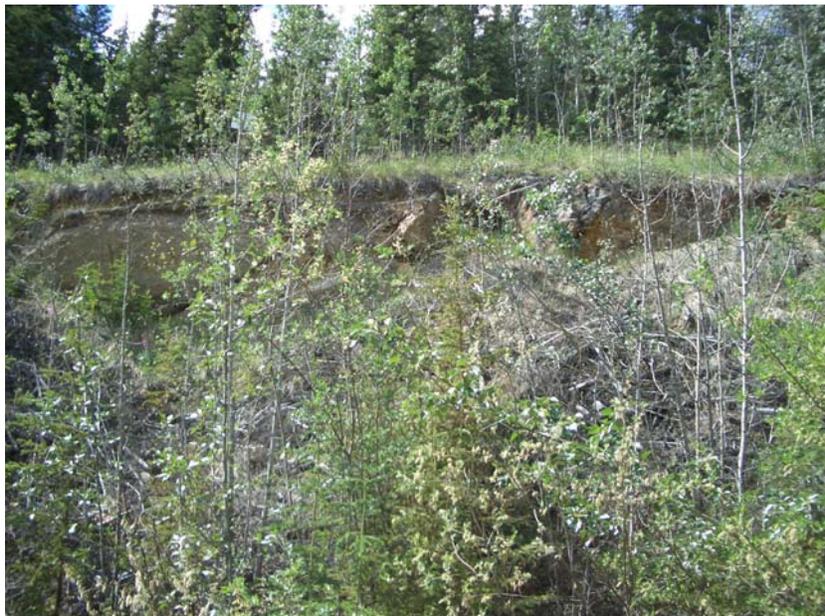
Plate 8 – Evidence of brushing around pit rim, looking west. Site S18, Figure 2 (June 21, 2007)

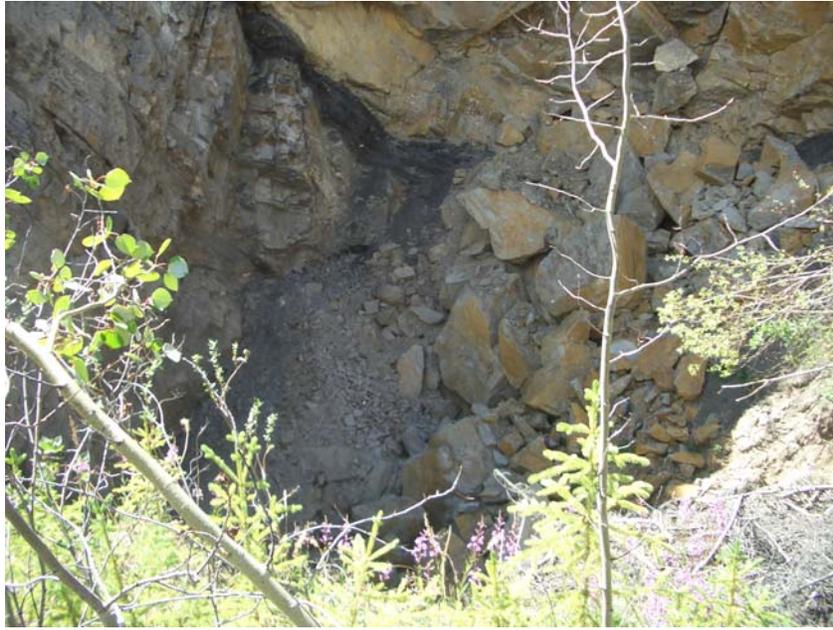
Open holes were located further to the south. These holes are indicated on Figure 2 as sites S13 through S20. Detailed descriptions of individual sites are provided in Table 2. All the holes were brushed back from the edge of the hole for visibility and signed as described above (Appendix 1, Plate 8). The width of individual pits varied slightly, but typically was estimated at 10m. Hole depth estimates range from 3m to 4m. All pit walls were visually inspected and showed evidence of numerous failure events. The high-wall, on the west side of each opening, was heavily brecciated and was actively ravelling at the time of inspection (Appendix 1, Plate 9).

Plate 9 – Opening highwall and pit bottom, looking west. Site S18, Figure 2 (June 21, 2007)

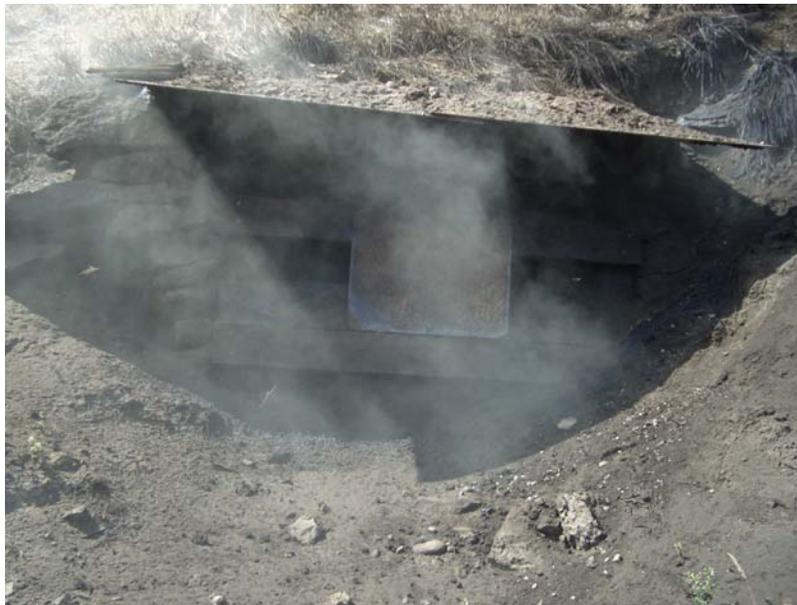
A potential vent to the underground was located at site S21 (Appendix 1, Plate 10). At the time of inspection a significant amount of grey smoke and heat was emitting from the opening. The wooden structure here was blackened from the smoke, intact and in fair condition. The opening was sealed with timbers and partially covered with a sheet of plywood. An unreadable sign was attached to the timbers at the top of opening mouth. It was concluded by the size and shape of the sign that it was placed at the same time as those found to the north. Vegetation within 2m of the vent was coated in soot and dying.

Plate 10 – Smoking vent to underground and remains of warning sign. Site S21, Figure 2. (June 21, 2007)

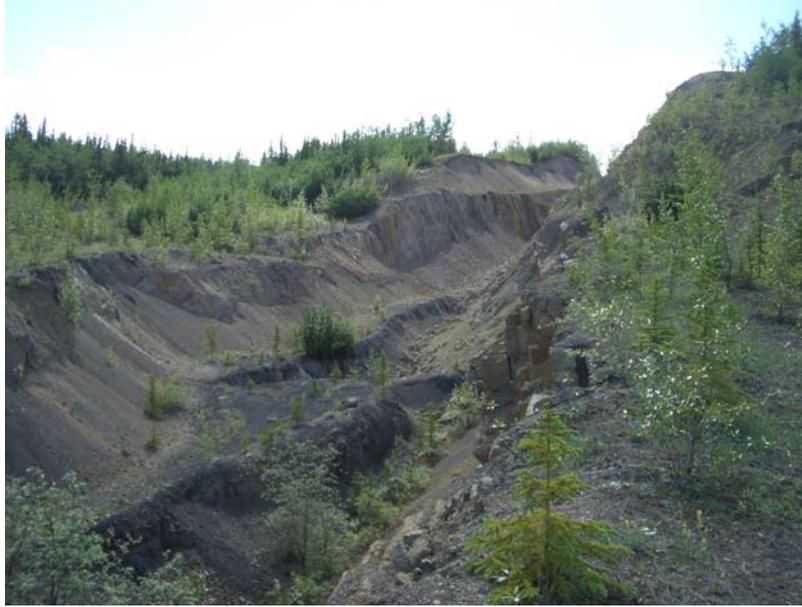
The open pit area was accessed from the northern entrance. The access road forks before the pit with the west, or right, branch ending abruptly at the pit edge. No warning signs are present at this location and the drop-off point is not apparent upon approach. From this location the pit can be viewed from the west side (Appendix 1, Plate 11).

Plate 11 – Open Pit as viewed from the north access road, west branch. , Figure 2. (June 21, 2007)

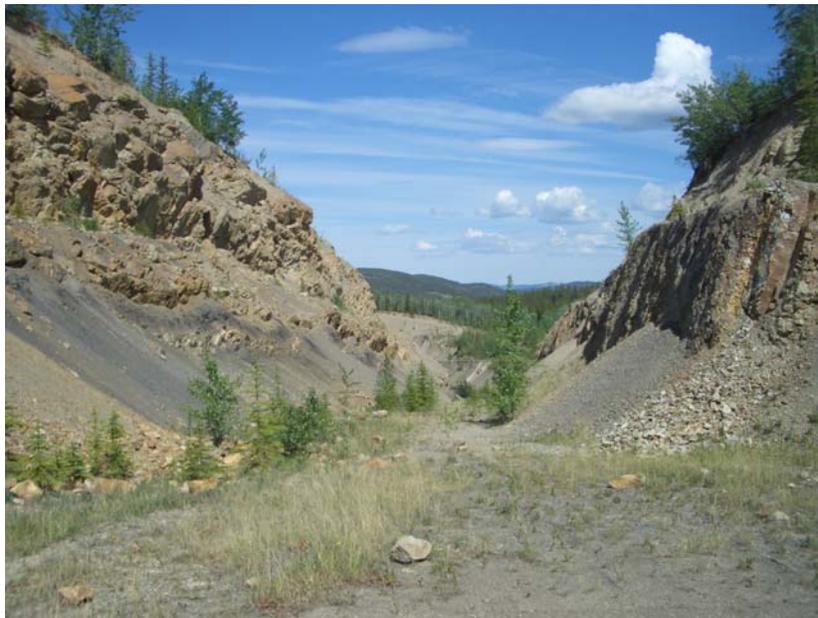
Most notable on the property was the risk of injury or death due to falling. The vegetation adjacent to the open pit has grown in up to the edge and is currently obstructing its view (Appendix 1, Plate 12). Also noted was the lack of signage warning of the pit presence when approaching by way of the access road west branch. Those persons operating recreational vehicles on the property and those on foot could mistakenly travel close to the rim and fall from the open pit wall.

Plate 12 – Open Pit as viewed from the pit floor. Site S3, Figure 2. (June 21, 2007)

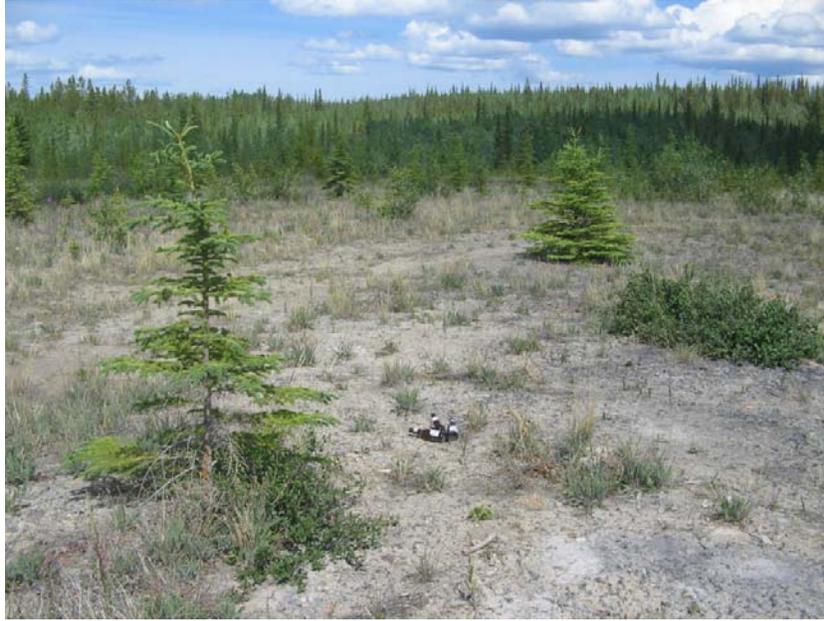
Plate 13 – Voluntary revegetation of waste rock dump and evidence of recreational use of area.
Site S4, Figure 2. (June 21, 2007)
