**WHITEHORSE COPPER MINES
TAILINGS STORAGE AND
WATER RECLAIM SYSTEM**

**FINAL OPERATIONS
AND ABANDONMENT**

80001 - D

August, 1982

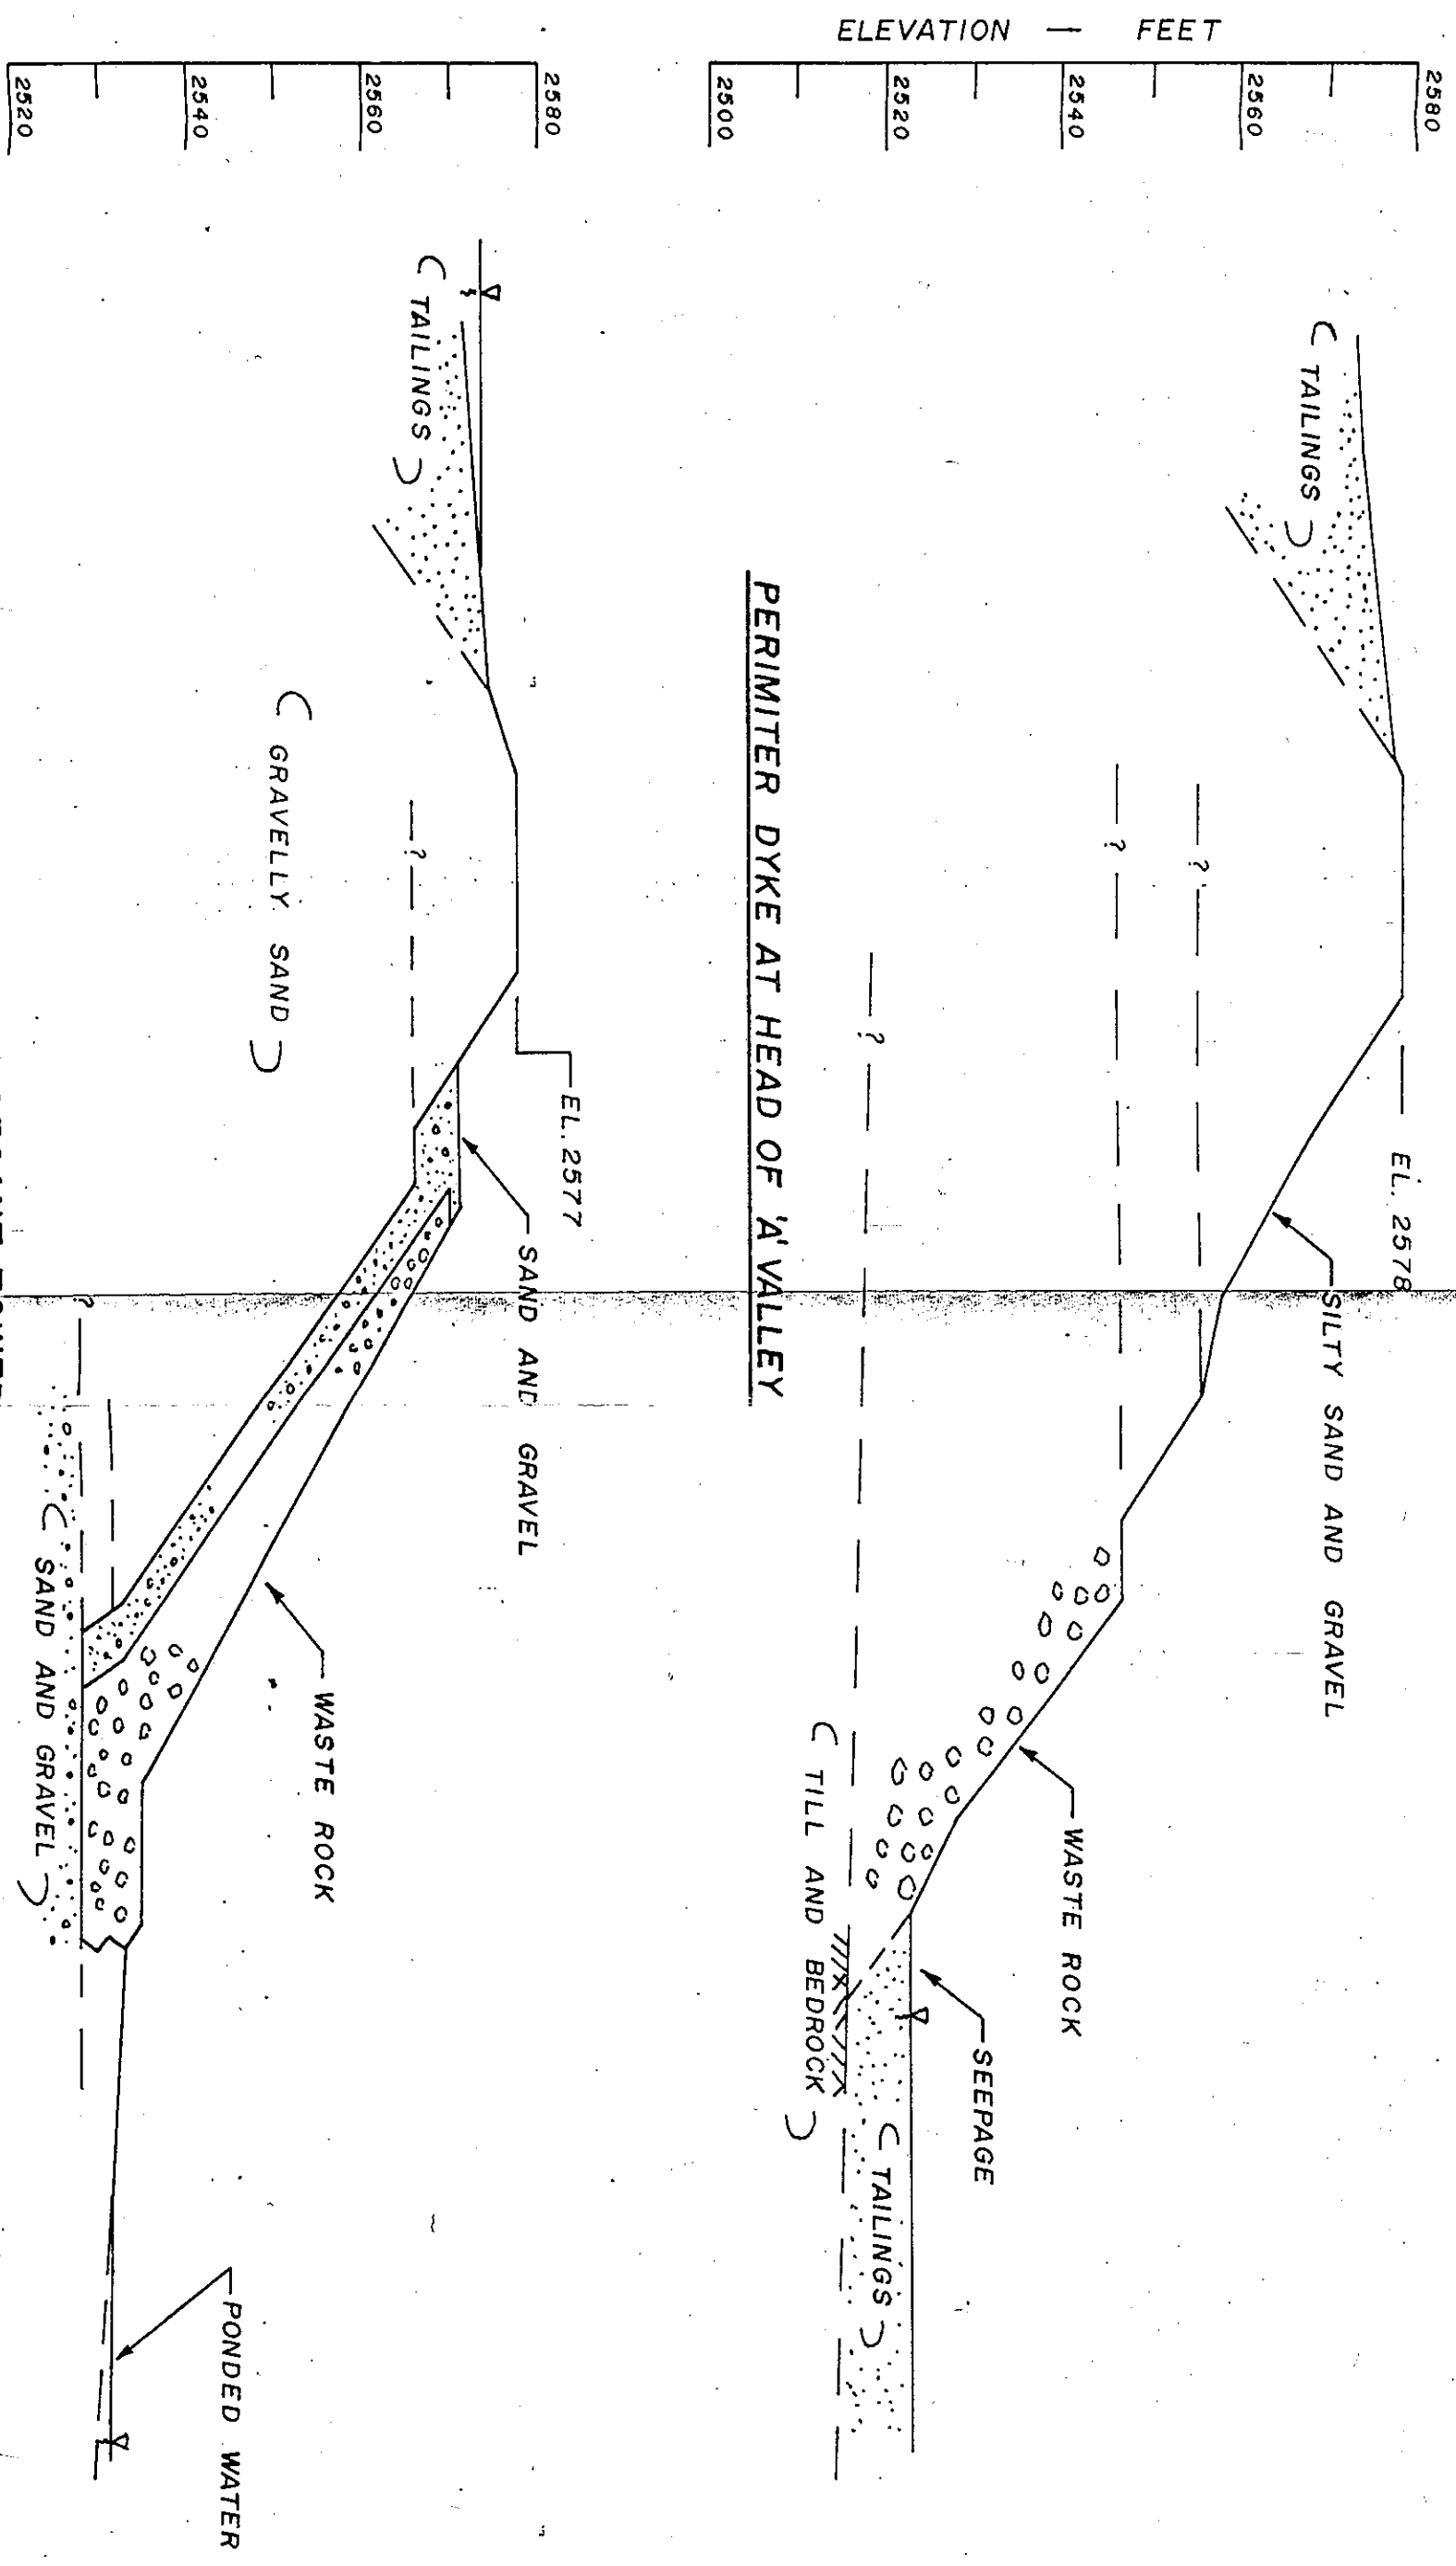
FIGURE 6

The perimeter dyke was developed during the early life of the mine and was completed to its present configuration by about 1968. There are no records of the work and little is known about foundation condition, fill materials, or construction methods. All of the available information has been derived solely from visual inspection and from several early photographs.

The available information indicates that the dyke is comprised primarily of granular earthfill materials borrowed from within the pond area. These materials appear to have been placed in a relatively random manner without sorting, compaction or survey control. There are indications, however, that the foundation area was stripped and that most of the fill was placed in horizontal layers corresponding to the various stages of construction. There are also indications that mine waste rock may have been used in the lower portions of the dyke and particularly in the section of dyke at the head of the 'A' Valley.

The general history and the observed conditions suggest that the higher portions of the dyke were probably developed using an upstream construction technique. The lower portions along the east and southeast boundaries of the pond appear to be comprised of borrowed fill only.

The southeast portion of the dyke is flanked by a fill constructed in 1975 to control seepage and improve dyke stability conditions. The fill is about 1,000 feet long and is comprised of waste rock and a sand and gravel filter zone as shown on Figure 6. The section of dyke protected by the fill is comprised primarily of gravelly sand.

Most of the crest and downstream slopes of the perimeter dyke are in fair condition but moderate surface erosion is occurring on the face of the north dyke and on the main dyke near the head of the 'A' Valley. The erosion is being caused by rainfall and meltwater runoff and by local mudflows which develop during the spring thaw period.

The erosion conditions do not present an immediate threat to the stability of the dyke. There are also indications that the conditions may be improving as a result of natural revegetation. There is, however, a general concern that the conditions could become more severe with time and could eventually jeopardize the stability of the dyke.

In view of these conditions, it would be desirable to carry out works to ensure that further erosion cannot occur. Because of the steep slopes and high fills, vegetation

of the dyke slope would be the only practical treatment. This may not be all that successful, however, because of the general soil conditions and harsh environment. Nevertheless, it would be a reasonable first stage treatment, and further measures could be defined on the basis of its success.

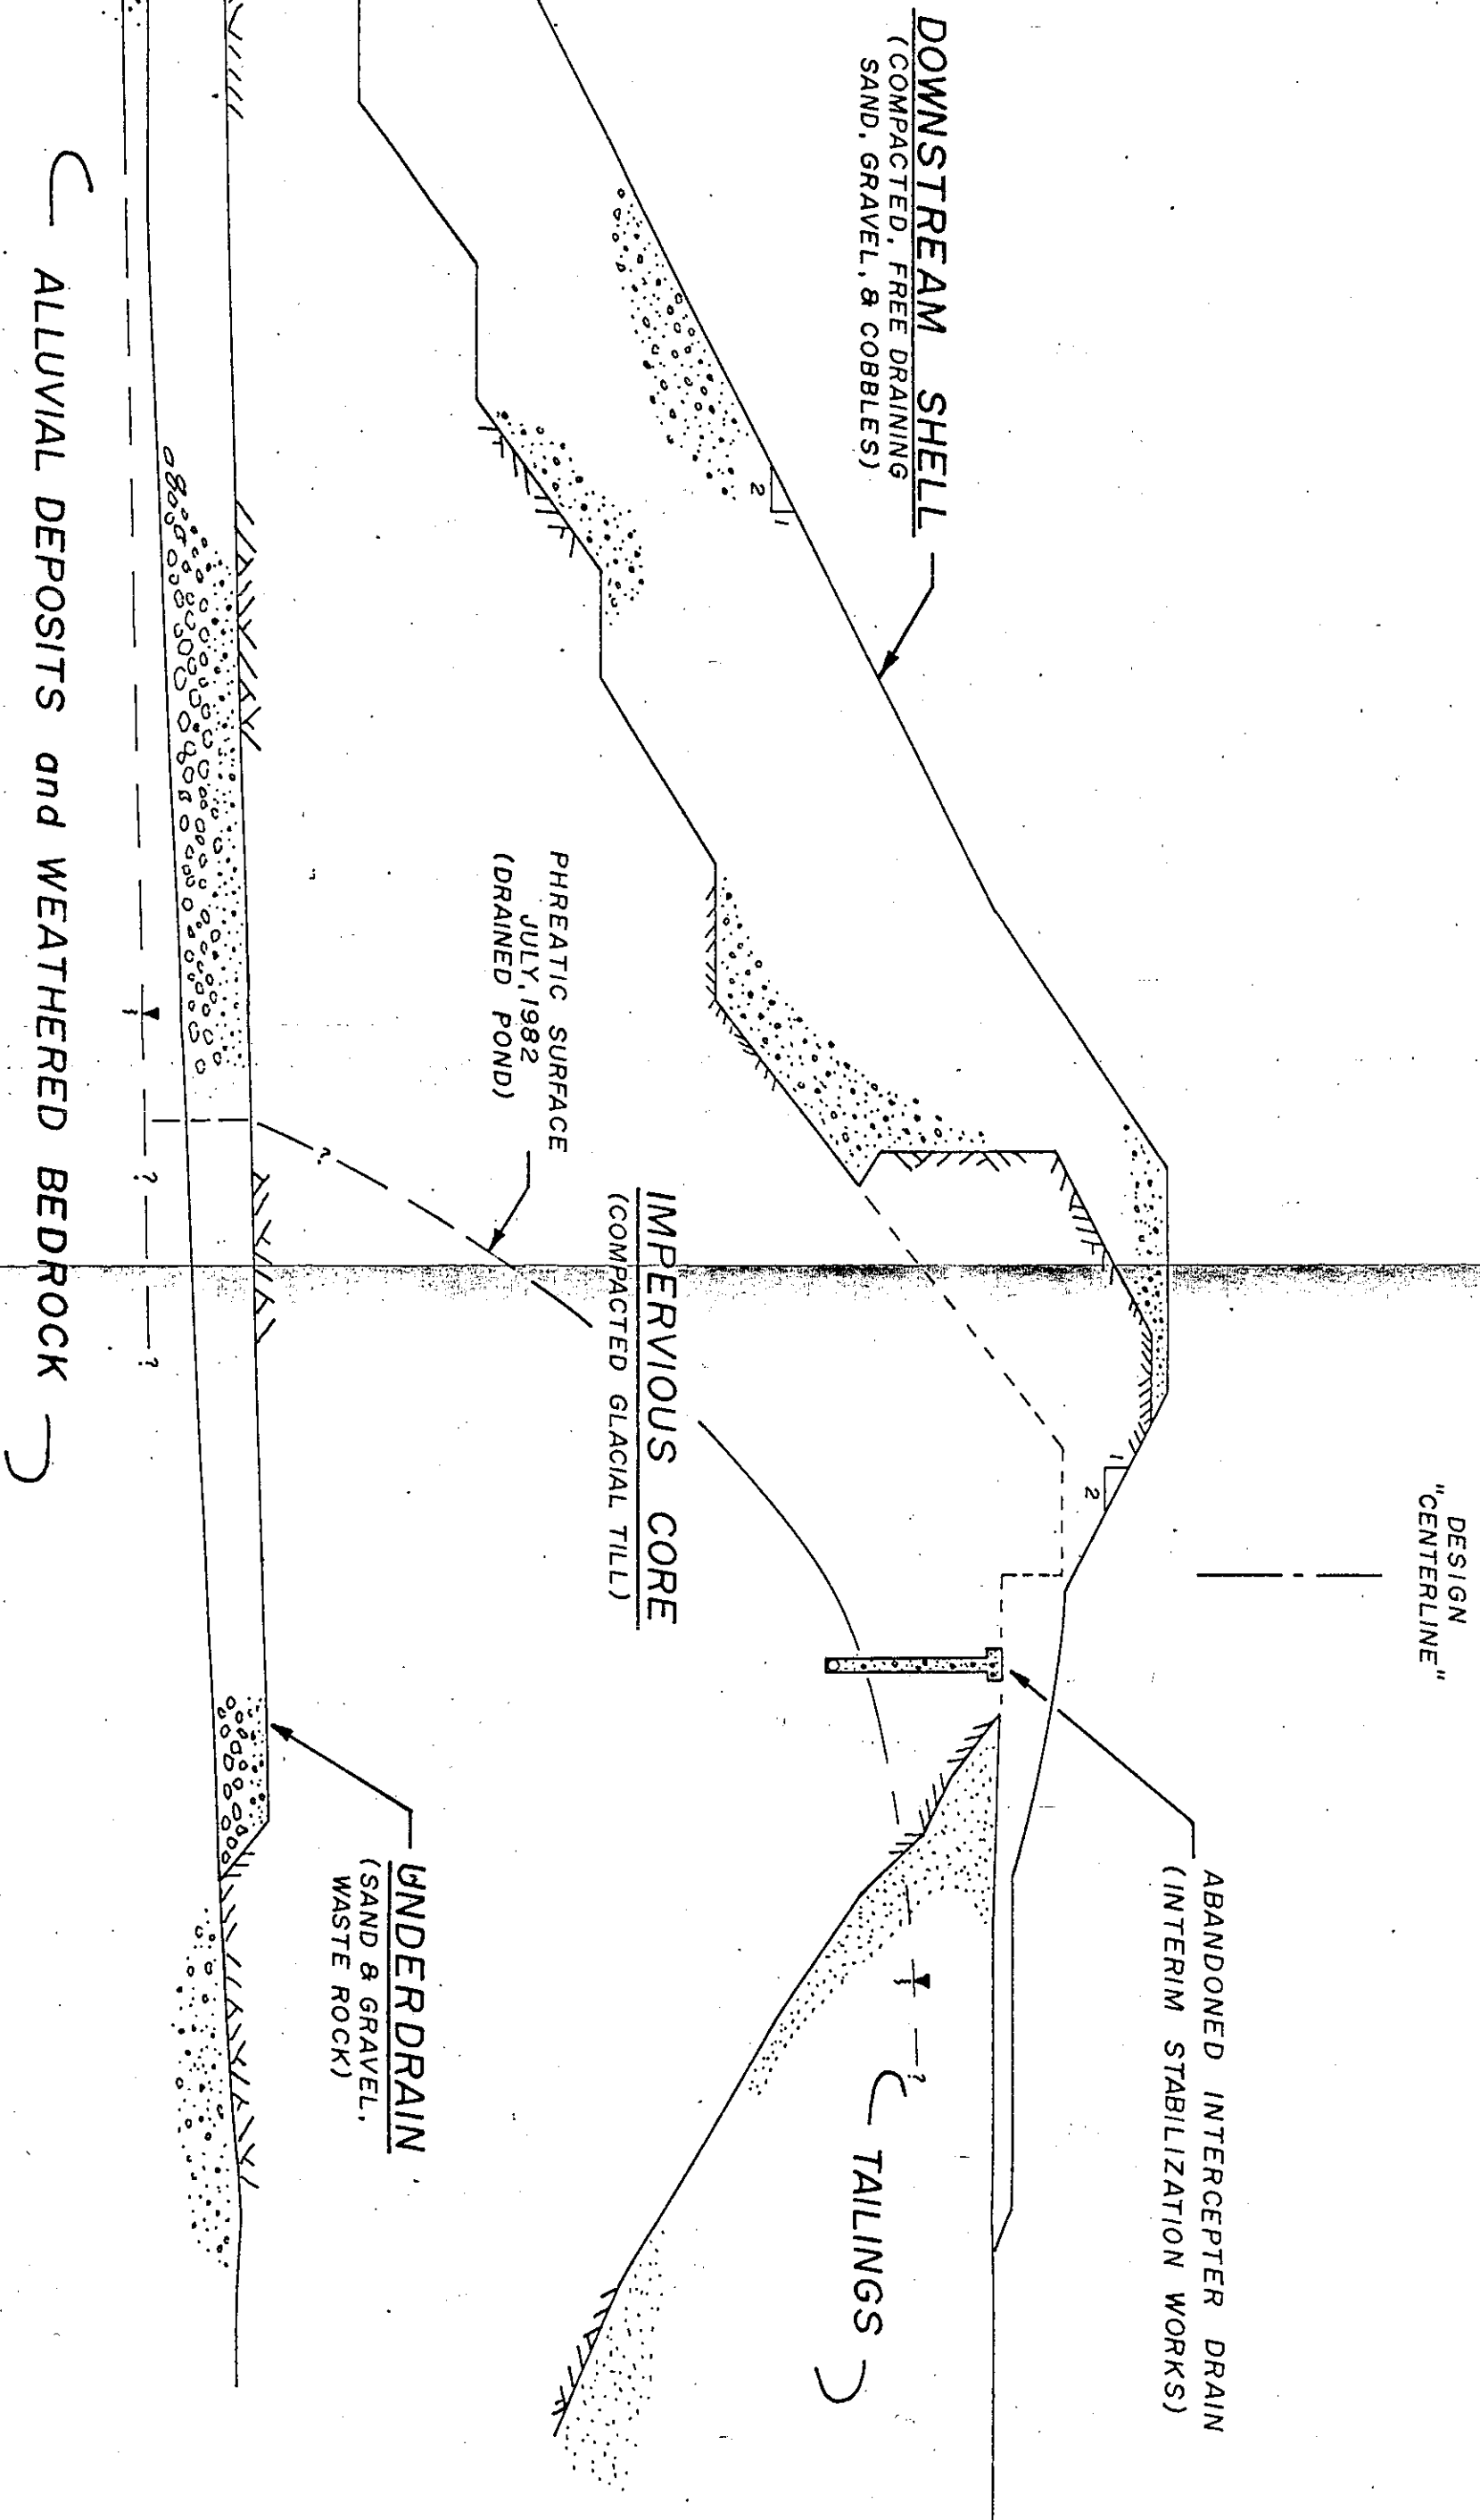
FIGURE 7

The 'A' Dam has been designed for abandonment and there are no specific concerns regarding its long term stability. It will, however, be necessary to develop positive drainage conditions within the pond to minimize surface recharge and to promote drawdown of the phreatic surface. This is particularly important in view of previous experience which suggests that the phreatic surface may remain near the boundary of the core and shell zones as long as recharge can occur.

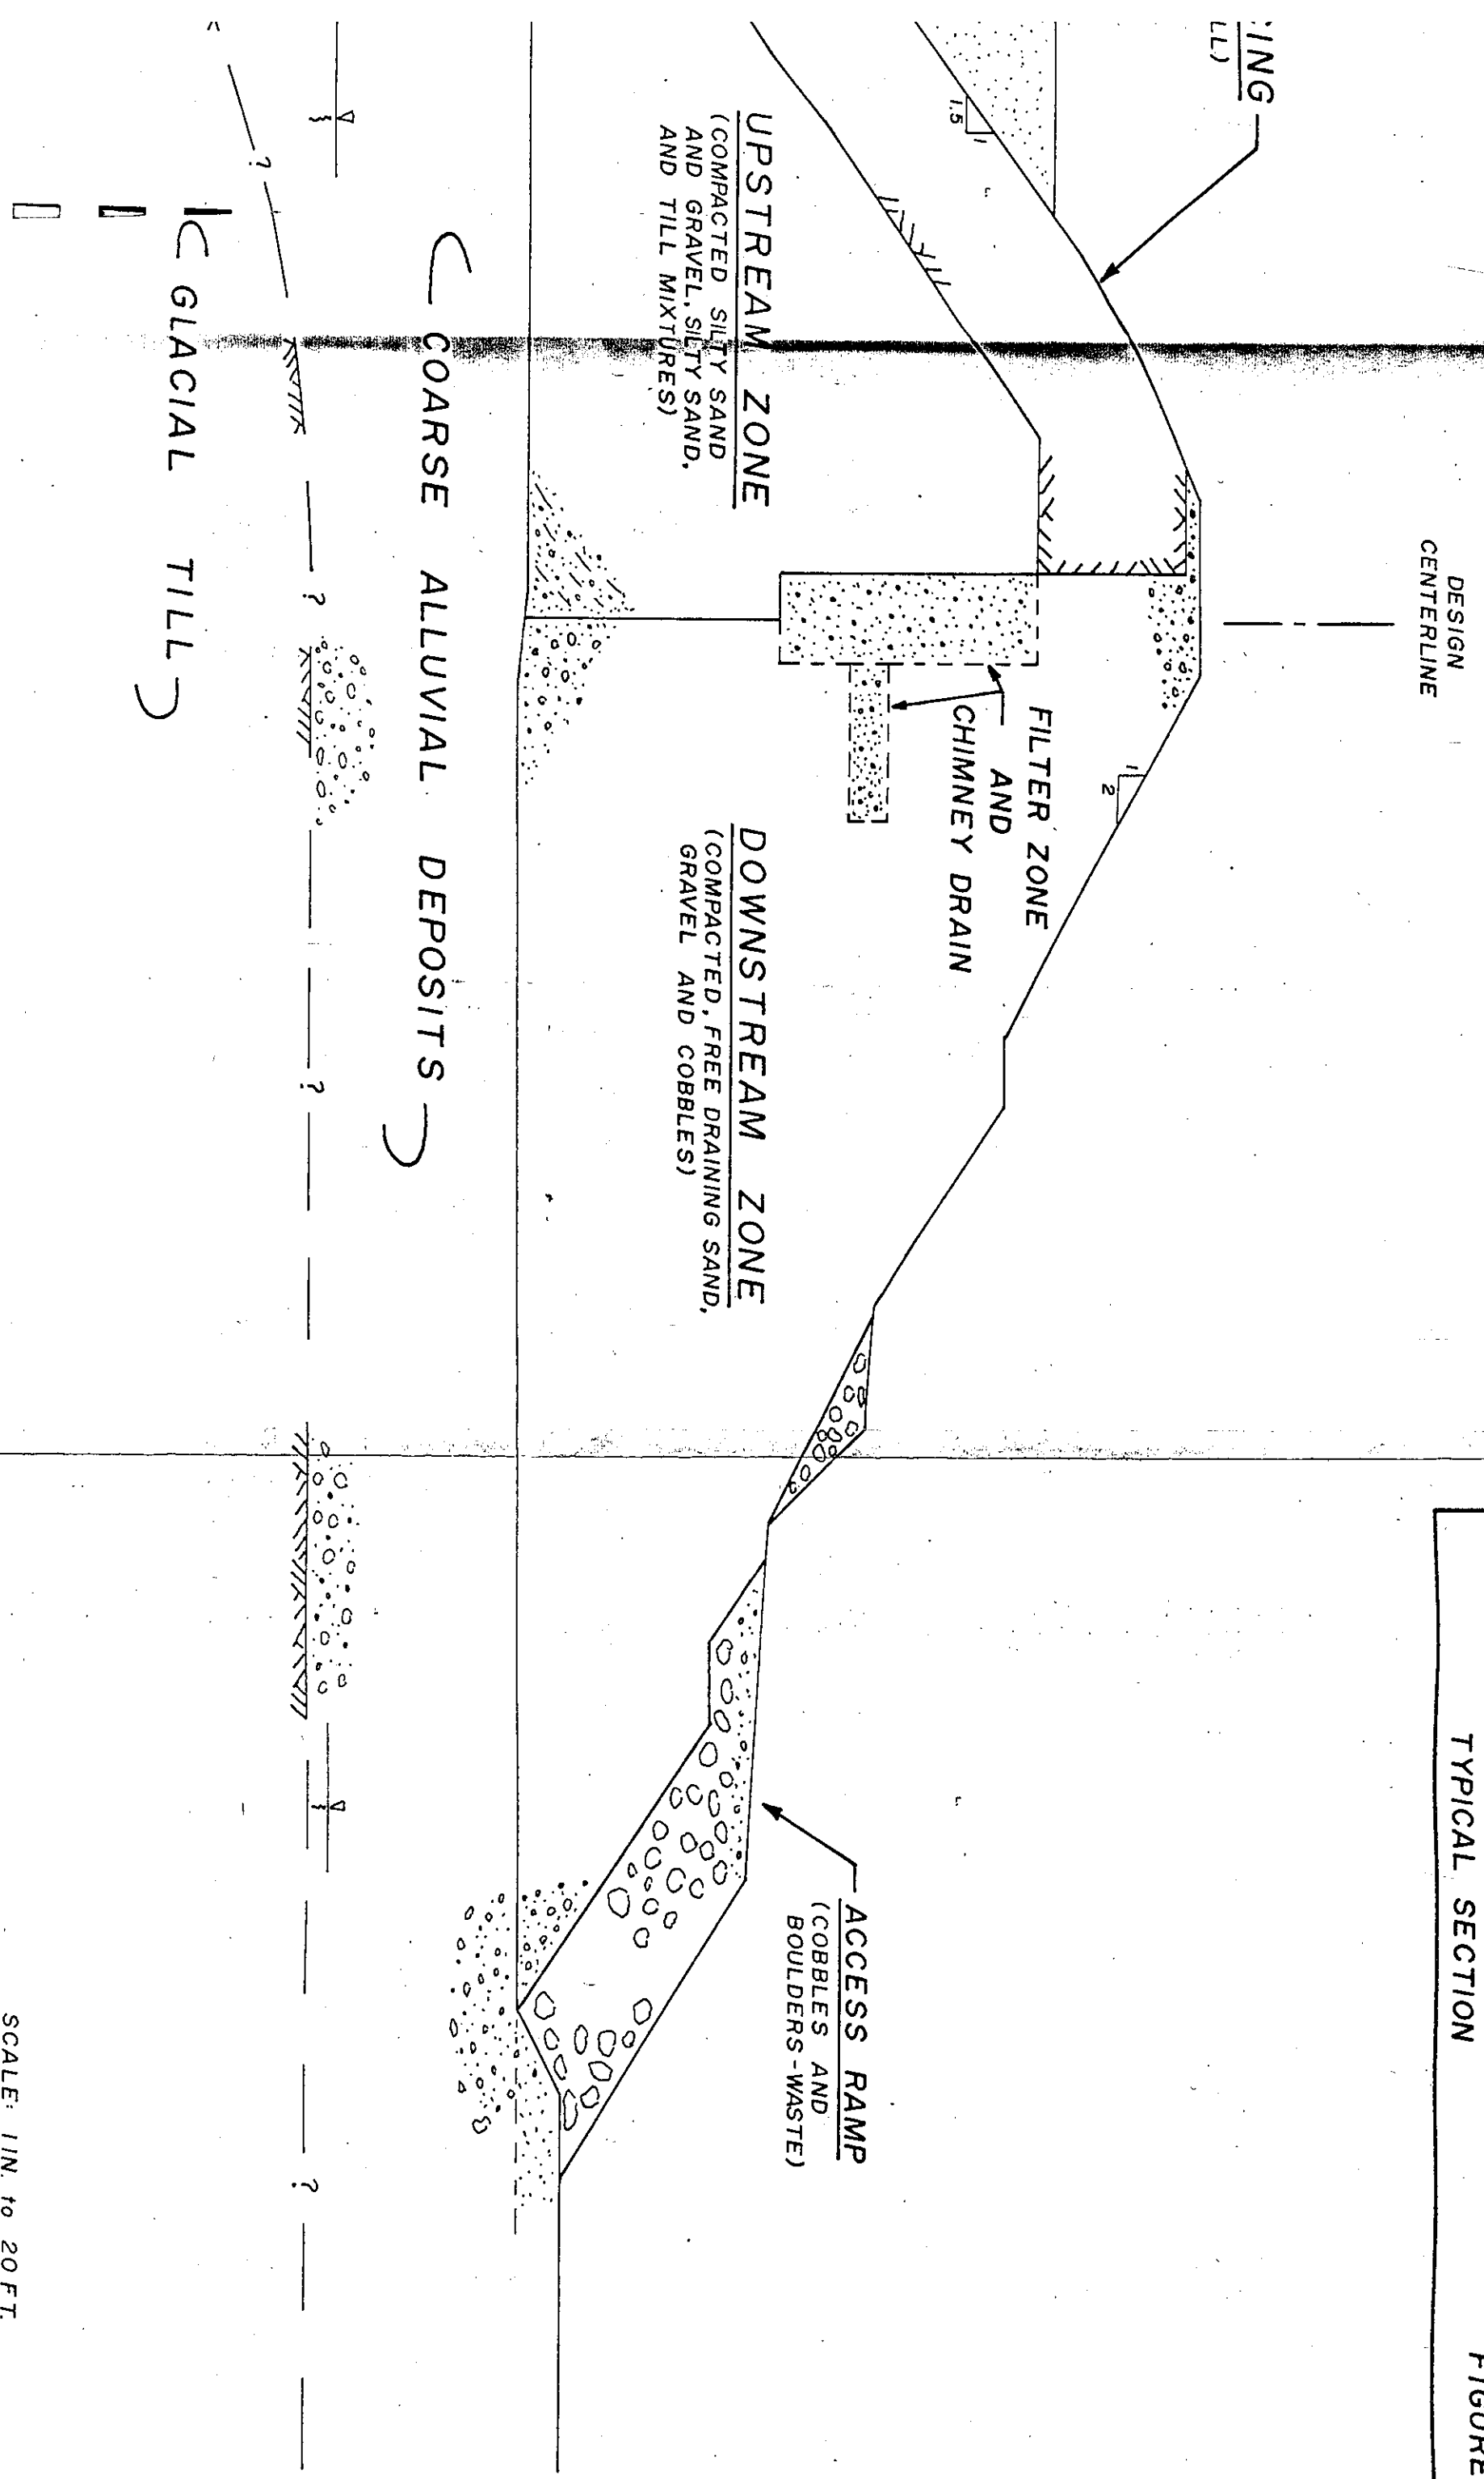
FIGURE 8

The 'B' Dam is a zoned earthfill structure with a relatively complex section as shown on Figure 8. The section is comprised of a downstream zone of freely draining granular materials, an upstream zone of low permeability, fine grained fills, and an impervious upstream facing. The main body of the dam is founded on the coarse alluvial deposits which underlie the valley but the impervious facing extends to the till strata within each abutment and to the till and weathered bedrock underlying the valley alluvium.

Because of the geotechnical conditions within the 'B' Valley, the valley will tend to pond water and the tailings will always remain in a saturated state. The 'B' Dam has been designed for these conditions and at this time there are no concerns regarding its long term stability. There are, however, various concerns with respect to seepage through the abutment sand strata and the long term stability of the abutment slopes.

Condition (i) would ensure that the eastern sand strata is covered to the maximum extent possible and that the western sand strata remains above the final pond level. Condition (ii) would ensure that the western stratum received the minimum cover needed to significantly reduce seepage flows.

If condition (i) is developed, a limited seepage problem would be expected along the east abutment and remedial measures to improve the stability of the slope would be required. If condition (ii) were in effect, only minor seepage would be expected on the east abutment and remedial measures should not be necessary. A limited seepage problem could exist on the west abutment, however, and treatment would likely be needed for that area. A configuration between (i) and (ii) would reduce seepage on the east abutment and increase seepage on the west abutment. A final tailings level above elevation 2508 would improve conditions on both abutments.

Remedial measures, if required, would depend on final conditions. On the east abutment, long term control could be attained through construction of a granular drainage blanket. On the west abutment, the most suitable alternative would depend on the final tailings configuration. If the pond was filled to near design capacity, a drainage blanket would probably be sufficient. However, if the final tailings surface was within or just above the sand stratum, the most suitable solution would probably involve a modified spillway design as outlined later in this report.

A full evaluation of seepage and stability conditions will require instrumentation of the dam and abutment areas. This work should be carried out while the pond is still in operation in order to assess changes which will occur when operations are terminated.
