July 8, 2009

EBA File: W14101095.006

Subject: **Annual Inspections of the On-site Earth Structures
Wolverine Mine Site, South Eastern Yukon**

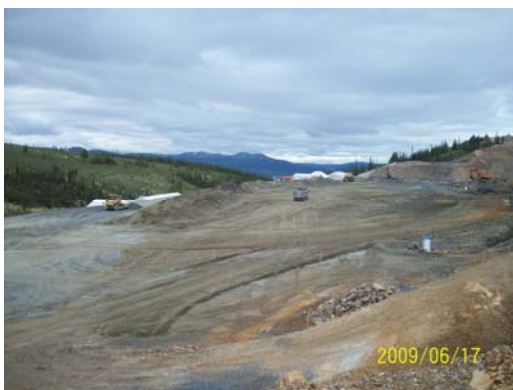
During the inspection, fill was still being placed along the south western sides. The fill slopes associated with the fill placement are considered stable and are constructed as per the 2:1 (H:V) design. There are some noticeable erosion channels along the south western side of the Mill fill that were created during the recent heavy rainfalls. Final design incorporates proper grading to divert surface runoff towards designated drainage ditches. Until this final grading occurs the erosion channels should be filled in with coarse grained material.

Photo 1: Looking W at excavation and fill placement at the Mill Site.

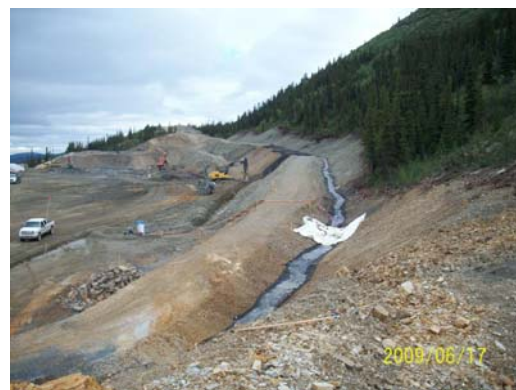
Most of this area is still under construction but a preliminary inspection of the slopes was completed for the Mill, Fuel Storage and Generator locations. The 1:1 (H:V) design cut slopes in the bedrock for these areas are considered stable. Along the cut slope between Ditch #1 and the Mill Pad the original design also called for a 1:1 slope, which is too steep for the material that was encountered during the excavation. In this area a frozen coluvium material was exposed and started to thaw causing failure and sloughing of the slope. YZC has completed temporary repair to reduce any further damage to the affected area. This repair work consisted of excavating the sloughed material, and covering the slope with geotextile and rock. It has been suggested that the long term solution will be to reconstruct an engineered fill with a more gradual slope, from the toe to the crest, along the affected area. YZC was informed and will carry out remedial actions.

Photo 2: Looking NW at excavator repairing downslope of Ditch 1.

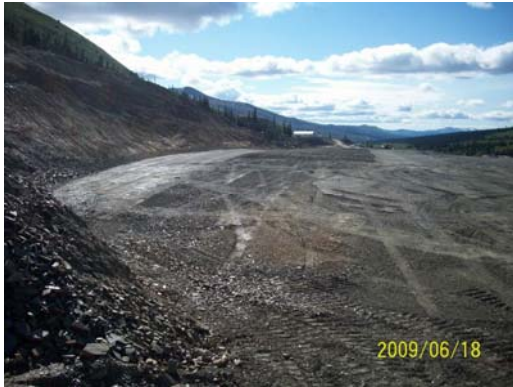
Photo 3: Looking SE at cut slope for Fuel Storage and Generator Pads.

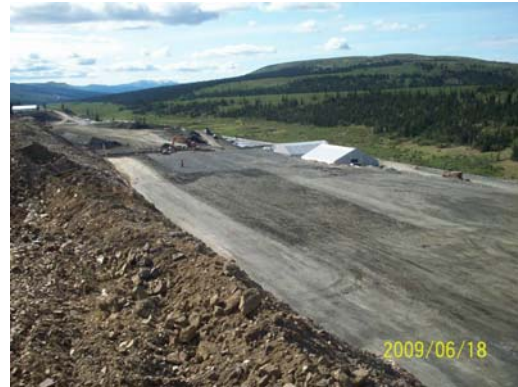
Photo 4: Looking down the cut slope at the Fuel Storage and Generator Pads.

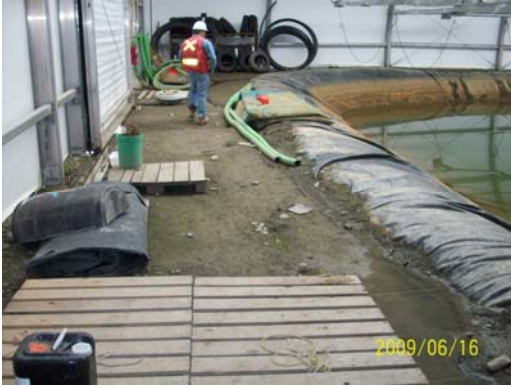
Sumps 1, 2 and 3 were constructed prior to 2009 and are situated within covered enclosures. All three sumps had noticeable settlement of the backfill along the perimeter liner key trench and buried propane lines - in some areas up to 150 mm of settlement. This settlement is an indication that the key trench and buried propane line backfill material was not compacted to specification during placement. There is no immediate attention required to filling these settlement areas but filling of these depressions would increase the perimeter grade elevations and reduce the amount of outside surface runoff from flowing into the sump. YZC was informed of these conditions and will carry out repairs as soon as possible. All three sumps were full of water during the time of the inspection so it was not possible to inspect the condition of the liners, but from what was visible there was no noticeable slumping of the liner slope. I was also told that there is a lot of sediment covering the bottom of each liner which would also make it difficult to inspect.

Photo 5: Looking NE from the western corner of Sump 1. Notice the settlement along the perimeter.

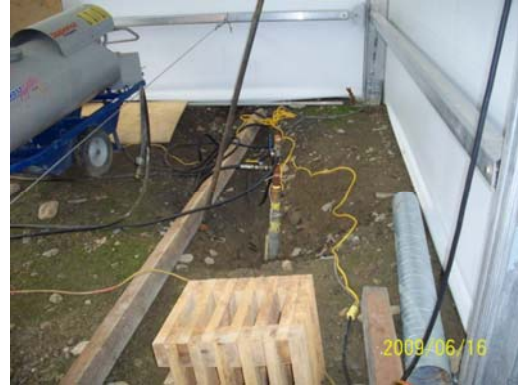
Photo 6: Looking at the NE corner of Sump 2 where there is noticeable settlement of the backfill over the buried propane line.

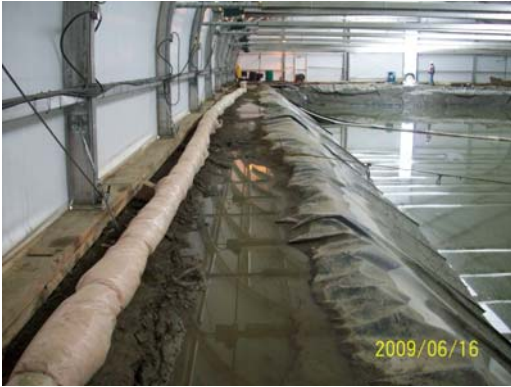
Photo 7: Looking at the liner key trench settlement along the perimeter of Sump 3.

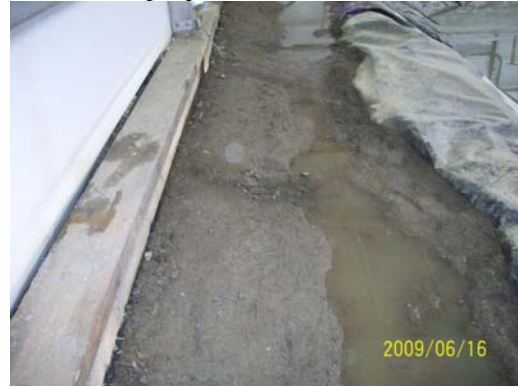
Photo 8: Looking at the seepage that is flowing in from beyond the perimeter of Sump 3's enclosure.

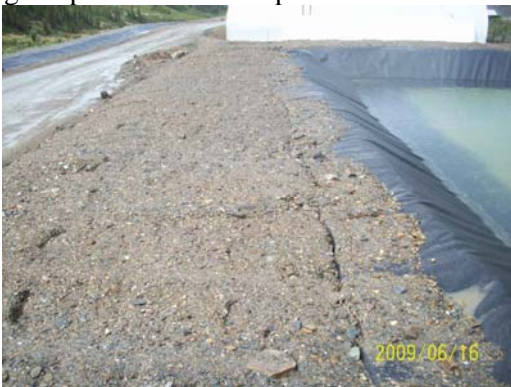
Sumps 4 and 5 were constructed earlier this spring and presently are not in covered enclosures. During the inspection the surface of the backfill along the perimeter of each sump was soft, which indicates that the backfill material was not compacted during placement. Presently there are no indications of fill deterioration but this area should be monitored and repaired as required. During the inspection Sump 4 was full of water and Sump 5 was empty. Sump 4's liner was not able to be inspected but from what was visible there was no noticeable slumping. A visual inspection of Sump 5's liner confirmed that there were no issues with the recent installation.

Photo 9: Notice the foot prints in the backfill material at Sump 4, which indicates that there was no compaction during placement.

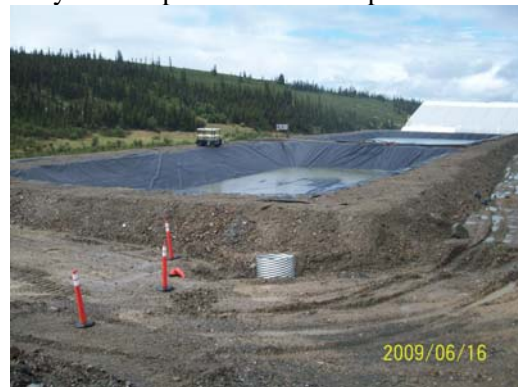
Photo 10: Looking west at Sumps 4 and 5. Sump 5 is empty.

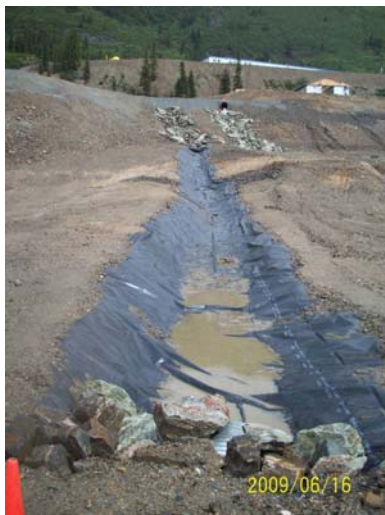
Photo 11: Looking East at the lower portion of Collection Ditch 2.

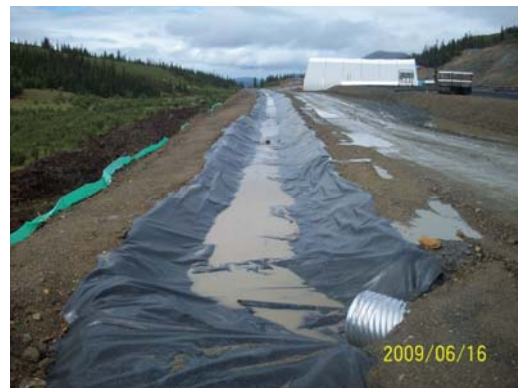
Photo 12: Looking NW at the alignment along Collection Ditch 3.

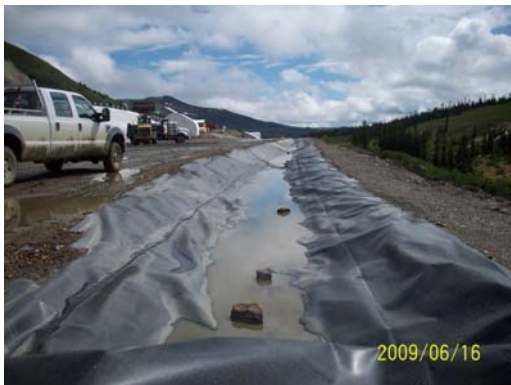
Photo 13: Looking SE at the alignment along Collection Ditch 4.

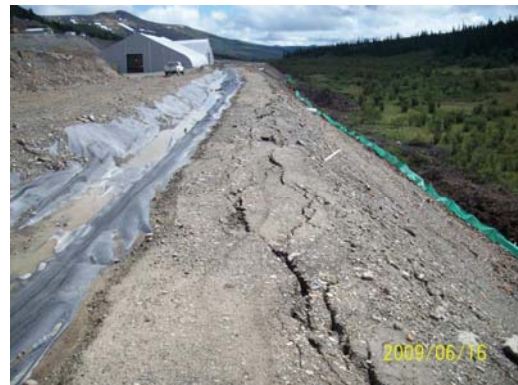
Only the lower portion of Collection Ditch 2 had been completed and this portion still required welding of the liner seams. Collection Ditches 3 and 4 were complete with the exception of the liner seams requiring welding. Along Ditch 4 there was a noticeable area where a large tension crack started to form along the western downslope between STA 0+070 and STA 0+170. YZC was immediately made aware of this situation and repair work commenced right away. Collection Ditch 5 was still under construction.

Photo 14: Looking SE at the tension crack along the downslope side of Collection Ditch 4.

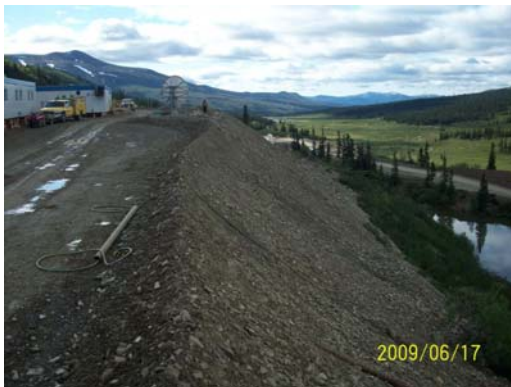
Photo 15: Looking SE from the NW corner of the Camp pad along the fill slope.

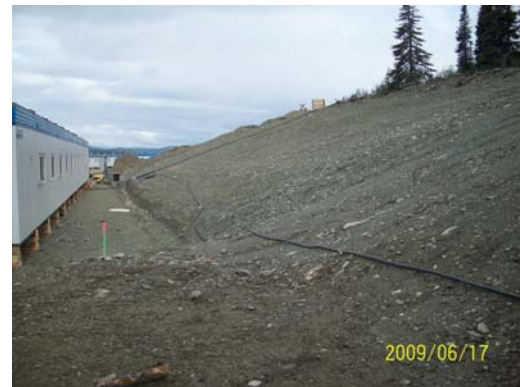
Photo 16: Looking NW from the SE corner along the back slope of the Camp pad.

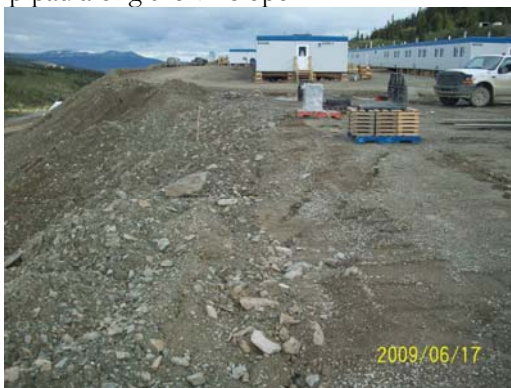
There were some noticeable settlement cracks along the perimeter of the southwest portion of the camp, and upper generator and water treatment pads. It looks as though these areas were constructed during the winter months and during the spring thaw settlement cracks have formed. These areas should be monitored and repaired as required.

Photo 17: Looking NW along the south west portion of the Camp pad at the area where settlement cracks have formed after spring thaw.

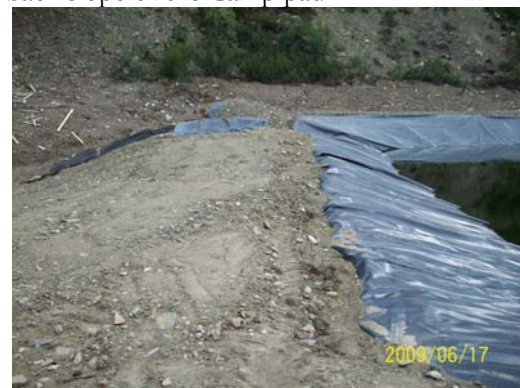
The treated effluent pond liner could not be inspected because the pond was full. The visible portion of the liner showed no indications of slumping. There was also noticeable settlement of the backfill along the liner key trench which indicates that the backfill material was not compacted during placement.

Photo 18: Looking at the settlement of the backfill material along the liner key trench of the treated effluent pond.

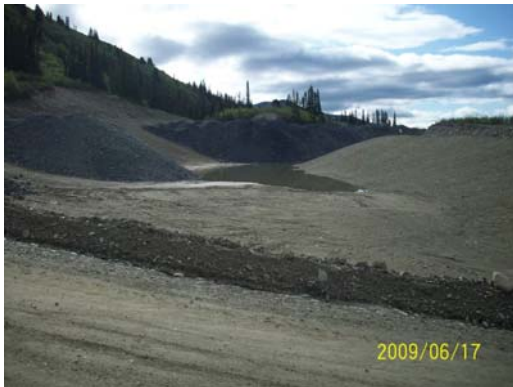
Photo 19: Looking SE at the Waste Rock and Ore Stockpile area.

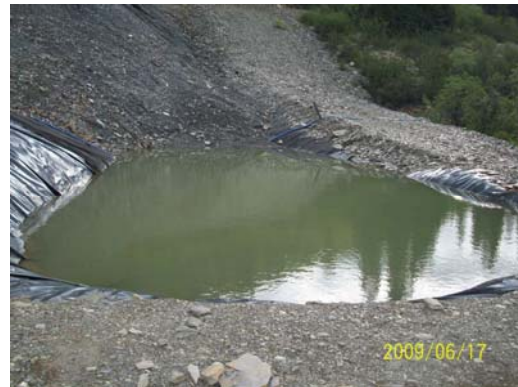
Photo 20: Looking east at the runoff collection sump for the waste rock end of the stockpile area.

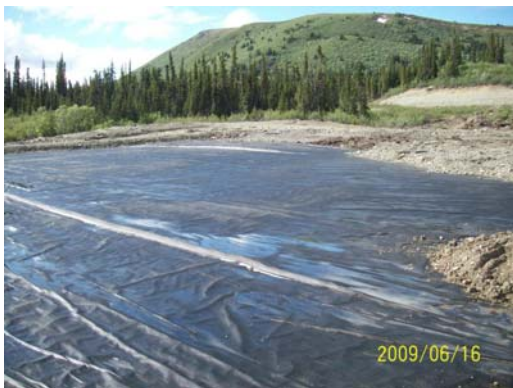
Photo 21: Looking north at the LTF.

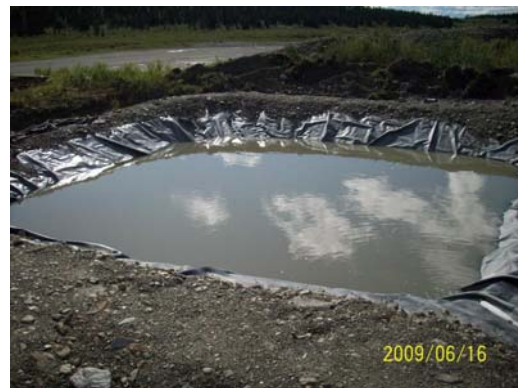
Photo 22: Looking west at the runoff collection sump that is located in the western corner of the LTF.

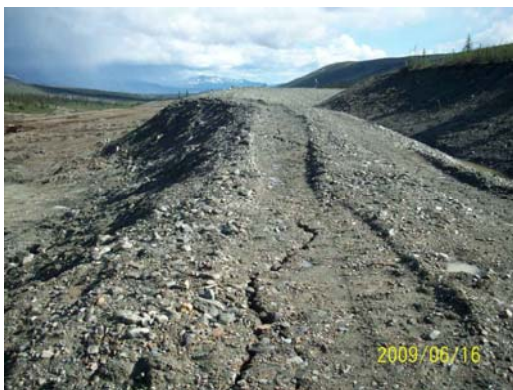
The Tailings Facility Diversion Ditches A and B were inspected and the fill portions (downslope sides) of both trenches had settlement cracks throughout. It is thought that the construction of the ditches was completed in late Fall - early Winter and the cracks formed in the uncompacted fill during the spring thaw. There is no immediate concern for these settlement cracks but they should be monitored and repaired before the Fall of 2009.

Photo 23: Looking south at the settlement cracks in the downslope fill portion of Ditch A.

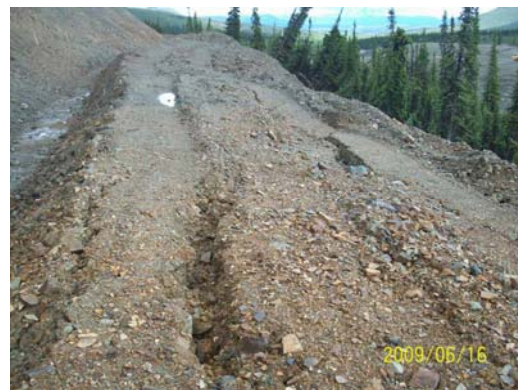
Photo 24: Looking SE at the settlement cracks in the downslope portion of the Ditch B.

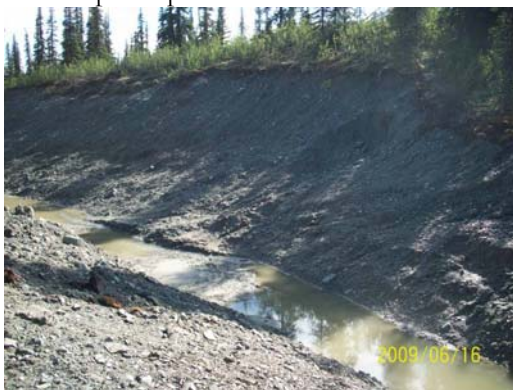
The upslope sides of both ditches were considered stable with the exception of two areas of localized sloughing, one area along the Ditch A and one area along Ditch B. There is no immediate concern but these areas should be monitored and should be repaired prior to Fall 2009. YZC was advised and will carry out remedial actions.

Photo 25: Looking SE at the cut slope of Ditch A. Notice the sloughing of the slope.

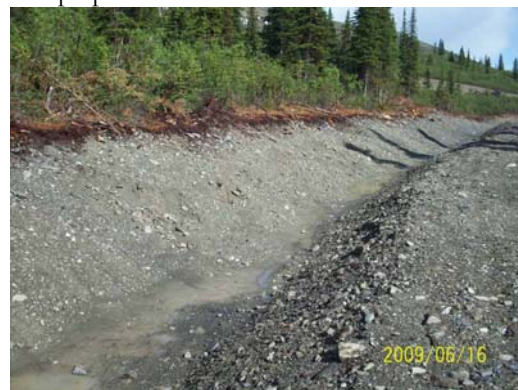
Photo 26: Looking SW at the cut slope of Ditch B at an area that is starting to slough.

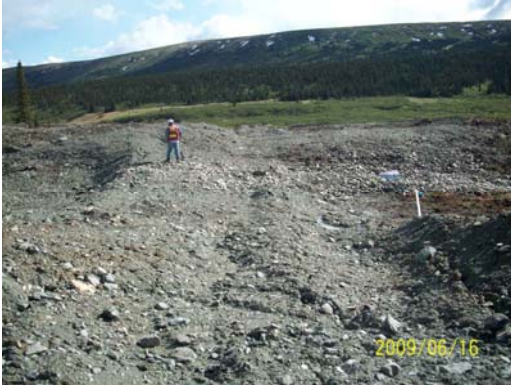
The buried CSP culvert portions of both Ditch A and B were also inspected and there was noticeable settlement depressions along both alignments that indicates that the pipes were installed in the late Fall – early Winter months. There is no immediate concern but the backfill along these alignments should be graded and compacted to reduce future erosion and settlement problems.

Photo 27: Looking SE at the buried CSP culvert alignment of Ditch A.

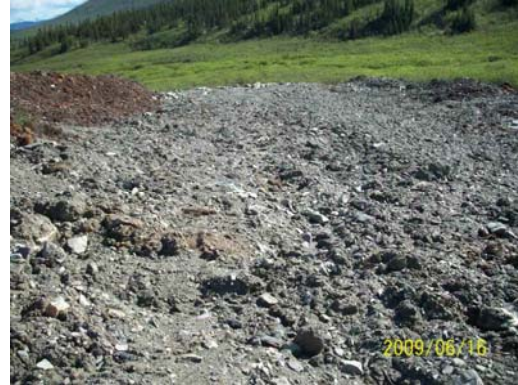
Photo 28: Looking south at the buried CSP culvert alignment of Ditch B.
