August 3, 2010

Yukon Zinc Corp.
#701 – 475 Howe Street
Vancouver, British Columbia
V6C 2B3

Wolverine Tailings Facility
Annual Tailings Facility Physical Inspection

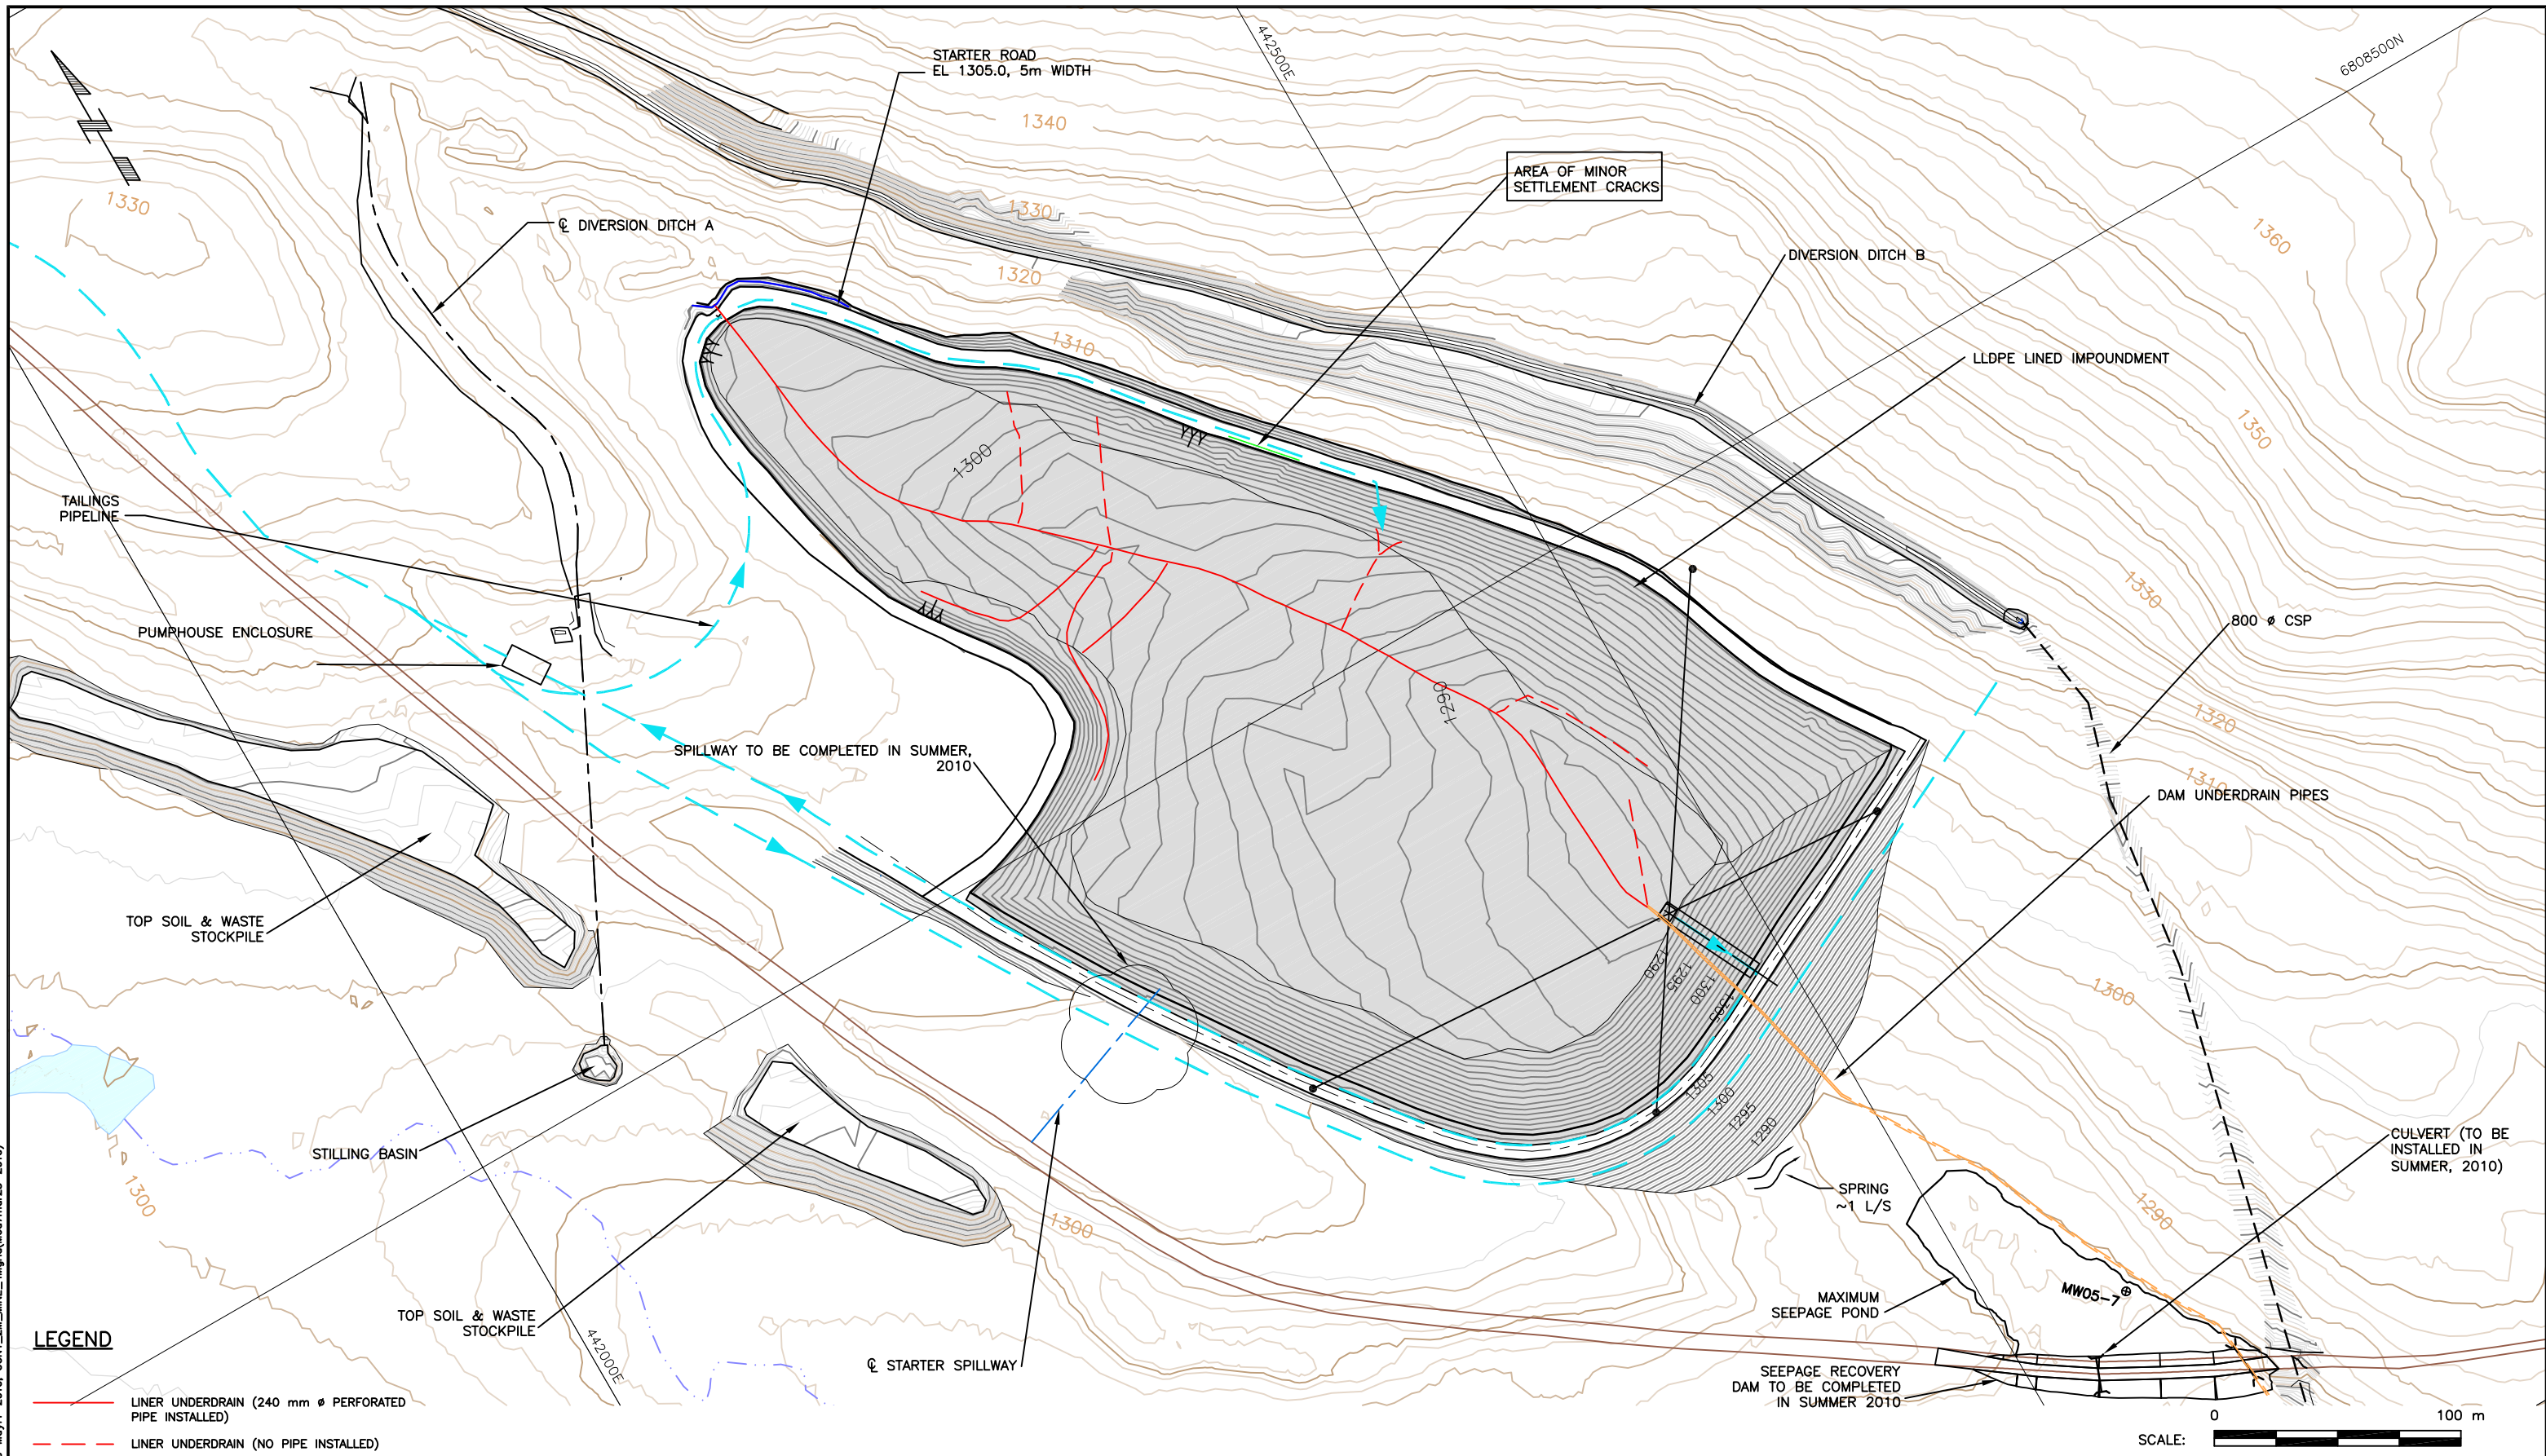
- The dam is in good condition and there are no signs of settlement, cracking or slope movement.
- Seepage was observed downstream of the dam near the right abutment and the location is shown in plan on the attached Figure 1. The seepage appeared to be coming from the low ridge (as opposed to through the dam). The flow rate was approximately 1 L/s.
- A moist area (as evidenced by a slight colour change) mid-way up the dam slope was observed. This area was noted in the As-Built Construction report and was due to placement of a moist fine soil layer. The layer does not influence the stability.
- The flow into the underdrains, at the top end of the impoundment, was estimated to be approximately 1.5 L/s. The flow exiting the underdrains, at the downstream toe of the dam, was estimated to be approximately 10 L/s.

- The east slope has what appear to be localized settlement cracks and small “sloughs”. These are likely due to the loose soil on the slope on which the liner has been installed. The minor cracks occurred over a length of approximately 15 m and are shown in plan on the attached Figure 1. The local sloughs, which may also be only variations in the slope during construction, are on the crest, about 300 mm from the top of the impoundment slope, and run parallel to the slope. As the water level and tailings level in the impoundment rises, this area will be stabilized, and as such is not a concern.

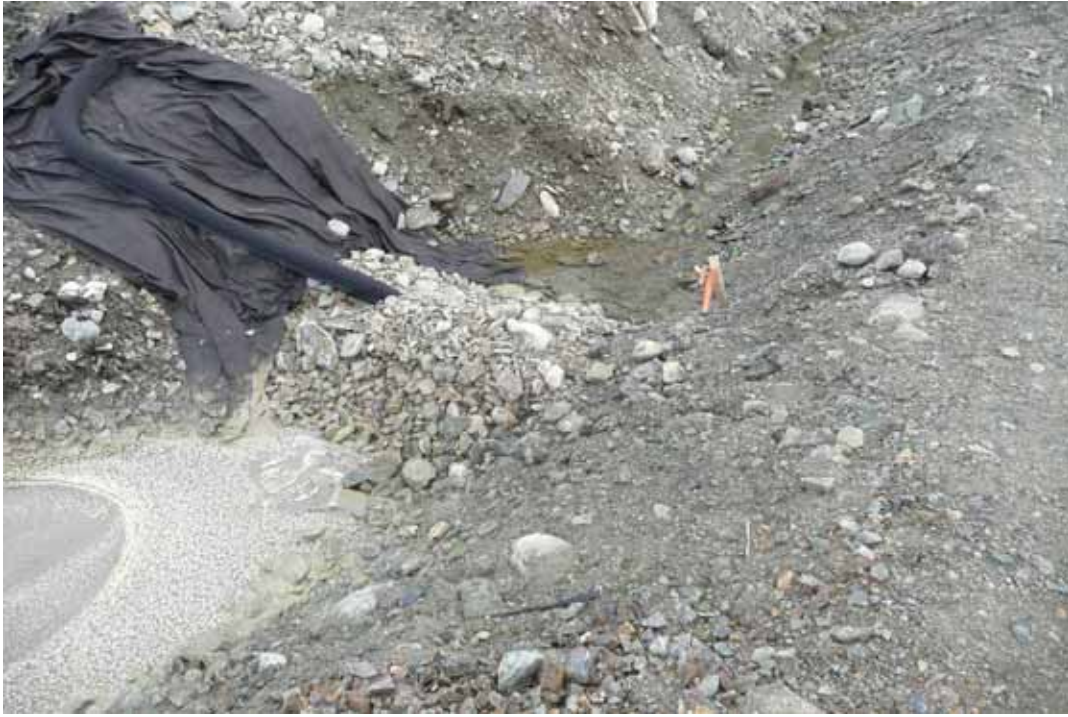
The liner underdrains, which consist of a French drain with perforated pipes under the liner and solid pipes under the dam are performing as designed. The inflows into the underdrains at the upstream end of the impoundment consist of 0.5 L/s from the area between Ditch A and the underdrain inlet, plus 1 L/s coming from the northern portion of Ditch B, which slopes toward the underdrain inlet.

Photo 8 Inlet to the underdrains at the upstream end of the impoundment

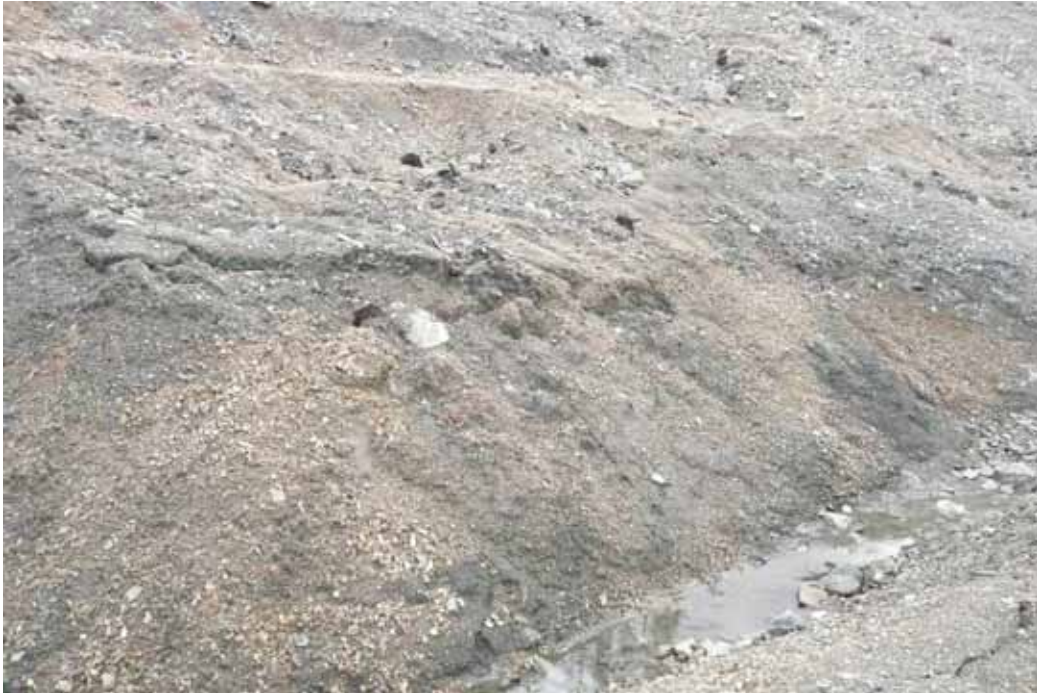
Photo 10 Inlet to the underdrain – flow from the upstream portion of Ditch B

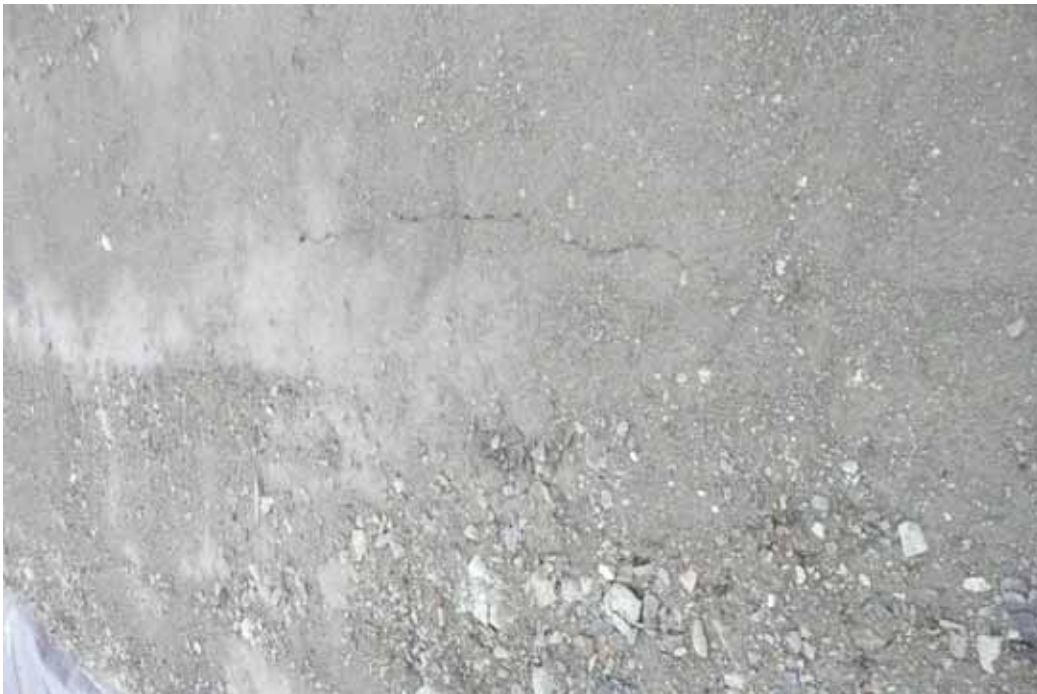
Photo 11 Minor settlement crack on perimeter road on the east side of the impoundment

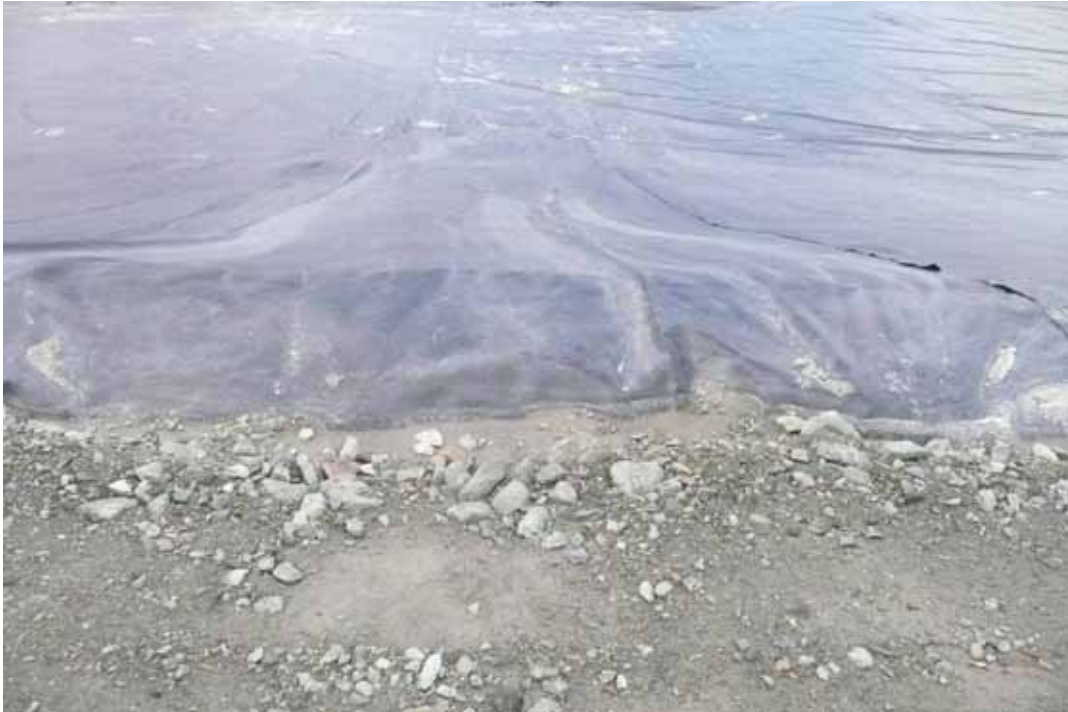
Photo 12 Minor slope slough under liner on the east side of the impoundment

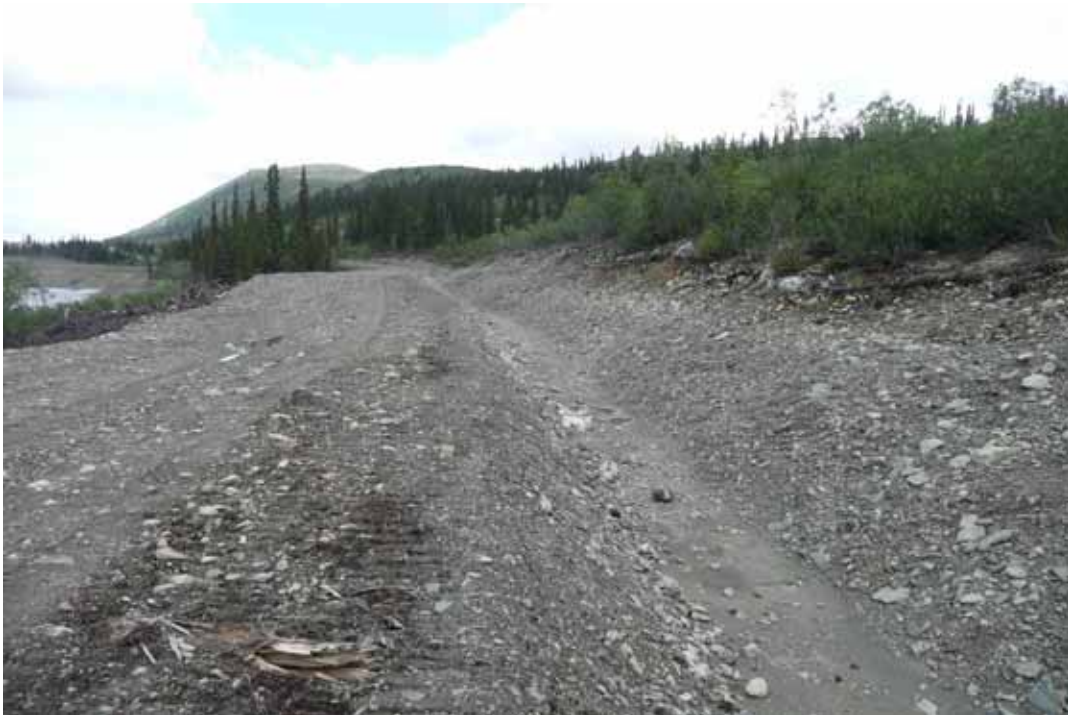
Diversion Ditch B had no flow. The soils in the base of the ditch and along the slope that the ditch traverses are relatively pervious and most slope runoff appears to infiltrate into the slope. This area should be observed after a heavy rain event and during spring freshet, to see whether the infiltrated water exits lower down the slope, above the liner and hence into the pond, or reports to the deeper groundwater under the liner. The ditch exits into a culvert, which extends down the slope towards the toe of the seepage dam, where it exits into a rockfill stilling basin. The stilling basin was in good condition.

Photo 17 Ditch B – no flow

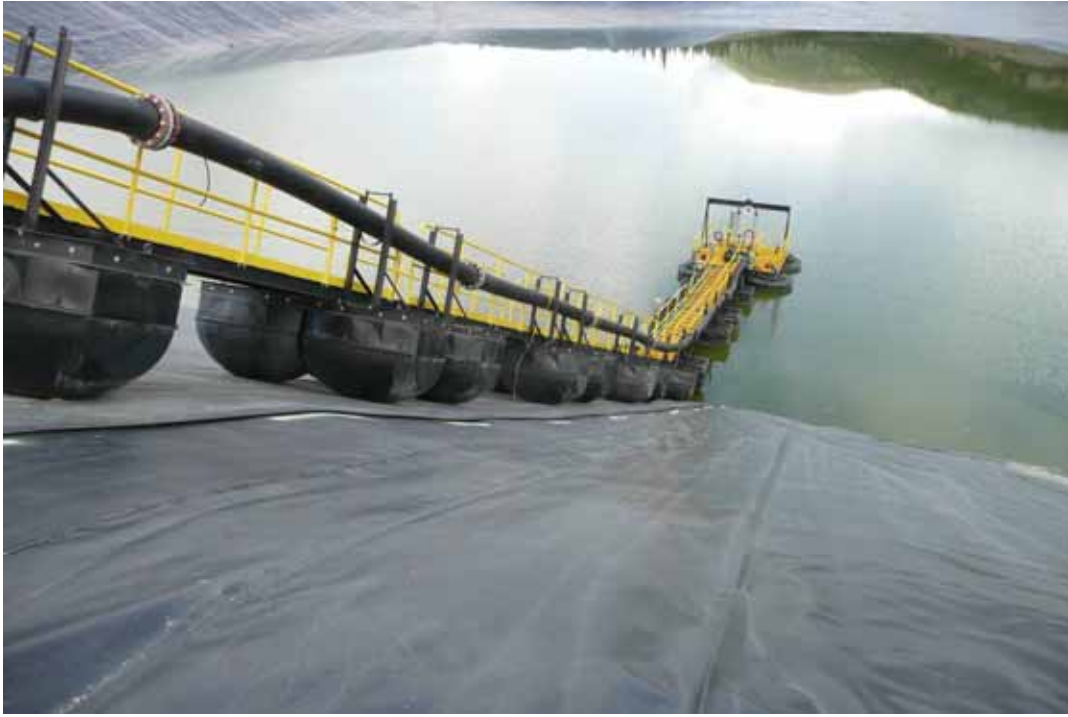
The tailings water reclaim pump barge, pumps and reclaim water lines have been installed and are readily accessible with a ramp down the upstream slope of the dam. A thick conveyor liner has been placed under the ramp to protect the geomembrane liner. The installation appears to have been carried out well and no areas of liner damage were observed.

Photo 22 Access ramp to pump barge – note protective liner layer

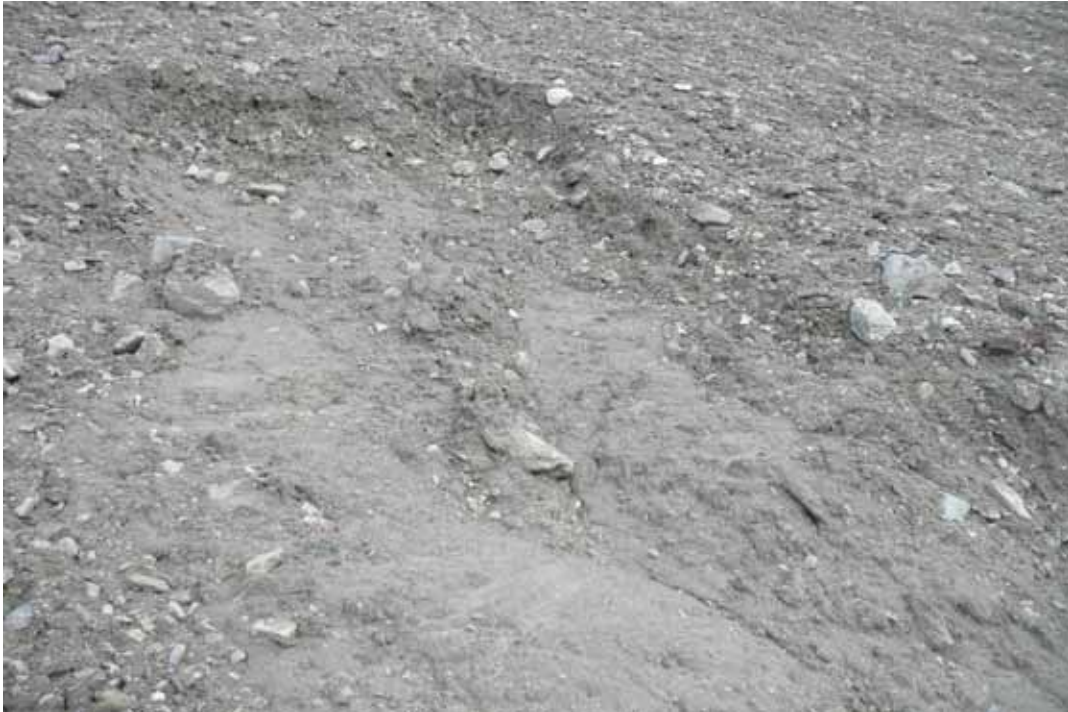
Photo 24 Moist area on left abutment of main dam

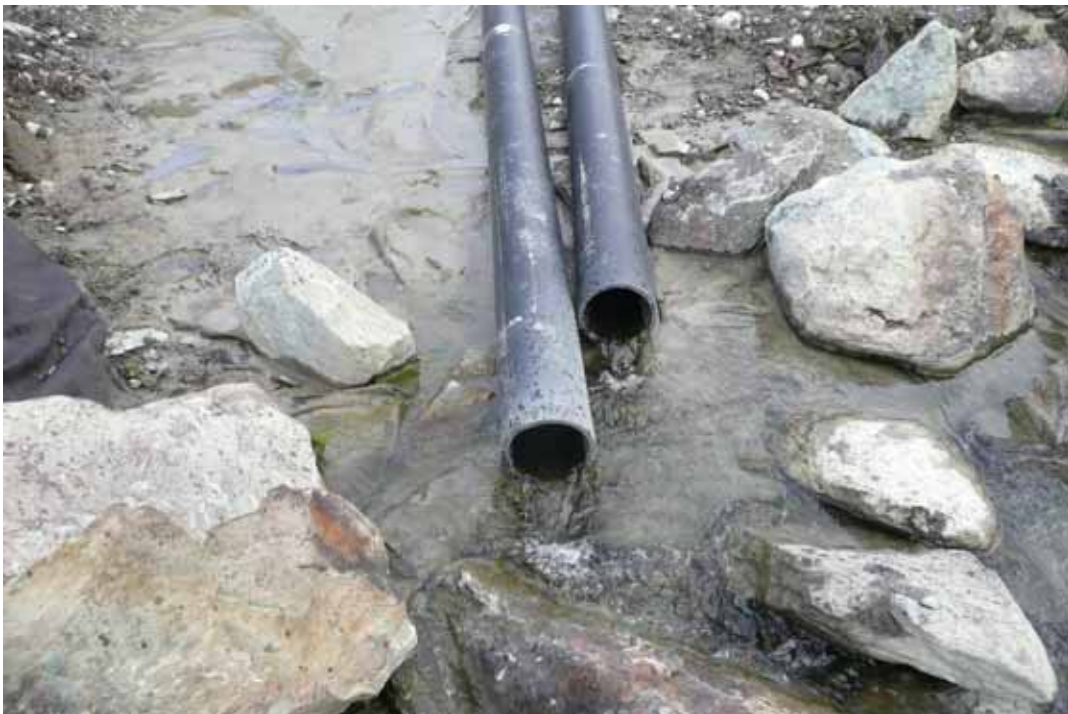
The flow out of the underdrains at the toe of the dam is approximately 10 L/s, indicating that the underdrains beneath the LLDPE liner are collecting approximately 8.5 L/s.

Photo 25 Underdrain pipes at toe of the dam – flow approximately 10 L/s

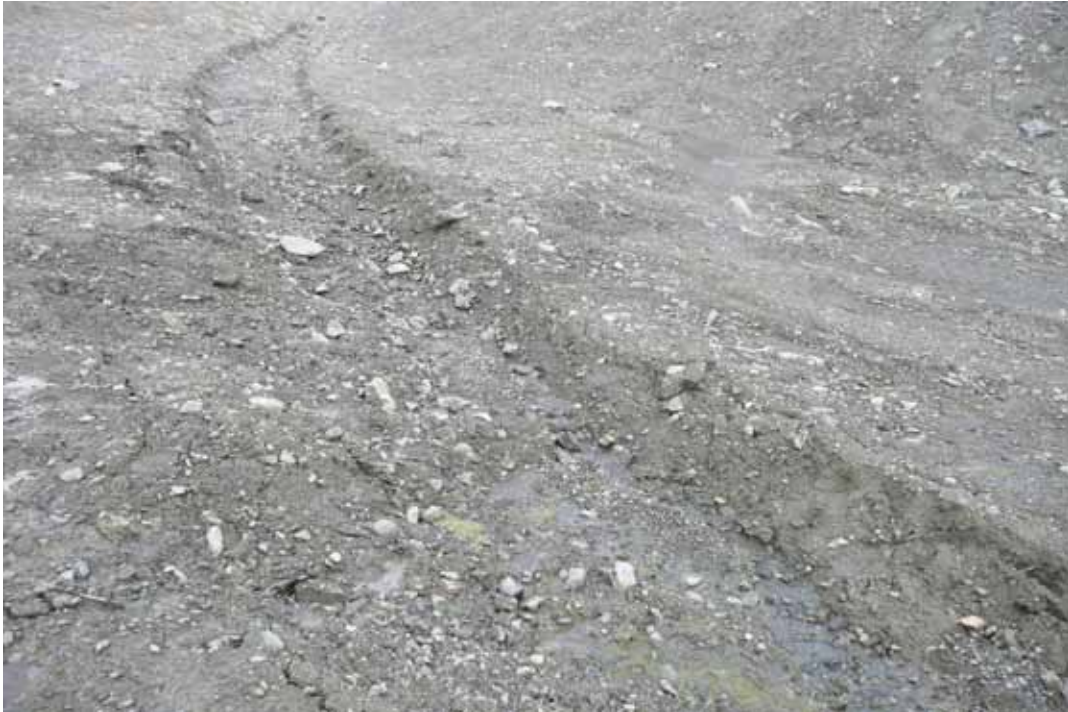
Photo 26 Seepage from low ridge near right abutment of dam - <1 L/s

1. Complete the 2010 construction works and installation of monitoring instrumentation.
2. Continue to operate the facility as described in the Operation, Maintenance and Surveillance Manual (Manual will be finalized in August after approval from Yukon Energy, Mines and Resources).
3. Observe the performance of Ditch B during high rainfall events and spring freshet to check if water reports to the impoundment or remains subsurface. If water emerges above the liner and flows into the impoundment, an estimate of the water flow rate should be made.
4. The settlement cracks along the perimeter road on the east side of the impoundment should be observed monthly to see if there are any changes.
5. Continue monitoring the spring near the toe of the dam to confirm that it is not significant.

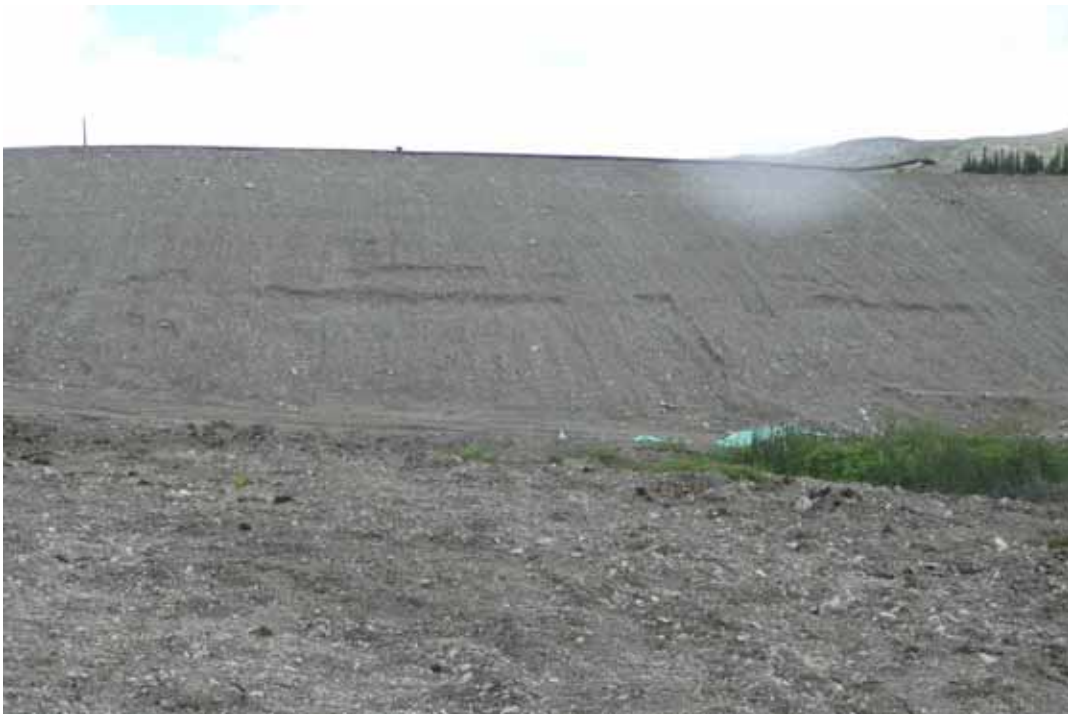
Photo 27 View of downstream slope of dam – note darker layers

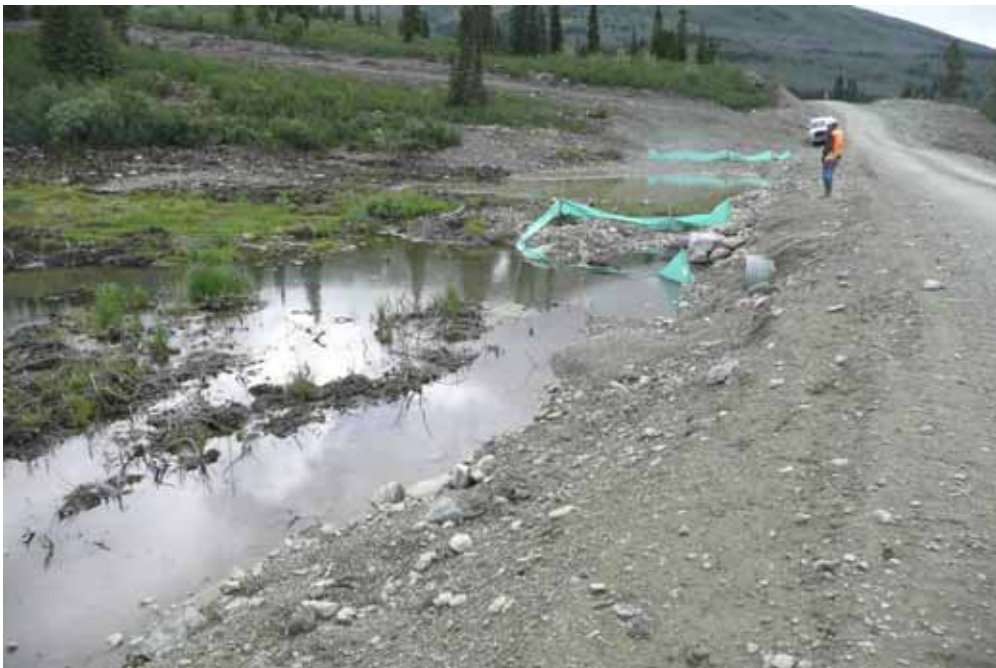
Photo 29 Seepage pond area – note culverts in road to be removed during construction of dam in August 2010

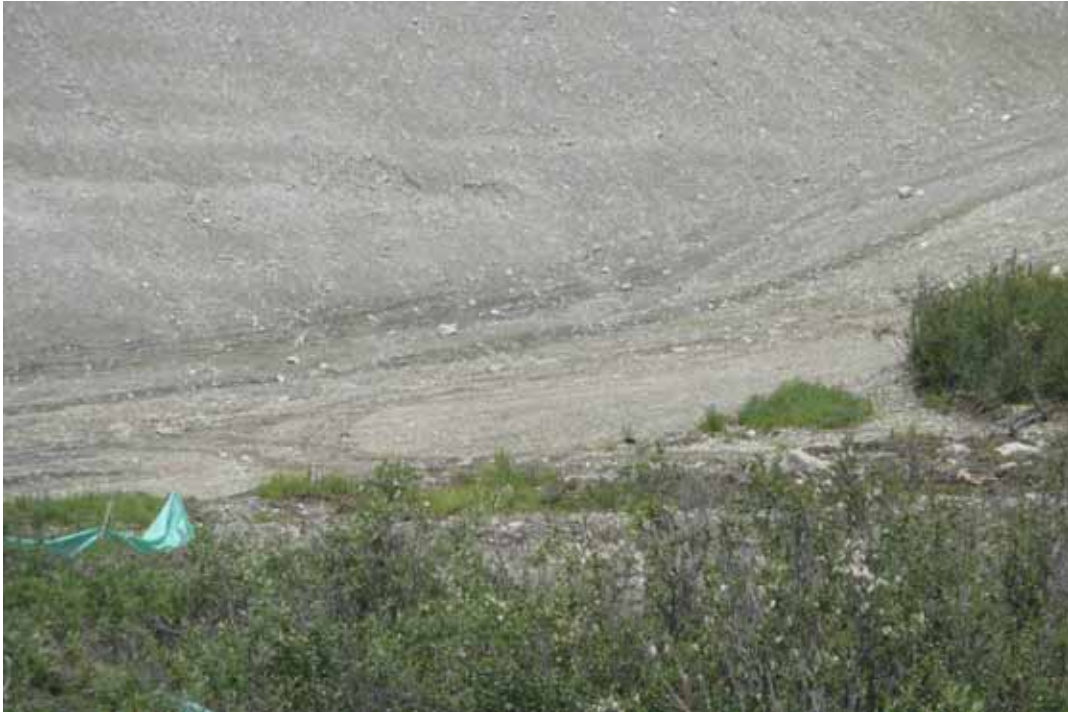
Photo 42 **View of moist areas on downstream slope of dam – left abutment**
