Rockland Ltd

January 2, 2011

Re: INSPECTION REPORT FOR QUARTZ MINING LICENSE - UNDERGROUND GEOTECHNICAL
INSPECTION

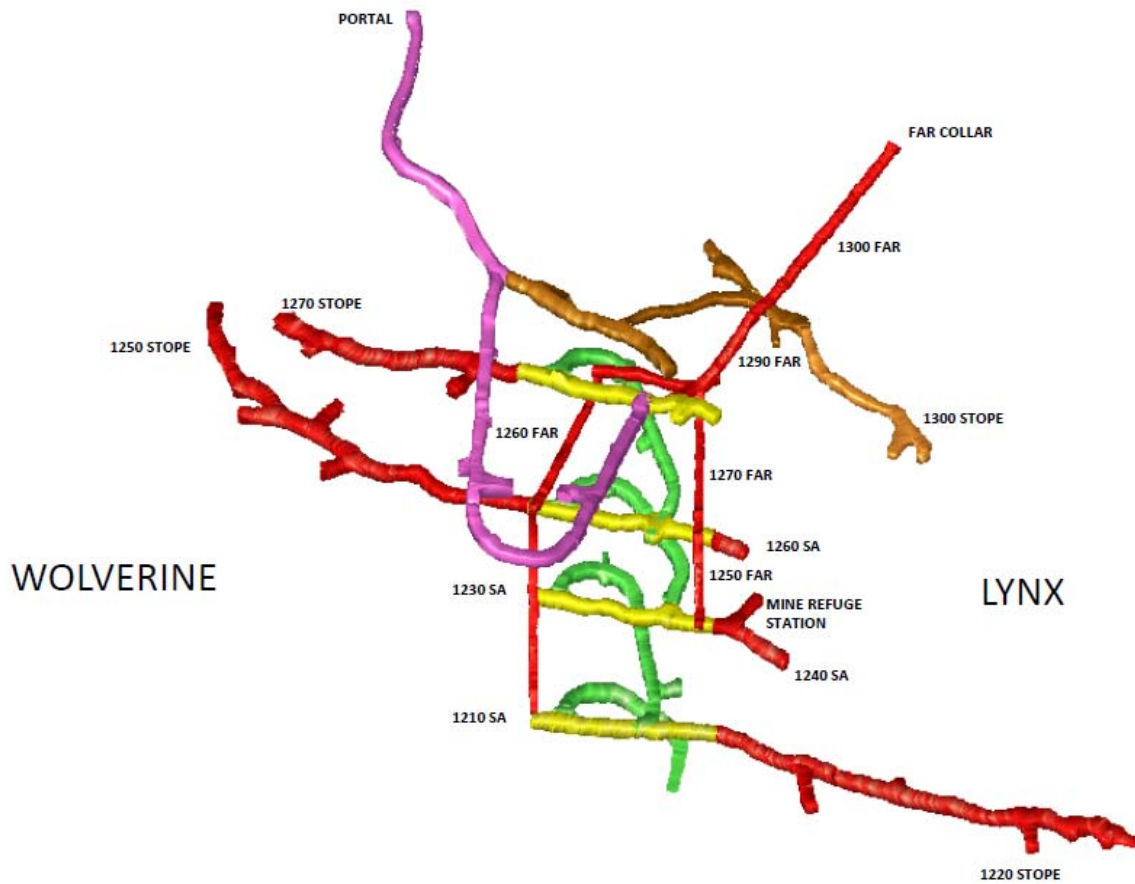
Figure 1: Ramp, SAs, Stopes and FARs at Wolverine mine
