August 15, 2012

ISSUED FOR USE  
EBA FILE: W14103029-01

**Subject:** 2012 Annual Observations of the On-site Earth Structures  
Wolverine Mine Site, South Eastern Yukon

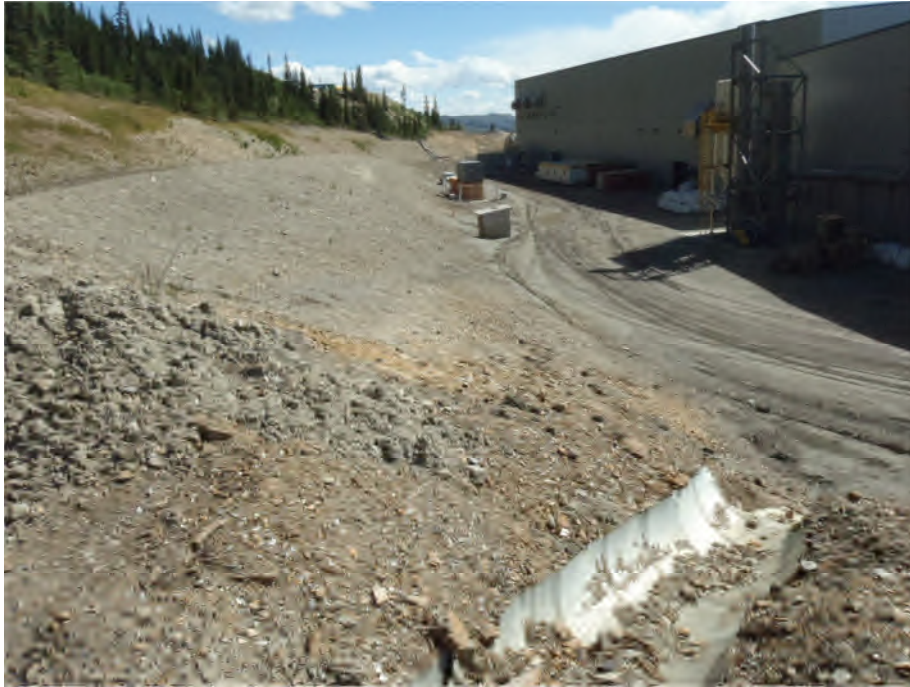
**Photo 1**

The 1:1 (H:V) design cut slopes in the bedrock for these areas are considered stable (Photo 1).

Looking SE along the backslope of the Mill location. (July 10, 2012)

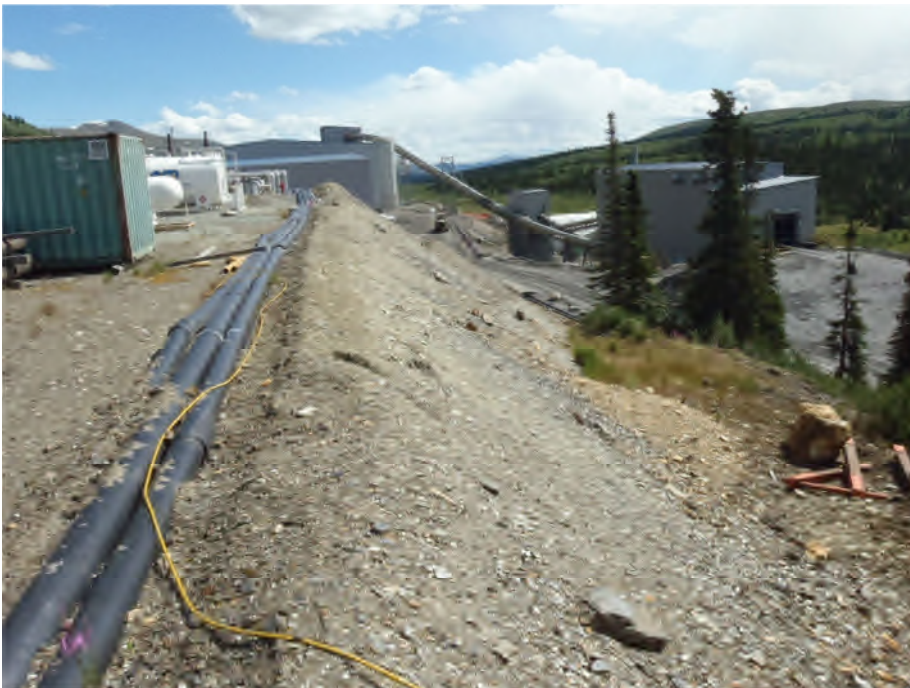
**Photo 2**

EBA observed the fill slope along the south western sides of the Mill, Fuel Tank Farm and Genset Pad locations (Photos 2 and 3). The fill slopes associated with the fill placement are considered stable and are constructed as per the 2:1 (H:V) design. As noted in previous annual inspection reports there are still some noticeable erosion channels (shown on Figure 1) along the south western side of the Mill fill that were created as a result of historical seasonal rain fall run-off events. This year proper perimeter berms and site grading was completed by YZC to divert surface runoff towards designated drainage ditches (Ditches 2 and 5). As for the erosion channels should still be filled in with coarse grained material.

Looking SE along the NW fill slope of the Tank Farm and Genset Pads. (July 10, 2012)

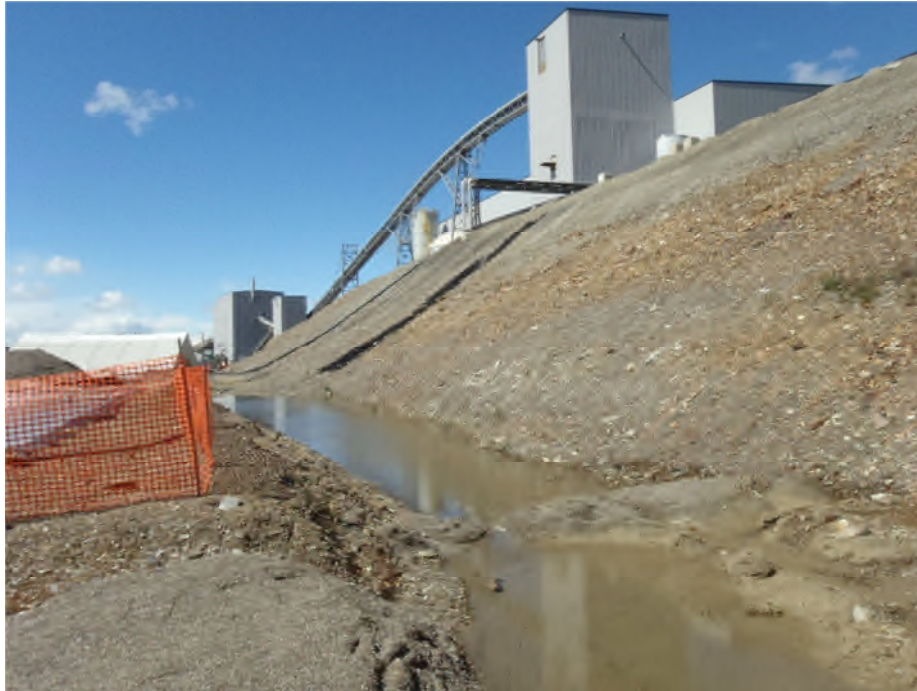
**Photo 3**

Looking NE at the fill slope of the Mill location. (July 10, 2012)

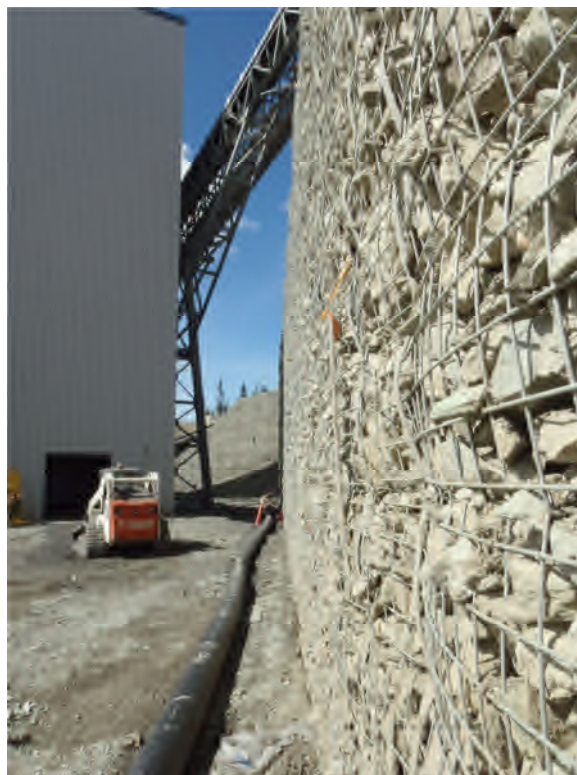
**Photo 4:**

EBA observed the Mechanically Stabilized Earth (MSE) wall (Photo 4) that is situated along the western portion of the south western side of the Mill fill and the north and east sides of the crusher building and there were no signs of bulging or noticeable zones of failure.

Looking NW at the MSE wall along the toe of the Mill fill. (July 10, 2012)

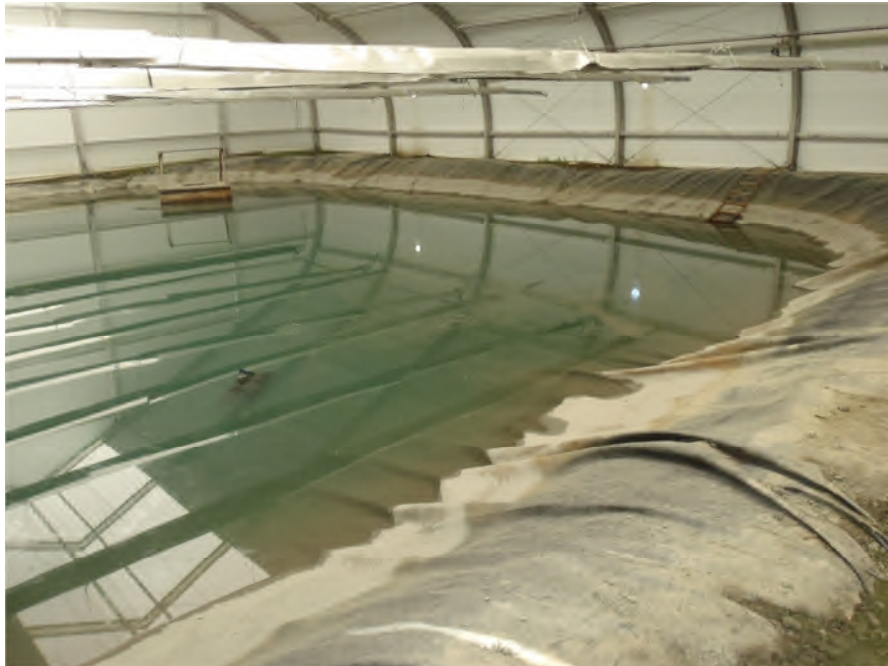
**Photo 5**

The foundations for Sumps 1, 2 and 5 were observed. Sumps 3 and 4 were decommissioned and filled in, Sump 1 (Photo 5) is no longer being used, Sump 2 (Photo 6) was full of sediment from the underground waste water and Sump 5 was being used for waste water and sediment storage from underground and run-off water from Ditch 2 (Photo 7). Both Sumps were full and it was not possible to see the entire condition of the liners.

Sump 1 half full of run-off water. (July 10, 2012)

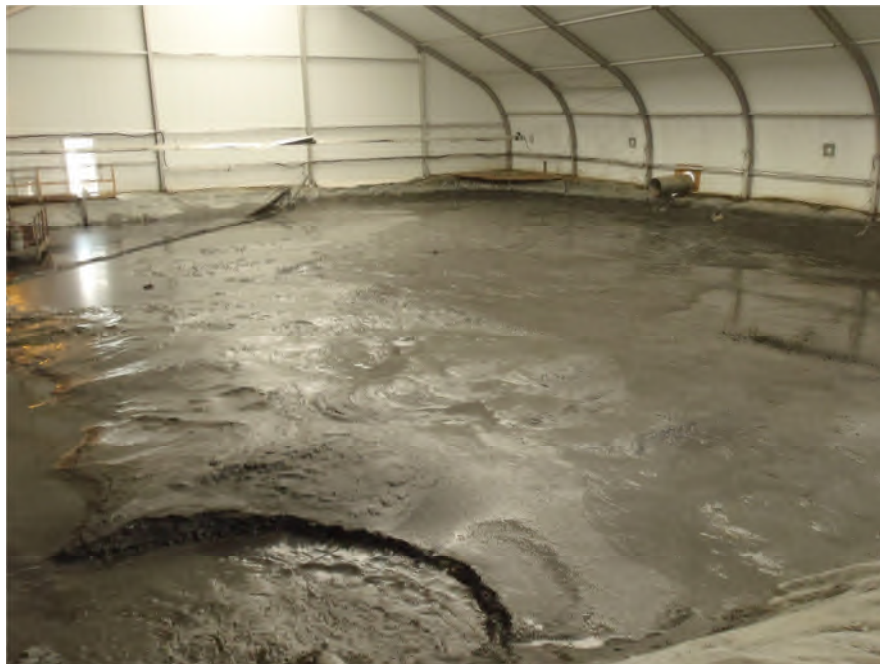
**Photo 6**

YZC's future plans are to decommission Sump 1. The foundation conditions noted in the 2011 annual observation report for Sumps 2 and 5 remain the same. There was still noticeable settlement along the key trenches of Sump 2 as the backfill material was not compacted during original construction.

Sump 2 full of sediment from the underground waste water. (July 10, 2012)

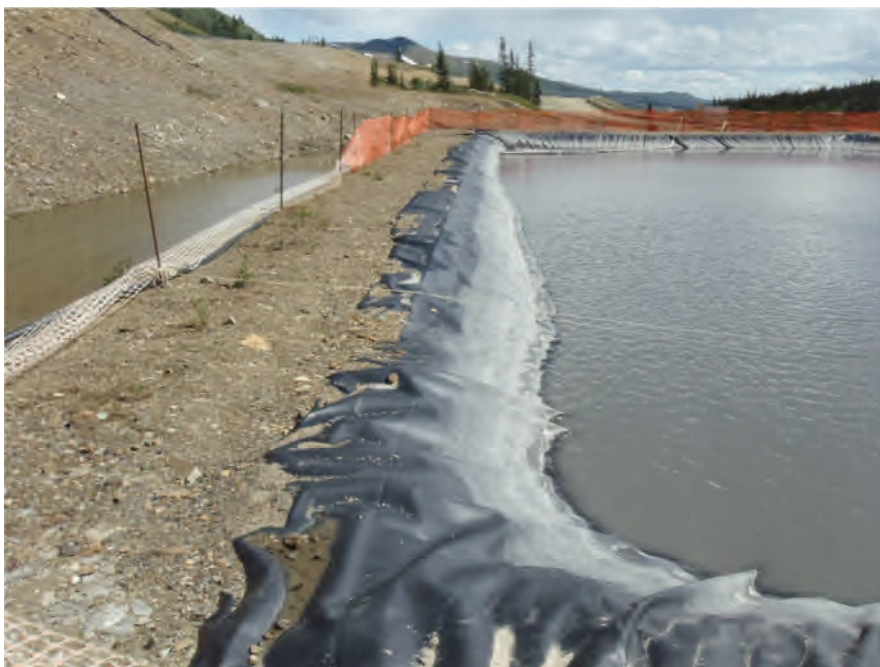
**Photo 7**

Containment of water and sediment in Sump 5. (July 10, 2012)

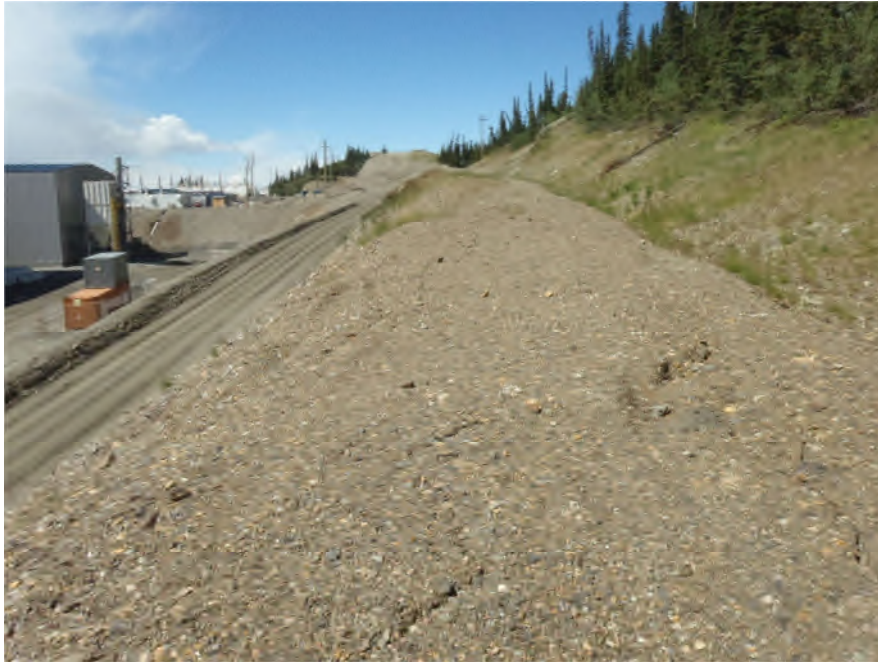
**Photo 8**

During the 2012 site visit, EBA noted that there were sections of diversion Ditch 1 that were lined with non-woven geotextile but for the most part the ditch remains unlined. There were small amounts of debris or slough from the upper slope deposited in the bottom of the ditch. In the future this material may have to be removed to allow for continuous water flow along the ditch bottom. As noted in previous observation reports the tension cracks and areas of settlement along the upper portion of the ditch embankment (Photo 8) were still noticeable. The tension cracks should be filled in to reduce the amount of water infiltration which may lead to instability of the embankment. The areas of settlement should also be graded to match the upper and lower sections of the ditch embankment.

Tension cracks and depression of an upper portion of the Ditch 1 embankment. (July 10, 2012)

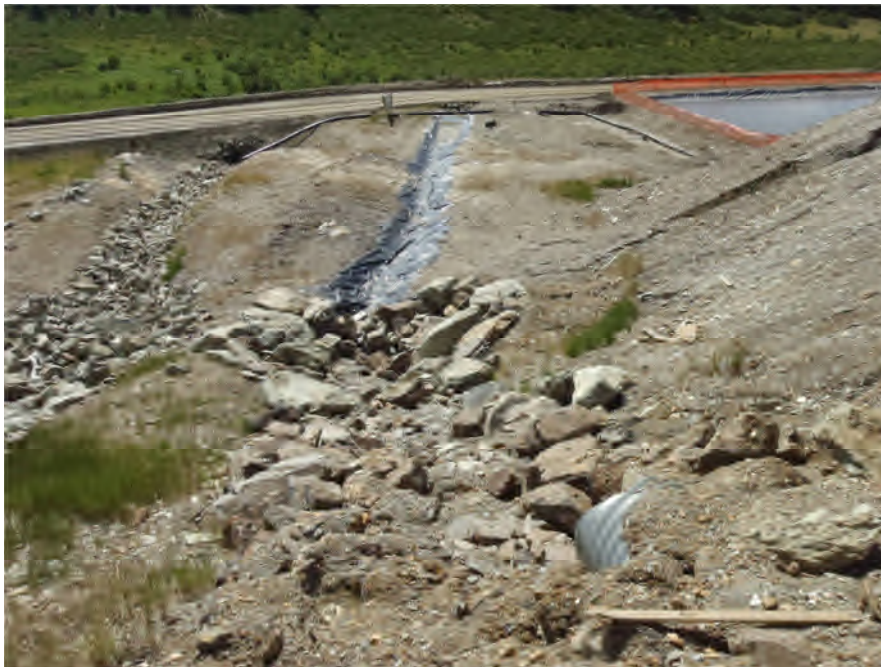
**Photo 9**

Ditch 2 was observed and only a portion of the collection ditch along the lower section between the Mill building location and the lower by pass road was lined. There were no observed issues noted with Ditch 2 (Photo 9).

The lower section of Ditch 2 that connects with Ditch 3. (July 19, 2011)

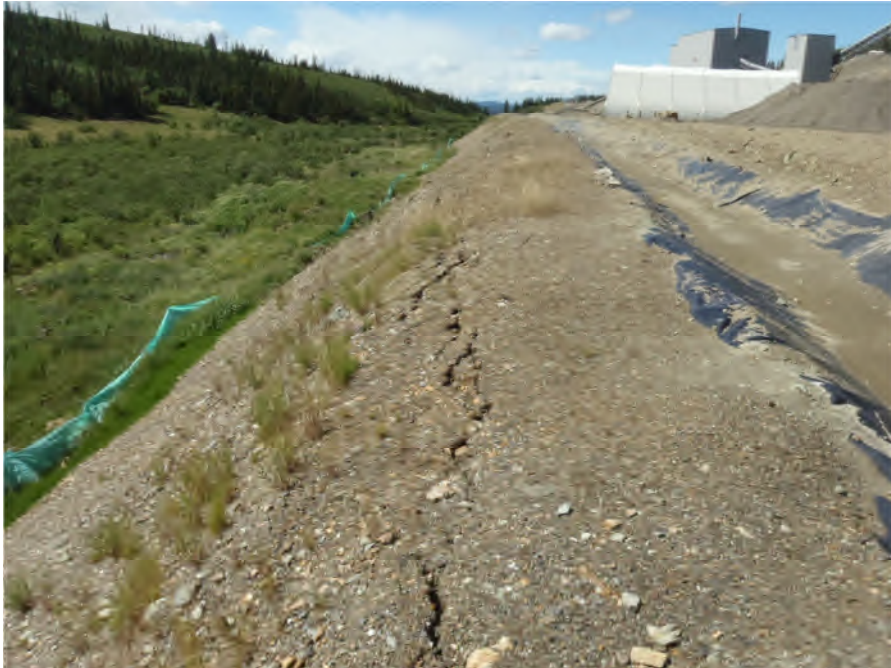
**Photo 10**

At the time of the site visit Ditch 3 was not being used and water from Ditch 2 was being pumped into Sump 5. Ditch 3 liner was damaged (tears and punctures) during the removal of sediment buildup from the previous year. Tension cracks and areas of settlement were also identified along the upper portion of the outer slope of Ditch 3 (Photo 10). Ditch 3's liner should be repaired and the tension cracks and areas of settlement should be filled to reduce the amount of water infiltration which may lead to instability of the embankment. The connector culvert from Ditch 3 to Sump 2 was completely plugged with sediment and will have to be cleaned out during the repair activities.

Looking NW at the tension cracks in the upper section of Ditch 3. (July 10, 2012)

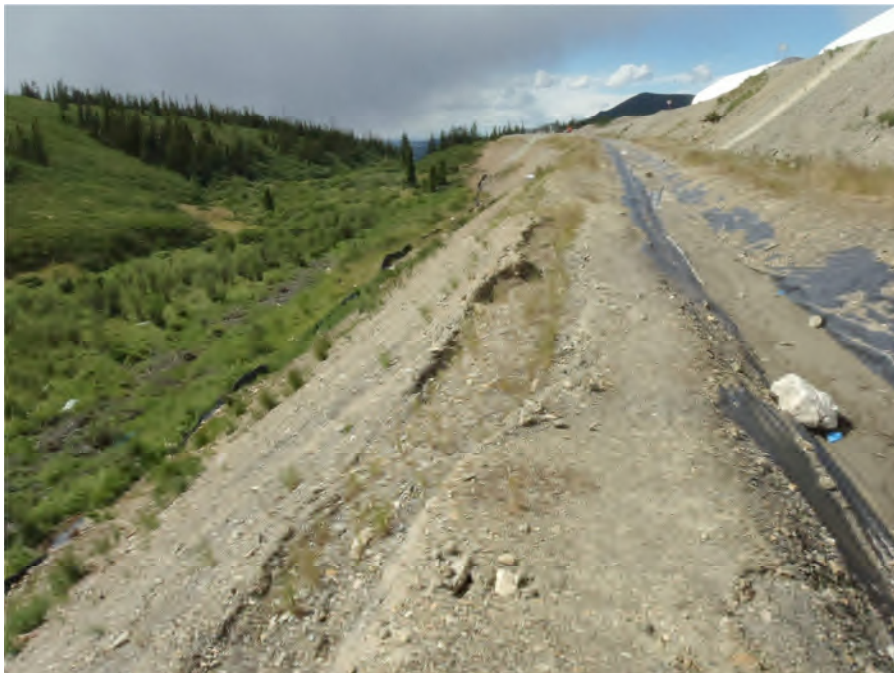
**Photo 11**

As noted in previous observation reports there were still many small tears or punctures of the liner along both side slopes of Ditch 4. The base of the liner appeared to be undamaged but the side slopes still require repair. There were other areas along of the ditch that require repair. There was numerous tension cracks and areas of settlement located along the crest and downslope side of the ditch (Photo 11), and erosion channels throughout the downslope side that require filling in to reduce the amount of water infiltration, which may lead to instability of the embankment (Photo 12).

Looking NW at a large tension crack and instability of the downslope side of Ditch 4. (July 10, 2012)

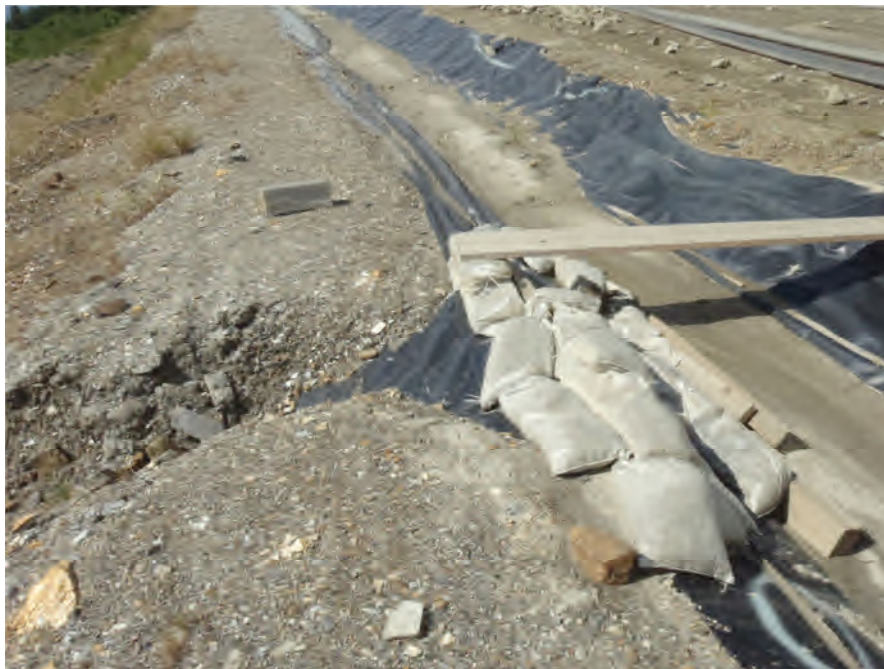
**Photo 12**

Looking NW at an erosion channel along Ditch 4 that requires repair. (July 10, 2012)

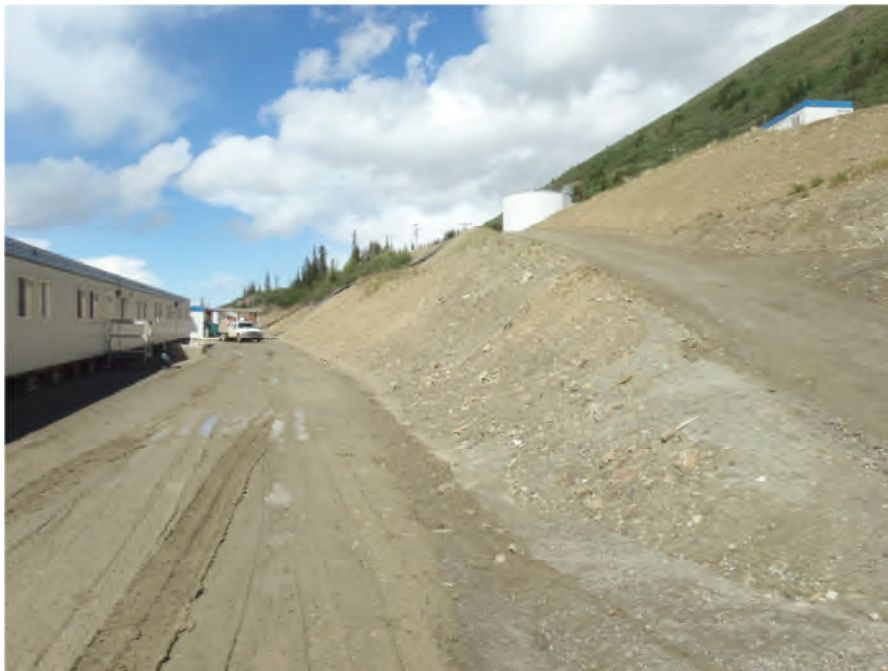
**Photo 14**

The 2:1 cut and 1.5:1 fill slopes for the camp pad, upper generator and water treatment pad, sewage treatment plant pad, and the treated sewage effluent pond were observed and the slopes were considered stable (Photos 14 and 15).

Looking NW along the backslope of the camp pad. (July 10, 2012)

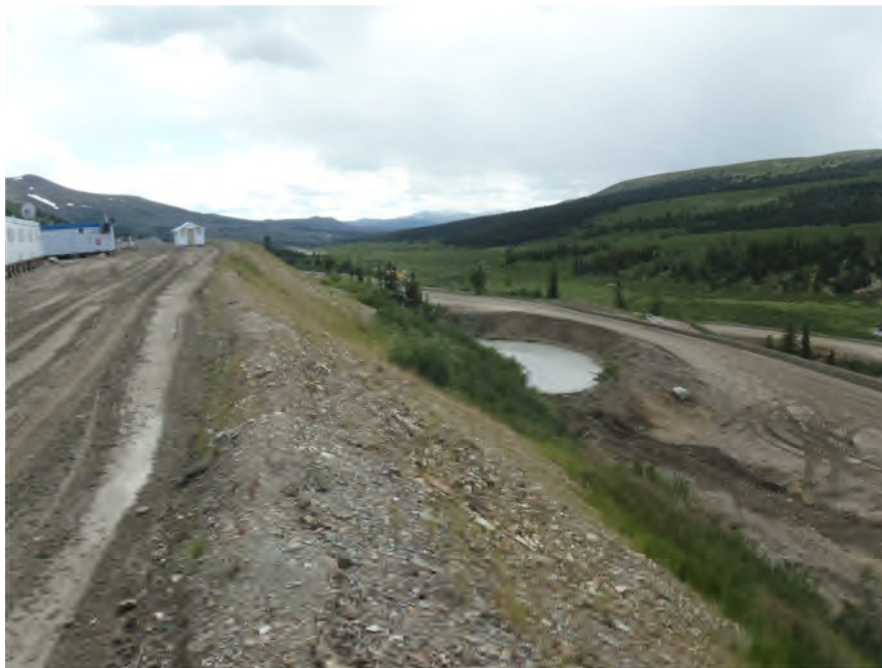
**Photo 15**

Looking SE along the downslope side of the camp pad. (July 10, 2012)

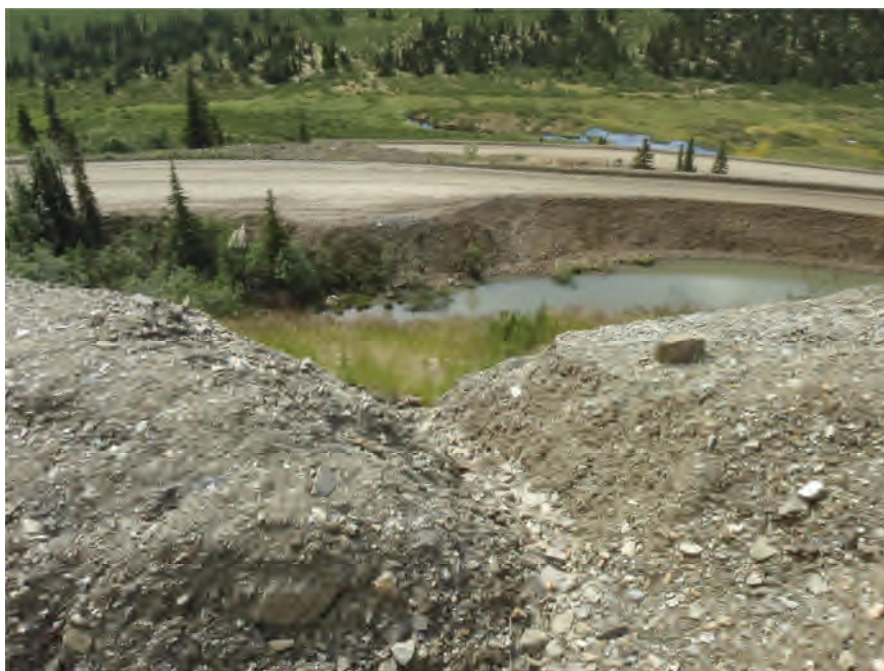
**Photo 16**

There were some noticeable tension cracks and erosion channels along the perimeter of the fill slope of the camp pad. Similar cracks and erosion channels were noted in previous observation reports (Photo 16). As mentioned in the previous reports these areas should be monitored and repaired as required.

One of the erosion channels along the downslope side of the camp pad. (July 10, 2012)

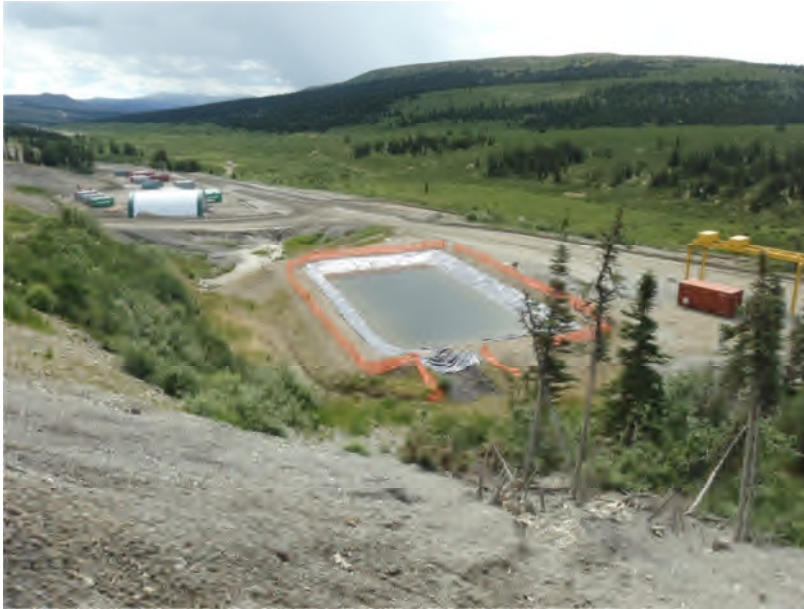
**Photo 17**

During the 2012 site visit the treated effluent pond, which is no longer being used as originally intended was half full of precipitation runoff, allowing for only partial visual observation of the liner (Photo 17). There were no indications of slumping or bulging of the liner. The perimeter exterior fill slopes were also reviewed and there were no noticeable signs of instability.

Looking at the former sewage effluent pond for the camp. (July 10, 2012)

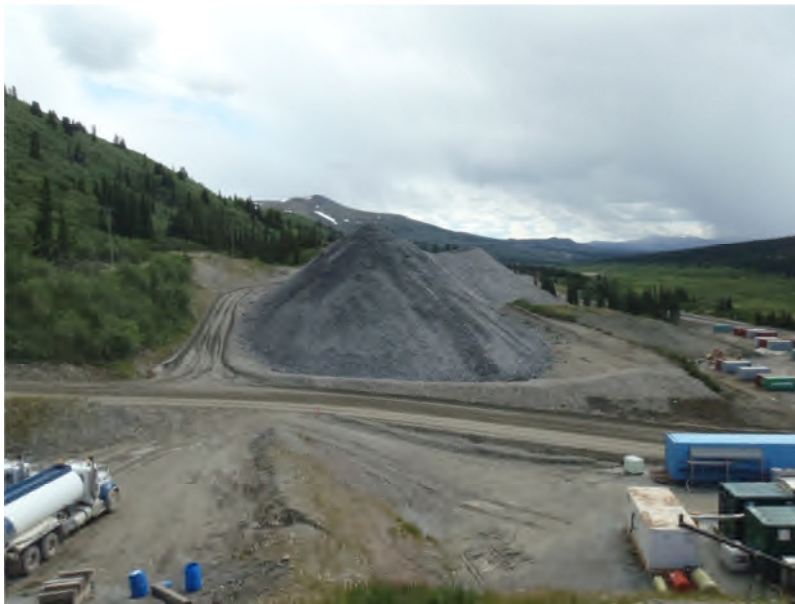
**Photo 18**

The cut and fill slopes in the facility were observed and considered stable (Photo 18). The collection sump was also observed and at the time was full of runoff water (Photo 19).

Looking SE at the Waste Rock and Ore Stockpile. (July 10, 2012)

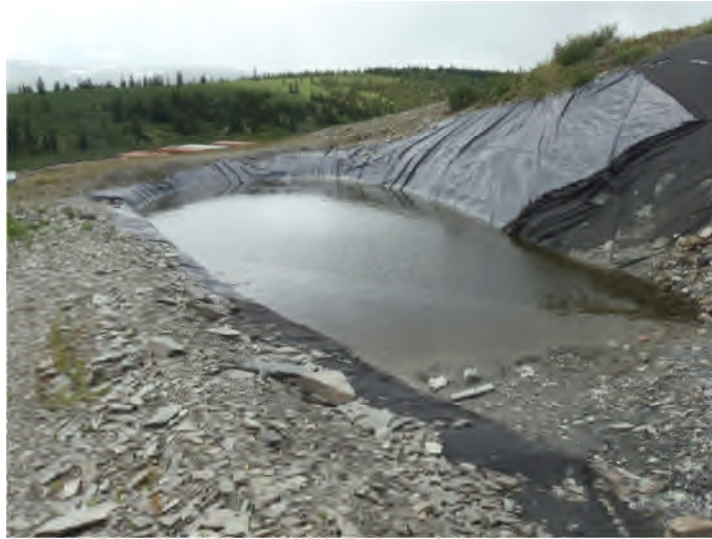
**Photo 19**

The Ore Stockpile area water run-off collection sump. (July 10, 2012)

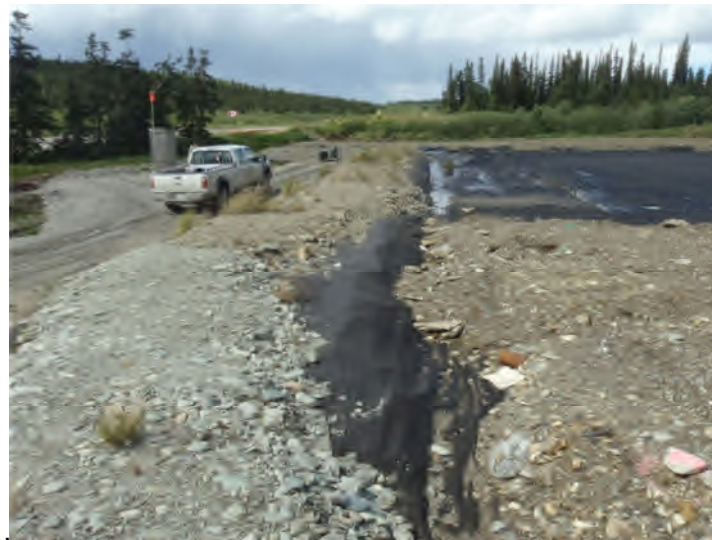
**Photo 19**

The berms and the liner of the land treatment facility (LTF) were observed and there was no noticeable deterioration of the berms or damage to the exposed liner (Photo 20). The LTF was about 50% full of hydrocarbon contaminated material and the collection sump was about 25% full of seasonal run-off (Photo 21).

Looking NW at the SW berm of the LTF. (July 10, 2012)

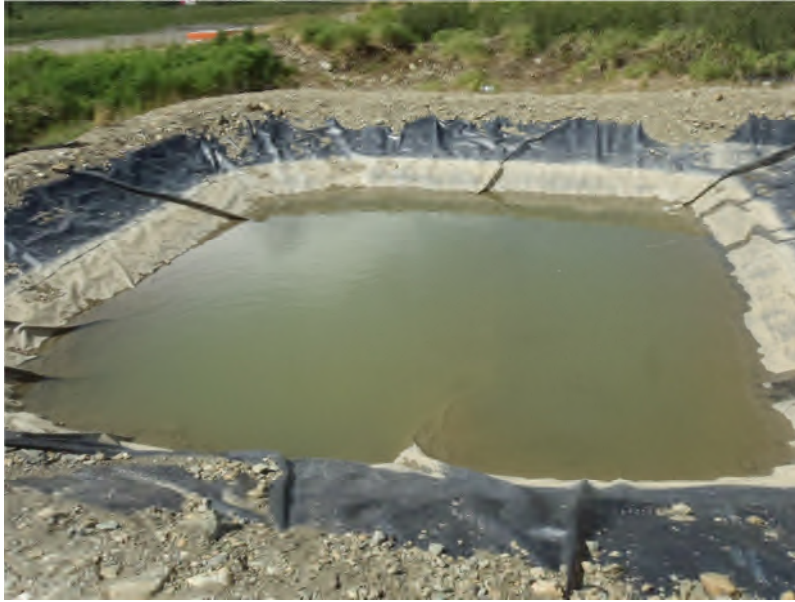
**Photo 20**  
Looking at the LTF sump. (July 10, 2012)

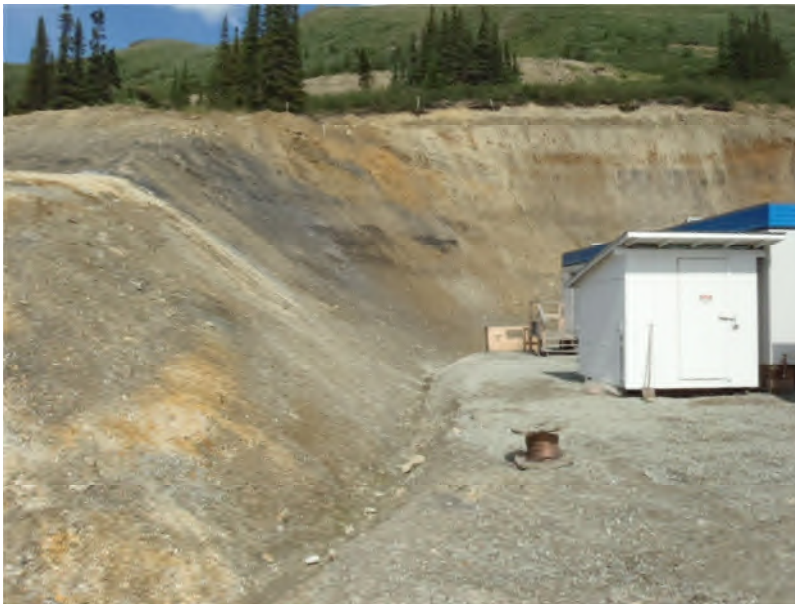
The 2:1 cut slopes for the vent raise and propane tank pad were observed and were considered stable (Photos 22 and 23).

**Photo 22**  
Looking at the backslope of the vent raise. (July 10, 2012)

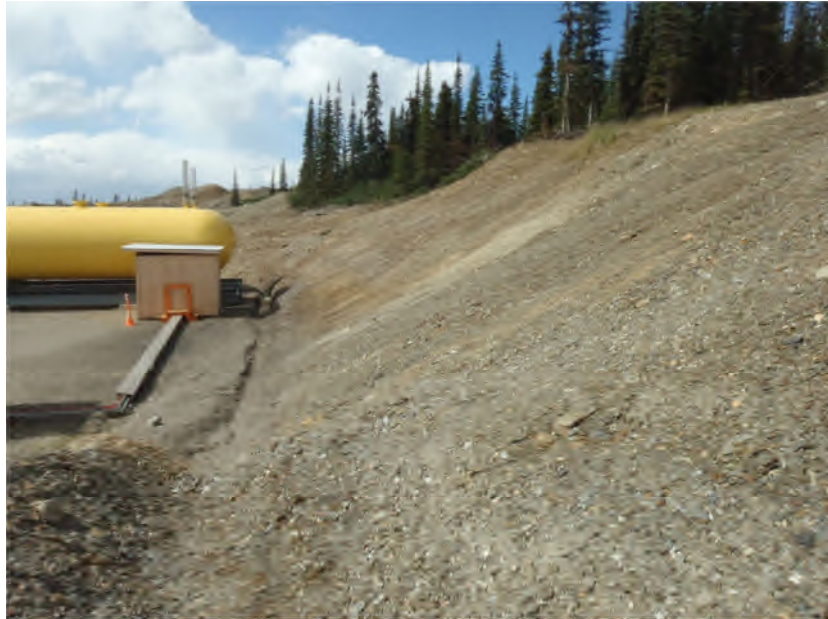
**Photo 23**

Looking at the backslope behind the propane tank pad. (July 10, 2012)

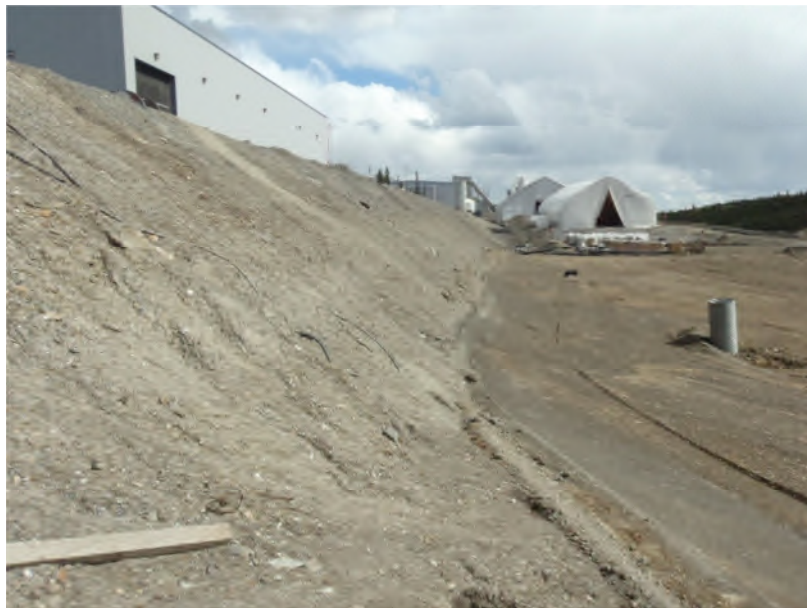
**Photo 24**

The 2:1 cut and fill slopes for the truck shop pad were observed and all of the slopes were considered stable (Photos 24 and 25).

Looking at the downslope of the truck shop pad. (July 10, 2012)

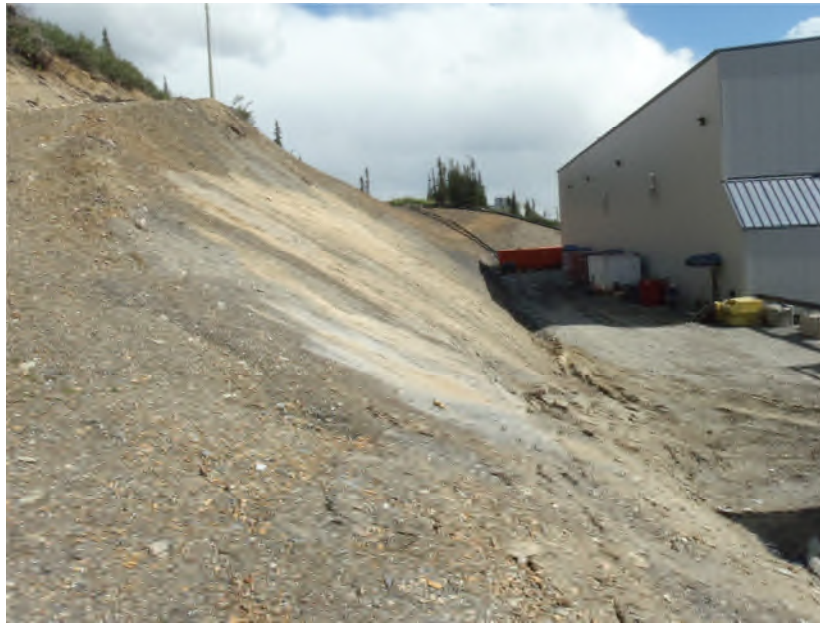
**Photo 25**

Looking at backslope behind the truck shop pad. (July 10, 2012)
