August 14, 2013

ISSUED FOR USE  
EBA FILE: W14103229-01

**Subject:** 2013 Annual Observations of the On-site Earth Structures  
Wolverine Mine Site, South Eastern Yukon

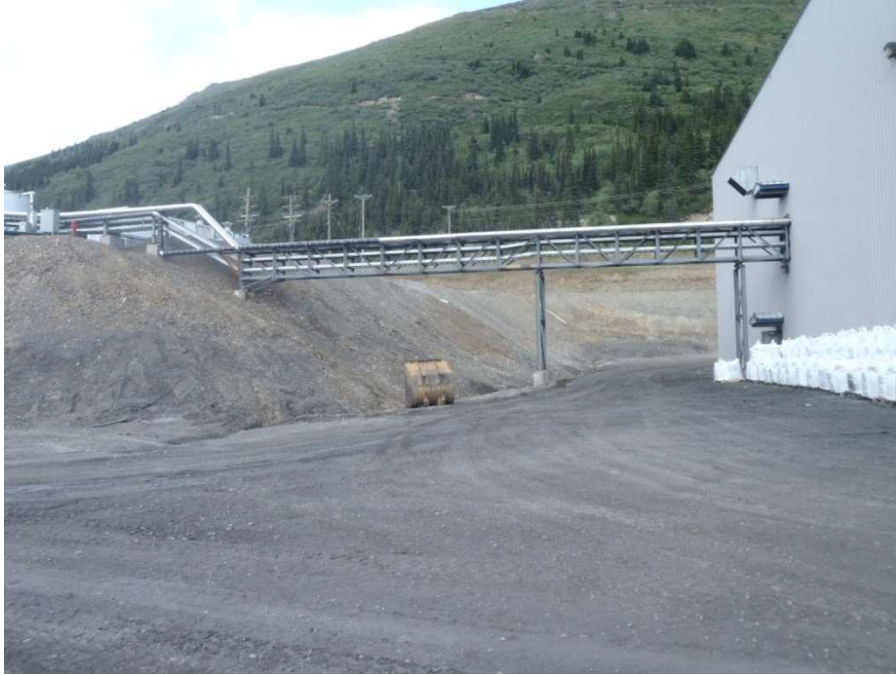
**Photo 1**

The 1:1 (H:V) design cut slopes in the bedrock for these areas are considered stable (Photo 1).

The backslope between the Genset Pad and Mill location. (July 9, 2013)

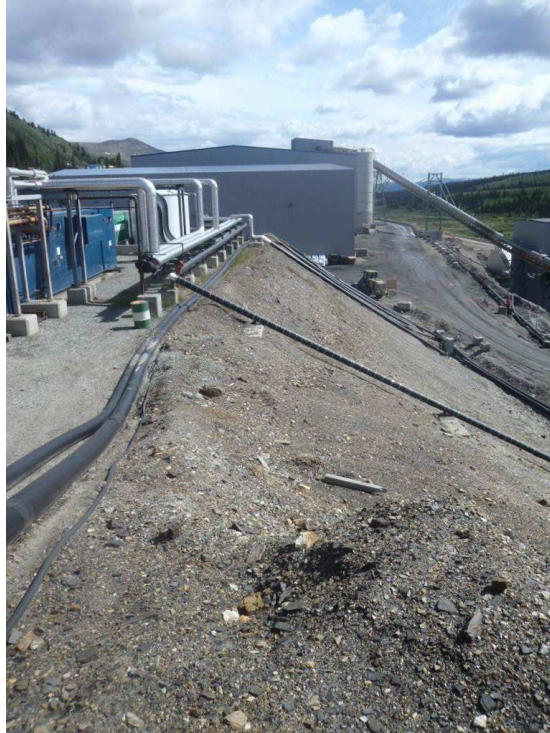
**Photo 2**

EBA observed the fill slope along the south western sides of the Mill, Fuel Tank Farm and Genset Pad locations (Photos 2 and 3). The fill slopes associated with the fill placement are considered stable and are constructed as per the 2:1 (H:V) design. As noted in previous annual inspection reports there are still some noticeable erosion channels (shown on Figure 1) along the south western side of the Mill fill that were created as a result of historical seasonal rainfall run-off events. Last year proper perimeter berms and site grading was completed and maintained throughout the year by YZC to divert surface runoff towards designated drainage ditches (Ditches 2 and 5). The erosion channels show no evidence of increasing in width and depth, but they should still be filled in with coarse grained material.

The NW fill slope of the Tank Farm and Genset Pads. (July 9, 2013)

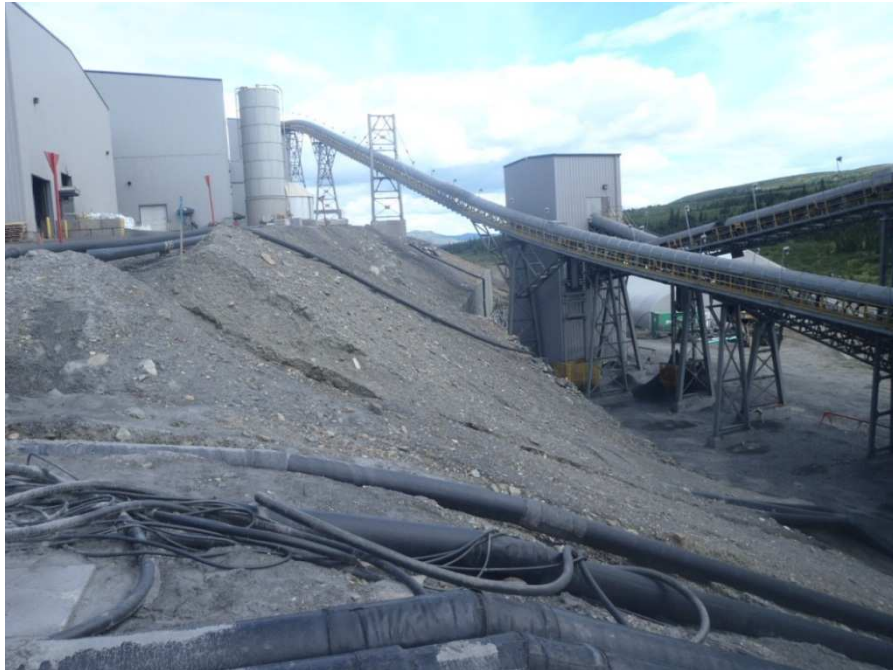
**Photo 3**

The fill slope of the Mill location. (July 9, 2013)

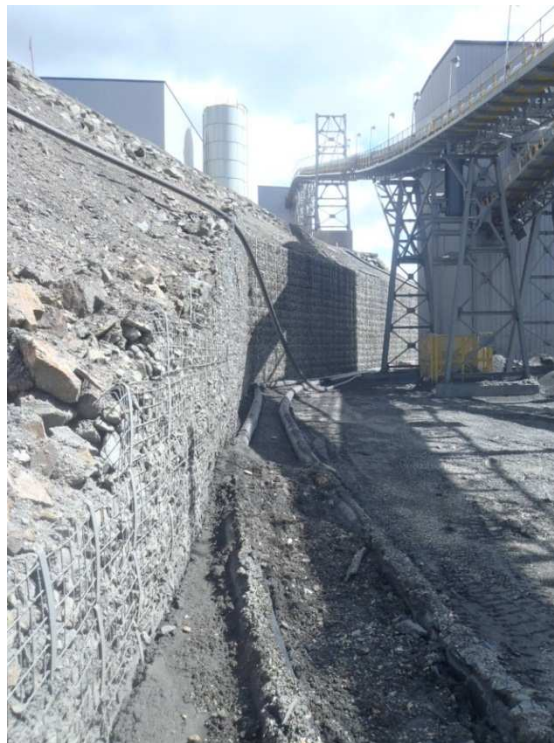
**Photo 4**

EBA observed the Mechanically Stabilized Earth (MSE) wall (Photo 4) that is situated along the western portion of the south western side of the Mill fill and the north and east sides of the crusher building and there were no signs of bulging or noticeable zones of failure.

The MSE wall along the toe of the Mill fill. (July 9, 2013)

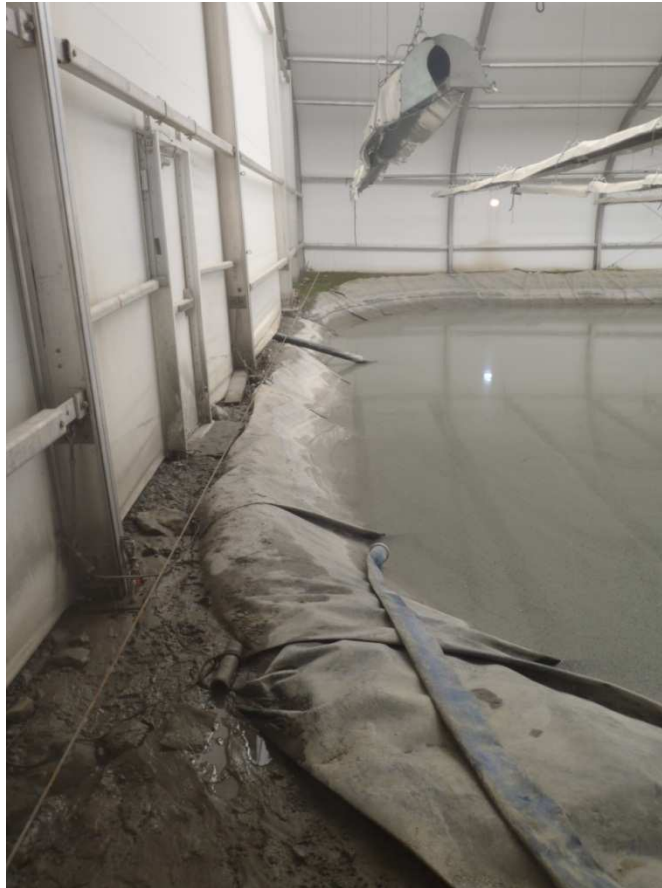
**Photo 5**

The foundations for Sumps 1, 2 and 5 were observed. Both Sumps 1 and 5 were being used for waste water and sediment storage from underground and run-off water from Ditches 2 and 5. Sump 1 (Photo 5) was full and it was not possible to see the entire condition of the liner. Sump 5 was only partially full and the liner was in good condition (Photo 6). During the site visit Sump 2 was not in service and was being reconstructed (Photo 7).

The foundation conditions noted in the 2012 annual observation report for Sumps 1 and 5 remain the same. There was still some noticeable settlement along the key trenches of Sump 1 as the backfill material was not compacted during original construction.

Sump 1 almost full of underground mine water. (July 9, 2013)

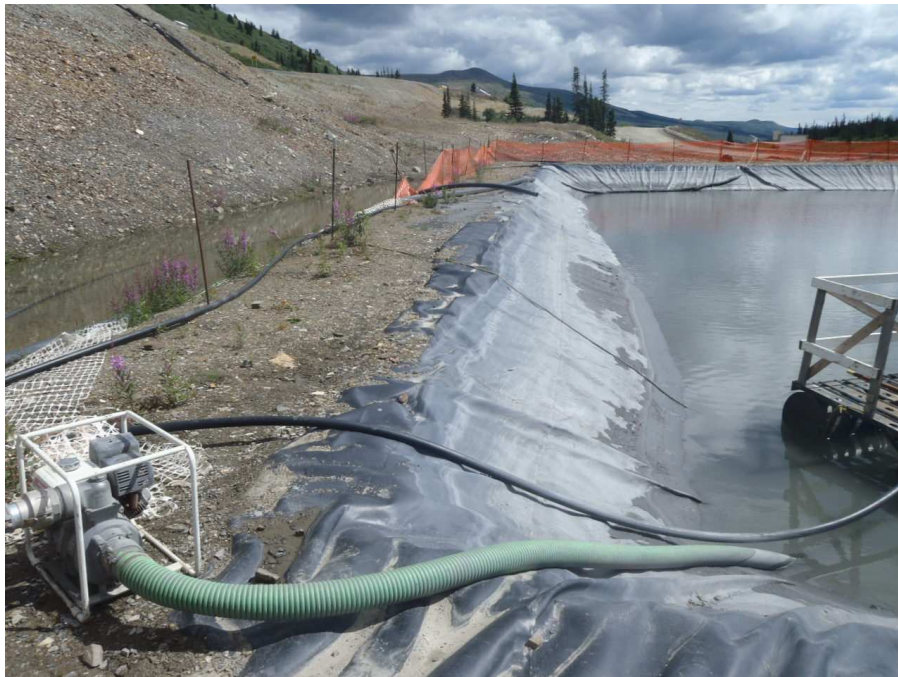
**Photo 6**  
Sump 5 full of underground waste water. (July 9, 2013)

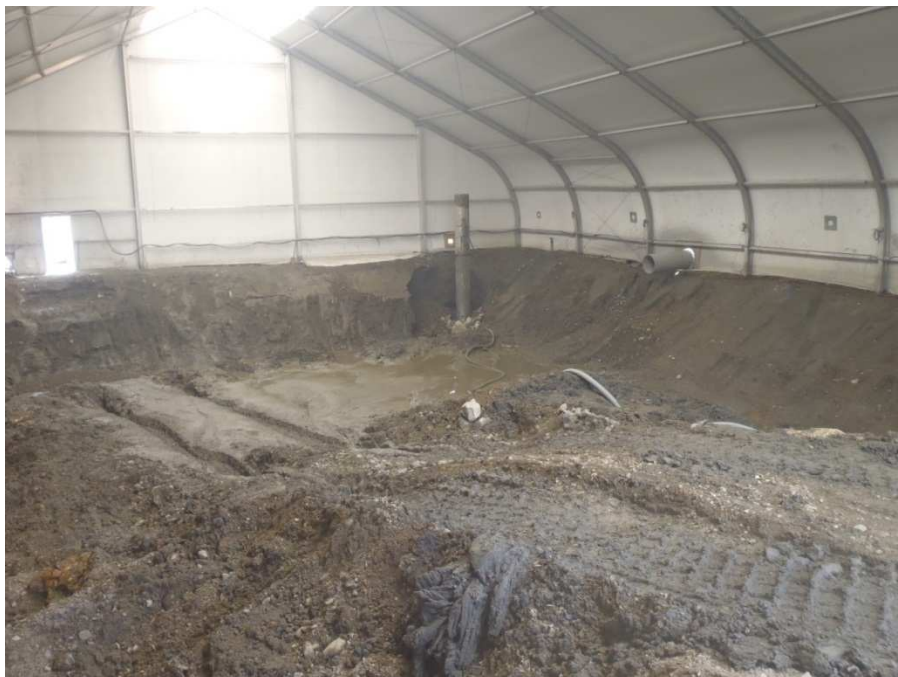
**Photo 7**  
Sump 2 being reconstructed. (July 9, 2013)

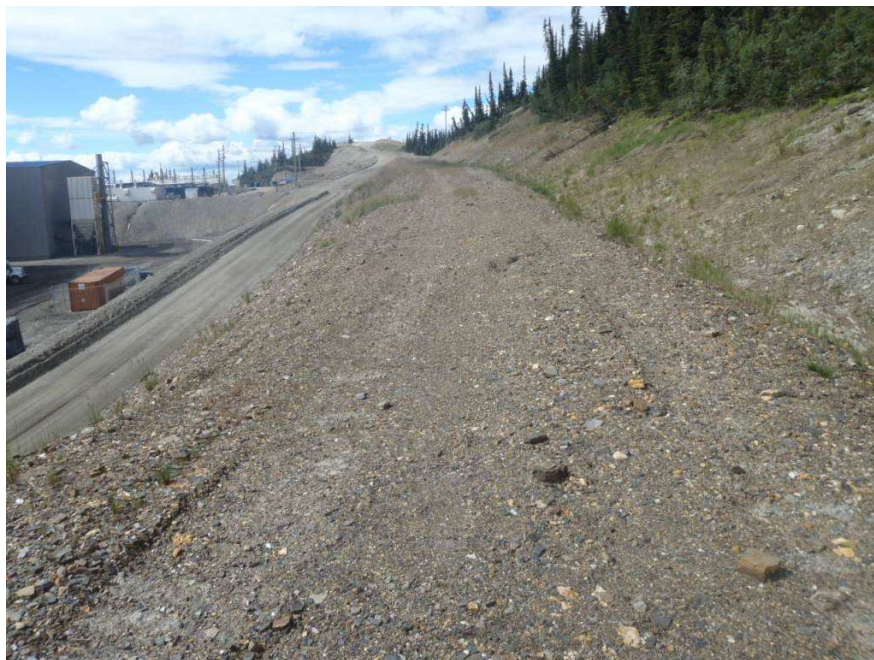
**Photo 8**

During the 2013 site visit and as noted during the 2012 site visit there were sections of diversion Ditch 1 that were lined with non-woven geotextile but for the most part the ditch remains unlined. There were small amounts of debris or slough from the upper slope deposited in the bottom of the ditch. In the future this material may have to be removed to allow for continuous water flow along the ditch bottom. As noted in previous observation reports the tension cracks and areas of settlement along the upper portion of the ditch embankment (Photo 8) were still noticeable. The tension cracks should be monitored and filled in as required to reduce the amount of water infiltration which may lead to instability of the embankment. The areas of settlement should also be graded to match the upper and lower sections of the ditch embankment.

Tension cracks and depression of an upper portion of the Ditch 1 embankment. (July 9, 2013)

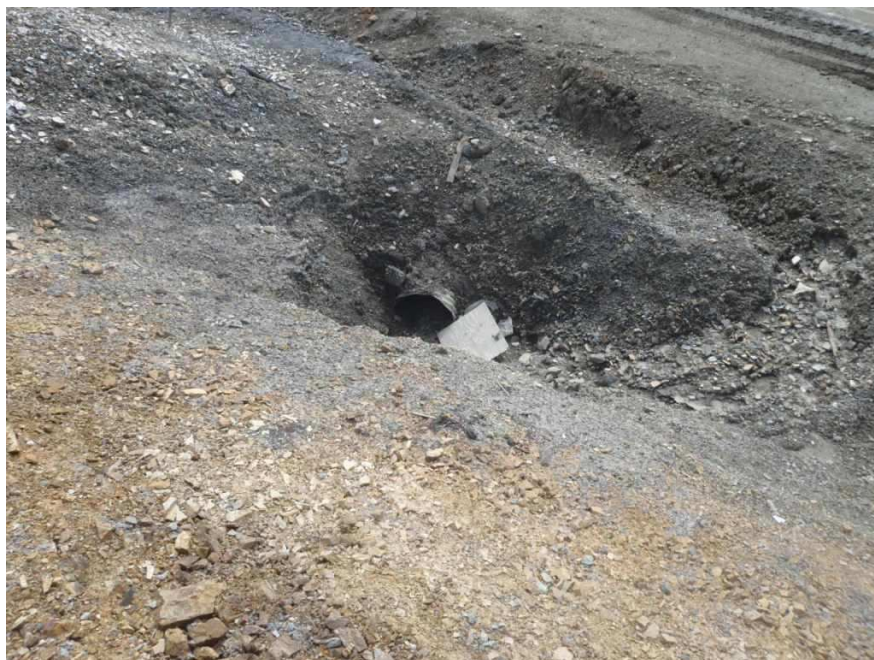
**Photo 9**

Ditch 2 was observed and only a portion of the collection ditch along the lower section between the Mill building location and the lower by pass road was lined. The inlet end of the culvert coming from the upper mill pad had been damaged and should be repaired to reduce the possibility of the inlet end plugging off (Photo 9).

The inlet end of the culvert from the upper mill pad to the lower section of Ditch 2. (July 9, 2013)

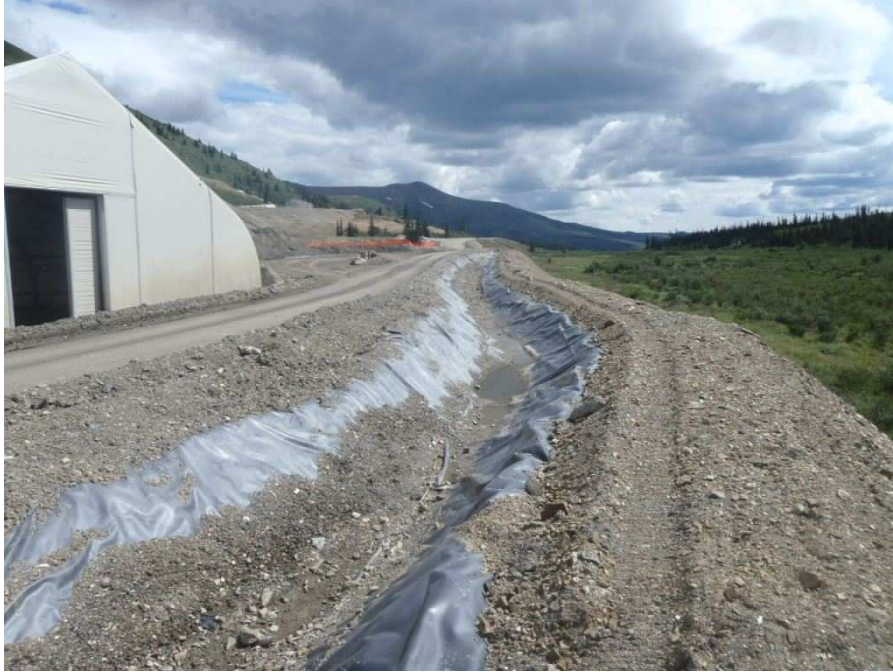
**Photo 10**

At the time of the site visit Ditch 3 liner had been replaced with a new liner but was not being used. Water from Ditch 2 was being pumped into Sump 5 as Sump 2 was being repaired and could not receive run-off water from Ditch 3. Tension cracks and areas of settlement noted during the 2012 site visit have been repaired (Photo 10).

The reconstructed Ditch 3. (July 9, 2013)

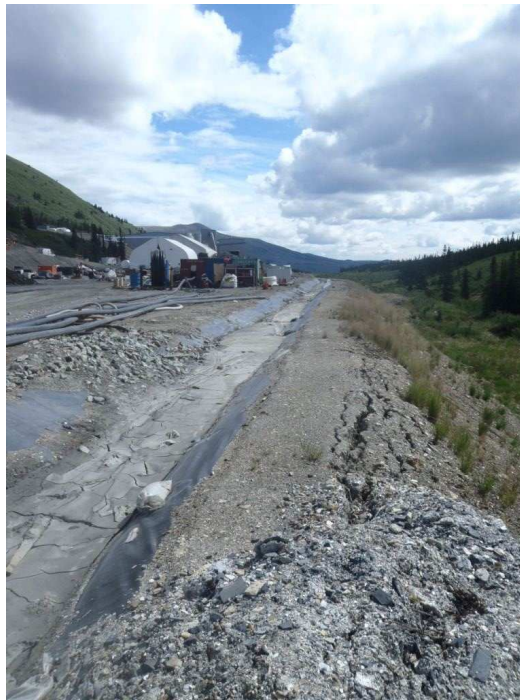
**Photo 11**

As noted in previous observation reports there were still many small tears or punctures of the liner along both side slopes of Ditch 4. The base of the liner appeared to be undamaged but the side slopes still require repair. There were other areas along of the ditch that require repair. There was numerous tension cracks and areas of settlement located along the crest and downslope side of the ditch (Photo 11), and erosion channels throughout the downslope side that require filling in to reduce the amount of water infiltration, which may lead to instability of the embankment (Photo 12). A portion of the northern end of the downslope side of Ditch 4 where there was noticeable settlement had been repaired (Photo 13). Fill material was placed along the areas of settlement to meet original design grades.

The NW end of Ditch 4 at the tension cracks along the downslope side. (July 9, 2013)

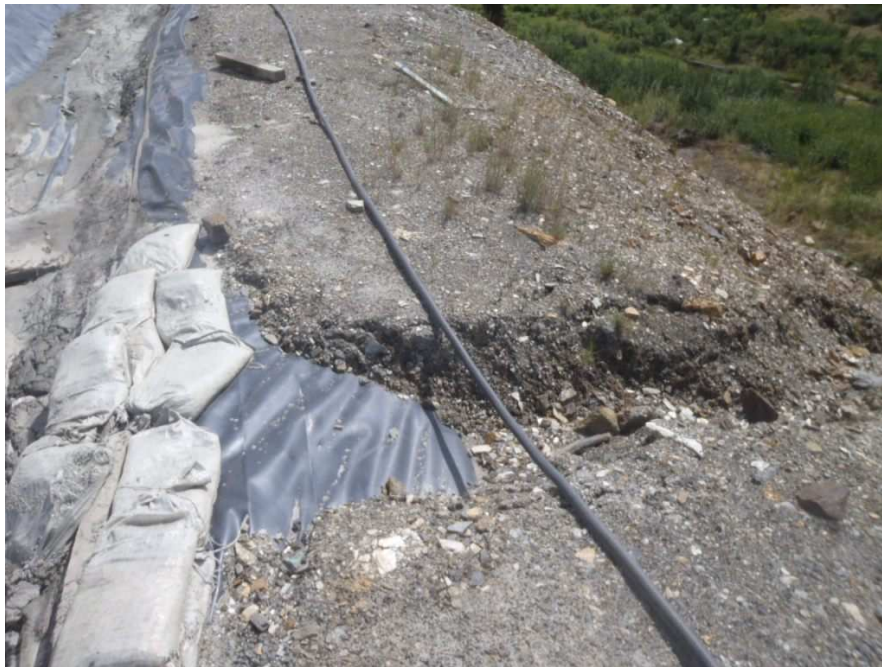
**Photo 12**

Looking SE at an erosion channel along Ditch 4 that requires repair. (July 9, 2013)

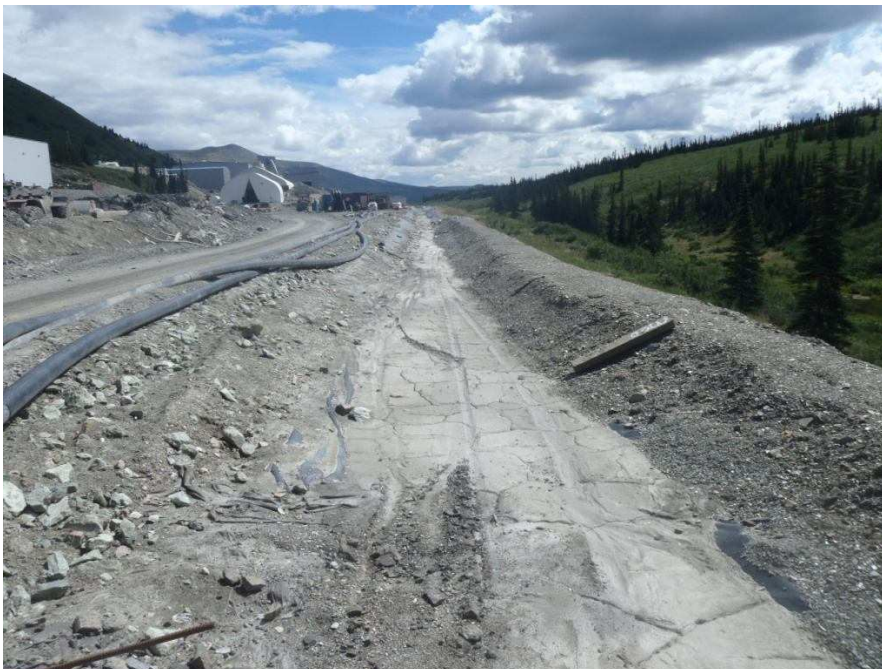
**Photo 13**

Looking SE from the NW end of Ditch 4 at the reconstructed downslope berm. (July 9, 2013)

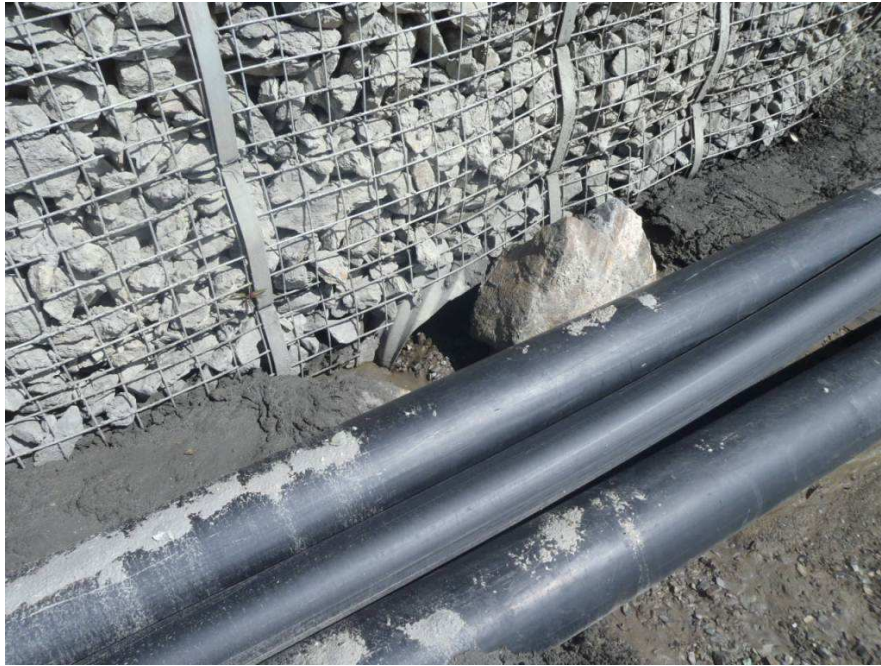
**Photo 14**

Ditch 5 was observed and the discharge end of the culvert located at the bottom of the MSE wall was almost completely plugged restricting run-off flow towards Sump 2 (Photo 14).

The discharge end of the Ditch 5 culvert the rock and debris should be removed. (July 9, 2013)

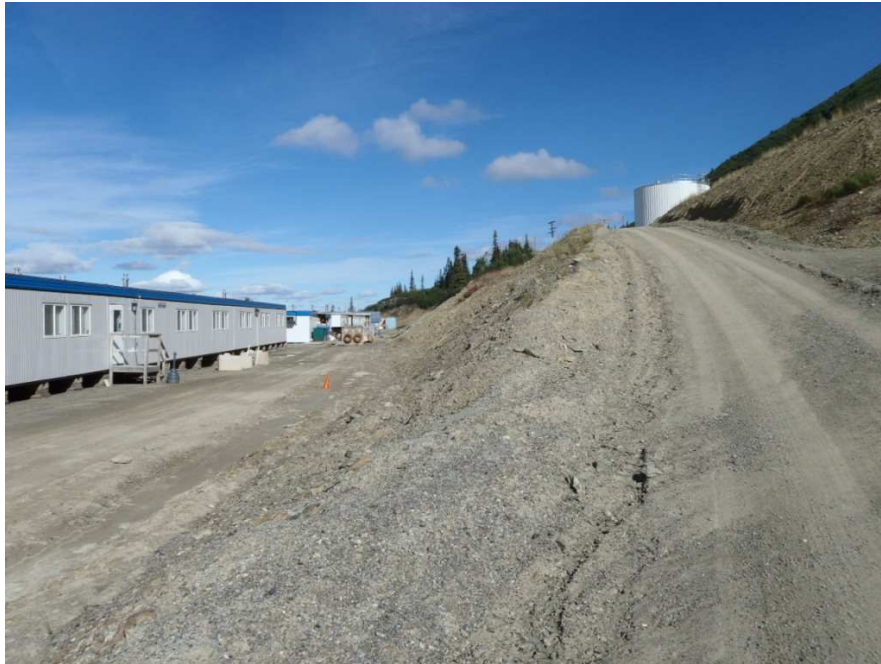
**Photo 15**

The 2:1 cut and 1.5:1 fill slopes for the camp pad, upper generator and water treatment pad, sewage treatment plant pad, and the treated sewage effluent pond were observed and the slopes were considered stable (Photos 15 and 16).

The backslope of the camp pad. (July 9, 2013)

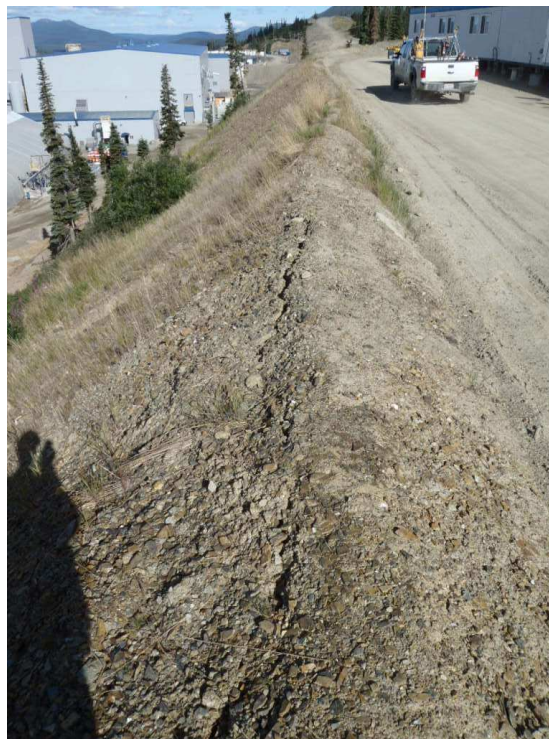
**Photo 16**

The downslope side of the camp pad. (July 9, 2013)

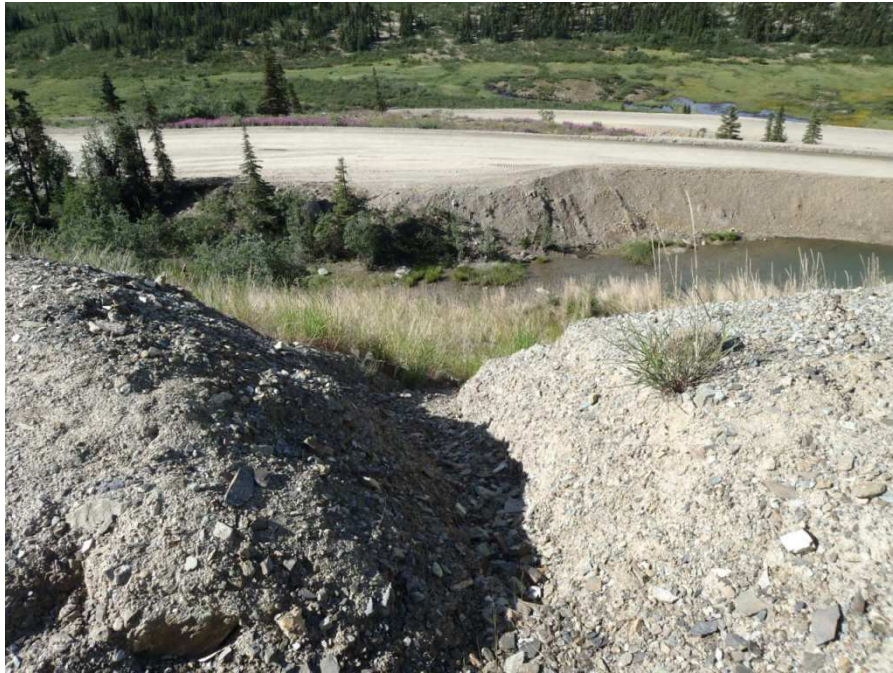
**Photo 17**

There were some noticeable tension cracks and erosion channels along the perimeter of the fill slope of the camp pad. Similar cracks and erosion channels were noted in previous observation reports (Photo 17). As mentioned in the previous reports these areas should be monitored and repaired as required.

One of the erosion channels along the downslope side of the camp pad. (July 9, 2013)

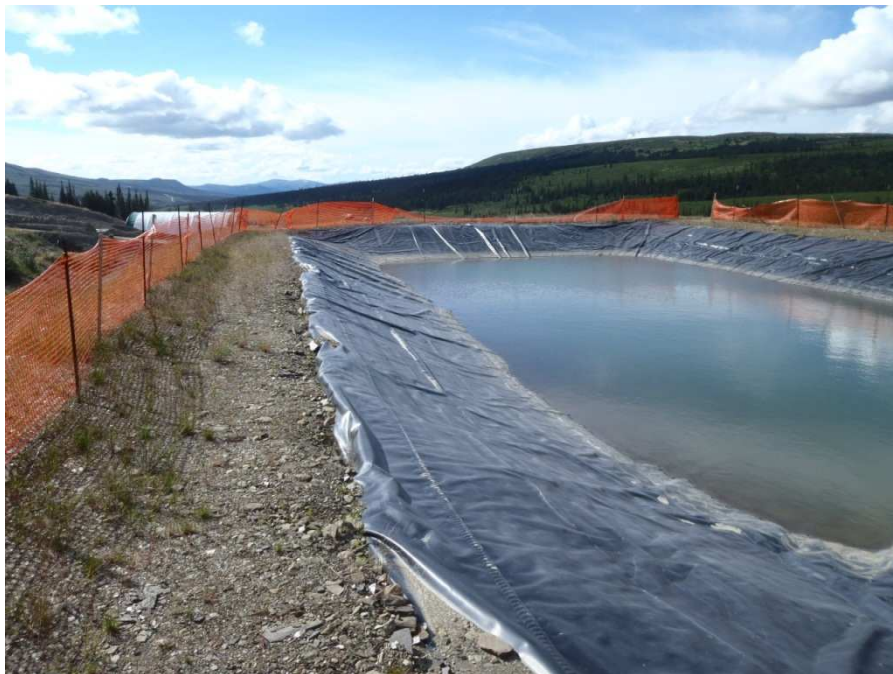
**Photo 18**

During the 2012 site visit the treated effluent pond, which is no longer being used as originally intended was half full of precipitation runoff, allowing for only partial visual observation of the liner (Photo 18). There were no indications of slumping or bulging of the liner. The perimeter exterior fill slopes were also reviewed and there were no noticeable signs of instability.

The former sewage effluent pond for the camp. (July 9, 2013)

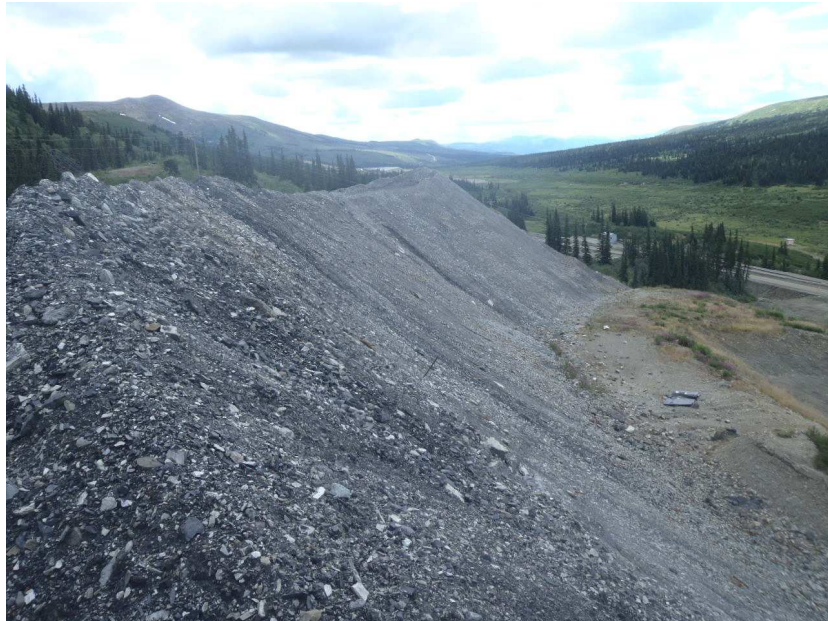
**Photo 19**

The cut and fill slopes in the facility were observed and considered stable (Photo 19). The collection sump was also observed and at the time was full of runoff water (Photo 20).

The Waste Rock and Ore Stockpile. (July 9, 2013)

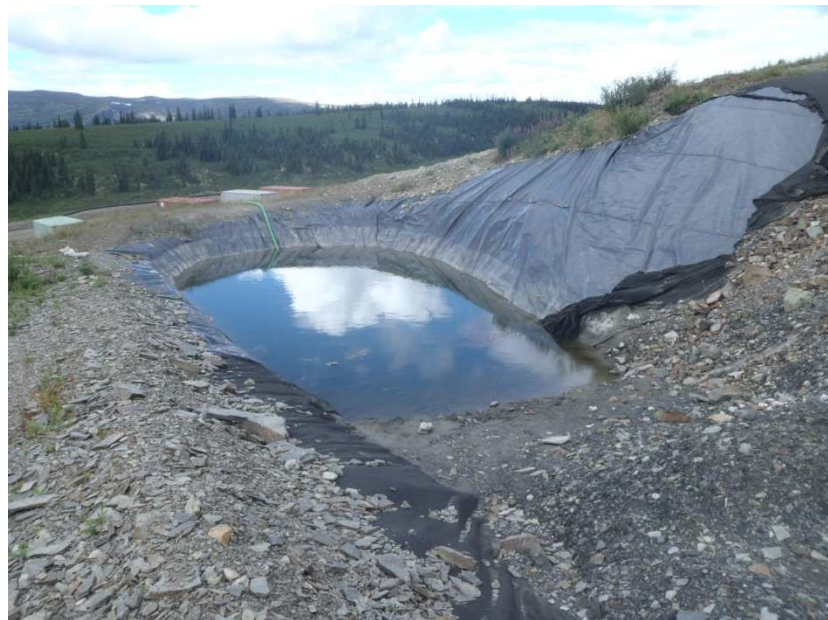
**Photo 20**

The Ore Stockpile area water run-off collection sump. (July 9, 2013)

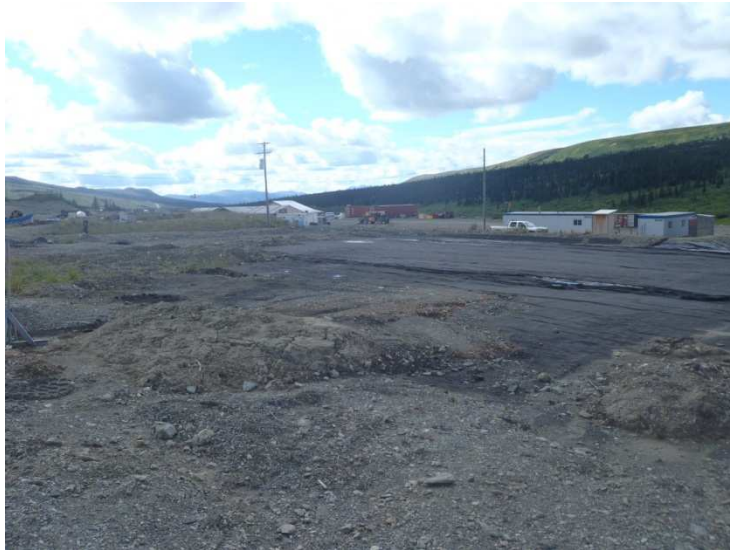
**Photo 21**

The berms and the liner of the land treatment facility (LTF) were observed and there was no noticeable deterioration of the berms or damage to the exposed liner (Photo 21). The LTF was about 50% full of hydrocarbon contaminated material and the collection sump was about 25% full of seasonal run-off (Photo 22).

The containment area of the LTF. (July 9, 2013)

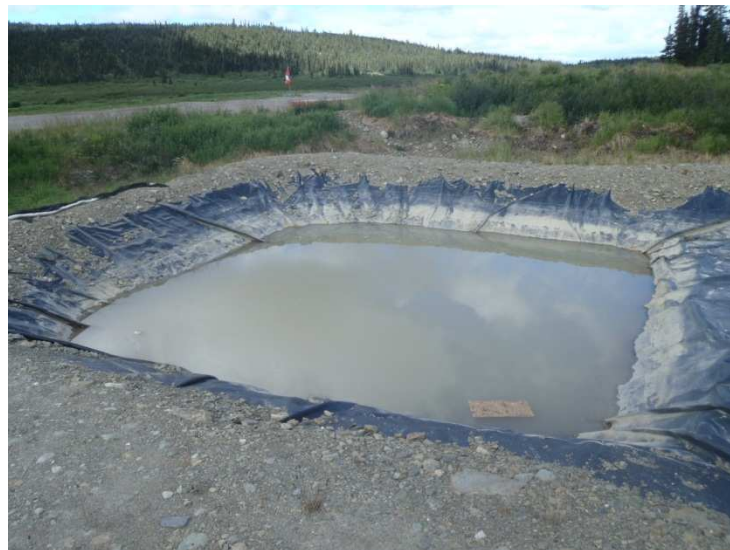
**Photo 22**

The LTF sump half full. (July 9, 2013)

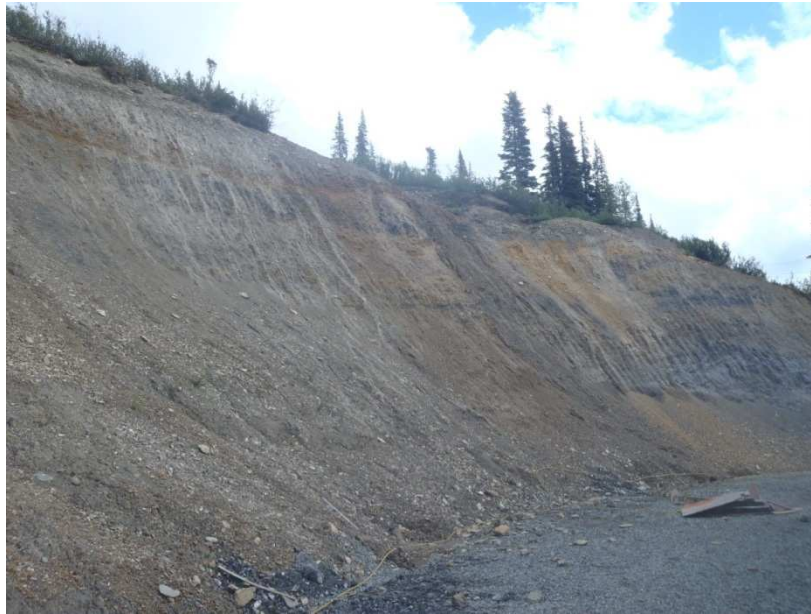
**Photo 23**

The 2:1 cut slopes for the vent raise and propane tank pad were observed and were considered stable (Photos 23 and 24). The vent raise back slope is showing some signs of erosion and should be monitored for instabilities at the top of the slope.

The backslope of the vent raise. (July 9, 2013)

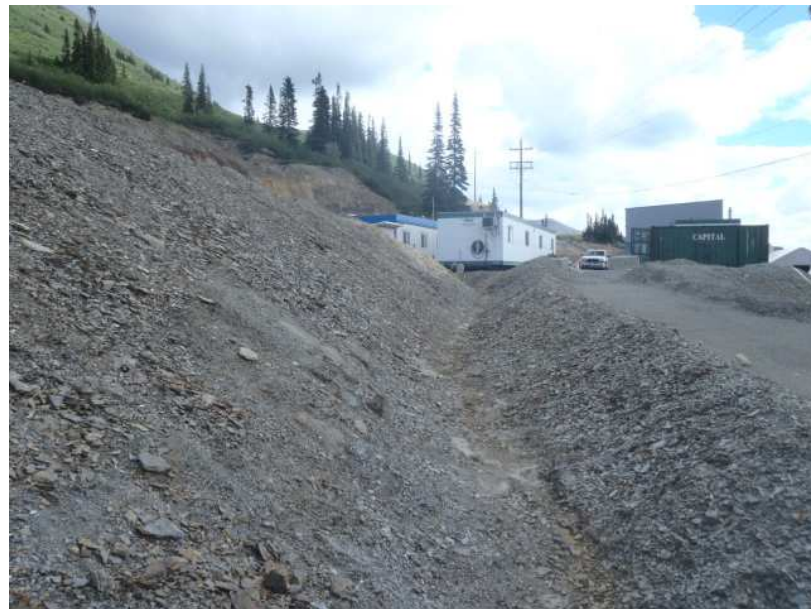
**Photo 24**

The backslope behind the propane tank pad. (July 9, 2013)

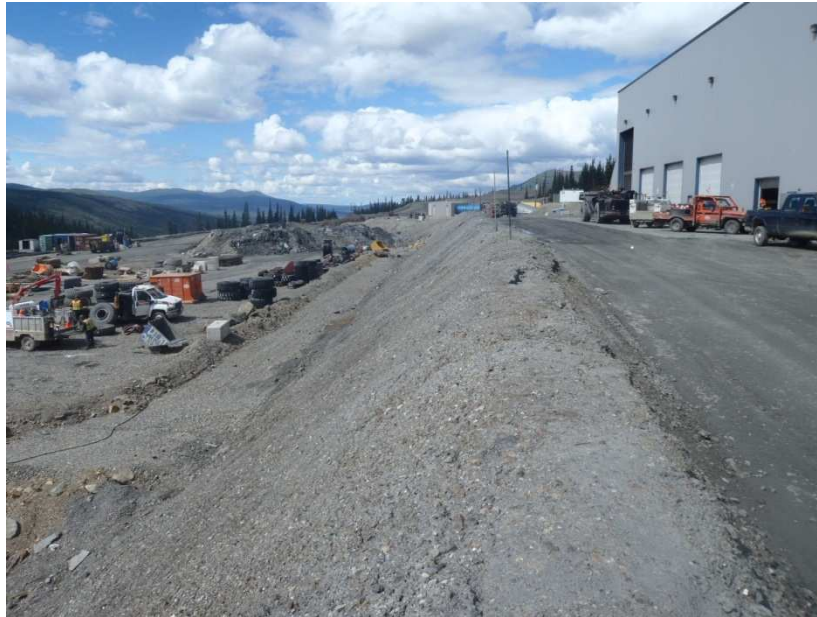
**Photo 25**

The 2:1 cut and fill slopes for the truck shop pad were observed and all of the slopes were considered stable (Photos 25 and 26).

The downslope of the truck shop pad. (July 9, 2013)

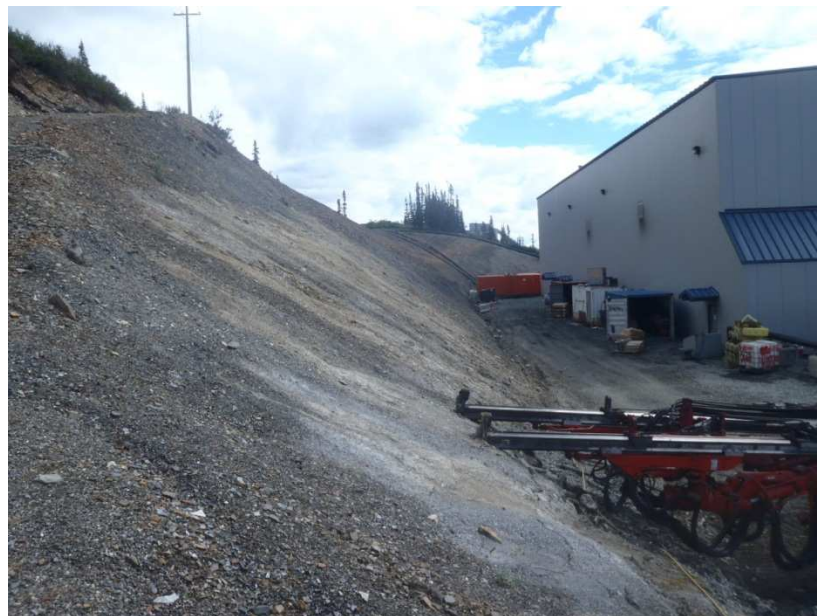
**Photo 26**

The backslope behind the truck shop pad. (July 9, 2013)
