July 16, 2014

ISSUED FOR USE  
FILE: W14103418-01

**Subject:** 2014 Annual Observations of the On-site Earth Structures  
Wolverine Mine Site, Southeastern Yukon

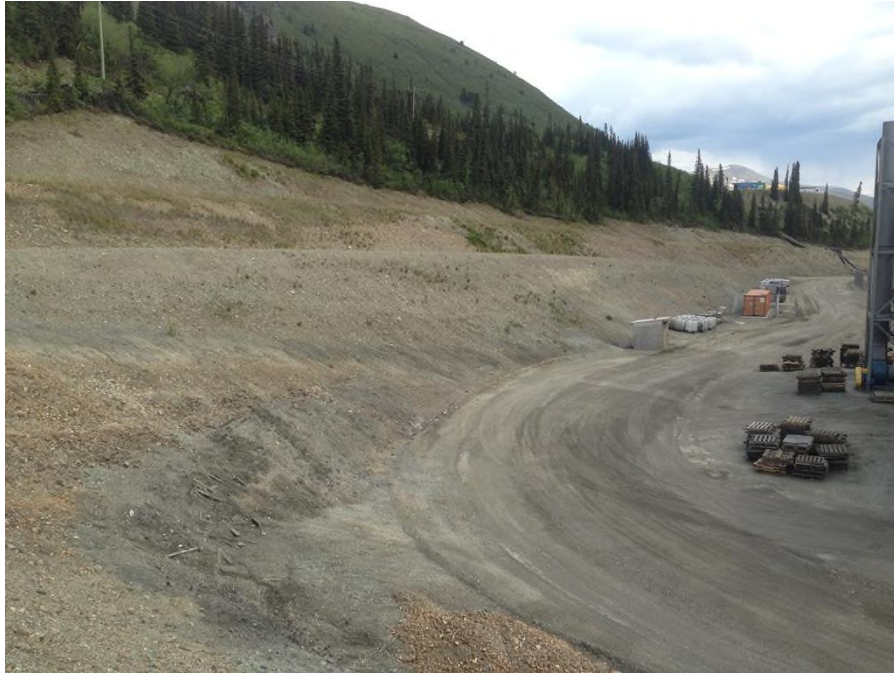
**Photo 1**

The 1:1 (H:V) design cut slopes in the bedrock for these areas are considered stable (Photo 1).

The bedrock cut backslope north of the mill location. (June 24, 2014)

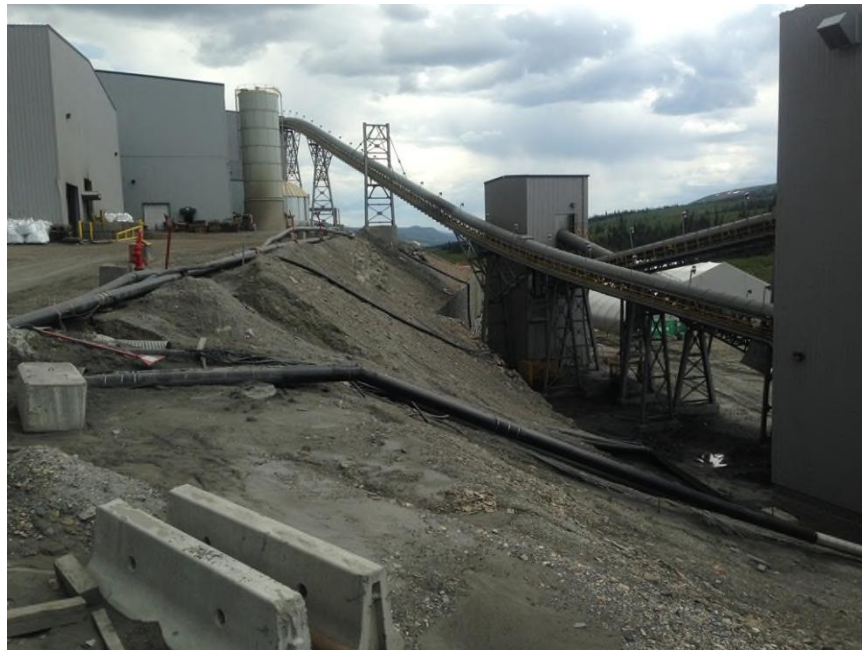
**Photo 2**

The fill slope along the western sides of the mill (Photo 2) associated with the fill placement are considered stable and are constructed as per the 2:1 (H:V) design. As noted in previous annual inspection reports, there are still some noticeable erosion channels (shown on Figure 1) along the southwestern side of the mill fill that were created as a result of historical seasonal rainfall run-off events. In 2012, proper perimeter berms and site grading was completed and has been maintained throughout the last couple of years by YZC to divert surface runoff towards designated drainage ditches (Ditches 2 and 5). As a result of this grading, drainage was directed towards the southwestern corner of the mill pad where a large erosion channel has formed (Photo 3).

The southern fill slope of the mill site between the concentrate loadout and crusher buildings. (June 24, 2014)

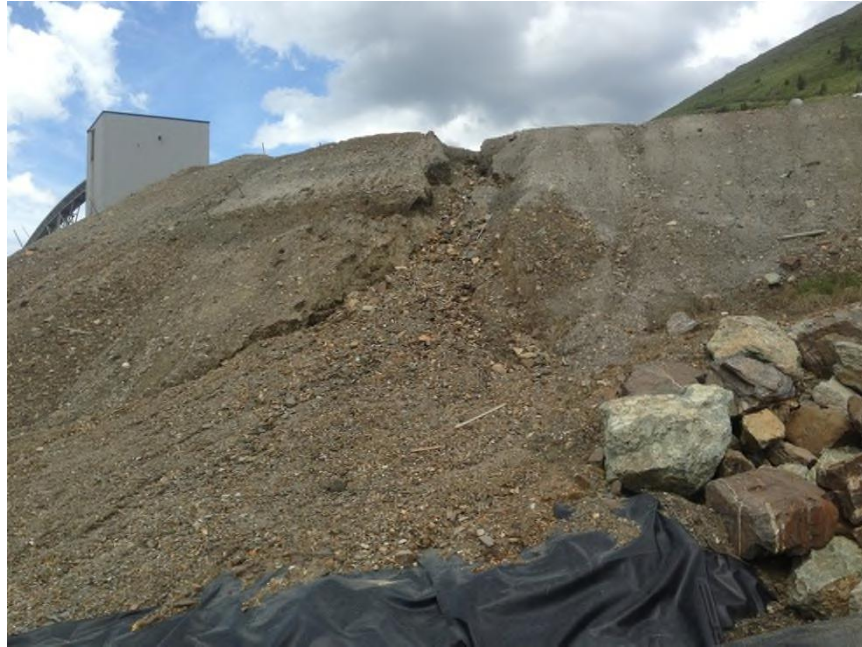
**Photo 3**

Large erosion channel along the eastern fill slope of the mill site pad location. (June 24, 2014)

Item Description	Recommended Maintenance	Status
Mill Area	Fill erosion channels with coarse grained material. Still large erosion channel that requires filling at southwestern corner of the mill pad	Majority of channels completed spring 2014.
Mill Area	The MSE wall has small rocks working their way through the mesh that are considered falling hazards and should be monitored and removed as required.	
Fuel Tank Farm and Genset Pads	Small erosion channel between the two pads along the southwestern slope that requires monitoring – repair as necessary.	
Genset Pad	The main drainage channel's splash trough has broken loose and should be repaired to reduce the amount of additional extensive erosion.	
Water Treatment Sump 1	Settlement in geomembrane anchor/key trench.	No work required. Planning decommissioning for summer 2014.
Ditch 1	Fill tension cracks and areas of settlement along berm.	Still only monitoring.

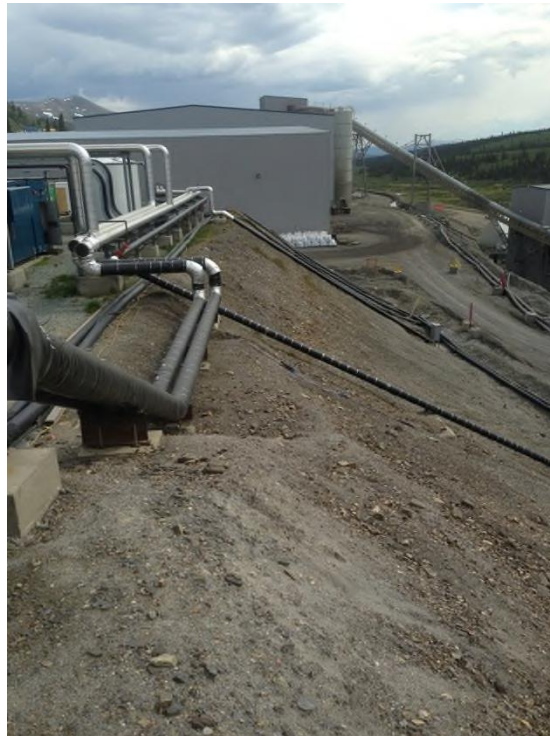
**Photo 4**

The eastern cut slopes, and western and southern fill slopes of the fuel tank farm and genset pad (Photo 4) were observed and it was noted that there was a small area of tension cracks and a small erosion channel occurring along the western fill slope between the fuel tank farm and genset pads (Photos 5 and 6). Along the southern fill slope of the genset pad the main drainage channel's splash trough has broken loose from the CSP half culvert resulting in extensive erosion at the culvert's outlet end of the CSP half culvert (Photo 7).

The southern fill slope of the Fuel Tank Farm and Genset Pads locations. (June 24, 2014)

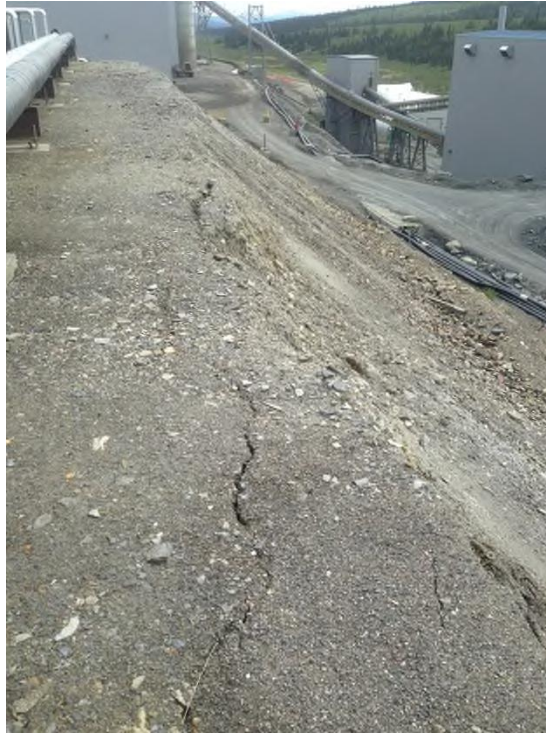
**Photo 5**

Small tension cracks along the southern fill slope of the genset pad location. (June 24, 2014)

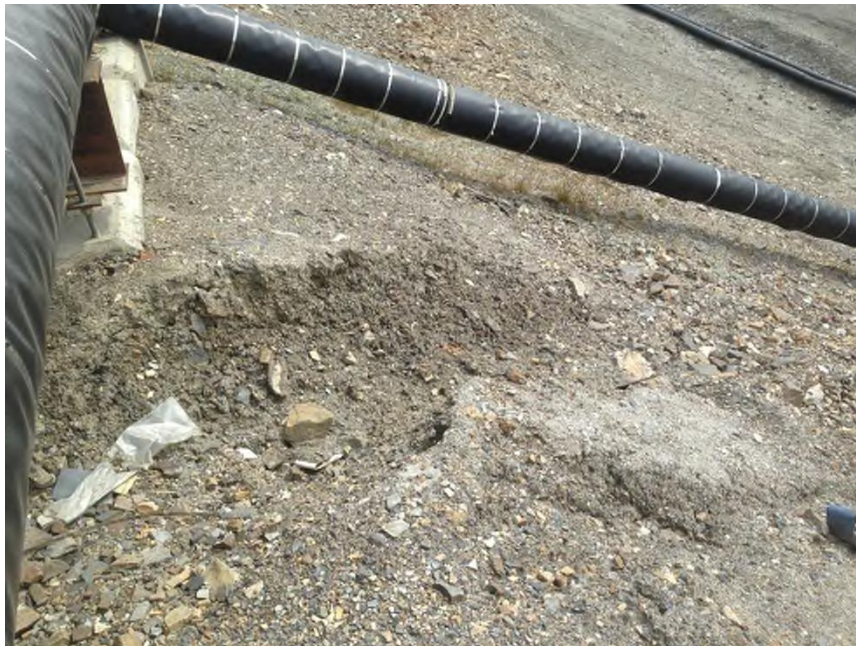
**Photo 6**

Small erosion channel along the southern fill slope between the fuel tank farm and genset pad locations. (June 24, 2014)

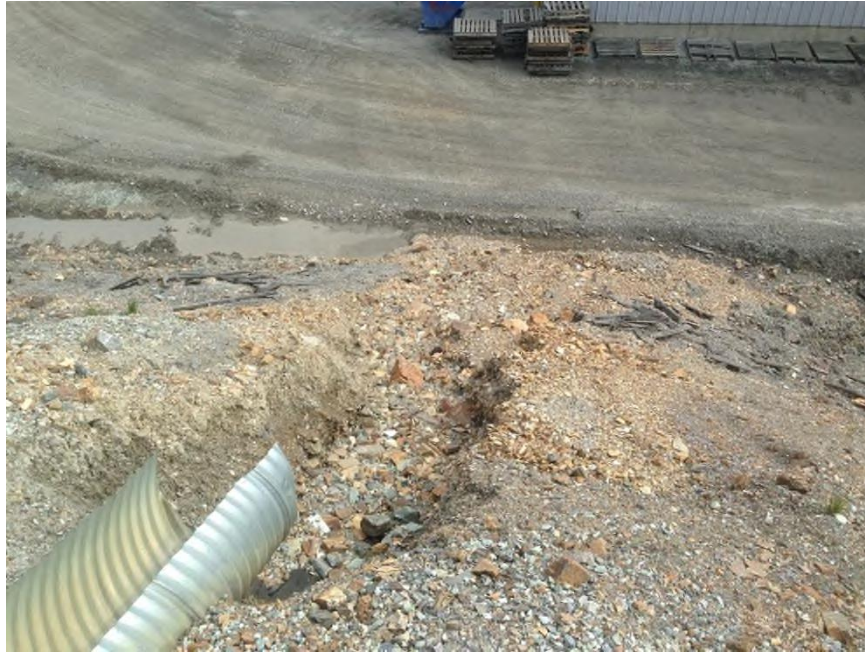
**Photo 7**

Genset pad runoff culvert location. Splash trough is missing and major erosion of the slope fill has occurred. (June 24, 2014)

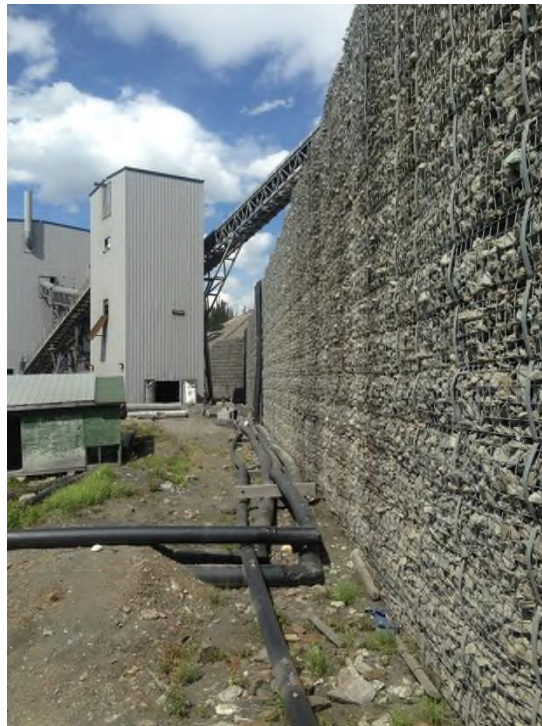
**Photo 8**

The Mechanically Stabilized Earth (MSE) wall (Photo 8) that is situated along the south western portion of the mill fill and the north and east sides of the crusher building were observed and there were no signs of bulging or noticeable zones of failure. There is the odd smaller rock that has worked its way through the wire mesh. These rocks are considered falling hazards and when labourers are working in the area along the MSE wall, they should be cautious of possible falling rocks.

The MSE wall along the toe of the Mill fill. (June 24, 2014)

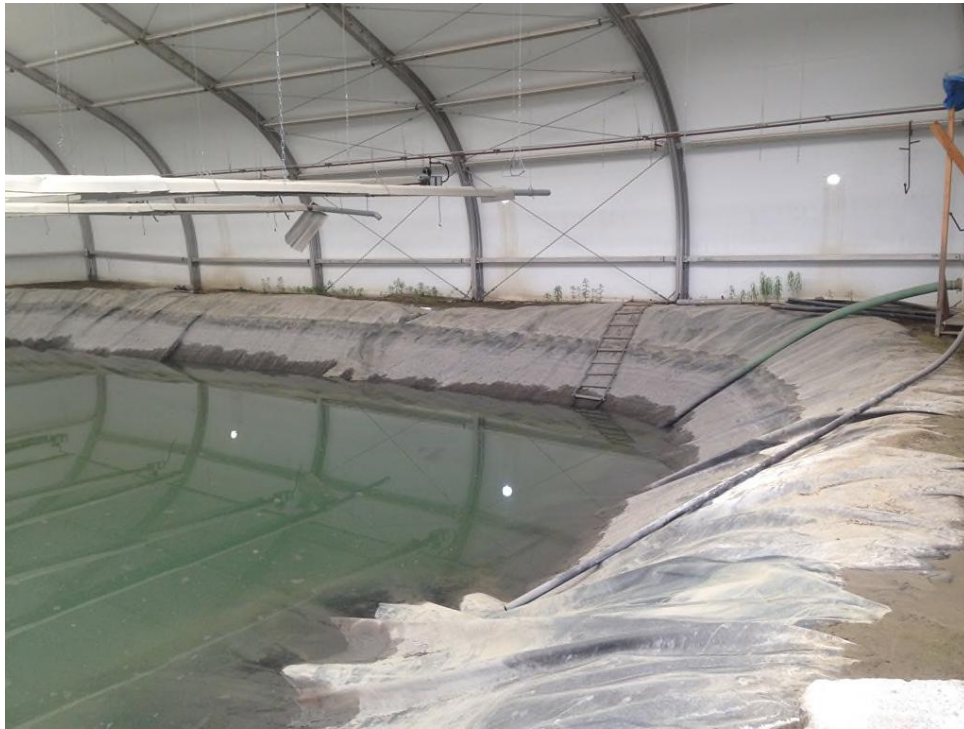
**Photo 9**

The foundations for Sumps 1, 2 and 5 were observed. Both Sumps 1 and 5 were not being used at the time of the site visit but still contained wastewater and sediment from underground. Sump 1 was about half full and there were areas of bulging in the liner indicating that groundwater continues to impact the liner placement when the sump is less than  $\frac{3}{4}$  full. The exposed liner of Sump 1 was visually inspected and found to be in good condition (Photo 9). Sump 5 was only partially full, mostly sediment with some water. The exposed liner of Sump 5 was visually inspected and found to be in good condition (Photo 10).

The foundation conditions noted in the 2013 annual observation report for Sumps 1 and 5 remain the same. There was still some marginal settlement along the key trenches of Sump 1 as the backfill material was not compacted during original construction. The foundation conditions for Sump 2 are good as this sump was reconstructed in 2013.

Sump 1 about half full of underground mine water. (June 24, 2014)

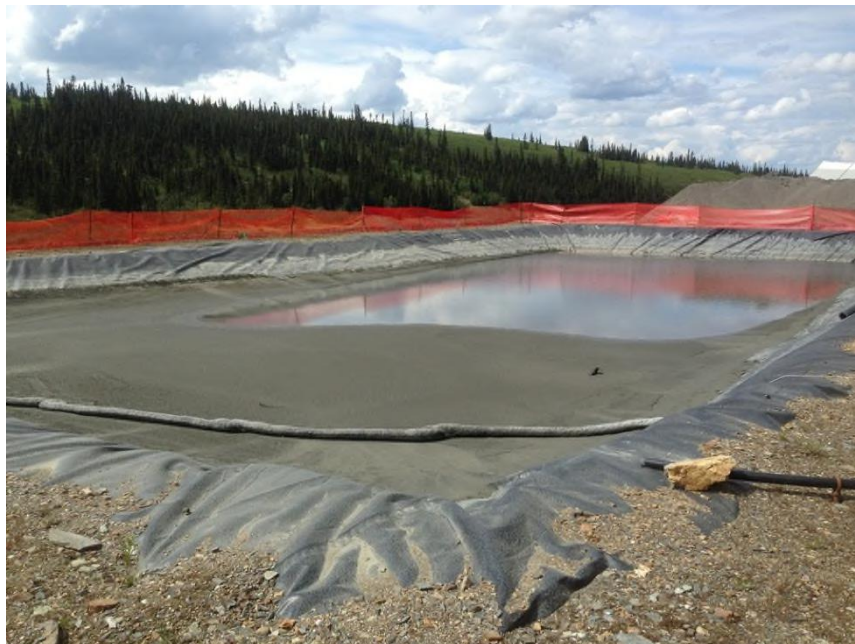
**Photo 10**

Sump 5 full of underground sediments and some waste water. (June 24, 2014)

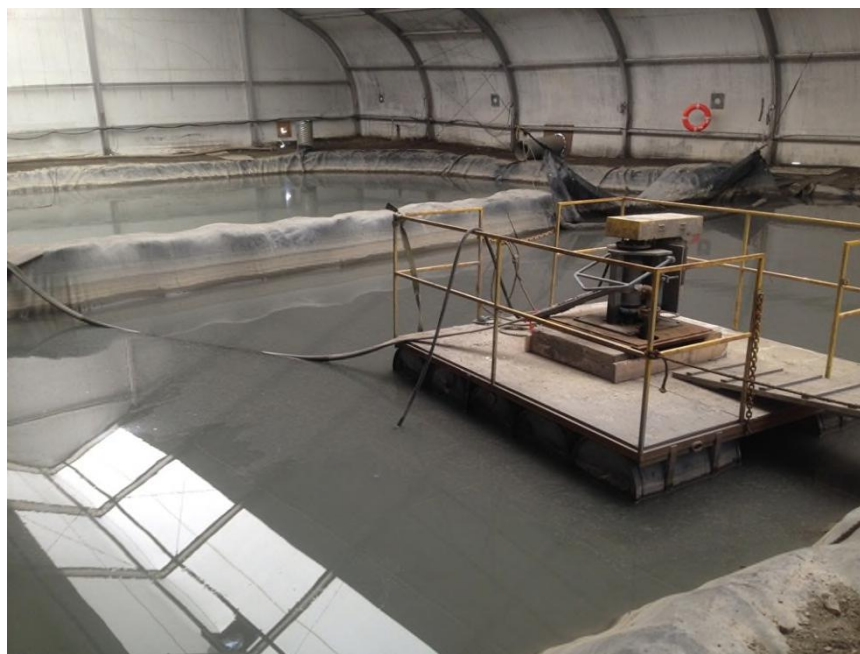
**Photo 11**

Sump 2 was reconstructed in 2013 and was in use during the site visit. It was being used to collect runoff water from Ditches 2 and 5, and the water from Sump 2 was being used as a water supply for underground workings (Photo 11).

Sump 2 reconstruction complete and full of surface runoff water from Ditches 2 and 5. (June 24, 2014)

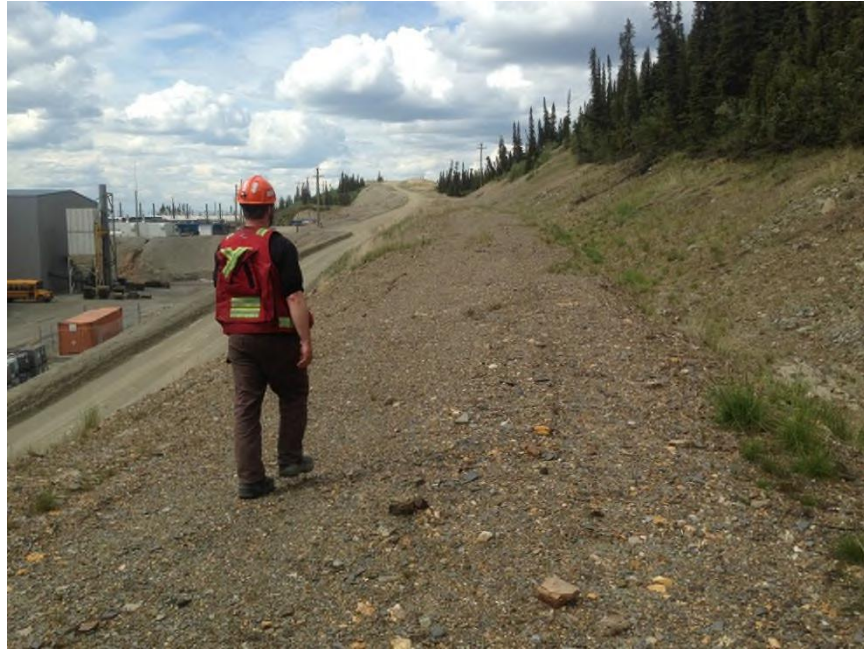
**Photo 12**

During the previous site visits, it was noted that there were sections of diversion Ditch 1 that were lined with non-woven geotextile but for the most part the ditch remains unlined. There were small amounts of debris or slough from the upper slope deposited in the bottom of the ditch. In the future, this material may have to be removed to allow for continuous water flow along the ditch bottom. As noted in previous observation reports, the tension cracks and areas of settlement along the upper portion of the ditch embankment (Photo 12) were still noticeable. The tension cracks should be monitored and filled in as required to reduce the amount of water infiltration which may lead to instability of the embankment. The recompacted areas of settlement should also be graded to match the upper and lower sections of the ditch embankment.

Tension cracks and depression of an upper portion of the Ditch 1 embankment. (June 24, 2014)

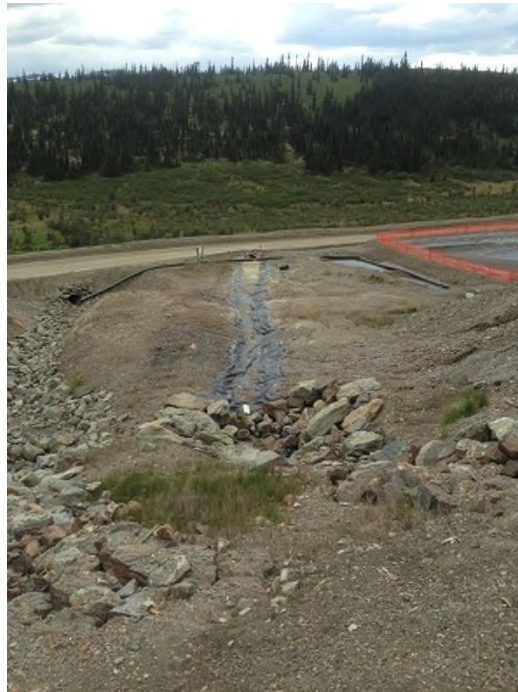
**Photo 13**

Ditch 2 was observed and only a portion of the collection ditch along the lower section between the mill building location and the lower bypass road was lined. The inlet end of the culvert coming from the upper mill pad should be monitored for potential plugging and may require periodic cleaning to allow for positive flow through the culvert. The lower portion of Ditch 2 was in good shape allowing for surface runoff to flow towards Ditch 3 (Photo 13).

The inlet end of the culvert from the upper mill pad to the lower section of Ditch 2. (June 24, 2014)

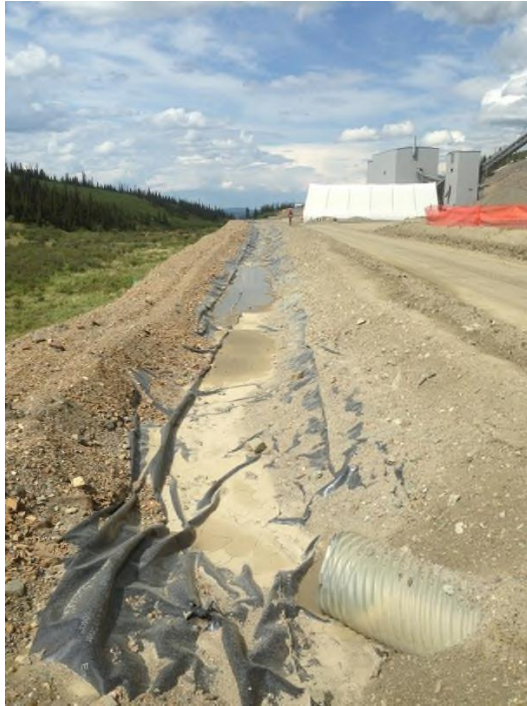
Ditch 3 liner was replaced last year and during this site visit there was no water flowing through it. Tetra Tech EBA was informed that it performed well for directing surface water collected from the Mill Pad through Ditch 2 during the Spring freshet. All surface runoff flowing through Ditch 2 and 3 is now directed into Sump 2. During the site visit there were small tension cracks noted along the exterior slope (Photo 14).

**Photo 14**  
The reconstructed Ditch 3. (June 24, 2014)

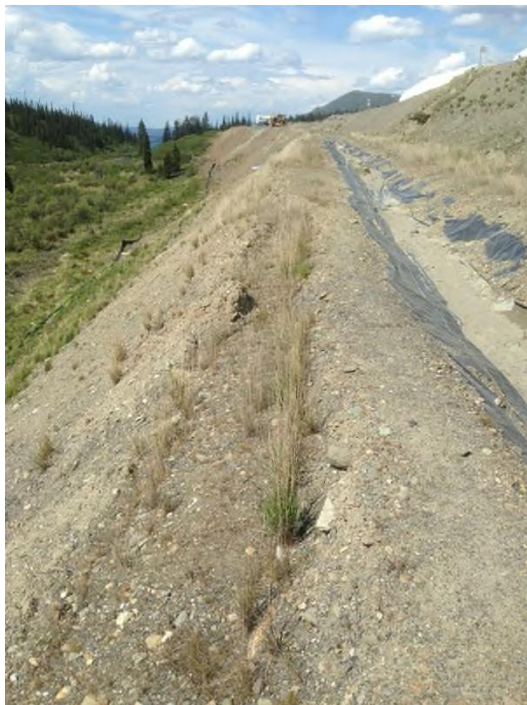
As noted in previous observation reports, there were still many small tears or punctures to the northern portion of the liner along both side slopes of Ditch 4. The base of the liner appeared to be undamaged but the side slopes still require repair. As noted in previous reports, there were still small tension cracks, areas of settlement located along the crest and downslope side of the ditch and erosion channels throughout the downslope side. There was no evidence of more recent additional movement as the crest and slope soils were promoting vegetation growth (Photo 15). As mentioned in the previous reports, these areas should be monitored and repaired as required. YZC did mention to Tetra Tech EBA that repairs to Ditch 4 are scheduled for this summer. It was also noted that along the upslope side of the ditch there was a lower portion of the embankment (native material) that was sluffing away undercutting the fill material for the lower bypass road next to the shotcrete batch plant (Photo 16).

**Photo 15**  
Vegetation growth throughout the tension cracks, areas of settlement and erosion channels. (June 24, 2014)

Ditch 3	Minor tension cracks in new fill placement.	Monitoring.
Ditch 4	Repair liner, fill tension cracks, areas of settlement and erosion channels.	Repair work planned for summer 2014.
Ditch 5	Clean out discharge towards Sump 2.	Completed spring 2014.
Ditch 5	Clean out construction debris from upper mill pad portion of ditch.	
Camp Area	Monitor tension cracks and erosion channels – repair as necessary.	Major southwestern erosion channel has been filled in with rock.
Truck Shop Area	Small area of slumping – repair as necessary

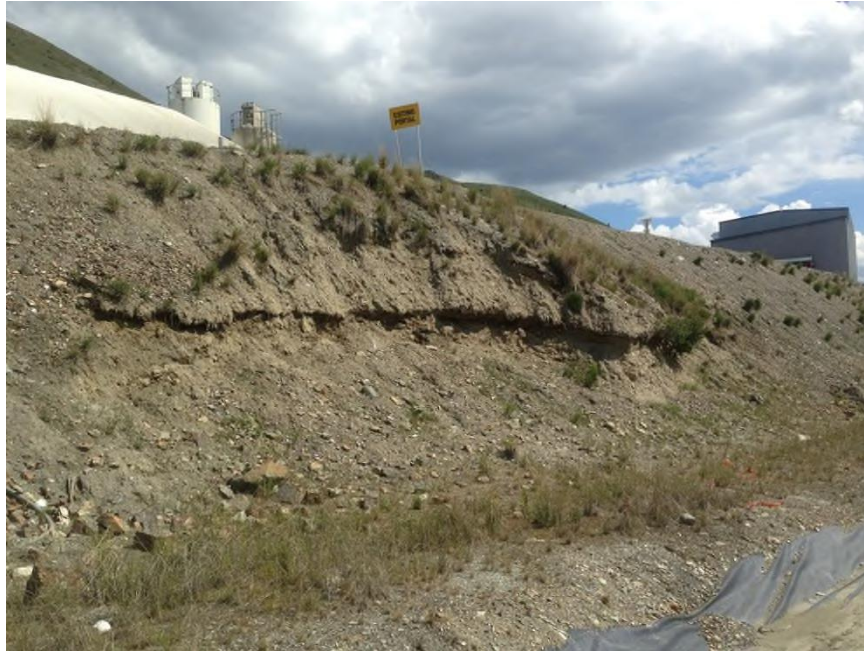
**Photo 16**

The lower sluffing portion of the fill slope of the lower bypass road near the shotcrete plant. (June 24, 2014)

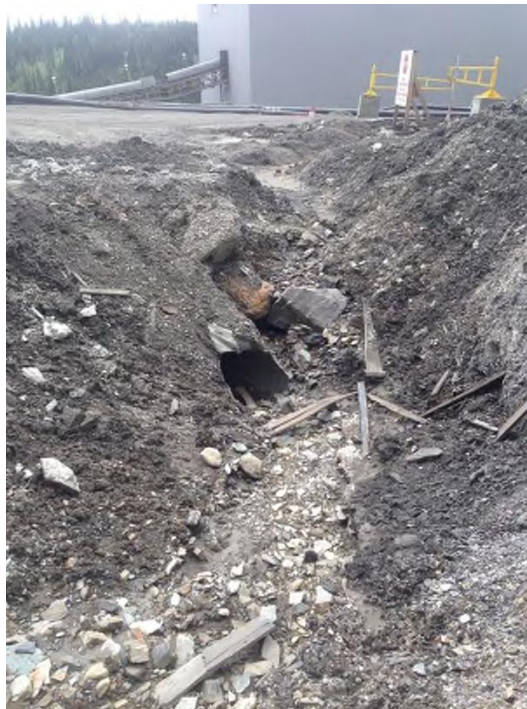
**Photo 17**

Ditch 5 was observed and the upper portion of the ditch on the mill pad had some construction debris littered throughout that could potentially plug off the inlet end or buried portion of the culvert (Photo 17). The discharge end of the culvert located at the bottom of the MSE wall had been cleaned out and future surface runoff is now able to flow towards Sump 2 (Photo 18).

The inlet end of the Ditch 5 culvert on the mill pad. (June 24, 2014)

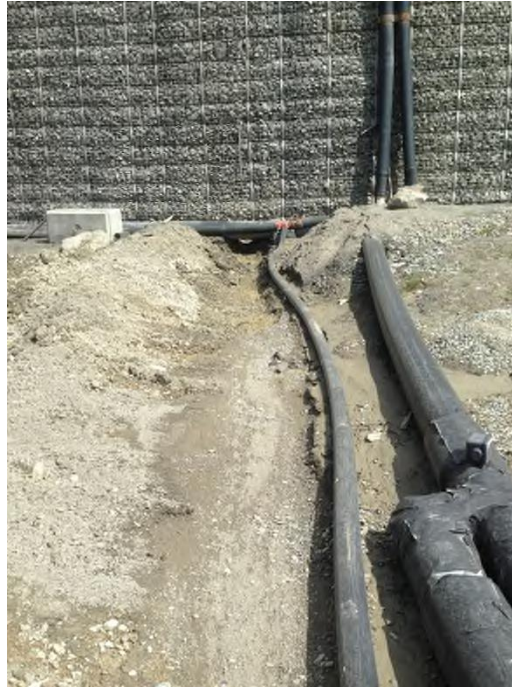
**Photo 18**

The discharge end of the Ditch 5 culvert allowing surface runoff flow towards Sump 2. (June 24, 2014)

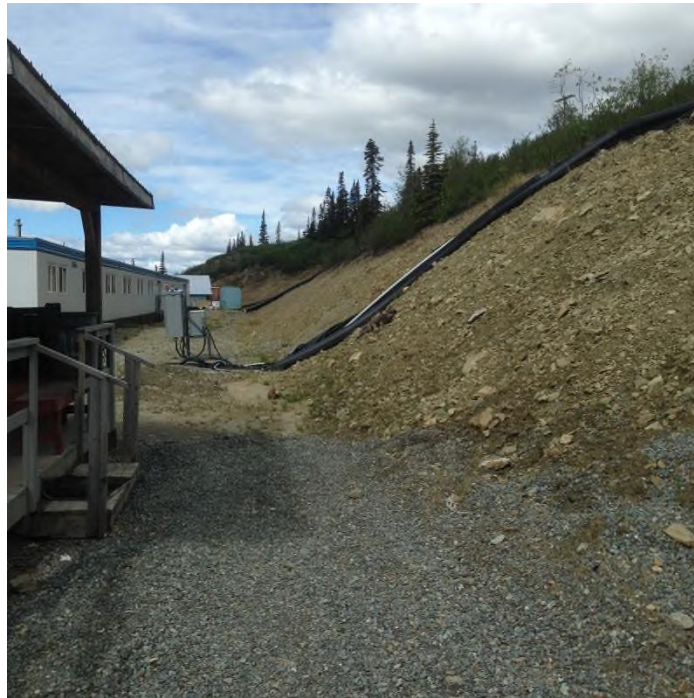
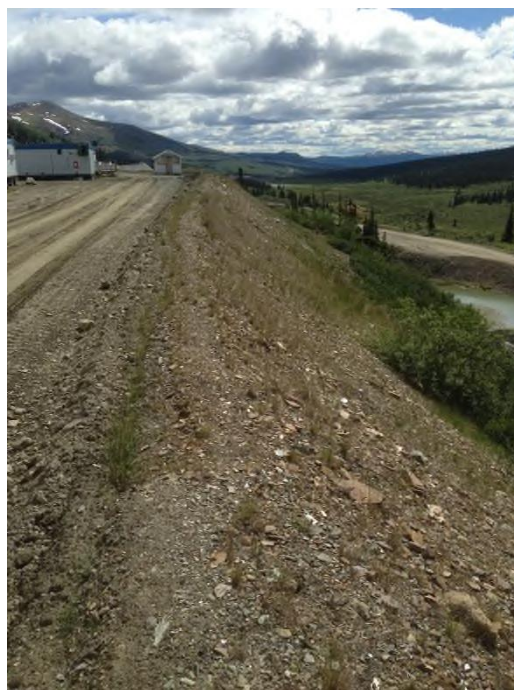
The 2:1 cut and 1.5:1 fill slopes for the camp pad, upper generator and water treatment pad, sewage treatment plant pad, and the treated sewage effluent pond were observed and the slopes were considered stable (Photos 19 and 20).

The backslope of the camp pad. (June 25, 2014)

The downslope side of the camp pad. (June 25, 2014)

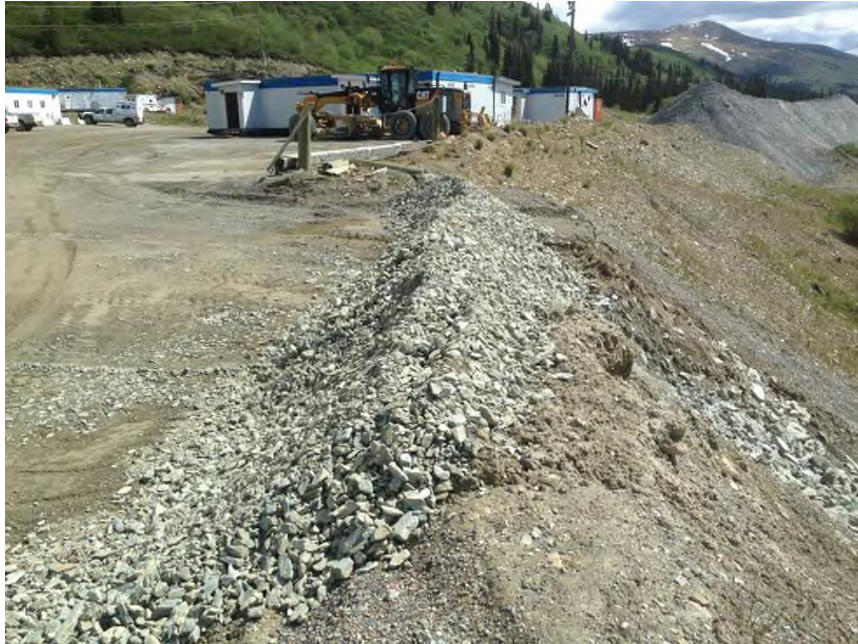
**Photo 21**

As noted during previous site visits, there were still some noticeable tension cracks and erosion channels along the perimeter of the fill slope of the camp pad. As mentioned in the previous reports, these areas should be monitored and repaired as required. There was one area of the fill slope at the southwestern end of the camp pad that developed into a very large drainage channel during spring freshet. To reduce the any further erosion of the fill slope, YZC filled in the channel with rock (Photo 21).

The southwestern erosion channel that was filled in with rock. (June 25, 2014)

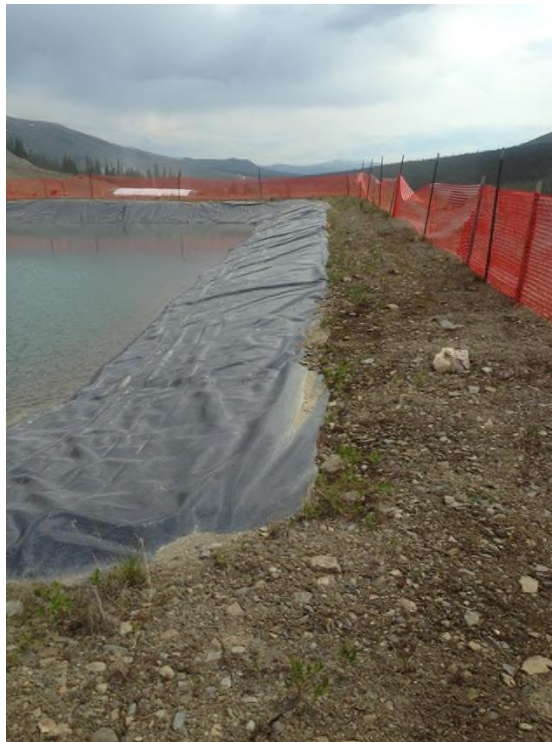
**Photo 22**

The treated effluent pond is no longer being used as originally intended and was half full of precipitation runoff, allowing for only partial visual observation of the liner (Photo 22). There were no indications of slumping or bulging of the liner. The perimeter exterior fill slopes were also observed and there were no noticeable signs of instability.

The former sewage effluent pond for the camp. (June 24, 2014)

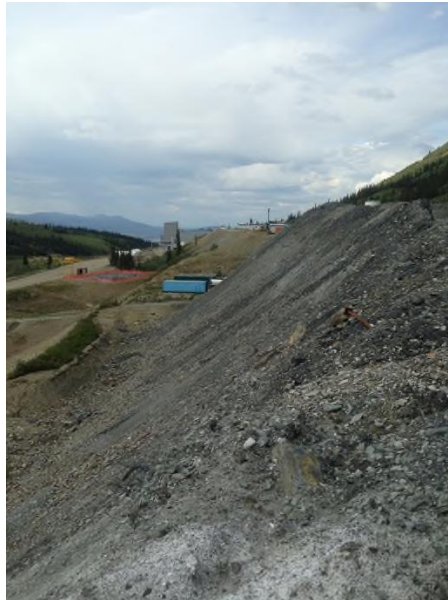
**Photo 23**

The cut and fill slopes in the facility were observed and considered stable (Photo 23). The collection sump was also observed and at the time was full of runoff water (Photo 24).

The waste rock and ore stockpile. (June 24, 2014)

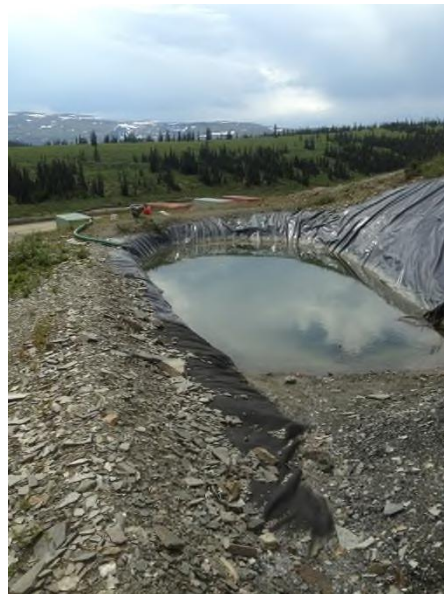
**Photo 24**

The ore stockpile area water run-off collection sump. (July 24, 2014)

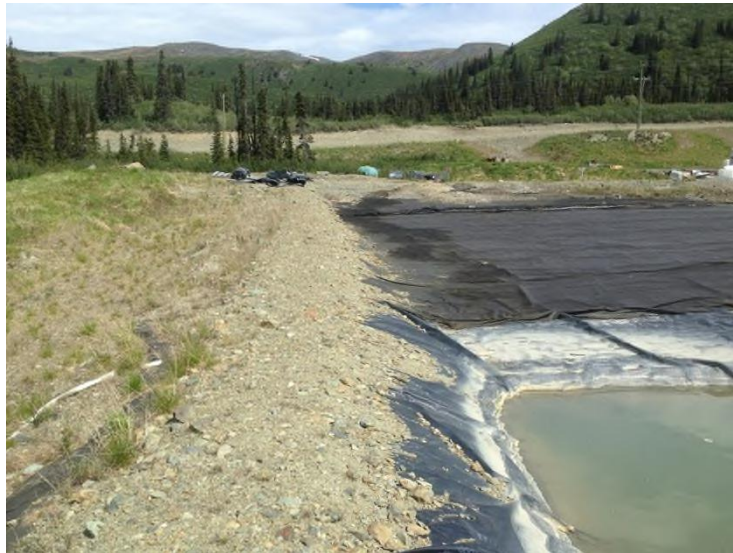
**Photo 25**

The berms and the liner of the land treatment facility (LTF) were observed and there was no noticeable deterioration of the berms or damage to the exposed liner (Photo 25). The LTF was about 50% full of hydrocarbon contaminated material and the collection sump was about 25% full of seasonal runoff (Photo 26).

The containment area of the LTF. (June 24, 2014)

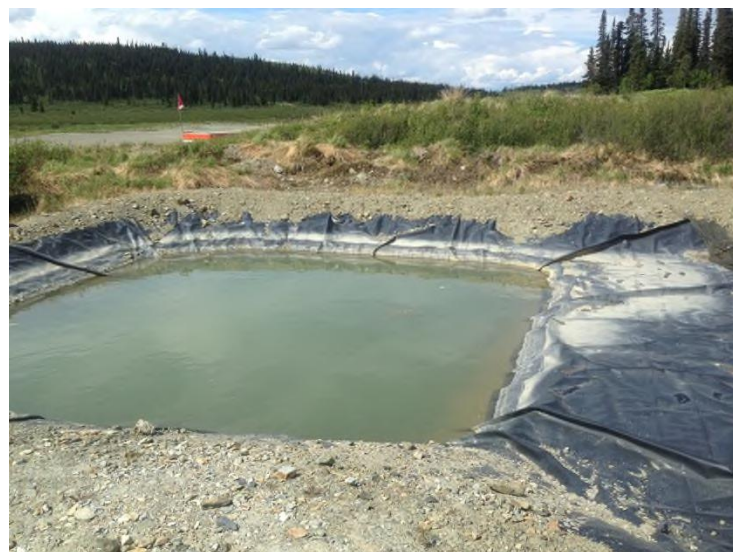
**Photo 26**

The LTF sump was  $\frac{3}{4}$  full. (June 24, 2014)

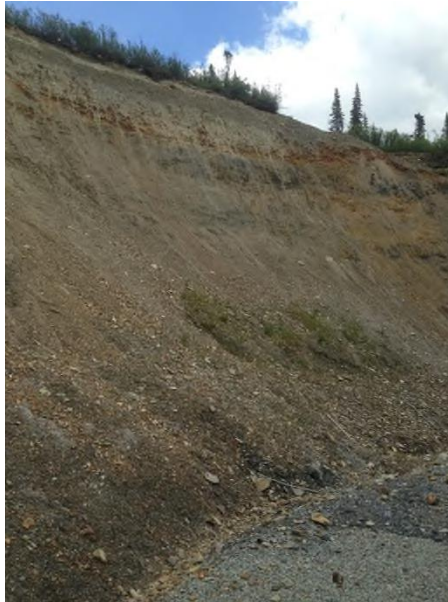
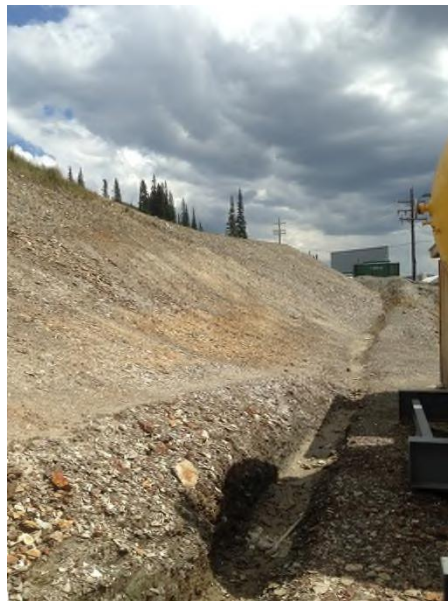
The 2:1 cut slopes for the vent raise and propane tank pad were observed and were considered stable (Photos 27 and 28). The vent raise back slope is showing some signs of erosion and should be monitored for instabilities at the top of the slope.

The backslope of the vent raise. (June 24, 2014)

The backslope behind the propane tank pad. (June 24, 2014)

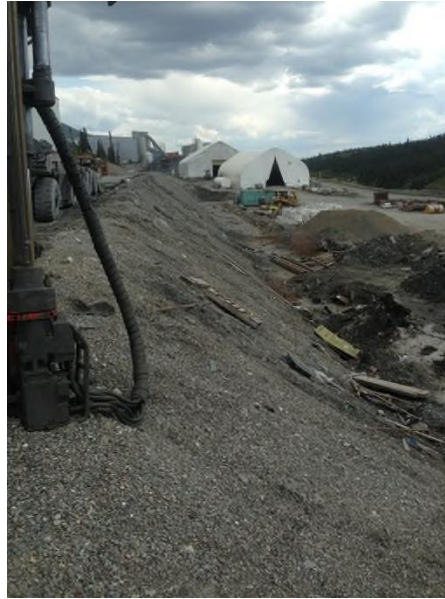
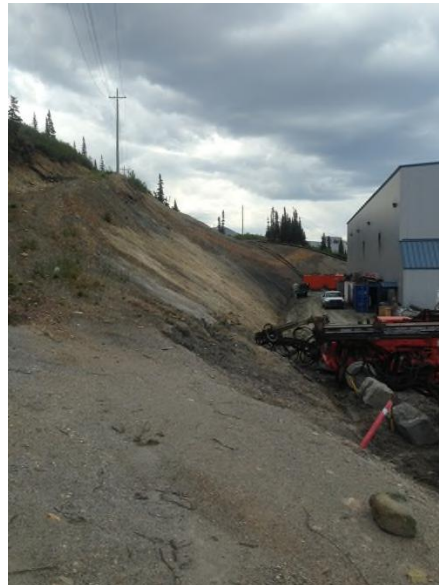
The 2:1 cut and fill slopes for the truck shop pad were observed and the majority of the slopes were considered stable (Photos 29 and 30). The northwestern end of the backslope has a small area of slumping that should be monitored and repaired as required.

The downslope of the truck shop pad. (June 24, 2014)

The backslope behind the truck shop pad. (June 24, 2014)
