August 11, 2015

Yukon Zinc Corp.
#701 – 475 Howe Street
Vancouver, British Columbia
V6C 2B3

Wolverine Mine
2015 Annual Physical Inspection of TSF and On-site Earth Structures

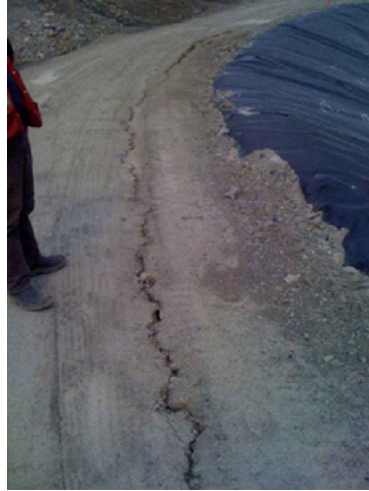
- 2013 observations: In the 2013 DSI cracking ranged from 1 mm to 7 mm wide was observed in this area along the crest of the impoundment. These cracks were not deeper and there was no slump or damage to the anchor of the liner noted.

2013: CRACKS AT NORTH END OF IMPOUNDMENT ON CREST

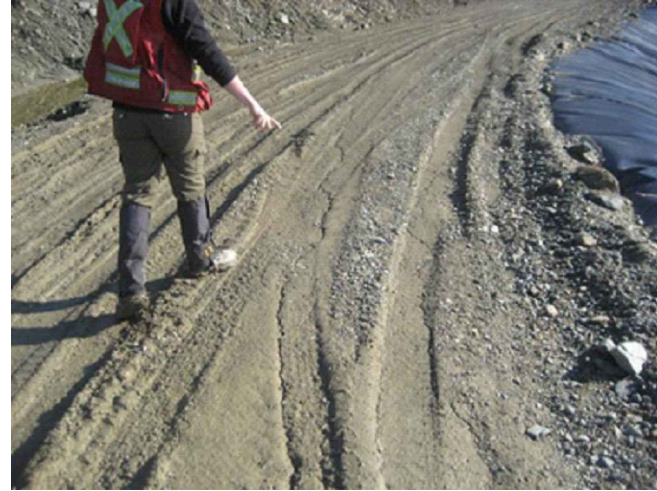
- 2014 observations: In the 2014 DSI both a slump and tension cracks were reported in this area. The length of the liner affected by the slump was approximately 3 m along the anchor trench. Cracking observed in 2013 was reported to be reopened and was approximately 100 m long parallel to the crest and was 1 mm to 10 cm wide.

2014: CRACKS AT NORTH END OF IMPOUNDMENT

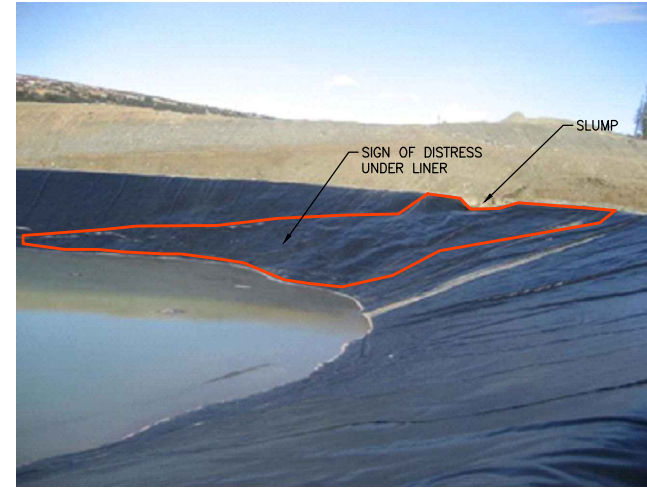
2014: SLUMPING IN NORTH END OF IMPOUNDMENT

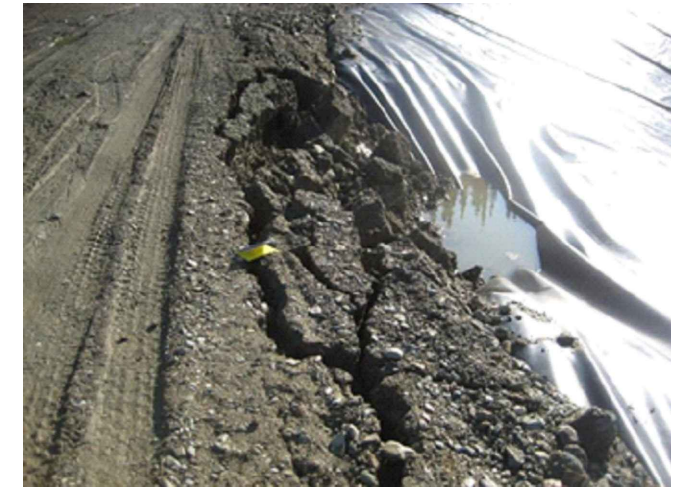
2014: CRACKS AROUND SLUMPING AREA

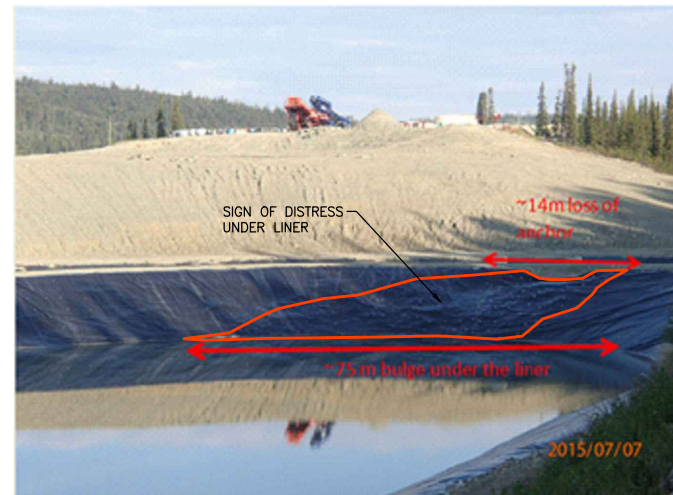
- 2015 observations: Slump along the anchor trench noticed in 2014 has deteriorated in 2014/15 and was approximately 14 m wide. The crest of the impoundment has been completely eroded with complete loss of anchor. Approximately 1.5 m of crest has been lost along the slump. The total height of tailings and water at the toe of the impoundment slope along the north end is less than 2 m and there was visible sign of distress in the slope underneath the liner under the slump and approximately 75 m west of the slump along the crest. At the slump location it appears soil underneath the liner has slid towards the downslope and created a bulge shape. No damage to the liner was visible due to this bulge except a puncture from an exposed rock (<5 cm). Tension cracks approximately 30 m long are visible upstream of the slump area but appear to be filled in with soil and are less than 10 cm deep.

The slump appears to be localized along the TSF slope and caused by an elevated water level. No tension cracks were observed upslope of the slump area in the crest or the waste dump during the site visit indicating a deep seated failure mechanism.

2015: SLUMP IN THE NORTH END OF IMPOUNDMENT

- Cover the entire slump area and cracks with a liner or equivalent product to prevent ingress of water from heavy rain events and spring melt. This cover should be placed before the winter season begins.
- Monthly survey of the slump area during the summer months.
- Visual monitoring on a weekly basis during the summer months.
- Immediately repair any damage to the liner caused by the slump.

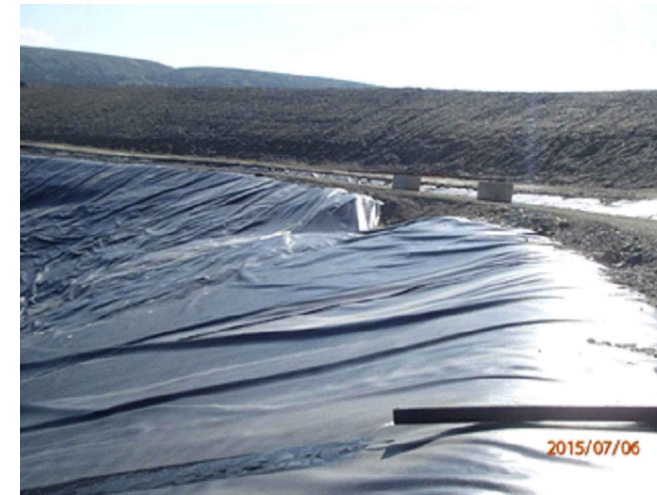
The liner was generally in good condition with no sign of tear or puncture. Anchor of the liner along the crest was in good condition except at the north end where anchor is damaged due to a slip in the TSF wall. Further details on this slip along the north slope are provided in Section 4. YZC inspects the liner for defects as a part of routine surveillance as laid out in the OMS. Defects are not considered a concern provided they are small and patched when they are found.

2015: ANCHOR FAILED IN 2014 CRACK AND SLUMP AREA

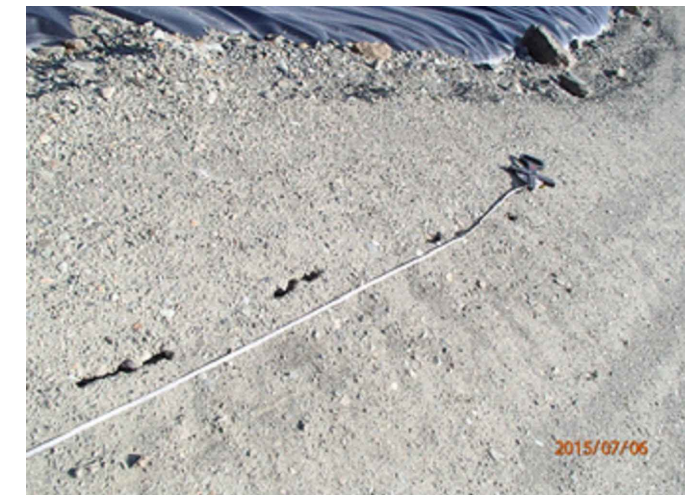
2015: TENSION CRACK UPSTREAM OF SLUMP APPEARED TO BE FILLED IN

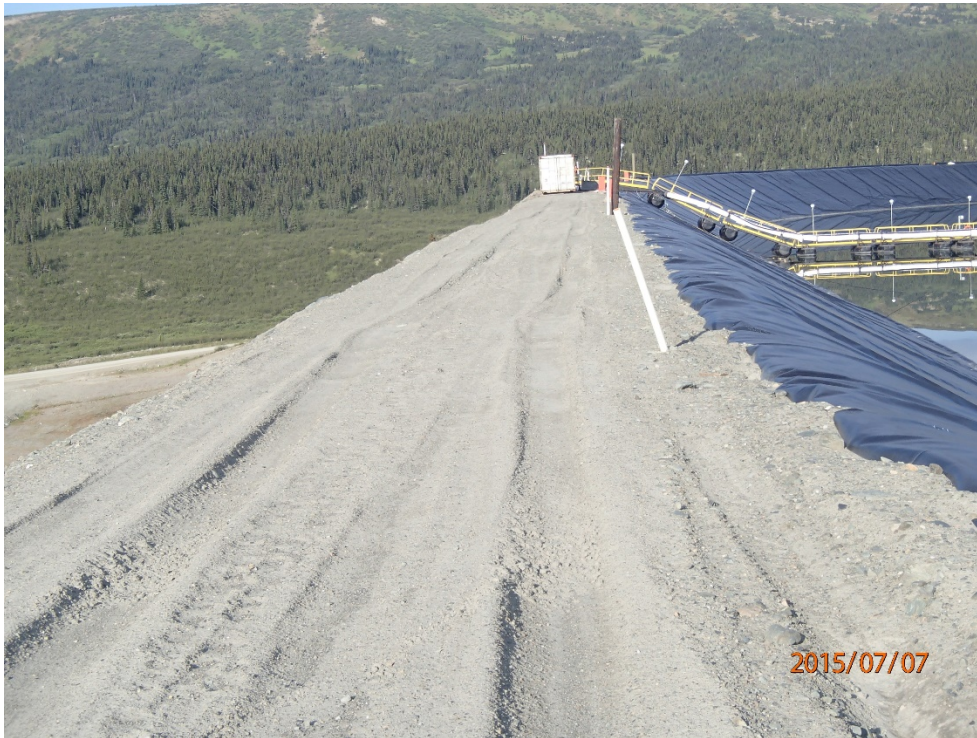
Photo 1 **South dam crest - looking west; ruts on the crest surface**

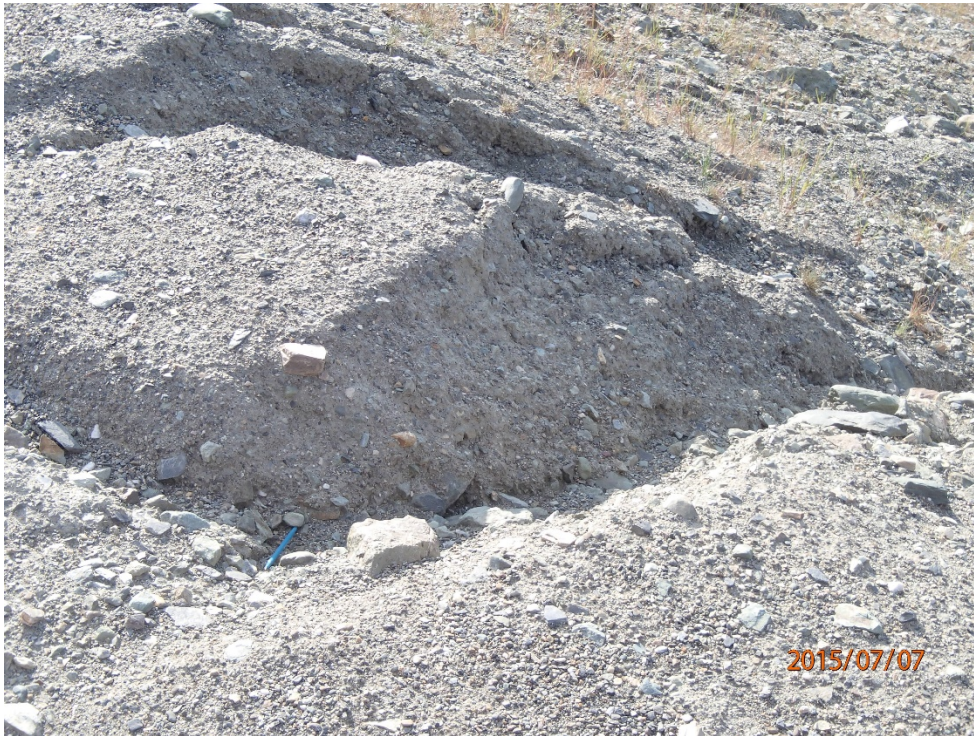
There were signs of localized erosion along the dam crest and downstream slopes. Erosion gullies originated along the downstream edge of the dam crest were in the order of 10 cm to 30 cm wide and 10 cm deep. Most of the erosion was observed along the south dam and north side of the west dam. The crest width of the dam was approximately 4 m at several spots along the north side of the west dam indicating continuing erosion of the dam crest. There were 10 cm to 15 cm deep ruts on the dam crest which can pond water after rain storm. Erosion of the dam crest and downstream slope will continue and may cause significant crest loss if some erosion protection measures (such as

Photo 2 South dam –erosion gully on downstream edge

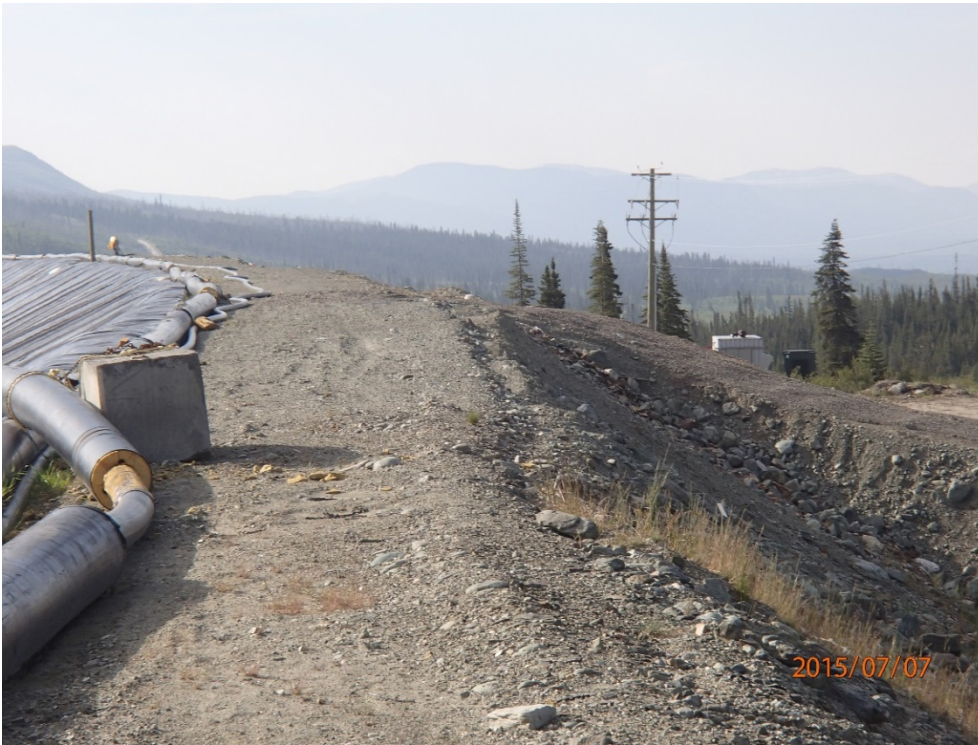
Photo 8 West dam crest - looking south, south of access ramp, less erosion and no crest loss

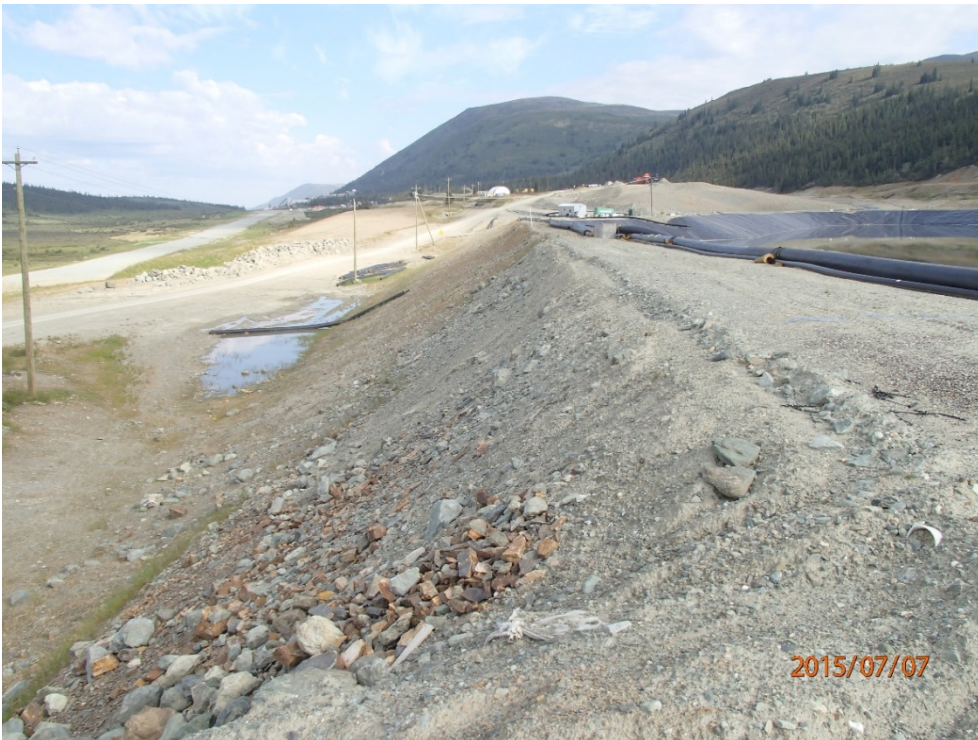
Seepage collection ditches along the toe of the dam were dry. There was ponded water along the south side of the west dam from recent rain but no seepage was observed from any of the dam faces or abutments.

Photo 9 West dam – downstream slope, looking north, north of access ramp, ponded rain water at the toe

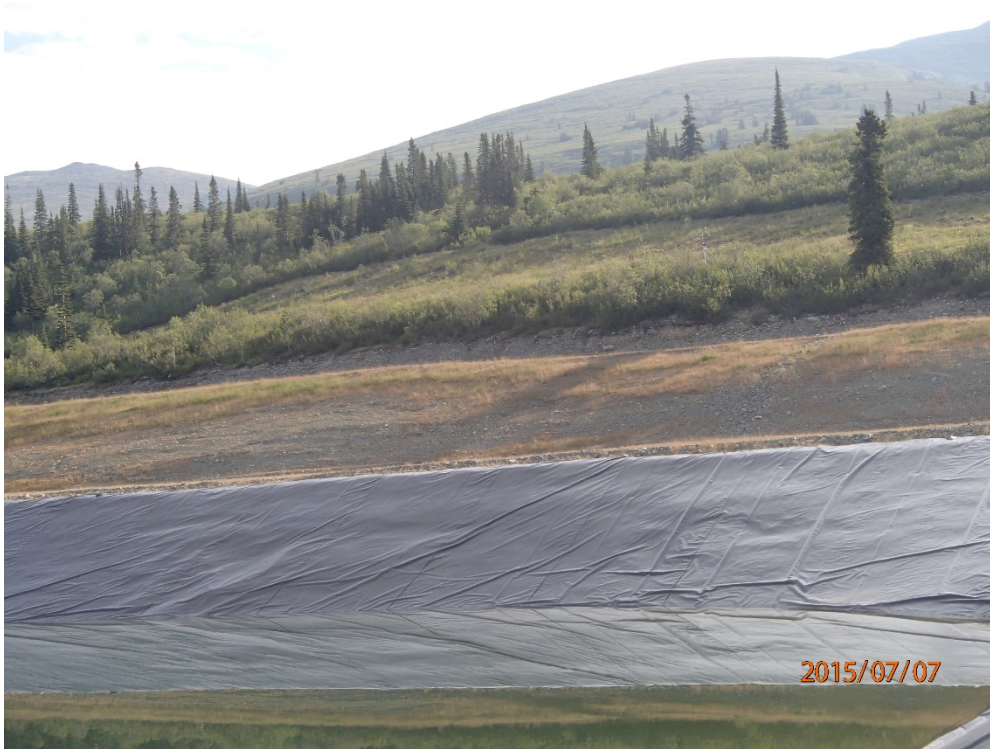
Photo 14 TSF east side liner– from west berm, minor bulging

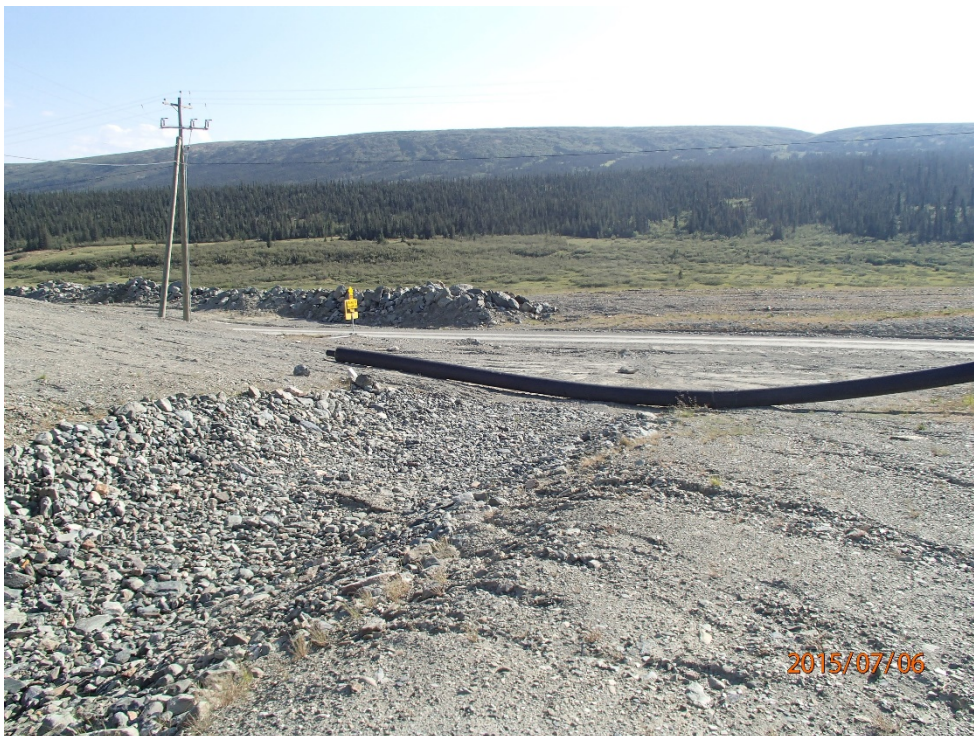
Currently the spillway channel reports to the east ditch along the Mine Haul Road. The closure spillway design extends the flow channel across the Mine Haul Road to report to the existing catch basin above Go Creek. YZC will extend the spillway to the catch basin for closure. The rip-rap in the spillway was in good condition. There is a piece of 8 inch insulated tailings line left at the downstream end of the spillway which is blocking the flow path and should be removed.

Photo 17 Spillway –looking downstream- rip rap ends upstream of the haul road and 12 inch redundant tailings line blocking the spillway

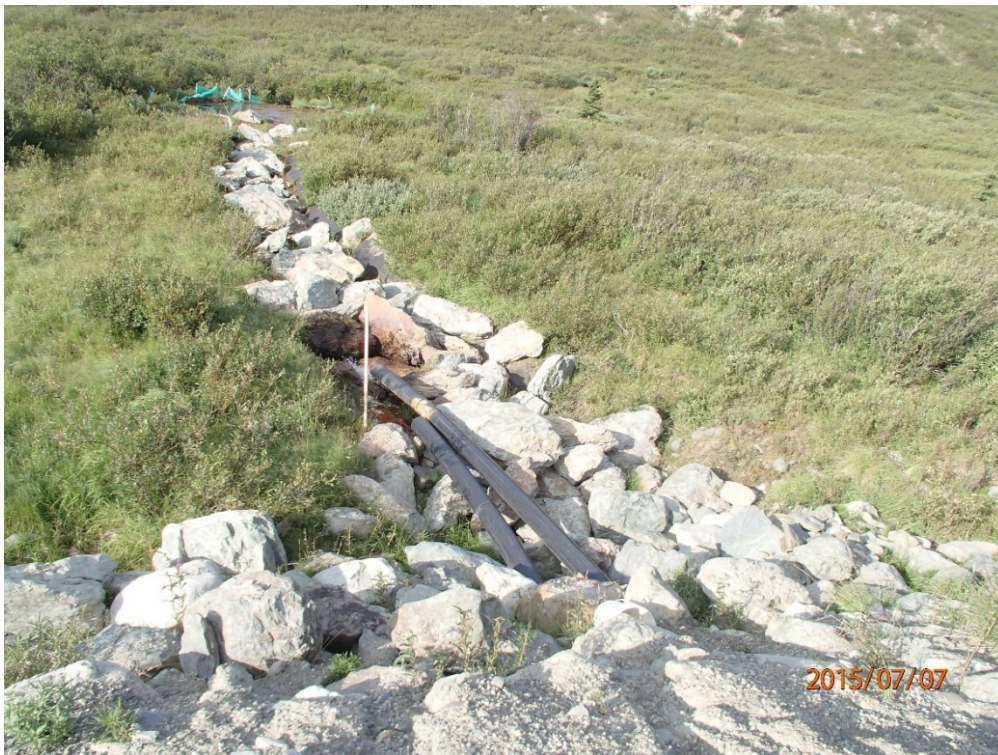
The flow out of the underdrains daylighting downstream of the seepage dam is approximately 5- 7 L/s, similar to flows observed during the 2014 DSI. Rip rap along the outlet area was in good condition.

Photo 19 Underdrain outlet – downstream of seepage berm

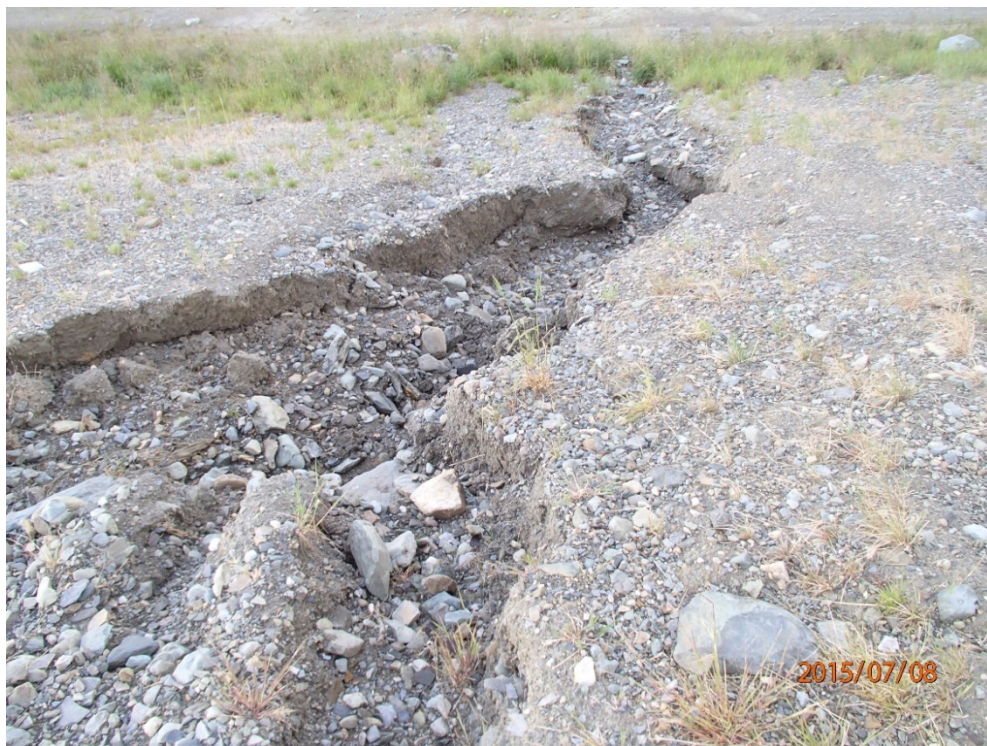
Photo 41 Northwest waste pile – erosion gully at the slope by the air strip

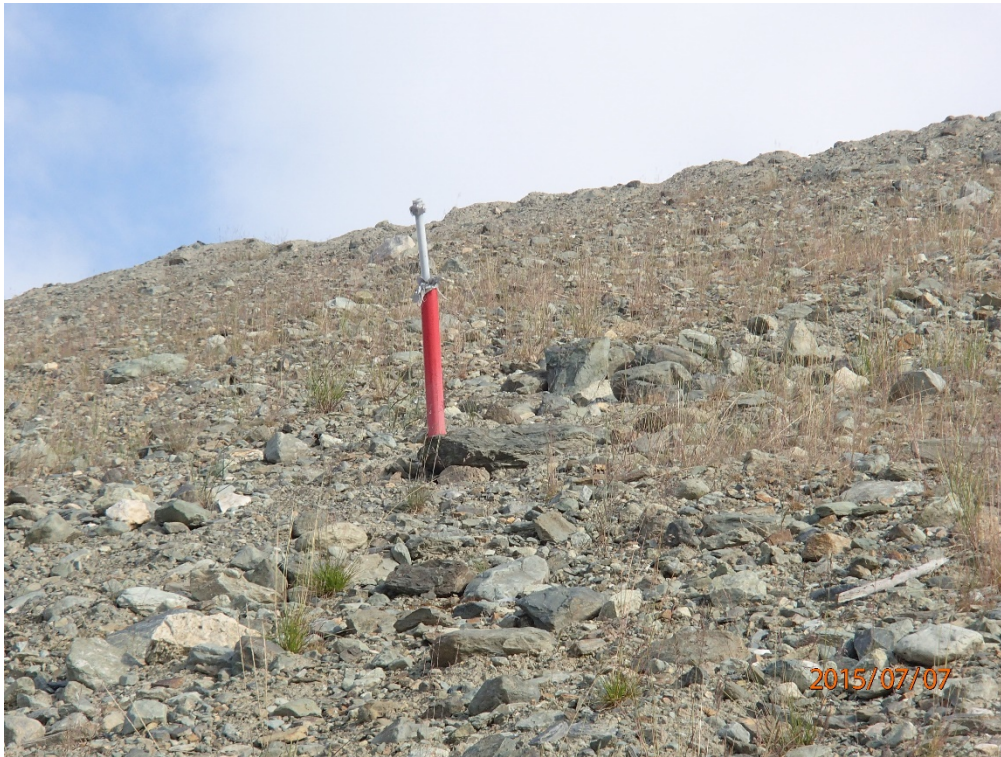
Two inclinometers (Figure 1) were installed in the downstream slope of the dam. Both inclinometers have been damaged. The inclinometer data collected to date has not indicated any significant slope movement. Since there is no new data since 2013, inclinometer data are not added to this report.

Photo 42 **Non-functional Inclinometer on the downstream slope**

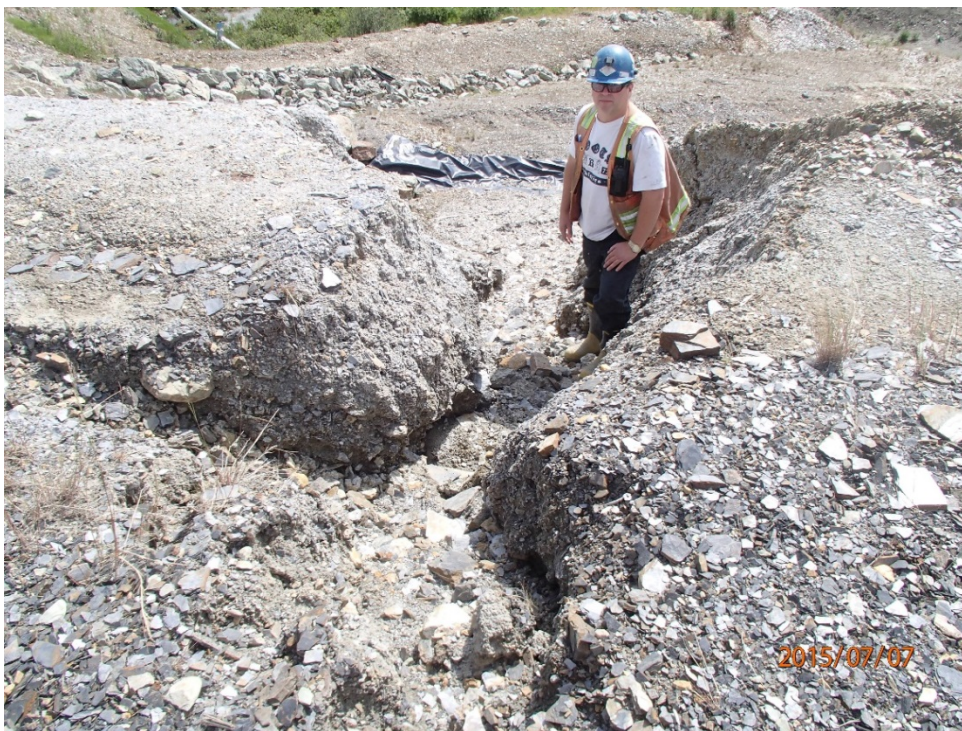
- Mill building – large erosion channel along the southeast corner of downslope observed in 2014 was not repaired; there was no photo record available from 2014 inspection for comparison, but it appears to be deteriorated as surface runoff from the Mill pad accumulates and drain through this gully.

Photo 3 Mill building pad – downslope at southeast corner, large erosion gully from previous year, not repaired

No.	Structure	Recommendation	Deadline for Action
M-15-1	Mill Building pad	Repair the large erosion gully in the downslope (south east corner) to prevent further deterioration from spring melt and runoff from heavy rainfall event.	A
M-15-2	Sump 2	Monitor the bulge in the liner in the cross dam and develop a mitigation measure to lower groundwater table, such as pumping.	B
M-15-3	Ditch 1	Monitor the tension crack on the ditch embankment and repair as required. Clean the culvert inlet and the construction litters and debris from the ditch bottom.	A
M-15-4	Ditch 2	Clean the plugged culvert inlet.	A
M-15-5	Ditch 4	Properly anchor the ditch liner by keying in along the ditch crest.	A
M-15-6	Camp Pad	Monitor five erosion gullies located along the south slope and repair as required.	B
M-15-7	Truck Shop pad	Repair the erosion gully in the downslope located west corner of the Truck Shop pad.	A

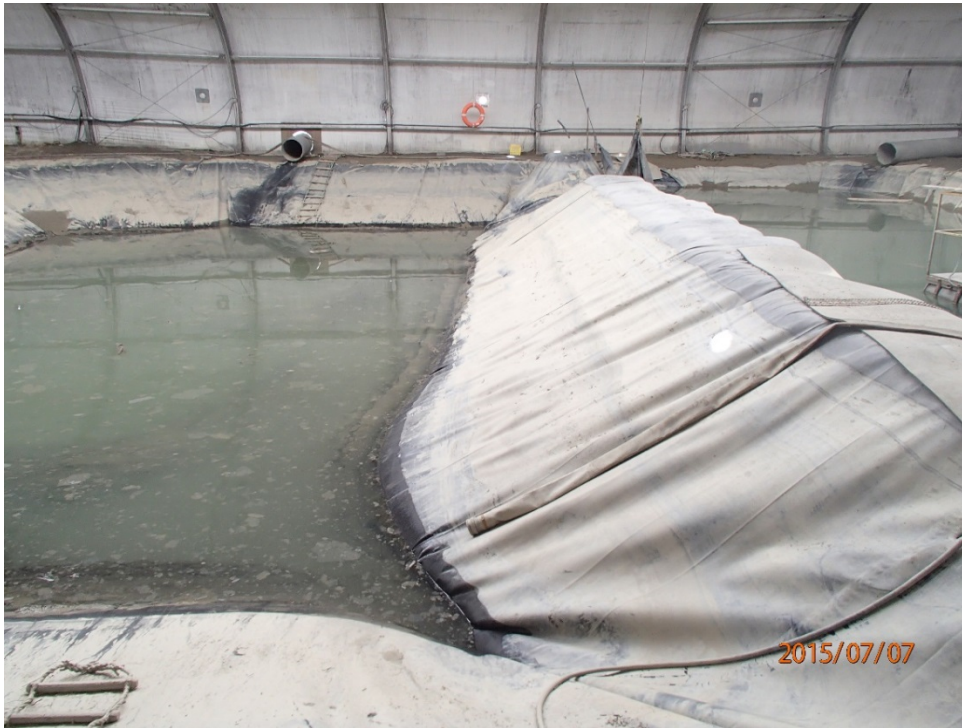
- Sump 2 – The liner was in good condition but a bulge was visible in the cross dam due to groundwater. A high water level could destabilize the dam and should be lowered by pumping.

Photo 12 Sump 2 – bulge in the liner in the cross dyke, caused by groundwater

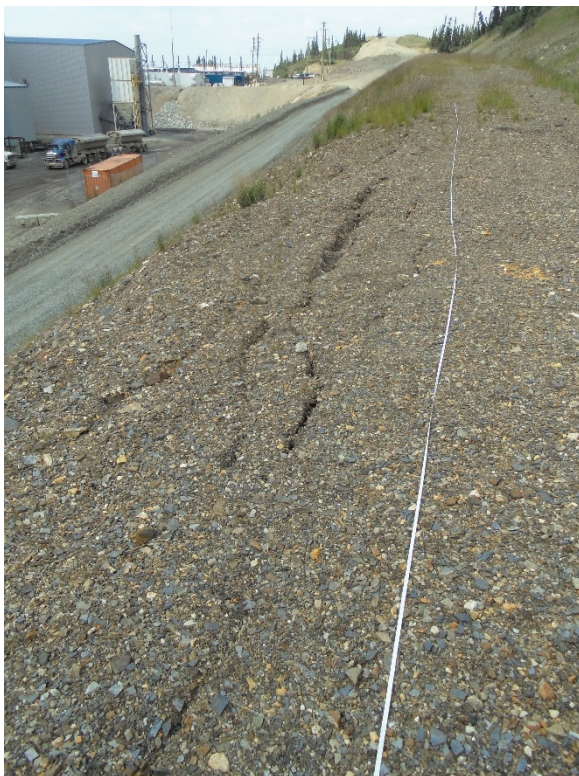
- Ditch 1 – A 20 m long tension crack was visible along crest of the ditch embankment. There was no sign of instability in the down slope or in the toe, but this area should be monitored and repaired as required. The inlet of the culvert that diverts surface runoff to downslope of the Mill pad was completely plugged with debris and should be cleaned. There was construction litter and debris in the ditch bottom, which should also be cleaned to maintain the flow capacity of the ditch.

Photo 15 Ditch 1 – 26 m long crack in the Ditch 1 embankment, looking north from corner of Mill building

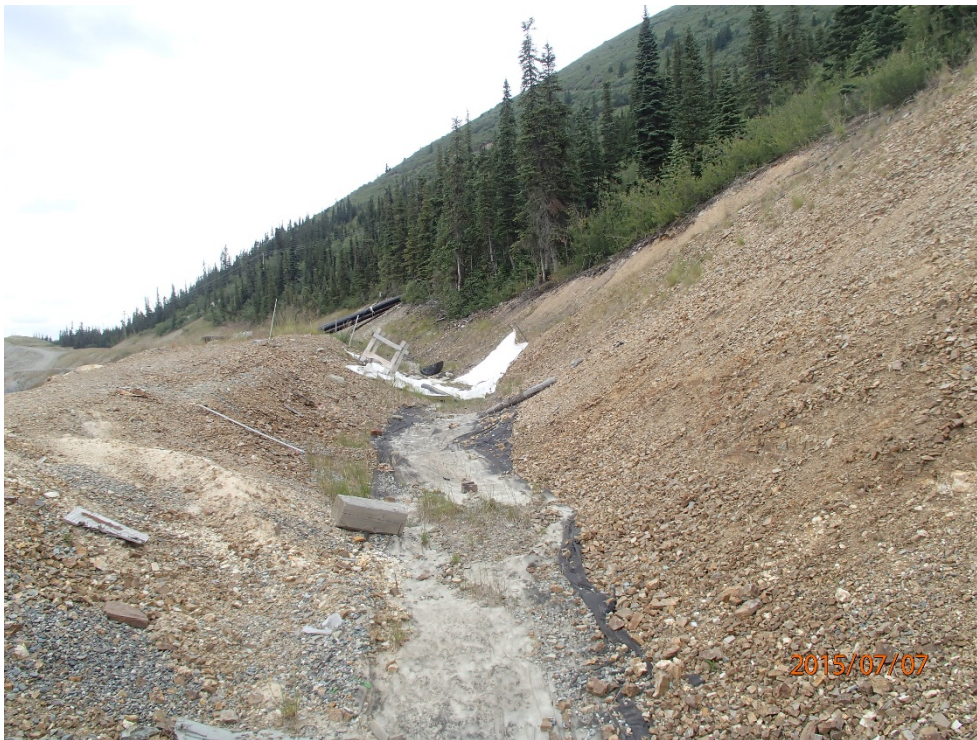
Photo 16 Ditch 1 –looking north, litter in the channel bottom

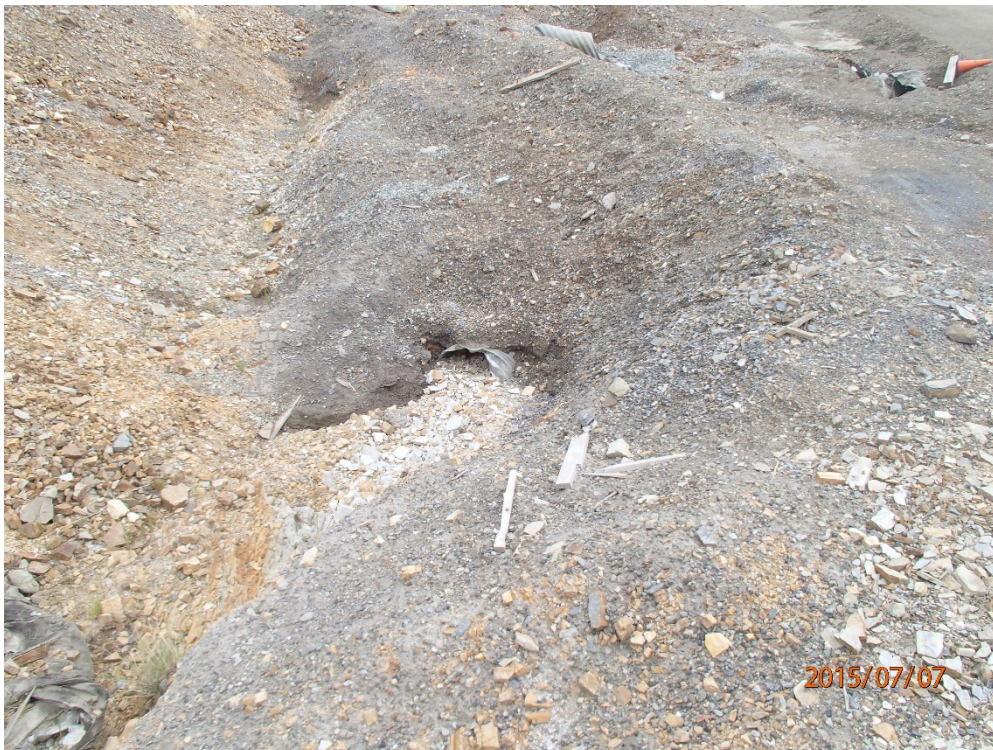
Photo 17 Ditch 1- culvert inlet completely blocked

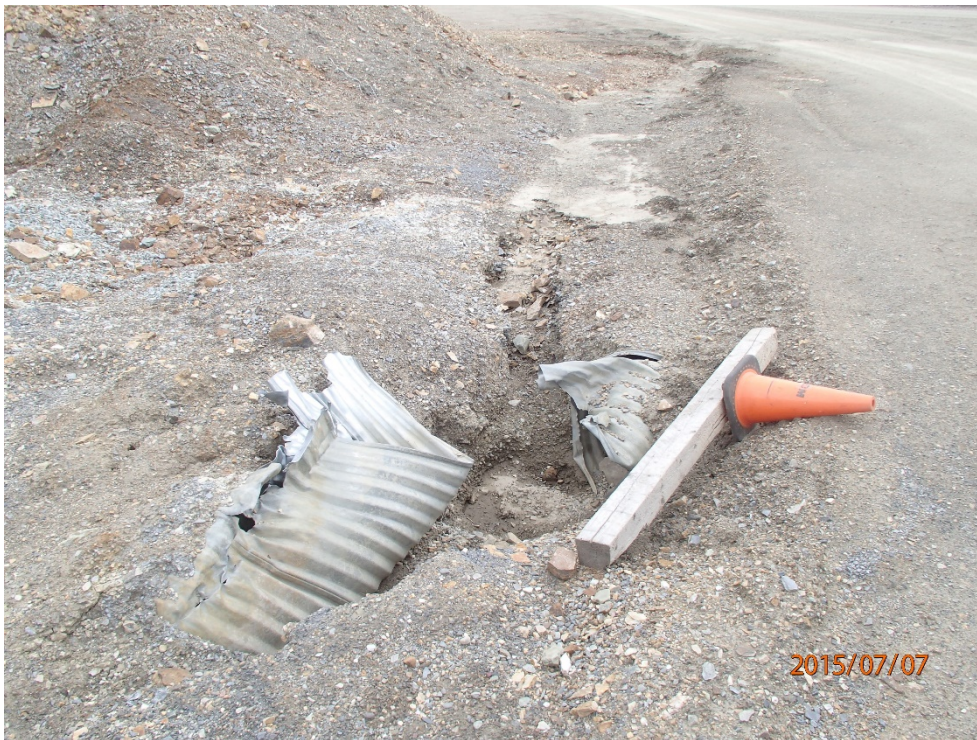
Photo 18 Ditch 1 – culvert damaged

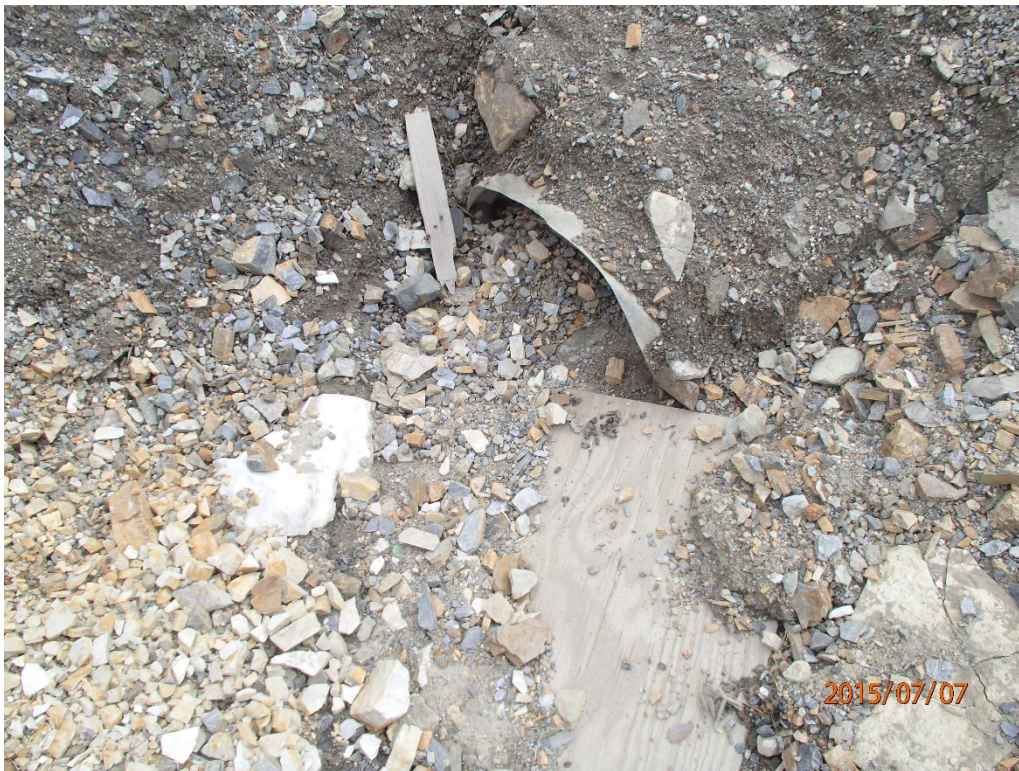
Photo 19 Ditch 2 – inlet for upper culvert, completely plugged, non-functional

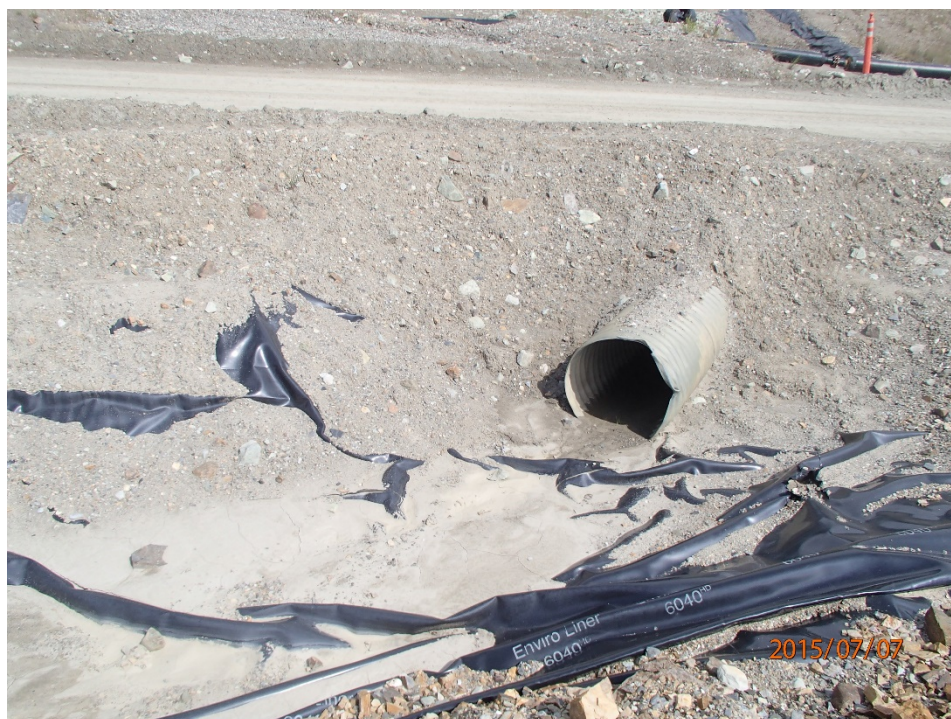
Photo 22 Ditch 3 – culvert outlet; channel bottom filled in and liner loose

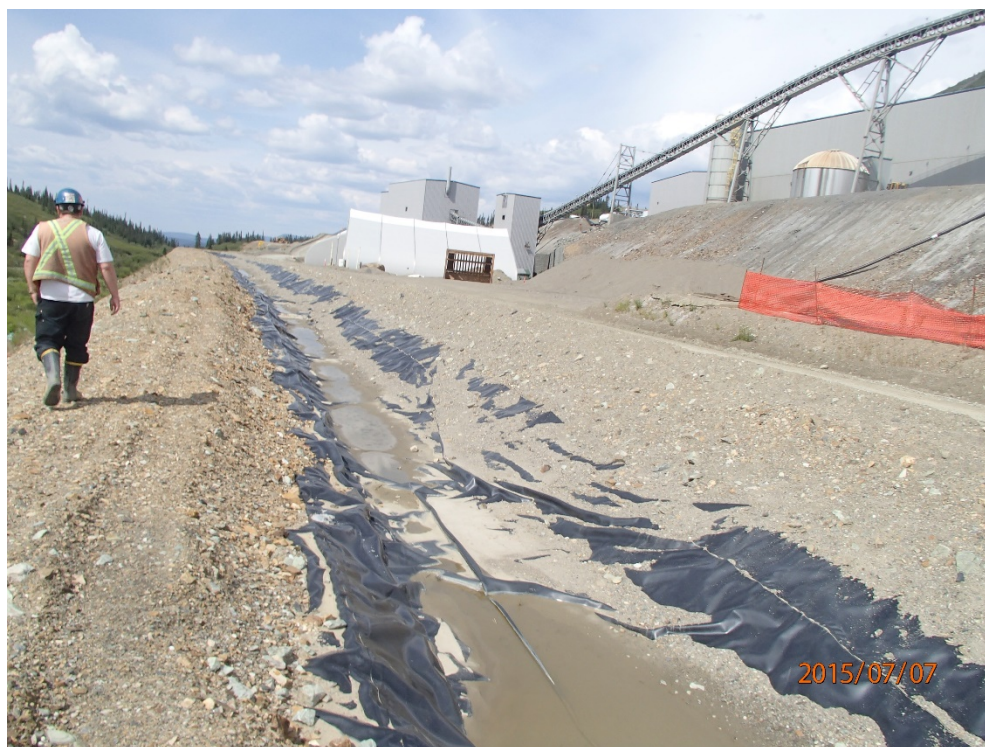
Photo 23 Ditch 3 – looking west, channel bed filled with silt and gravel

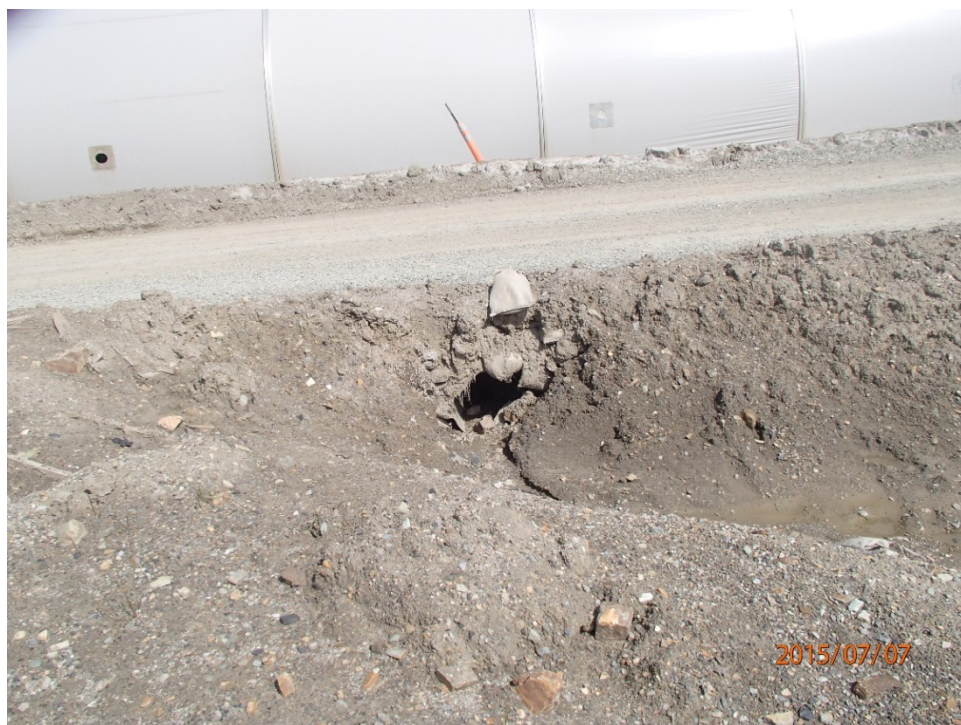
Photo 24 Culvert inlet to Sump 2- damaged and blocked

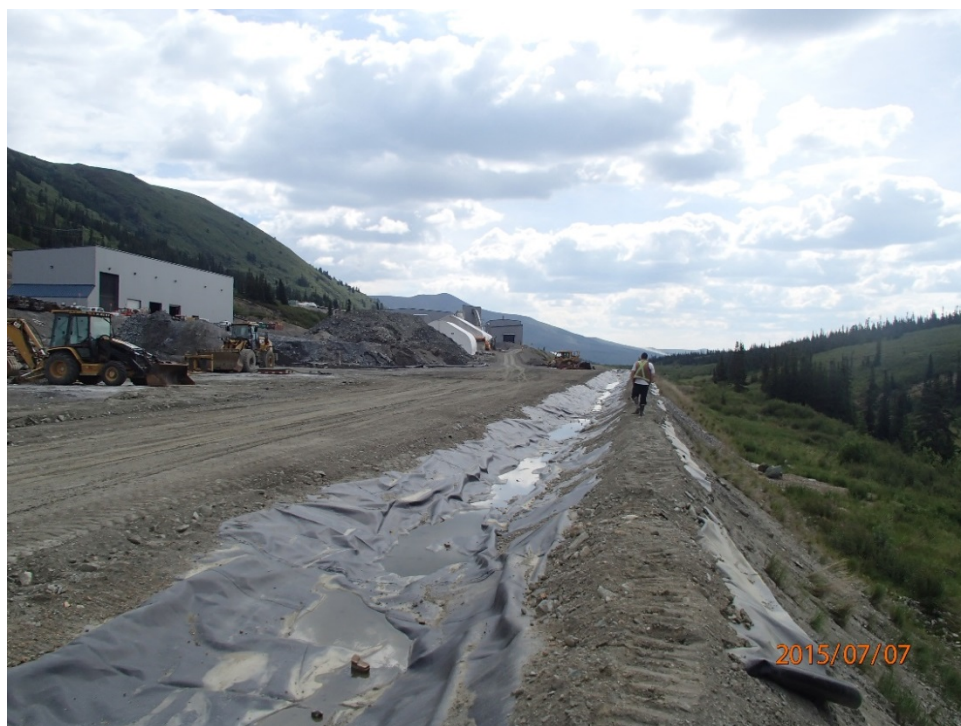
- Ditch 4 – This ditch was lined in 2014 and 2015, but the liner was not anchored properly. The end of liner on the channel crest was covered with un-compacted fill, which may erode during a large rain event. The liner should be keyed to the channel crest to prevent further damage. The ditch bottom was filled in with debris washed from the upslope and should be cleaned to promote flow.

Photo 25 Ditch 4 – lined channel looking east, liner along the downstream side loosely anchored by uncompacted fill, may wash away after large rainfall event (2015 construction)

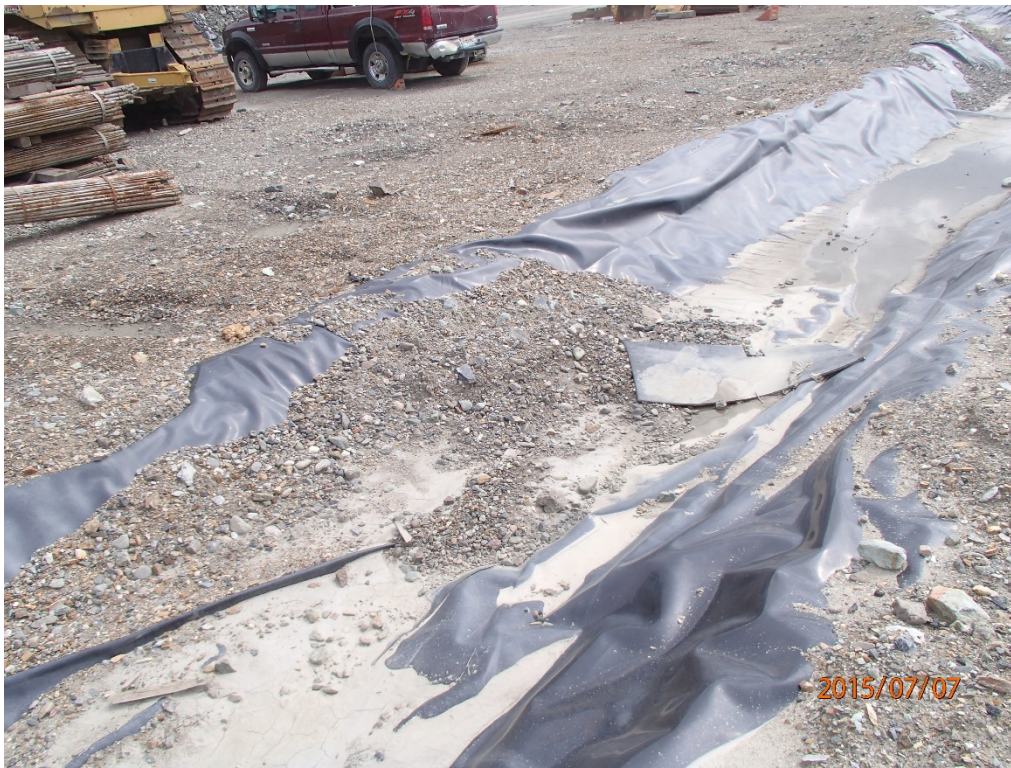
Photo 26 Ditch 4 – ditch bottom silted and filled with washed rock, reduced flow capacity

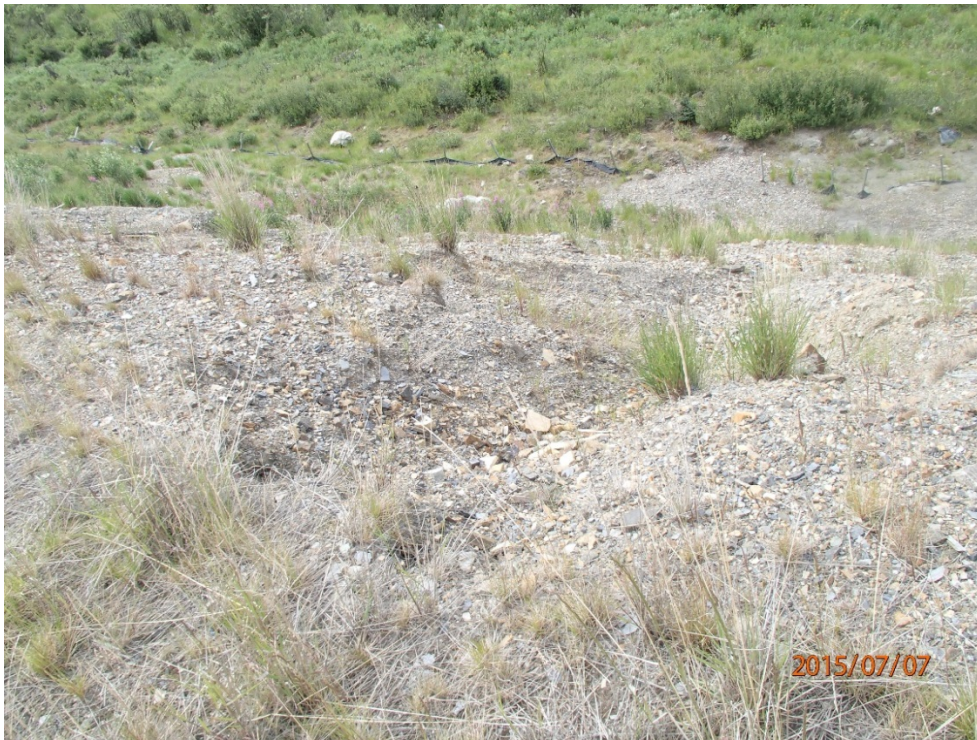
Photo 27 Ditch 4 – erosion channel in the downslope

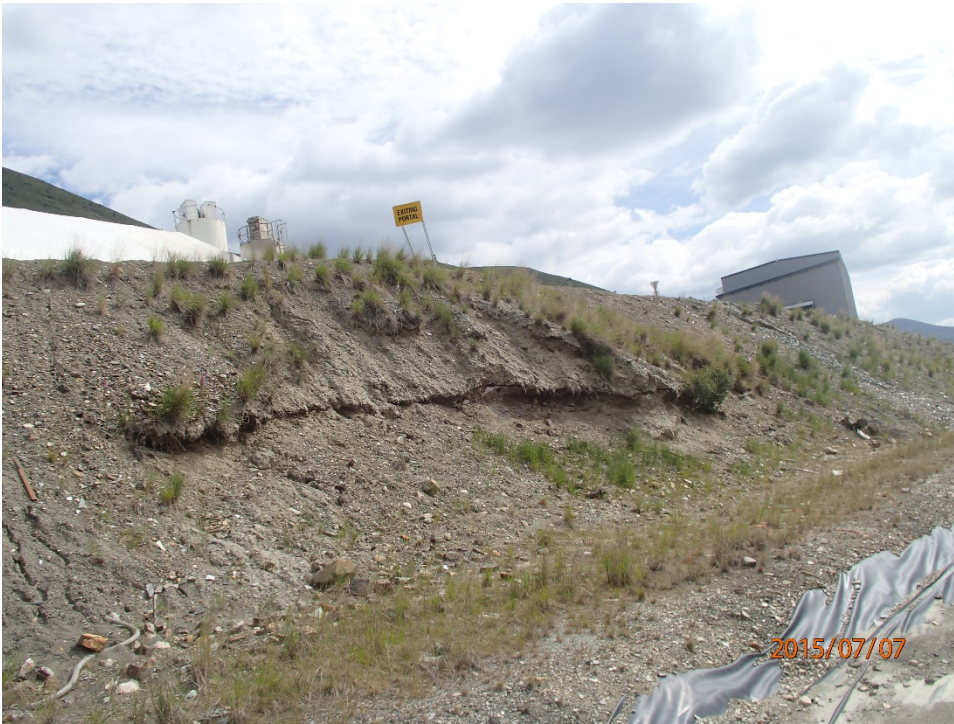
Photo 28 Ditch 4 – area of undercutting in the upslope noted in 2014 report was repaired (downslope of shotcrete and cement plant)

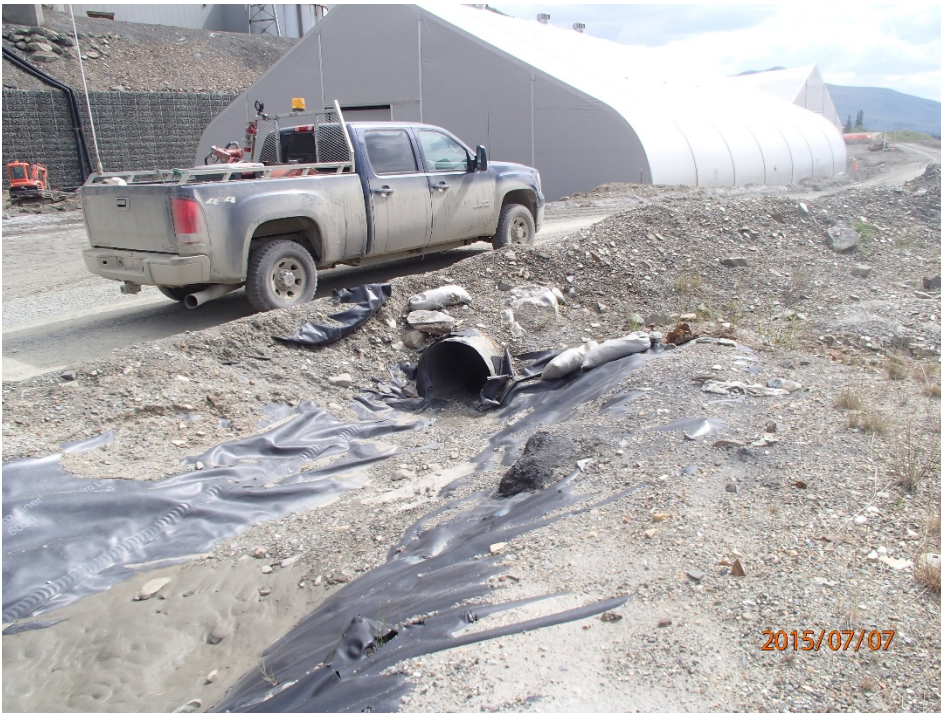
Photo 29 Ditch 4 – inlet for culvert, channel bottom and culver invert filled with sand, silt and gravel

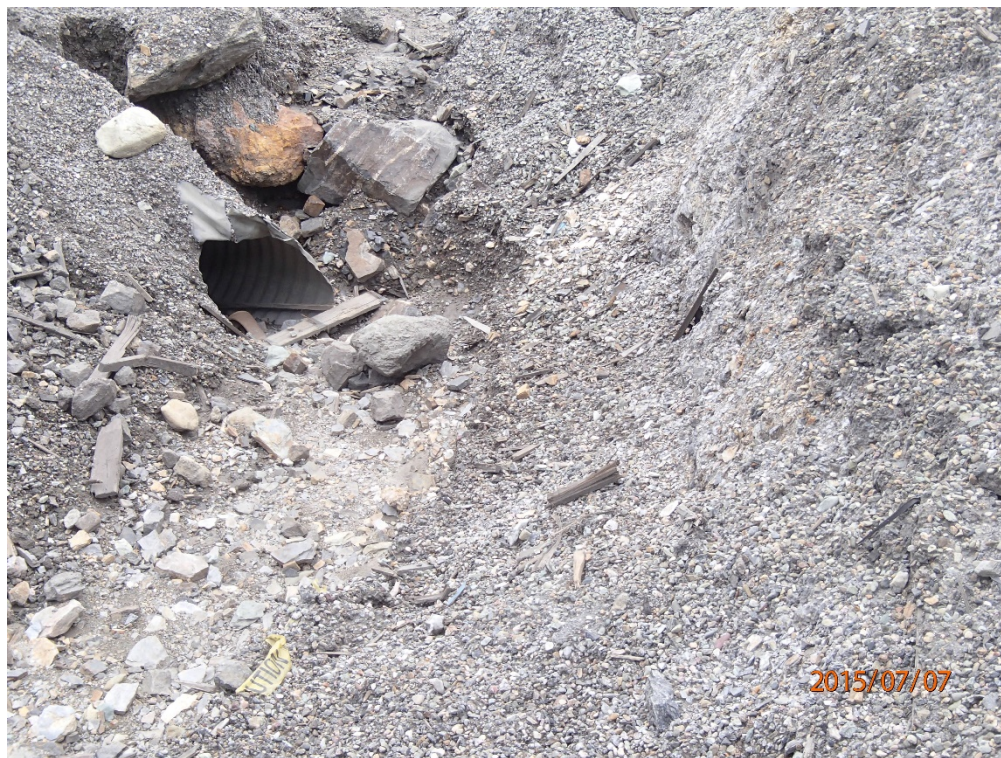
Photo 31 Ditch 5 – culvert inlet, channel bottom filled in and partially blocked with litter
