August 11, 2015

Yukon Zinc Corp.
#701 – 475 Howe Street
Vancouver, British Columbia
V6C 2B3

Wolverine Mine
2015 Annual Physical Inspection of TSF and On-site Earth Structures

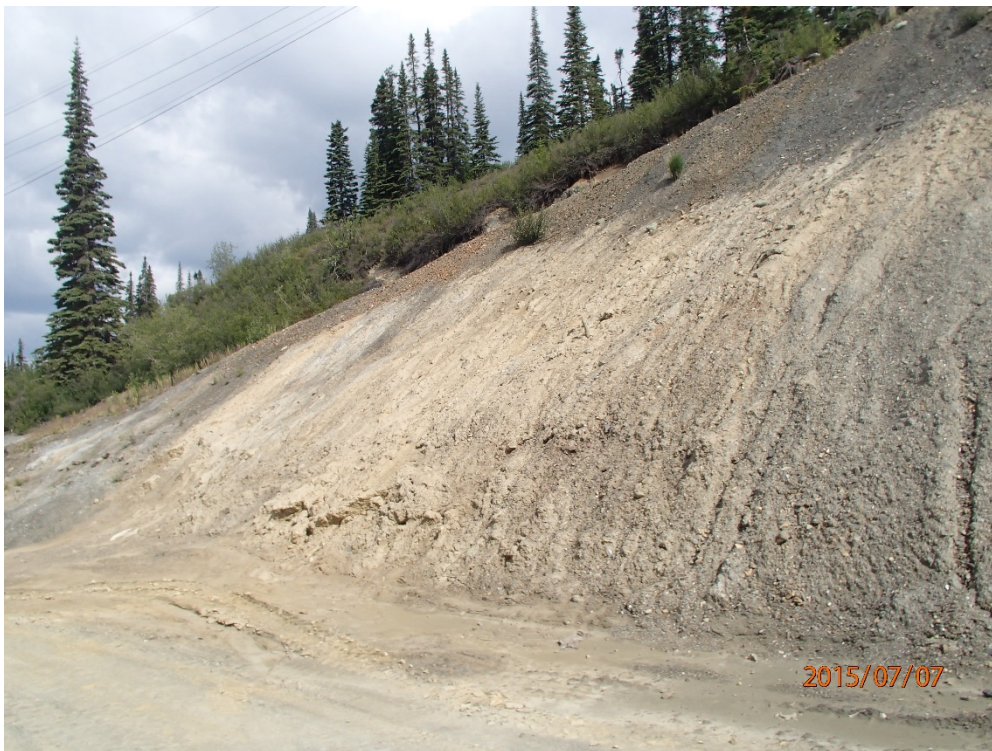
Photo 49 Truck shop pad – back slope, signs of sloughing
