# **Yukon Zinc Corp.**

**Wolverine Mine**

***Dam Safety Review***

***Tailing Storage Facility and Earth Structures***

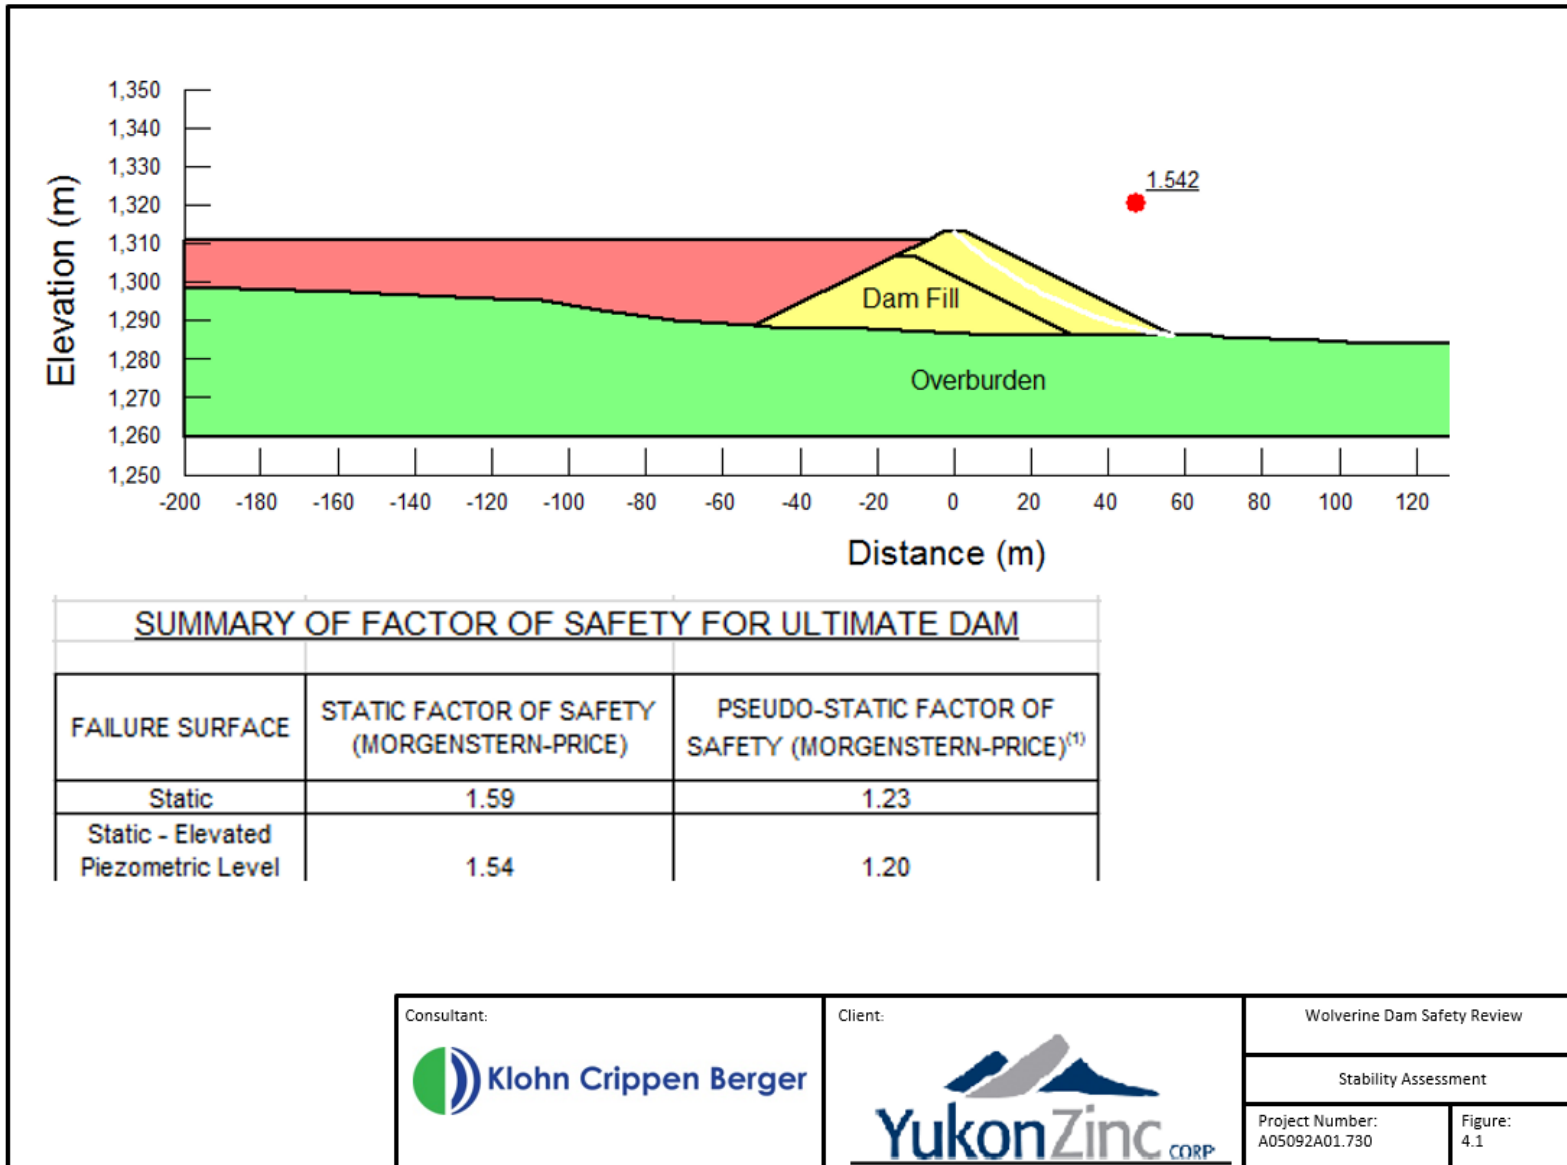
**Figure 4.1 Stability Analysis**

The analyses were performed for the highest dam section. Only failure geometries that include at least half the width of the dam crest were considered in the analysis. The material properties were taken from the most recent design update report (KCB, 2010). The pore pressures assumed are based on the vibrating wire piezometer data collected in 2017.

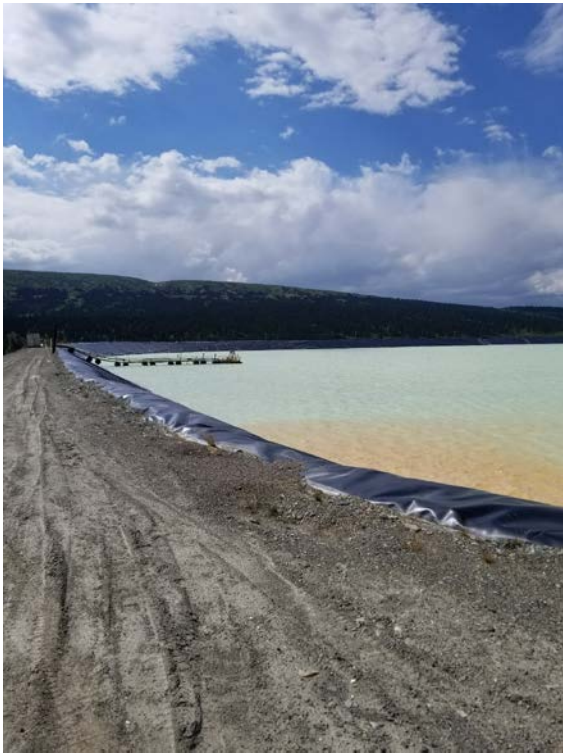
**Photo 3**      **Minor rutting on dam crest near left abutment**

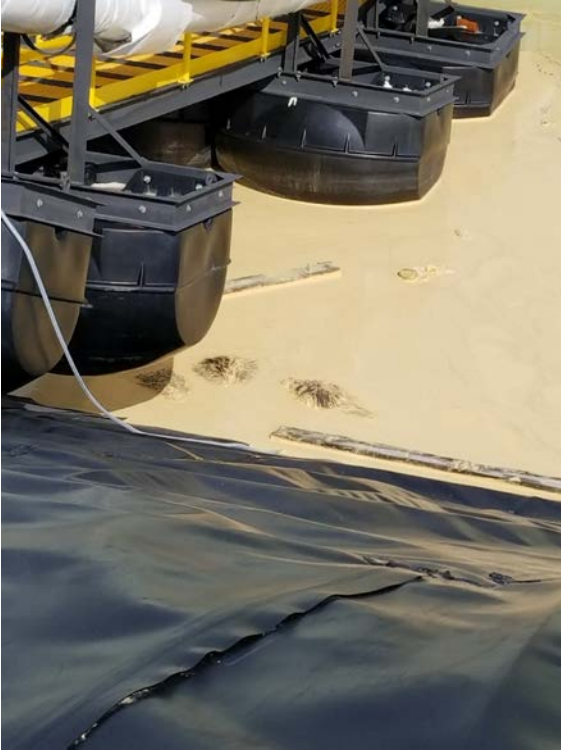
**Photo 5 Debris and dead animals in pond**

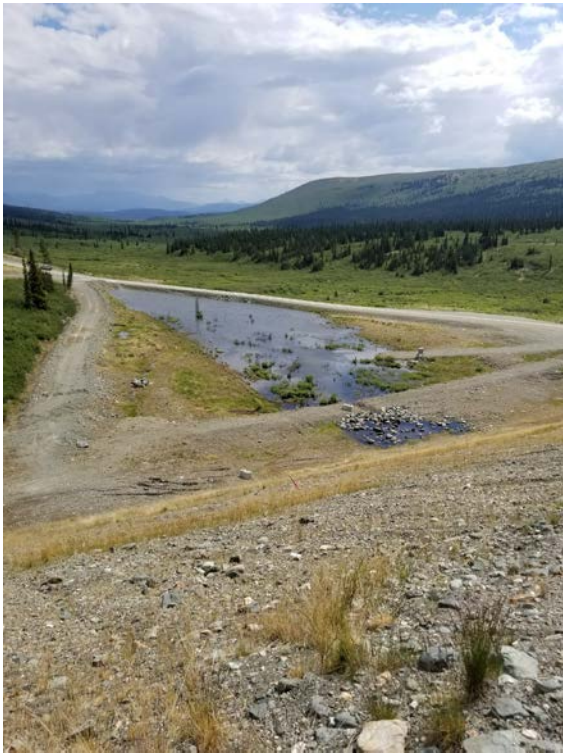
The facility is lined so there is very low seepage from the tailings expected. The seepage collection dam appears to collect mostly local runoff and foundation seepage. Seepage observed at the toe of the dam is likely natural groundwater seepage.

Visual observations of seepage during the 2017 DSR along the South leg of the toe were observed were limited to damp soil but not actual flowing water.

**Photo 9** D/S slope, seepage at toe leading into seepage pond

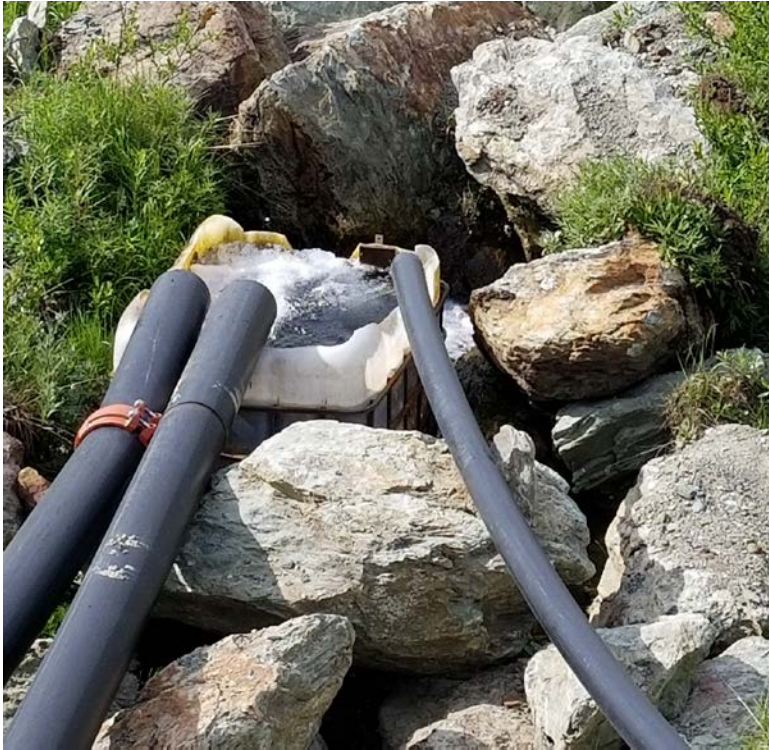
**Photo 11** Discharge pipes running near full from recent rains

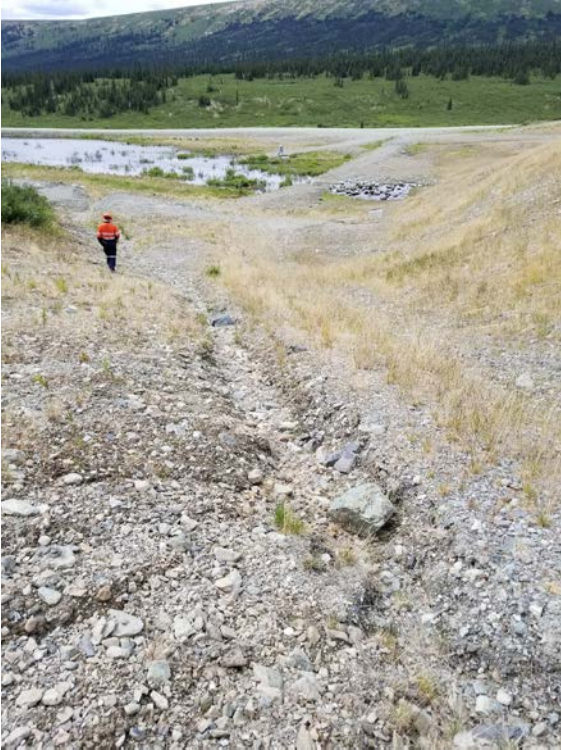
The dam has performed satisfactorily to date based on the instrumentation data and the annual inspections. Localized minor erosion gullies on the dam slopes were noted during the site visit. This superficial erosion does not present an immediate concern to stability, and the risk can be mitigated through regular repairs. In the long term, a plan for erosion protection should be developed. This plan may include re-grading to a shallower slope angle in some locations to improve vegetation growth. Additional berms and erosion protection may be required for closure.

**Photo 17** Erosion gully near d/s toe of dam

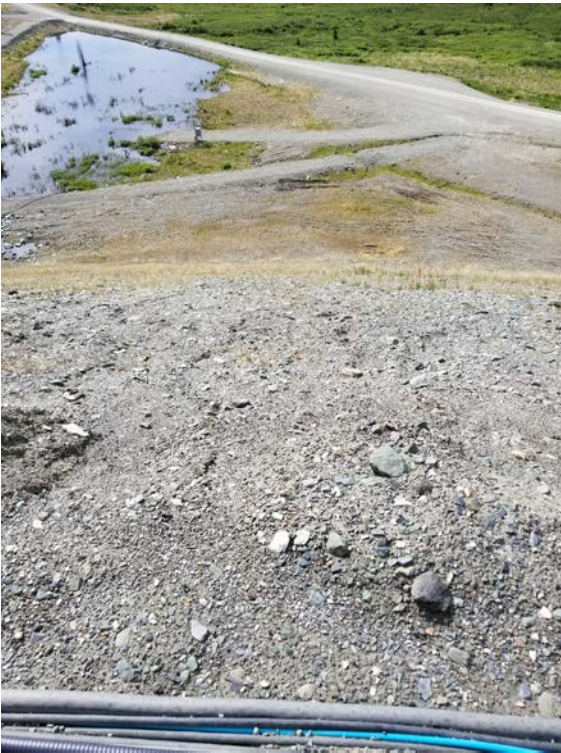
**Photo 18** Minor erosion gullies on downstream slope

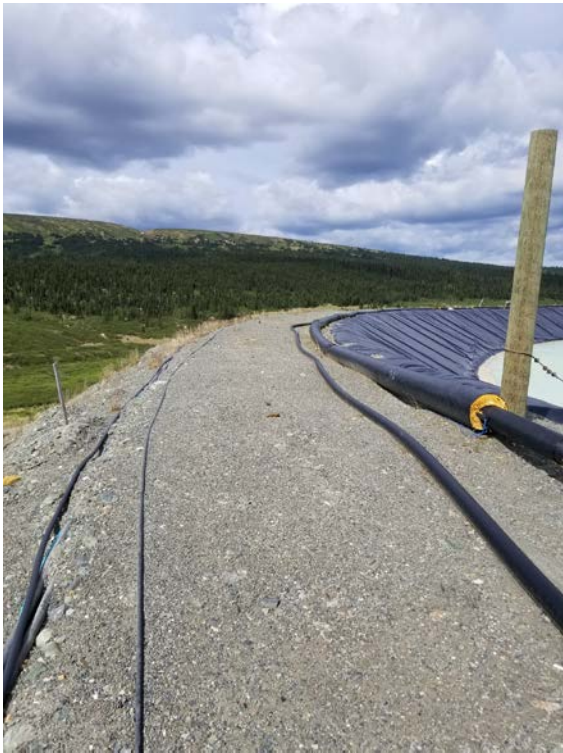
**Photo 19** Dam crest, anchor post, minor veg on d/s slope

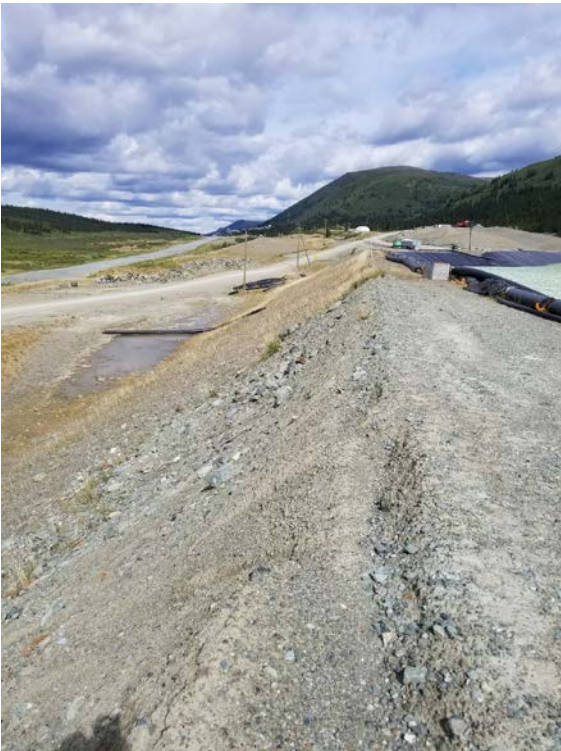
**Photo 22**      **Minor ponded water from recent rainfall**

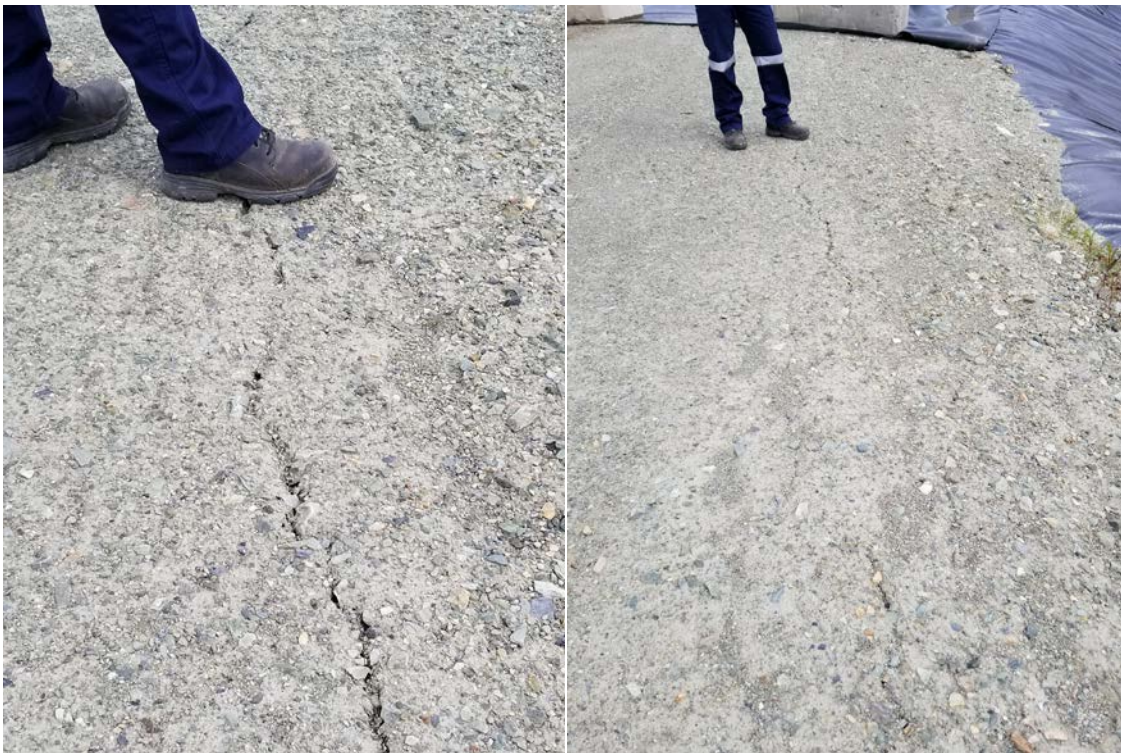
The north end of the impoundment has slumped under the liner. This section of the impoundment is excavated into natural ground and there is no constructed embankment at this location. This area is adjacent to the upstream end of the liner under drain system. The slope failure is likely a combination of high groundwater levels from region sources, seepage from Ditch A before it was lined and potentially high water levels from the liner under drain. This instability does not presently pose a dam safety hazard. But as the liner is damaged there is potential for seepage of contaminated tailings water into the environment if it is not repaired in a timely manner. A short term remediation (recommended by the EOR) of the slump area was implemented but the movement continues and a long term solution is required.

**Photo 24** Cracking in dam crest near north end slump

The area can be repaired now fairly easily, as there is less than 1 m of tailings in the area. The area will have to be isolated keep the tailings and water away from the area. An aquadam (inflatable dam) could be used as an isolation structure and water pumped over into the main pond. The liner could then be pulled back and the soft, failed materials removed and replaced with compacted granular fill. A new lined area could be installed and work completed to ensure long term stability of the area.

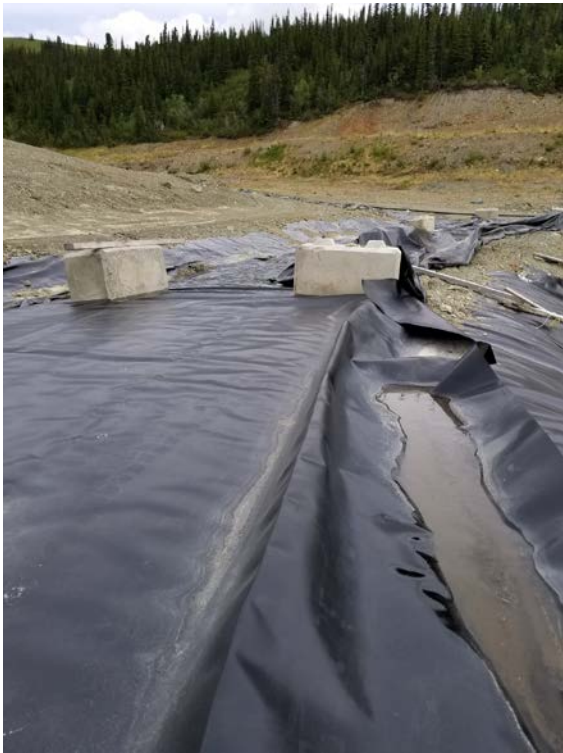
**Photo 25** Temporary cover over slump area

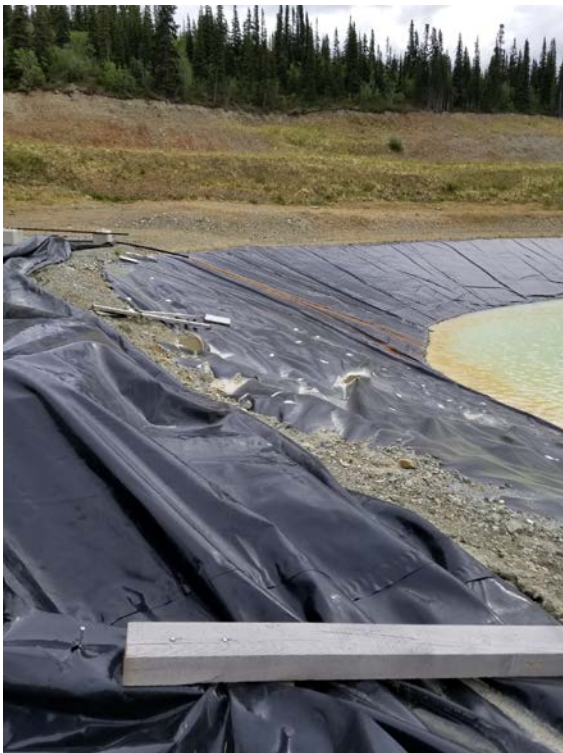
**Photo 26** Debris from monitoring set up

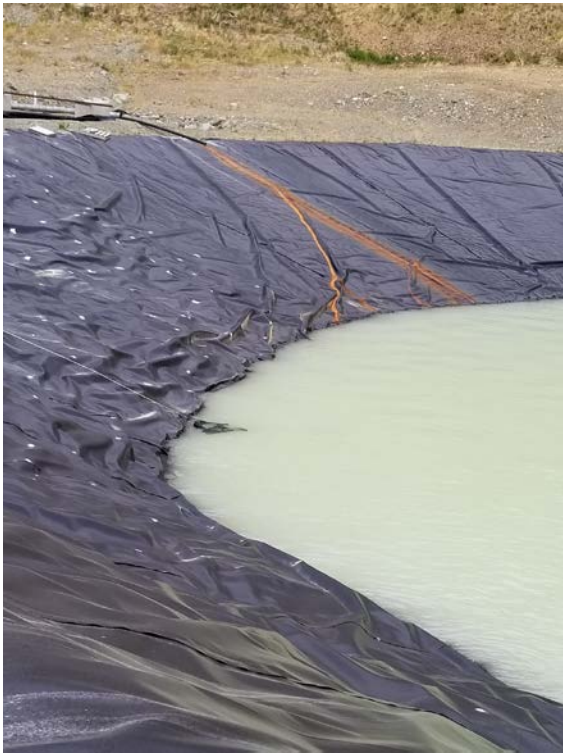
The most relevant failure mode is related to geotechnical stability, with respect high phreatic levels in the embankments. The risk of this is considered to be low, but the slump that has occurred at the north end of the impoundment shows that there is some potential for instability in the cut slope under the liner.

At this time, there is no evidence of a significant rupture in the liner. The pond level is continuing to rise slowly from inflows from other sources on site. If there was a tear in the liner the water would be flowing into the under drain system and unlikely to rise at the rate it has shown. If the mine remains in care and maintenance and there is no water treatment plant available, the pond level will continue to rise. If the mine goes back into operations, then tailings will again be deposited in the tailings facility. If the mine goes to full closure, then the pond will be pumped out and the tailings covered. We recommend that the liner area be repaired before the pond level rises another 1 to 2 meters or additional tailings are placed in the area. However, if the pond level will be managed through water treatment or the move to full closure then there is no reason to repair the area.

**Photo 27**      **Slump at north end**

The repair will also provide an opportunity to inspect the upper section of the underdrains and make sure they are not blocked and adding to ponding at the upstream end of the impoundment.

The repair should be fully documented. This information will be required for future management of the TSF in both operation and closure.

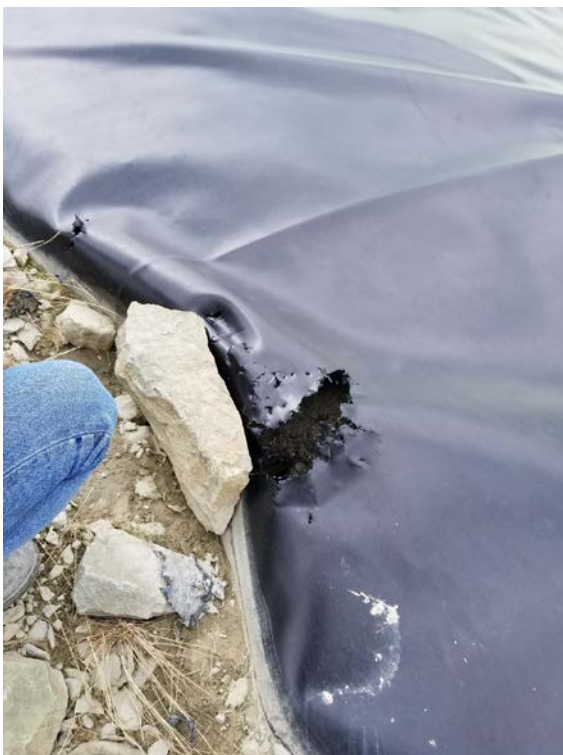
**Photo 28**      **Animal burrow into liner**

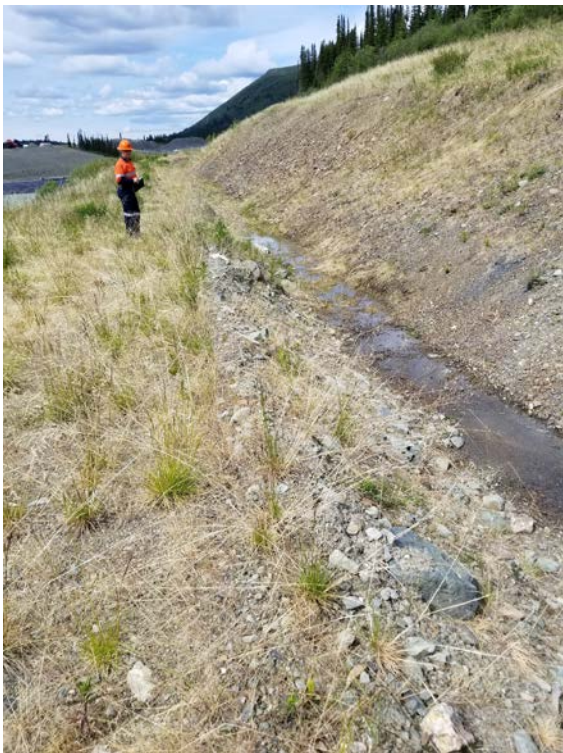
**Photo 30      Ditch B Some Ponding Water**

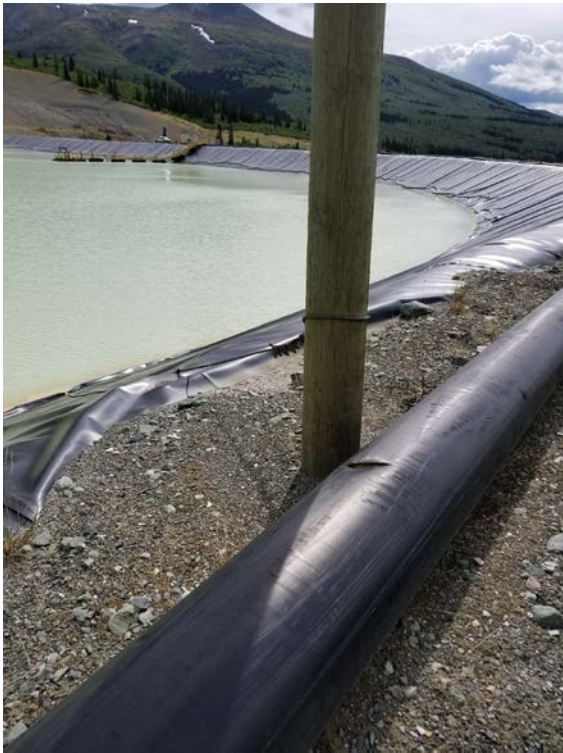
**Photo 35** Reclaim barge anchor – minor damage in tailings pipeline

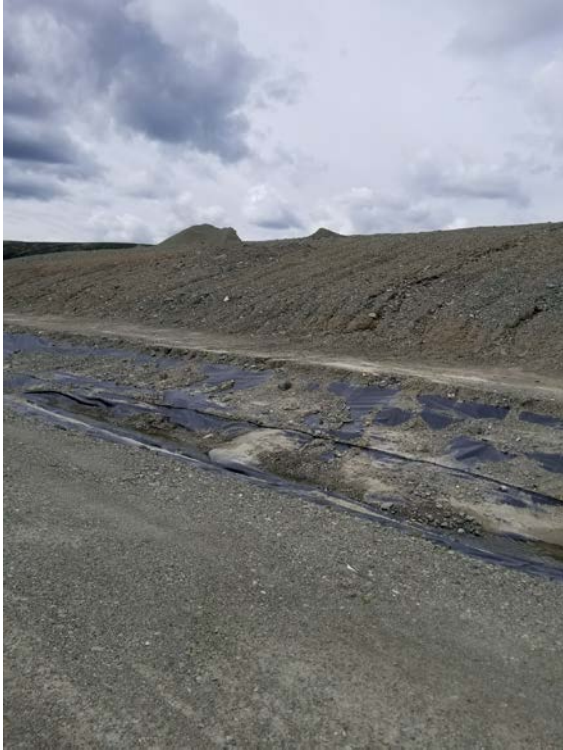
**Photo 45** Debris collecting in ditch from surface erosion

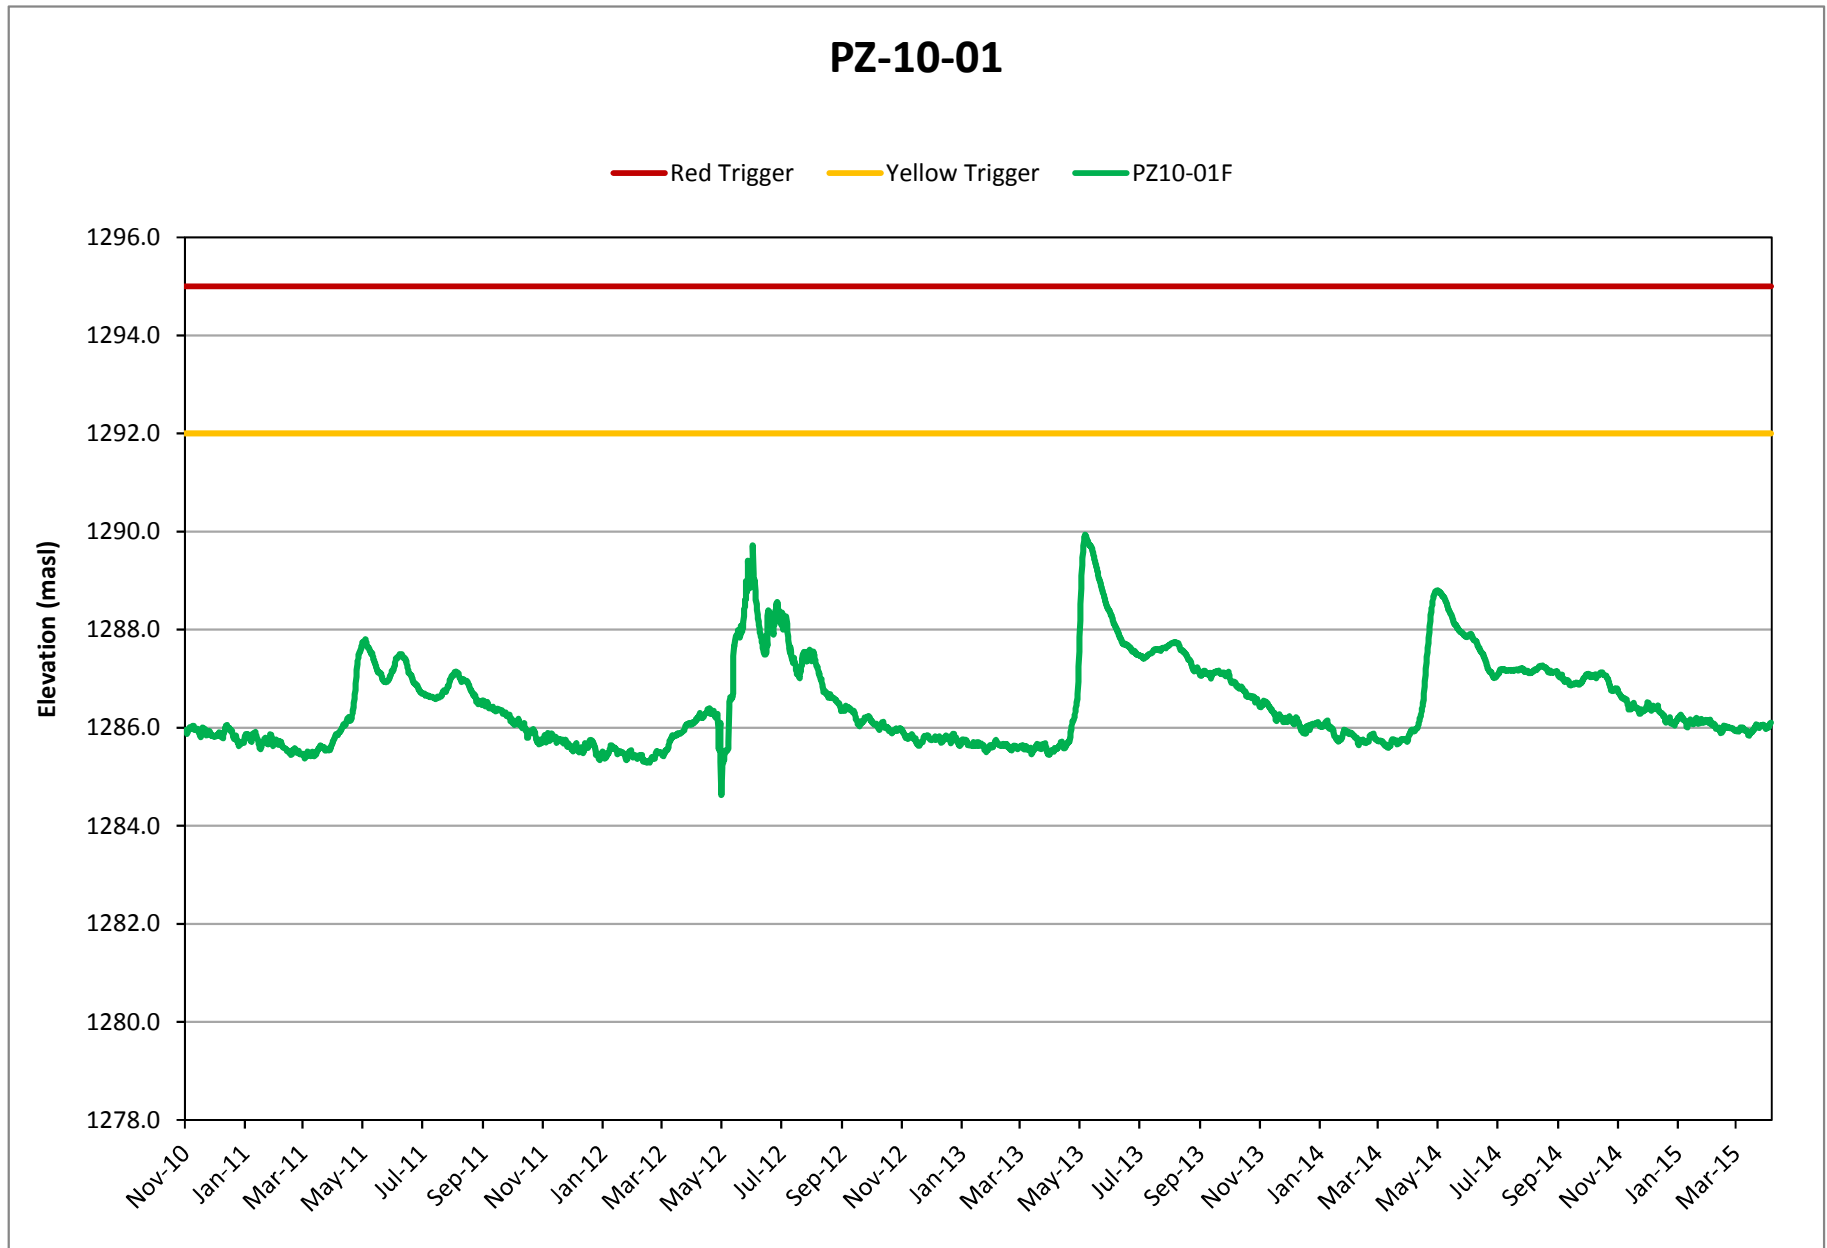
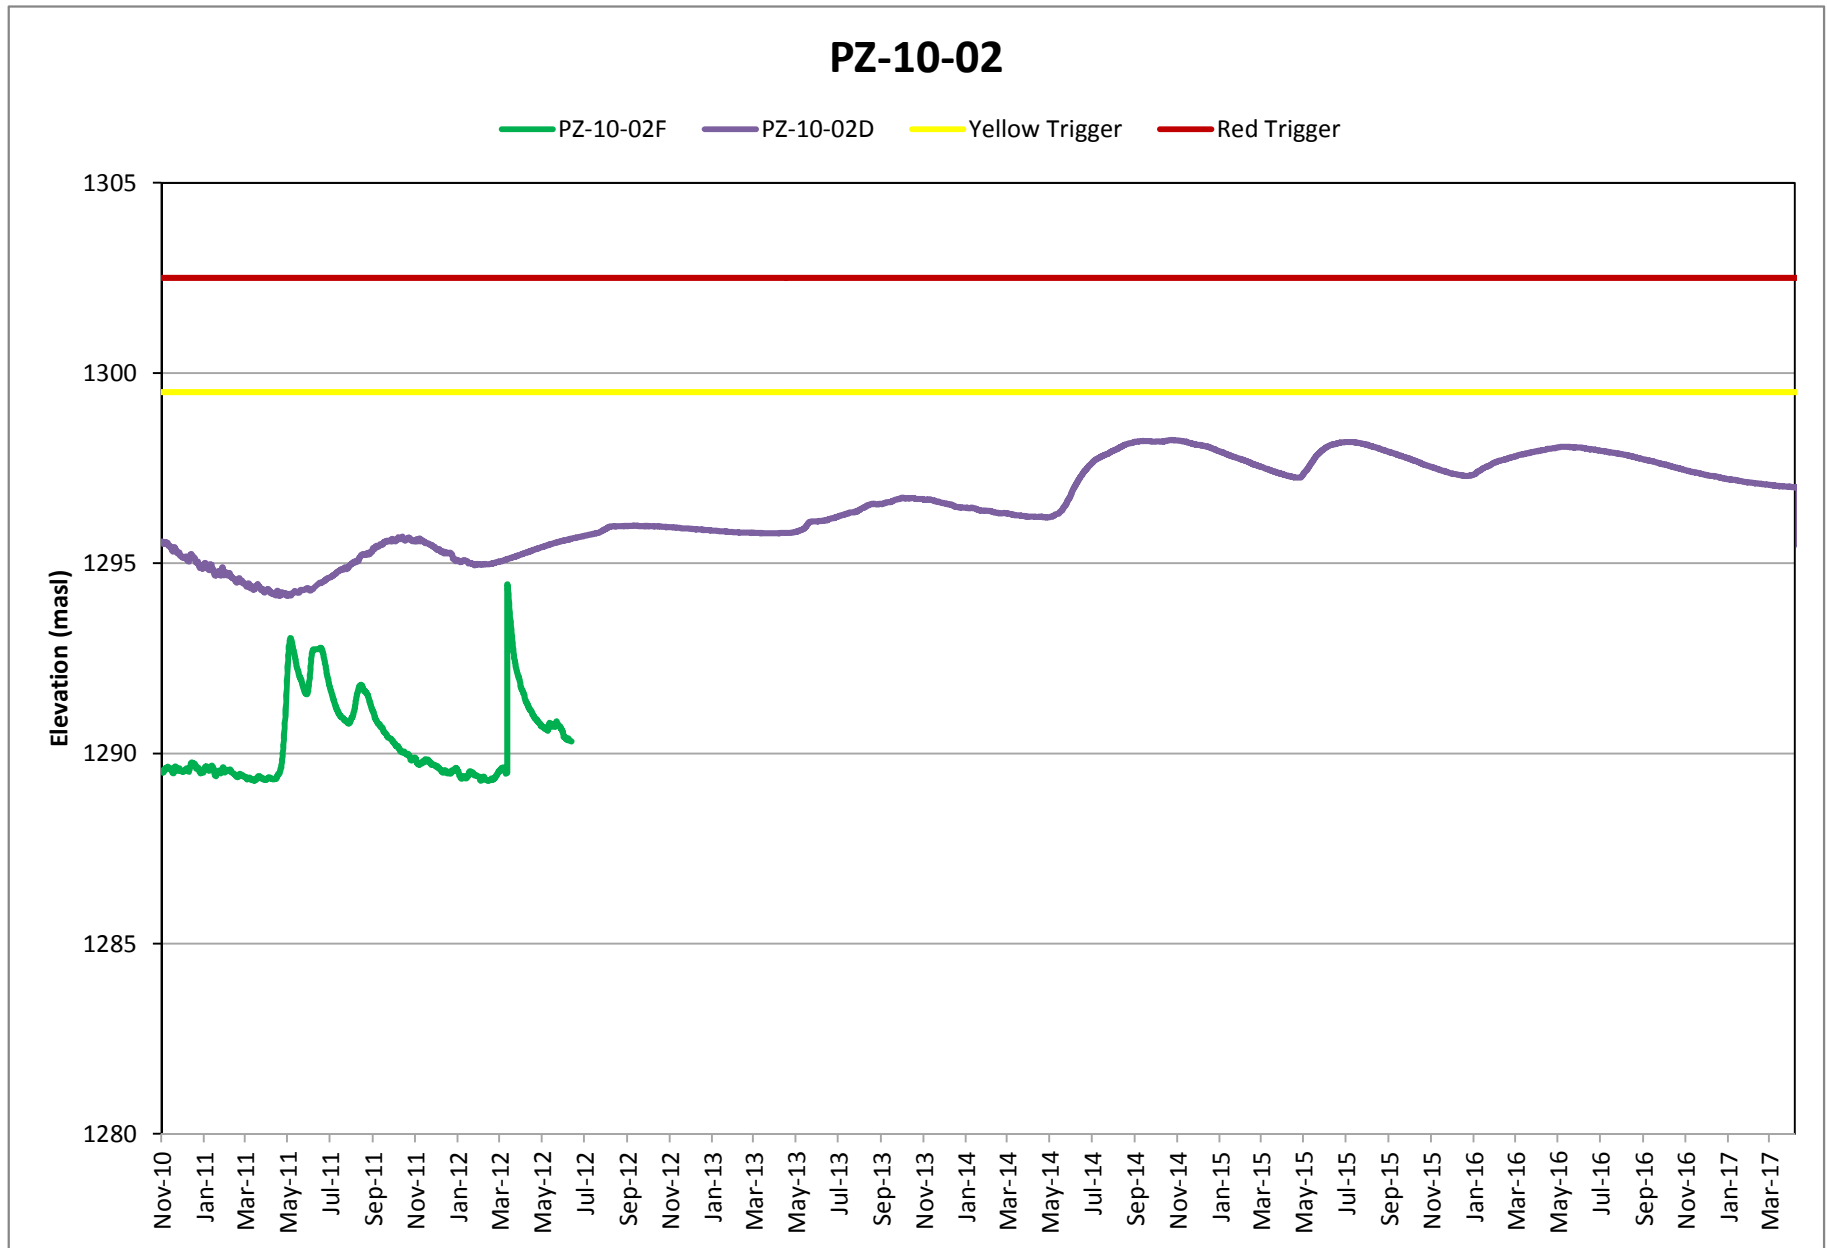
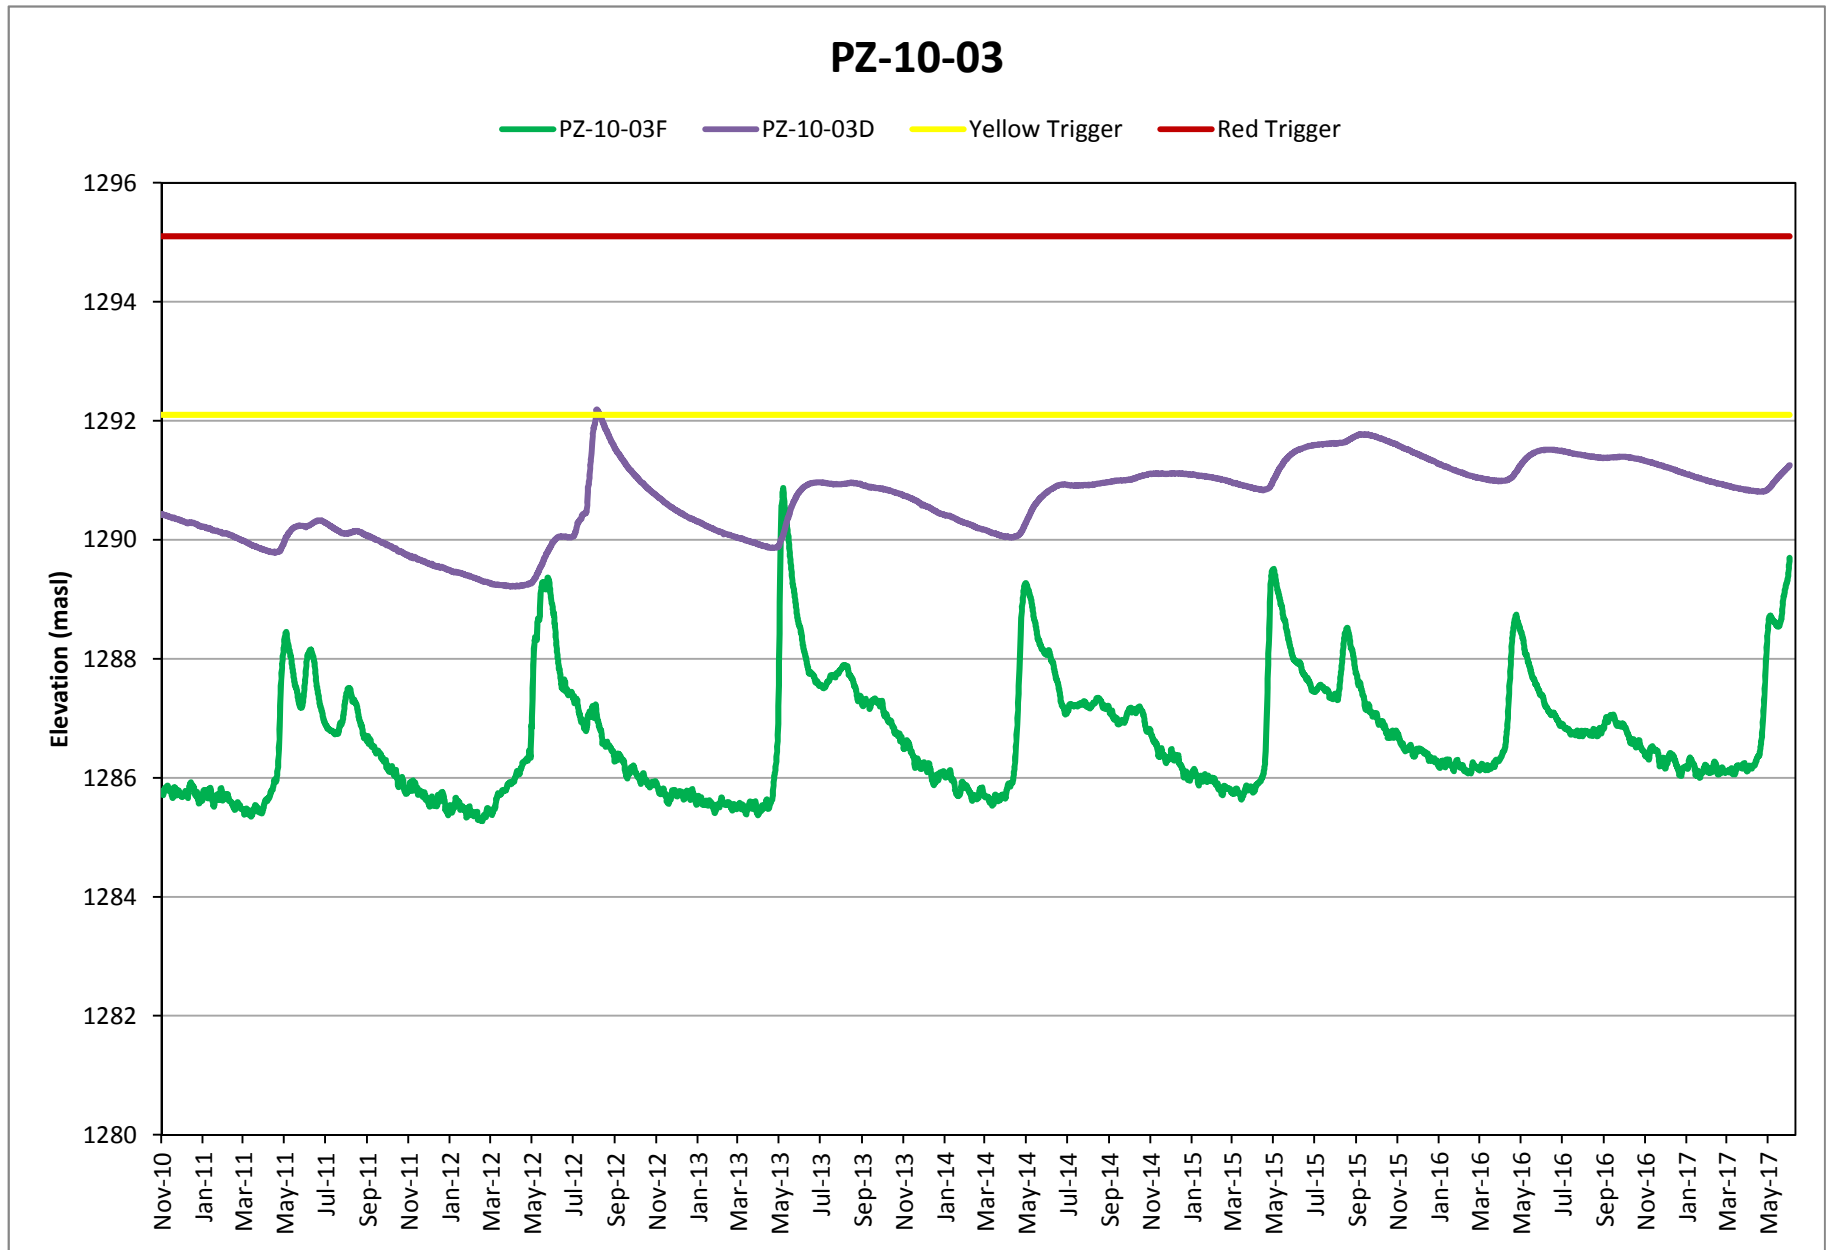
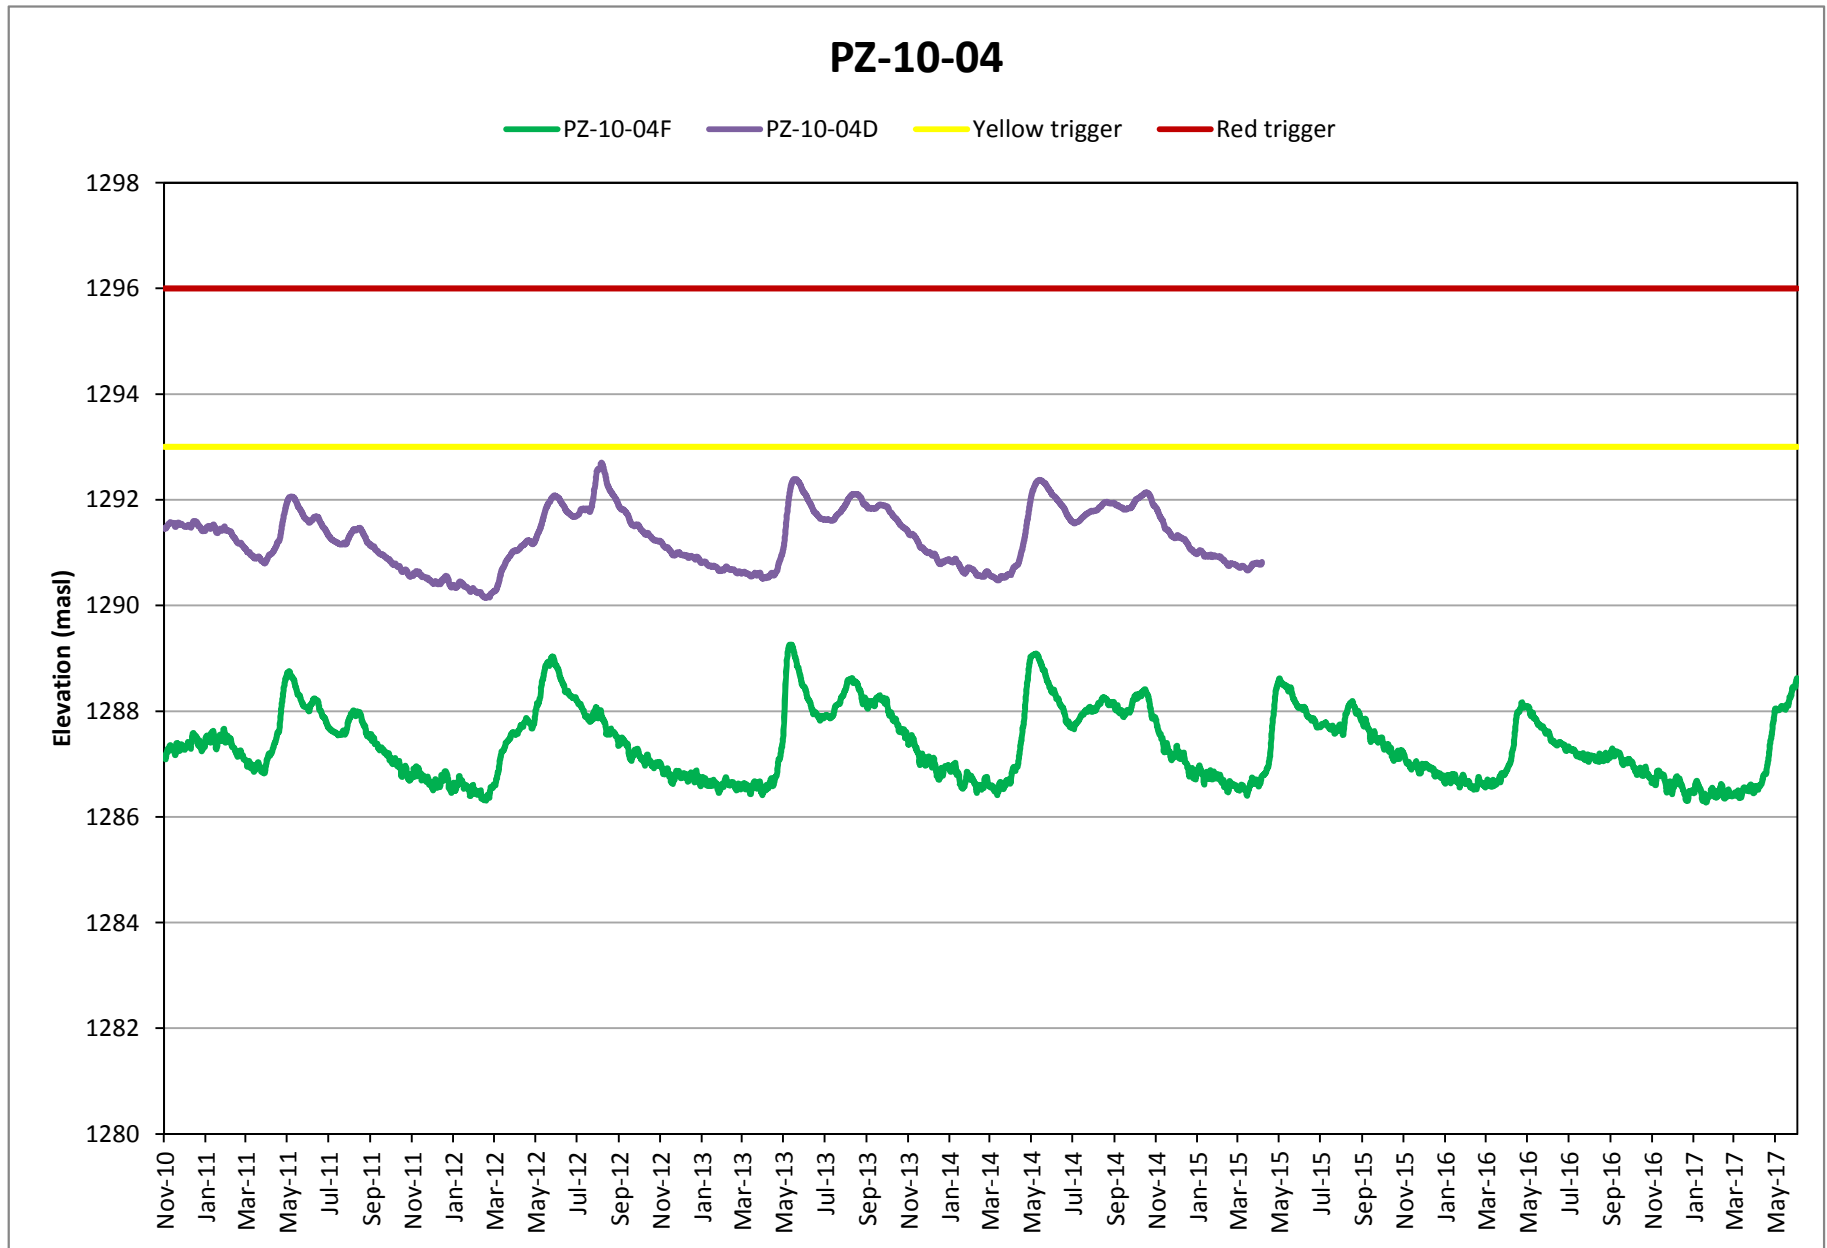
Piezometer Data

The four remaining vibrating wire piezometers are installed in the dam fill and in the foundation. They show seasonal fluctuations but have largely stabilized in a range. The piezometers had been slowly increasing but since 2015 have largely stabilized. The phreatic surface remains low within the dam fill and is currently below the Yellow or Red alert levels. If the dam is raised in the future, then number of piezometers should be reviewed. The piezometer plots are presented in Appendix III.
