## **Wolverine Project**

**QUARTZ MINING LICENSE QML-0006**

**2008 ANNUAL REPORT**

**Prepared by:  
Yukon Zinc Corporation  
Vancouver, British Columbia**

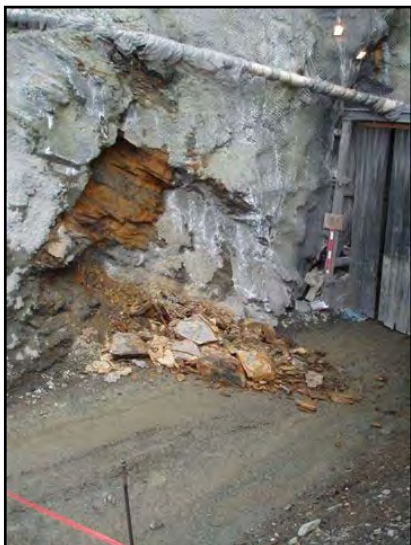
**Picture 4-1: View of the rockfall area immediately after the event, 5/07/08.**

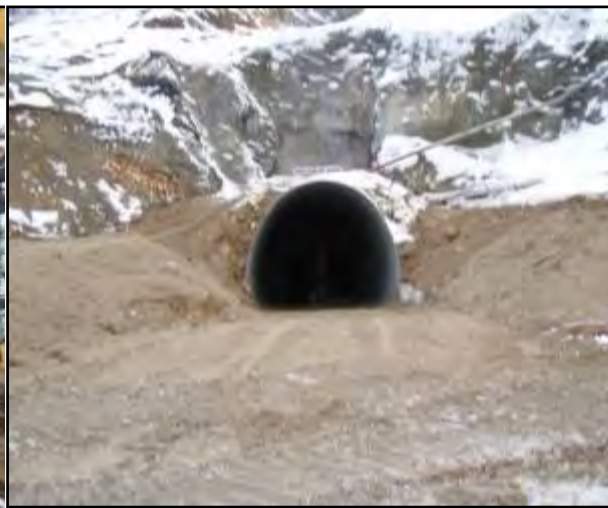
**Picture 4-6: Backfilling and leveling completed, 10/30/08.**

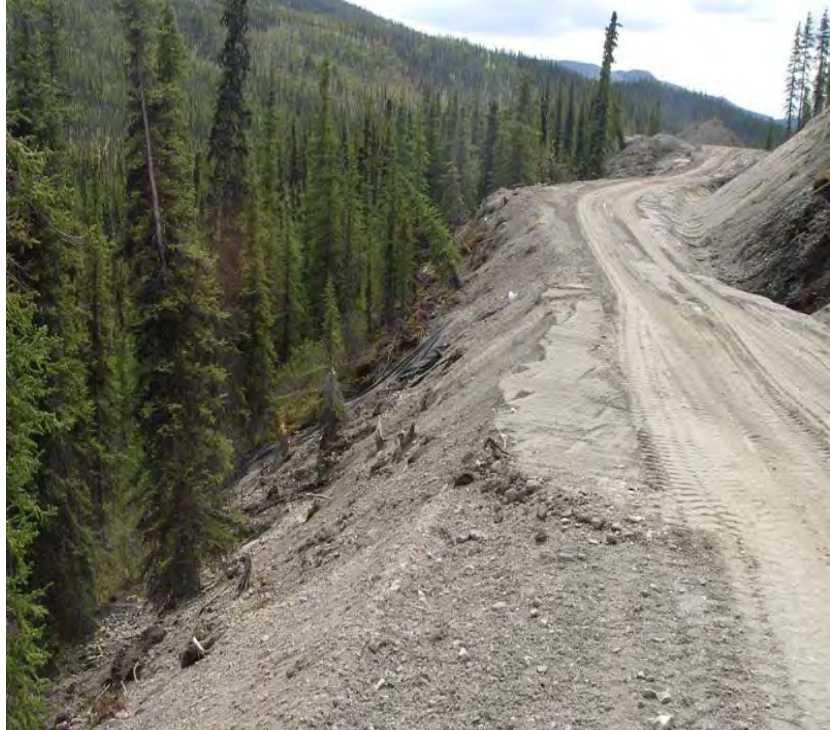
06\_21\_08 Fill slope Sloughing, looking Empty

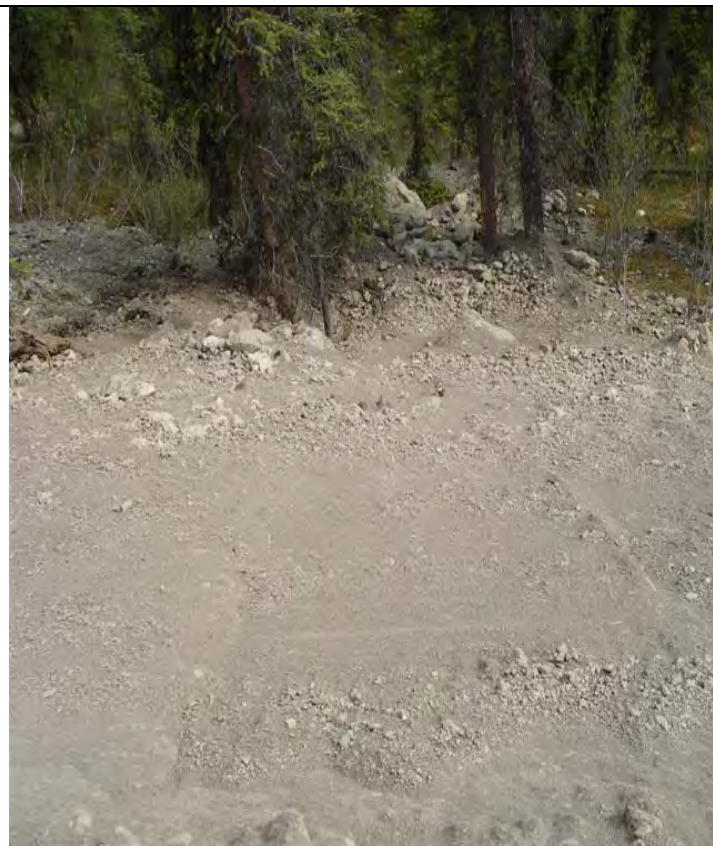
06\_06\_08 Toe of repaired section, notice large rip-rap repaired section where bench was cut.

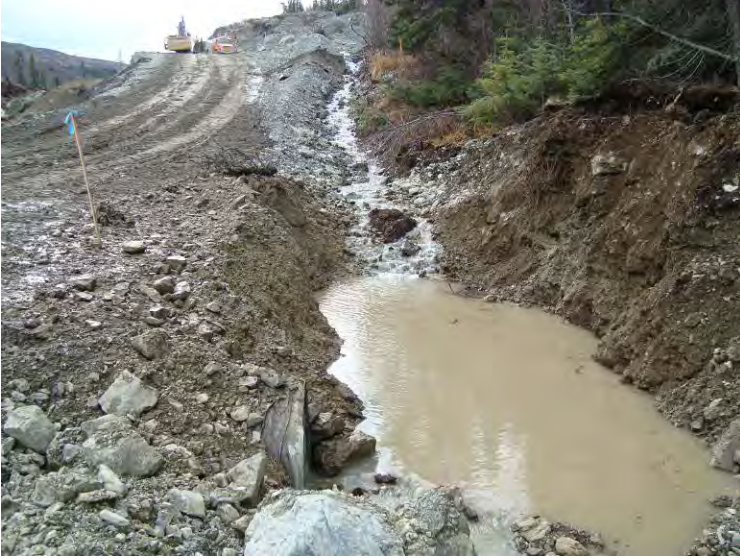
10\_01\_08 Sediment pulse from ditching (facing up chain (UC))

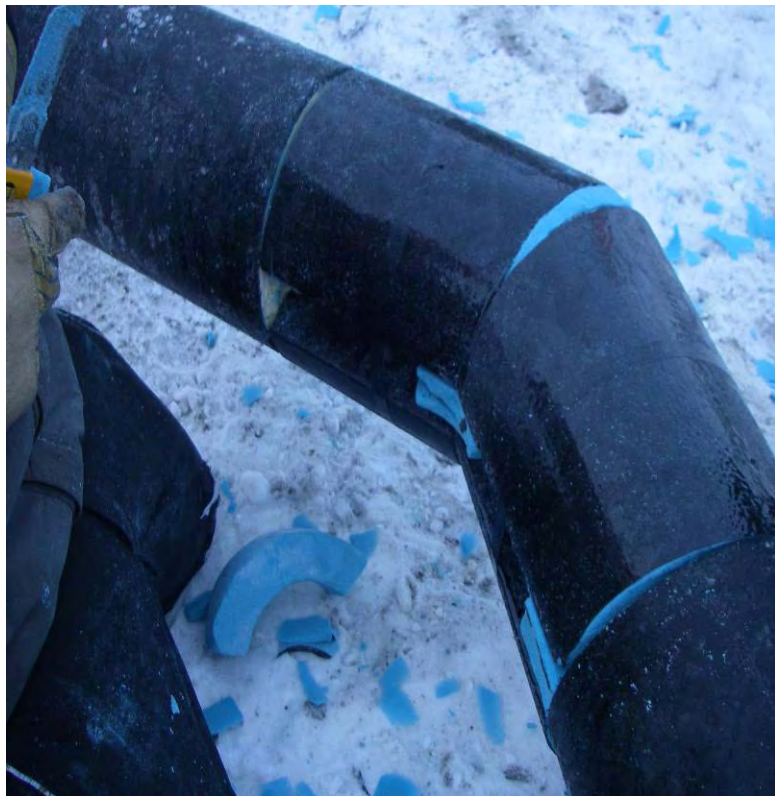
11-05-08 View of Elbow insulation kits and heat shrink, adjustments for kits required

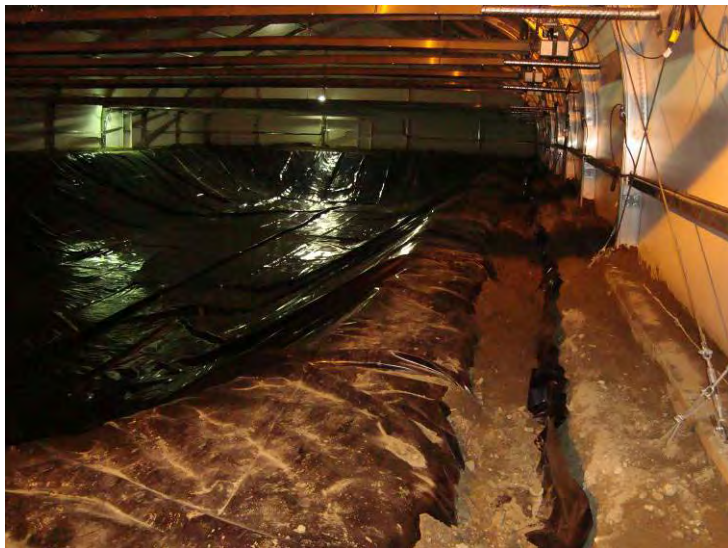
11-26-08 Geotextile lined sump, incomplete locktrench

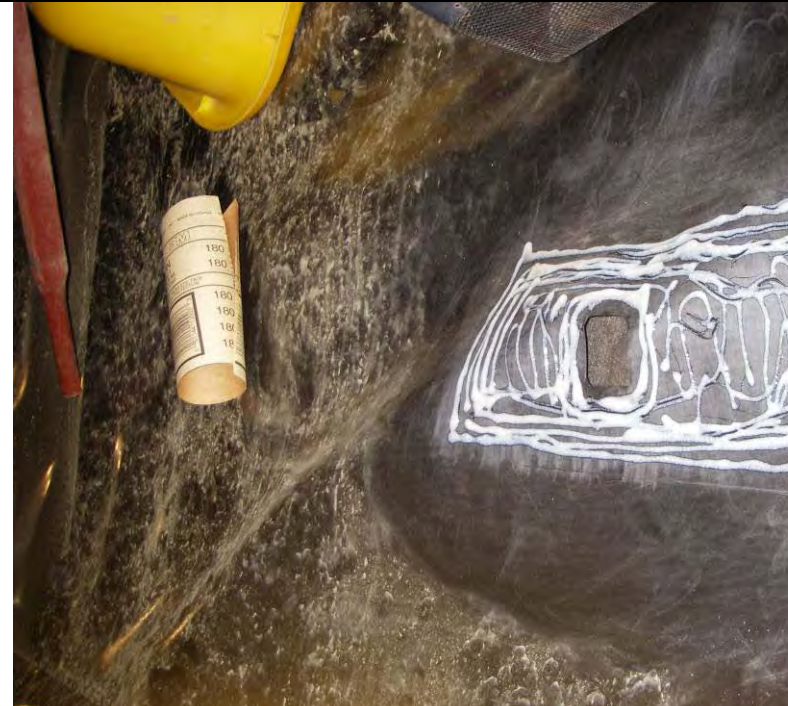
12-07-08 Liner puncture repair at Southwest corner of pond using 20:1 3M repair kit

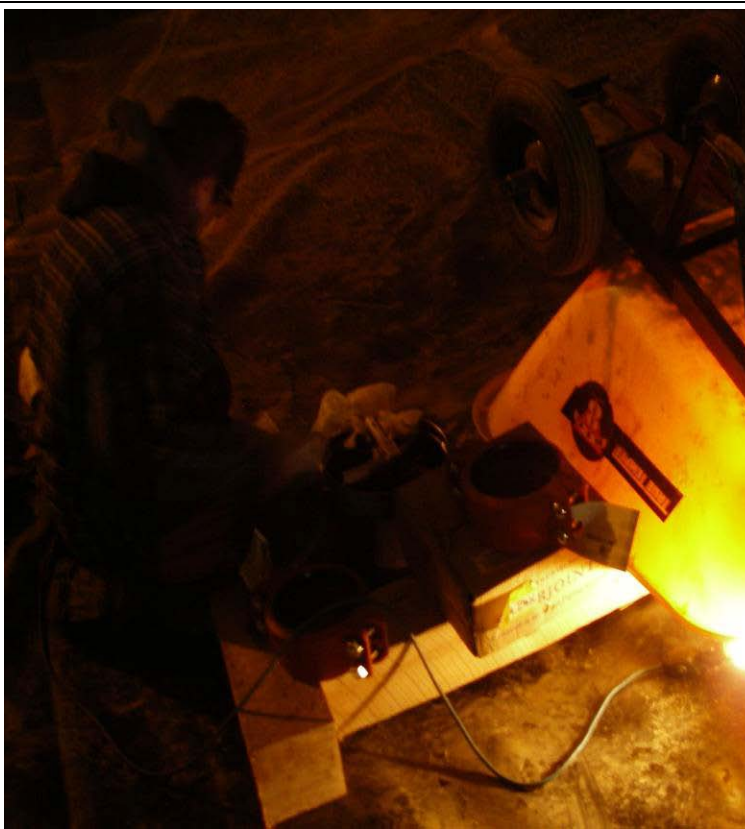
12-08-08 Repair curing for 2 days at 20 deg. C

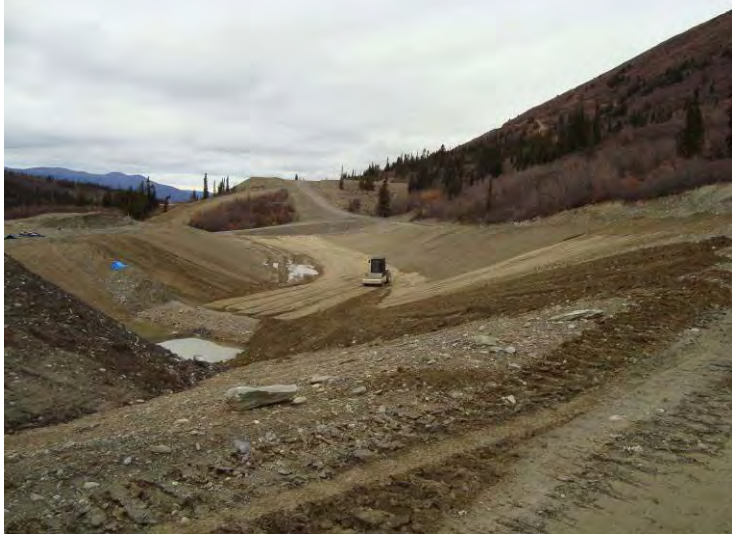
09/29/08 Packing clay liner, completed Phase I repairs (Facing NW) 1615	09/29/08 Waste rock Sump 1615
