## WOLVERINE MINE

# QUARTZ MINING LICENSE QML-0006

# 2010 ANNUAL REPORT

Prepared by: Yukon Zinc Corporation Vancouver, British Columbia

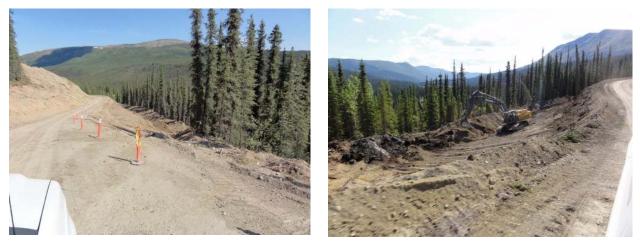
Picture 8-1: Road widening to improve sight lines at corner; subsequent work would entail preading of windrowed material on fill slope-slope stabilization.

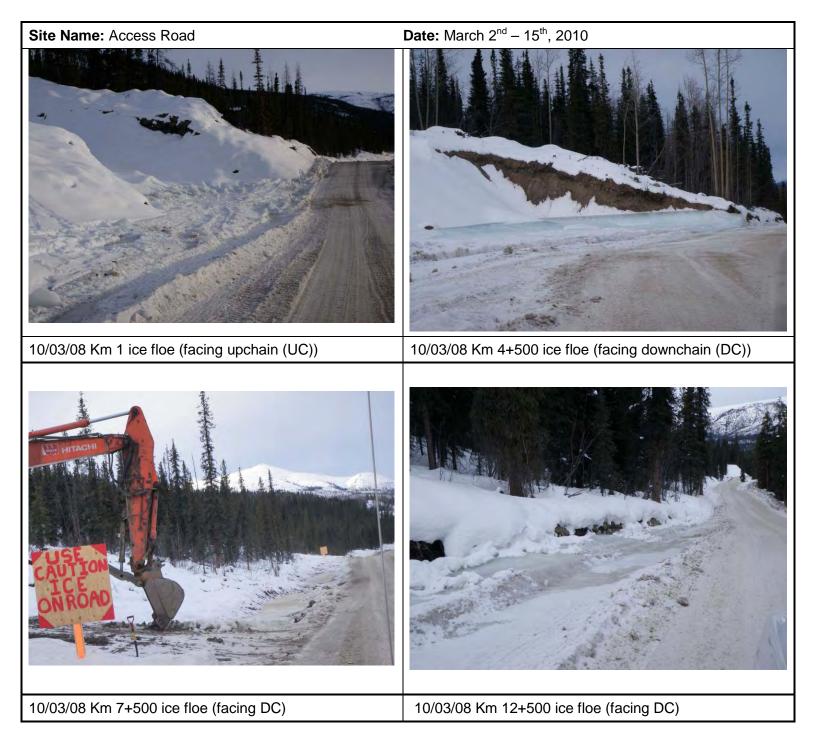
Part 1 – Site Description		
Date: March 16 <sup>th</sup> – 27 <sup>th</sup> , 2010	Inspector(s): Jaymie Skidmore	
Site Name: Access Road	Location/Co-ordinates:	
	Wolverine access road - Km 0 to Km 32	
Site Location Description: The Wolverine Mine site access road starts at Km 190 on the Robert Campbell Hwy and ends at the YZC Exploration Camp at Wolverine Lake. The total length of the access road is 32 Km and passes through several different bioclimatic regions. The key water crossings include; Pitch, Putt, Bunker, Chip and Bogey, Hawkowl, Go and Campbell Creeks.		
Weather Conditions: Unusually warm winter conditions.		
March daily temperature averages to date range from -1	0°C to 0°C. Periods of melt and then heavy snow fall.	
Part 2 – Site Assessment		
<ul> <li>Activity:</li> <li>Continual clearing of snow and road grading.</li> <li>Maintenance of areas of ice floes</li> <li>Weather cooled down March 23<sup>rd</sup> with some heavy snow fall and freezing road.</li> </ul>

Site Status: Ice floes are occurring at Kms: 1, 4+500, 7+500 and 12+500 Road remains in good repair Very wet slippery conditions during warmer weather, icy as weather cools. Assessed Risk: Low		
Photos Attached: Yes (6)		
Samples Taken: No		
Additional Information Attached: No		
Part 3 – Mitigation Requirements		
Mitigation Required: None at this time, will need to stean the summer period. Ongoing maintenance required. Mitigation Condition: good	n some culverts in spring and install more culverts over	
Part 4 –Monitoring Requirements		
Follow-up Monitoring: Continue to monitor road drainage runoff, monitor for sediment loading in ditches and draina	es, as well as areas of ice and water accumulation. During ages.	
Monitoring Frequency: Weekly and more frequently once	e runoff period starts	
Reporting Requirements: Environmental monitoring rep	ort every two weeks

**Date:** March 16<sup>th</sup> – 27<sup>th</sup>, 2010 Site Name: Access Road 10/03/16 Km 1.5 ice build up has been removed to 10/03/16 Km 4.5 ice built up. Ditching put in place to prevent further overflow. divert runoff. 10/03/16 Ditching in place, snow removal and grading to 10/03/16 Km 7.5 ice build up removed to prevent future divert runoff due to snow melt. flooding.

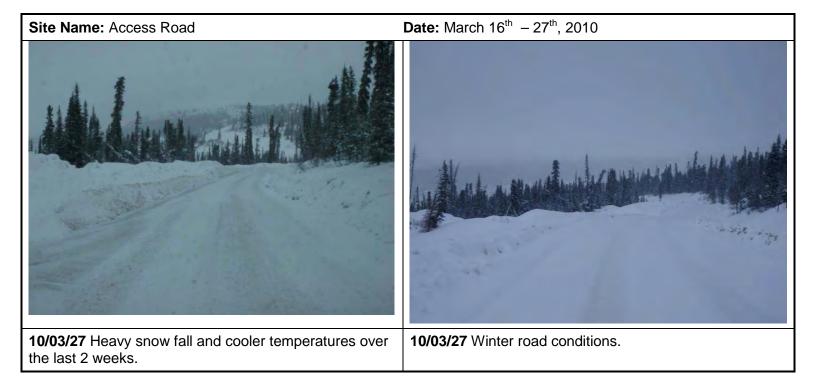
Part 1 – Site Description		
Date: April 3 <sup>rd</sup> , 2010	Inspector(s): Jaymie Skidmore/Jennie Gjertsen	
Site Name: Access Road	Location/Co-ordinates:	
	Wolverine access road - Km 0 to Km 32	
Site Location Description: The Wolverine Mine site access road starts at Km 190 on the Robert Campbell Hwy and ends at the YZC Exploration Camp at Wolverine Lake. The total length of the access road is 32 Km and passes through several different bioclimatic regions. The key water crossings include; Pitch, Putt, Bunker, Chip and Bogey, Hawkowl, Go and Campbell Creeks.		
Weather Conditions: Unusually warm winter conditions.		
April daily temperature averages to date range from -10°	°C to 0°C. Periods of melt and then heavy snow fall.	
Part 2 – Site Assessment		
<ul> <li>Activity:</li> <li>Continual clearing of snow and road grading. (road at this time is clear of snow and mainly mud)</li> <li>Maintenance of areas of ice floes and mud</li> <li>Warm weather causing melt and flooding in areas.</li> </ul>

Site Status: Ice floes are beginning to melt causing some flooding at Kms: 1, 4+500, 7+500 and 12+500 Road is not in very good condition due to melt Very wet and muddy conditions during warmer weather, icy as weather cools.		
Assessed Risk: Low		
Photos Attached: Yes (9)		
Samples Taken: No		
Additional Information Attached: No		
Part 3 – Mitigation Requirements		
Mitigation Required: None at this time, will need to stear the summer period. Ongoing maintenance required.	n some culverts in spring and install more culverts over	
Mitigation Condition: good		
Part 4 –Monitoring Requirements		
Follow-up Monitoring: Continue to monitor road drainage runoff, monitor for sediment loading in ditches and drainage	es, as well as areas of ice and water accumulation. During ages.	
Monitoring Frequency: Weekly and more frequently once	e runoff period starts	
Reporting Requirements: Environmental monitoring rep	ort every two weeks

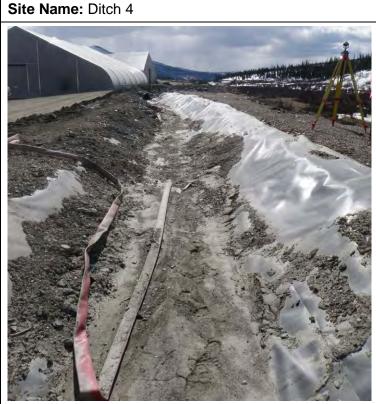
10/05/13 Sediment build up (south end)

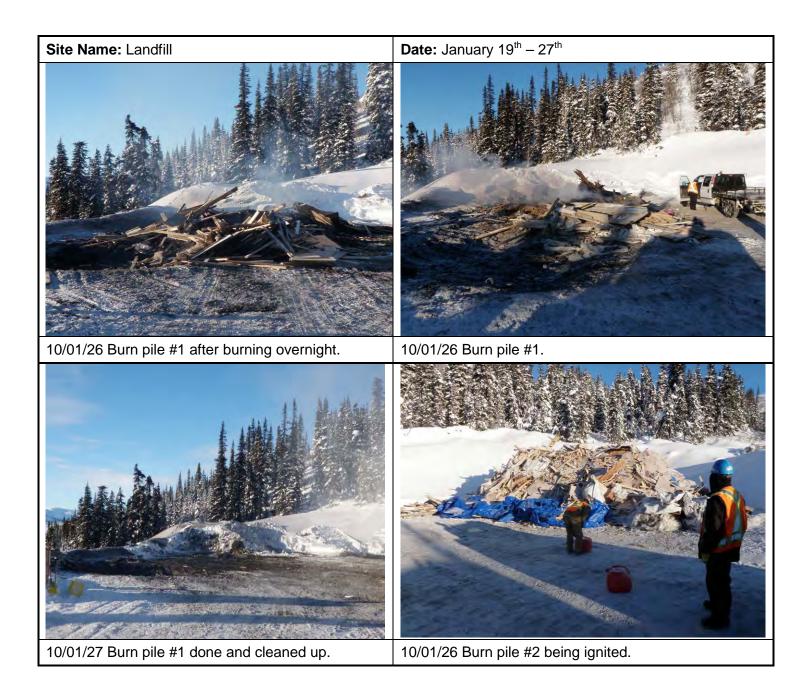
Site Name: Landfill	Date: January 19 <sup>th</sup> – 27 <sup>th</sup>
10/01/26 Burn pile #2.	10/01/26 Burn pile #2 after burning all day.
10/01/27 Burn pile #2 after burning over night.

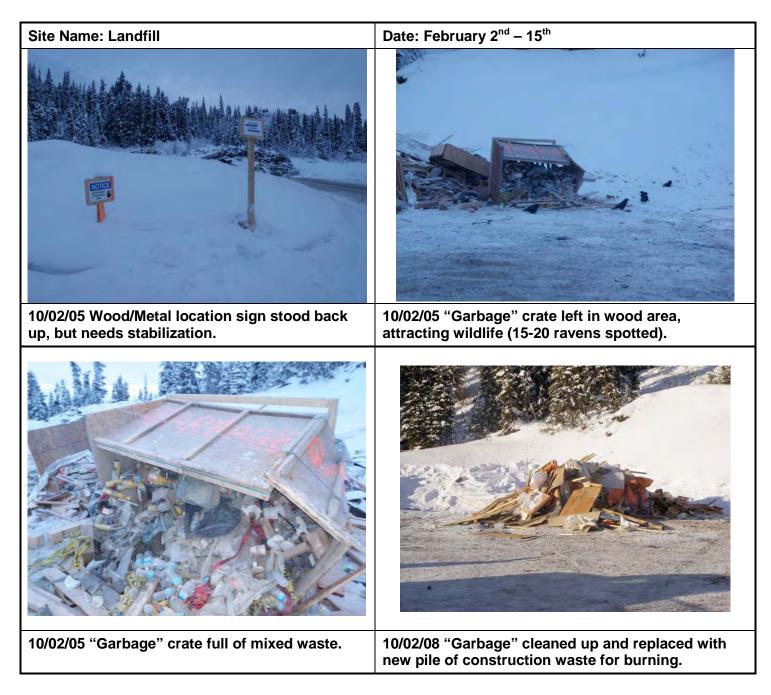
Site Name: Landfill	Date: February 2 <sup>nd</sup> – 15 <sup>th</sup>
10/02/12 Wood/Metal location sign stabilized.	10/02/12 Wood only brought up to burn pit. No Raven in sight.
10/02/13 Incinerator area tidy
