WOLVERINE PROJECT  
MILL BYPASS ROAD  
CONSTRUCTION REPORT AND DRAWINGS

Yukon Energy, Mines and Resources  
Quartz Mining License QML-0006 Condition 7.8

Yukon Zinc Corporation  
Vancouver, British Columbia

June 9, 2009

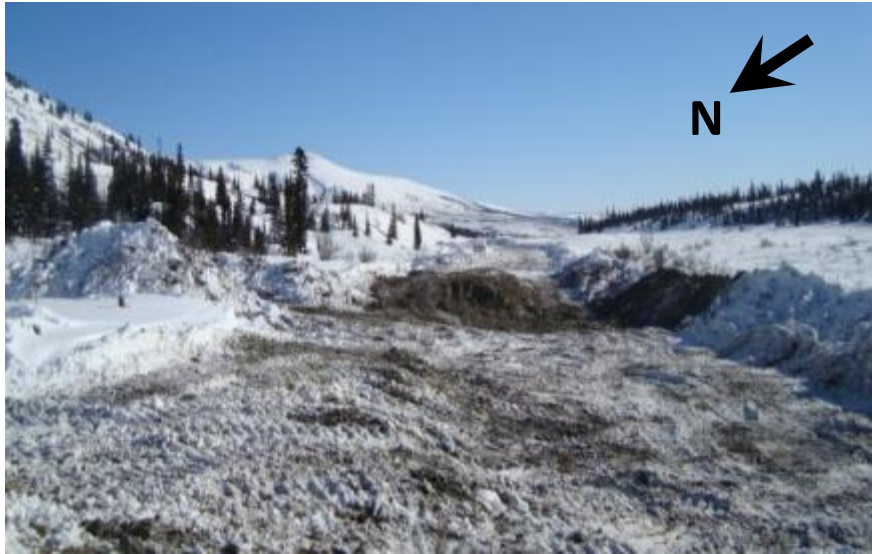
**Picture 1. Snow Clearing and Organics Removal of Mill Bypass Road (March 31, 2009)**

Construction began with snow clearing and organics removal (Picture 1), and organics were stored on the downslope shoulder of the road.

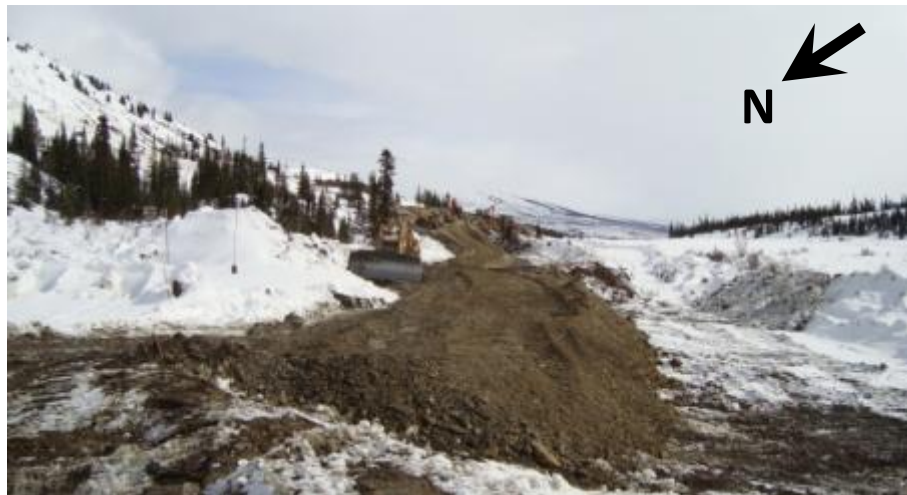
**Picture 2. Road Bed Fill and Compaction of Mill Bypass Road (April 1, 2009)**

Road bed material taken from the area was machinery compacted to produce the final road (Picture 2).

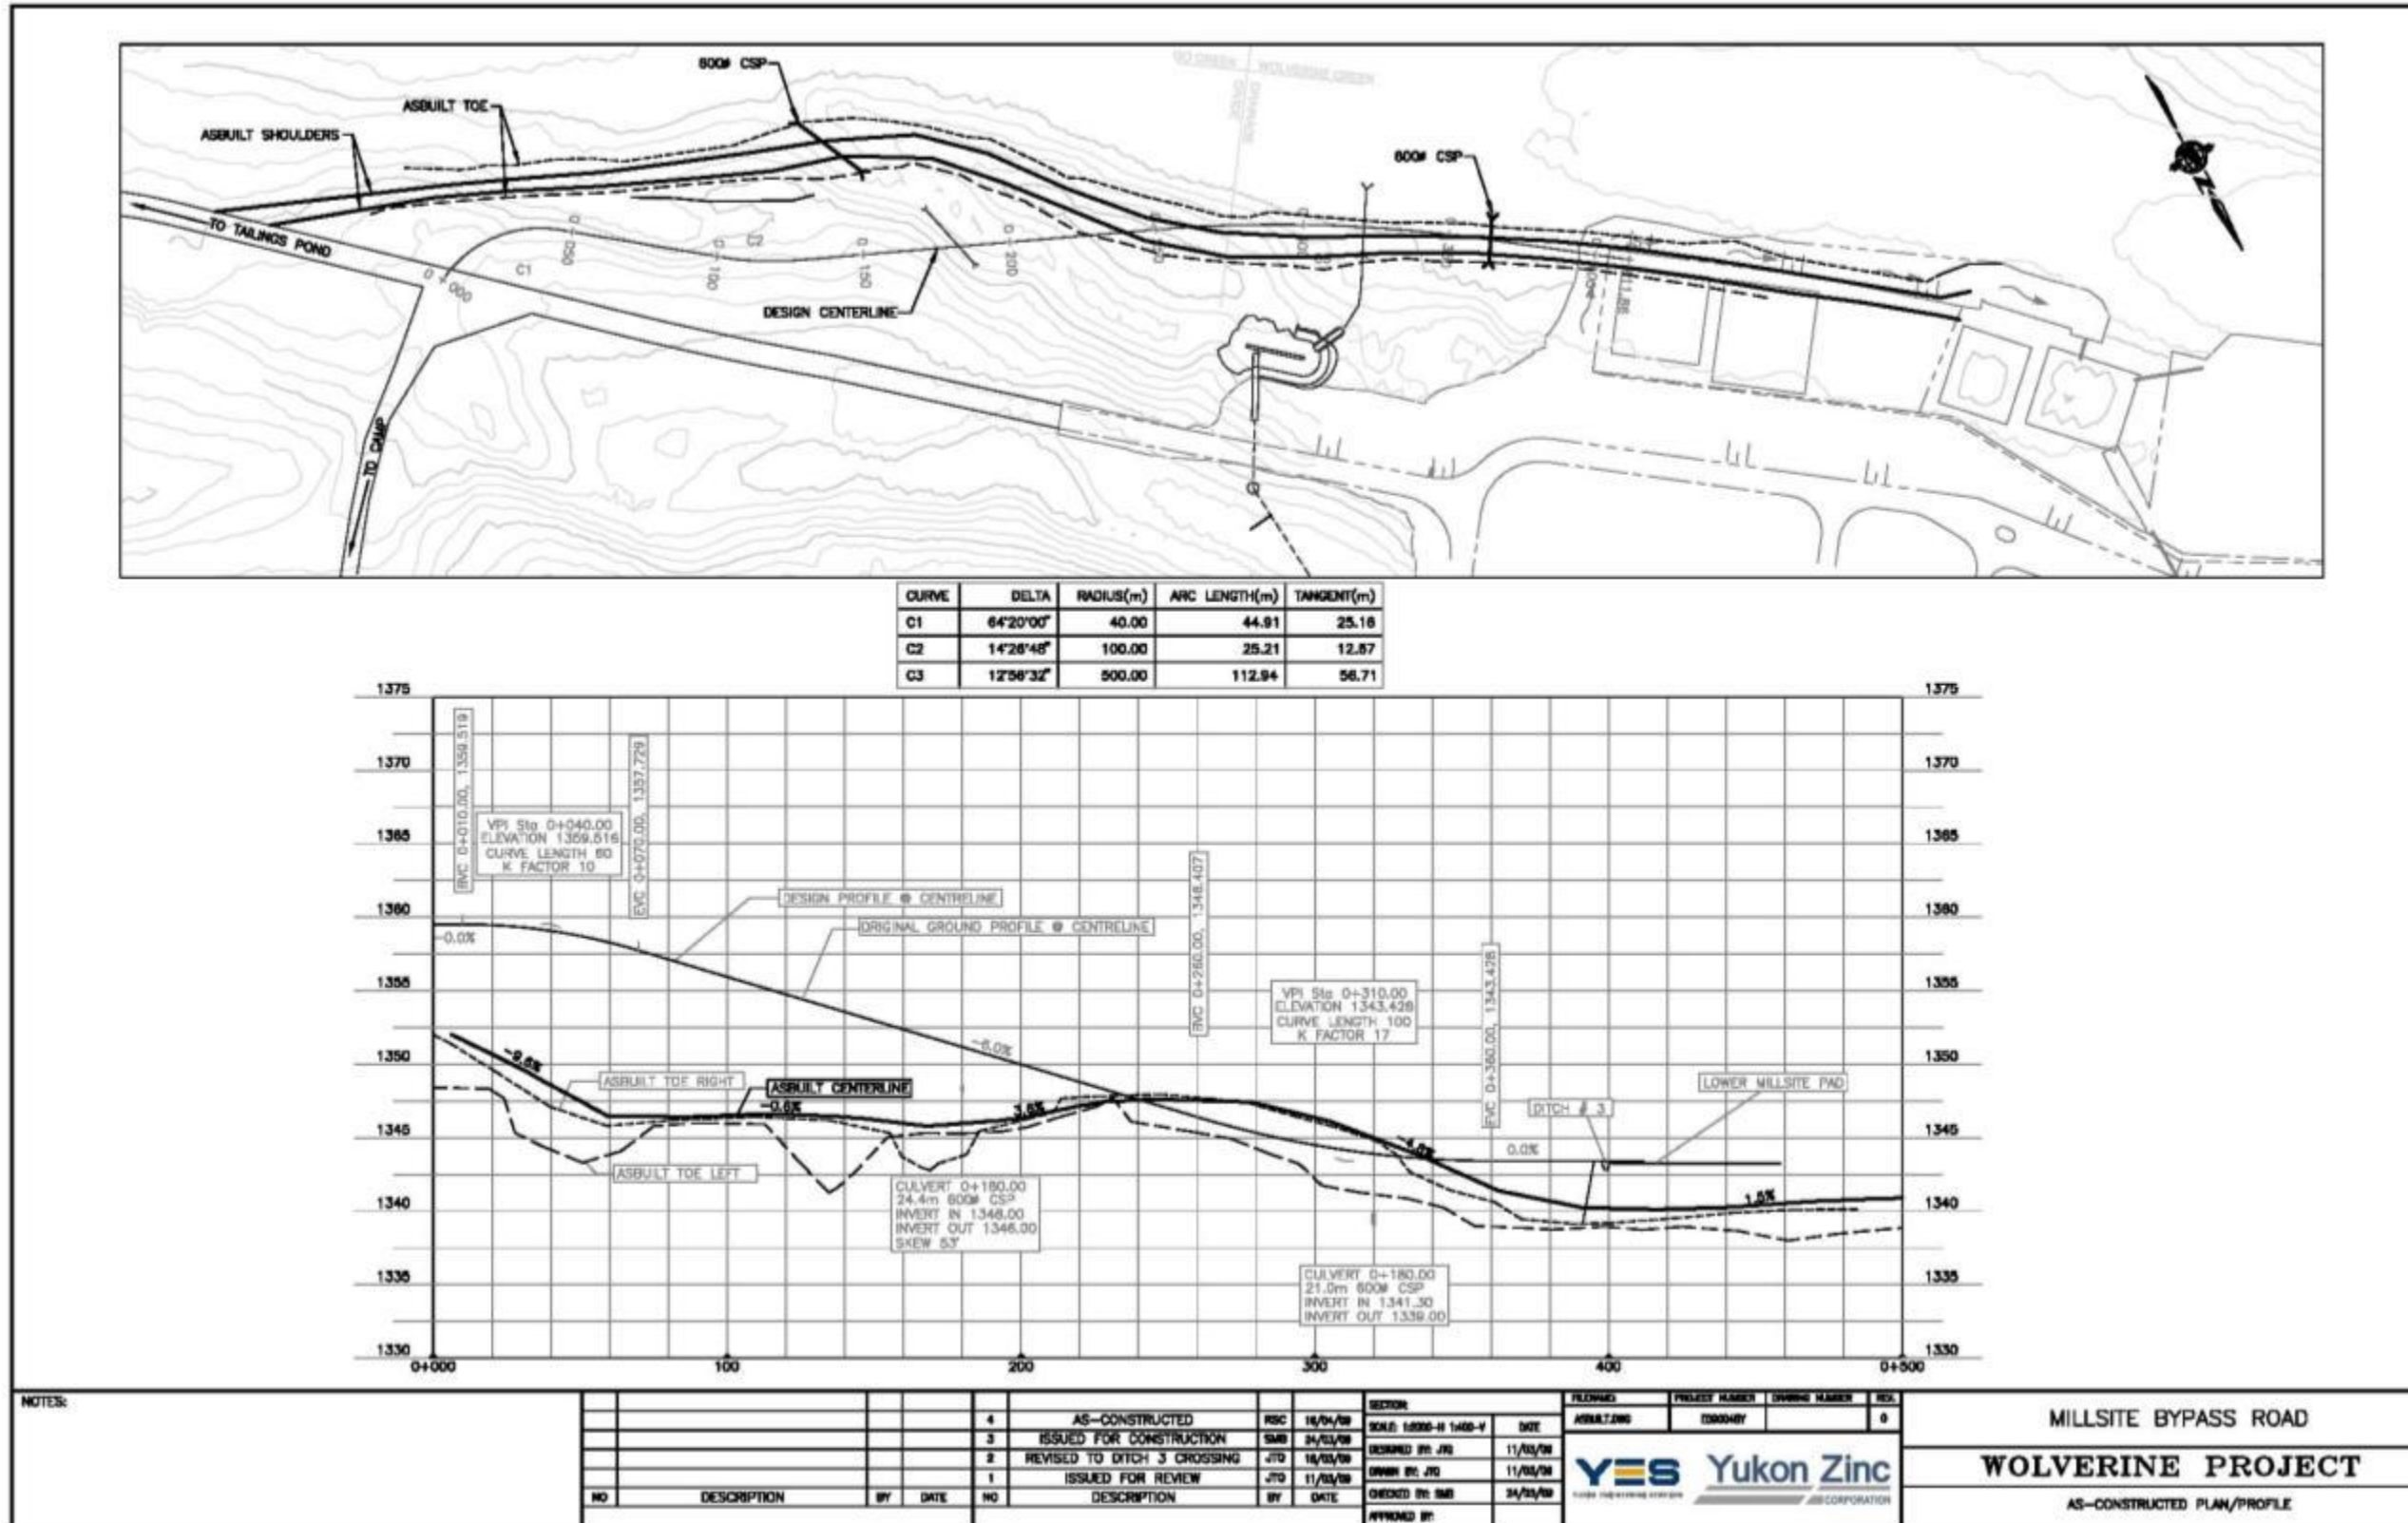
Figure 4. Mill Bypass Road As-built Drawing – Yukon Engineering Services

The Mill Bypass Road construction activities included snow and organics removal, earthworks and culvert installation. The YES as-constructed drawing for the Mill Bypass Road is provided in Figure 4; as-constructed details varied from issued for construction details due to site conditions which resulted in minimized excess cut and fill by maximizing the use of the natural contours of the terrain. Construction details are provided below, and the environmental construction monitoring report is provided in Appendix A.

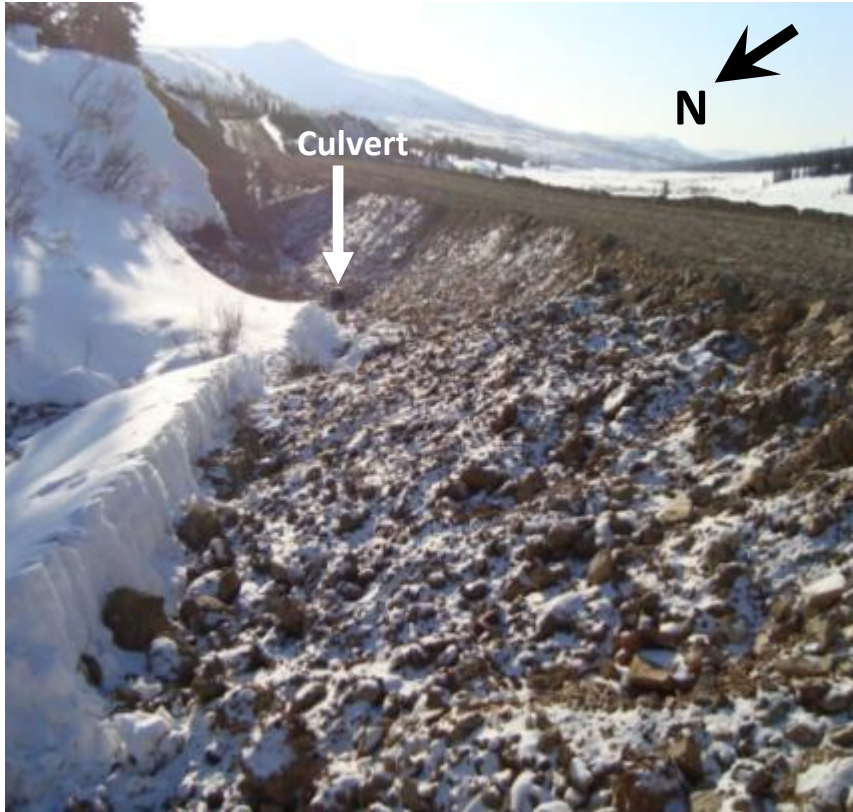
**Picture 3. Completed Mill Bypass Road (April 3, 2009)**

Culverts were installed to permit overland flow from the water treatment discharge pipe to Go Creek (Picture 3) and from Ditch #1 to Wolverine Creek (Picture 4).

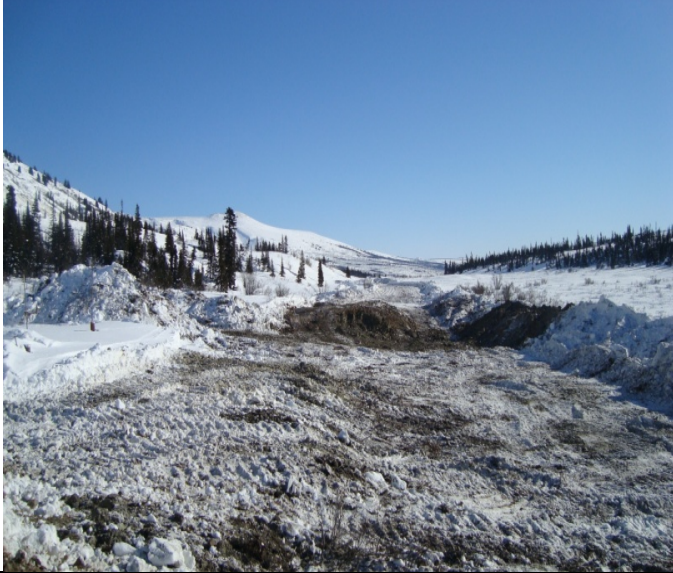
**03\_31\_09** Photo looking D/C taken by sump#1. The end of bypass road. MW to the left of in the snow in the photo.

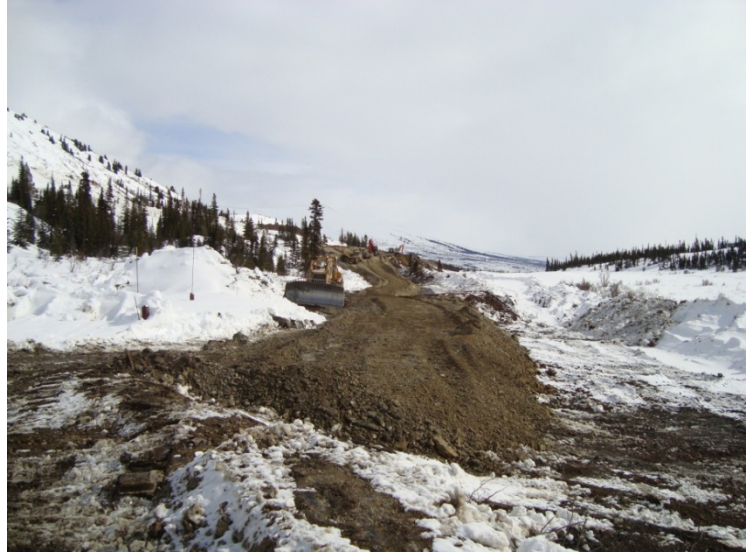
**04\_01\_09** Equipment building temporary bypass road which will eventually be Ditch #3. Looking D/C towards new camp.

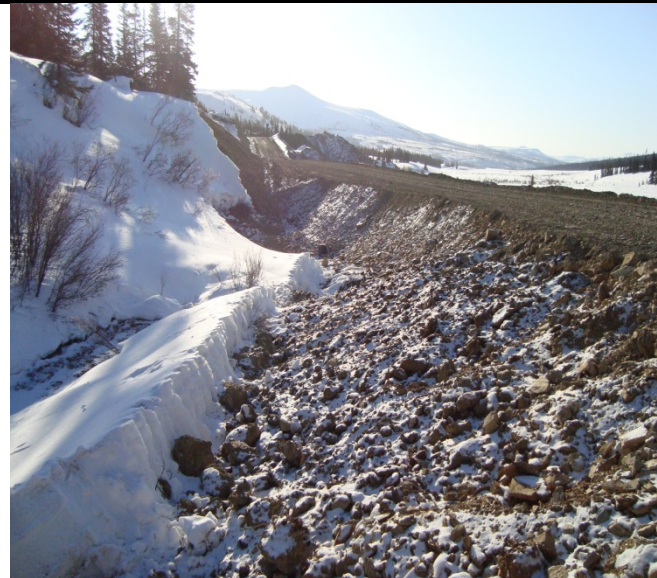
**04\_03\_09** Photo looking D/C. Road is going over discharge culvert. Culvert in the middle of photo.

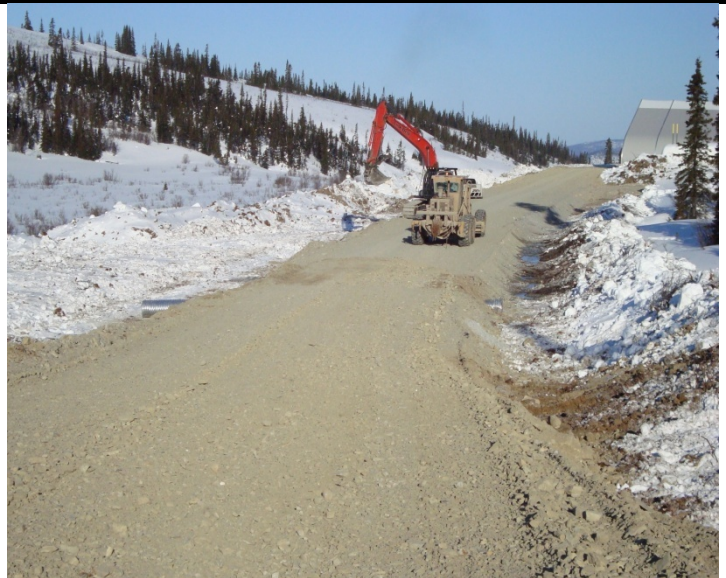
**04\_03\_09** Excavator is ditching and grader making a pass over on the road. Photo taken looking U/C towards Sump#1. Culvert in place at the low point.

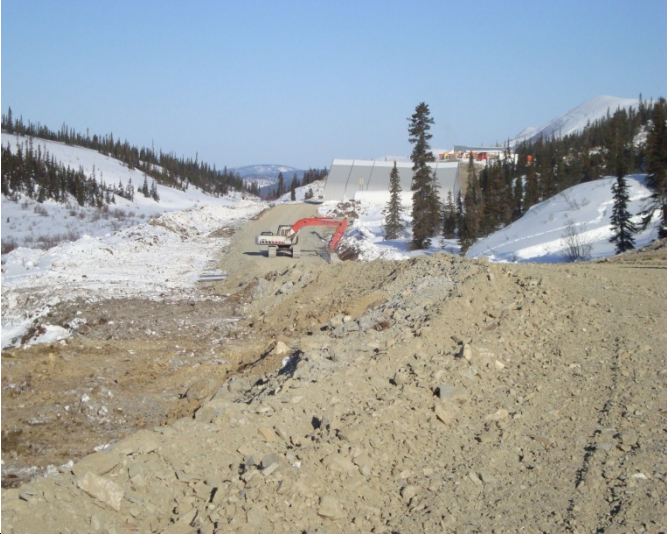
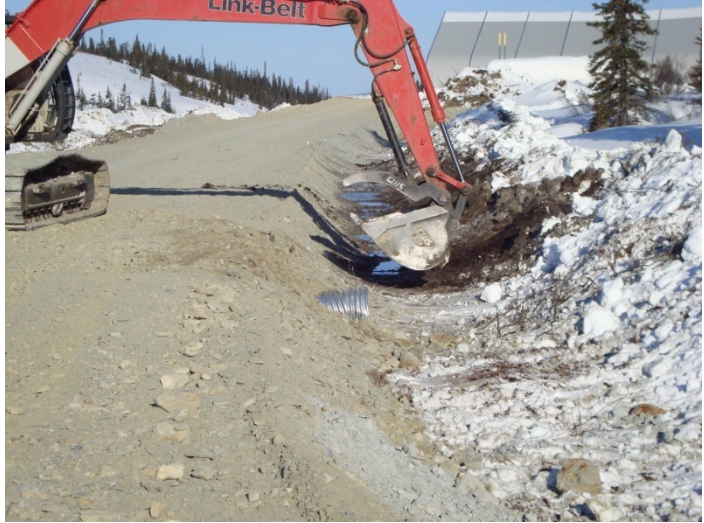
<b>04_03_09</b> Temporary bypass looking towards Sump #1.	<b>04_03_09</b> Excavator leveling ditch. Culvert at the low point.

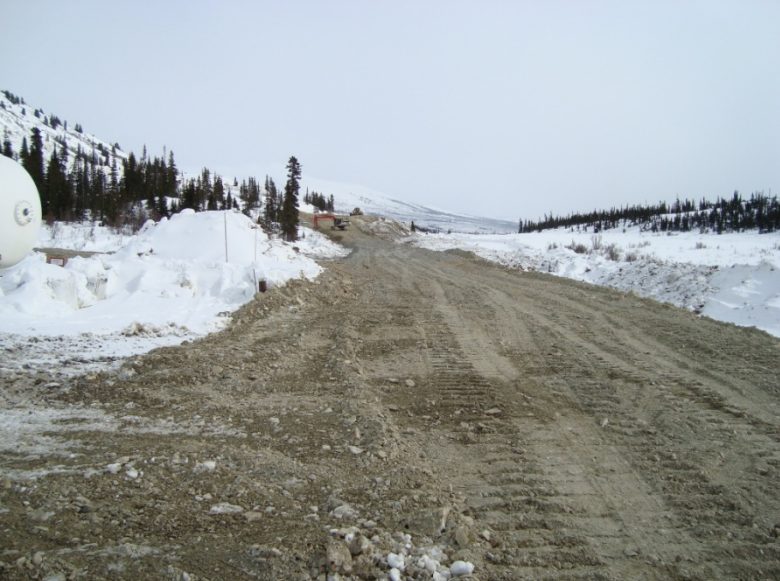
<b>04_03_09</b> Temporary Road complete. Looking South.
