THE WHITEHORSE ESCARPMENT

(Prepared for the Advisory Committee on Northern
Development, Department of Northern Affairs and
National Resources)

R.F. Legget and G.H. Johnston

Report No. 136
of the
Division of Building Research

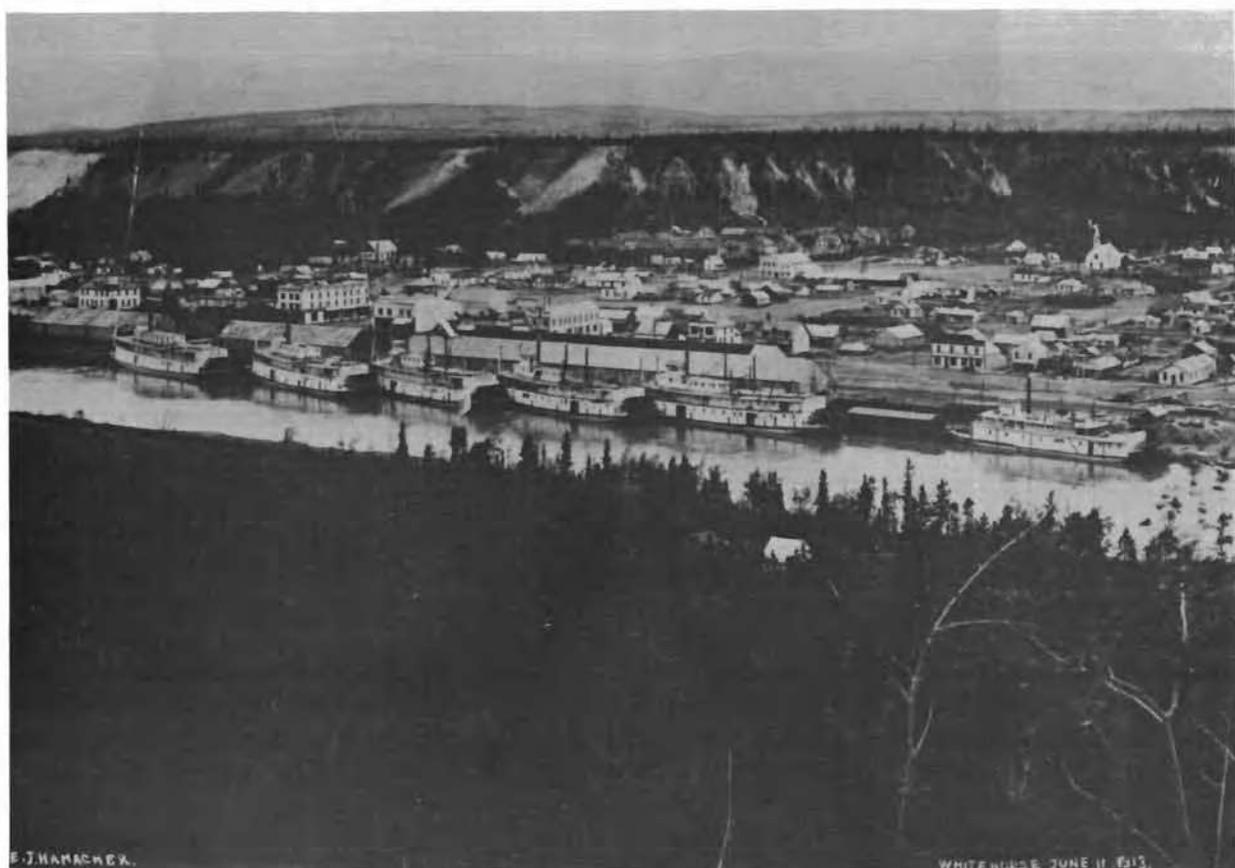
It can be seen from Fig. 1 (June 13, 1913) that those parts of the slope which then had no trees or standing vegetation had a surface cover of grass, which no doubt, is the same as the grass cover existing on similar slopes in the vicinity today. It will also be noted that what appear to be mud flows were even then taking place on the face of the escarpment but were minor and much less extensive compared to those occurring at the present time.

Figure 1. Whitehorse - June 11, 1913. Note "bridle path" on face of escarpment. (Photo taken by E. J. Hamacher; original print loaned by W. D. McBride, Whitehorse.)

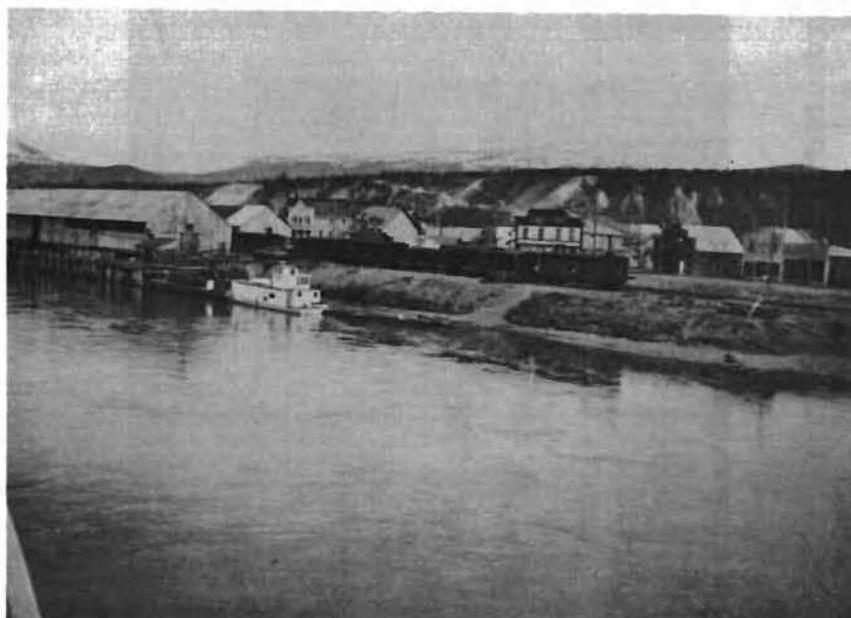
Figure 4. Town of Whitehorse and escarpment, 1938. (Note "bridle path" and Whitepass and Yukon route access road to airfield.) (Geol. Survey of Canada photo No. 84601)

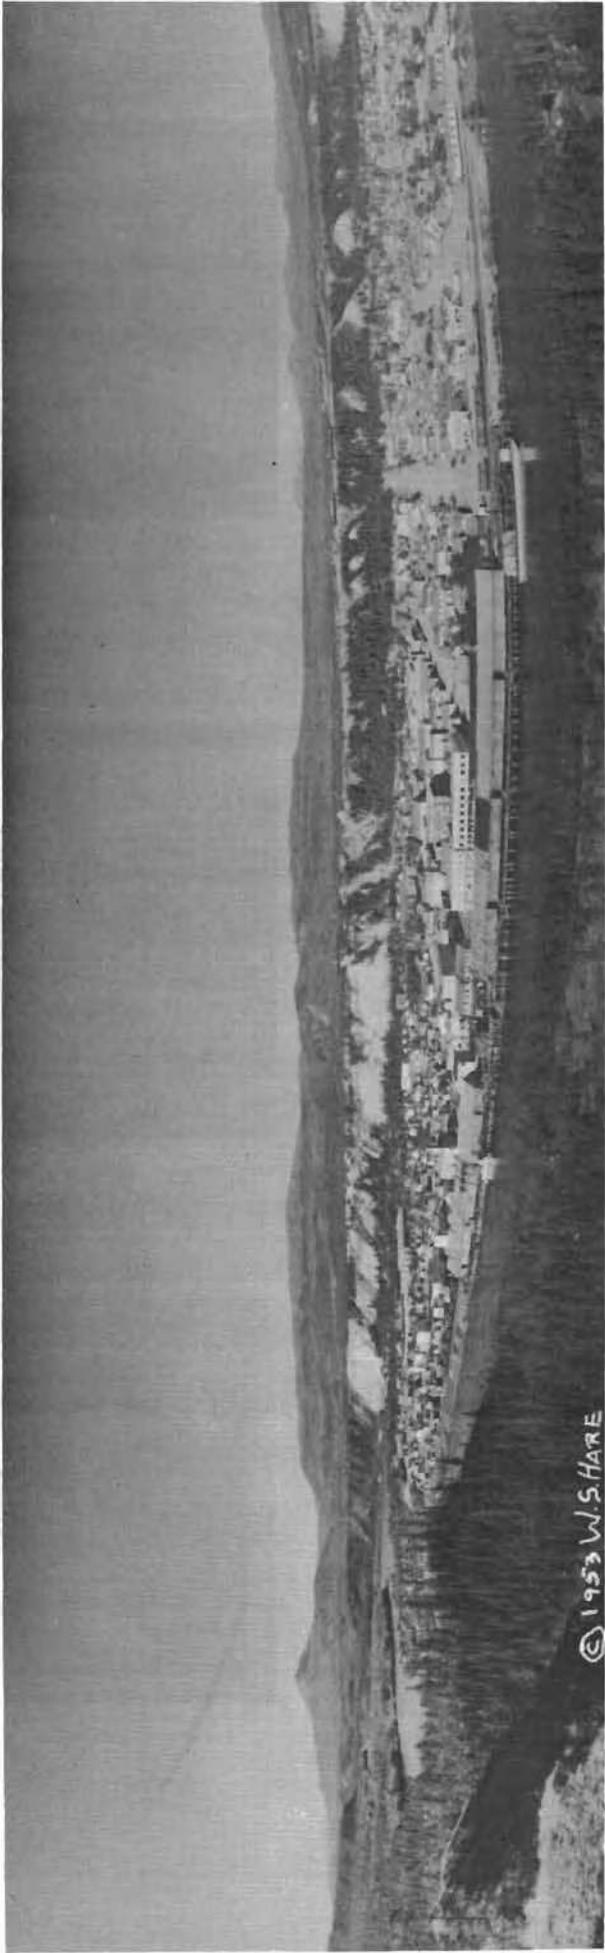
In contrast with what is shown on old photos (Figs. 1 and 4), which show the face of the escarpment in a relatively well-wooded condition, the vegetation today (Fig. 5) has been totally destroyed or at least badly disrupted on that portion from the southern extremity of the building area on the top of the escarpment to approximately a point in line with the cross runway or about 1,000 feet north of the northern limit of the building area. The total length of escarpment involved is about 4,000 feet.

Figure 5. Whitehorse, 1953 (Photo by W.S. Hare)

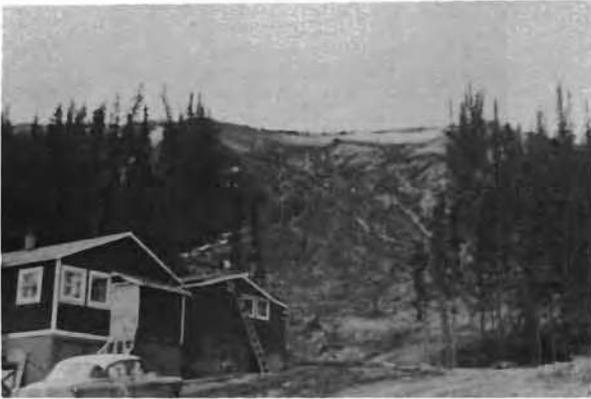
At the time of the junior writer's visit (29 April to 10 May 1957) sloughing of the escarpment was taking place along the whole face. Large drifts of snow still remained at the tops of two of the large scalloped portions north of the building area (Fig. 9). The face of the escarpment, wherever flows were occurring, was found to be frozen. Melt water from the snow-drifts and the frozen face picked up material as it trickled down the slope. The soupy mixture dammed up at obstructions on its way down the slope until a sufficient quantity accumulated so that 2 or 3 cubic feet of material would then slide as a mass increasing in velocity and aided by the slippery surface of the frozen face. By the time it reached the bottom of the slope, the material was flowing in a relatively large stream which decreased in velocity as it spread out on the flats below. At night, because of cooler air temperatures, the flows diminished greatly, in some cases ceasing altogether, indicating that this first sloughing was caused primarily, if not totally, by melt water.

Figure 6. Mud flows on escarpment, east end of cross runway, May 1957. (Note snow drift at top of scalloped portion (DBR photo BR 6762))

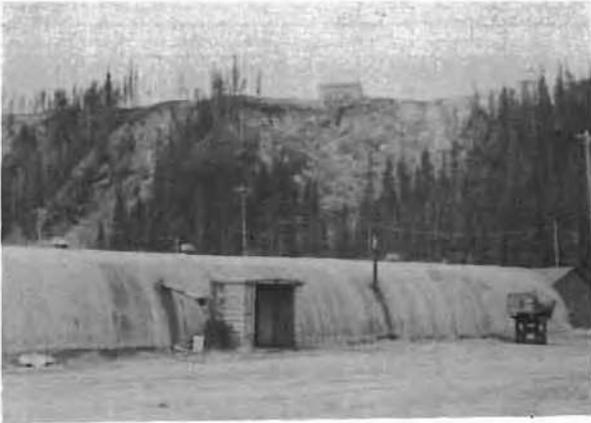
Figure 7. Sloughing on slope at DOT garage (at top of bank), May 1957 (DBR photo BR 6763)

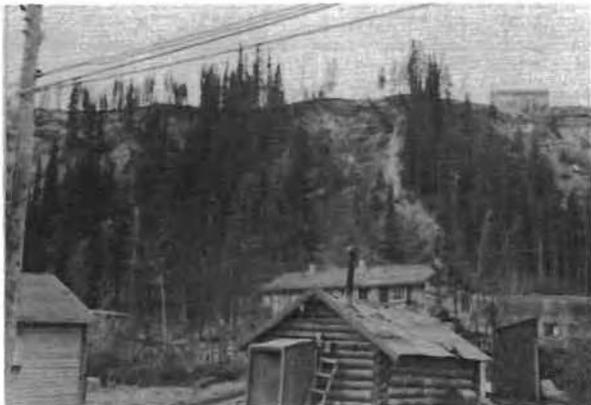
Figure 8. Sloughing near DOT garage, May 1957. (DBR photo BR 6764)

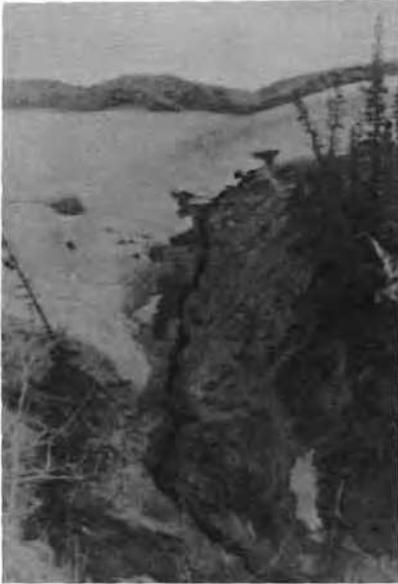
Surface run-off from the airfield had caused gullying in two places adjacent to the east end of the cross runway (one being opposite the culvert through the road to the west side of the field). Both had dried up but had evidently carried a good deal

Figure 9. Snow drift on scalloped area east of cross runway. Gully caused by surface runoff from airfield can be seen at edge of slope in line with gullying on face, May 1957 (DBR photo BR 6765)

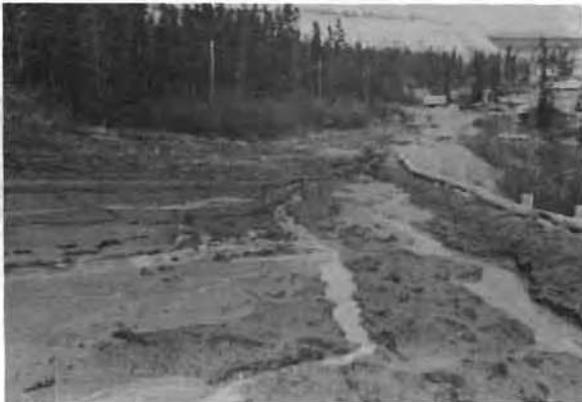
Figure 10. "Mud" streams flowing down lower sections of abandoned access road, May 1957 (DBR photo BR 6766)

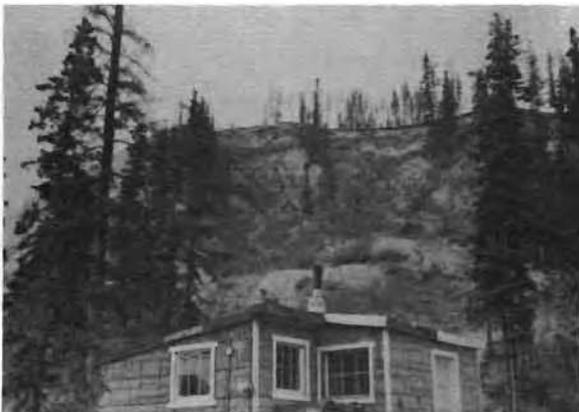
Figure 11. Erosion of bank behind DOT residences (at top of slope), May 1957 (DBR photo BR 6767)

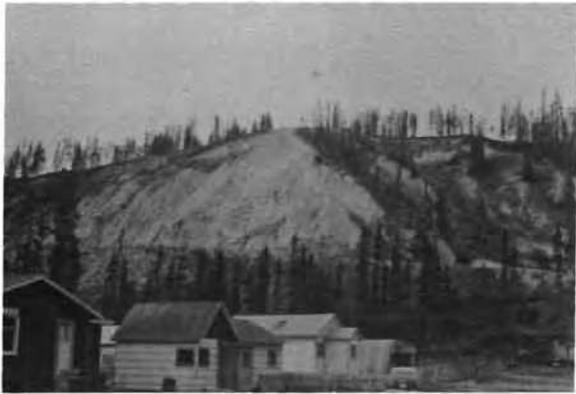
Figure 12. Dry face of escarpment immediately behind DOT residences (at top of slope), May 1957 (DBR photo 6768)

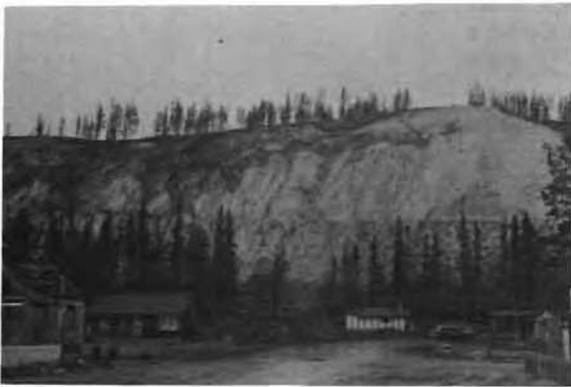
Figure 13. Another view of dry face of escarpment, May 1957 (DBR photo 6769)

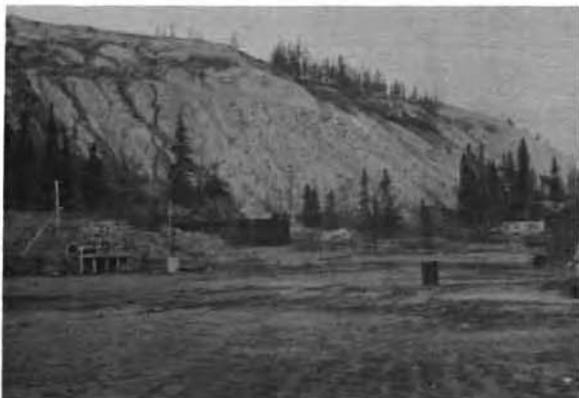
Figure 14. "Mud" runs flowing around oil storage tanks and down into town over railway Y tracks, May 1957 (DBR photo BR 6770)

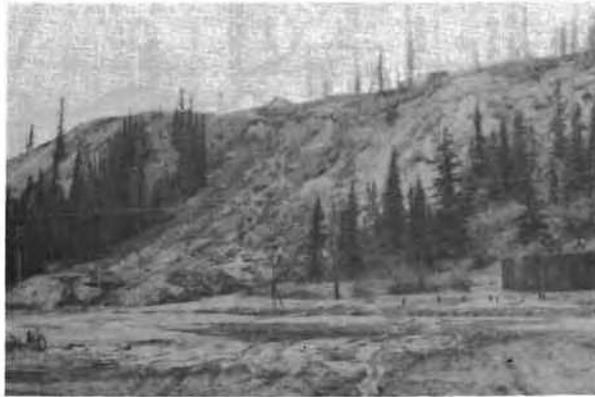
Figure 15. Extensive sloughing on slope has completely obliterated access road at its upper end, May 1957 (DBR photo BR 6771)

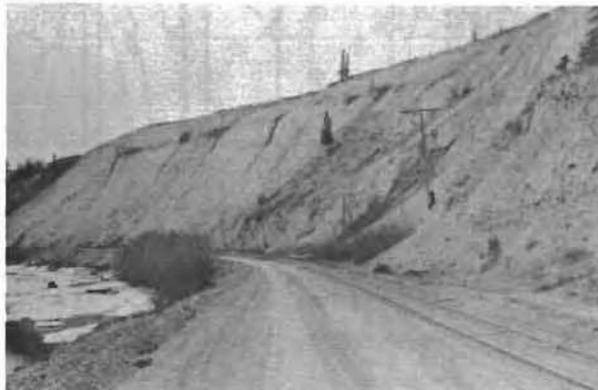
Figure 16. Steep, dry slope adjacent to railway south of Whitehorse, May 1957. Note occurrence of some gullying on face and also soil stratification on right side of photo (DBR photo BR 6772)

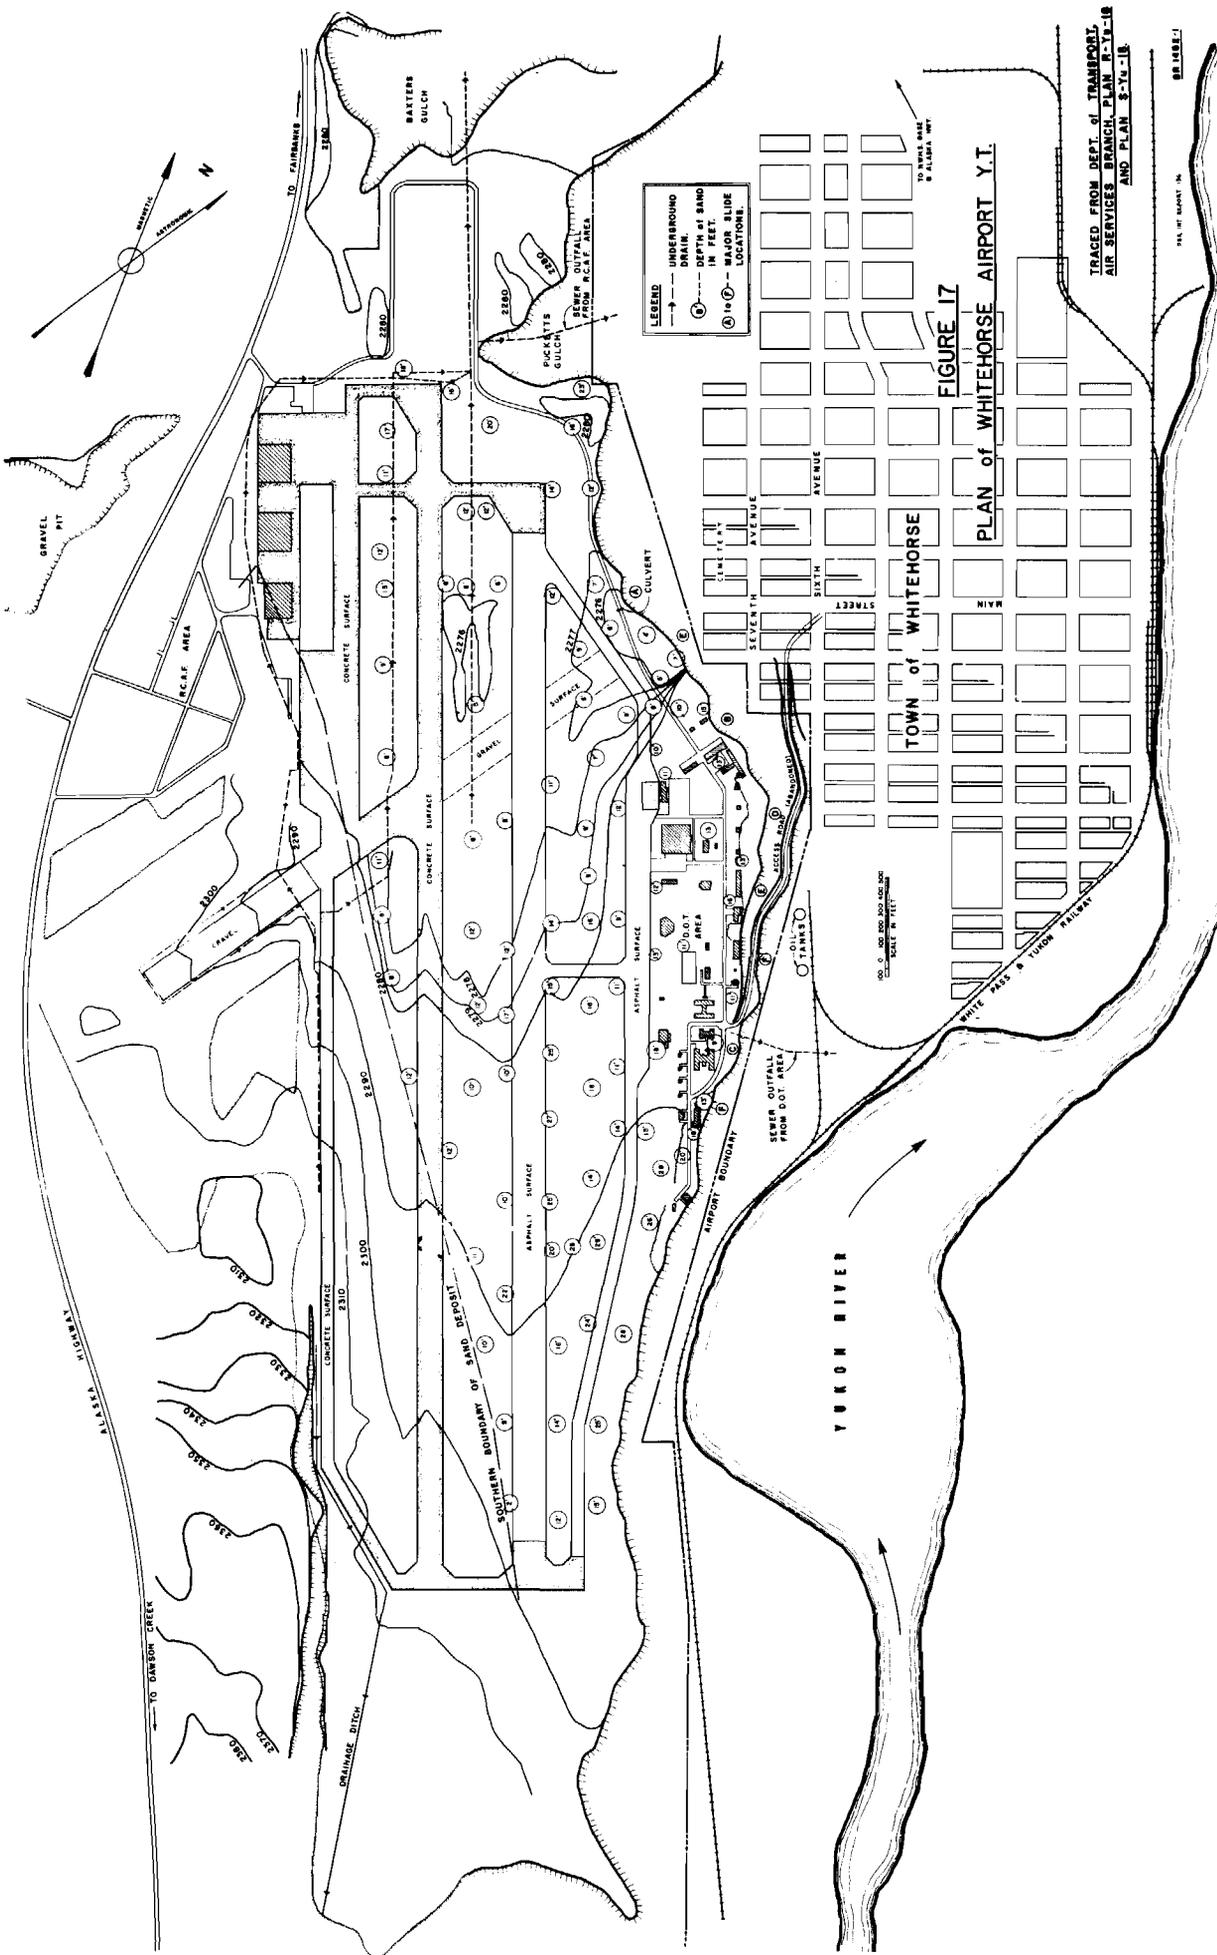
FIGURE 17

In 1950, further sliding of the slope around the outfall sewer necessitated cribbing and backfilling to prevent freezing and further damage to the line. The occurrence of more slides (D, Fig. 17) along the escarpment was endangering several dwellings in the Town of Whitehorse at the base of the slope. A preliminary engineering investigation by D.O.T. engineers indicated the need for considerable study of the problem before remedial measures could be taken.

The most serious slides occurred (A and E, Fig. 17) in 1953 when large quantities of "soupy" material flowed down into the Town of Whitehorse causing considerable damage to private property. Light snowfall (and thus deep frost penetration) and excessive rainfall in the preceding winter and during the spring respectively were thought to have been a major contributing factor. Sloughing and mud flows, varying in degree of seriousness, have occurred each year since, on the face of the escarpment (F, Fig. 17).
