MPERG Report 2007-3

# Gold Run Creek Erosion Control Project 2006 Follow-up Monitoring

# Gold Run Creek Erosion Control Project

## 2006 Follow-up Monitoring

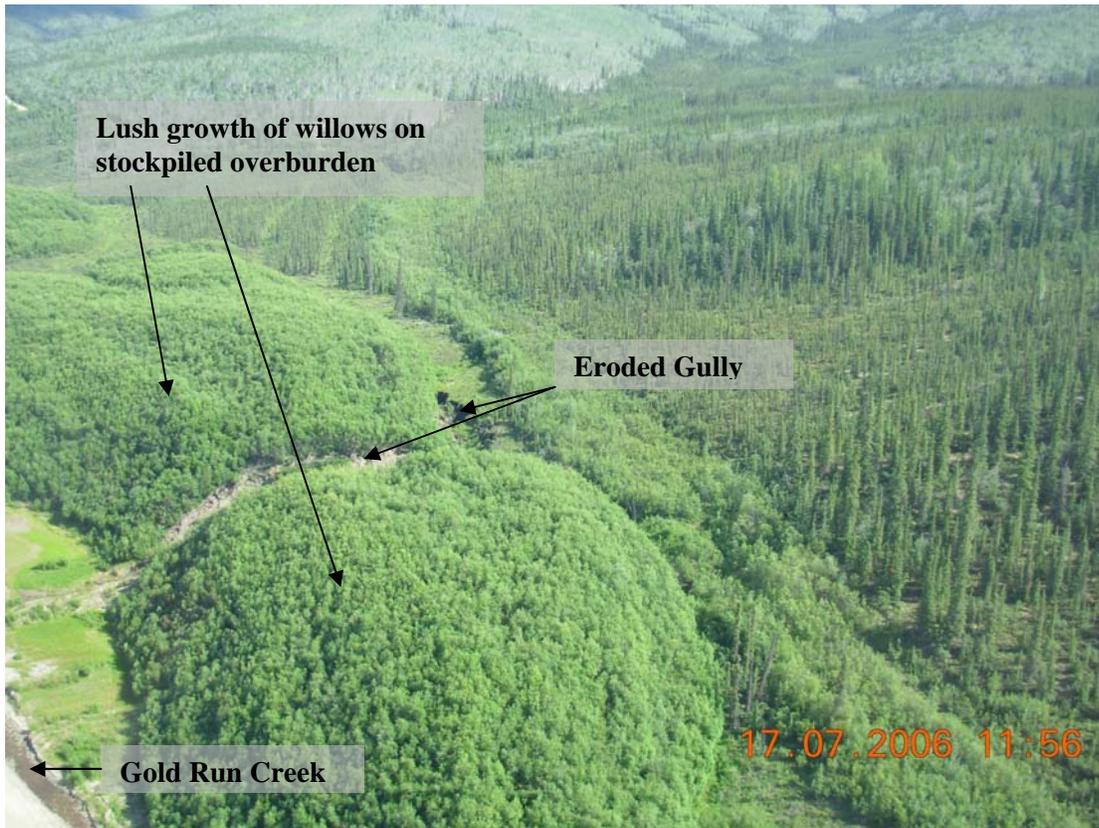
Aerial shot of the eroded gully taken on July 17, 2006.

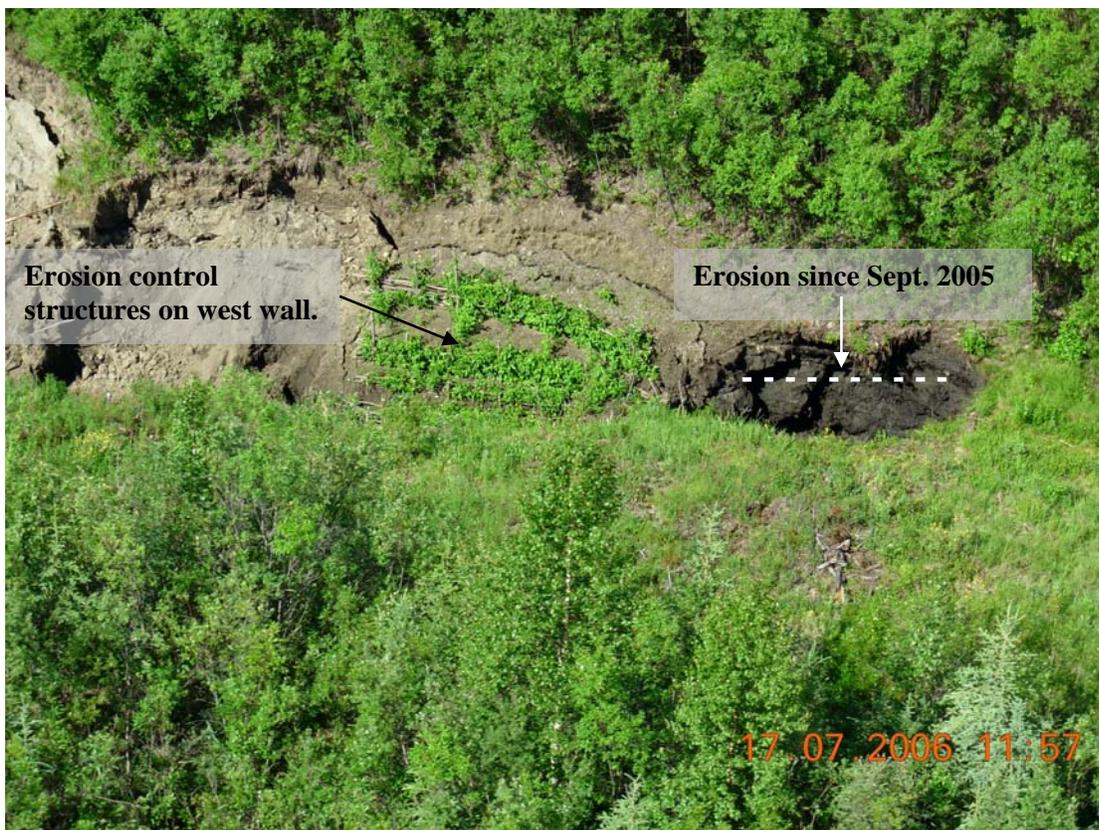
- The flume, constructed from live willow cuttings, had failed to direct the flow of water over the retaining walls, resulting in further upstream erosion in the gully. Although a pipe had been installed in September 2005 to divert flow around the flume temporarily for the fall, this probably was not effective by spring. The erosion had extended the gully upslope by an estimated 5 metres since the retaining walls and flume were constructed in September 2005. It is assumed that the flume failure and the new erosion began with the spring runoff and continued as the permafrost melted in the summer.

Aerial shot of the erosion control structures and increased erosion, taken on July 17, 2006.

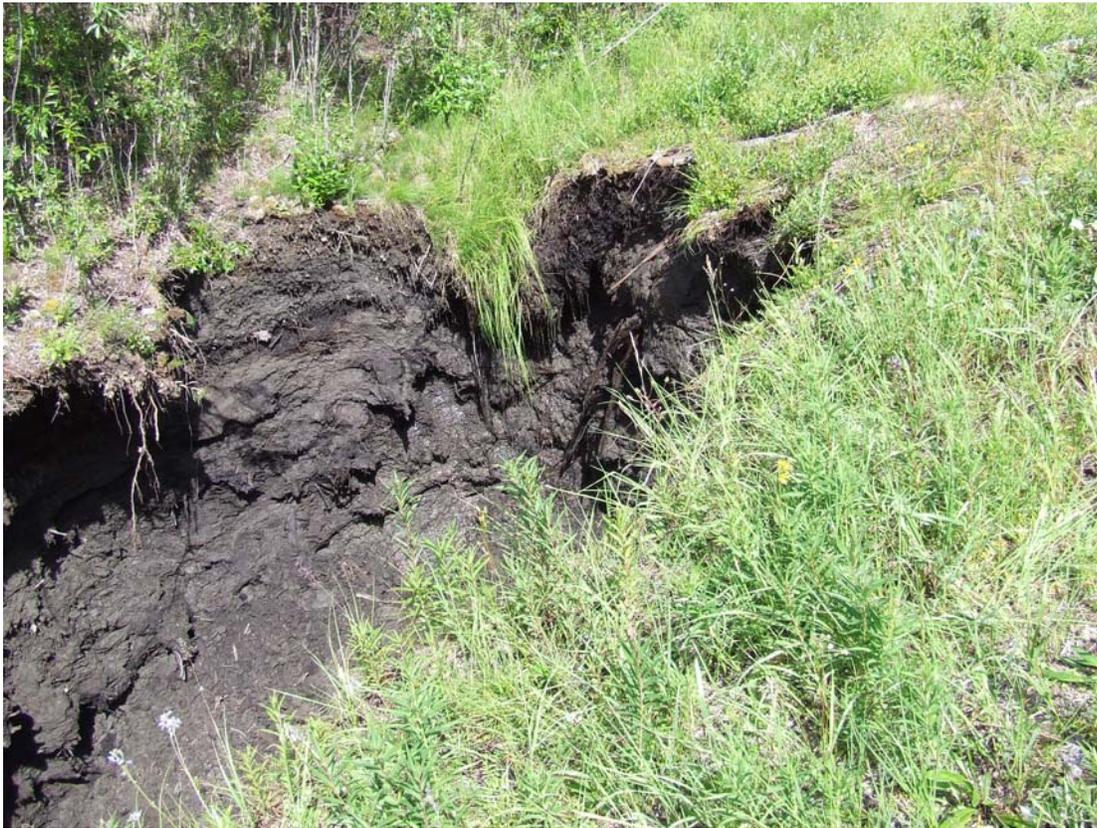
Top of the gully has eroded back approximately 5 additional metres since Sept 2005.

The malfunction and collapse of the flume, constructed from live willow cuttings, was the obvious cause of failure of the erosion control project at the Gold Run Creek site. In order for this project to succeed, it is apparent that a reliable technique for conveying water discharge during spring runoff and subsequent permafrost melt is required to permit the live reinforced retaining walls to have time to grow and strengthen so that they can perform their purpose.

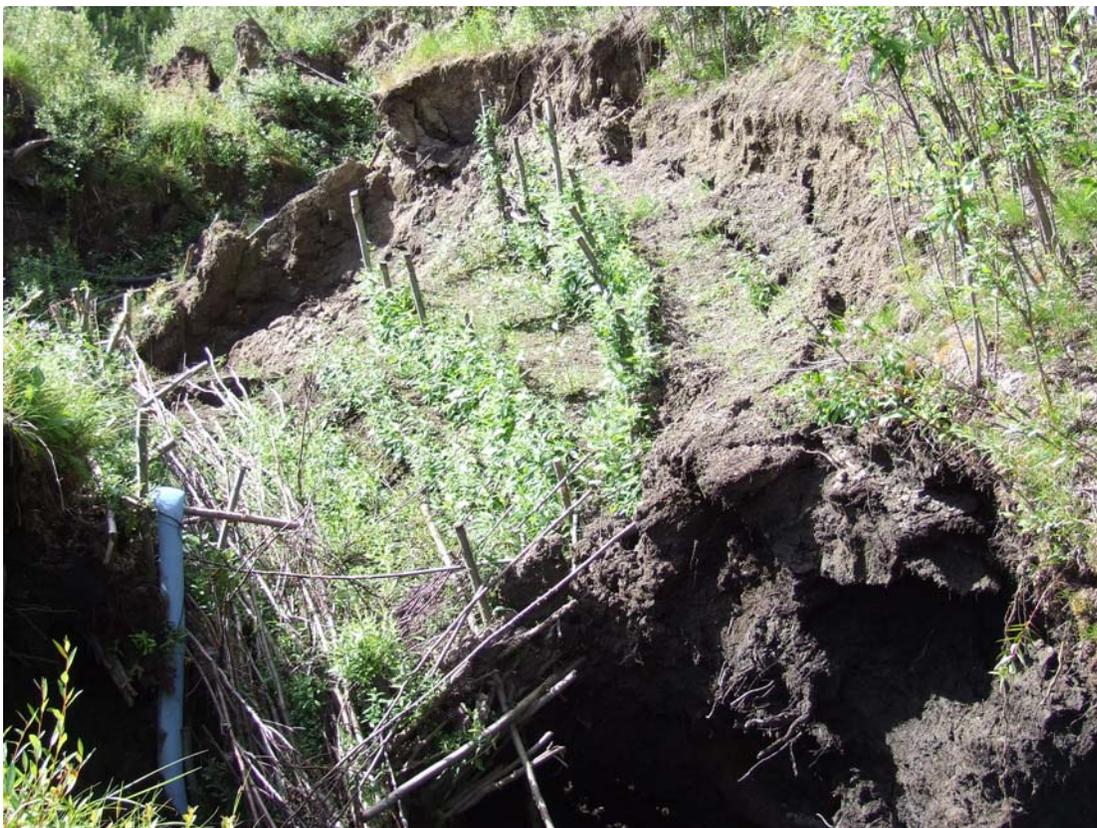
- The earth retaining walls, supported by live willow cuttings, had remained intact. The willow cuttings were showing a significant growth of new shoots and roots (see site photographs in Appendix A).

Looking from the top of the gully to the collapsed flume and the intact retaining wall structures, July 18, 2006. Note new grass growth on the terraces of the west retaining wall.

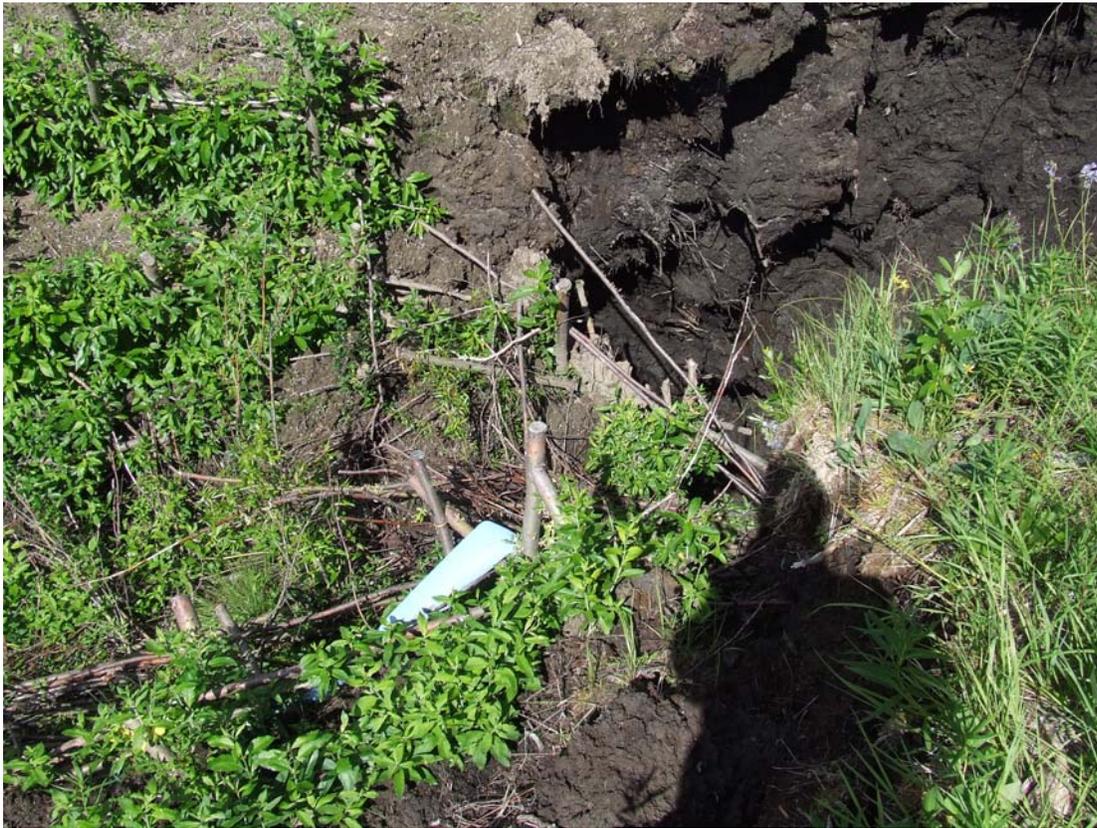
Good growth on both of the side walls, however the top tier of the rear wall has collapsed along with the flume. July 18, 2006.

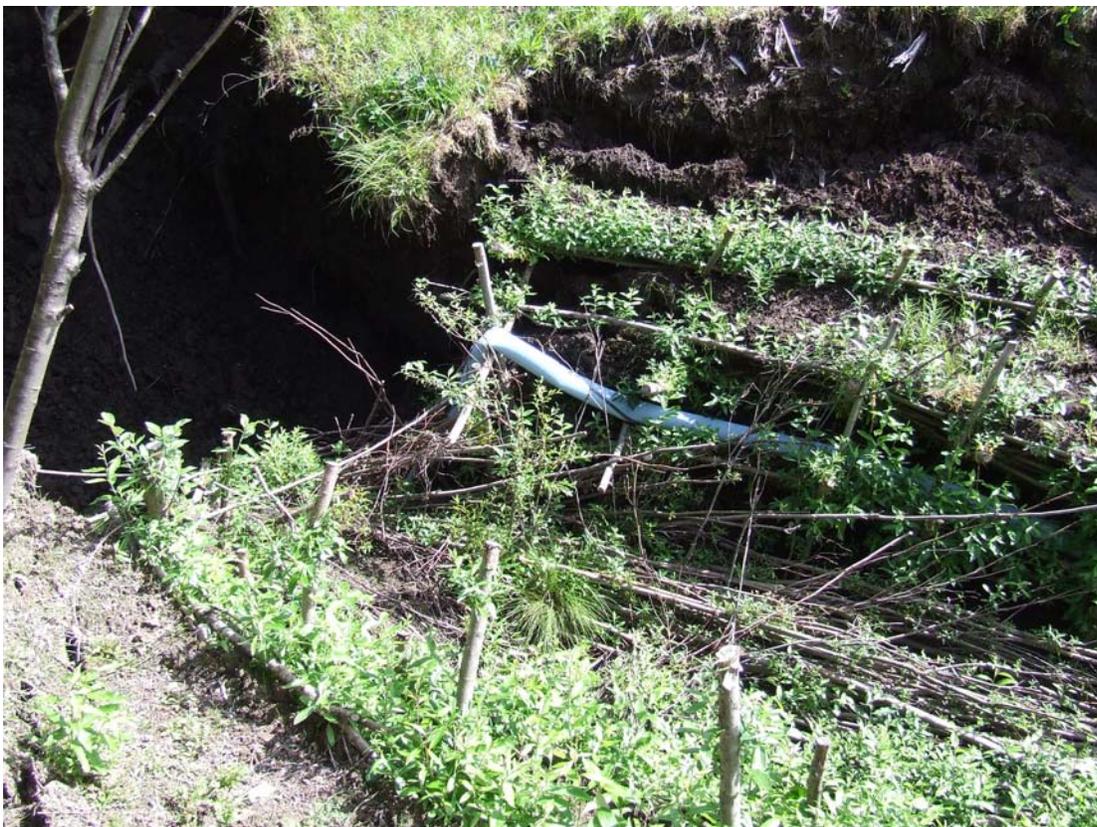
Good growth on the structures of the side walls abutting the newly eroded area, July 18, 2006. Note young willow sprouts on the remaining portion of the flume at the base of the retaining walls.

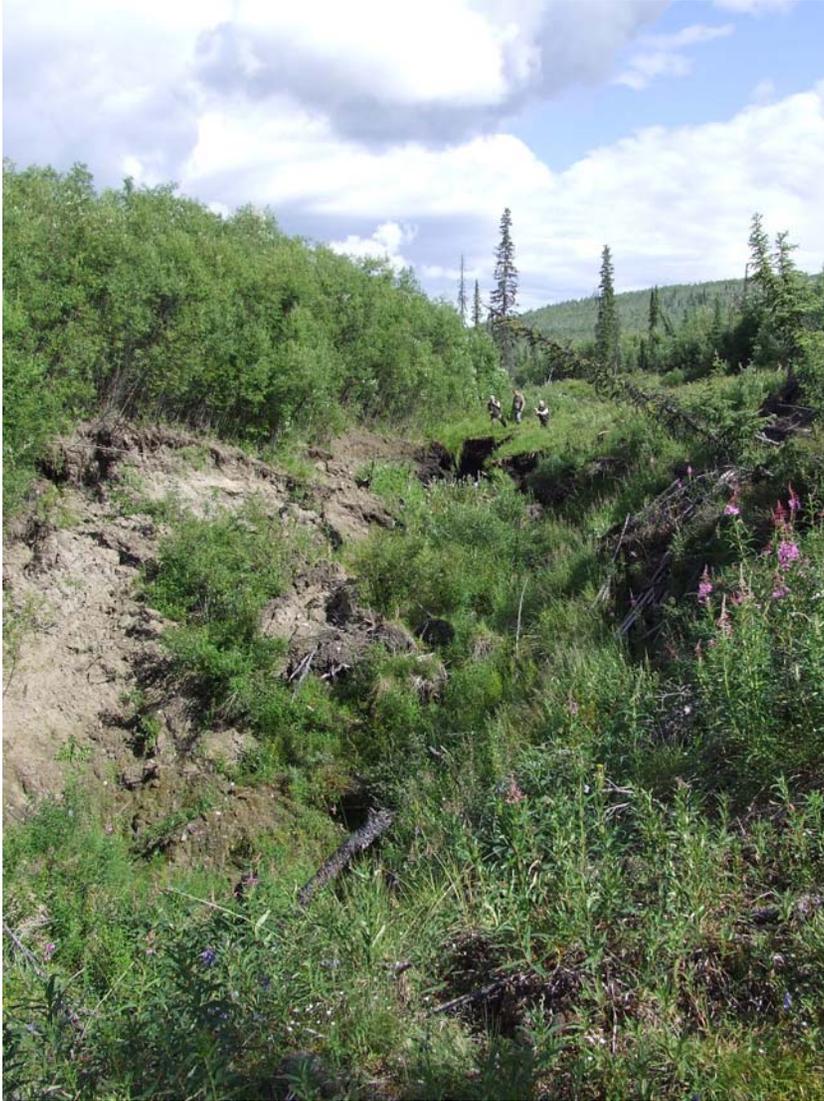
- A good regrowth of willows was observed at the cutting donor site at the top of the overburden stockpile.
- Some sections of the gully continue to stabilize, with a good growth of plant material covering the gully floor and walls.

Looking toward the control structures, stabilized area of gully in foreground.

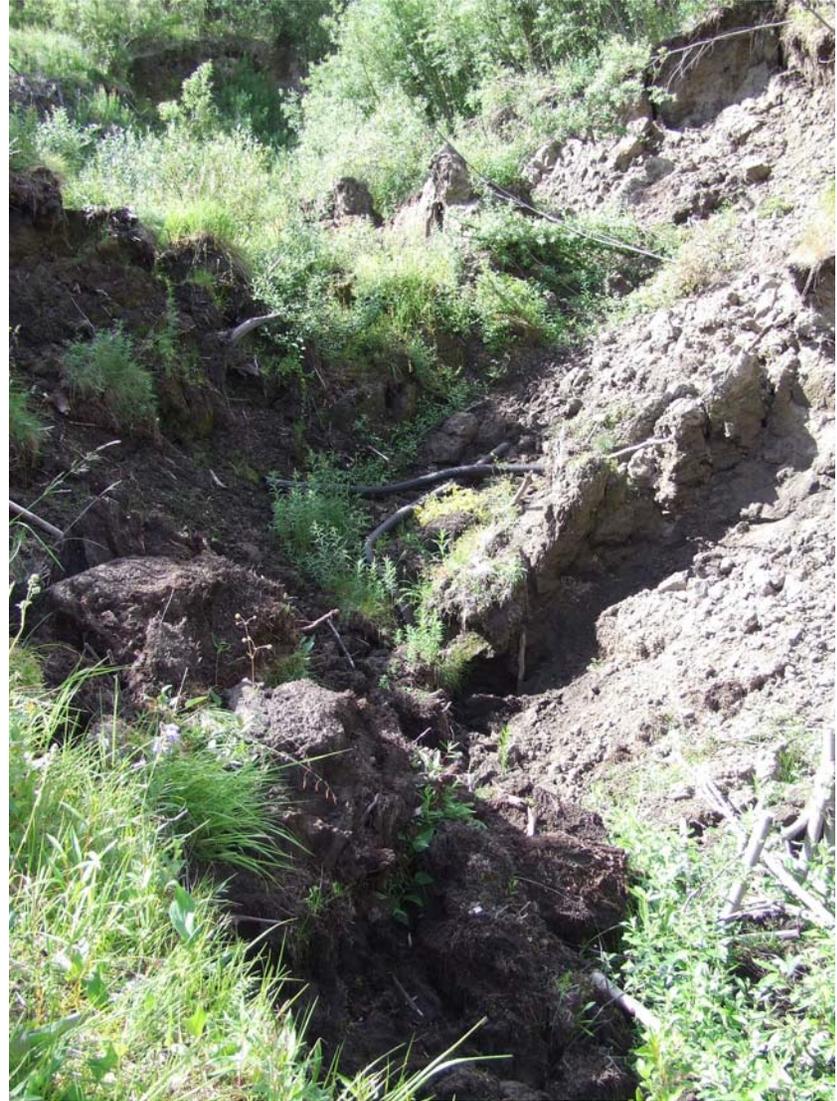
Looking back from control structures to the stabilized area, July 18, 2006. Willows growing on floor of gully where the Big-O pipe had lain.

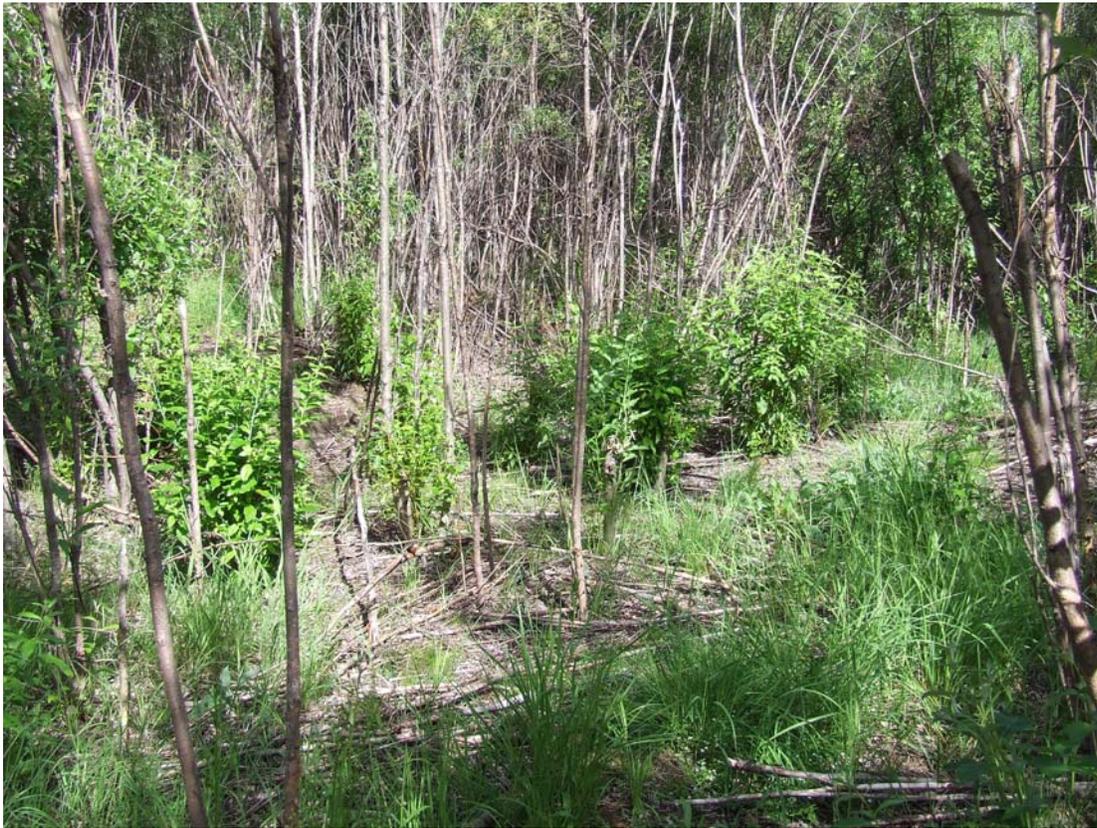
Regrowth of willows at the donor site, July 18, 2006.

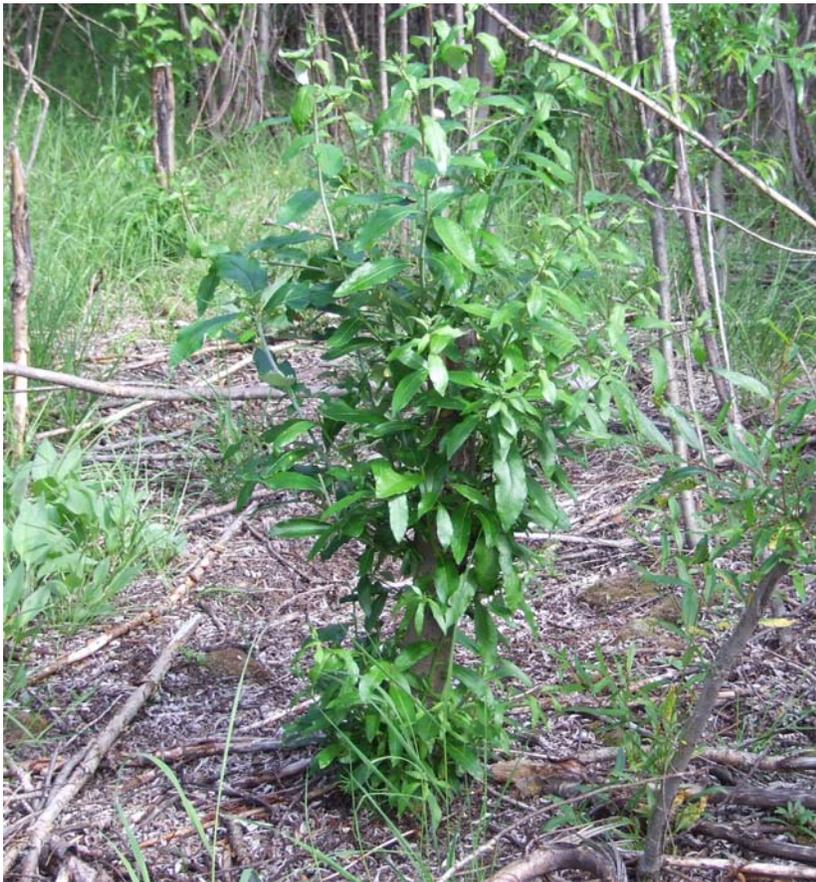
One of the donor willows sporting robust regrowth over the first growing season since harvesting, July 18, 2006.

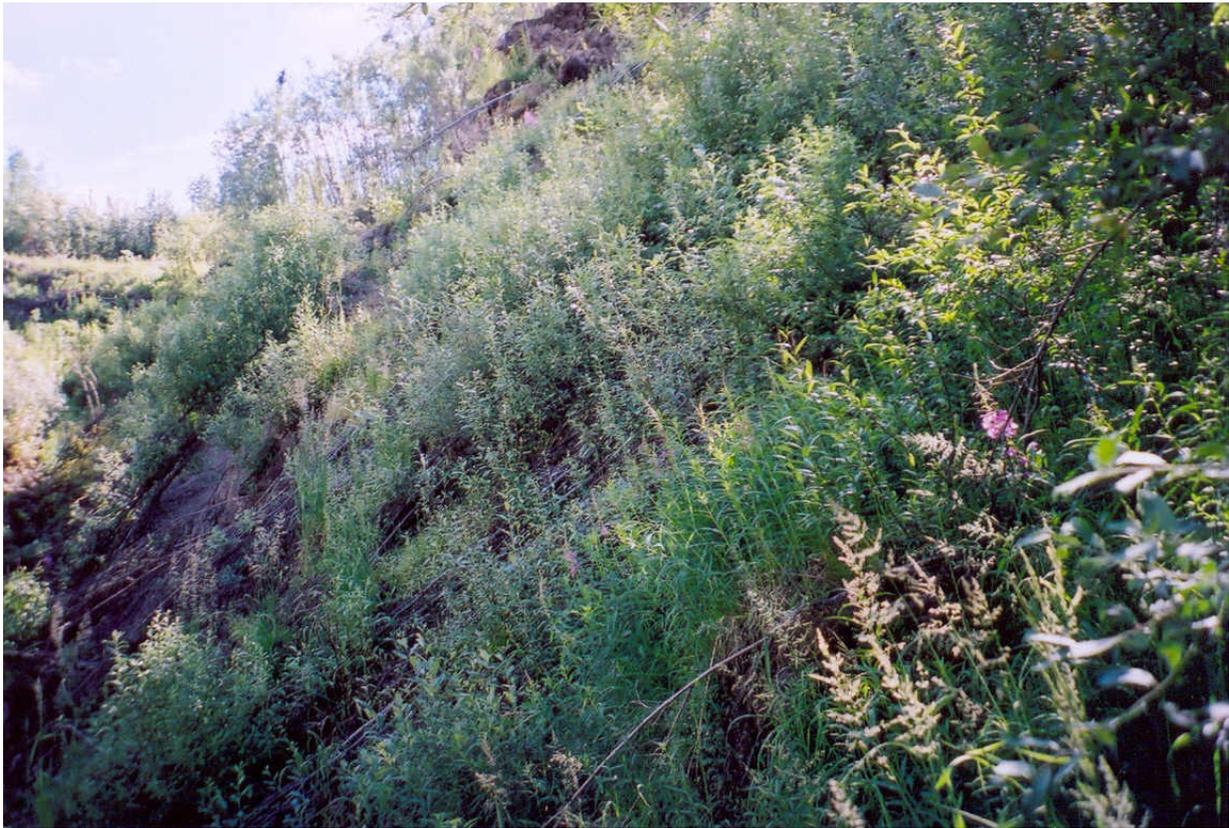
- Slumping of the northwest facing wall near the gravel plug had induced mature willow trees to fall onto the surface of the steep gully wall. In September 2005

these willows were sending up shoots from their prone position, assisting in the stabilization of the slope. Willows were continuing to grow here in July 2006.

Willows growing from fallen trees on the southeast slope near the gravel plug, July 18, 2006.

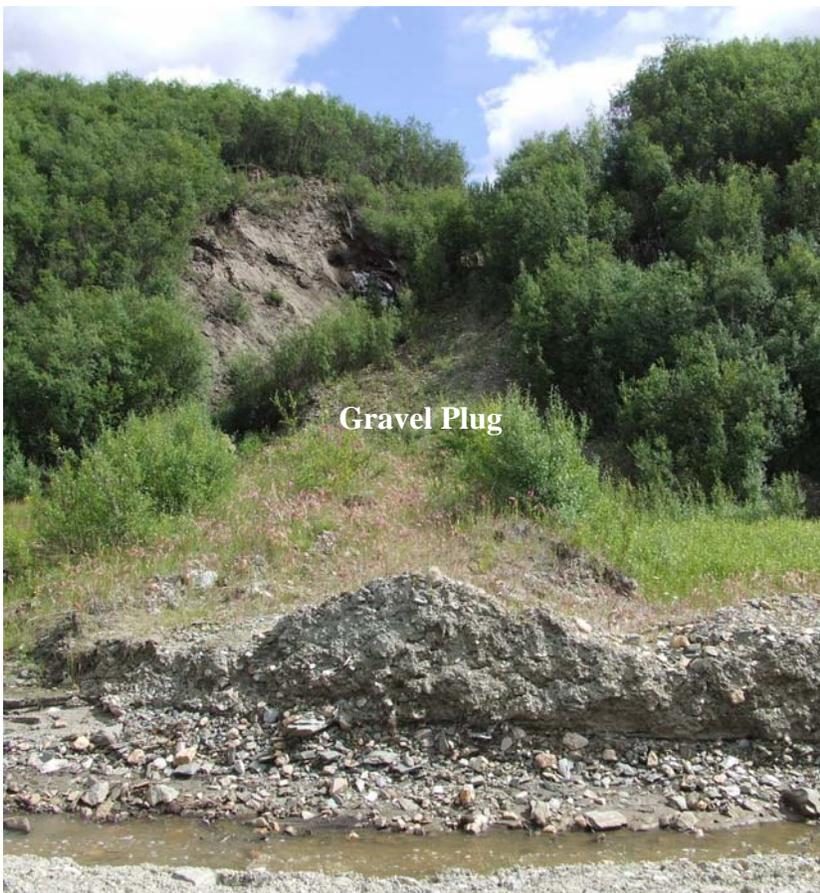
The gravel plug is re-vegetating naturally, July 18, 2006.

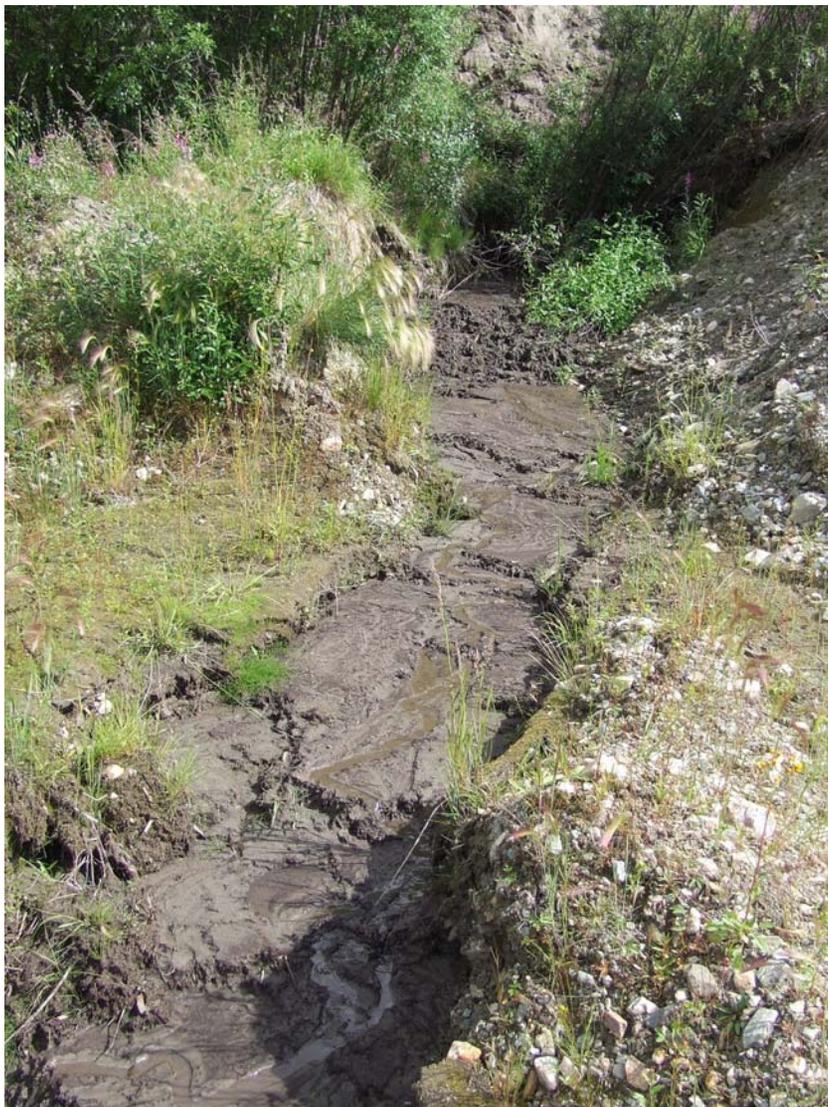
- Most of the willow cuttings staked in the watercourse upstream from the control structures had survived and were sprouting new growth.
- There was very little flow of water in the erosion channel at the time of the survey. The estimated discharge at the downstream end of the gully, before its confluence with Gold Run Creek, was 10 to 20 mL/sec.

Flow at base of cut was estimated at 10 to 20 mL/sec, July 18, 2006.

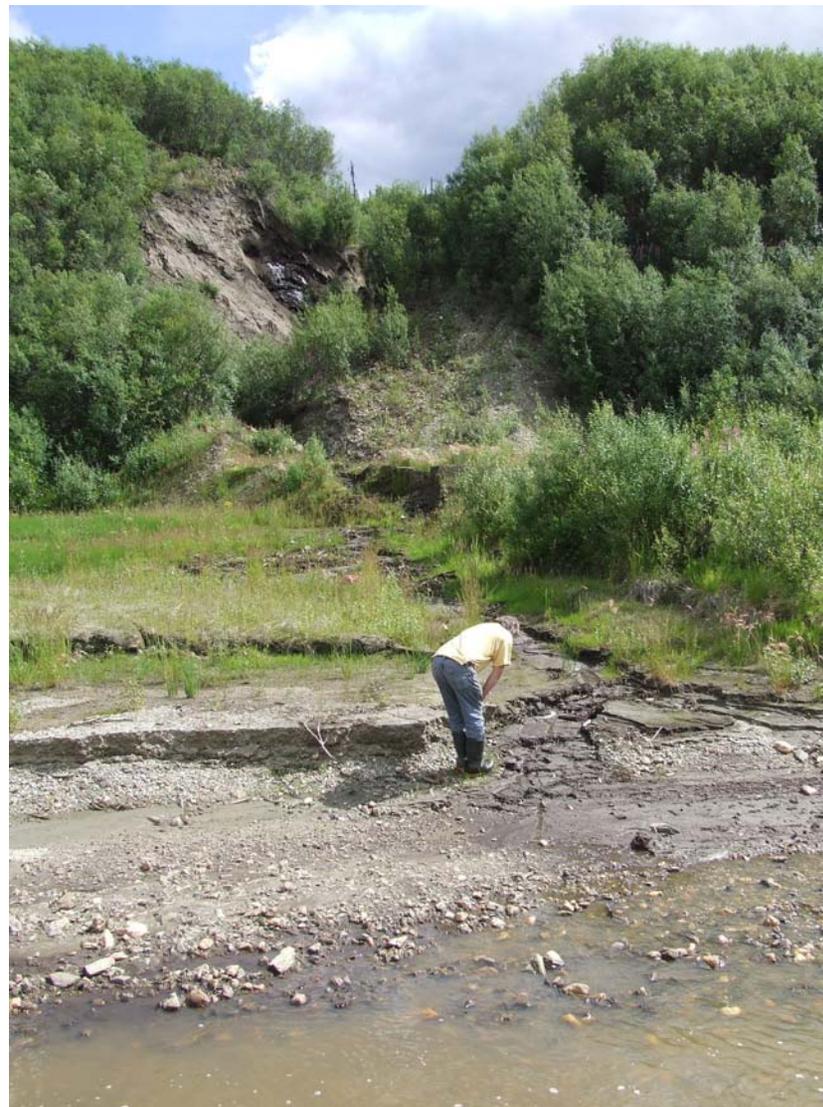
Confluence of flow from the cut and Gold Run Creek, July 18, 2006
