MPERG Report 2009-3

A Review of Several Yukon Revegetation Projects and Techniques

EDI Environmental Dynamics Inc.

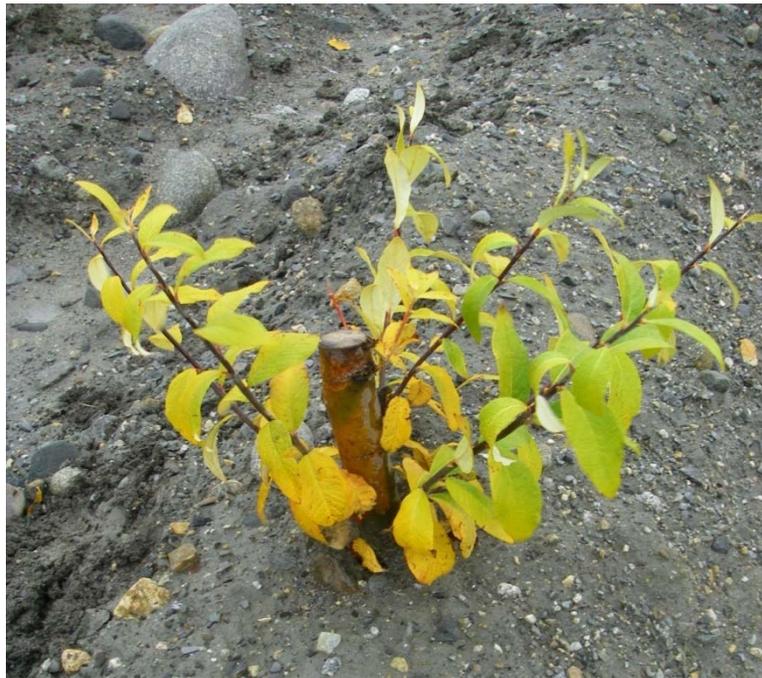
Live staking is one of the most basic forms of bioengineering. In this technique, cuttings are inserted into the ground vertically (Photo 1). In our review, we found numerous projects that used this method, most with varying levels of success. One of the most successful projects was the live staking conducted along the banks of Porter Creek in Rabbits Foot Canyon, Whitehorse during the summer of 2002. Recent monitoring showed that native vegetation has re-colonized the majority of the site. The vegetation on the stakes was on average 1.5 m high. Soils were made of fines and the site was quite moist. These soil conditions were favourable for live willow cuttings and likely contributed to the success of the treatment at this location.

Photo 1: Close-up view of a willow live stake planted at the Faro Mine in 2007. Photo taken in fall of 2008.

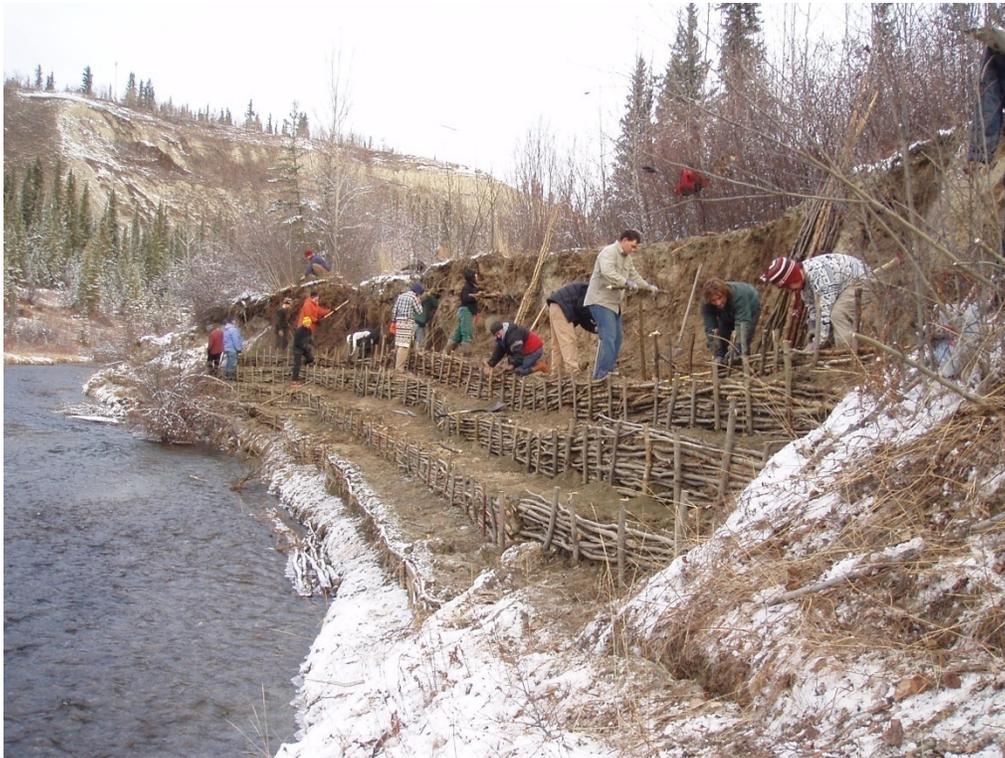
Wattle fences are a method of using live cuttings to construct retaining walls. The fence holds back the soil and forms a narrow terrace on a slope or bank (Photo 2). The stakes in the fence end up forming a “live fence” when they start to sprout. Wattle fences were constructed at the former Range Road Dumpsite and at Goldrun Creek. The wattle fence was installed in 2005 at Goldrun Creek to stop erosion in a gully (Laberge Environmental Services 2006). During inspection in 2008, we observed the majority of these structures undercut due to erosion, which caused them to collapse. The remnants of one section of the fence were still intact and showed good growth. We found similar conditions and results on an eroding bank on McIntyre Creek at the former Range Road Dumpsite. Wattle fences installed in the fall of 2005 collapsed over the course of the next couple of years. The topography now reflects a rough slope, rather than a stepped slope. Few of the cuttings showed live growth in 2008.

Photo 2: Wattle fences installation along McIntyre Creek, Whitehorse, fall 2005.

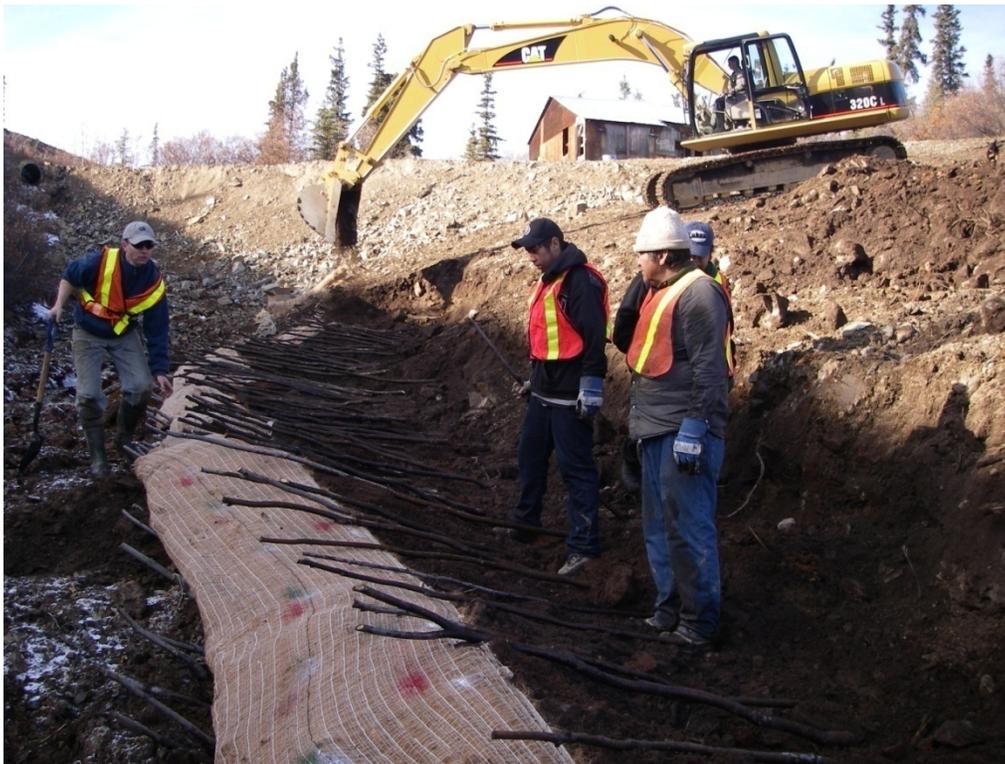
Brush layers are horizontal rows of live cuttings buried in cut slopes or backfilled material (Photo 3). Typically, brush layers are applied to steeper slopes, where the cuttings help bind and retain the fill material. Brush layers installed along the Mendenhall River, a side channel of the Mayo River, and at the former Range Road Dump sites showed moderate to good success. Although survival rates of cuttings were as low as 28% (Range Road) when the site was visited in 2008, growth on the ones alive was good. The heavy stocking rate of this technique may have compensated for stem mortality. In all cases, it appears that enough growth has established to help stabilize the sites. Of note, this technique was by far the most successful bioengineering technique at the Mendenhall site where EDI implemented several different bioengineering methods (including brush mattresses, live stakes, and live fascines; P. Tobler pers. comm.).

Photo 3: Brush layer installation at the Mt. Nansen mine site, near Carmacks. Rows of live cuttings are laid down into the slope, wrapped in bio-degradable erosion control matting, and buried (September of 2008).

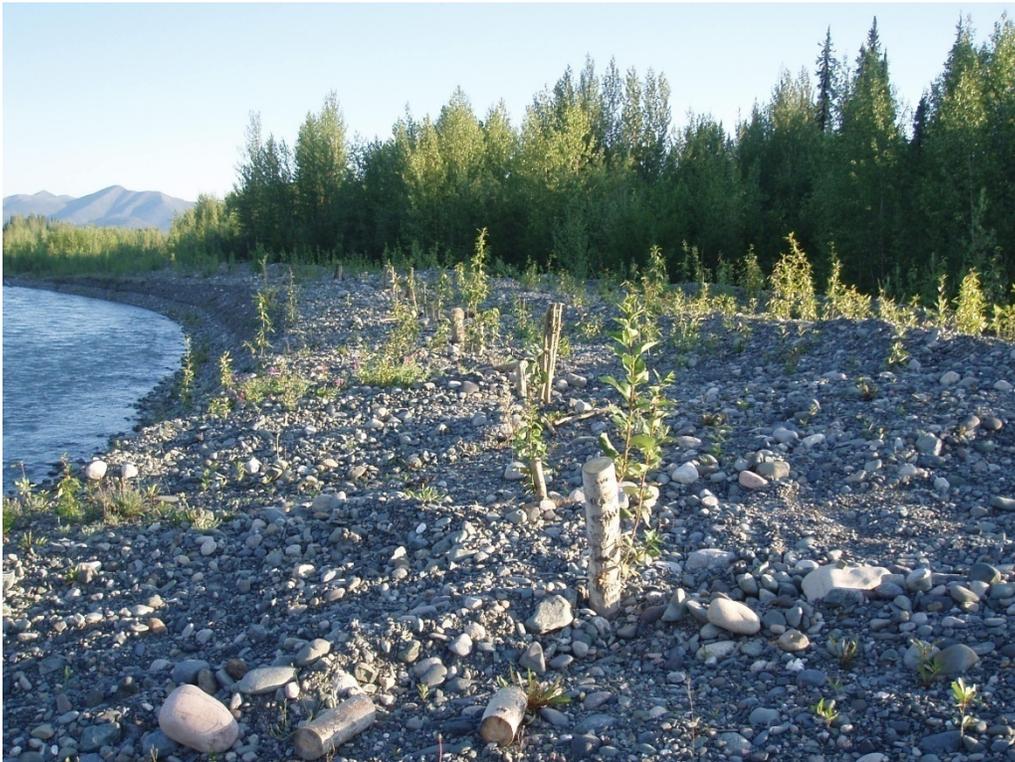
Live palisade installation involves large diameter (>5 cm) cuttings that are planted vertically, much like vertical stakes. The palisade can be as big as a tree trunk and requires the use of an excavator to plant. This technique is applied mostly along eroding stream banks and helps to create a root network that will stabilize the bank (Polster 2001; Photo 5). Live palisades planted along a side channel of the Klondike River at Germaine Creek (M. Miles and Associates Ltd. and Polster Environmental Services Ltd. 2007) and Beaver Creek (P. Tobler pers. comm.). The live palisades at Germaine Creek showed low survival rates (estimated at 17 % in 2008); at Beaver Creek, initial observations show a high survival rate and good growth of live palisades.

Photo 5: Row of live palisades along Beaver Creek near KM 1921 of the Alaska Highway, upstream of the Bridge (planted in fall of 2004, photo July 2005)

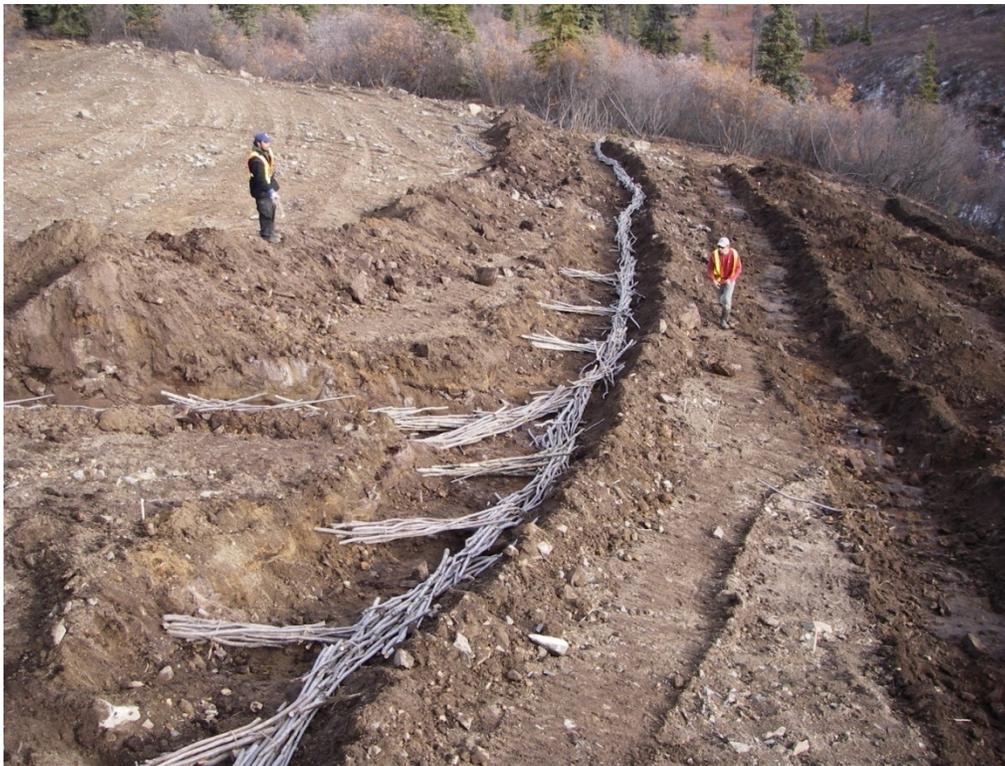
Live pole drains or flumes are constructed from bundles of live cuttings and are used to safely collect and funnel water down moist slopes, without causing excess erosion (Photo 6). These structures are partially buried in the ground and can be effective treatments on slopes where excess moisture is a concern (Polster 2001). In Yukon, there are at least two sites where live pole drains/flumes have been installed. Two live pole drains made from willow at Noname Creek were installed at the top of a steep, erosion prone slope in the fall of 2001 (Laberge Environmental Services 2002). Although a forest fire burned the area in the summer of 2004, monitoring in 2008 showed good growth along the length of both pole drains and no erosion concerns.

Photo 6: Live pole drain being installed at the Mt. Nansen Mine near Carmacks in September 2008 near. Trenches containing bundles of live cuttings were backfilled to complete the installation.

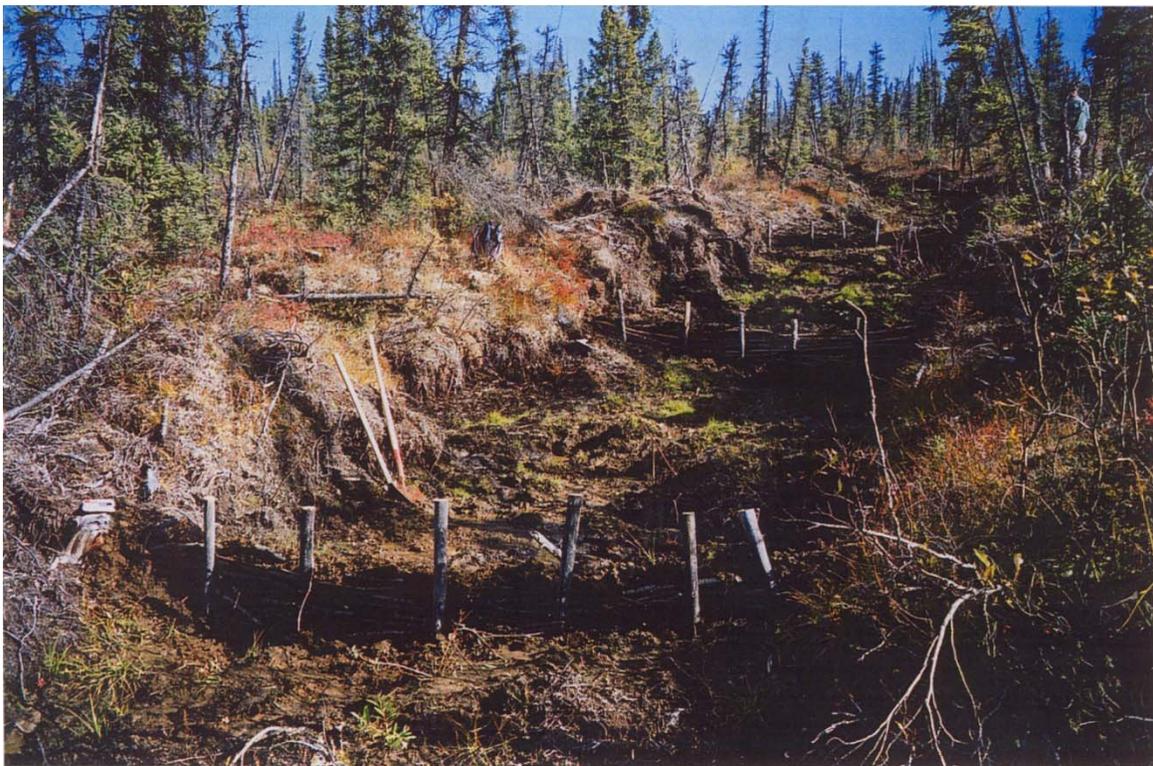
Live gully breaks are wattle fences constructed in gullies; they are supported by vertical stakes and built perpendicular to the slope (Photo 9). These structures help to prevent torrents from developing in the gullies. Live gullies breaks, made in 2001 from willow cuttings at Noname Creek showed good growth when we visited the site in 2008, and we noted no substantial erosion concerns.

Photo 9. Live gully breaks installed at Noname Creek west of Carmacks in the fall of 2001. Photo courtesy Laberge Environmental Services 2008.

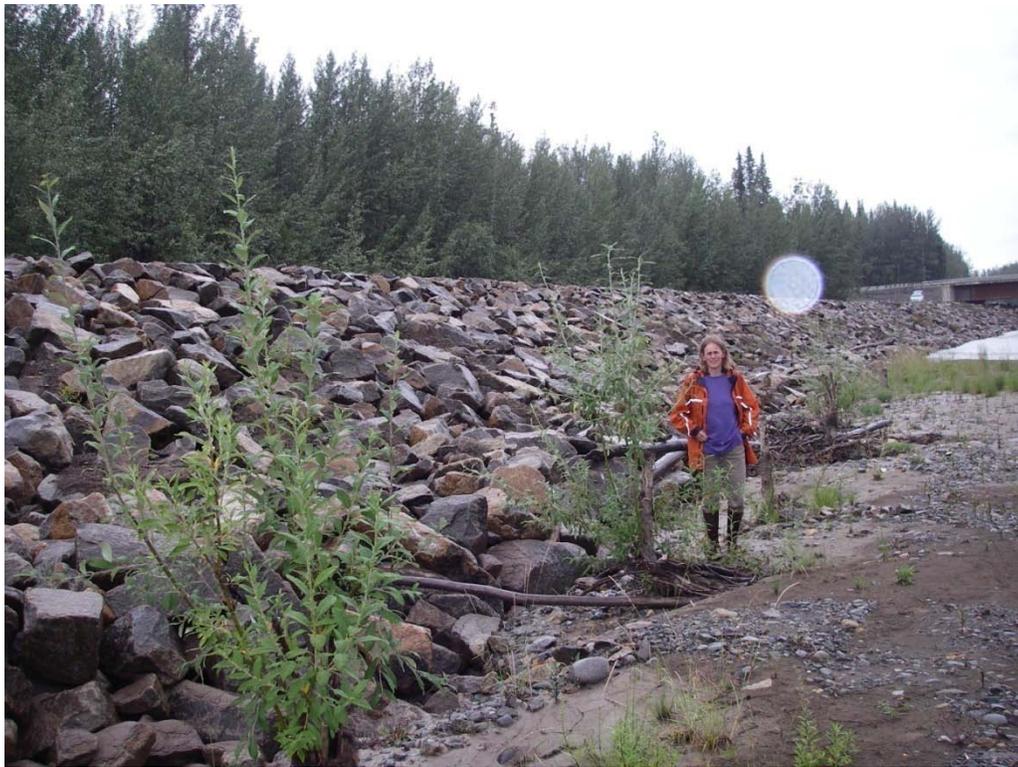
Live Palisades: Notable growth has been observed (often in excess of 2 m) on the majority of cuttings (Photo 2). Few mortalities were noted.

Photo 2. Photo of growth on live palisades, upstream of the Beaver Creek bridge. Photo taken in July 2007.

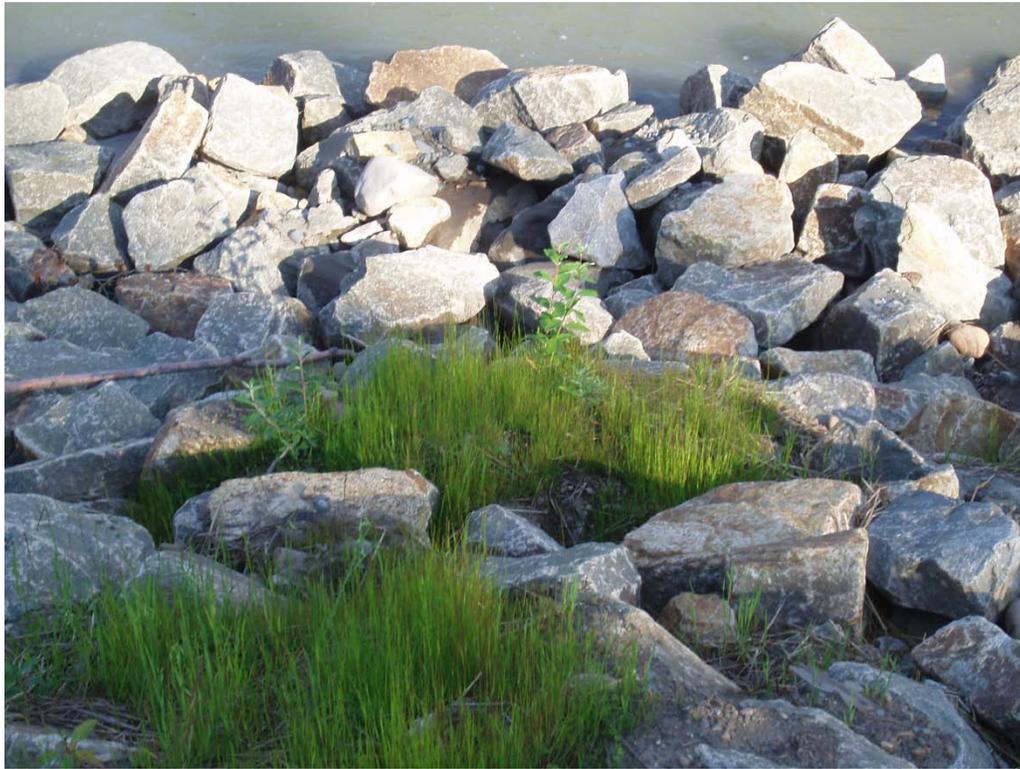
Live Staking in Soil in Void of Riprap (Pocket Planting; including grass seeding): In the first growing season, extensive grass growth was observed (Photo 3); however, this grass cover appeared to die out in subsequent seasons. Many live stakes were showed growth, during all site visits (Photo 4). Many of the stakes were > 1 m high in 2007. No evaluation on the success rate was completed.

Photo 3. Photo of pocket planting on riprap, upstream of the Beaver Creek bridge. Photo taken in August 2005.

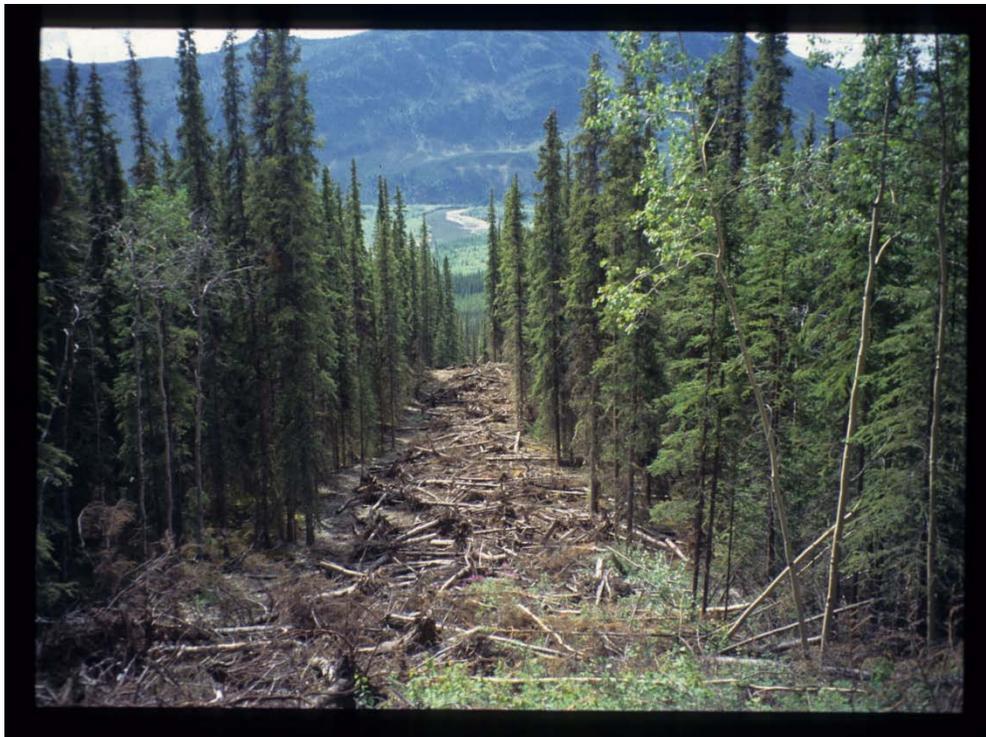
Photo 2. View of a re-filled trench at the Breakaway property near Ross River in 1997, note vegetation growing in the foreground. Photo courtesy of the Yukon Geological Survey.

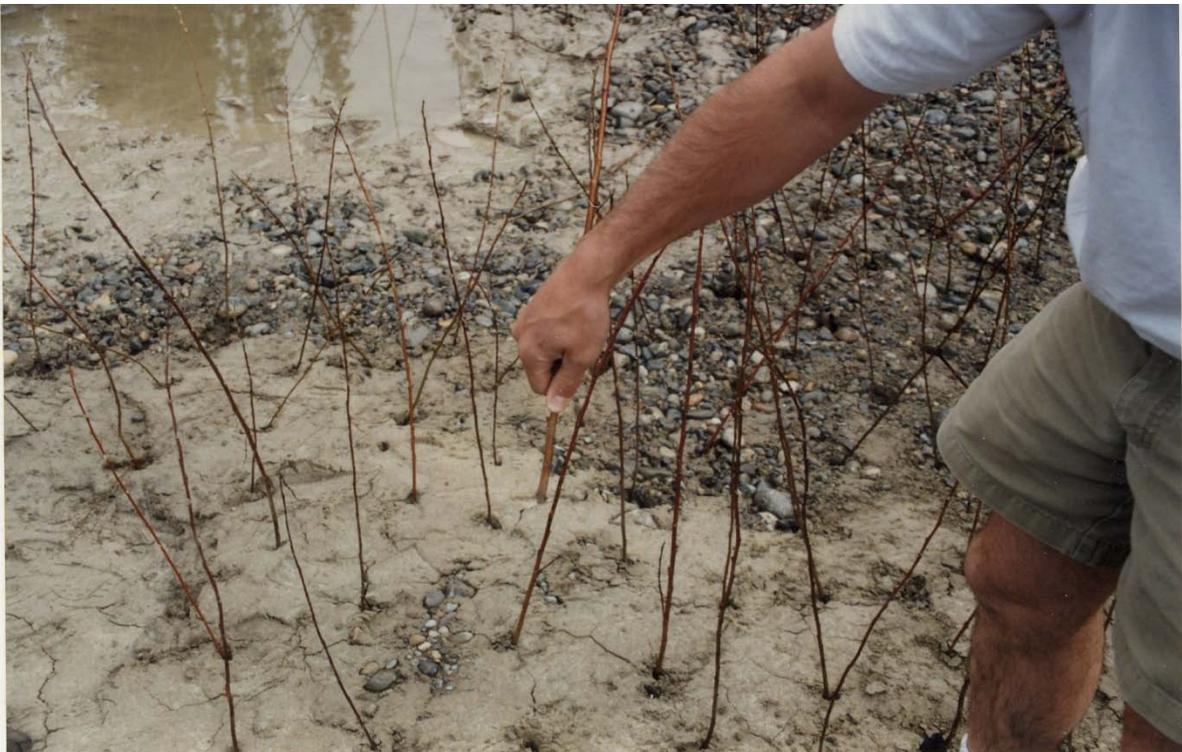
Photo 2. Close up view of some of the live stakes planted along Croucher Creek, near downtown Whitehorse, upstream of the bridge. Note the small diameter of the stakes, which likely contributed to their poor survival. Photo taken on May 31st, 1996. (Photo courtesy of Department of Fisheries and Oceans).

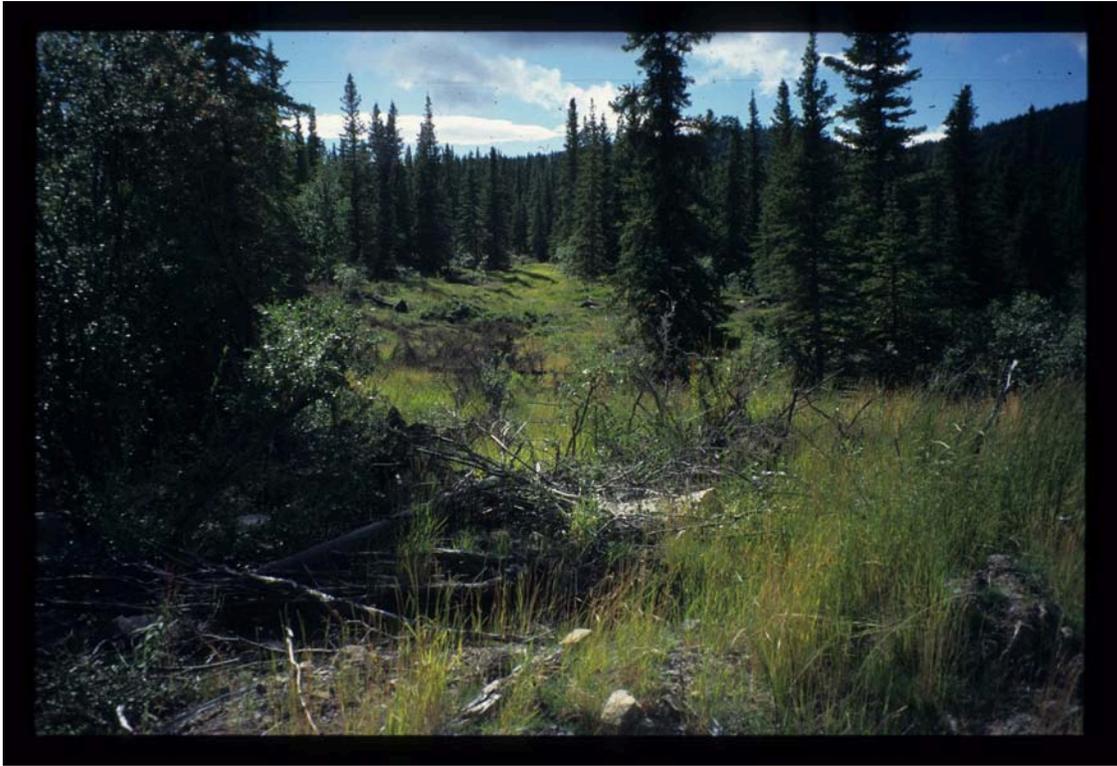
Photo 1. View of a trench reclaimed in 1994 at the Division Mountain coal exploration property, west of Braeburn. Lush grass and shrub growth is evident. Photo taken in 1997, courtesy of the Yukon Geological Survey

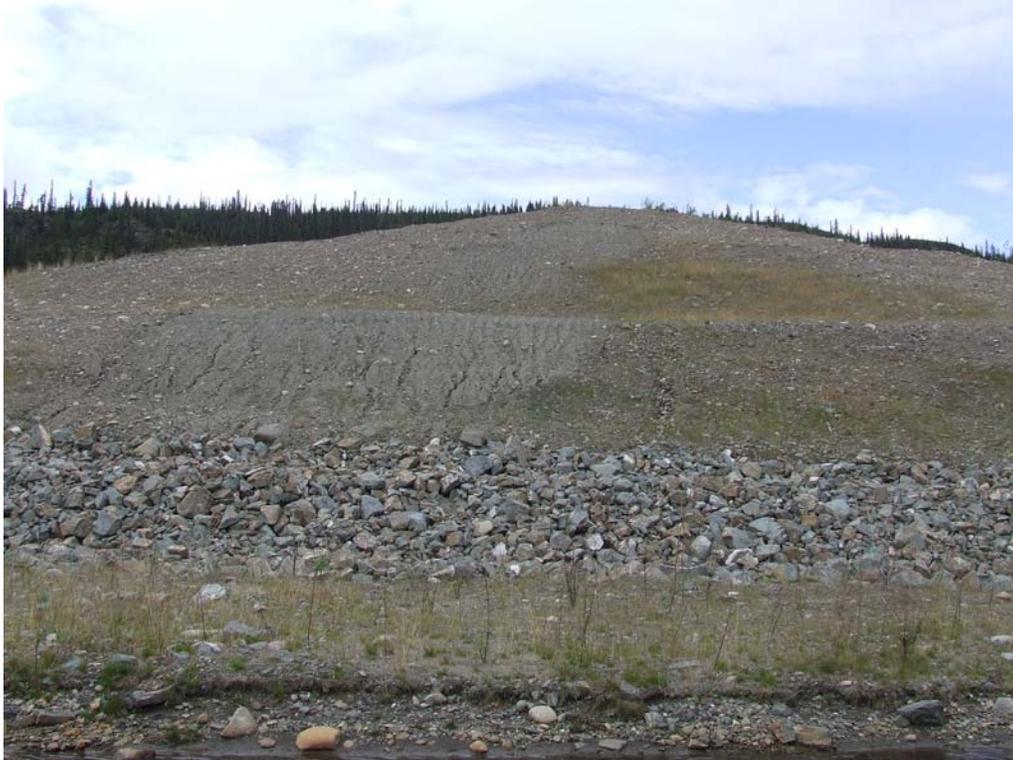
Photo 1. View of the south side of the breached dam at the Anvil Range mine site, near Faro, in the summer of 2006. Areas of the compacted core (visible in the background) still have limited vegetation cover. Photo courtesy of Laberge Environmental Services.

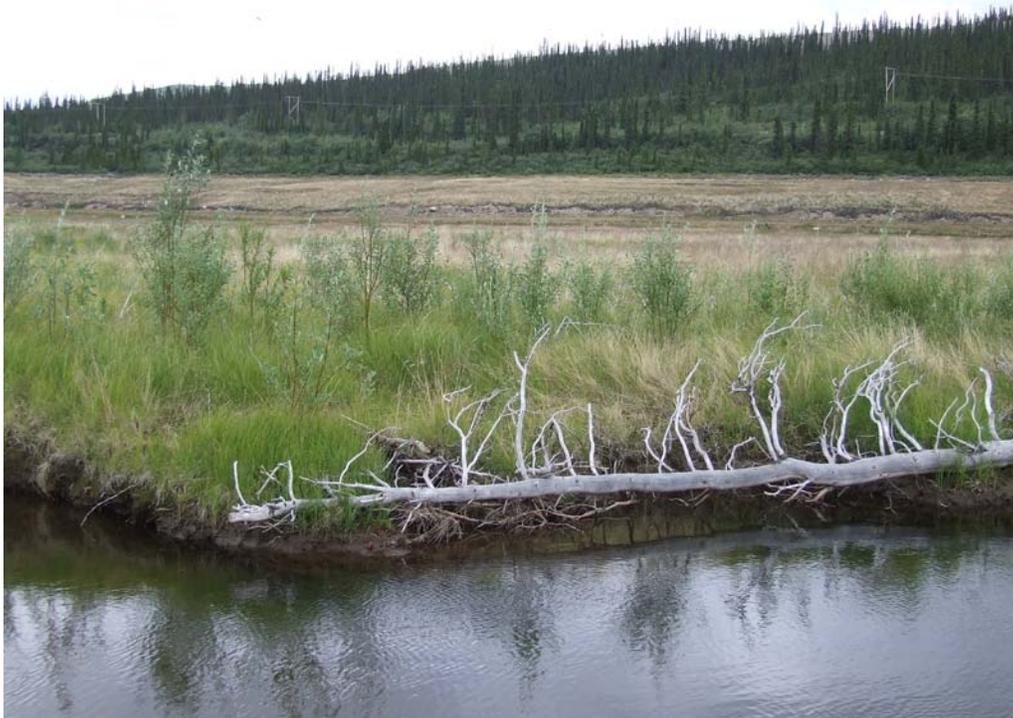
Photo 2. View of live staked willow on the south fork of Rose Creek at the Anvil Range mine site, near Faro, in the summer of 2006. Good growth is evident on several of the stakes. Photo courtesy of Laberge Environmental Services.

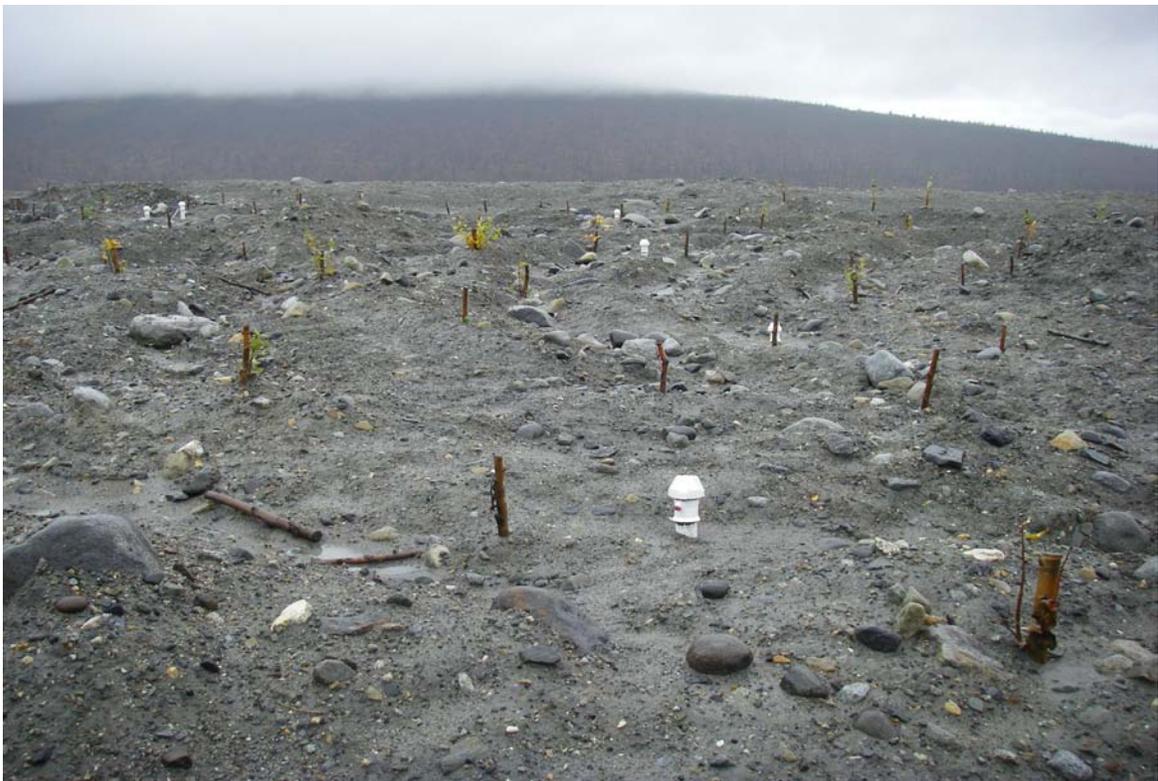
Photo 2. View of the lysimeter plot at the Anvil Range mine site, near Faro, in September of 2008. Note the emergent shoots on several of the stakes.

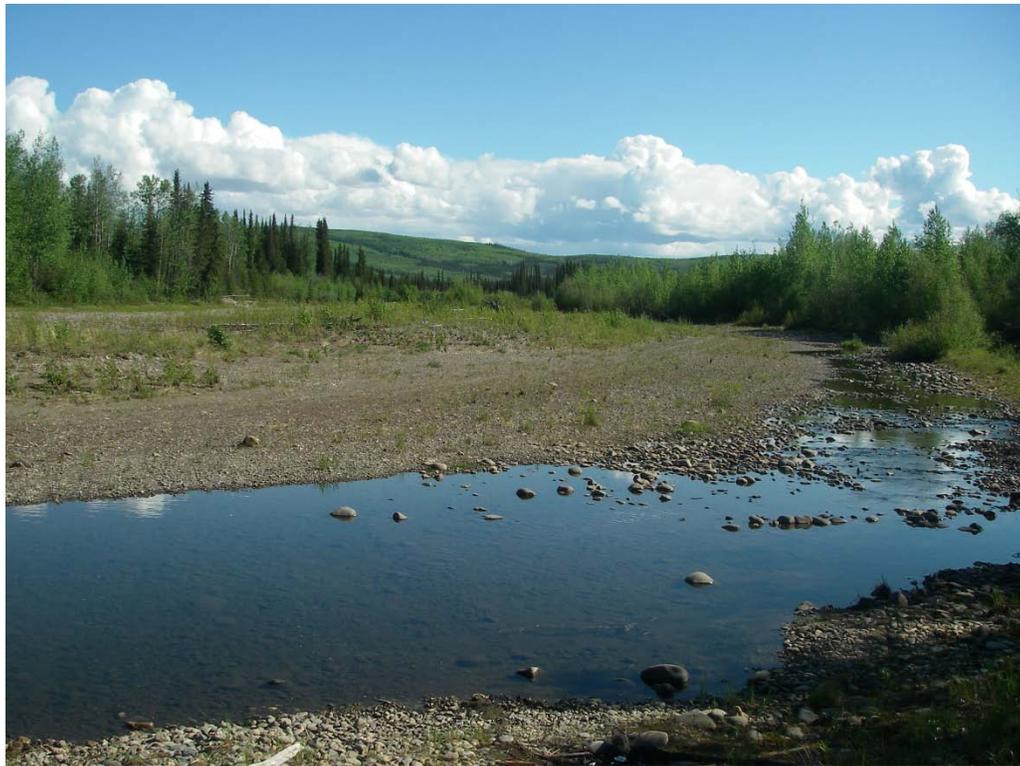
Photo 2. View of the gravel bar staking on the mid-channel island of Germaine Creek, a tributary of the Klondike River near Dawson. Photo taken during the most recent monitoring event, in July of 2008. Note the increased sedimentation on the right side of the island.

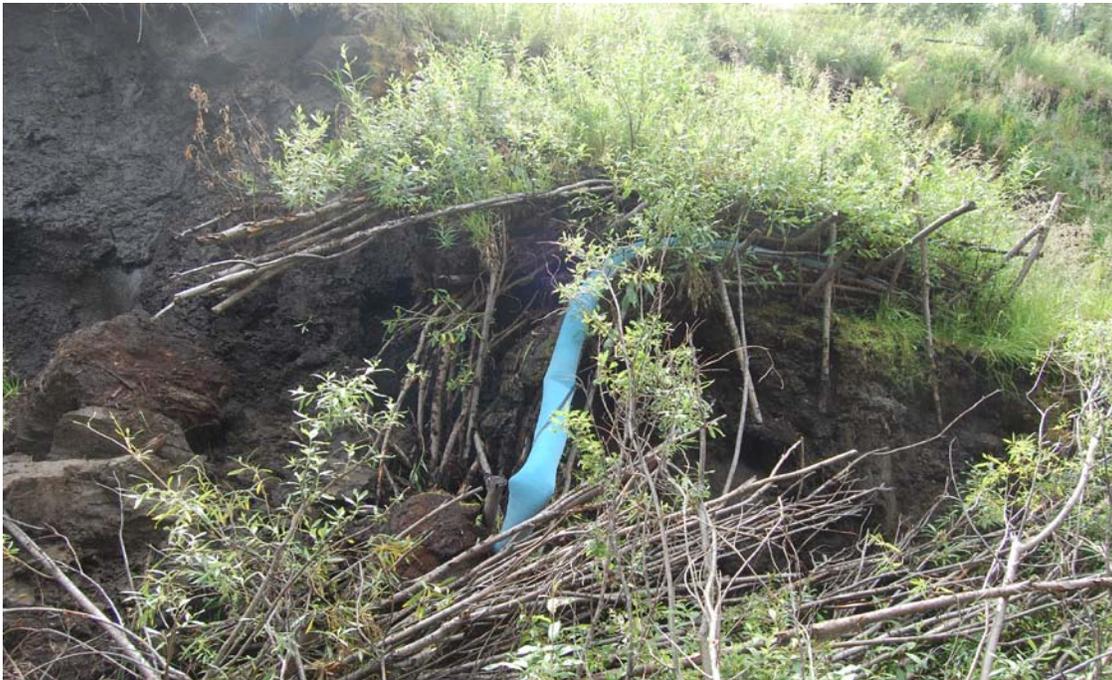
Photo 2. View of the collapsed live retaining walls (wattle fences) and undercut live willow flume on the Gold Run Creek erosion cut, approximately 50 km south east of Dawson City, in July, 2008. Note that the wattle fences have been undercut and have collapsed.

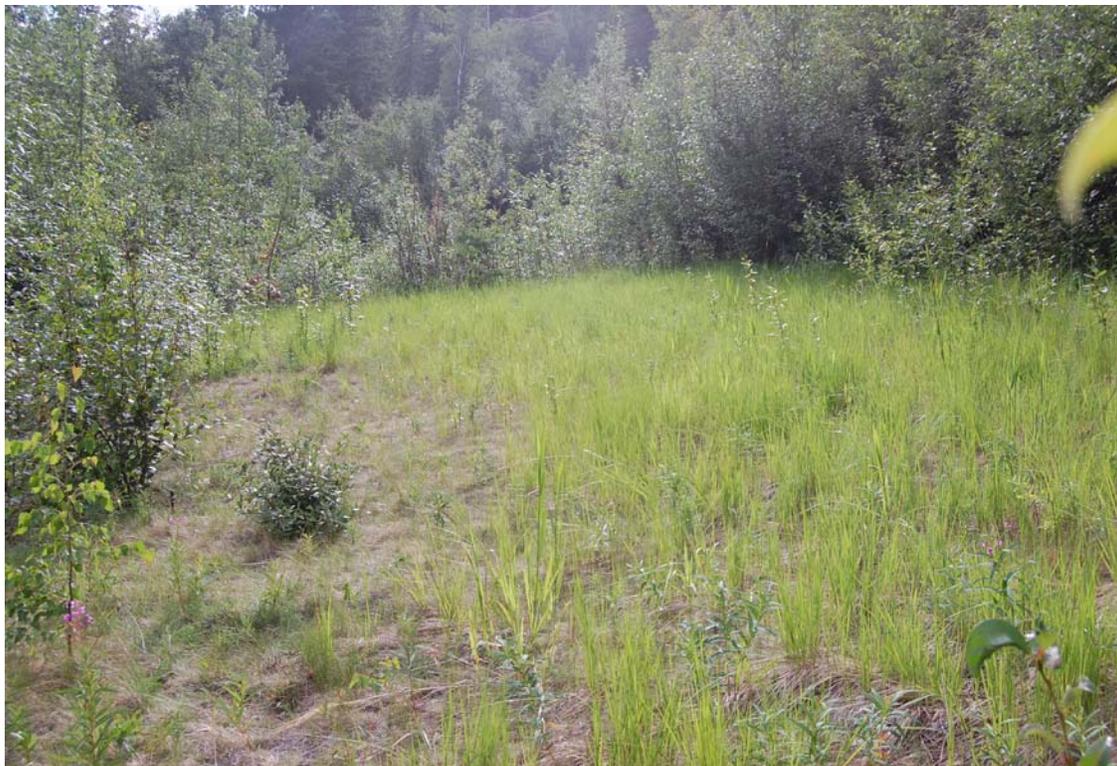
Photo 2. View of the Hawk Trench test plots, near Eldorado Creek, in July 2008. The control plot is in the background and the topsoil plot is in the foreground. Note the large mats of dead grasses which have impeded succession.

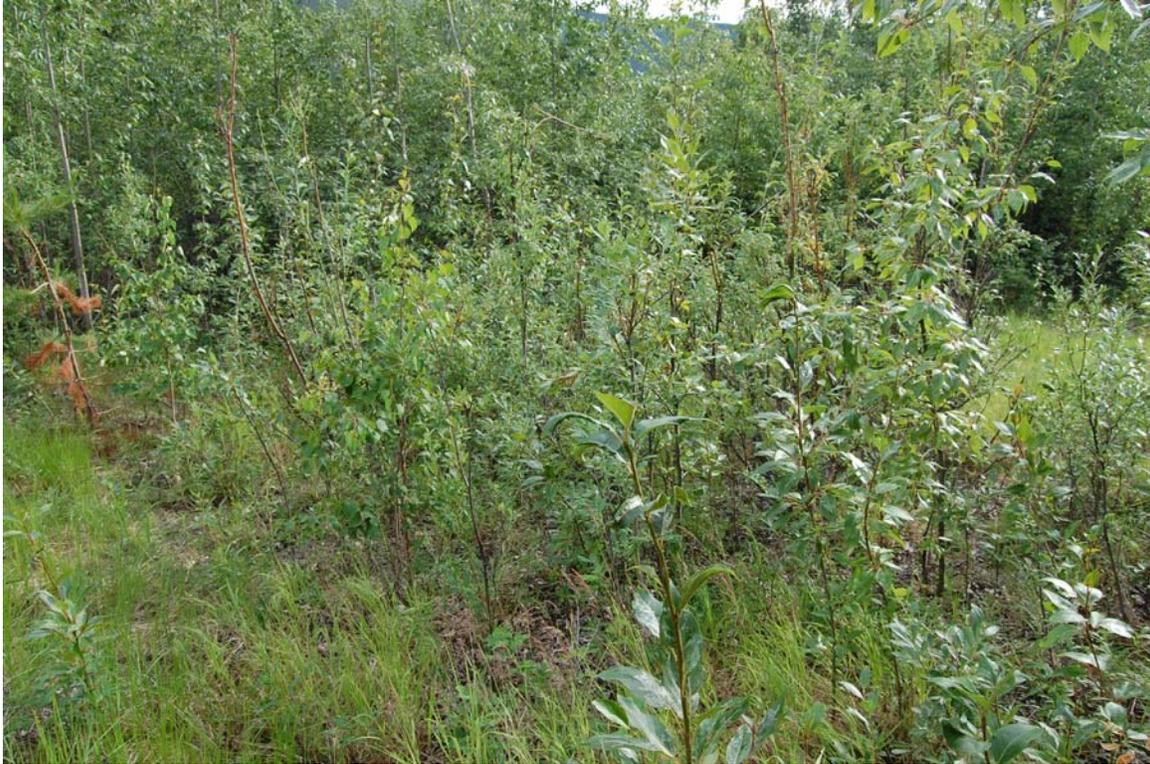
Photo 3: View of the control plot at the Hawk Trench site, near Eldorado Creek in July 2008. Note the extensive growth of shrub species, similar to the nearby forest.

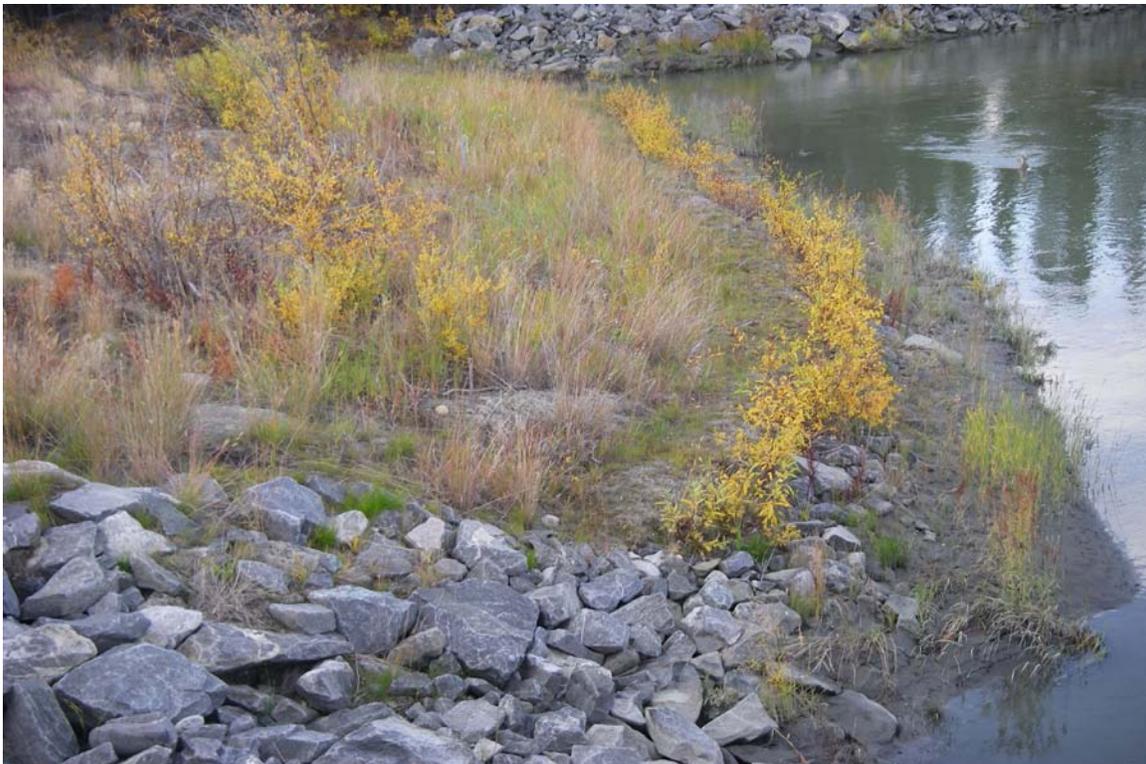
Photo 2. View of the brush layers (right), brush mattress (middle, little growth) and transplants (left) at the new Mendenhall River crossing near KM 1557 of the Alaska Highway during the latest monitoring event, conducted on September 17th, 2008.

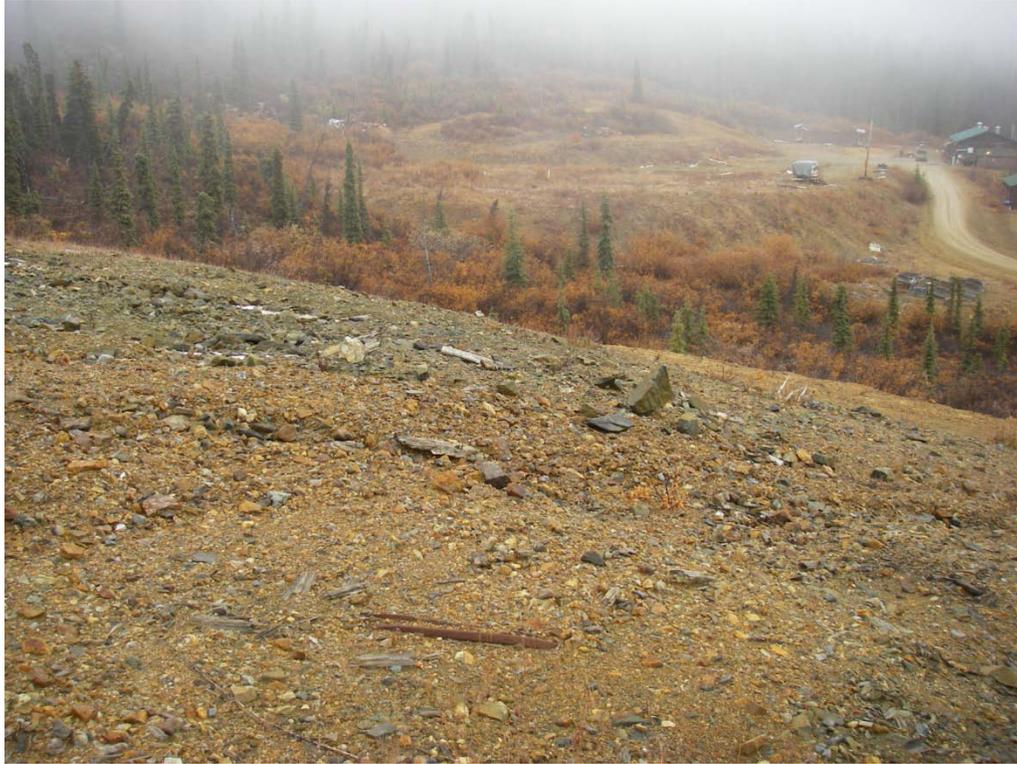
Photo 1. View of the Huestis hillside at the Mt. Nansen Mine site near Carmacks. Note minimal vegetation cover. Photo taken on October 2, 2008.

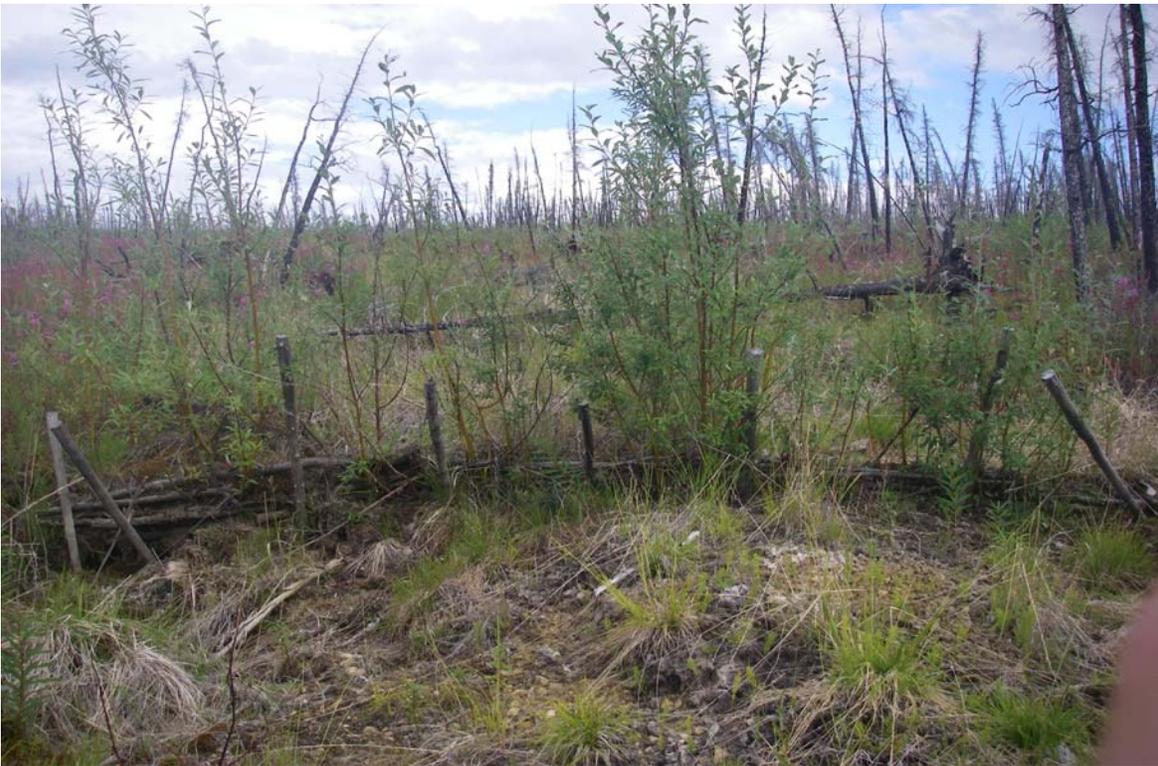
Photo 2. Upslope view of a live gully break on Noname Creek, 90KM west of Carmacks. Photo taken during the most recent monitoring, conducted in August 2008. Note that the visible growth has occurred since the forest fire of 2005 (no burn marks were visible).

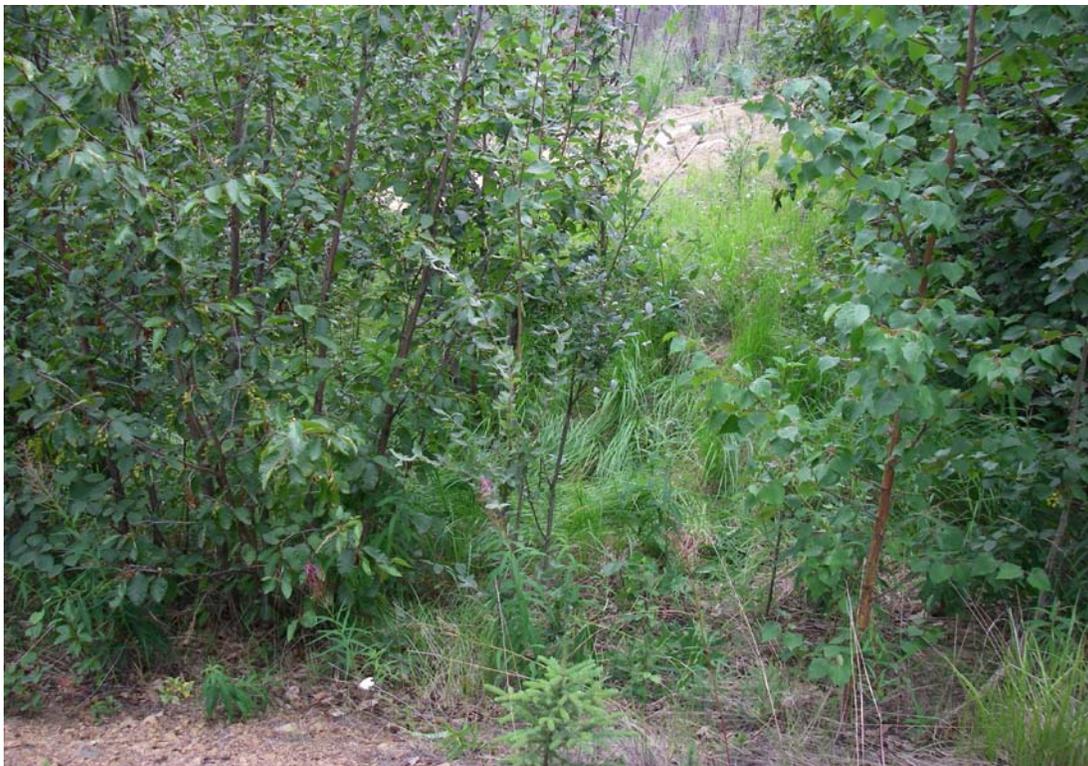
Photo 2. View of the topsoil plot (plot 3), approximately 90 km west of Carmacks, in August 2008. This was the only plot that retained notable grass cover.

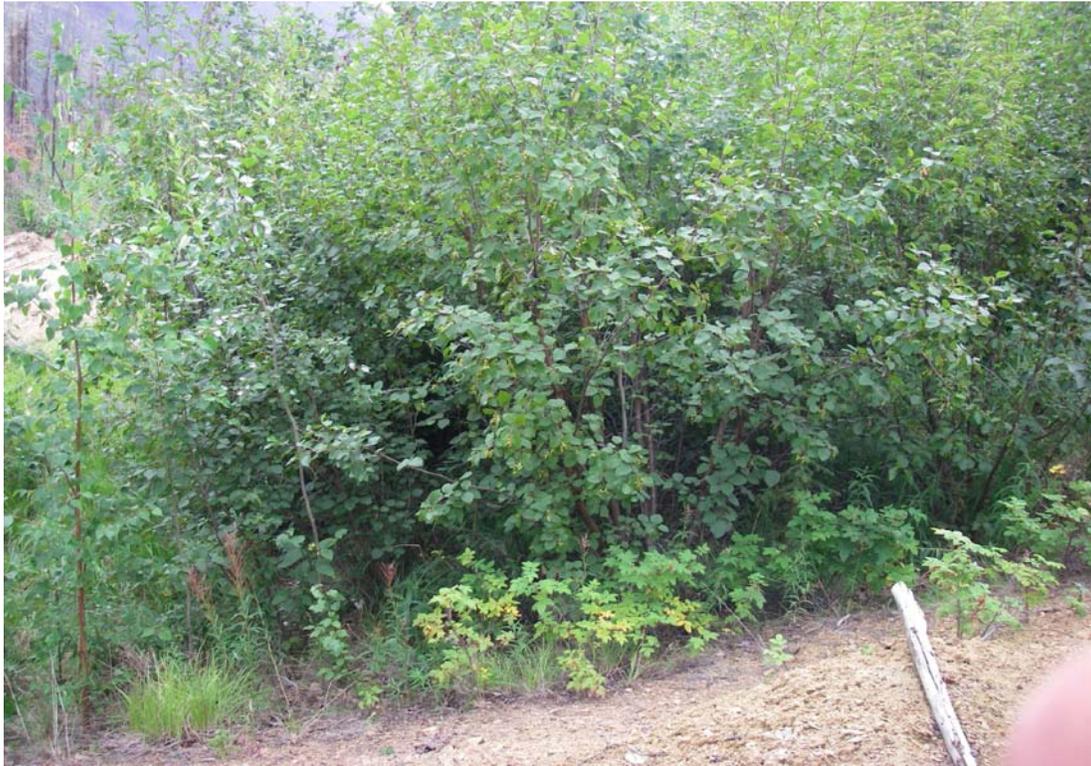
Photo 3: View of the control plot, approximately 90 km west of Carmacks, in August 2008. Note the large amount of alders that now cover almost the entire plot area.

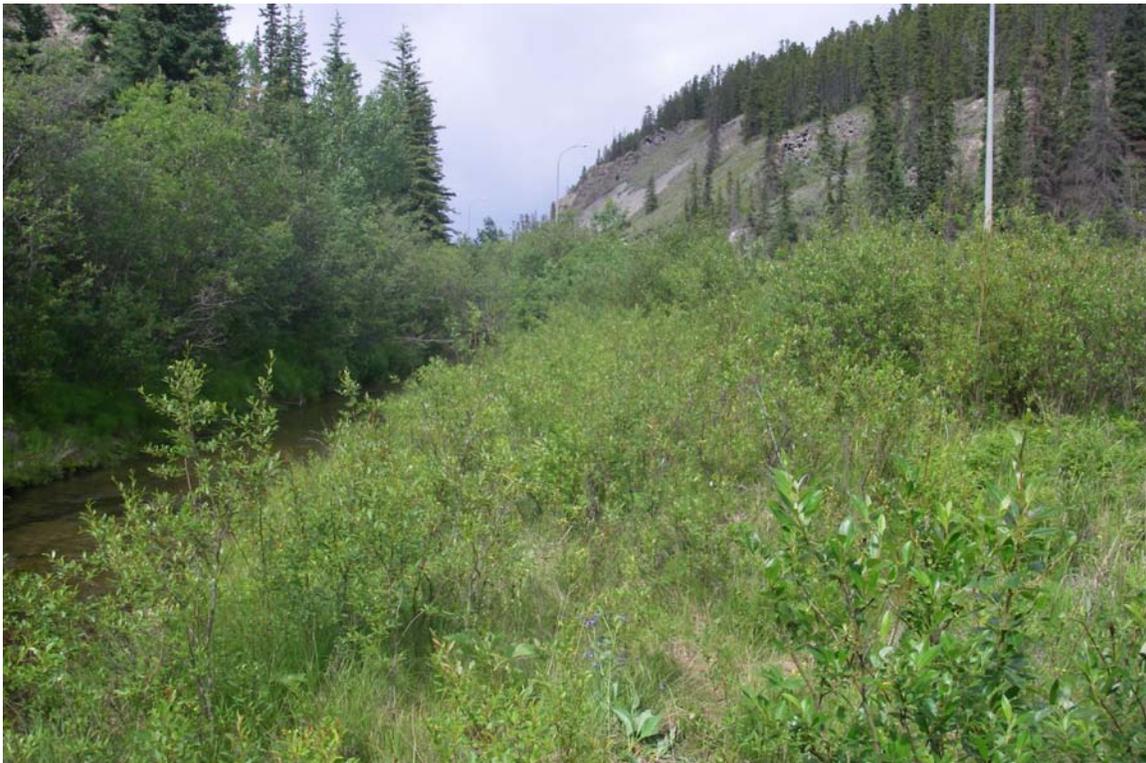
Photo 2. Downstream view of the live staking works along the right bank of Porter Creek, near Whitehorse during the most recent monitoring in July of 2008. Note that willows have begun to re-colonize the areas between the rows of live stakes.

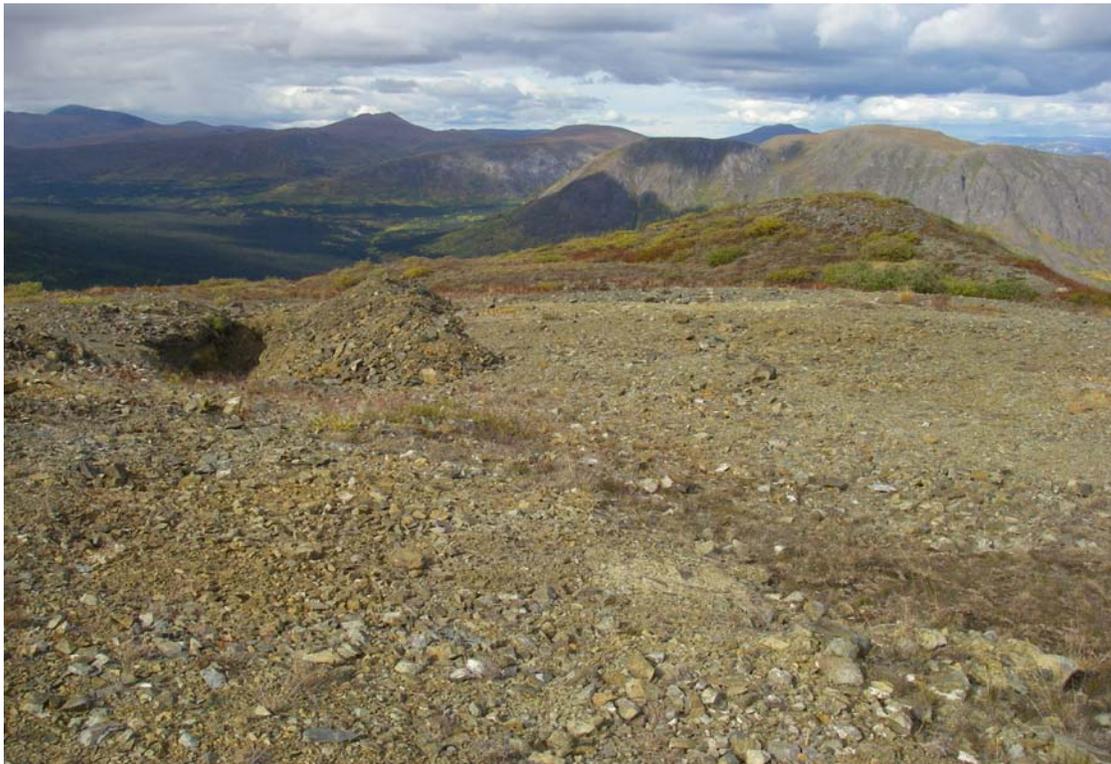
Photo 2. View of the Red Ridge test plots, approximately 65 km southwest of Whitehorse during the most recent monitoring in September 2008. The corner of the topsoil plot is visible in the bottom right corner of the photo. Note the large trench which has been cut across plots 4,2 and 1.
