MPERG Report 2009-3

A Review of Several Yukon Revegetation Projects and Techniques

EDI Environmental Dynamics Inc.

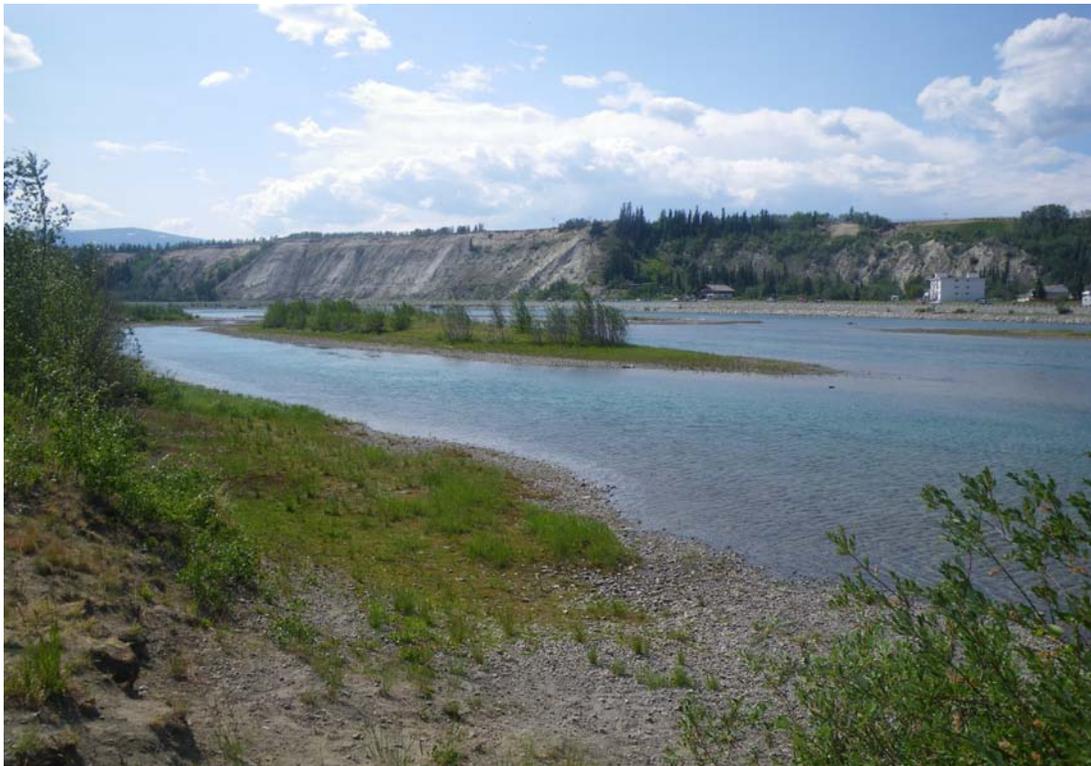
Photo 2. View of the Robert Service Way fisheries compensation channels, in downtown Whitehorse in July 2009. Note alder and willow which have established on the seeded area.
