NATURAL LAND RECLAMATION FOR MINERAL EXPLORATION PROPERTIES AND PLACER MINES IN YUKON

BULLETIN 5

by
C. Mougeot
Mougeot GeoAnalysis

APPENDIX ONE
PLATES

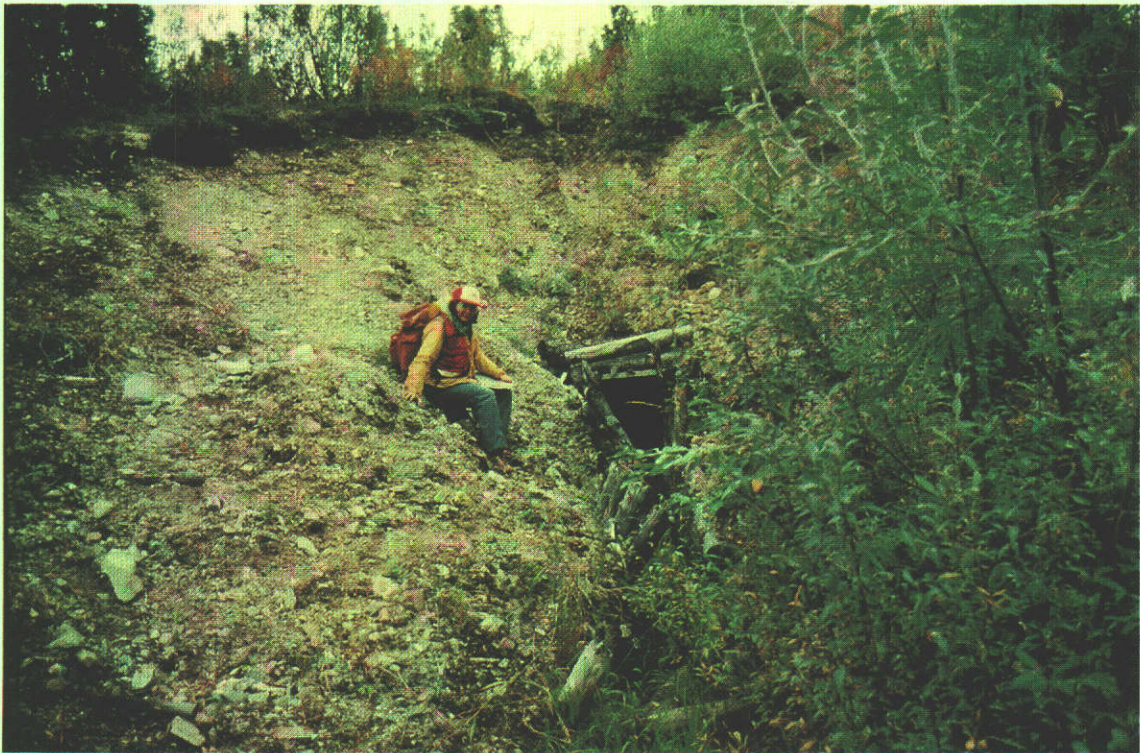
Plate 2-1 Adit dated at 1912, Lone Star Property.

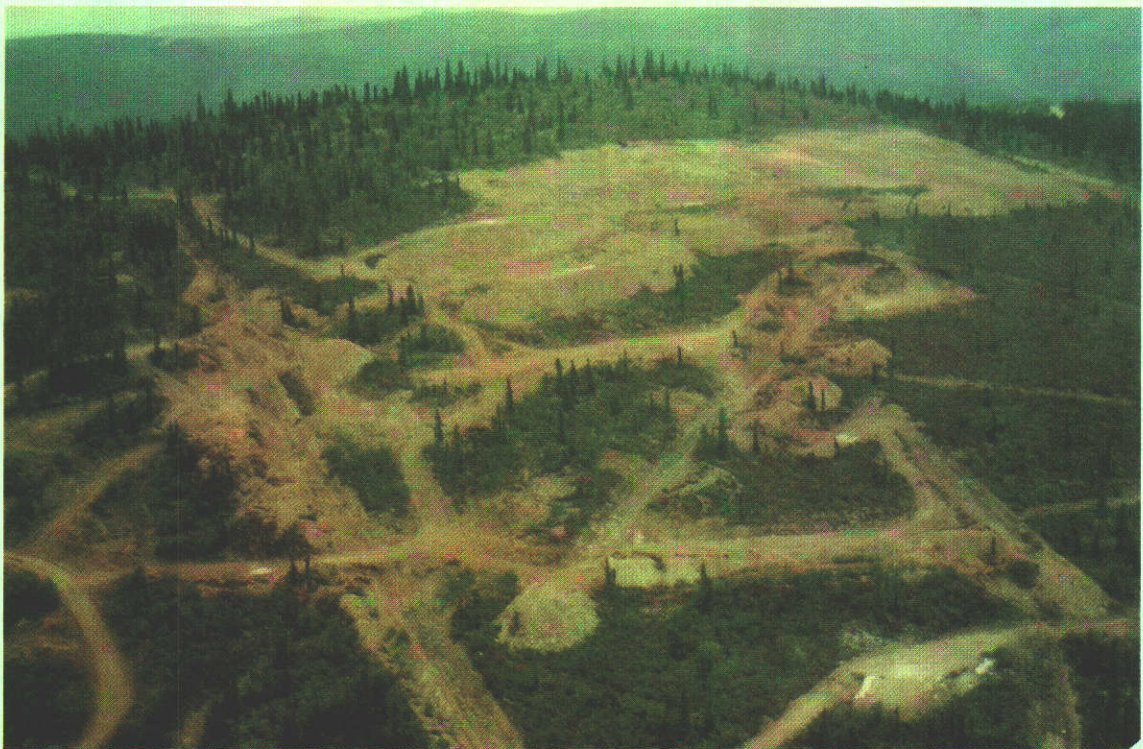
Plate 2-4 Overview of Lone Star trenches. Large stripped area is LSFIELD.

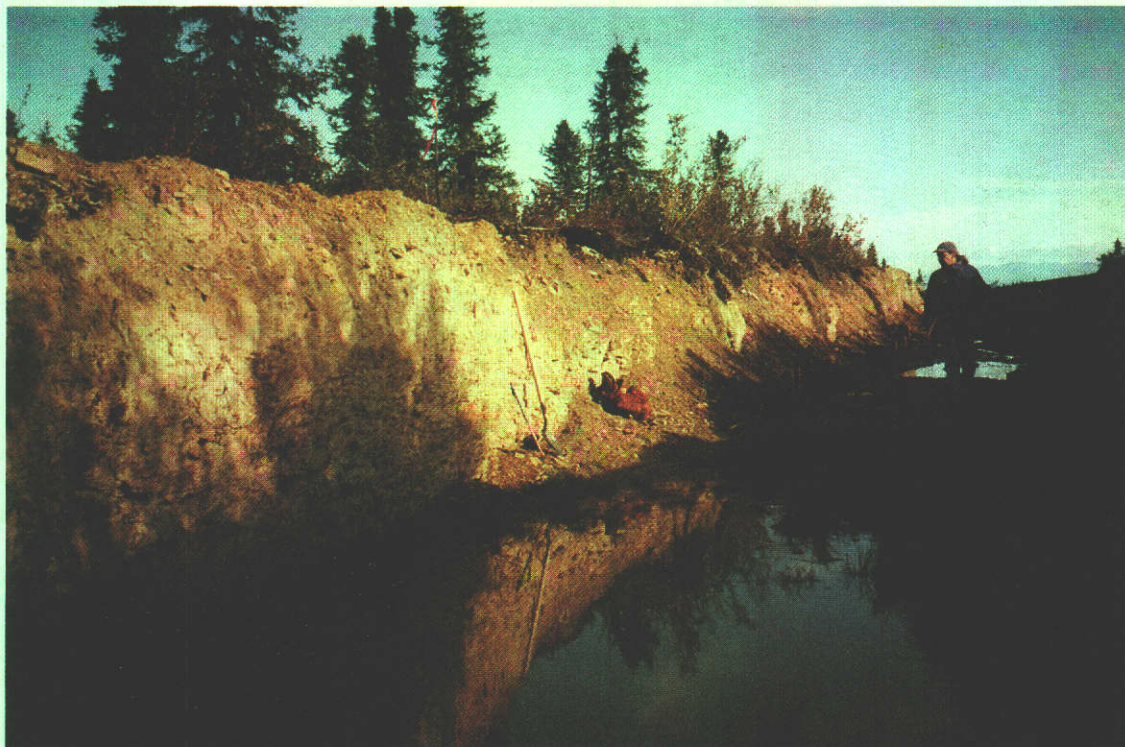
Plate 2-7 Portion of 88TR20 originating at the crest of the hill. Sites 88TR1a, 88TR1b and 88TR1c. This trench is very sparsely revegetated. Steep bedrock walls are not vegetated.

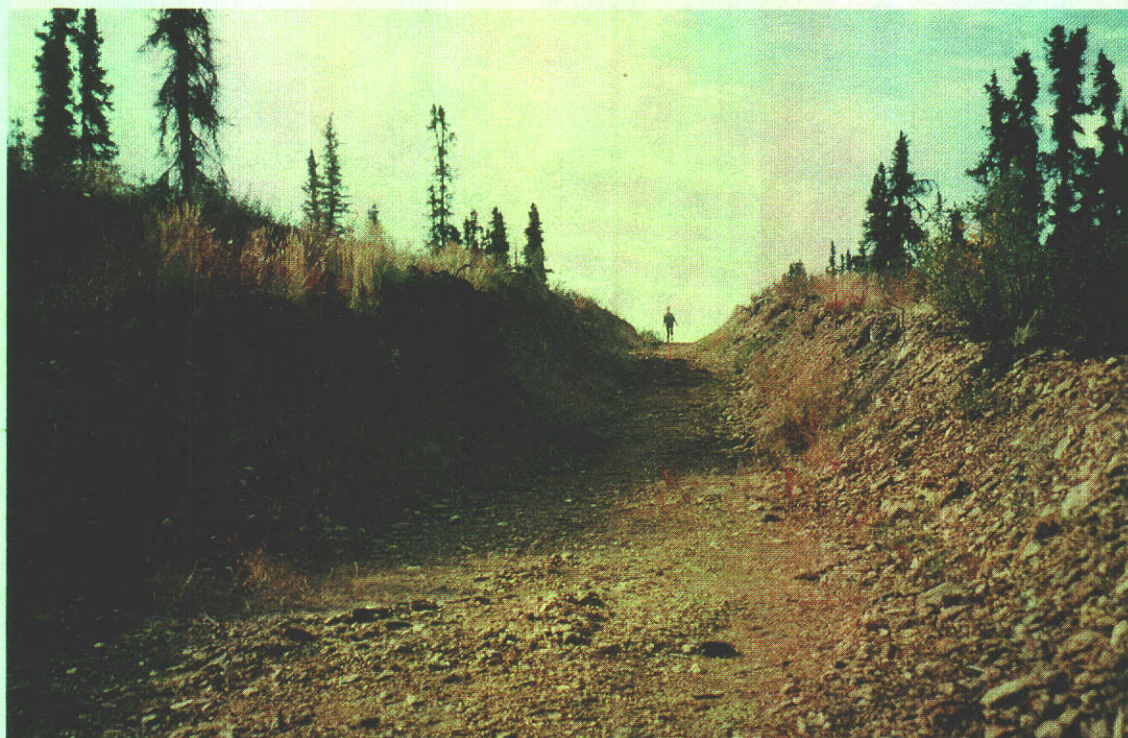
Plate 2-8 Trench 88TR20, sites 88TR2a, 88TR2b and 88TR2c. Vegetation patches visible on the wall are slumping from the surface. Pioneer vegetation is concentrated at the toe of the colluviated material.

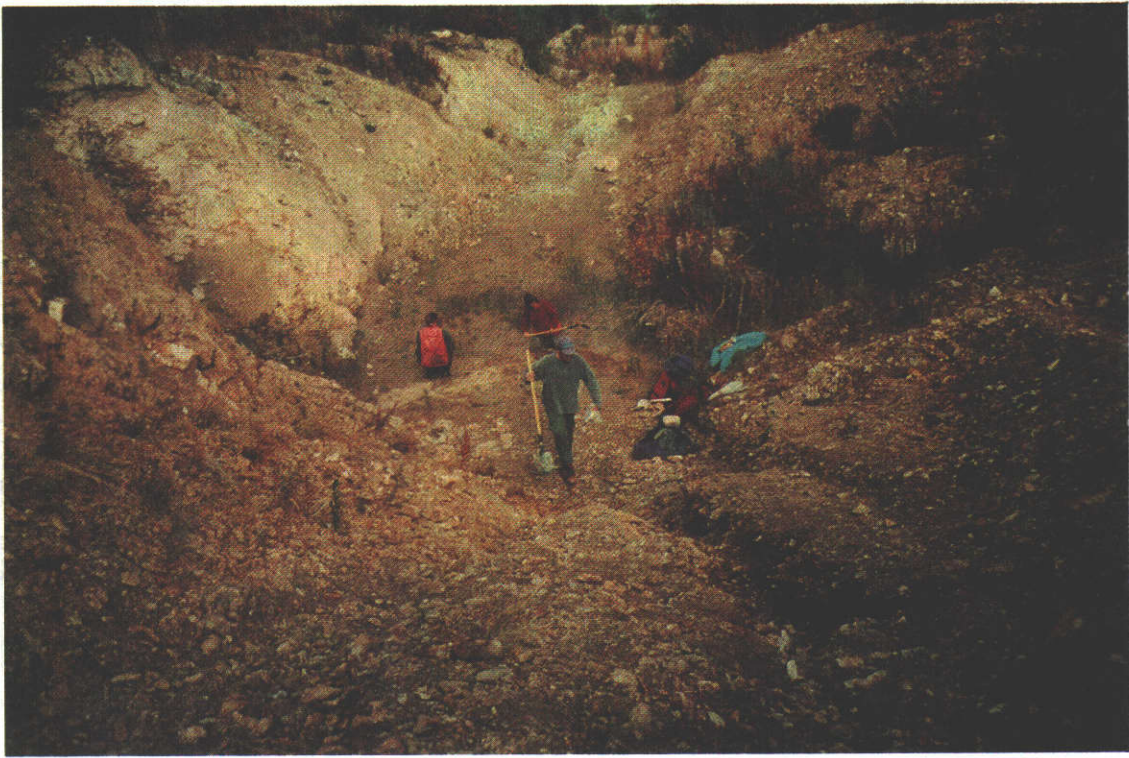
Plate 2-5 Trench LS3. Very sparse revegetation is concentrated at the bottom of the slumped wall material. Gullying is developing at the floor of this steep trench parallel to the hill side.

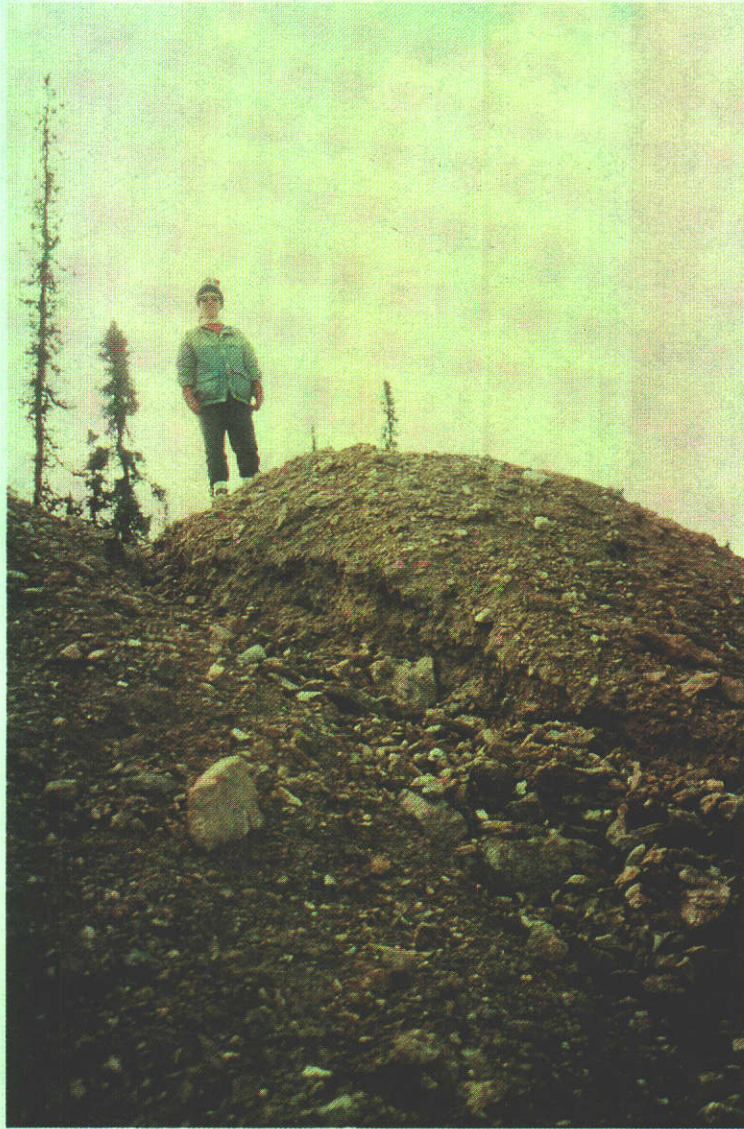
Plate 2-9 Drill pad at the lower end of trench 88TR20. Gullies are developing in the soft material.

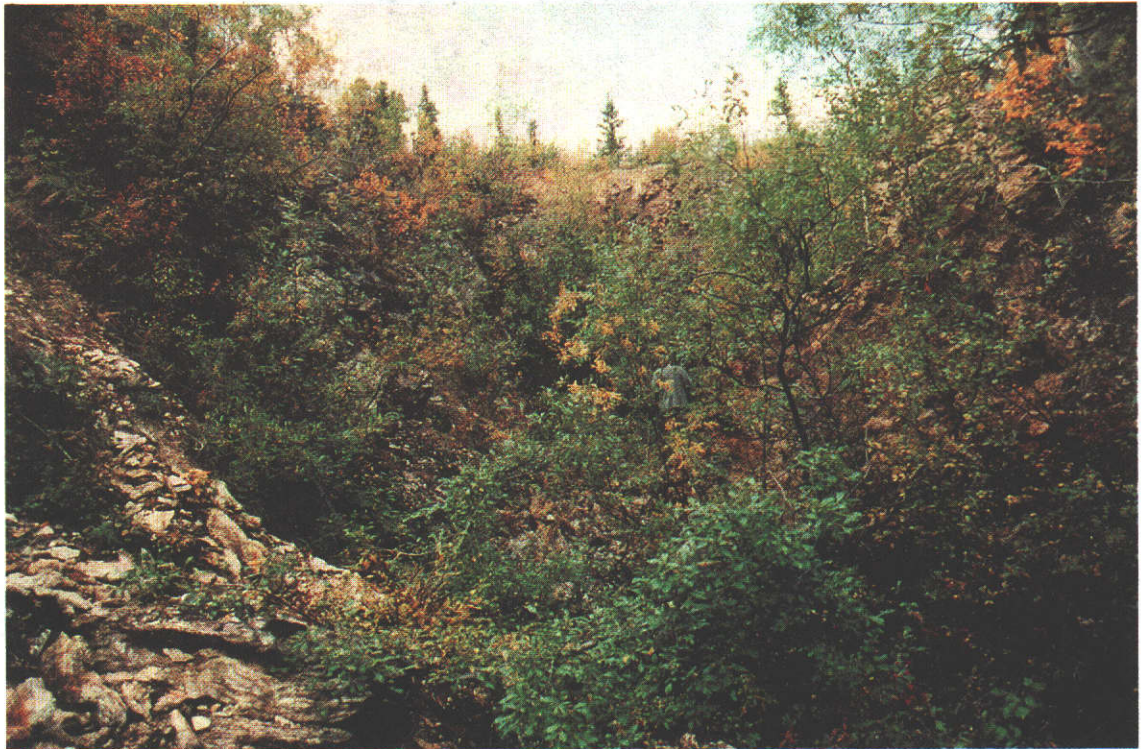
Plate 2-12 Site 11TRd, thick regrowth and stable slopes on the inactive walls of the trench.

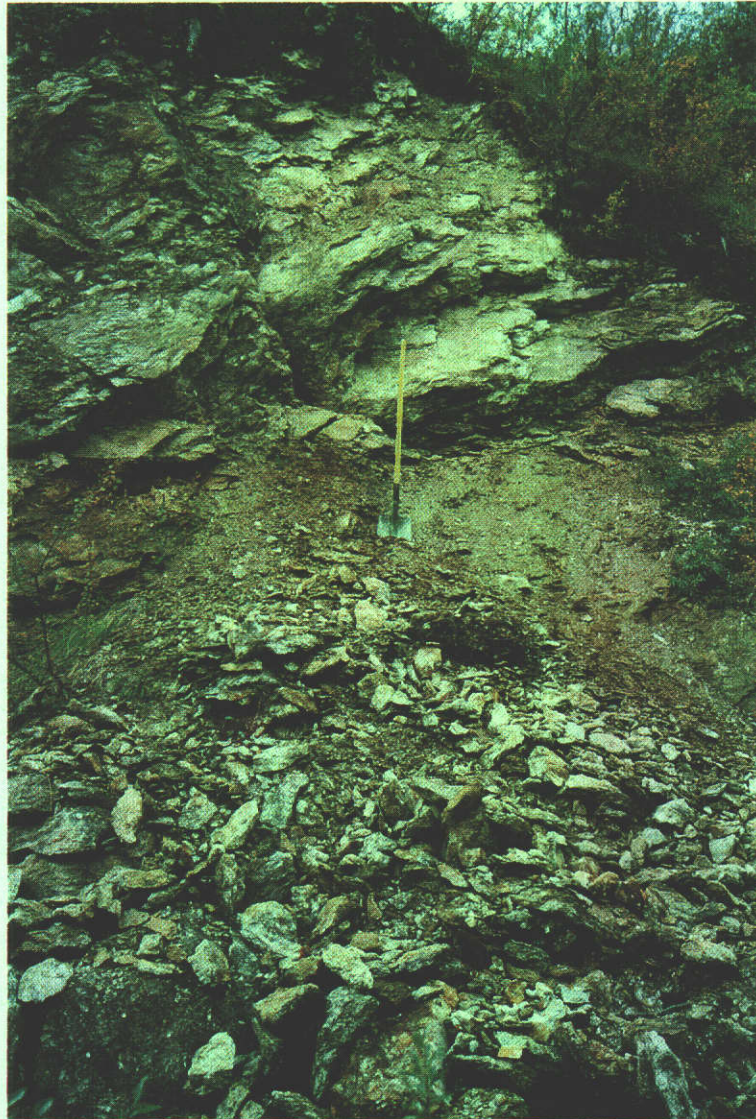
Plate 2-13 Slumping on unstable wall portion are still occurring. Such surfaces are bare of vegetation (site 11TR1e).

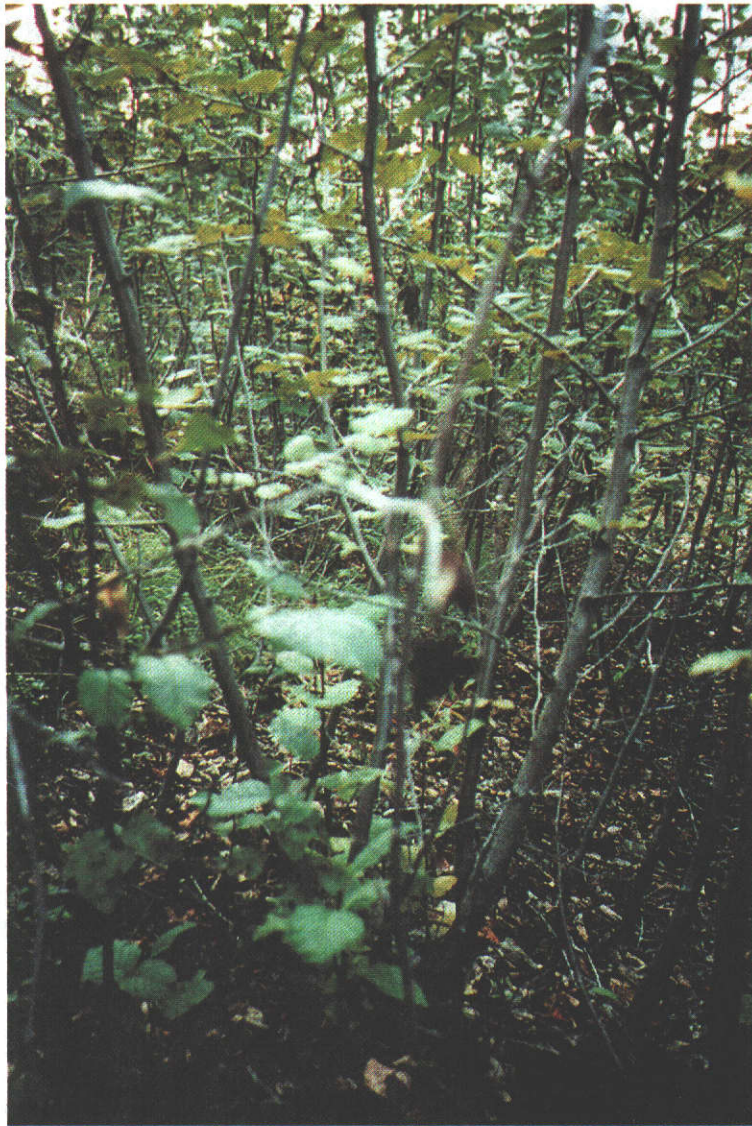
Plate 2-11 Dense shrub growth on the floor of TR61.

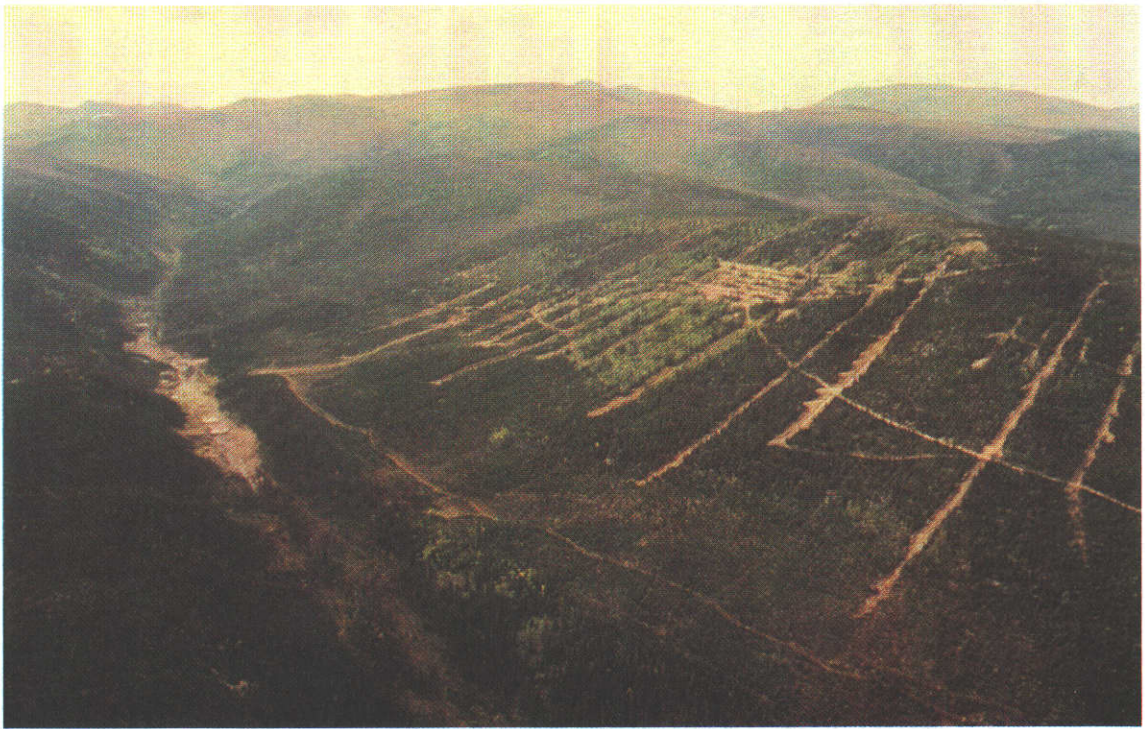
Plate 2-16 Overburden pile at site LSFIELD6.

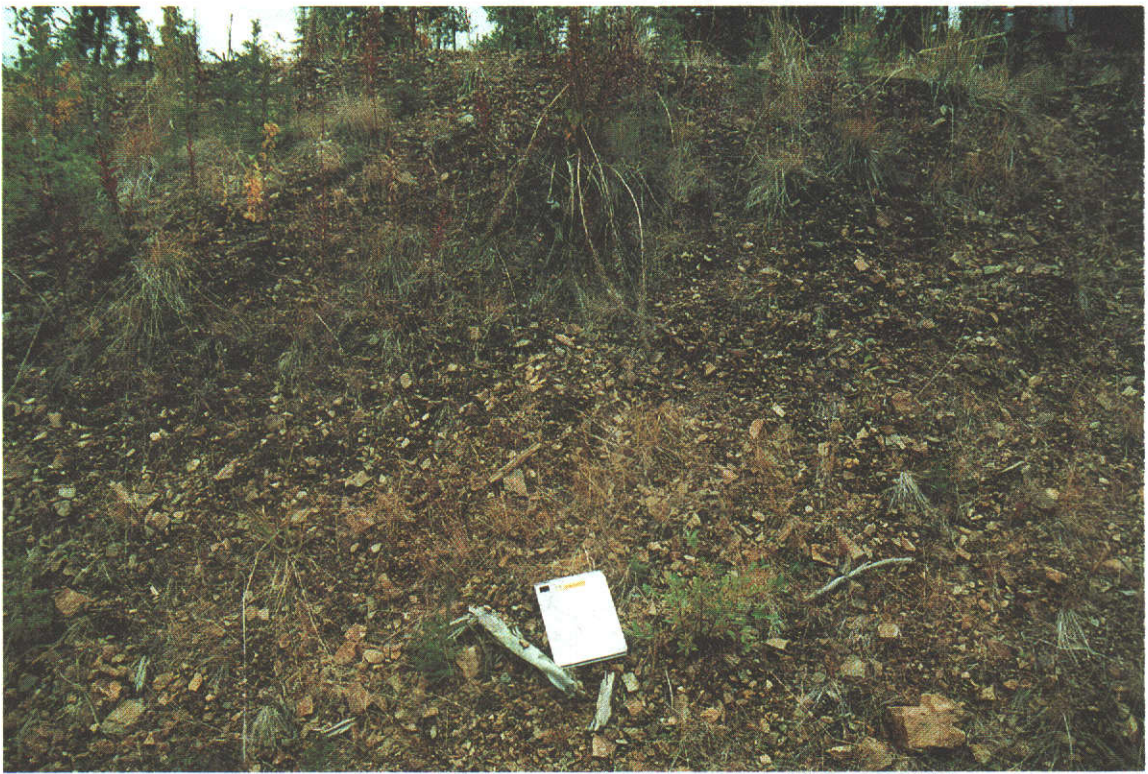
Plate 3-4 Slumping vegetation, trench N1B, 1989.

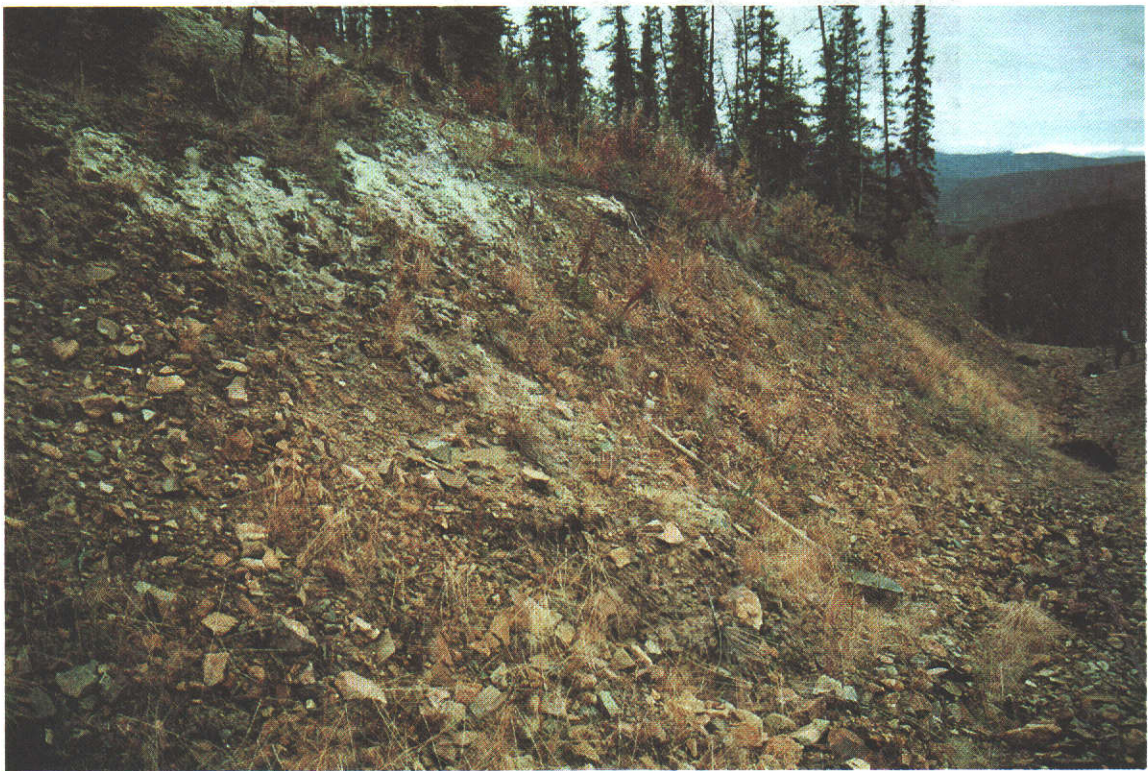
Plate 3-5 Trench N1B, with thick ash layer close to the surface. Slope is partially revegetated.

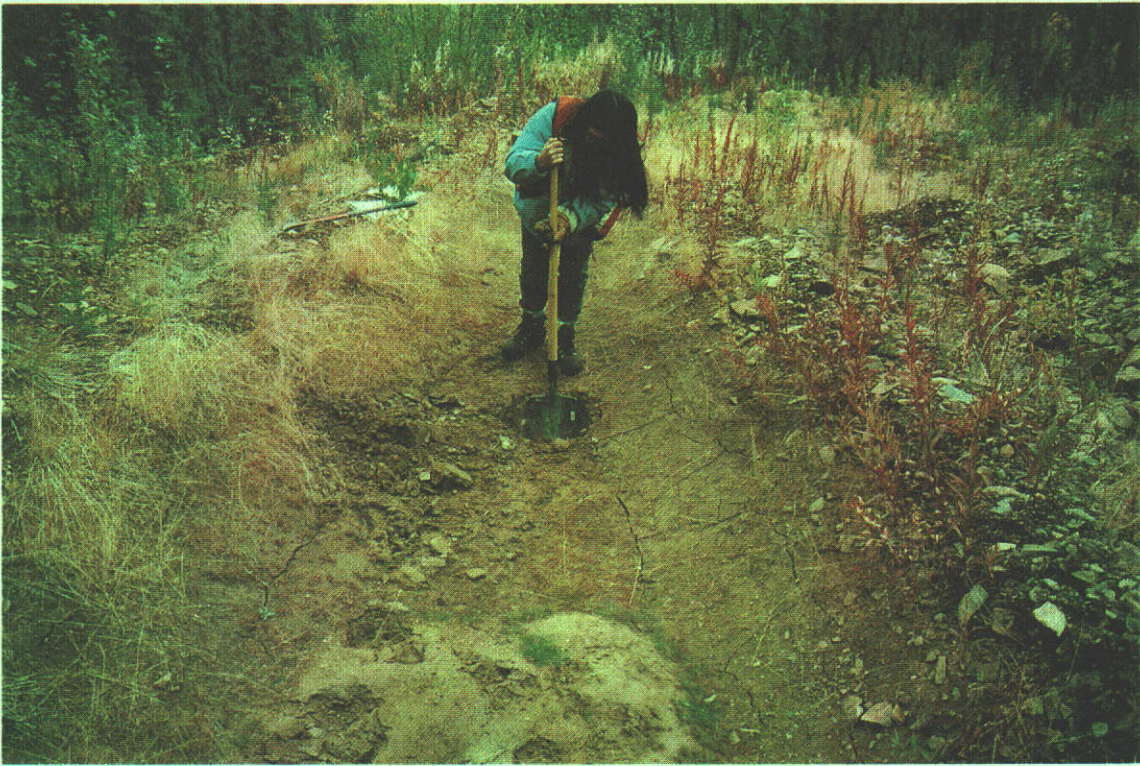
Plate 3-6 Trench N3. Fine-grained material accumulates at the floor and lower end of the trench.

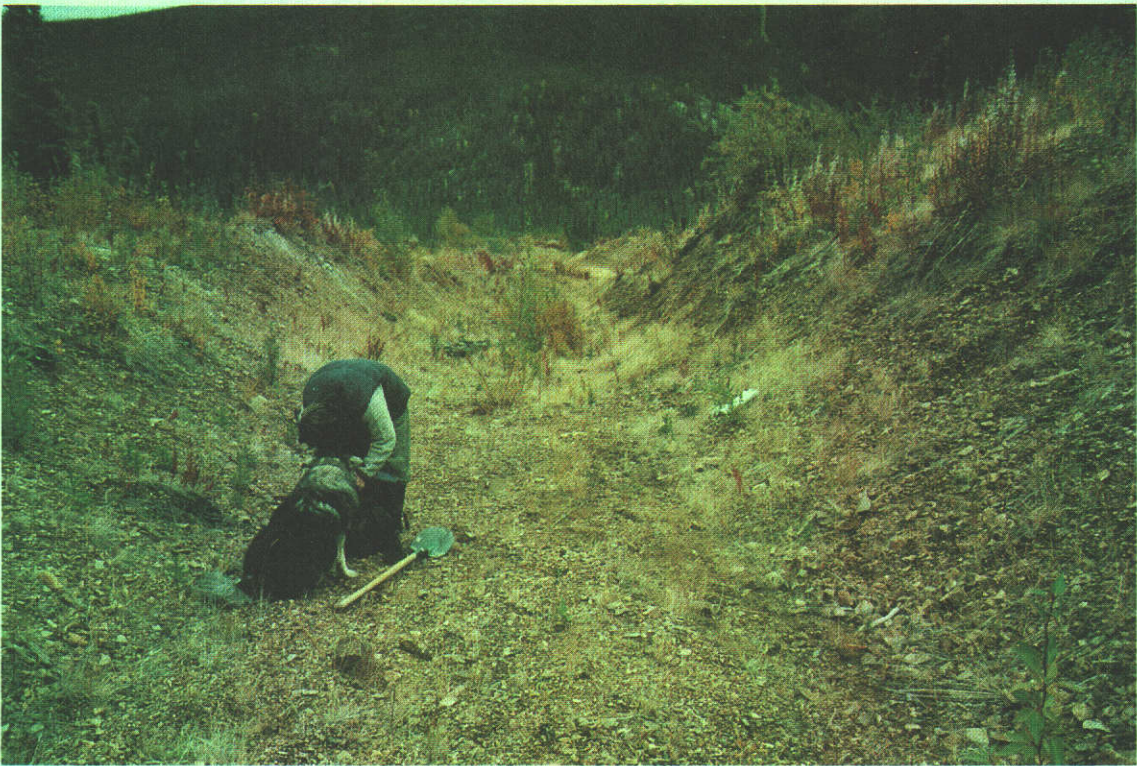
Plate 3-7 Trench N4A. Vegetation is dominated by grass and forb species and is concentrated on the lower colluviated portion of the wall and floor of the trench.

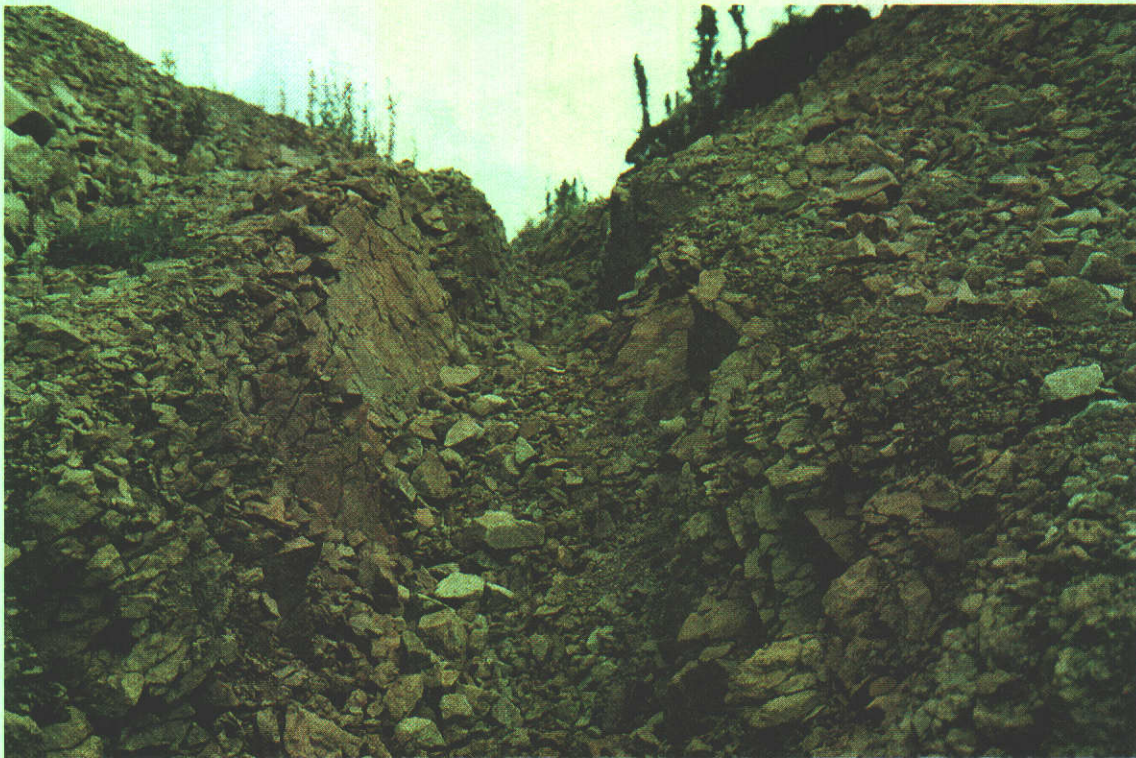
Plate 3-11 Trench R2B, very sparse to no revegetation on this recent trench (1993?).

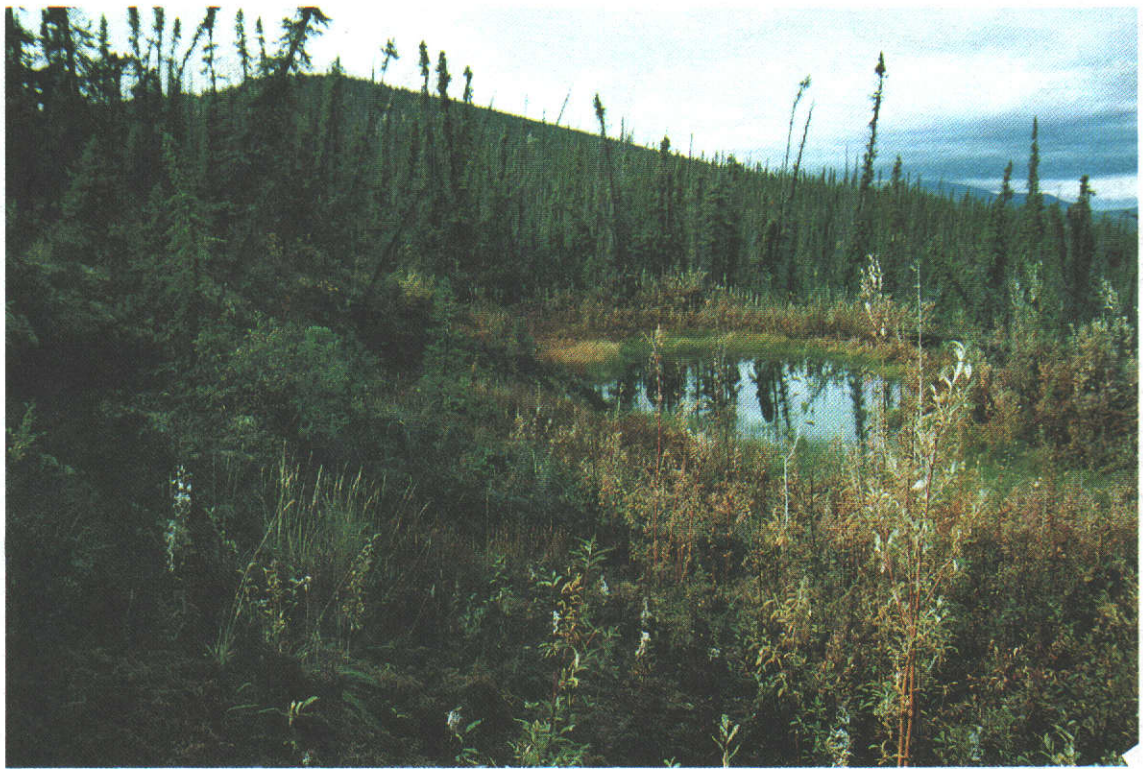
Plate 3-13 Site R2Aa . Melting permafrost contributes to the abundant moisture at this site. Slumping (tipping trees) is still active.

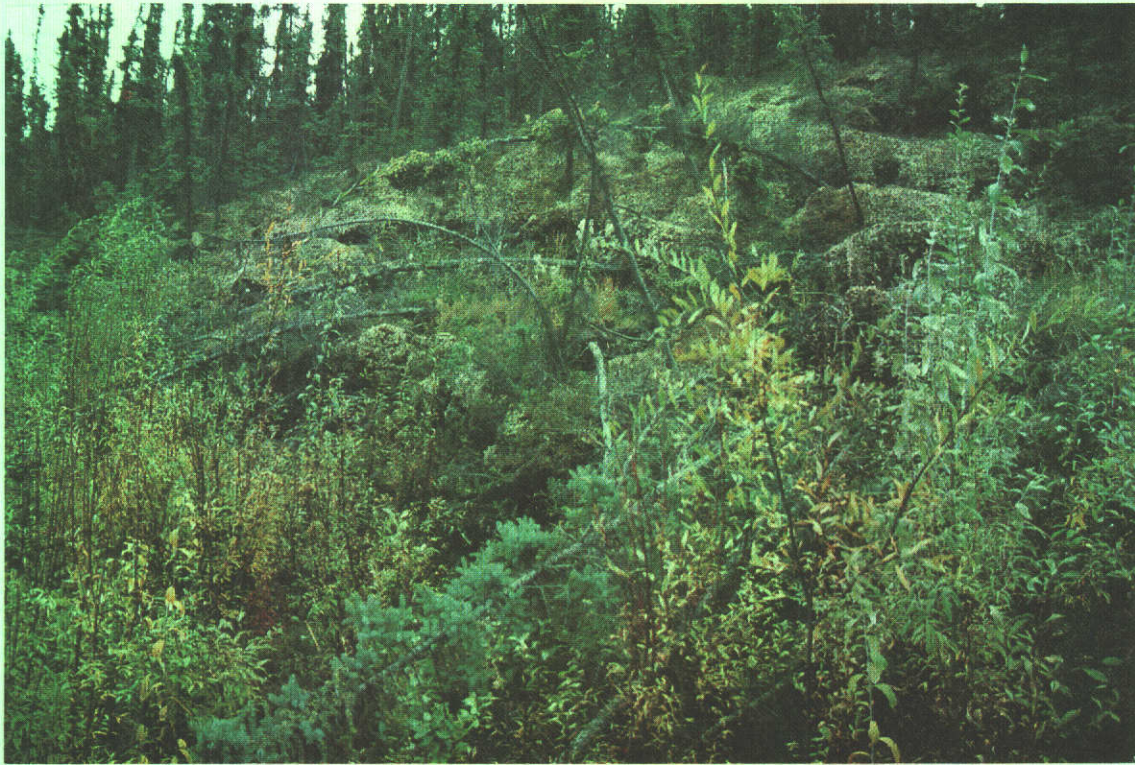
Plate 3-14 Site R2Ab, densely revegetated trench. This successful revegetation is partially due to the degrading permafrost which provides ample moisture and remobilized vegetation clumps.

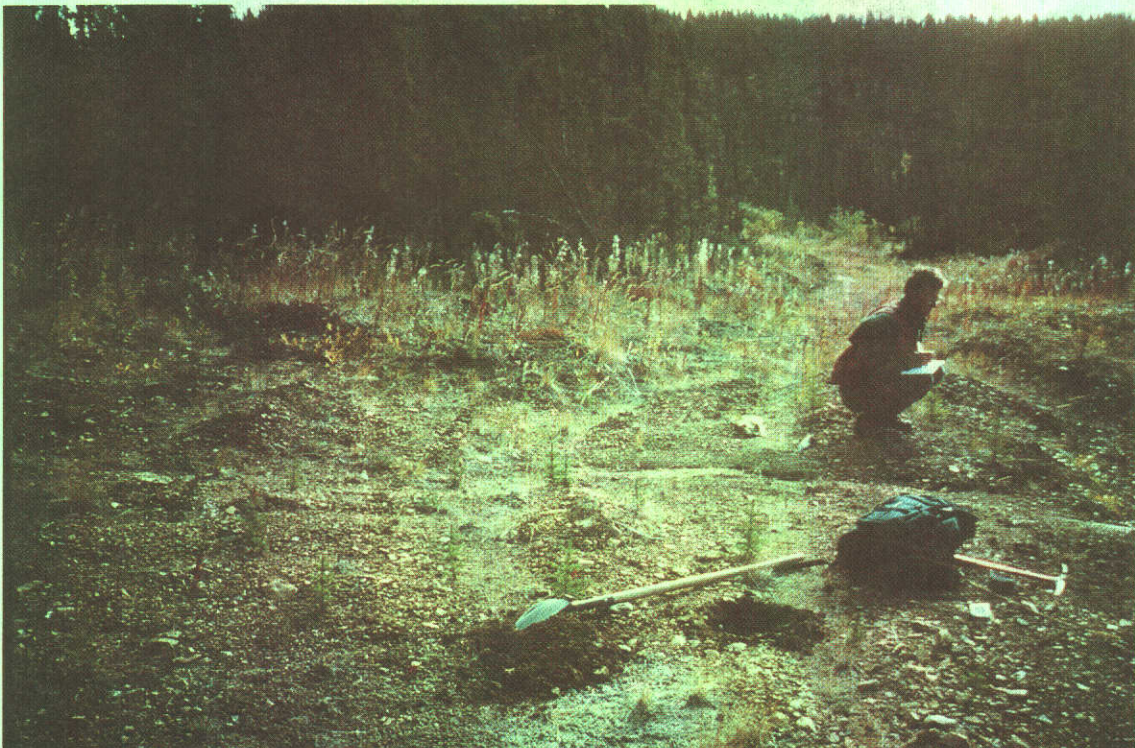
Plate 3-15 Drill pad R6. Compact surface is sparsely revegetated.

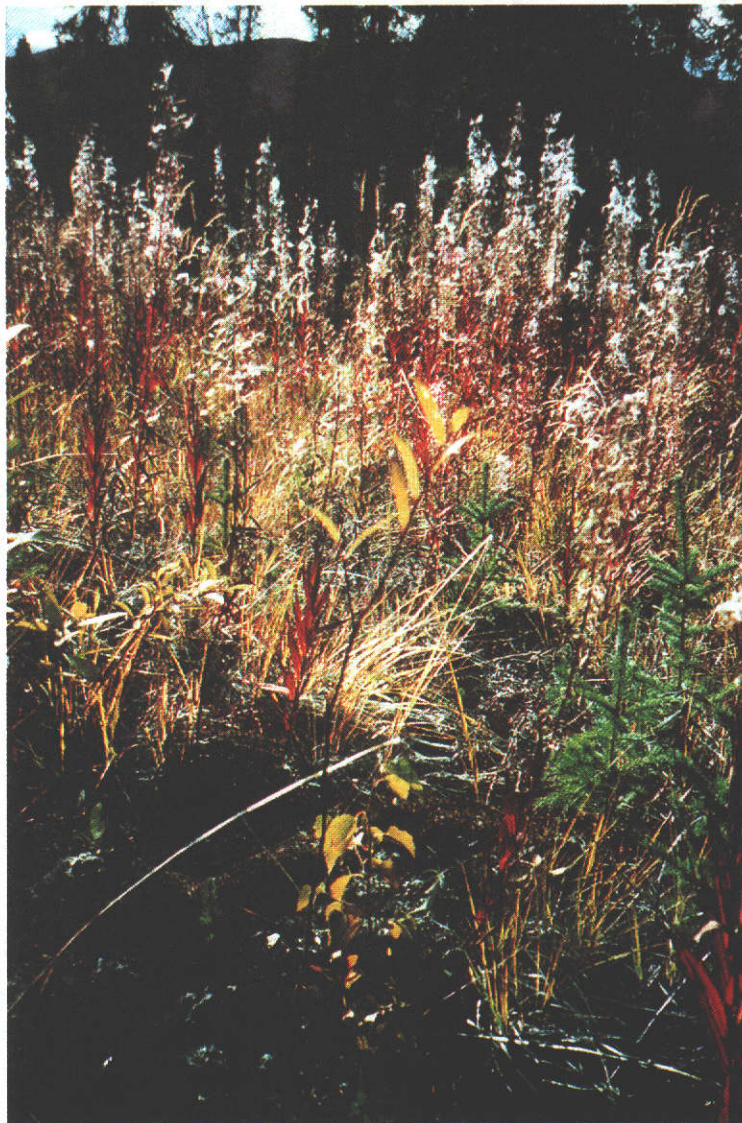
Plate 3-16 Drill pad R6. Dense growth of grasses and fireweed on the loose surface of drill pad rim.

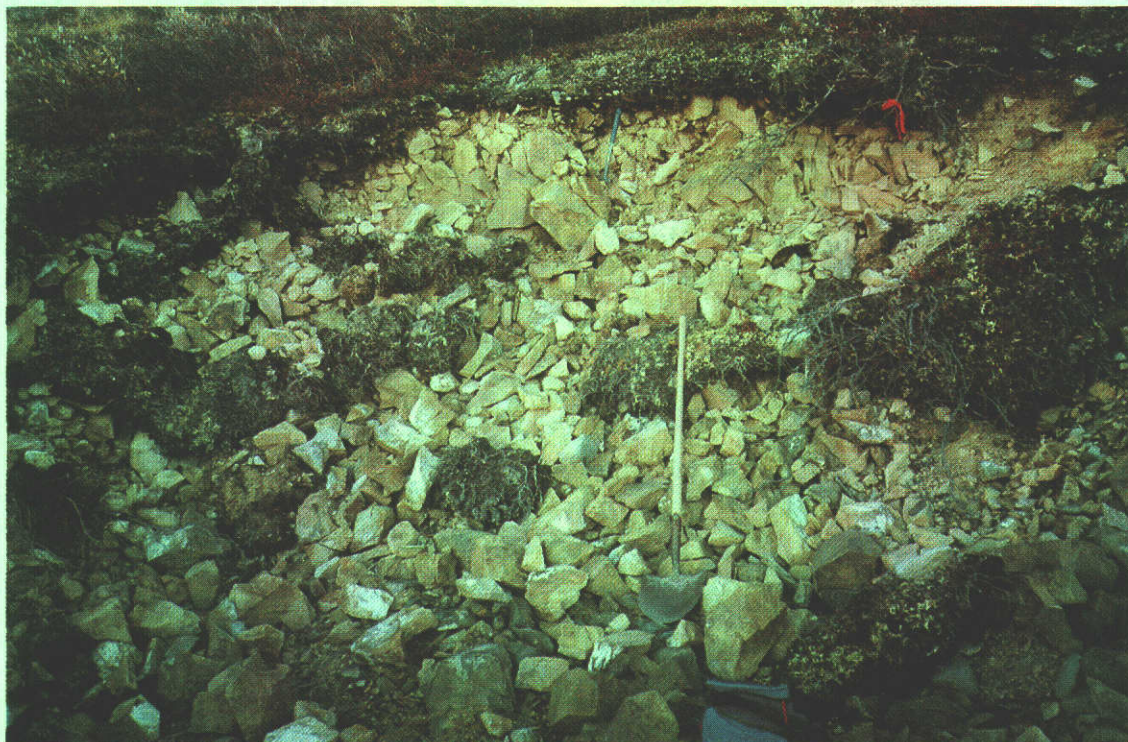
Plate 4-3 Trench RR3, 1988. Trench is unvegetated except for a very sparse forb layer and slumping patches of the original surface. Trench material is very coarse.

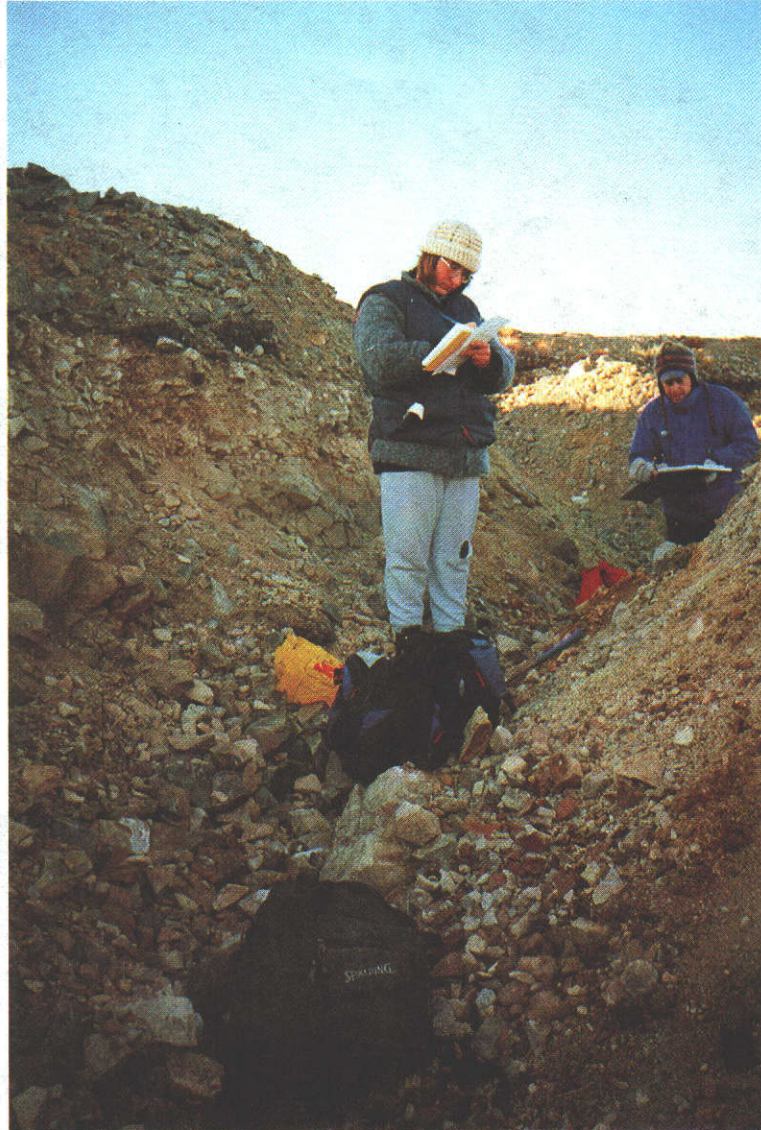
Plate 4-2 Trench RR2, 1988, trench is basically unvegetated.

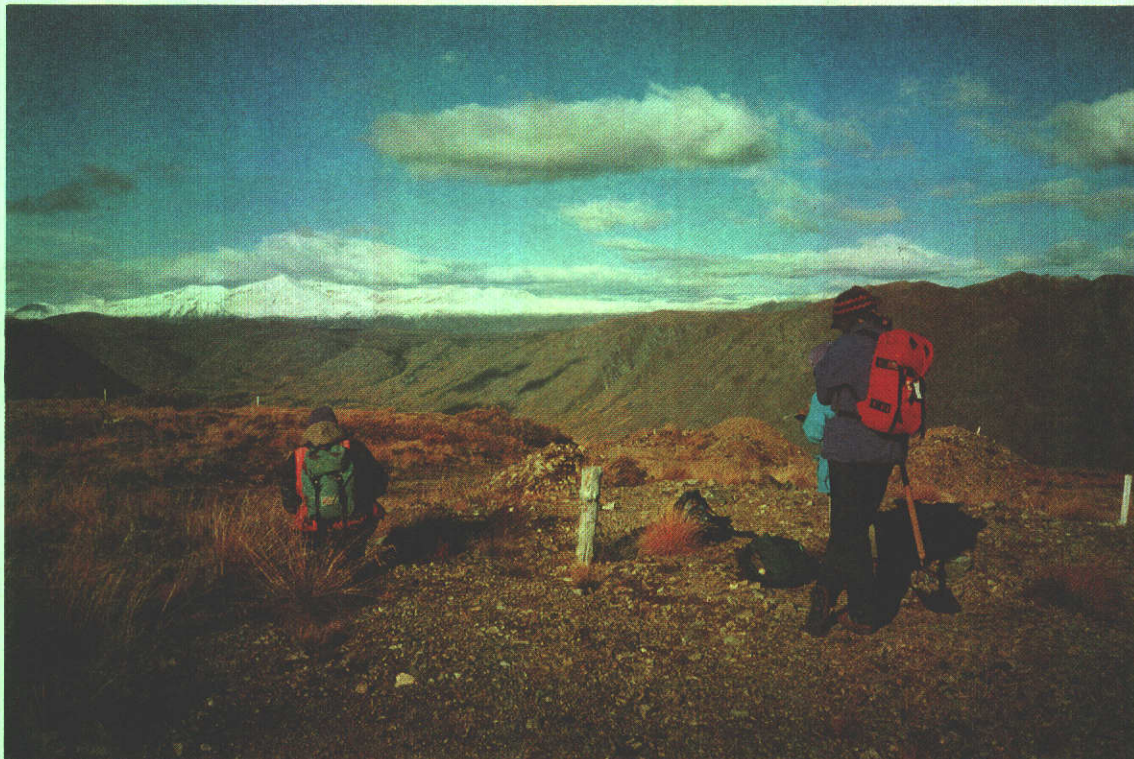
Plate 4-4 Drill pad SR8802, Site RR9. Site is very sparsely revegetated.

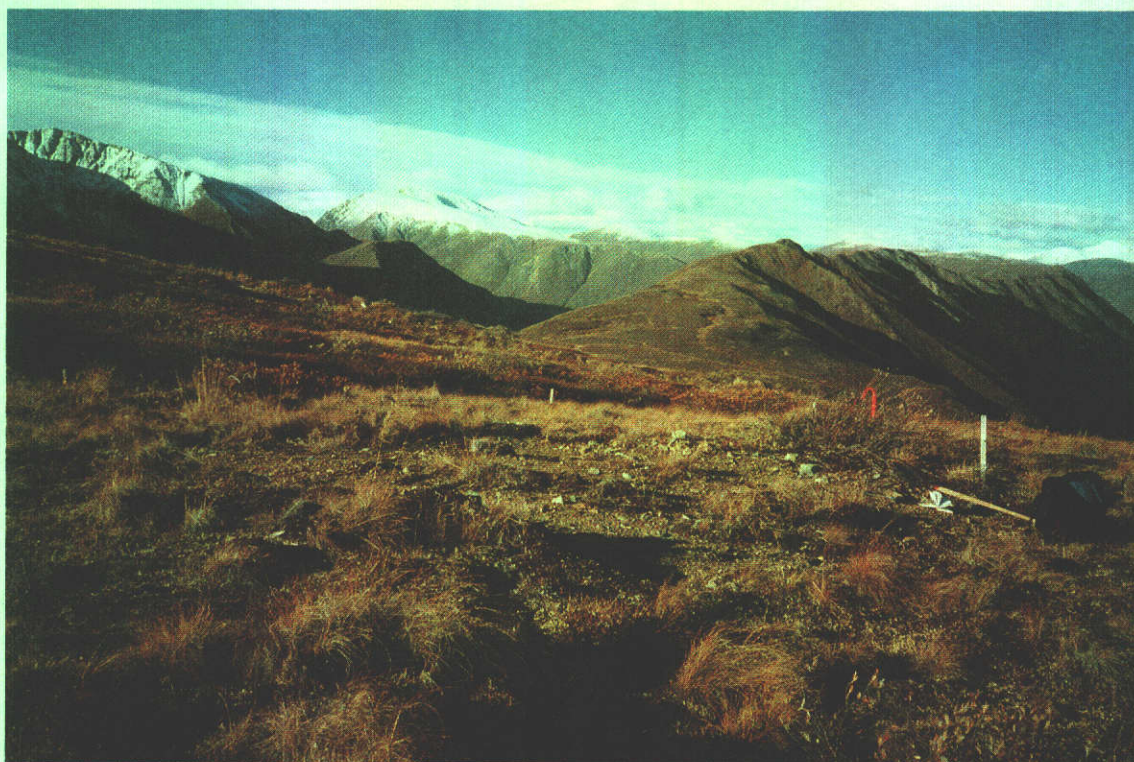
Plate 4-5 Site RR7 consists of cat tracks. Ripped surface has remnants of original vegetation and incoming pioneer plants.

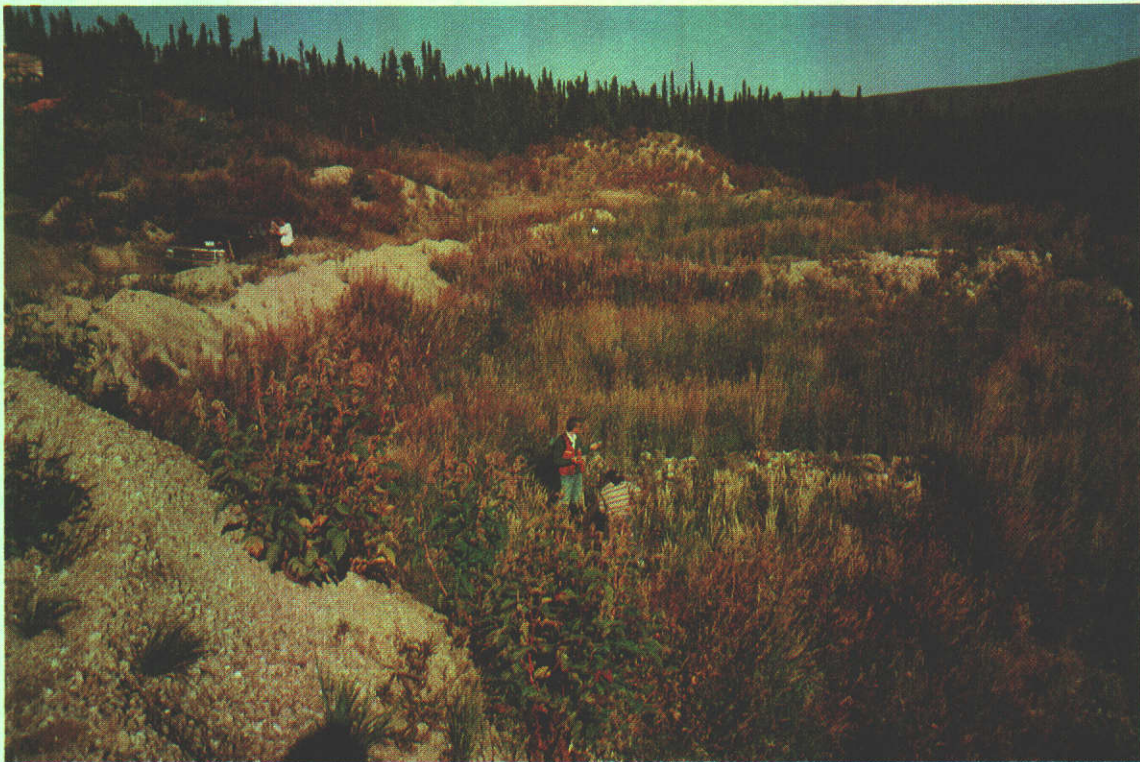
Plate 5-2 7 Pup property, 1991 settling pond surface is densely revegetated by shrubs, grasses, forbs and mosses.

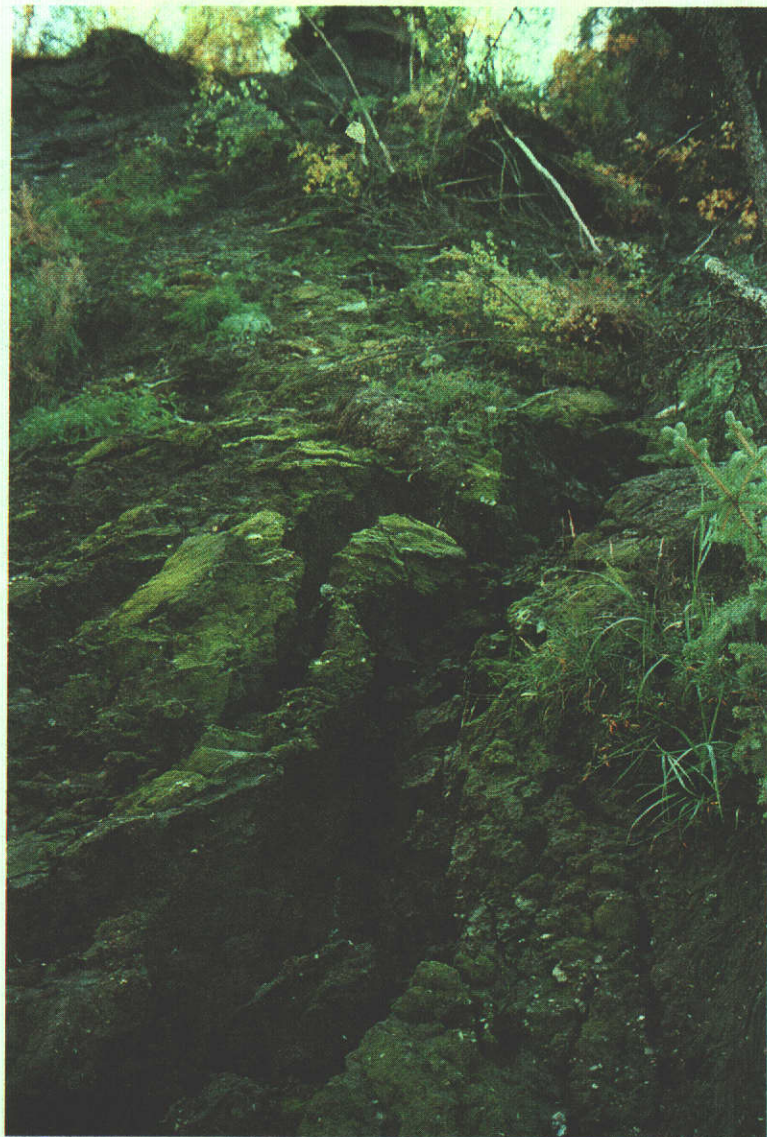
Plate 5-6 1990 cut, Oro Grande operation. Slope is actively slumping and failing as permafrost is melting.

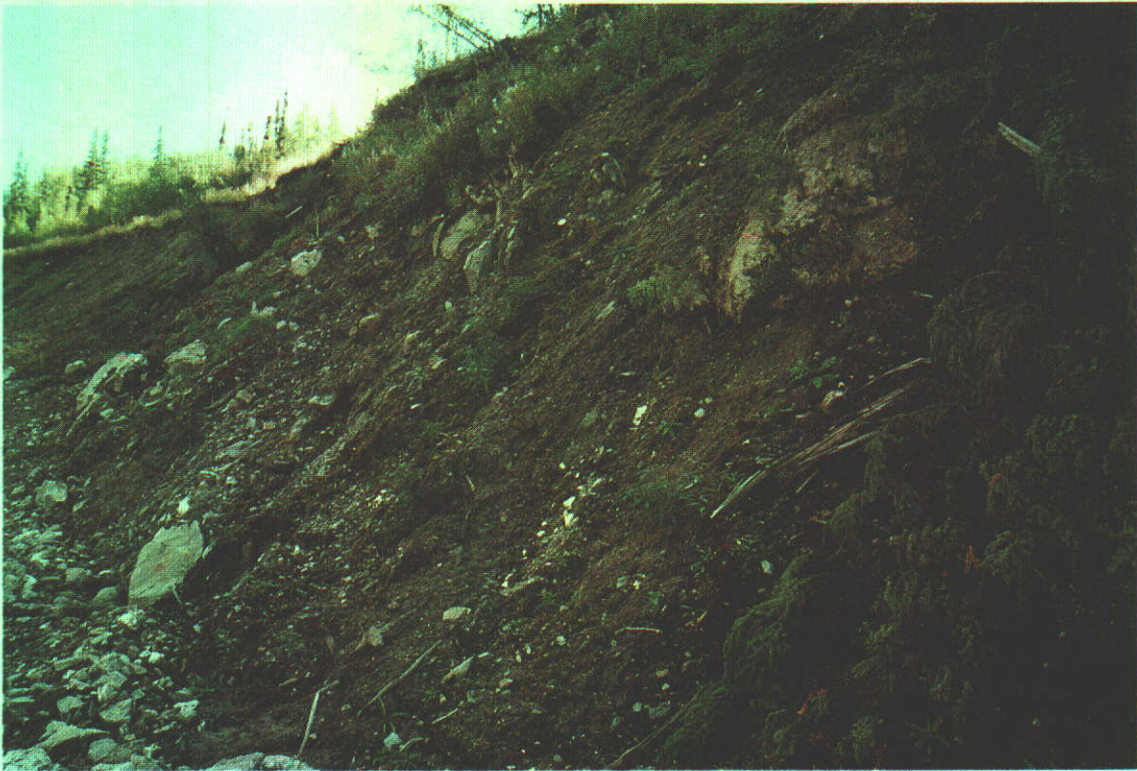
Plate 5-7 1992 cut, Oro Grande operation. Most of the vegetation consists of slumped fragment of original forest floor.
