NATURAL LAND RECLAMATION FOR MINERAL EXPLORATION PROPERTIES AND PLACER MINES IN YUKON

BULLETIN 5

by
C. Mougeot
Mougeot GeoAnalysis

APPENDIX ONE
PLATES

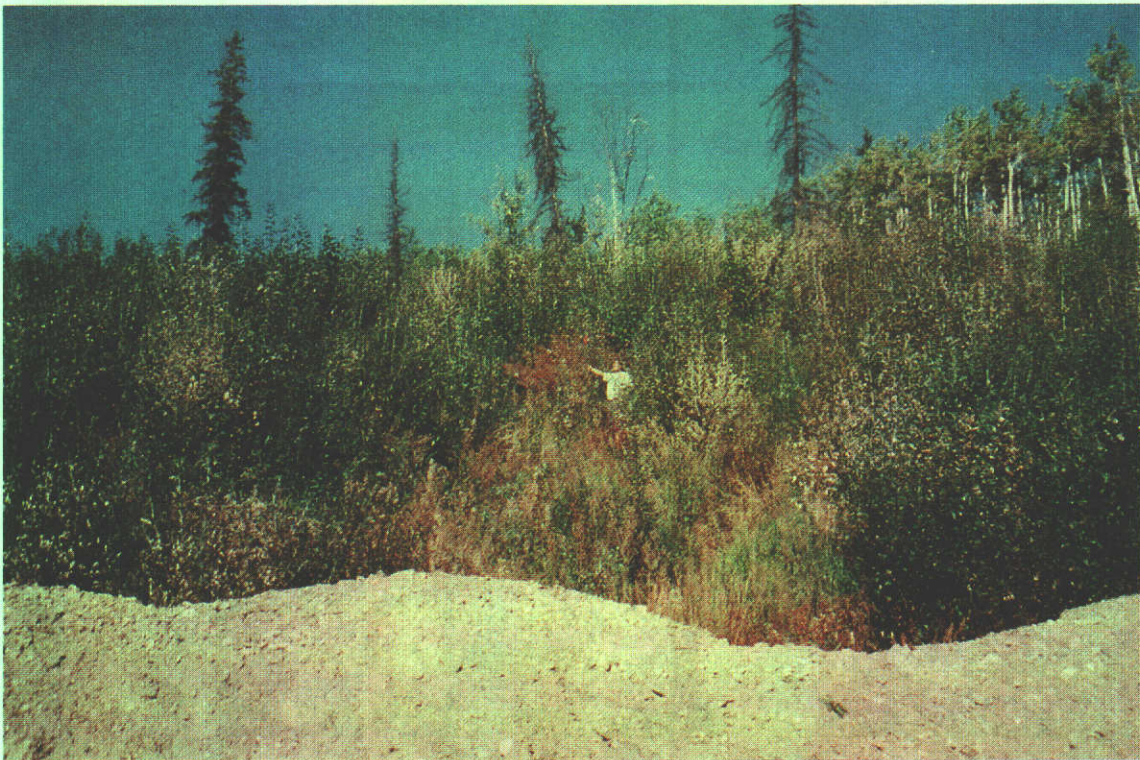
Plate 5-8 1990 Tailing and overburden pile, densely vegetated. Oro Grande operation

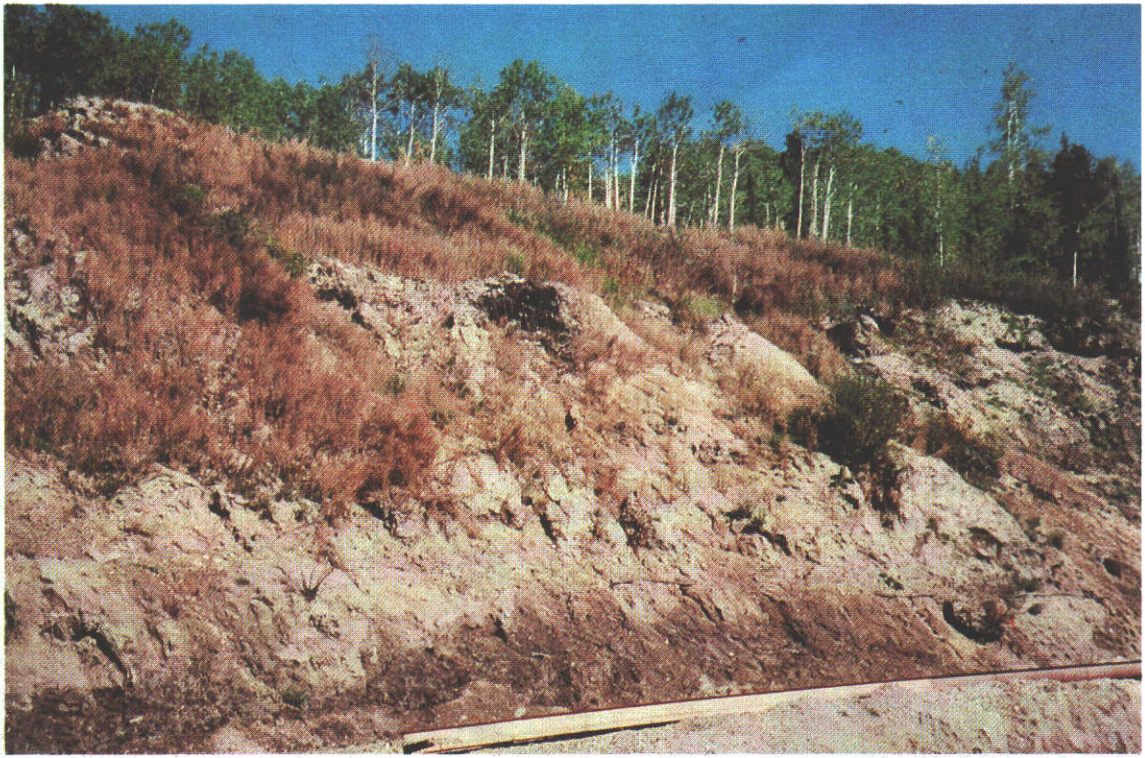
Plate 5-9 1992 Tailing pile, Oro Grande operation. Gulying and surface erosion very active.

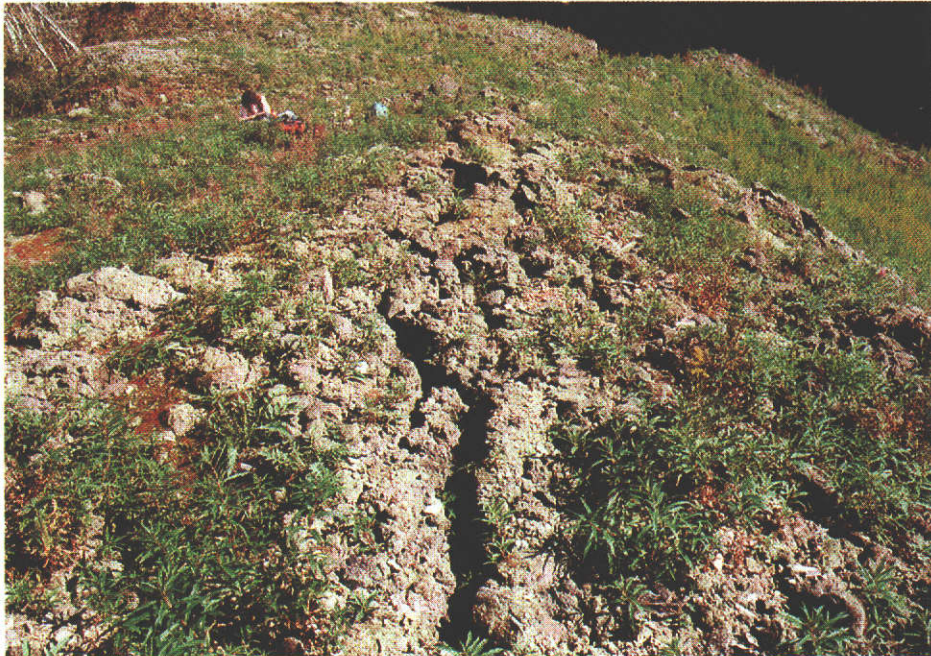
Plate 5-10 1993 tailing pile, Oro Grande operation. Separation fractures at the surface of the pile. Revegetation by forb is quite dense.

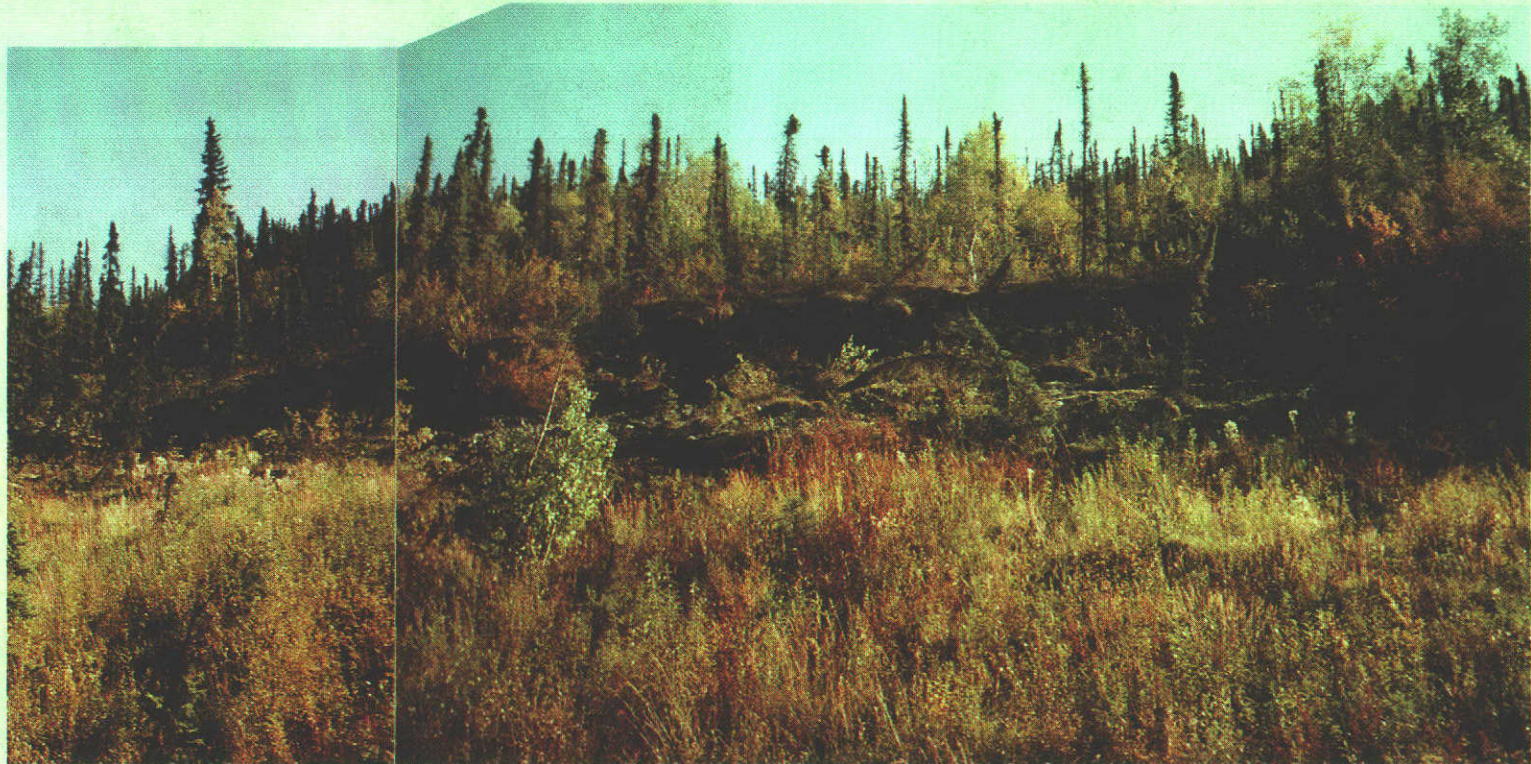
Plate 5-11 NG1, 1978 cut, Nugget Gulch. The slumping material appears terraced or benched and the slope profile is much lower than the original near vertical cut.

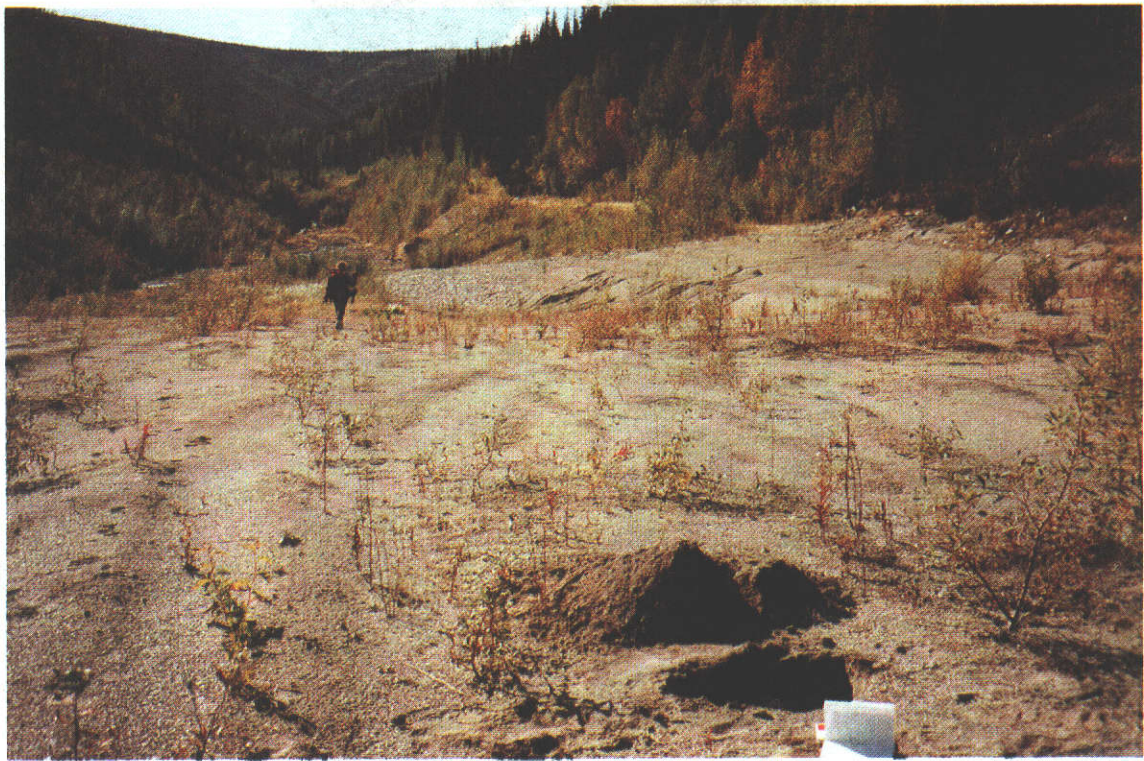
Plate 5-13 NG3 and NG4. Well sorted tailings composed mainly of gravel and sand show low rate of revegetation. Gullying is visible on the slope in background.

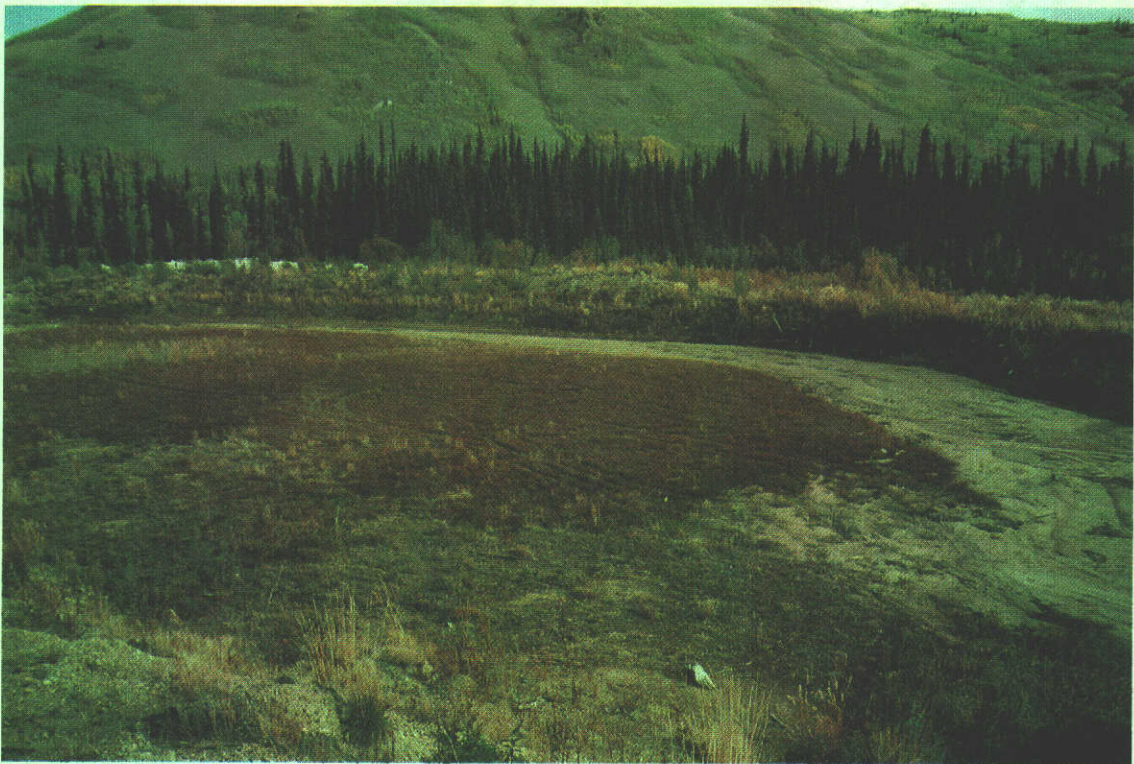
Plate 5-17 RC1, moderately well revegetated settling pond, Revenue Creek

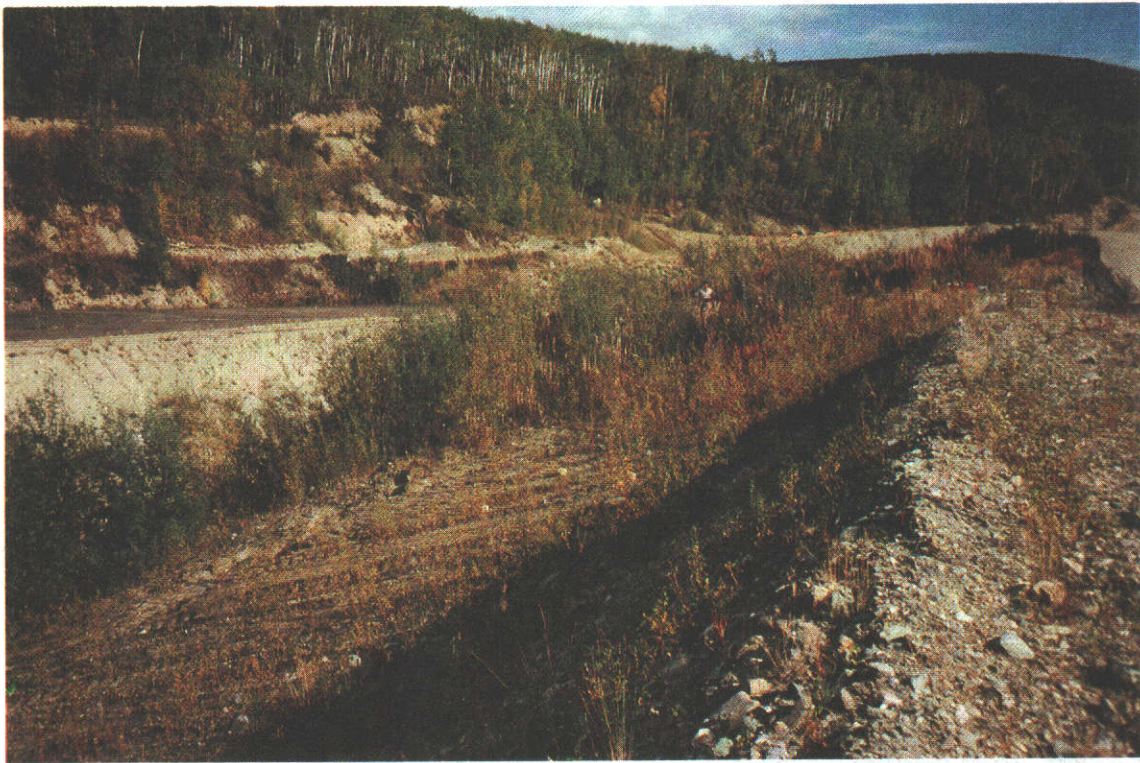
Plate 5-14 NG5, 1988 tailing pile and overburden, Nugget Gulch. Revegetation is fairly dense on the loose surface in the background and less so on the more compacted surface in the foreground

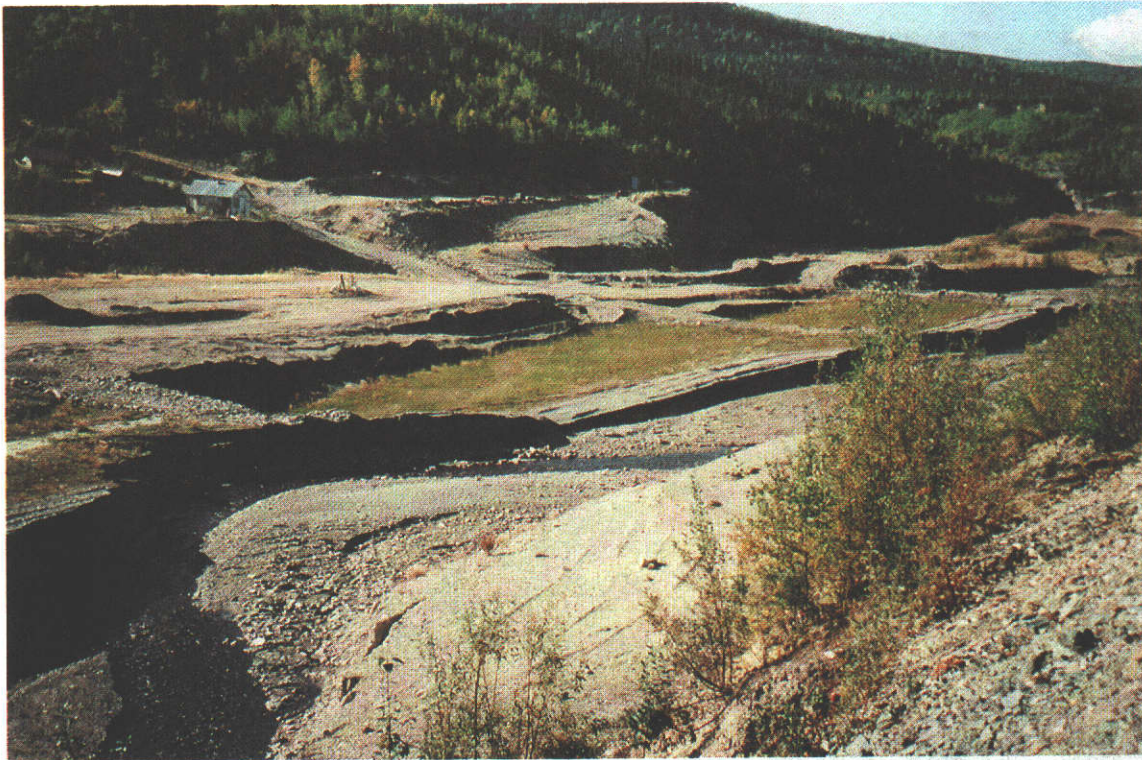
Plate 5-15 Settling pond on Eldorado Creek. Surface is densely revegetated. Sidewall is undercut by stream
