Mineral Resources Directorate, Yukon

RECLAMATION PRACTICES AND RESEARCH

ON MINERAL EXPLORATION PROPERTIES IN THE YUKON TERRITORY

Reclamation Practices and Research on Mineral Exploration Properties in the Yukon Territory

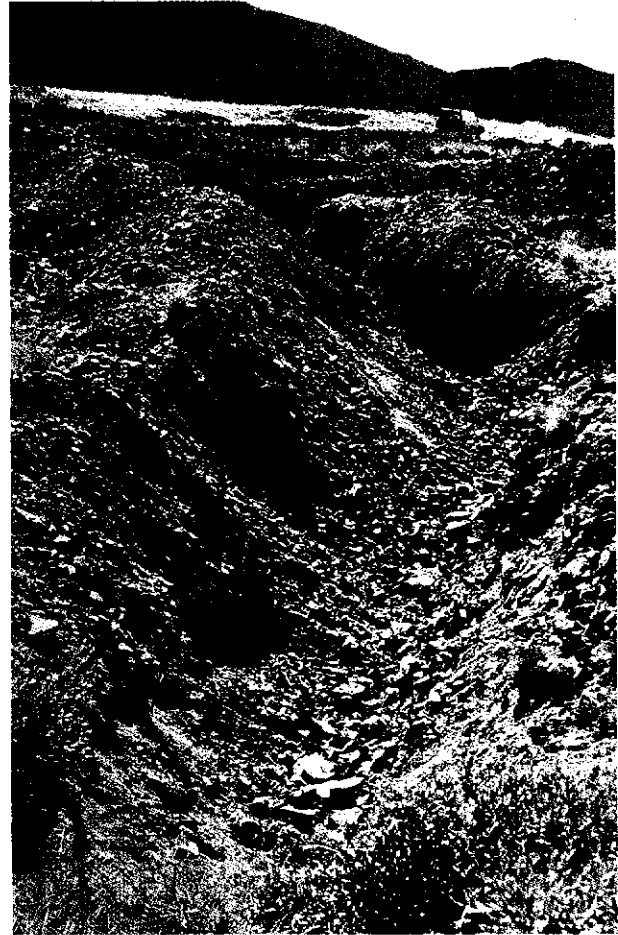
6. View of trench before reclamation, Red Ridge

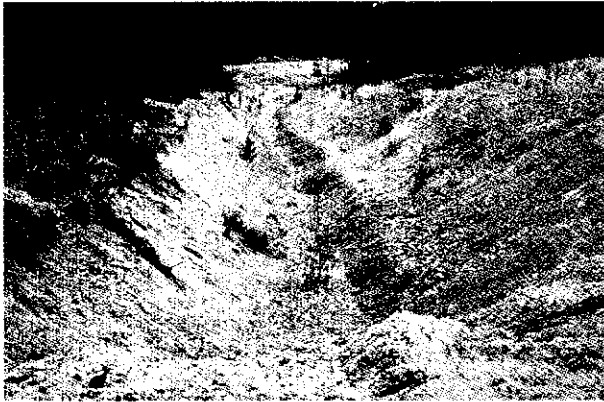
The down slope direction or orientation of the trench is regarded as the worst for instability for such an exploration cut, channelling run-off, and guaranteeing erosion of fine material. A depositional fan has formed at the lower end of this trench over the past six years from the fine material washed out of the upper part of the trench, including the short section in this reclamation test (Figure 13).

13. Nucleus trench showing depositional fan.

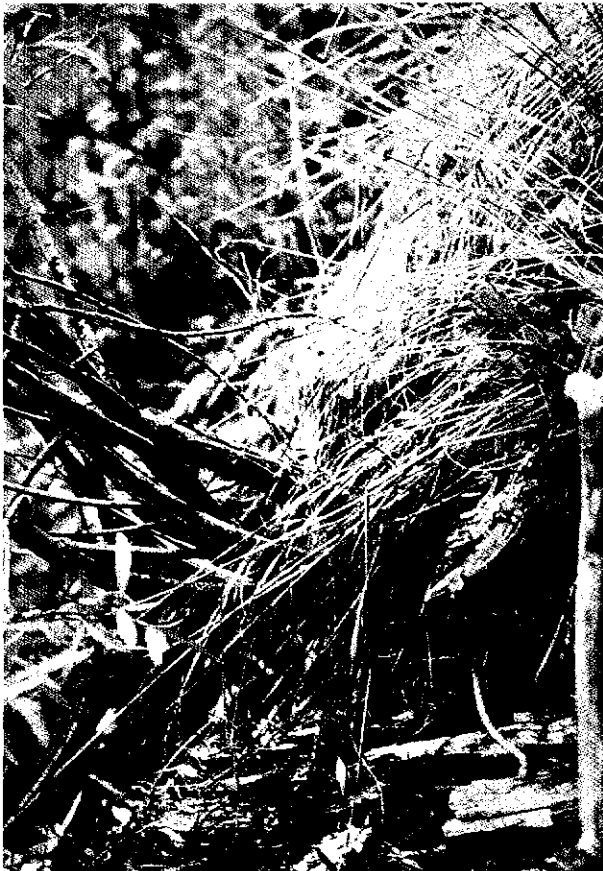
24. Hawk, slumping effects direction of shrub growth

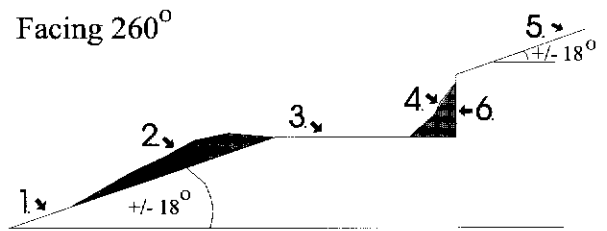
23. Cross Section, Hawk, trench before backfilling

1. Undisturbed downhill slope
2. Excavated material at an angle of repose of 35 degrees
3. Floor of trench, horizontal
4. Material slumped from trench high wall at angle of repose
5. Undisturbed uphill slope, 20 degrees
6. Schist high wall, subvertical

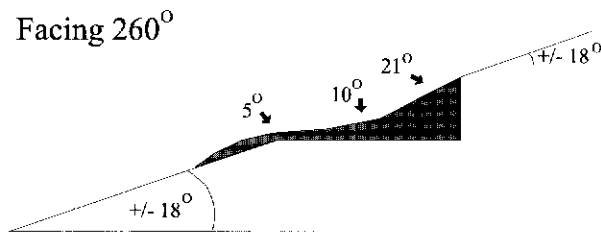
25. Cross Section, Hawk, trench after backfilling

The measured slopes range from 21 degrees at the top to less than 10 degrees on the downhill side. Such slopes are regarded as being stable in this setting of fairly rapid growth. Further, any fine material that does move from the steeper part of the newly formed slope should deposit on the gentler part. The options are limited by the geometry of the original hillside - the average slope of any reclamation profile must average out at about 18 degrees.

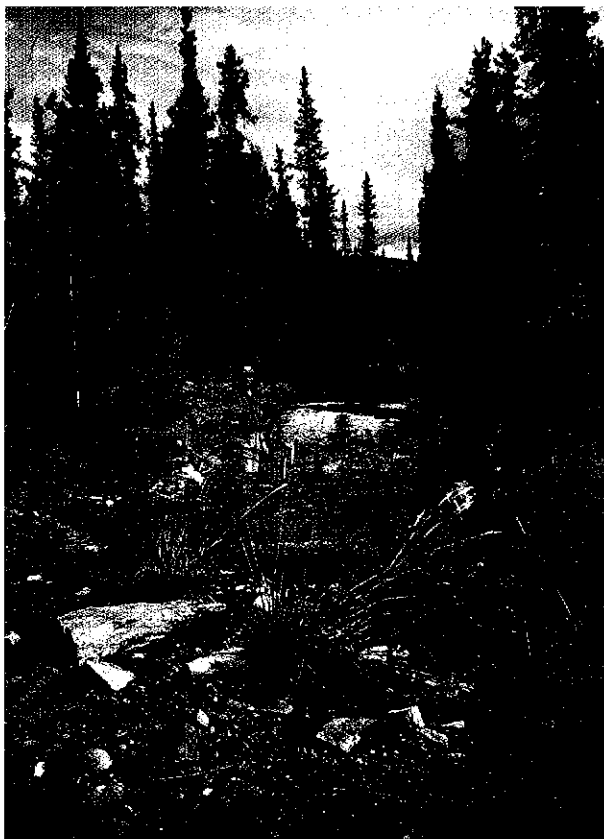
34. Non-reclaimed 1972 trench at the Division Coal property (August, 1997)

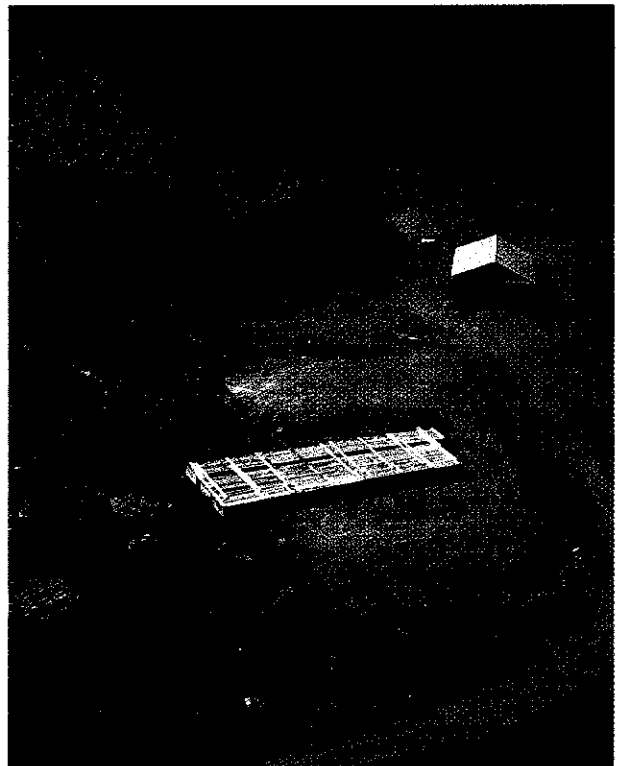
41. The shed and core still remaining at the Howard's Pass property (August, 1997)
