OPEN FILE 2004–18

A regional characterization of landslides in the Alaska Highway corridor, Yukon

C.A. Huscroft, P.S. Lipovsky and J.D. Bond

Huscroft, C.A., Lipovsky, P.S. and Bond, J.D., 2004. A regional characterization of landslides in the Alaska Highway corridor, Yukon. Yukon Geological Survey, Open File 2004-18, 65 p., report and CD-ROM.

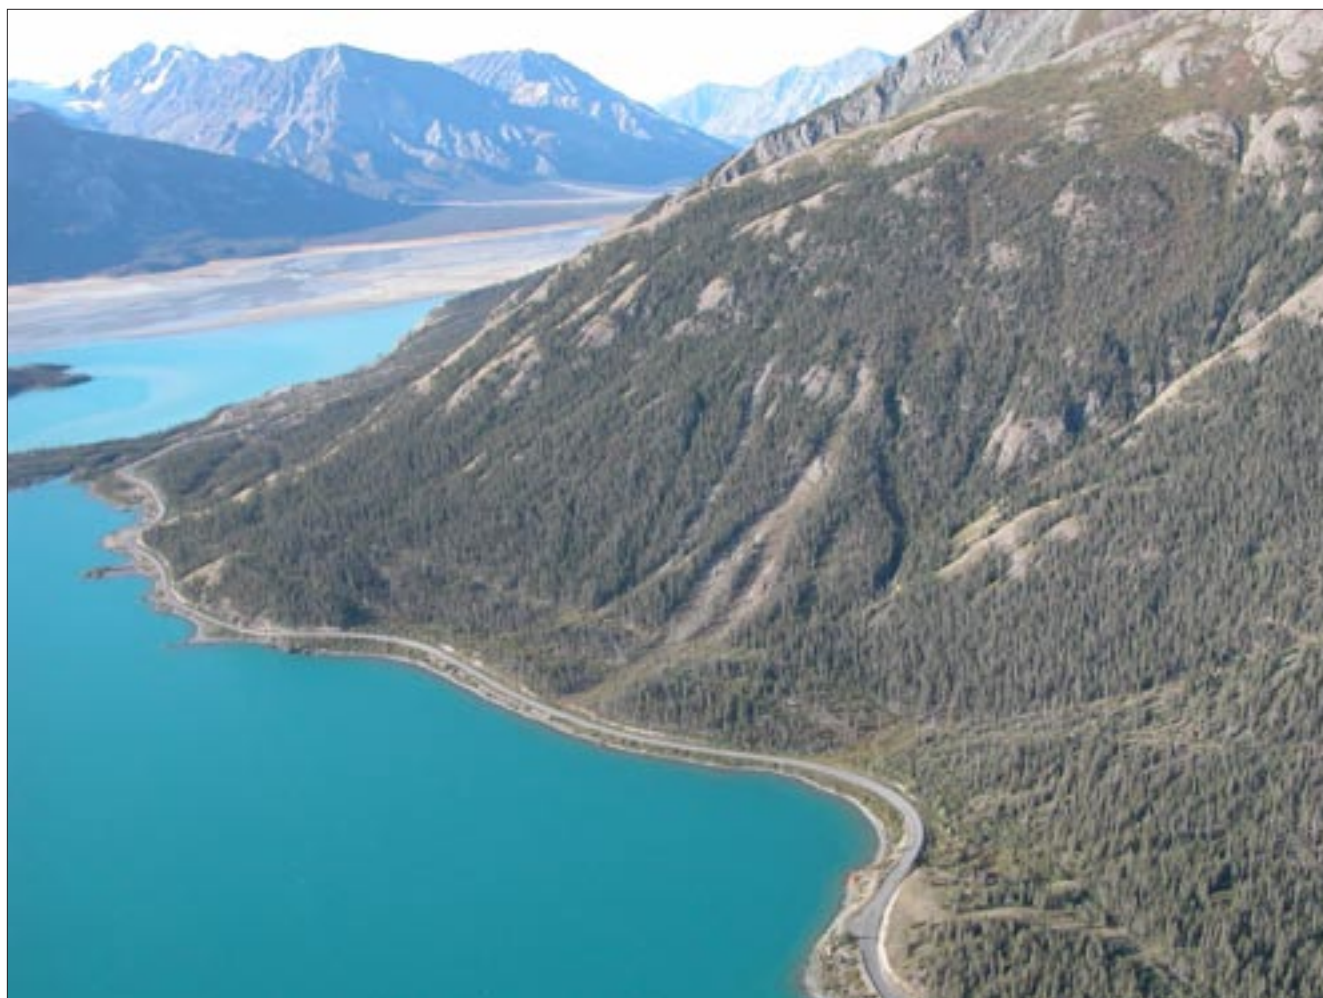
Cover photo. Southward view of 1988 Horseshoe Bay debris-flow scar. Alaska Highway runs along the southwestern shore of Klwane Lake in foreground. Slims River delta is in the background.

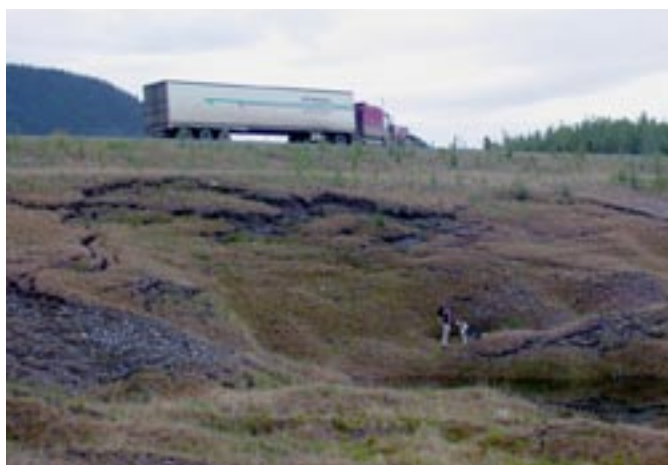
Figure 9. Debris slide related to growth of a thermokarst depression adjacent to the Alaska Highway near Dry Creek (see Figure 8). Thermokarst activity was initiated after overlying vegetation and gravel was removed by aggregate mining for highway construction.

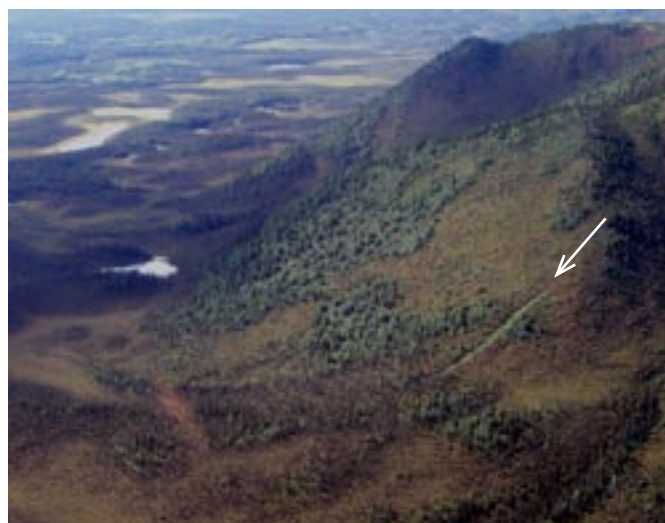
Figure 10. Active-layer failure scar (arrow) on an isolated upland within the Wellesley Depression landslide zone. This type of landslide is related to the extensive permafrost located in the area.

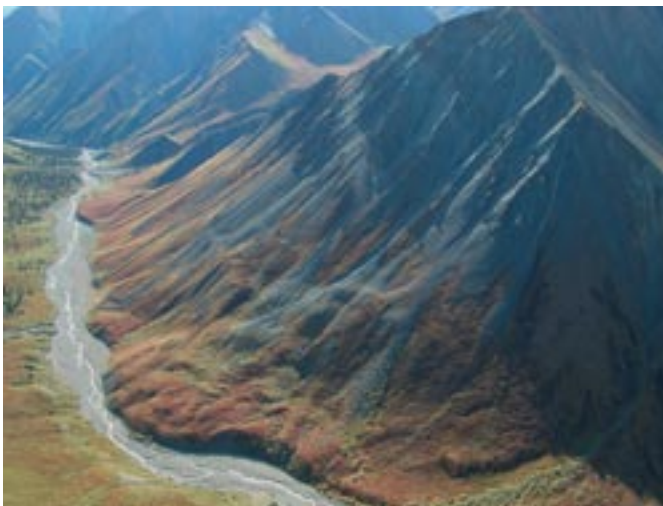
Figure 12. Slow deformation of steep colluvial slope within Kluane Ranges indicating the presence of abundant ground ice. Many slopes within the Kluane Range exhibit similar behaviour.

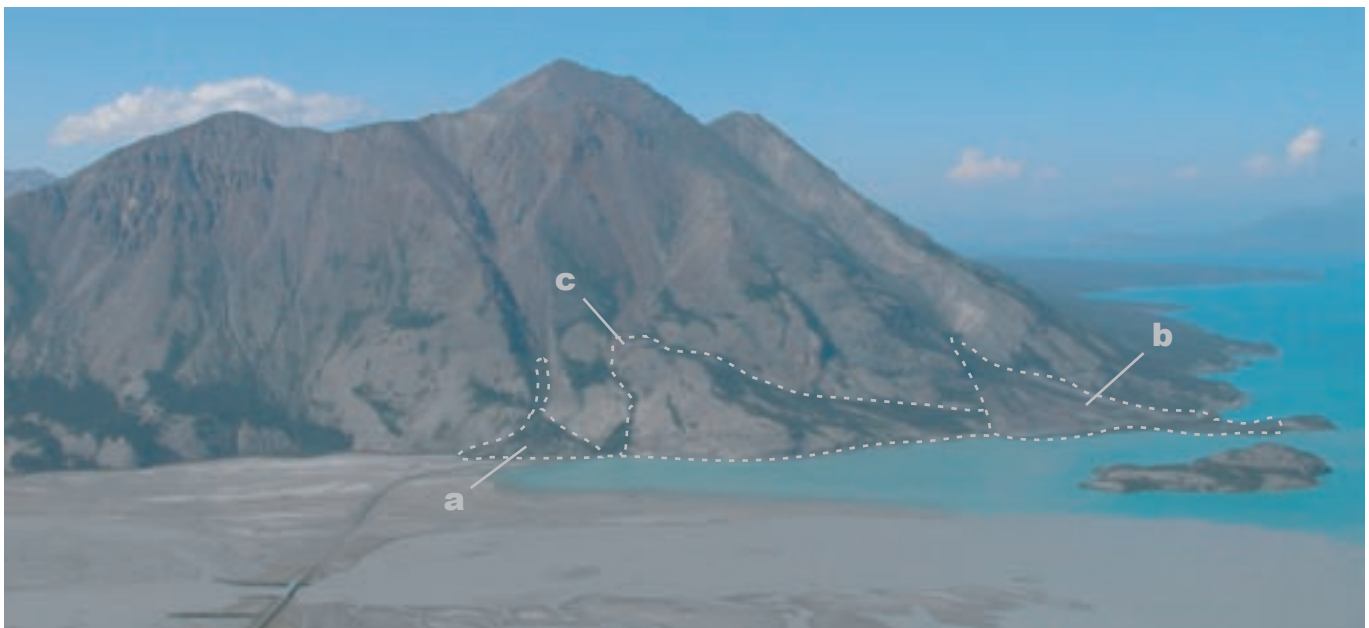
Figure 14. Looking northwest at landslide deposits along the base of Sheep Mountain and the Slims River delta, including (a) debris flow fan, (b) and (c) rock avalanche deposits.

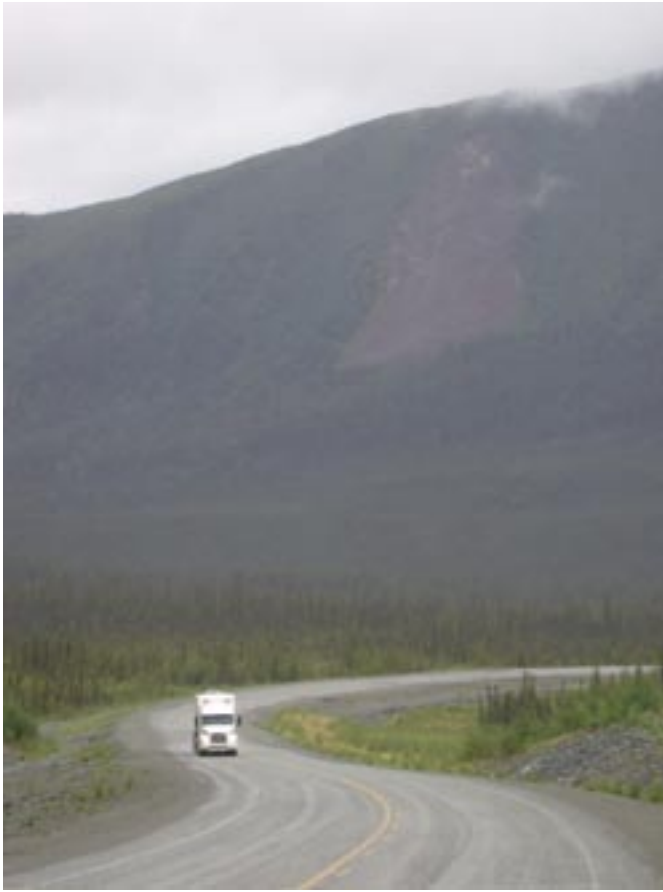
Figure 15. Looking east at Wolf Creek rock slide, Alaska Highway in foreground.

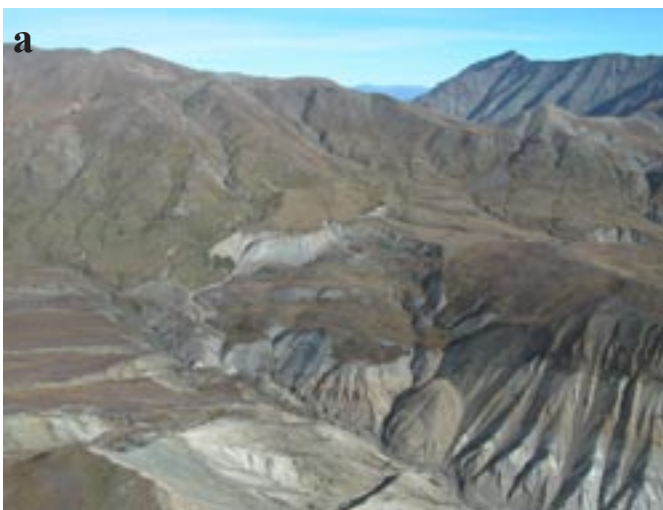
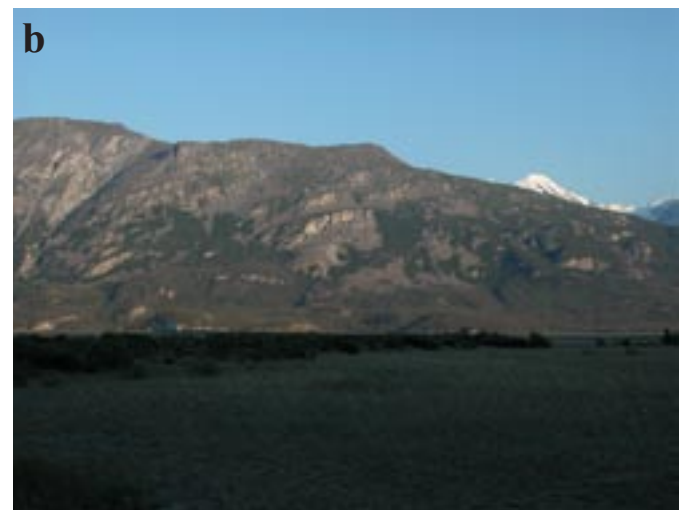
Figure 16. Examples of large rock slumps within Kluane Ranges. (a) Rock slump along upper Sheep Creek; (b) Complex rock slump and related rock fall on northwestern slope of Outpost Mountain. Alaska Highway crosses base of the slope along the left-hand side of photograph.

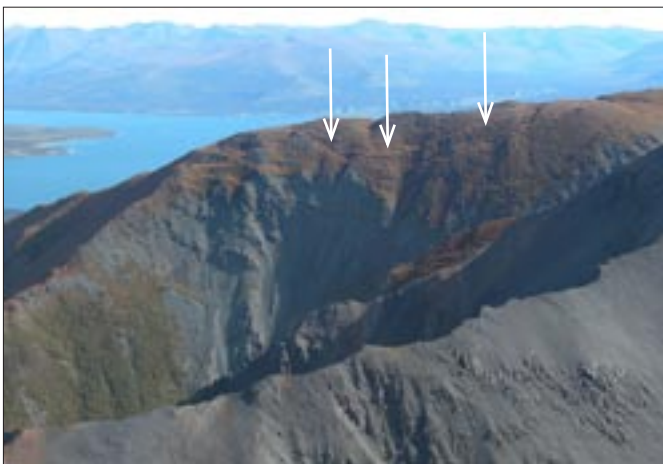
Figure 17. Uphill-facing scarps (indicated by arrows) related to lateral spreading of bedrock ridges above Kluane Lake (in background) near Nines Creek.

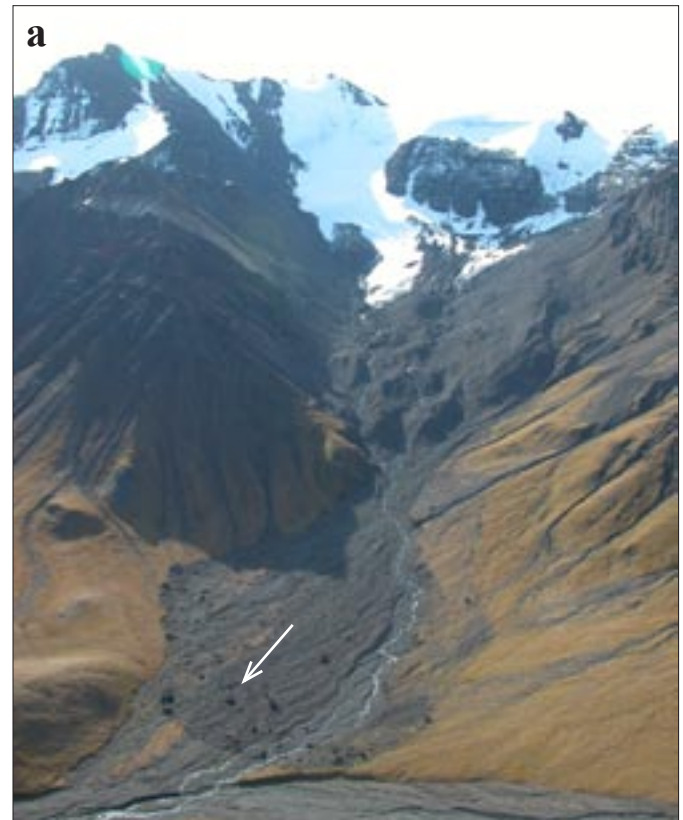
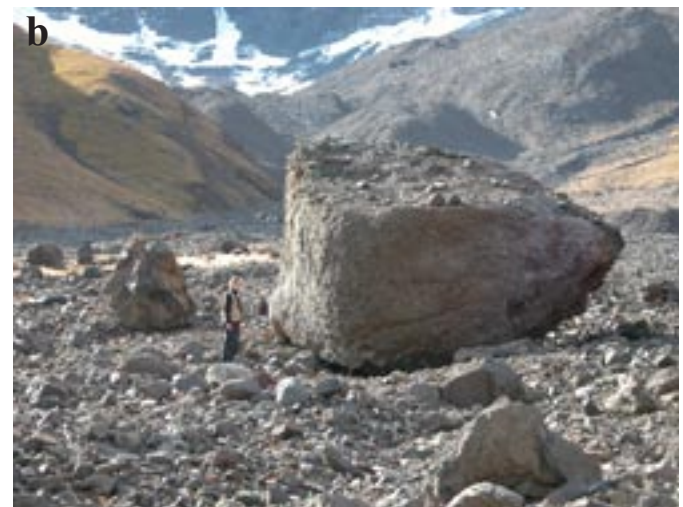
Figure 18. Deposits of a large rock and ice avalanche. (a) Arrow points towards boulder photographed in (b). The source of the avalanche is above the steep right-hand rock faces. (b) Boulder with perched stones that travelled over 1 km from the source area. Rock and snow hazards have not been assessed in the corridor.

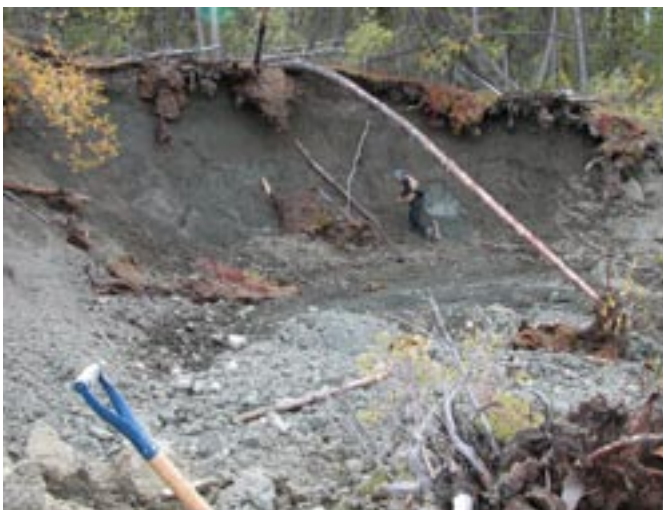
Figure 19. *Retrogressive thaw slump headscarp along the Dezadeash River. Veins of ice were visible within the headscarp. Small flows of lacustrine silt and clay were active during field visit.*

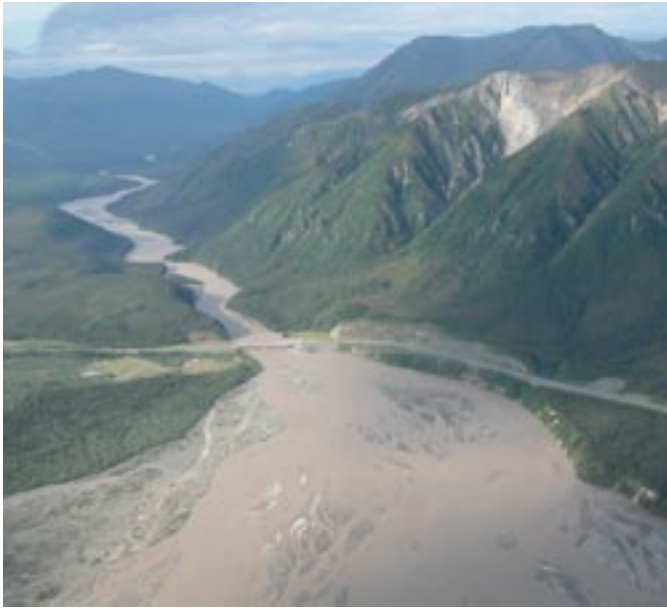
Figure 20. Debris flow fan and catchment on north White River crossing.

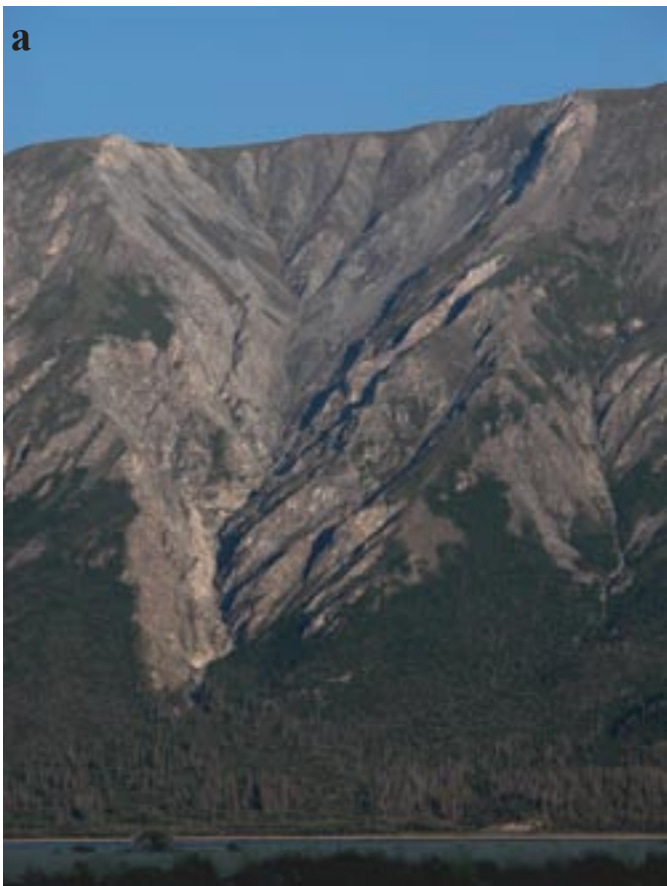
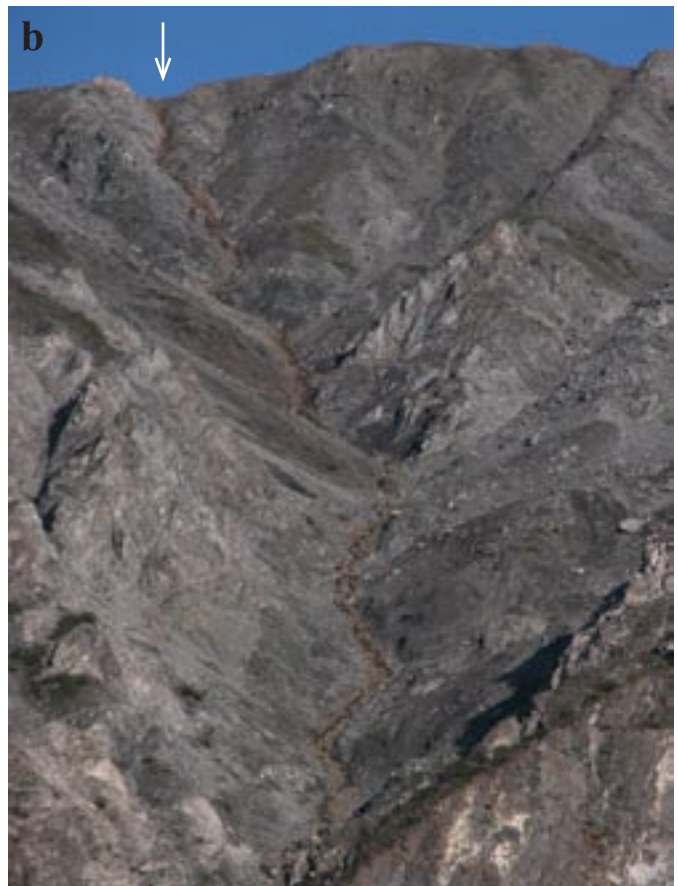
Figure 21. (a) North-facing gullies along Kluane Lake. These catchments were source areas for debris flows that blocked the Alaska Highway during rainstorm events. (b) The brown-coloured debris in the bottom of the gully is the product of an active-layer detachment failure that occurred on the plateau surface, near arrow.

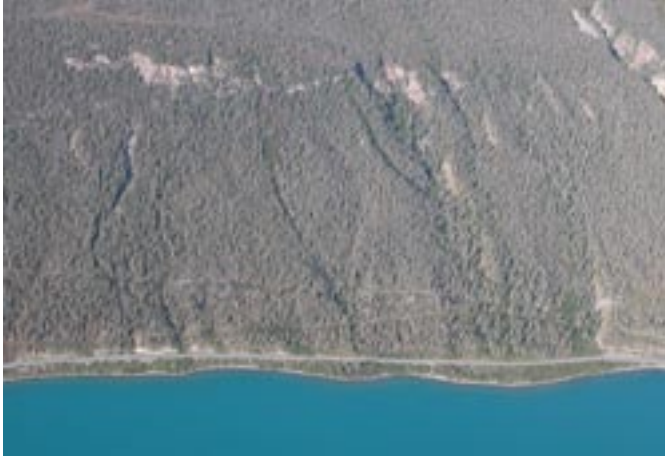
Figure 22. Debris flow scars above Alaska Highway north of Williscroft Creek.

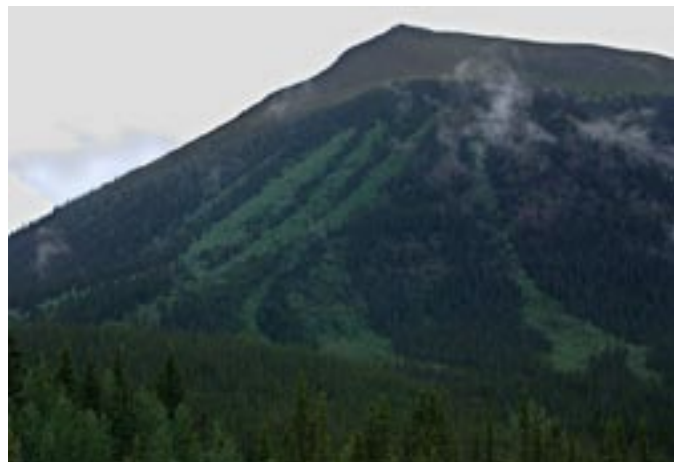
Figure 23. Overgrown shallow debris flows which initiated due to active-layer detachment failures.

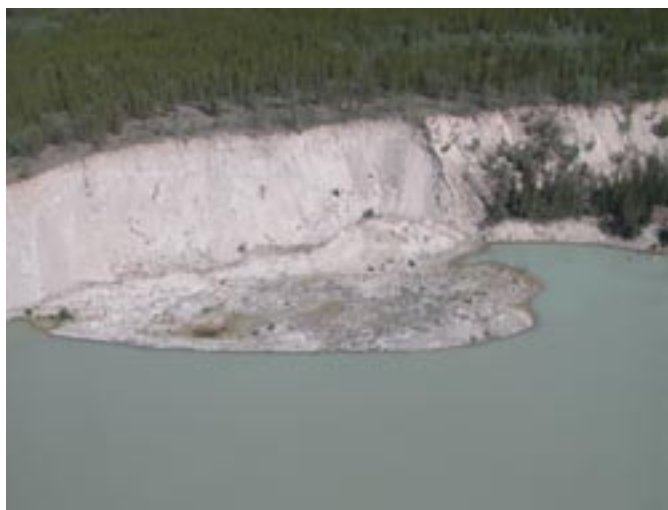
Figure 25. Earth slide due to river erosion and undercutting of glaciolacustrine silts in the Takhini Valley.

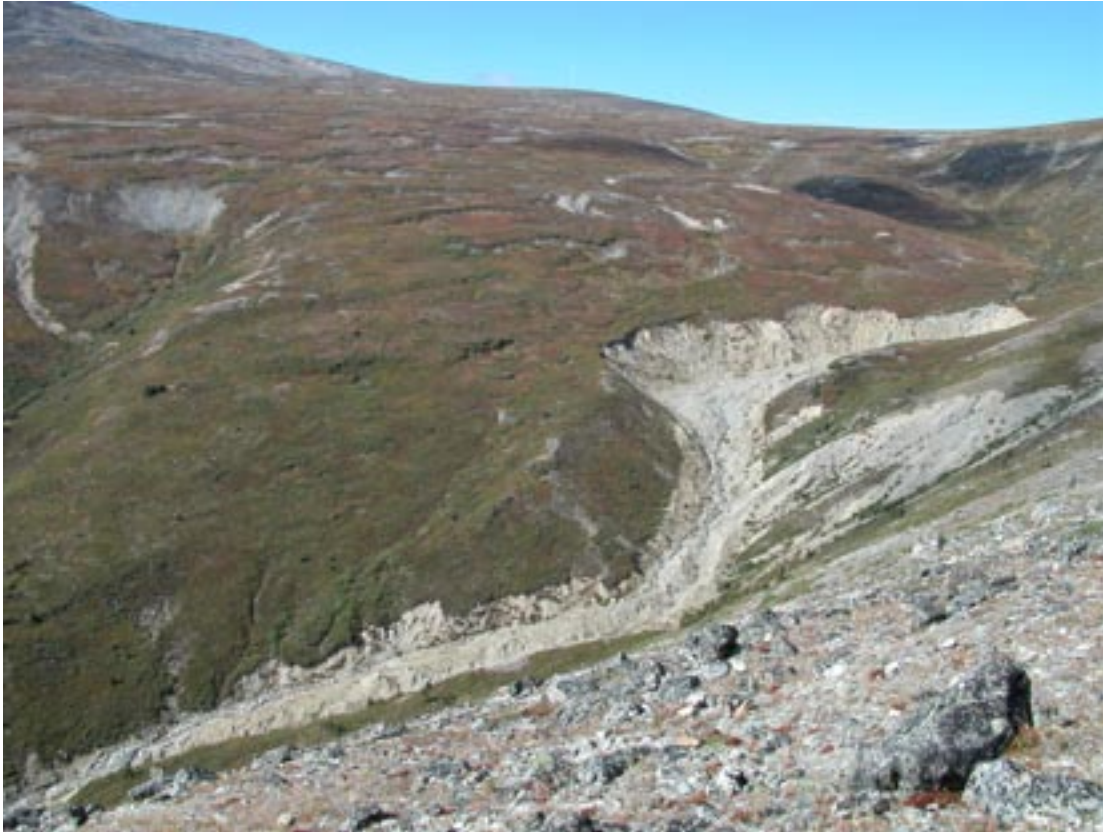
Figure 26. Upper catchment of Kusawa Lake debris-torrent system. Permafrost was encountered within 1 m of the surface within the undisturbed hillslope, 20 m behind the headscarp. The landslide scar is approximately 300 m wide.

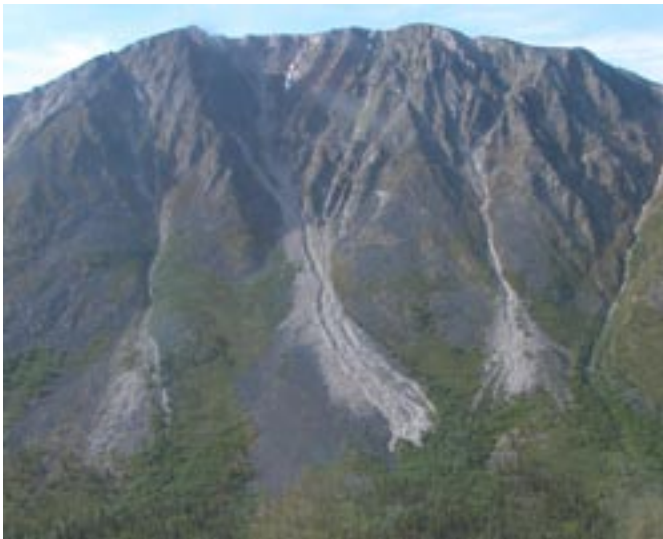
Figure 27. Pond Creek debris flows.

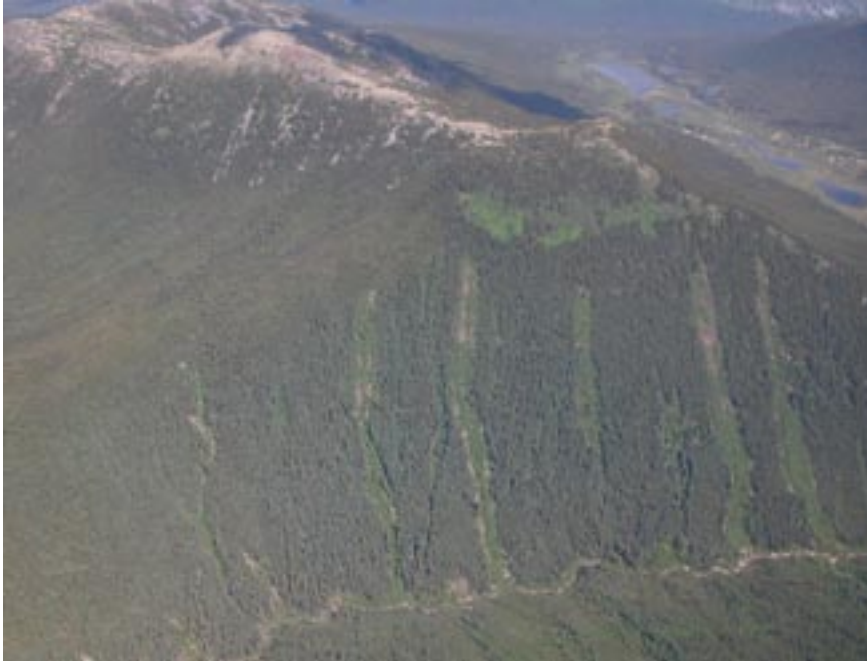
Figure 29. Typical setting of debris flows on steep till-covered slopes of the Kaska Mountains zone. Note how scars extend from upper hillslopes to valley bottom.

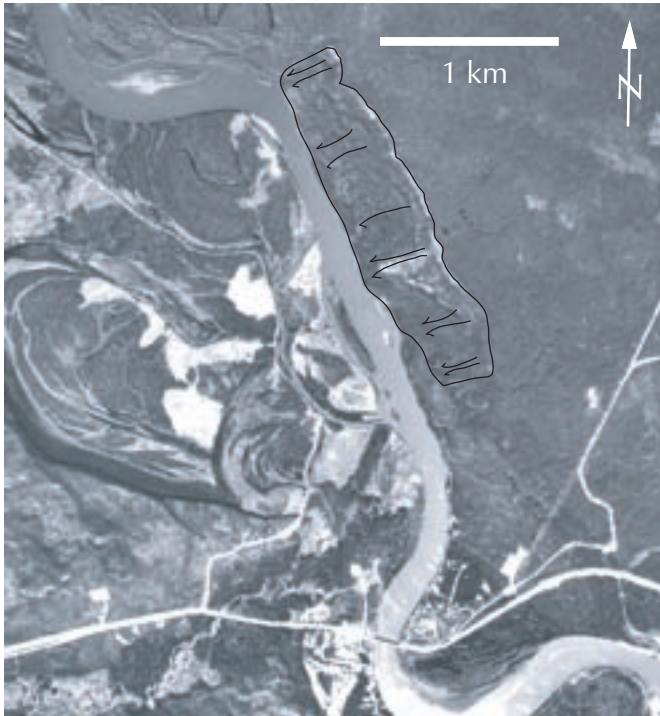
Figure 31. Aerial photograph of large rock slumps (outlined in black) within Pleistocene basalt and till adjacent to the Alaska Highway's crossing of the Liard River (National Air Photo Library number A27829-56, Natural Resources Canada).

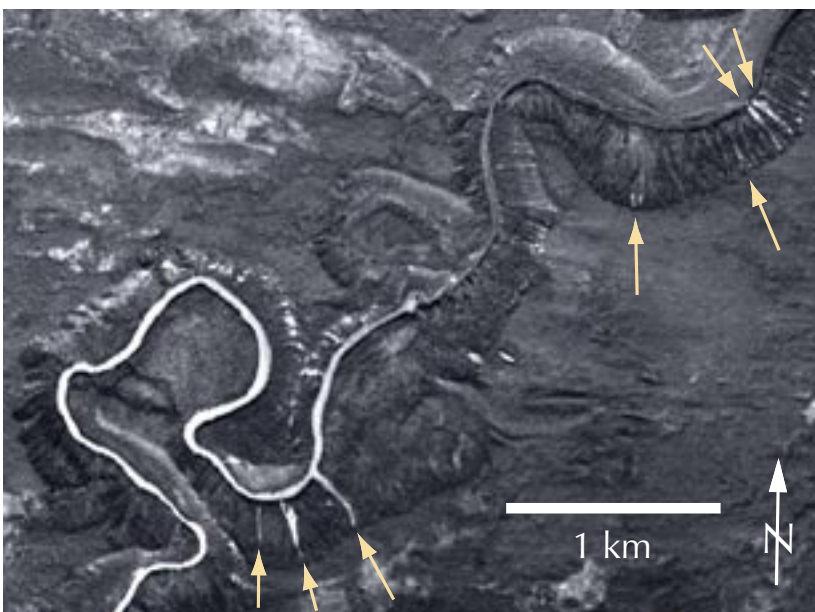
Figure 32. Aerial photograph of debris flows (arrows) along the Little Rancheria River. Note that the majority of the failures occur on north-facing slopes (National Air Photo Library number A27829-10, Natural Resources Canada).

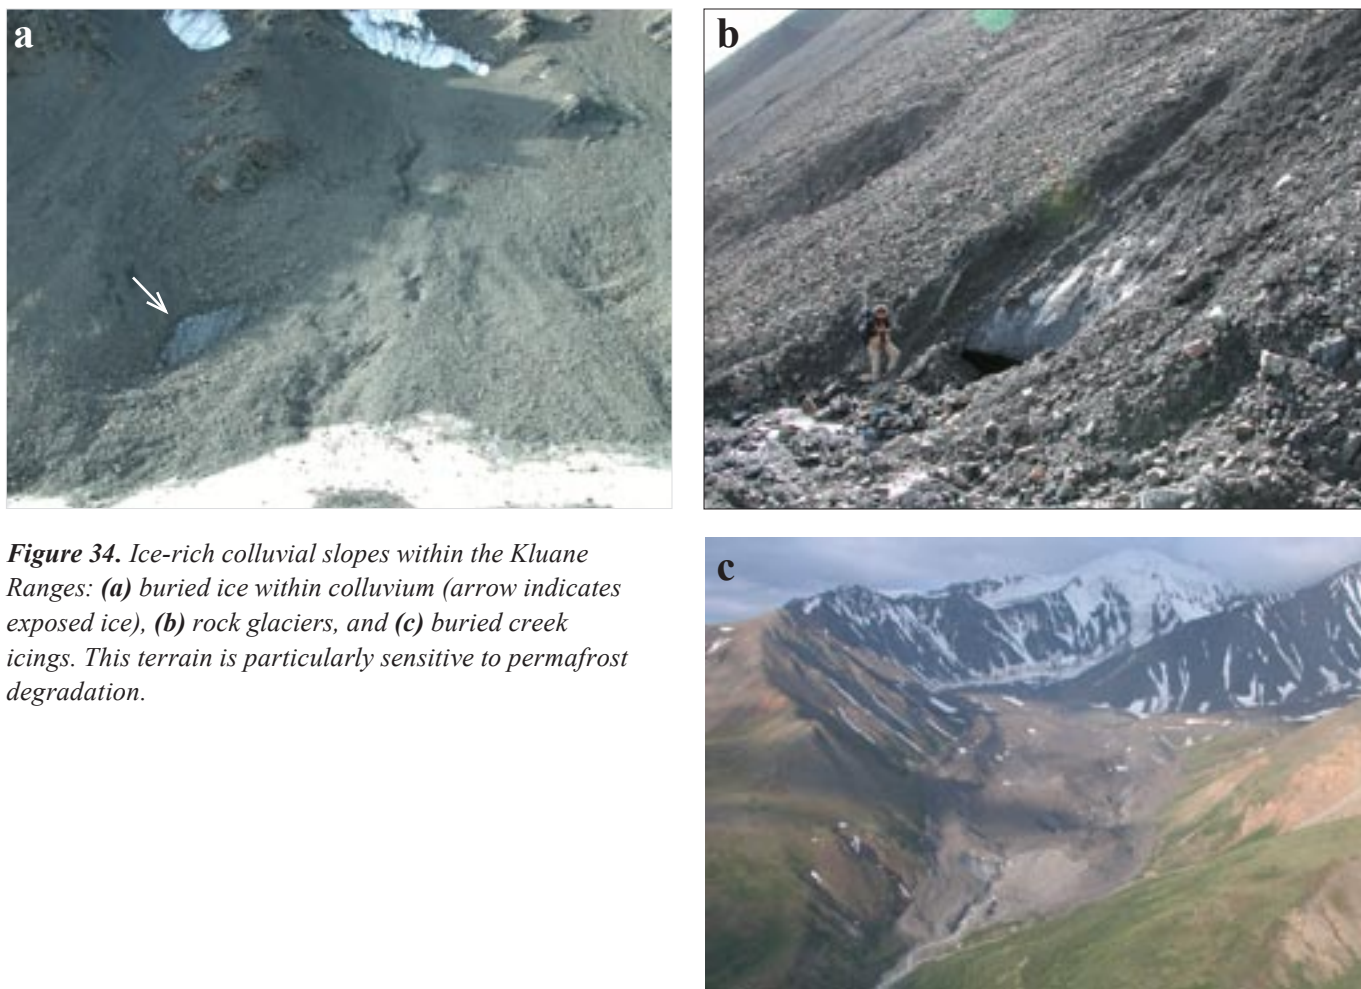
Figure 34. Ice-rich colluvial slopes within the Kluane Ranges: (a) buried ice within colluvium (arrow indicates exposed ice), (b) rock glaciers, and (c) buried creek icings. This terrain is particularly sensitive to permafrost degradation.

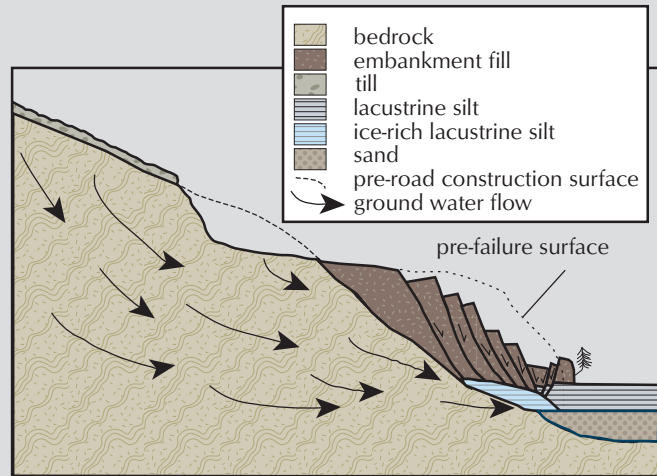
Figure II. Schematic cross-section, derived in part from testhole data, displaying stratigraphy, ground ice and inferred failure conditions. Ground-ice accumulations in lacustrine silts commonly occur at the base of bedrock slopes throughout the Alaska Highway corridor (Rampton et al., 1983).

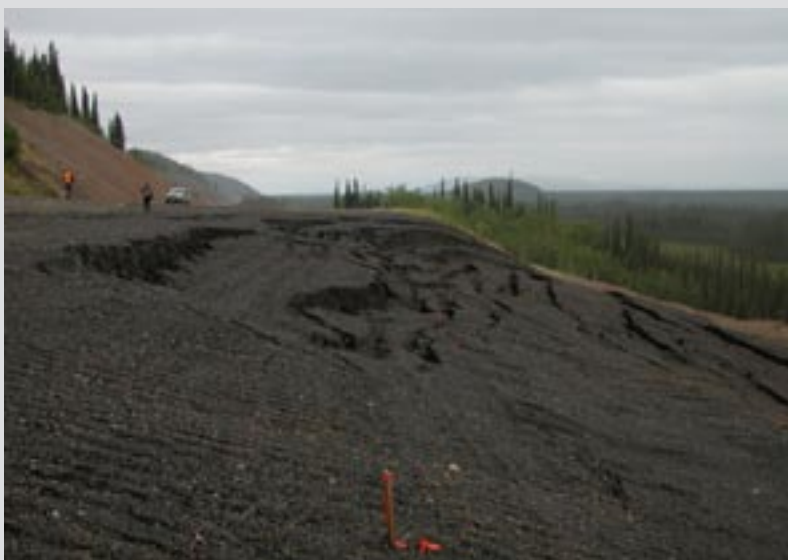
Figure I. Initiation area of failure caused by subsidence due to permafrost thaw at the base of the slope. Note car parked on Alaska Highway shoulder for scale. View looking southeast.

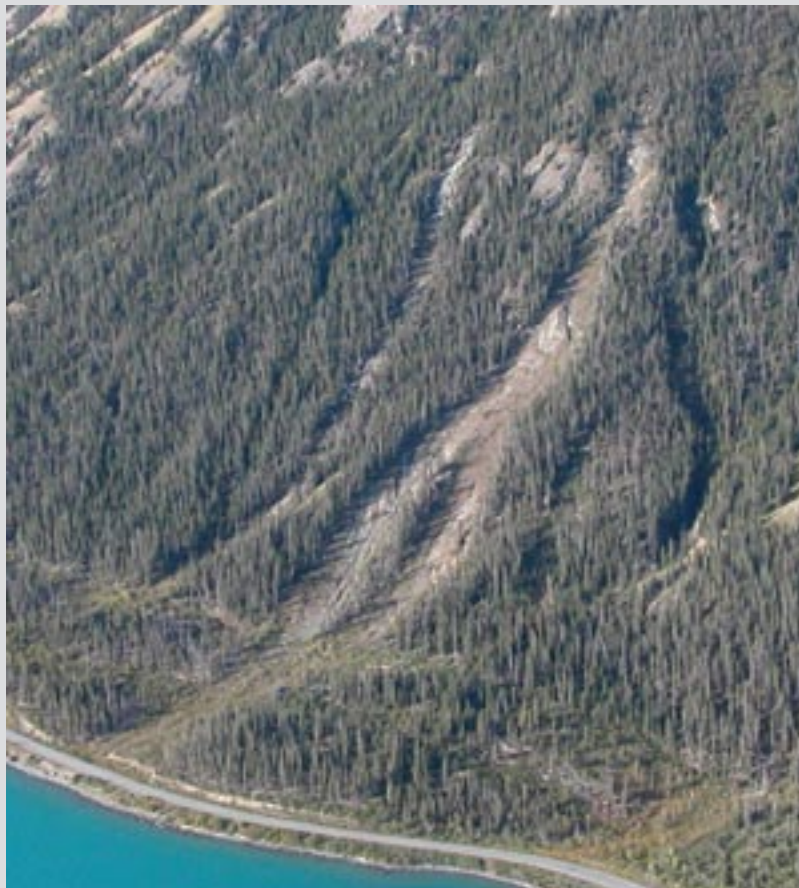
Figure III. Oblique aerial photograph of Horseshoe Bay debris flow which occurred in 1988 after heavy rains.

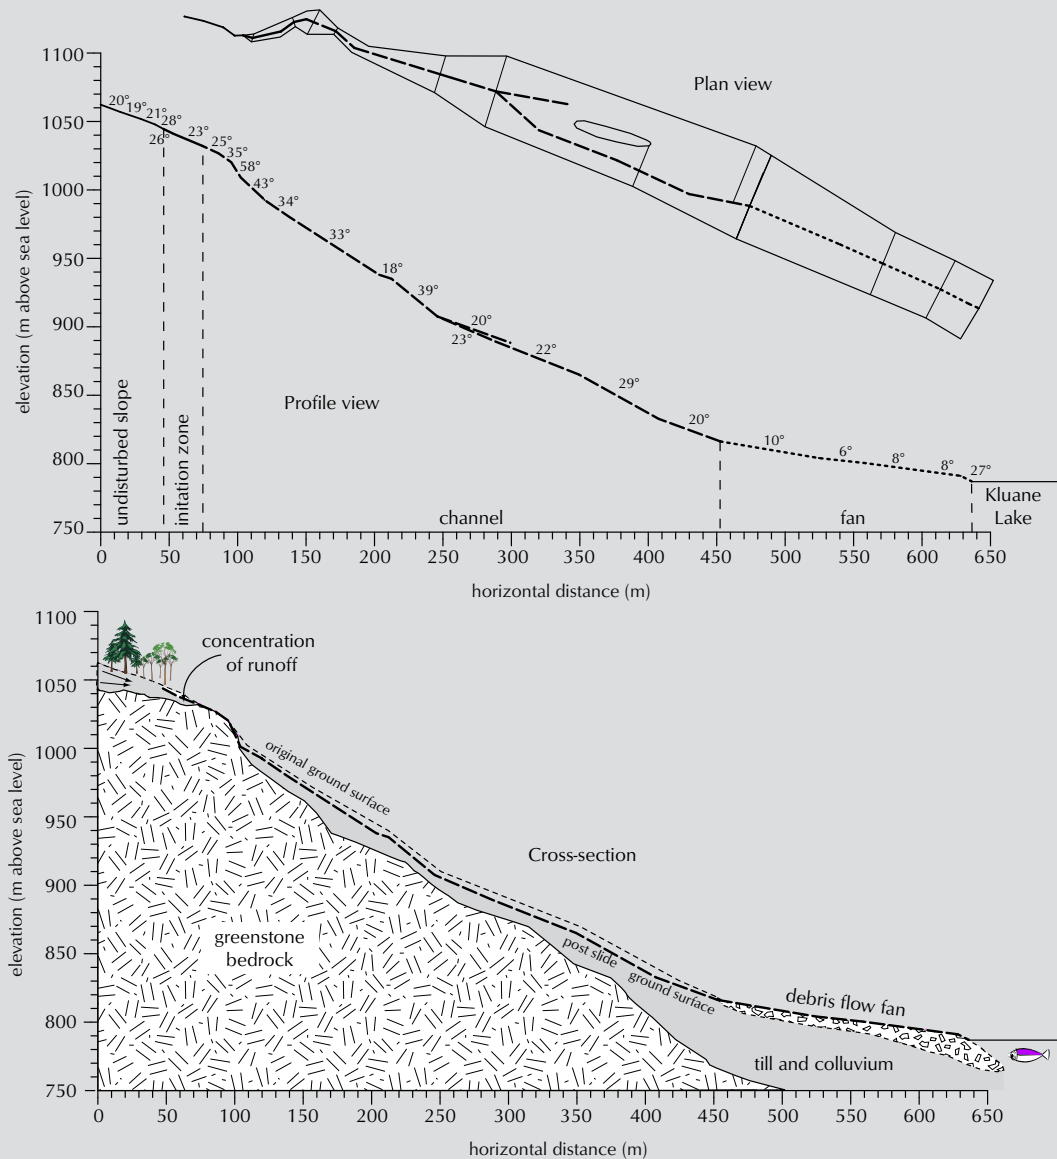
Figure IV.
 (a) Surveyed cross-section and plan view of Horseshoe Bay debris flow.
 (b) Schematic cross-section of surface and inferred subsurface conditions of Horseshoe Bay debris flow.

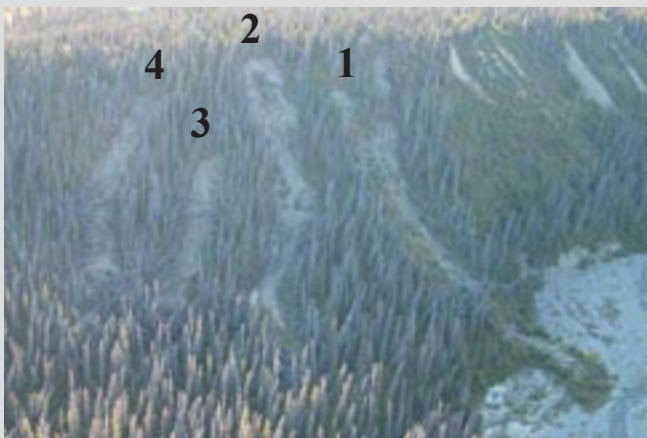
Figure V. Oblique aerial view of Silver Creek active layer failures (debris flows). Landslides are numbered 1 through 4.

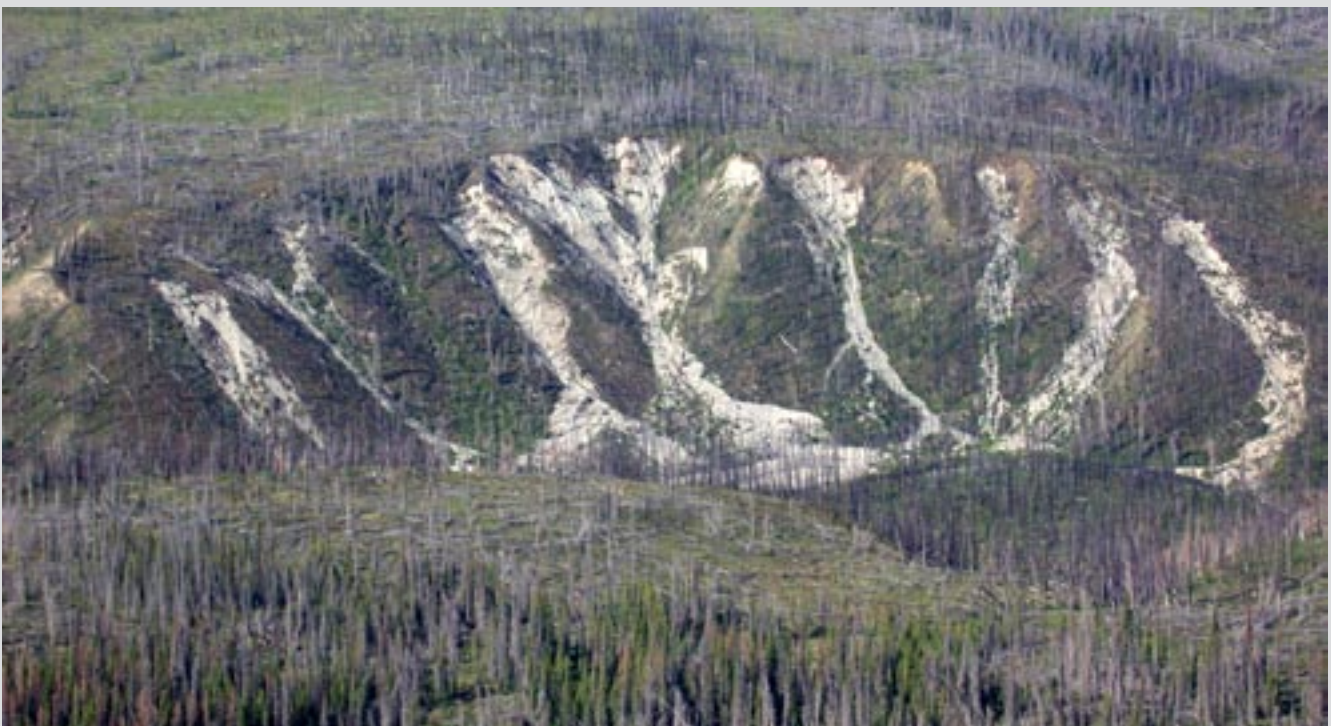
Figure VIII. Oblique photograph of debris flows originating from the scarp of a terrace formed in glacial material along Marshall Creek.

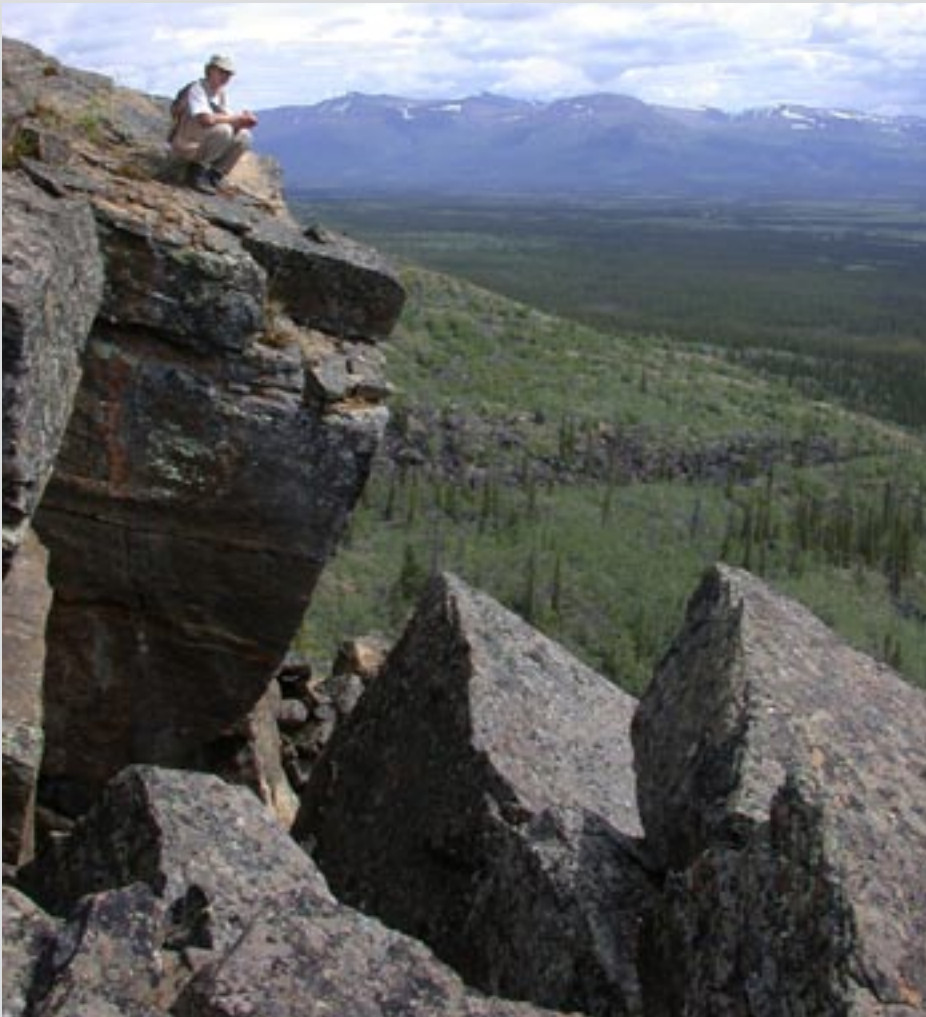
Figure X. Active toppling on western flank of Aishihik rock slide. The toppling movement has disturbed roots of live vegetation in adjacent hillslope.

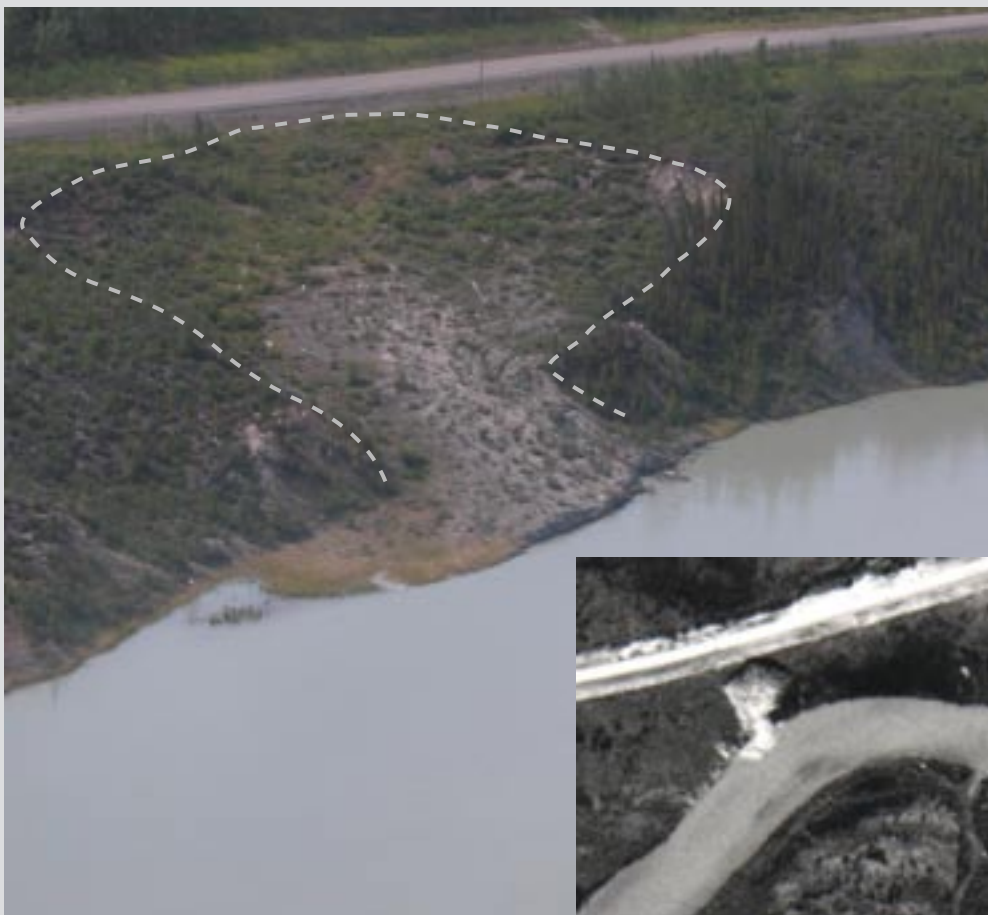
Figure XII. (a) Oblique aerial photograph taken in 2003 of Takhini River retrogressive ground ice slump adjacent to the Alaska Highway. Cracks in highway embankment propagated during summer 2003. Permafrost thaw was triggered by river undercutting. Forest fire, proximity to highway, and forest cover removal in adjacent agricultural fields all contribute to continued subsidence in the area. Dashed line highlights remnant headscarp. (b) Inset aerial photograph (A27217-257) of Takhini River retrogressive thaw slump in 1987.

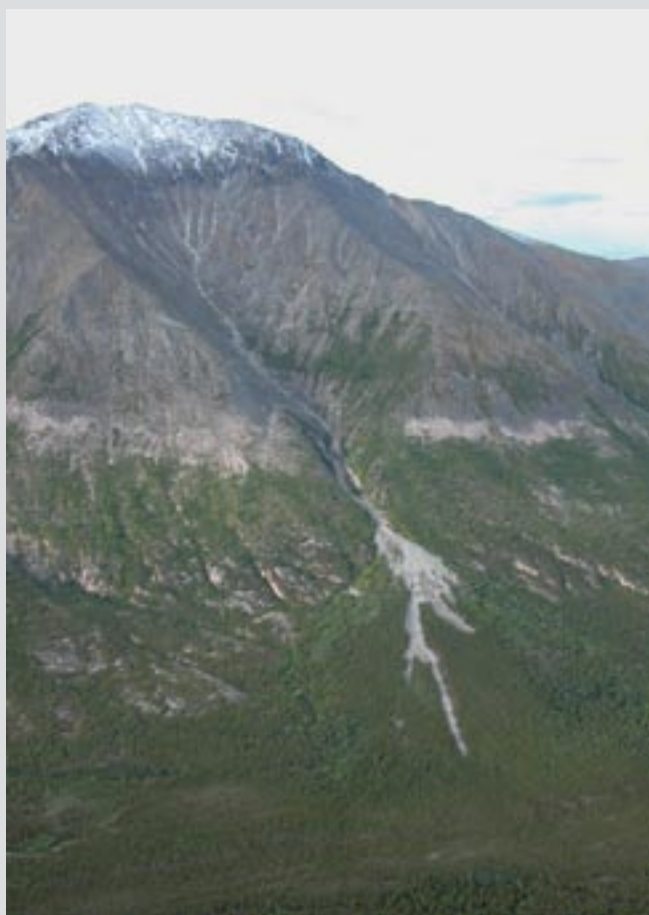
Figure XIII. Oblique photograph of debris-flow catchment and fan. A debris flow in the early 1990s came within 60 m of a proposed pipeline easement situated in the valley bottom (foreground).

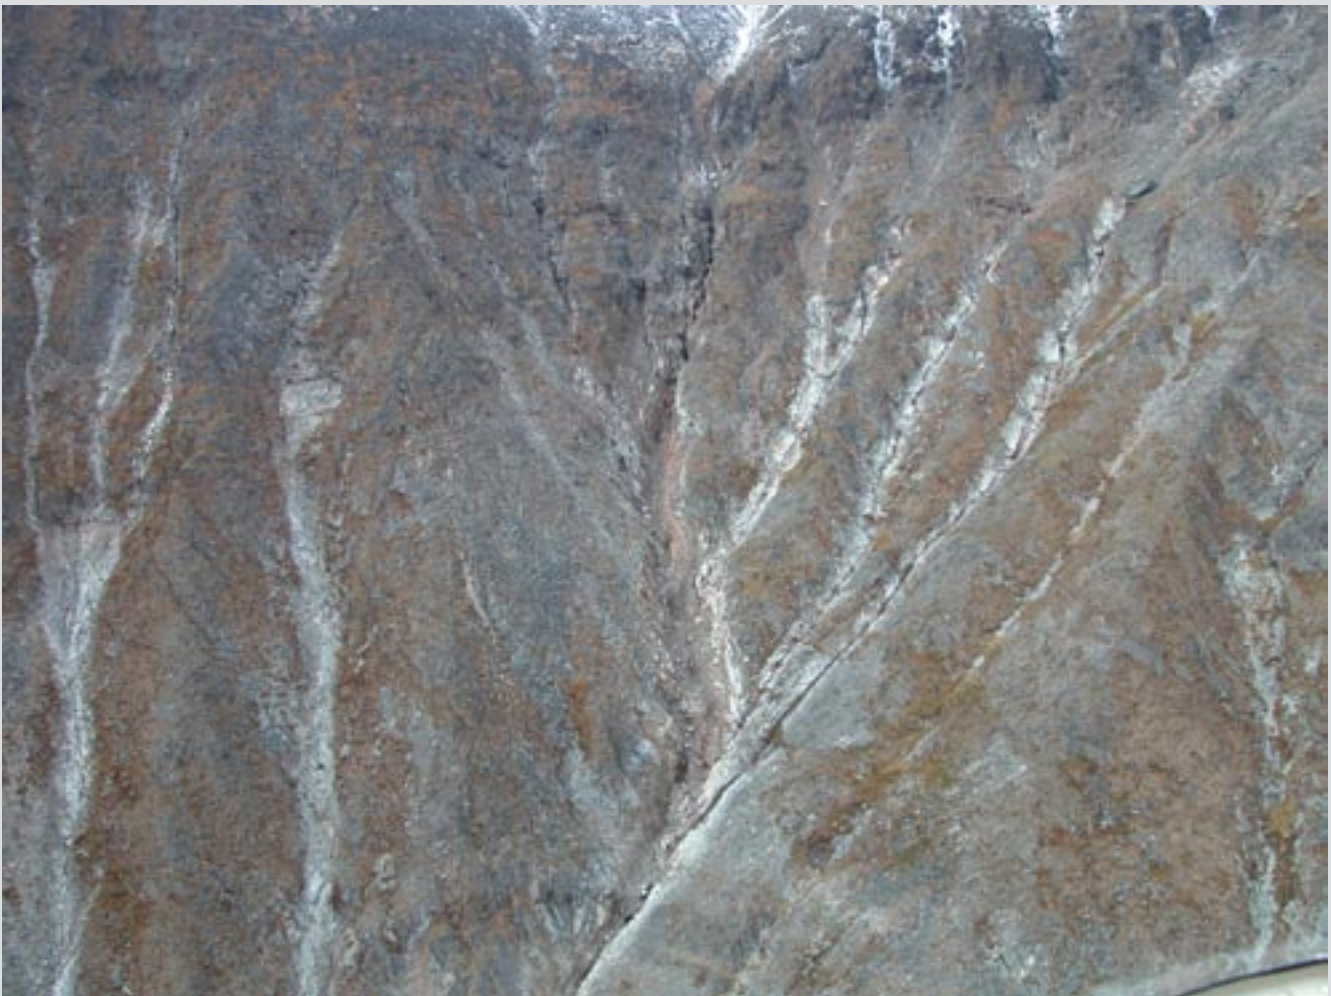
Figure XIV. Catchment area of Ibex valley debris-flow system displaying light coloured fresh-looking channels, where debris and snow are able to accumulate.

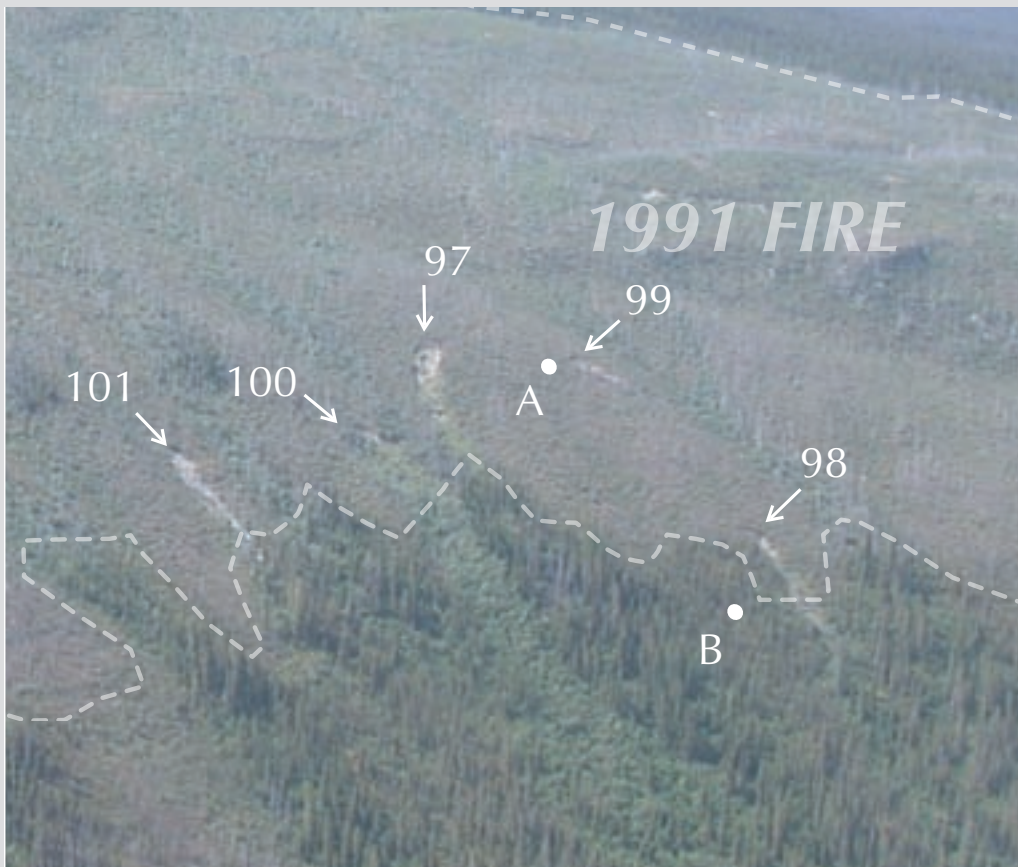
Figure XV. Oblique aerial view (2003) of active layer detachment slides and secondary debris flows on the north-facing slope of Haeckel Hill.
